Plain language report on river bed changes at Balclutha

Prepared for Otago Regional Council

June 2025

NIWA CLIENT REPORT No: 2025196CH
Report date: June 2025
NIWA Project: ORC25501

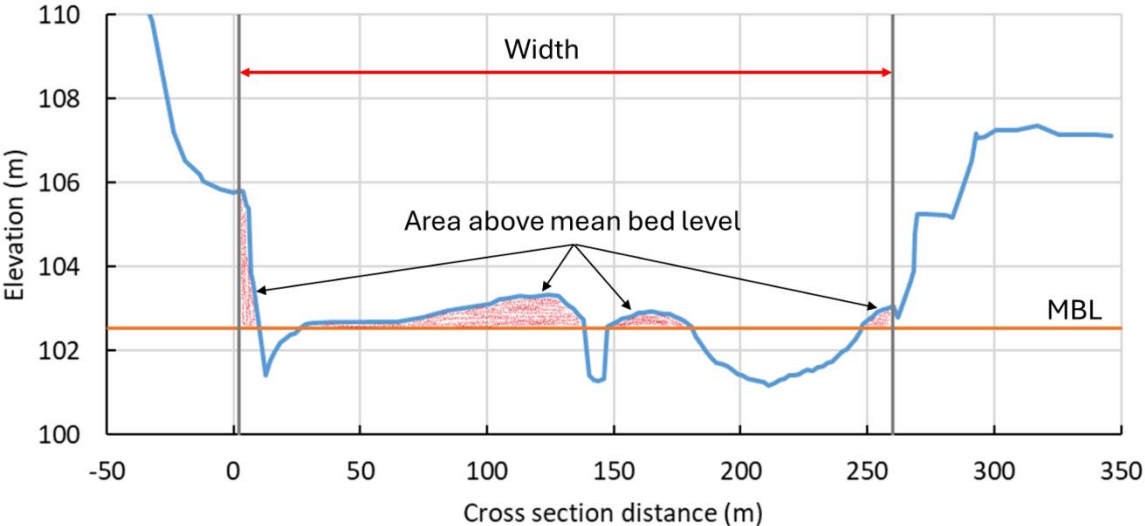
Figure 2-3: Illustration of area above average bed level for cross-section C1 in 2024.

Figure 2-3 shows an example of how these data can be used to identify gravel bars. The area above average bed level is shaded in red. This area is divided by the total width to give a consistent comparison between cross-sections. An increase over time means an increase in the range of bed level across a cross-section, which indicates the growth or enlarging of bars, or the formation of deeper channels.

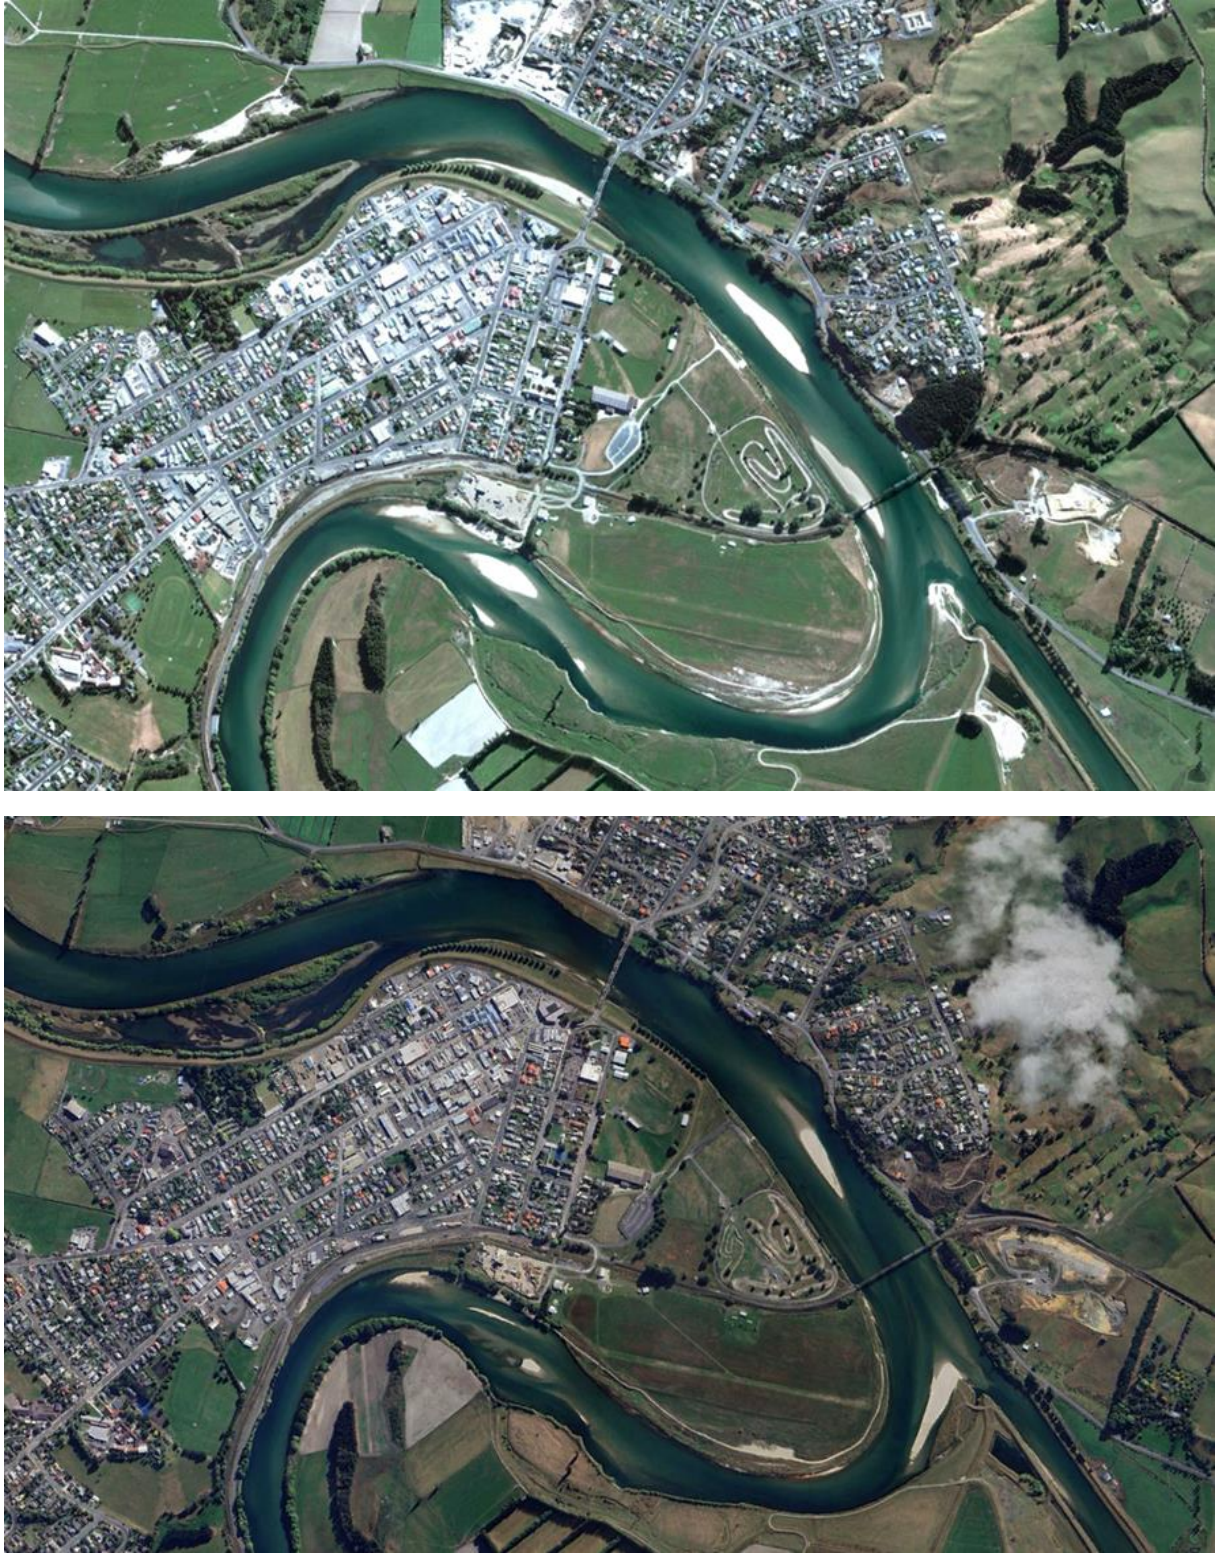
Figure 5-10: Imagery of the Clutha River at Balclutha in March 2013 (top) and March 2024 (below). The bars between the two bridges have moved downstream.

The location of the mid-river bar between cross-sections C2 and C3 has remained relatively stable over the years.

The long, thin, right-bank bar extending from C4 to C5 is stable over the years and becomes progressively more vegetated until by 2025 it resembles a river berm.

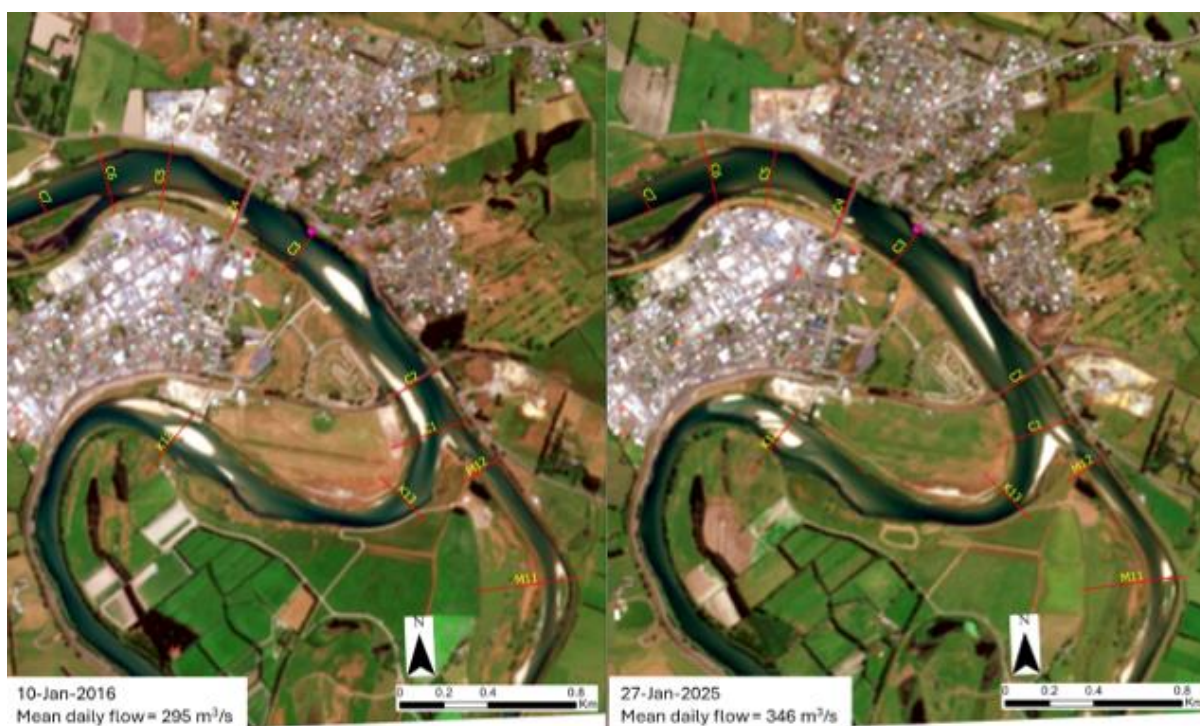
Figure 5-11: Satellite imagery of the Clutha River at Balclutha on two dates: January 10, 2016 (left) and January 27, 2025 (right). Imagery from Sentinel-2 satellite data. Red lines indicate the cross-section locations. The flow monitoring site is shown with a magenta dot.

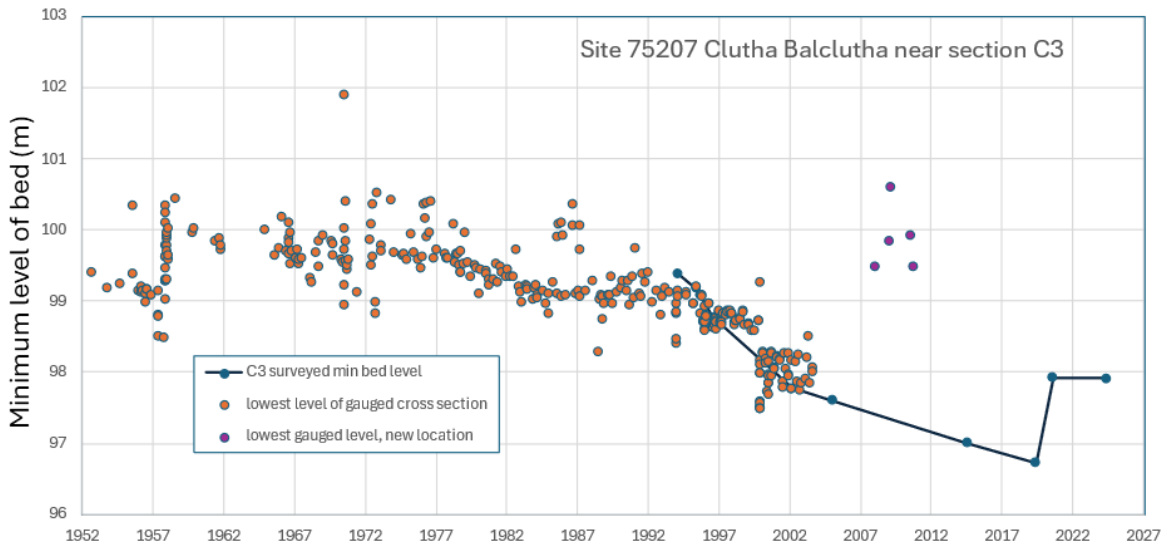
Figure 5-12: Minimum bed level at times of NIWA flow measurements near section C3. NIWA measurements after 2007 (bright red dots) apply 180 to 250 m upstream of the previous cableway location.

Up until 2010, the maximum water depth was recorded at the time of a NIWA measurement. Subtracting the maximum water depth from the water surface level gives the minimum bed level at the time of the measurement. The minimum bed levels from measurement data are shown in orange on Figure 5-12. After 2007, NIWA changed to jet boat measurements, made 180 to 250 metres upstream of the previous cableway. Recording of maximum water depth was subsequently discontinued. A few maximum bed depths made at the new location are shown in bright red on Figure 5-12. Also shown are the ORC cross-section survey minimum bed levels at section C3 (from Figure 5-7). An abrupt rise in minimum bed level occurred during the 1957 November flood. From the 1970s to the present the minimum bed level at section C3 has been getting lower.

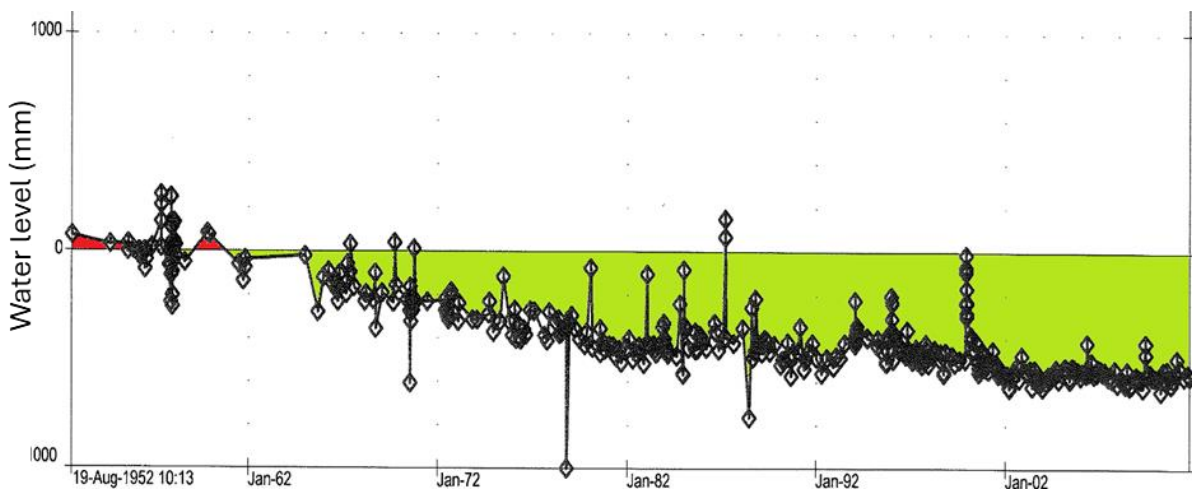
Figure 5-13: Water level for a given flow compared with preservation of 1952 bed levels. Red areas have a higher water level and green areas are lower than what they would have been in 1952.

Figure 5-13 shows the differences between measured water levels and what the water level would have been if there had been no changes in the river bed since 1952. Figure 5-14 shows differences in water levels compared to what they would have been with the December 1978 river bed. While individual measurements are made at different flows, and it is not meaningful to interpret every little change in these graphs, the graphs reveal the overall, long-term trends.

According to these plots, water levels fell gradually from 1952 to be about half a metre lower by 1982. From 1983 to mid-2000 the levels oscillated with no net trend, then dropped approx. 0.2 m to reach another fairly stable state for the most recent 20-year period.

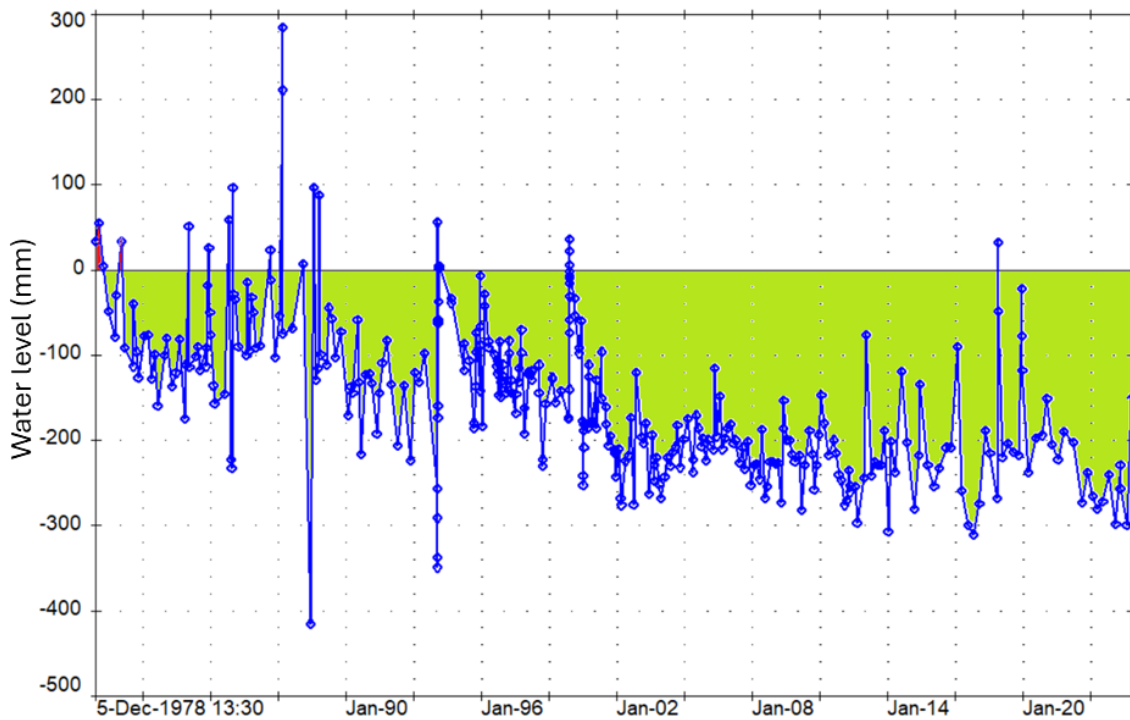
Figure 5-14: Water level for a given flow compared with preservation of 1978 bed levels. Red areas have a higher water level and green areas are lower than what they would have been in 1978.

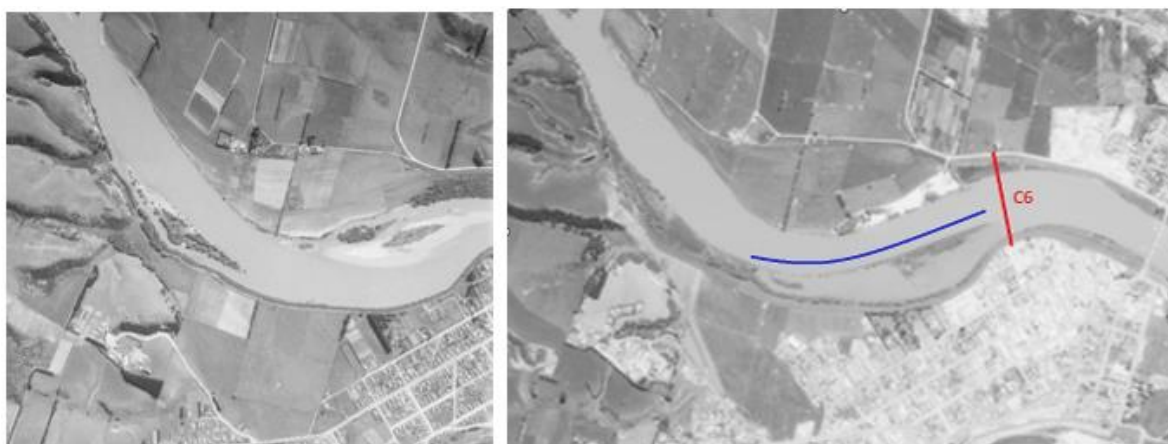
Figure 6-1: Aerial photographs from 1946 (left) and in 1995 (right). Blue line indicates the mid-channel river training works upstream of cross-section C6.

In general, observed changes correspond to the expected long-term, river response following a severe reduction in sediment input (i.e., Roxburgh Dam construction). Bed levels and water levels have initially fallen, and the rate of lowering appears to have tailed off with time. Recent reports that gravel bars are more evident at Balclutha may be due to the bar movement noted above and the fact that a stable bar can become more visible and appear to be higher if the river level falls alongside the bar. There has been a clear change in shape at section C6. The deepest point used to be in the channel on the right side but is now in the centre. Historic aerial imagery (Figure 6-1 below) shows that between 1946 and 1995, mid-channel river training works narrowed and re-directed the channel upstream of C6. These works are likely to be the explanation for the channel movement at C6. There were also river training works to re-narrow the entrance to the Matau branch in the early 1970s⁴.

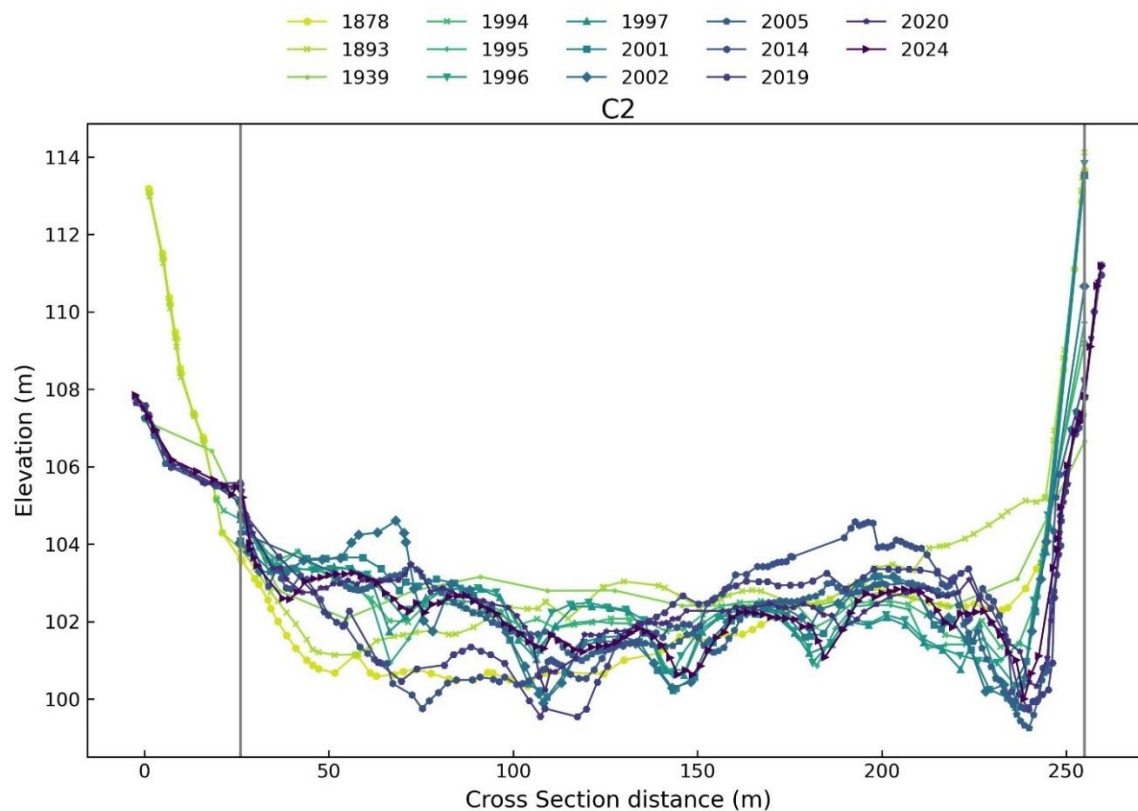
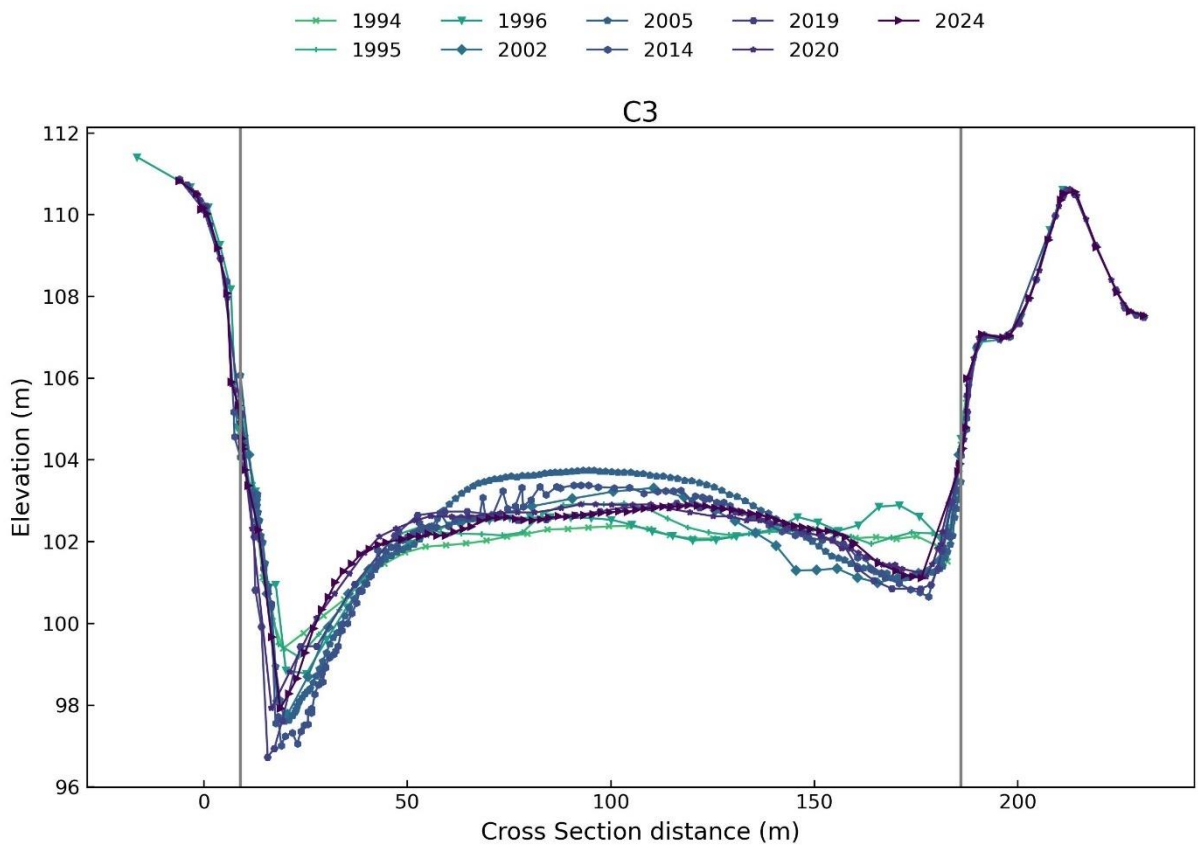
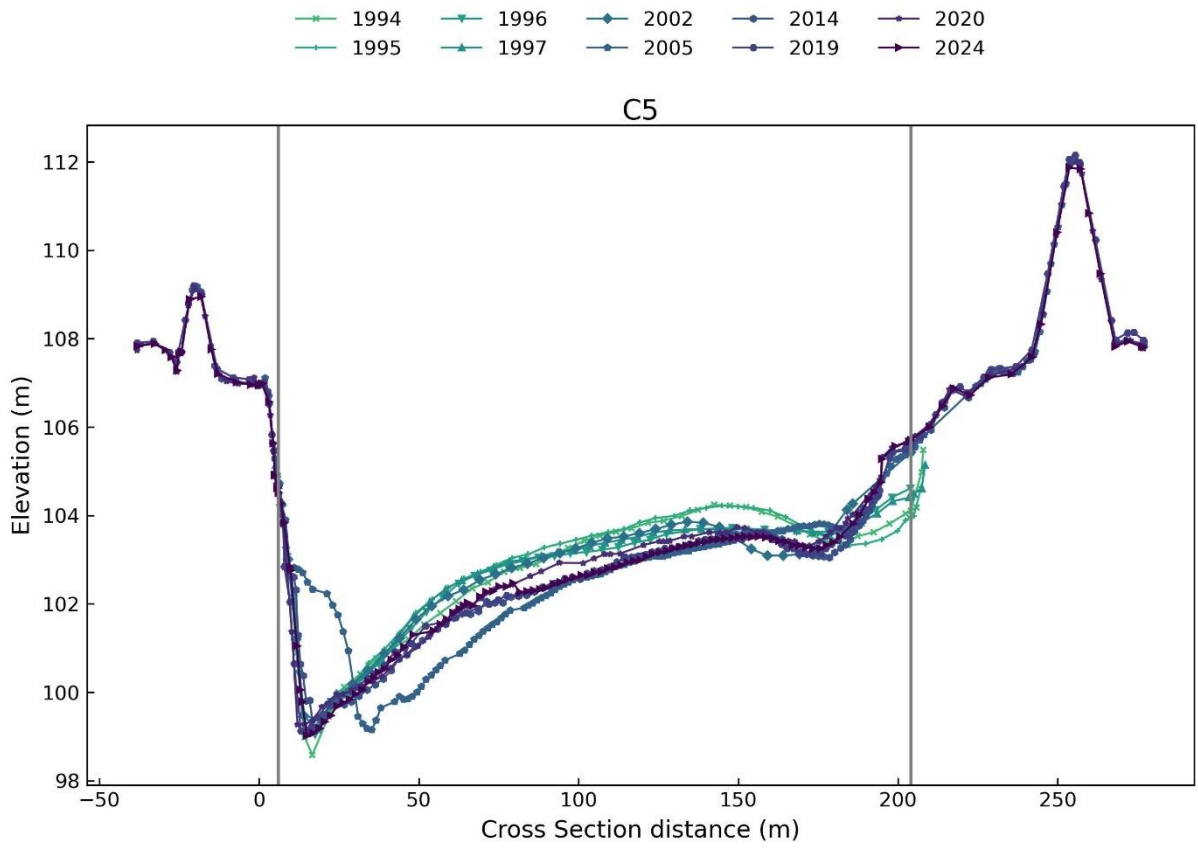
All cross-sections are viewed looking downstream.

Figure A-1: Cross-sectional profiles of C2 to C7, M11, M12, K12, and K13 for all surveyed years.

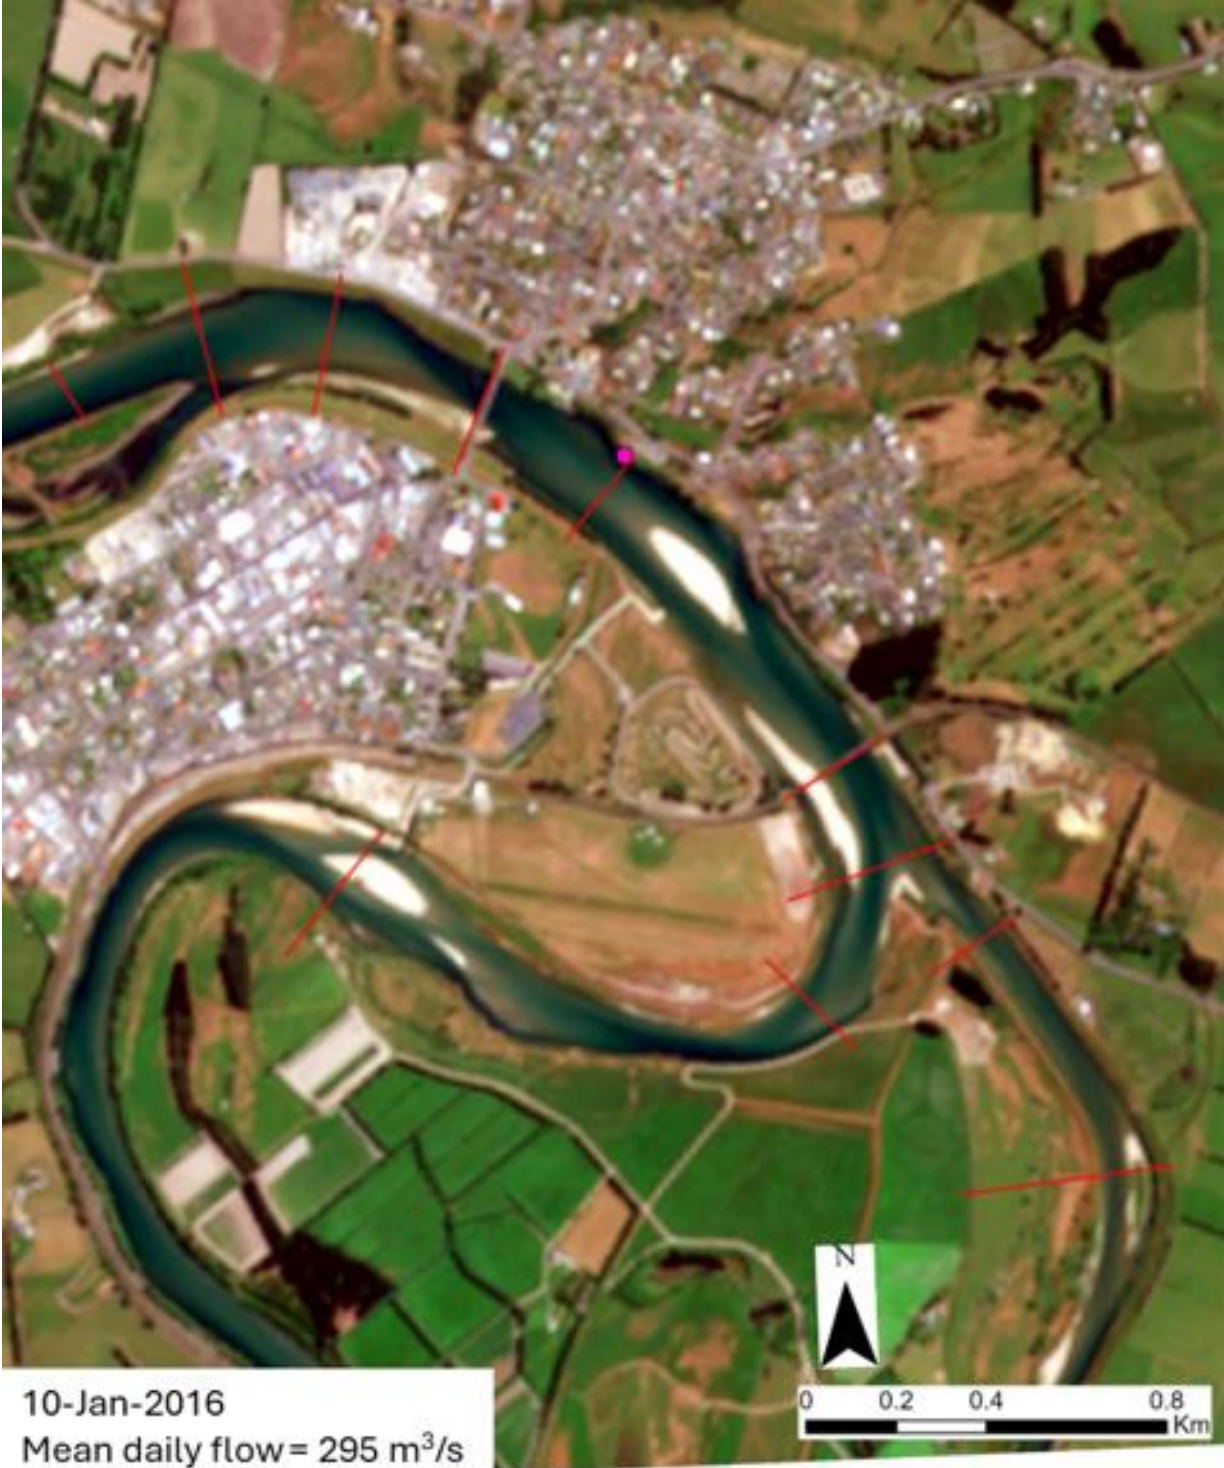
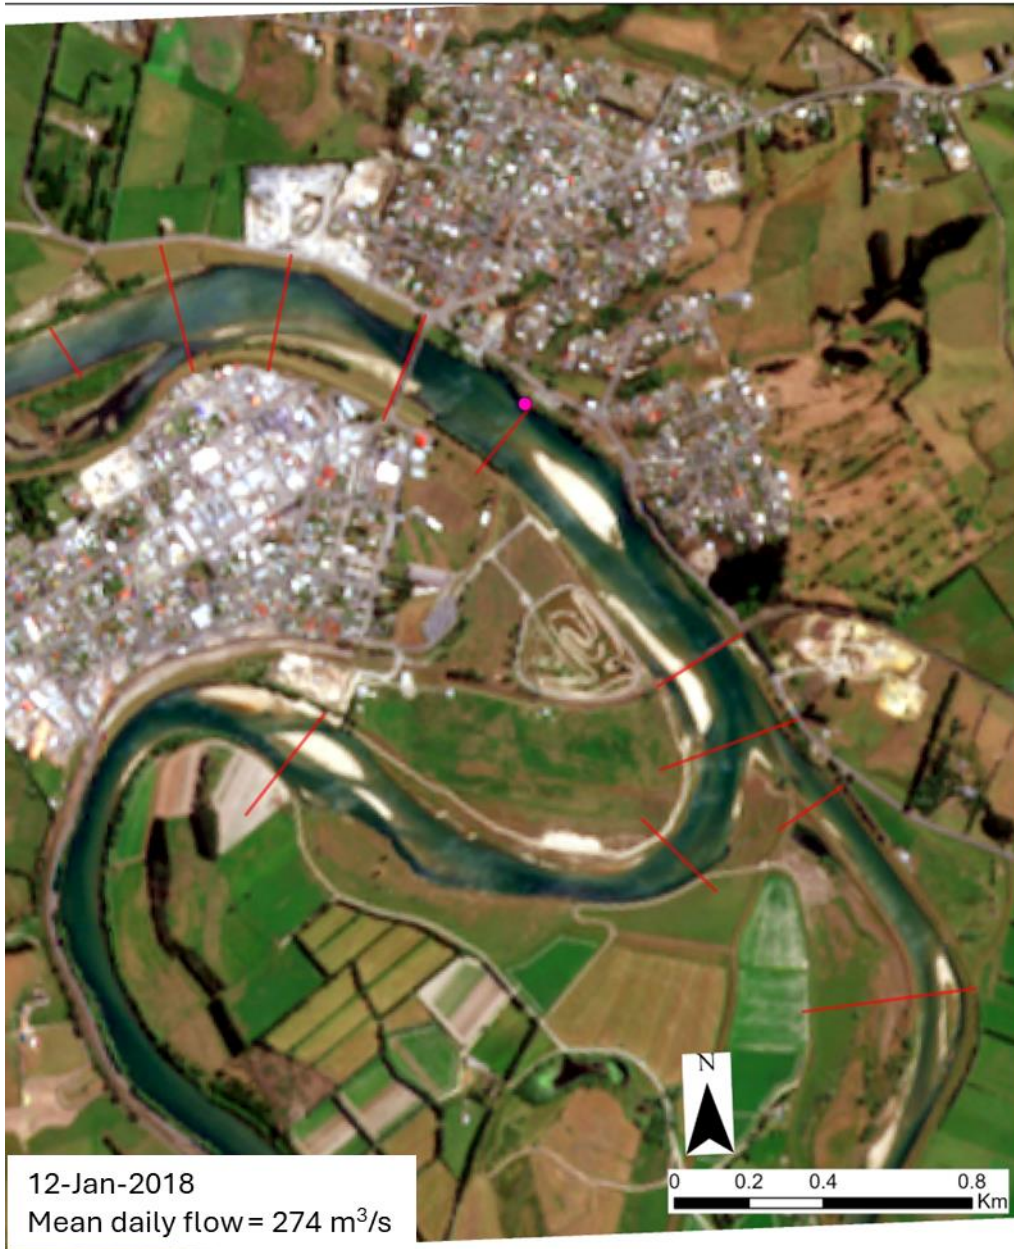
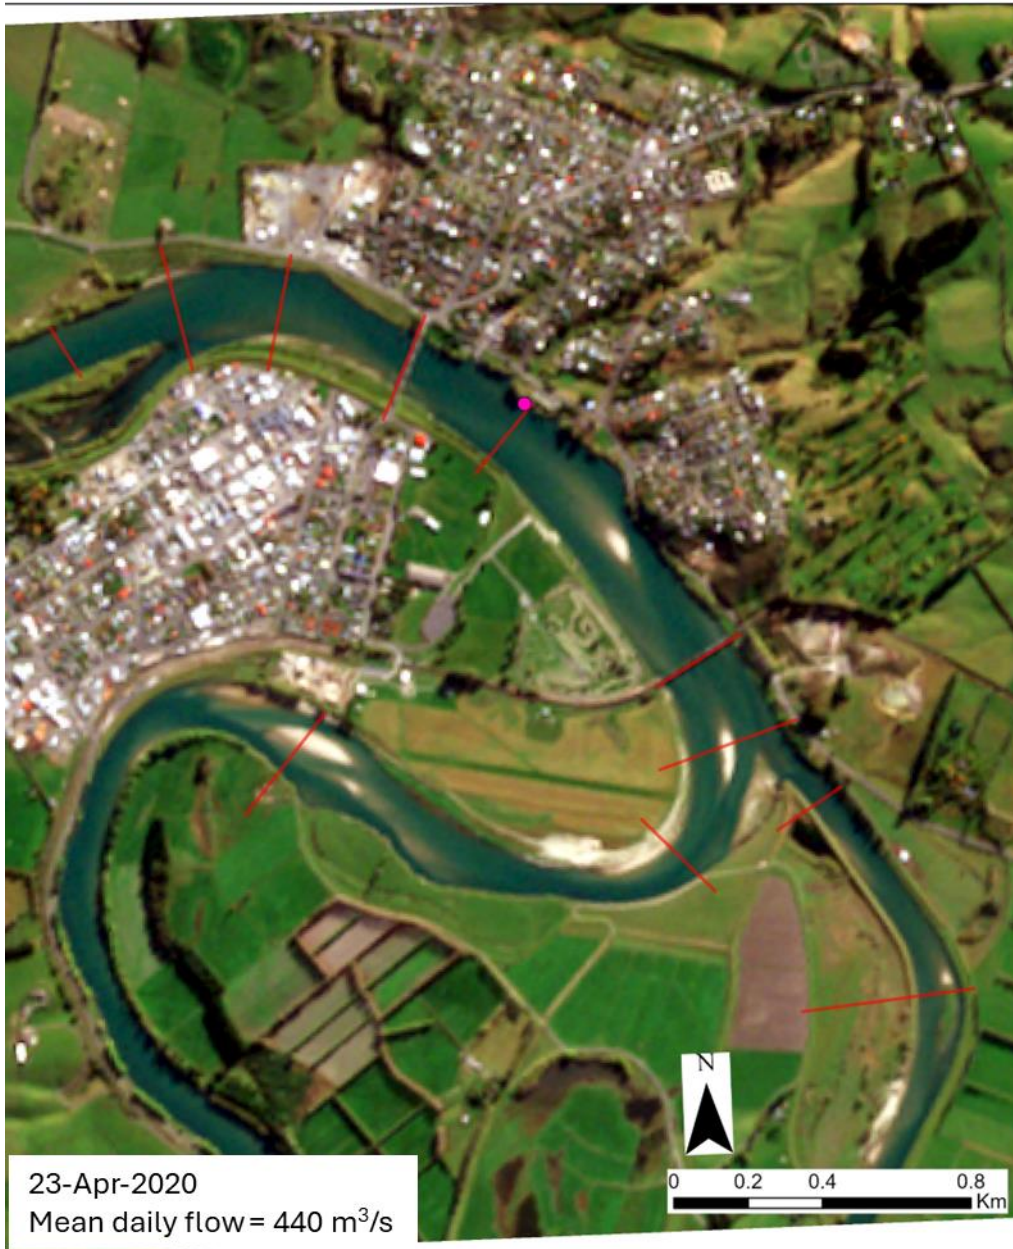
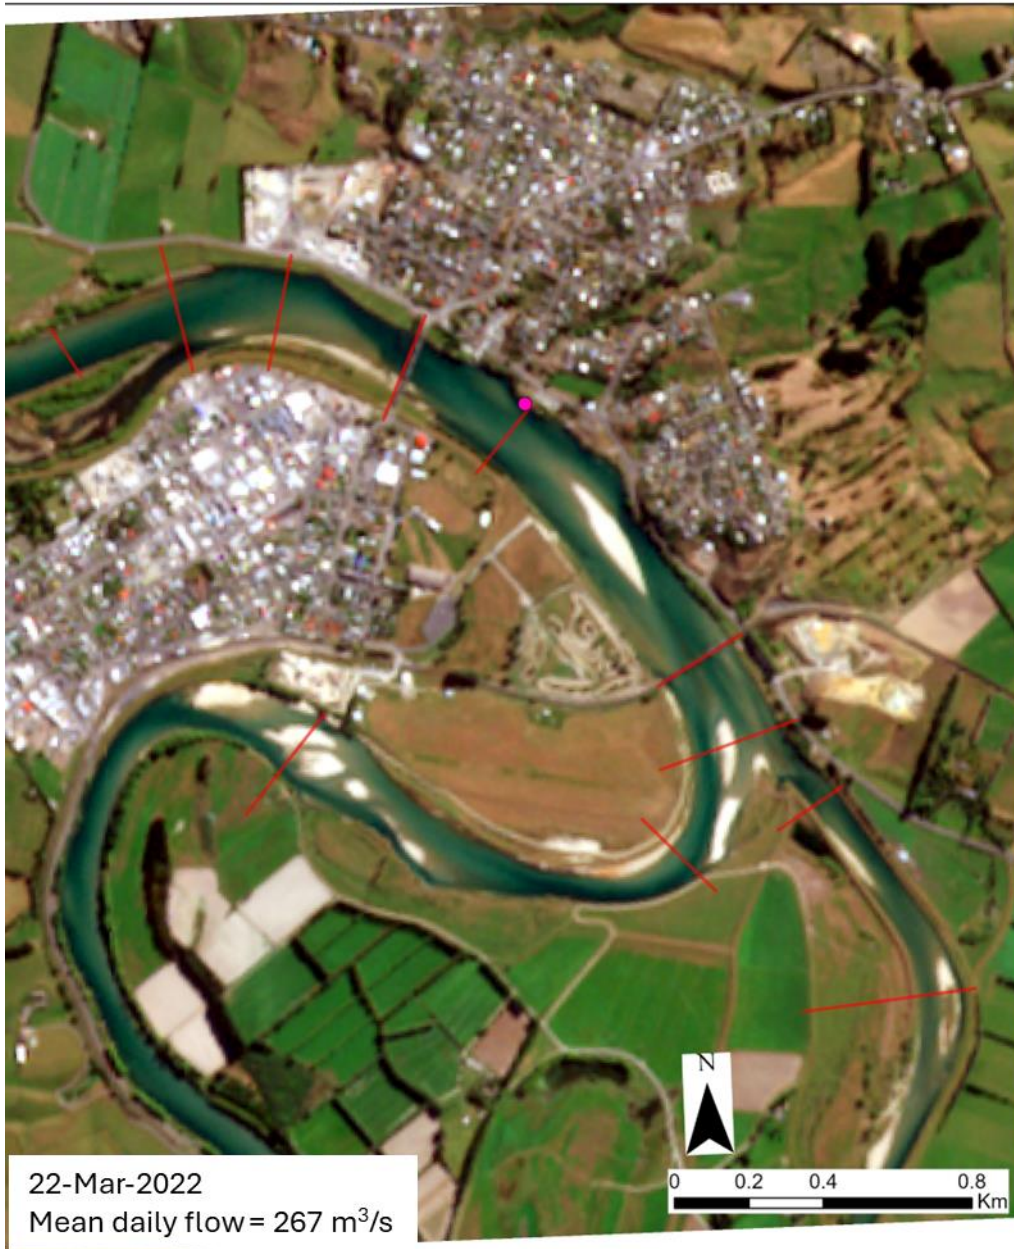
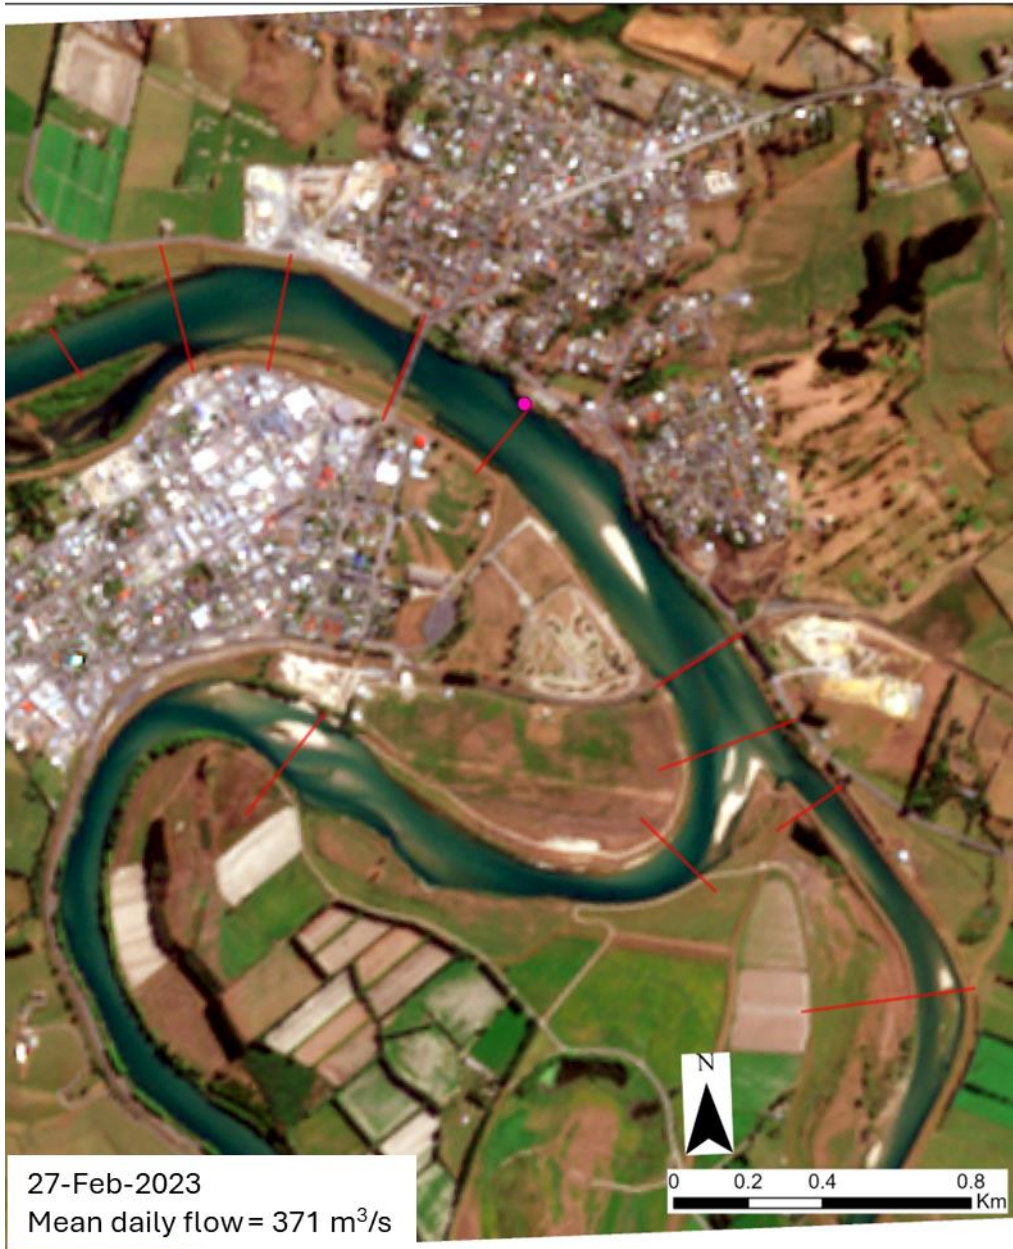
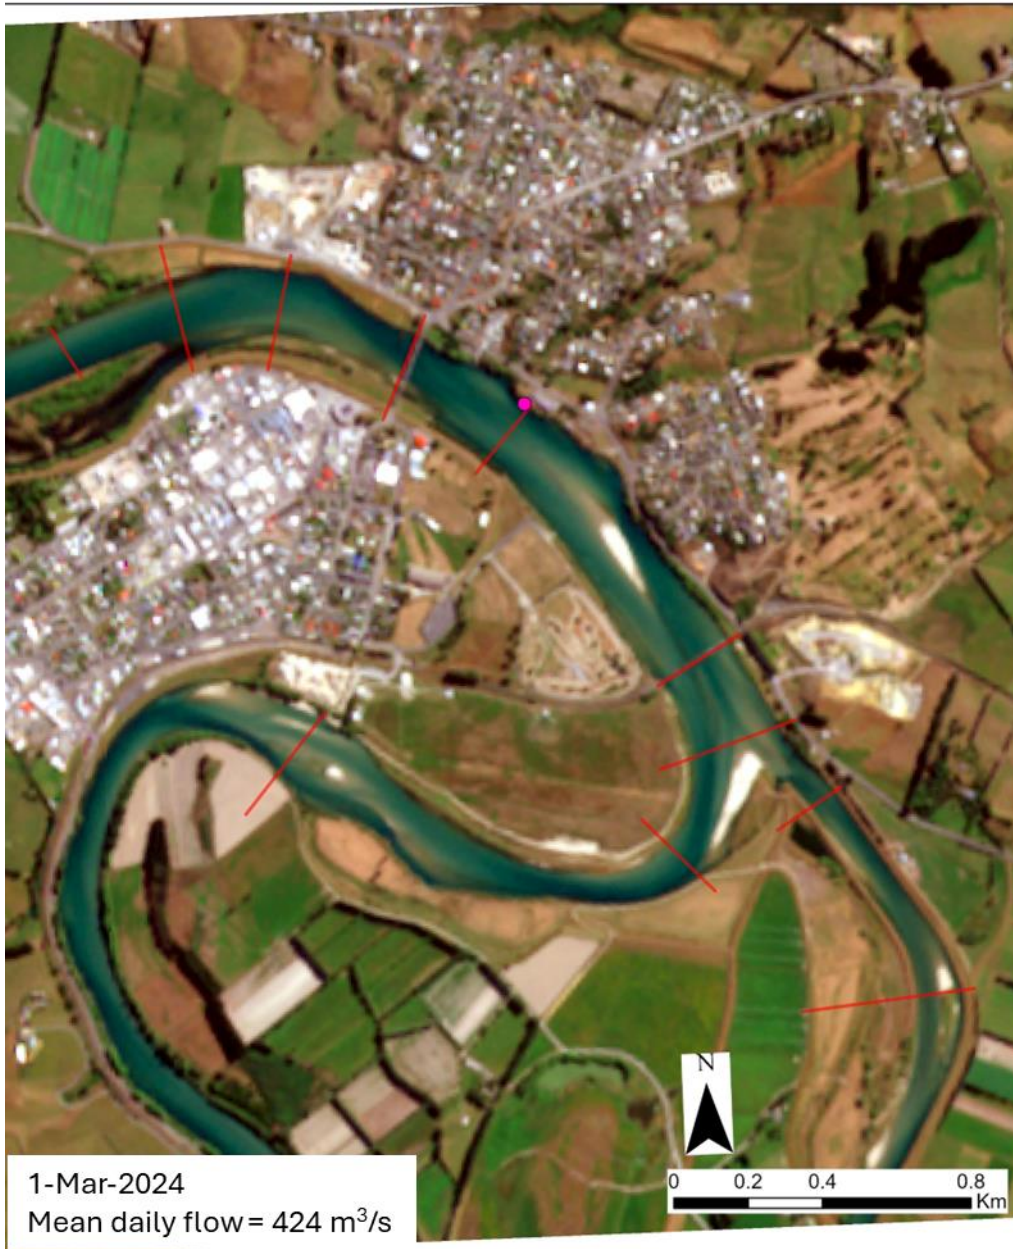
Figure B-1: Satellite imagery of the Clutha River at Balclutha for seven years between 2016 and 2025. The exact date of the satellite capture and average daily flow values are inserted in bottom left of each image. Red lines indicate cross-section locations.
