IN THE MATTER of an application for resource
consents for Project Next
Generation

BY **PORT OTAGO LIMITED**
Applicant

**STATEMENT OF EVIDENCE OF REGINALD MAURICE DAVIS
ON BEHALF OF PORT OTAGO LIMITED**

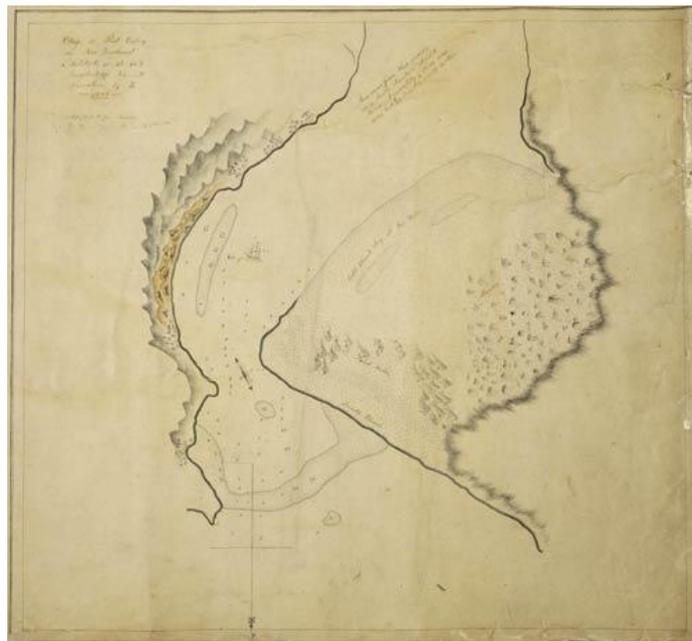
Figure 1 "Port Oxley" drawing by James Herd dated 1826

6.2 What is probably the first chart of the harbour, drawn in 1824 and titled Port Oxley, shows an anchorage in what is now known as Harington Bend. The chart extends only a short distance beyond the bend and is shown in Figure 1.

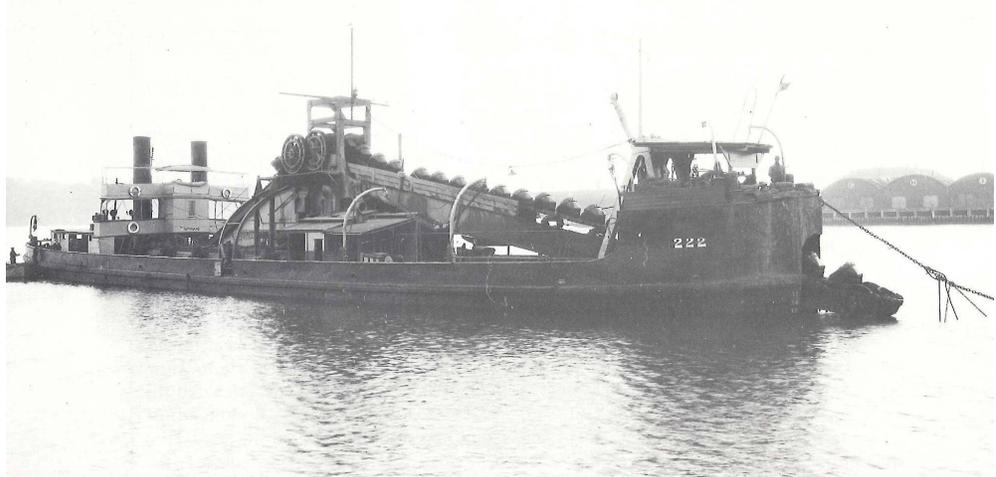
Figure 4 The bucket-dredge 222

- 7.3 The early efforts of the first two dredgers were concentrated in improving the berths and access to the Dunedin basin.
- 7.4 A third bucket dredger, the 222 was built in Scotland and delivered to the Harbour Board in 1882, see Figure 4. This was a hopper dredger and was acquired for its capability, albeit somewhat limited, to dredge the bar at the harbour entrance. This dredger did major development work at the entrance, Harington Bend and Deborah Bay.
