Port Otago Ltd

Next Generation –
Channel Development

Short History of Otago
Harbour Development
and Dredging

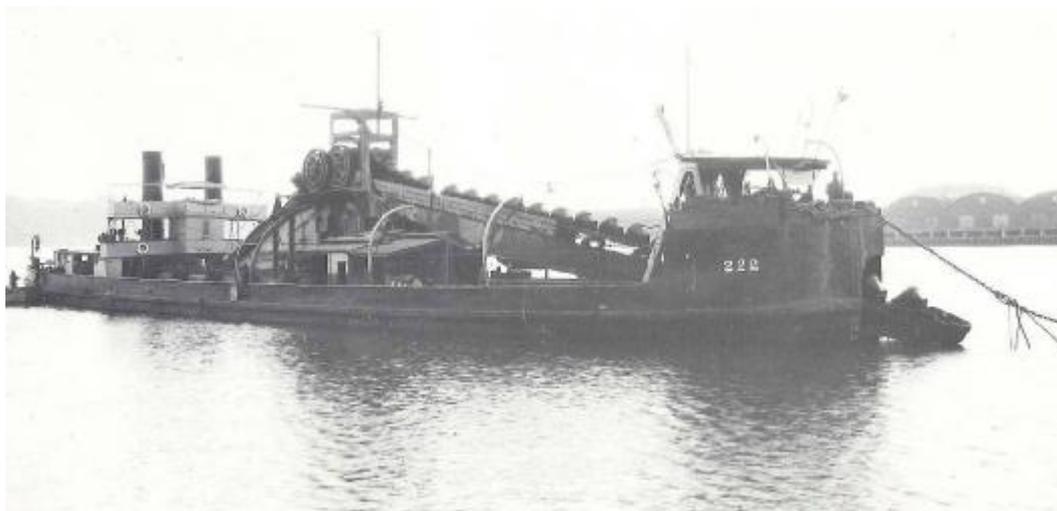
Figure 4 The bucket-dredge 222

A third bucket dredger, the 222 was built in Scotland and delivered to the Harbour Board in 1882, see [Figure 4](#). This was a hopper dredger and was acquired for its

capability, albeit somewhat limited, to dredge the bar at the entrance. This dredger did major development work at the entrance, Harington Bend and Deborah Bay.
