Channel Morphology and Sedimentation in the Cardrona River

Summary Report February 2010

Cardrona river

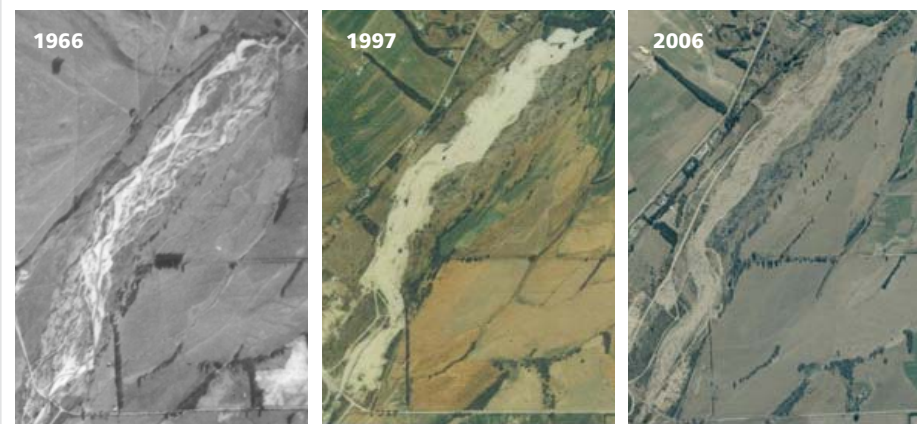
Figure.3 Aerial photography of the Cardrona River between State Highway 6 and Ballantyne Road located between 3.0 and 5.1 km upstream of the Clutha River confluence.

Downstream of The Larches to the State Highway, a prevailing depositional zone in the river form exists, as the river loses transport potential beyond the confines of The Larches. Naturally, these reaches are dominated by a wide, braided channel margin subject to lateral migration however, over recent decades extensive modification of these areas, including commercial gravel extraction and river works, has removed the braided complexity of the channels (Figure.3).

Changes in the Cardrona River channel morphology are also apparent in aerial photography where imagery taken in 1966 exhibits a naturally braided, sediment-rich active channel margin. Subsequent photography, during the late 1990's and 2006, indicates that the braided complexity of the natural river form has been lost due to extensive modification of the active channel and a reduction in sediment replenishment rates.

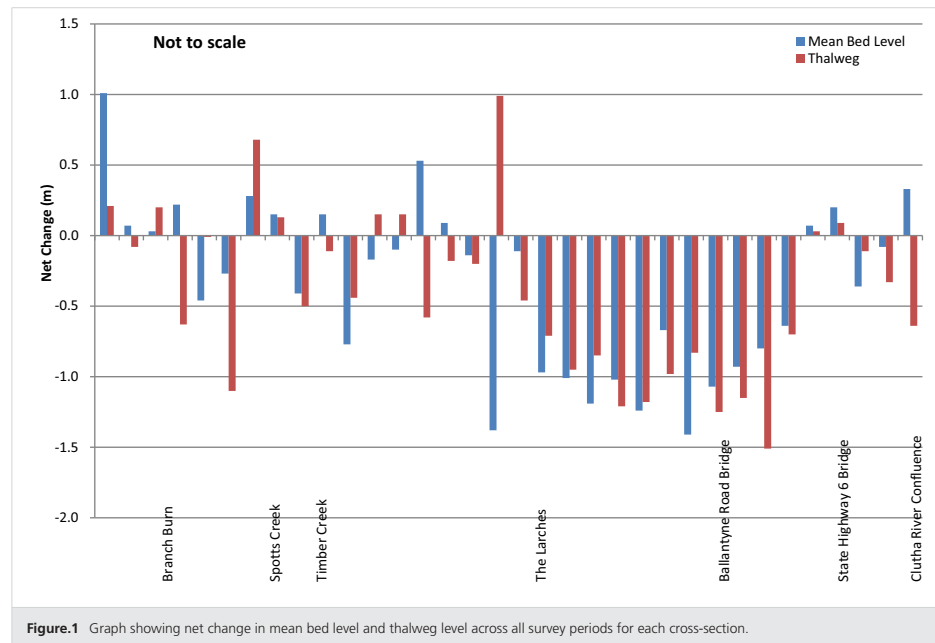
Figure.1 shows the net change in mean bed and thalweg levels calculated for each cross-section over each respective survey period. Of the 34 comparable surveyed cross-sections, the mean bed level experienced net degradation at 22 locations with 12 cross-sections experiencing net aggradation. Two cross-sections experienced net aggradation greater than 0.5m over surveyed periods.

Comparatively, 13 cross-sections experienced net degradation greater than 0.5m, 12 of which are located between The Larches and the State Highway 6 Bridge (a distance of 6.9km). The greatest change in mean bed level, at cross-section 41 just upstream of Ballantyne Rd, occurred during the period 1988 and 2007 with degradation of 1.41m. Notably, cross-section 54-2, in the vicinity of The Larches, experienced net degradation of 1.38m over the nine year survey period 1988 to 2007.

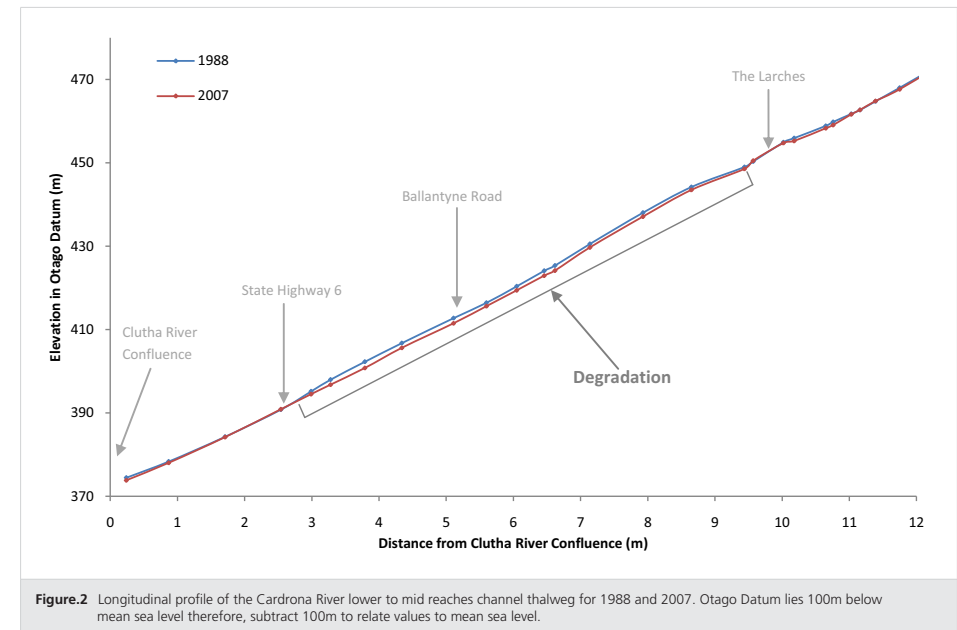
Observations of the longitudinal profile indicate that the Cardrona River form has, in general, been subject to a presiding degradational trend from 1988 to 2007. The shape of the 2007 profile indicates that active channel sediment storage, particularly in the 6.9km reach downstream of The Larches (Figure 2), has significantly decreased.

Of the 34 surveyed locations, two cross-sections had thalweg levels that increased by greater than 0.5m, a phenomenon largely attributed to a significant change in channel form. In comparison, 16 cross-section locations experienced lowering, or degradation, of the channel thalweg by 0.5m or greater over each respective survey period.
