TAIERI GORGE RAILWAY CULVERT FLOODWATER CONVEYANCE ASSESSMENT FINAL REPORT

24 APRIL 2024

FINAL REPORT

Otago Regional Council

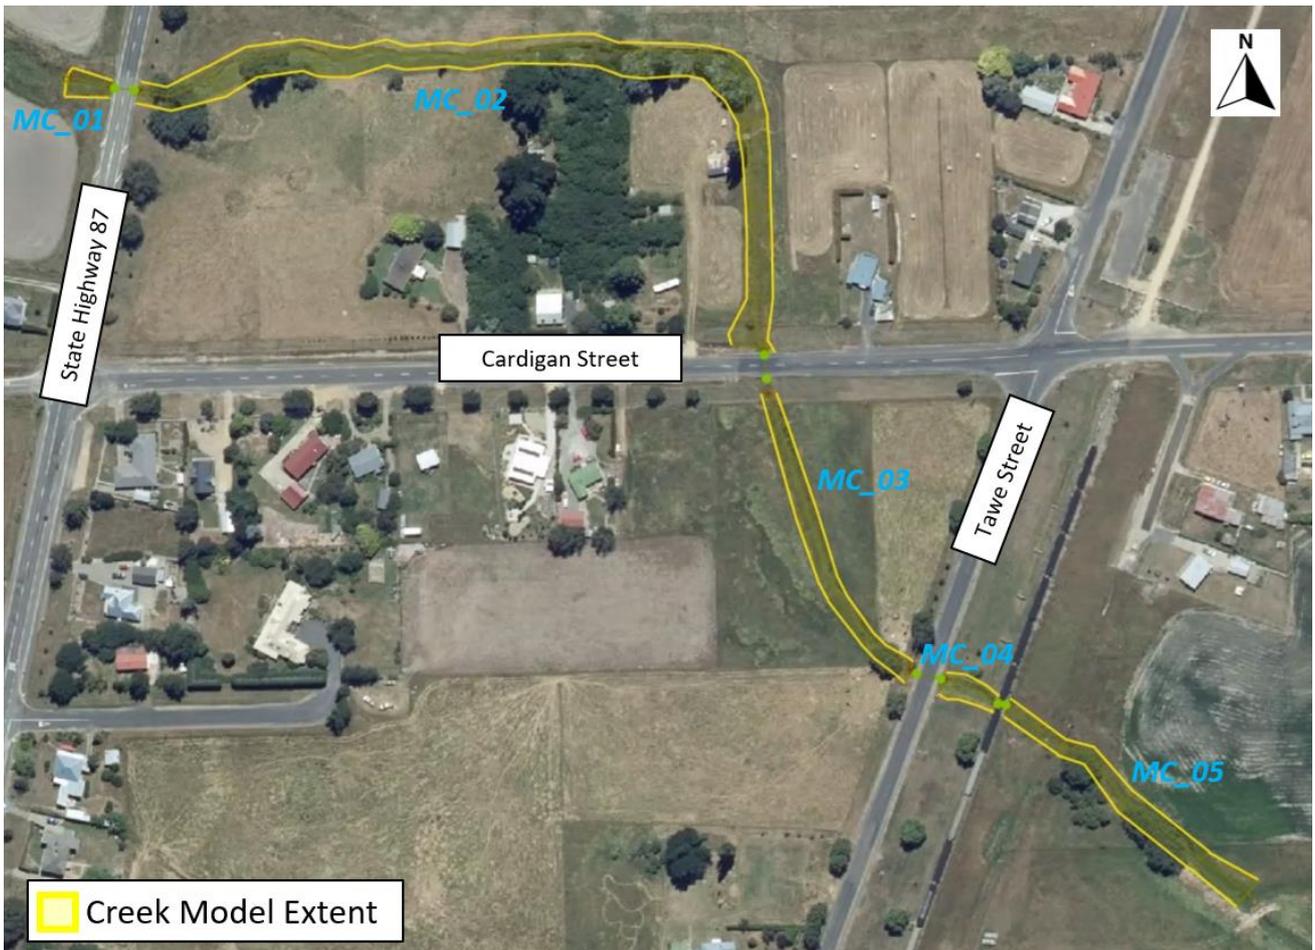
The extents of the creek model are shown on Figure 2-1. The model consists of five creek reaches and has four road/ rail crossings which have all been modelled as culverts.

Figure 2-1: Creek Model Extents (Creek Reach References in Blue)

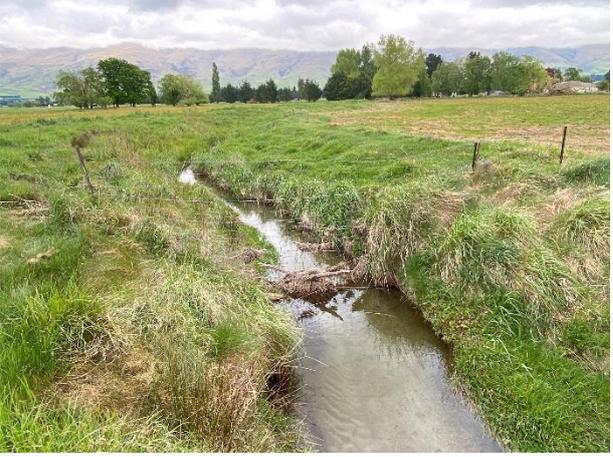
CREEK REACH REFERENCE	DESCRIPTION	MANNINGS N VALUE	PHOTO
MC_01	<p>Excavated channel, stoney bottom with weedy banks.</p> <p>Some debris in flow channel.</p>	0.035

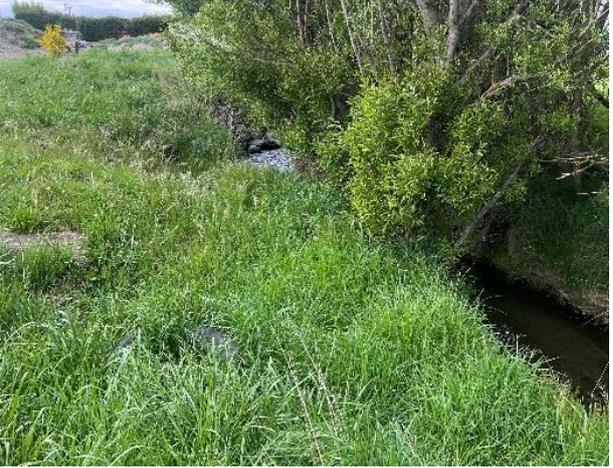
MC_02	<p>Excavated channel, stoney bottom with weedy banks.</p> <p>Some debris and vegetation in flow channel.</p>	0.035

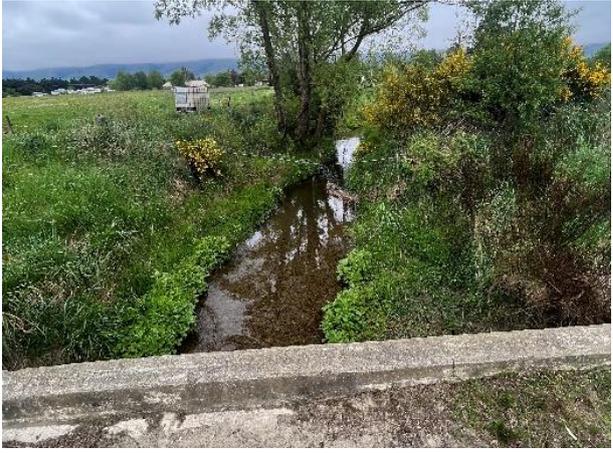
MC_03	<p>Excavated channel, stoney bottom with weedy banks</p>	0.035

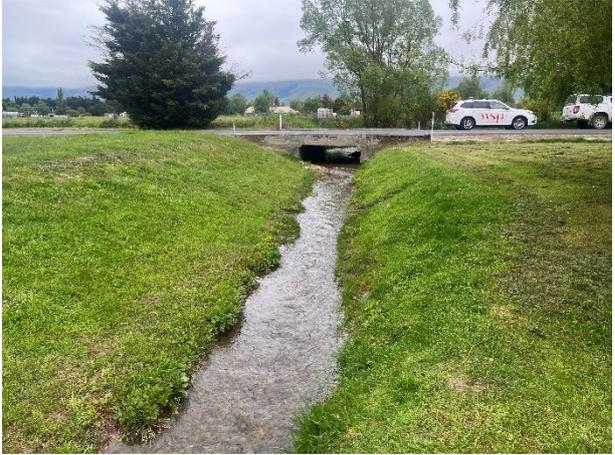
CREEK REACH REFERENCE	DESCRIPTION	MANNINGS N VALUE	PHOTO
MC_04	Excavated channel, clean with vegetation recently cleared.	0.018

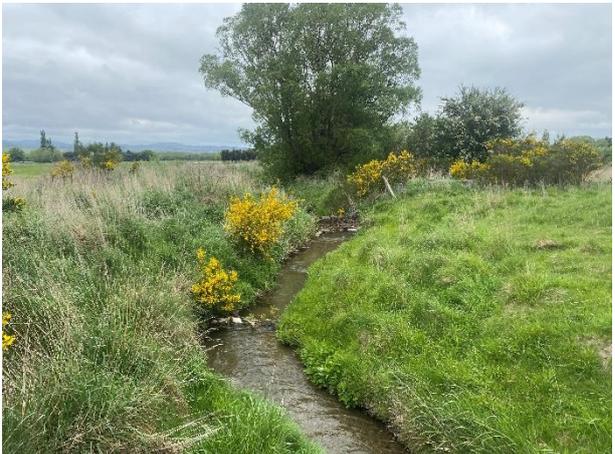
MC_05	Excavated channel, stoney bottom with weedy banks. Some debris and vegetation in flow channel.	0.035

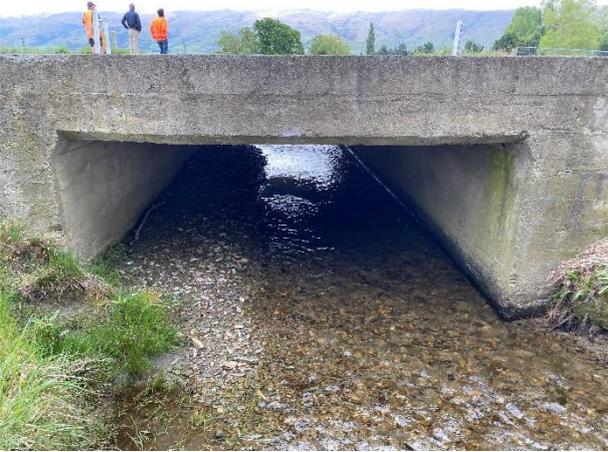
STRUCTURE	DIMENSIONS	PHOTO
State Highway 87	Width: 2,750 mm Height: 1,250 mm

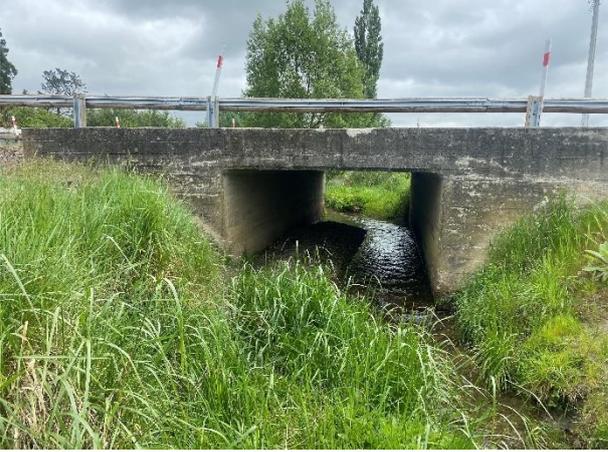
Cardigan Street	Width: 2,800 mm Height: 1,700 mm

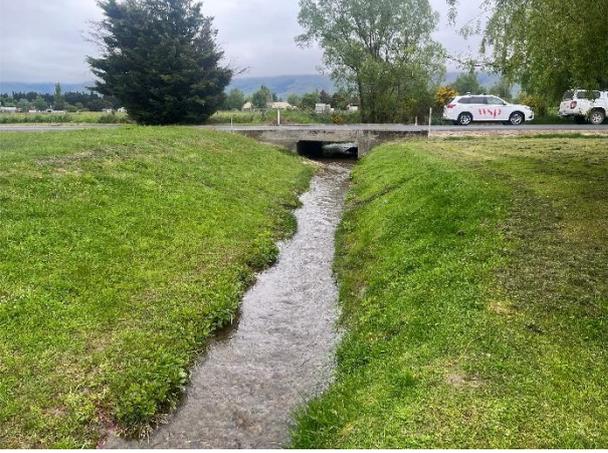
Tawe Street	Width: 2,750 mm Height: 900 mm

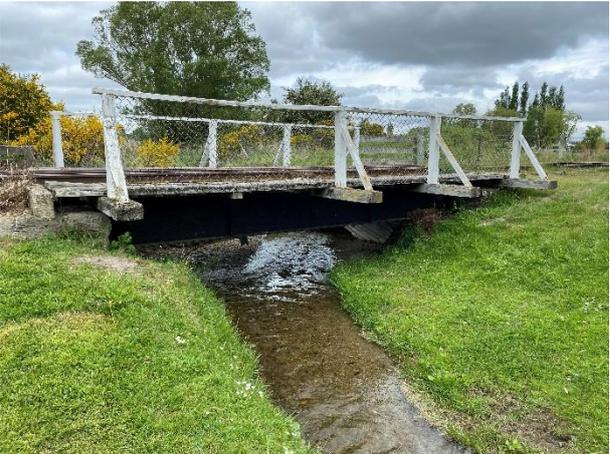
STRUCTURE	DIMENSIONS	PHOTO
Railway Culvert	Irregular shaped culvert with dimensions sourced from GeomaticsNZ Ltd survey. Maximum Width: 5300 mm (directly below beams) Maximum Height: 829 mm

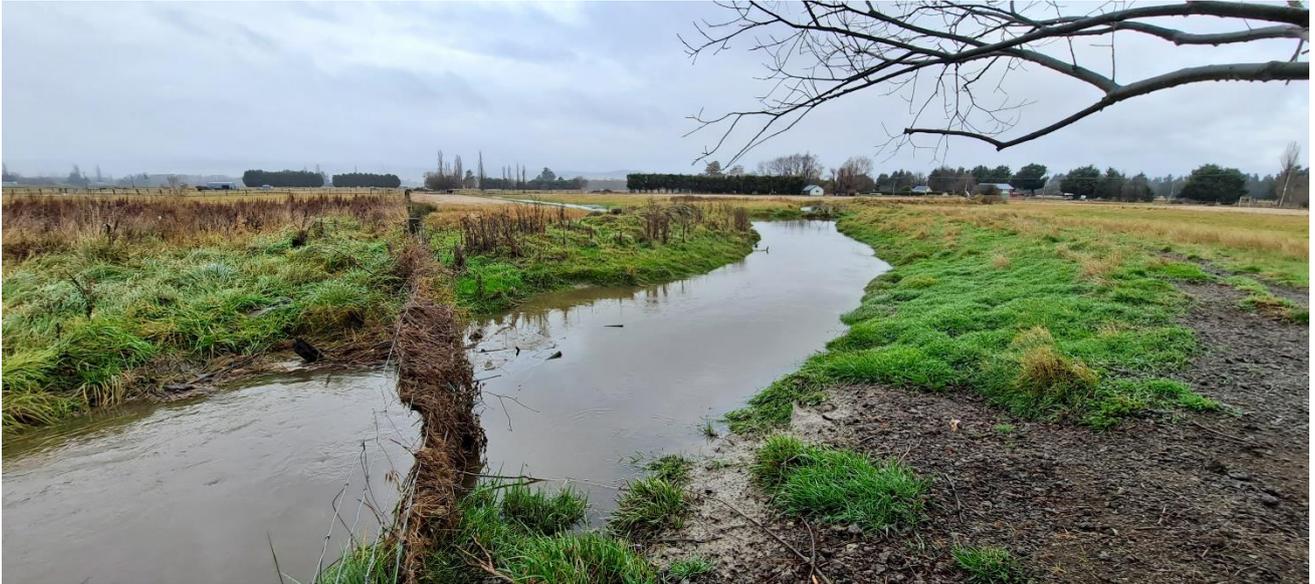
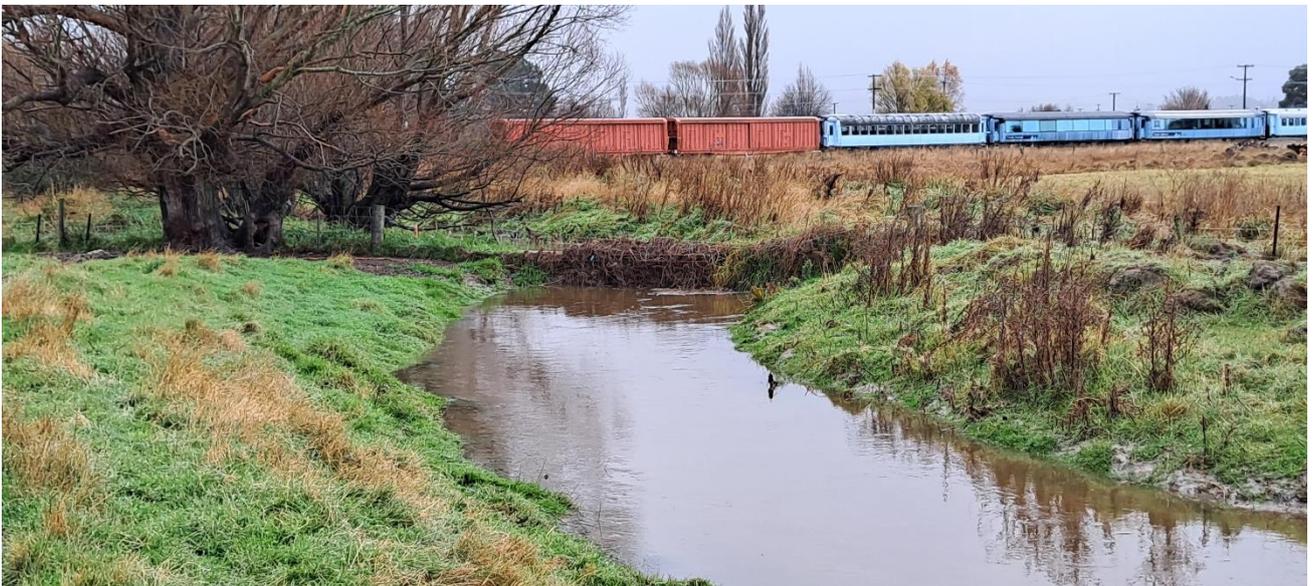
A downstream boundary condition (water level) for the creek model was estimated by reviewing photos taken following large rainfall events. Debris was observed on a fence line downstream of the railway culvert following a large rainfall event in May 2021 (see Figure 2-2 and Figure 2-3). It is estimated the debris line is 0.5 m above the creek bank.

Figure 2-2: Debris on Fenceline Downstream of Railway Culvert (Looking Downstream)

Figure 2-3: Debris on Fenceline Downstream of Railway Culvert (Upstream Downstream)

This boundary condition was applied in model simulations as a constraint level at the downstream end of creek reach MC_05.

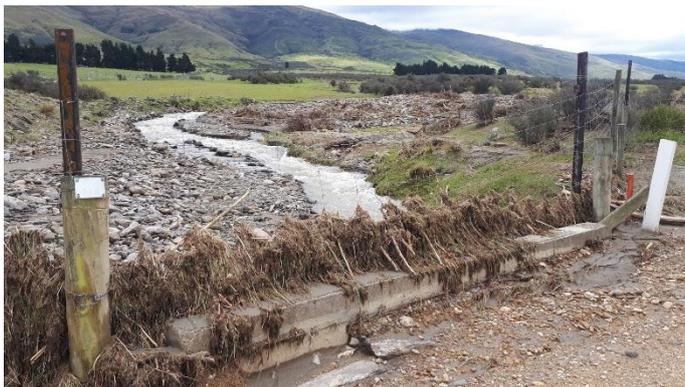
Figure 3-7: Gladbrook Road Culvert Looking Downstream (Photo Provided by ORC)

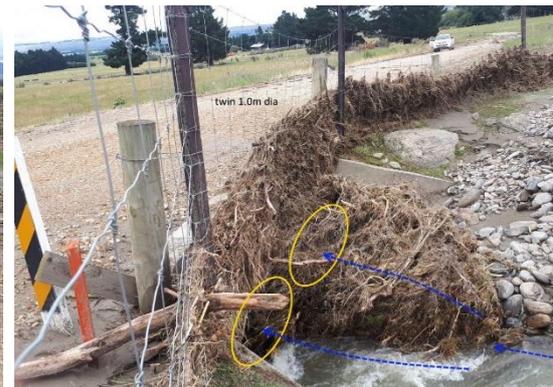
Figure 3-8: Upstream end of Gladbrook Road Culvert with Yellow Circles Showing Approximate Locations (Photo Provided by ORC)

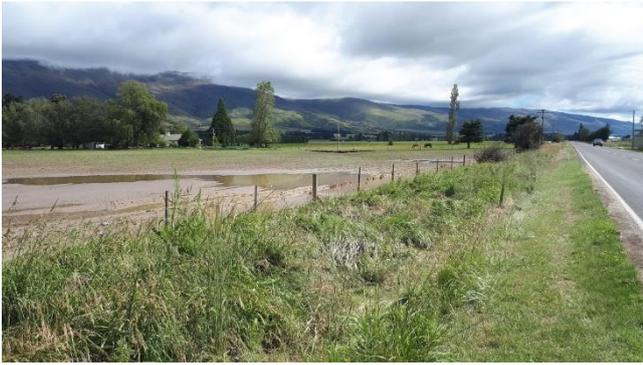
- There is evidence March Creek overflowed its banks upstream of the State Highway 87 crossing, with flood debris seen on the fence line approaching the level of the highway (see Figure 3-12 and Figure 3-13). Debris accumulation was also observed on a fence line downstream of the highway (see Figure 3-14).
- Sediment was observed on the Tawe Street bridge, indicating the roadway was overtopped (see Figure 3-15).
- Sediment was observed in the swale between the Tawe Street crossing and Rail Bridge (see Figure 3-16), indicating back up from the railway culvert constraint or overland (from the upstream breakout) re-entering the main channel.
- Flood debris were observed accumulated on the railway culvert fence, indicating overtopping (see Figure 3-17).

Figure 3-12: Standing Water in Paddock Upstream of State Highway 87 Crossing (Photo Provided by ORC)

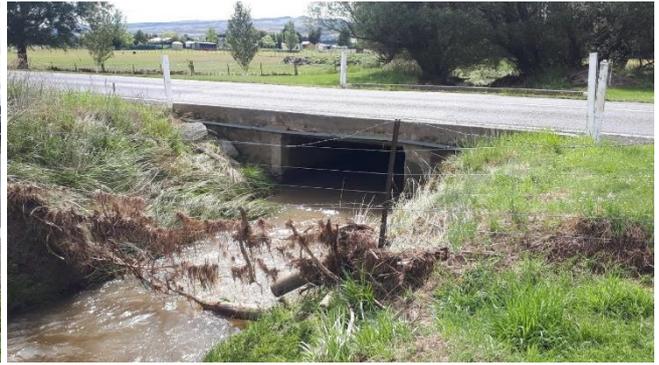
Figure 3-13: Flood Debris on Fenceline Upstream of State Highway 87 Crossing (Photo Provided by ORC)

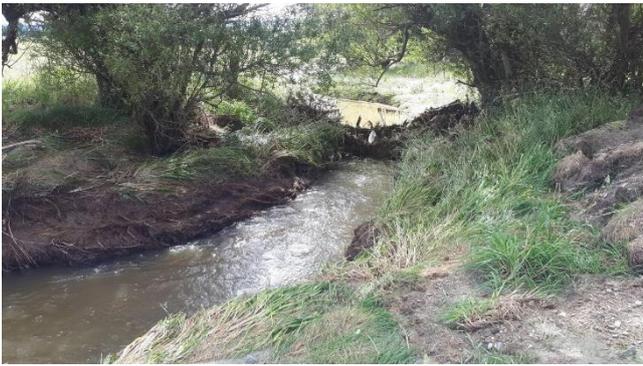
Figure 3-14: Debris on Fenceline Downstream of State Highway 87 Crossing (Photo Provided by ORC)

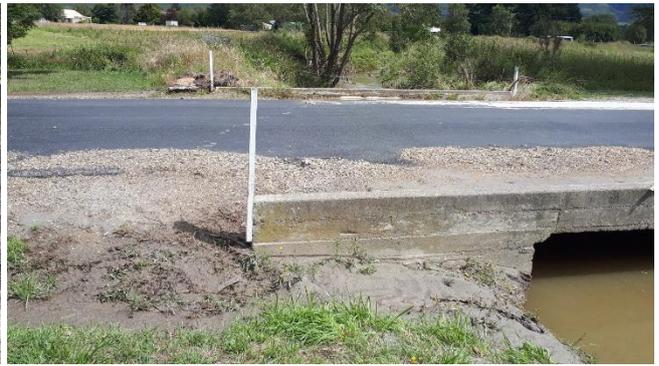
Figure 3-15: Sediment on Top of Tawe Street Crossing, Indicating Overtopping (Photo Provided by ORC)

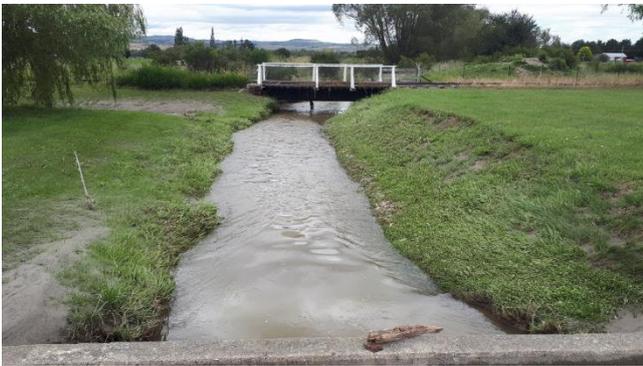
Figure 3-16: Sediment in Swale Between Tawe Street Crossing and Rail Bridge (Photo Provided by ORC)

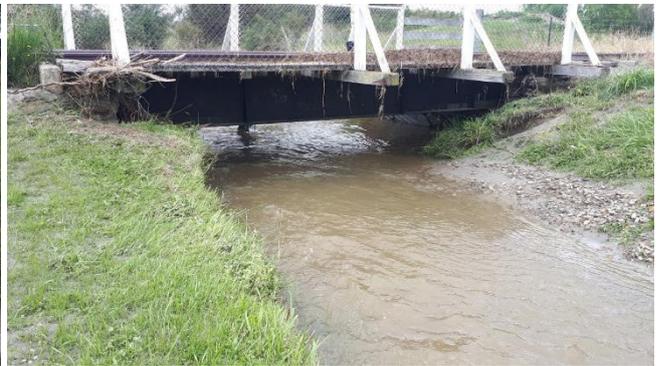
Figure 3-17: Flood Debris Accumulation on Railway Culvert (Photo Provided by ORC)

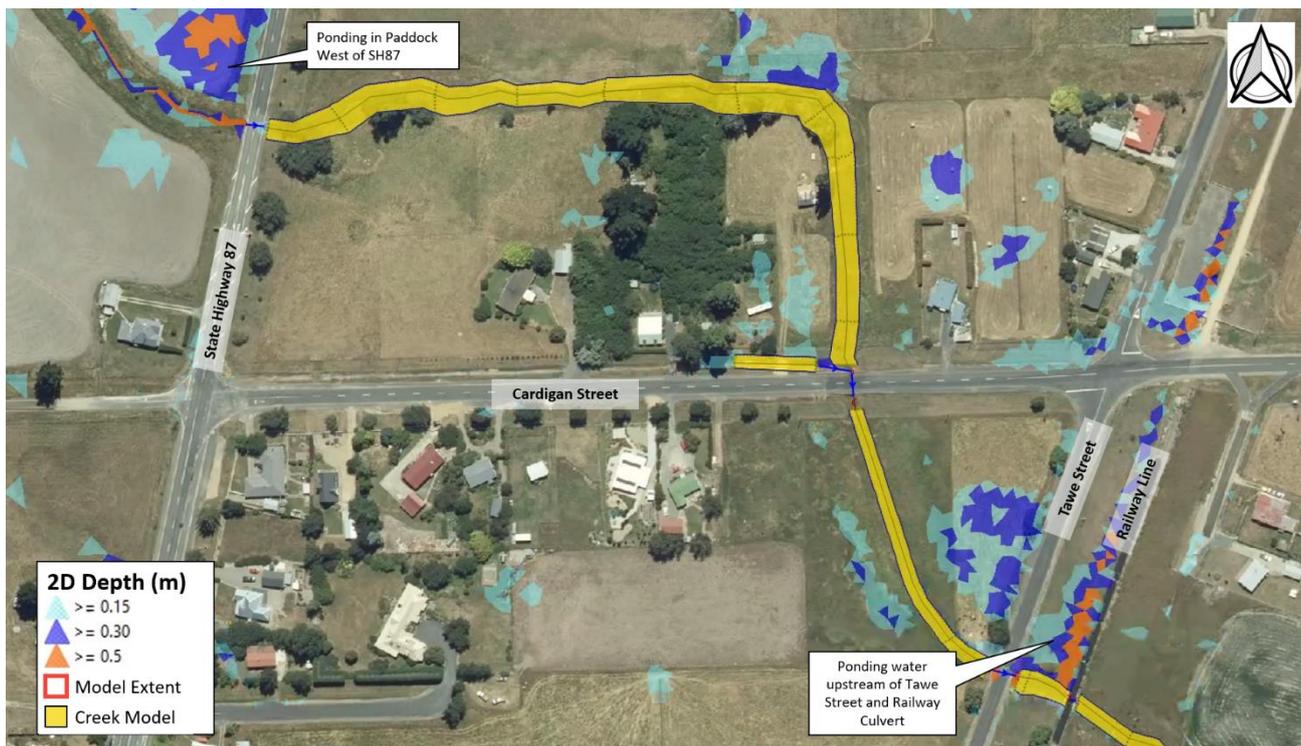
Figure 3-18: Validation Event 2 Model Results from State Highway 87 to Railway Culvert

- Upstream of State Highway 87, the model does not predict either of March Creek or Dewar Creek overtop their banks. This is consistent with ORC observations during this event.
- During peak flow in the creek, the model predicts the railway culvert is under capacity, resulting flow in the creek overtopping its banks between Tawe Street and the railway culvert (reach MC_04). It is believed these results correspond to actual conditions, as flood debris was observed to have accumulated along the railway culvert fence line.
- Ponded water due to the limited creek capacity below the rail bridge is predicted by the model, which has confirmed by sediment accumulation seen in photos.

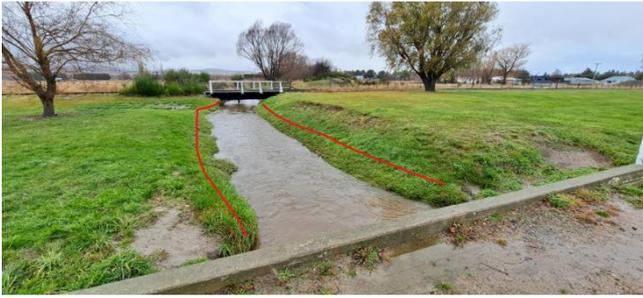
For the 28 May 2021 event no overtopping of March Creek was observed from Gladbrook Road to Cemetery Road. ORC staff provided marked up pictures showing the maximum water level between Tawe Street and the railway culvert (see Figure 3-19 and Figure 3-20). There were no reports of flooding adjacent to March Creek through Middlemarch.

Figure 3-19: Maximum Creek Water Level (Red) Tawe Street Bridge to Railway Culvert (Photo Provided by ORC)

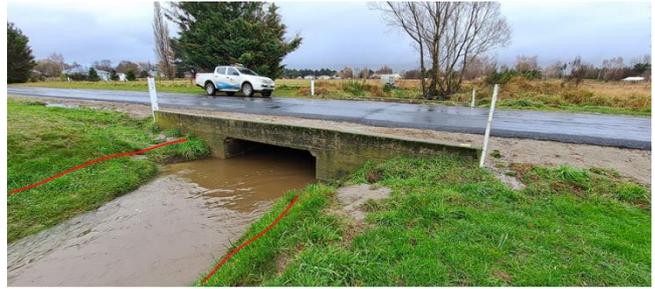
Figure 3-20: Maximum Creek Water Level (Red) at Tawe Street Bridge (Photo Provided by ORC)

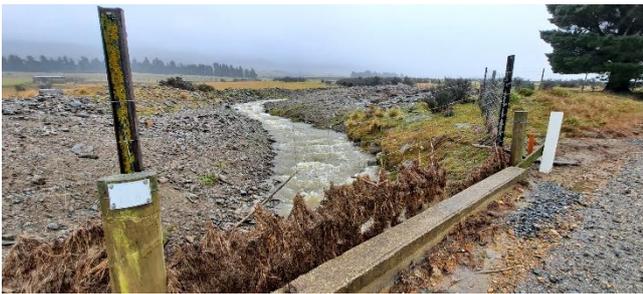
Debris was observed accumulated on the Gladbrook Road crossing of Dewar Creek (see Figure 3-21) however this debris may have been from events earlier in the year.

Figure 3-21: Flood Debris Accumulation on Dewar Creek Culvert at Gladbrook Road (Photo Provided by ORC)

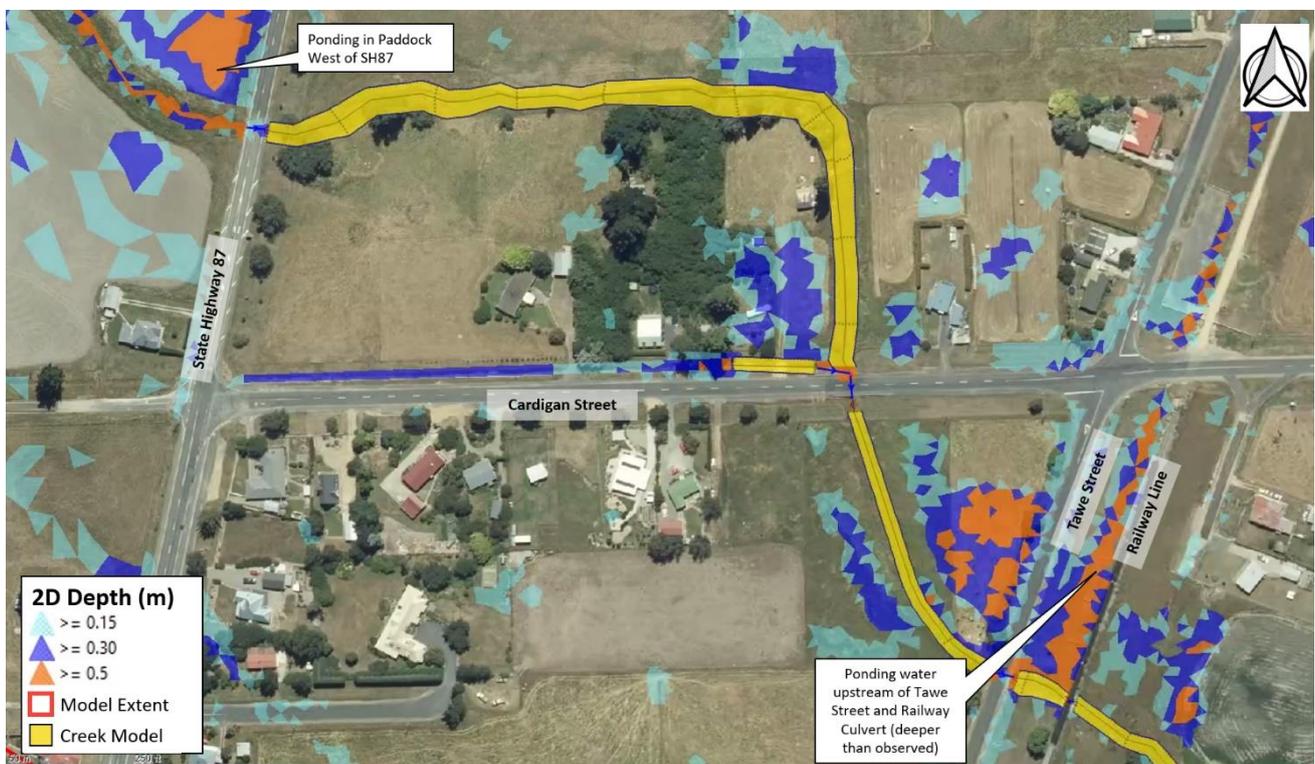
Figure 3-22: Validation Event 3 Model Results from State Highway 87 to Railway Culvert

- This rainfall event has an estimated ARI of 2 - 5 years in the upper catchment and 2 years in Middlemarch, being larger than the March 2021 event at both locations. However, the extent of observed flooding for this event was less than was observed during the March 2021 event. The model predicts a greater extent of flooding in Middlemarch for this event than the March 2021 event.
- Upstream of State Highway 87, the model does not predict either of March Creek or Dewar Creek overtop their banks. This is consistent with ORC observations during this event.
- During peak flow in the creek, the model predicts the railway culvert is under capacity, resulting in the creek overtopping its banks between Tawe Street and the railway culvert (reach MC_04) and Cardigan Street and Tawe Street (reach MC_03). The predicted peak water level is greater than indicated on marked up photos provided by ORC.
