Management and Reduction of Debris Flow Risk in Roxburgh, Otago

Engineering Options Report (Conceptual Design)

Otago Regional Council

Golder Associates (NZ) Limited

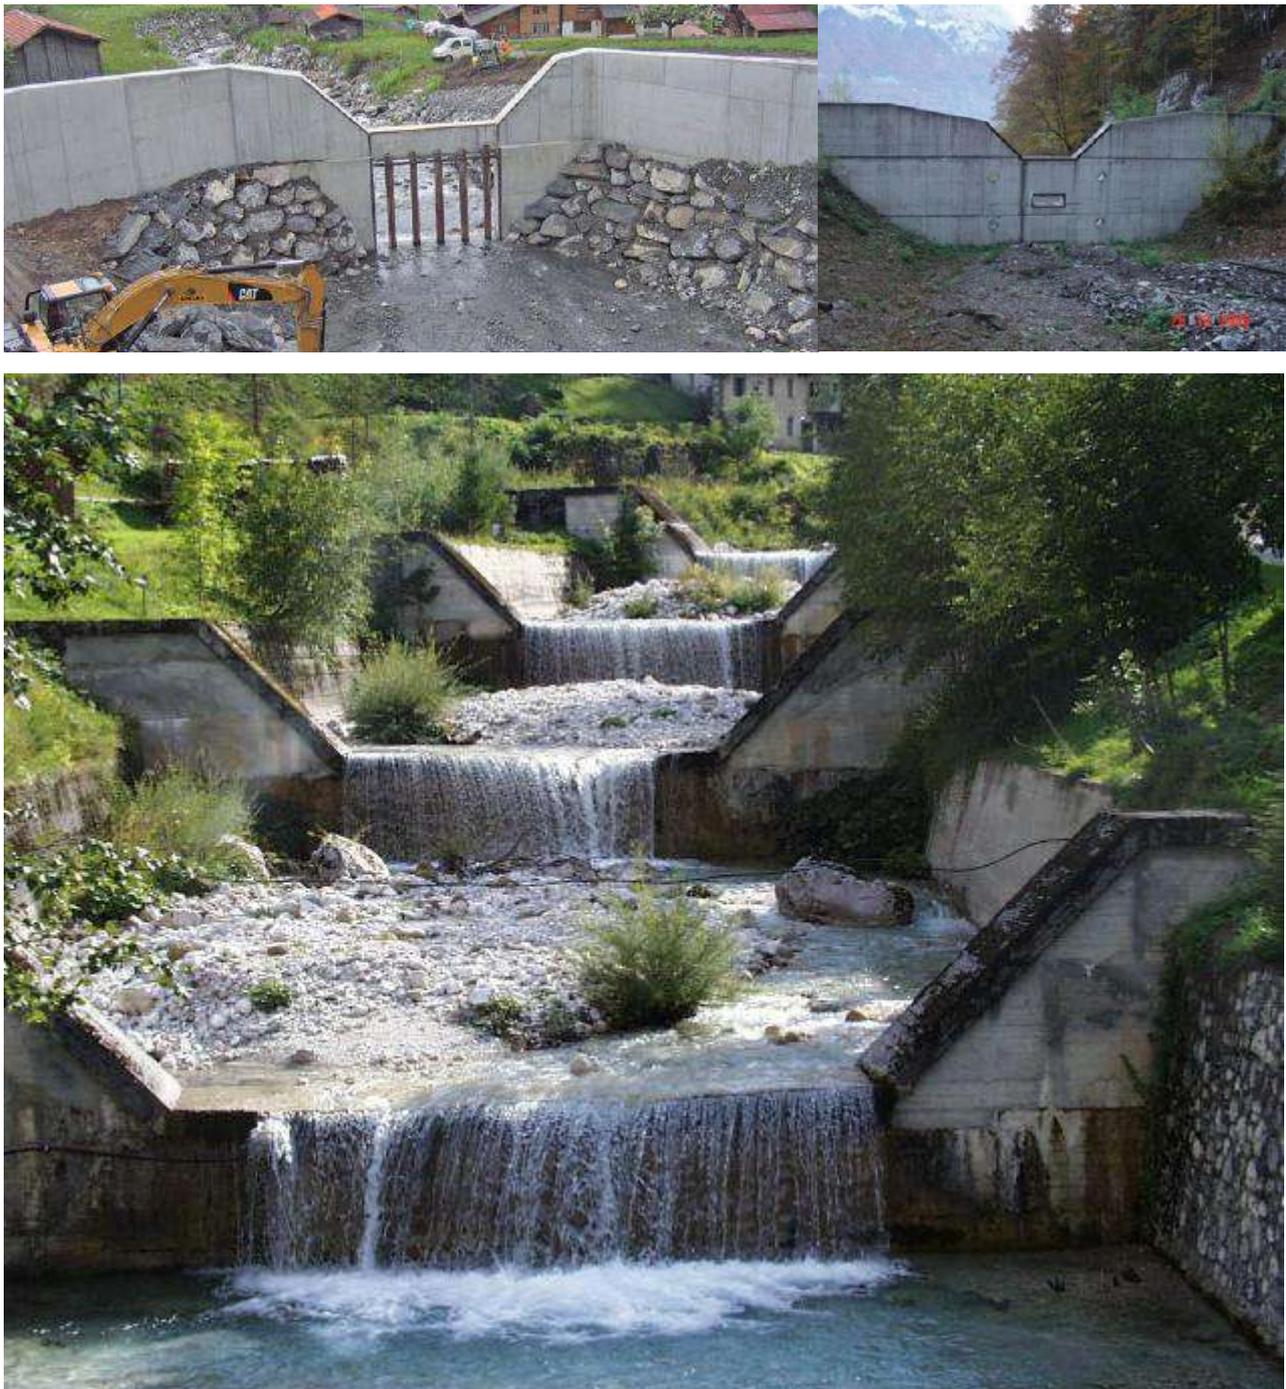
Figure 1: top left: concrete retention structure with central steel rake to separate debris material from water (source: Herzog Ingenieure, Davos, Switzerland); top right: concrete sediment retention structure in Switzerland (source: (Wendeler, 2016)); bottom: series of check dams in European Alps (Comiti, Lenzi, & Mao, 2013).

Retention structures can be rigid or flexible structures. Rigid structures can be built e.g., as concrete dams, concrete or steel pillars, see Figure 1 below.

A staircase-like sequence of check dams (see Figure 1) are constructed of concrete, fences, gabions or other materials in order to control channel bed incision and to retain sediment volume within the channel upstream of the sensitive fan areas. Stream transport capacity is reduced and sediment is deposited in the reach immediately upstream of the check dam. This leads to a reduction of channel and sidewall scour and it also minimizes debris flow occurrence in those reaches. Check dams are usually built in reaches where debris flows would initiate in order to reduce the potential for debris flows to occur in the

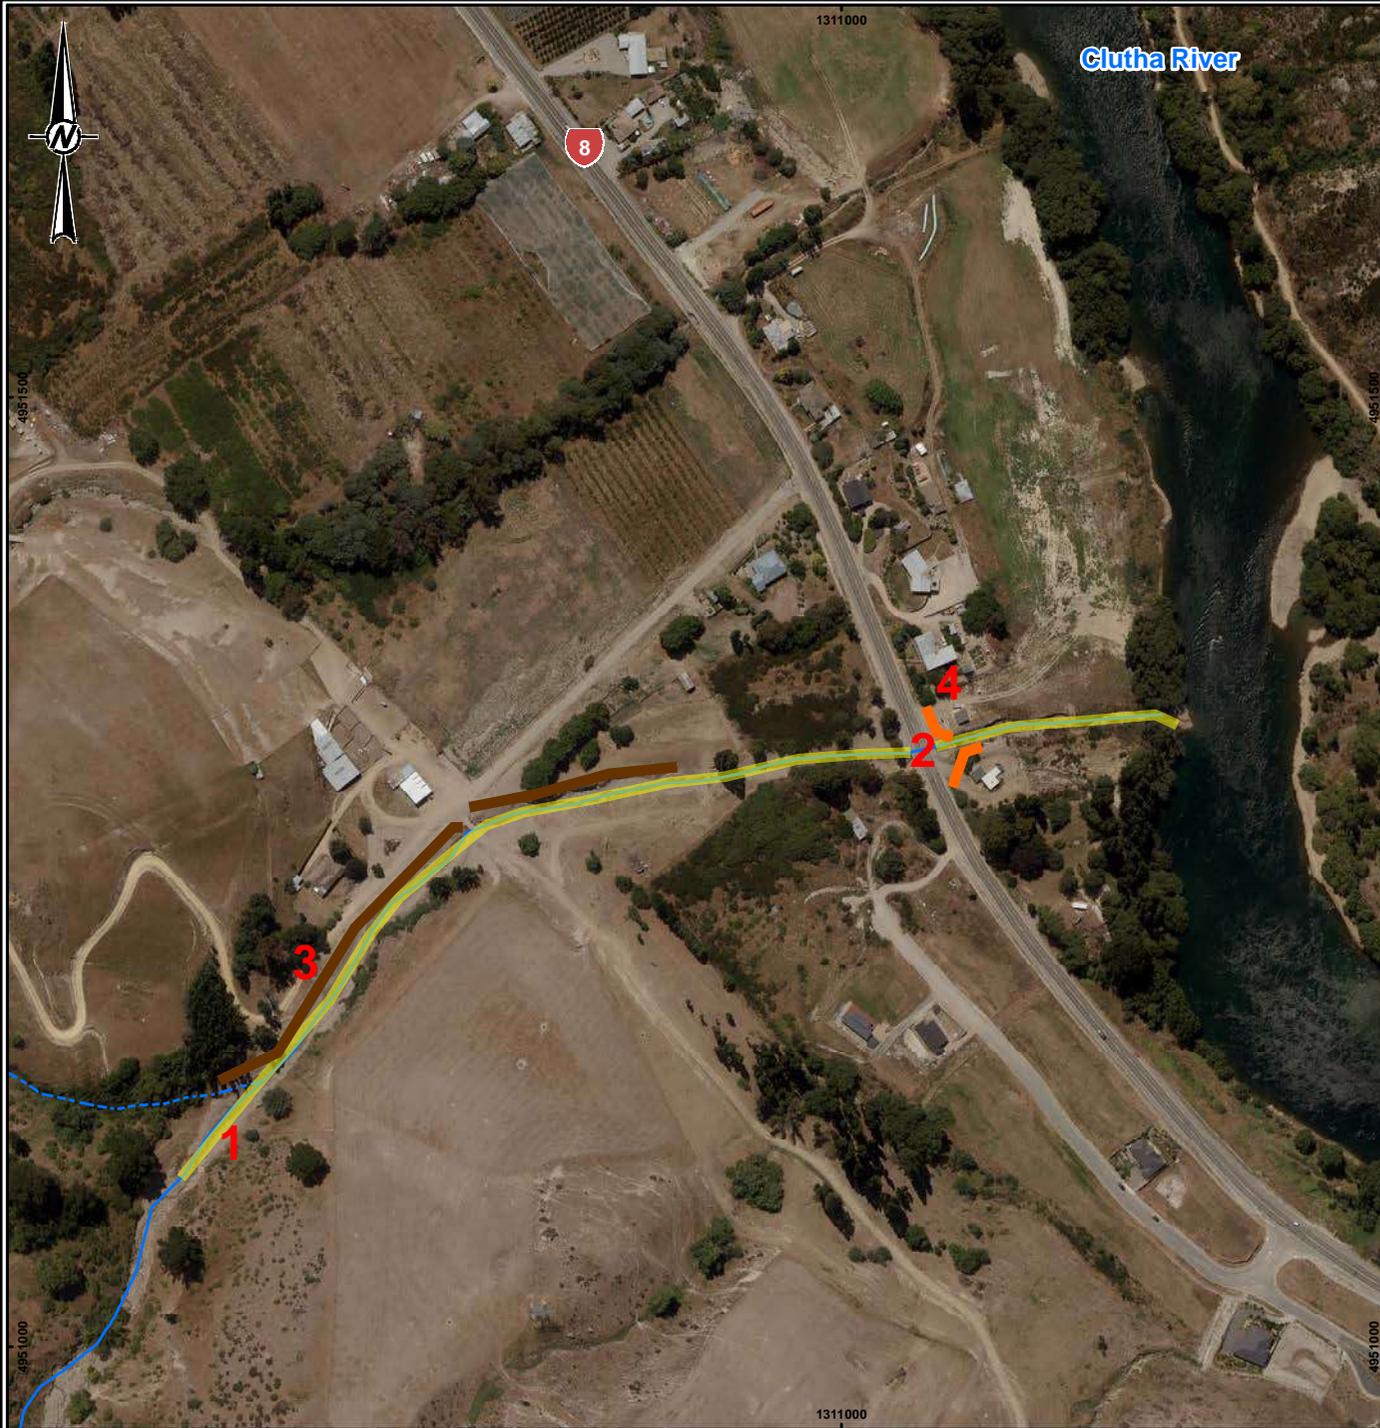
- Creek
- 1 No. mitigation option
- Debris excavation
- Lateral deflection levee
- Deflection / diversion structure

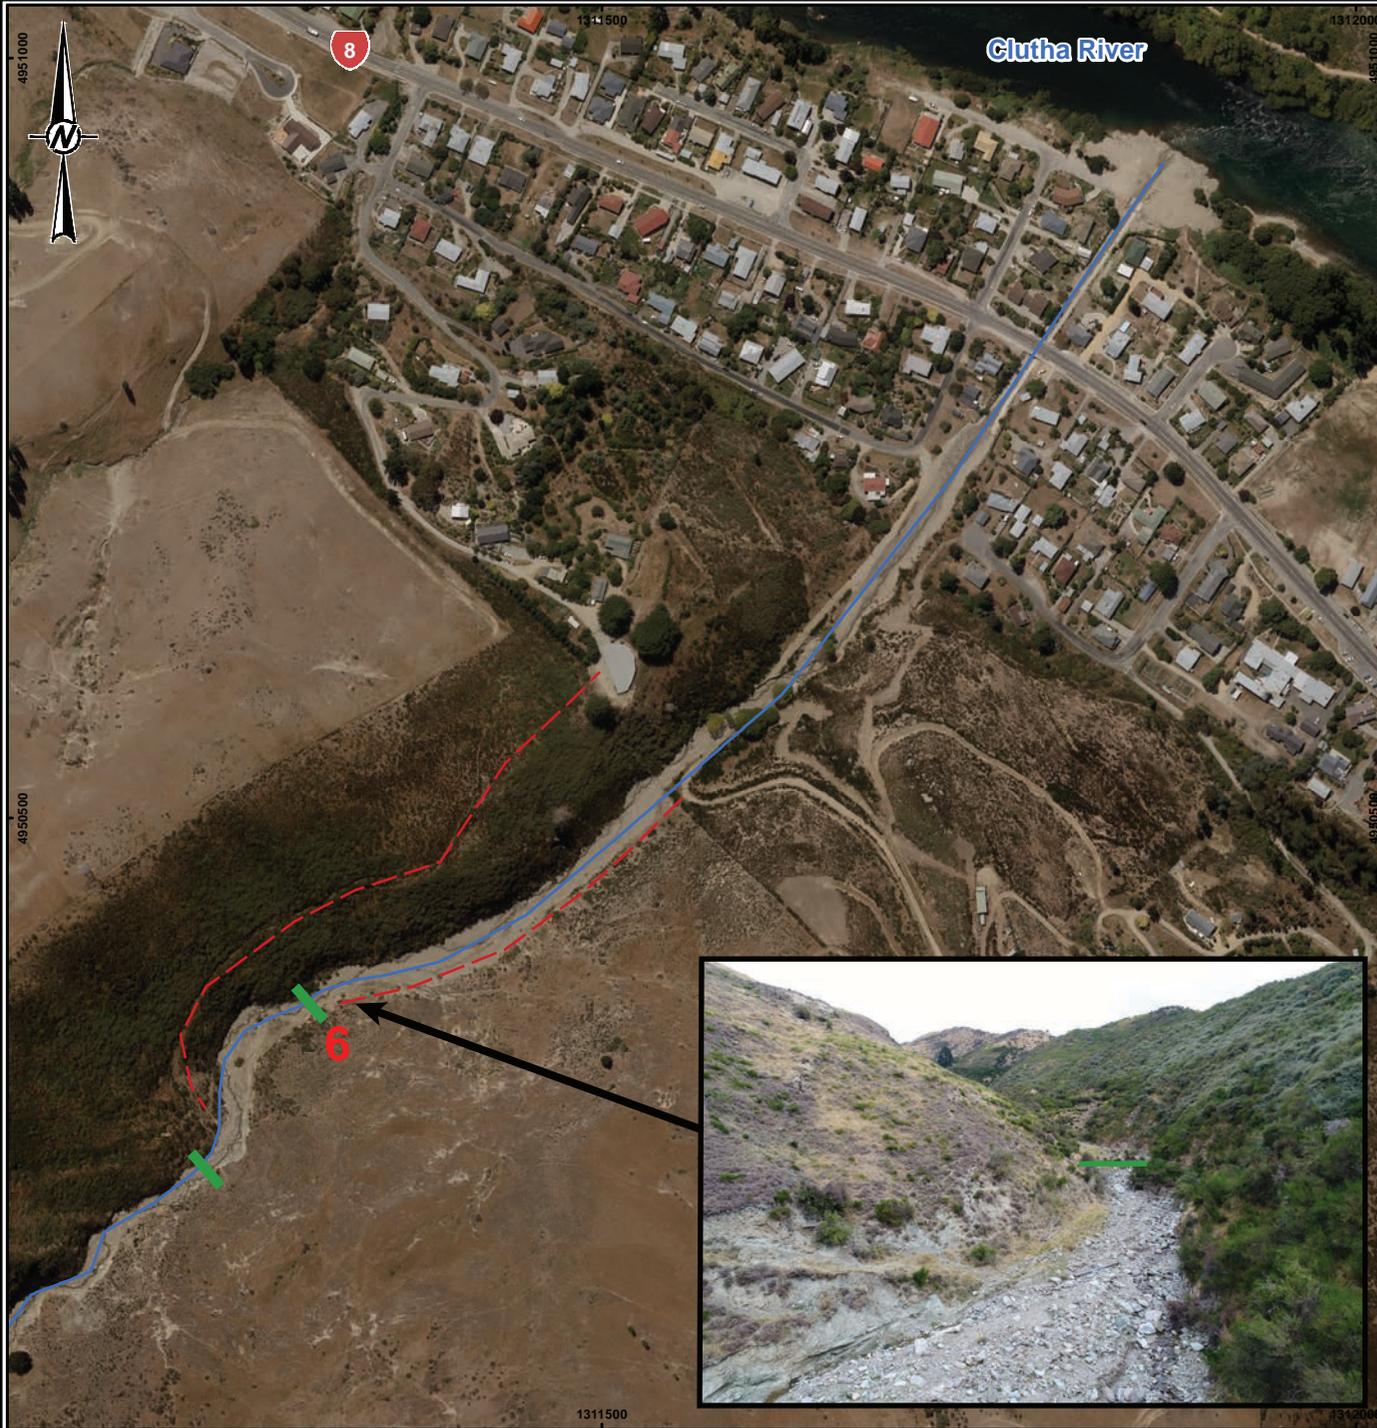
- Creek
- 1** No. mitigation option
- Retention structure
- - - Indicative location of site access track

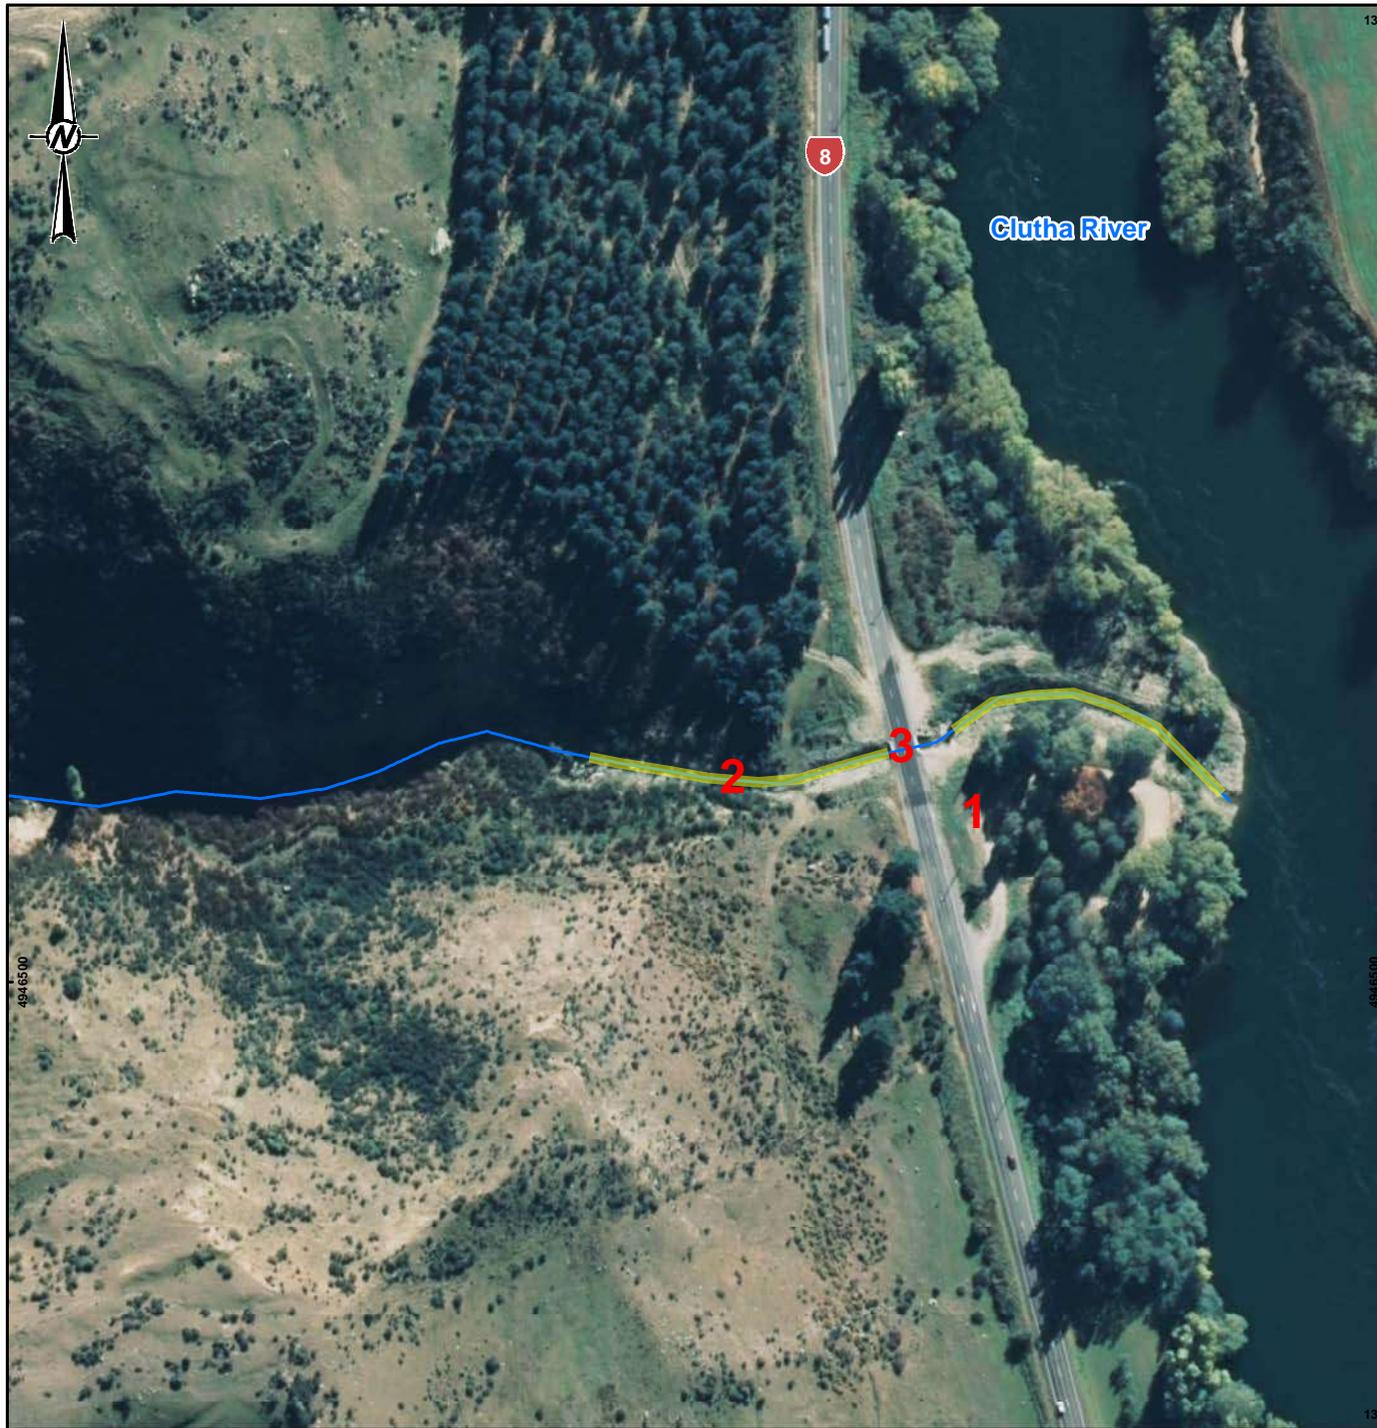
PROJECT No.	REPORT	REV.	FIGURE
18113634	004	0	08

- Creek
- 1 No. mitigation option
- Debris excavation

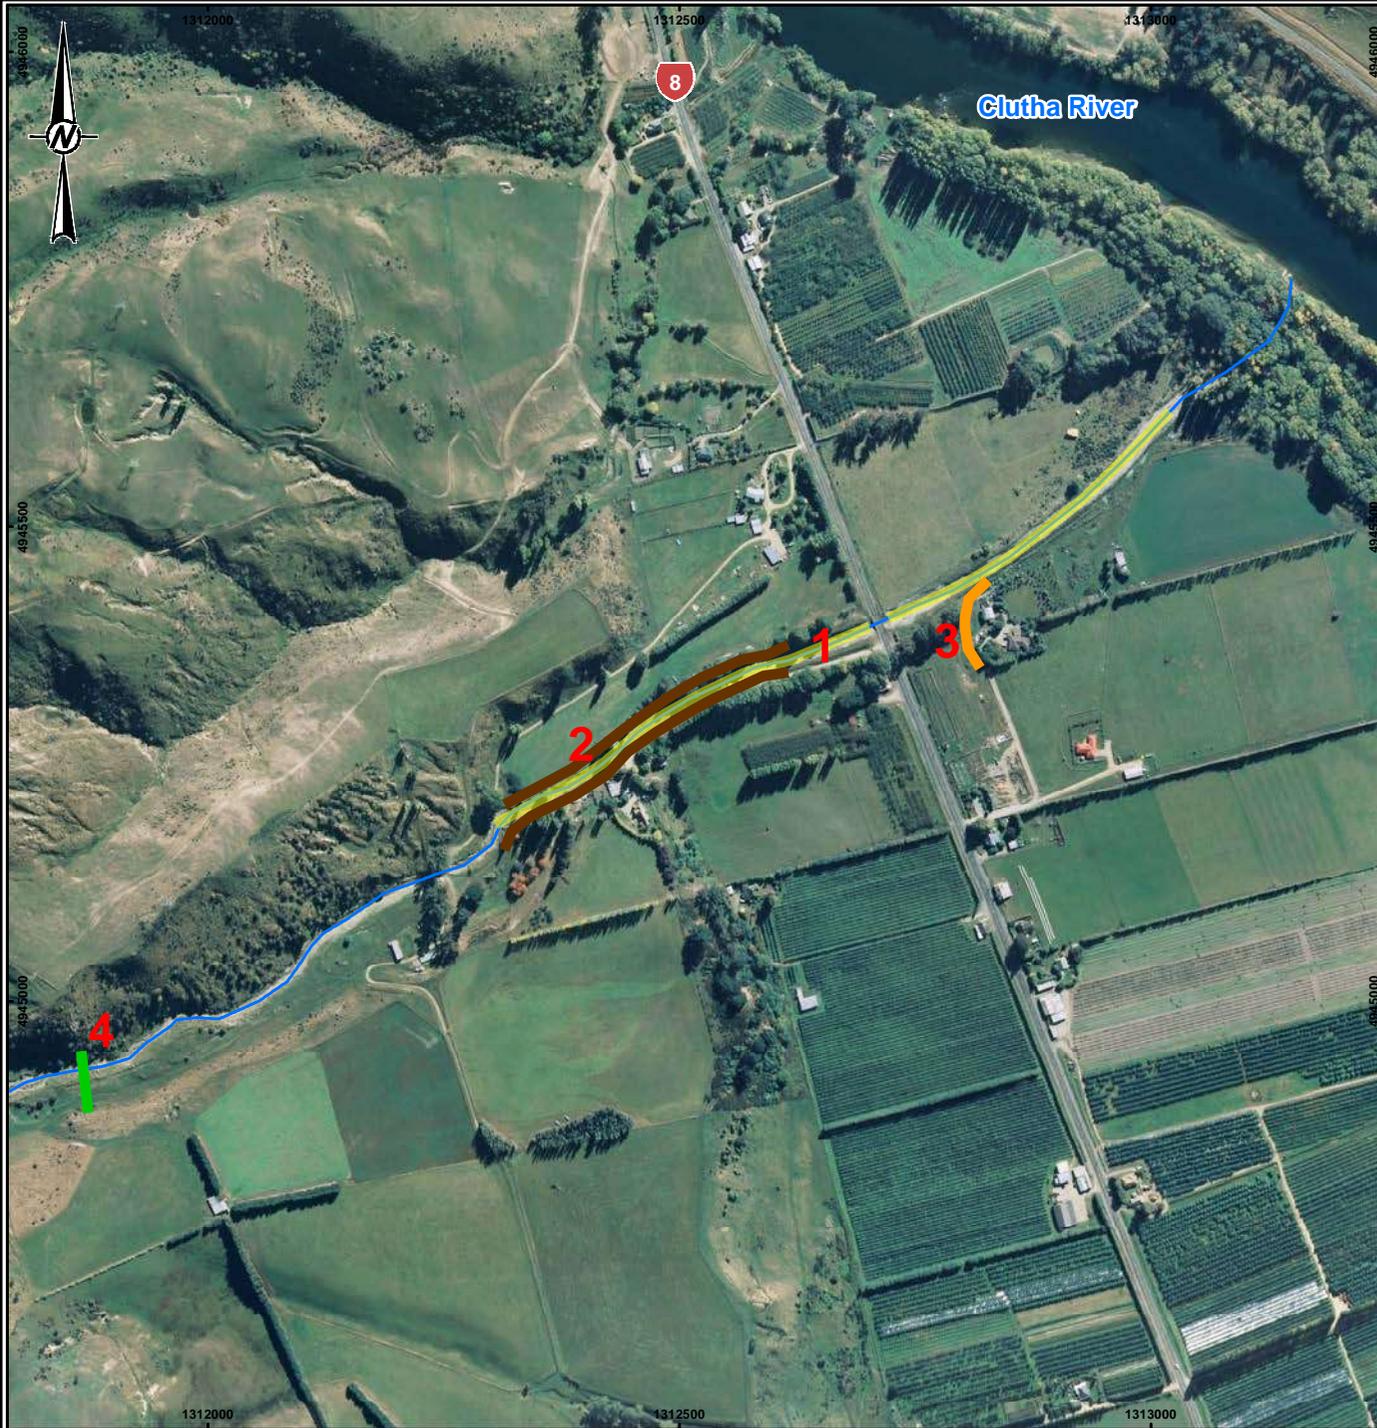
- Creek
- 1 No. mitigation option
- Debris excavation
- Lateral deflection levee
- Deflection structure
- Retention structure

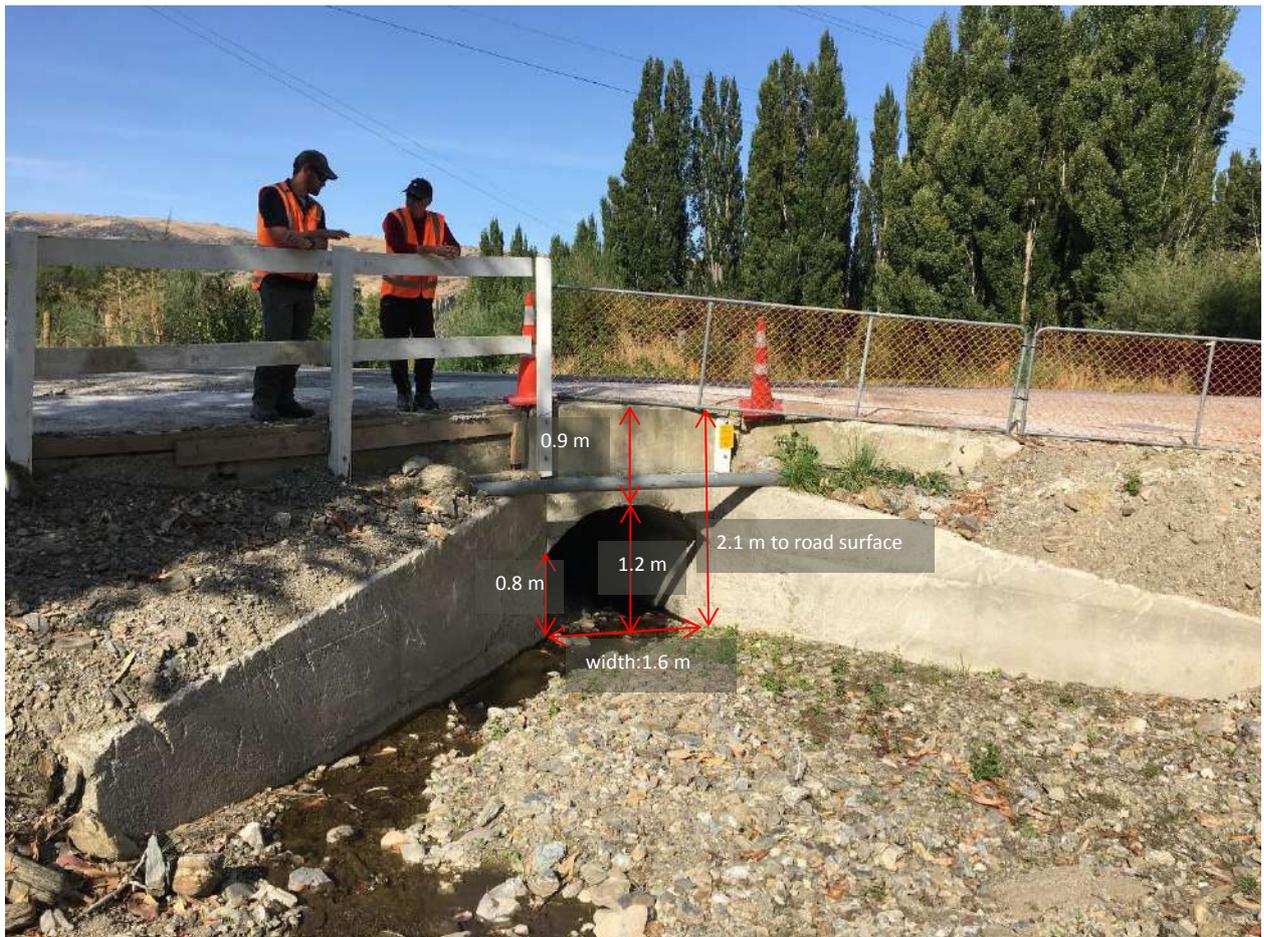
Figure 1: Pumpstation Creek – SH8 crossing, view from upstream.

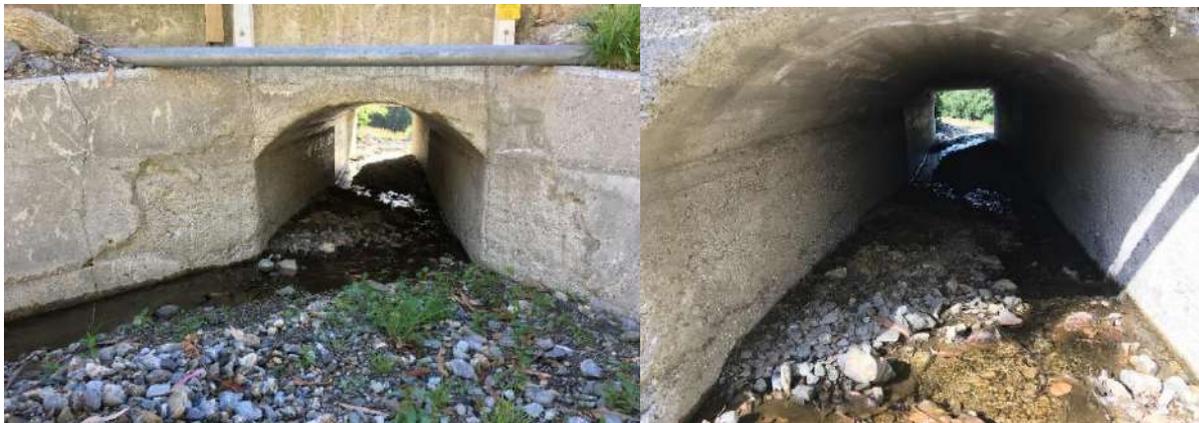
Figure 4: Pumpstation Creek – SH8 crossing, culvert, views from upstream.

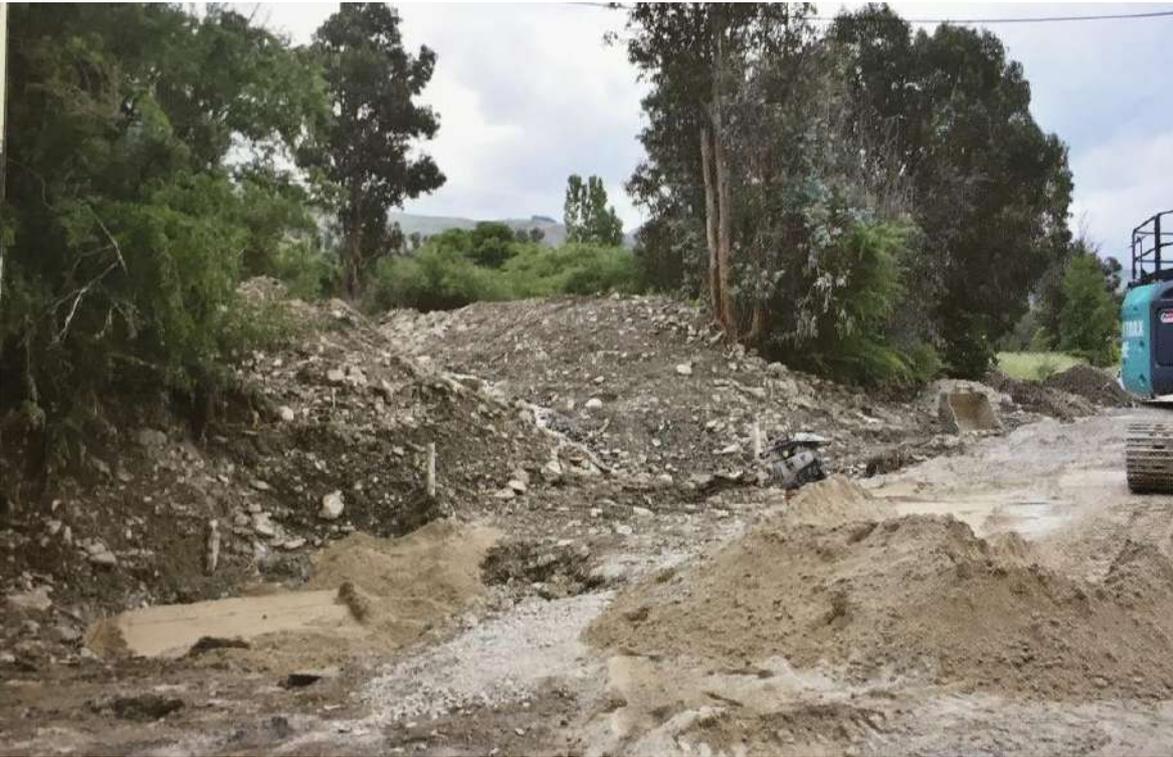
Figure 7: Pumpstation Creek – after 26 November 2017 event, looking upstream from SH8 (source: Withington, Teviot Valley Tempest, 2018).

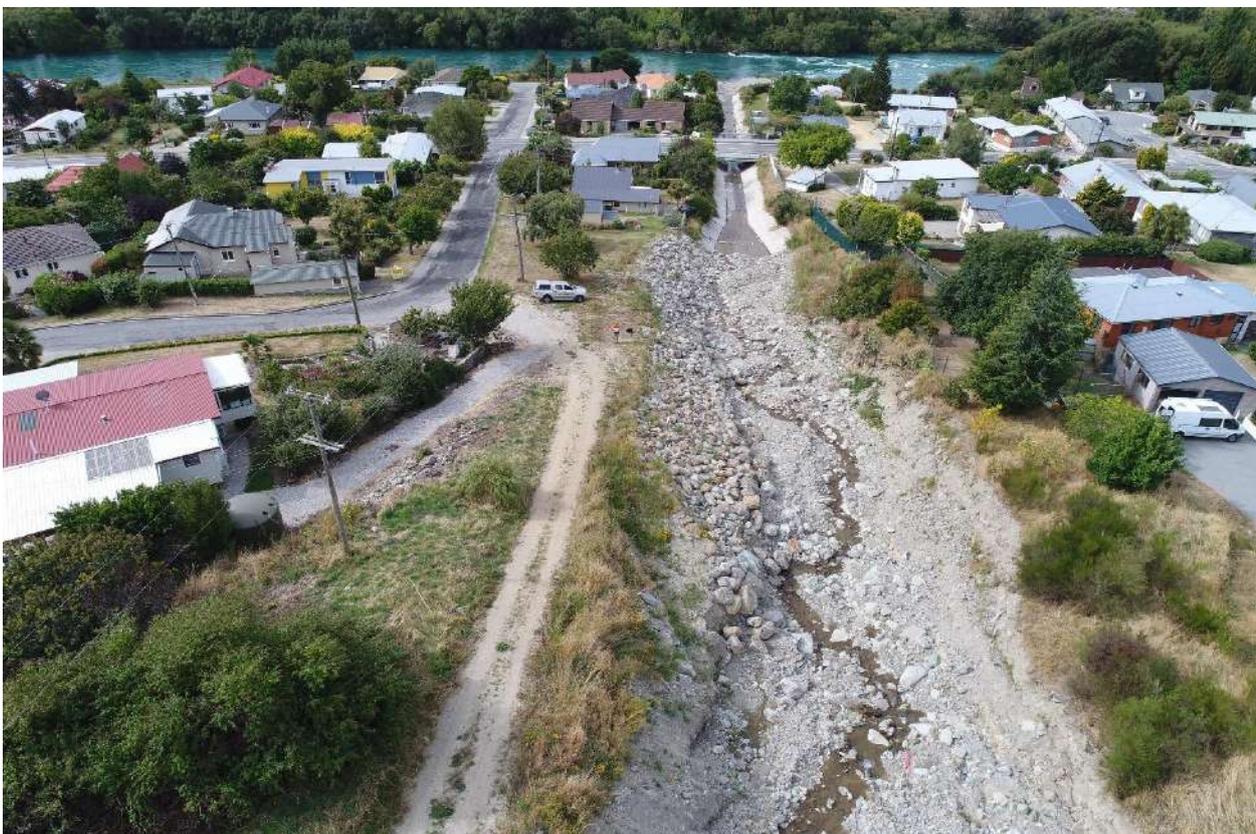
Figure 8: Reservoir Creek – UAV image, view of channel upstream of entrance to lined concrete flume.

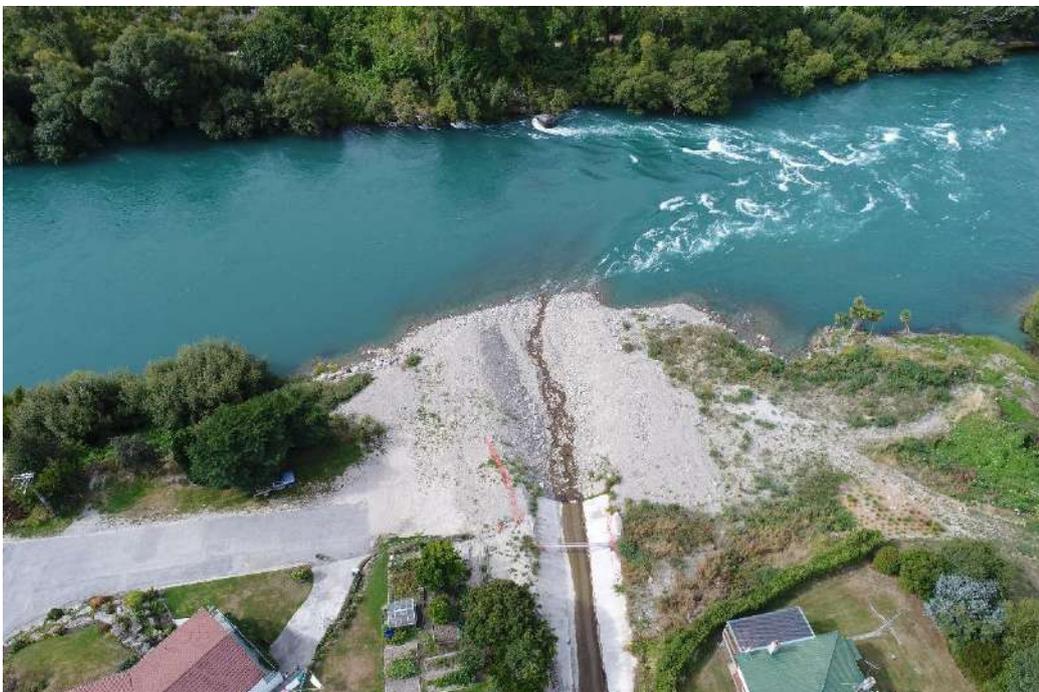
Figure 12: Reservoir Creek, UAV view of debris fan into Clutha River.

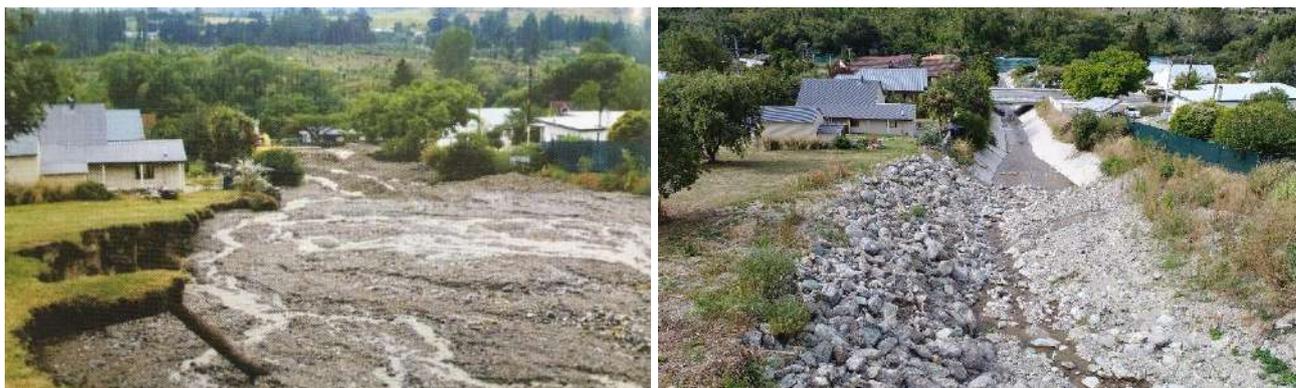
Figure 15: left: Aggradation of debris at entrance to concrete channel after 26 November 2017 event (source: Withington, Teviot Valley Tempest, 2018); right: Channel status 26 February 2019.

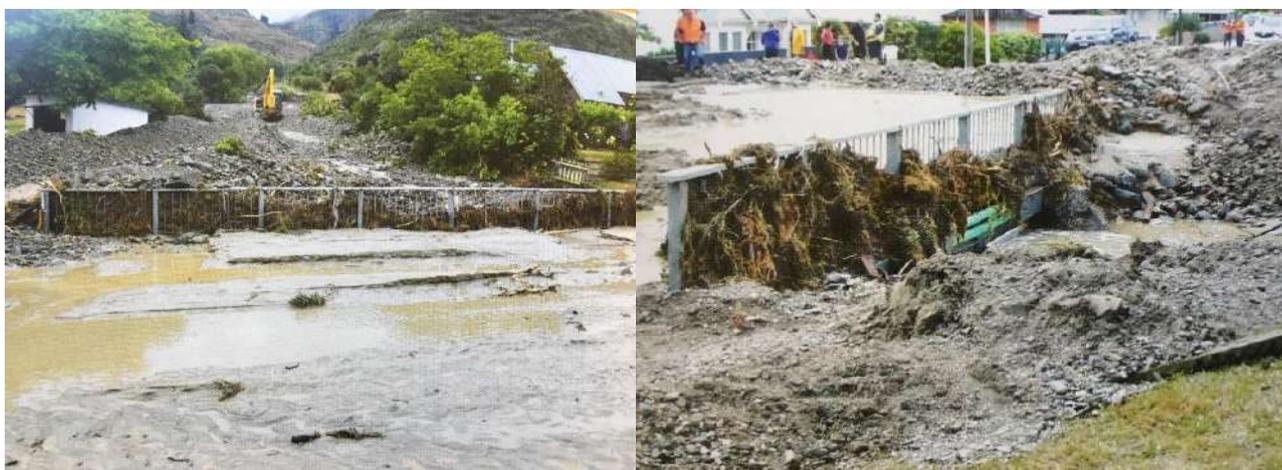
Figure 16: Aggradation of debris above SH8 crossing and avulsion of water and fine debris on 26 November 2017 (source: Withington, Teviot Valley Tempest, 2018).

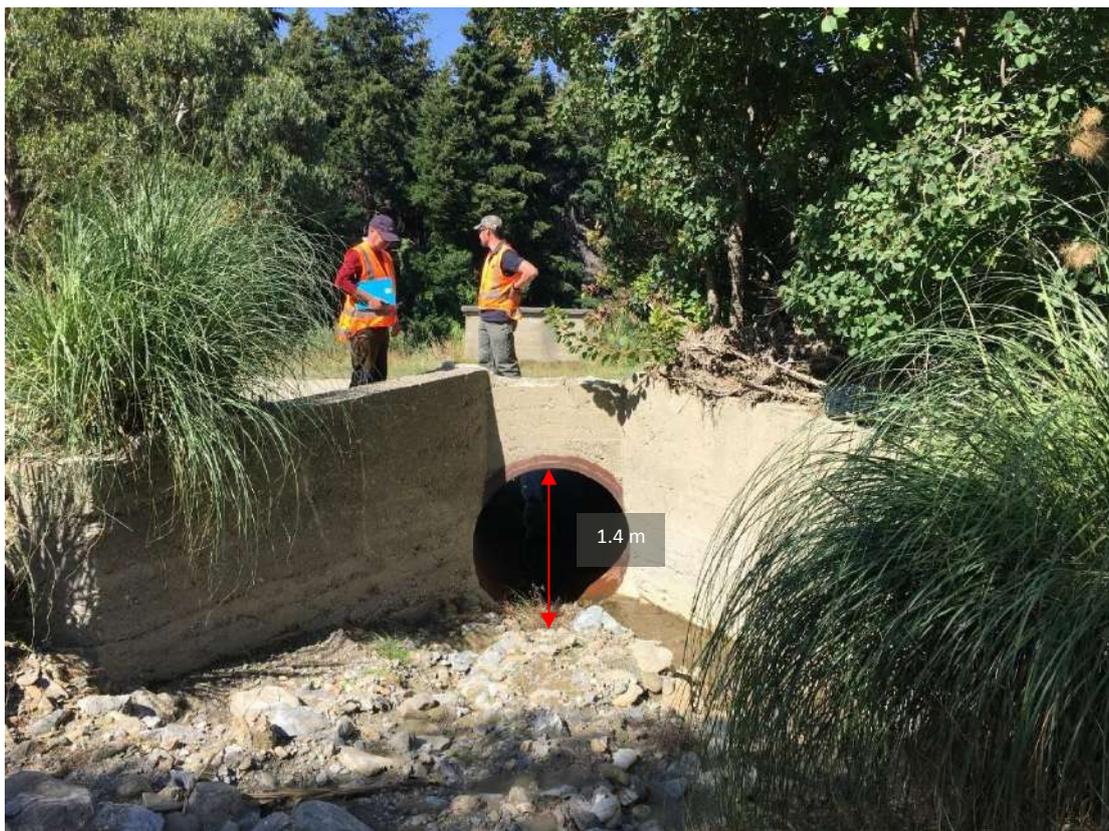
Figure 17: Golfcourse Creek - Culvert at old road above SH8 level, view from upstream.

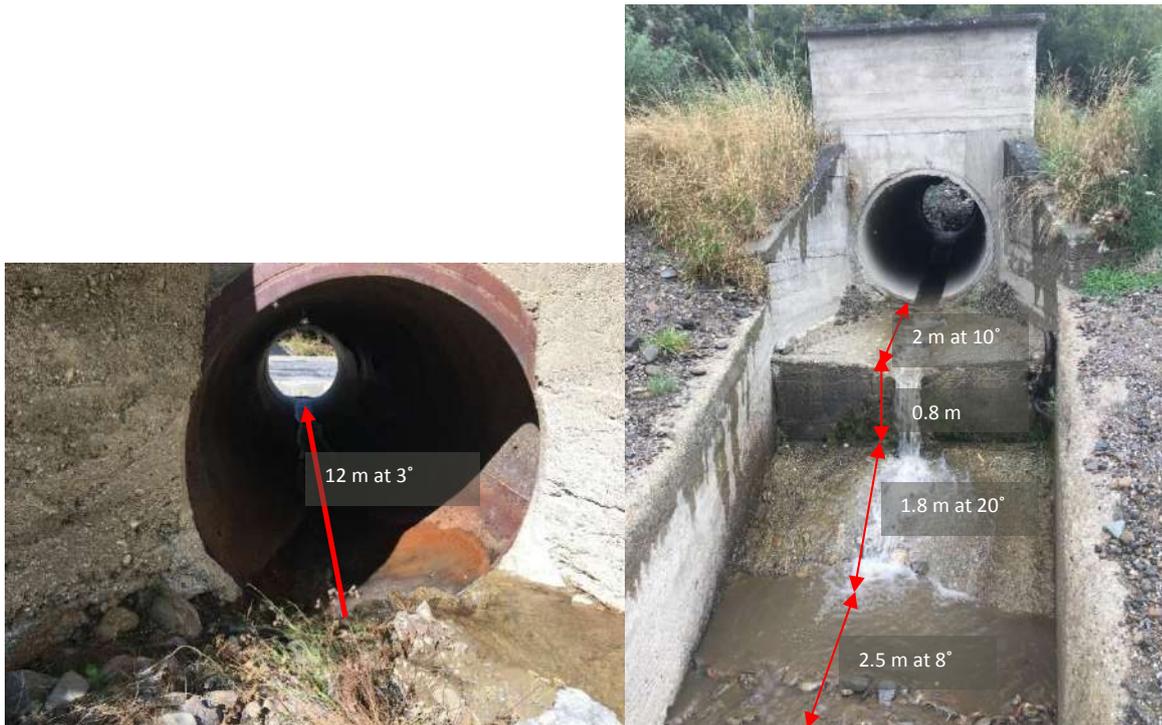
Figure 19: left: old road culvert, view from upstream; right: old road culvert, view from SH8.

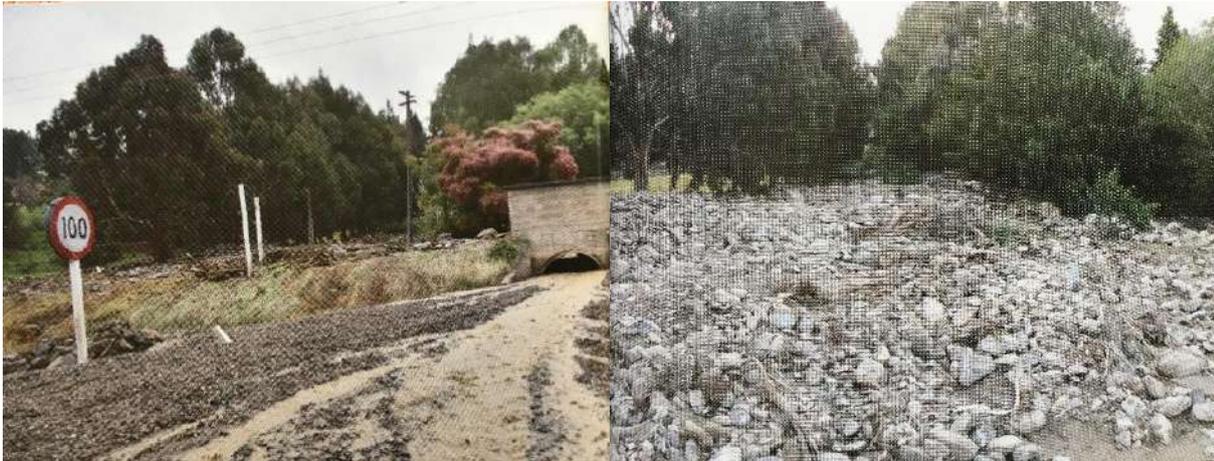
Figure 23: Golfcourse Creek - November 2017, left: looking from downstream at old road culvert; right: looking at channel upstream (source: Withington, Teviot Valley Tempest, 2018).

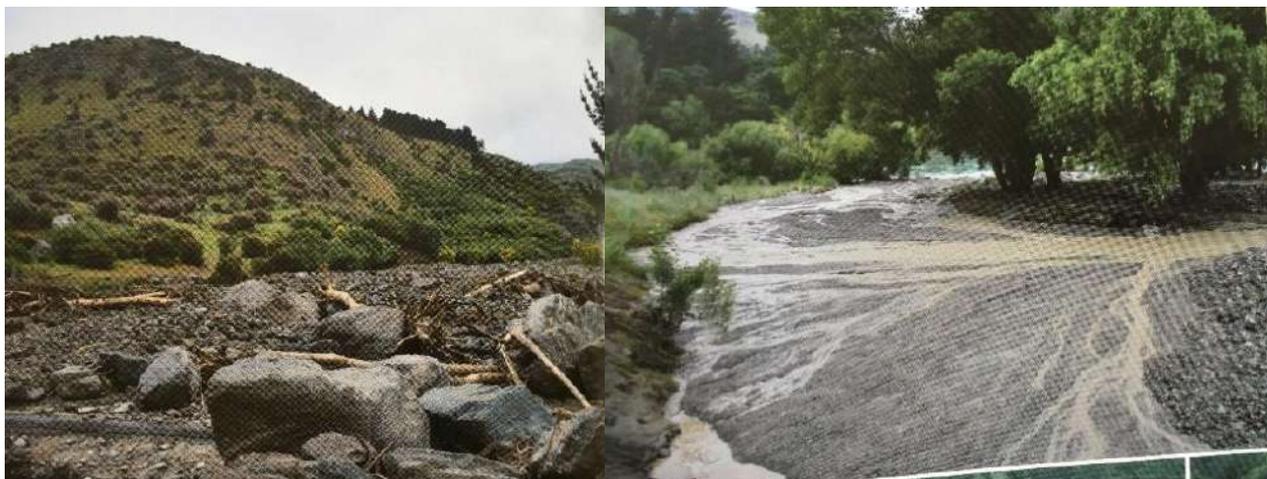
Figure 27: Black Jacks Creek - Nov 2017, left: view SH8 and upstream; right: view from SH8 downstream (source: Withington, Teviot Valley Tempest, 2018).

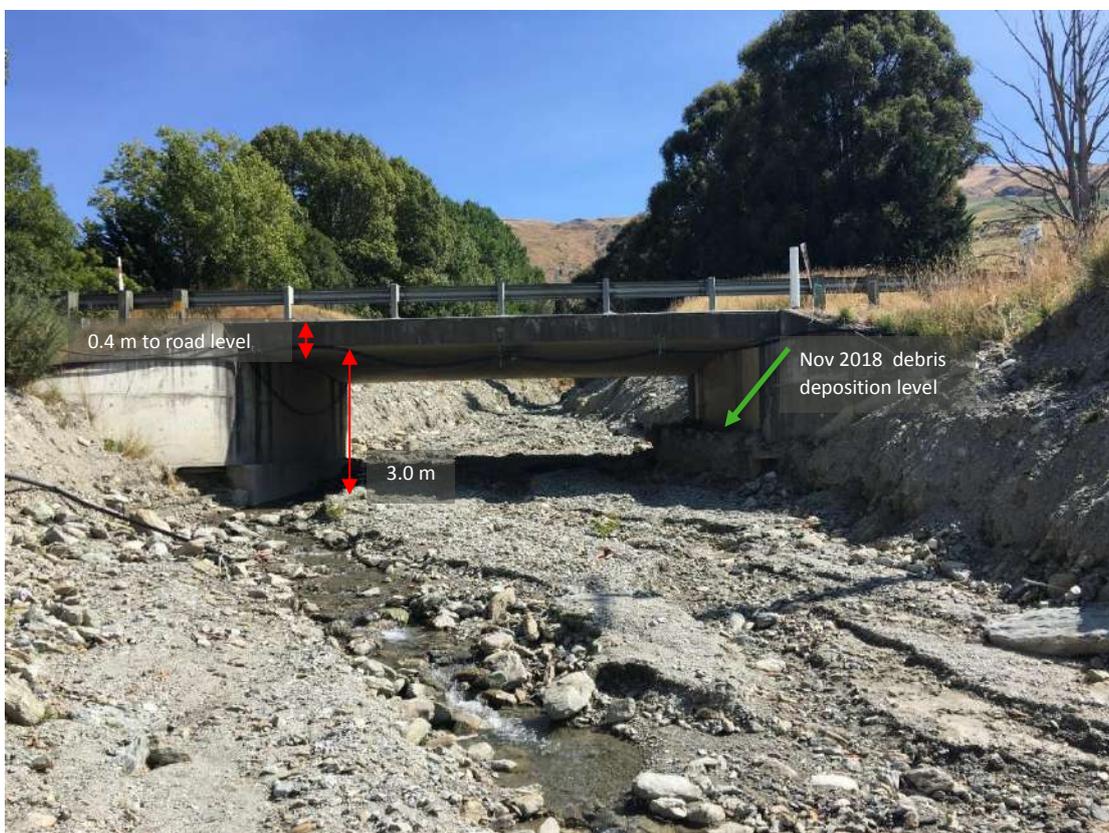
Figure 30: Stevensons Creek - SH8 crossing, view from downstream; channel recently cleared by heavy machinery.
