# Patterns of Water Quality in the Pomahaka Catchment

Otago Regional Council 2010

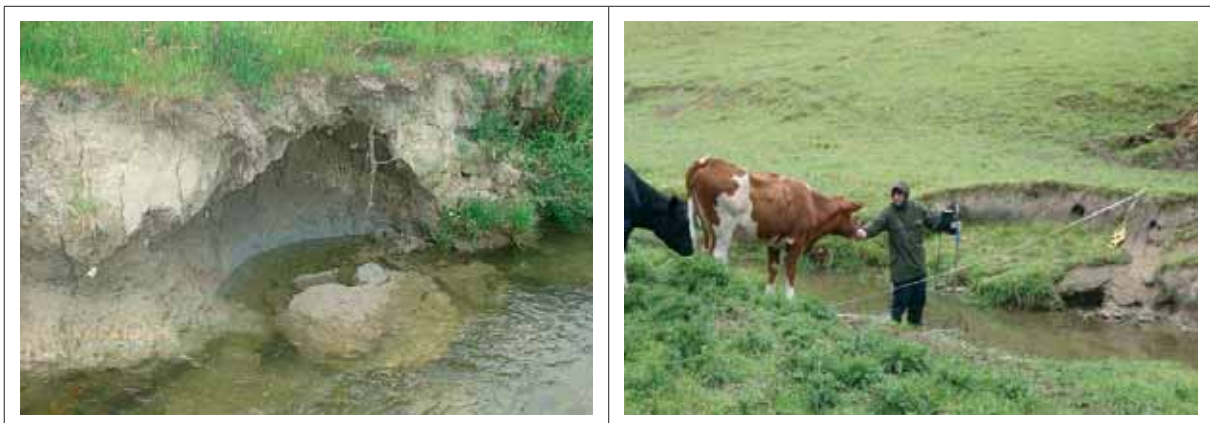
The results of the habitat surveys showed there is degradation in habitat condition in many of the tributaries to the Pomahaka River. There was generally a notable increase in finer sediment as the streams flowed through productive land. The sources of the fine sediment were unvegetated banks that showed active erosion, and which had signs of stock access (Figure E1). This was observed particularly in the Wairuna and Washpool streams, and the Heriot and Crookston burns. The Washpool stream was the most heavily sedimented stream with an estimated 100% sediment cover.

**Figure E-1: Stock access and bank slumping/collapse.**
