Pomahaka River catchment

Land use, water quality, and ecological health investigation

In December 2008, the Otago Regional Council (ORC) initiated an intensive investigation into water quality and ecological health in the Pomahaka River catchment, south-west Otago.

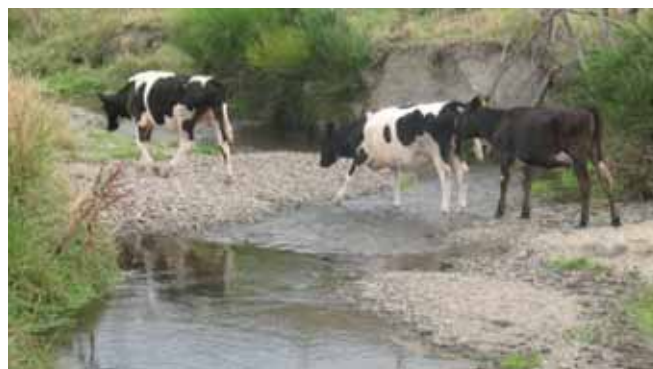
Cattle in an unfenced Pomahaka River tributary.

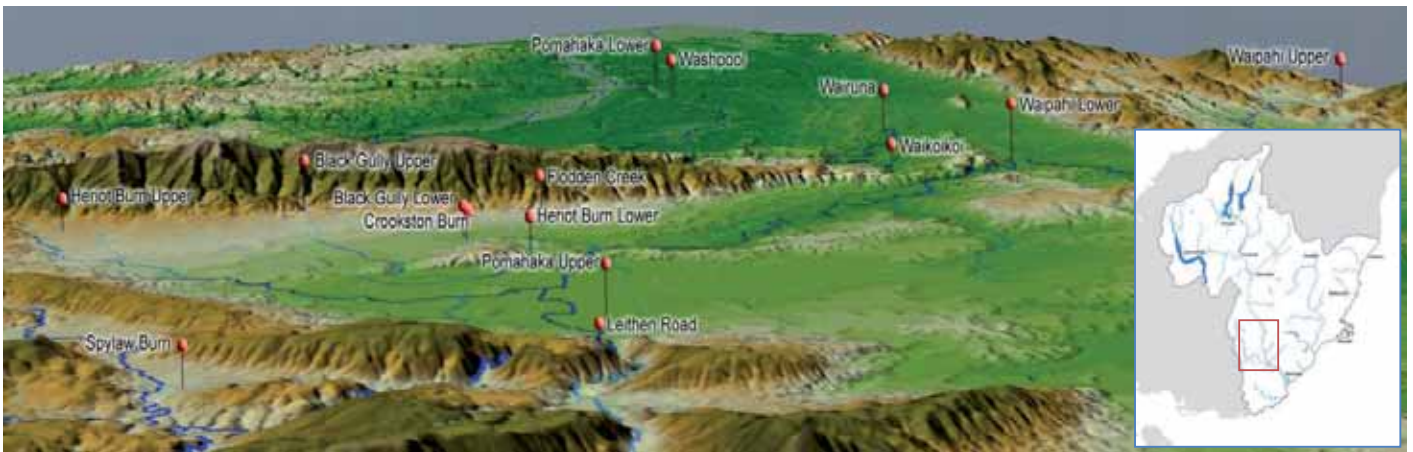
Sampling sites throughout the Pomahaka catchment.

Over a 14-month period, 10 water samples were collected monthly from 12 tile drains on land mainly used for dairy farming, and from nine tile drains from land predominantly used for sheep farming. Fifteen stream sites (including three control sites) were also sampled fortnightly for ten months. Water samples from the tile and mole drains, and the streams were analysed for nutrients (dissolved reactive phosphorus (DRP), total phosphorus (TP), nitrite-nitrate nitrogen (NNN), total nitrogen (TN) ammoniacal nitrogen (NH_4), suspended sediment (SS), and faecal bacteria (*Escherichia coli* (*E. coli*)). In the 2009-2010 summer, all streams had physical habitat, macroinvertebrate communities, and fish communities assessed to quantify the effect, if any, poor water quality was having on instream values.

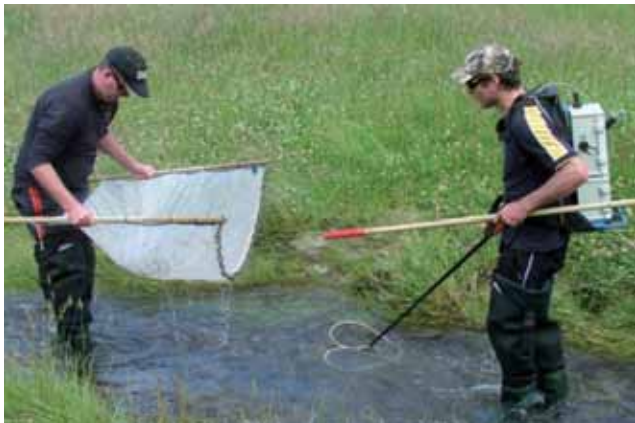
Electric fishing in the upper Heriot Burn.

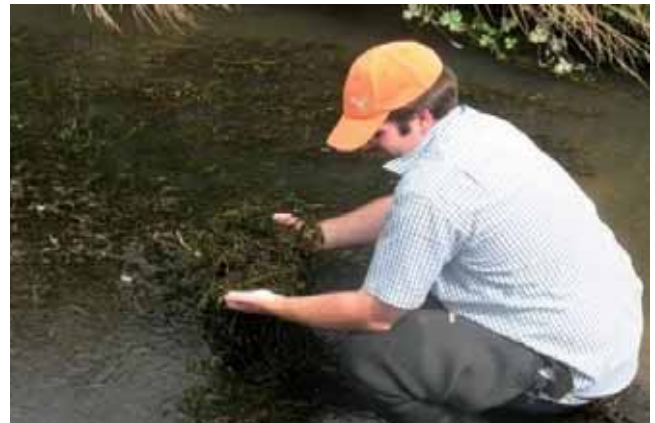
A dense macrophyte mat that has proliferated in the Wairuna River (common in nutrient enriched waterways).

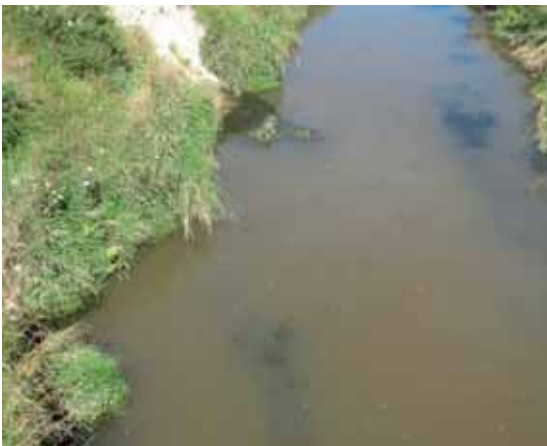
Turbid water in the Wairuna Stream during base flow in the middle of summer.

SS concentrations in the upper Herriot Burn, upper Waipahi River, lower Waipahi River, and the Wairuna are excessively high. These high values are likely to be the result of stock access, natural stream bank erosion during high flows, and channelised streams naturally claiming back their original morphology. DRP concentrations were above the guideline value in the Crookston Burn, Wairuna Stream, and Washpool Stream, with the latter two sites having excessively high DRP (probably as a result of inappropriate dairy effluent management). NNN concentrations were also well above the guideline value in all streams, except for the control sites. However, these values may be of less concern as they are at their highest during the winter when there is a low risk of prolific algal growth and during summer, algal growth is likely to be limited by DRP.

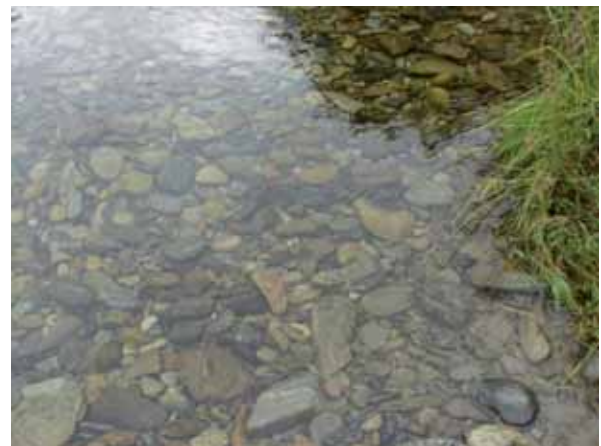
Coarse gravel substrate at upper Black Gully. This is what streams flowing through agricultural land can look like with good riparian management.

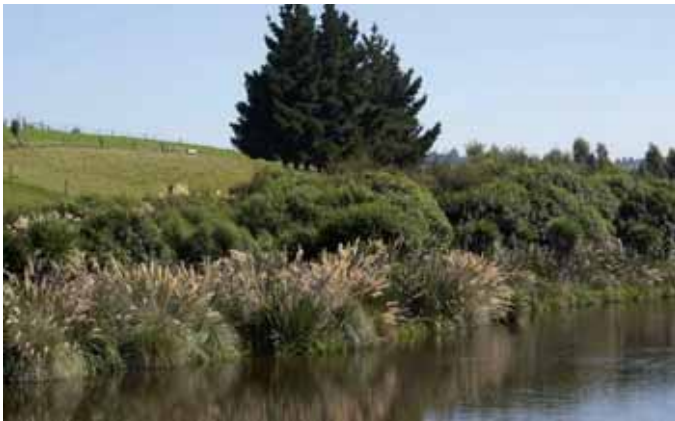
Well-planted riparian buffers provide a range of ecological and aesthetic benefits.

Streams such as the Herriot Burn, lower Black Gully, and Crookston Burn would all benefit from stream fencing and riparian planting.

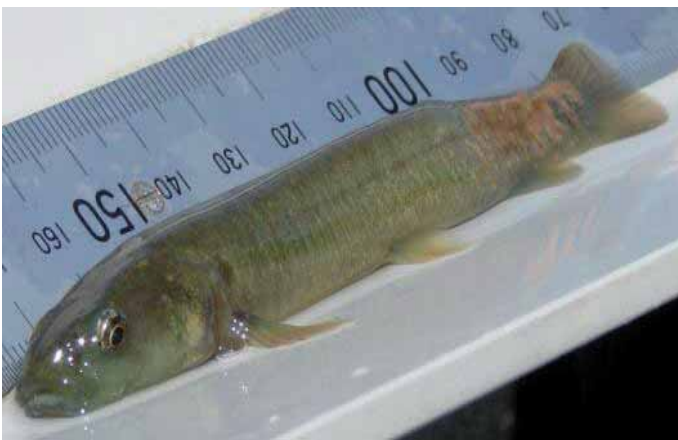
Clutha flathead galaxiid (*Galaxias Sp. D*), which is a threatened native species due to predation by invasive species and habitat loss through fine sediment smothering habitat.

Fishery surveys revealed that poor water quality did not always result in degraded fish communities (such as in the Crookston Burn, which had poor water quality, but good trout communities). There are a number of streams that, with minimal improvements in land use management, could support excellent fish populations in the near future. Spylaw Burn, Leithen Burn, and Crookston Burn all had excellent trout populations, while the upper Black Gully site had excellent populations of native fish (primarily Clutha Flathead galaxiids).

The Washpool Stream and Wairuna Stream all had poor trout populations, and were the worst two sites in the entire catchment for fish values. The biggest threat to fish populations in this study was the impact of fine sediment through bank erosion (both natural and stock induced). This is because fine sediment smothers the habitat necessary for invertebrates (fish food) and fish. Sediment can also introduce phosphorus to streams, because it tends to attach to sediment. *E.coli* is harboured in fine sediments and is re-suspended during higher flows.
