TECHNICAL COMMITTEE AGENDA

11.1. Director's Report on Progress

Prepared for: Technical Committee
Report No. EHS1834
Activity: Governance Report
Prepared by: Gavin Palmer, Director Engineering, Hazards and Science
Date: 23 November 2018

2. November 2018 Otago Flood

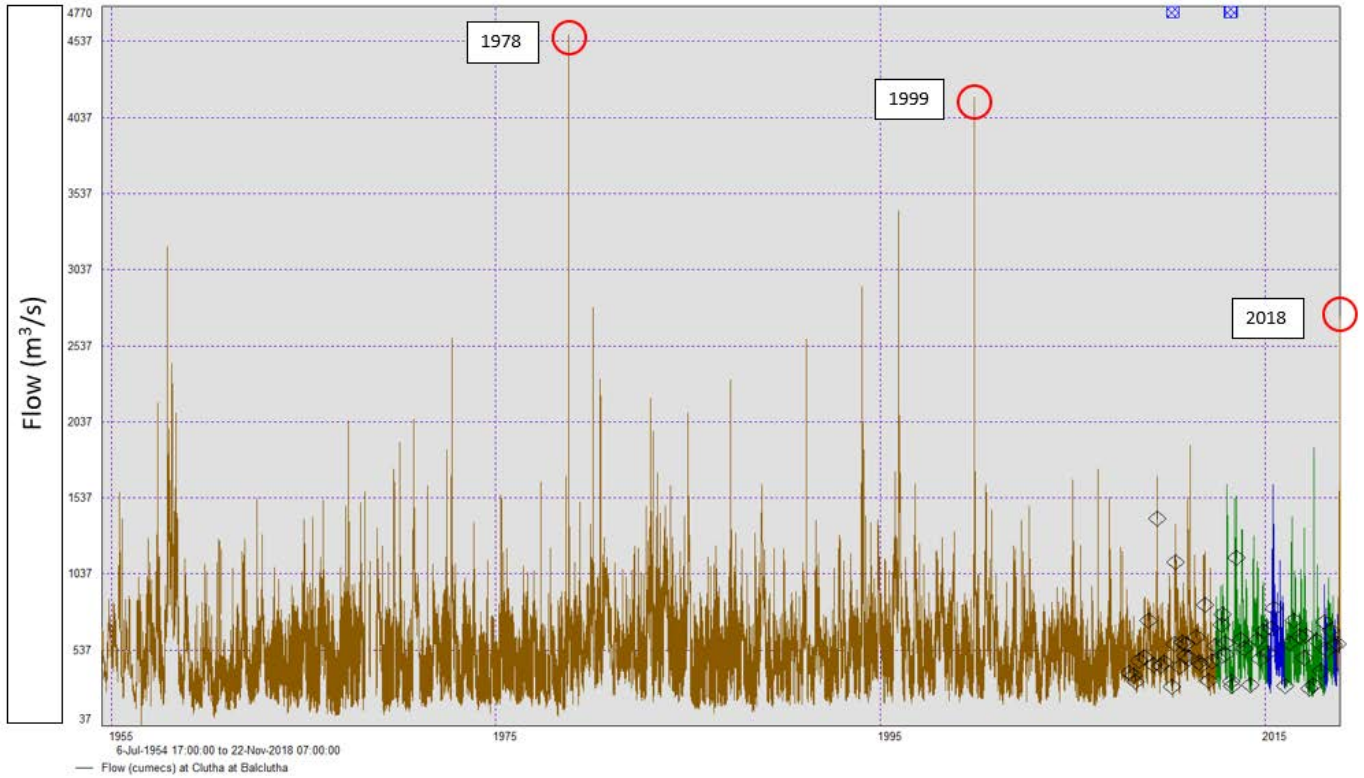
Figure 1. Flow in Clutha River/Mata-Au at Balclutha, 1954 to present.

The Lower Clutha Flood Protection and Drainage Scheme¹ and the Lower Taieri Flood Protection Scheme² reduced the flood hazard during the event for approximately 30,000 hectares of land including the townships of Balclutha and Mosgiel and Dunedin International Airport. The peak flow in the Clutha River/Mata-Au (2,700m³/s) was the highest since 1999 (Figure 1). The flow came very close to the design flow for the Barnego flats (2,850m³/s) but was less than the design flow (5,600m³/s) for Balclutha (Figure 2). The Inch Clutha floodway operated for the first time since 1999 and for the first time since the spillway gates were removed in 2011. The gates were removed to eliminate risks associated with operating them.

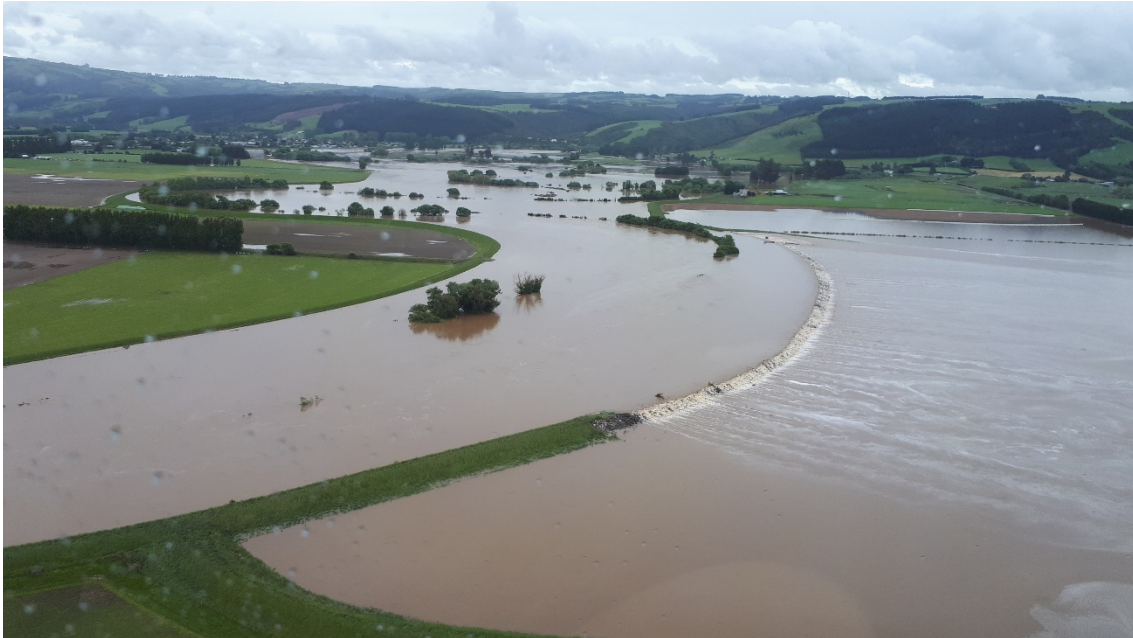
Figure 3. Riverside Spillway (Lower Taieri Flood Protection Scheme) at 1052hrs on 21 November 2018. Water is flowing into the East Taieri Upper Pond at right. The Taieri River (at left) was flowing at approximately 900m³/s, after peaking at 1,400m³/s approximately 11 hours earlier.

Overflow occurred at the Riverside Spillway (Taieri River) for approximately 32 hours (Figure 3), commencing on the morning of 20 November. Up to 29 million cubic metres of water was detained in the East Taieri Upper Pond, reducing the peak flow in the Taieri

River further downstream. The ponding area has a capacity of approximately 35 million cubic metres. Water levels in the Lower Taieri River remain high and so the remaining capacity is being closely monitored.

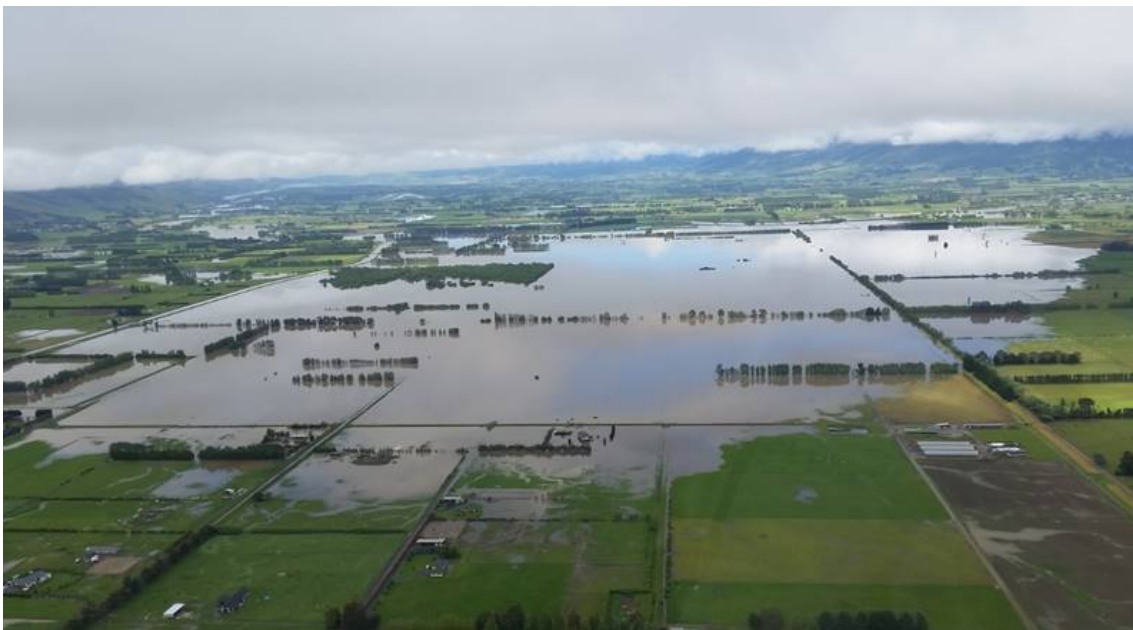
Figure 4. Looking south to the East Taieri Upper Pond (Lower Taieri Flood Protection Scheme) at 0945hrs on 22 November 2018. The pond had just reached its maximum height and volume for this event, to date (approximately 29 million cubic metres of water). The Taieri River and Riverside Spillway (Figure 3) are at the far end of the pond.

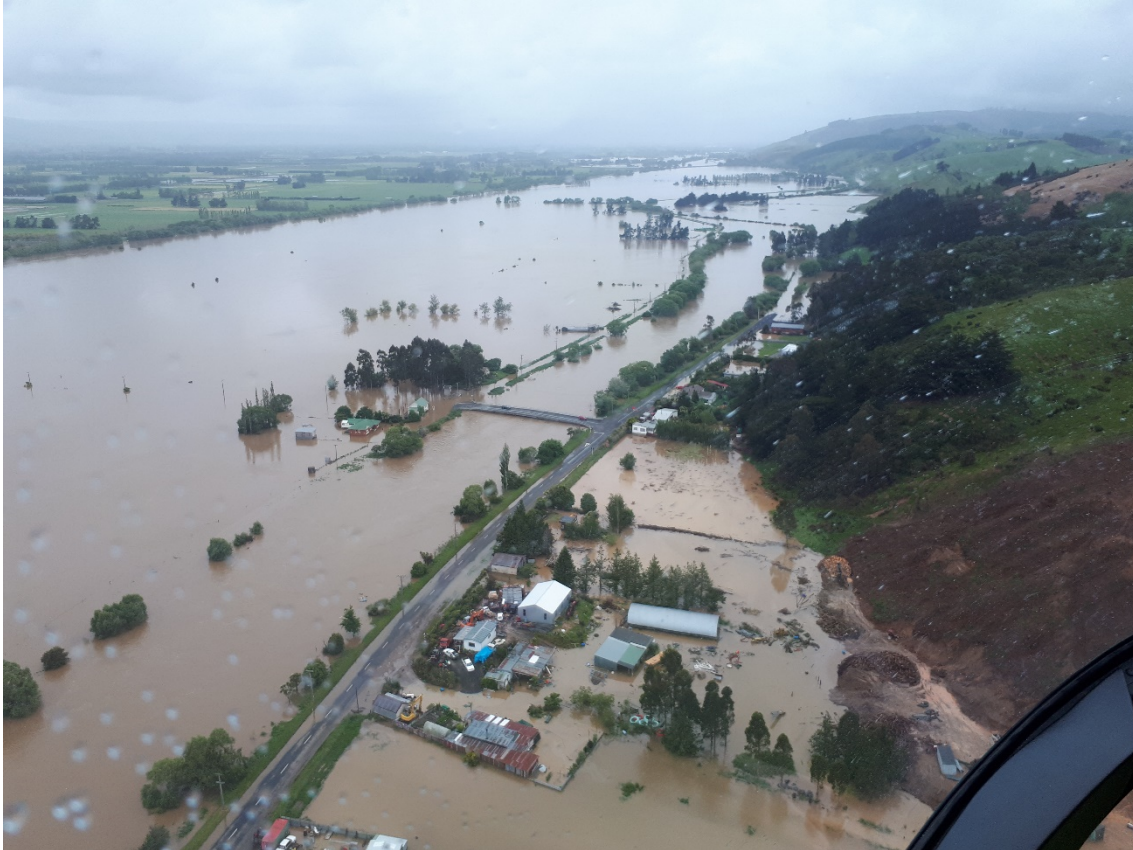
Figure 5. Henley settlement, looking north, at 1133hrs on 21 November 2018. The Taieri River and Silver Stream had peaked earlier that day. The Henley floodway (Henley Outer Bank Area) is at left. The road bridge across the Taieri River is at centre.

The settlement of Henley was flooded and as at the date of this report parts of it remain underwater (Figure 5). Similar flooding occurred in 2006, 2007, 2010, 2013, 2015 and 2017. The settlement lies outside the primary floodbanks of the Lower Taieri Flood Protection Scheme and outside the West Taieri Drainage Scheme.

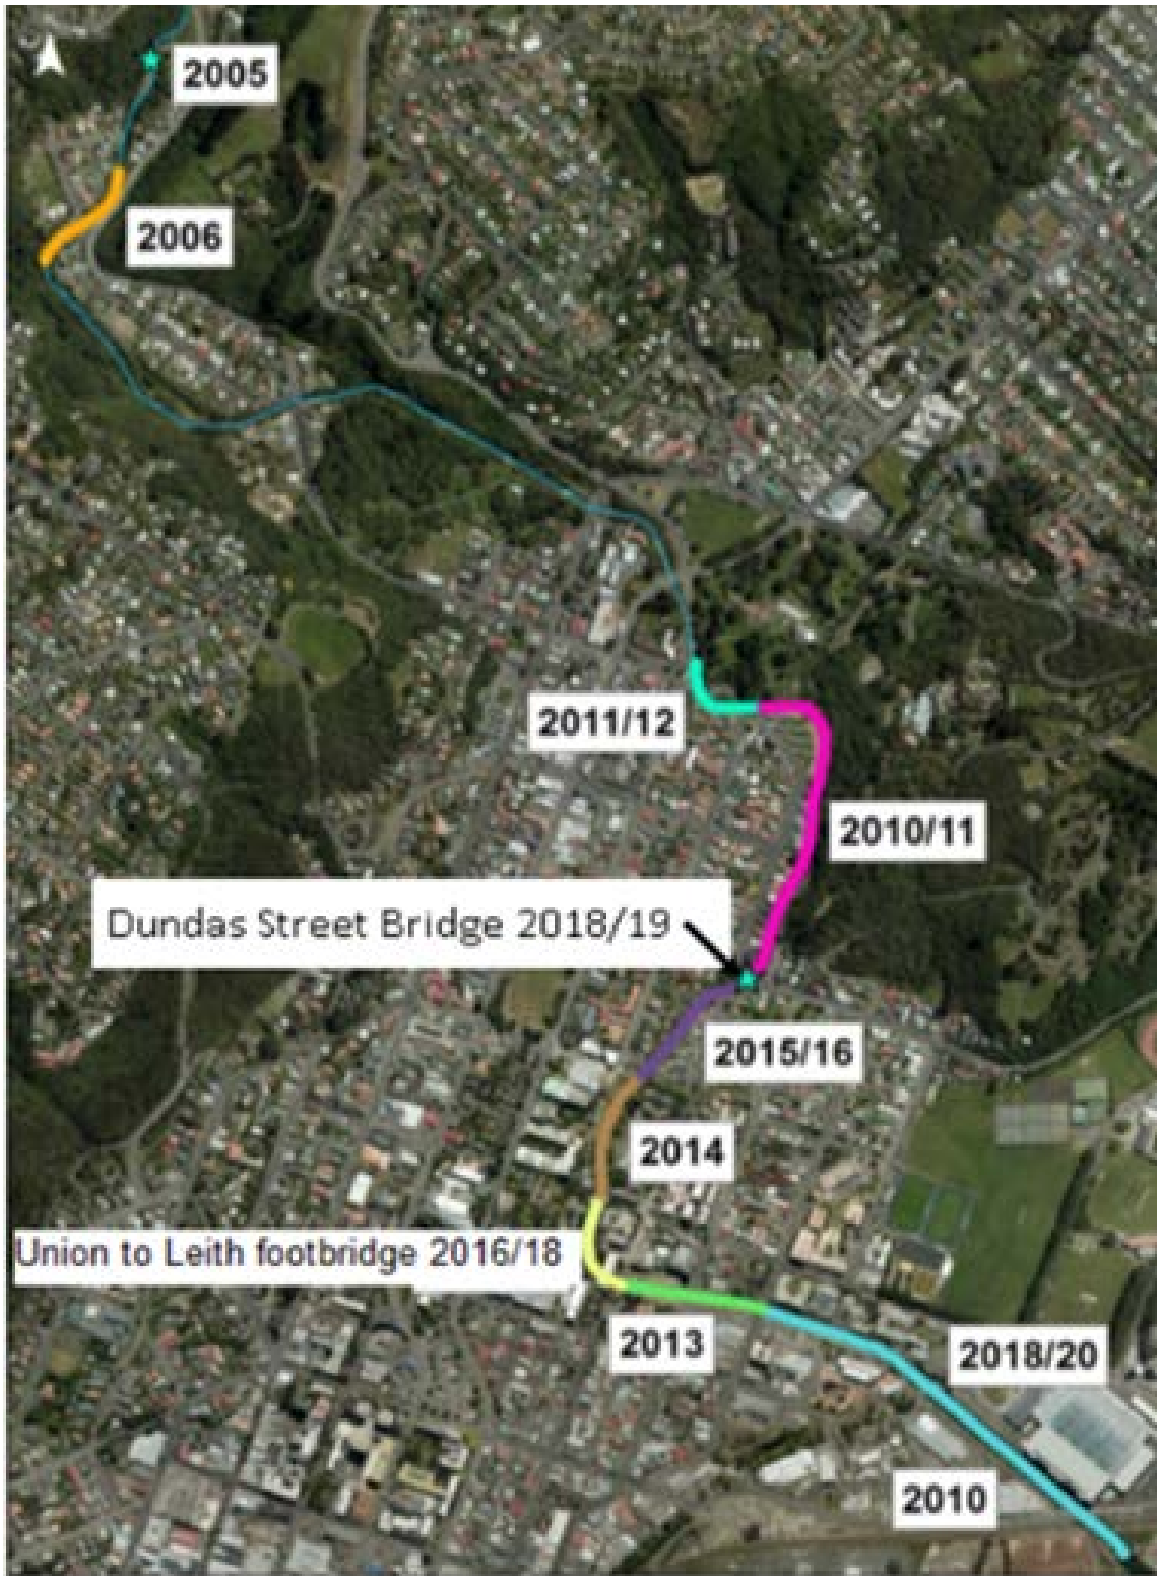
Figure 6. Staging of construction of the Leith Flood Protection Scheme.

In accordance with the resolution made by Council on 31 October 2018, a contract for construction of the Dundas Street Bridge stage has been formed with Downer New Zealand Limited (Downer). The contract sum is \$2,726,830.69 (excluding GST). The proposed works will complete the flood protection capital works of the Leith Flood Protection Scheme (Figures 6 and 7).

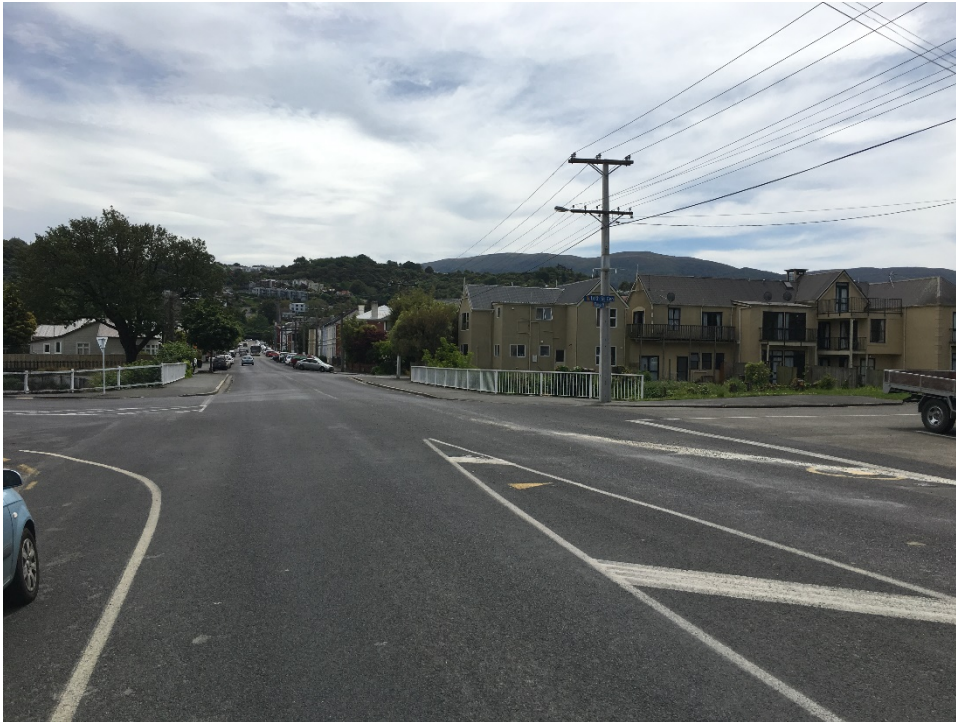
Figure 7. Looking west along Dundas Street to Dundas Street bridge (14 November 2018). The Water of Leith flows under the bridge from right to left.

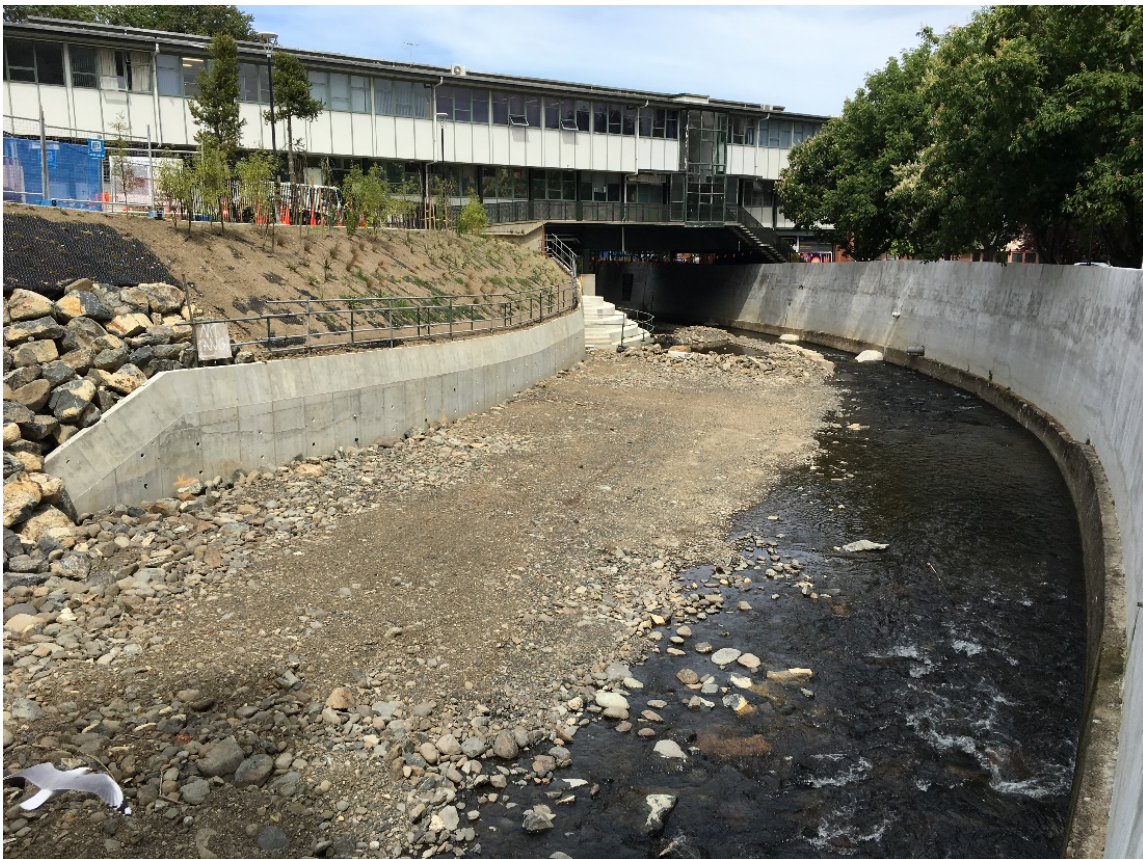
Figure 8. Looking downstream along the bed of the Water of Leith towards the Information Technology Services (ITS) Building (14 November 2018). River flows have been temporarily diverted to the right.

Engineering works on the Union to Leith Footbridge stage of the Scheme resumed on 12 November 2018 following the planned shutdown during the most recent university examination period (17 October to 11 November 2018). The shutdown avoided noise and disruption to students and staff. The last of the instream bed level control weirs are being constructed and rock riprap is being placed between the weirs (Figures 8 and 9). These works were disrupted by the flood that occurred on 20 November 2018 (see 2 above). Downer has advised that it will take approximately one week to reinstate the work site, including the haul road, to its pre-flood state. They advise that this stage of the Scheme will be completed in December 2018. For reasons of efficiency Downer has been retained to repair flood damage near the Leith footbridge, some of which occurred in earlier floods. This will require only a small area of land to be worked on, outside of the river bed.

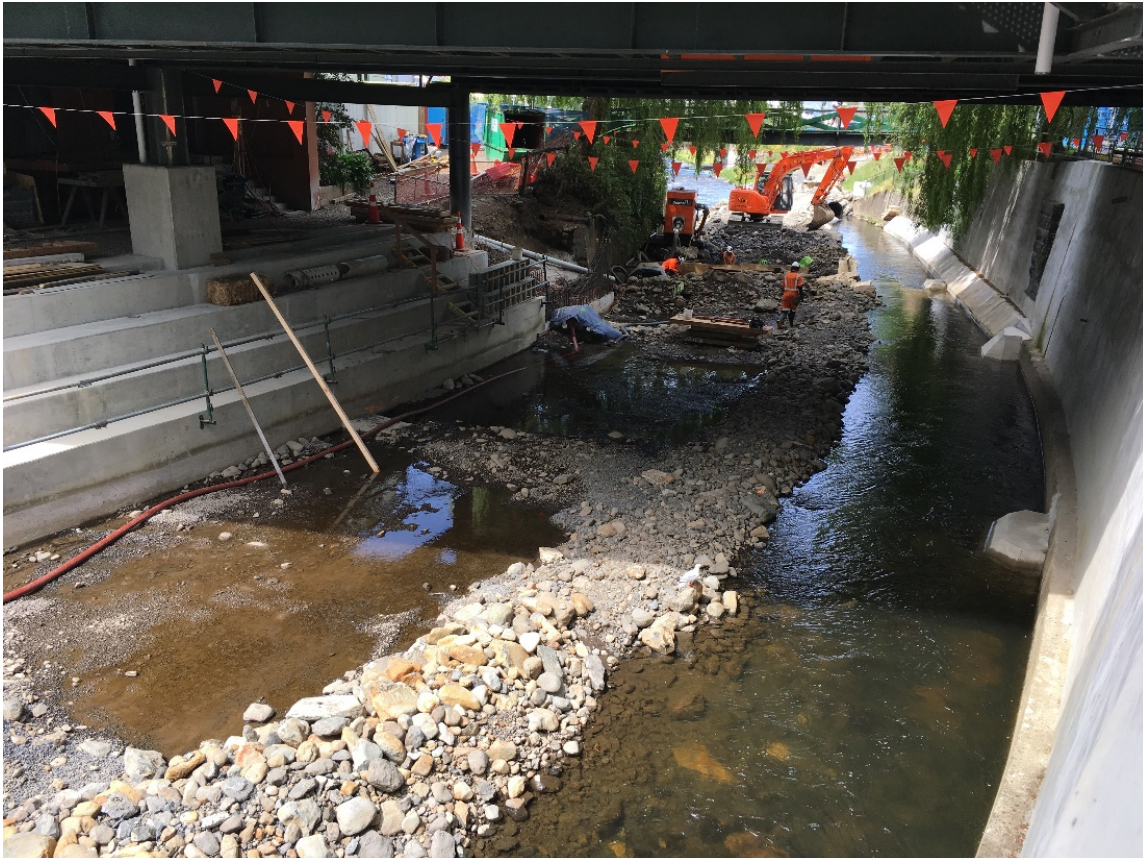
Figure 9. Looking downstream along the bed of the Water of Leith under the Information Technology Services (ITS) Building (14 November 2018). Work is taking place on the last of the instream weirs.
