Technical Committee - 21 March 2019 Attachments

8.1. Minutes.....	2
8.1.1. Minutes of Technical Committee - 30 January 2019.....	2
10.1. Leith Amenity Enhancement.....	7
10.1.1. Appendix 1 Images of Working Group Development Concepts A 3 Size.....	7

Water of Leith Flood Protection Scheme. Forth Street - Harbour
Amenities Improvement Concept

Waitaki District Coastal Hazards

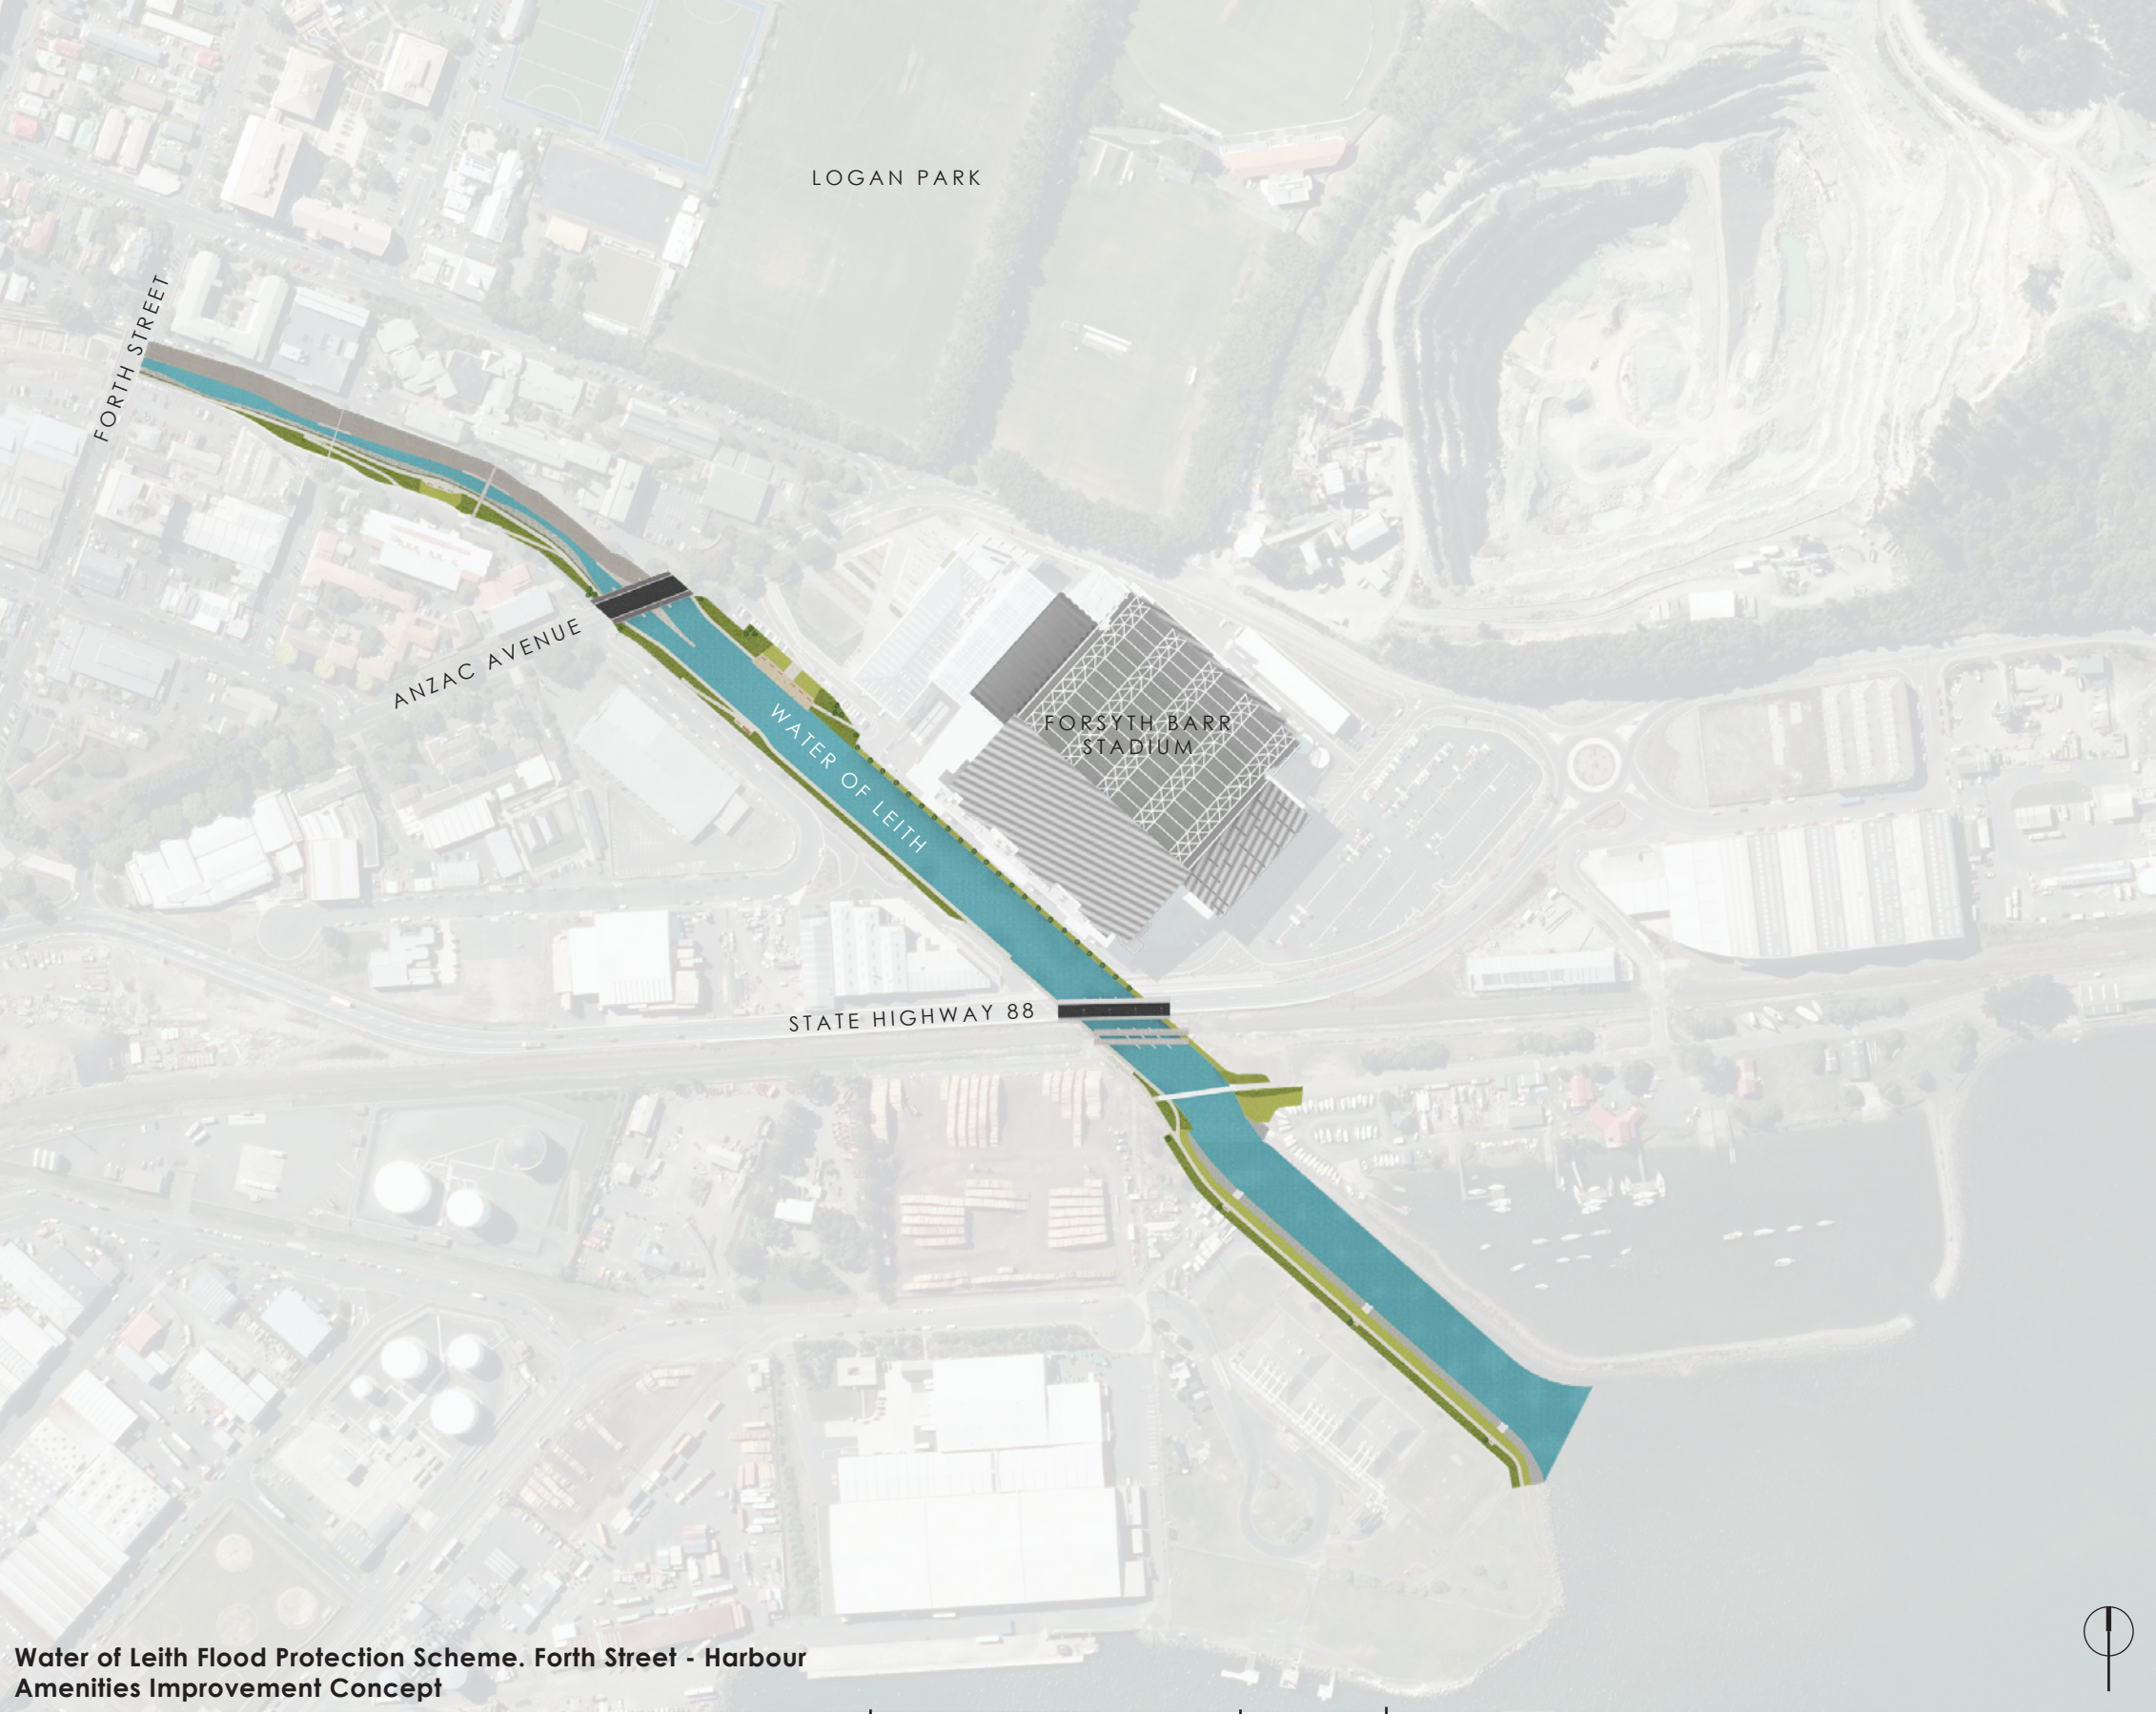
client / project name: OTAGO REGIONAL COUNCIL
drawing name: **FORTH STREET TO HARBOUR - OVERALL PLAN**
designed by: Dave Compton-Moen / Mike Moore
original issue date: 17 MAY 2018
scales: 1:4000 @ A3

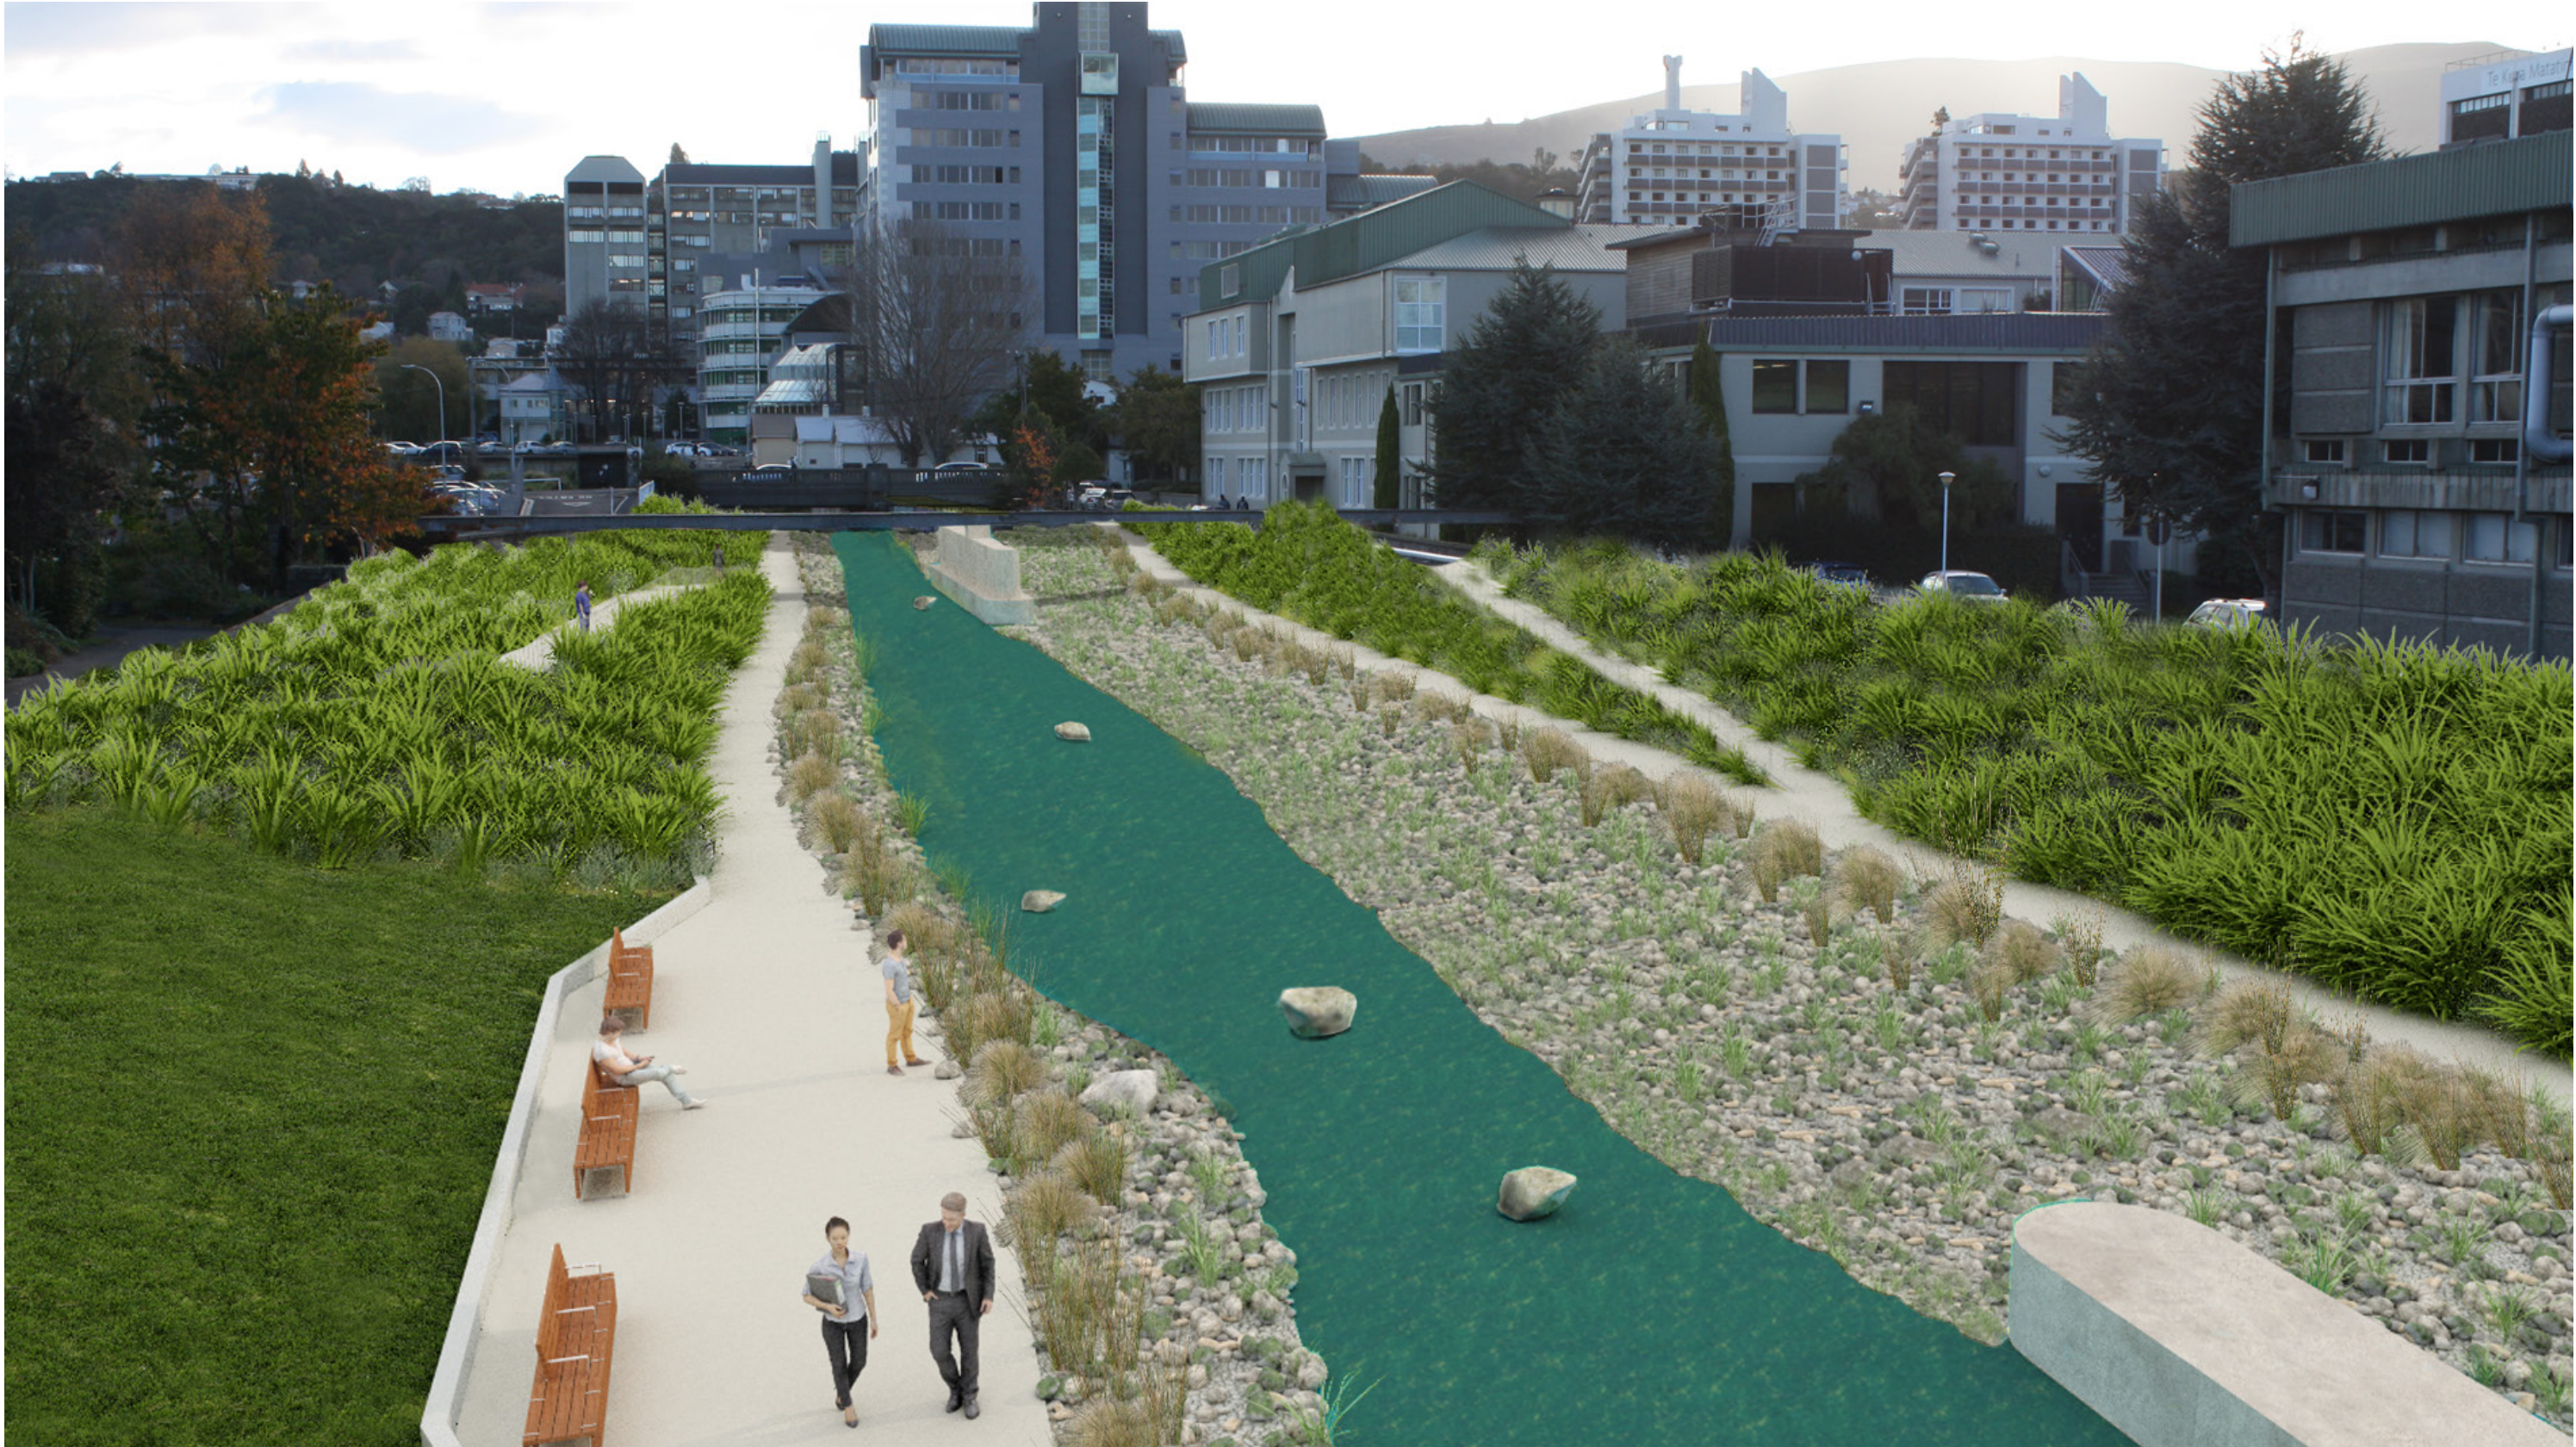
client / project name: OTAGO REGIONAL COUNCIL
drawing name: **FORTH STREET TO ANZAC AVENUE - PERSPECTIVE A**
designed by: Dave Compton-Moen / Mike Moore
original issue date: 17 MAY 2018
scales: NTS

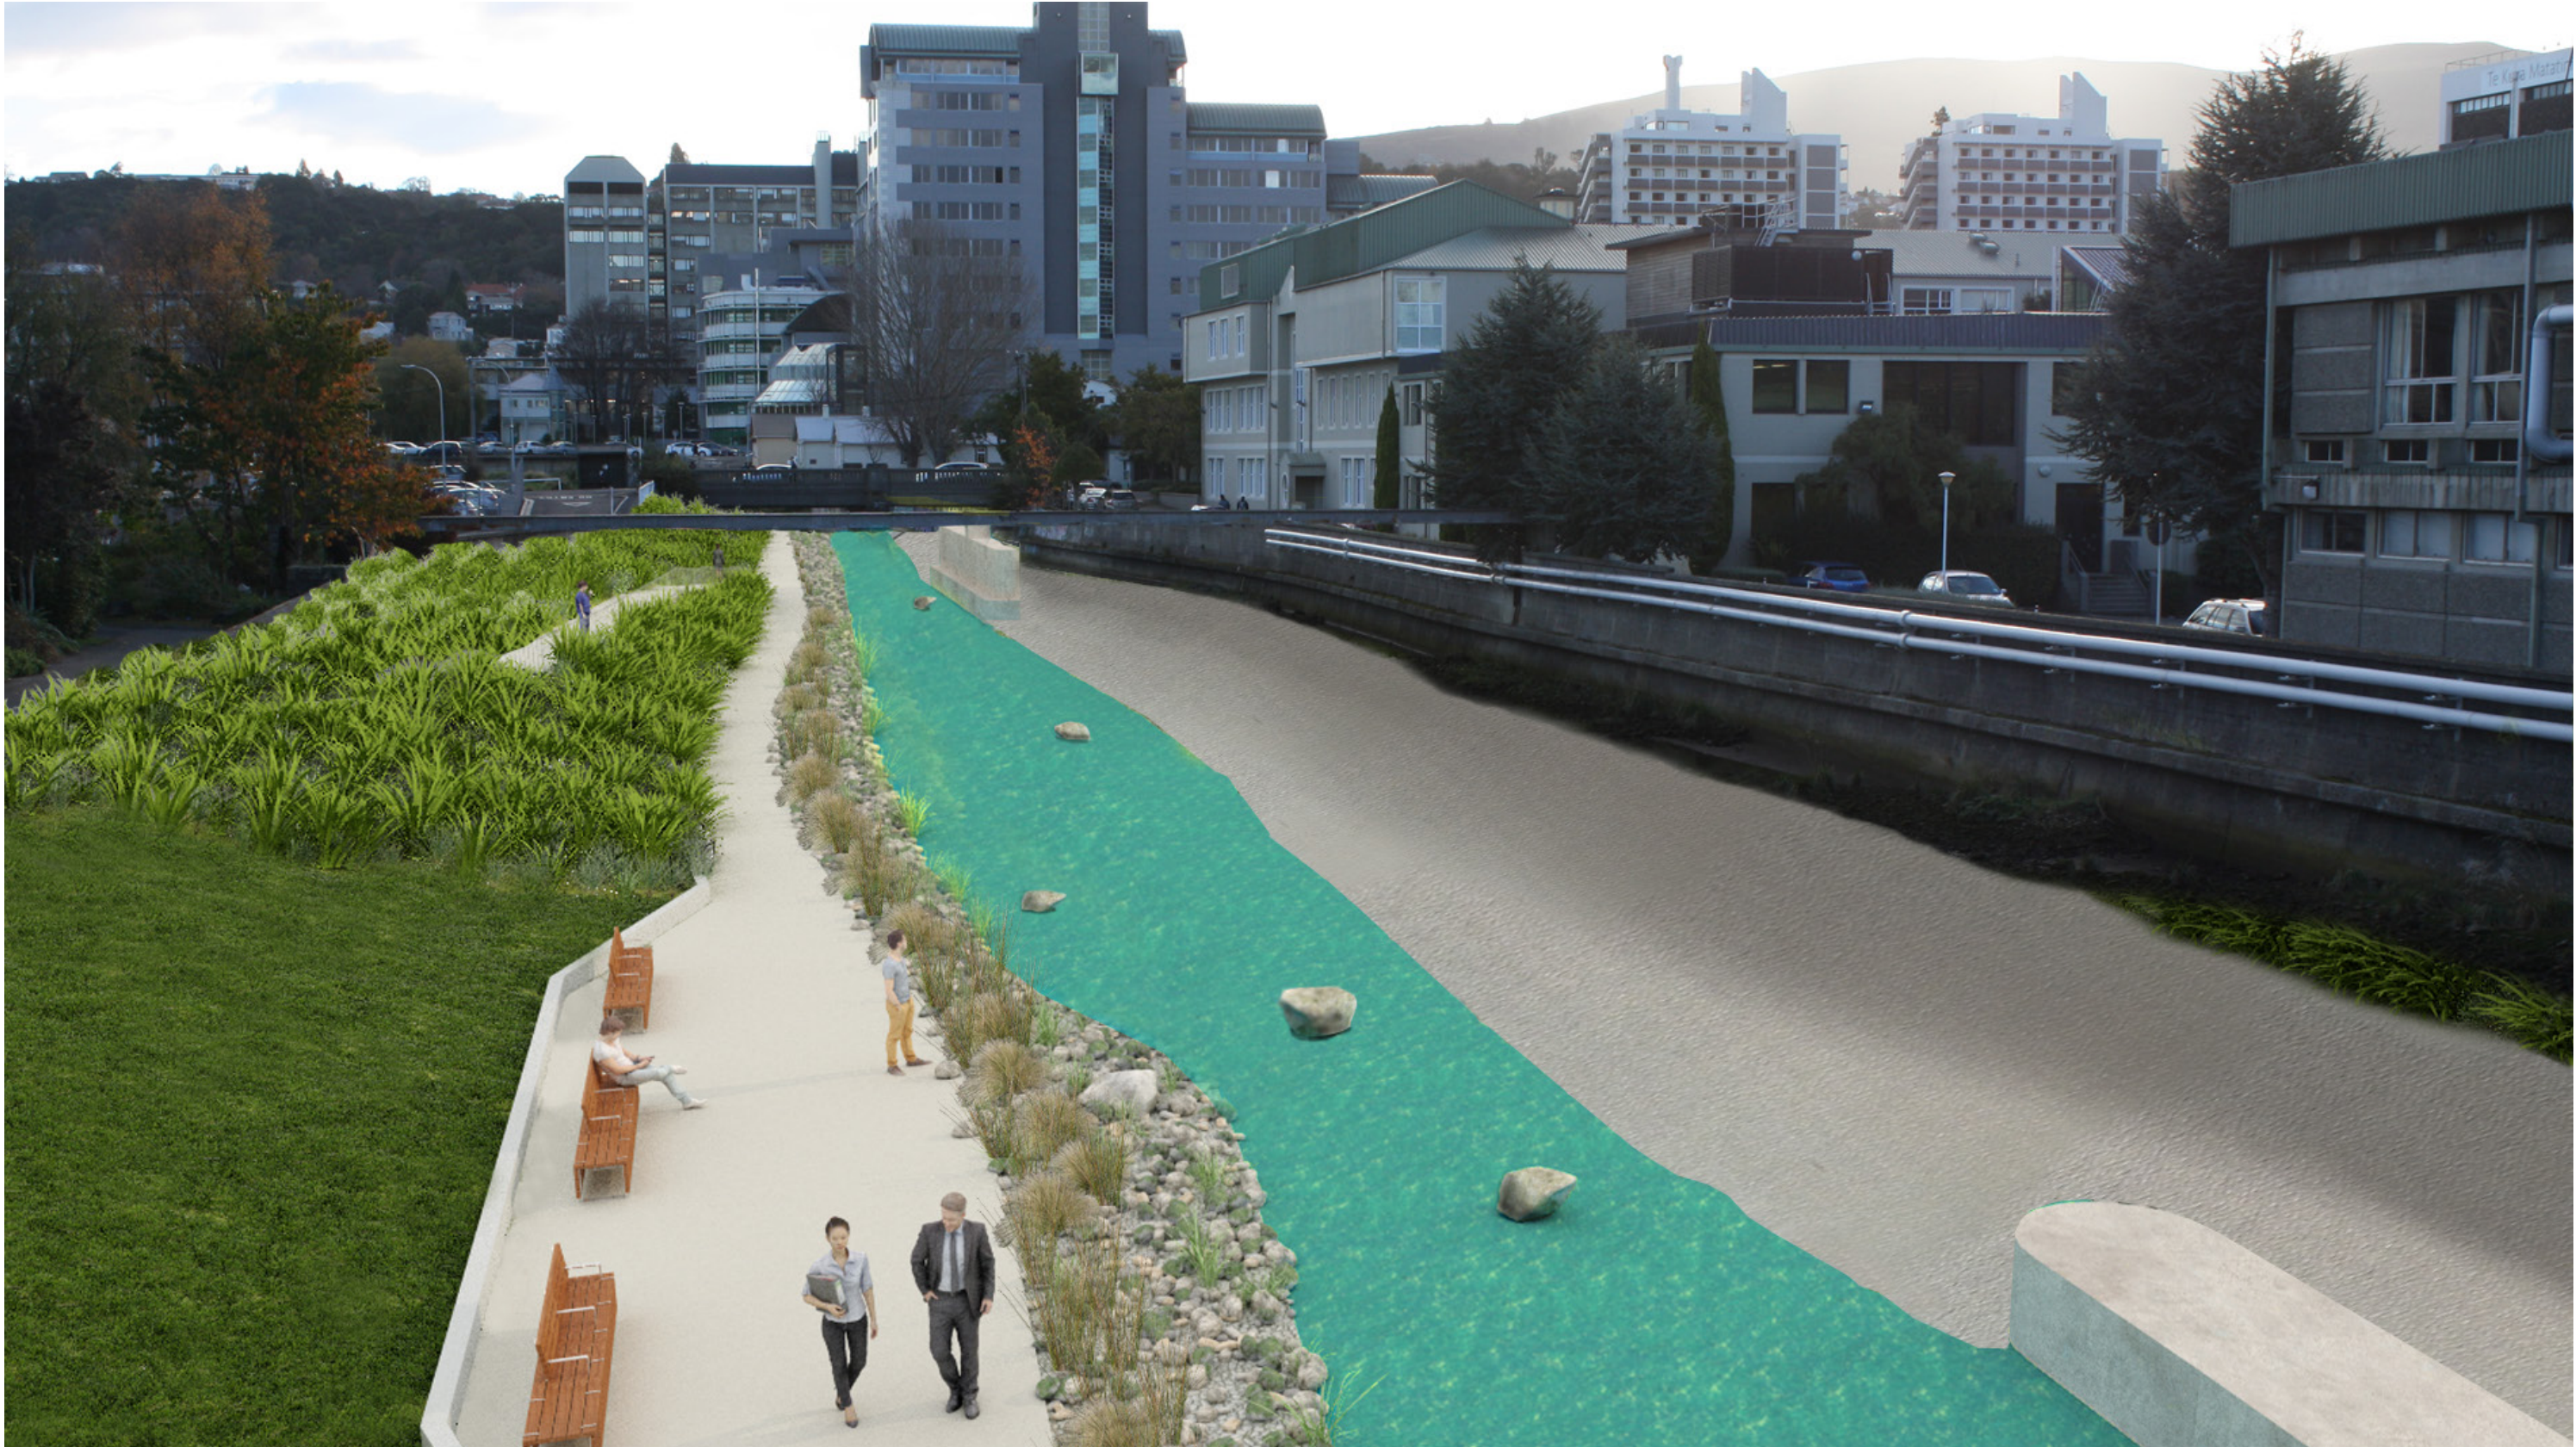
client / project name: OTAGO REGIONAL COUNCIL
drawing name: **FORTH STREET TO ANZAC AVENUE - PERSPECTIVE A- OPTION 2**
designed by: Dave Compton-Moen / Mike Moore
original issue date: 17 MAY 2018
scales: NTS

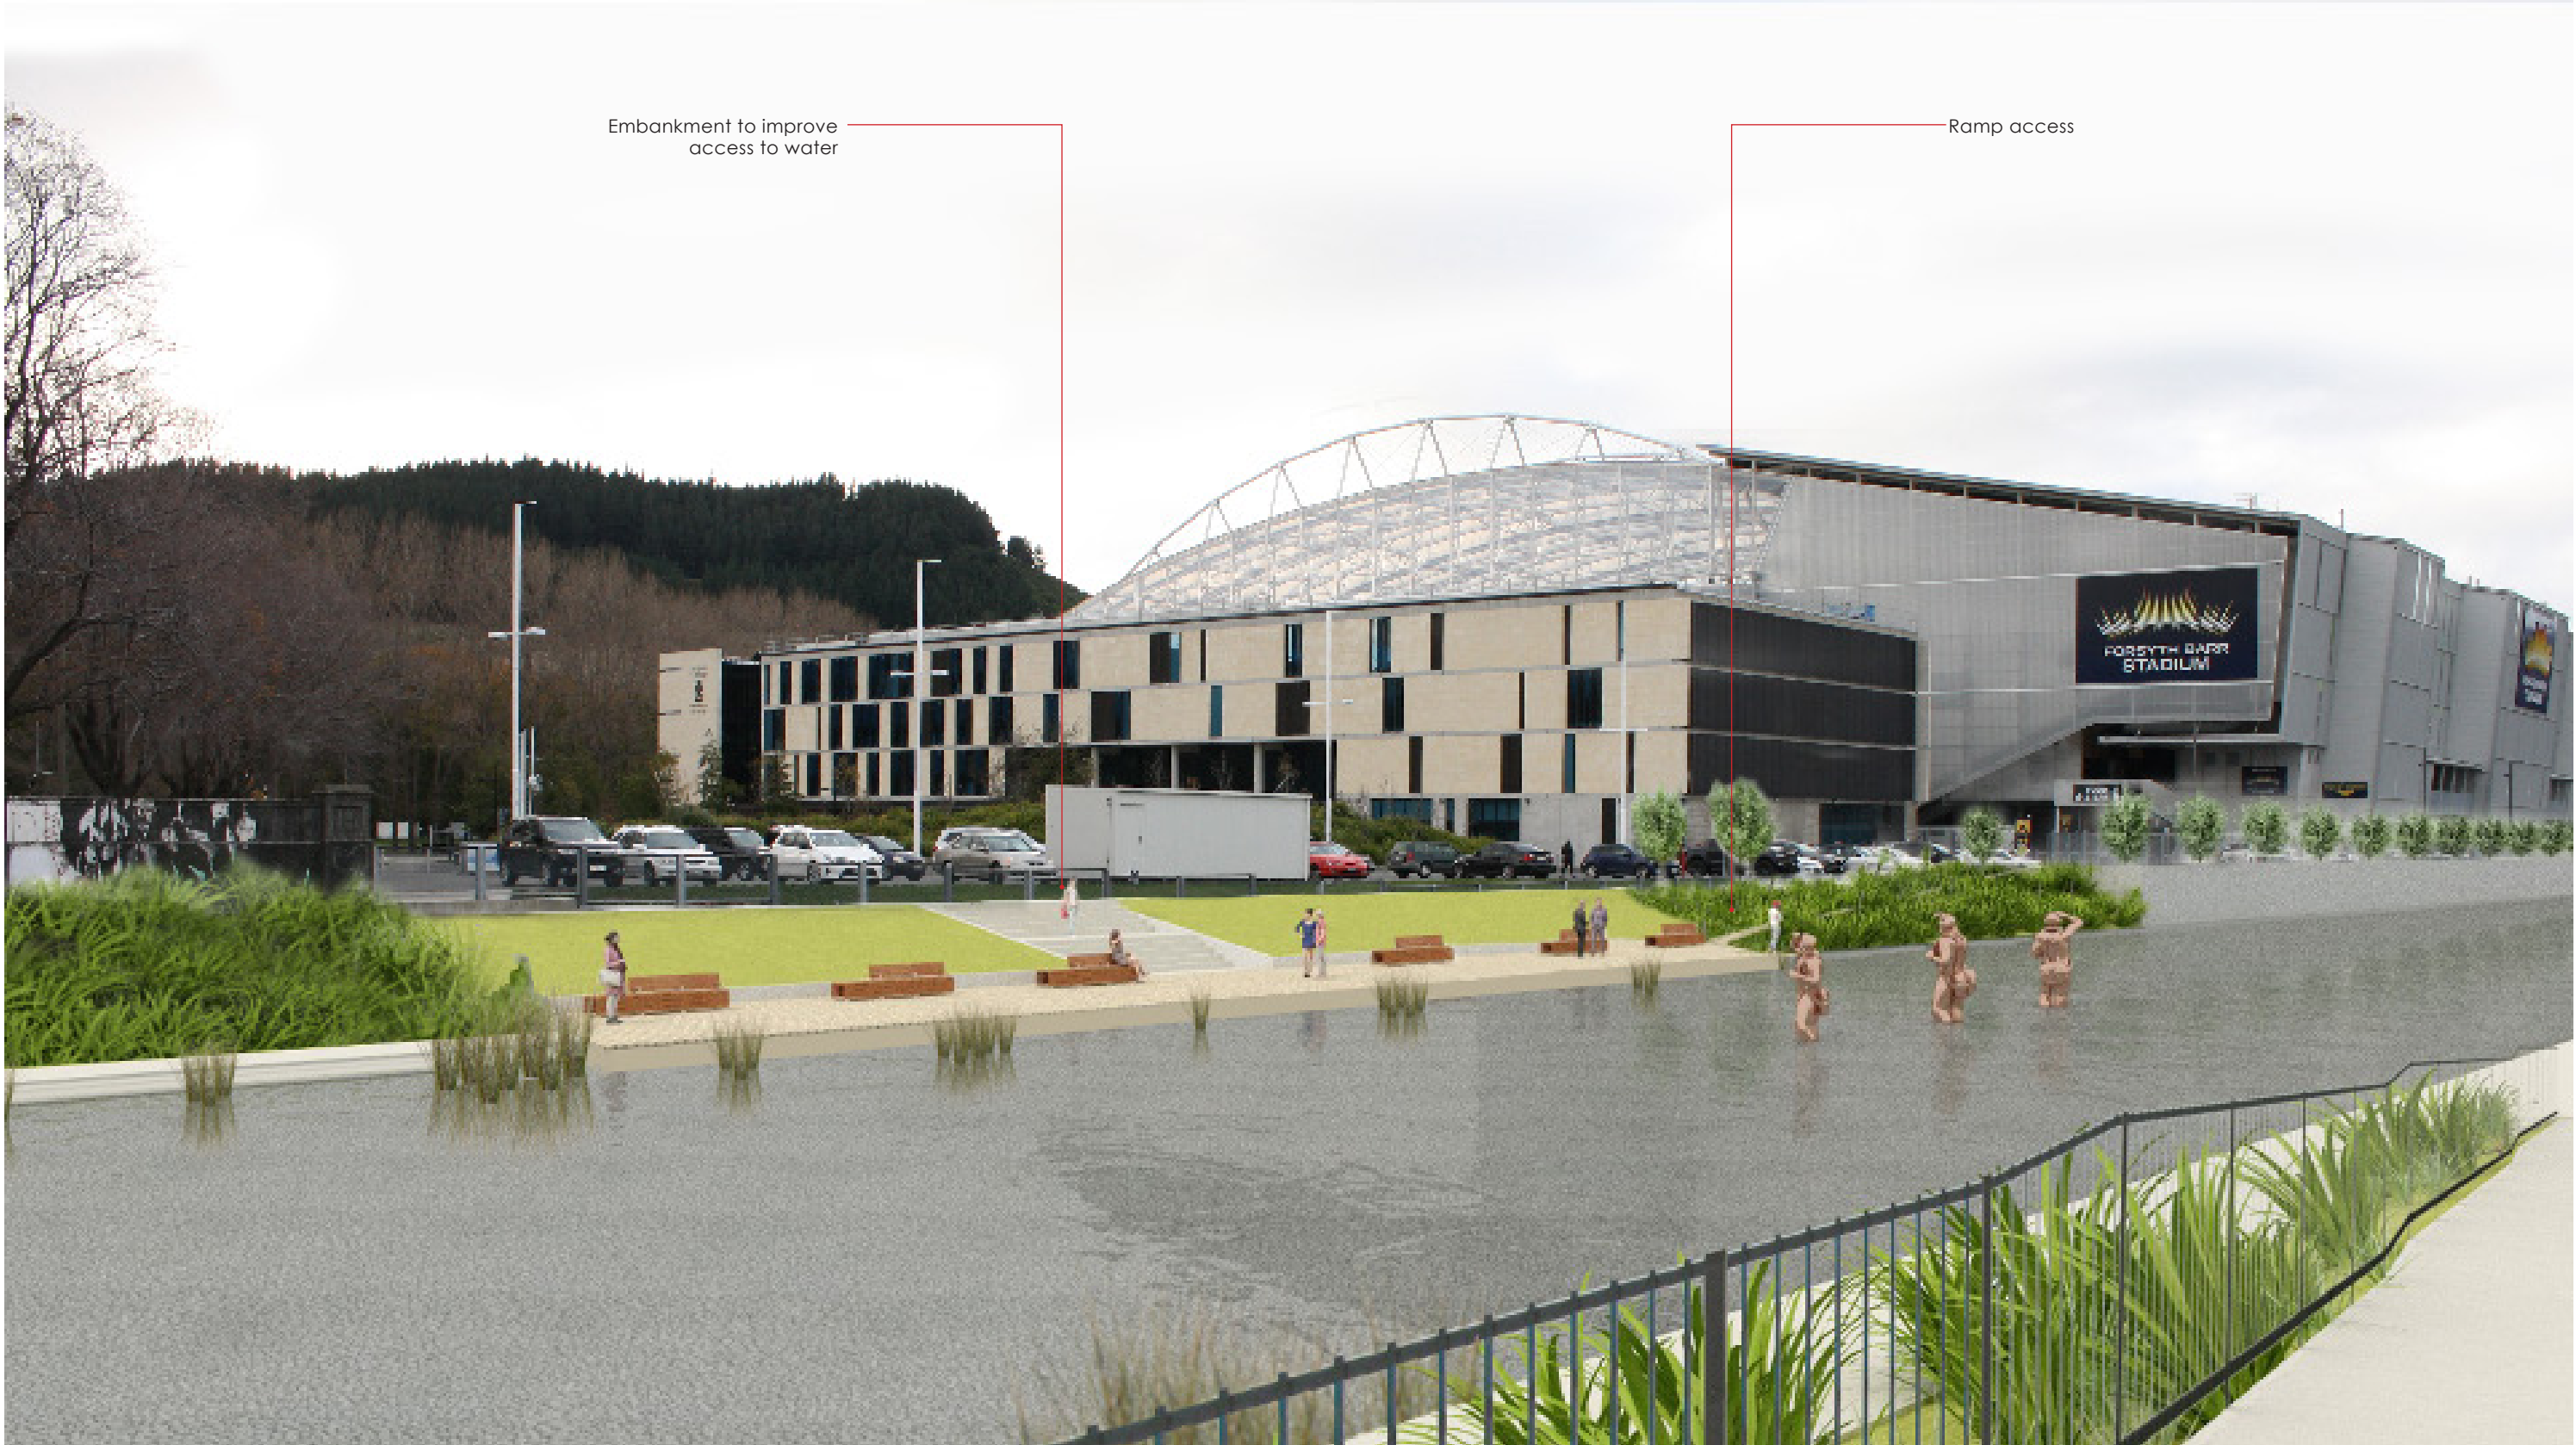
client / project name: OTAGO REGIONAL COUNCIL
drawing name: **ANZAC AVENUE TO STATE HIGHWAY 88 - PERSPECTIVE B**
designed by: Dave Compton-Moen / Mike Moore
original issue date: 17 MAY 2018
scales: NTS

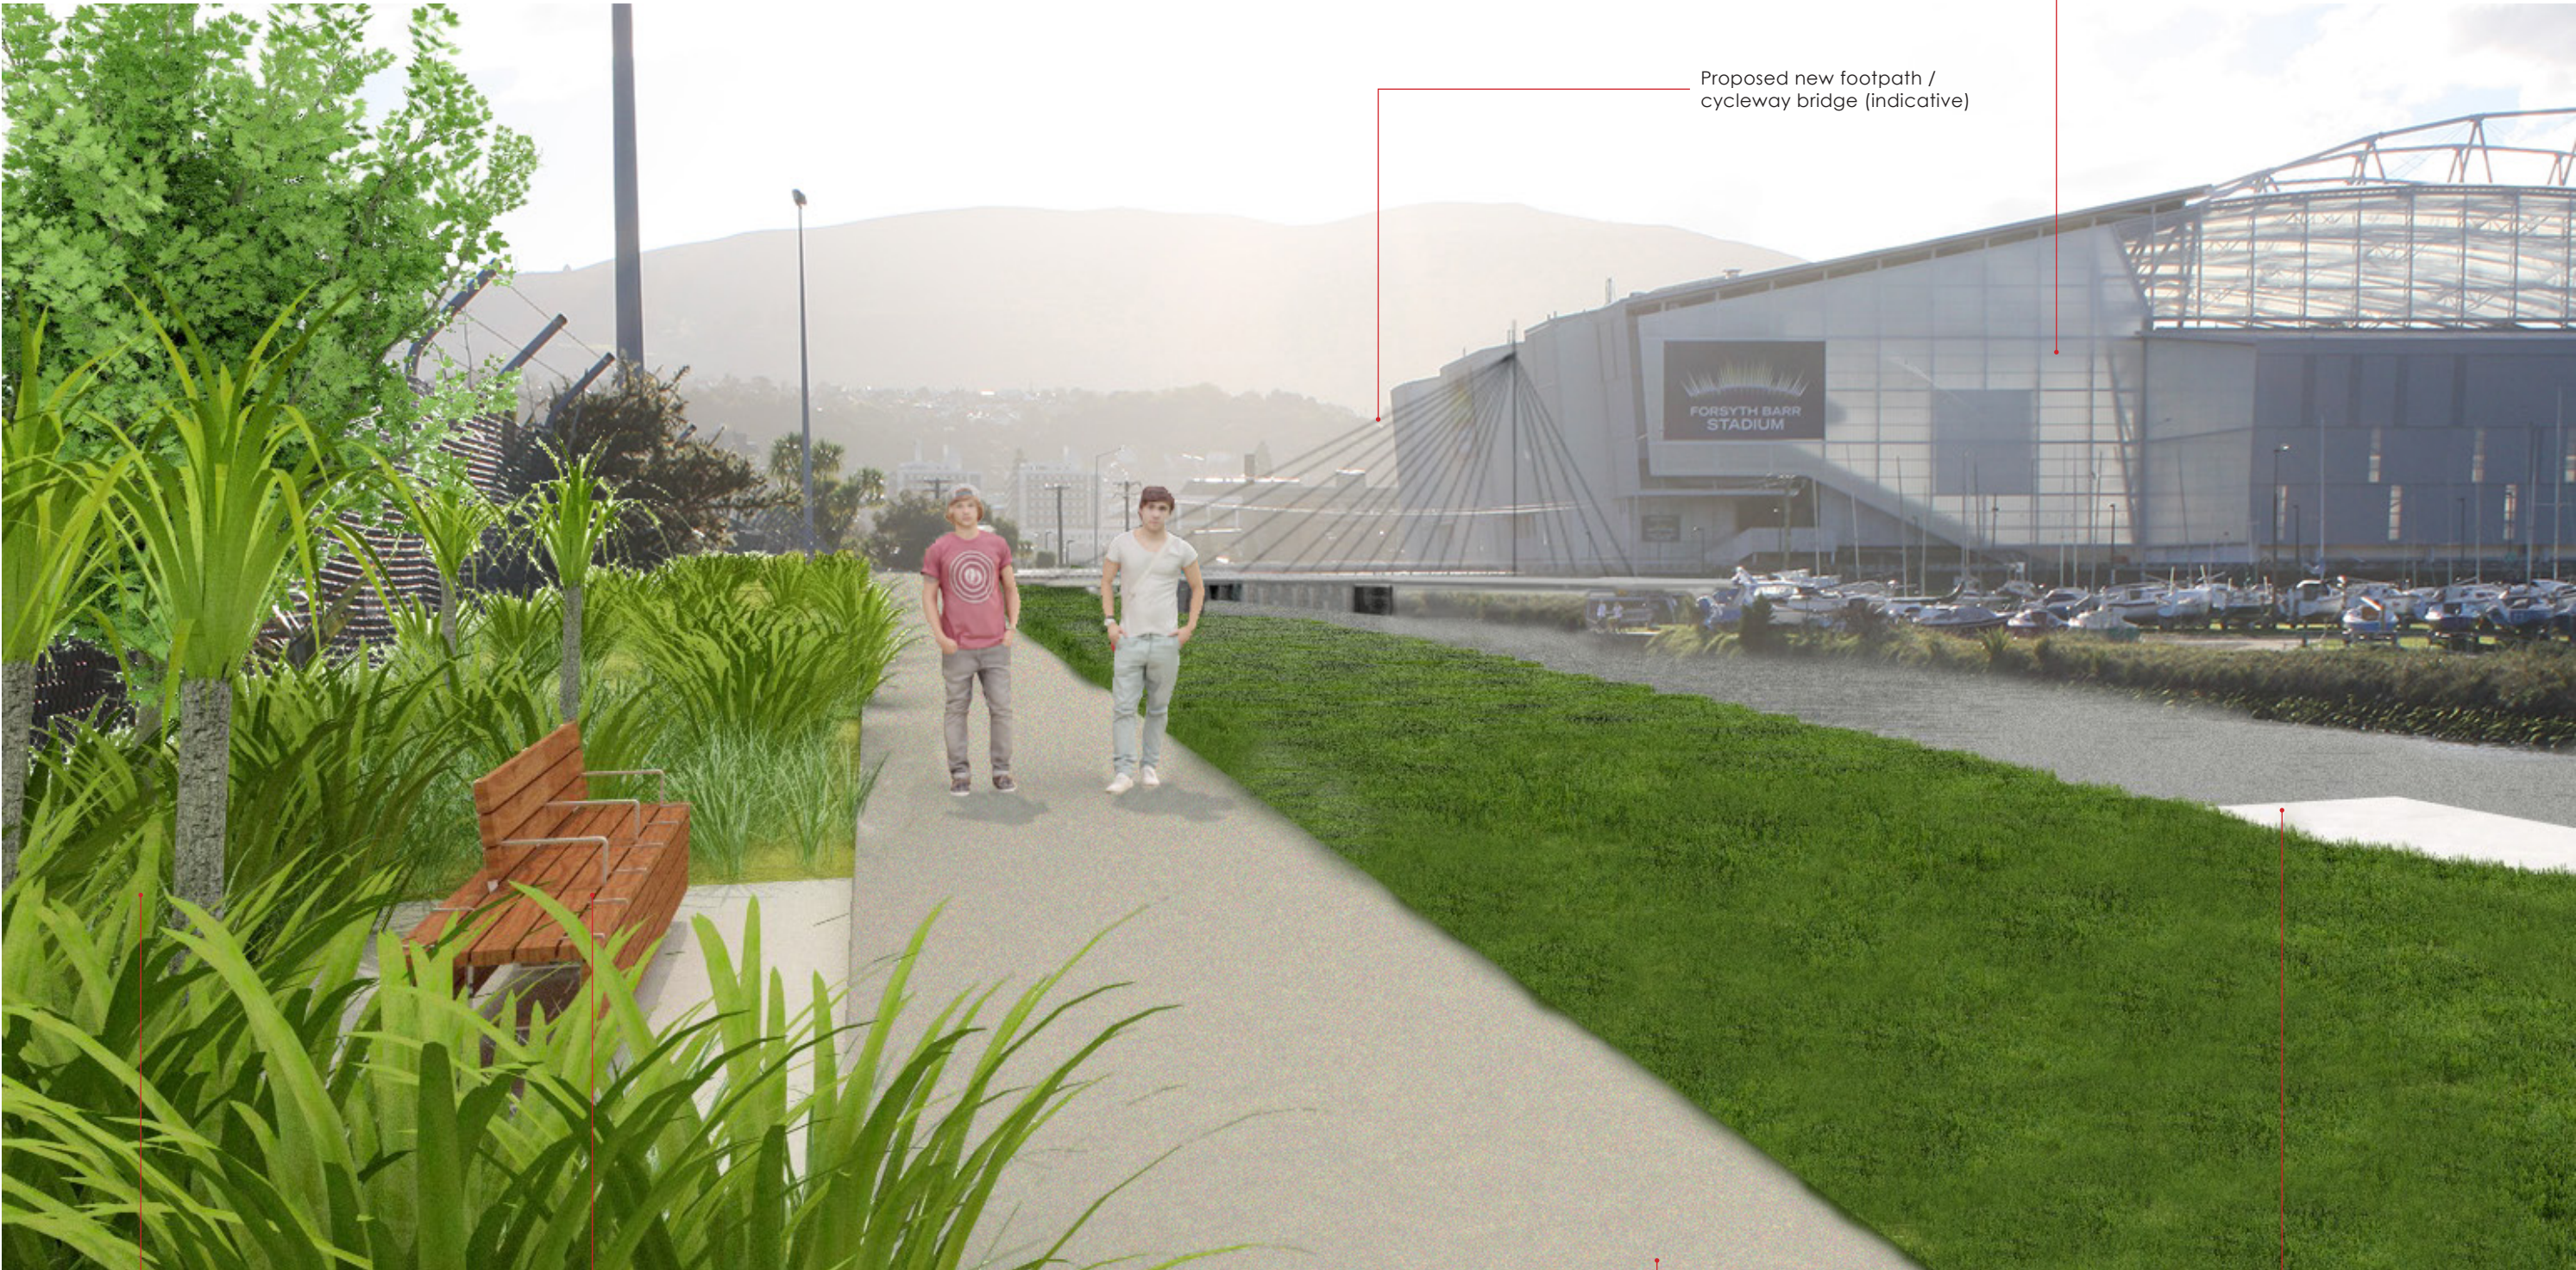
client / project name: OTAGO REGIONAL COUNCIL drawing name: STATE HIGHWAY 88 TO OTAGO HARBOUR - PERSPECTIVE C designed by: Dave Compton-Moen / Mike Moore original issue date: 17 MAY 2018 scales: NTS		revision no:	amendment	approved	date

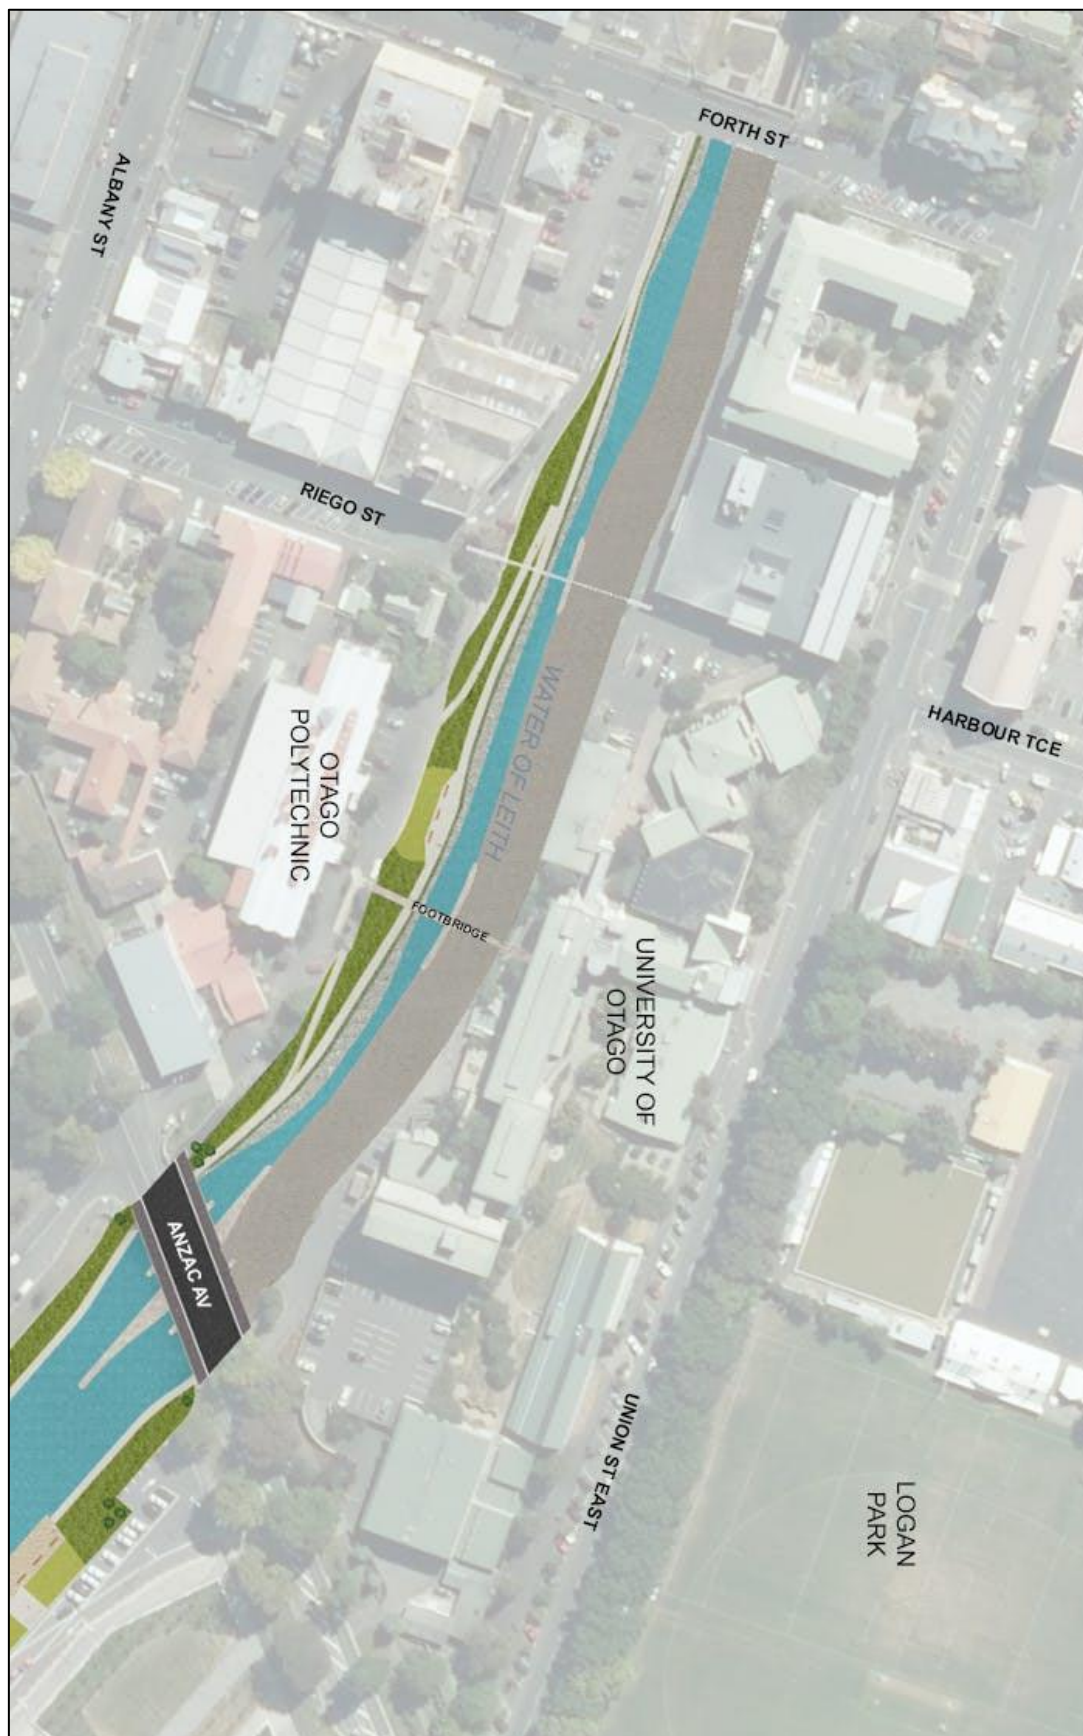
APPENDIX A – Plan of Forth Street to Anzac Avenue

- 1. Forth Street to Anzac Avenue** - This section of the Leith should be returned to as “natural” stream state as possible, mirroring the project works completed above the Forth St bridge.

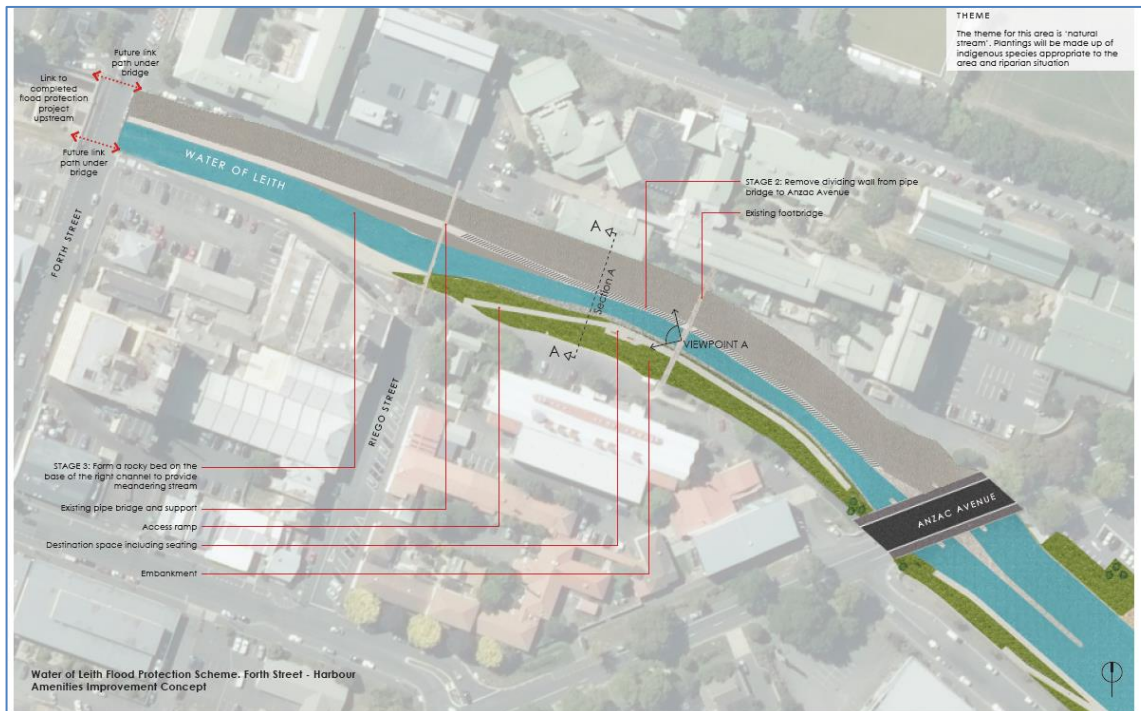
4.1 Forth St – Anzac Avenue: Right Bank outside Otago Polytechnic \$2.30M

- Form new embankment, river level walking path, access ramps, soft landscaping, street furniture, and seats \$840K,
- Option 1: remove central concrete wall \$0.65M,
- Option 2: line right bank concrete bed with bluestone boulders \$0.81M

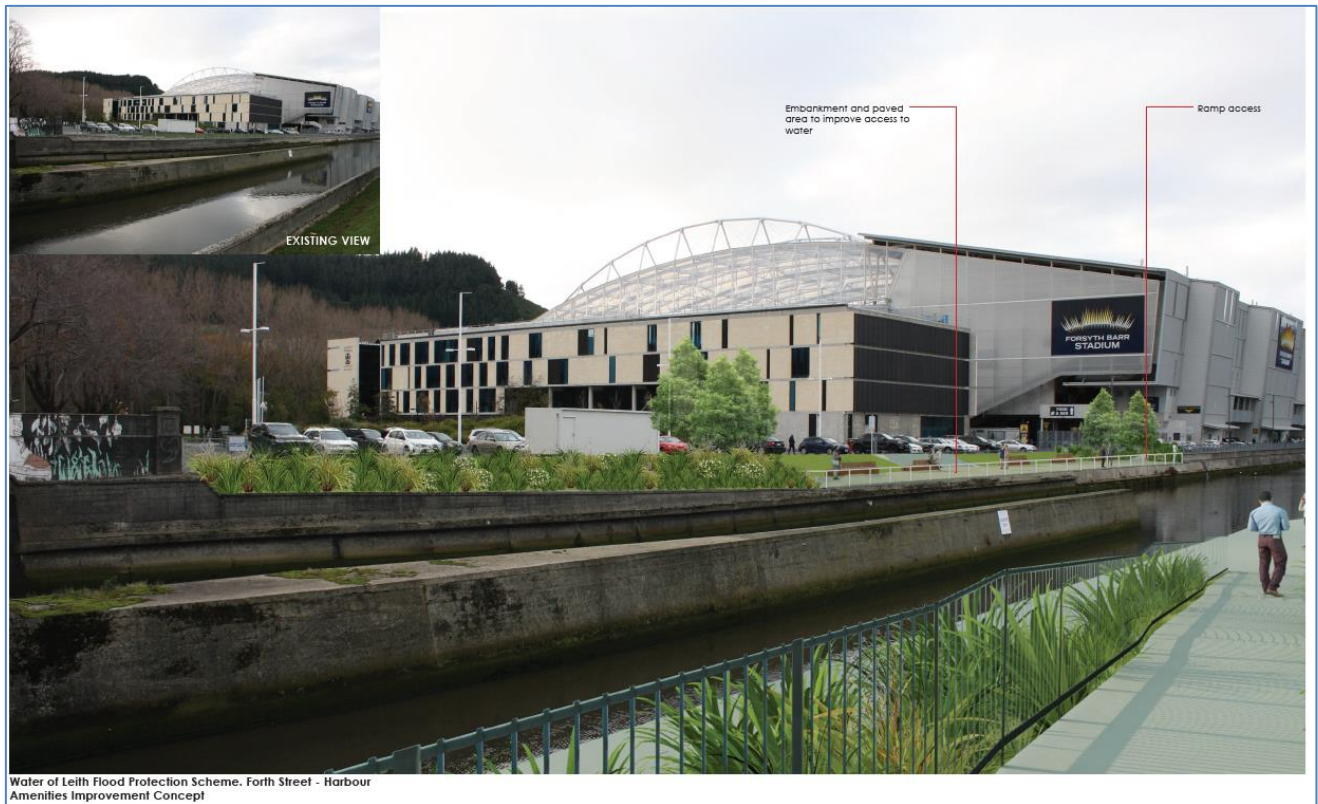
- Left Bank: form new embankment, low retaining wall, river level walking path and access ramps \$622K,
- Right Bank: form new sunken terrace slab, low perimeter wall, steps, access ramp, and grass \$625K, and
- Remove channel centre dividing wall and repair the concrete bed \$0.22M
