Technical Committee - 21 March 2019 Attachments

8.1. Minutes.....	2
8.1.1. Minutes of Technical Committee - 30 January 2019.....	2
10.1. Leith Amenity Enhancement.....	7
10.1.1. Appendix 1 Images of Working Group Development Concepts A 3 Size.....	7

Water of Leith Flood Protection Scheme. Forth Street - Harbour
Amenities Improvement Concept

Waitaki District Coastal Hazards

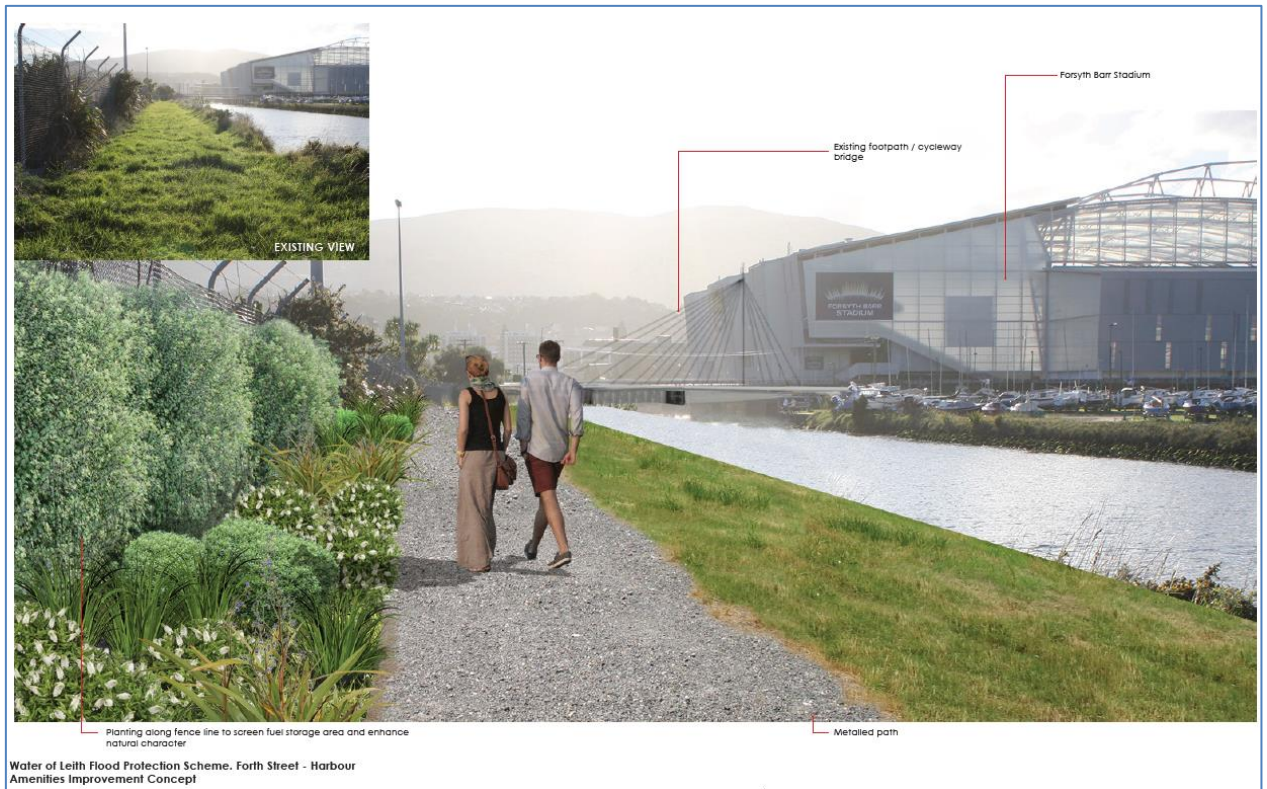
- 2 m wide gravel path
- Soft planting outside gas holding facility,
- Step access to fishing place
- Picnic table at right bank point with outstanding view of harbour

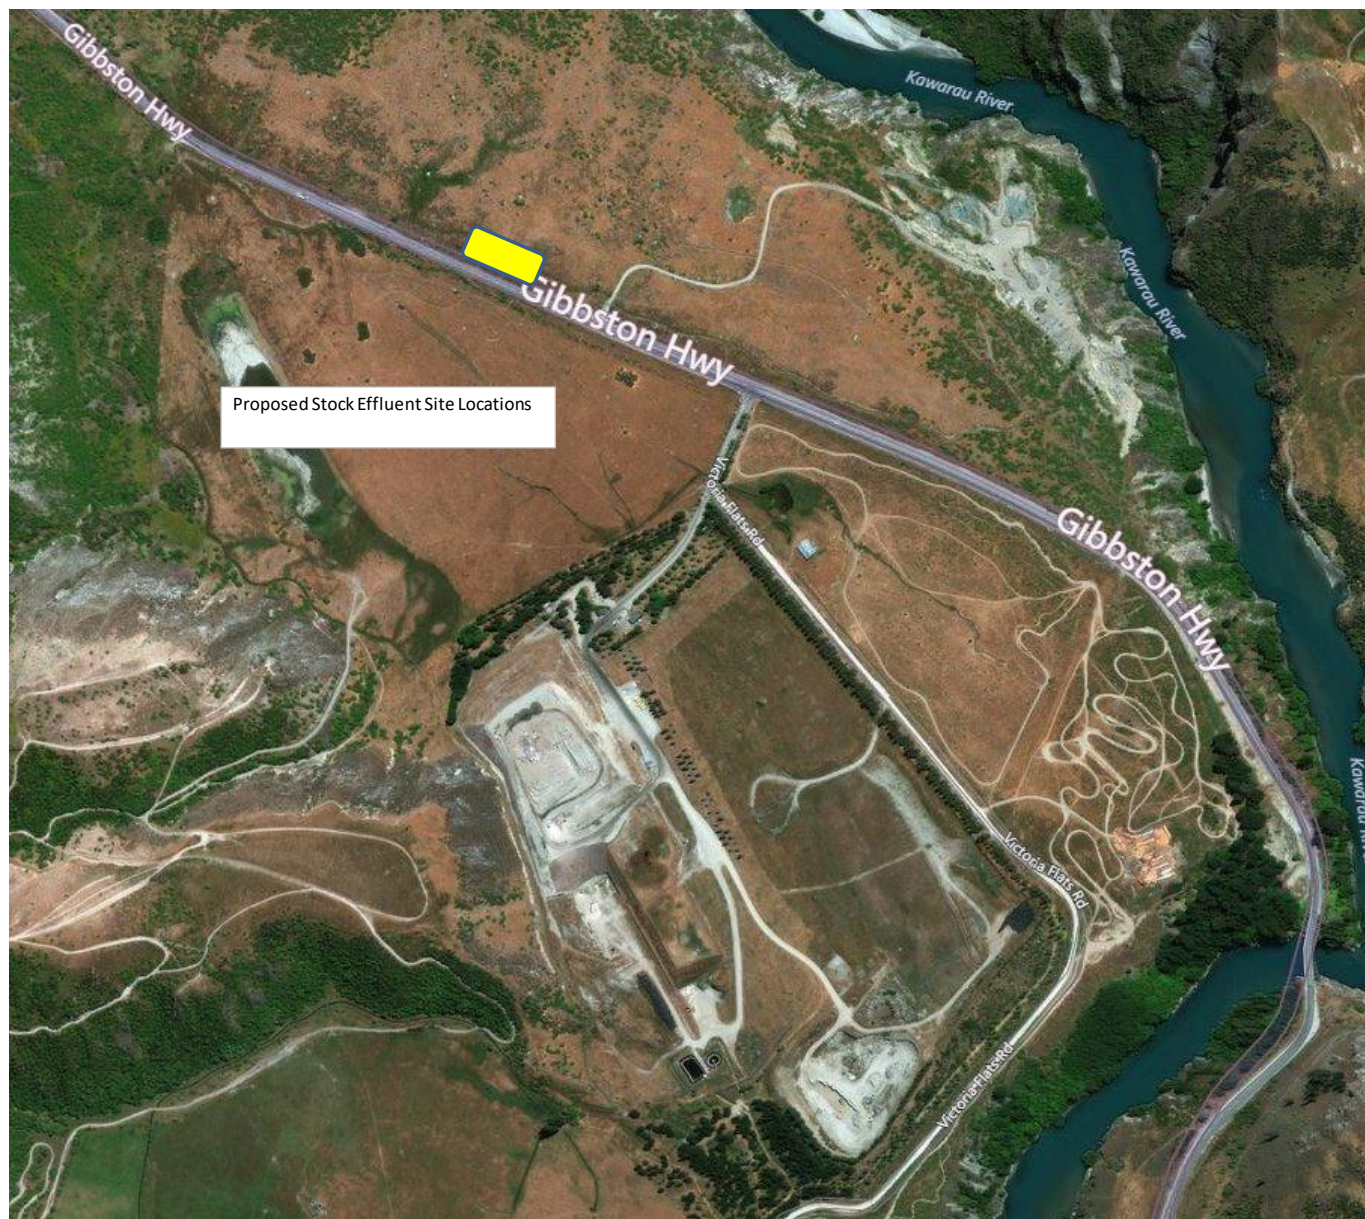
Site Location Plan - Ripponvale Road Area

Proposed Stock Effluent Site Locations

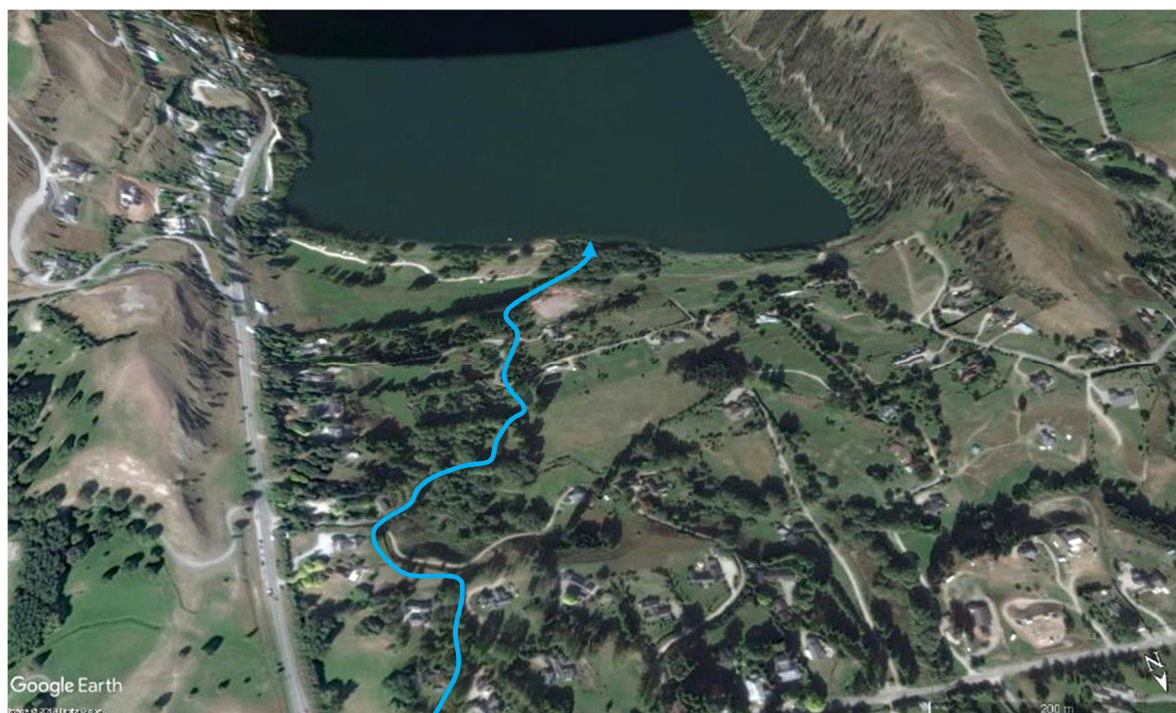
Figure 2-2 3D view of Mill Creek (blue line) where it enters Lake Hayes. Source: Google Earth.

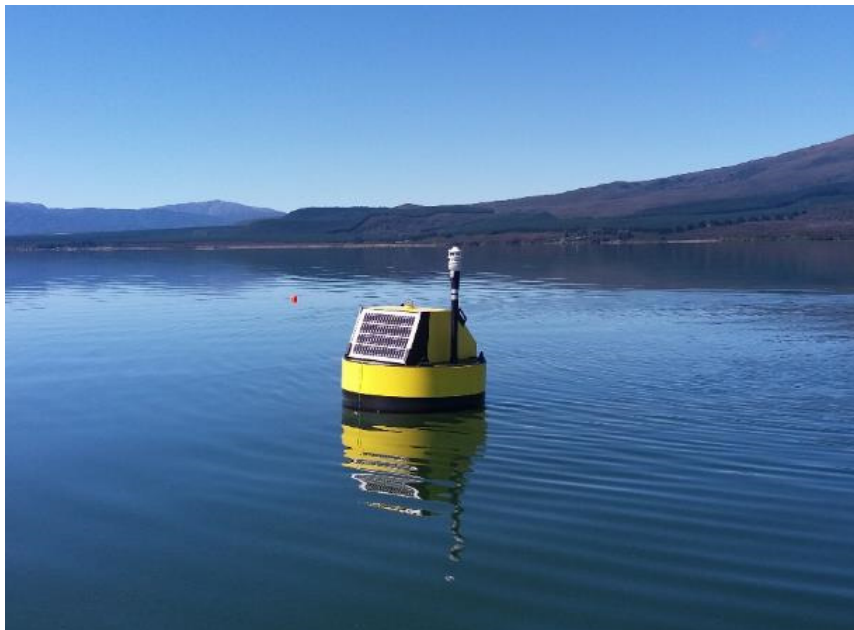
Figure 4-1 Monitoring buoy similar to that to be installed in Lake Hayes by ORC

ORC is deploying a permanent water quality monitoring buoy in the lake during the 2018/19 summer, and also expanded its sampling program. The buoy is expected to be operational by April 2019. Additional data from continuous and sample type monitoring will help track physical, chemical and biological changes in the lake over time. In particular, it will help to identify any long-term trends in water quality (noting that it may take some years for these to become apparent).

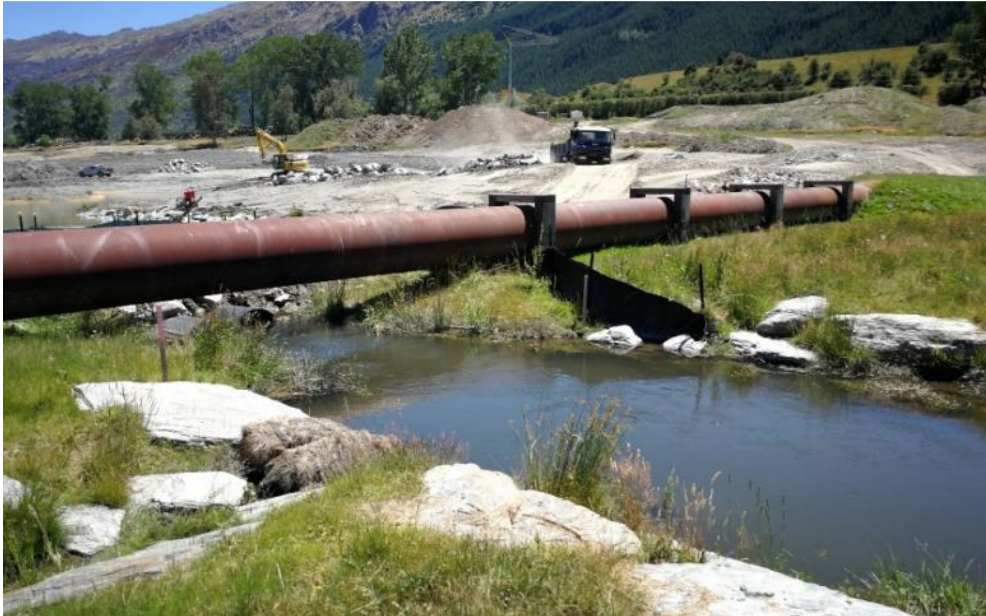
Figure 5-1 Arrow Irrigation Company pipeline as it crosses Mill Creek, January 2019. Credit: D Hanan

This method involves augmenting the flow of Mill Creek with water from the Arrow Irrigation Company irrigation scheme.⁷ Water would be taken from the company's pipeline where it crosses Mill Creek (Figure 2-1, Figure 5-1), about 4.5km upstream from the creek's outlet into Lake Hayes. Water from the Arrow River is low in nutrients compared to water in Mill Creek and Lake Hayes, and therefore 'cleaner'. Monitoring also shows that water in the Arrow is colder than that in Mill Creek.

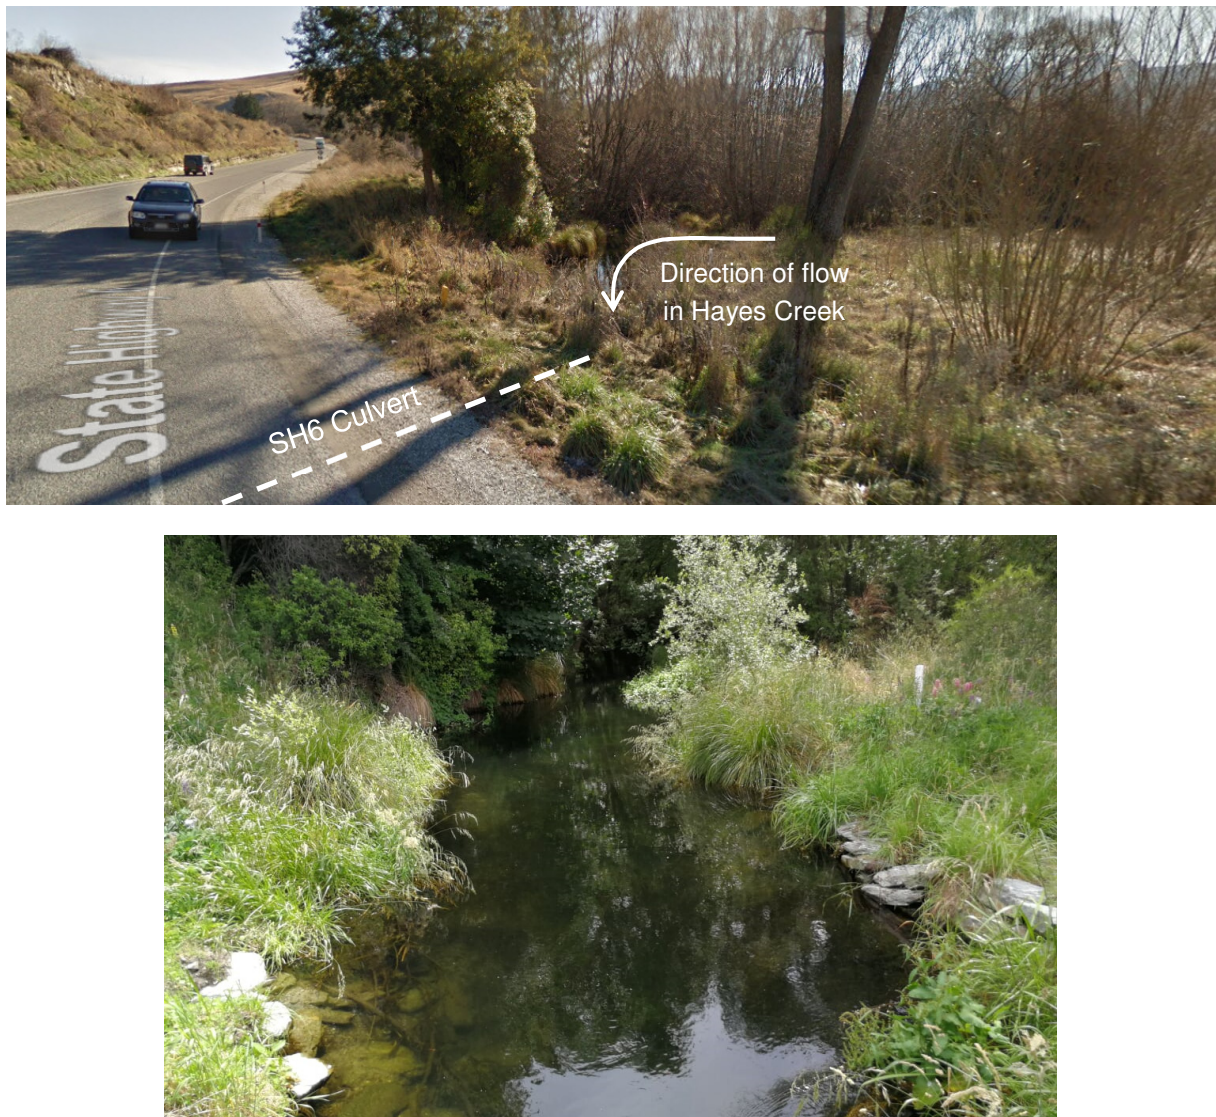
Figure 7-3 Top: General view of Hayes Creek, upstream of SH6. Bottom: Closer view of the potential location for the weir and flanking walls, just upstream of SH6.

An inspection of the outlet area (Figure 7-3) indicates that such a system may be constructible, although further hydraulic and engineering investigations would be required to determine the specific design. The inspection shows that the diameter of the hypolimnetic withdrawal pipe could be as large as 400mm, although a larger pipe would cost more and have a greater visual impact.

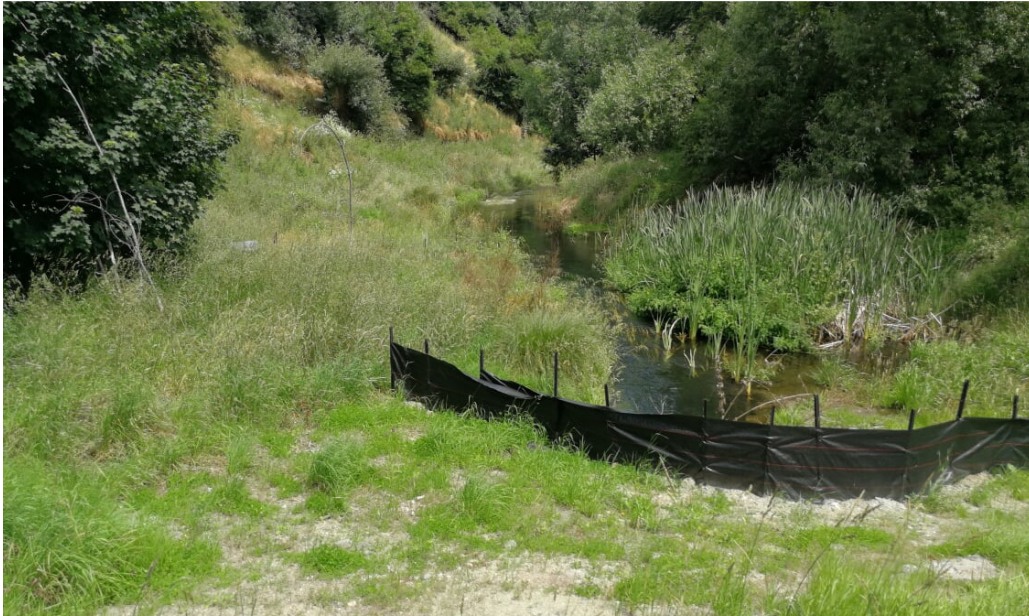
Figure 7-4 View of Hayes Creek, downstream of the SH6 Culvert.

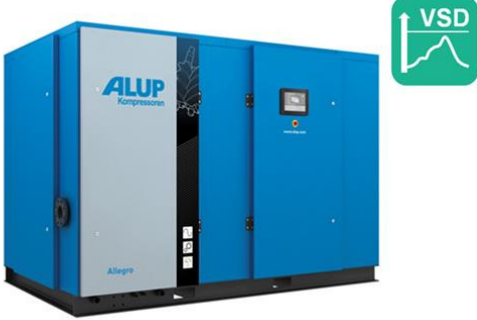
Item	Preferred location	Requirements
Compressor	Lake Hayes Reserve	<ul style="list-style-type: none"> A 132-kW variable speed compressor (Largo 132)

<ul style="list-style-type: none"> Noise level: 77 dB(A), equivalent to loud talking (almost shouting). Dimensions: 2800 x 1755 x 1960. 3-phase, 400v electricity supply. <p>This model compressor was selected based on the specifications set out in Gibbs (2018a), in regards to the amount of air required, hole diameter, and the length of aeration pipe.</p>
Compressor shed	Lake Hayes Reserve	<ul style="list-style-type: none"> Dimensions 4800 x 3600 x 2400 Specifically designed for noise reduction Ventilated. Vehicle access. Building consent (QLDC). Comply with requirements of the Arrowtown – Lake Hayes Reserve Management Plan, 2013 (QLDC)
Air supply pipe	From compressor shed into the lake, then to Bendemeer Bay	<ul style="list-style-type: none"> Air supply pipe extends a total distance of about 900 m. On land, it would be buried to a depth of 600 mm.

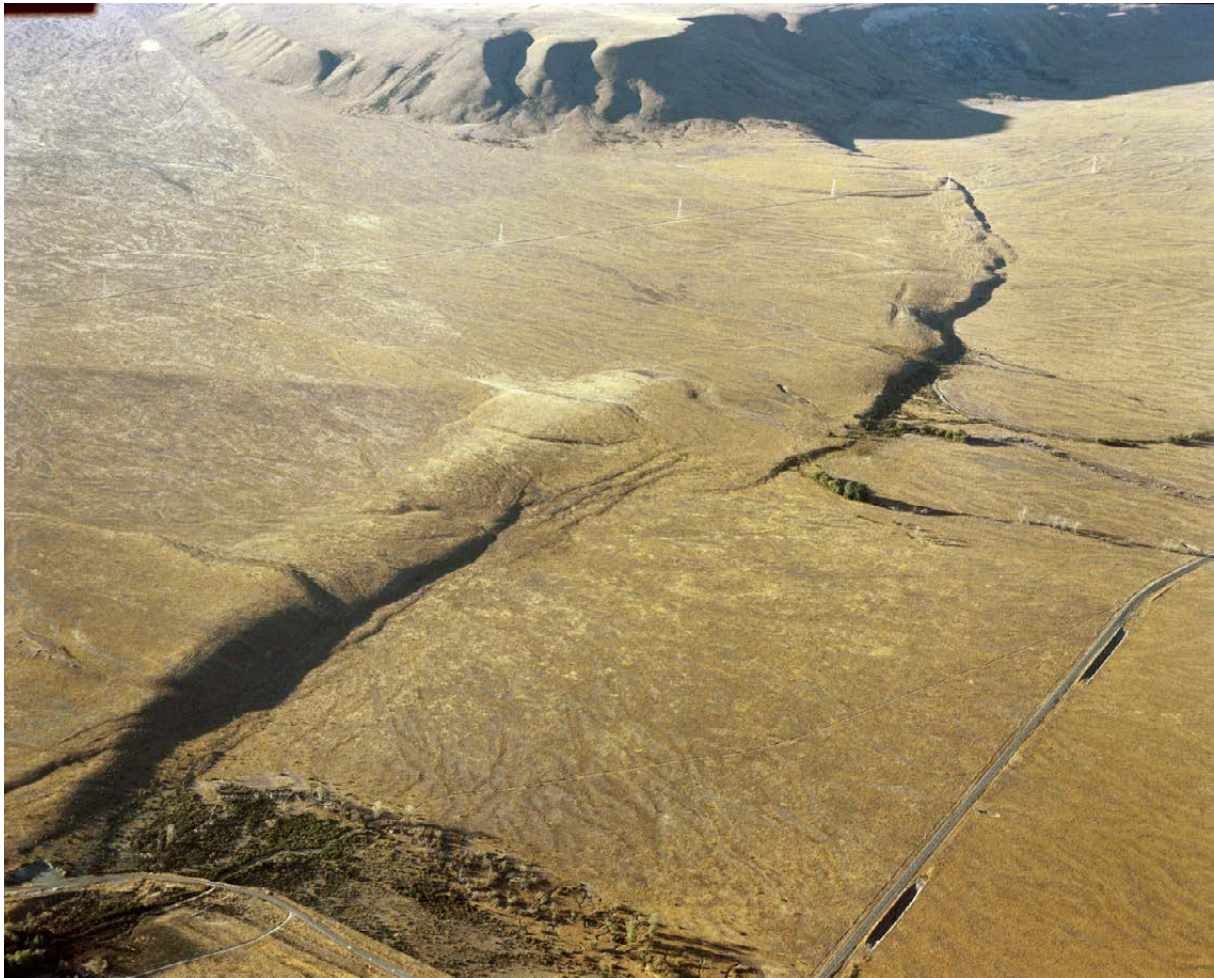
Figure 1.3 A northward oblique aerial view of ground-surface deformation across the Ostler Fault Zone, in the Waitaki District of Canterbury, about 12 km southwest of Twizel. The fault zone runs from lower left to upper right and has offset and buckled a ~22,000-year-old glacial meltwater outwash plain, with well-preserved relict braided channels (Putnam et al. 2013). This location is one of the best expressed examples of fault deformation in New Zealand, because it is entirely across old landforms. This view shows complicated elements of main and subsidiary fault offsets and folds, across a zone that is several hundreds of metres wide. All these elements form part of a single entity, the Ostler Fault Zone. This figure is taken from Barrell (2016), where a more detailed description of the features in this view is provided. Photo: GNS Science, CN576/B and VML ID: 5151. D.L Homer, taken 1995.

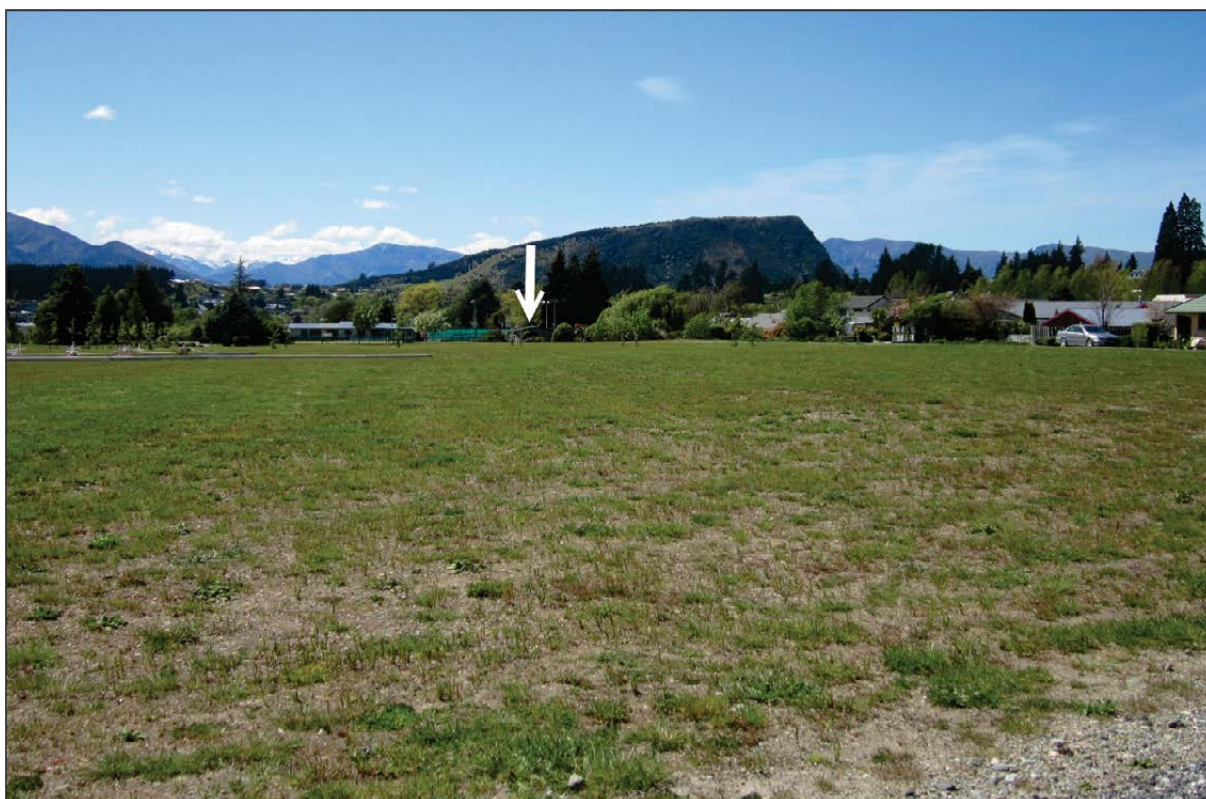
Figure 5.6 A view east across a likely monocline fold at Wanaka Cemetery. Figure 5.5 shows the approximate location of monocline relative to this photo location. Even though the photograph looks across an originally-flat lake-beach landform and was taken at ground level on the up-warped side of the suspected monocline, the roofs of buildings in the distance, on the down-warped side, are at or below the horizontal line of sight. The white arrow denotes the roof of a building at Wanaka Tennis Club, which is also marked in Figure 5.5 along with the photo location. Photo: GNS Science. D.J.A. Barrell.

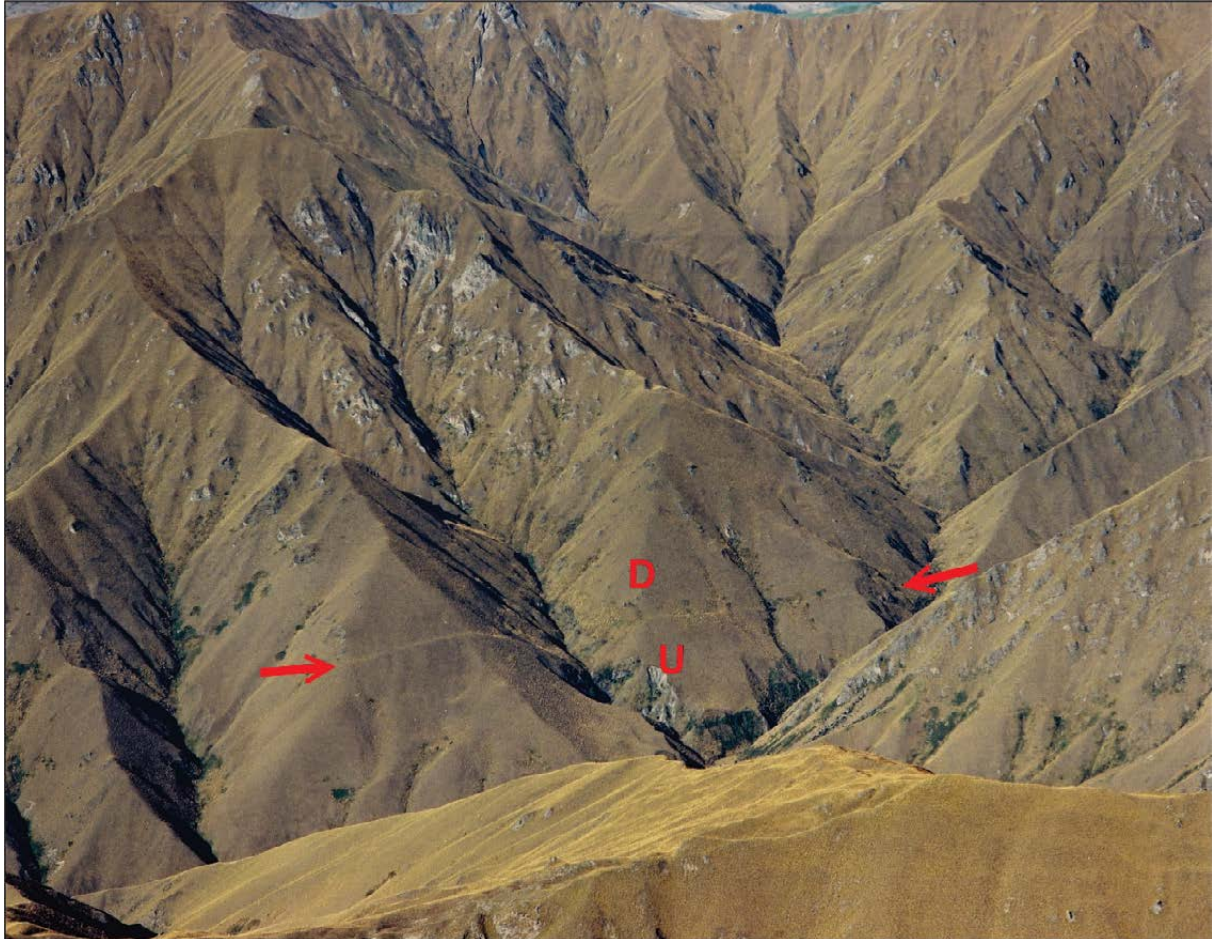
Figure 5.7 A view east across a geologically-young fault offset of hillslope landforms on the Highland Fault, in the catchment of Fern Bern, about 12 km west of Wanaka township. The fault scarp position is highlighted by red arrows, and the sense of up versus down movement is lettered. The fault scarp is upthrown on the downhill side. Photo: GNS Science, CN 10350/31H and VML ID 5035. D.L. Homer, taken 1987.

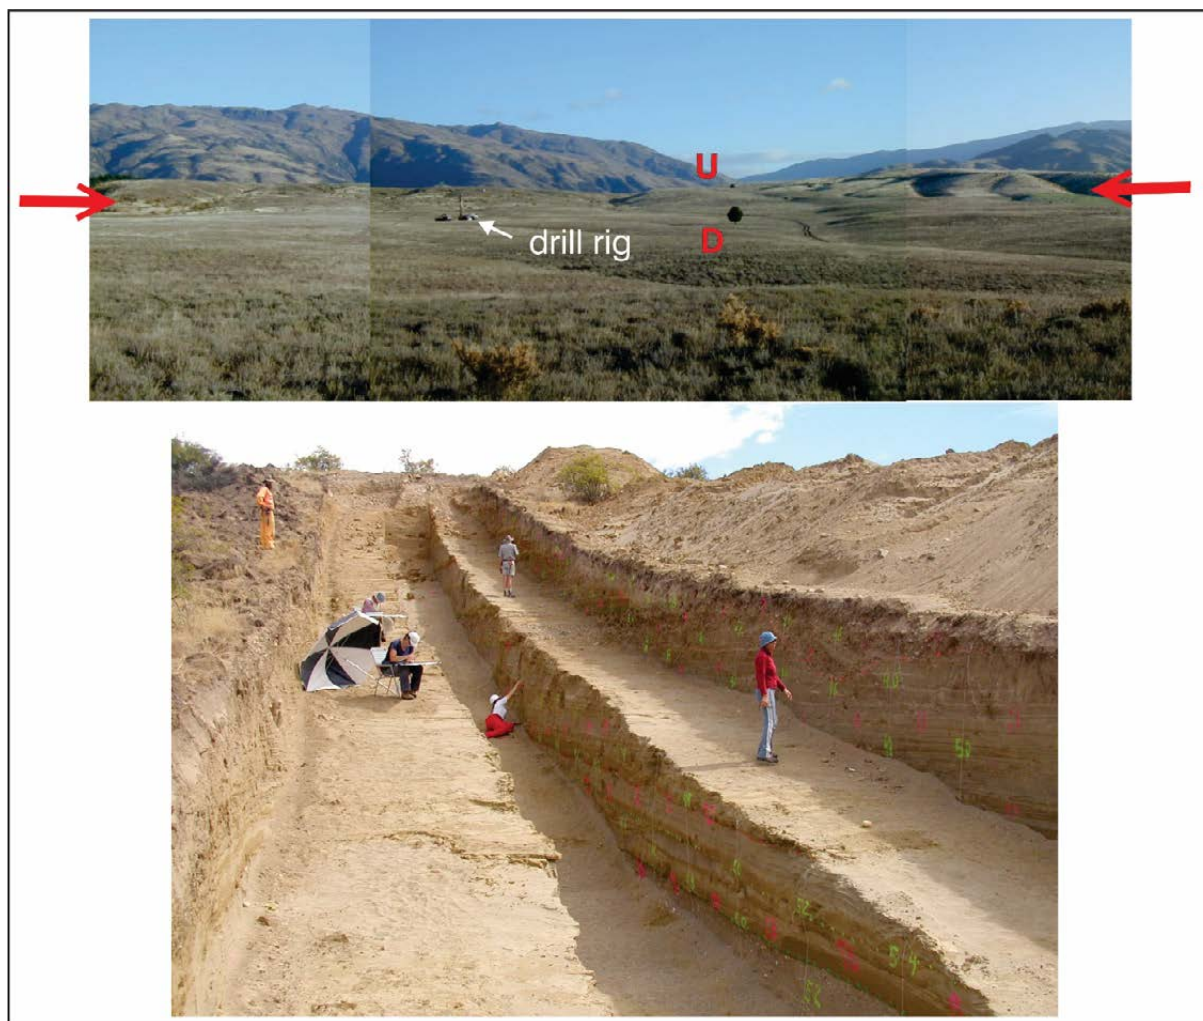
Figure 5.8 Views of a Dunstan Fault Zone monocline fold immediately northeast of Clyde. **Upper panel:** A panorama looking northwest towards a broad topographic step that is a monocline scarp, highlighted by red arrows and up versus down letter annotation. The arrowed drilling rig illustrates scale. The monocline extends north-northeast across high-level terraces of the Clutha River. Clyde township lies on low terraces of the Clutha River, immediately to the left of this view. **Lower panel:** Named the 'Reservoir-3 monocline', the fold scarp was examined in a geological investigation trench, positioned at the point of the left-hand arrow in the upper panel. In this northward view, the trench showed that the Clutha River sediments here are tilted by monocline movement. The sediments have a dip from horizontal of between 4° to 5°, whereas the usual depositional angle of Clutha River sediments is less than 1°. Geological dating showed that the river sediments are at least 200,000 years old, and the overall investigation finding was that the monoclinal warp of the river deposits is between 20 and 25 m high, up to the northwest. Photos: GNS Science, D.J.A. Barrell, taken April 2005 (upper) and February 2006 (lower).

Geological investigations over the past 15 years have shown that geologically-recent deformation associated with the Dunstan Fault Zone has extended southwest towards Clyde, rather than diverting west-southwest along the southern margin of the Cairnmuir Mountains, as was thought previously (e.g. Turnbull 2000). A monocline fold has deformed old, high-level, river terraces immediately north of Clyde township (Figure 5.8), but there has been no discernible deformation of the lower river terraces upon which Clyde is situated. Further investigations and assessment would be needed to determine potential ground deformation hazards and risks for Clyde in relation to a future rupture of the Dunstan Fault Zone.

There is a structural change in the Dunstan Fault Zone at the Clutha River (Figure A2.1). To the northeast, the Reservoir-3 monocline has produced what the available evidence indicates to be a gentle warp of the peneplain surface (GNS Science unpublished data 2007; see Figure 5.8 in the body of the report). Southwest of the river, the Cenozoic strata are dragged into a near-vertical configuration along what has variously been referred to as the Clyde Fault or Earnsclough Fault (the latter is applied in the QMAP dataset and is used here). Along the Clutha River at the Clyde Dam is the well-documented, north-northwest striking River Channel Fault, which has a steep dip to the east. Near Dairy Creek, immediately upstream of the dam, is a wide zone of steeply southeast dipping sheared and faulted schist, identified in the QMAP dataset as the 'Cairnmuir Fault – Dairy Creek segment'. A long-standing difficulty in interpreting

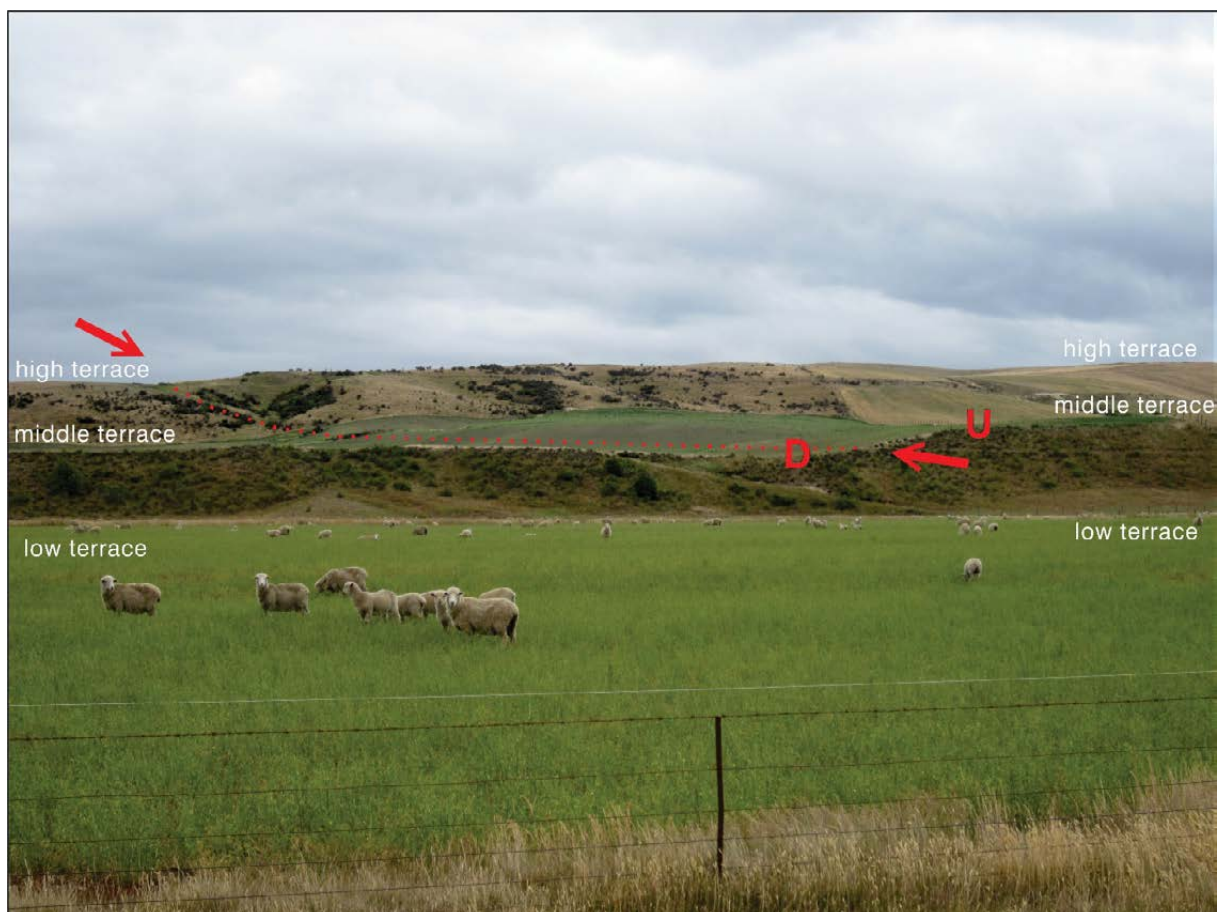
Figure 5.9 View of the scarp of the Stranraer Fault (Waihemo Fault Zone) across middle to high-level terraces of the Little Kye Burn valley, about 6 km east of Naseby. The base of the fault scarp is denoted by the red arrows and the dotted red line, while the sense of movement is highlighted by up versus down lettering. As seen here looking northwest from Little Kyeburn Road, 3 km north of the Dansey Pass Road intersection, the scarp appears to be about 10 m high on the middle terrace, and about 15 to 20 m high on the high terrace. The low terrace is probably ~18,000 years old and has not offset by the fault. Photo: GNS Science, D.J.A. Barrell, taken January 2018.

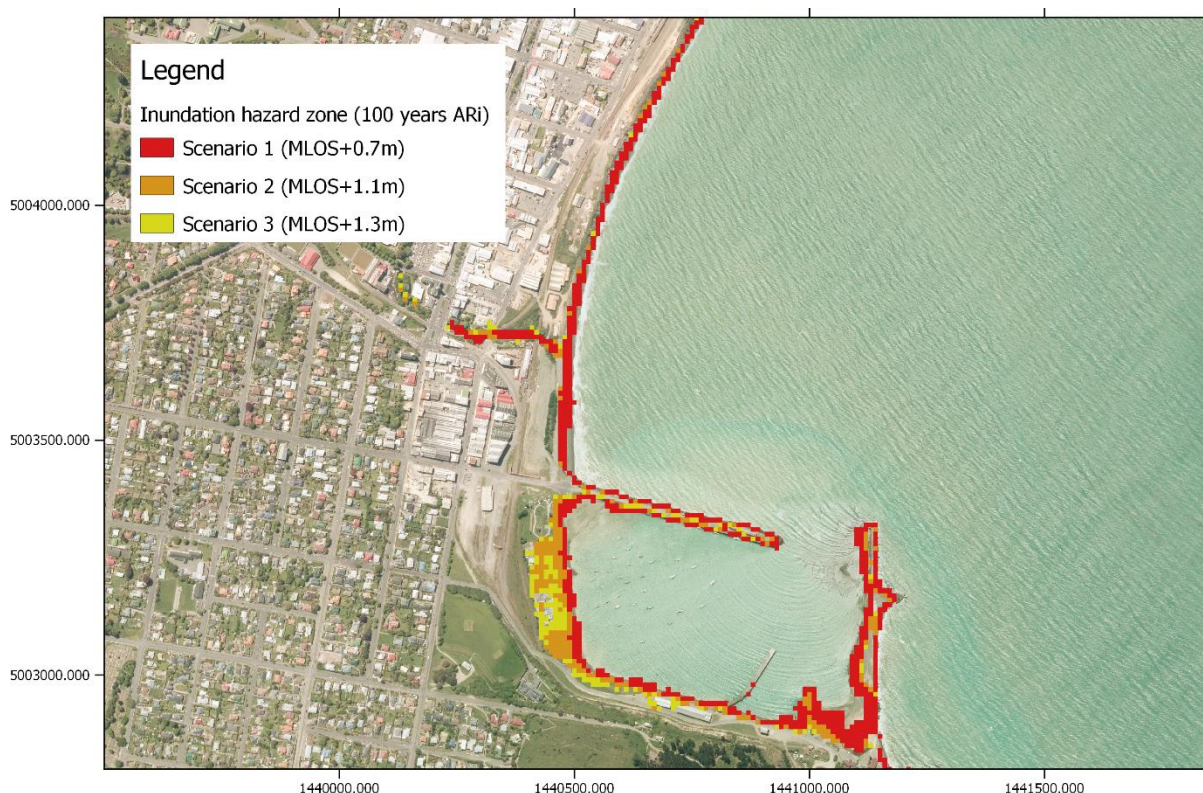
Figure 2-10: Coastal inundation hazard zone extents for Oamaru. Zones are based on the 100-year ARI inundation event and a SLR of +0.7 m (Scenario 1), +1.1 m (Scenario 2) and +1.3 m (Scenario 3).

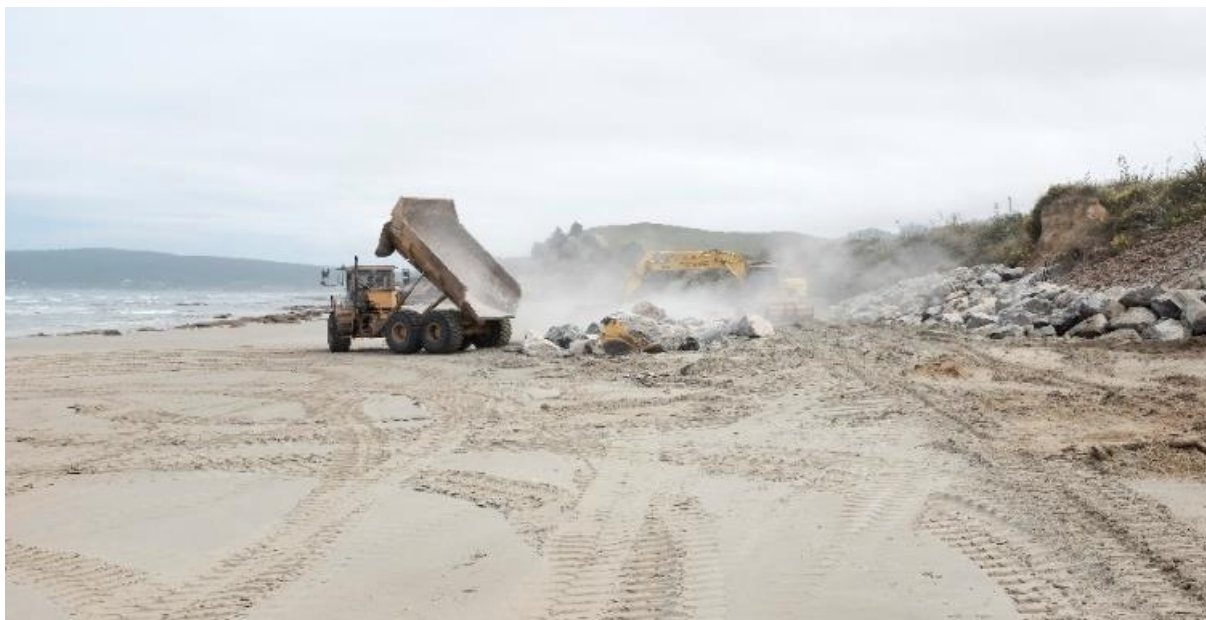
Figure 3-1: Armouring of the backshore cliff on Katiki Road (7/12/2017).

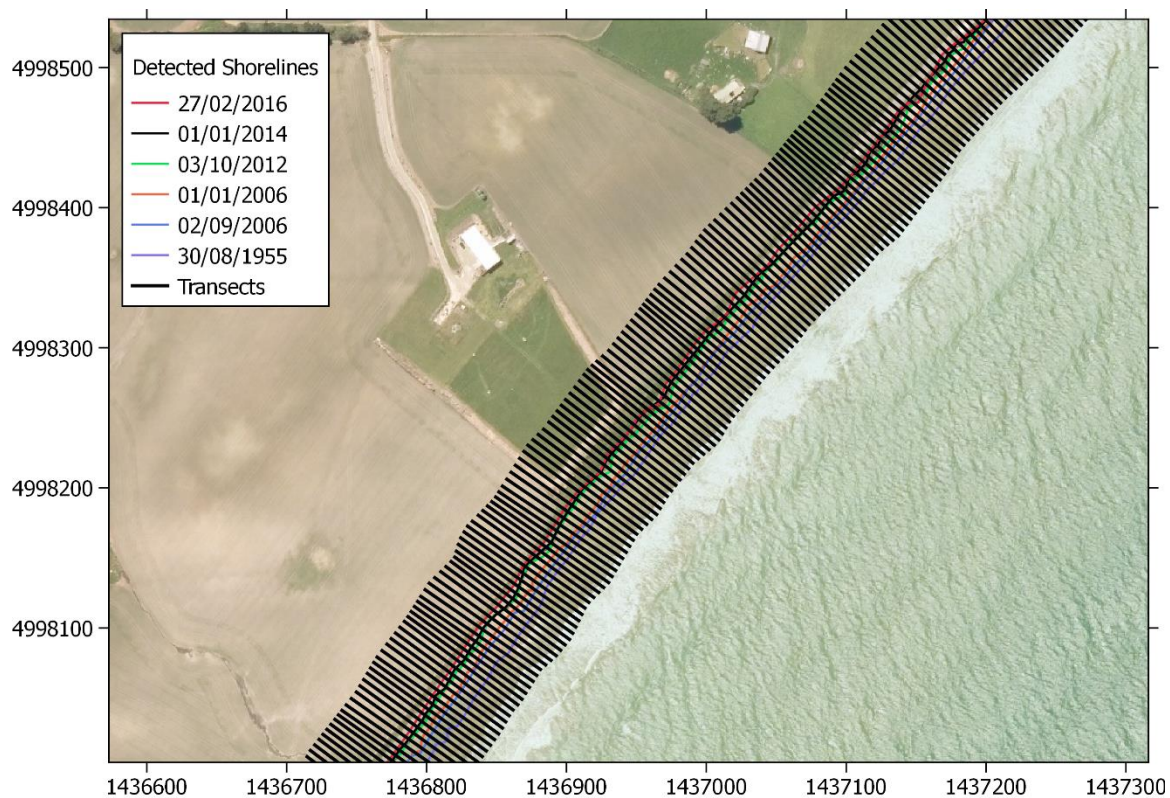
Figure 3-3: Example of transects perpendicular to the coast. The distance alongshore between each transect is 5 m. [Image source: LINZ].

The dataset of historical shoreline positions was used to calculate historical average retreat rates at stations every 5 m along the entire Waitaki District coast (19,408 stations in total). Transects perpendicular to the coast were constructed at each station using the AMBUR software (Jackson et al. 2012) (Figure 3-3). Then, the intersections between the mapped shorelines and each of the transects were captured and their offset from an arbitrary reference offshore was calculated (Figure 3-4).

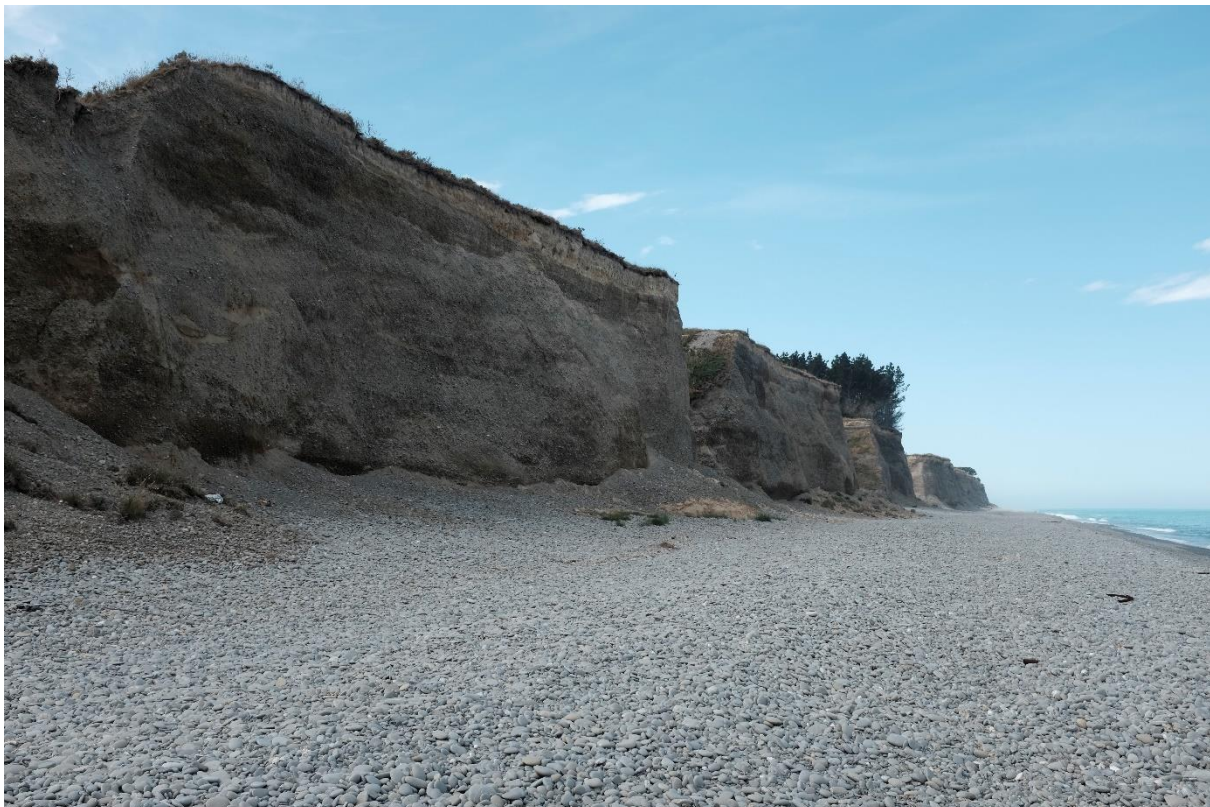
Figure 3-11: Example of unconsolidated cliff morphology: north of Oamaru. Note mainly gravel cliffs with loess cap.

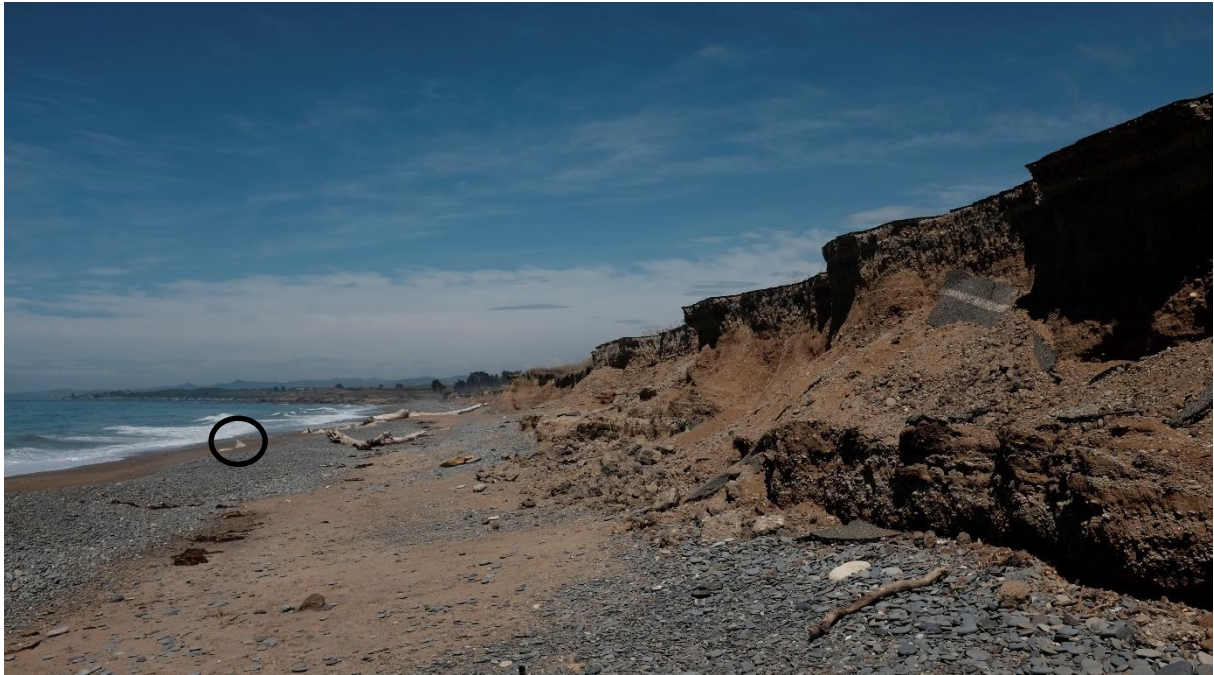
Figure 3-12: Example of unconsolidated cliff morphology: Beach Road. Note remnants of the old coastal road on the cliff top and scattered light-coloured blocks from a failed rip-rap wall in the distance (circled).

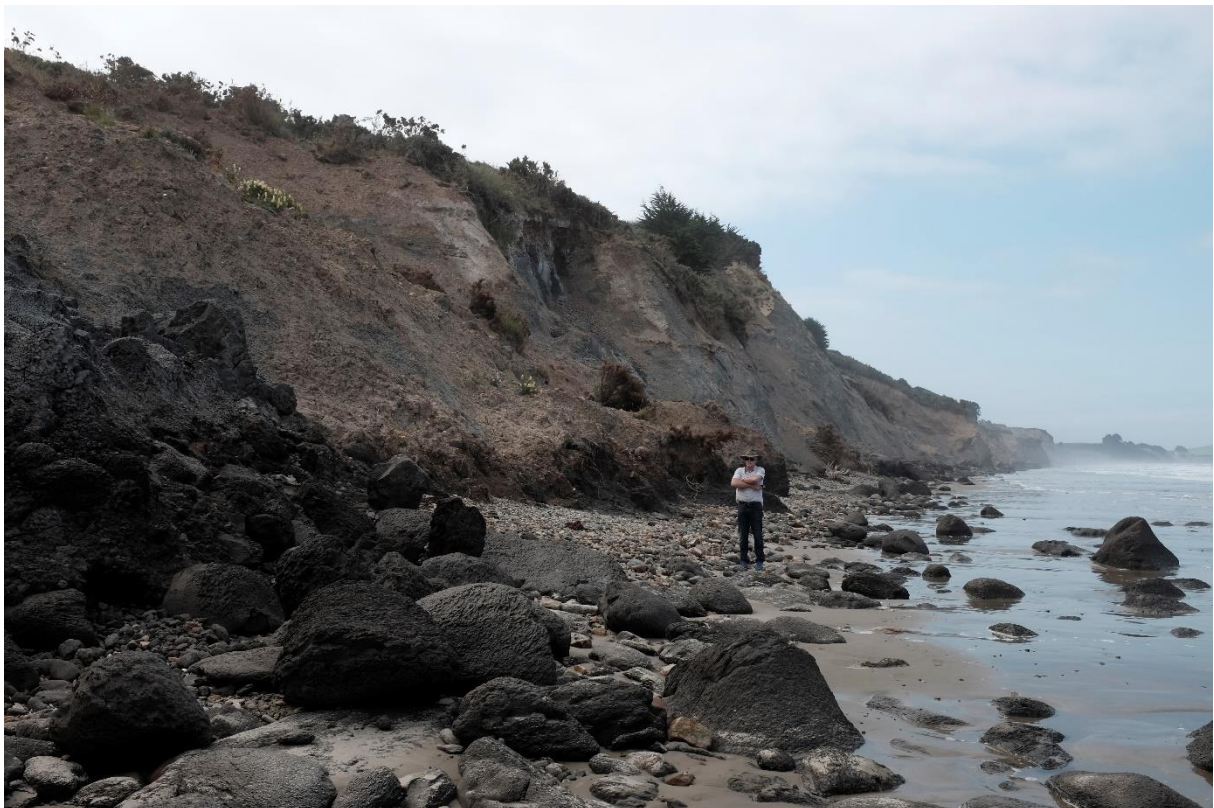
Figure 3-13: Example of unconsolidated cliff morphology: Hampden. Note cliffs formed in soft mudstone containing scattered concretions.

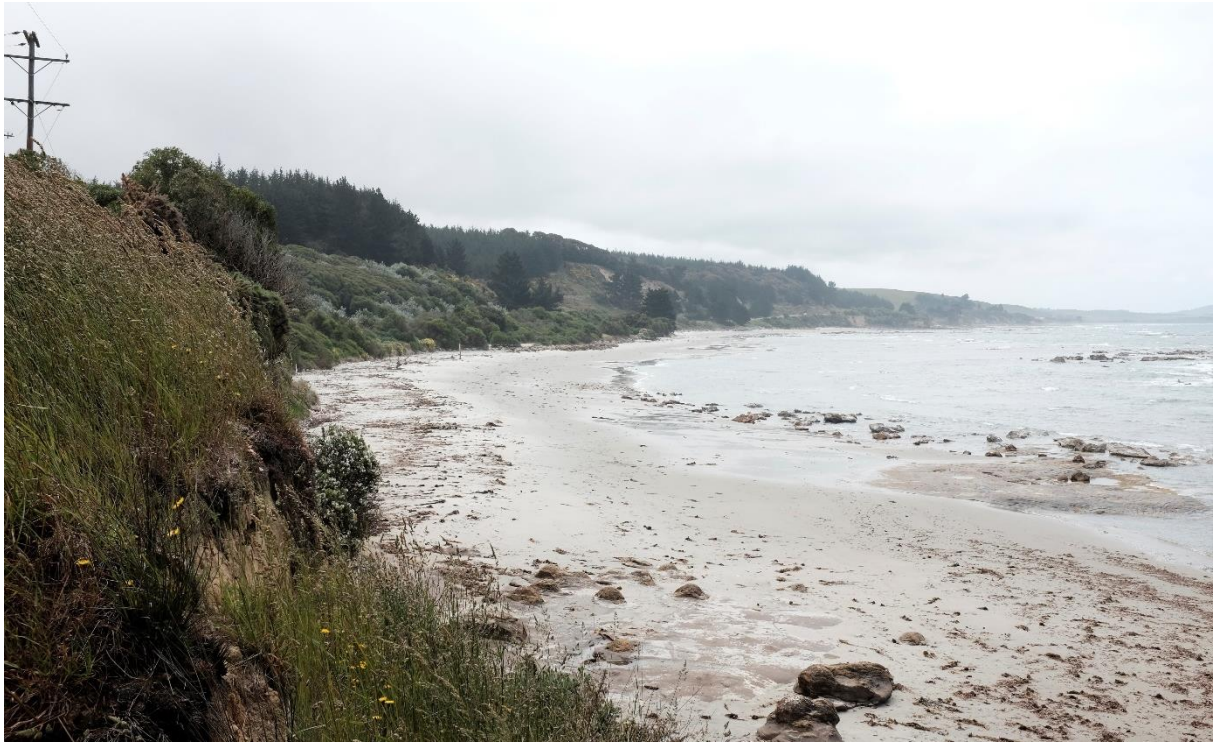
Figure 3-15: Example of geologically controlled beach: South Katiki Beach. Note the outcropping reefs on the right and near the top of the beach.

The Waitaki District beaches are predominantly perched beaches that are often backed with low cliffs. Perched beaches are beaches that are underlain and/or fronted seaward by hard substrate (reefs, pavements, shallow bedrock, etc) (e.g., Figure 3-15). The response of these types of beach to sea-level rise is poorly understood (Gallop et al. 2011) as the form and character of the nearshore substrate and backshore could either damp or amplify the effect of sea-level rise. In the case of the Waitaki District coast, there is not enough information to robustly assess the effect of an accelerated sea-level rise on these shorelines. Using the standard Bruun model or variations, developed for beaches with a sand-formed offshore profile and a sandy backshore, would lead to exaggerated shoreline retreat by predicting shoreline positions too far into the backshore. Therefore, for geologically controlled beaches, no acceleration of erosion due to sea-level rise was accounted for.
