Technical Committee - 21 March 2019 Attachments

8.1. Minutes.....	2
8.1.1. Minutes of Technical Committee - 30 January 2019.....	2
10.1. Leith Amenity Enhancement.....	7
10.1.1. Appendix 1 Images of Working Group Development Concepts A 3 Size.....	7

Water of Leith Flood Protection Scheme. Forth Street - Harbour
Amenities Improvement Concept

Waitaki District Coastal Hazards

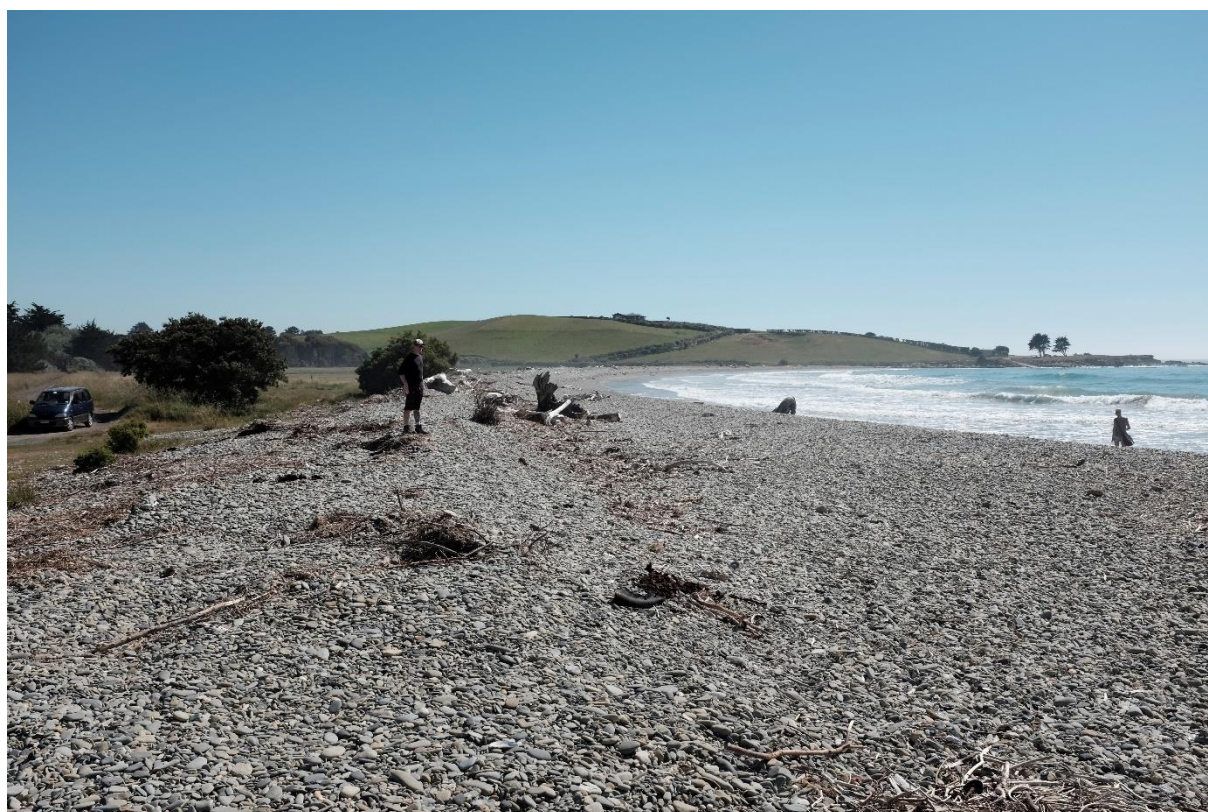
Figure 3-16: Example of thin sand/gravel barrier morphology: Kakanui barrier.

Kakanui gravel barrier is a thin barrier (as opposed to the wide, flat-topped barrier at the Waitaki River mouth) and is located on top of a sandy subtidal beach that may also show a Bruun-type response to sea-level rise. Therefore, the approach used for Kakanui Beach was similar to that used for a dune backed beach. In the Kakanui case, however, the Bruun-type response may overestimate the shoreline retreat due to sea-level rise because of the proximity of geological controls (i.e., nearshore substrate, adjacent rocky headlands) which are not taken account of by the Bruun model.

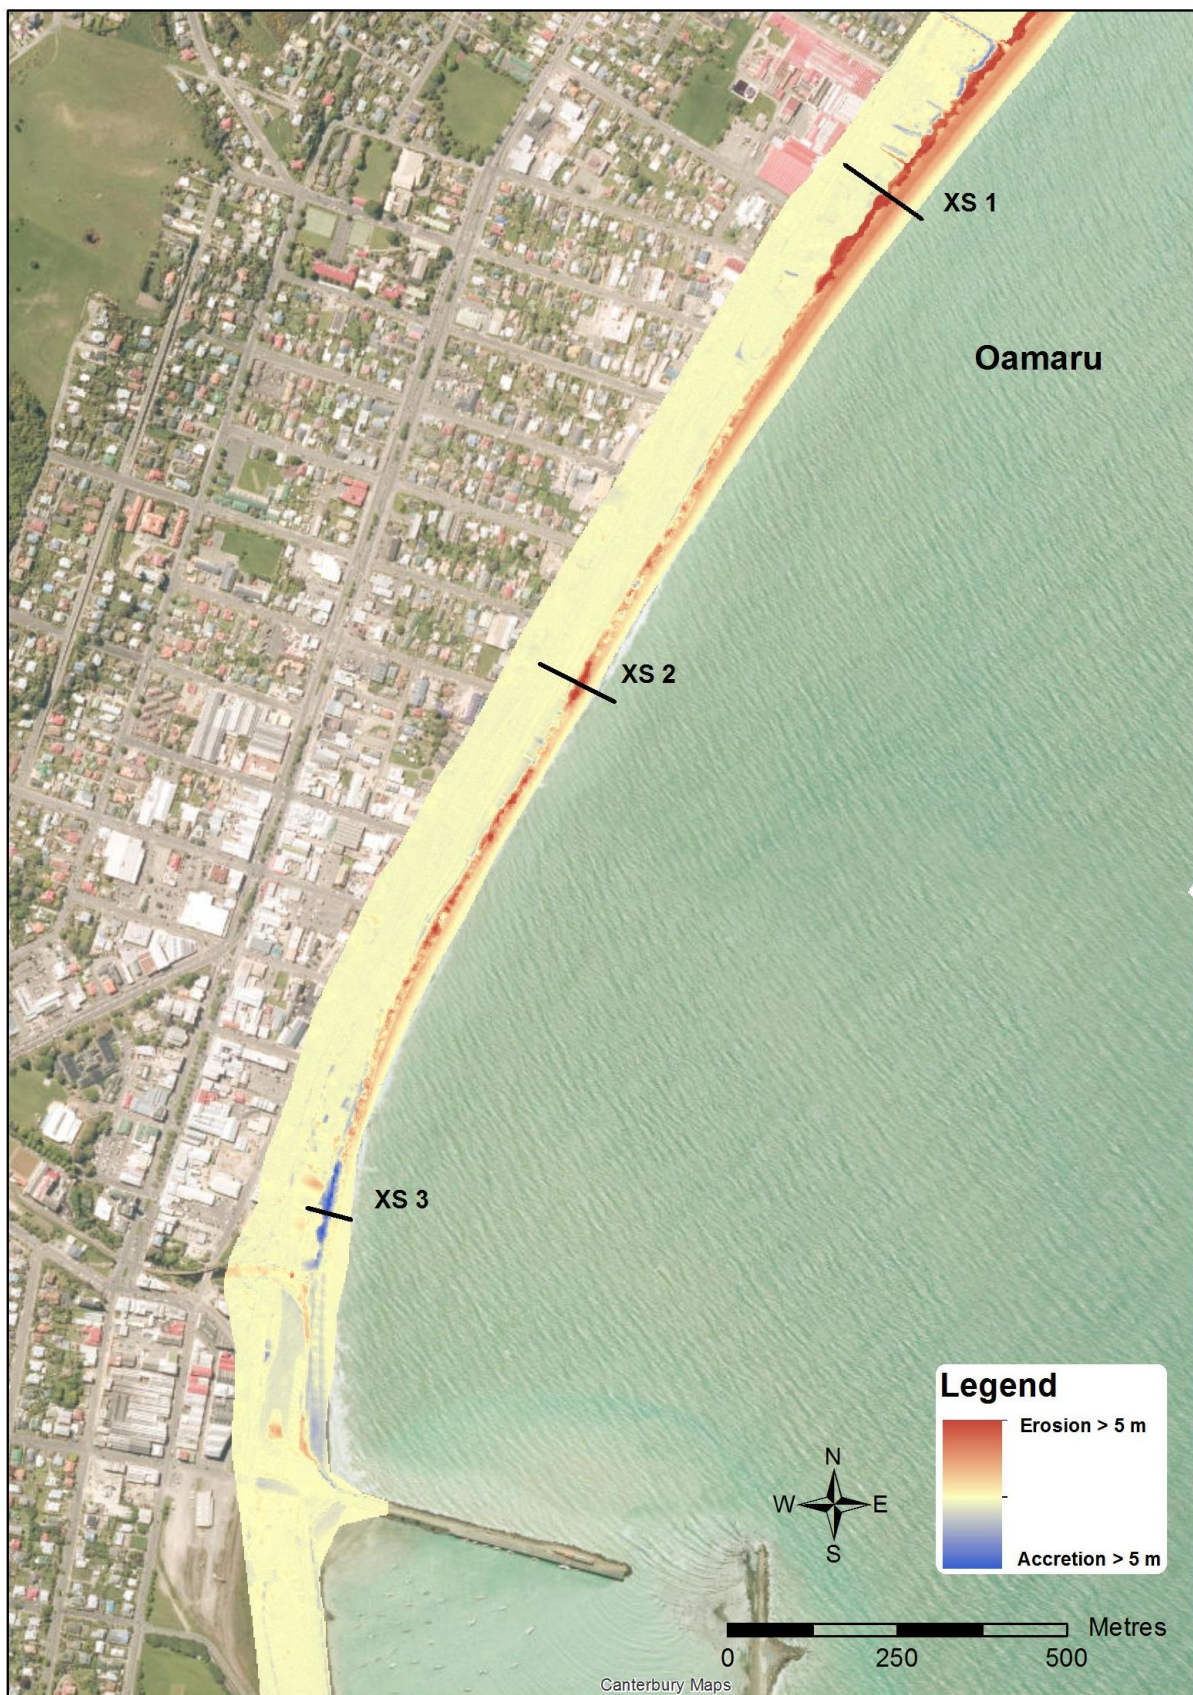
Figure 3-24: Difference in elevation between 2004 and 2016 near Oamaru based on LiDAR surveys.

Figure 3-26: Elevation profile near Usk Street. Elevation was extracted from the 2004 and 2016 LiDAR surveys. Note that this profile is located on the armoured part of the coast and shows the degradation of the rock armouring between the two dates. Profile location shown in Figure 3-24.

Figure 3-27: Elevation profile north of Oamaru Creek. Elevation was extracted from the 2004 and 2016 LiDAR surveys. Note the increased elevation here shows the recent placement of rock armouring. Profile location shown in Figure 3-24.

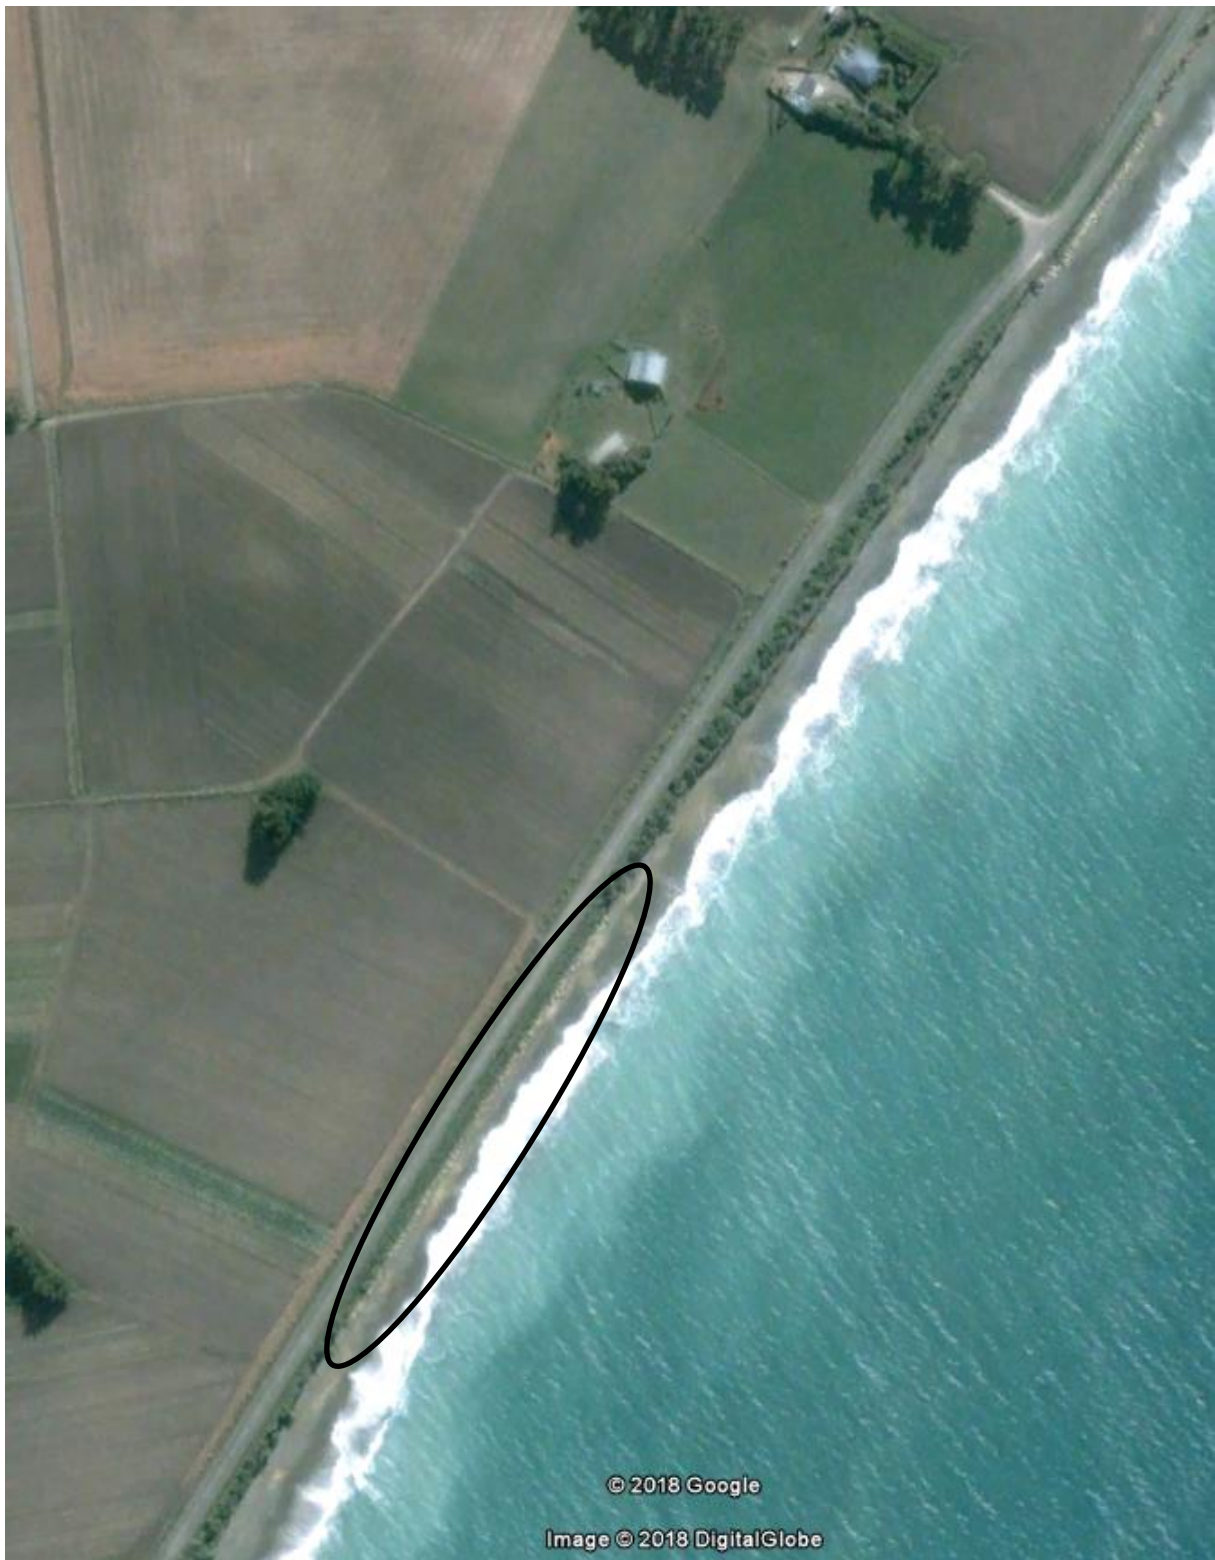
Figure 4-1: Riprap section on Beach Road viewed on satellite imagery of 02/09/2006. The riprap (circled in black) was installed prior to 2003. Imagery source: DigitalGlobe.

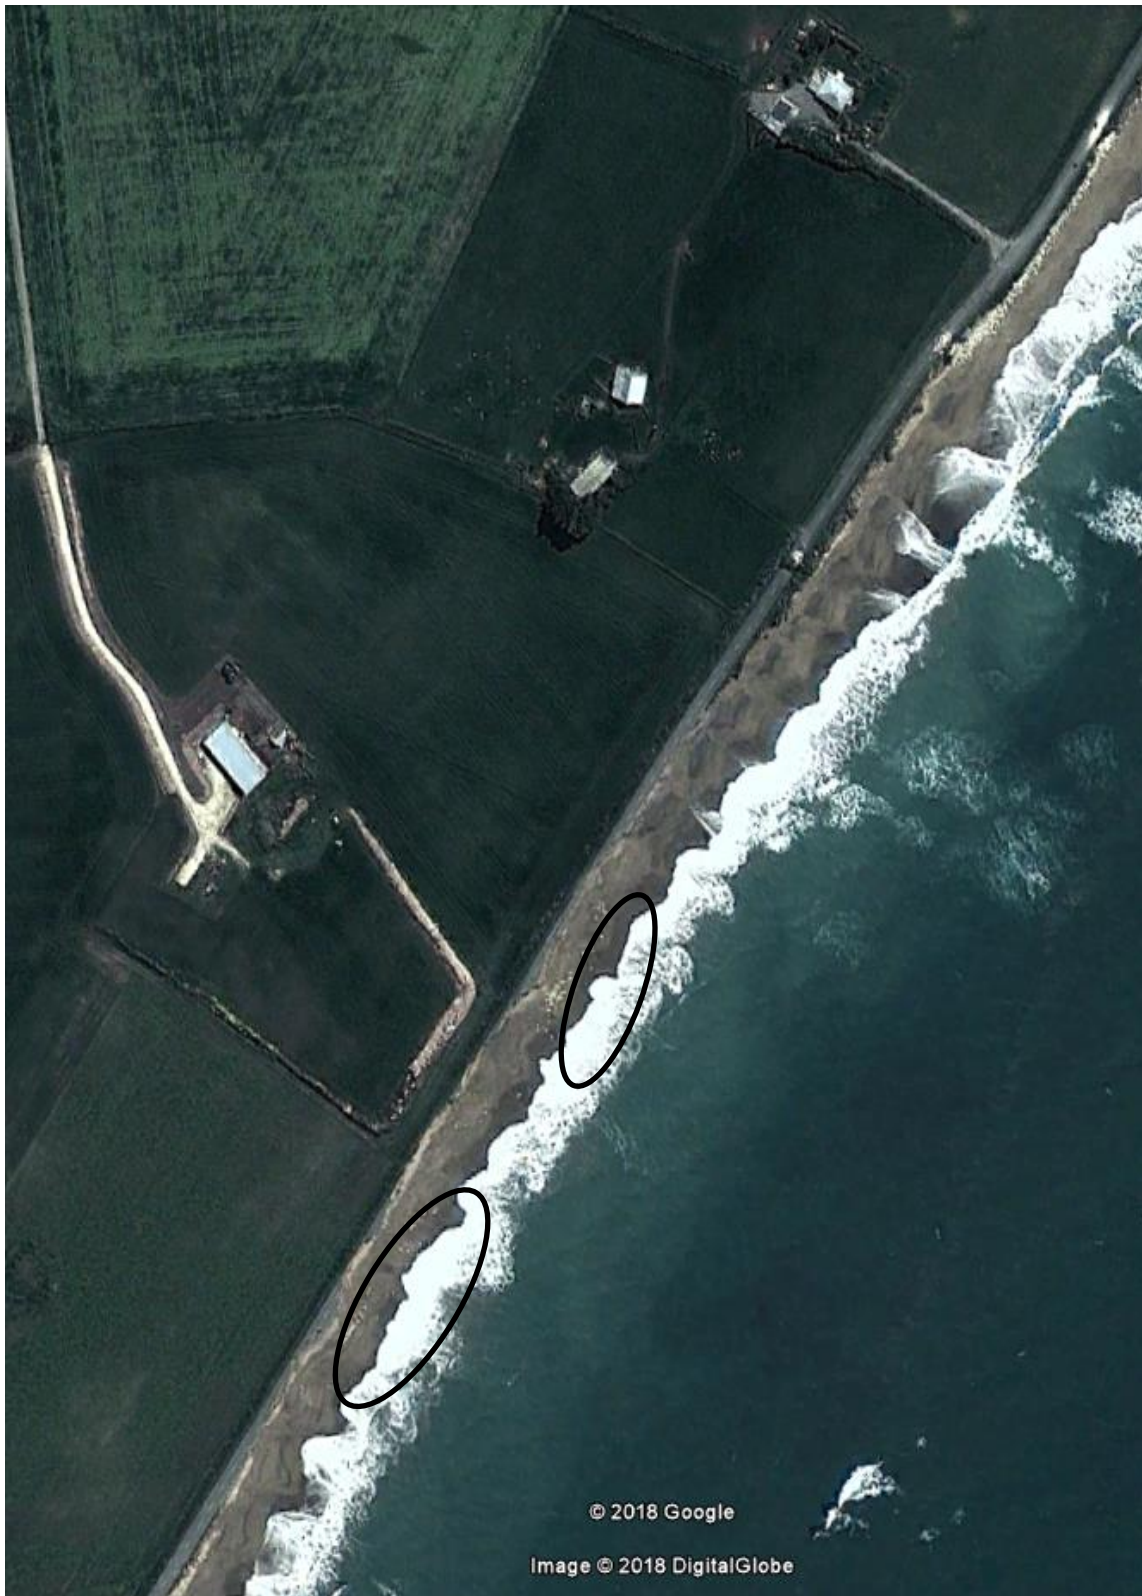
Figure 4-2: Riprap section on Beach Road viewed on satellite imagery of 03/10/2012. The view is the same as shown on Figure 4-1. Note the material of the failed riprap scattered on the foreshore (circled in black). Imagery source: DigitalGlobe.
