MANAGEMENT AND REDUCTION OF DEBRIS FLOW RISK IN ROXBURGH, OTAGO

OVERVIEW GEOMORPHIC PROCESSES - GOLFCOURSE CREEK

PROJECT No.
18113634

REPORT
003

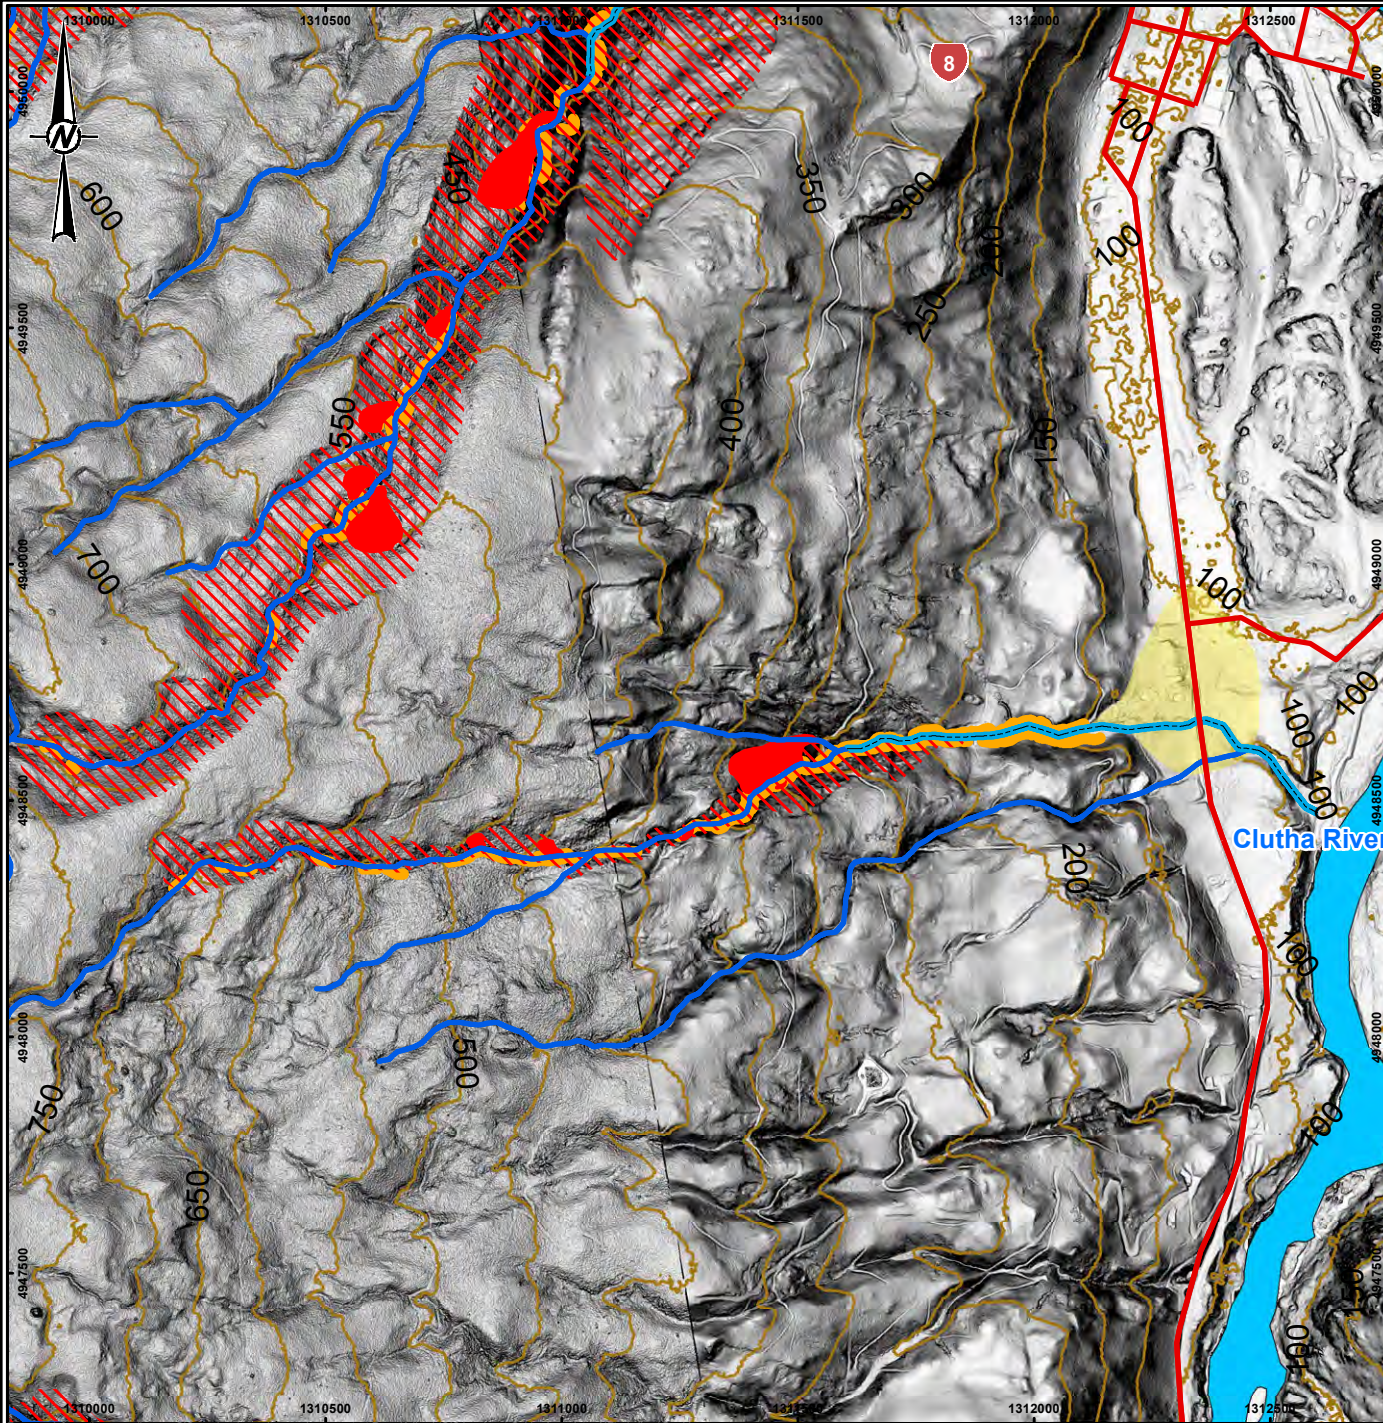
FIGURE
008

- Slope instability
- Slope instability - Recently activated
- Active bank erosion
- Creek
- Creek - Debris deposition
- Debris fan
- Topographic contour
- NZ roads
