NEW BEAUMONT BRIDGE - NOTICE OF REQUIREMENT AND RESOURCE CONSENT APPLICATIONS - NZ TRANSPORT AGENCY

New Beaumont Bridge
Notice of Requirement for an Alteration to a
Designation and Resource Consent Applications

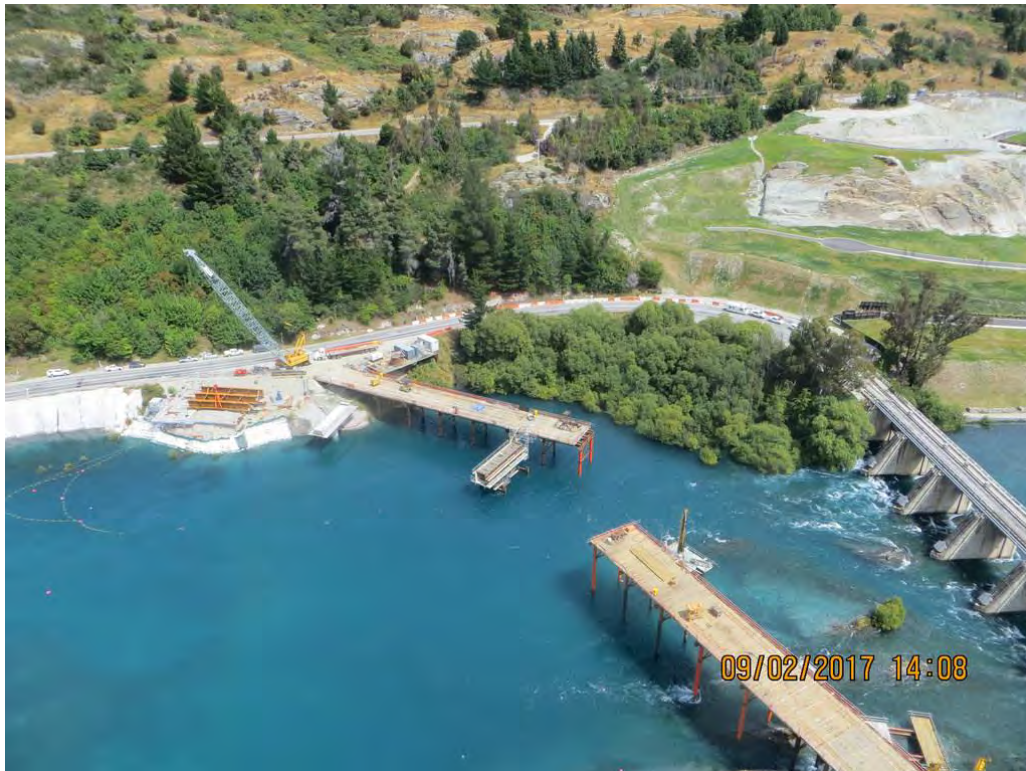
Figure 6: Photograph of temporary platforms - Kawarau Bridge

- The platform will be located on one side (likely downstream) of the new bridge so that it can be used for access to piling and pier construction, as well as lifting in the beams once the bridge substructure is complete. Gravel work platforms (causeways) located at ground level (constructed on top of the existing river bed) may also be used for access to pier locations where practical instead of, or to supplement, any temporary staging.

In the event of high flow events if any temporary gravel causeway was overtopped and washed away (or partially washed away) this would require the causeway to be reformed. The work could be undertaken throughout the construction period as required. All work would be in accordance with the contractor’s Erosion, Sediment and Dust Control Plan (ESDCP). On completion of the bridge construction, all temporary causeways will be disestablished, and the riverbed reinstated.

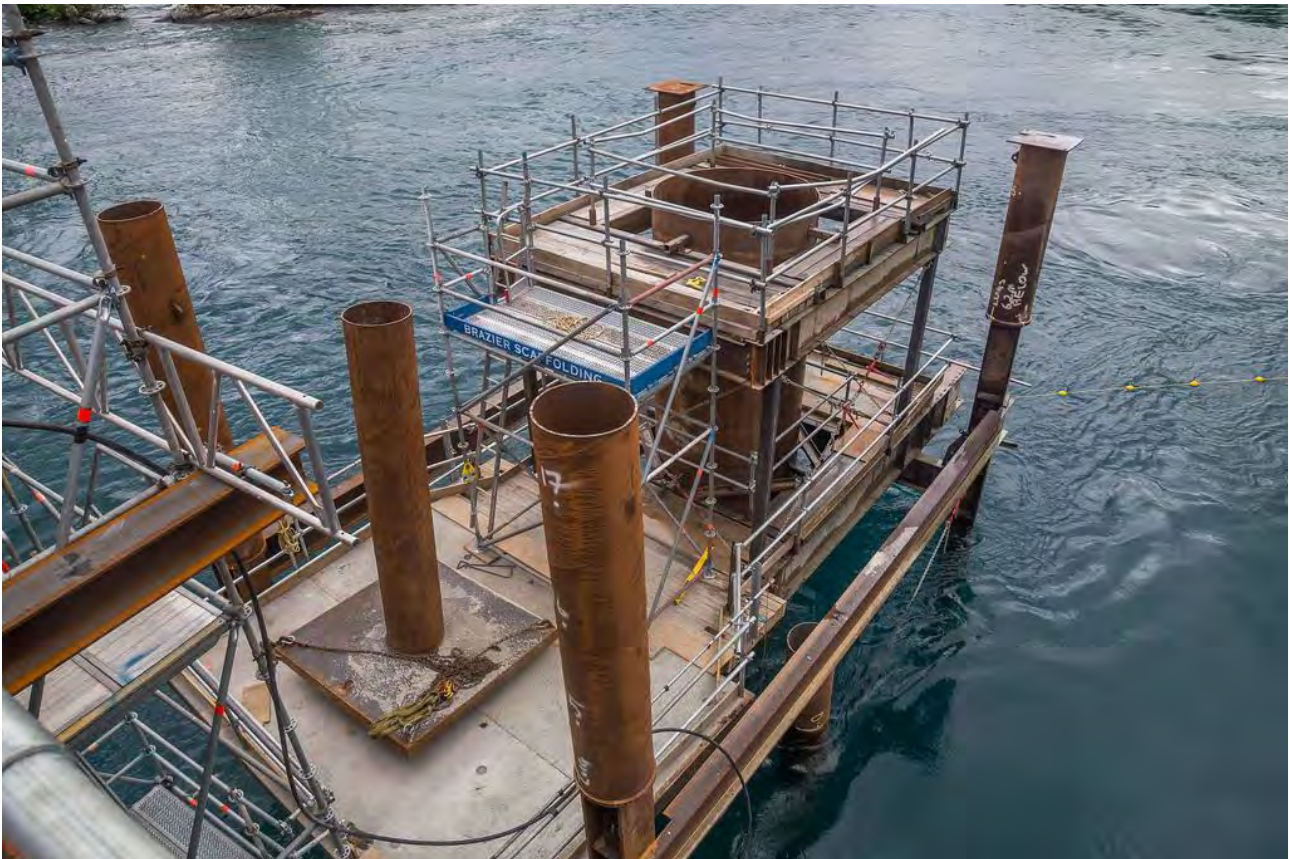
Figure 7: Example of Pile setup

As part of constructing concrete piles for piers once the pile is driven, reinforcing will be placed inside the casing and the casing will be filled with concrete (by piping concrete under water down to the base of the pile – known as the tremie method) – shown in **Figure 7** below. It may be near impossible to pump out water from the piles during this process meaning that as concrete is placed it will displace the water. In these cases, the contractor will allow the displaced water to spill out of the casing onto adjacent areas where it will be captured and prevented from being discharged to the river. In cases where the liquid has high sediment levels, normally the last 1-2m of water above the wet concrete, the liquid will be collected and removed from the pile casing.

- Construction of bridge pier foundations will require excavation of bedrock up to 10m below ground level to form cylindrical piles, one at each pier location. Reinforcing steel will be placed into the pile excavation and backfilled with concrete to form the foundation which will be extended above ground level to form the bridge pier.

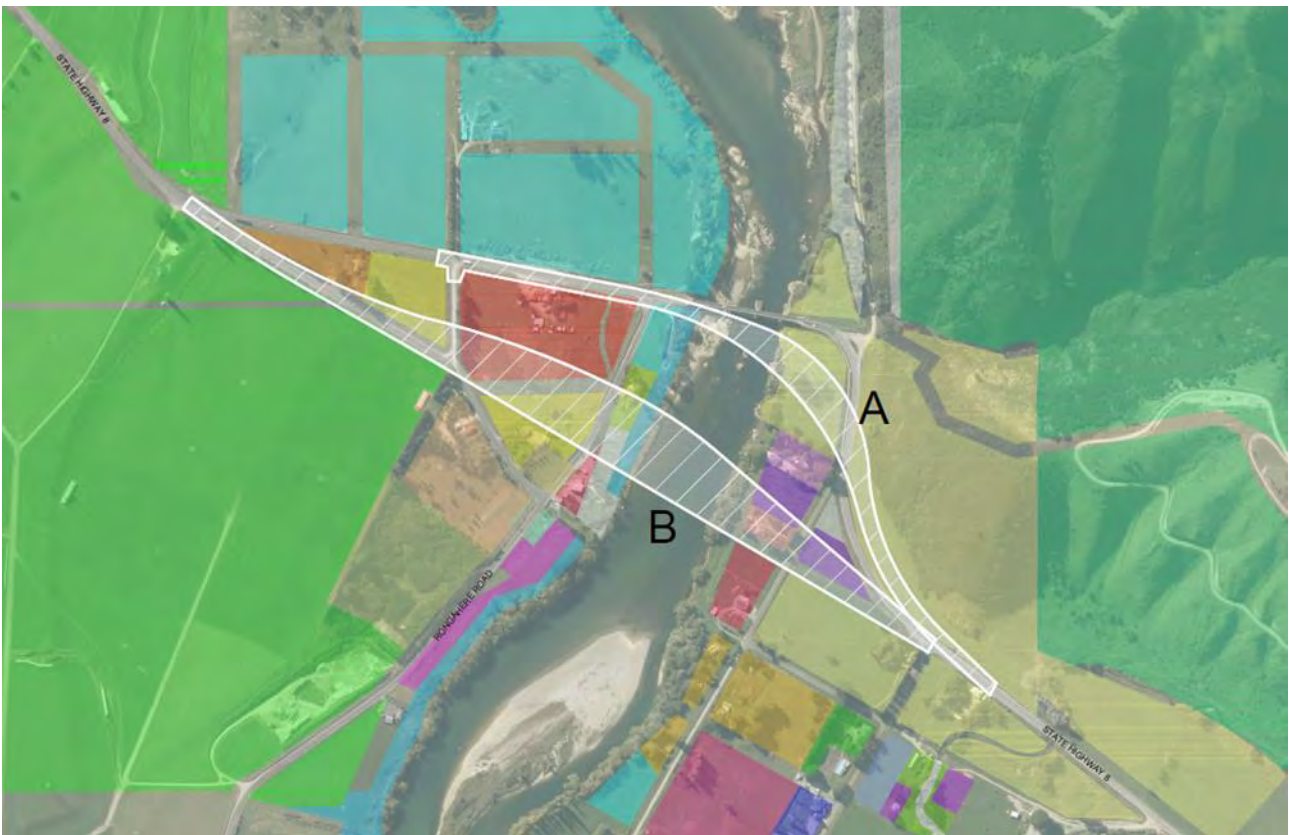
Figure 8: Business Case Option

As part of the detailed business case for the new bridge, two alignments (Ribbons A and B as shown below in **Figure 8**) were investigated and consulted on with the community. Ribbon A is a curved route to the immediate south of the existing bridge. Ribbon B (in a general sense) would follow the alignment of Eastferry / Westferry streets. A clear preference from the community was for an alignment on the north side of the Beaumont township as opposed to the 'straight line' option (for further detail refer to Section 7). It is also noted the Ribbon B would require a much longer SH8 realignment and impact considerably more properties than Ribbon A.

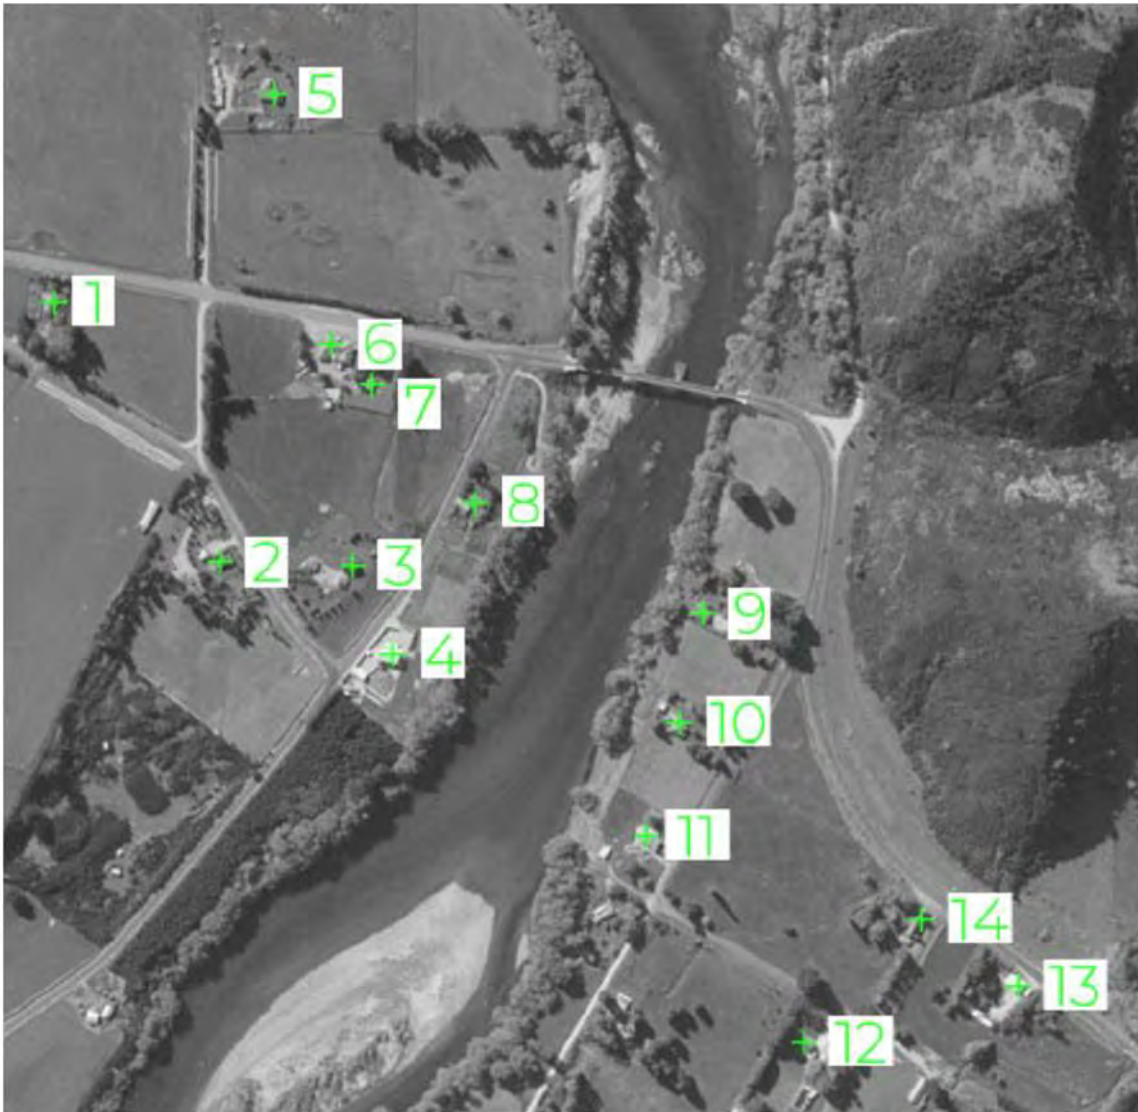
Figure 9: Noise and Vibration Assessment Locations

Given the project will result in a changed highway alignment, and that there will be considerable construction required including piling, an assessment of the effects, both from construction and from operational have been assessed (WSP-Opus 2019). The noise and vibration assessment assessed 14 locations as shown in Figure 9 below.

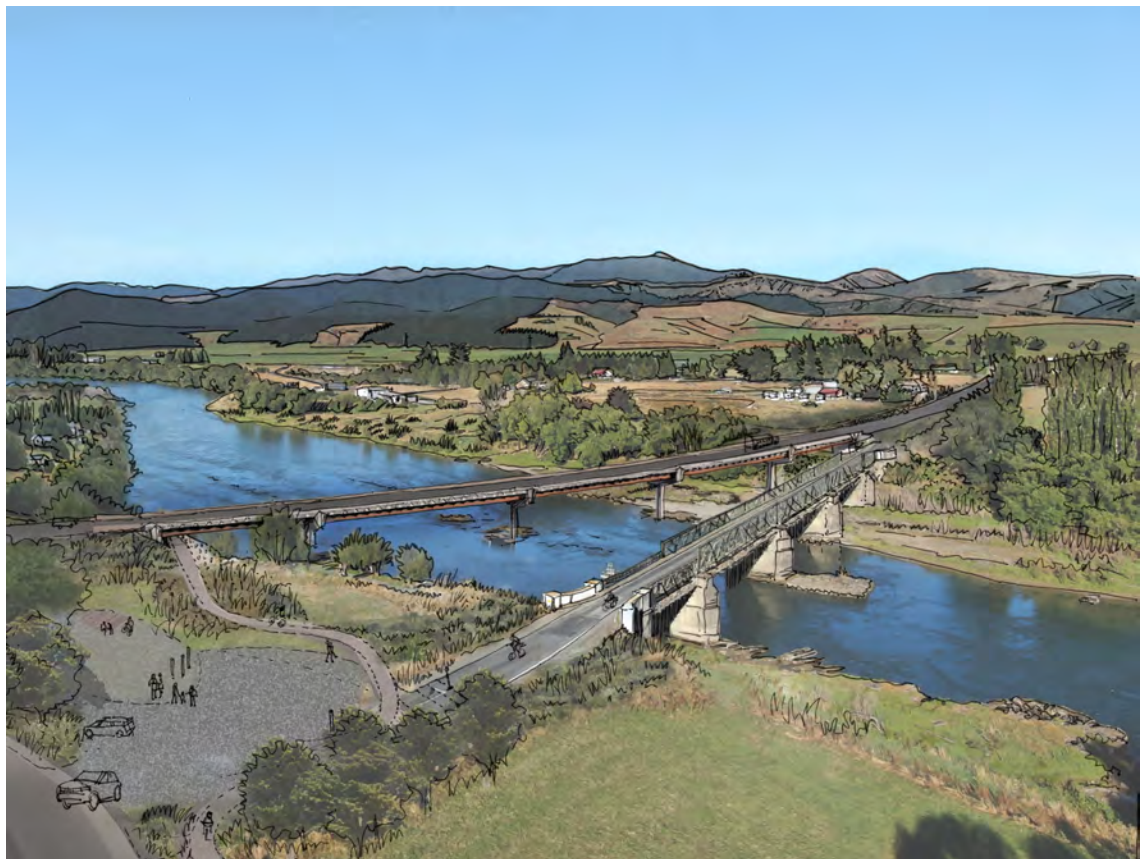
Figure 1 Artists impression of the new State Highway 8 bridge over the Clutha River at Beaumont, looking downstream showing the existing bridge in the foreground.

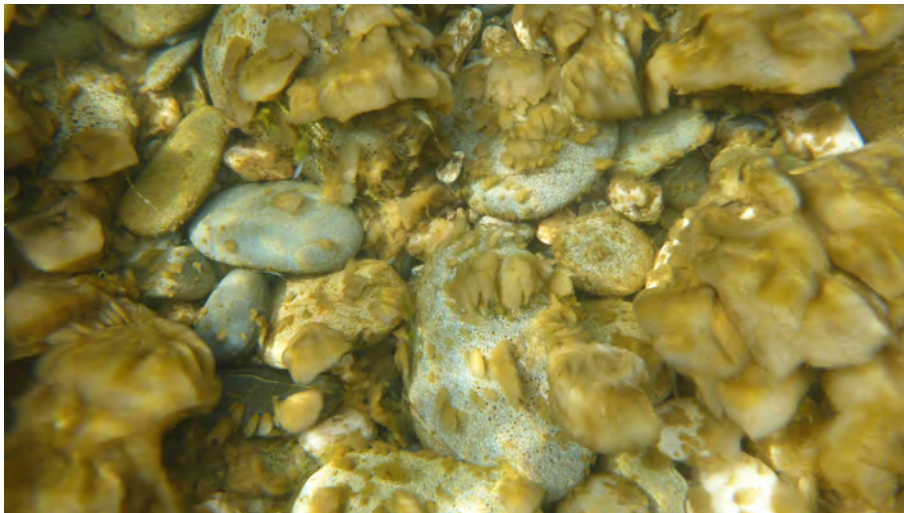
Figure 4 Photograph of the bed substrate and representative algae cover at the Beaumont sampling site in April 2014 by Ludgate & Ryder (2014).

Underwater video footage collected by Underwater Solutions Ltd. in August 2018 showed that bedrock outcrops had cover of didymo and bryophytes (aquatic mosses), while gravels generally had little or sparse periphyton cover.

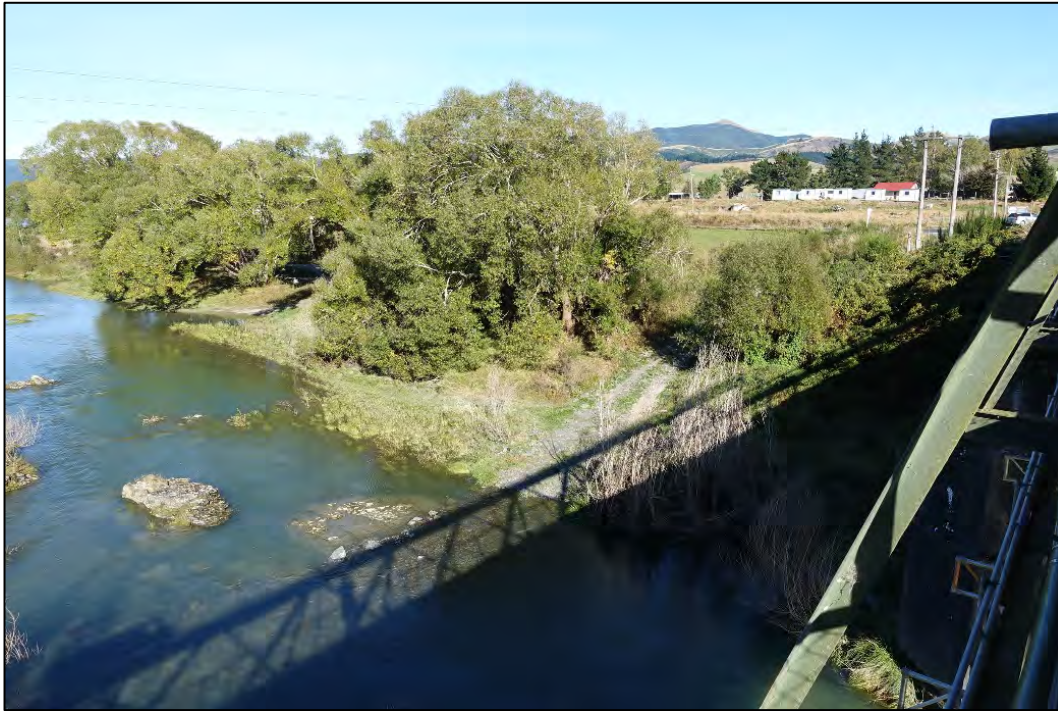
Figure 6 Riparian area (west of Clutha River/Mata-Au) showing an overview of the area south of Beaumont Bridge towards the existing boat ramp.

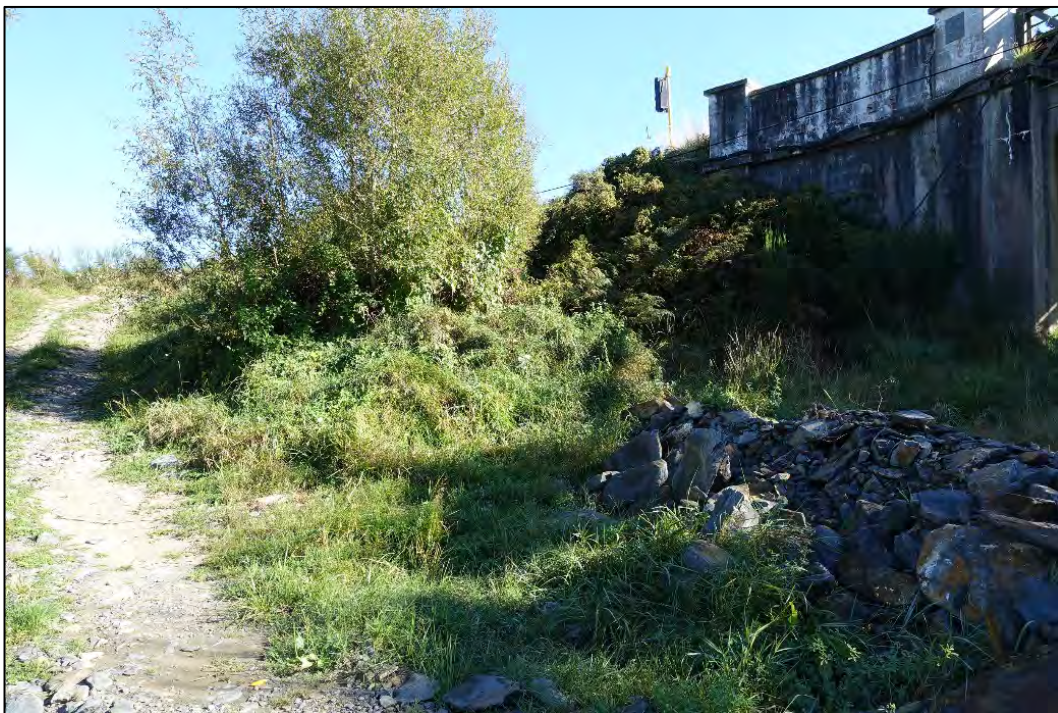
Figure 7 Riparian area (west of Clutha River/Mata-Au) showing a close-up view of vegetation immediately south of the existing Beaumont Bridge.

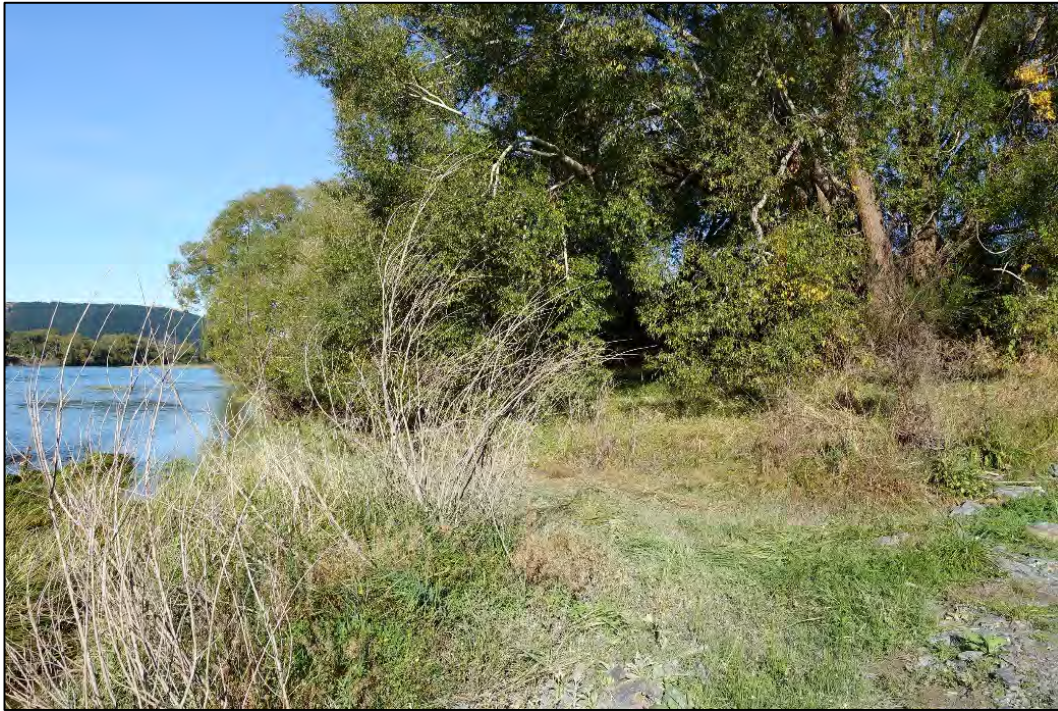
Figure 8 Riparian area (west of Clutha River) c. 20m below existing Beaumont Bridge. Taller crack willow and rank grass dominated the vegetation at this location.

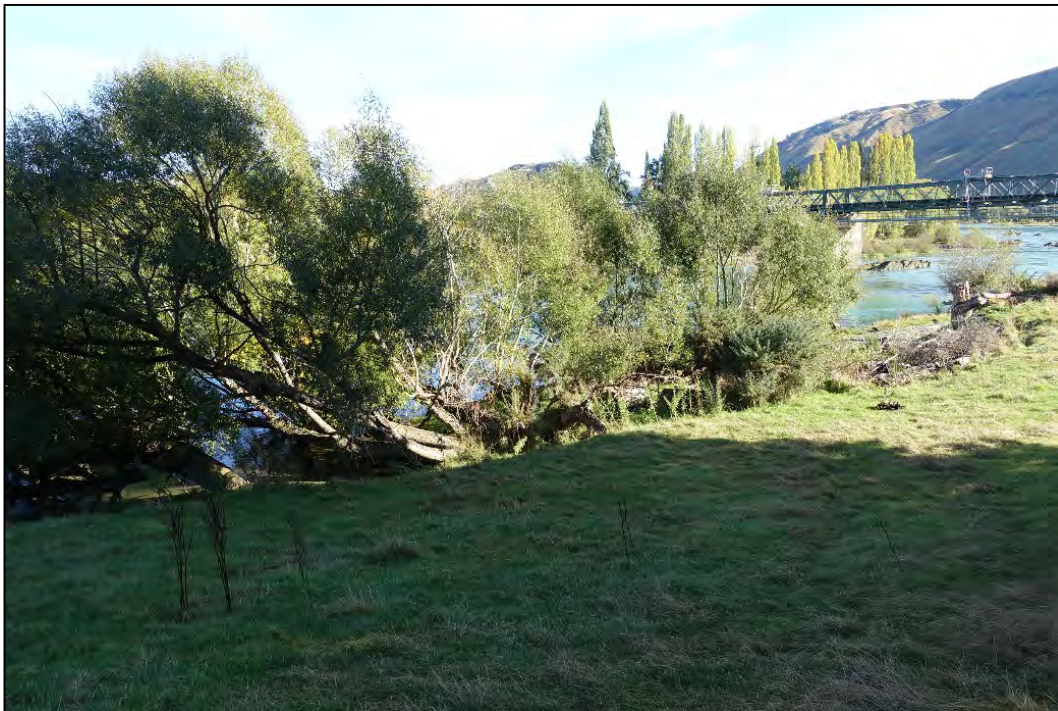
Figure 9 Riparian area (east of Clutha River/Mata-Au) showing crack willow dominant with pasture grassland..

Riparian area – east of river (Figure 9)

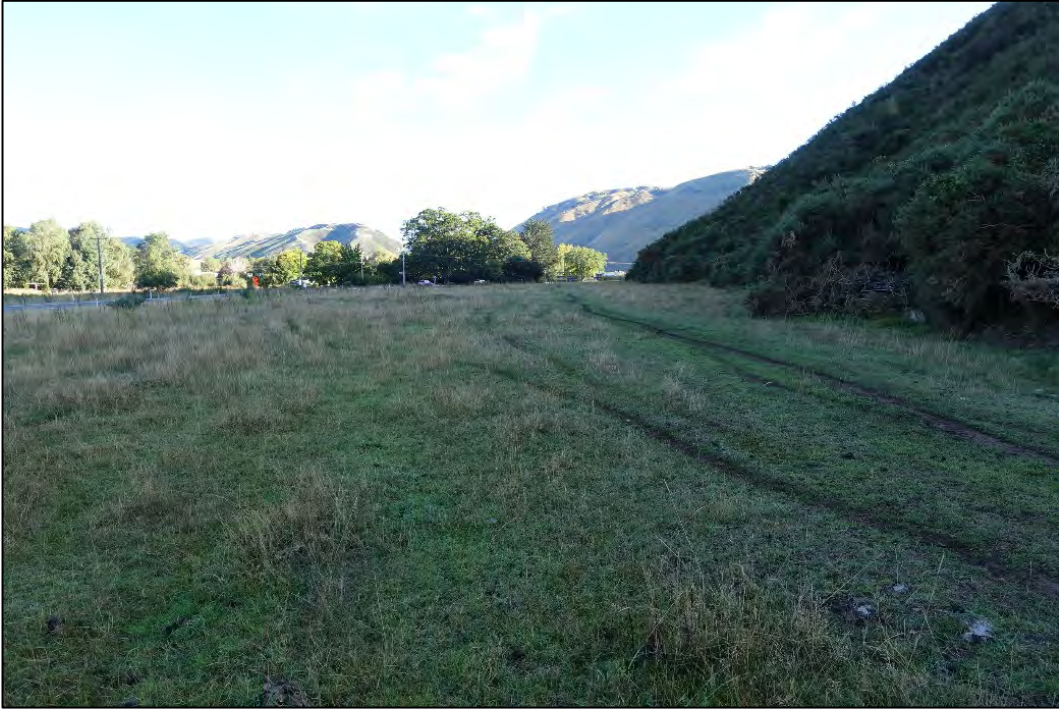
Figure 10 Pasture Grassland (east of Clutha River/Mata-Au). View looking north-west towards Beaumont Bridge. The adjacent hill-slope primarily supported Scotch broom, gorse and other scattered exotic trees.

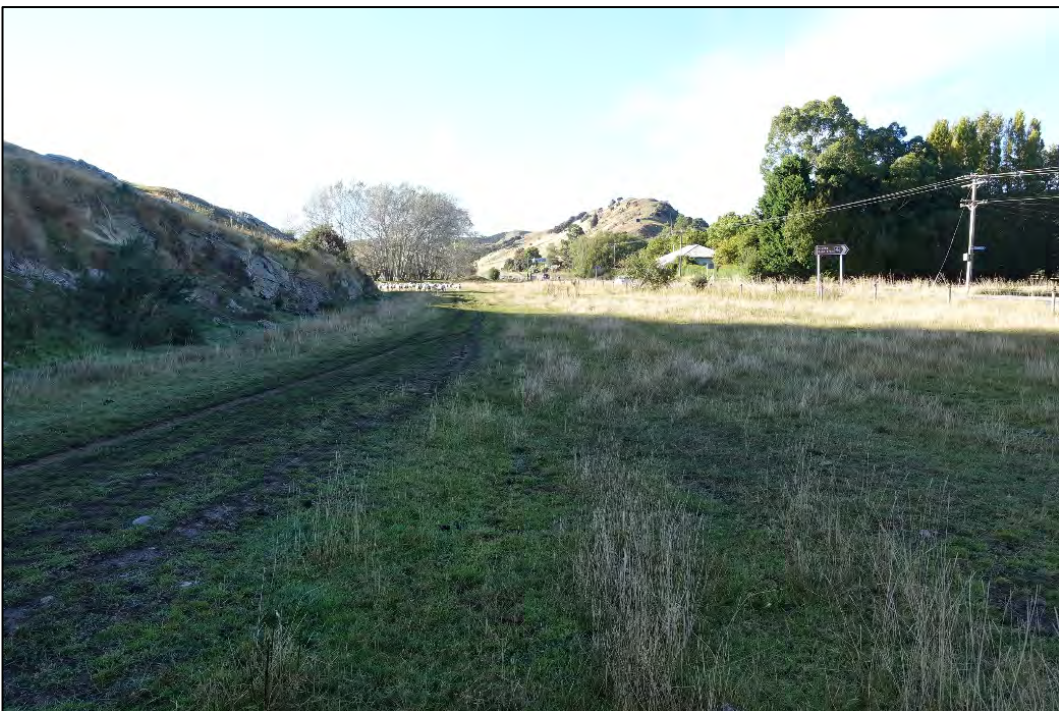
Figure 11 Pasture Grassland (east of Clutha River/Mata-Au) looking south-east towards Low Burn..

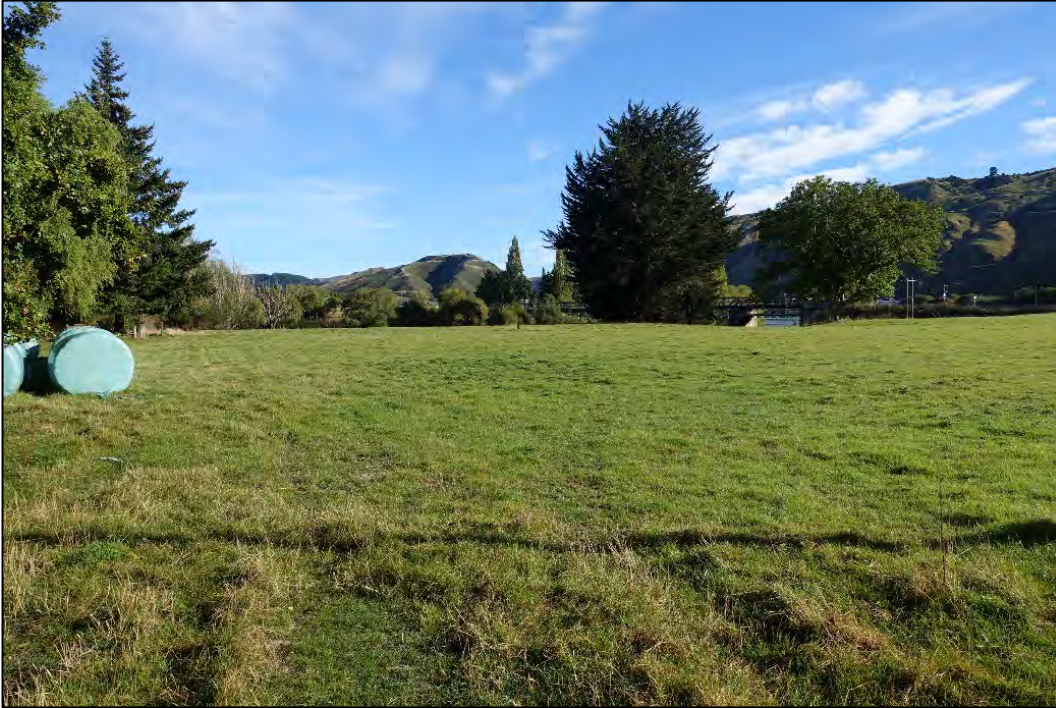
Figure 12 Pasture Grassland (east of Clutha River/Mata-Au). View across a small paddock towards the Clutha River showing a large macrocarpa tree (centre) adjacent to a small totara (not visible), both of which will likely be removed for the realignment.

larger plants present (e.g. flax, toetoe, *Coprosma crassifolia*, totara and *Pittosporum tenuifolium*) are represented by 1-3 individuals at most; these losses can easily be offset with planting, post-development. The only conspicuous losses within the pasture grassland areas will be one large macrocarpa (*Cupressus macrocarpa**) and a small adjacent totara (*Podocarpus totara*) from the paddock on the eastern side of the Clutha River (Figure 12). In addition, approximately 12 crack willow* could be removed from the riparian areas. These localised losses represent a loss of potential roosting habitat or shelter for riverine birds such as grey teal or black shags. It is not known, however, how often these birds are present within the footprint (none were sighted at the time of the vegetation survey); and similar habitat exists for many kilometres upstream and downstream of the footprint.

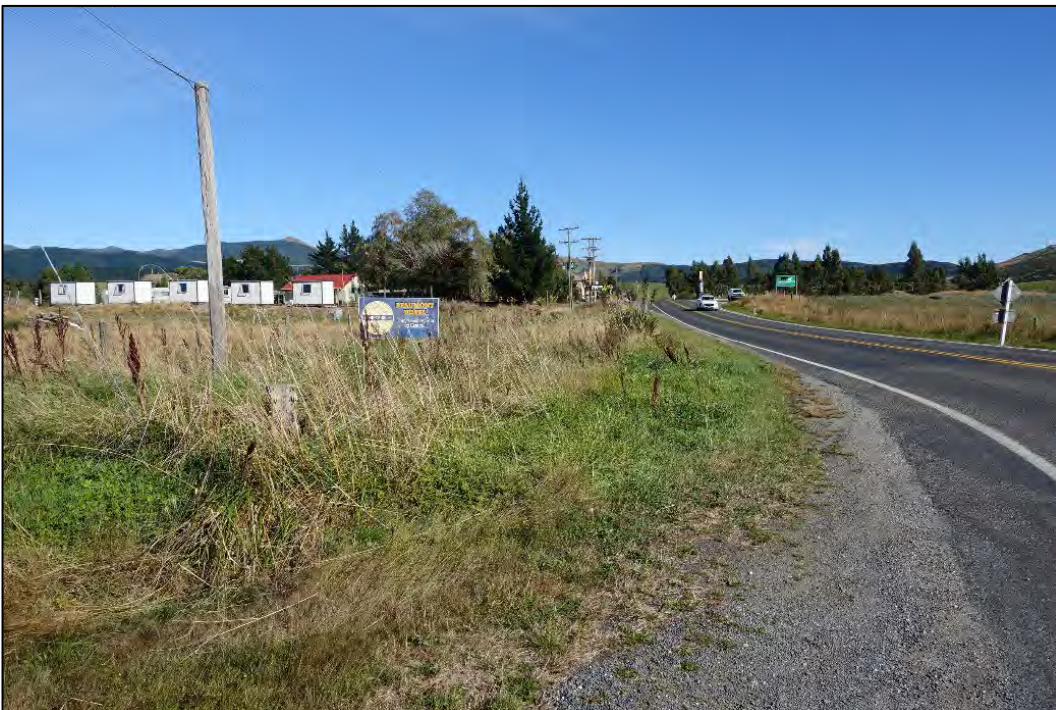
Figure 13 Roadside vegetation (west of river). View west towards Beaumont Hotel.

Roadside Vegetation (Figures 13 & 14)

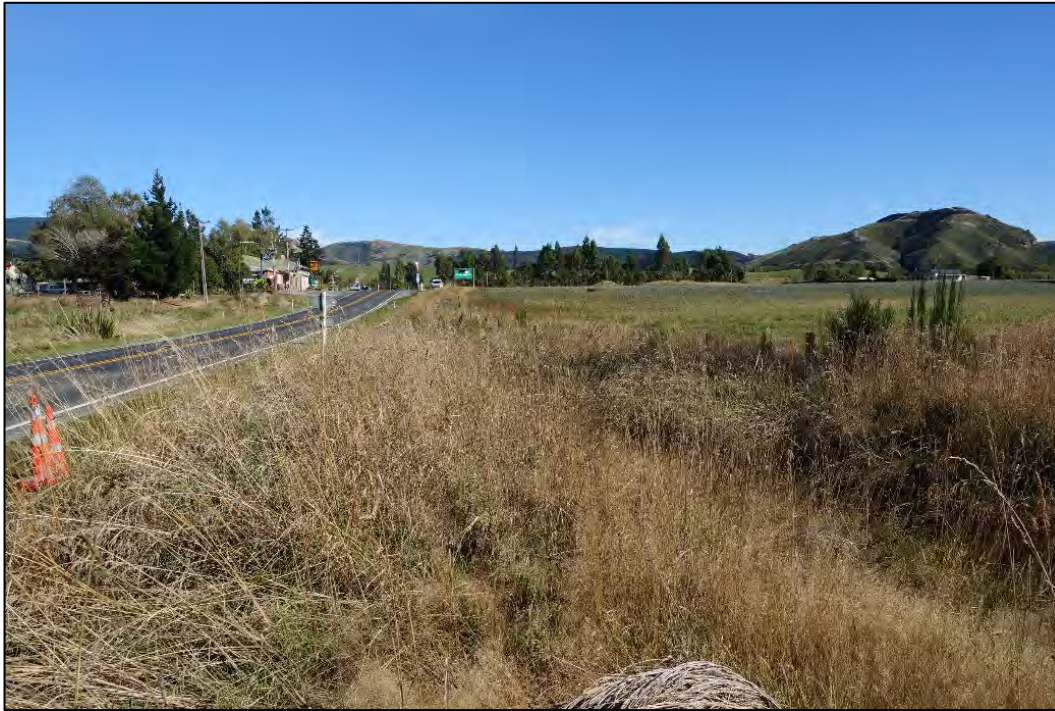
Figure 14 Roadside and pasture grassland (west of Clutha River/Mata-Au). View west towards Beaumont Hotel.

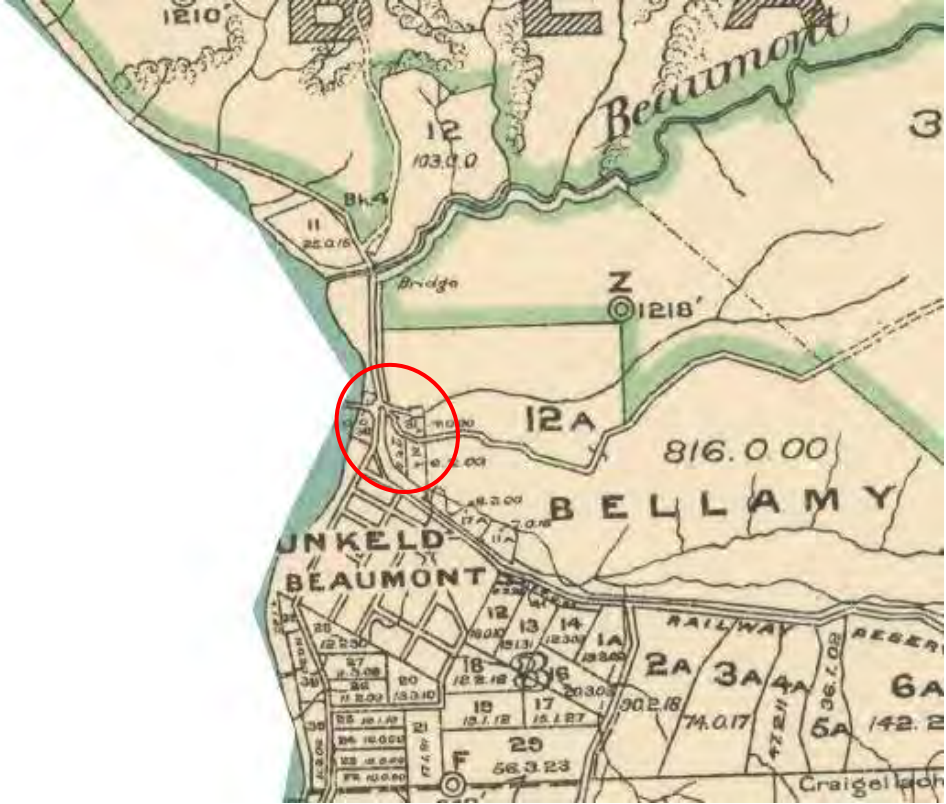
Photograph Year and Source	Observations
<p>1929 Maps Past</p>

<p>Only the eastern part of the site can be seen on this map. However, the road bridge is evident and it can be noted that a railway is running across the western most part of the site.</p>

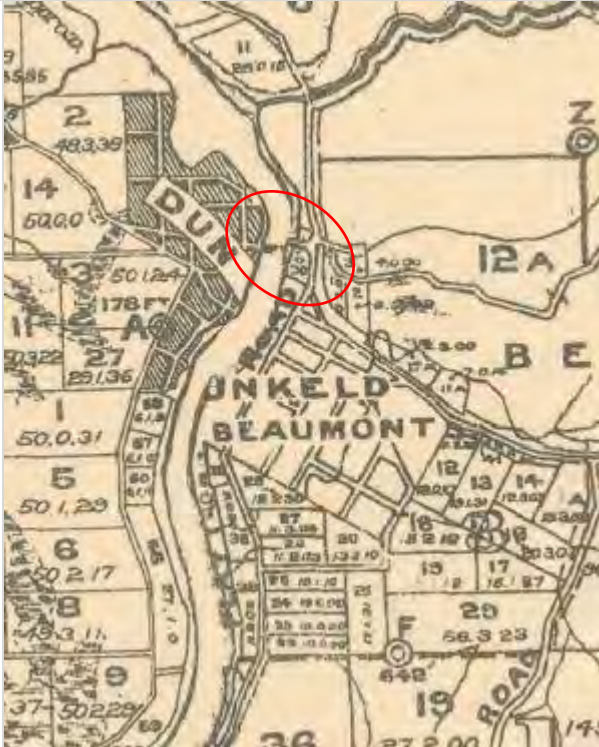
Photograph Year and Source	Observations
<p>1949 Maps Past</p>

<p>The whole of the site can be seen, the western back of the river appears to be built up.</p>
<p>1959 Maps Past</p>

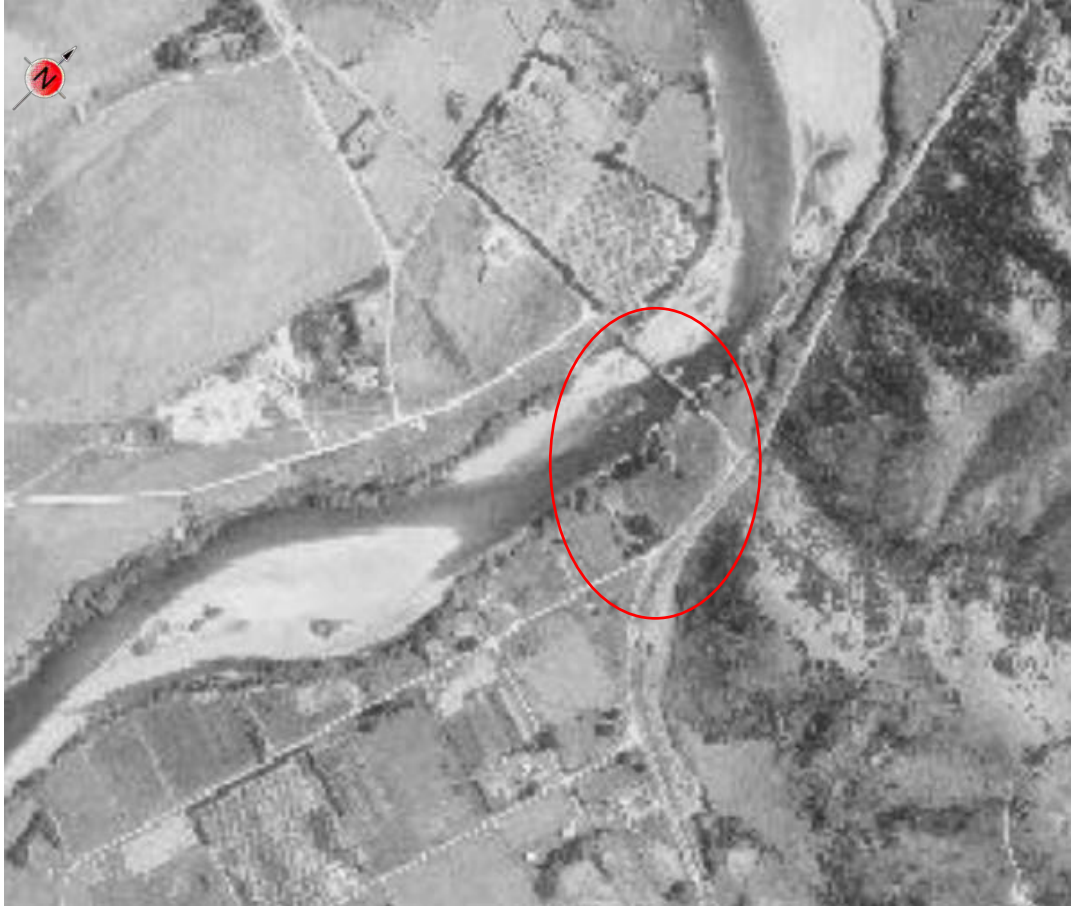
Photograph Year and Source	Observations
<p>1964 Retrolens Aerial Photograph Survey No.: SN1627 Elevation: 14,000 Run No.: B Photo No.: 1 Scale: 37,800</p>

<p>A track can be seen extending towards the river in the western part of the site. There are no apparent changes to the surrounding area.</p>
<p>1979 Maps Past</p>

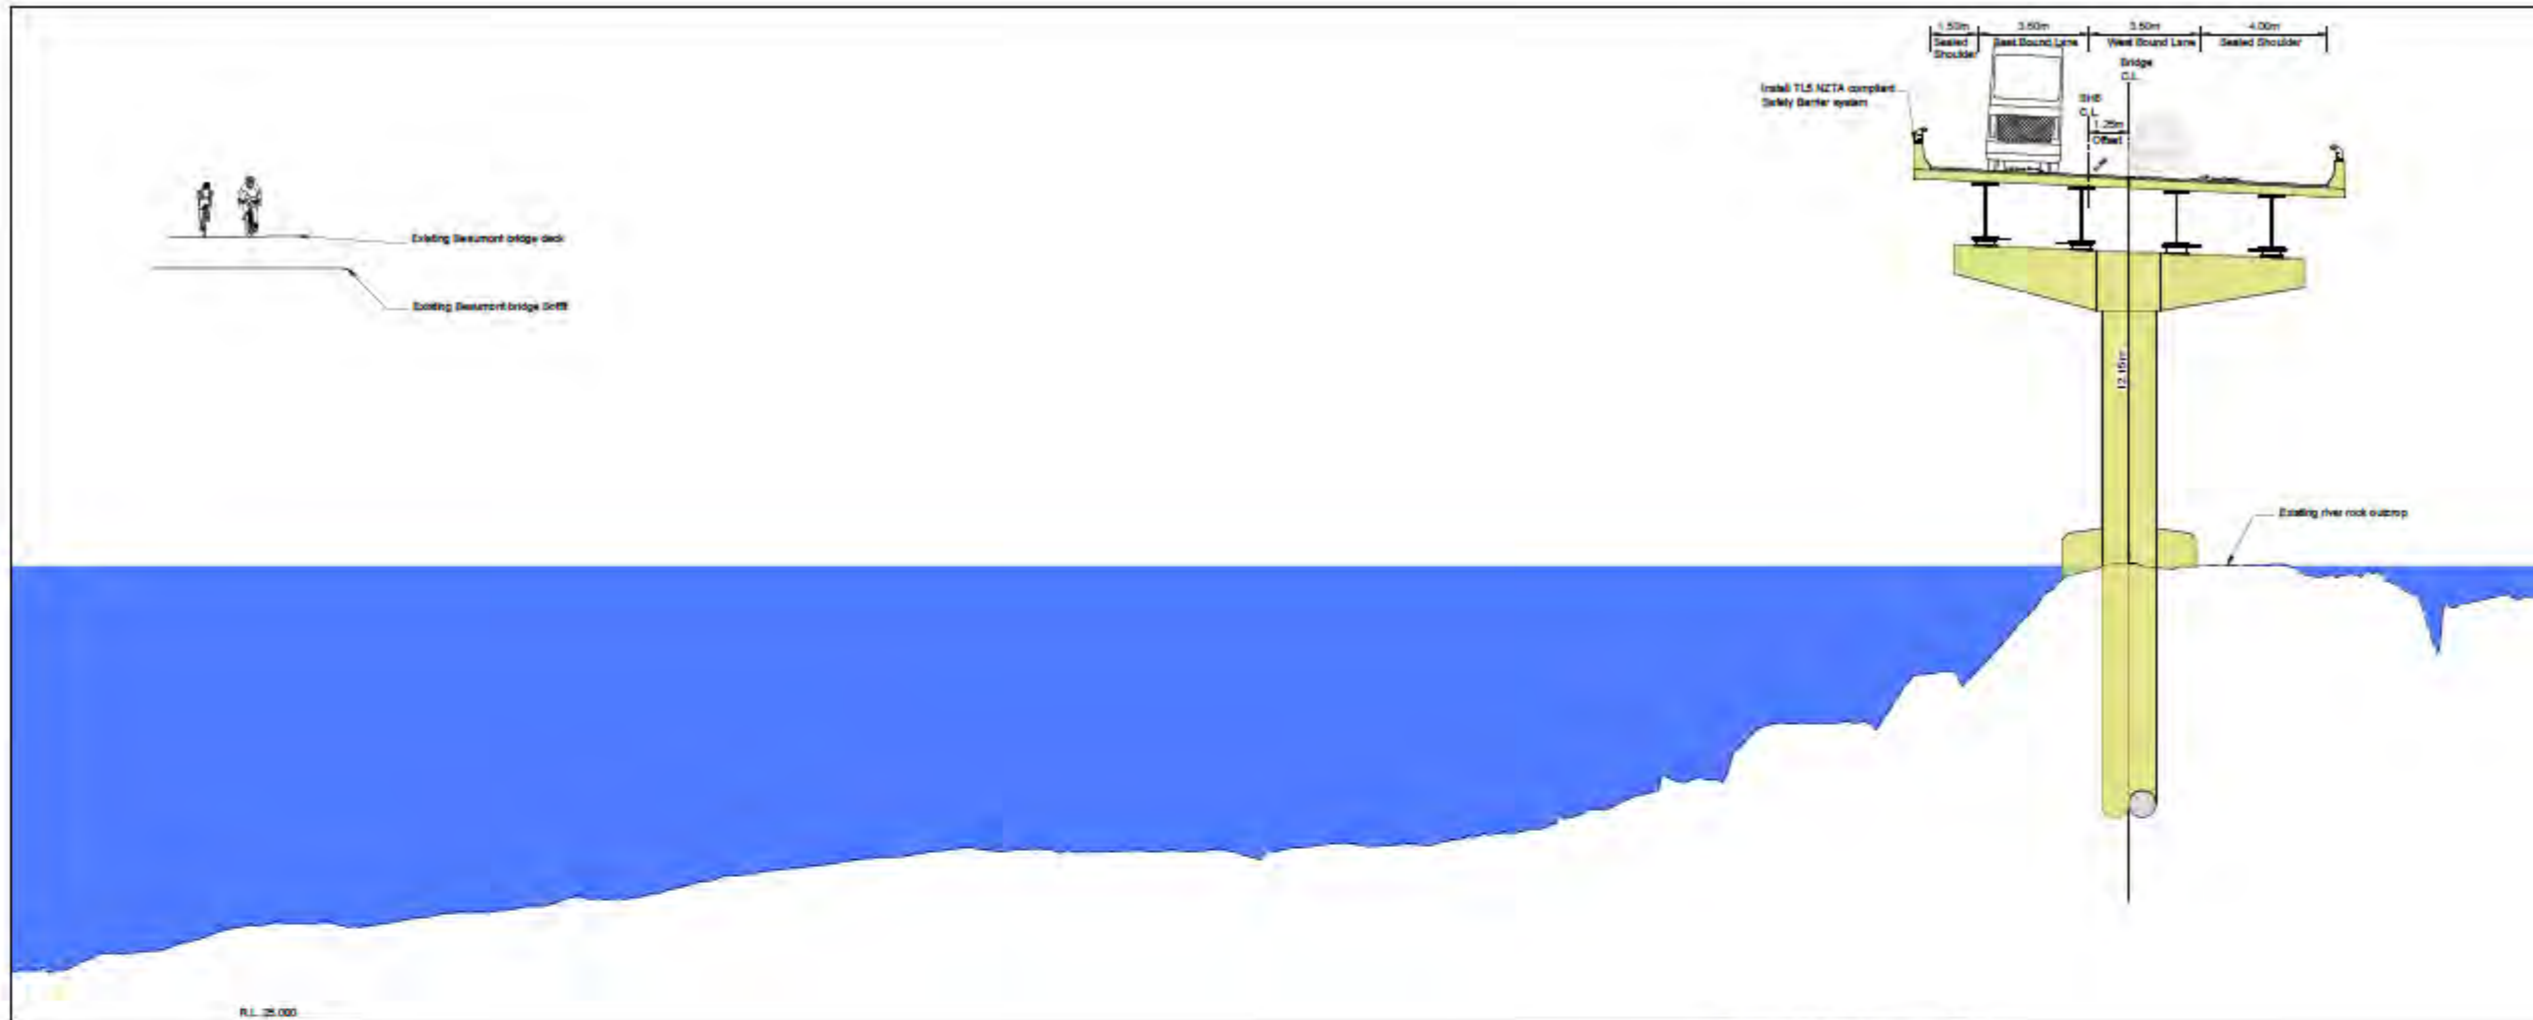
CROSS SECTION S6
(CHA. 6305 - OUTCROP PIER LOCATION) SID-3

R.L. 28.000

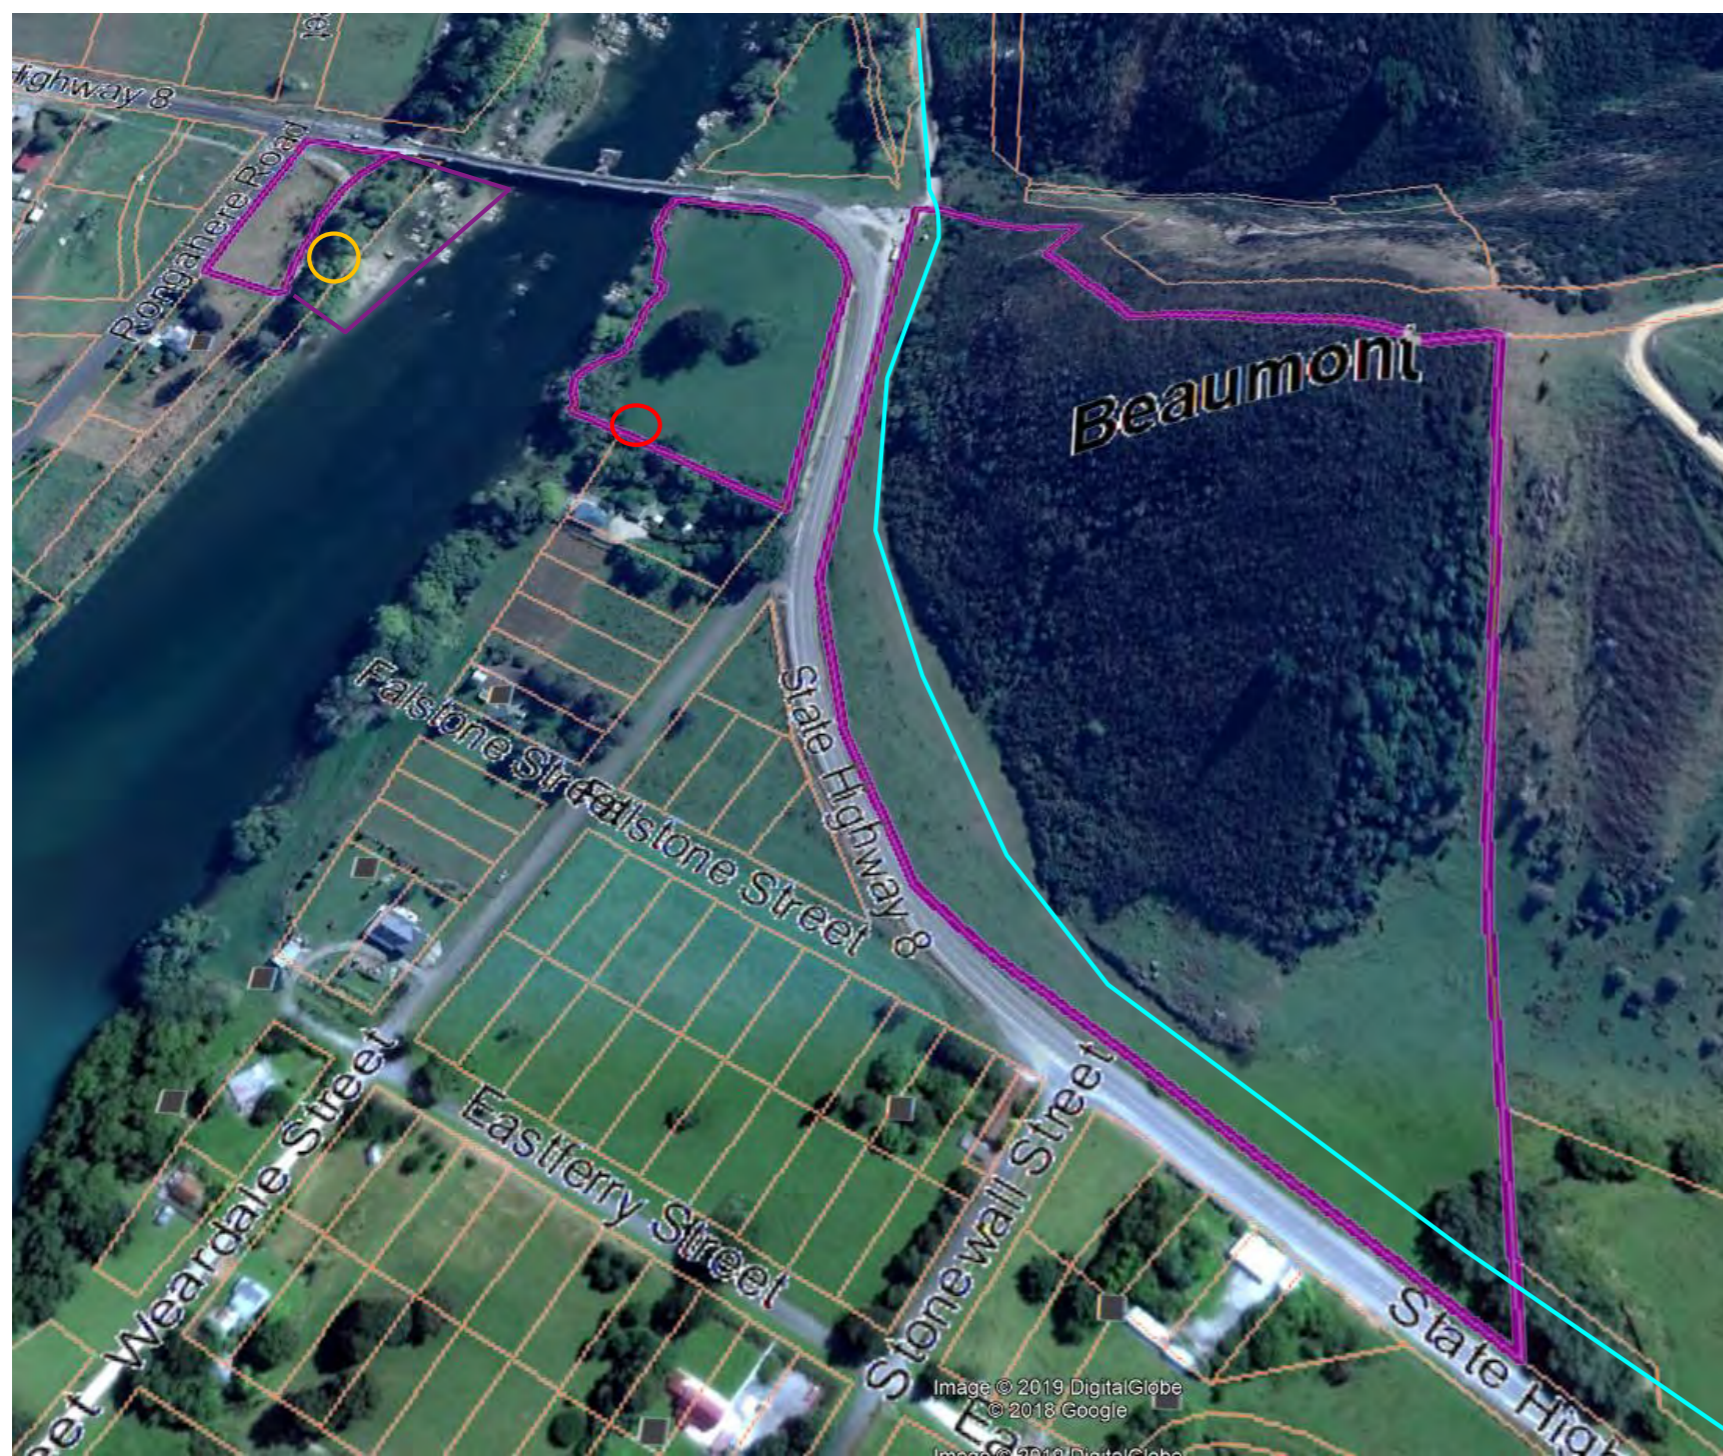
Appendix D: Site Layout Plan

- Approximate site boundary
- Possible Sheep dip
- car parking area
- Railway line

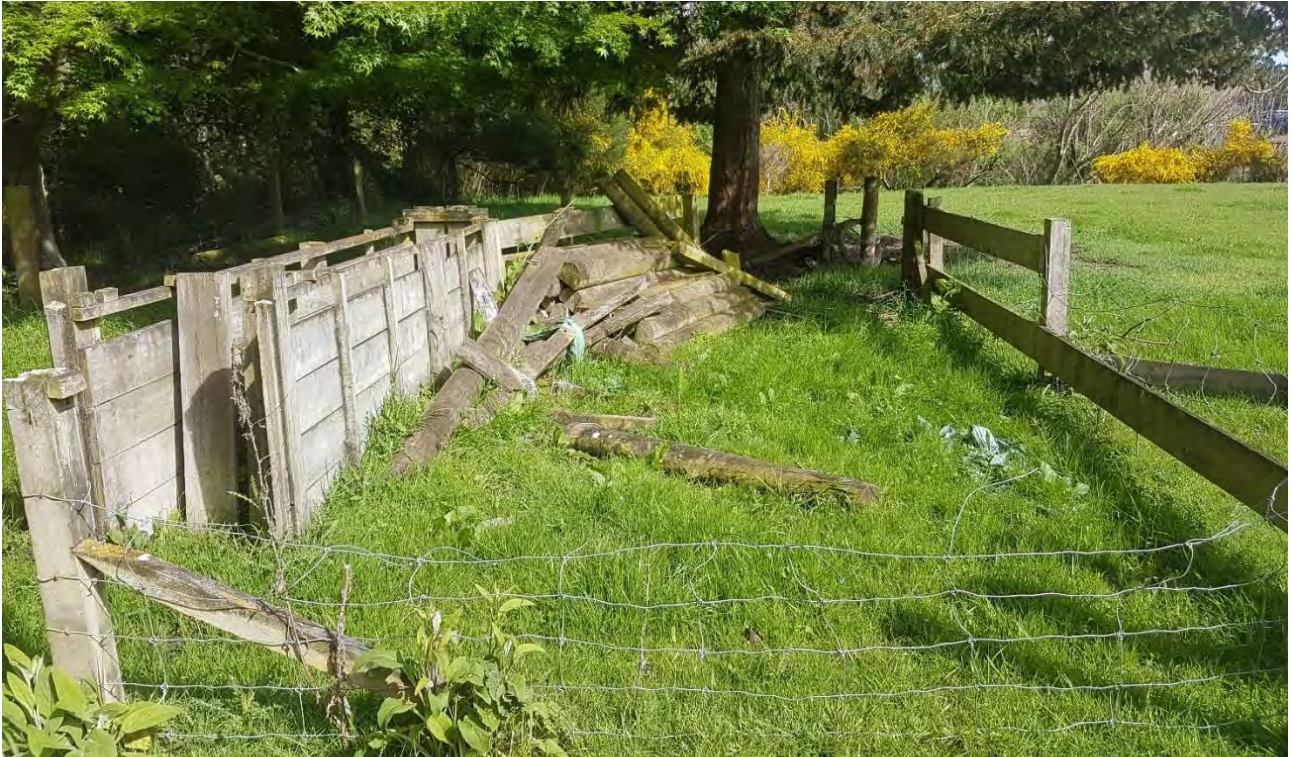
Photo 3: Sheep dip/drenching run in eastern bank paddock
