NEW BEAUMONT BRIDGE - NOTICE OF REQUIREMENT AND RESOURCE CONSENT APPLICATIONS - NZ TRANSPORT AGENCY

New Beaumont Bridge
Notice of Requirement for an Alteration to a
Designation and Resource Consent Applications

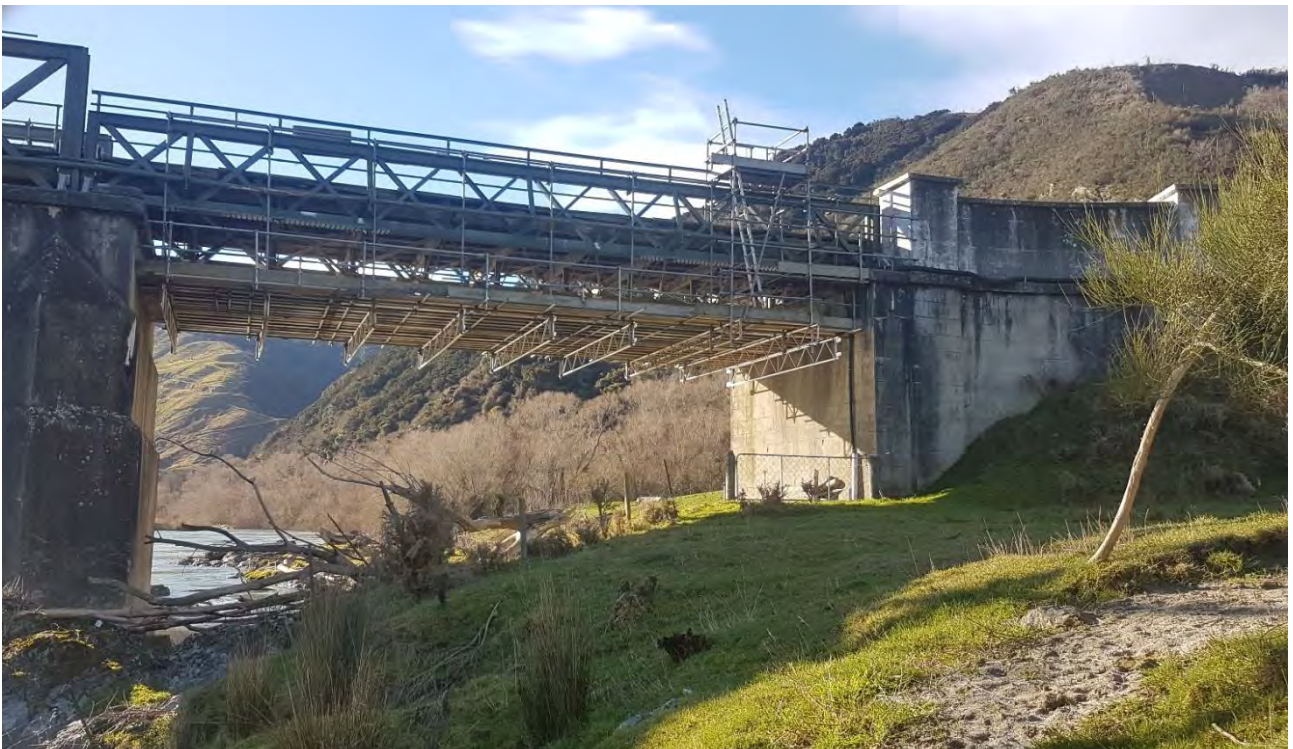
Photo 4: Eastern abutment of existing bridge

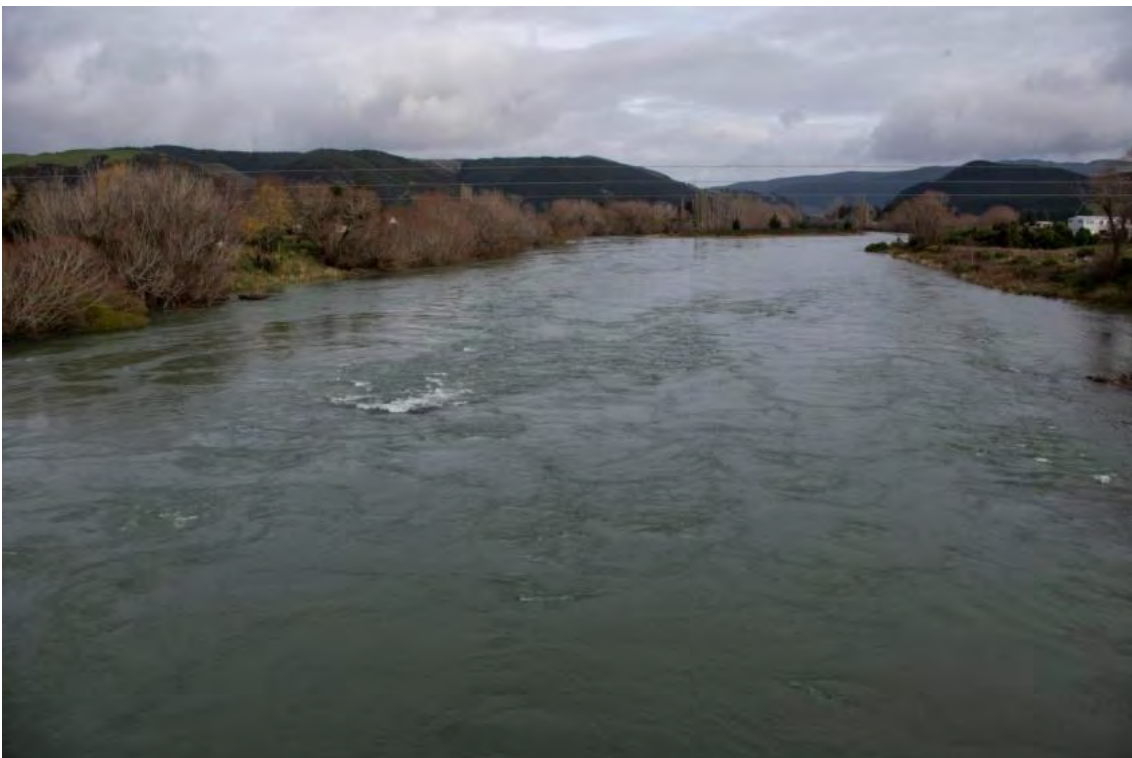
Figure 1-1 View of the Clutha River looking downstream from the existing bridge towards the site of the proposed bridge

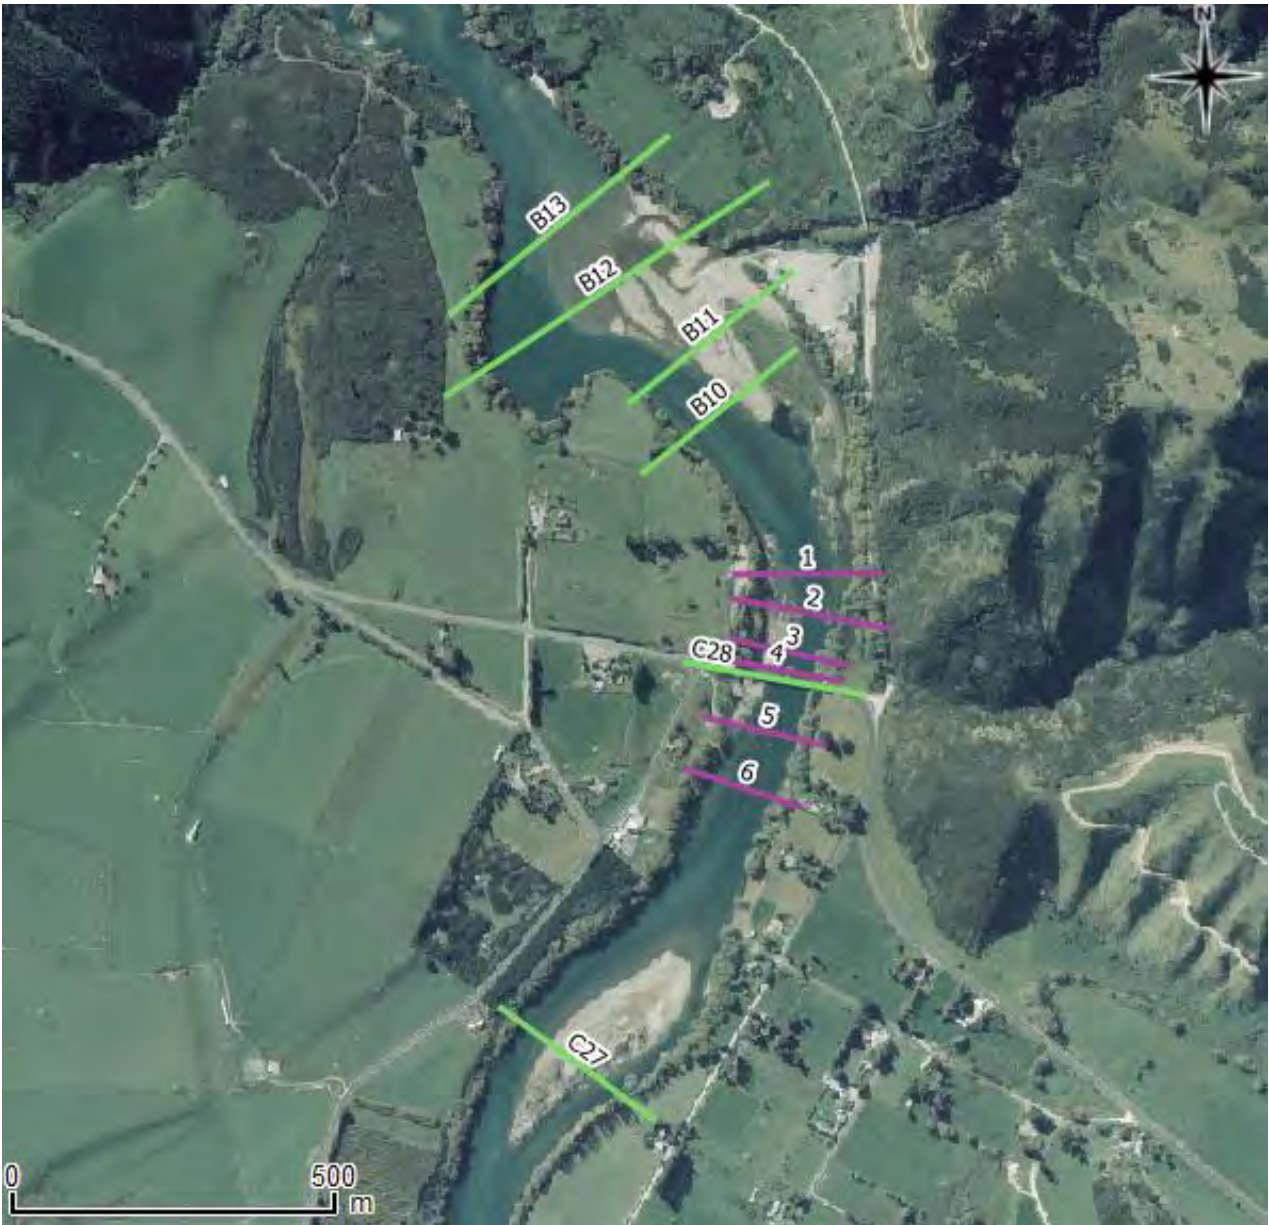
Figure 3-1 Cross-sections surveyed by Eliot Sinclair (shown in pink) and by ORC (shown in green)

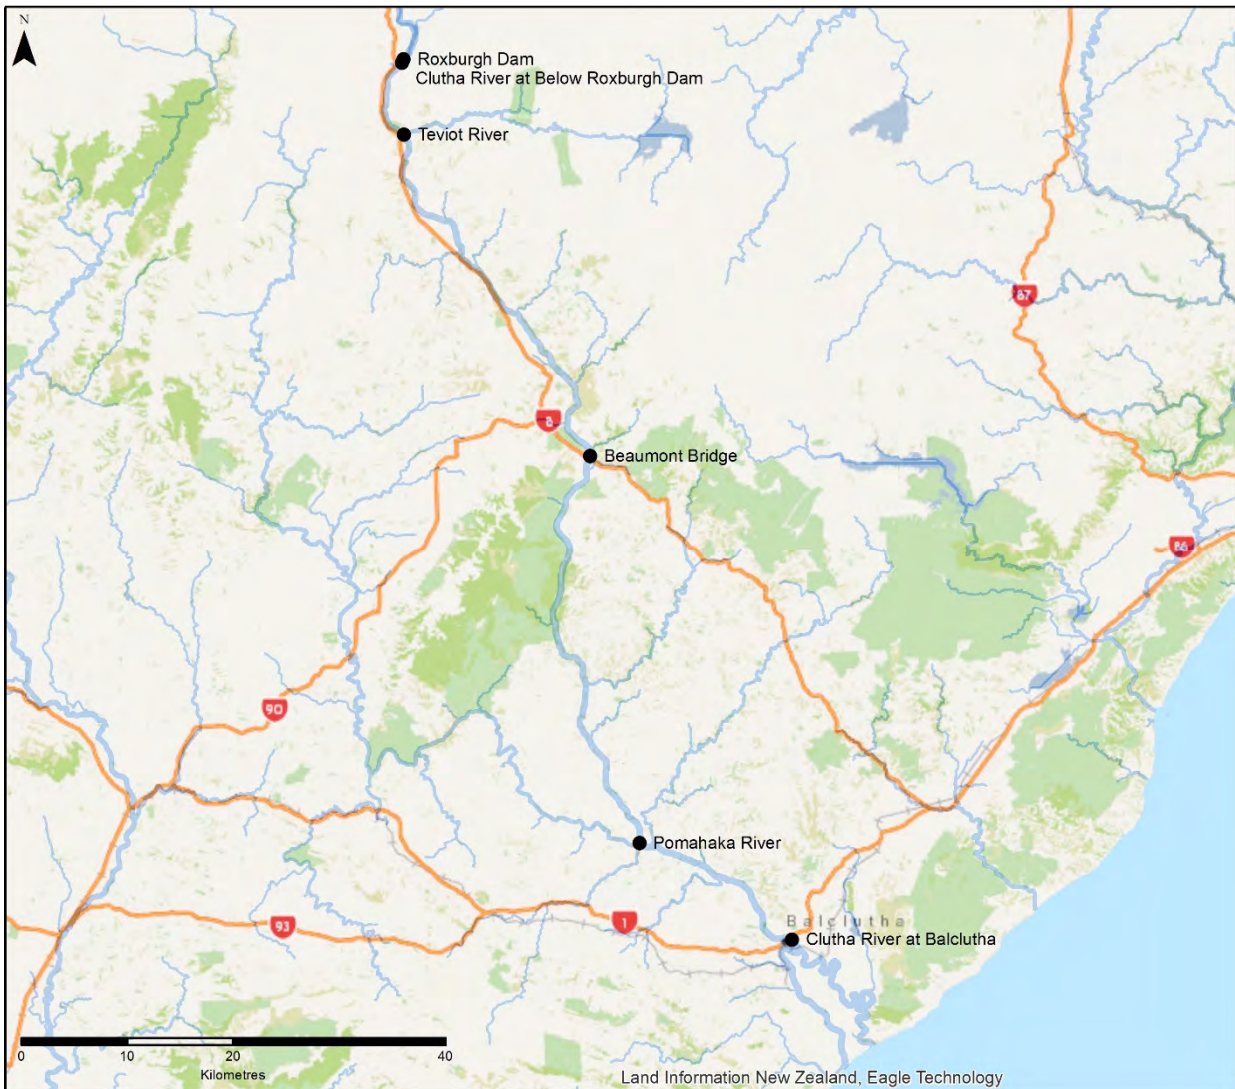
Figure 1.1 Location of the Beaumont Bridge, Roxburgh Dam, and flow sites of relevance.

The Beaumont Bridge is located near the town of Beaumont, below the Roxburgh Dam in the Clutha catchment. The Roxburgh Dam is currently operated by Contact Energy Ltd. The Clutha River discharges into the Pacific Ocean, just downstream of the town of Balclutha (Figure 1.1).

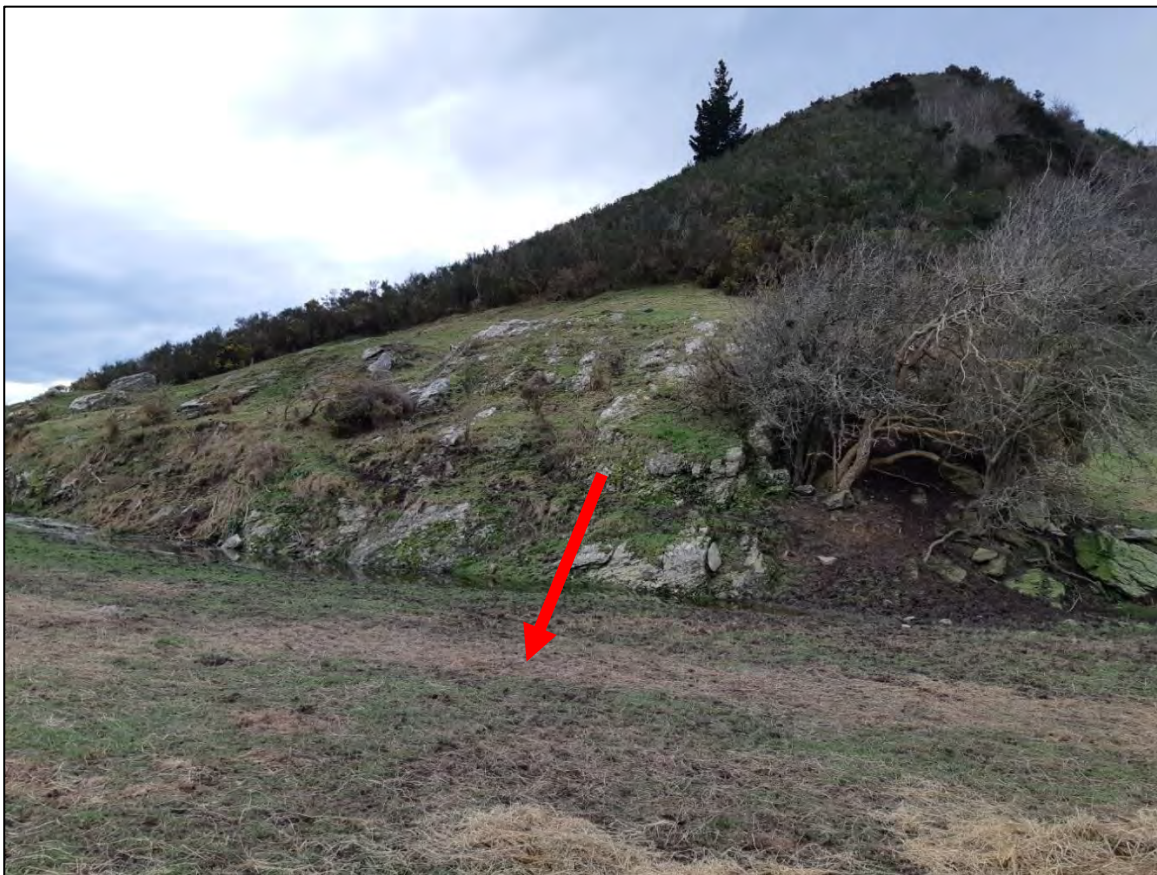
Figure 16. Photograph showing the old rail alignment (red arrow) looking north from eastern extent of Project area

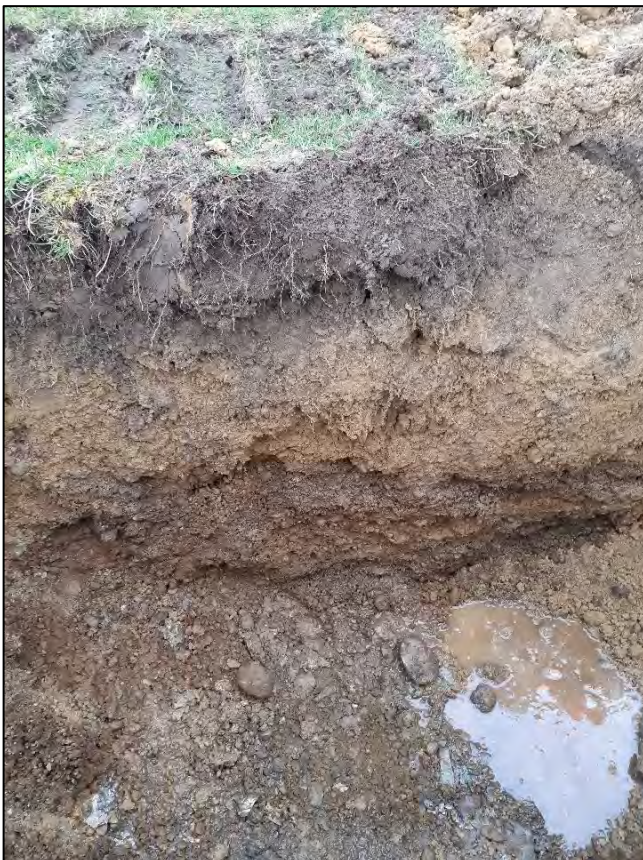
Figure 18. General strata throughout the geotechnical trial pits

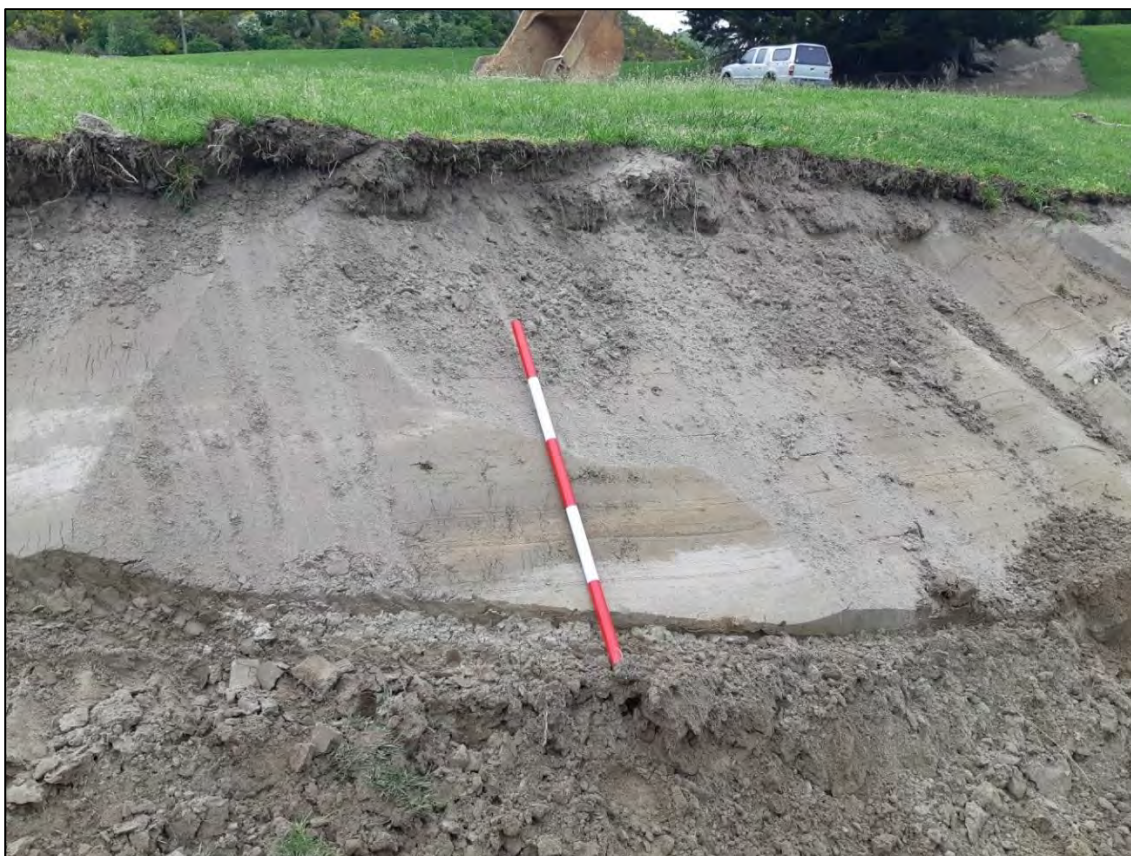
Figure 20. Photograph detailing a batter edge on the true left of the bank of the Mata-au

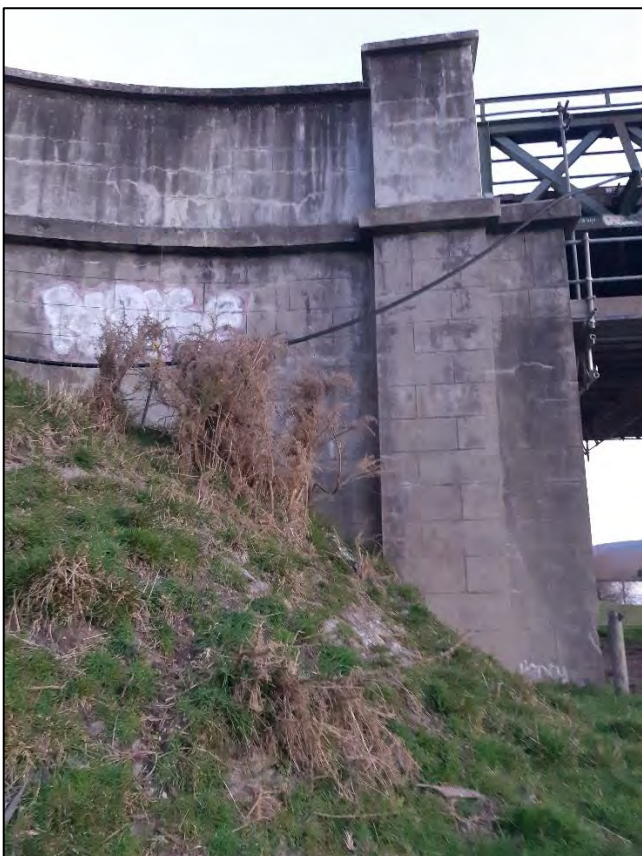
Figure 22. View looking south of the eastern Beaumont Bridge abutment, showing the built-up bridge approach in foreground

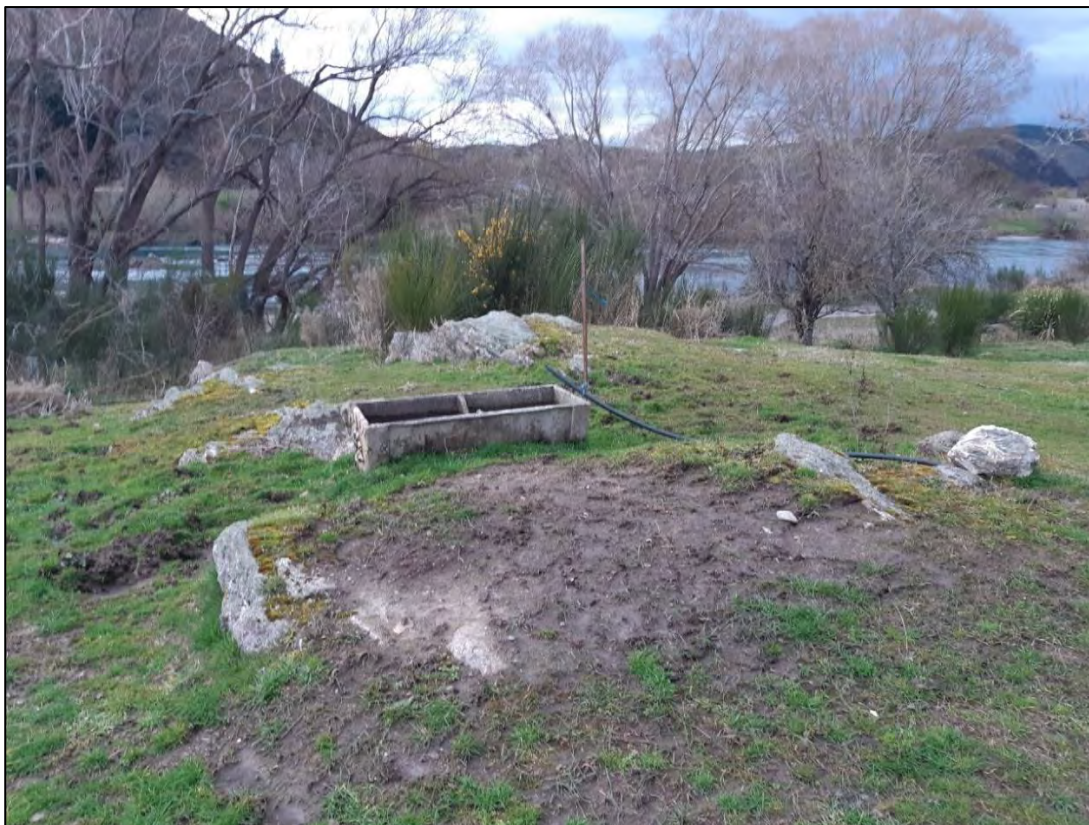
Figure 25. Photograph from south west of the Beaumont Bridge within the project area. Visible is part of a structure likely associated with an 1870s house

In the paddock immediately east of Rongahere Road existed a flat terraced platform (Figure 25 to Figure 27) near to where a house was depicted on the 1882 map (Figure 10). It is likely that this contains subsurface evidence pertaining to the house, such as a house foundation, rubbish pits and/or latrines. No subsurface investigations were undertaken.

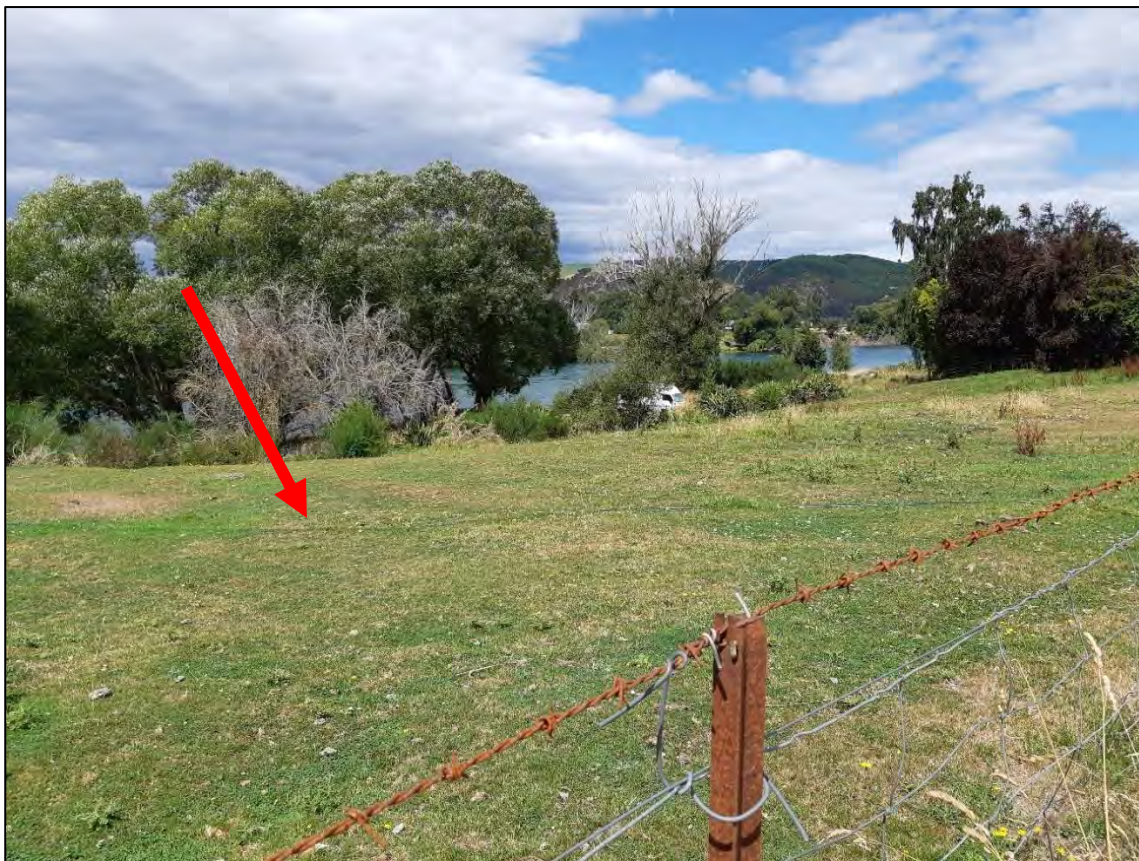
Figure 27. Approximate location of the 1870s house - visible is the flat platform area (red arrow)

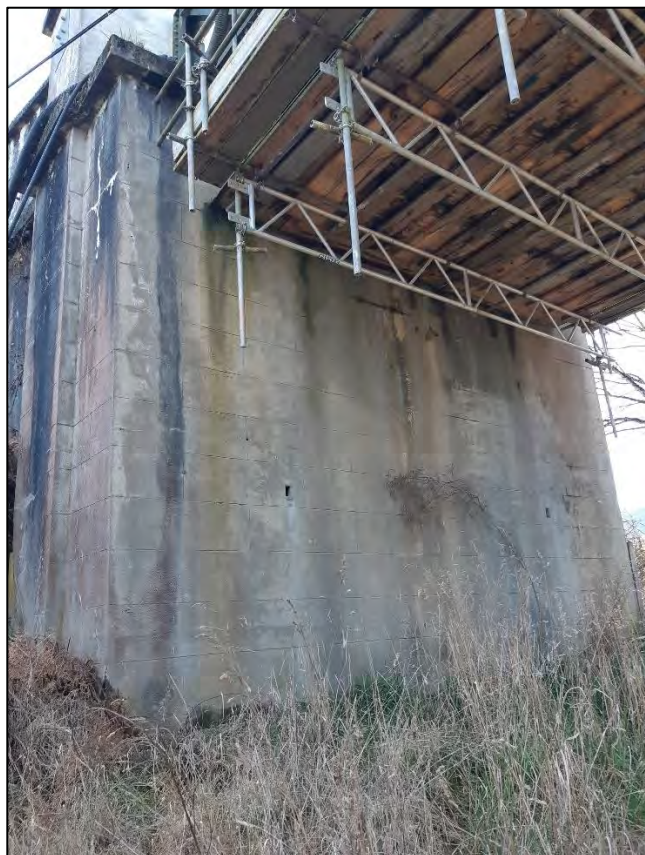
Figure 28. View looking north west of the Beaumont Bridge west abutment

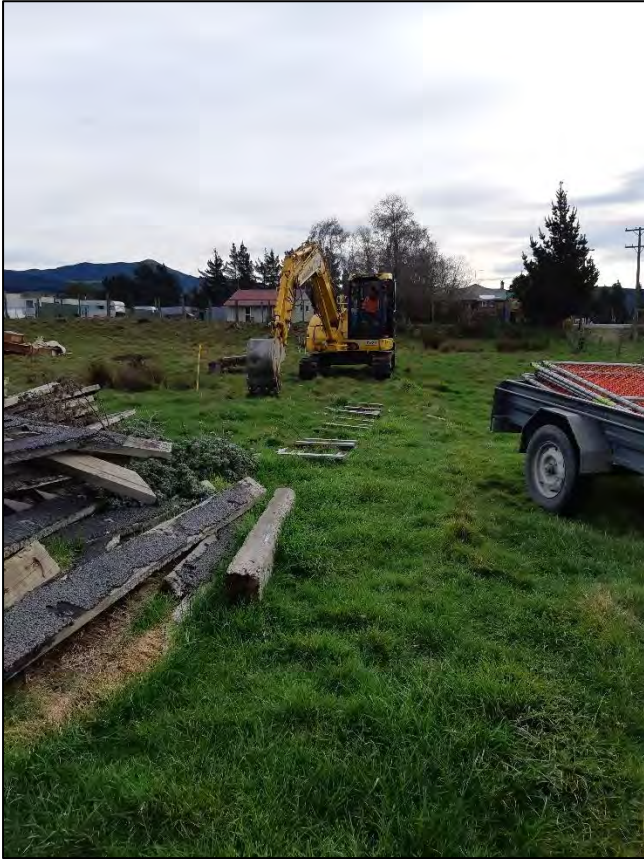
Figure 29. View of paddock between Rongahere Road and the Beaumont Hotel during monitoring, looking west

Moving further west, the paddock that was immediately east of the Beaumont Hotel was examined because of the road alignment through this paddock (Figure 29). There was a shallow topsoil underlain by bedrock encountered from within the two test pits in the Project area. The current Beaumont Hotel was built upon the same location as the old Bridge Hotel (Figure 30). A camping ground at the rear of the hotel site is located approximately where the stable was depicted in the 1882 map (Figure 10). No visible evidence of archaeological remains existed within this part of the Project area, however, these could survive below the surface.

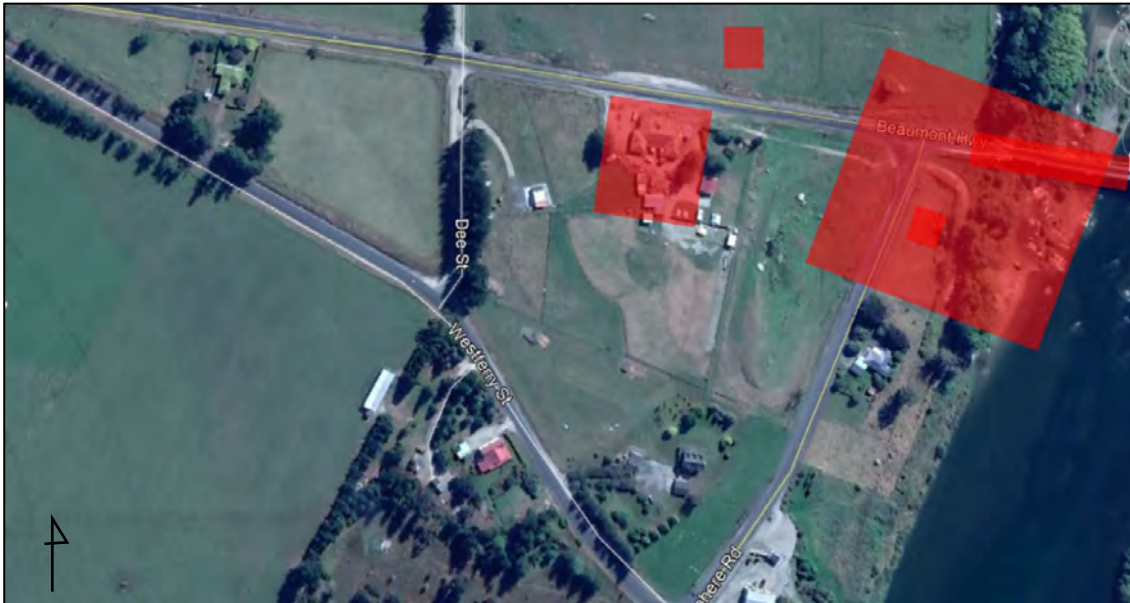
Figure 32. Archaeological risk areas that require monitoring - western extent of Project area

- That an Archaeological Authority should be applied for from Heritage New Zealand Pouhere Taonga prior to the works, under Section 44(a) of the HNZPTA. An Archaeological Management Plan should be prepared to support this application.
- That risk areas highlighted in Figure 32 and Figure 33 of this assessment be referred to as a guide to areas that should be monitored by an archaeologist during the construction phase of the new Beaumont Bridge.
- That further consultation with Iwi is undertaken as part of the archaeological authority application.
- That any encountered archaeological remains are recorded and investigated using standard archaeological practice.

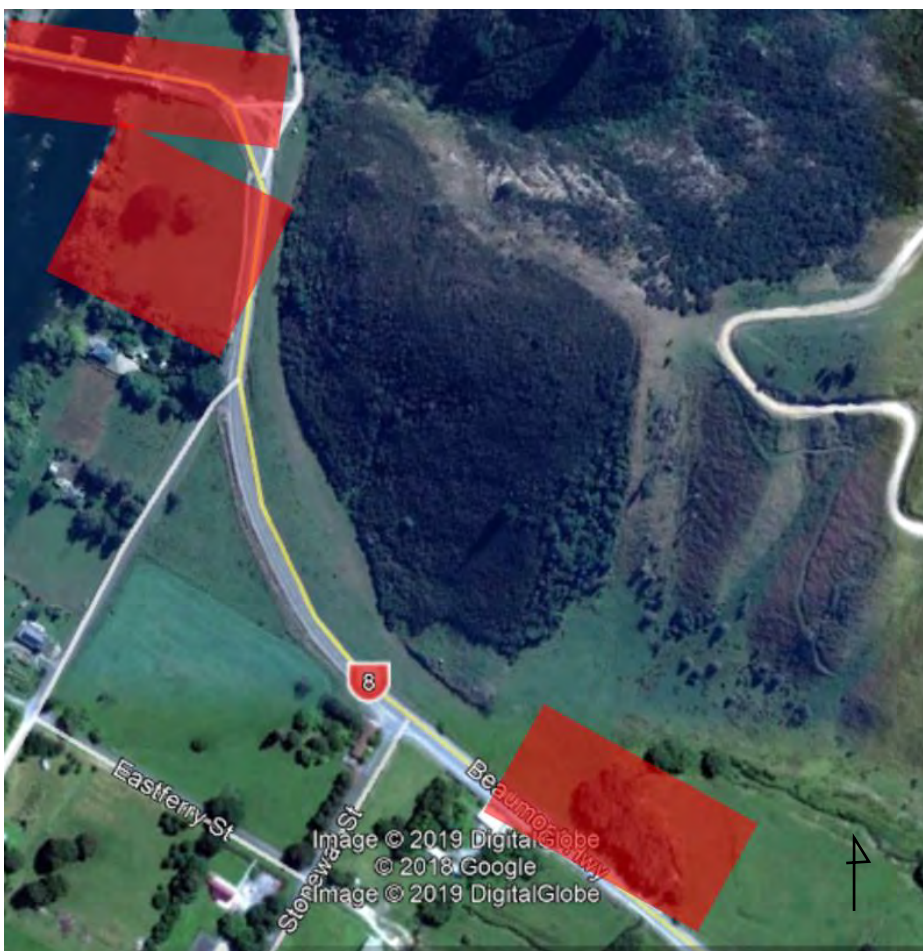
Figure 33. Archaeological risk areas that require monitoring - eastern extent of Project area

The archaeological authority should also specifically pertain to the following two images that were prepared to highlight the risk areas associated with the scope of works at Beaumont (Figure 32 and Figure 33). The red polygons highlight the general risk areas, which are based on (from west to east):

- That an Archaeological Authority should be applied for from Heritage New Zealand Pouhere Taonga prior to the works, under Section 44(a) of the HNZPTA. An Archaeological Management Plan should be prepared to support this application.
- That risk areas highlighted in Figure 32 and Figure 33 of this assessment be referred to as a guide to areas that should be monitored by an archaeologist during the construction phase of the new Beaumont Bridge.
- That further consultation with Iwi is undertaken as part of the archaeological authority application.
- That any encountered archaeological remains are recorded and investigated using standard archaeological practice.

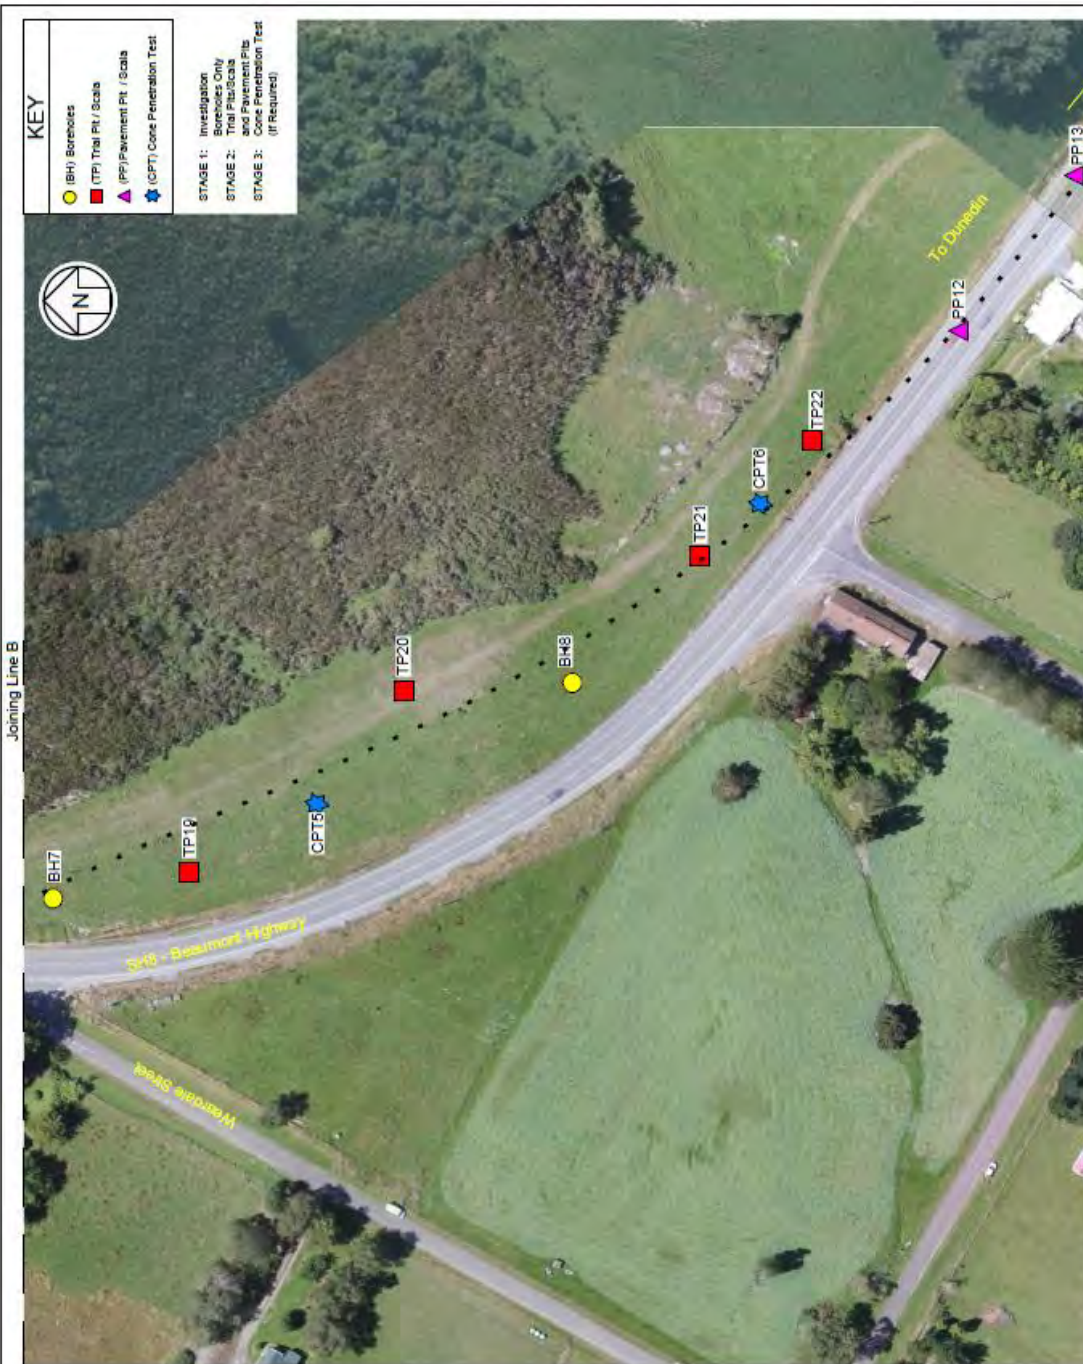
- (BH) Boreholes
- (TP) Trial Pit / Soils
- ▲ (PP) Pavement Pt / Soils
- ★ (CPT) Cone Penetration Test

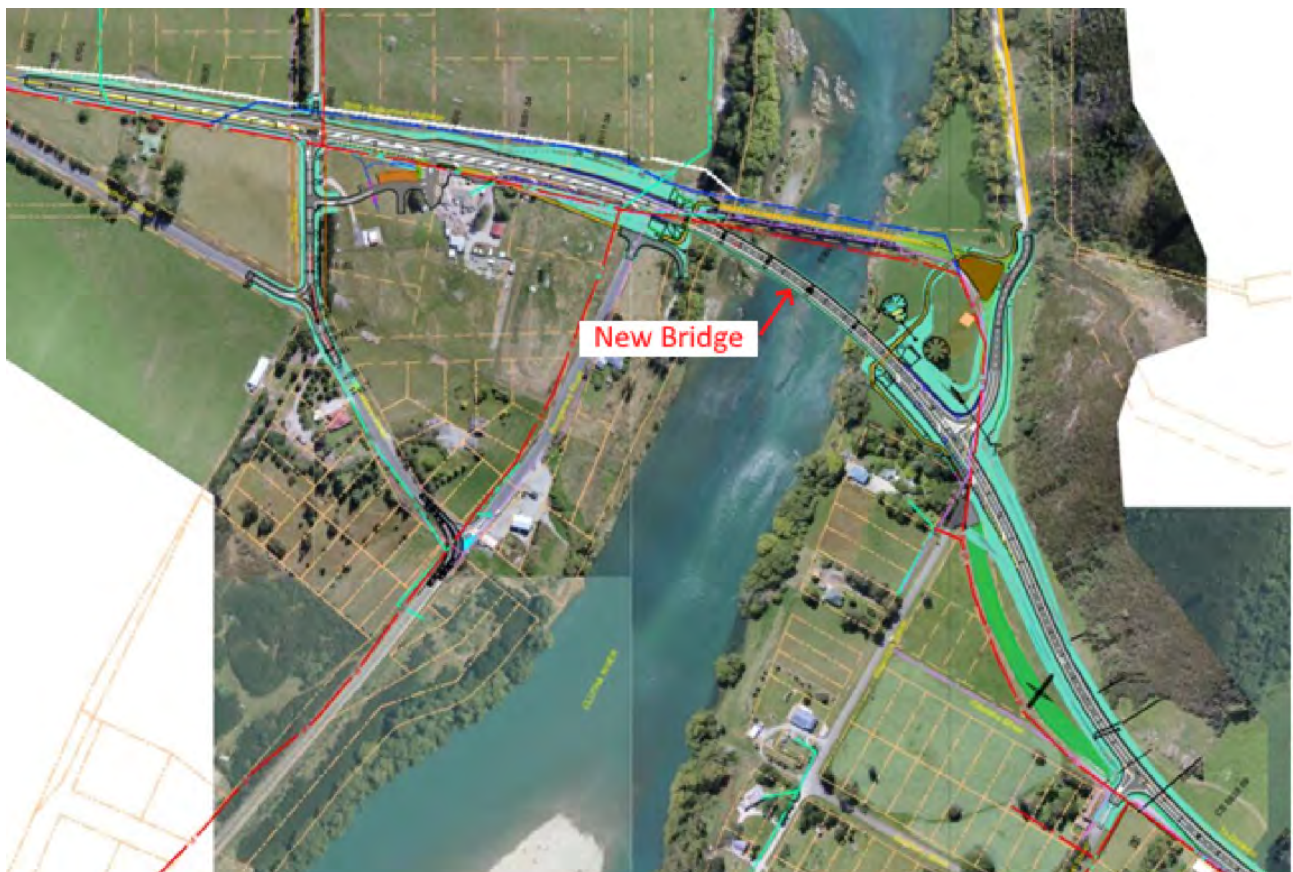
The new bridge will be installed slightly to the south of the existing bridge, which will be retained. An image of the proposed Project is shown below in Figure 1-1.

Figure 1-1. Image of the proposed new bridge and the realignment of SH8.

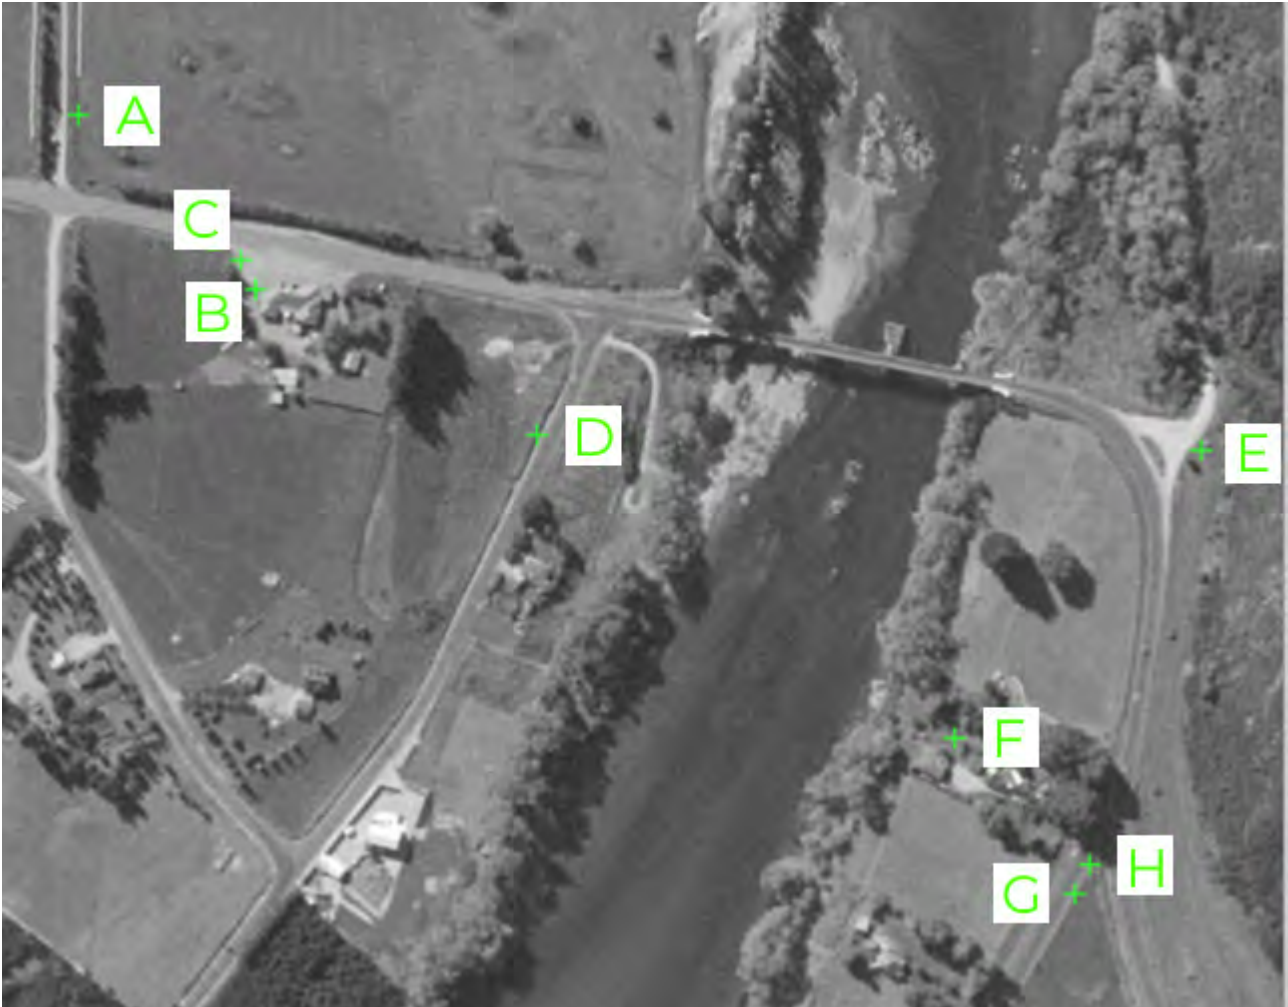
A site visit was made to Beaumont on the 1st of May 2019 to take noise and vibration measurements. Figure 2-1 shows the locations used for the on-site noise and vibration measurements. Noise measurements were made at Locations A, B, D, E, F and G. Measurements were made of traffic induced vibrations at two locations, C and H, while measurements of soil vibration attenuation were made at Location E.

Figure 2-1. Noise and vibration measurement locations.

Noise measurements were made on site using a calibrated sound level meter⁷ and generally in accordance with New Zealand Standard NZS 6801: 1991 *Measurement of sound*. Each noise measurement duration ranged from 15 minutes to 60 minutes, with traffic counted during the noise measurement. The noise measurements were intended to be used to validate the predictive road-traffic noise model rather than to establish the typical or representative noise levels at the locations.

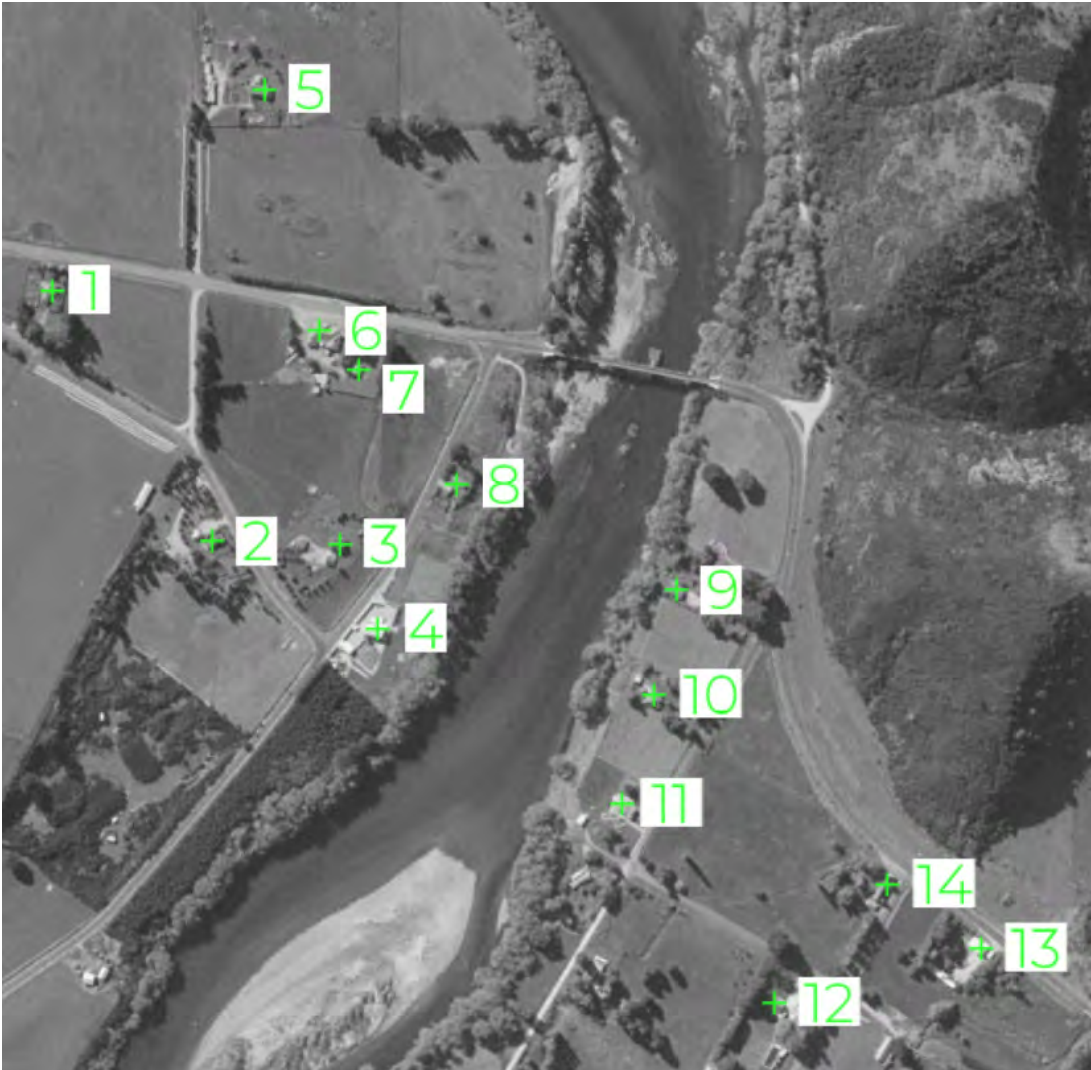
The properties assessed are shown below in Figure 3-1. For operational noise and vibration, properties within approximately 200 m of the Project have been assessed (all properties shown in Figure 3-1 other than PPF 4). All of the properties shown in Figure 3-1 have been assessed for construction noise and vibration. Predictive models of operational and construction noise and

Figure 3-1. Locations of property buildings assessed for noise and/or vibration effects.

Table 3-6. Preliminary assessment of receivers that should be addressed in a Construction Noise and Vibration Management Plan. (Receiver numbers reference Figure 3-1.)

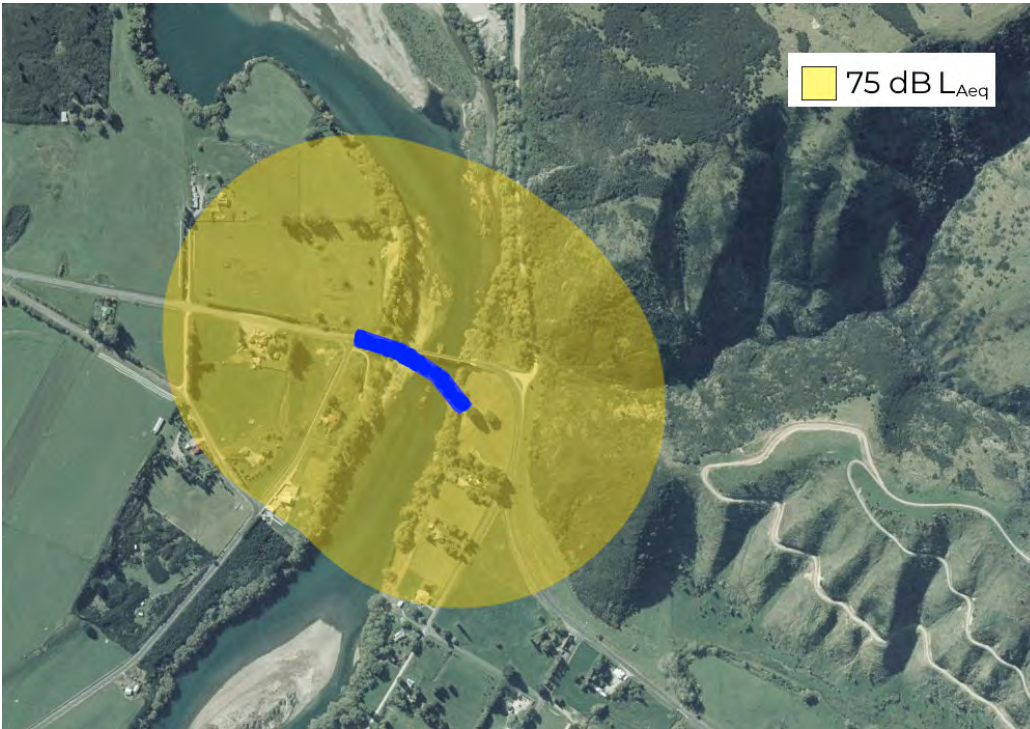
This appendix shows the noise and vibration contours used for assessing the construction noise and vibration effects if no additional management is exercised. Figure B-1 shows the contour for 75 dB L_{Aeq} estimated for piling operations while Figure B-2 shows the vibration contours estimated for the same activity. The highlighted areas on these plots show the areas where the stated level is predicted to be exceeded, if no additional management is exercised.

Figure B-1. Construction noise contour for percussive piling.
