5 August 2020

# ORC Glenorchy flood response

## Update 01 | August 2020

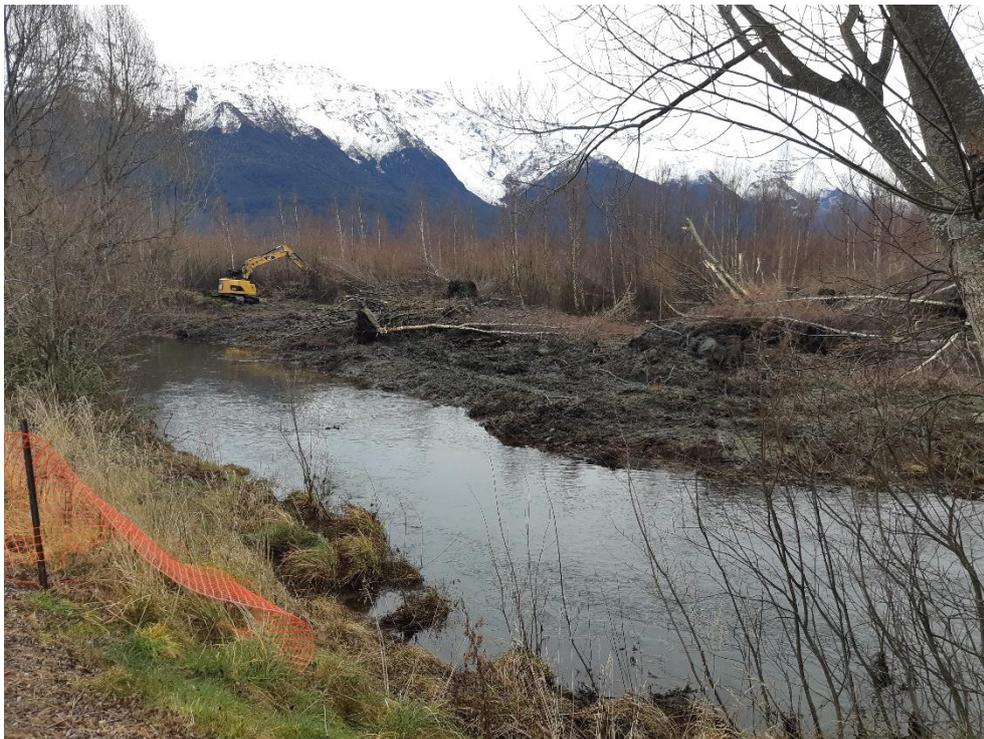
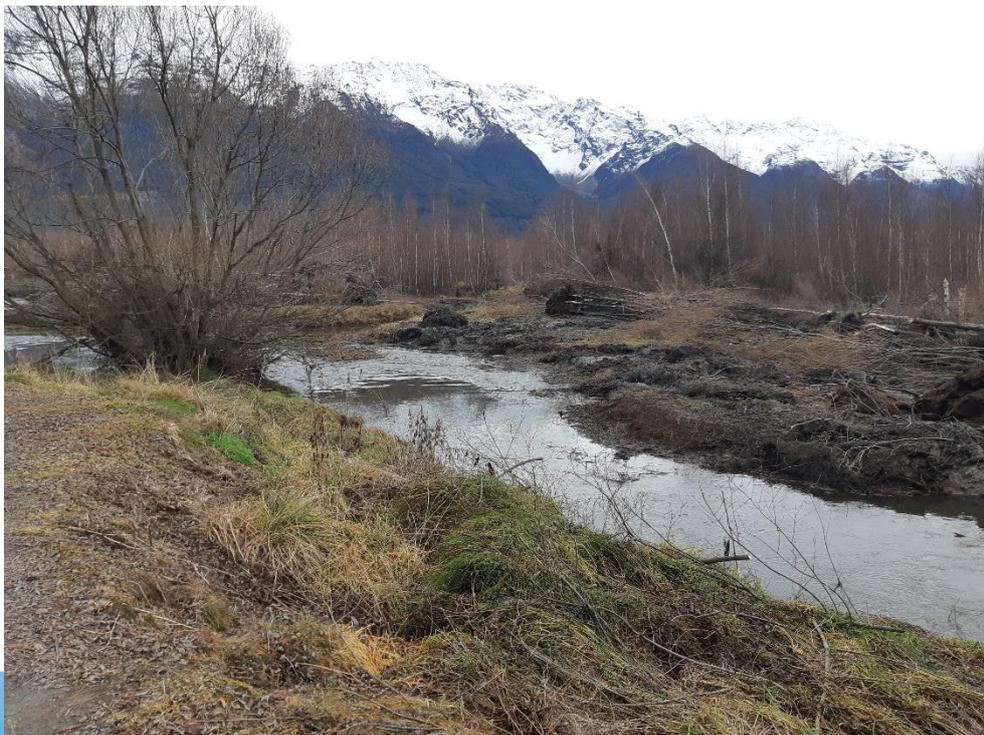
**Photos showing works in progress to remove willow trees from the right bank of Lagoon Creek**

Earlier in the year, we were given feedback that the willows and other vegetation that have grown in Lagoon Creek are clogging up the natural flow of the river. In response, we have collaborated and shared costs with the Department of Conservation (DOC), to remove trees from the right bank of Lagoon Creek (see photos below). It is expected this vegetation clearance will be concluded by the end of August 2020. We will include inspections of Lagoon Creek into our river inspection programme and will undertake future clearance works as necessary.

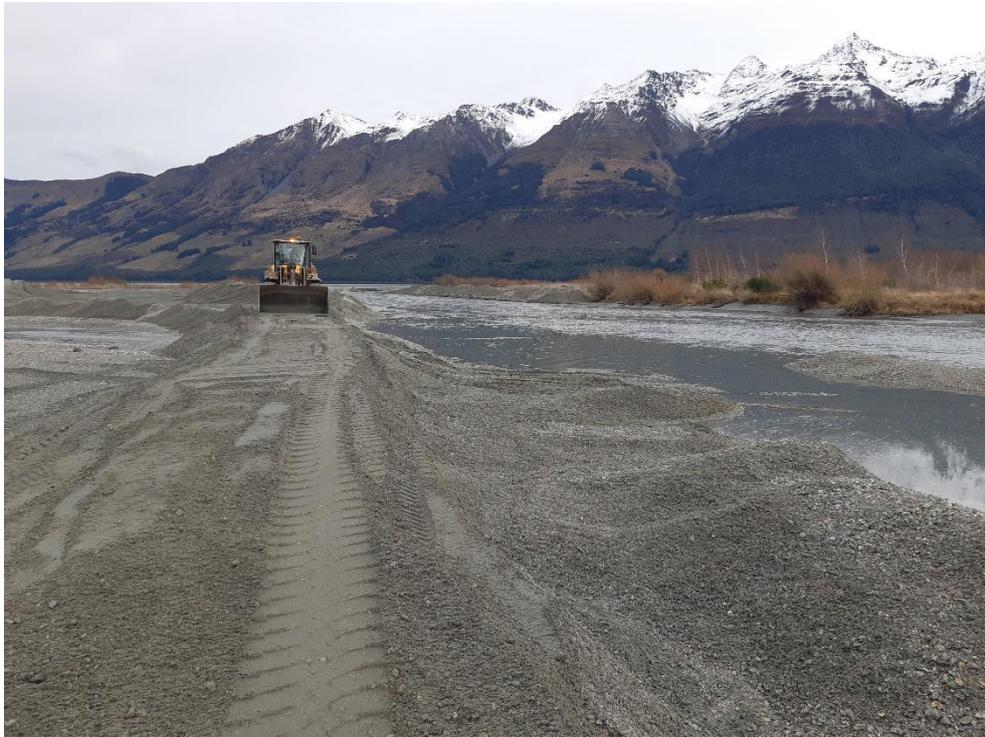
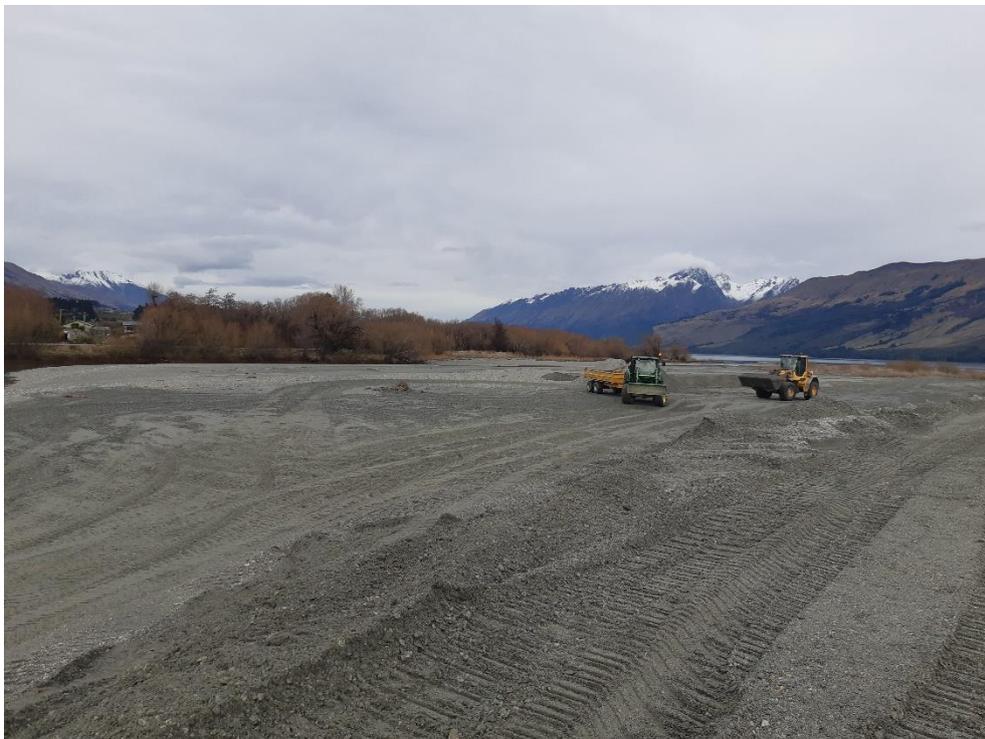
Photos showing works in progress on the Rees delta to realign the Rees River channel towards the western side of the delta.

Gravel removal as a method to realign the channel is underway this week as a short term measure to assist the drainage from the Lagoon Creek into the Rees River. It is expected that this channel work will be completed by the end of August 2020. This work has involved excavation of a channel about 250 metres long on the western side of the Rees delta (see photos below).

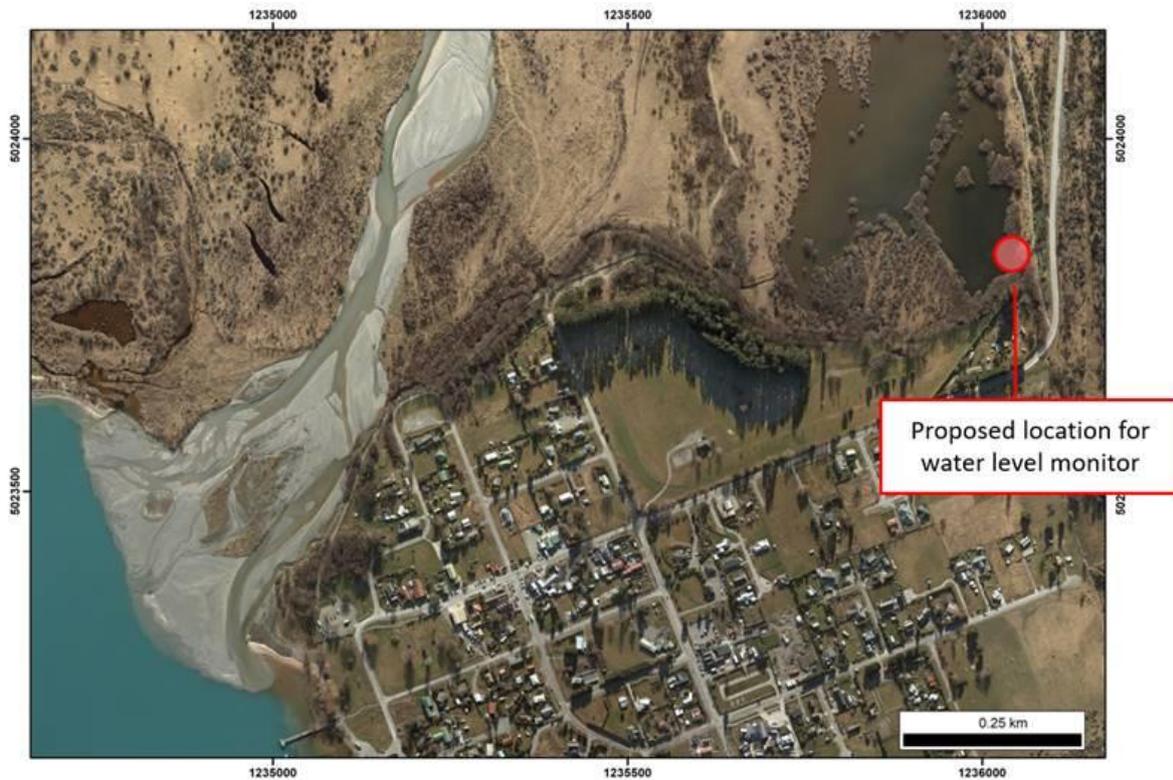
Map showing the proposed location for a water level monitor in the Glenorchy Lagoon.

We have a concession application sitting with DOC to install a water level monitor in Glenorchy Lagoon. This is proposed to be located at a site along the south-eastern shoreline of the lagoon as shown in the map below. This monitor will provide valuable data as to what the level of the lagoon is – which will then provide a better understanding of how the lagoon is changing over time and assist with the community flood response. The data from this monitor will be available in real-time on our WaterInfo website for the community to access (<http://water.orc.govt.nz/WaterInfo/Default.aspx>). We expect to receive a decision on our application by the end of August. If approved, hardware is ready to go and will be installed within one to two weeks of receiving permission.
