Head of Lake Wakatipu

Natural Hazards Assessment

Prepared for
Otago Regional Council
Prepared by
Tonkin & Taylor Ltd
Date
March 2021
Job Number
1015117

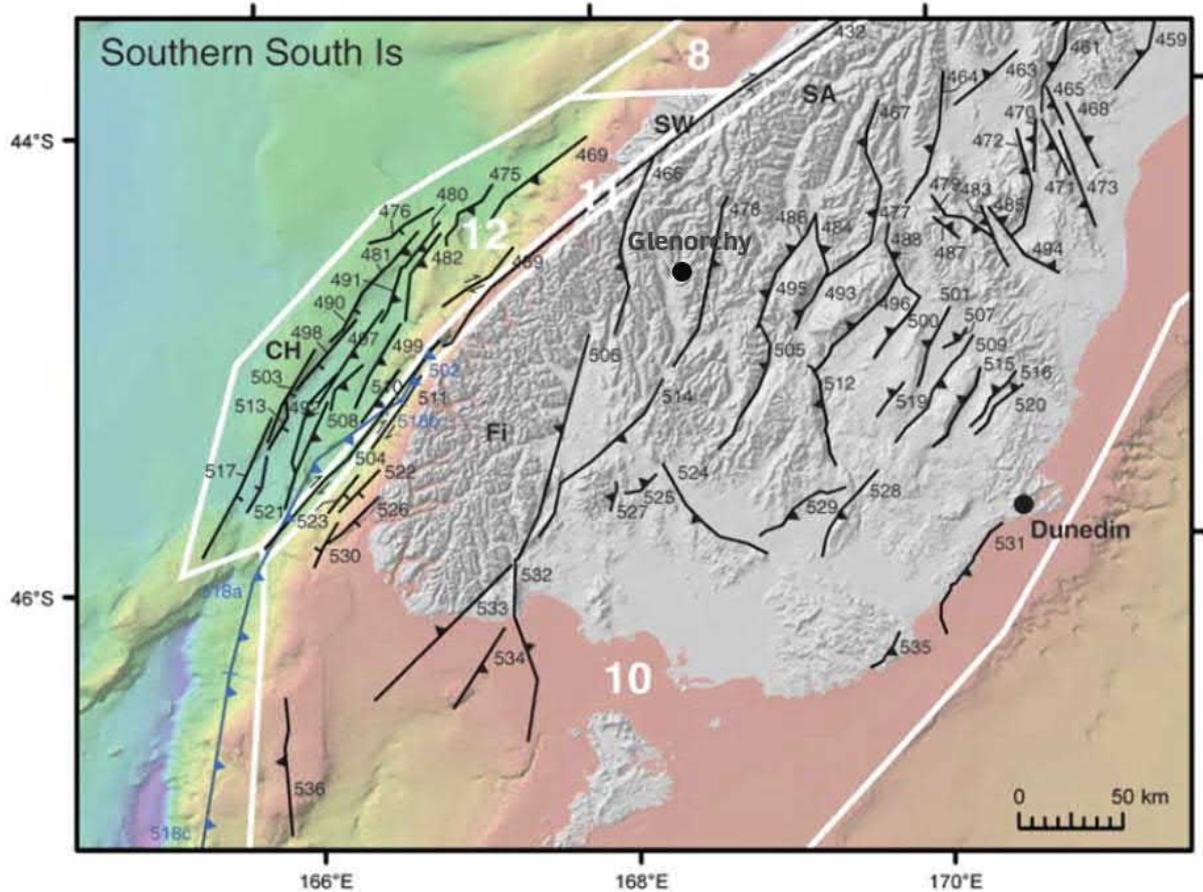
Figure 5-1: Individual known fault sources applied in the Stirling et al (2012) National Seismic Hazard Model in and surrounding the Project area.

Seismicity in New Zealand is estimated using the National Seismic Hazard Model (NSHM) published by Stirling et al (2012). This model outlines known fault sources and their characteristics of magnitude and average recurrence of rupture. Across New Zealand, the tectonic setting and the seismicity varies. Figure 5-1 shows the individual known fault sources in and surrounding Project area and the wider region. This is from both the Stirling et al (2012) National Seismic Hazard Model dataset and Barrell (2019). There are some differences between these datasets, so to demonstrate the variability, both are presented in Table 5-1.

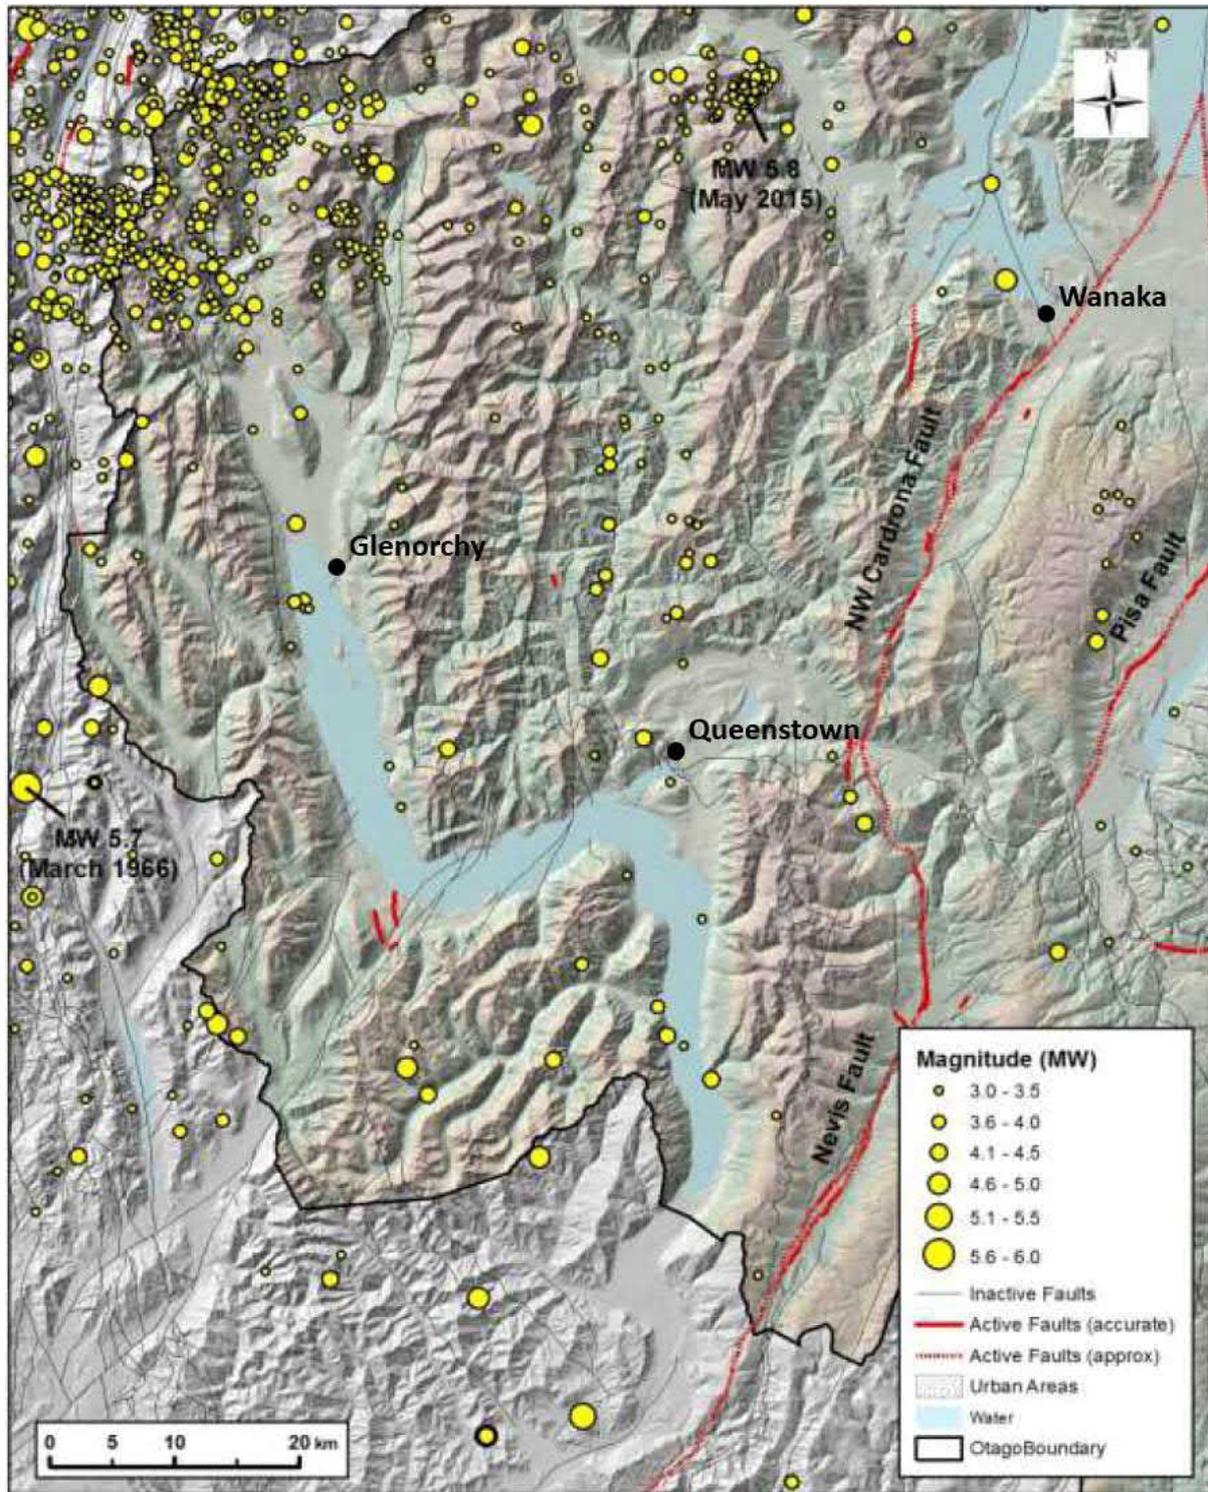
Figure 5.2: Historic seismicity in the Wakatipu area (ORC 2015, data from GeoNet accessed July 2015)

Historical observation records of large earthquakes in New Zealand exist back to approximately 1840. The study of the seismic hazard in the Queenstown Lakes District (ORC 2015) presents historic seismicity in the Wakatipu area, with earthquakes larger than MW 3.0 from 1942 to July 2015, reproduced here as Figure 5.2. Two earthquakes larger than MW 5.5 have been recorded over that period (labelled). The highest concentration of earthquakes occurs towards the Alpine Fault in the northwest of the Head of the Lake. The Alpine Fault is approximately 55 km from Glenorchy, but is very close to the headwaters of the Dart and Rees Rivers

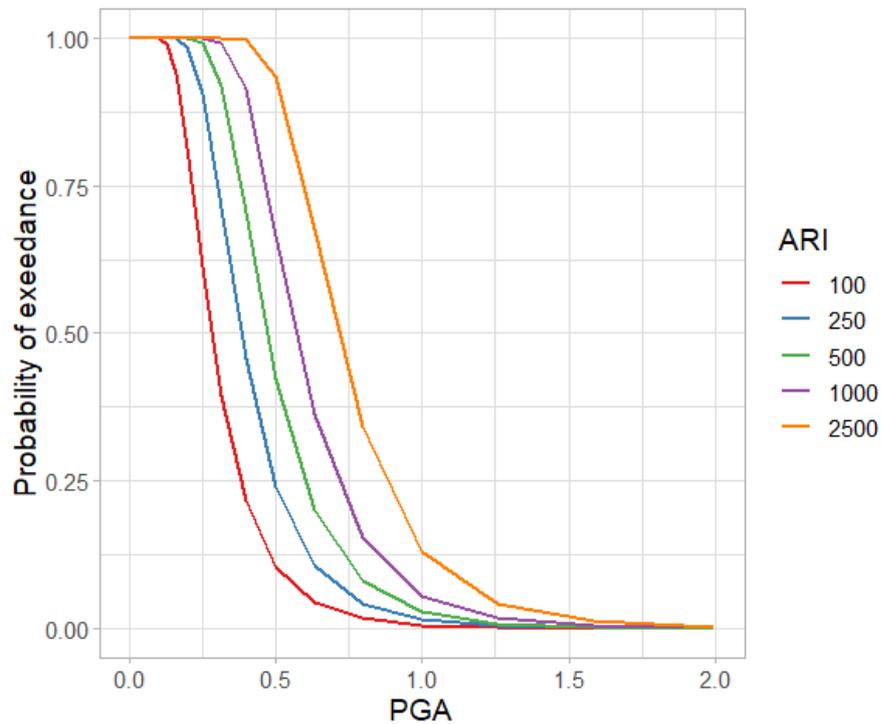
Figure 5.3: Seismic hazard exceedance probability curve

Using the OpenSHA platform to model the seismic hazard relates the probability of exceedance versus PGA (refer Figure 5.3). This makes use of the NSHM data for both the background and fault data from GNS as of 2018, and applies the Bradley (2013) ground motion prediction equation with the $V_{s30} = 250$ m/s. This highlights the variable probability for each ARI. However, further analysis would be required to check the sensitivity with the revision of some of the fault recurrence intervals.

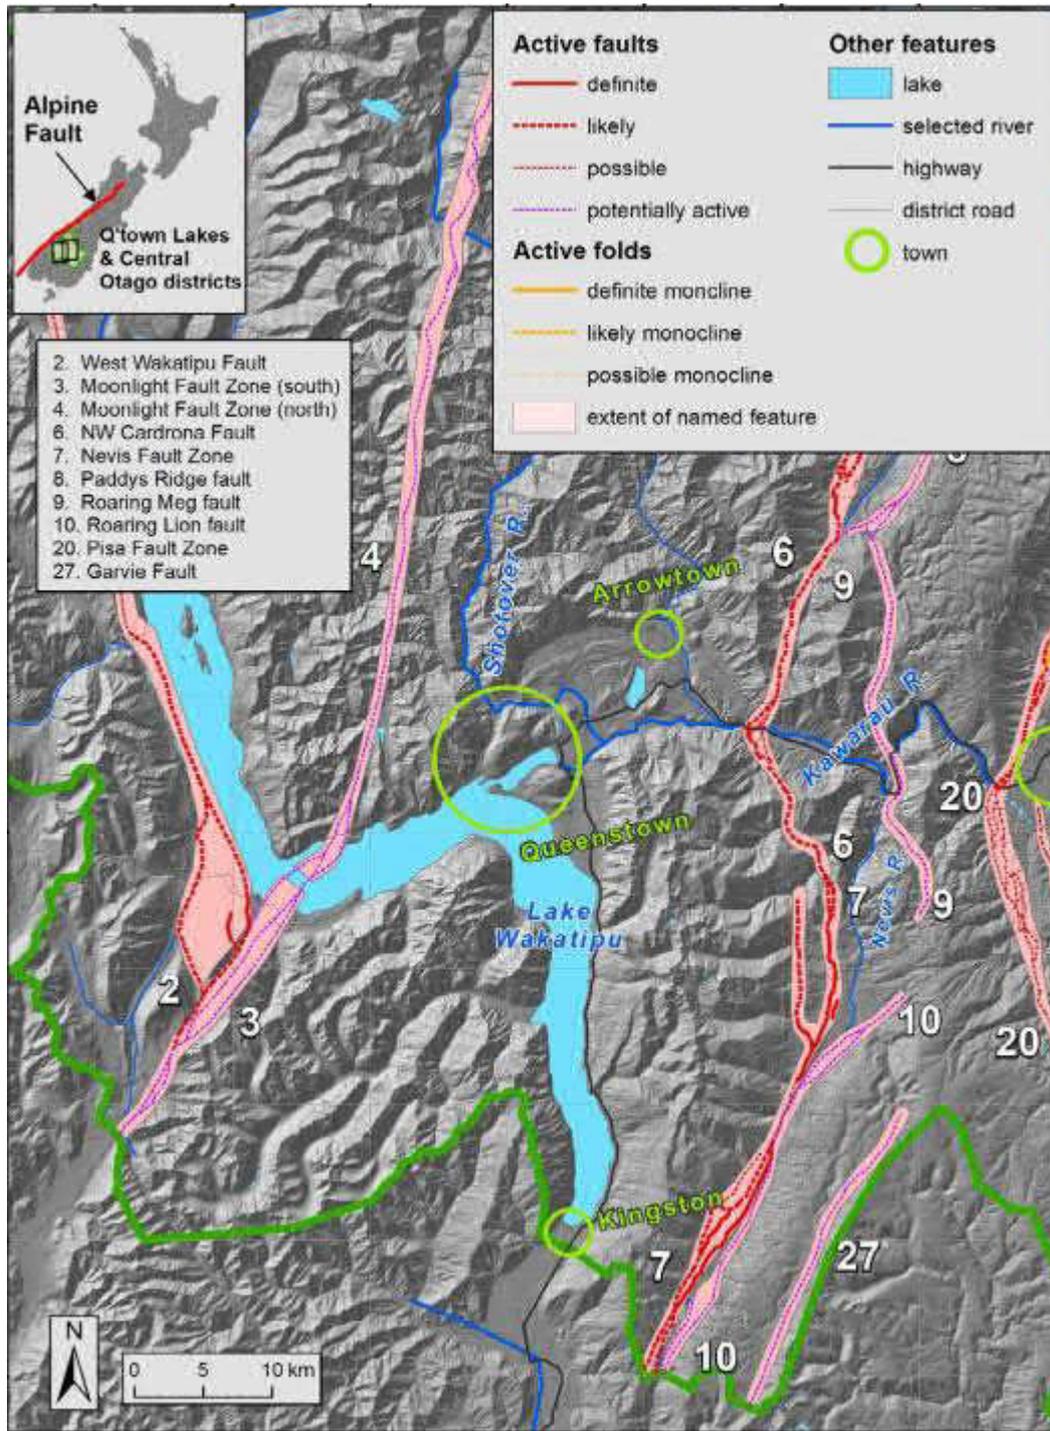
Figure 5-4: Major Faults near the Project area (Barrell 2019)

A feature previously considered to be associated with the Moonlight Fault is now attributed to the West Wakatipu Fault, with an estimated recurrence level of 20,000 years (Barrell 2019). Each of these faults are presented in the Figure 5-4. This demonstrates the difficulty associated with assessing seismic recurrence.

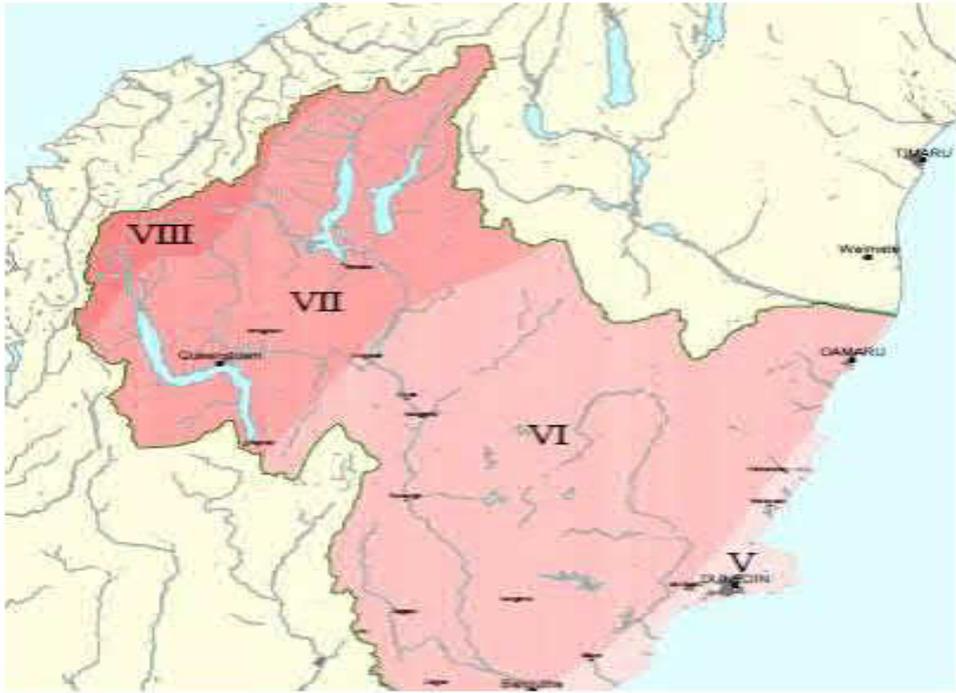
Figure 5-5: 100-year ARI MM Intensities (Murashev and Davey (2005) in ORC 2015)

The faults in the general vicinity are estimated to cause Modified Mercalli (MM, refer Appendix D) intensities of VII and VIII (100-year ARI), and IX and VIII (2,500 year ARI) levels of seismic shaking in the Project area, as shown on Figure 5-5 and Figure 5-6.

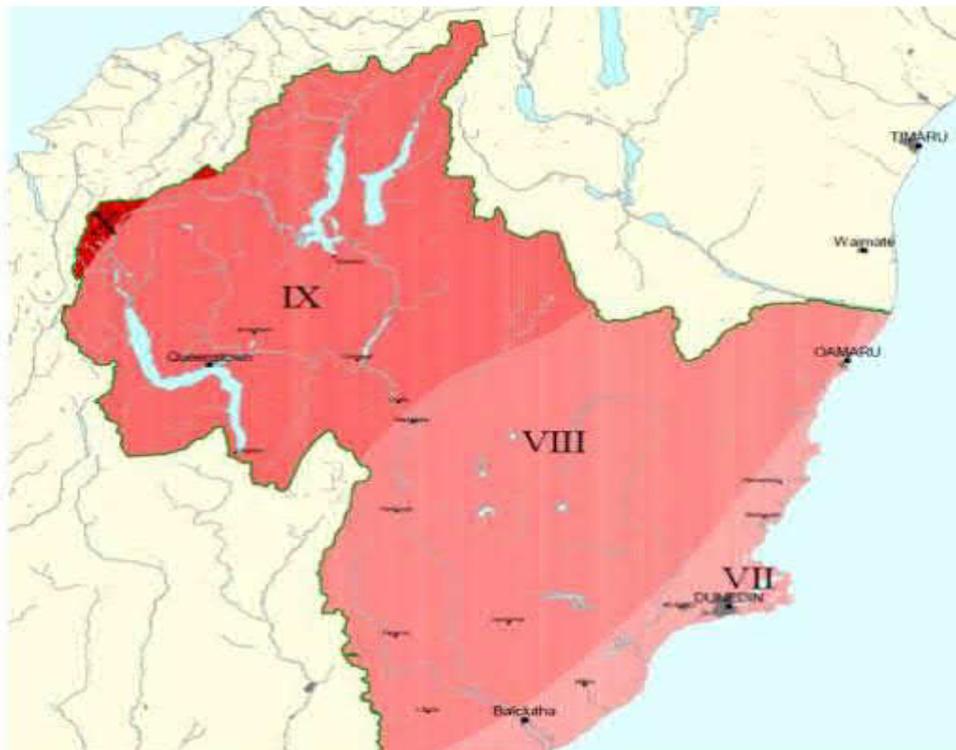
Figure 5-6: 2,500-year ARI MM Intensities (Murashev and Davey (2005) In ORC 2015)

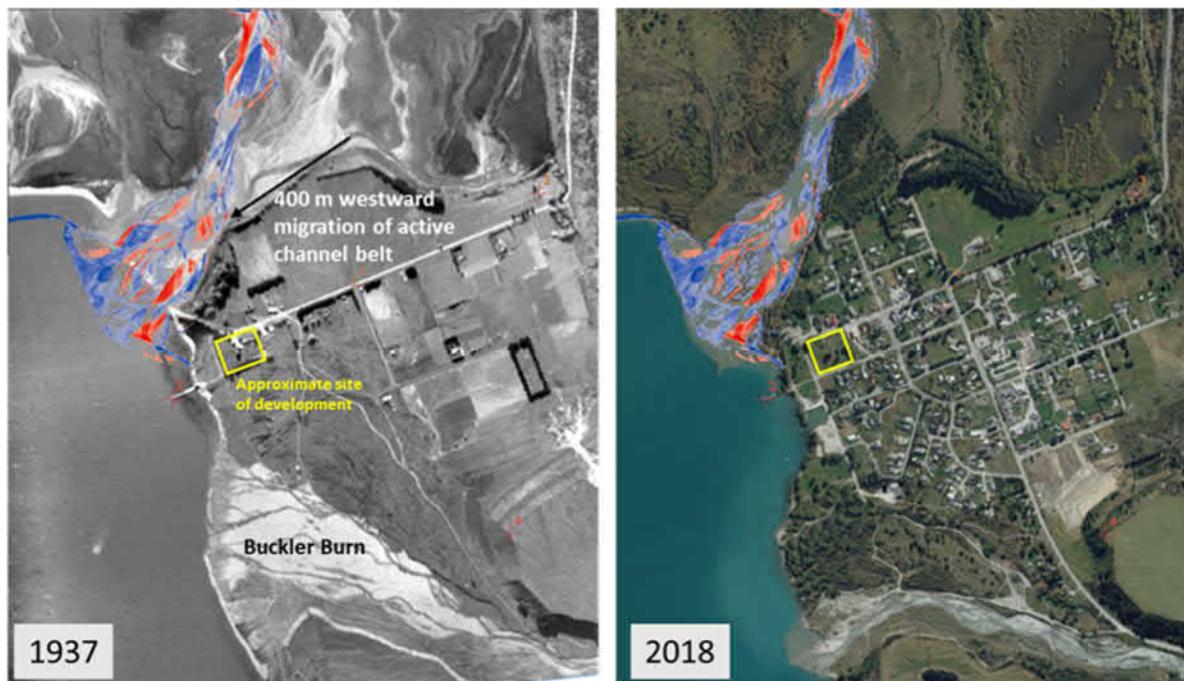
Figure 8-1: Georeferenced aerial photographs from 1937 and 2018 showing westward migration of the active fairway of the Rees along the northern perimeter of Glenorchy and southerly migration of the Buckler Burn (Brasington 2020)

The southerly migration and narrowing of the active fairway of the Buckler Burn are also clearly evident in Figure 8-1. This snapshot shows only the difference between two fixed dates.

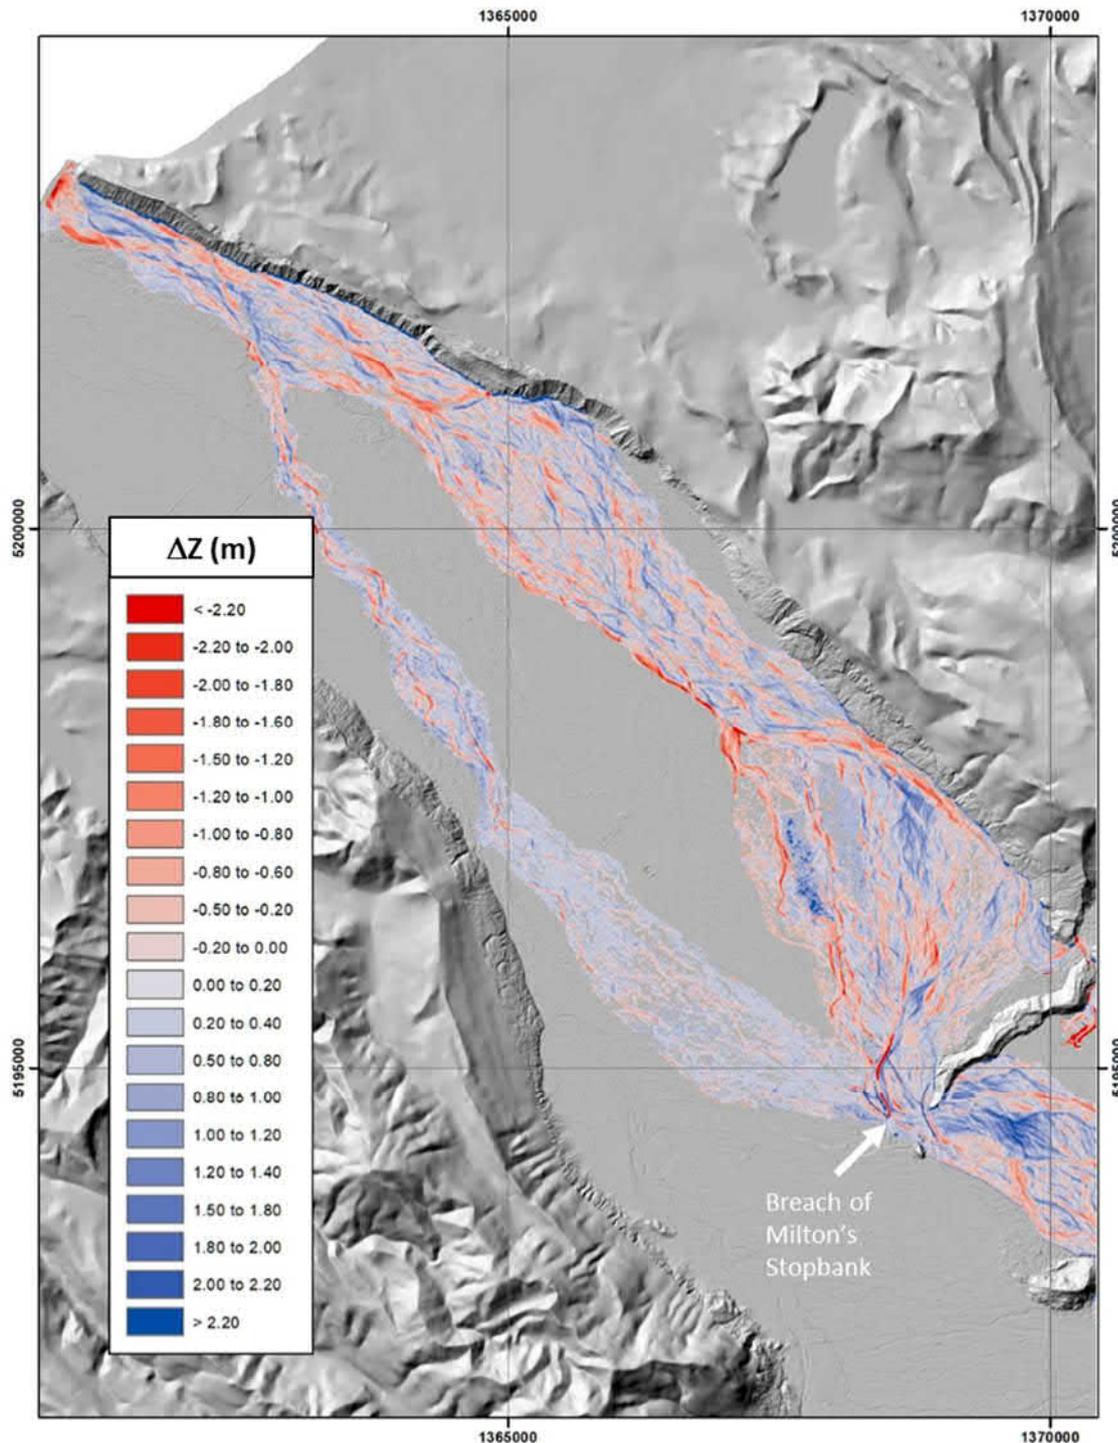
Figure 8-2: The pattern of outbreak flooding from the Waiho River in March 2019. The colour scale shows the difference in elevation between the two lidar surveys. Areas of erosion are shown as negative changes and coloured in shades of red, while areas of bed level increase or sedimentation, are shown in shades of blue

The scale of effects can be illustrated by comparing precise topographic models obtained from aerial lidar surveys commissioned by the West Coast Regional Council before this event (June 2016) and shortly after (April 2019). Analysis of the differences between the elevations in these two models enabled mapping of the distribution of erosion and deposition and the changes in the riverbed levels. This pattern is shown graphically in Figure 8-2, which clearly maps the extent of out of bank flooding along the southern floodplain.

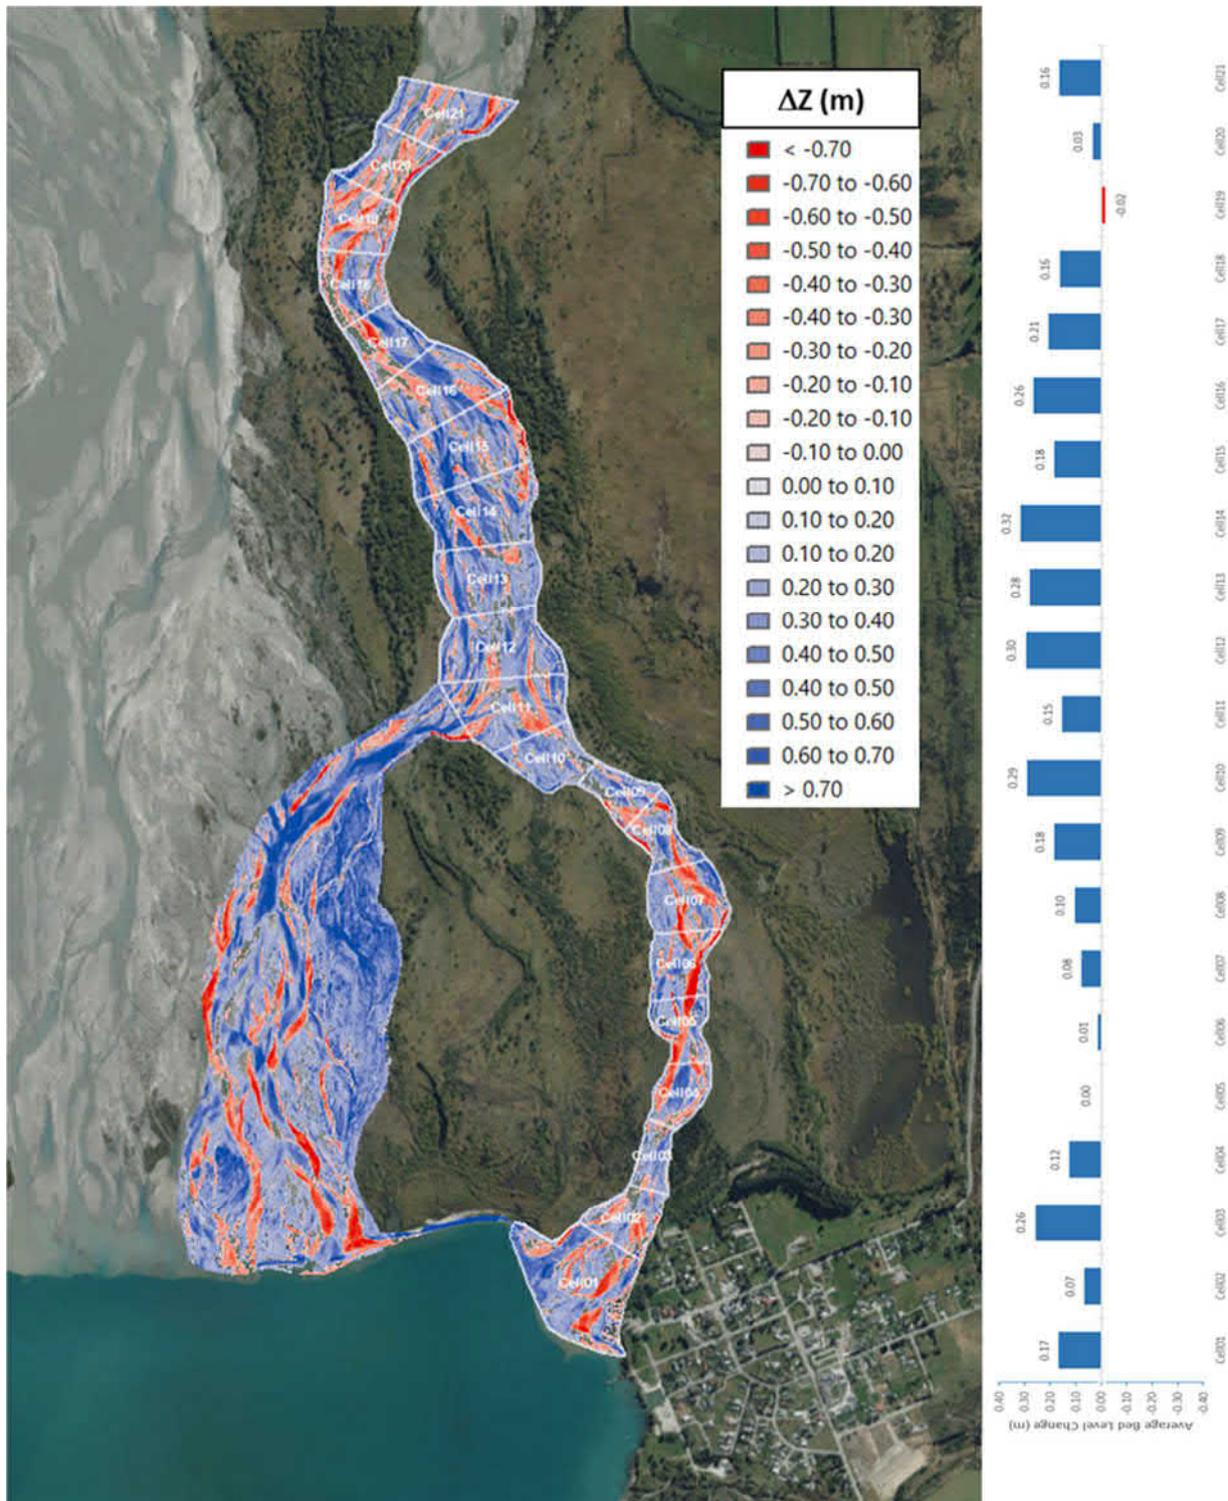
Figure 8-3: Map of bed level changes on the Rees River determined by the comparison of lidar data obtained for the ORC in 2011 and 2019. The inset graph shows the derived vertical bed level change for the 200 m cells (labelled 1 to 21) upstream from the delta. In this positive elevation changes (coloured in blue) represent increases in bed level, while negative changes (e.g., cell 19) reflect areas where the channel has, on average, degraded or incised (Brasington 2020c)

The consistent pattern of aggradation throughout the lower Rees is striking and suggests that the rate of bed level increase estimated by simply propagating the advancing delta slope upstream (i.e., 0.5 m in 50 years is potentially conservative).

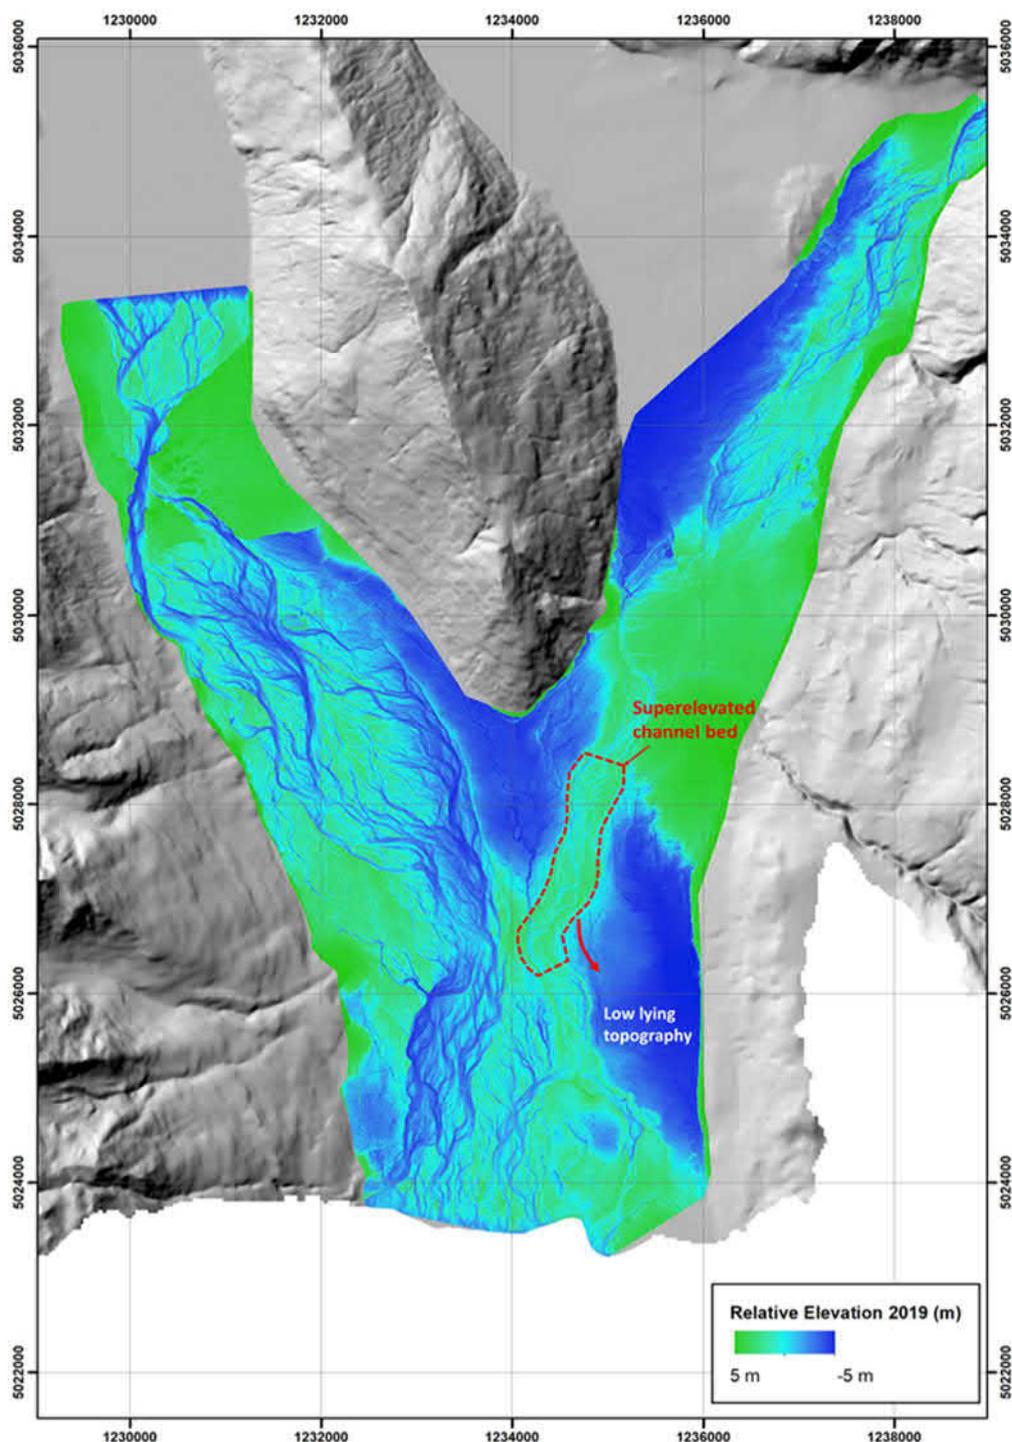
Figure 8-4: Relative elevation model of the Rees-Dart valley floor. This is computed by comparing the valley floor elevations to the adjacent average level of the riverbed. The analysis is based on a 1 m resolution lidar topographic dataset acquired in 2019 (Brasington 2020c)

provided by comparing the relative elevation of the valley floor to the local level of the active riverbed. This analysis has been computed using the 2019 LiDAR data, which covers the lower 20 km of the Rees River. The resulting 'relative elevation model' is plotted in Figure 8-4. Areas that are low relative to the adjacent active riverbed level are plotted in increasingly dark shades of blue, while those above the active bed are plotted in shades of green.

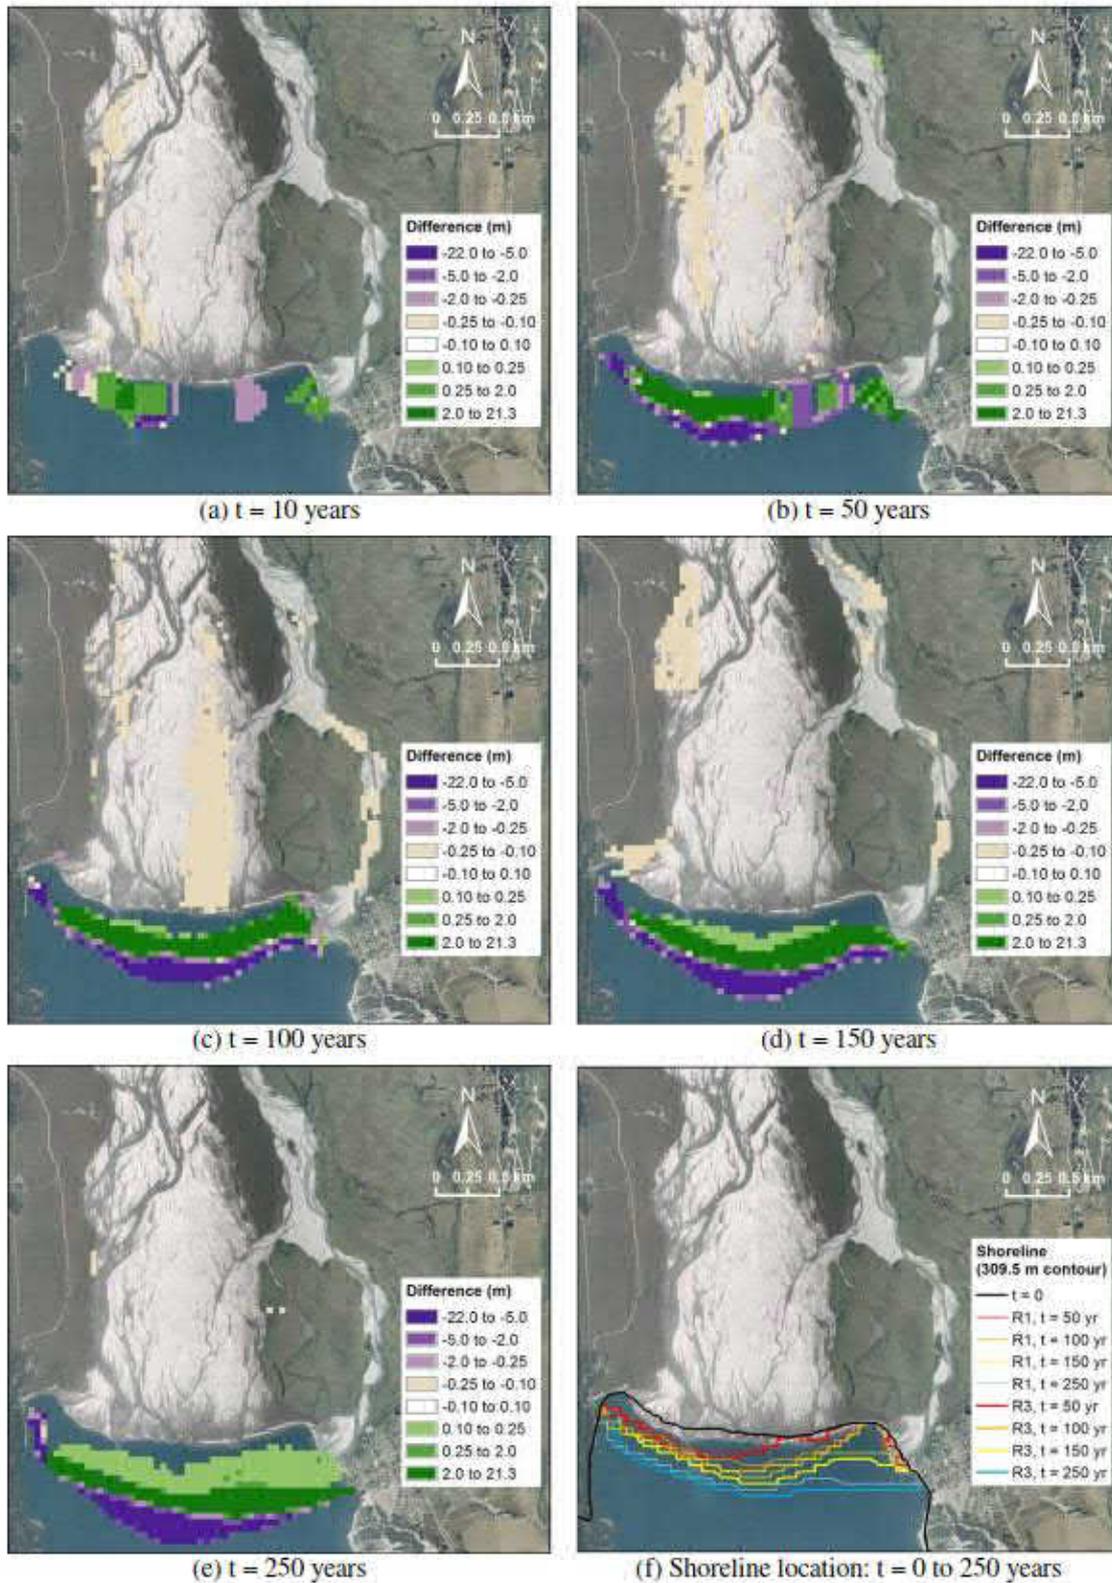
Figure 10.1 Estimation of lake shoreline with time Source (Wild 2012)

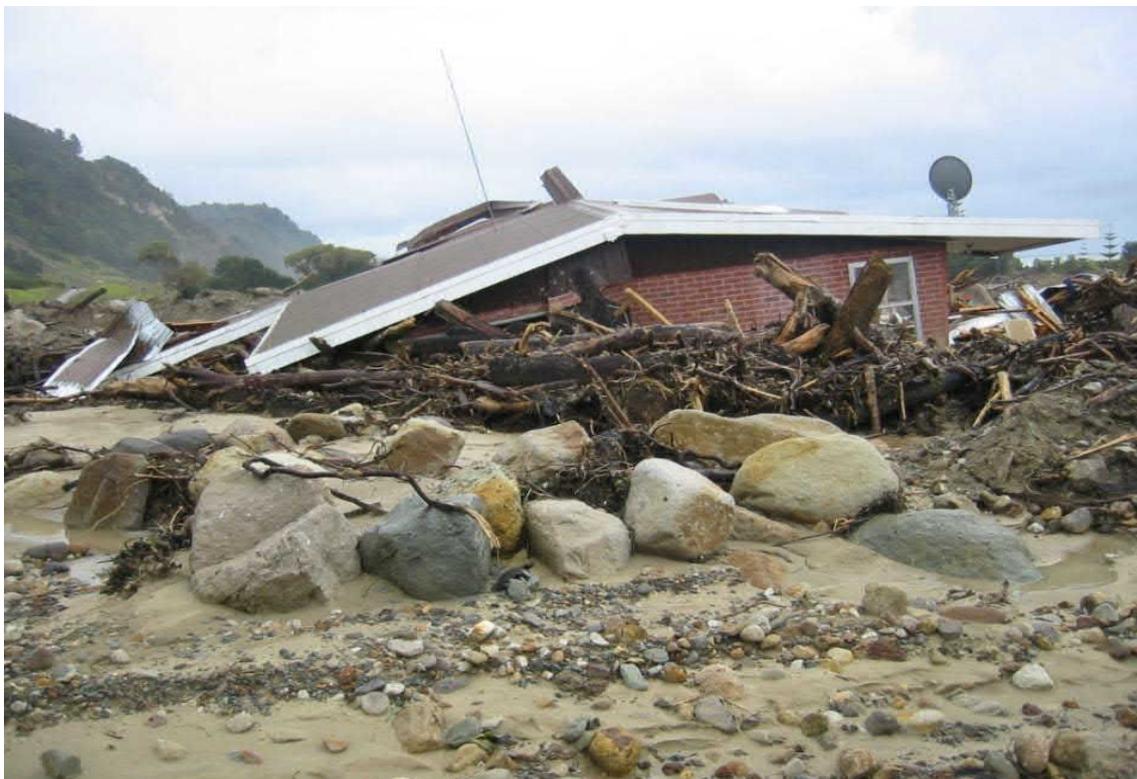
Figure 10.2 Rainfall triggered debris flow (Matata 2005)

We have good recent examples of what inundation by landslip debris looks like, as shown in Figure 10.2 to Figure 10.6.

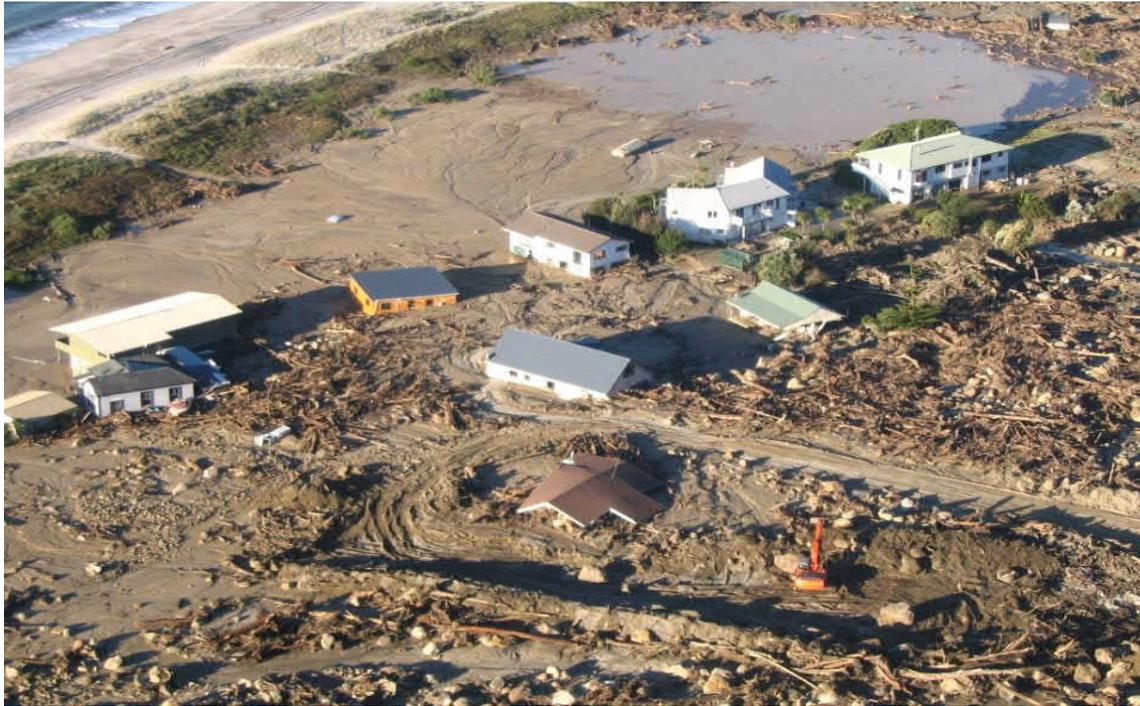
Figure 10.3 Rainfall triggered debris flow (Matata 2005)

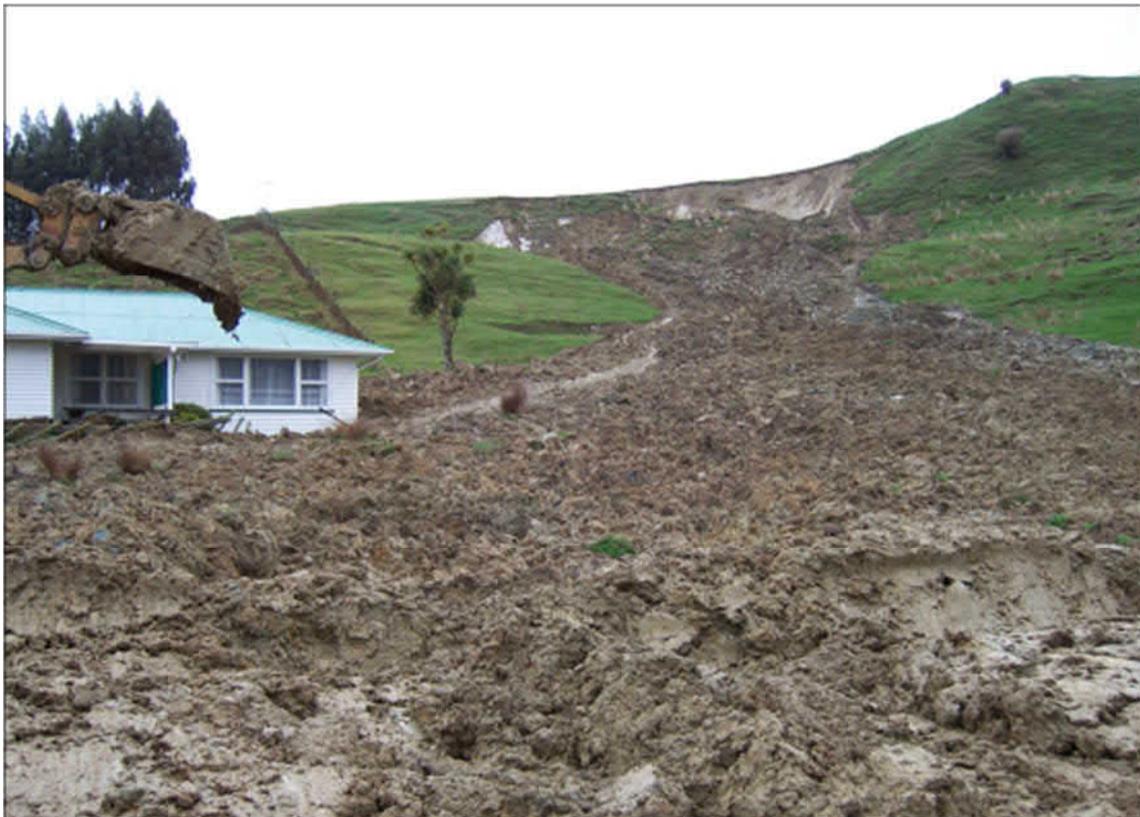
Figure 10.4 Rainfall triggered debris flow (Hunterville 2006)

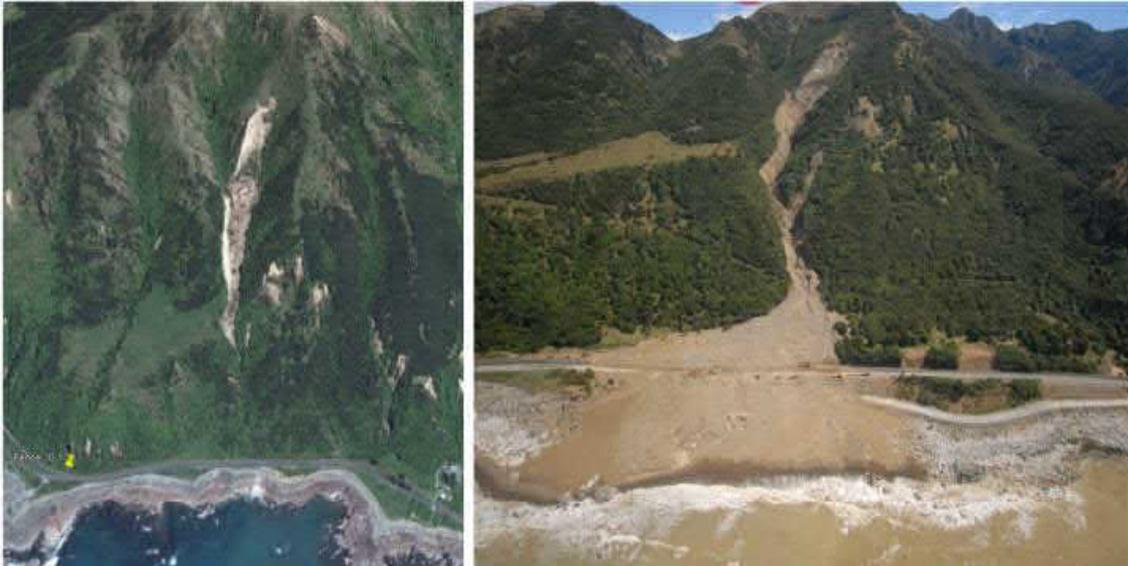
Figure 10.5 *Rainfall induced debris flow 2018 post Kaikoura Earthquake 2016 (GNS Science)*
Note The earthquake-triggered landslide debris in 2016 (on the left) becomes a rainfall-triggered debris flow 15 months later in 2018 (on the right).

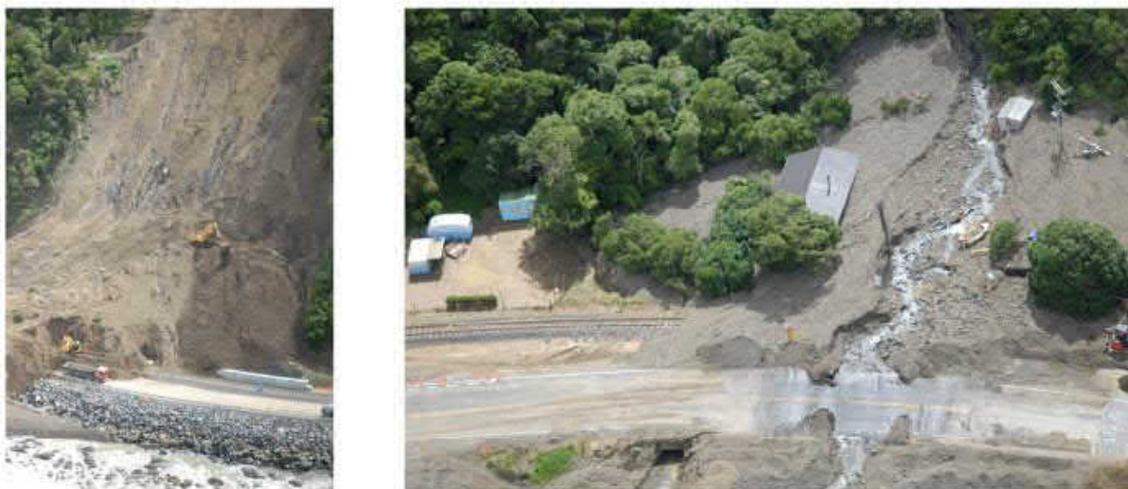
Figure 10.6 *Rainfall induced debris flows 2018 post Kaikoura Earthquake 2016 (GNS Science)*
Note the size of the debris protection wall relative to the size of the debris flow, in the left image

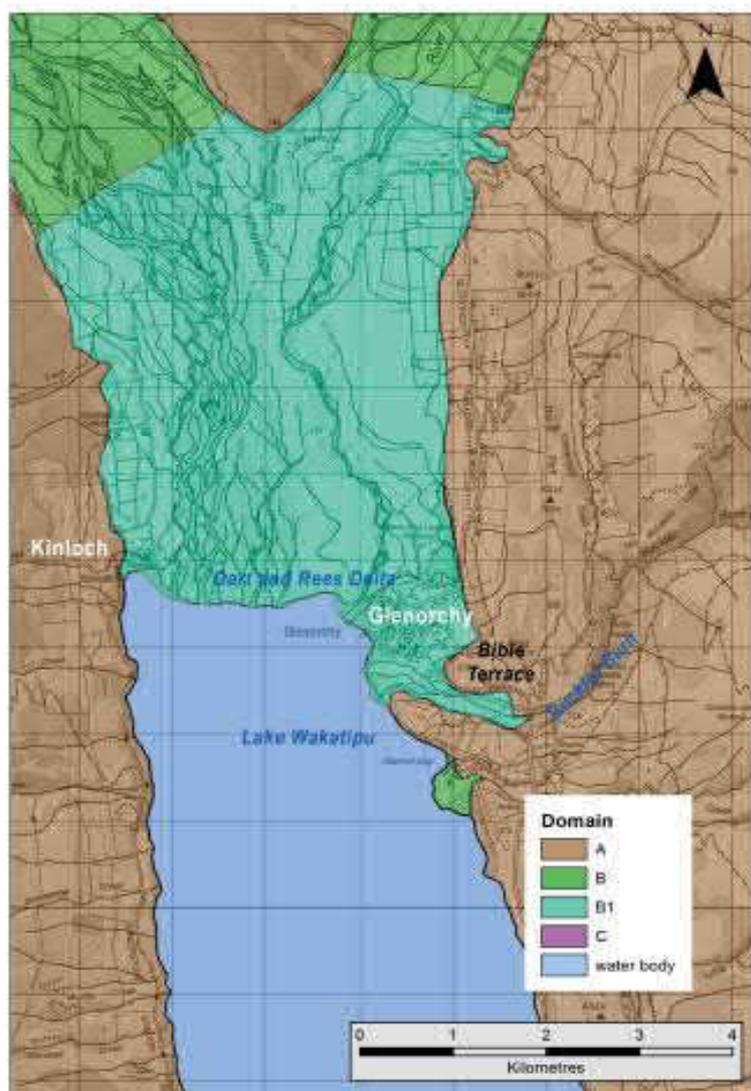
Figure 10.7 Liquefaction susceptibility in the Project area (GNS 2019)

In 2019, GNS assessed the liquefaction susceptibility for the whole of Otago. The GNS assessment mapped the much of the Project area as "low to moderate susceptibility (B), but with some geotechnical evidence of susceptibility (B1)". The GNS mapping, broadly consistent with the 2013 T+T assessment, is shown in Figure 10.7.

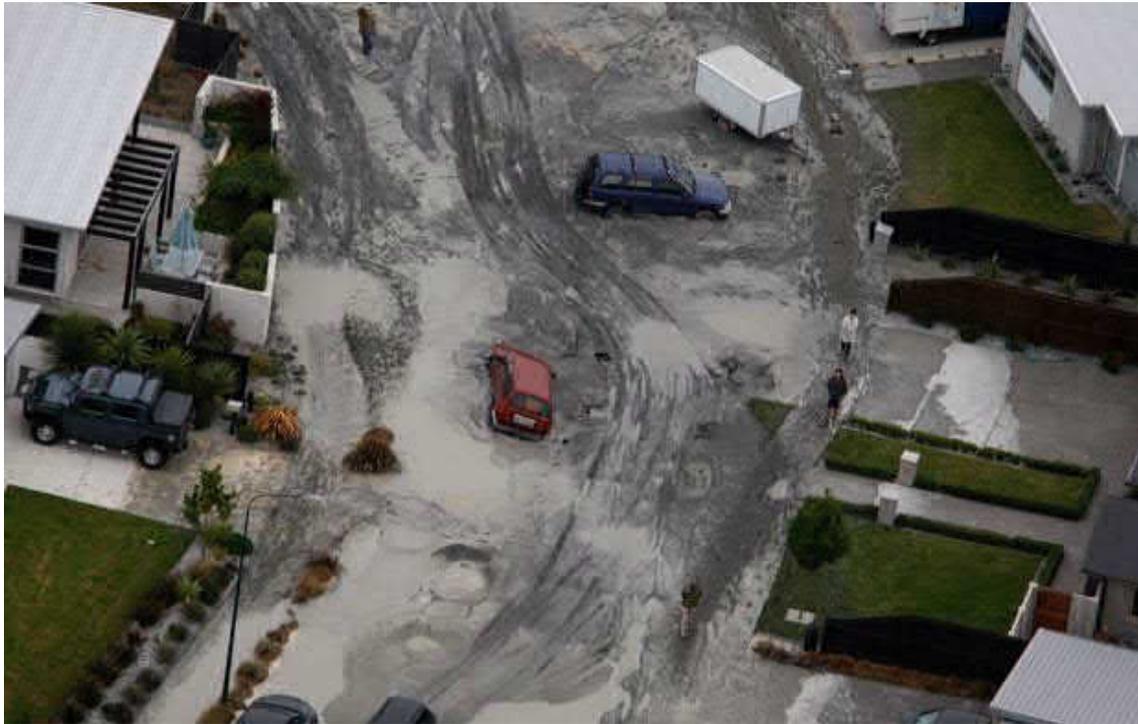
Figure 10.8 Inundation from ejected sand and water from liquefaction, Christchurch 2011 (EQC)

From the Canterbury Earthquake Sequence from 2010 to 2011 there is a very good appreciation of what inundation by sand and water as a result of earthquake triggered liquefaction looks like, as shown in Figure 10.8 to Figure 10.10.

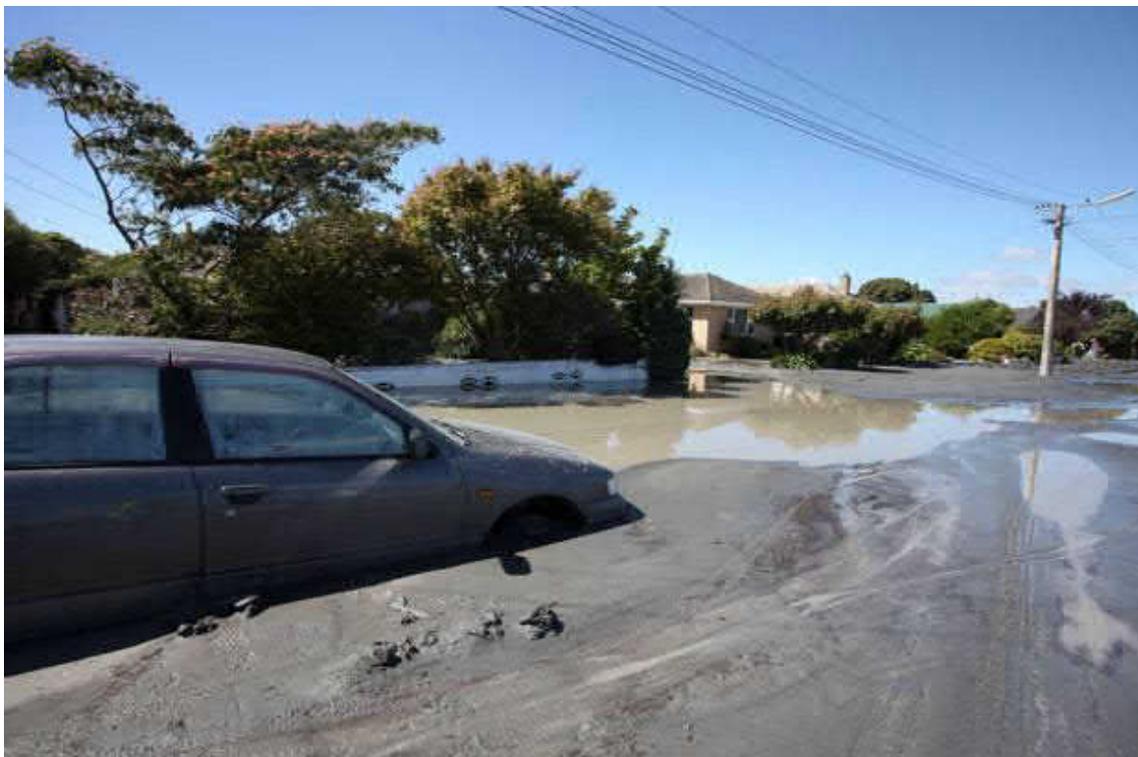
Figure 10.9 Inundation from ejected sand and water from liquefaction, Christchurch 2011

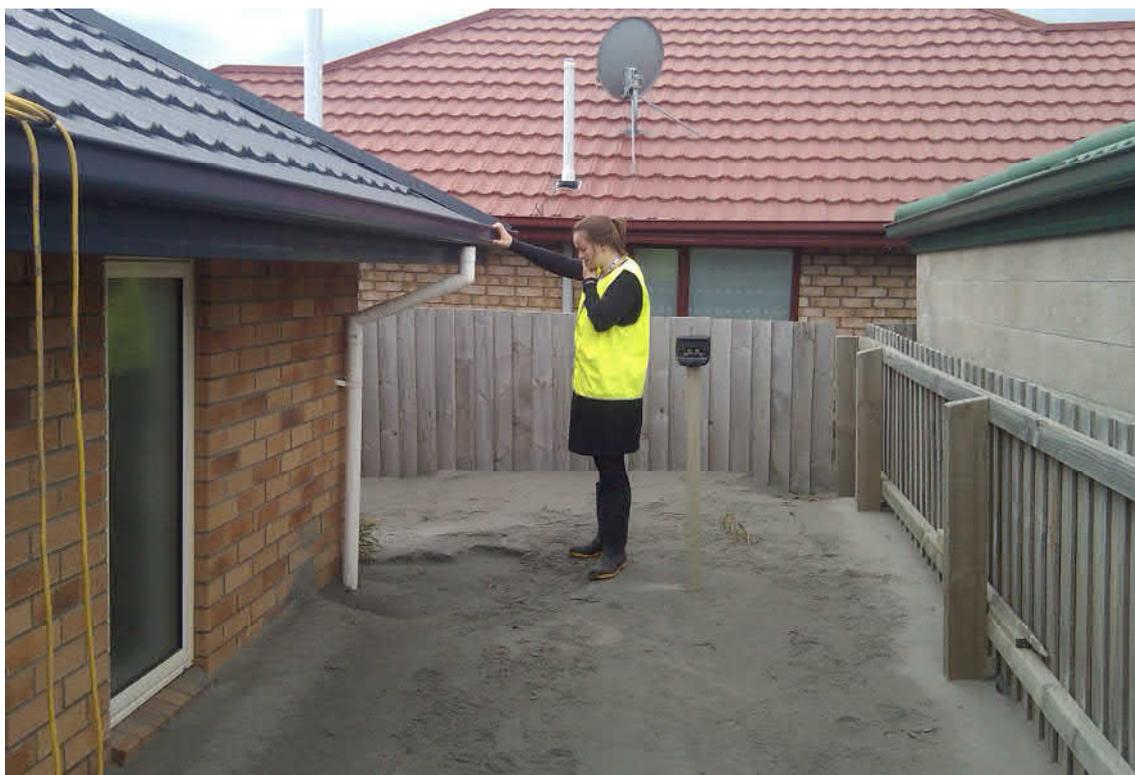
Figure 10.10 Inundation from ejection of sand from liquefaction, Christchurch 2010
