Head of Lake Wakatipu

Natural Hazards Assessment

Prepared for
Otago Regional Council
Prepared by
Tonkin & Taylor Ltd
Date
March 2021
Job Number
1015117

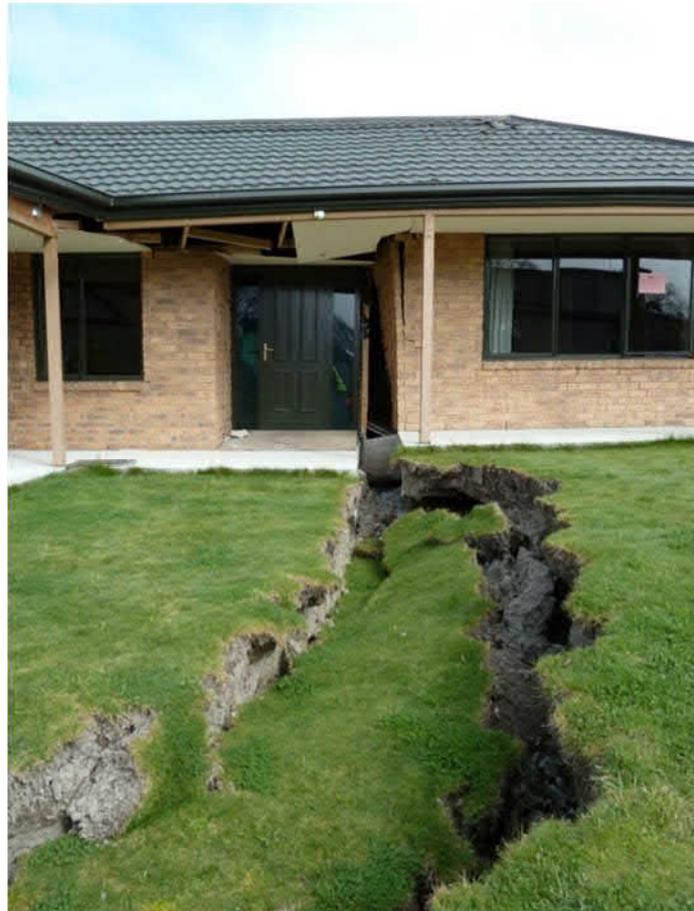
Figure 10.11 Lateral spreading, Kaiapoi

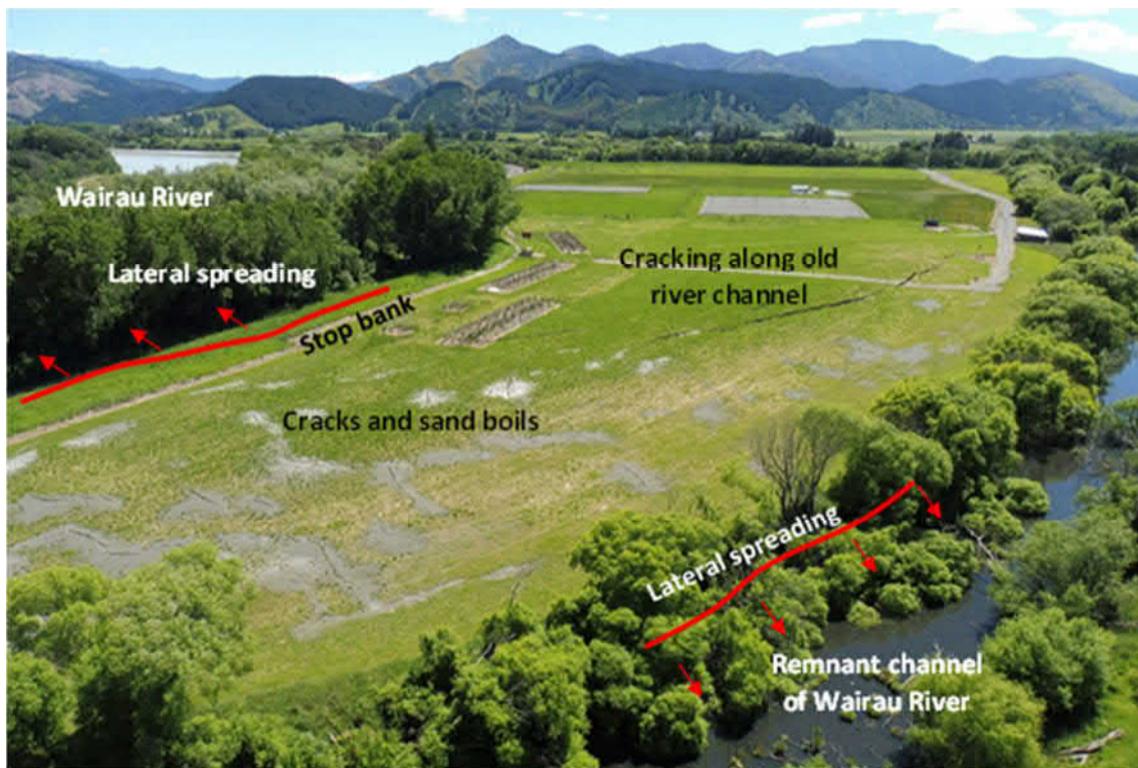
Figure 10.12 Lateral spreading, Wairau River, Blenheim

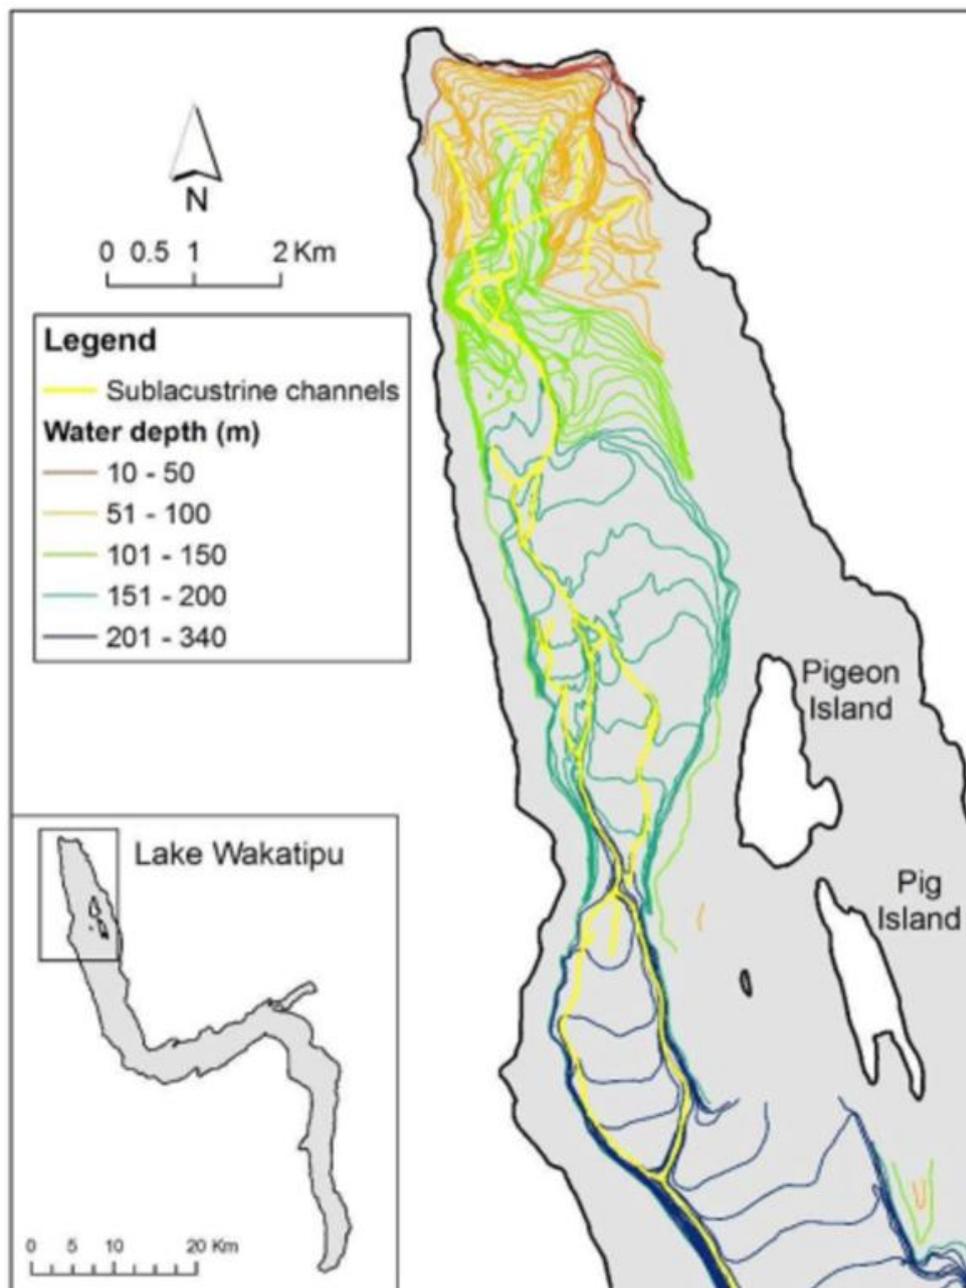
Figure 10.13 Bathymetry of the Head of Lake Wakatipu (NIWA)

The potential for significant lateral spreading to occur around the Head of Lake Wakatipu is because of the rapid deepening of the bed of the lake, as shown in the bathymetry (Figure 10.13)

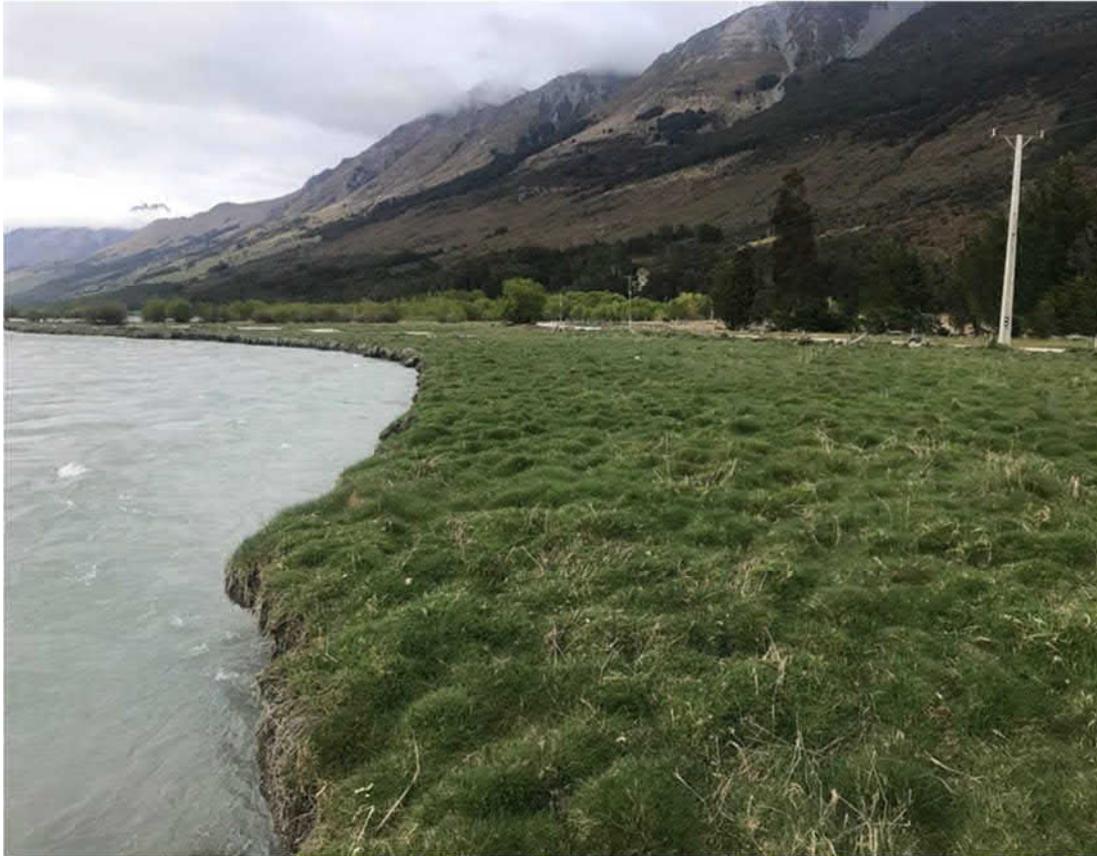
Figure 10.14 Lower Dart River, true right bank, 8 October 2020 (J Glover)

Areas of past deposition by the Dart and Rees Rivers, as well as alluvial fans from rivers and streams, are being actively eroded by the Dart and Rees Rivers. A very recent example is the rapid erosion of alluvial deposits at Kinloch on the true right bank of the Dart River, as shown in Figure 10.14 and Figure 10.15.

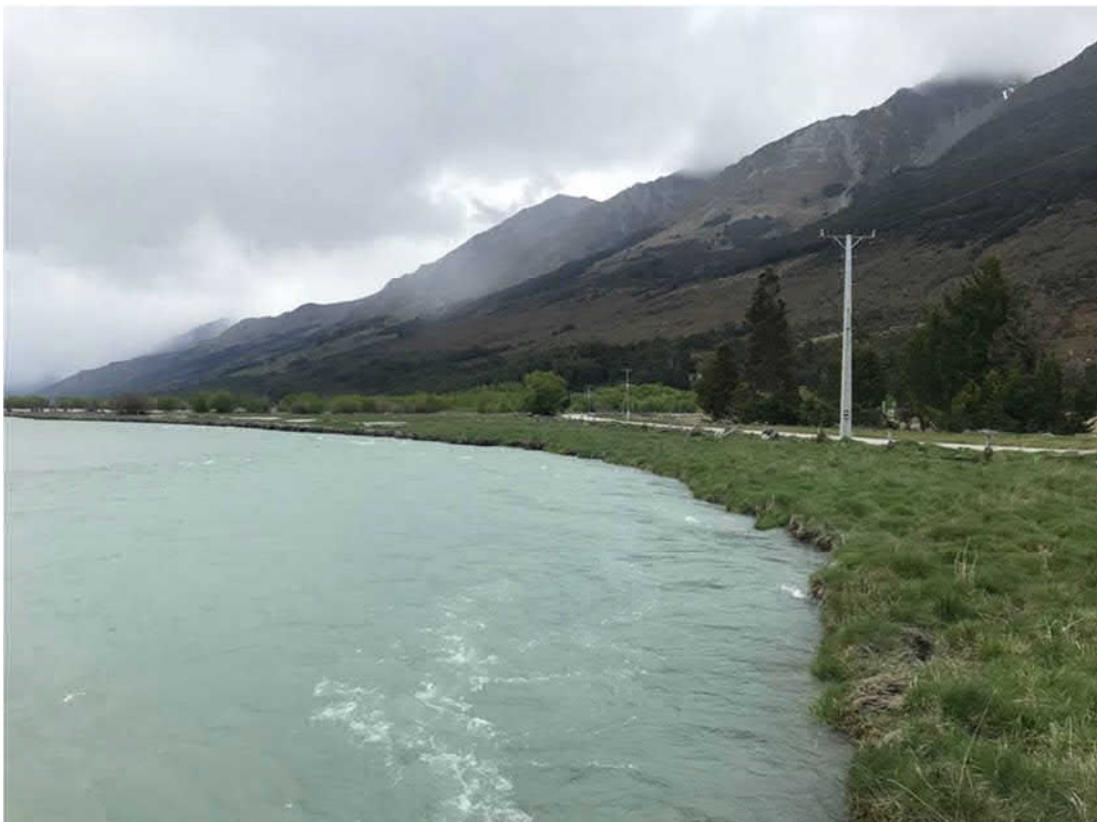
Figure 10.15 Lower Dart River, true right bank, 15 October 2020 (J Glover)

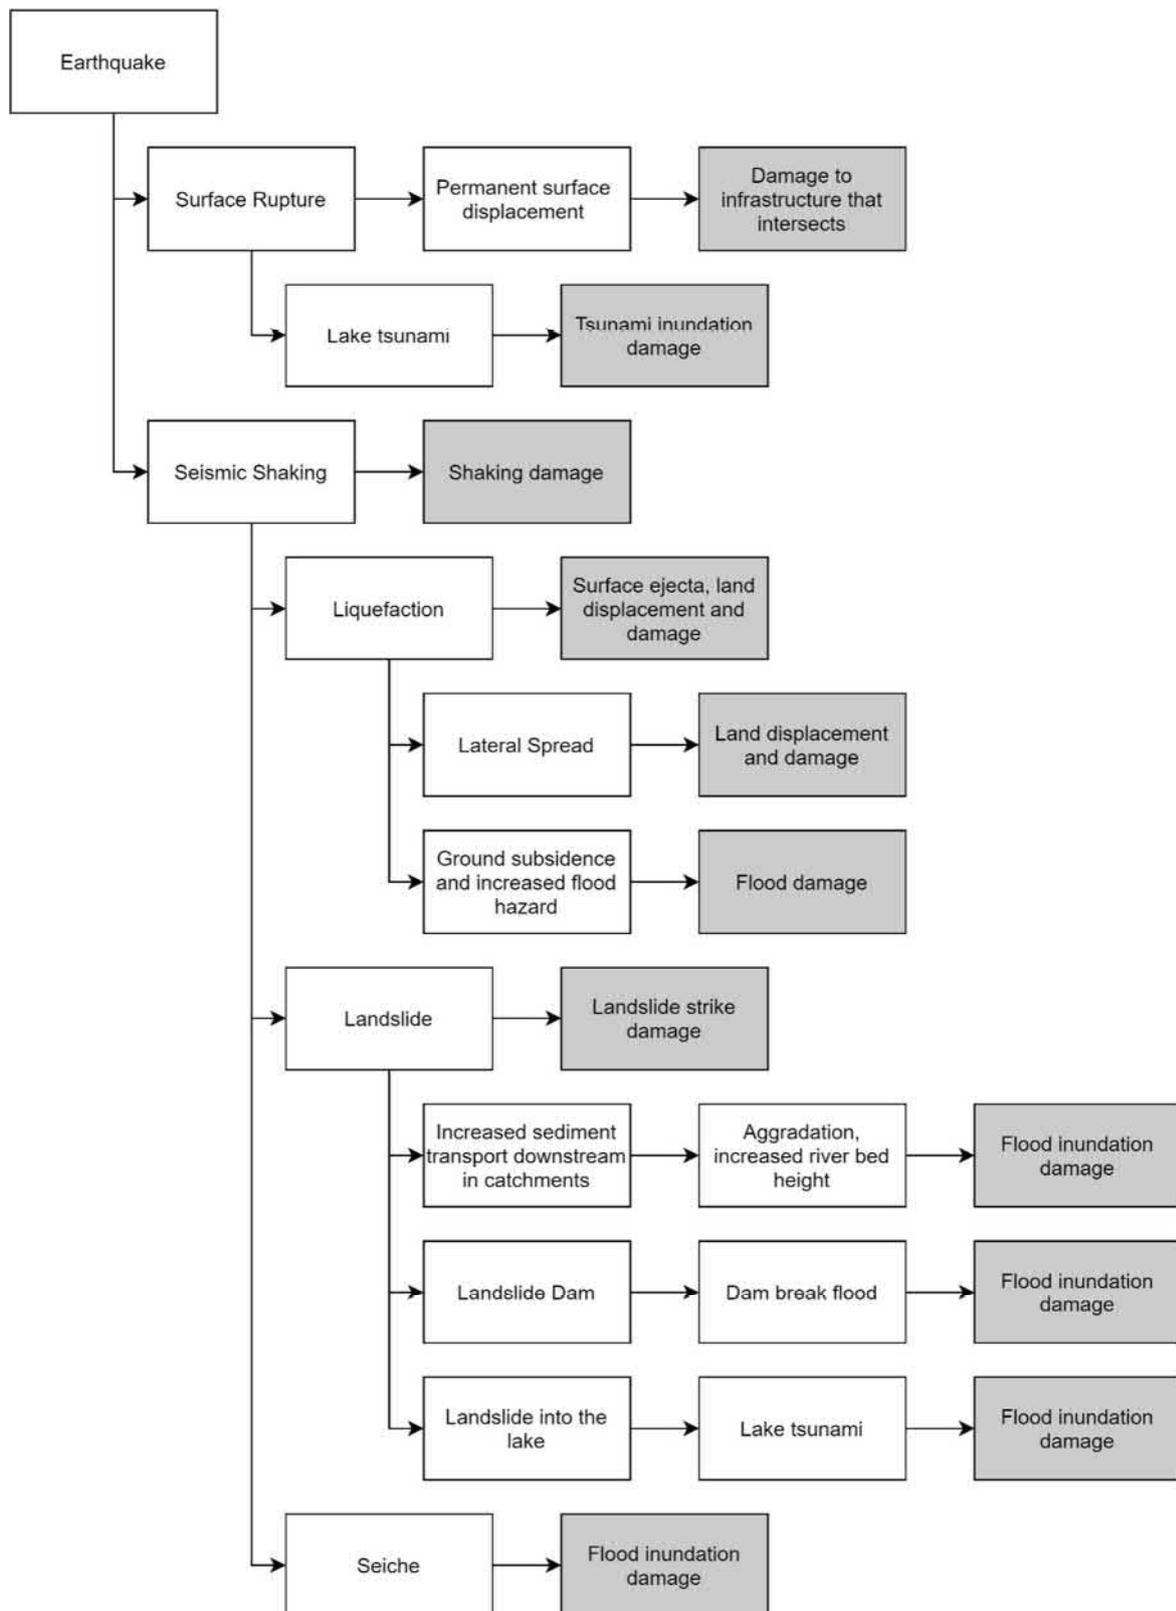
Figure 11-1 Flow diagram of hazardous phenomena resulting from an earthquake. Each branch terminates at the grey boxes which outline the damage inducing phenomena

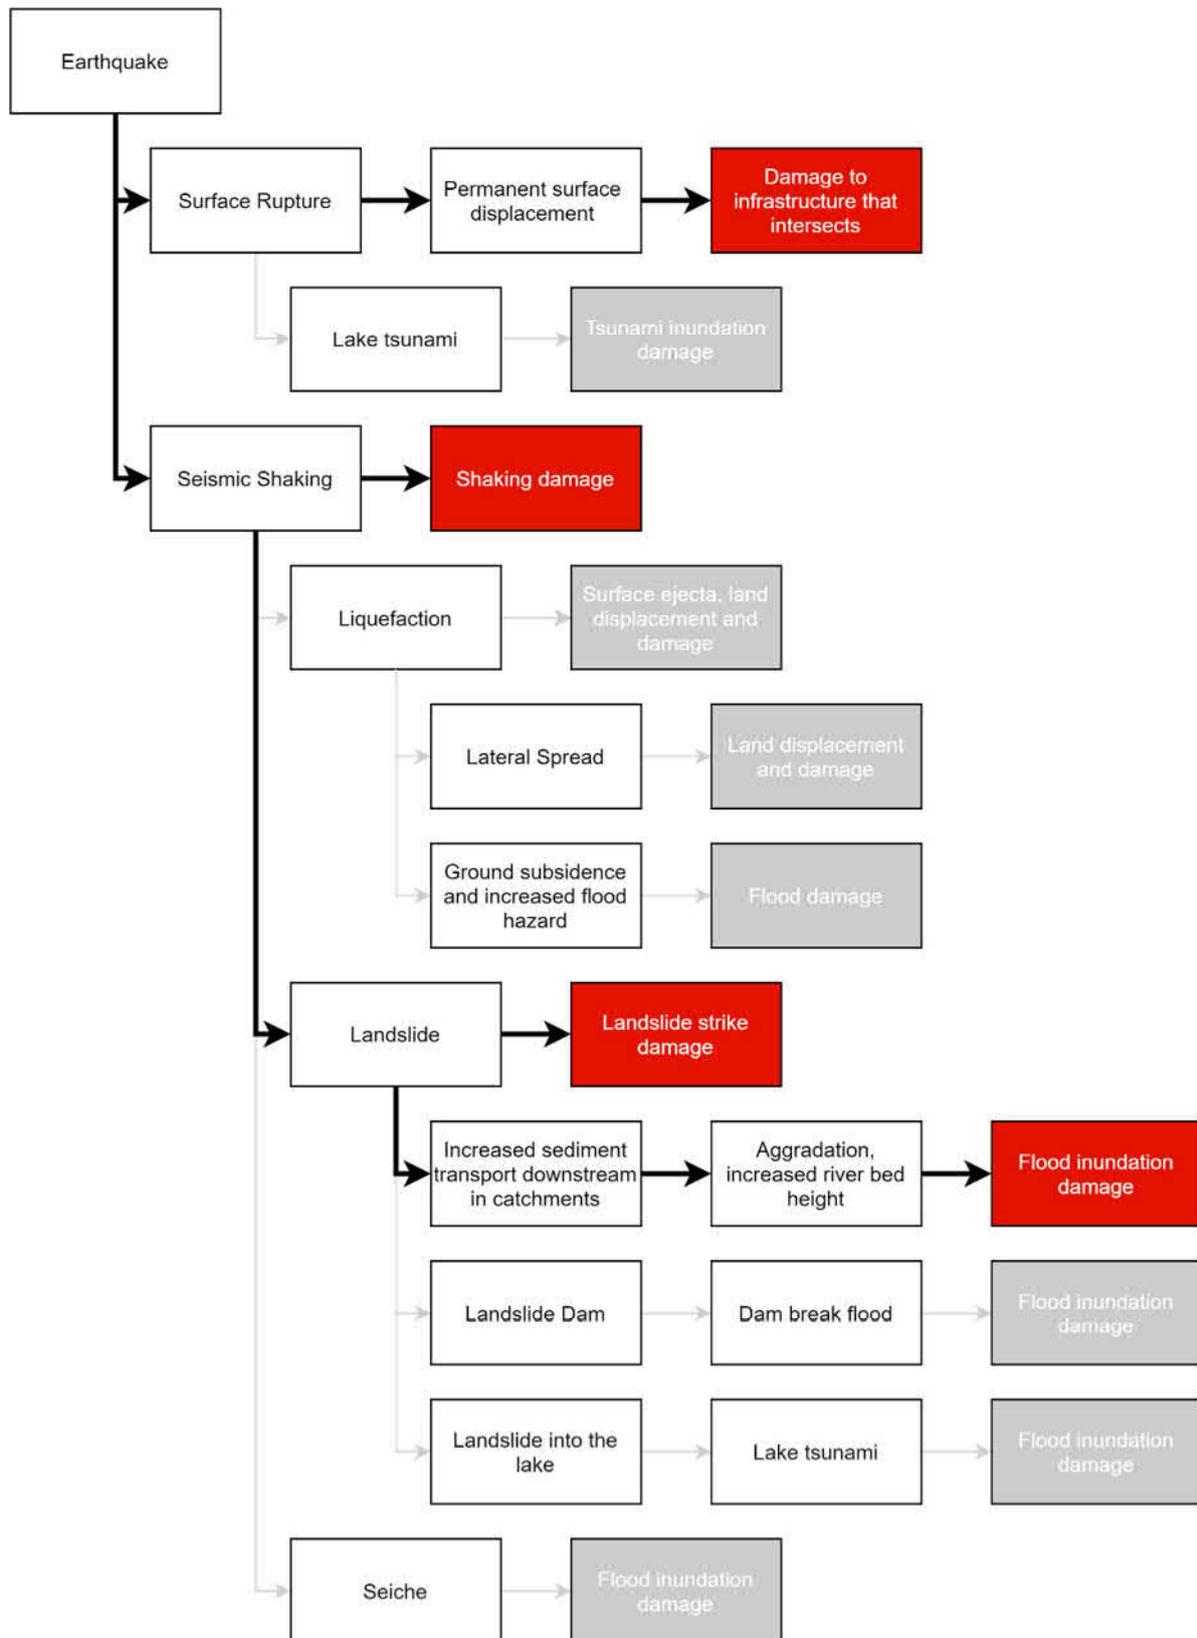
Figure 11-2 Natural disaster scenario used within this study – black arrows illustrate the sequence of the hazards scenario and red boxes represent the damage inducing phenomena

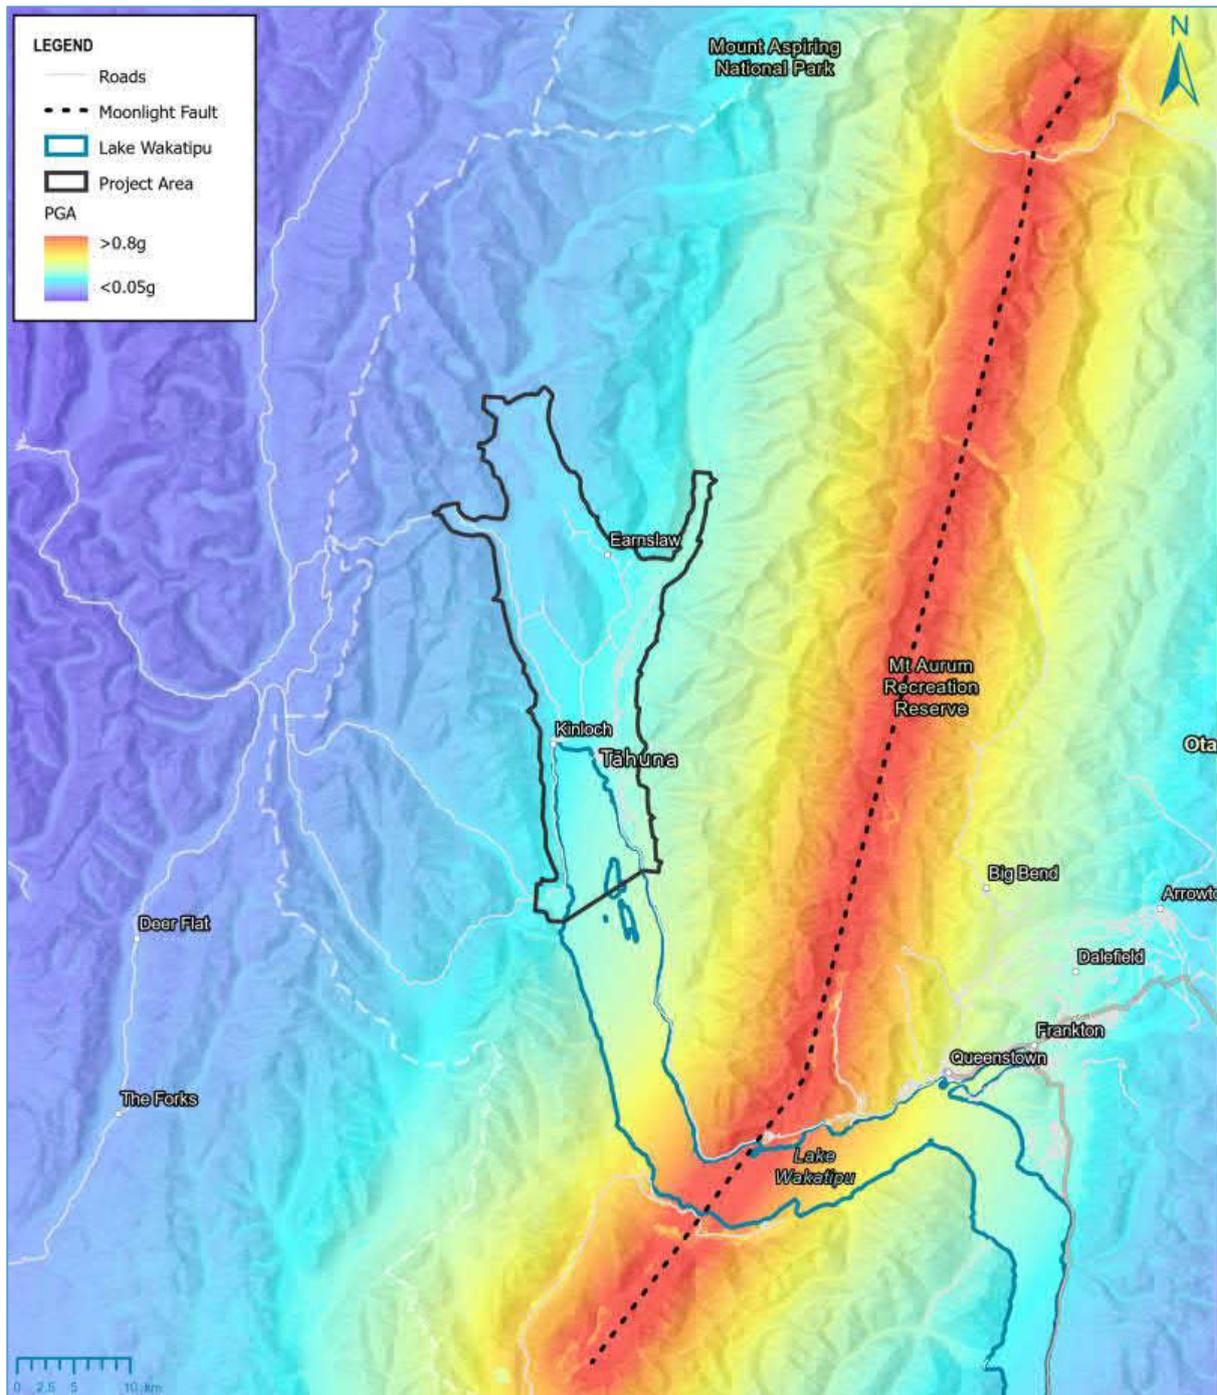
Figure 11-3 PGA map of a characteristic median rupture of the Moonlight Fault rupture. Rupture parameters are from Stirling et al. (2012) and V_{s30} is from Foster et al (2019).

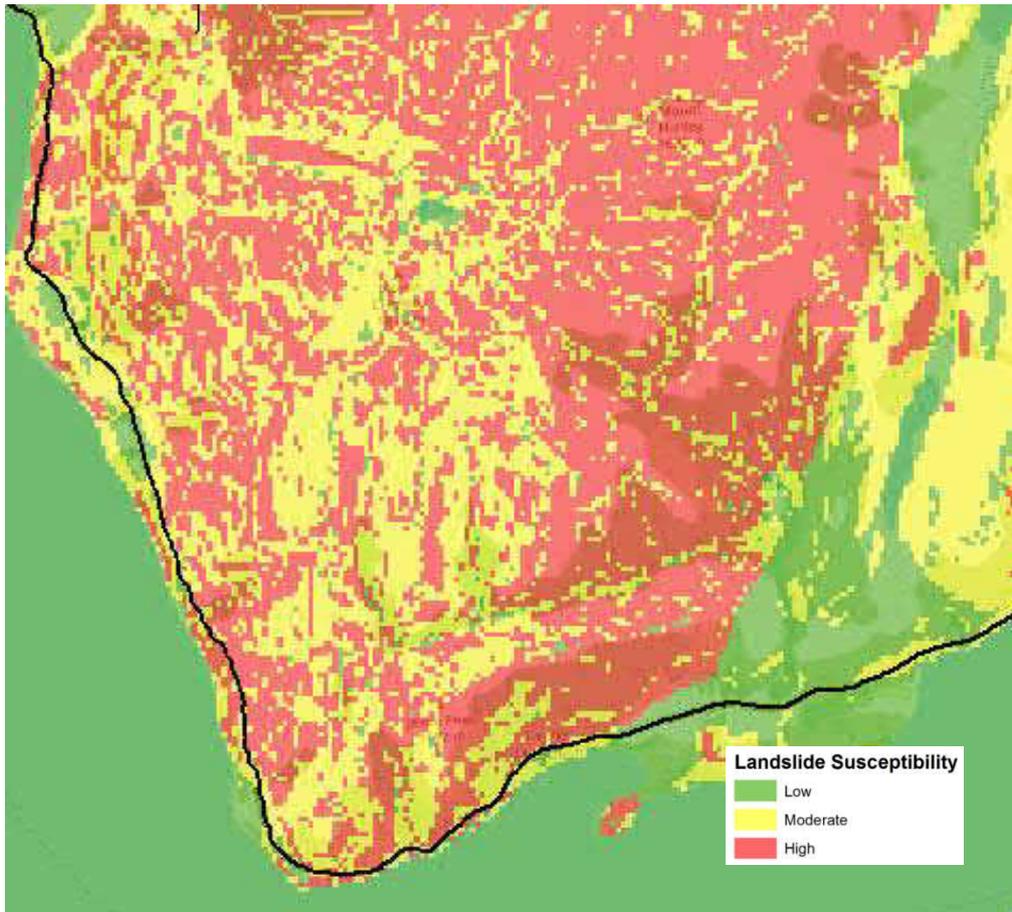
Figure 11-4 Example of the landslide evacuation susceptibility along the Glenorchy-Queenstown Road

the road more susceptible of landslide evacuation and can subsequently be aggregated up to characterise the length of road within each landslide susceptible rating.

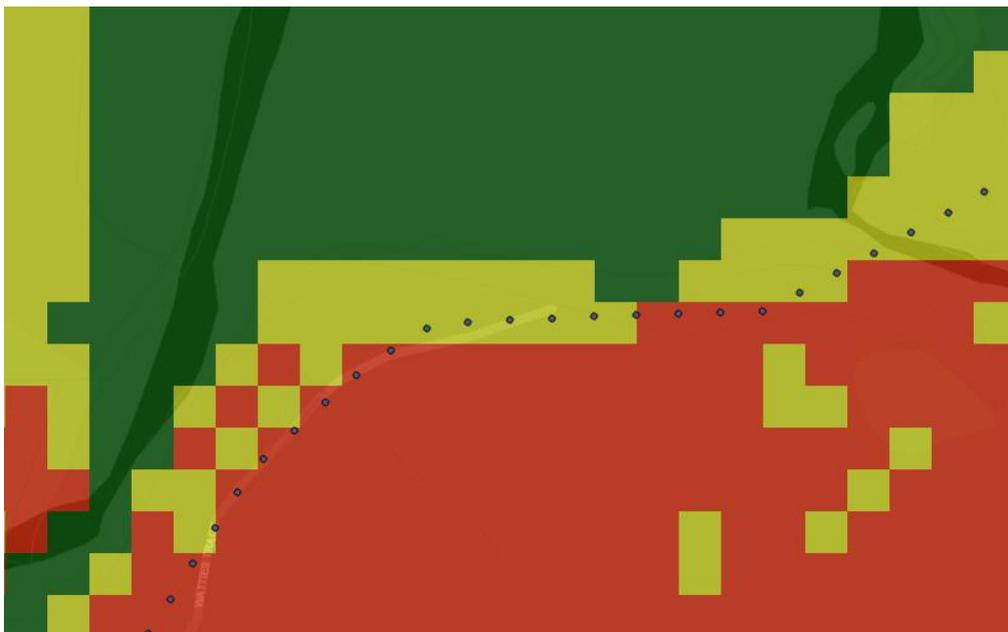
Figure 11-5 Example of landslide evacuation susceptibility assigned to 50 m interval points along the road

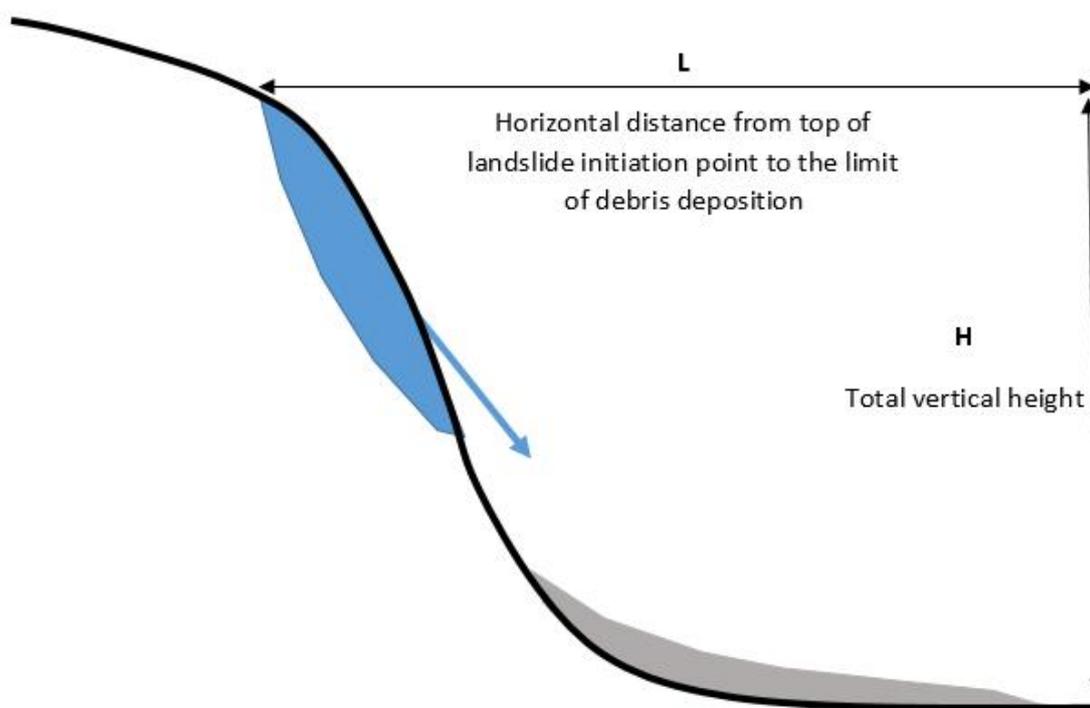
Figure 11-6 Relationship applied in this assessment between landslide evacuation and inundation

Landslide inundation modelling is also critical to identify above ground assets that could be impacted by runouts. The runout distance for debris generated by landslide initiation (L) is recognised as being a function of the elevation through which the debris descends (H) as well as the overall debris volume (Hunter and Fell 2003; McDougall 2014). The relationship between H and L (refer Figure 11-6) varies from 0.7 for small landslides with volumes of a few tens of cubic metres through to approximately 0.4 for large landslides with volumes of thousands or tens of thousands of cubic metres. This relationship indicates that large landslides carry more mass, and the greater potential energy drives the deposition zone further (L).

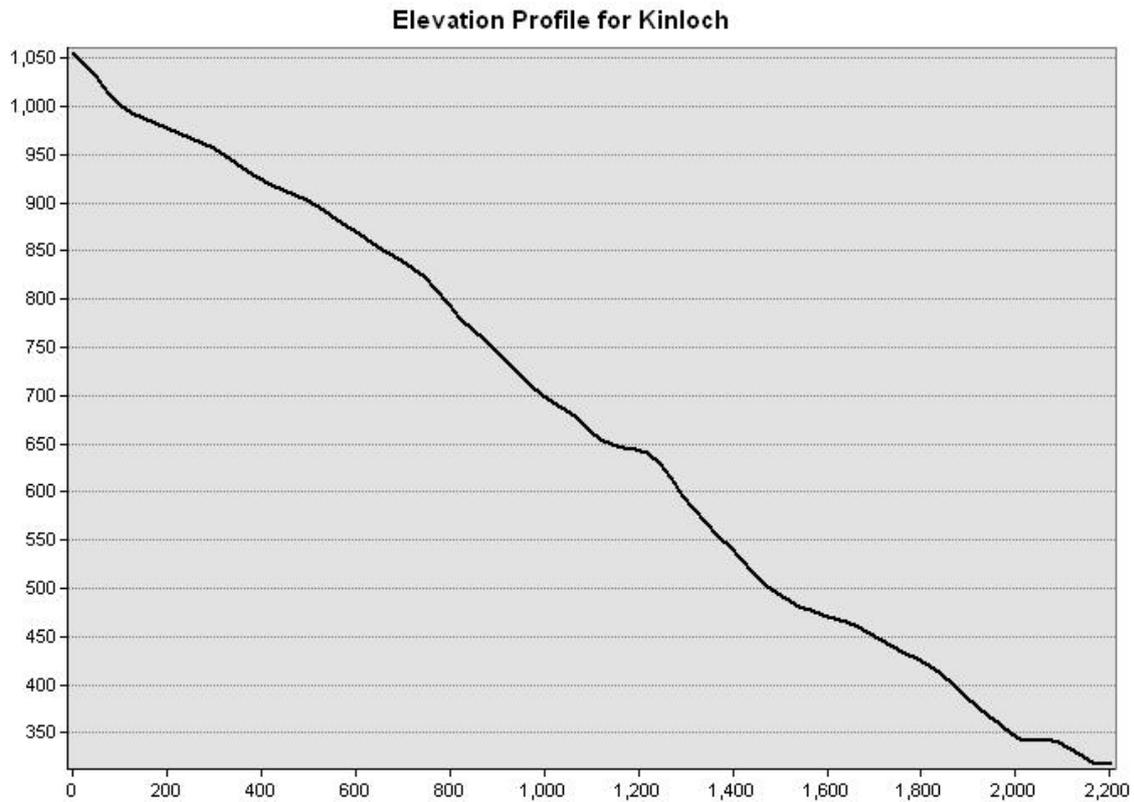
Figure 11-8 Elevation profile for Kinloch, where the town centre is located to the right

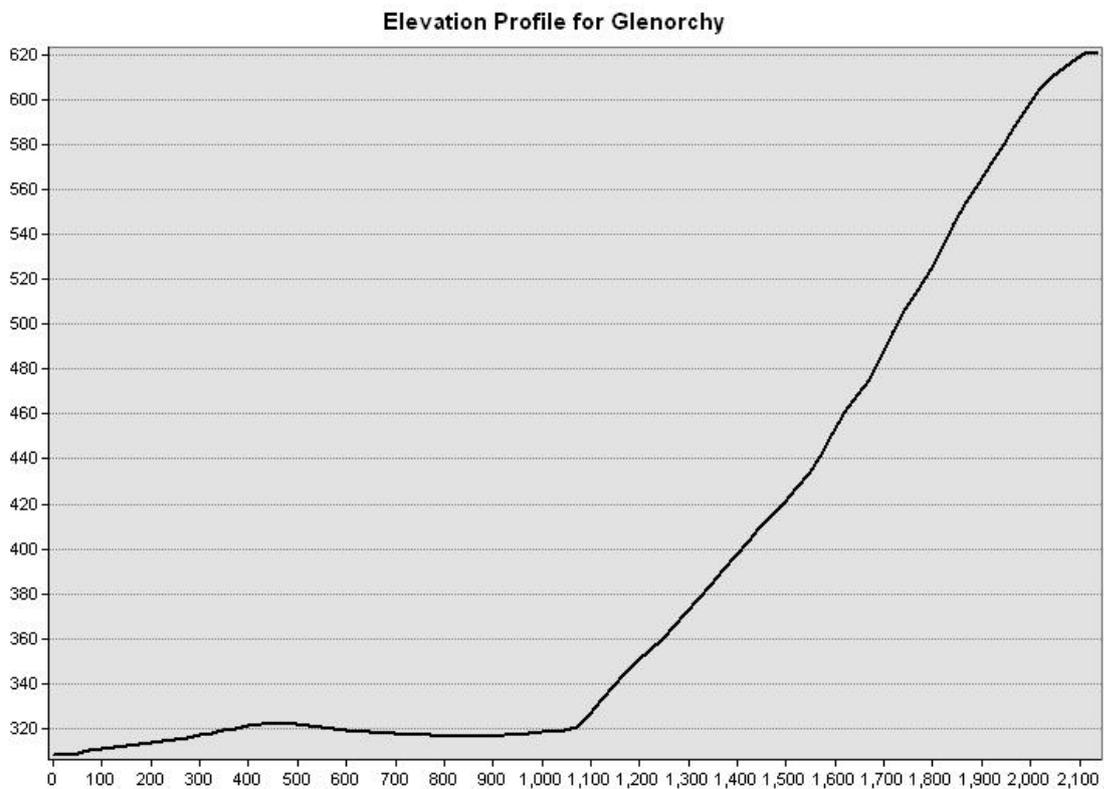
Figure 11-9 Elevation profile for Glenorchy, where the centre of town is located to the left

By comparison, the profile of the slope behind Glenorchy (Figure 11-9) demonstrates the town is between 700 m to 1 km recessed from the slope. This distance makes it less likely for landslide debris to inundate the land downslope, even from catastrophic failures of the slopes above the town.

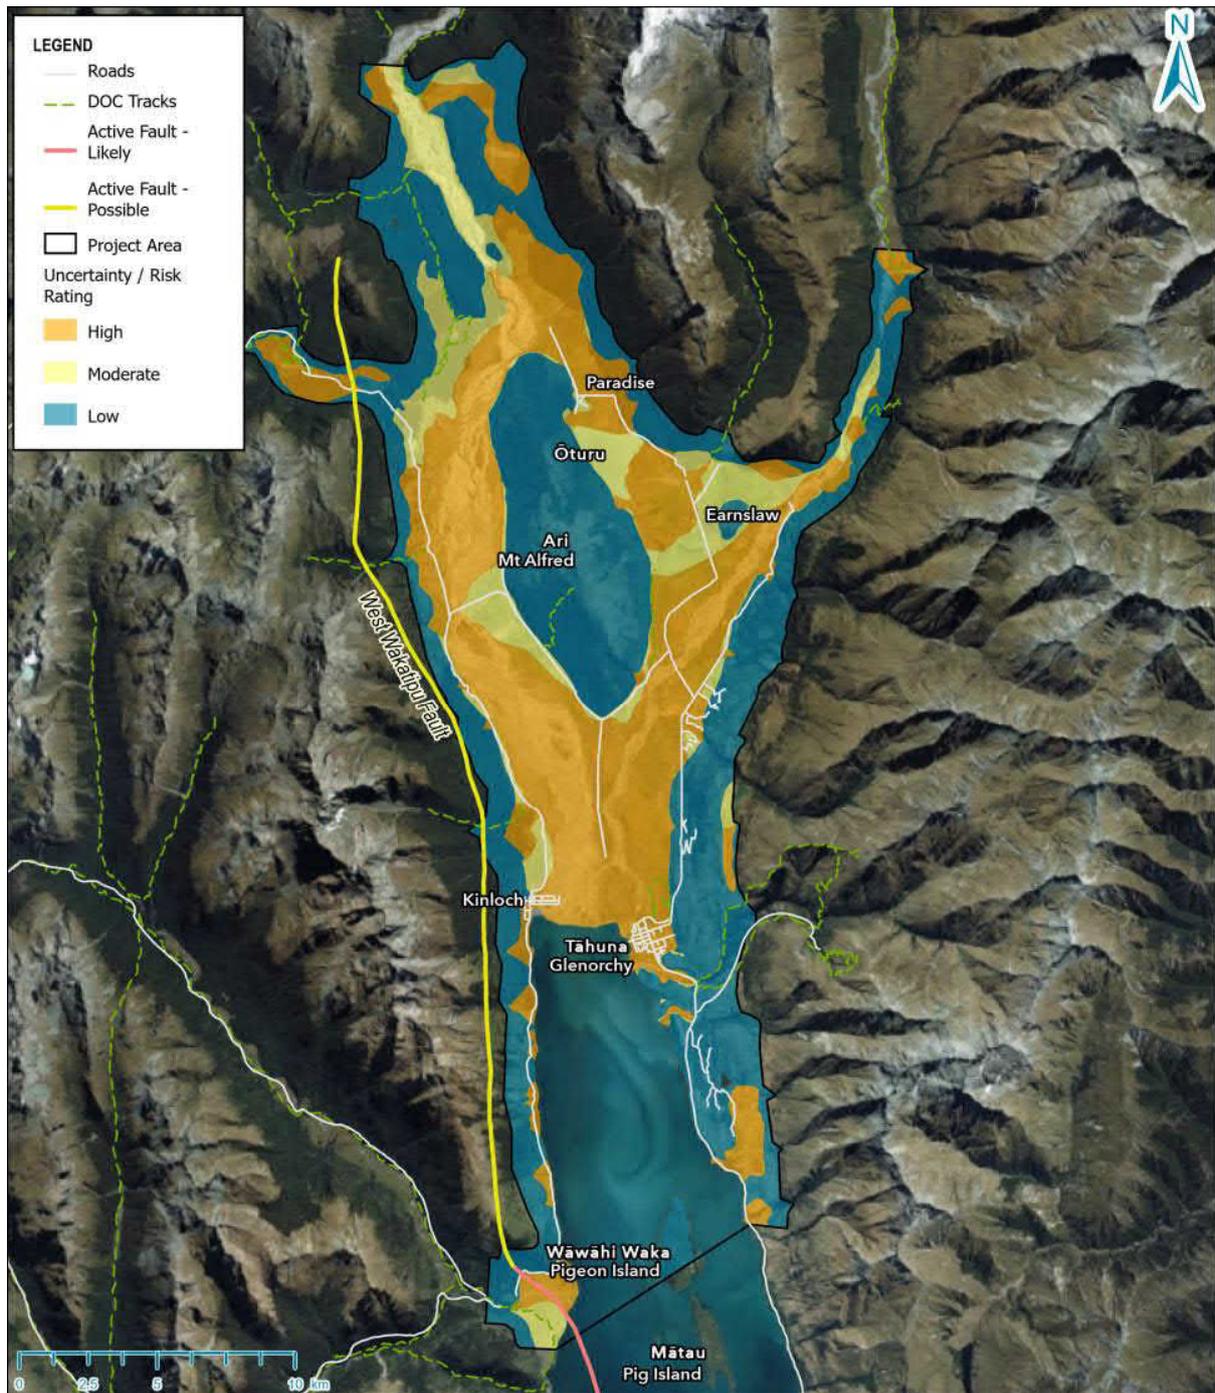
Figure 12.1: Head of Lake Wakatipu Risk Uncertainty

respect to natural hazards. These are shown in, and the map is also presented in Appendix E and is available in the ORC/QLDC web-based viewer.

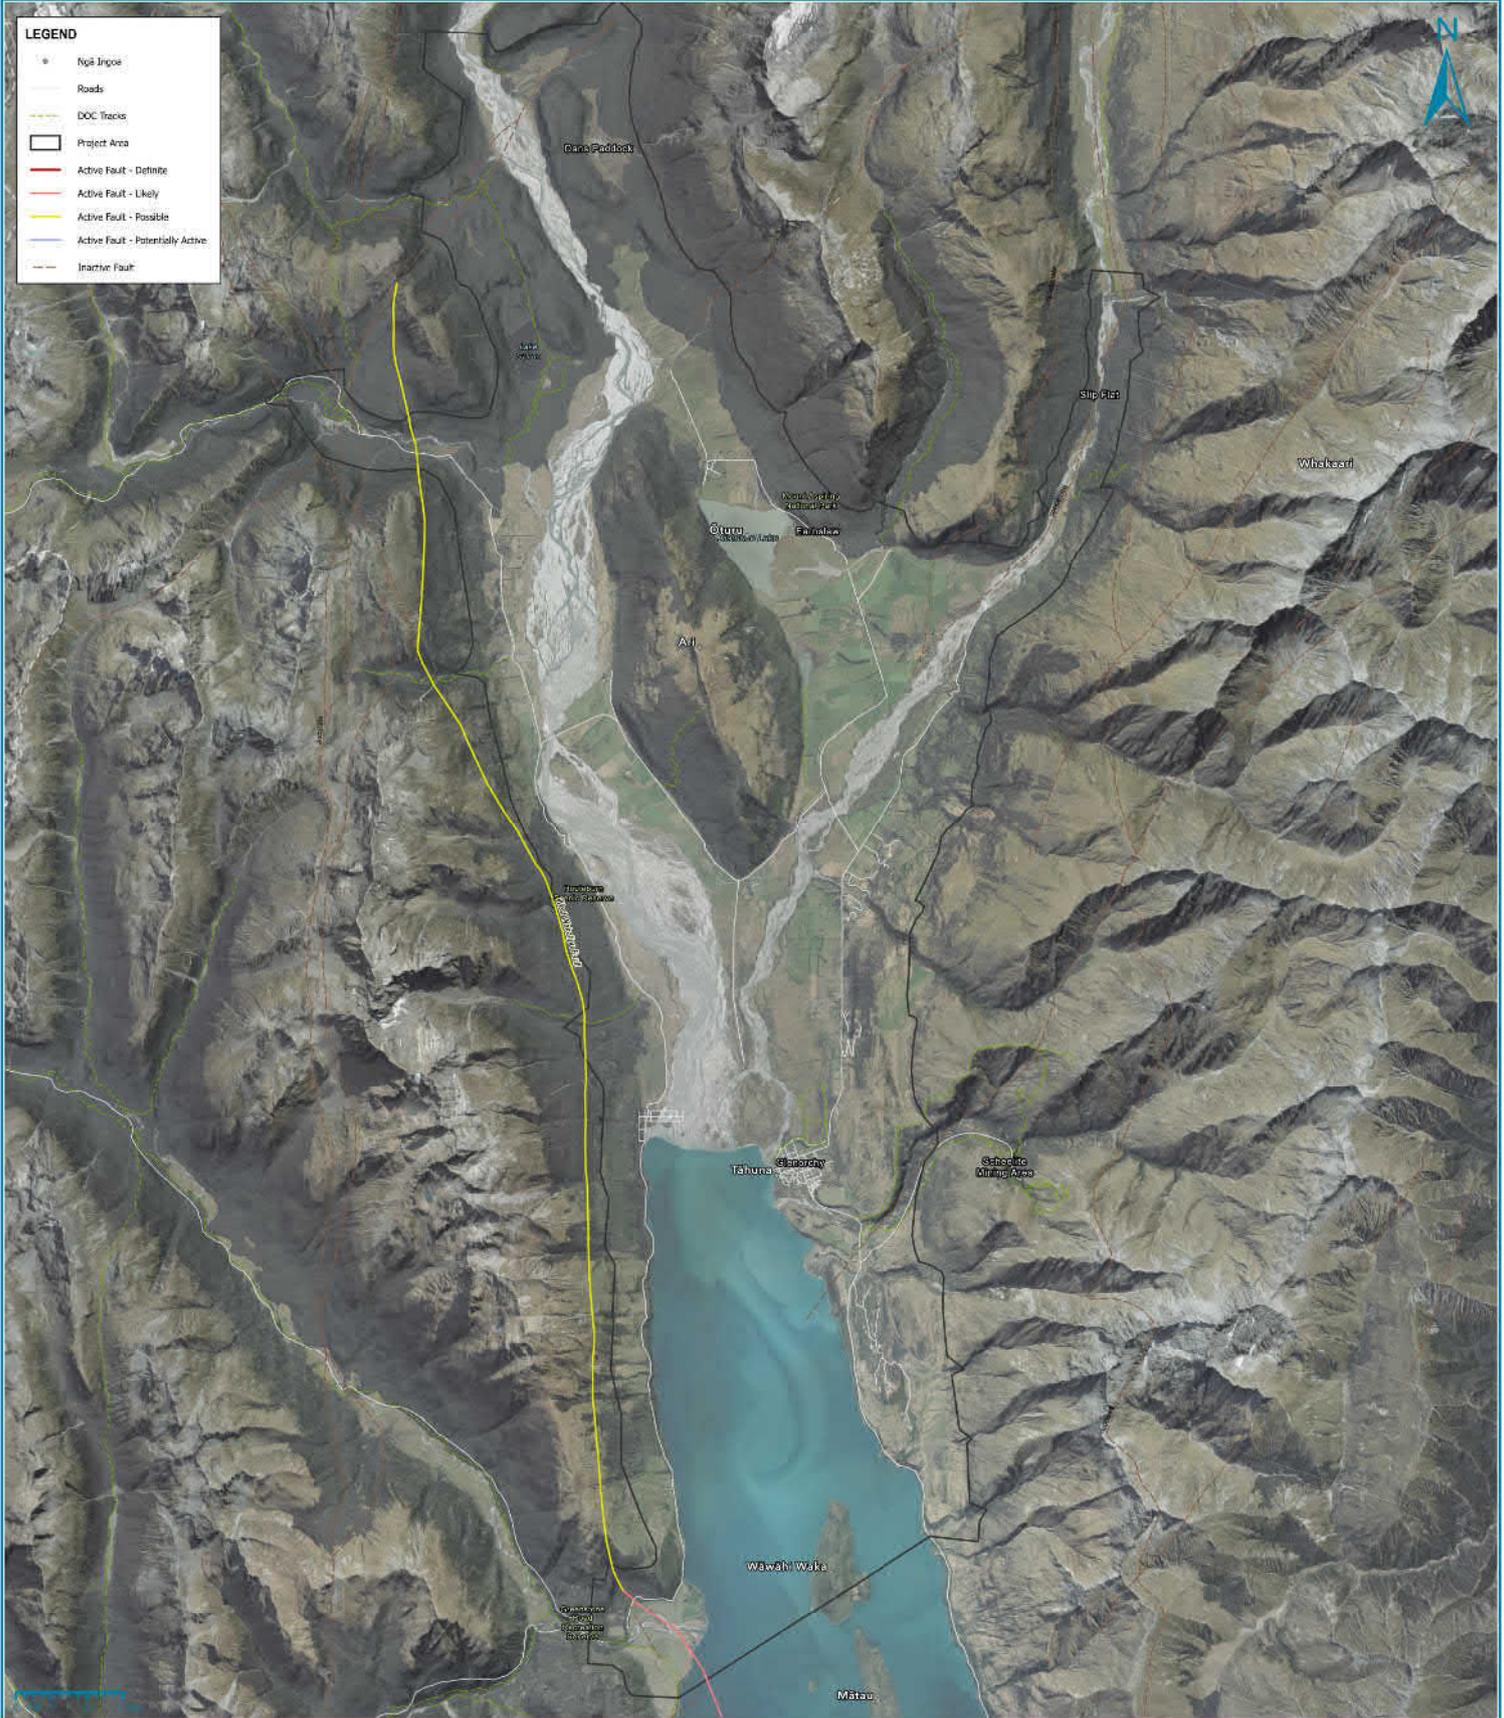
Seismic Faults

Notes: This layer shows active faults mapped at regional scale (approx. 1:250,000) in the Queenstown Lakes and Central Otago districts by GNS for the ORC (2019). It depicts the locations of active and potentially active faults at or near the ground surface.
 Definite = clear evidence for the existence of an active fault or fold.
 Likely = good reason to suspect the existence of an active fault or fold.
 Possible = some reason to suspect the existence of an active fault or fold.
 Potentially active = a known or suspected fault without identified geologically recent activity, but which could conceivably experience activity in the future.

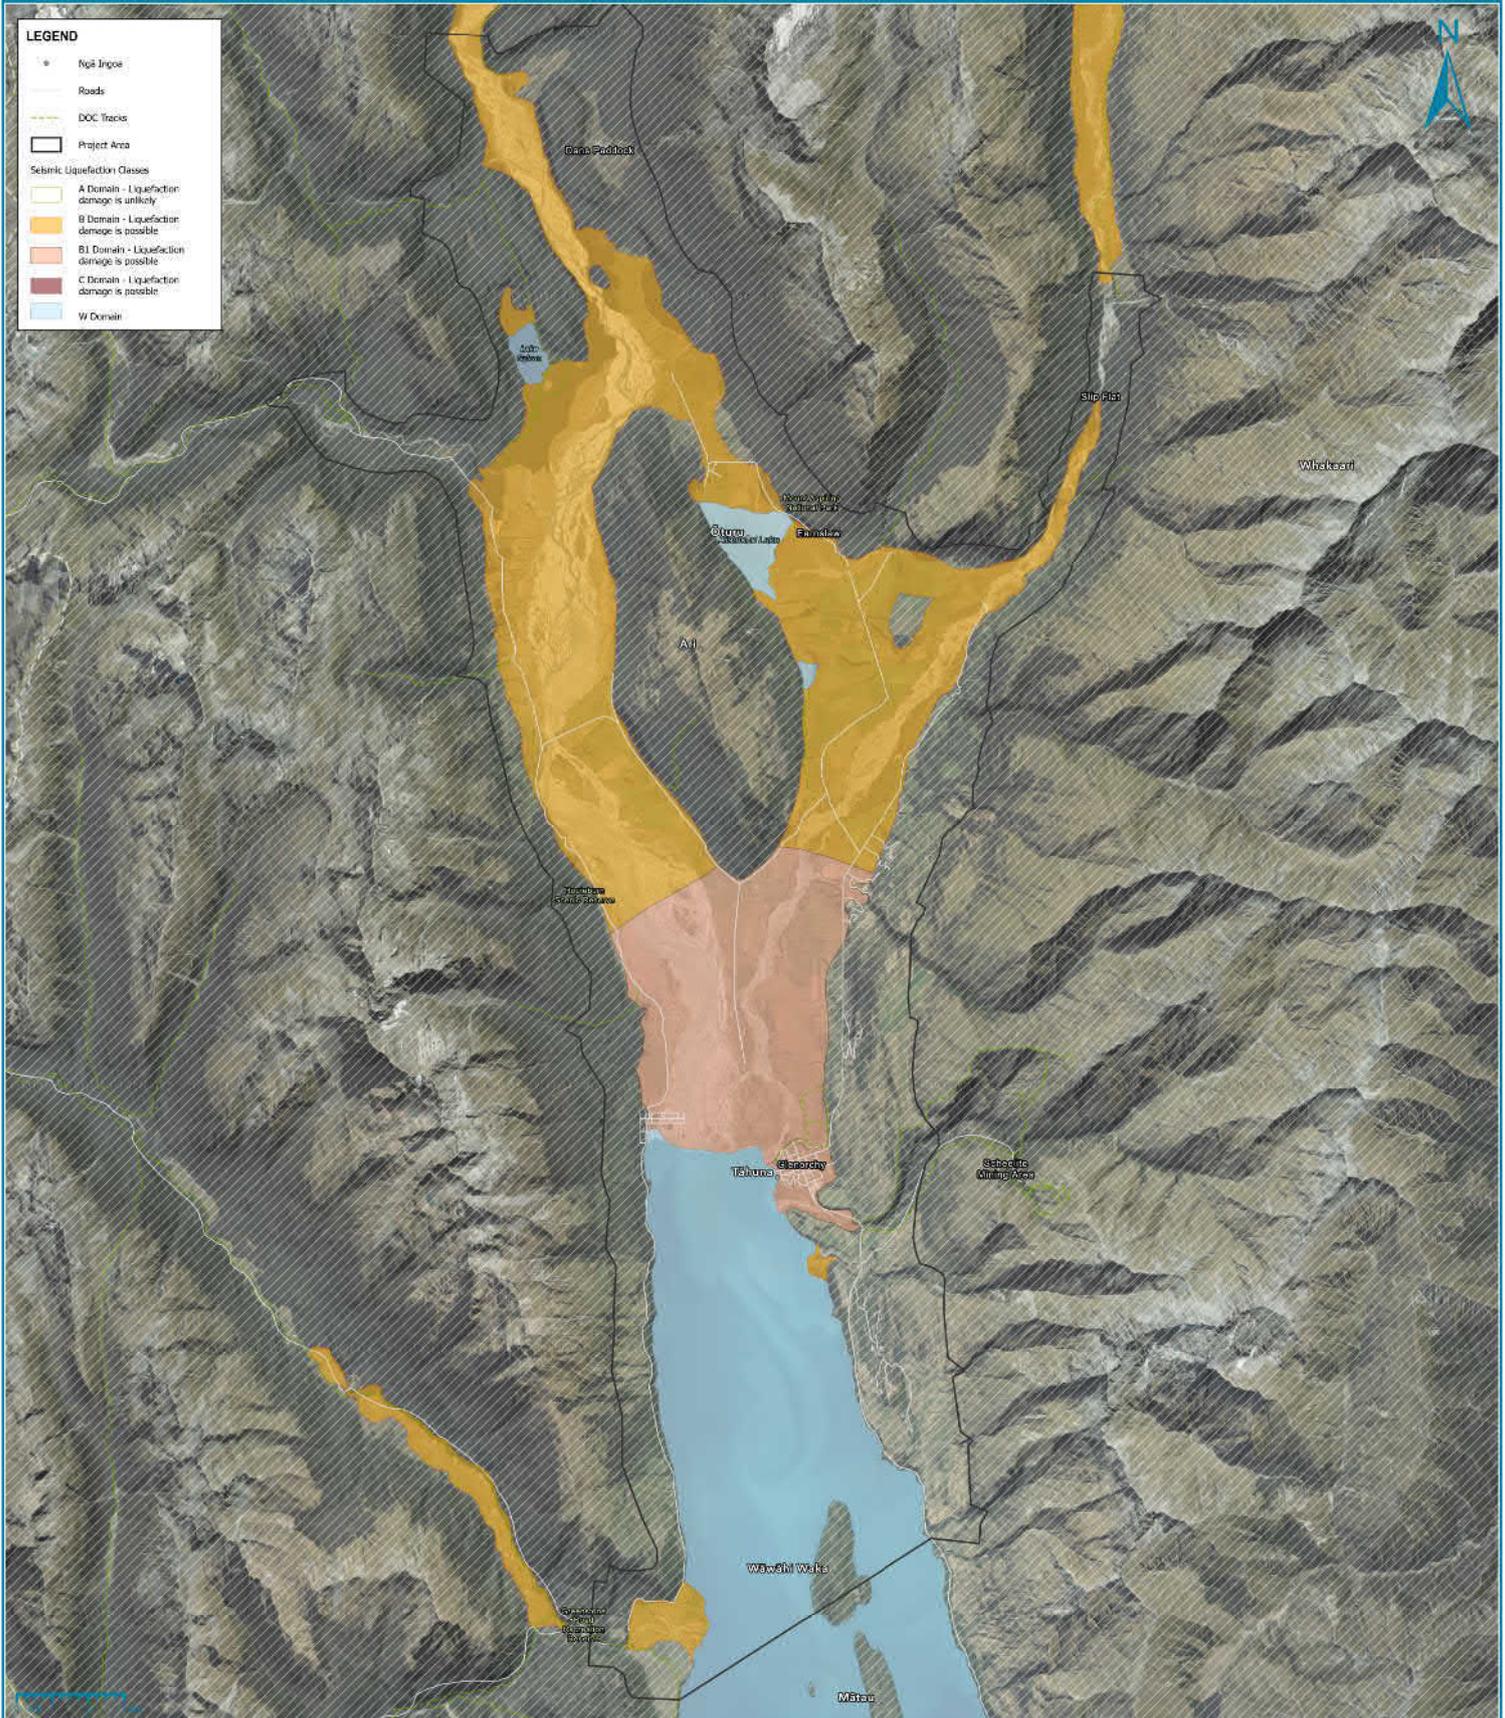
Liquefaction Hazard

Notes: This 2019 data set prepared by GNS for ORC identifies areas that are assessed as being underlain by sediments which may have some liquefaction susceptibility. Domain A - Liquefaction damage is unlikely. The ground is predominantly underlain by rock or firm sediments. There is little or no likelihood of damaging liquefaction occurring.
