Head of Lake Wakatipu

Natural Hazards Assessment

Prepared for
Otago Regional Council
Prepared by
Tonkin & Taylor Ltd
Date
March 2021
Job Number
1015117

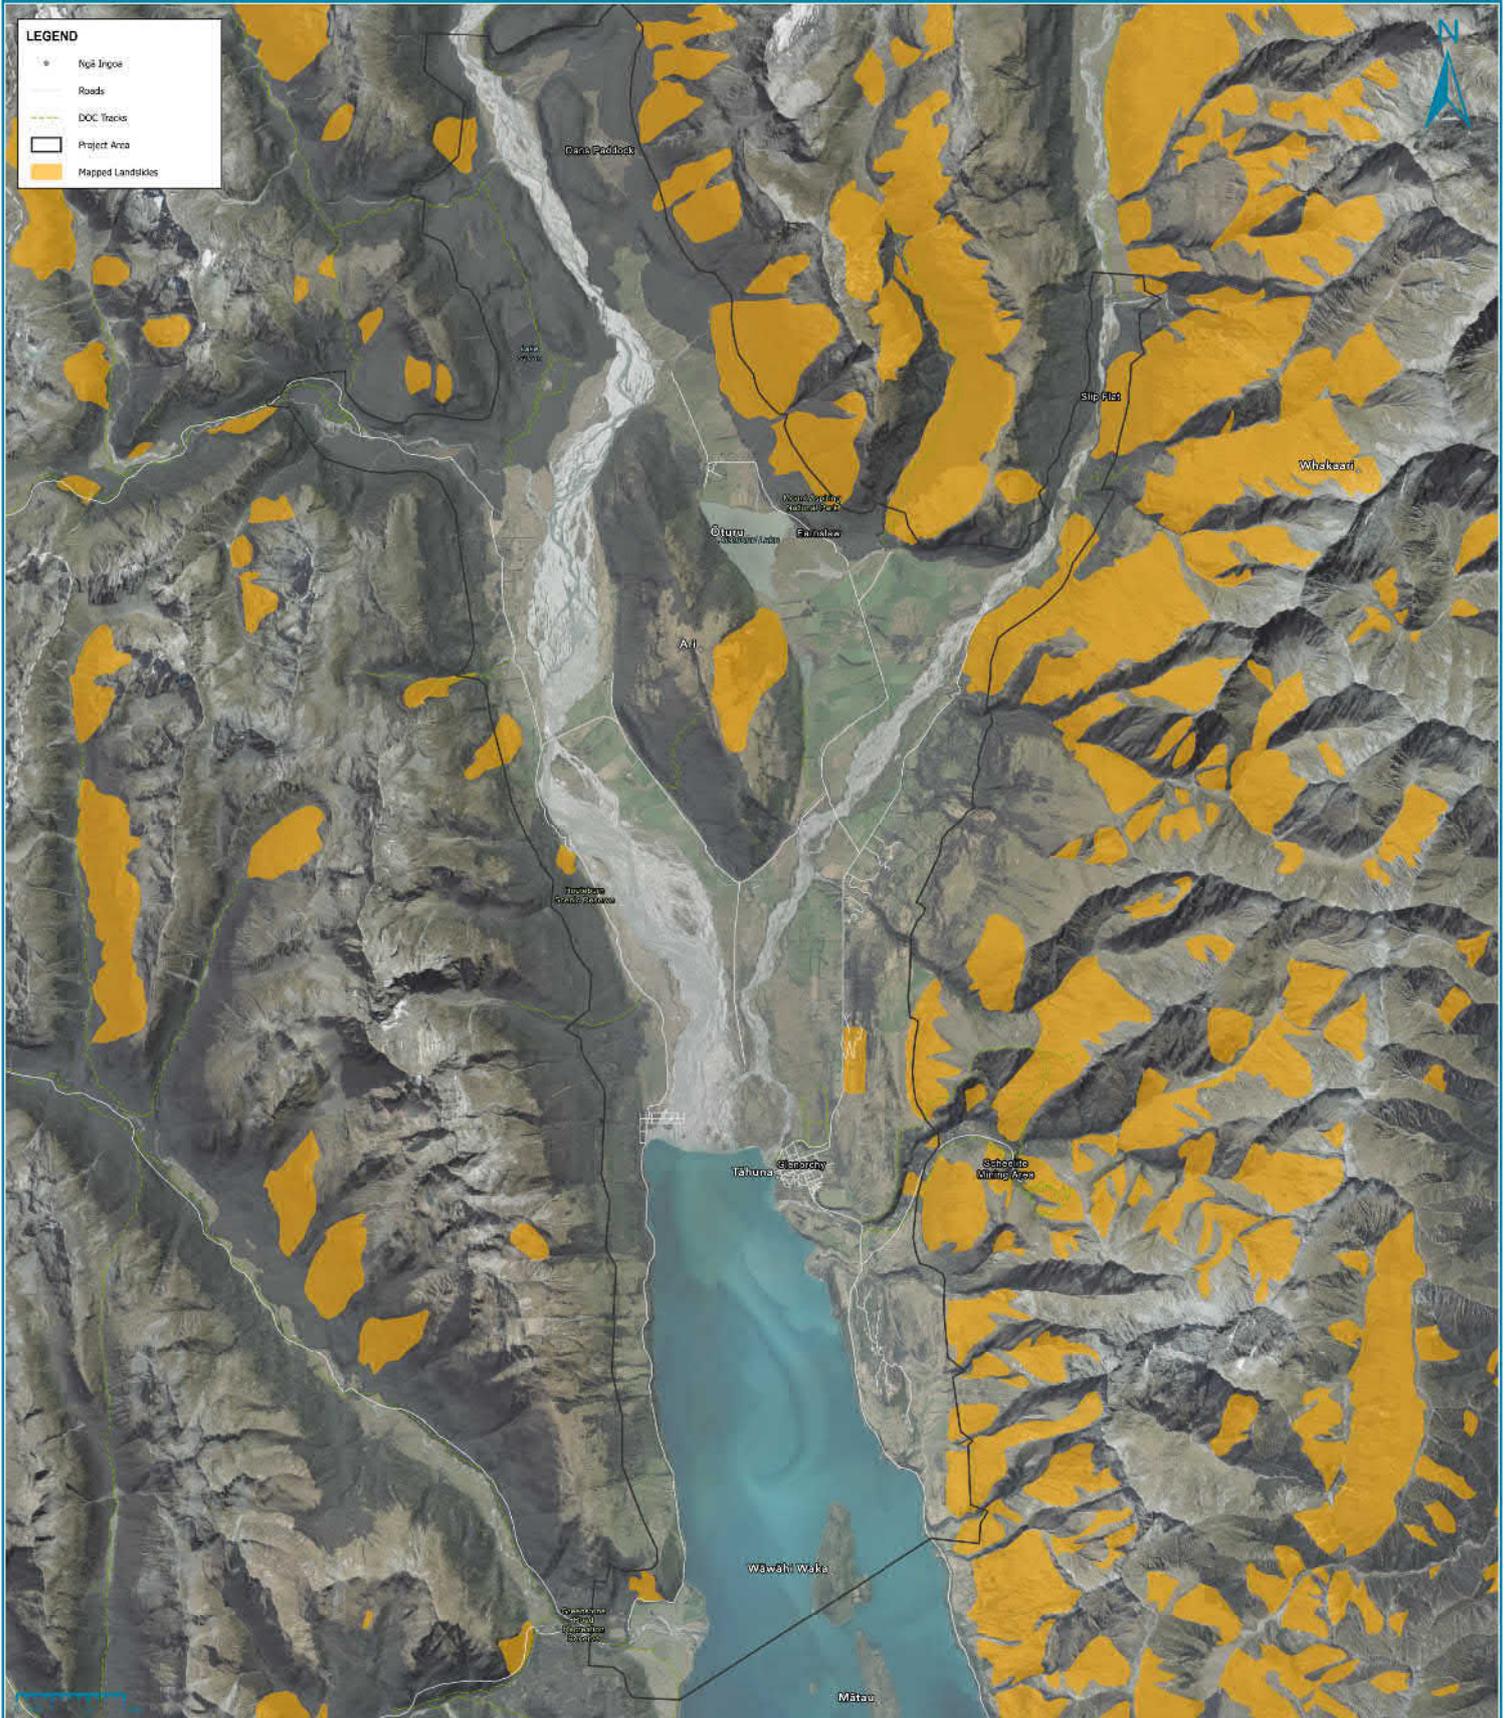
Mapped Landslides

Notes: This layer shows mapped landslides from GNS (Turnbell 2000, Barrell et al 2009) for ORC.

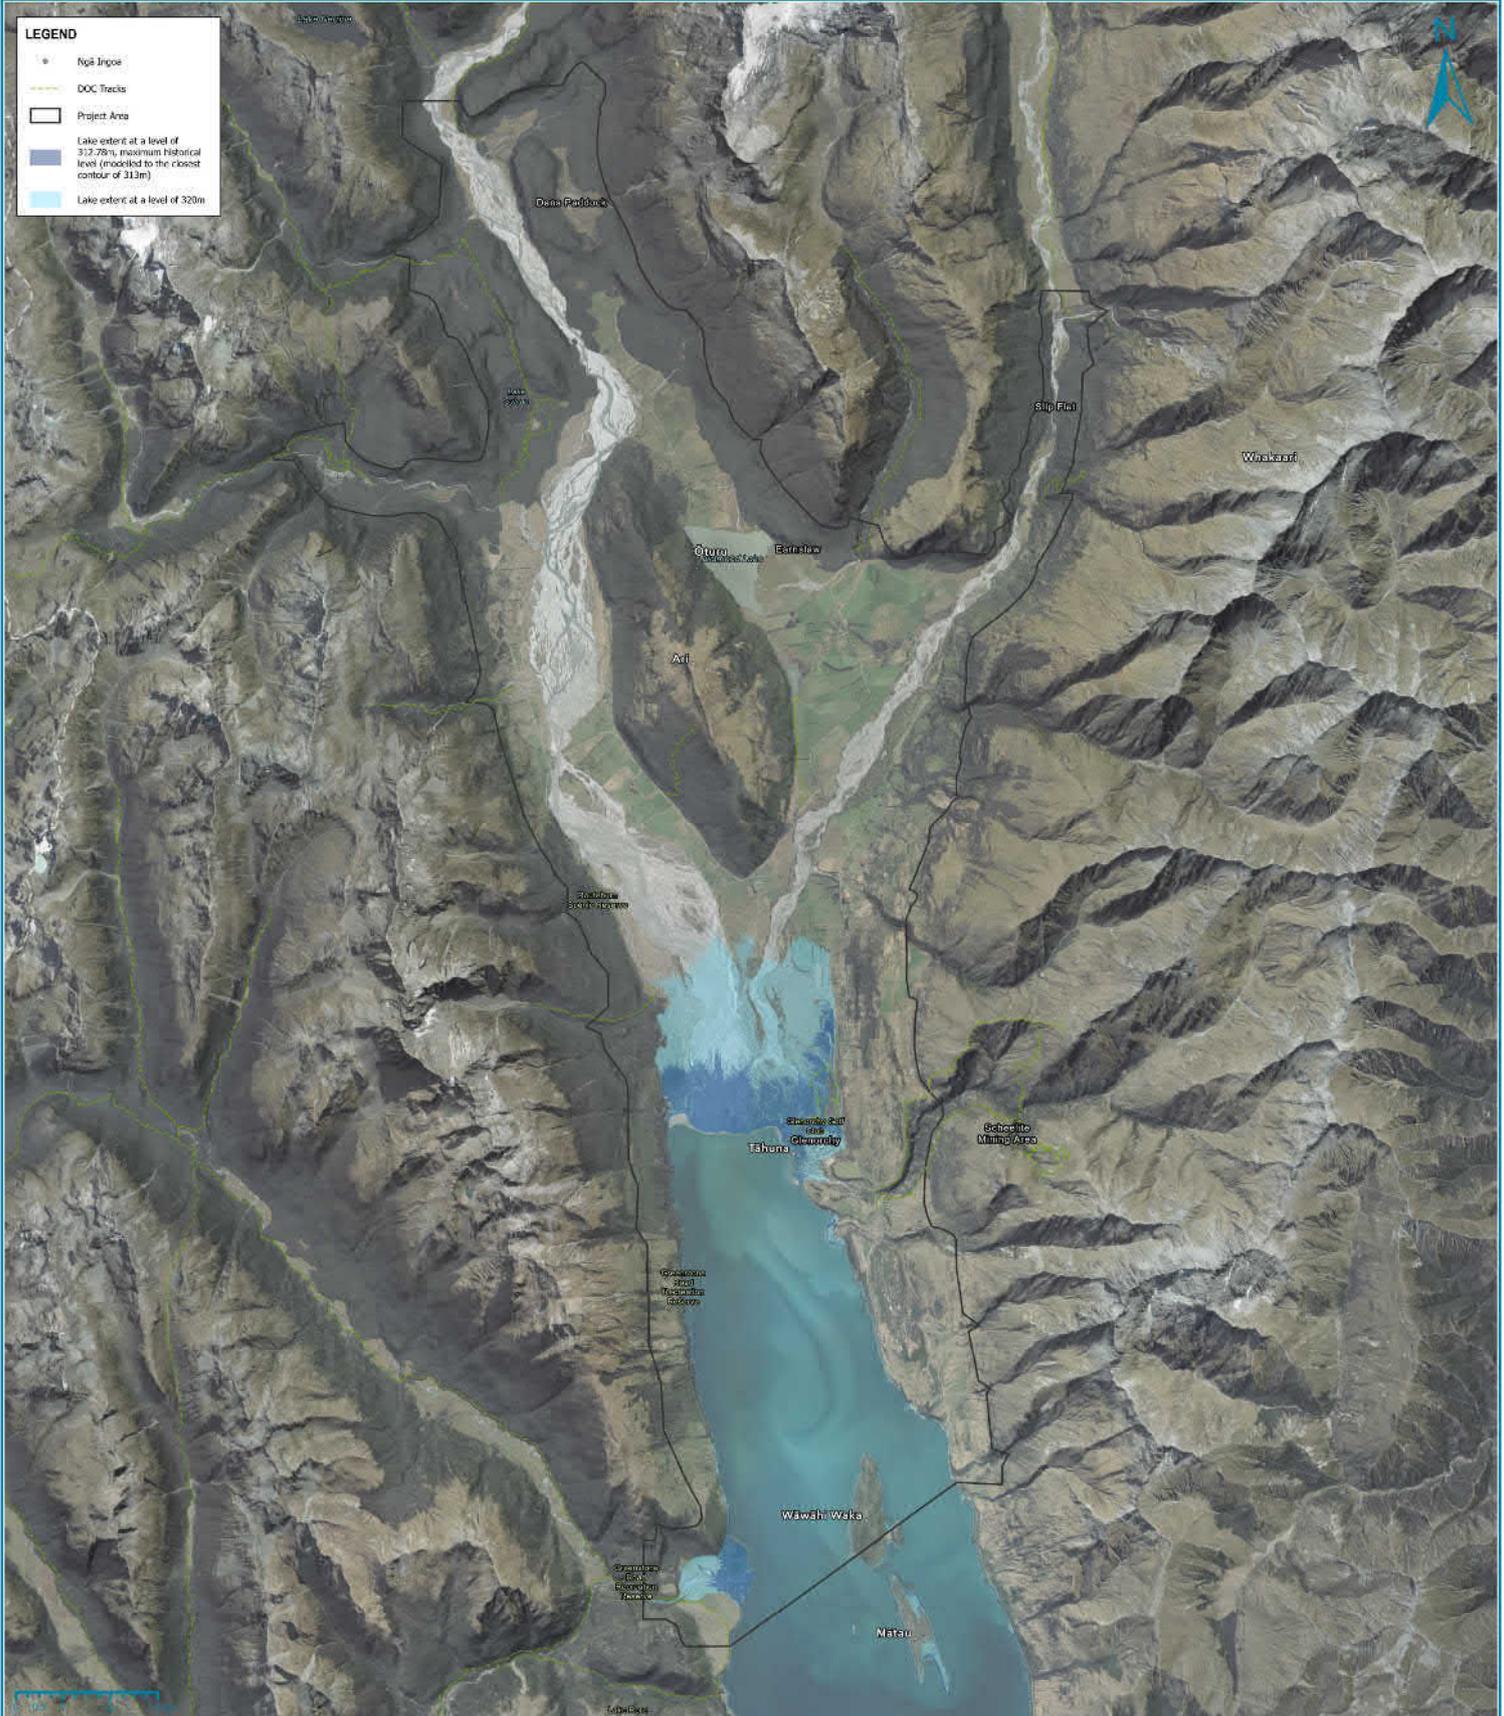
Notes: The map shows the flooded area from the historic maximum lake level. Should the Kawarau River become blocked by a landslide dam, extents show how more land could be flooded as the level rises further. The maximum case was informed by Thompson (1996) that states the inundation from a landslide blocking the Kawarau River could result in a rise in lake level of 30m (to 340m above sea level). Lesser potential lake level rises, are provided to allow comparison. These were developed using a bathtub approach using the provided DSM provided by ORC, 2019.

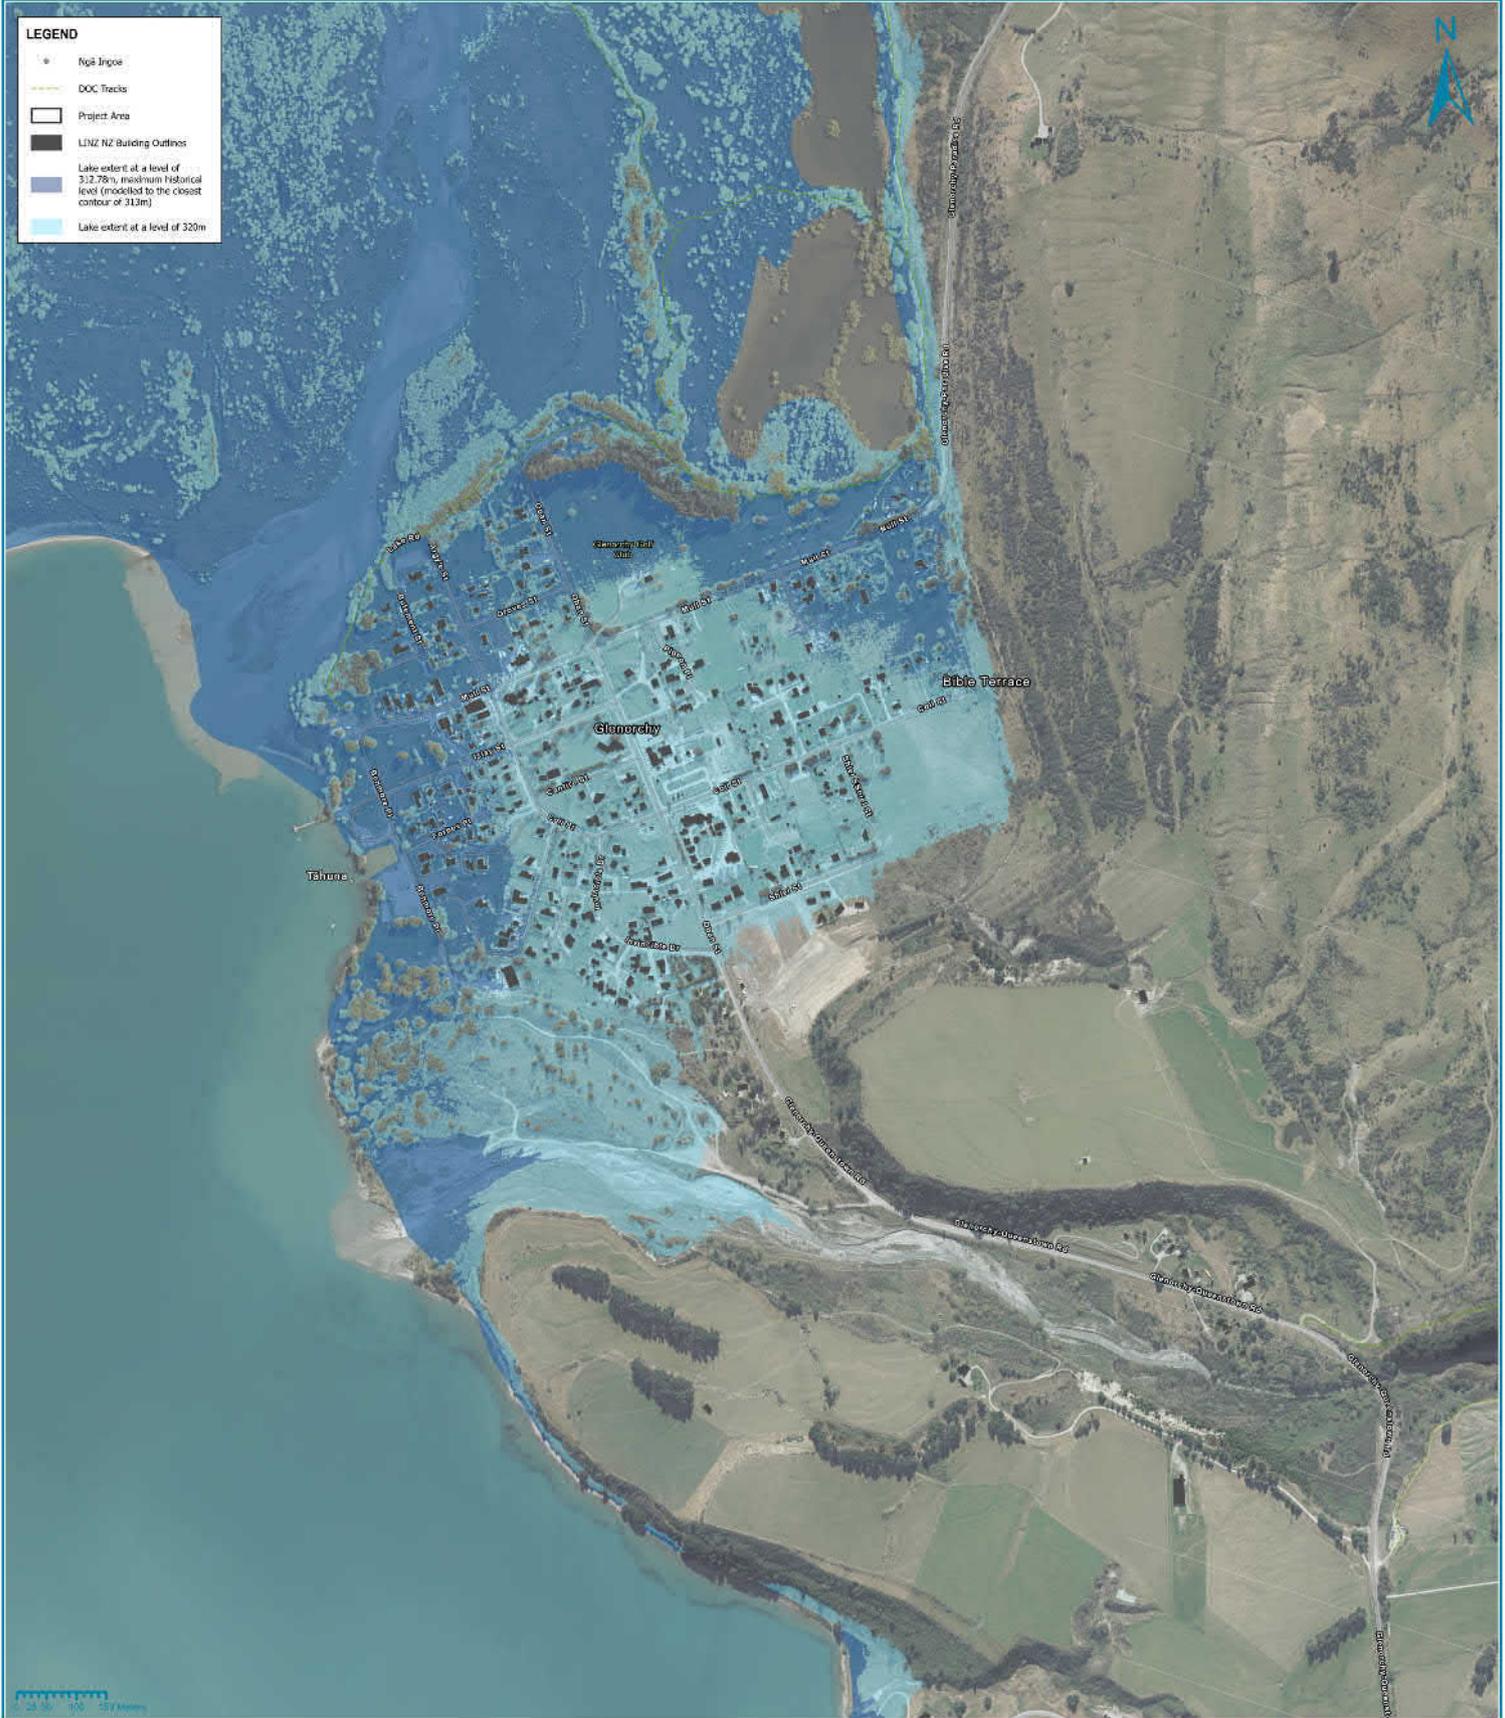
Inundation Due to Lake Level Rise

Notes: The map shows the flooded area from the historic maximum lake level. Should the Kawarau River become blocked by a landslide dam, extents show how more land could be flooded as the level rises further. The maximum case was informed by Thompson (1996) that states the inundation from a landslide blocking the Kawarau River could result in a rise in lake level of 30m (to 340m above sea level). Lesser potential lake level rises, are provided to allow comparison. These were developed using a bathtub approach using the provided DSM provided by ORC, 2019.

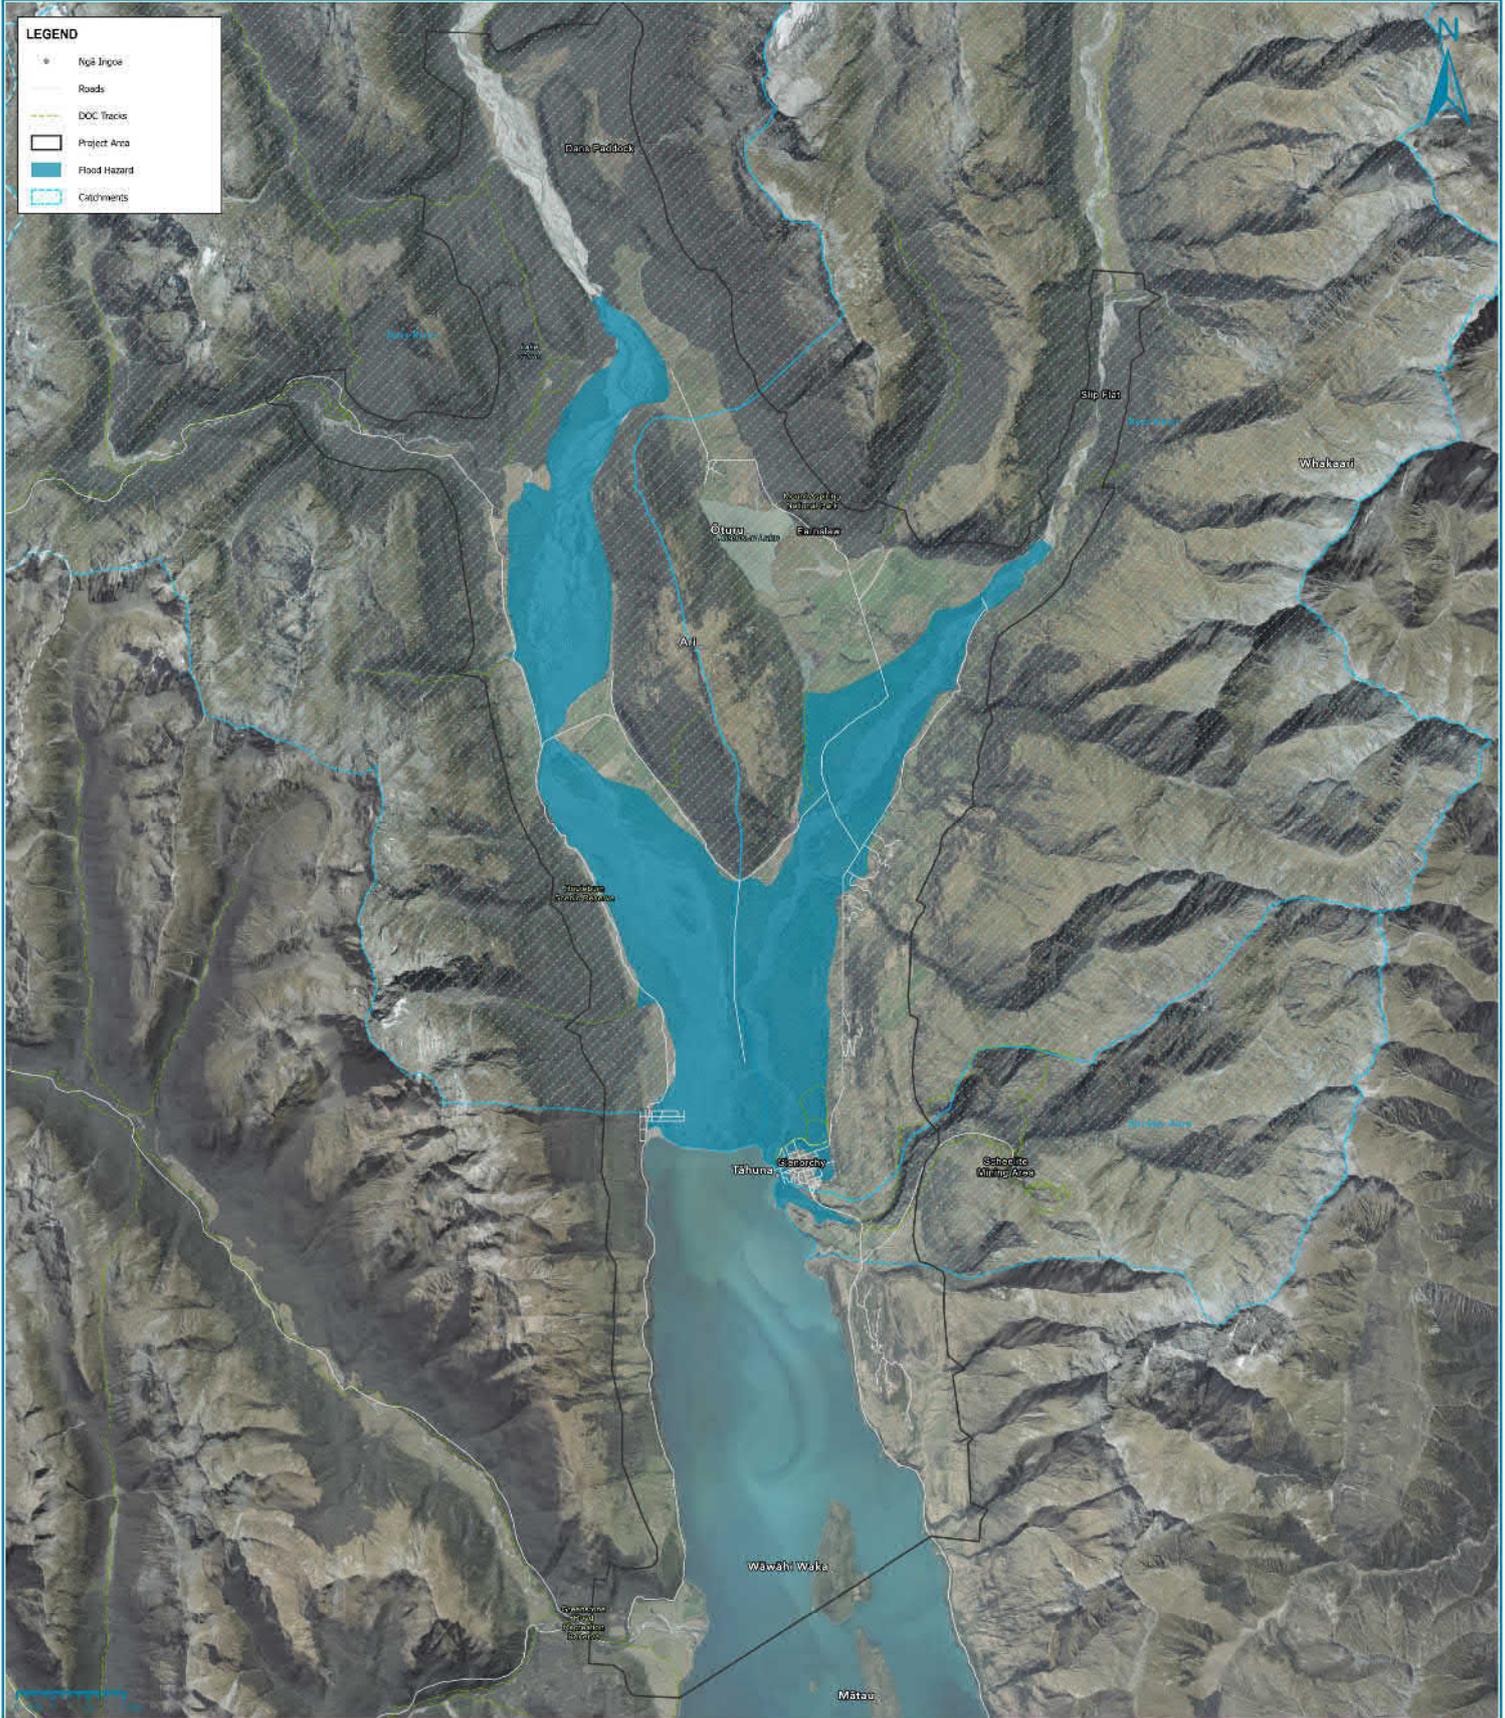
Flood Hazard

Notes: The mapped flood hazard area from the Otago Natural Hazard Database shows land which is at risk of inundation due to flood events in rivers and lakes. It does not include flooding due to overloading of the urban stormwater network. In addition, flood extents are only shown for areas where this hazard has been documented and investigated – the flood hazard area does not cover sections of some rivers and lakes where we don't not hold sufficient information to accurately assess flood hazard.

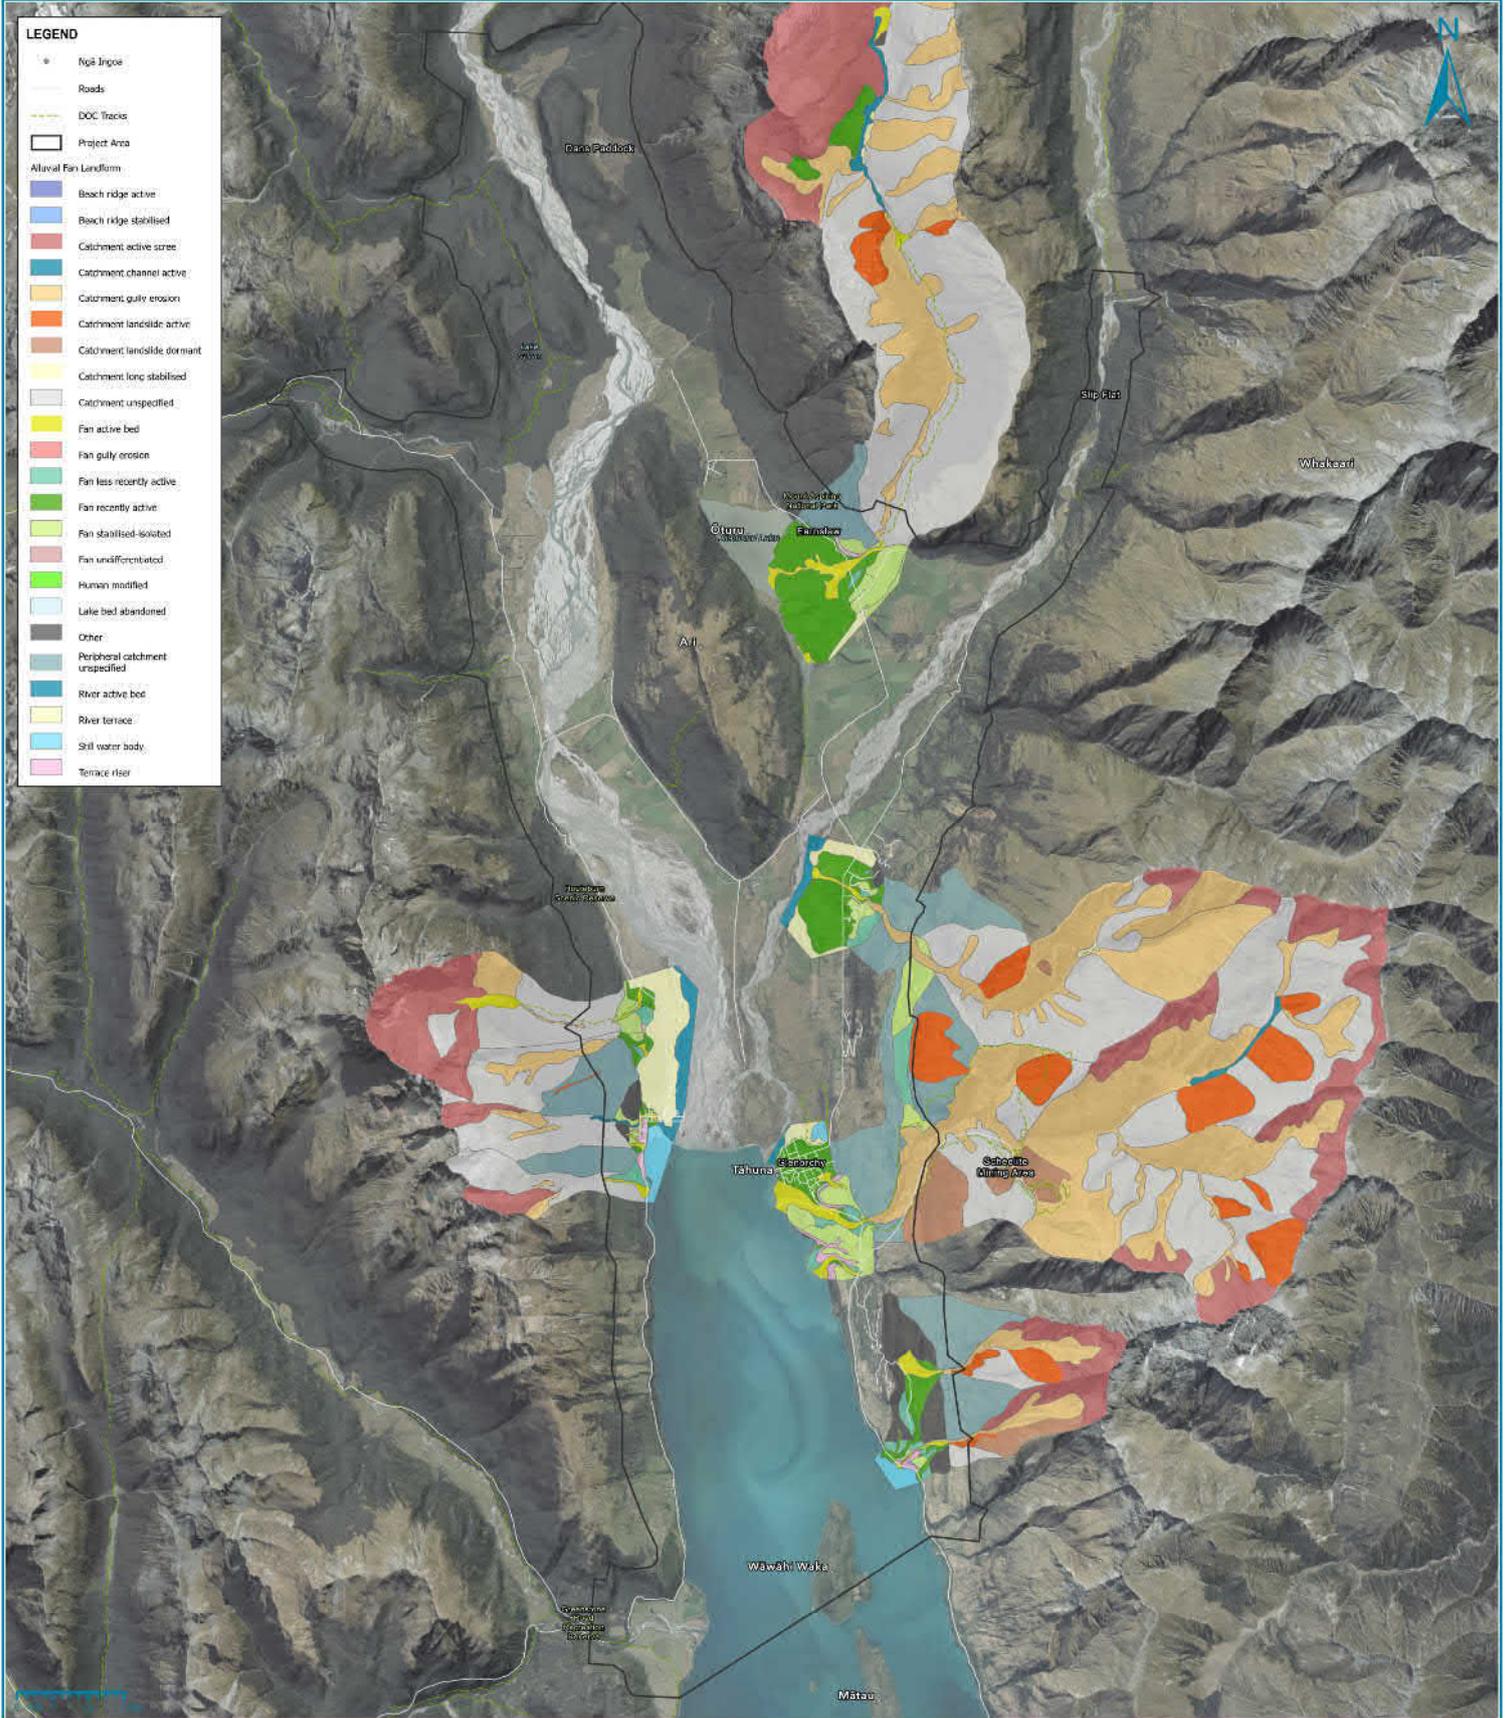
Alluvial Fan - Landform

Notes: This layer displays alluvial fan landform channels mapped at selected locations throughout Otago, as mapped by GNS for ORC in 2009 as part of the ORC Alluvial Fans Project. The main hazards affecting alluvial fans include inundation by floodwater, debris flow and debris flood deposits, channel migration, deposition, and erosion. The considerable buildup of sedimentation may result from alluvial fan floods. However, debris and flood flows are only intermittent and usually occur over decades or centuries.

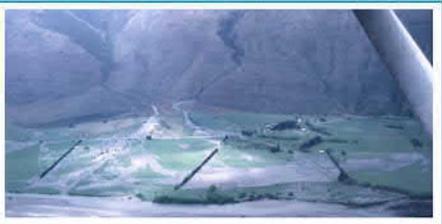
Alluvial Fan Activity

Notes: In this layer, alluvial fans are mapped at regional scale (1:50 000 - 1:250 000) throughout the area by Opus as part of the ORC Alluvial Fans Project (as reported by Opus, July 2007; March 2009). The main hazards affecting alluvial fans include inundation by floodwater, debris flow and debris flood deposits, channel migration, deposition, and erosion. The considerable buildup of sedimentation may result from alluvial fan floods. However, debris and flood flows are only intermittent and usually occur over decades or centuries.

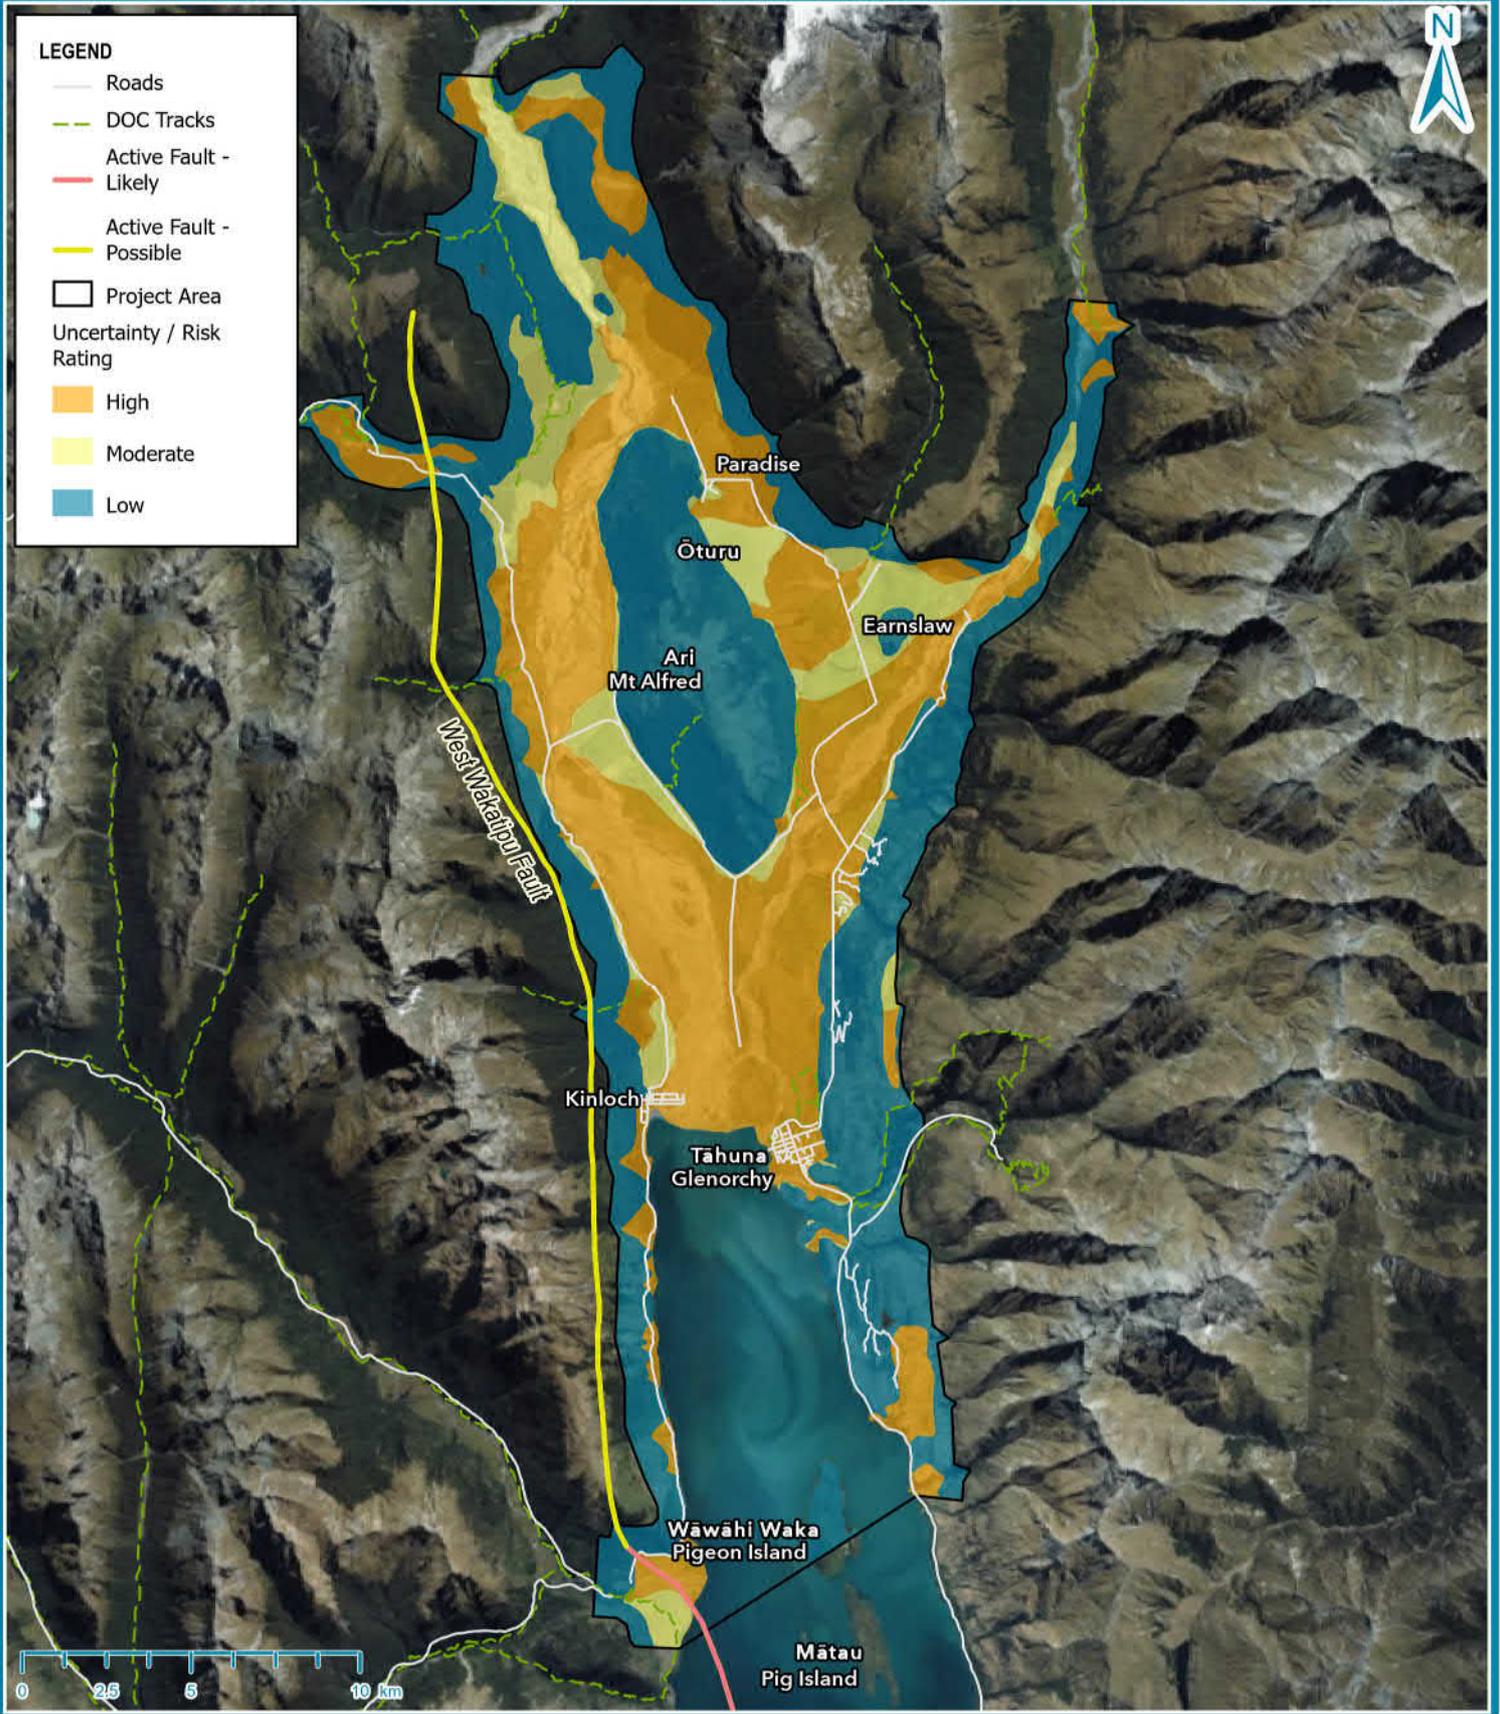
Natural Hazard Uncertainty And Risk Rating

High uncertainty / risk includes areas within: Floodplain, active alluvial fans, 312m lake level rise and avulsion of the Rees River.

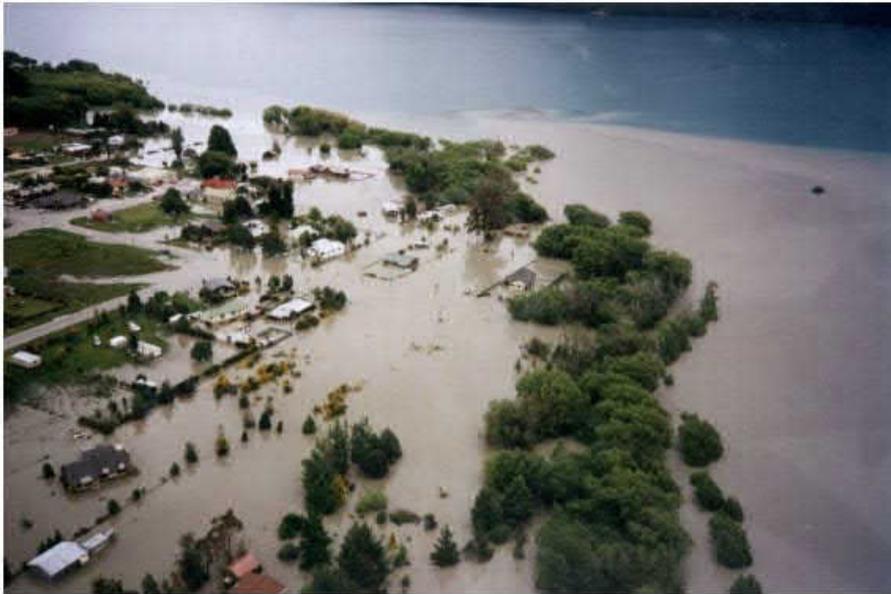
Photo 1 Flooding in Glenorchy, November 1999 (ORC)

We know what flooding looks like in Glenorchy from documented flood events in 1999 and 2020 (refer Photos 1 and 2).

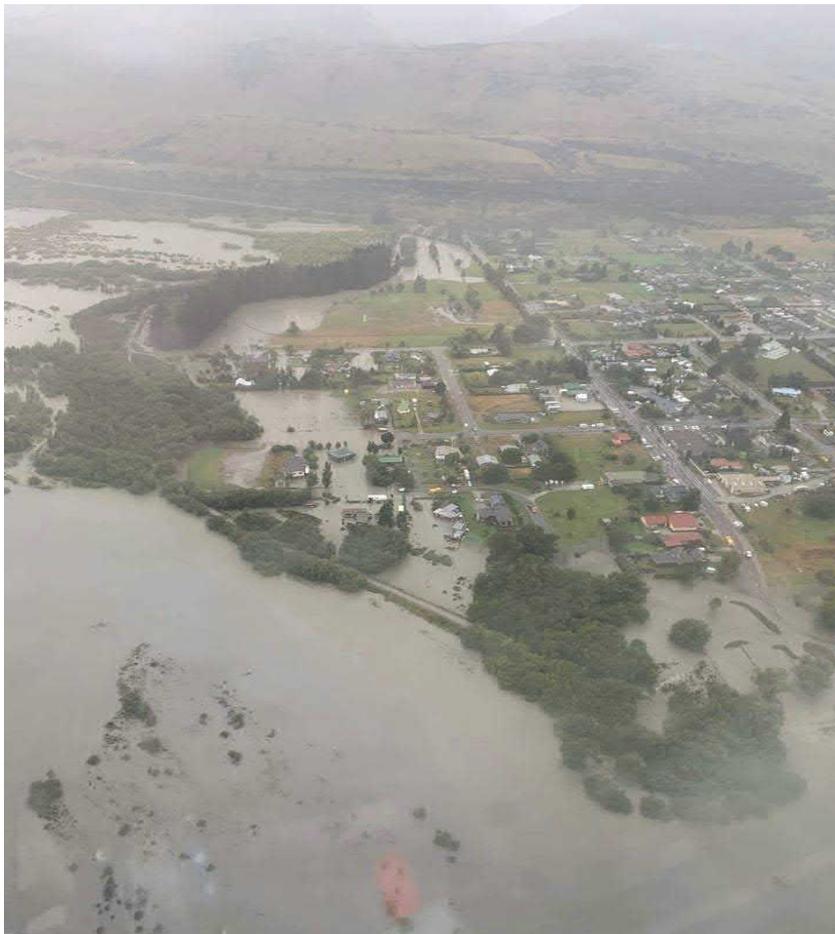
Photo 2 Flooding in Glenorchy, February 2020 (ORC)

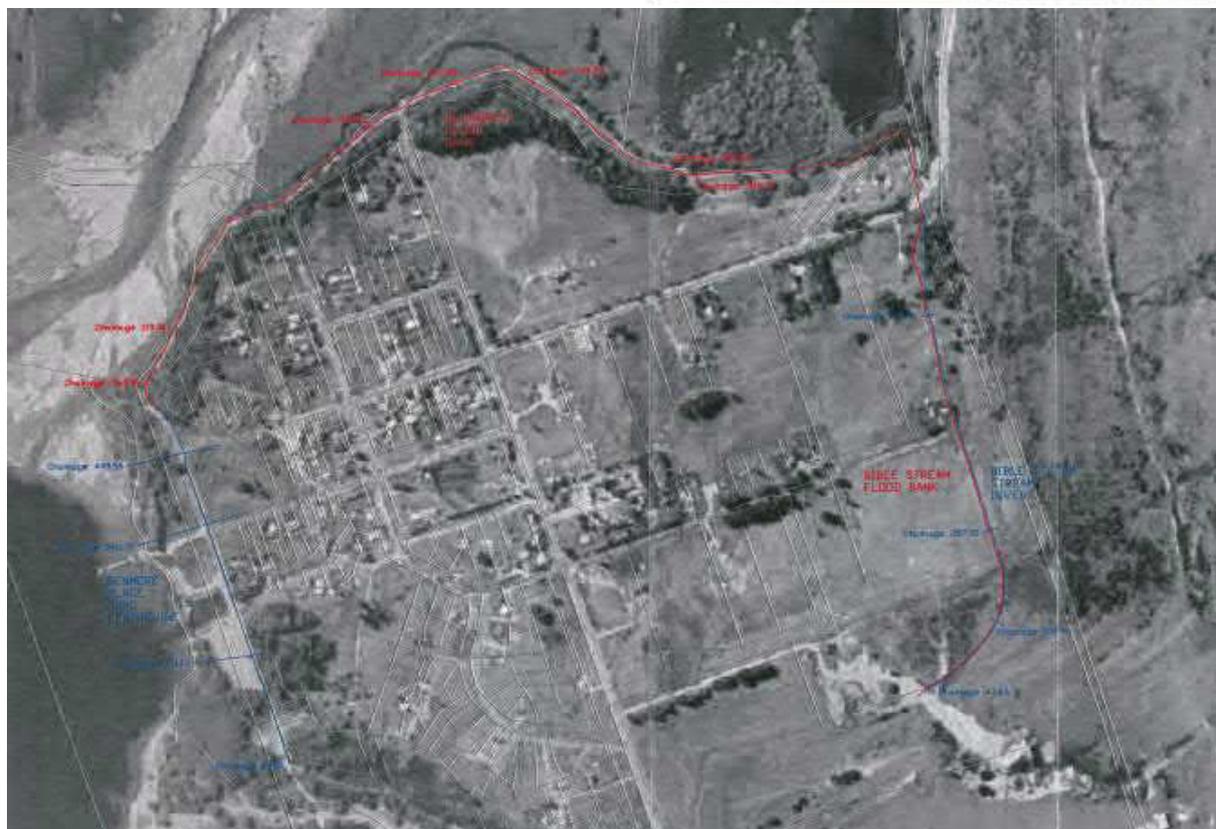
Figure Appendix F.2: Glenorchy flood protection structures, i.e., stop banks (ORC)

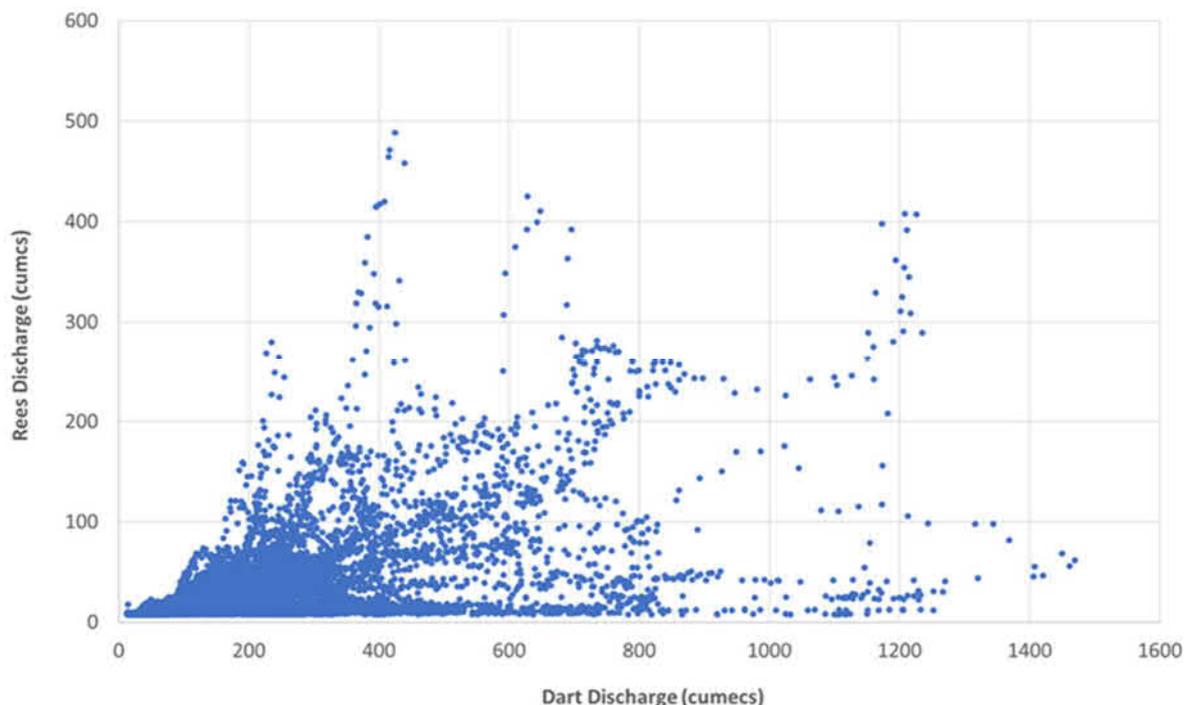
Figure Appendix F.3: Scatterplot showing the correlation between the discharge (river flow) of Dart and Rees Rivers between September 2009-March 2011 (Brasington 2020c)
