# Supporting Natural Hazards Information Dart and Rees floodplains

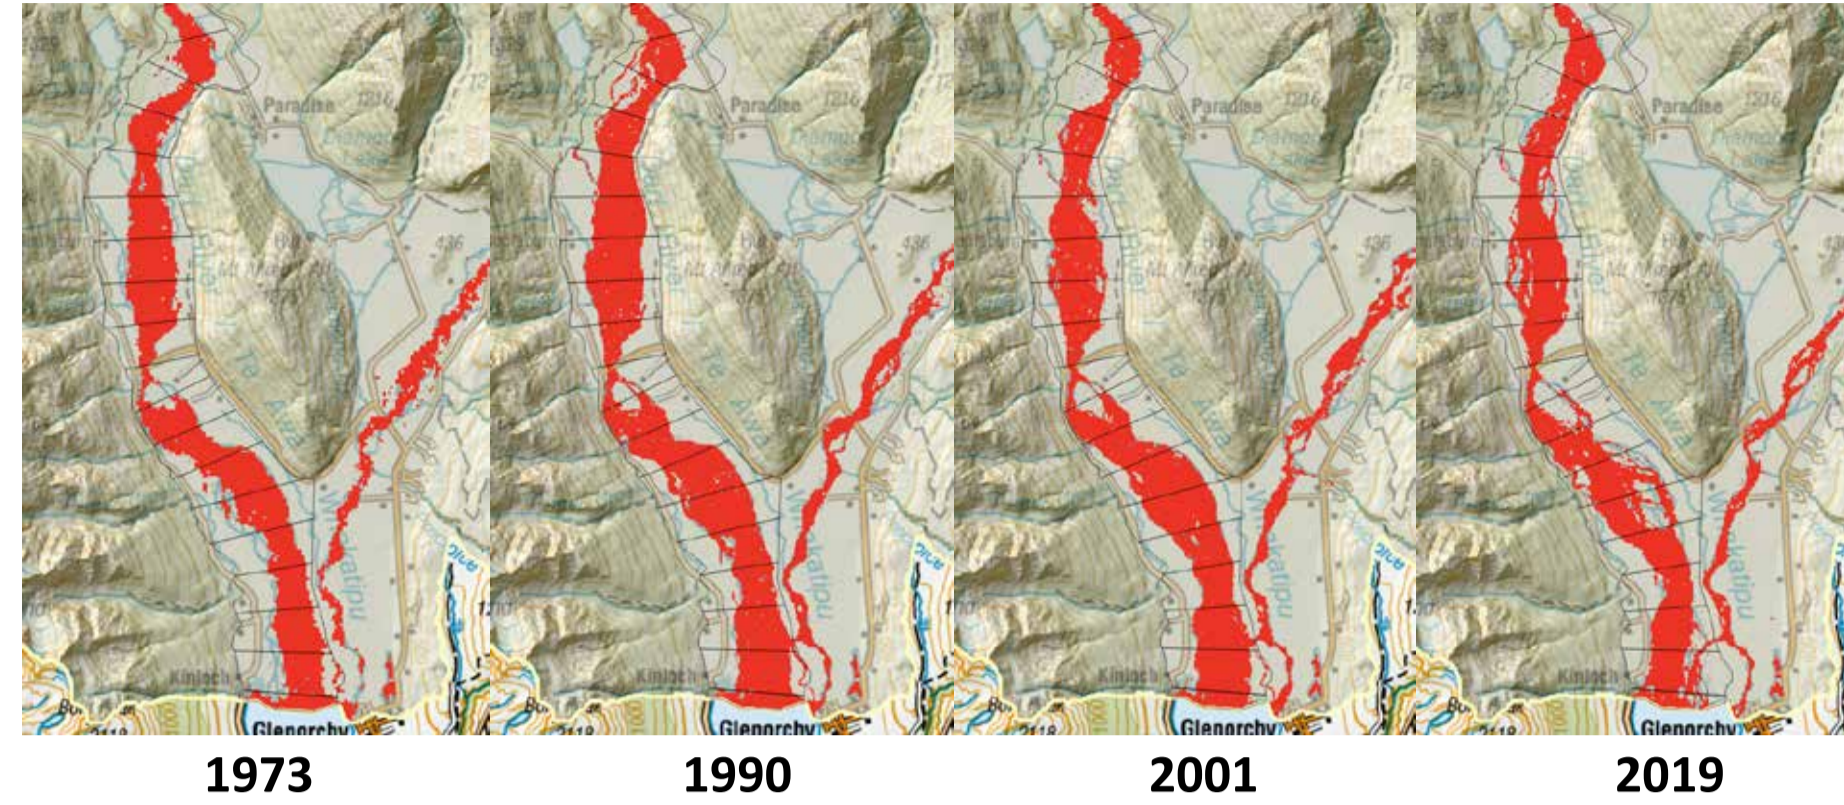
Analysis of the active river channels over about the last 50 years,

- Westwards migration of the lower section of the Dart River
- Widening of the Dart River channel width from 1970s to 1990, and narrowing from 2000s to 2019.

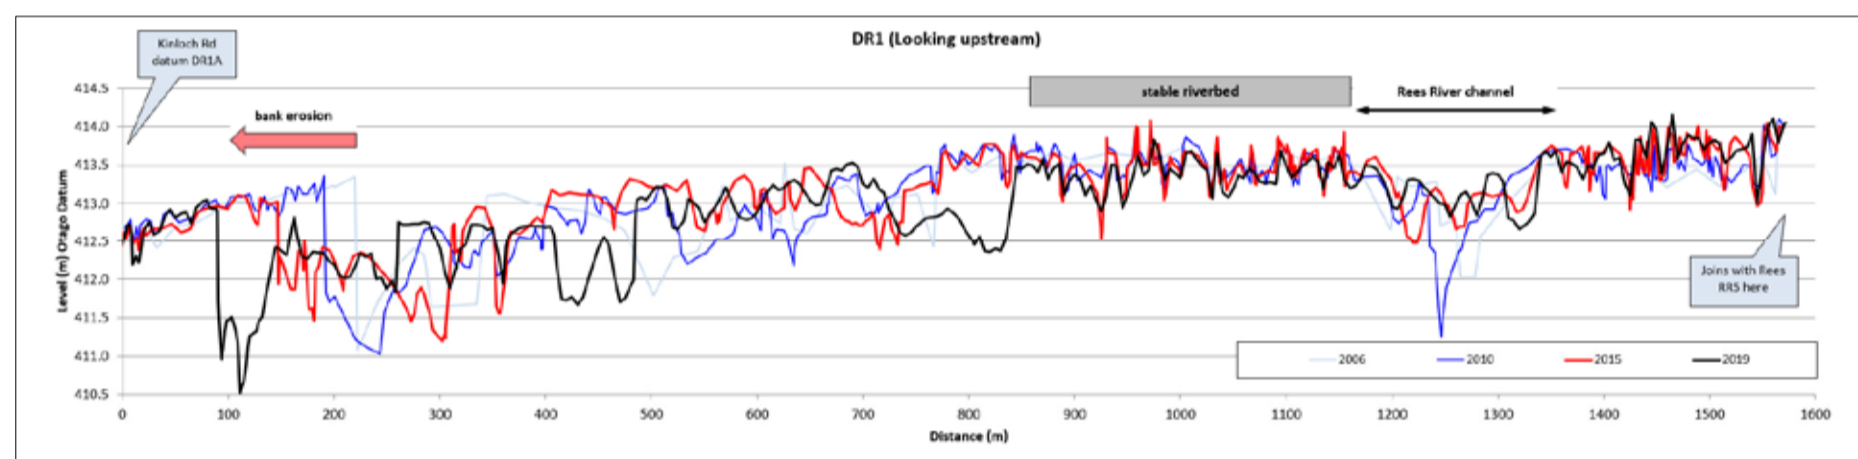
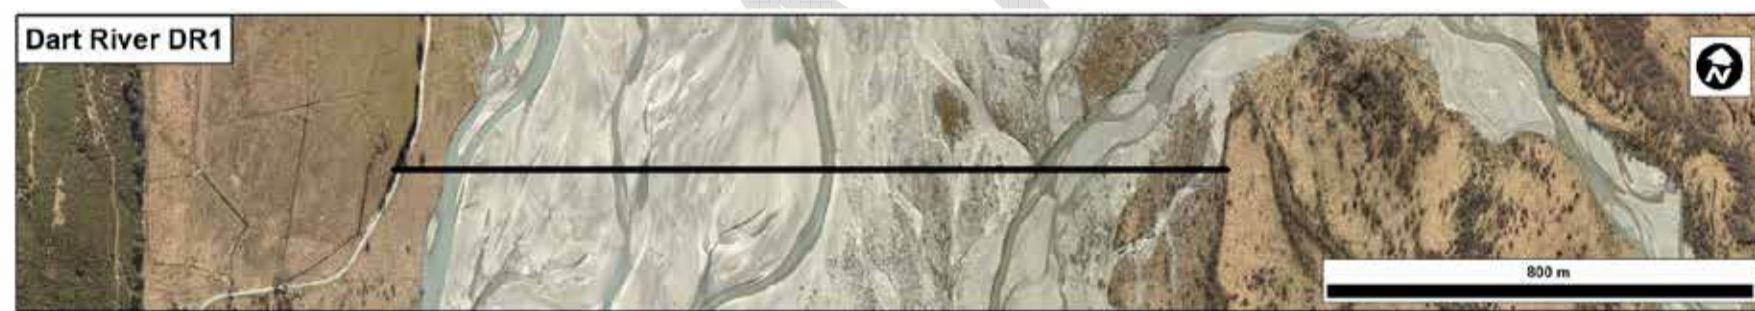
Dart River cross section DR1, surveys from 2006-2019. Showing westwards channel migration, and also a lowering of the western river bank height.

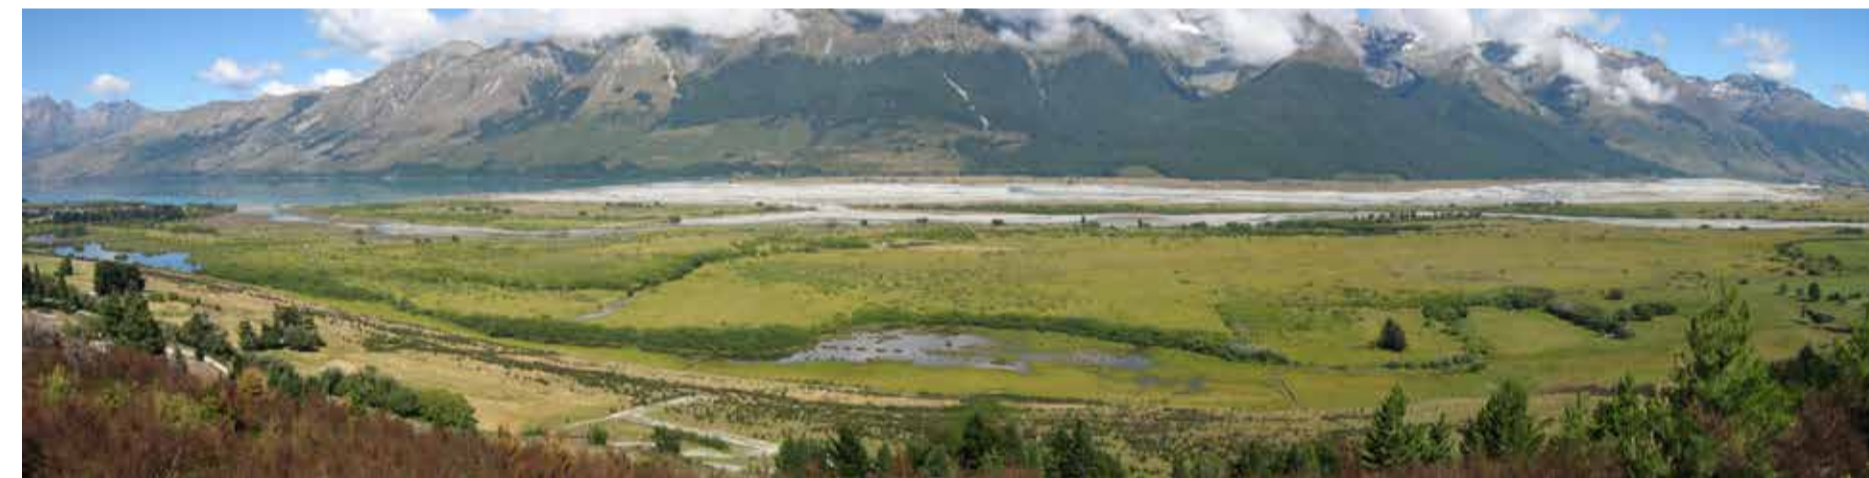
Overview of the Dart-Rees floodplain area – viewed looking westwards towards Kinloch and Humboldt Mountains.

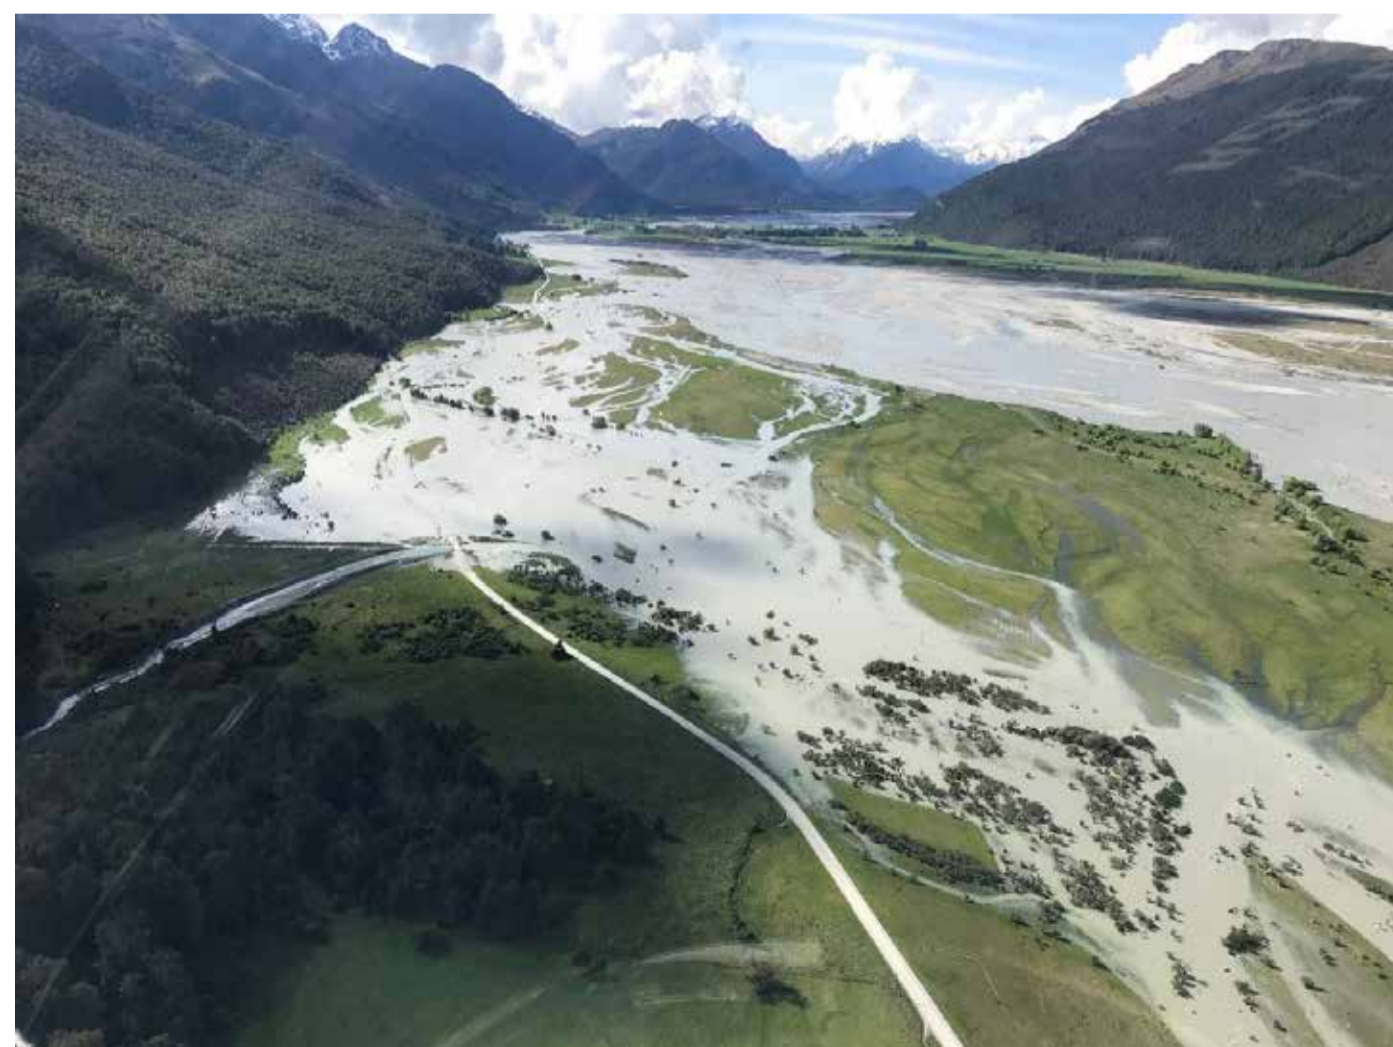
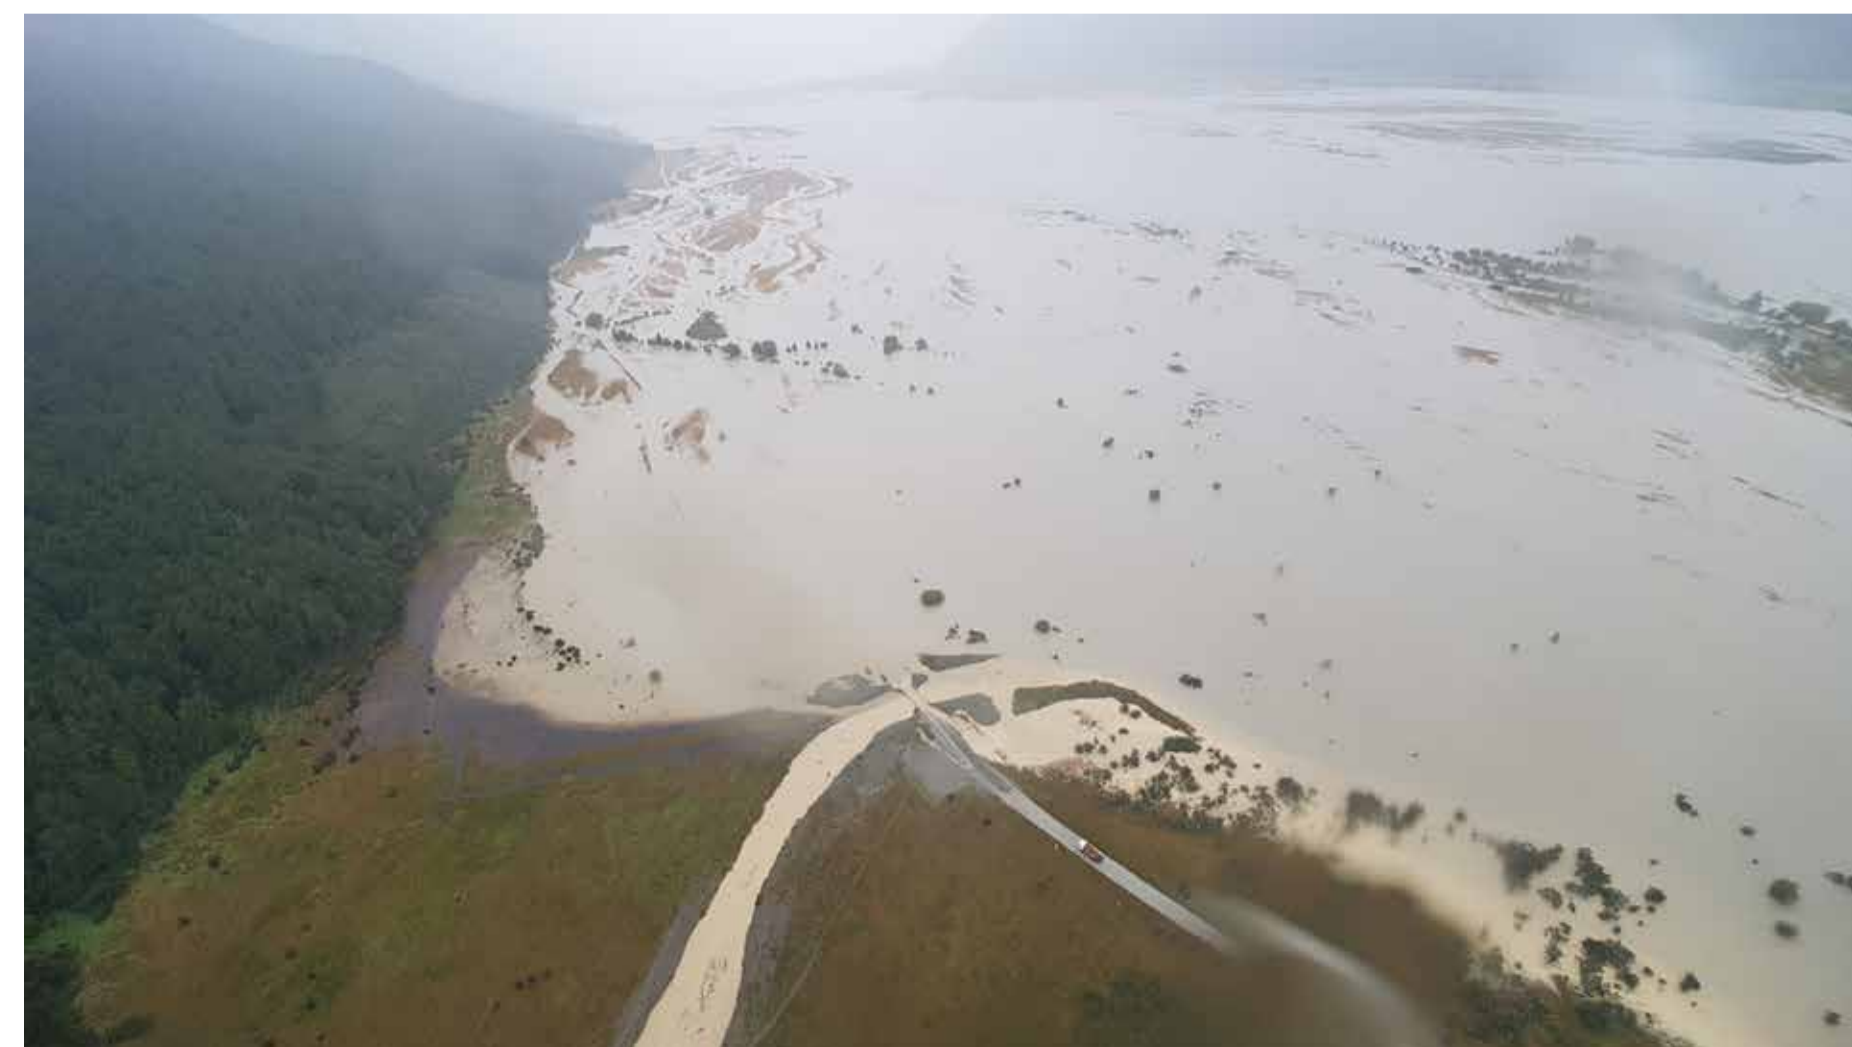
Examples of Dart River flooding in moderate (November 2019) and large (March 2019) flood events. [LH photo above credit to Geoffrey Thompson]

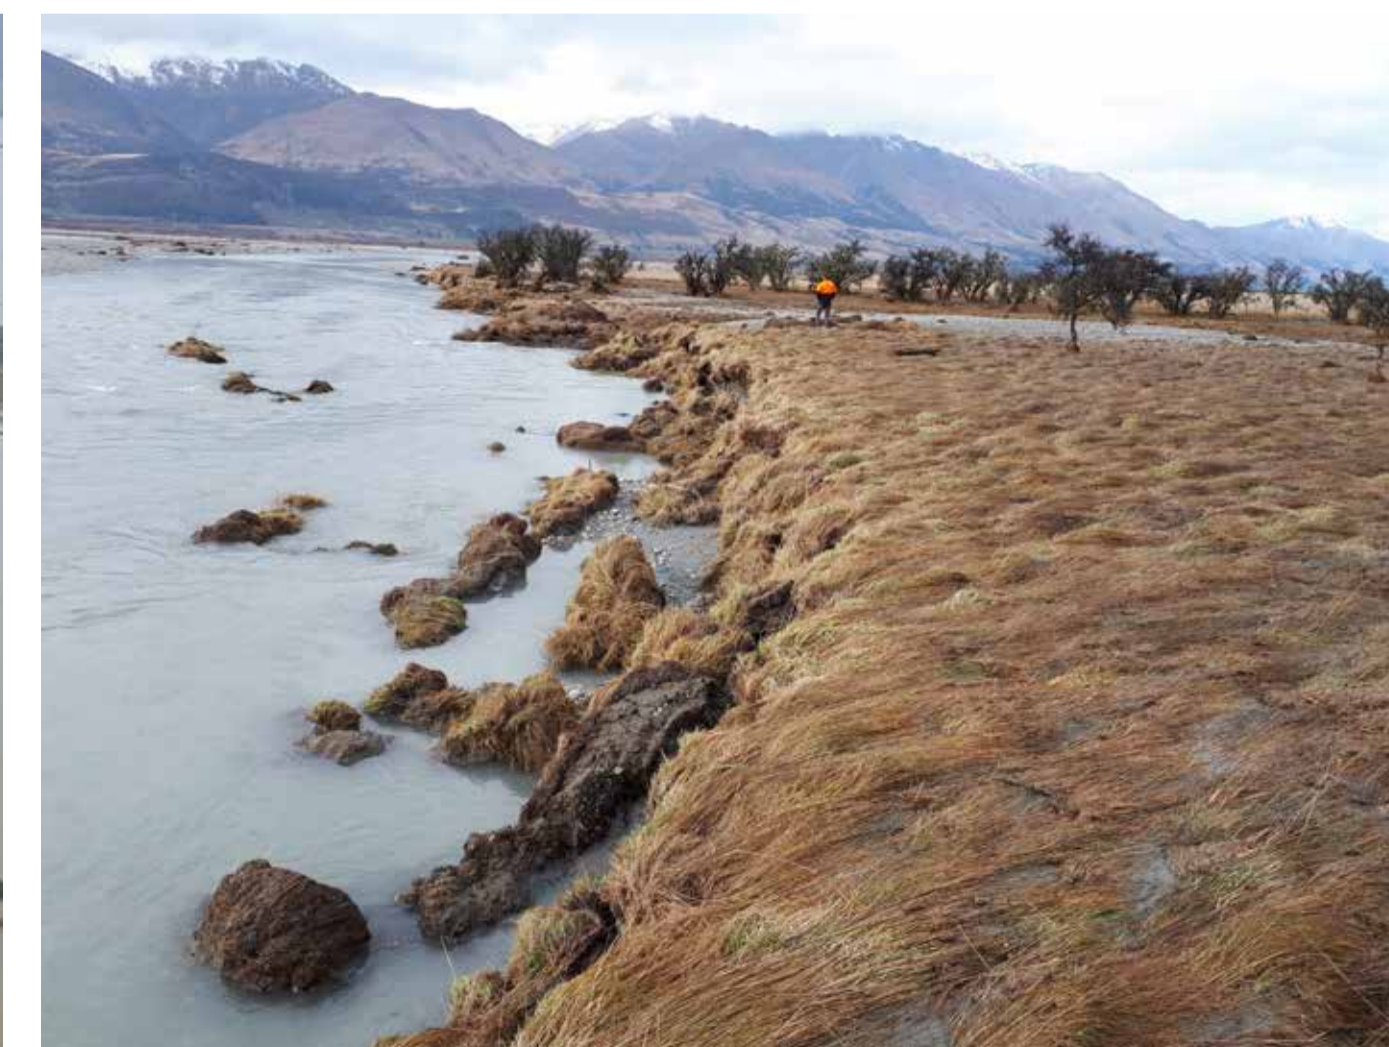
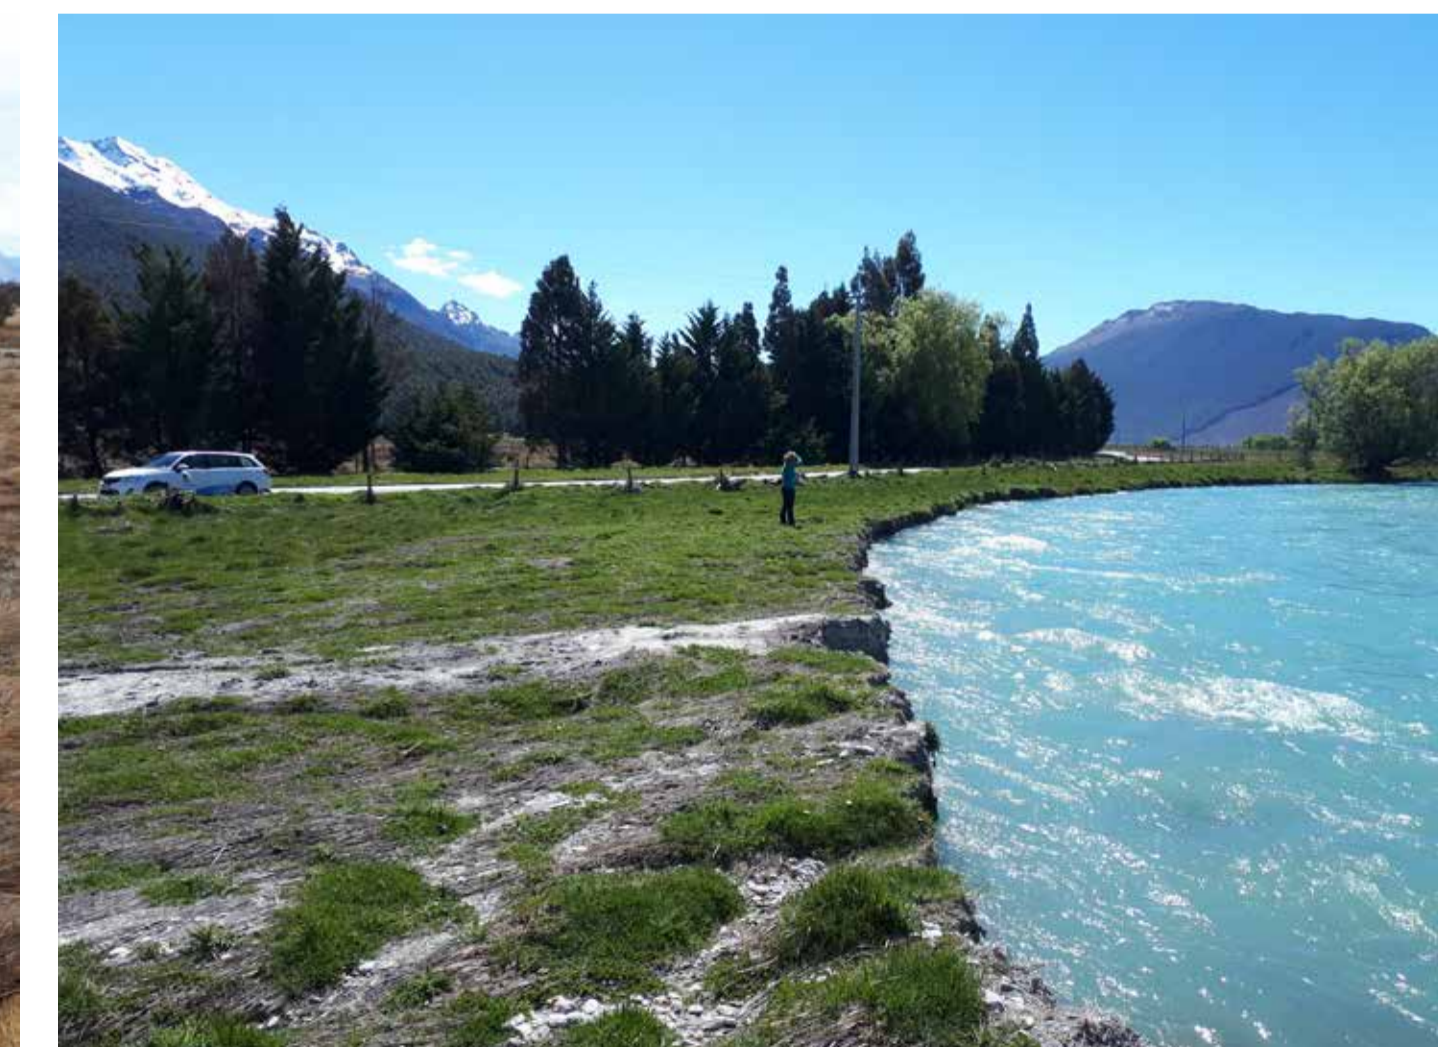
Examples of Dart floodplain erosion
