# Supporting Natural Hazards Information Rees River and Glenorchy

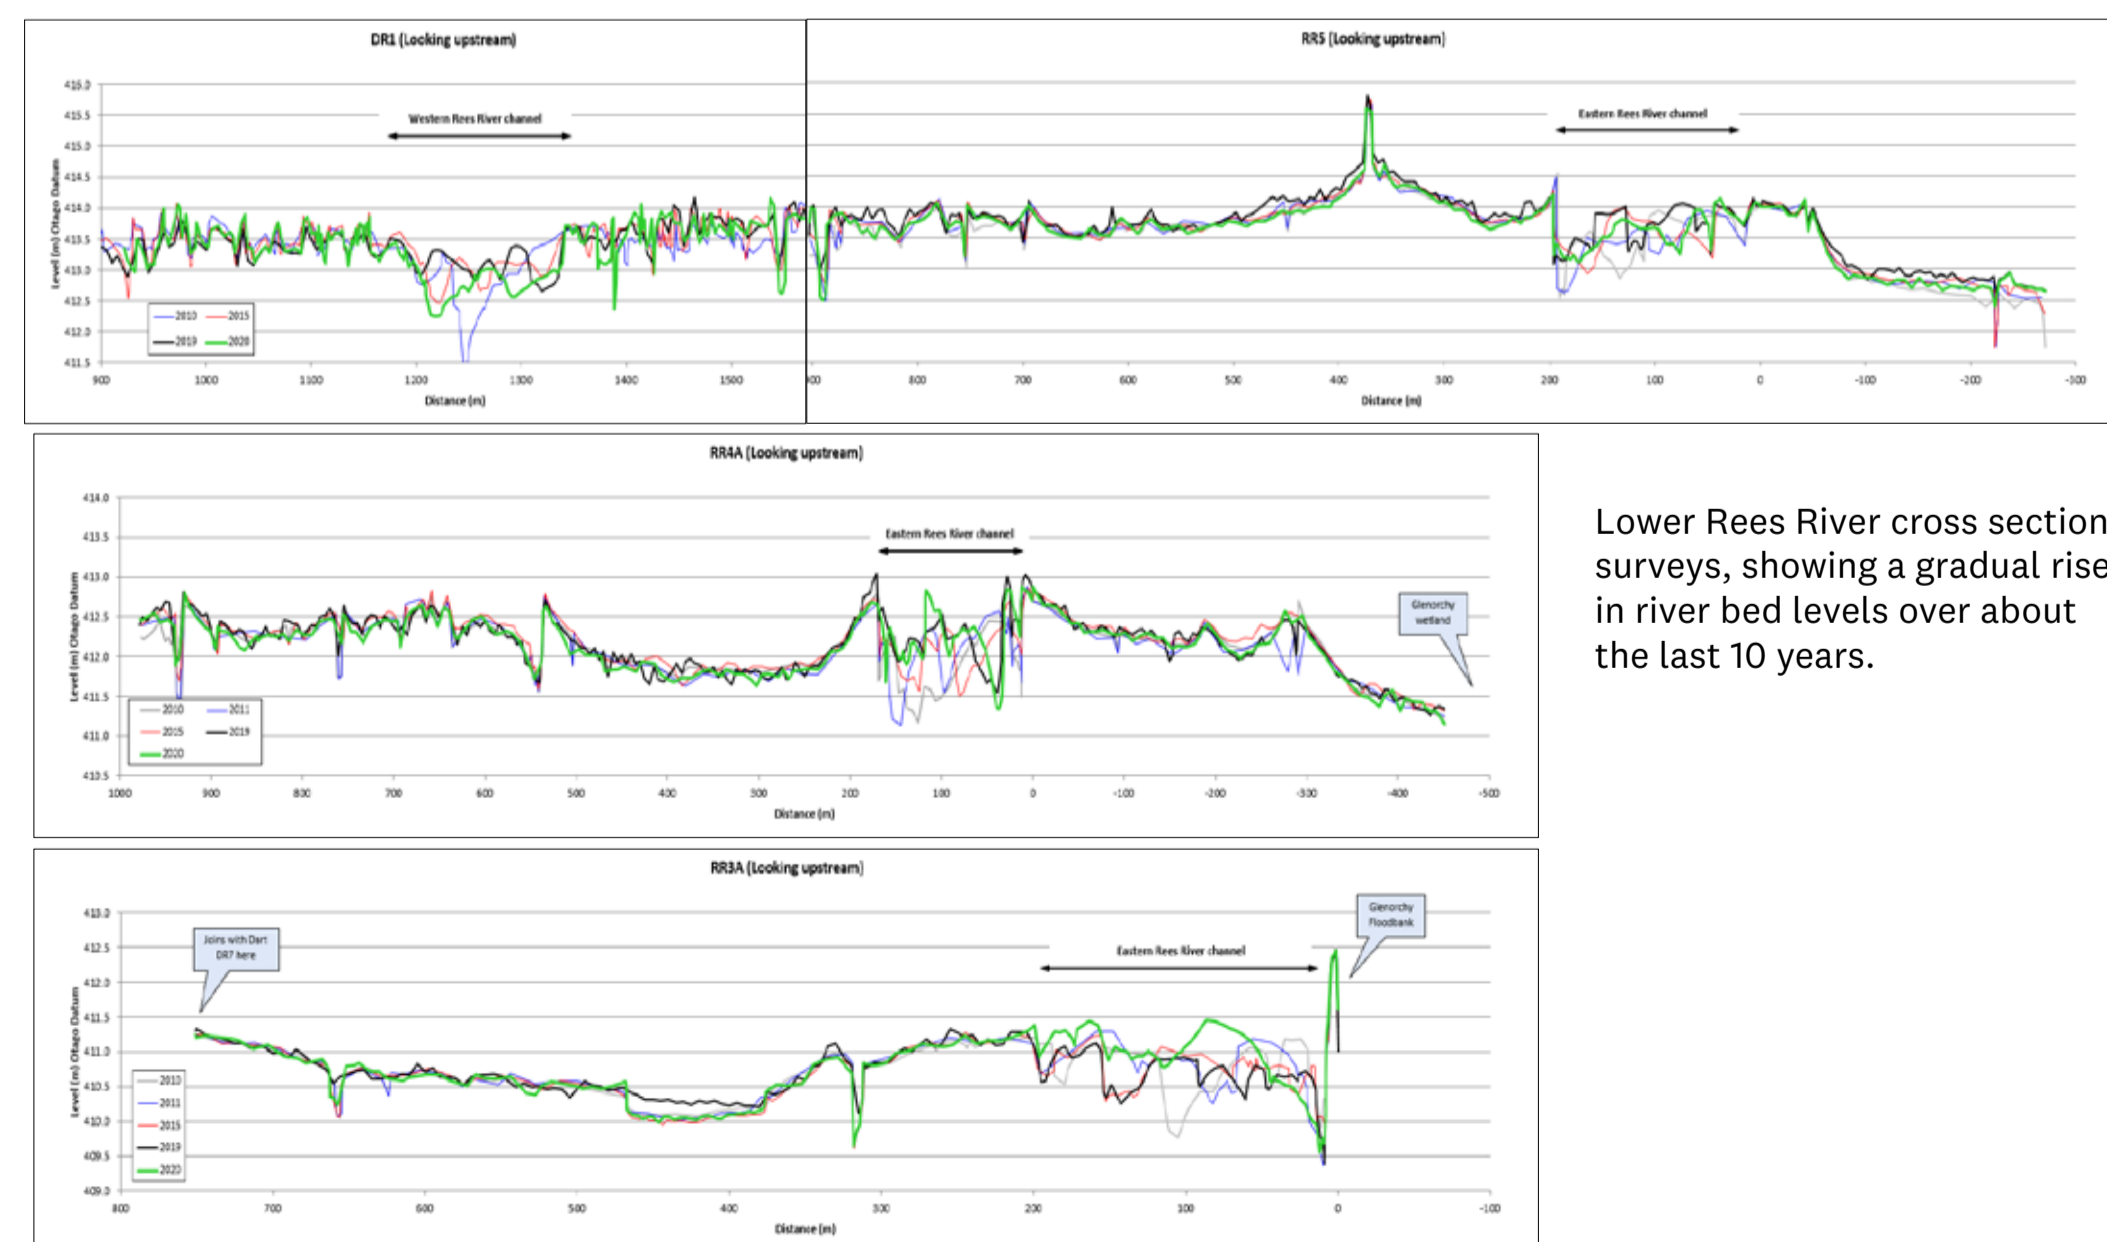
Lower Rees River cross section surveys, showing a gradual rise in river bed levels over about the last 10 years.

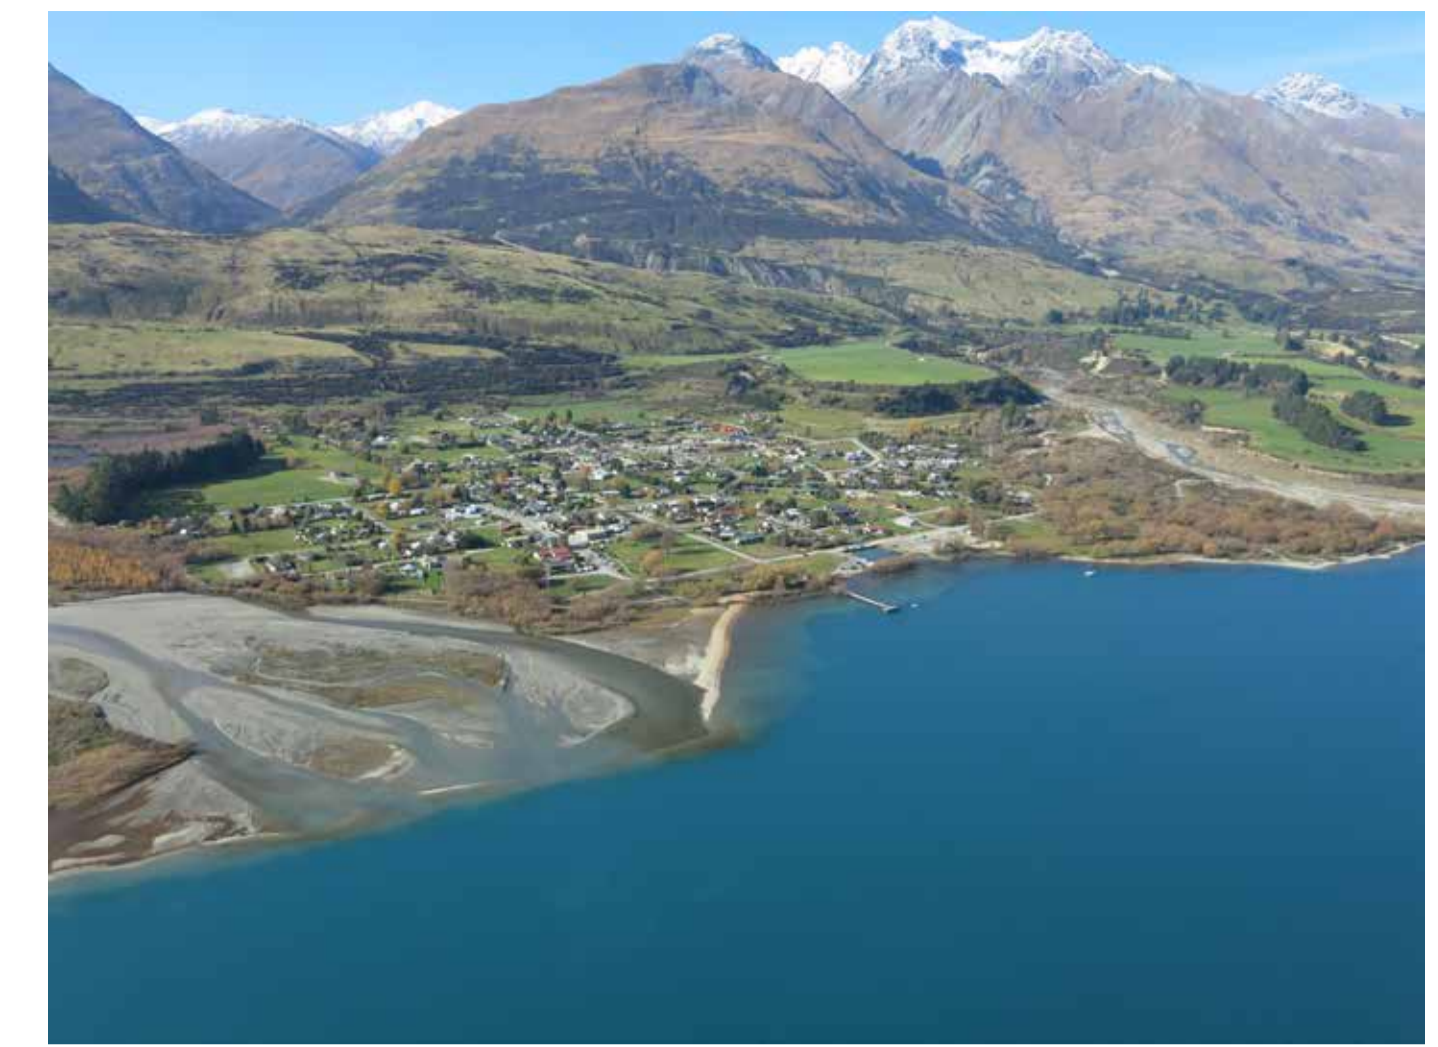
Overview of the Glenorchy area, showing the township located between the Rees River and Delta to the north, and Buckler Burn to the south.

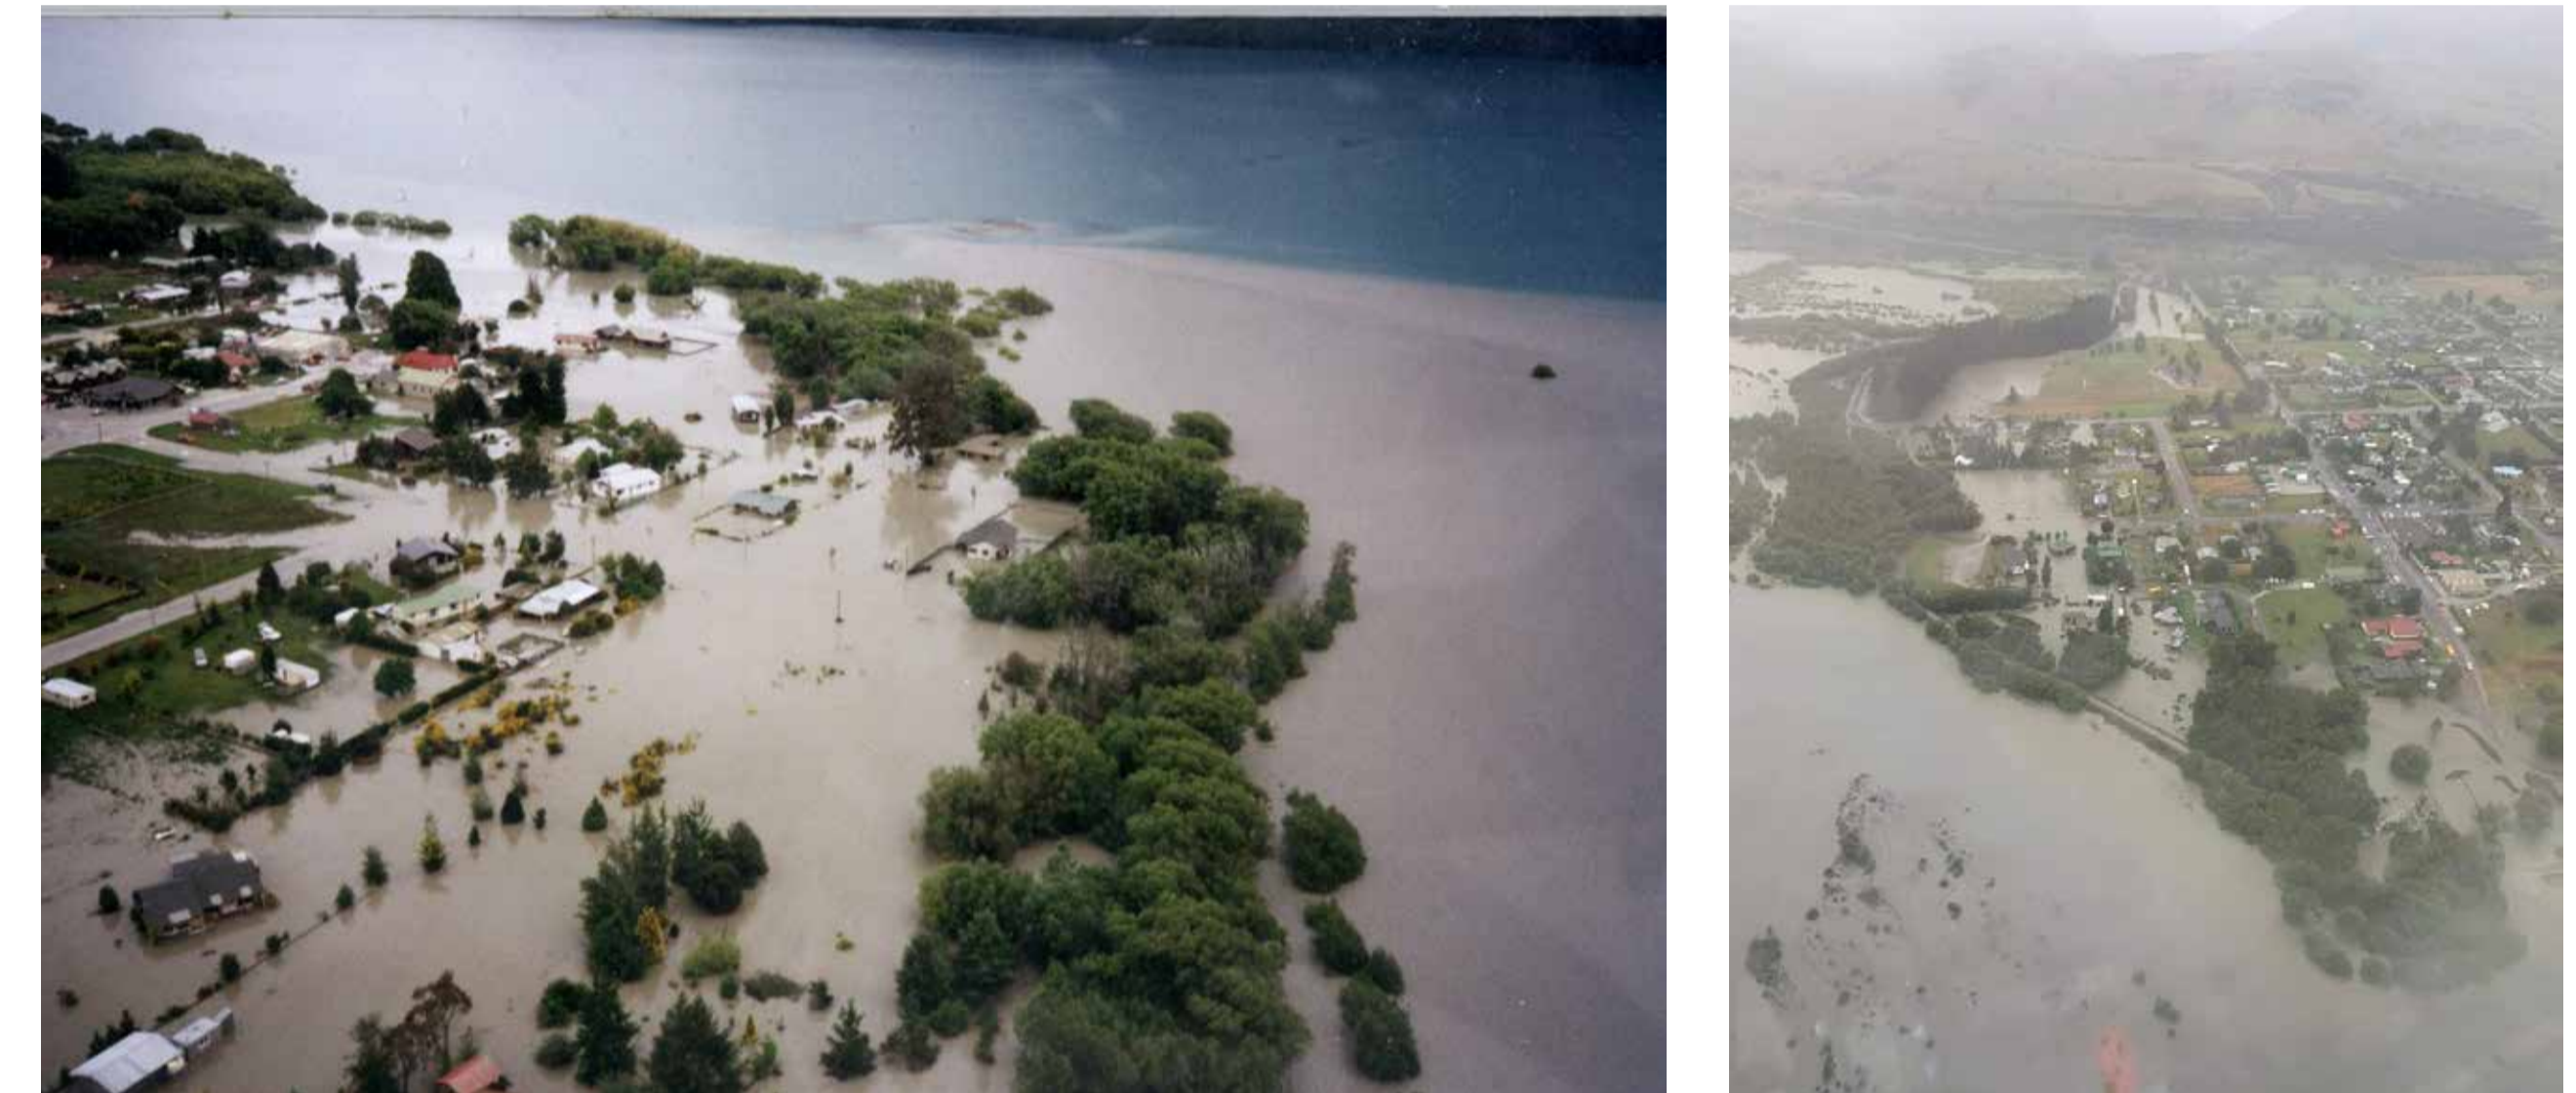
Significant flooding events in Glenorchy: December 1999 (above), and February 2020 (right) [RH photo above credit to Luke Hunter]

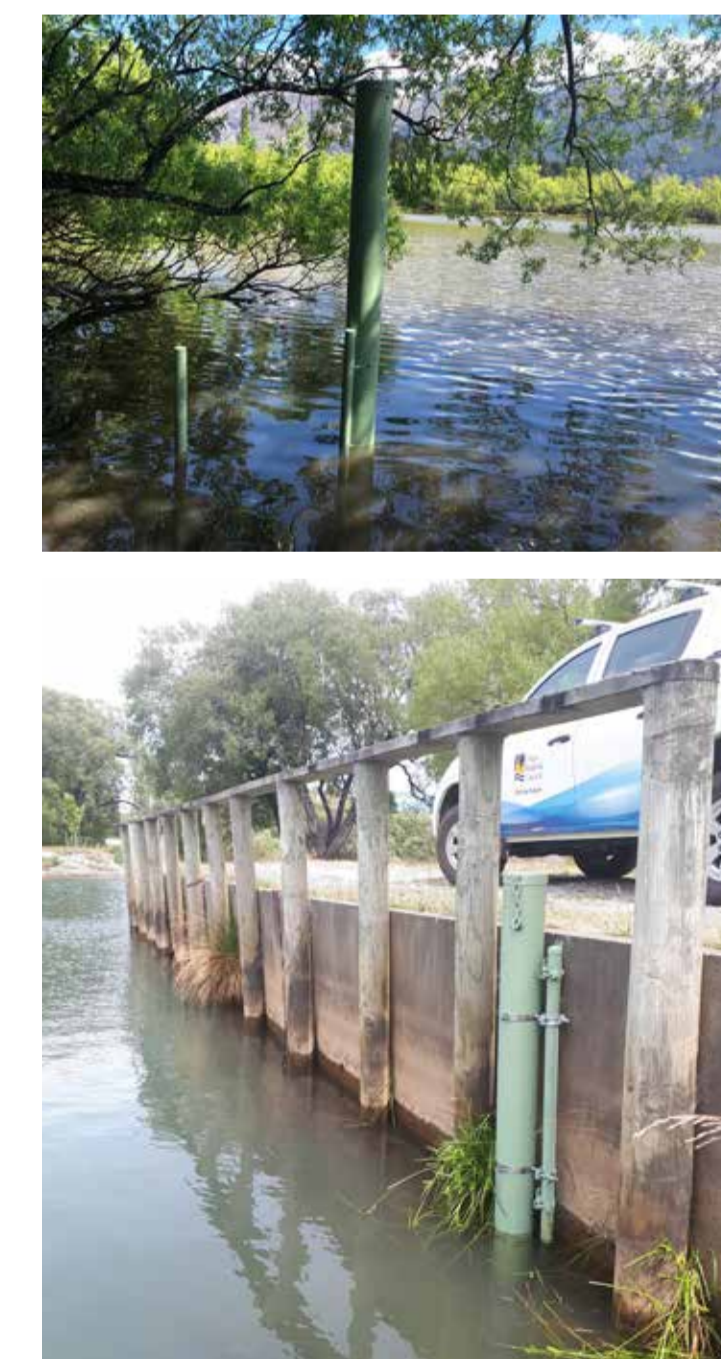
New water level monitors in place at the Glenorchy Lagoon (right), and at the Glenorchy boat ramp (left).

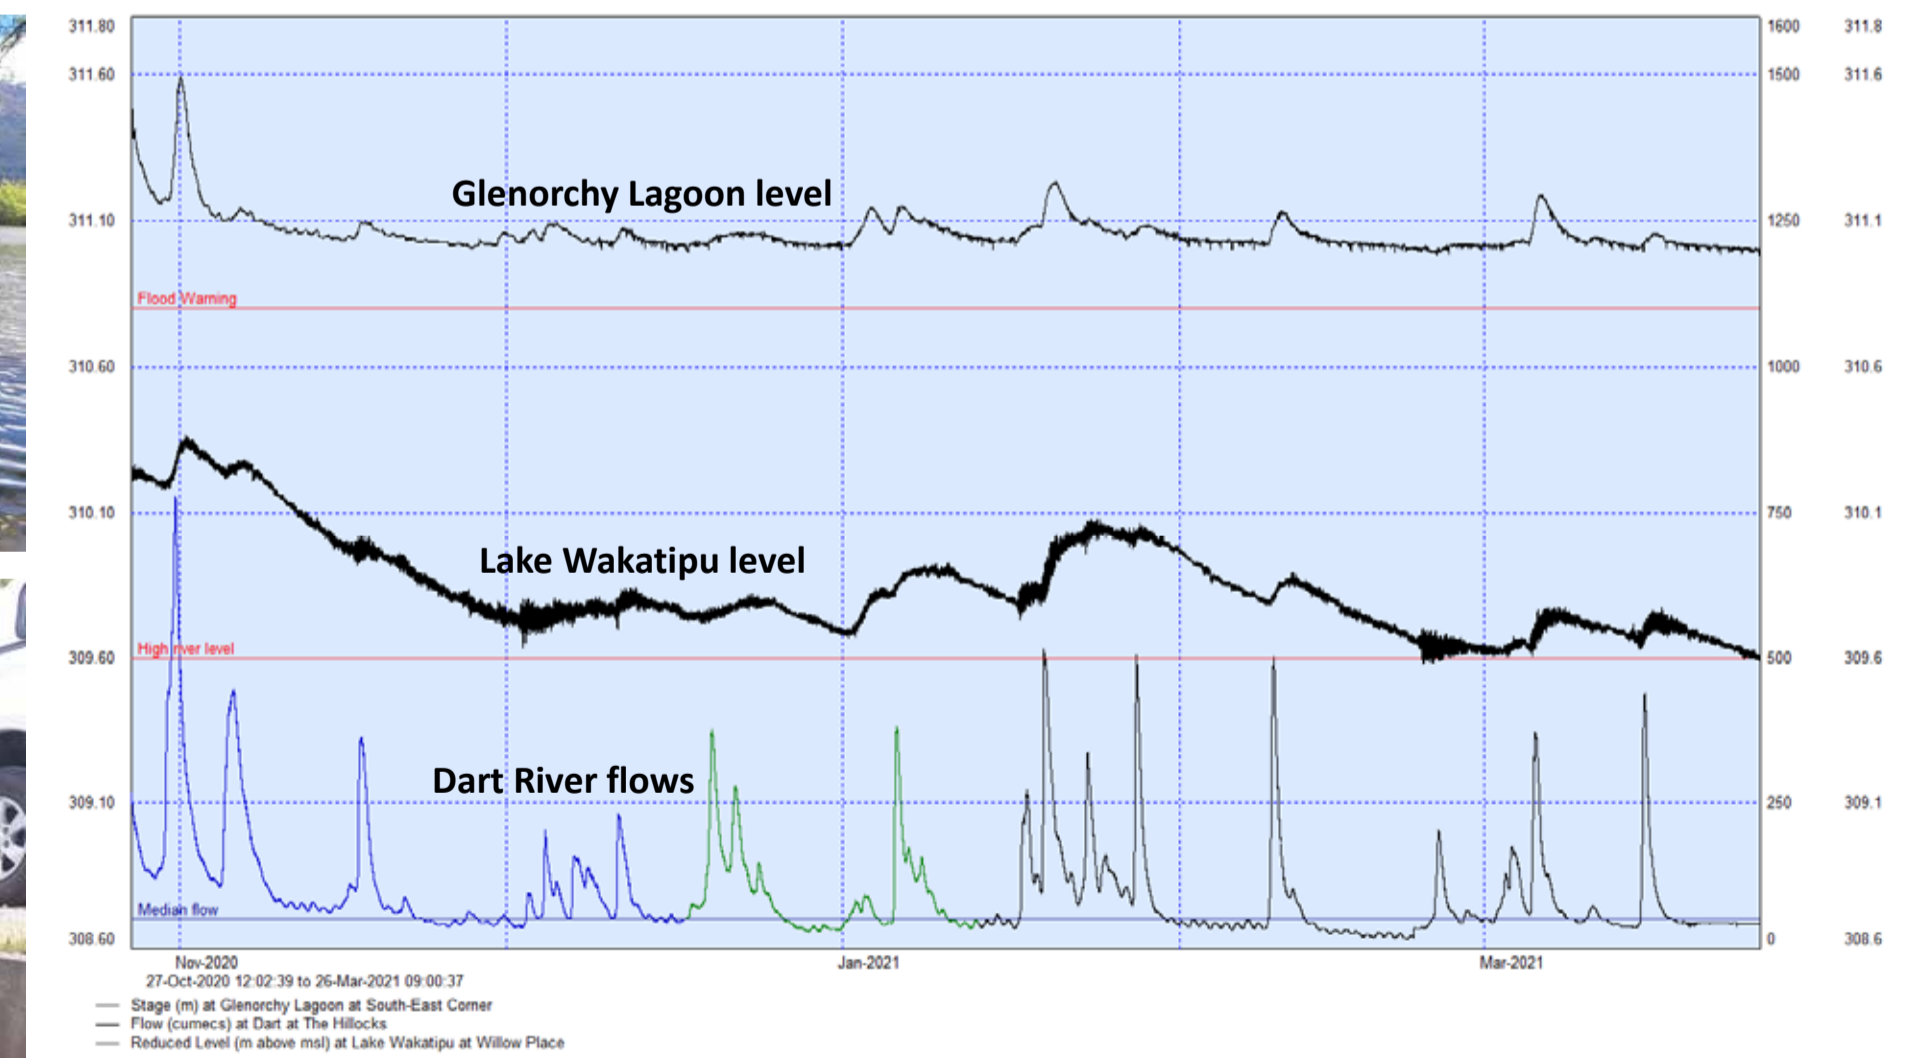
Comparison plot of monitoring data for the Dart-Rees area, showing relationships between river flows, lagoon levels and the lake level.
