# Shotover WWTP

## Surface Water and Groundwater Assessment

Queenstown Lakes District Council

<b>Project name</b>		Shotover WWTP Disposal Field Alternative Discharge					
<b>Document title</b>		Shotover WWTP   Surface Water and Groundwater Assessment					
<b>Project number</b>		12645246					
<b>File name</b>		12645246_Surface_Water_and_Groundwater_Assessment.docx					
Status Code	Revision	Author	Reviewer		Approved for issue		
			Name	Signature	Name	Signature	Date
S3	Rev0	Dusk Mains Alice Hales	Anthony Kirk	On file	Ryan Orr	On file	28/04/2025
S4	Rev1	Dusk Mains	Anthony Kirk

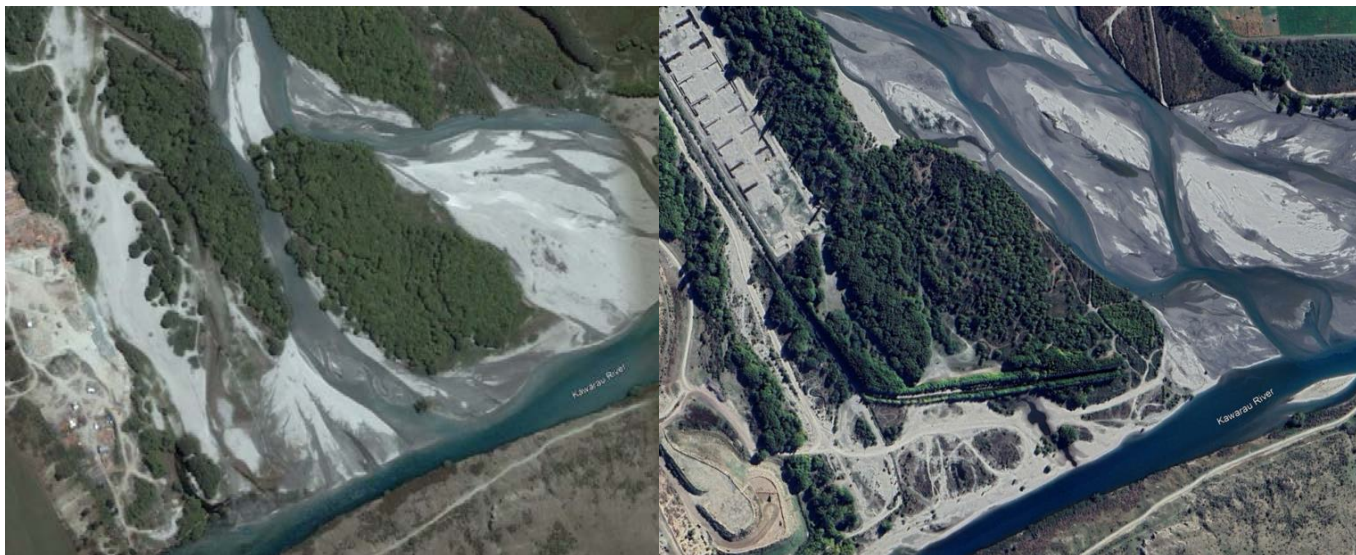
**Figure 3.6** Shotover River Comparison 2006 and 2023

The river training line crosses the former main river channel (as seen in the 2006 photo (left)). As a result, this area became a low-flow area with fine sediment accumulating within the former channel and deposition of gravel across the former channel mouth. Vegetation has established within the former channels and behind the training line structure. The comparison also shows that the disposal field is situated on a former river channel, that was historically referred to as the 'high flow' channel.

The influence of the river and presence of historical channels are likely to influence groundwater flow through the delta gravels. A review of historical aerial photographs (Appendix A) was undertaken to identify former channel features and where they may influence groundwater flow within the delta gravels. Figure 3.6 shows the Shotover River delta in 2006 and 2023. In 2011, the river training line was constructed with aim of reducing the risk of flooding to Queenstown. During the 1999 floods significant flood flows down Shotover River resulted in Kawarau River backing up and raising Lake Wakatipu levels.

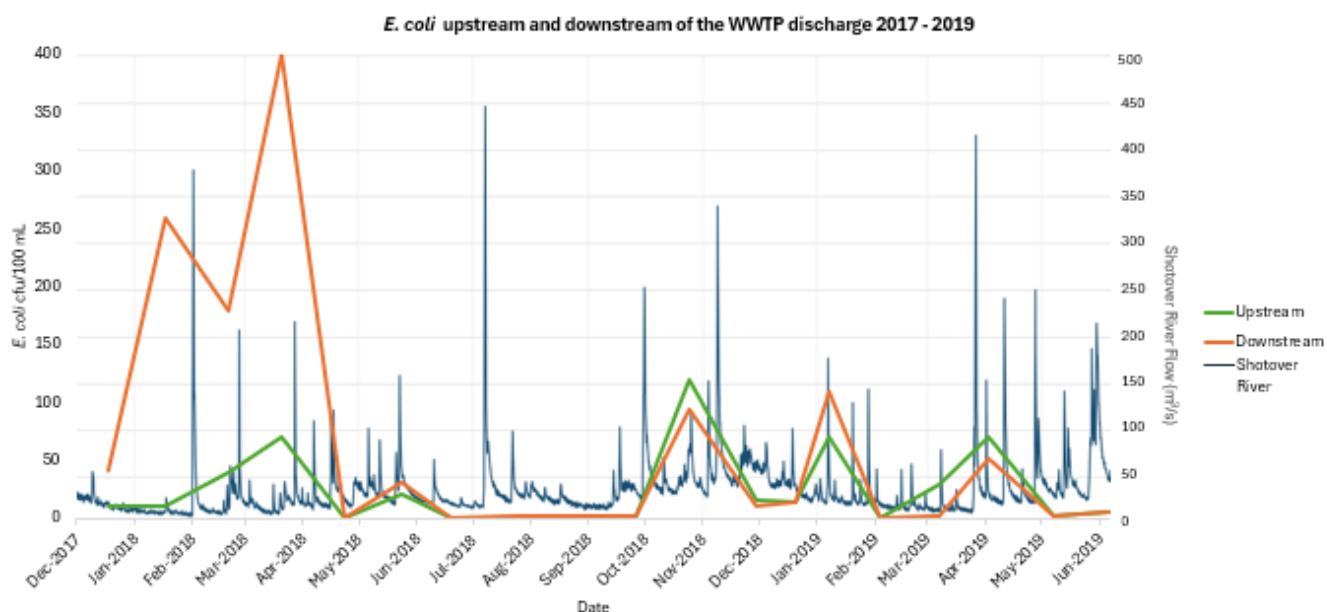
Figure 3.11 *E. coli* results from 50 m upstream and 50 m downstream of the WWTP discharge 2017 – 2019

Minor differences in river level under low flow conditions can significantly influence the occurrence and extent of temporary channels at the riverbank and where mixing of the discharge occurs within the river, with this evidenced in observations made following recommencement of the discharge in April 2025. Water levels in the Shotover River were very low from December 2017 through to February 2018, with elevated nitrogen and phosphorous concentrations at this time particularly high and demonstrating that wastewater was likely ponding in a small channel that extended past the routine d/s monitoring location. From that period, river levels while remaining low with intermittent high flow events, remained within a relatively consistent range through to October 2018, at which point higher flow conditions were apparent with the occurrence of snowmelt.

The significantly reduced influence of the historical discharge on water quality following April 2018 and into 2019 is considered to be primarily attributed to changes to the river level and how that influences discharge mixing in the Shotover River. Improvements in wastewater quality, in particular the level of disinfection, resulting from the plant upgrades is also expected to be influential in the apparent improvement in effects to water quality.

Water quality monitoring was undertaken upstream and downstream of the Shotover River discharge, as a requirement of the previous surface water discharge consent. Water quality data for the period 2017 to 2019 has been considered as most representative of the current conditions, as it incorporates the Stage 2 upgrades to the treatment plant.

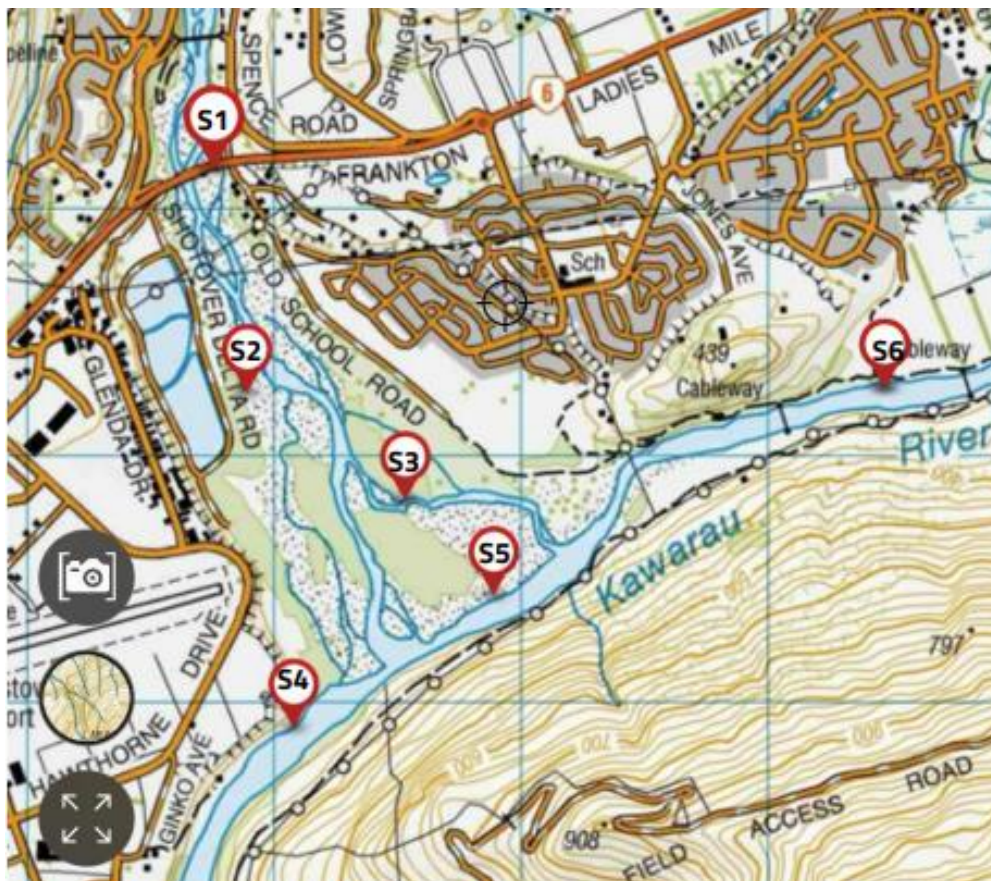
Figure 3.14 Landpro sampling locations August 2024 (Landpro 2024)

The results of this sampling, displayed in Figure 3.15 (reproduced from LandPro, 2024), and is considered representative of Shotover River winter conditions, prior to recommencement of the discharge to the river.

- Increases in inorganic nitrogen concentrations (both nitrate-N and ammoniacal-N) between the upstream location S2 and downstream location S3, suggest a likely influence of wastewater management on the Shotover River downstream of the discharge area.
- The detectable dissolved phosphorous concentration in S3 further suggests an ongoing influence from the area of wastewater management, approximately 5 years following cessation of wastewater discharge to the Shotover River.
- Visual clarity of the Shotover River is often low, and lower than that evident in the Kawarau River.

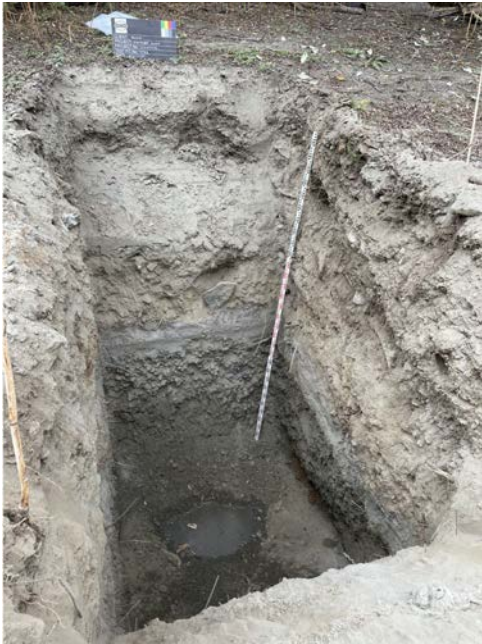
314.1 0		D		B- 2.10 1.65				
313 1								FILL: Sandy fine to coarse GRAVEL with some cobbles and refuse; grey. Dry; sand, fine to coarse, refuse consists of concrete.
312 2								Fine SAND; light grey. Dry.
311 3								Sandy fine to coarse GRAVEL; light grey. Dry; sand, fine to coarse. 2.60 Becomes moist. 2.80 Becomes wet.
	End of Hole @ 3.3m, C

Notes and Comments: End of Hole @ 3.3m Hole terminated due to hole collapsed below ground water level.		Inclination: Vertical		Orientation:		Ground Water Level			
		Contractor: Speight Drilling Equipment: CAT308				Date	Time	Reading (mbgl)	Hole depth (mbgl)
Refer to explanation sheets for abbreviation and symbols. Shear Vane values are corrected.						02/04/25	03:50	3.2	3.3

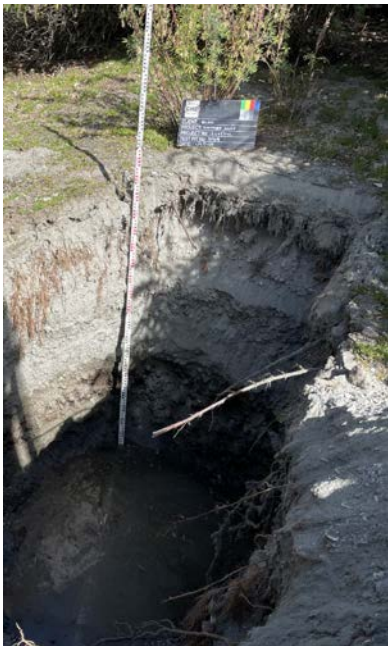
1.10 Becomes moist. 1.10 - 1.80 Brown banding.	M					
			1.60 Becomes saturated	S					
2 309 3 308			End of Hole @ 1.8m, C

Notes and Comments: End of Hole @ 1.8m Hole terminated due to hole collapsed below ground water level.		Inclination: Vertical		Orientation:		Ground Water Level			
		Contractor: Speight Drilling Equipment: CAT 310				Date	Time	Reading (mbgl)	Hole depth (mbgl)
Refer to explanation sheets for abbreviation and symbols. Shear Vane values are corrected.						01/04/25	14:45	1.7	1.8

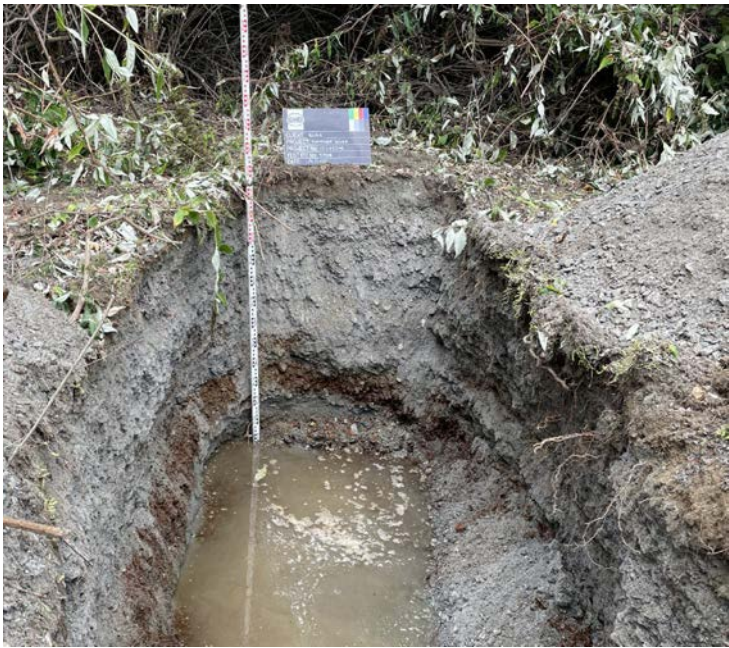
309	2.0		0.60 - 0.80 Brown banding, 50mm thick. 0.80 - 1.00 Brown banding, 200mm thick.	W					
			Medium to coarse SAND with some gravel and trace cobbles; grey. Wet; gravel and cobbles, fine to coarse, subrounded to subangular; schist.	S					
			Sandy fine to coarse GRAVEL with some cobbles; grey. Saturated; subrounded to subangular; schist; sand, medium to coarse.						
			End of Hole @ 1.4m, C						
308	3.0

Notes and Comments: End of Hole @ 1.4m Hole terminated due to hole collapsed below ground water level.		Inclination: Vertical		Orientation:		Ground Water Level			
		Contractor: Speight Drilling		Equipment: CAT 310		Date	Time	Reading (mbgl)	Hole depth (mbgl)
Refer to explanation sheets for abbreviation and symbols. Shear Vane values are corrected.						01/04/25	12:45	1.2	1.4

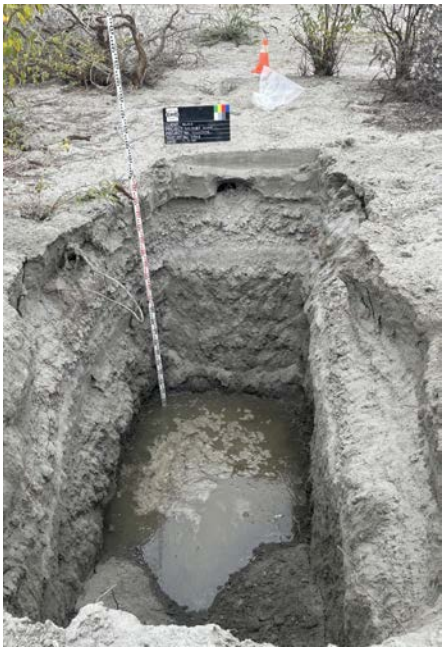
Sandy fine to coarse GRAVEL with minor cobbles; light grey. Dry; gravel, subrounded to subangular, schist; sand, fine to coarse.	D					
			Gravelly fine to coarse SAND with trace cobbles; light grey. Dry; gravel, subrounded to subangular, schist. 1.20 m becomes moist	D					
				M

1.80 m Becomes wet 1.90 Becomes saturated End of Hole @ 2m, C	W S					
<div>

</div>									
Notes and Comments:				Inclination: Vertical		Orientation:		Ground Water Level	
End of Hole @ 2m Hole terminated due to hole collapsed below ground water level.				Contractor: Speight Drilling Equipment: CAT 310		Date	Time	Reading (mbgl)	Hole depth (mbgl)
						01/04/25	11:30	1.9	2
Refer to explanation sheets for abbreviation and symbols. Shear Vane values are corrected.

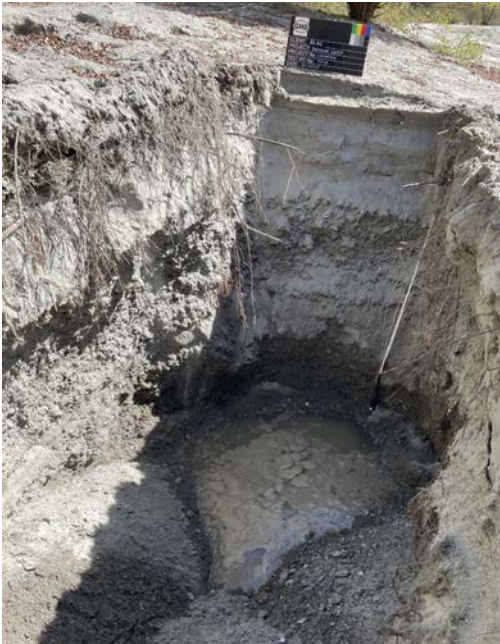
1.90 Becomes saturated	S				
307	3		End of Hole @ 2.2m, C

Notes and Comments: End of Hole @ 2.2m Hole terminated due to hole collapsed below ground water level.		Inclination: Vertical		Orientation:		Ground Water Level			
		Contractor: Speight Drilling		Equipment: CAT 310		Date	Time	Reading (mbgl)	Hole depth (mbgl)
Refer to explanation sheets for abbreviation and symbols. Shear Vane values are corrected.						26/03/25	12:25	1.9	2.2

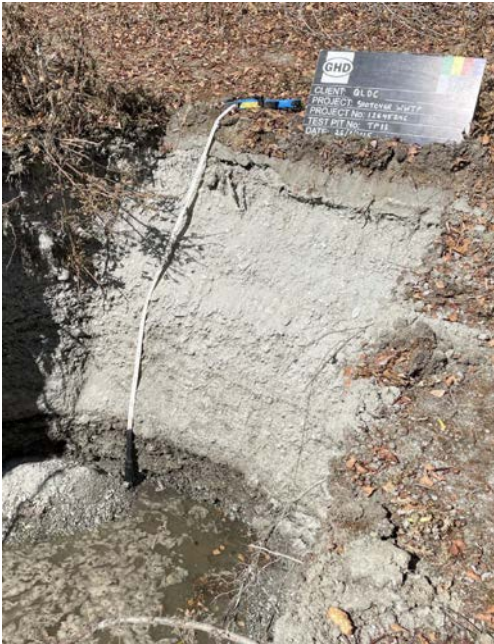
0.150		TOPSOIL: SAND with some organics; light grey. Dry; organics, roots.	D					
	309		Sandy fine to coarse GRAVEL with trace cobbles: light grey. Dry; gravel and cobbles, subrounded to subangular, schist gravel; sand, fine to coarse. Lenses of gravelly sand.						
	1		1.10 m becomes wet	W					
	308		1.35 Becomes saturated	S		BLK 2 bags 1.40		26-03-2025	
	2		End of Hole @ 1.4m, C						
	307								
	3								
	306								
<div>

</div>									
Notes and Comments: End of Hole @ 1.4m Hole terminated due to hole collapsed below ground water level.  Refer to explanation sheets for abbreviation and symbols. Shear Vane values are corrected.				Inclination: Vertical Orientation:		Ground Water Level			
				Contractor: Speight Drilling Equipment: CAT 310		Date	Time	Reading (mbgl)	Hole depth (mbgl)
						26/03/25	13:30	1.35	1.4

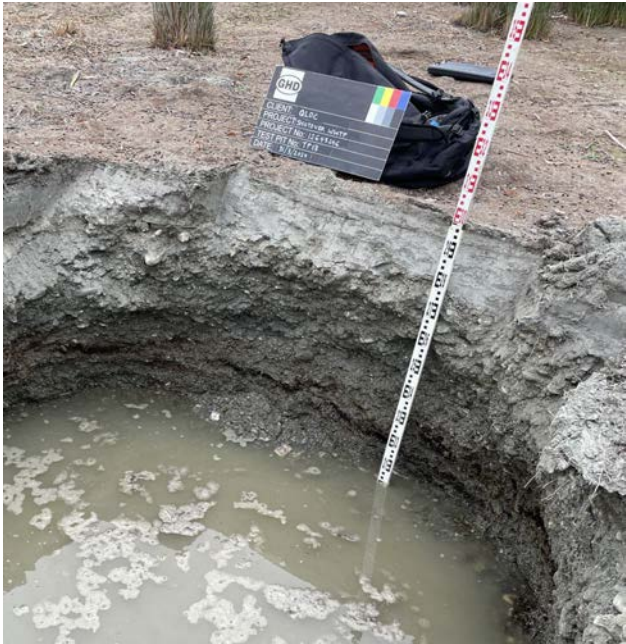
Sandy fine to coarse GRAVEL with trace cobbles; grey. Moist.	M					
			0.50 Dark brown banding						
308.7	1.0		0.90 Becomes saturated	S					
			End of Hole @ 1m, C						
307.7	2.0								
306.7	3.0

Notes and Comments:  
End of Hole @ 1m  
Hole terminated due to hole collapsed below ground water level.

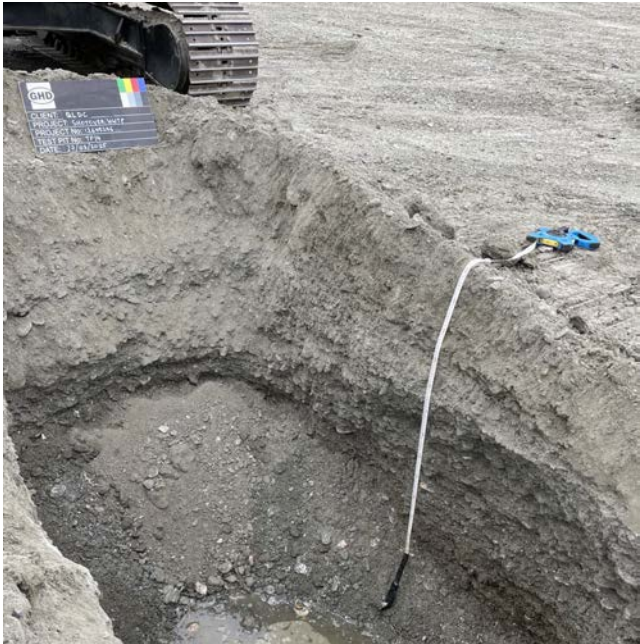
Sandy fine to coarse GRAVEL with trace cobbles: light grey. Dry; gravel, subrounded to subangular, schist; sand, fine to coarse, micaceous.	D					
308.9	1		1.00 Brown banding.						
307.9	2		1.40 Becomes saturated	S					
306.9	3		End of Hole @ 1.5m, C

End of Hole @ 1.5m  
Hole terminated due to hole collapsed below ground water level.

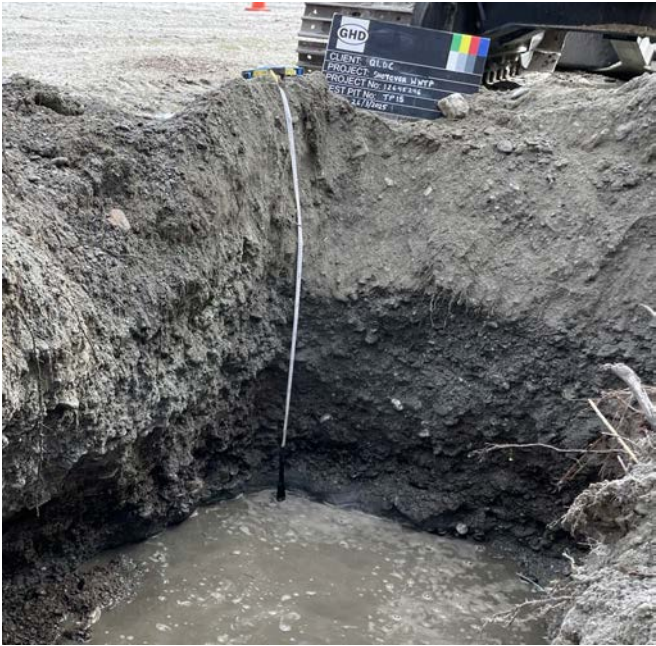
0.60 Moist 0.60 - 1.15 Becomes mottled orange	M					
308	1		Medium to coarse SAND with trace gravel; grey. Wet; gravel, subrounded to subangular, schist; sand, micaceous.	W					
307	2		Observed at the base of pit: Sandy fine to coarse GRAVEL; light grey. Saturated; gravel, subrounded to subangular, schist gravel; sand, medium to coarse.	S					
306	3		End of Hole @ 1.3m, C

Notes and Comments: End of Hole @ 1.3m Hole terminated due to hole collapsed below ground water level.		Inclination: Vertical		Orientation:		Ground Water Level			
		Contractor: Speight Drilling		Equipment: CAT 310		Date	Time	Reading (mbgl)	Hole depth (mbgl)
Refer to explanation sheets for abbreviation and symbols. Shear Vane values are corrected.						26/03/25	15:15	1.2	1.3

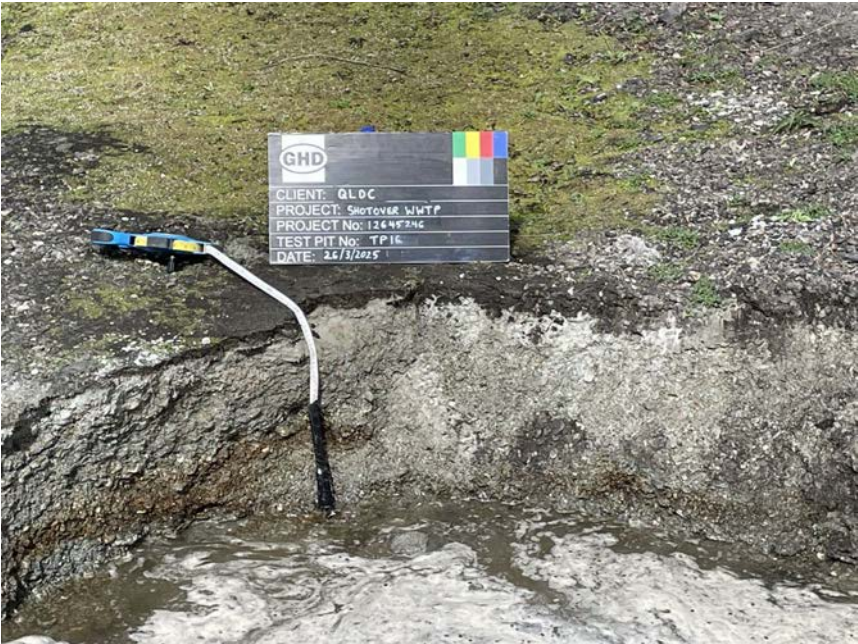
</div>									
Notes and Comments: End of Hole @ 0.6m Hole terminated due to hole collapsed below ground water level. Refer to explanation sheets for abbreviation and symbols. Shear Vane values are corrected.				Inclination: Vertical Orientation:		Ground Water Level			
				Contractor: Speight Drilling Equipment: CAT 310		Date 26/03/25	Time 02:30	Reading (mbgl) 0.4	Hole depth (mbgl) 0.6

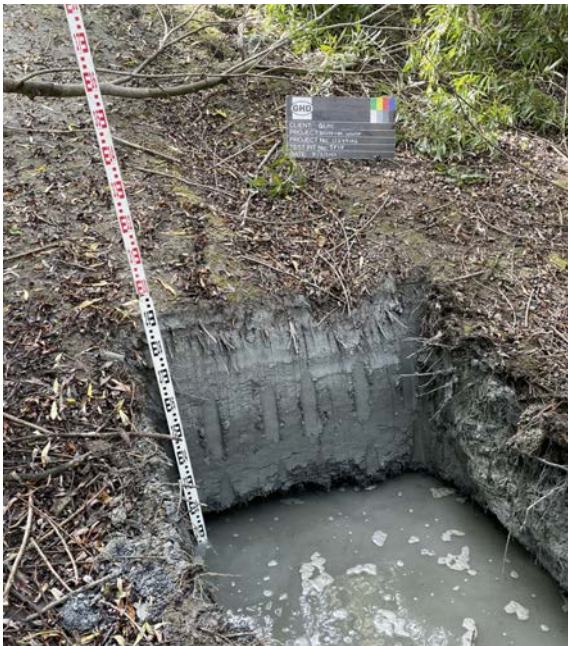
309.5	0.7		Fine to medium SAND with some gravel; grey. Moist; gravel, fine to medium, subrounded to subangular, schist gravel.	W					
309.0	1.0		Fine to coarse GRAVEL with minor sand; grey. Wet; subrounded to subangular, schist gravel, sand, medium to coarse.						
308.0	2.0		End of Hole @ 1m, C						
307.0	3.0

Notes and Comments: End of Hole @ 1m Hole terminated due to hole collapsed below ground water level.		Inclination: Vertical		Orientation:		Ground Water Level			
		Contractor: Speight Drilling		Equipment: CAT 310		Date	Time	Reading (mbgl)	Hole depth (mbgl)
Refer to explanation sheets for abbreviation and symbols. Shear Vane values are corrected.						31/03/25	12:40	0.8	1

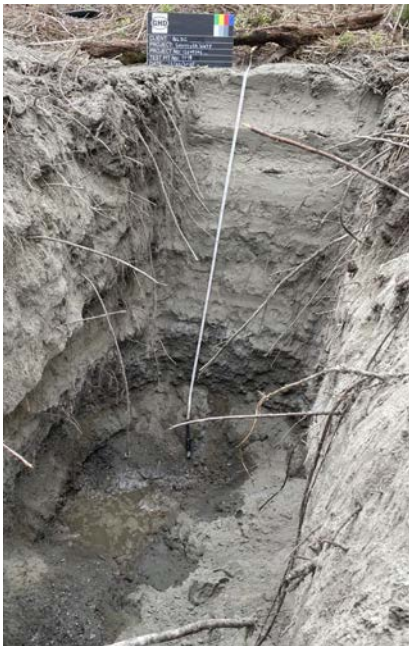
Fine to medium SAND with some gravel; light grey. Dry.	D	BLK-1 bag	0.30				
1	1.55		Sandy fine to medium GRAVEL with trace cobbles; light grey. moist.	M						1.55

2	309		2.40 Becomes Wet	W						
3	308		End of Hole @ 2.6m, C

Notes and Comments: End of Hole @ 2.6m Hole terminated due to hole collapsed below ground water level.		Inclination: Vertical		Orientation:		Ground Water Level			
		Contractor: Speight Drilling		Equipment: CAT 310		Date	Time	Reading (mbgl)	Hole depth (mbgl)
Refer to explanation sheets for abbreviation and symbols. Shear Vane values are corrected.						27/03/25	00:00	2.55	2.6

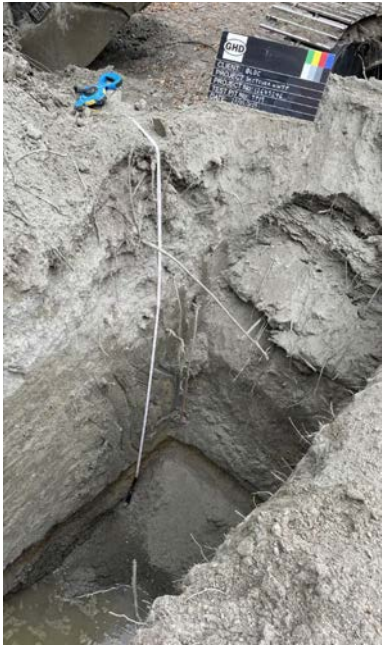
Sandy fine to coarse GRAVEL with trace cobbles; grey. Wet; subrounded to subangular, schist; sand, medium to coarse. 2.60 Becomes saturated End of Hole @ 2.8m, C	W S

Notes and Comments: End of Hole @ 2.8m Hole terminated due to hole collapsed below ground water level.  Refer to explanation sheets for abbreviation and symbols. Shear Vane values are corrected.				Inclination: Vertical      Orientation:		Ground Water Level													
				Contractor: Speight Drilling Equipment: CAT 310		Date	Time	Reading (mbgl)	Hole depth (mbgl)										
						27/03/25	00:00	2.7	2.8

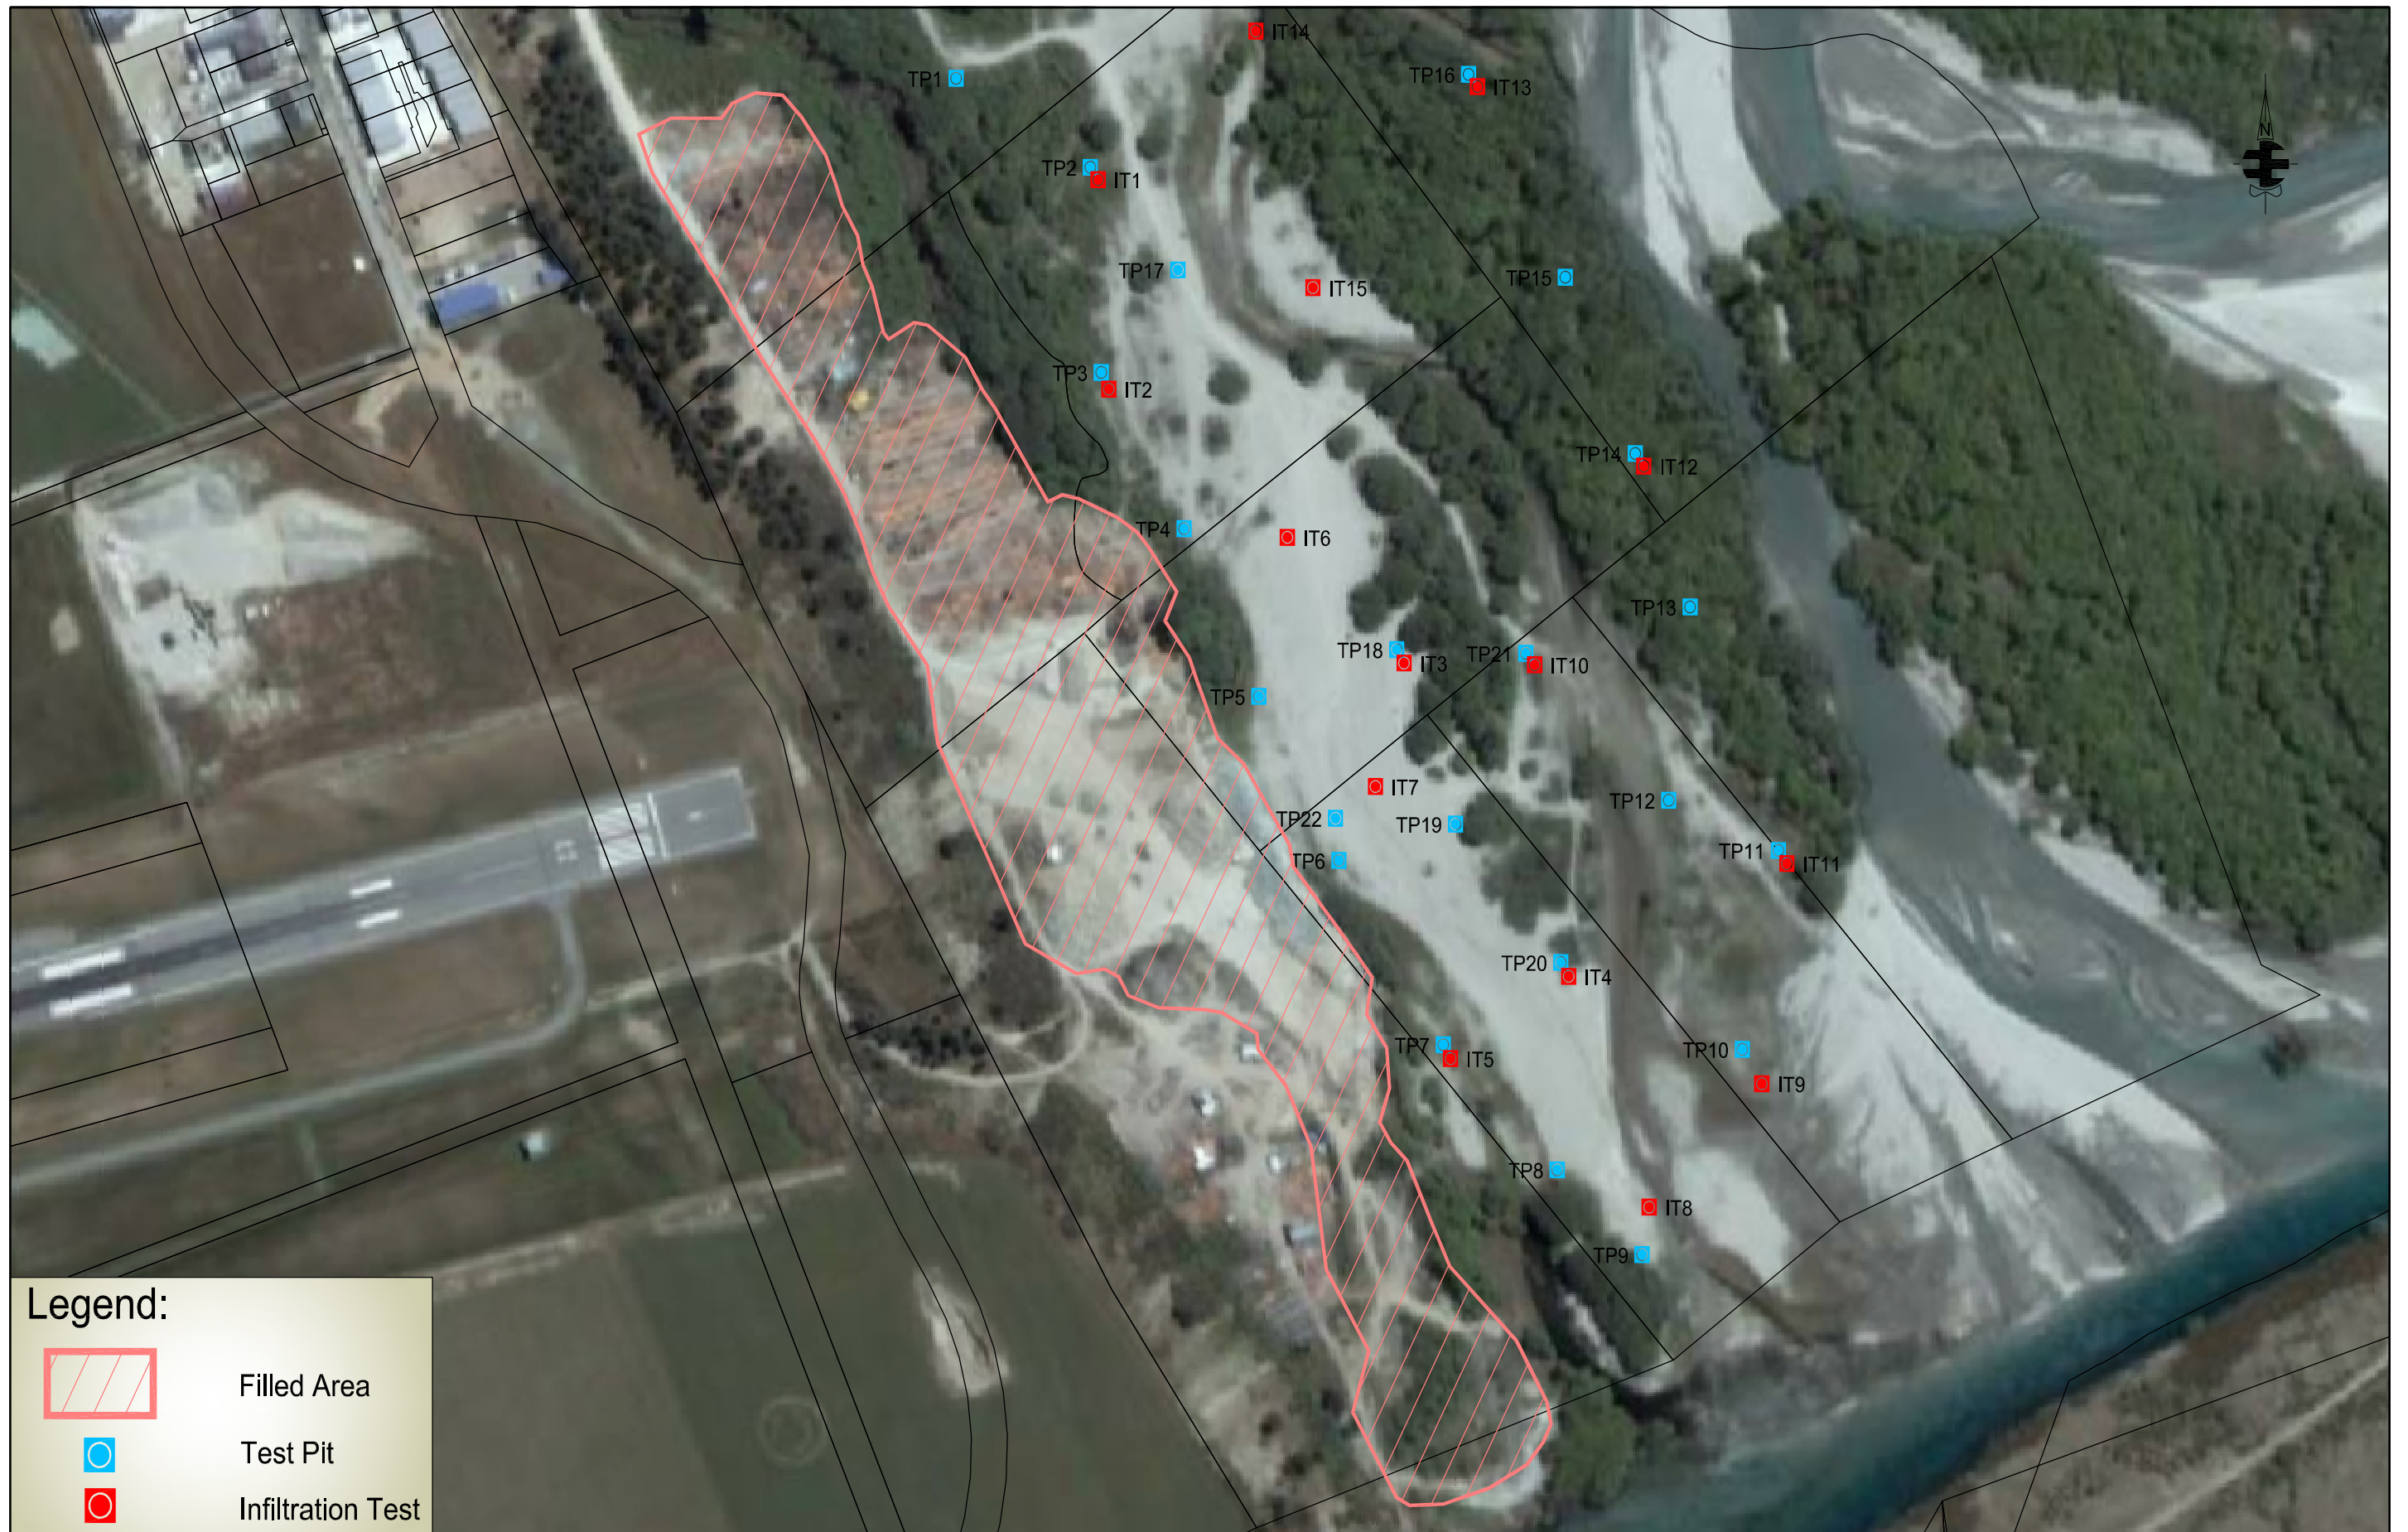
## SHOTOVER DELTA TEST PIT AND INFILTRATION TEST LOCATION PLAN

Infiltration Test

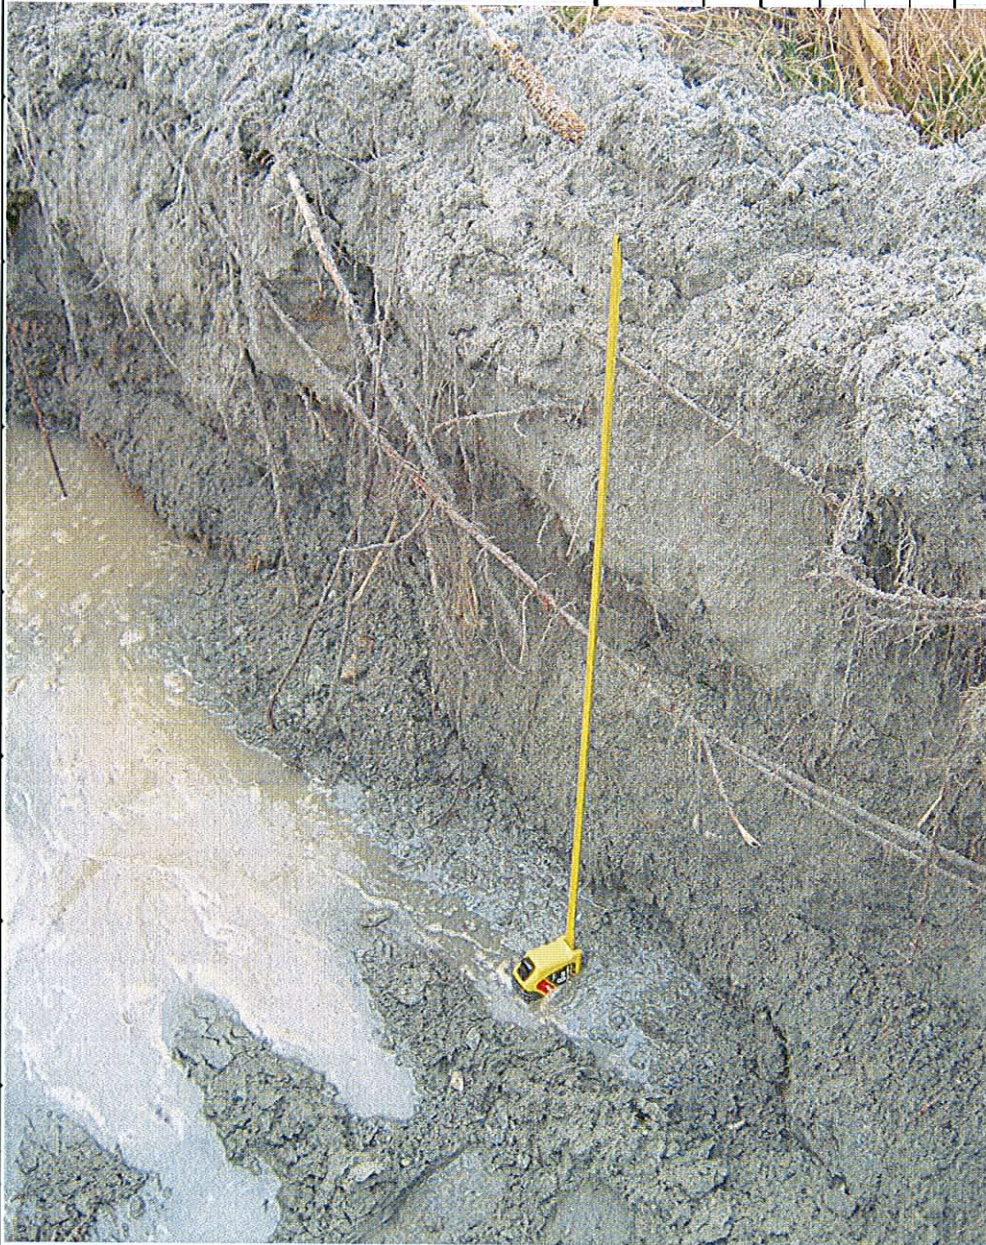
Hole No:	22
Job No:	9017QLD
Logged by:	HW
Date drilled:	
Checked by:	MR
Date checked:	
Max depth:	1.10

STRATA DESCRIPTION		USCS	Graphic Log	Water Table	Samples	S.P.T			SCALA PENETROMETER				
						N uncorrected			(mm/blow)				
						50	100		34	50	100	150	
0.0	grey silty sand , massive soil structure, firm soil strength, well graded, tightly packed	SM	X X X X										0.0
0.5	grey sand , well graded , tightly packed, soft soil strength with fine and medium and coarse schist gravels	SW		Δ									0.5
1.0													1.0
1.5													1.5
2.0													2.0
2.5													2.5
3.0													3.0
3.5													3.5
4.0													4.0
4.5													4.5
5.0													5.0

A photograph of a soil profile, likely from a borehole or excavation. The soil is grey and silty, with visible roots and some darker, more organic material at the top. A yellow measuring tape is placed vertically against the soil face, indicating depth. The tape shows markings from 0 to 5.0 meters. The soil profile is divided into two main layers: a top layer of grey silty sand (SM) and a bottom layer of grey sand with fine, medium, and coarse schist gravels (SW). The boundary between the two layers is marked with a dashed line at approximately 0.5 meters depth. The photograph is overlaid on a grid that corresponds to the depth scale on the right side of the table.

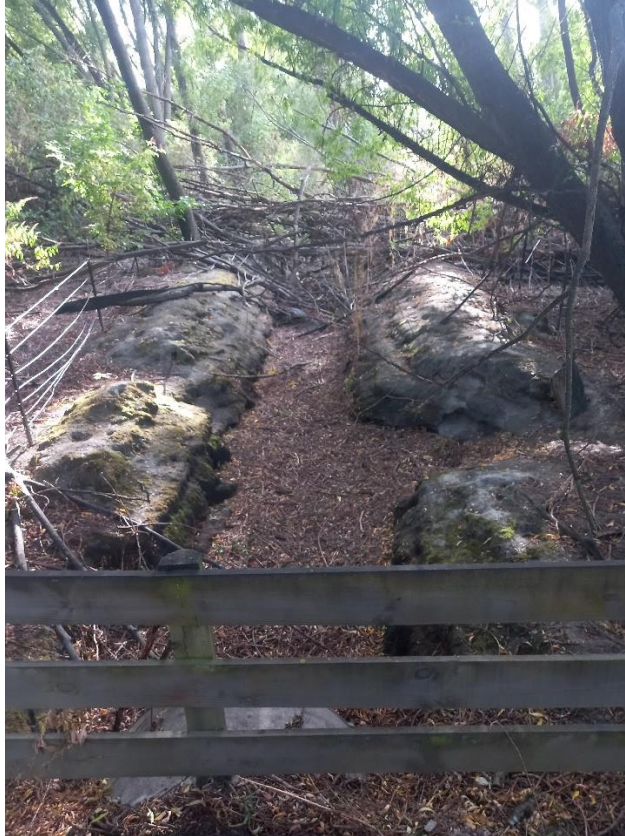
Discharge channel prior to  
vegetation clearance (March  
2025)

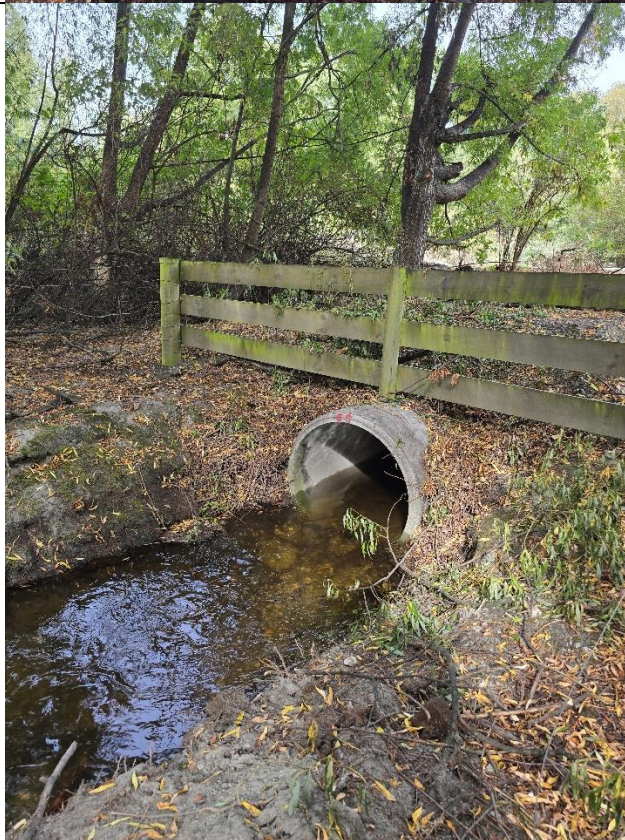
Discharge channel 31 March  
2025

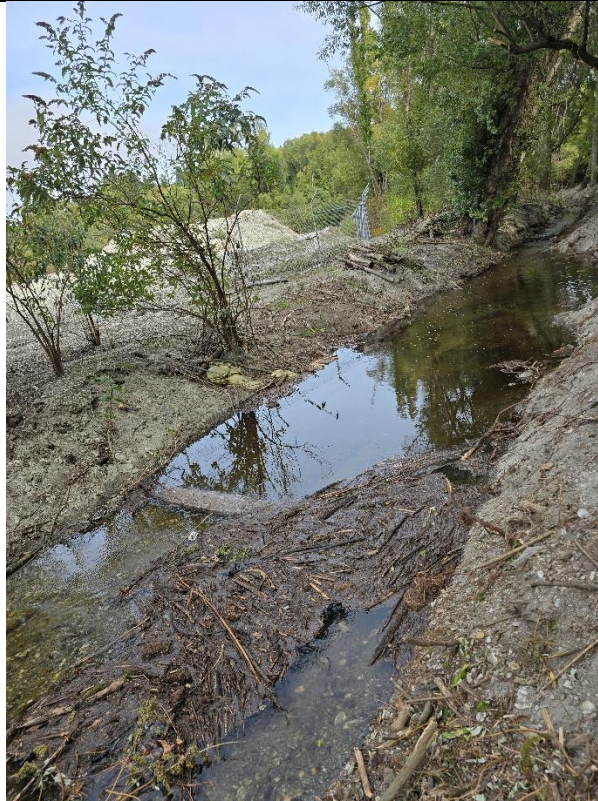
Discharge channel 31 March 2025. Vegetation being washed down channel

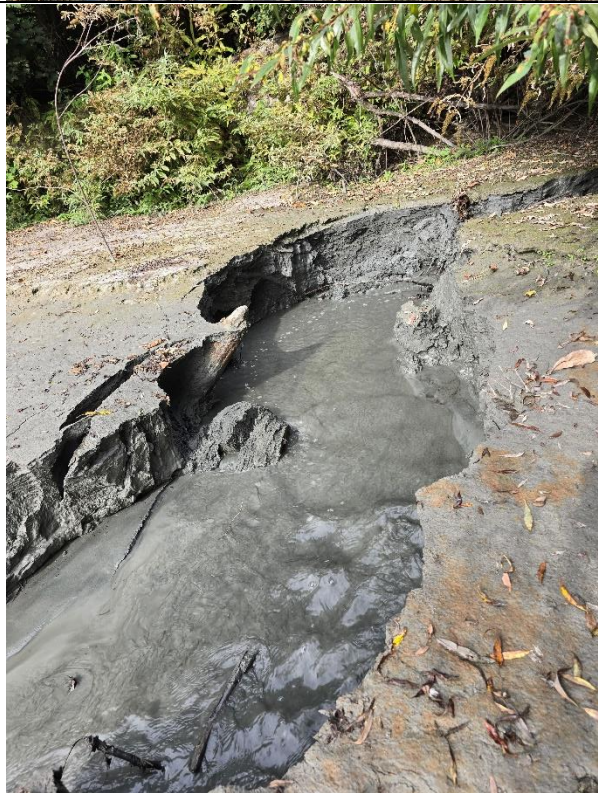
Erosion at river edge. 31 March 2025.

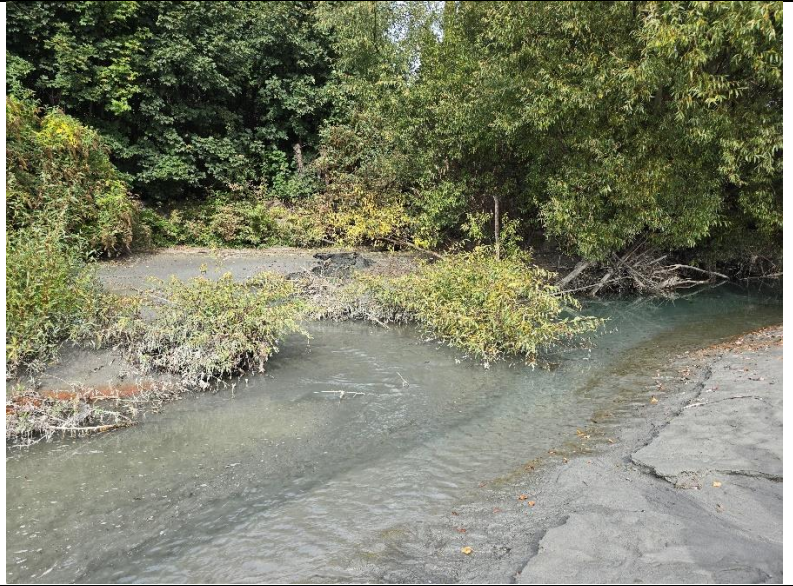
Discharge to River, 31 March  
2025  
Surface water sample location  
RS16

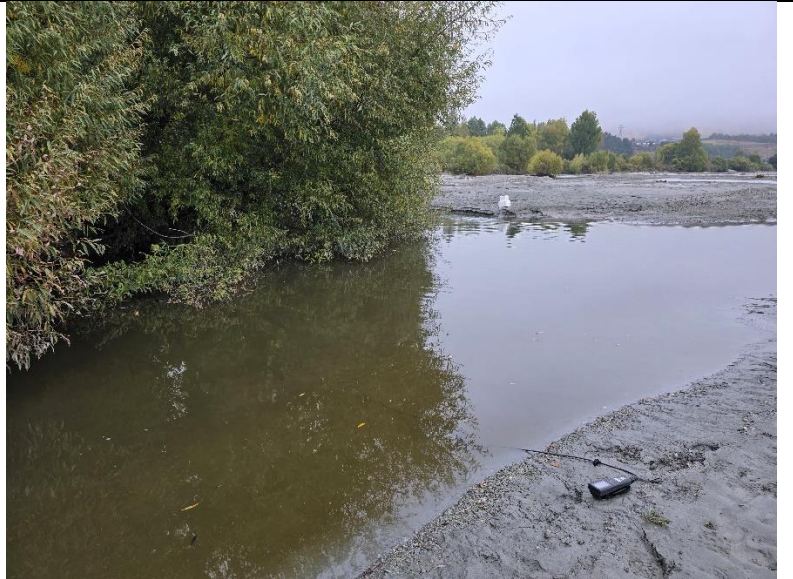
Pool at end of discharge  
channel (RS16) looking  
upstream. 1 April 2025.

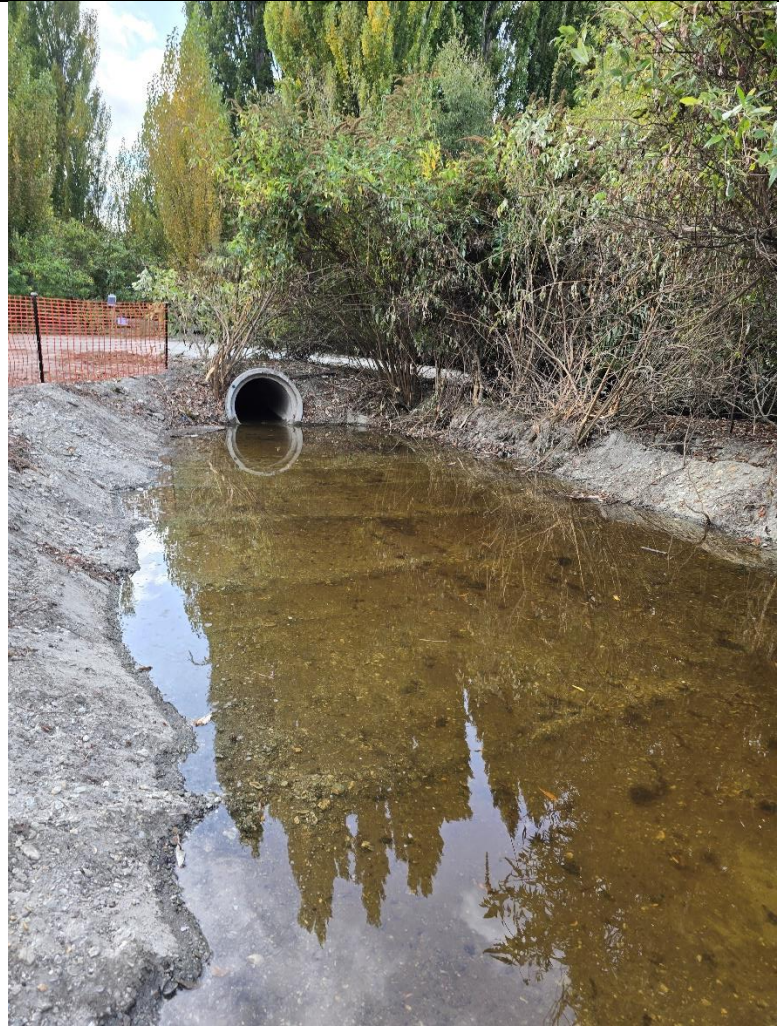
Discharge channel downstream  
of last culvert.  
2 April 2025

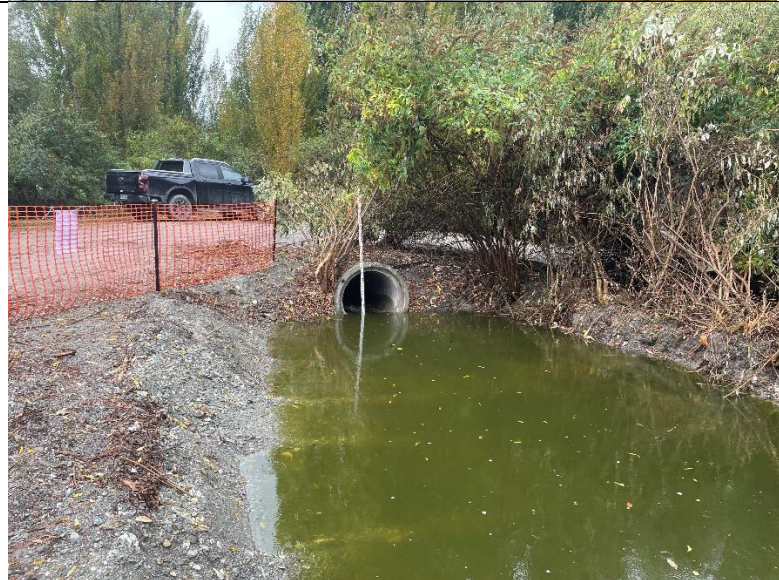
Discharge channel downstream  
of last culvert.  
3 April 2025

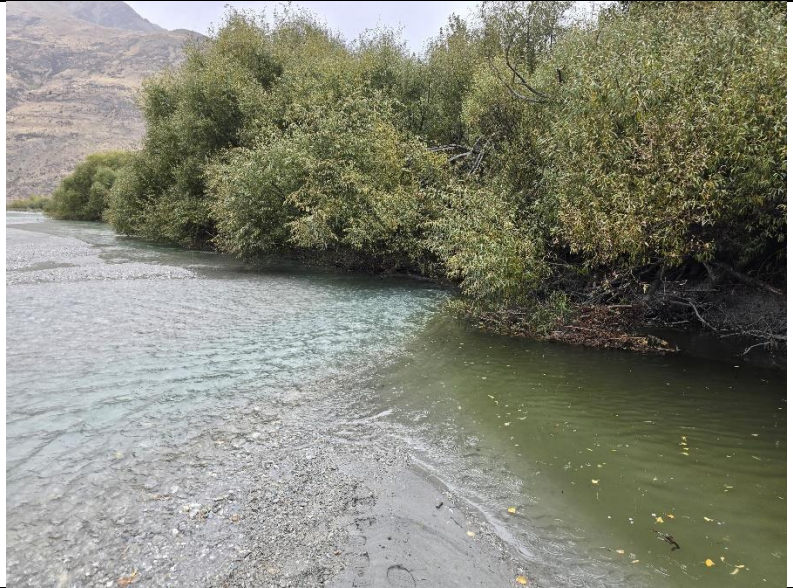
Mixing of discharge with river water. Downstream of RS16.  
7 April 2025.

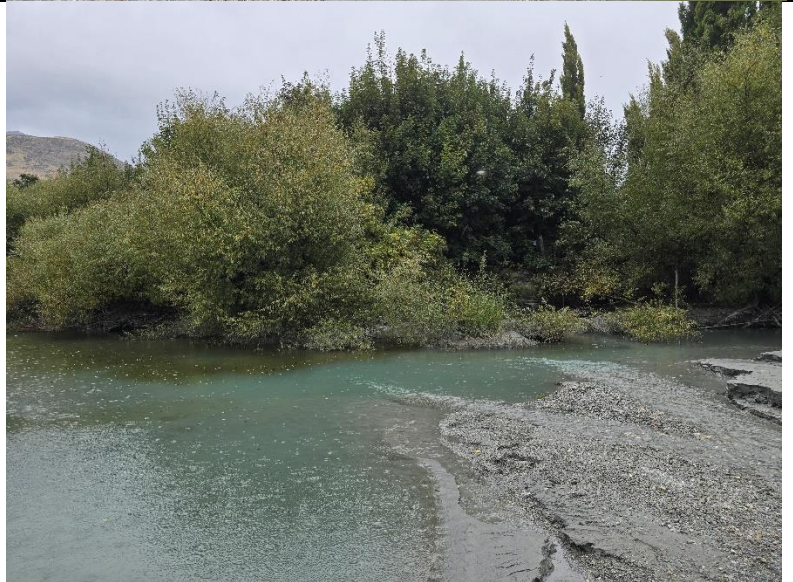
Pooled area at end of discharge channel (RS16). 7 April 2025

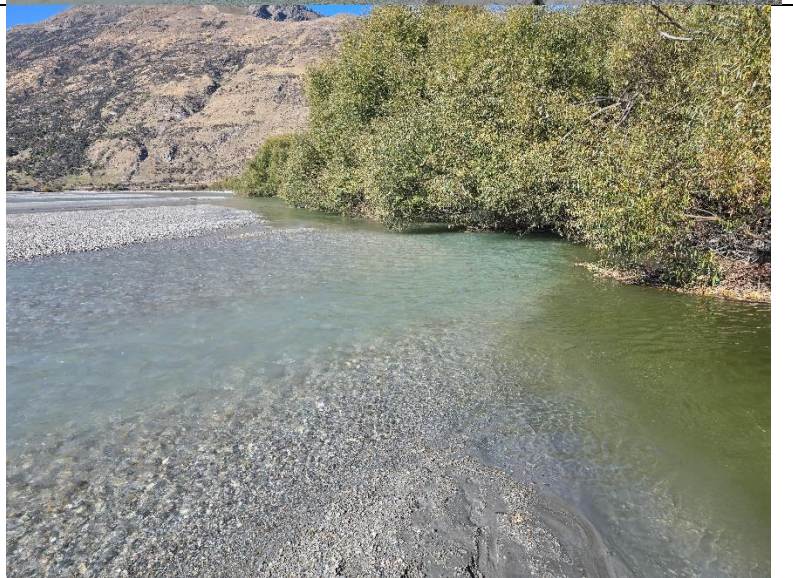
Mixing of discharge with river water. Downstream of RS16.  
10 April 2025.
