# Fairfield Landfill Ecological Assessment

Waste Management NZ Ltd

✦ March 2025

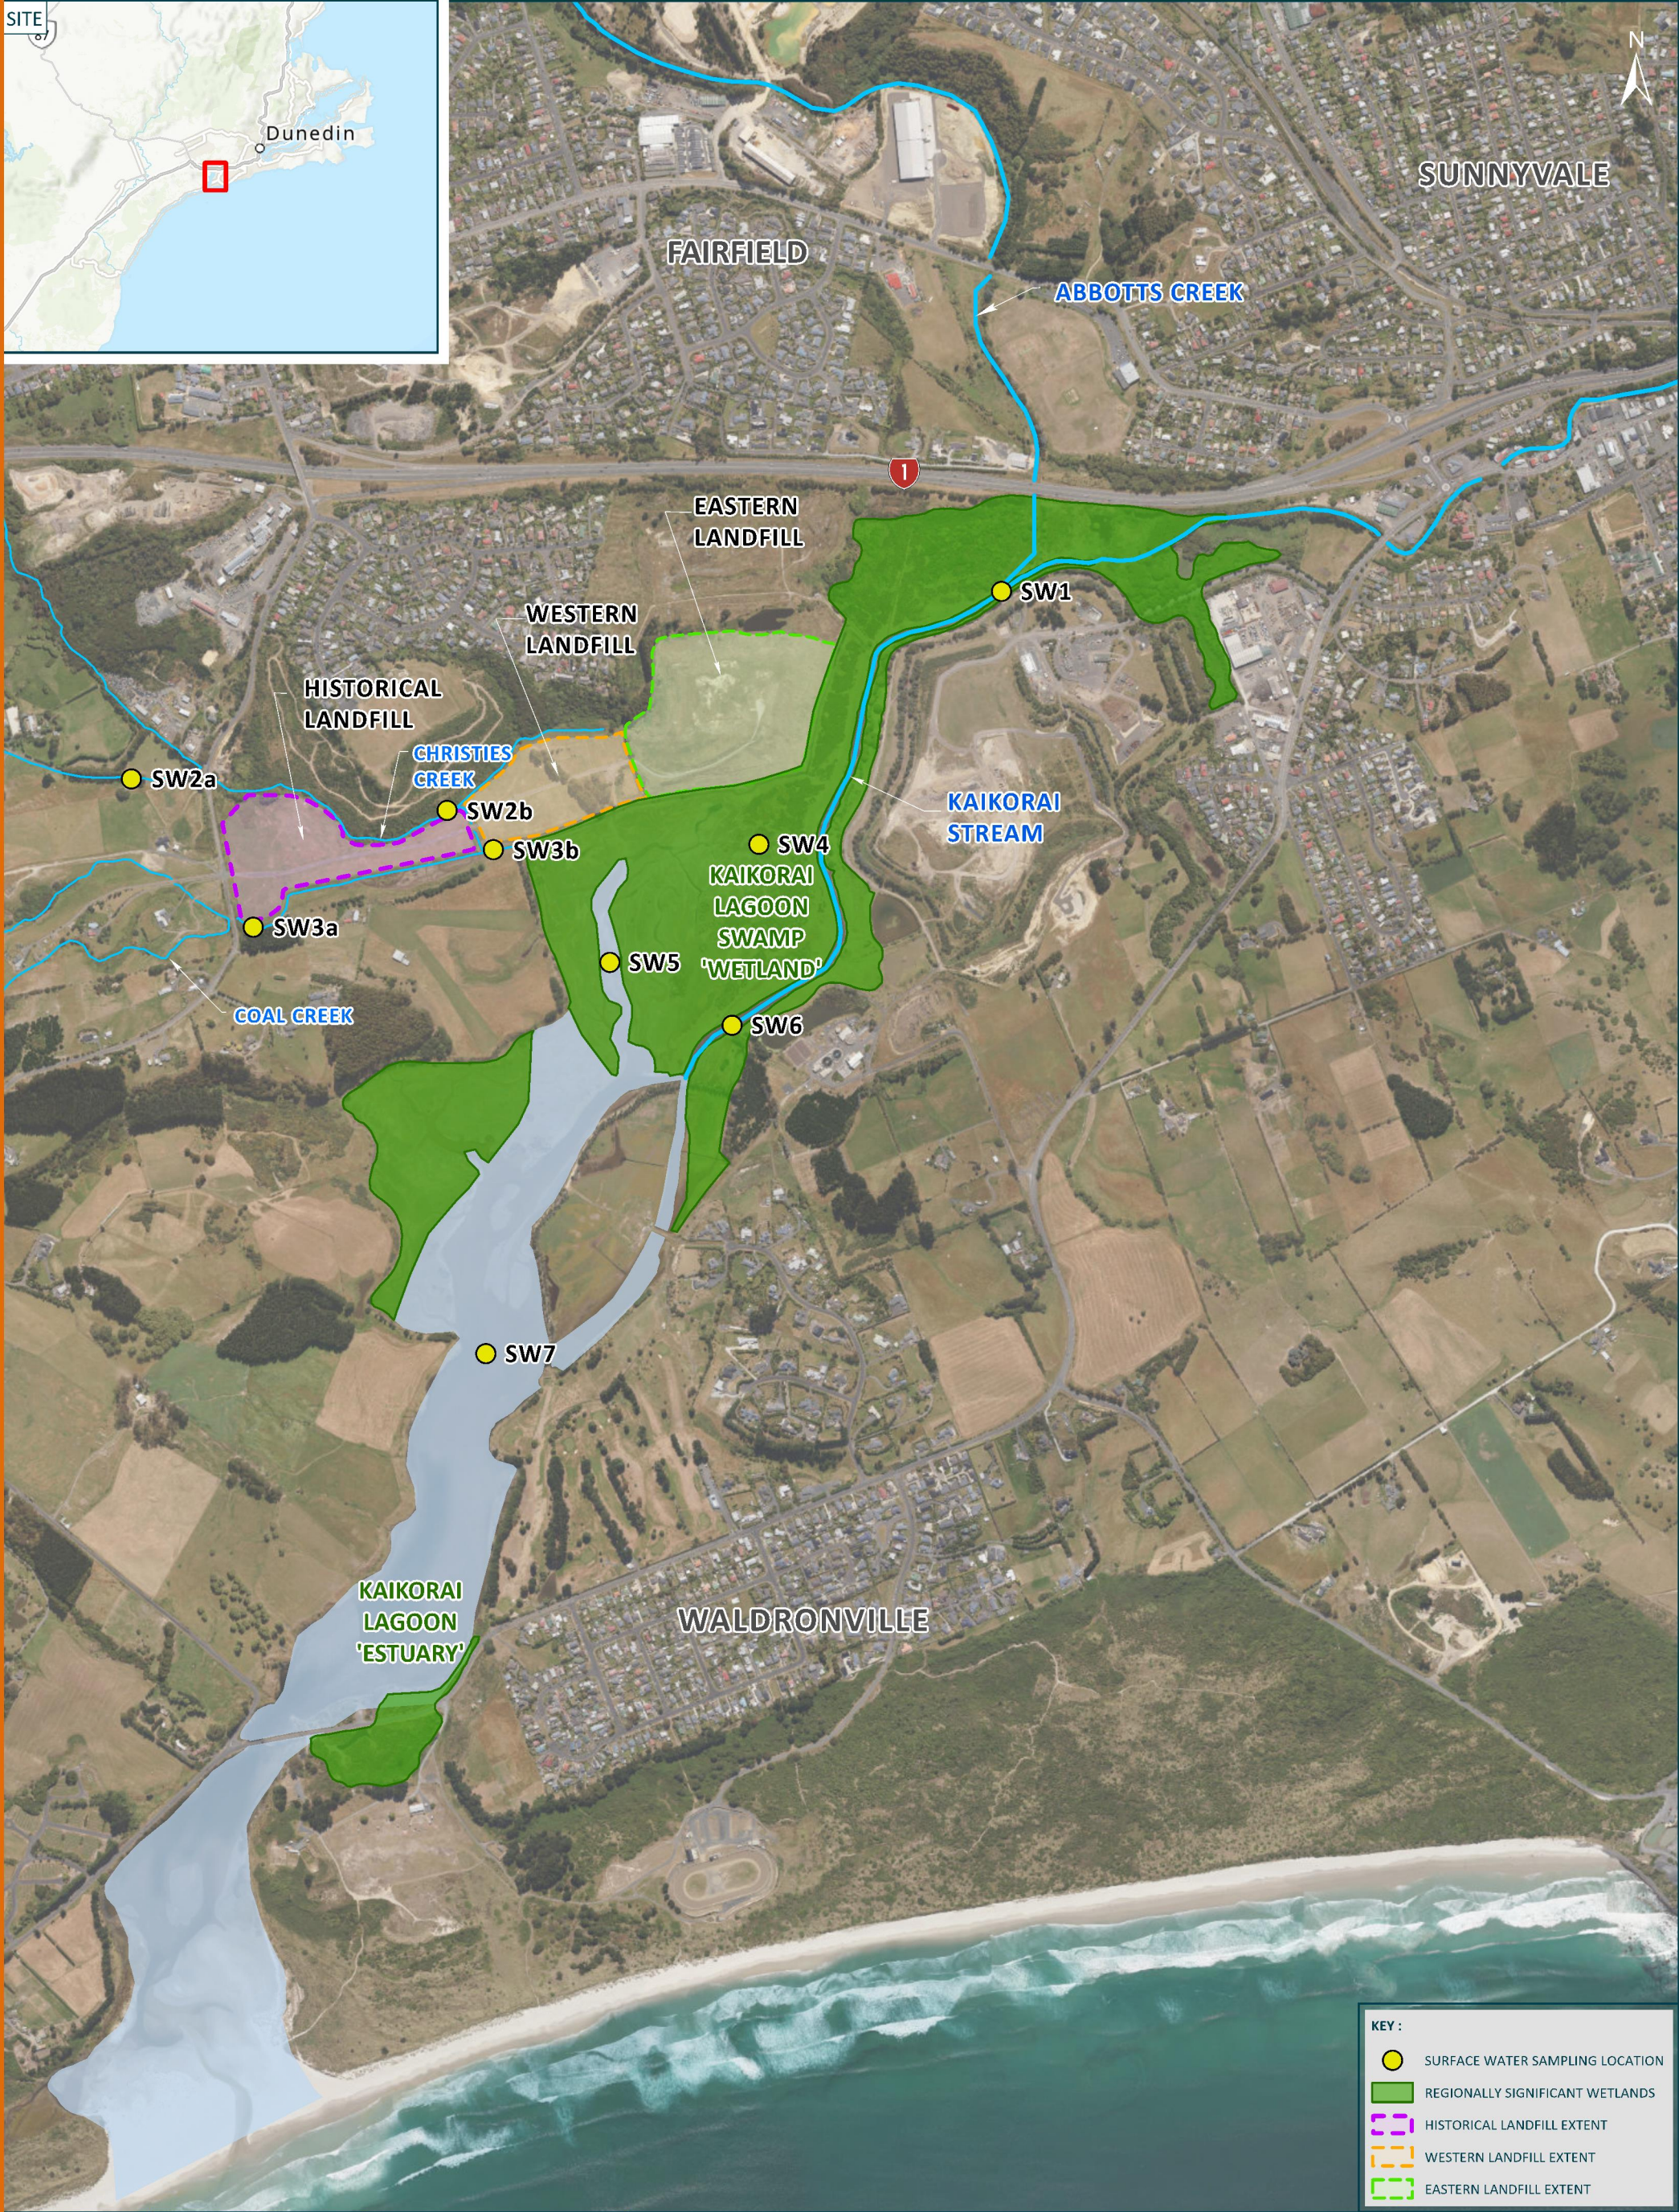
Several tributaries flow into Kaikorai Stream and/or Kaikorai Lagoon Swamp. These include Kaikorai Stream (from the NE), and Christies Creek and Coal Creek (from the NW). These waterways are classified as 'Cool-Dry Low Elevation' streams according to the River Environment Classification (REC) (MfE, 2010).

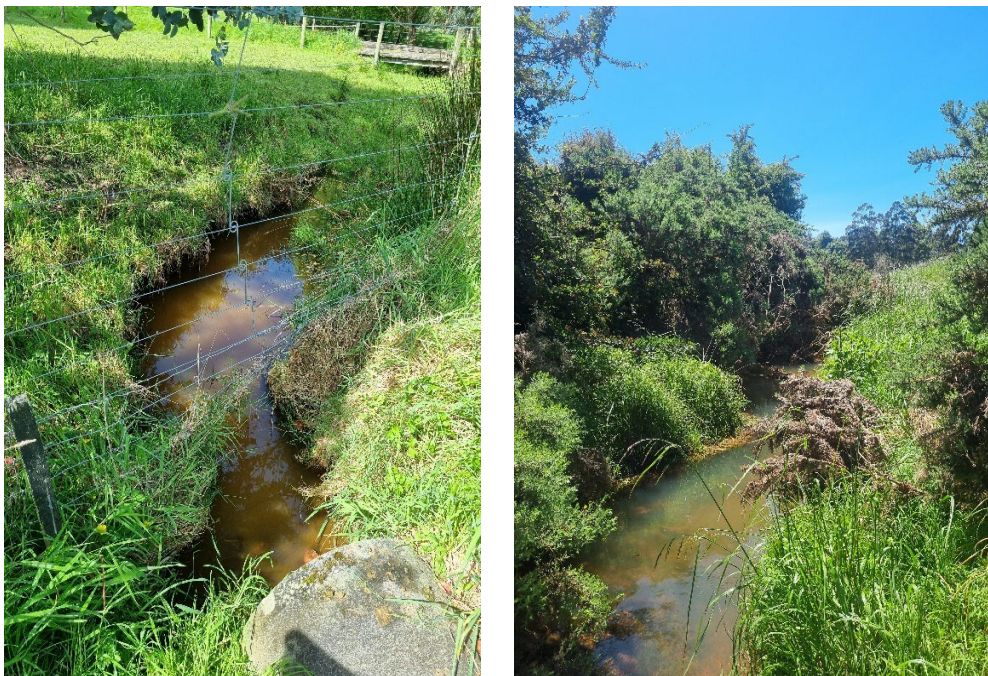
**Figure 2:** Christies Creek SW2a looking downstream (left) and Christies Creek SW2b looking downstream (right).

- ∴ **Christies Creek SW2a** was a tributary that was disconnected from the downstream channel due to a perched culvert and dense rank grasses (Figure 2). It provided some shade and fish cover via an undercut bank, but scored low for habitat provision. Due to stagnant nature of water at this site, water quality results were impacted and not suitable for comparison with other sites (Table 5).

- ∴ **Christies Creek SW2b**, located downgradient of the Historic Landfill, had a wide riparian buffer with mature vegetation on the true left and rank grass with shrubs on the true right (Figure 2). Abundant fish and invertebrate cover from overhanging vegetation, undercut banks, and woody debris resulted in a high habitat score. Figure 3 shows a culvert that is situated upstream of the confluence with Coal Creek.

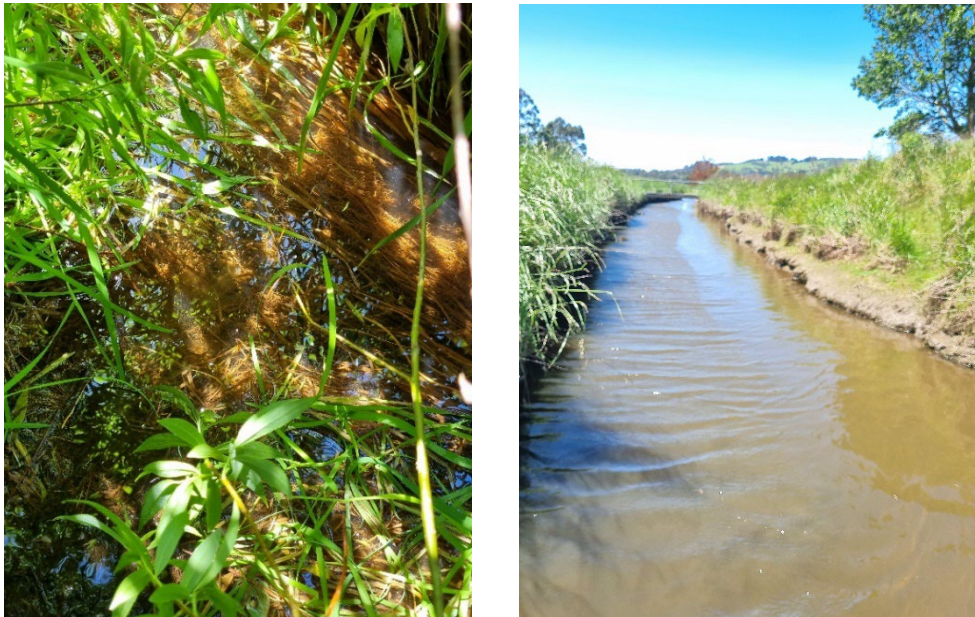
**Figure 4:** Coal Creek SW3a (left) and Coal Creek SW3b (right).

- ∴ **Coal Creek SW3a** had a dense stand of juvenile willow growing both instream and within the riparian buffer (Figure 4). While the willows appeared to choke the waterway with root mats and debris, it did provide some fish cover. Their invasive nature limited overall habitat quality, however they also contributed positively by offering shade and enhancing bank stability, which are high-scoring habitat features.

- ∴ **Coal Creek SW3b**, located in Coal Creek 50 m downstream of the Christies Creek confluence, was at the interface of fresh and estuarine conditions (Figure 4). Salinity measured 0.9 ppt (low-brackish) (ANZECC, 2000). Sites upstream of this location were freshwater. The site had riparian buffers consisting of long rank grass, which provided limited shade but contributed to bank stability. Fish cover included overhanging vegetation and undercut banks, though it was not abundant.

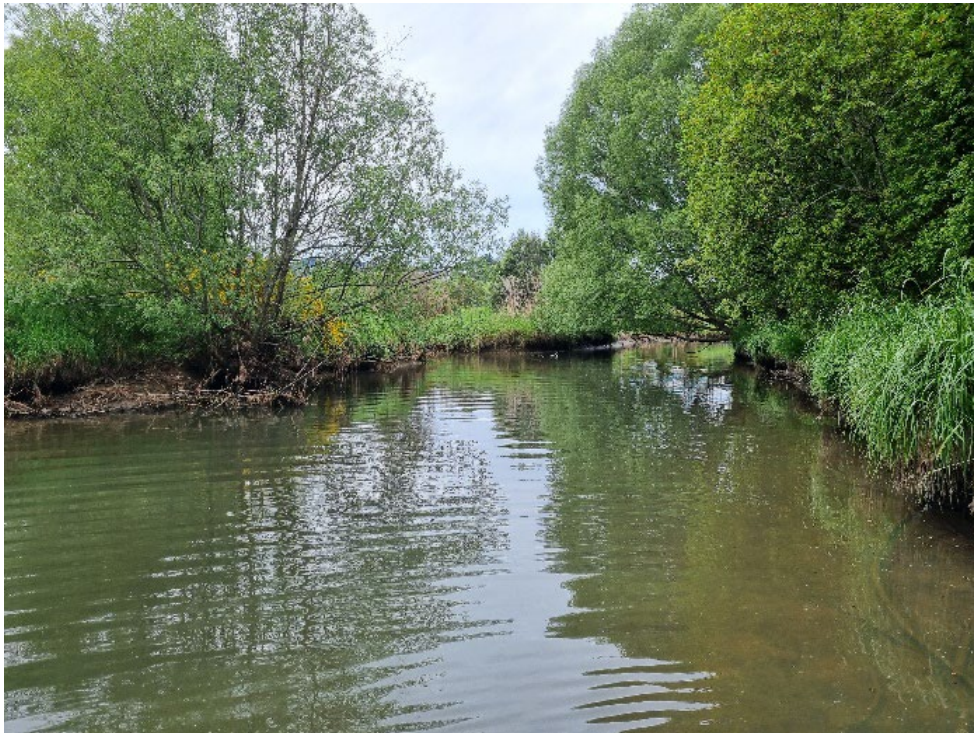
**Figure 5:** Kaikorai Stream (SW1) looking upstream.

- ∴ **Kaikorai Stream SW1** was located in the Kaikorai Lagoon 'Wetland' (Figure 5). The stream channel featured undercut banks abundant with overhanging vegetation with some woody debris, providing habitat for fish and invertebrates. The site also exhibited a high cover of deposited fine sediment that was readily re-suspended when disturbed. The riparian zone was wide, offering moderate shade from mainly exotic riparian trees and rank grass.

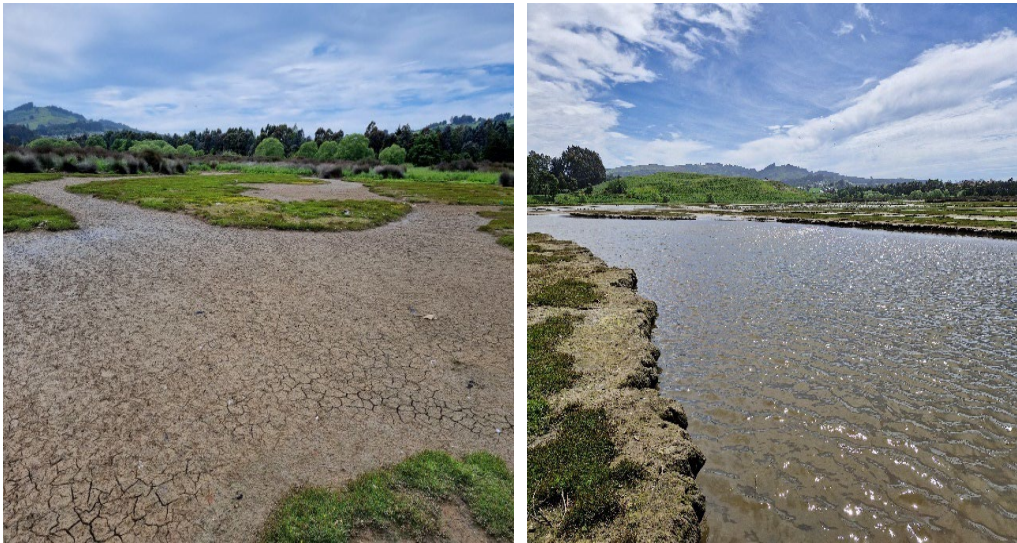
**Figure 6:** Upper estuary site SW4 looking north (left) and SW5 looking upstream (right).

- ∴ **Upper estuary SW4** was located in the Kaikorai Lagoon 'Wetland', approximately 150 m west of the main Kaikorai Stream (Figure 6). Unlike SW5, this site lacked a distinct channel, was dry, and did not appear to experience tidal inundation.
- ∴ **Upper estuary SW5** was located in the Kaikorai Lagoon 'Wetland' (Figure 6). The estuary channel substrate was predominantly fine sand. Limited fish and invertebrate cover was present with undercut, but eroding banks.

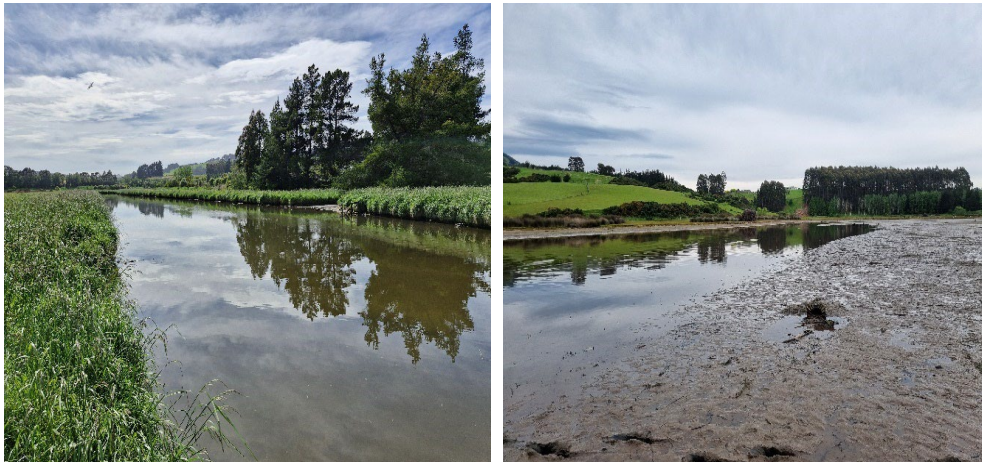
**Figure 7:** Kaikorai Stream SW6 looking upstream (left) and Central Estuary Site SW7 looking upstream (right).

- ∴ **Kaikorai Stream SW6** was located in the upper estuarine reach of Kaikorai Lagoon 'Wetland'. The area contained overhanging rank grasses, providing some fish cover. Over 75% of the stream bank showed signs of erosion. The riparian buffer was wide with short dense rank grass/vegetation and little shade. Some woody debris provided instream habitat. Soft sediment was the dominant stream bed substrate, becoming resuspended when disturbed.

**SW7** was located in the central estuary, this was the most downstream site, where the convergence of all the tributaries forms one main channel. The substrate at this site was notably less compact, softer and more unconsolidated. The wetted channel at low tide was more predominant in the western edge. Little to no native vegetation surrounded the estuary borders at this location.

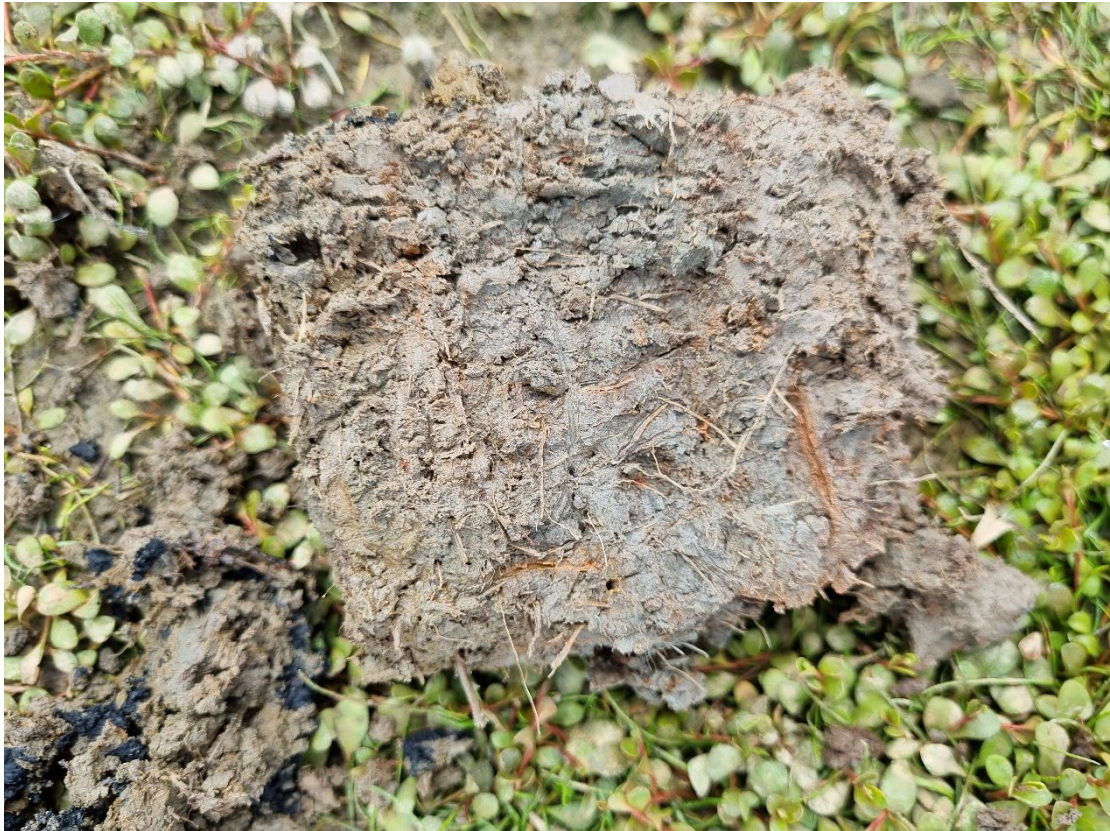
**Photograph 1: (Sediment core from Upper estuary SW4)**

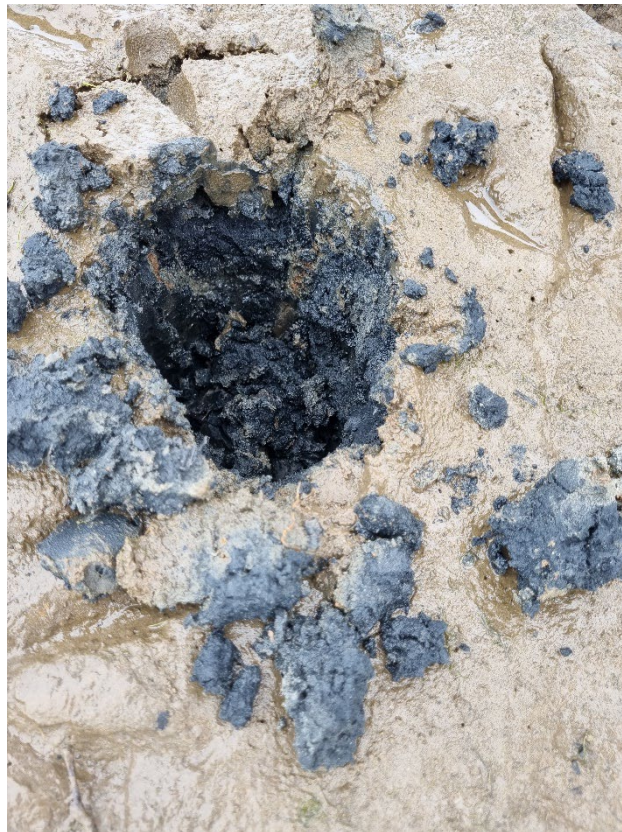
**Photograph 2: (Sediment grain size from SW4)**

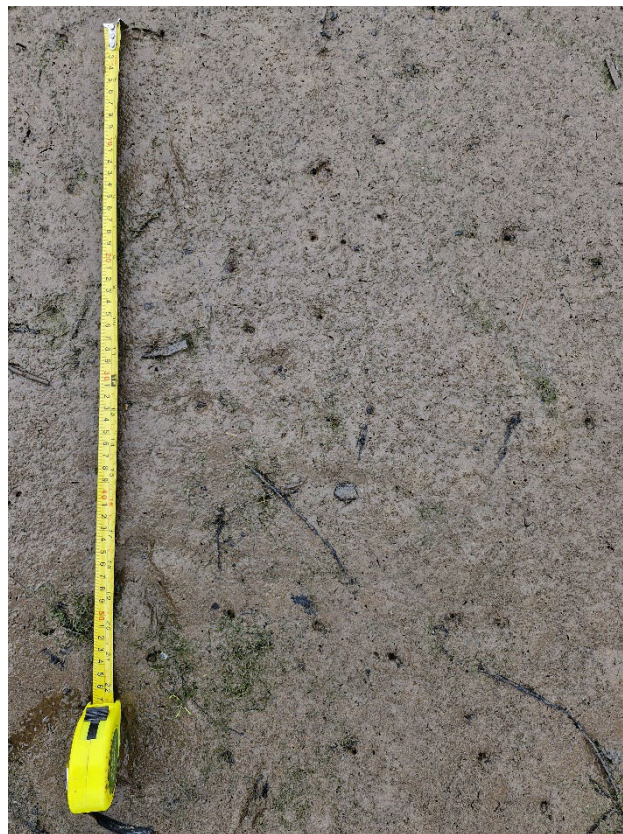
Downstream, in the central estuary at site SW7, the survey plot recorded a low cover of sea grass (less than 5%), with the remaining area being bare sand. The low percentage of seagrass at this site may indicate environmental stress or degradation. Its absence could be having flow-on effects on the overall health of the estuary.

**Photograph 4: (SW7 Vegetation Plot)**

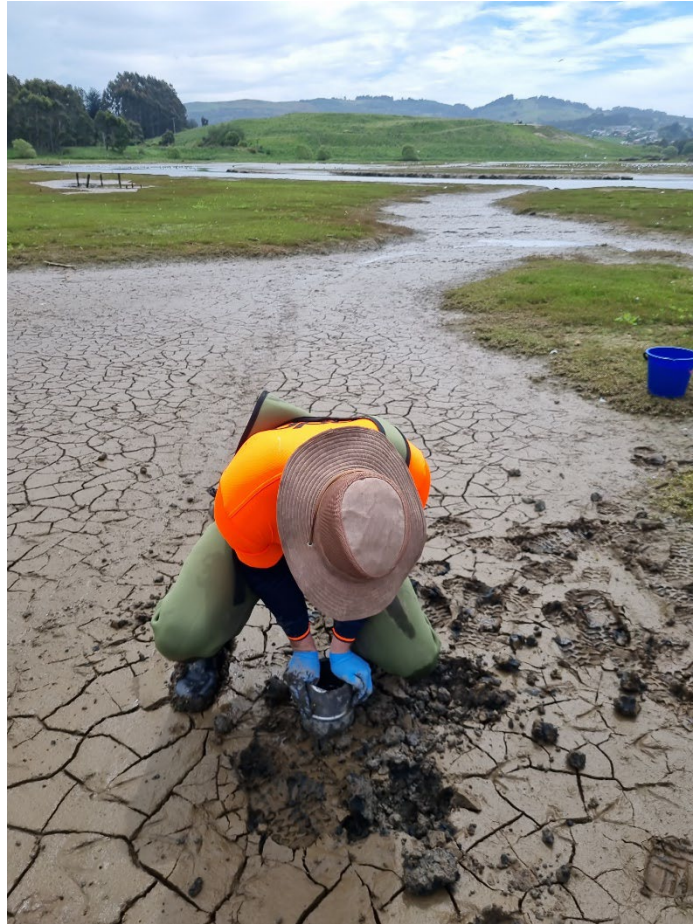
SW5 sediment cores showed an accumulation of fine sediments suggesting ongoing sedimentation. The presence of water at 0.120 m bgl indicated a shallow groundwater influence, which may contribute to anoxic conditions. Profile characteristics were:

**Photograph 5: (Sediment core in upper estuary at SW5, adjacent to the estuarine channel shown in Figure 9 of report)**

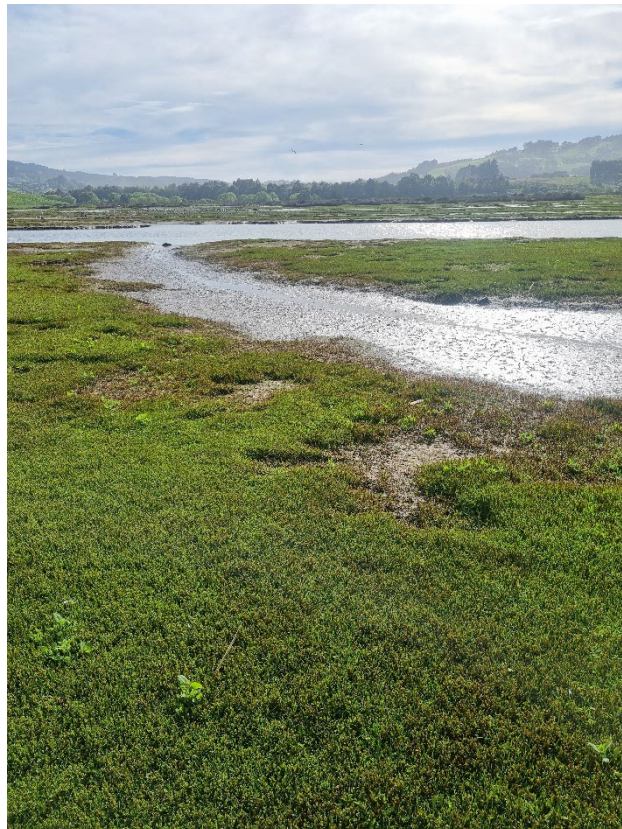
**Photograph 9: (SW5 estuarine channel, sampled channel full of water in the background)**

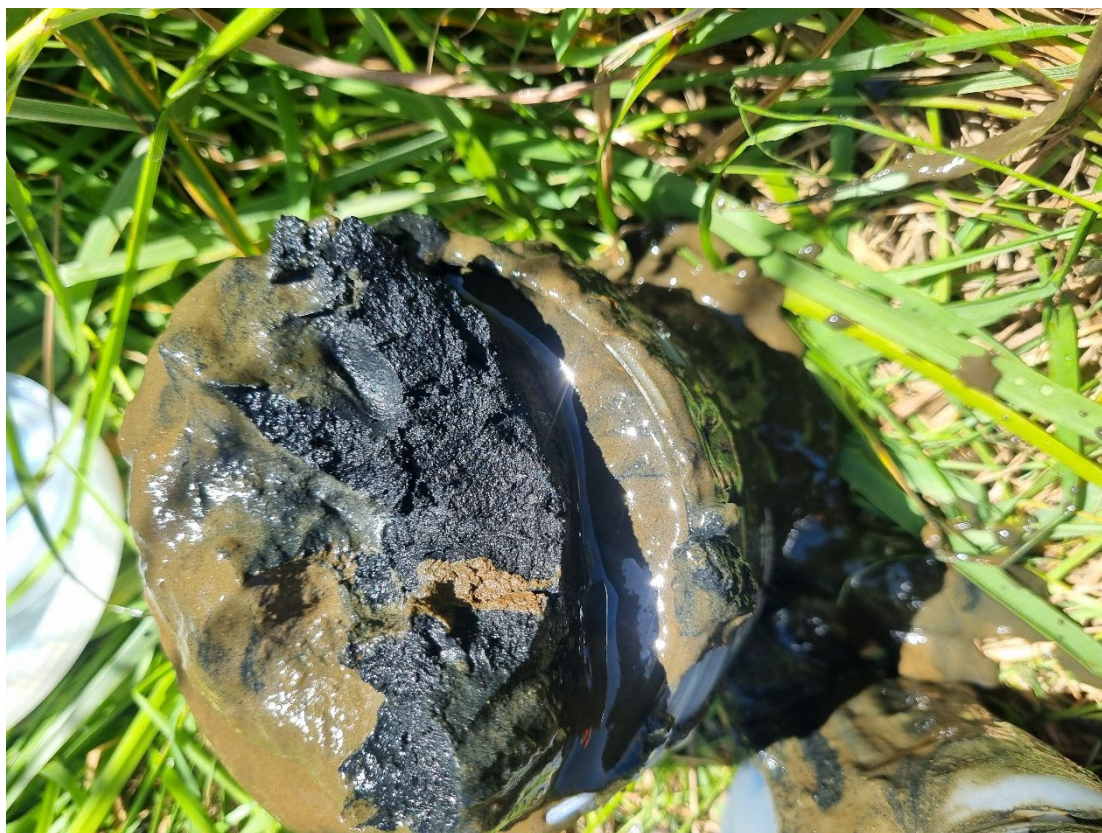
**Photograph 13: (SW3b, sediment sample)**
