Waste Futures – Green Island Landfill Closure

Surface Water Report – October 2024 Update

Dunedin City Council

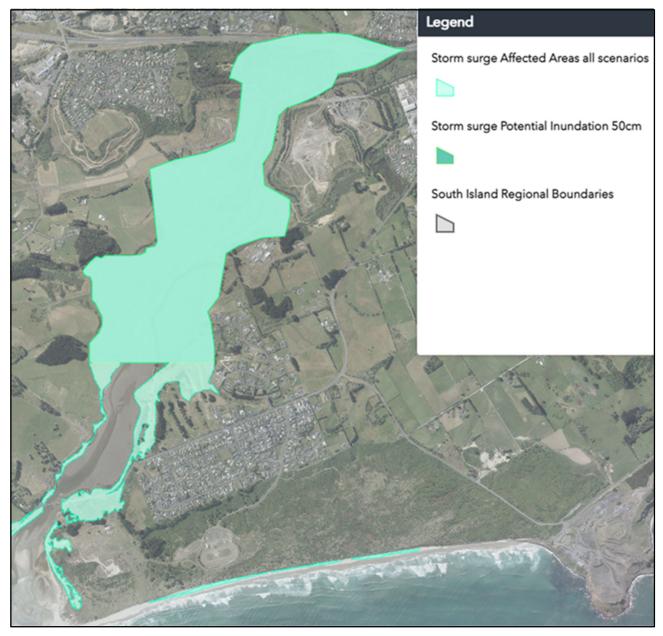
Figure 7 ORC hazard map for storm surge risk (Source: ORC Online Natural Hazards Portal, <u>www.maps.orc.govt.nz</u>)

Sea level rise may result in a general increase in water levels within the estuary and the lower reaches of Kaikorai Stream, adjacent to the landfill, and this could result in an increase in ingress of water into the leachate system via groundwater. This is discussed further in the Groundwater Technical Report (GHD 2023B).

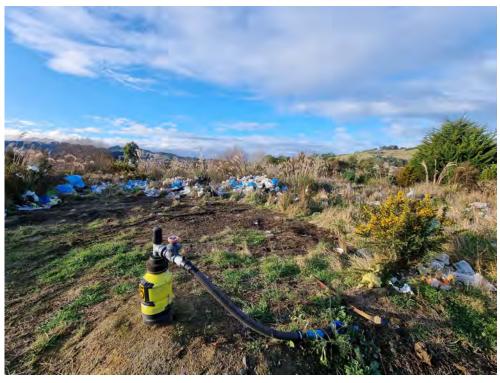
Photograph 1: Large volume of wind blown waste within the 'final cap' area outside of the litter fence.

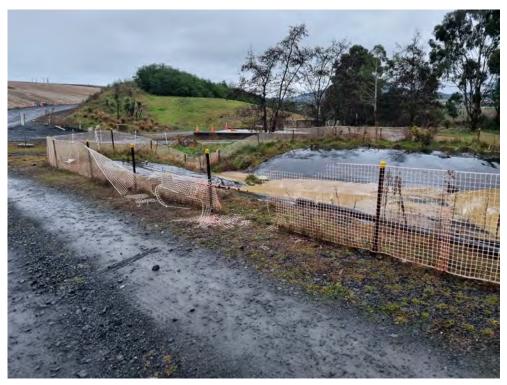
Photograph 15: Orange netting to be replaced around the silt pond, adjacent to the previous tyre storage location.

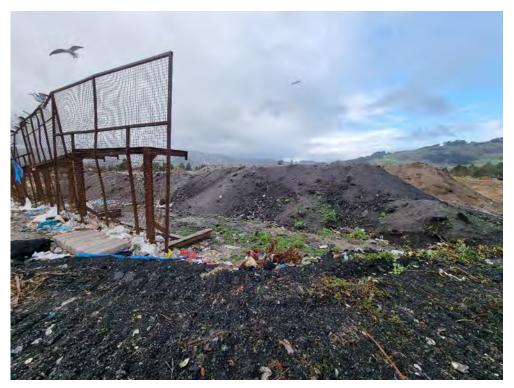
Photograph 16:The litter fence and stockpiled material within the vicinity of the tip face which will be utilised as final capping material.

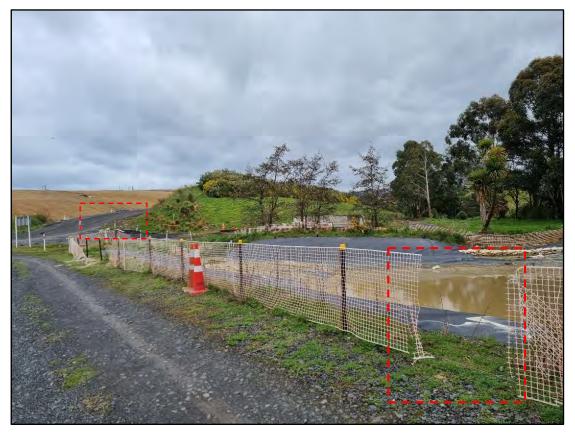
Photograph 3: Orange netting which requires replacement around the northern stormwater detention / sedimentation pond.

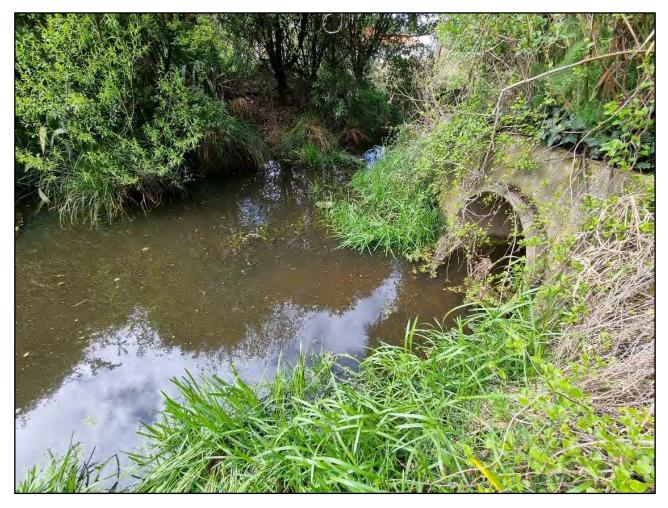
Photograph 17: The north eastern wetland, with outflow pipe from south eastern wetland to the right of picture. High water levels can be noted.

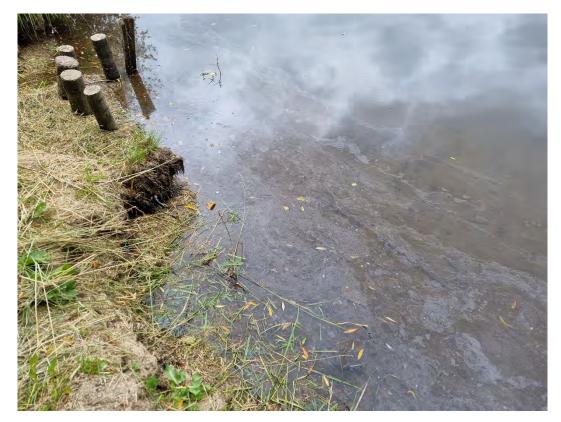
Photograph 12: Biological sheen noted on the surface water adjacent to GI3 in the Kaikorai Stream.

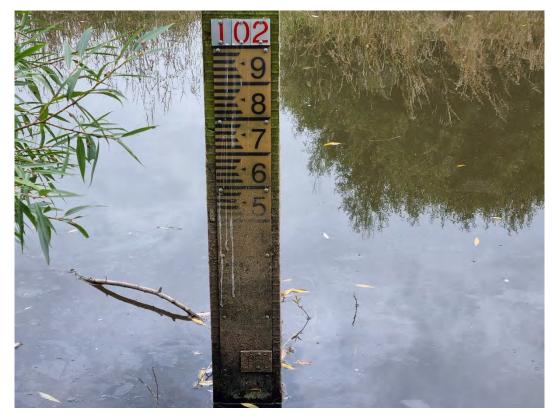
Photograph 13: All staff gauges require cleaning to make the numbers and ticks legible.

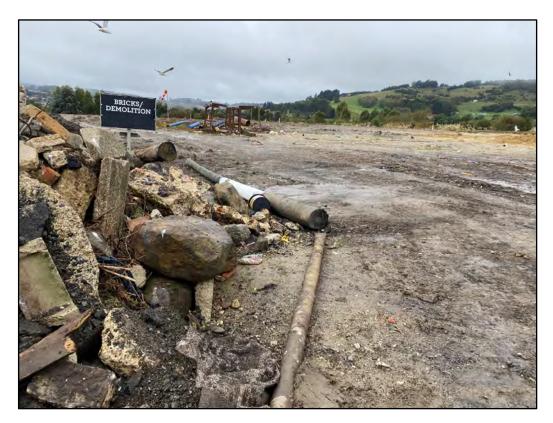
Photograph 5: Timber and buckets noted present in the bricks / demolition waste stockpile.

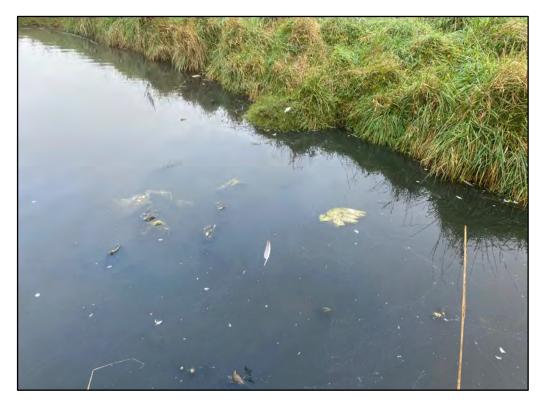
Photograph 6: Wind-blown litter present on the surface and base of the Western Sedimentation Pond
