# **Toitū Te Hikapupu/Pleasant River Restoration Project**

## **Year 4 Monitoring Report - to June 30, 2025**

Date: 14 October 2025

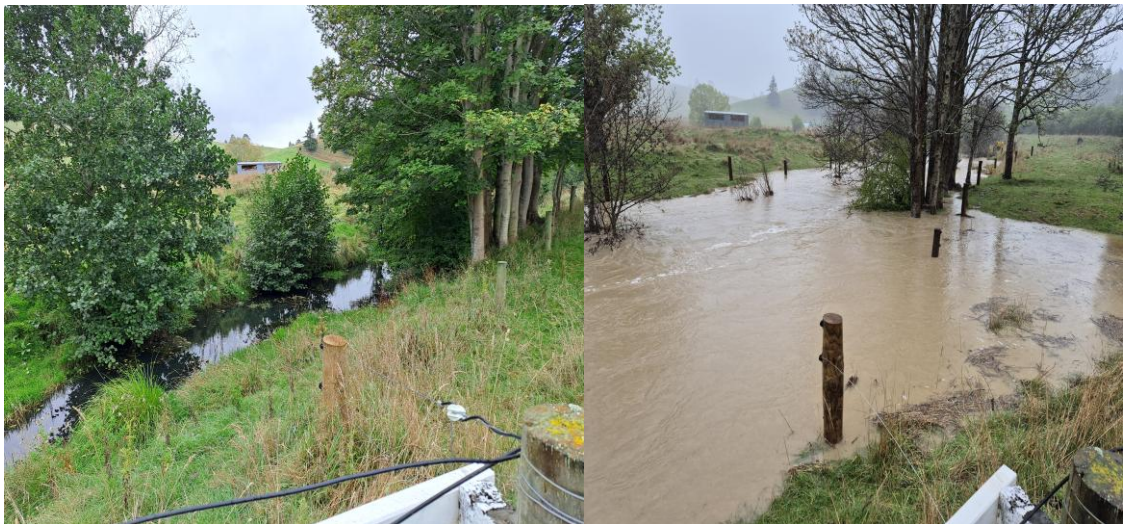
Figure 6. Te Hikapupu/Pleasant River at the Stenhouse Road bridge at low discharge in November 2023 (left) and at high discharge in October 2024 (right).

Grab samples were taken across the full range of discharge volumes observed during the monitoring period (Figure 5). An illustration of this range is shown in Figure 6 with photographs taken from the bridge on Stenhouse road.

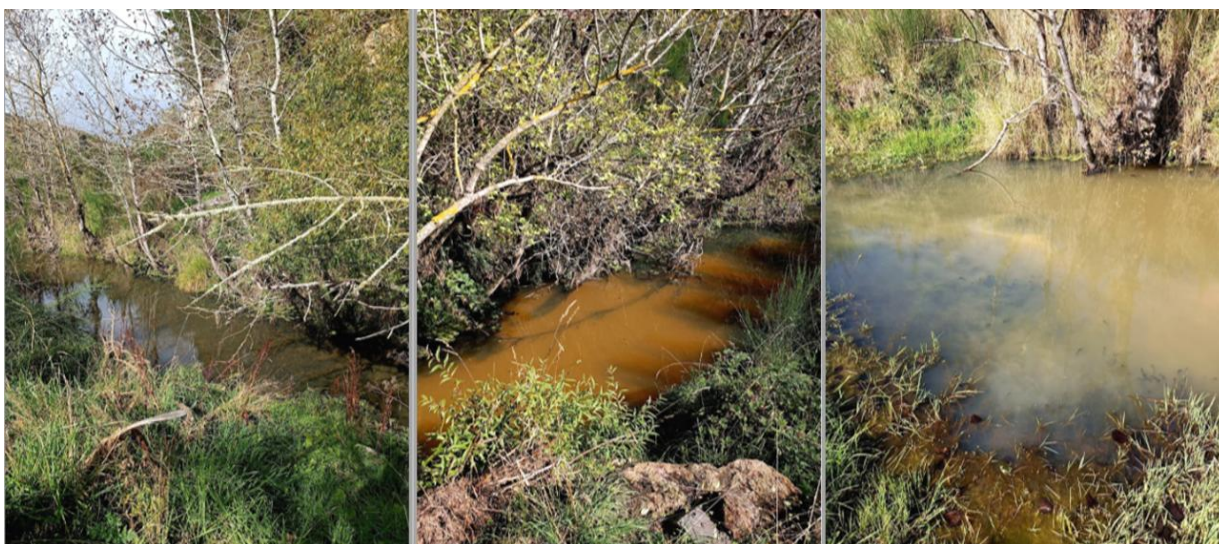
Figure 11. Examples of water discolouration associated with groundwater seeps and microbial iron oxidation in Te Hākapupu/Pleasant River.

Areas of temporary localised turbidity occur in Te Hākapupu/Pleasant River (Figure 11). The colouration potentially comes from iron oxide (essentially rust) produced by iron-oxidising bacteria as part of their biological process and occurs when groundwater with low-oxygen and high iron content meets surface water with higher oxygen concentrations (Blöthe and Roden, 2009). It may also be related to the type of base rock, which has high levels of iron.

During monitoring at the mid Hikapupu site it was observed that there was significant water discolouration immediately upstream in the absence of any noticeable inputs from surface discharge (Figure 11). The discolouration occurred over approximately 50m, with the orange colour indicating the presence of oxidising bacteria (see section 5).

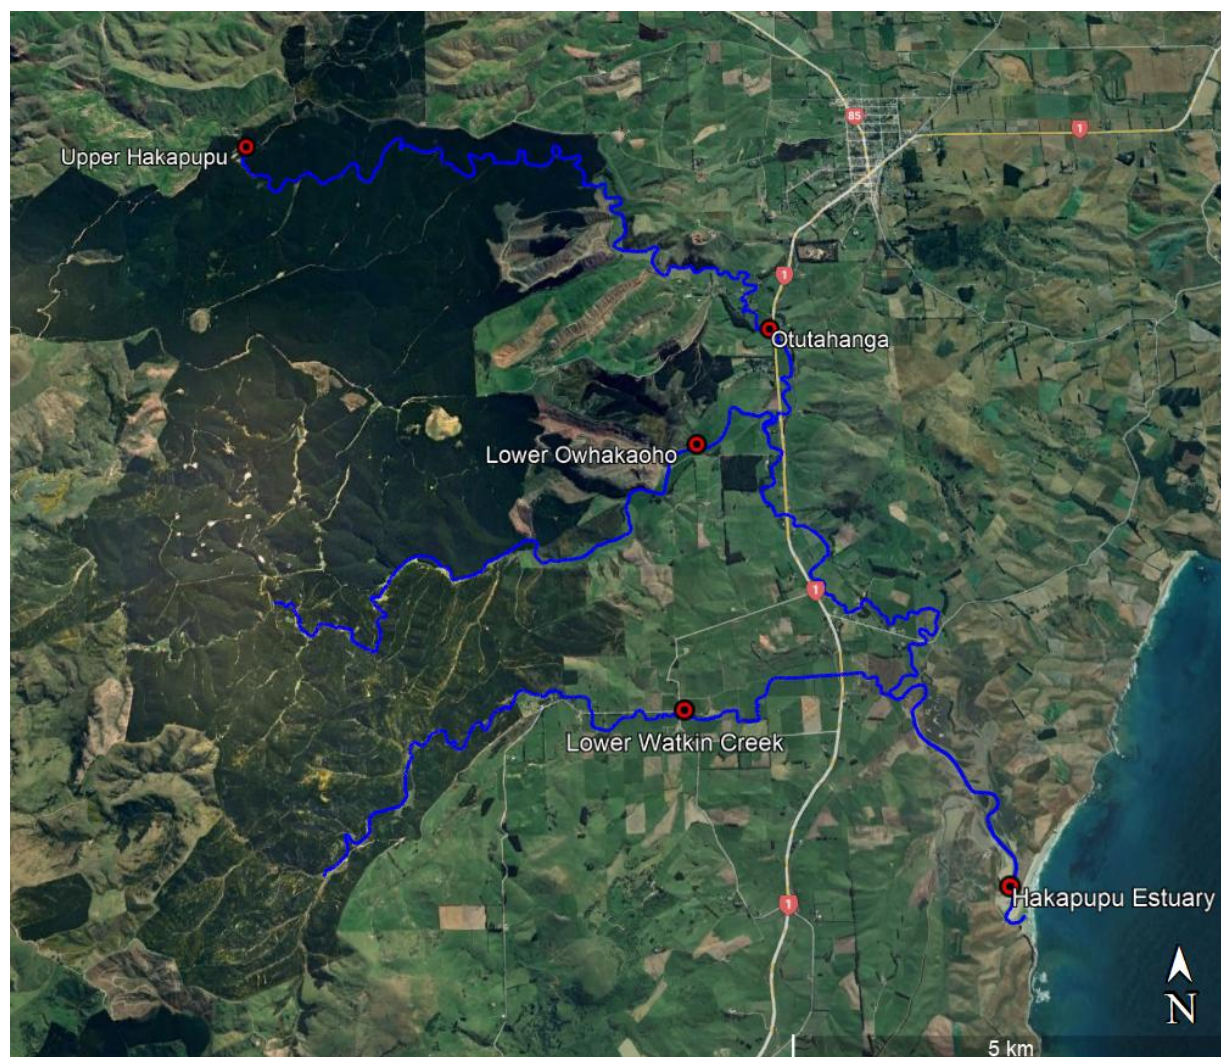
Figure 13. Locations of fish monitoring sites in Te Hākapupu/Pleasant River catchment.

Kāti Huirapa Rūnaka ki Puketeraki undertook fish surveys in March 2024 to compliment the ecological monitoring undertaken in the previous year. River discharge at the time was low, with no surface flow connection through much of the mid to lower catchment and habitat was restricted to isolated pools. Monitoring was undertaken at four freshwater sites and one estuary site in Te Hākapupu catchment

(Figure 13) using hīnaki (fyke nets) in the river and drag nets in the estuary. Three hīnaki were set overnight at each site and baited with paua offal, while drag nets were dragged in 100m runs on an incoming tide.

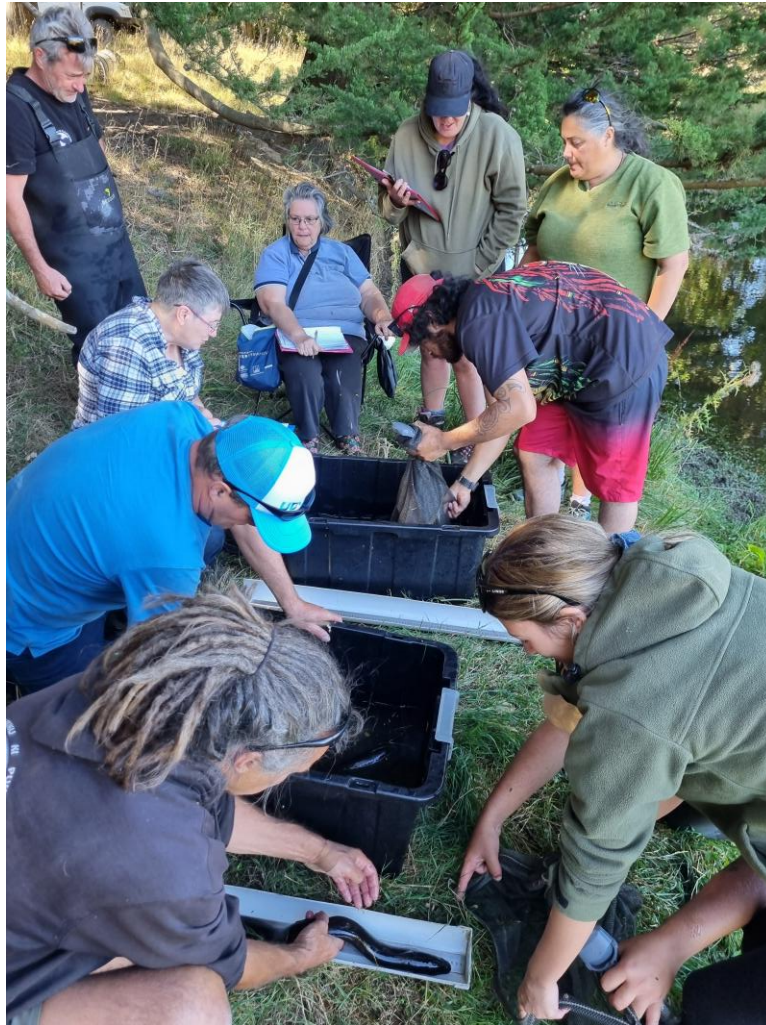
Figure 14. Rūnaka members measuring and weighing tuna at the Otutahanga (Paterson Road) monitoring site.

All tuna (eels) captured were measured and weighed (Figure 14), while smaller species were identified to the species level and measured.

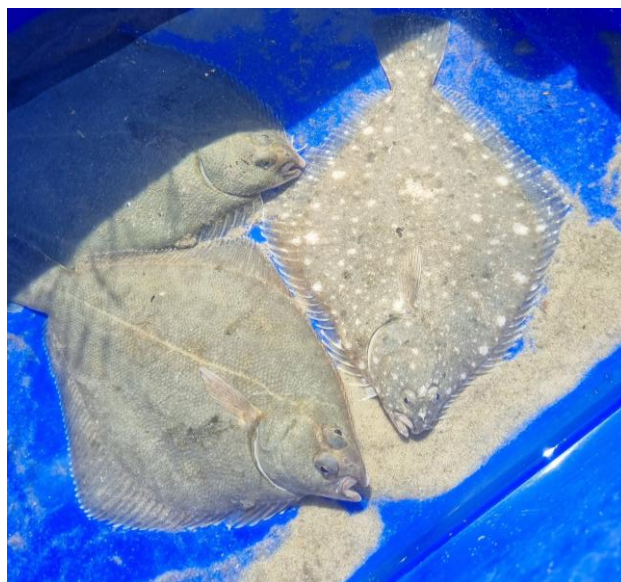
Figure 17. Pātiki (sand flounder) captured in Te Hākapupu/Pleasant River estuary.

From the 6,000m<sup>2</sup> of habitat sampled, a total of five pātiki (sand flounder, *Rhombosolea plebeia*) were captured that measured between 27 and 30cm (Figure 17).

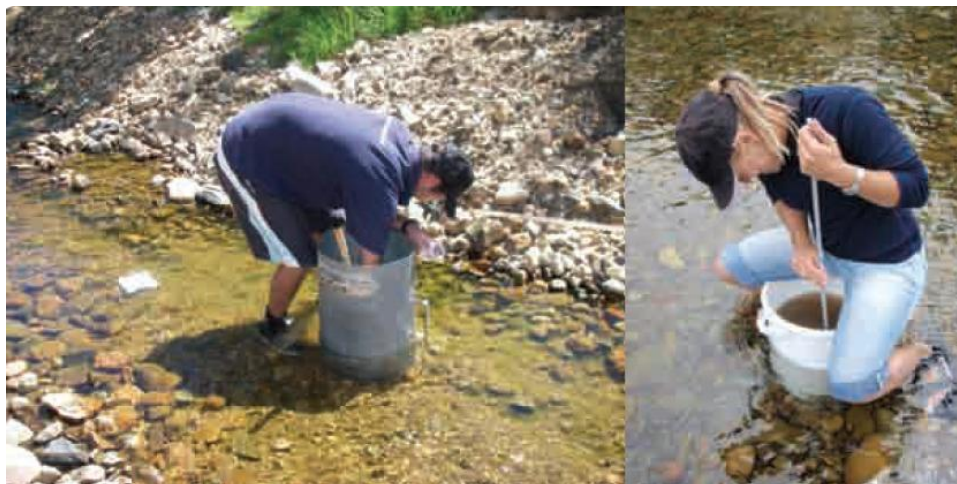
Figure 19. Photos of sample collection using the Quorer method.

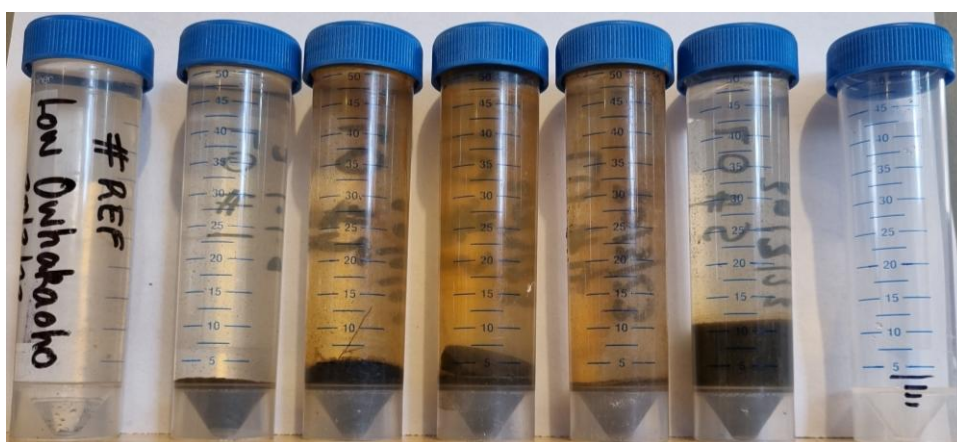
Figure 20. Sediment samples taken using the Quorer method.

At least five replicates are taken from each site, and water in each sampling tube is allowed to settle for 24 hours before measuring the total volume of sediment in each tube (Figure 20). For a more detailed sediment analysis, samples can be sent to a laboratory to assess the amounts of organic and inorganic sediment within each sample. The volumetric Quorer method is simpler, quicker, and less cost compared to the weight-based assessment that requires specialist equipment and laboratory analysis.

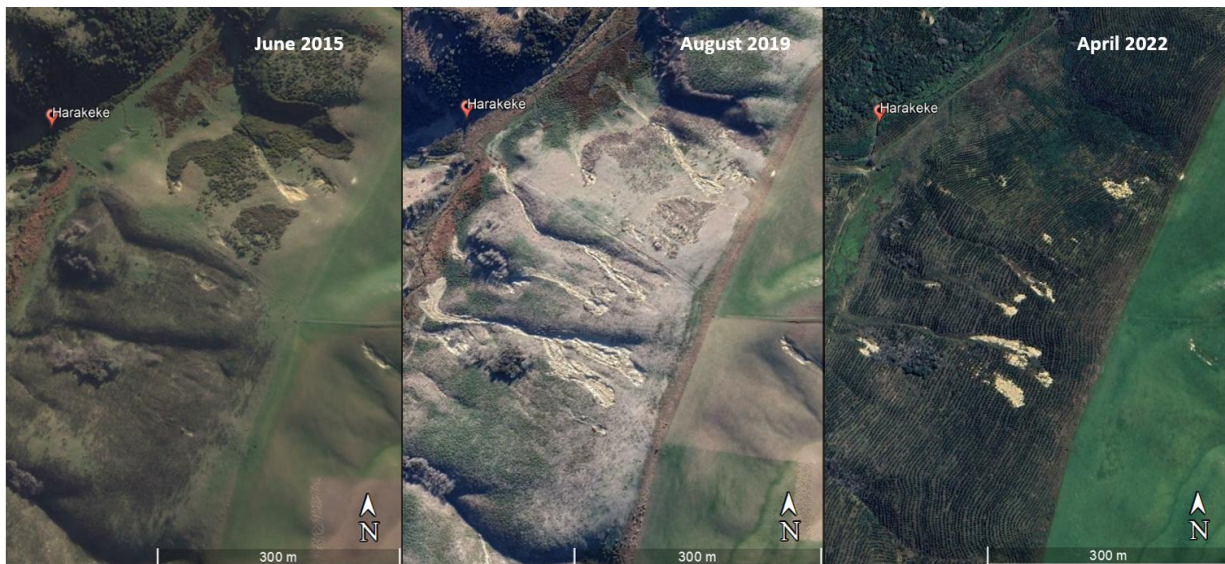
Figure 23. Time series photos of changes in vegetation cover and resulting erosion at the Harakeke monitoring site following aerial spraying in 2017 in preparation for planting of commercial forestry.

Observations made during the 2021/22 monitoring suggest the high levels of sediment may have been due to erosion caused by the aerial spraying of land near the Paru site in preparation for planting forestry. There is evidence of erosion in satellite imagery in the years preceding the project of the hills on the true right of Watkin Creek, upstream of the Paru site (Figure 23).

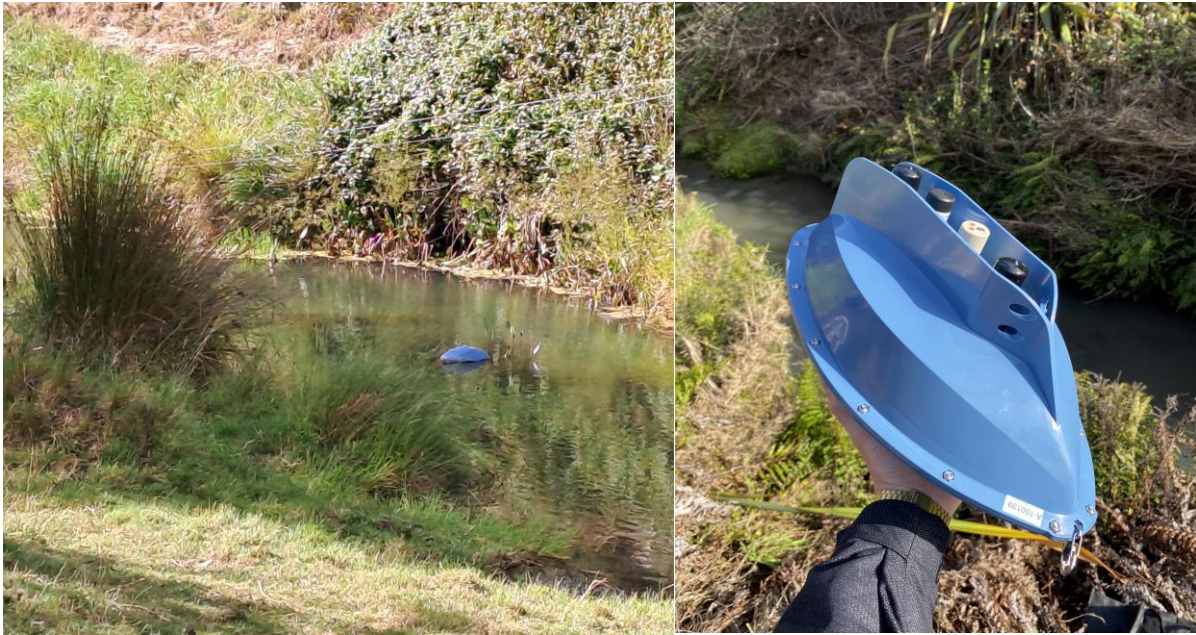
Figure 26. Aquawatch 'Waka' in Te Hikapupu/Pleasant River (left) and showing the water quality sensors (right).

Aquawatch ‘Waka’ (Figure 26) are a recently developed technology that enables high-frequency water quality monitoring. The waka relay results for turbidity, dissolved oxygen, temperature, pH, and conductivity at fifteen-minute intervals to a website. The data is checked by Aquawatch and is made available through the dashboard on their website, where it can be viewed as a time series for each analyte.

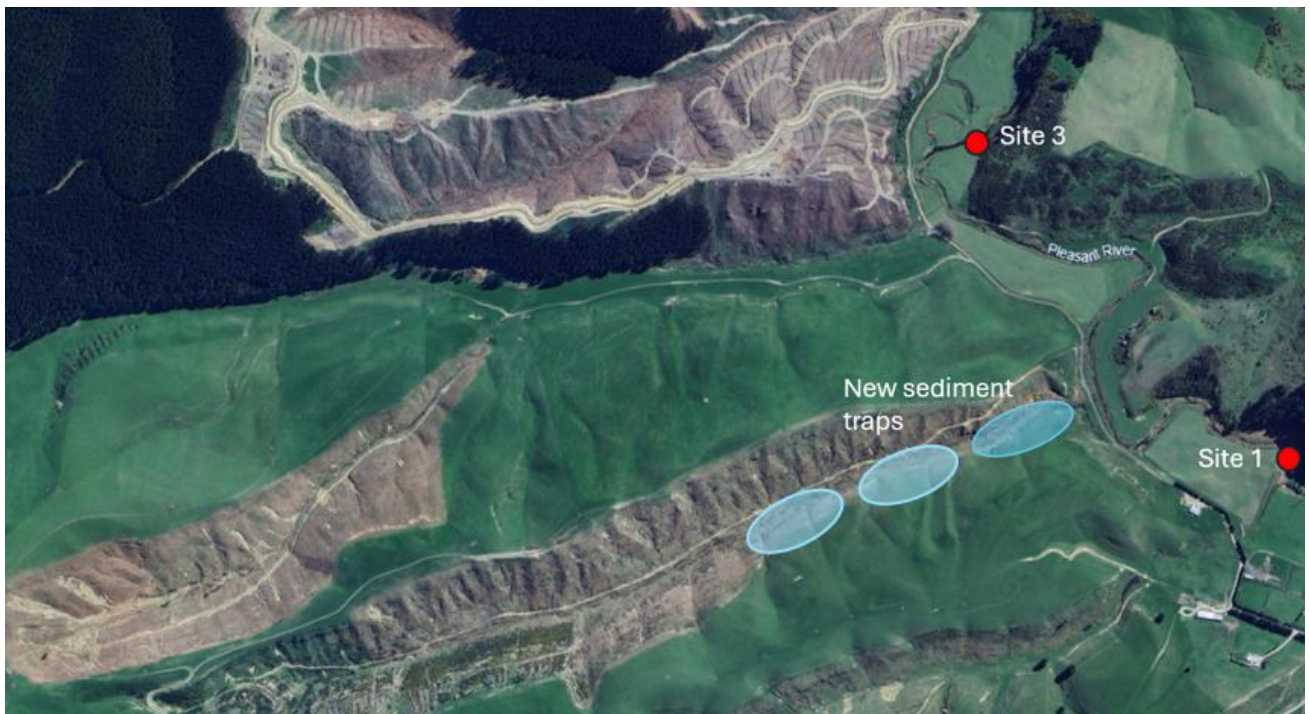
Figure 31. The sub-catchment area with recent commercial forest harvest and area of active erosion on adjacent farmland (including indicative locations of sediment traps) established in 2023 from which discharge into Te Hikapupu/Pleasant River was monitored with Aquawatch waka. Site 3 is upstream of the erosion-prone sub-catchments and site 1 is downstream of the sub-catchments.

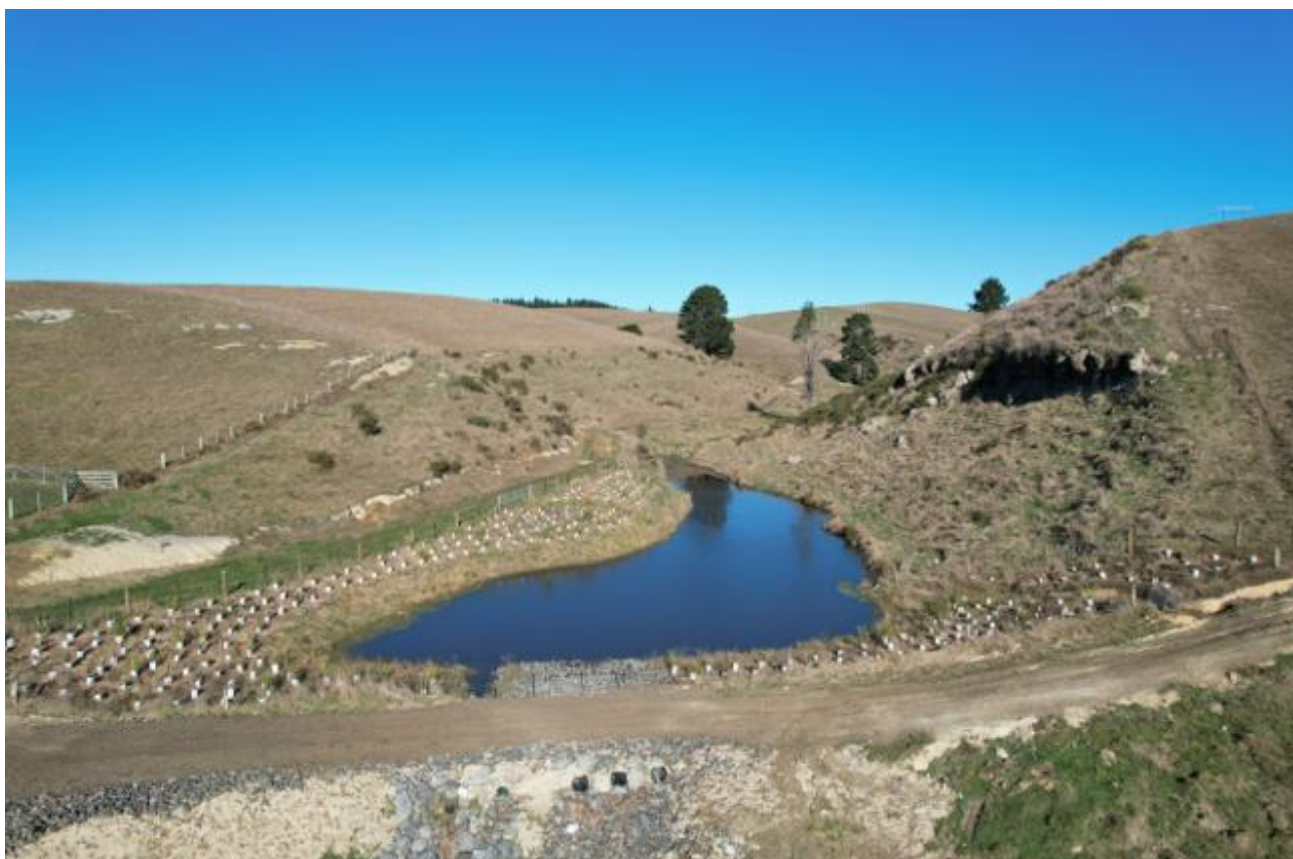
Figure 32. One of the series of sediment traps (shown by the blue ovals in Figure 31) established in June 2024, part way through the monitoring period, in the watercourse within an erosion prone gully on farmland discharging into Te Hikapupu/Pleasant River.

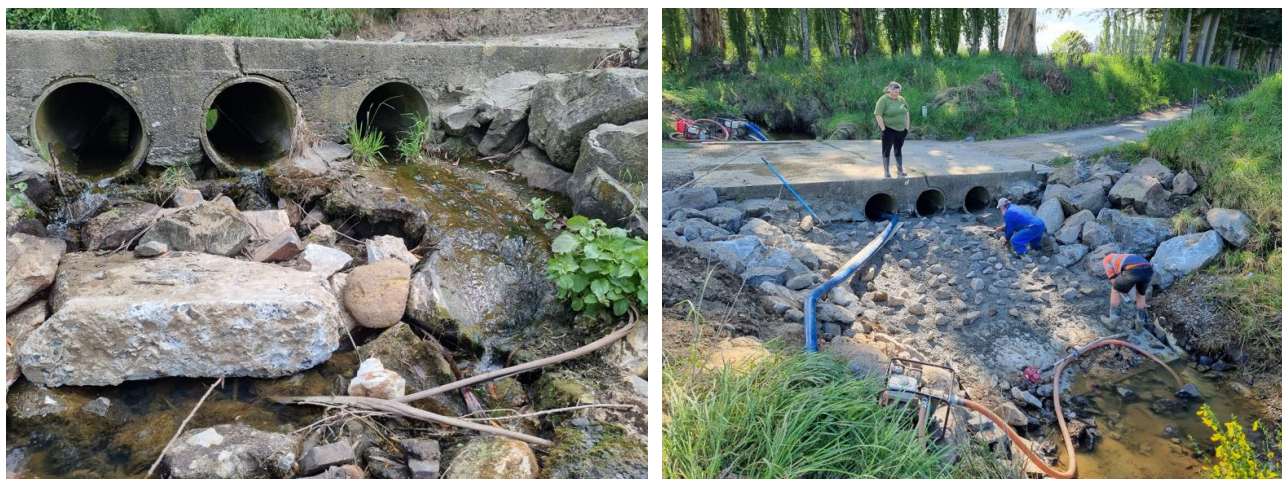
Figure 35. The Brooklands Road ford before (left image) and during (right image) construction of a rock ramp to improve fish passage.

In response the Toitū Te Hākapupu project has established a rock ramp at the Brooklands and Patterson Road fords and has facilitated three additional farm culvert replacements. These improvements have resulted in a marked increase in fish passage in the lower Hākapupu catchment.

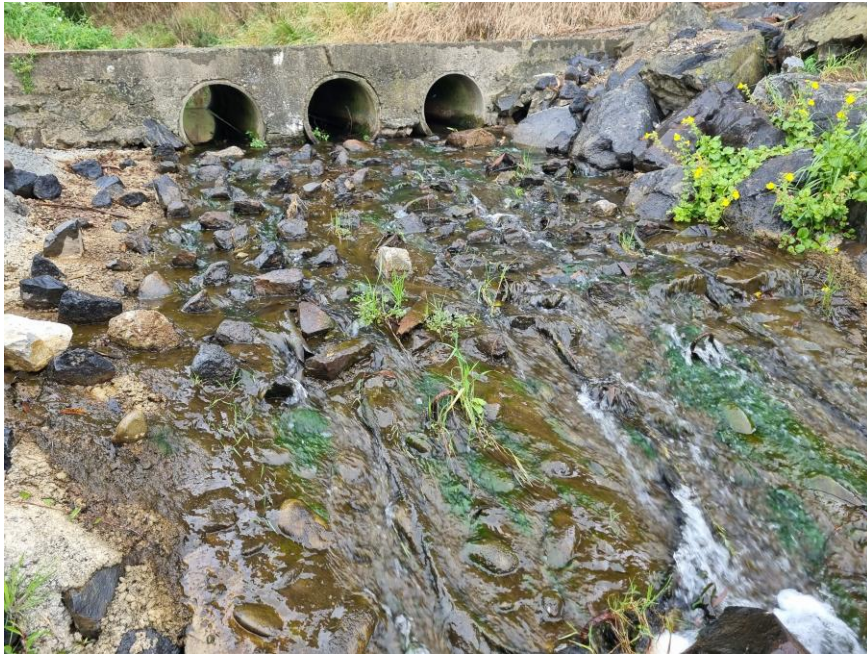
Figure 36. The established rock ramp at Brooklands Road ford.
