**Otago Alluvial Fans Project: Supplementary
maps and information on fans in selected
areas of Otago**

**GNS Science Consultancy Report 2009/052
April 2009**

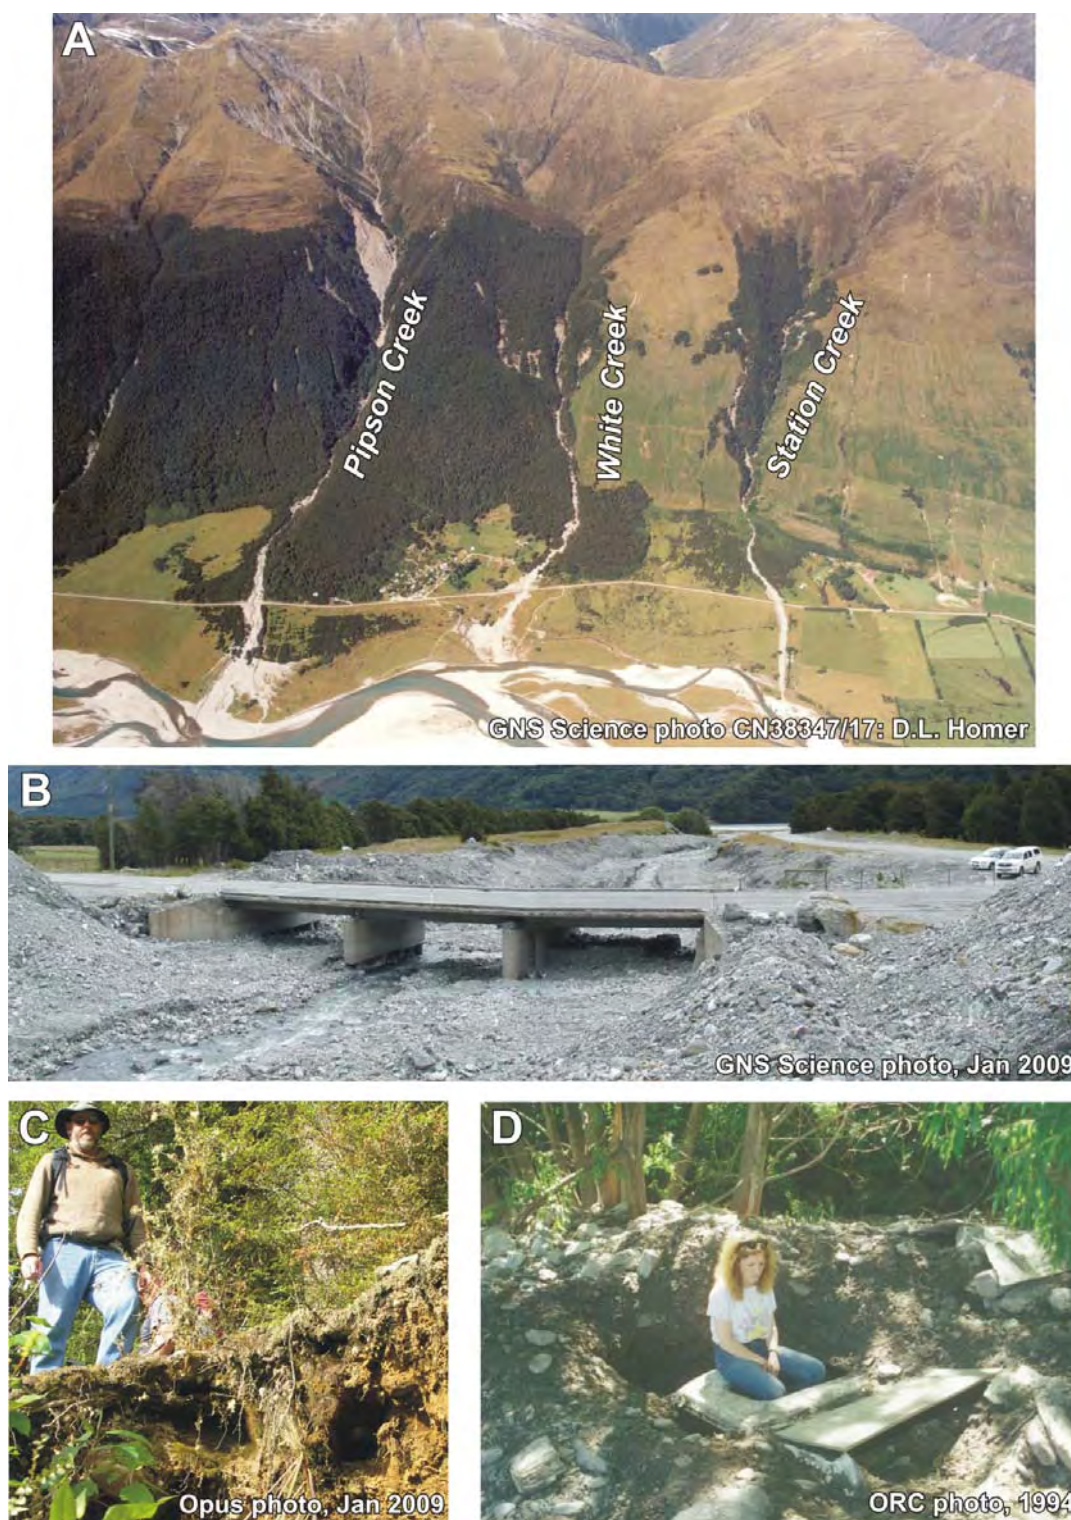
Figure 4: Features of fans at Makarora. (A) In this aerial view of Makarora, the 'fan active' beds of Pipson, White and Station creeks are easily identifiable by their bare sediment. The active bed of Makarora River (foreground) flows from left to right. (B) The 'fan active bed' of Pipson Creek at State Highway 6 is constrained within artificial embankments of gravel. (C) Mature brown-weathered soil on a 'fan less recently active' terrace surface on the north side of White Creek. (D) Aggradation at Wharf Creek during a high-intensity rainstorm in 1994 buried this car (shown with its sunroof exhumed).

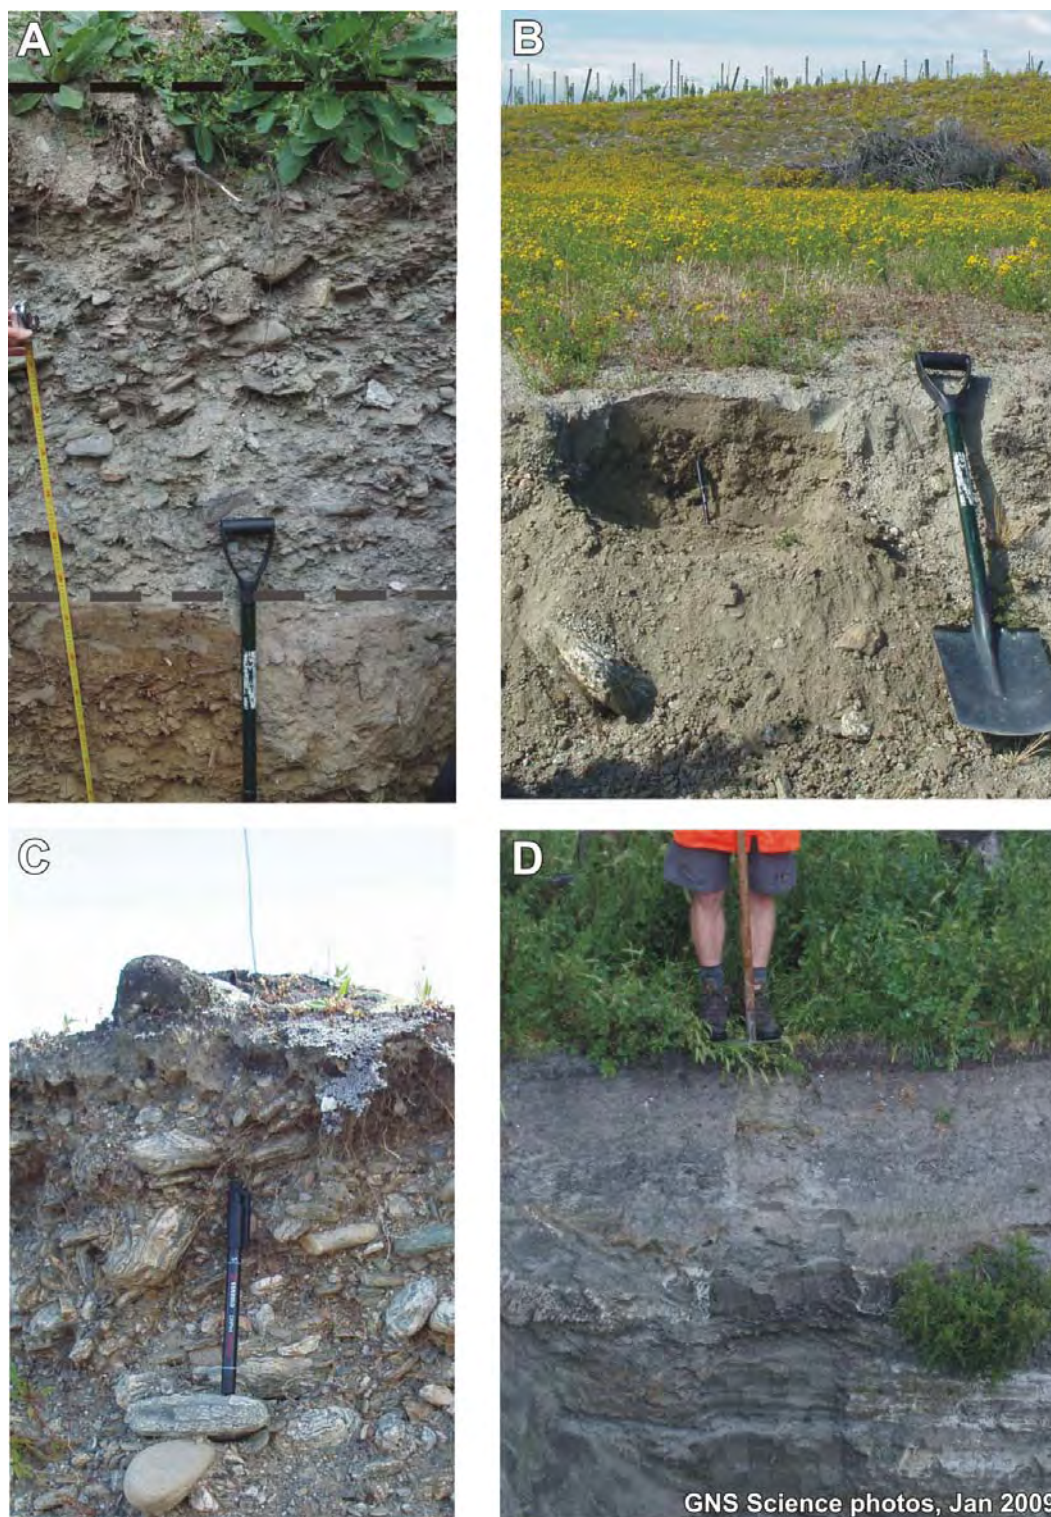
Figure 5: Examples of soil maturity. (A) At Hospital Creek, Hawea Flat, 'fan less recently active' sediments with a mature brown-weathered soil are buried (at the grey line) by grey 'fan recently active' sediments, on which an immature (raw) soil is developed (black line). (B-C) Differing soil maturities on fan terraces of Tinwald Burn, Cromwell; a mature light-brown soil on a 'fan less recently active' terrace (B) versus an immature (raw) grey soil on a 'fan recently active' terrace (C). (D) An immature soil profile developed on grey 'fan recently active' sediments at the foot of Coronet Peak, Queenstown.

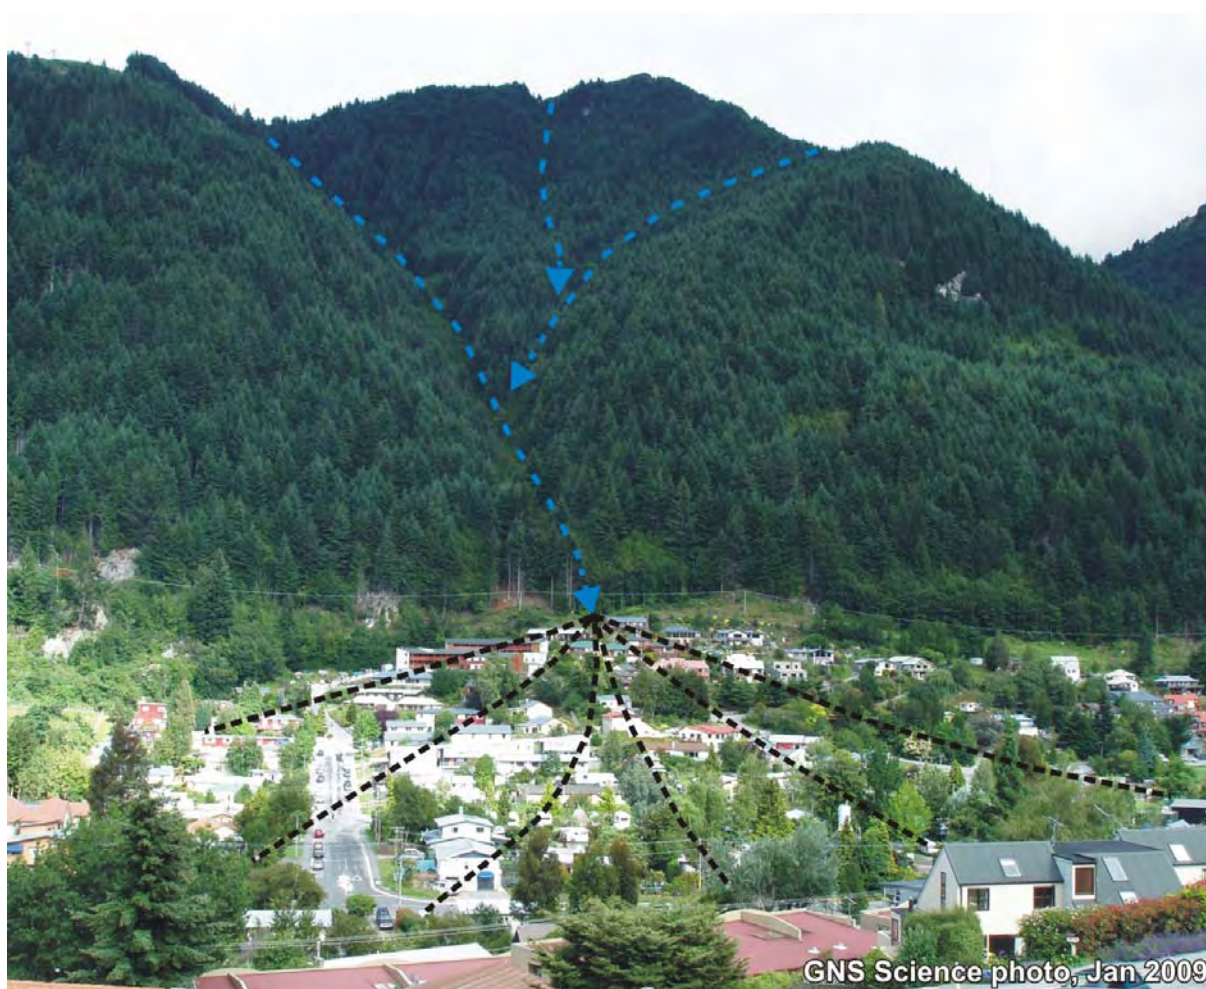
Figure 6: A fan in an urban area at Queenstown. This view looks northwest towards a forested catchment of about 46 hectares which drains (blue lines) from the eastern side of the Skyline Gondola (skyline, far left). The fan radiates out (black lines) from the mouth of the gully, near Reavers Lane.

This is an example of an aggradational fan that, within the period of European settlement, appears to have had little if any sediment supplied from its catchment, and thus its potential for sedimentation may not be less readily apparent.

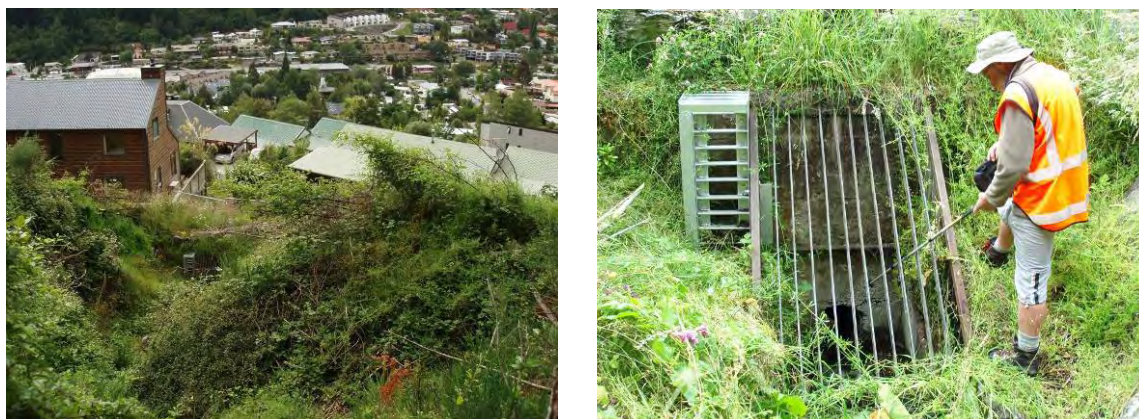
Figure 7: Drainage reticulation at the head of the 'Reavers Lane fan' in Queenstown. LEFT: a view down the lowest reach of the gully that has formed the 'Reavers Lane fan', upon which the buildings are sited. The culvert that collects all drainage from the gully is to the left of centre. RIGHT: The grill-covered culvert is intended for water but not for gravel or boulders. (GNS Science photos, Jan 2009).

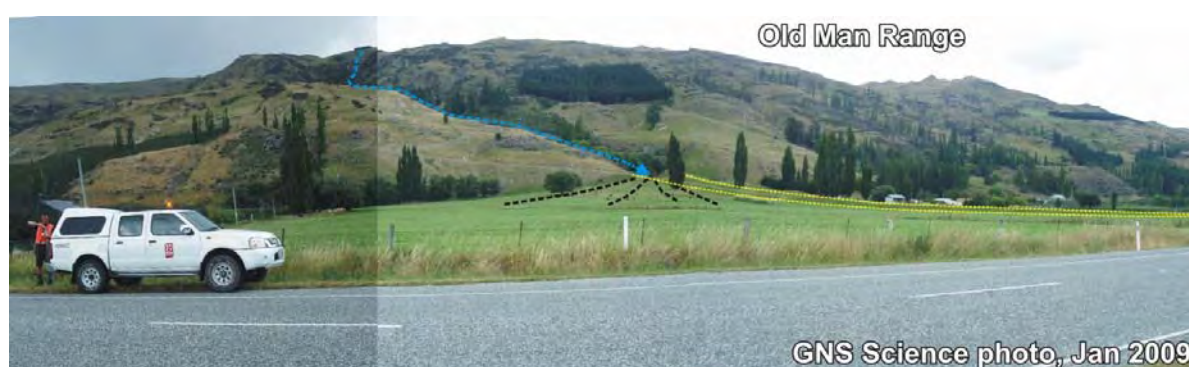
Figure 8: A small aggradational fan north of Roxburgh. ABOVE: The fan radiates out (black lines) from moderate-sized catchment (blue arrow) onto an abandoned terrace of the Clutha River. Embankments (yellow) create an artificial channel for floodwater and sediment that extends out across the river terrace. BELOW: A view up the artificial channel (GNS Science photos).

Figure 8 illustrates a fan that has a very small extent (6 ha) compared with the size of its catchment (140 ha). The Clutha River terrace onto which it is built is at least several thousand years old. This suggests that since the fan began to form, its catchment has produced only very small amounts of sediment. However, judging from the size of the artificial channel, this catchment is likely to have caused flooding and sedimentation problems on the fan in historic times.

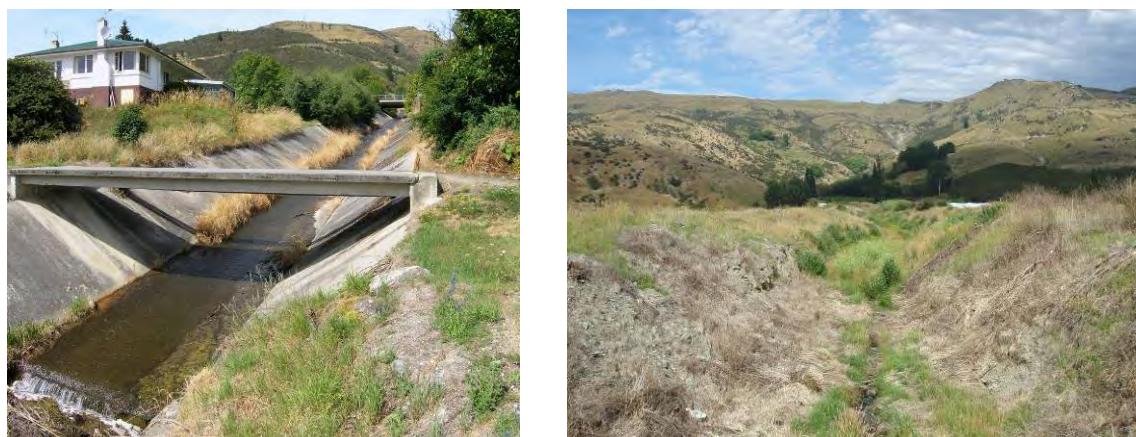
Figure 9: Different types of artificial channel at Roxburgh. LEFT: A steep concrete-lined channel conveys Reservoir Creek down its equilibrium to slightly terraced fan in the Roxburgh urban area (Opus photo, Jan 2009). RIGHT: Gravel embankments up to 4 m high constrain the course of Slaughterhouse Creek on the centre of its equilibrium to aggradational fan, north of Roxburgh. The gradient of its channel is much less than that of Reservoir Creek, and the Slaughterhouse Creek channel therefore has a correspondingly lesser ability to transport coarse sediment such as gravel or boulders (GNS Science photo, Jan 2009).

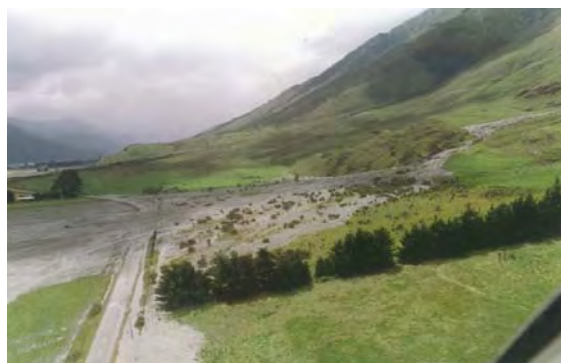
Cemetery Creek alluvial fan: breakout and deposition of gravelly sediment across paddocks and the highway after a major rainstorm in 1994 (*Otago Regional Council photo*).

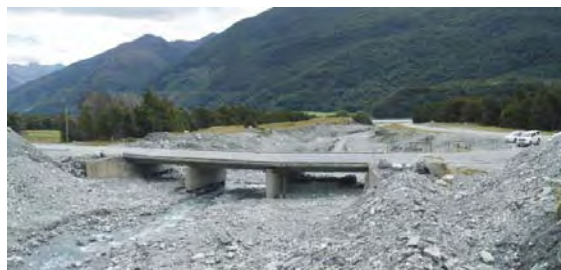
Pipson Creek fan at the highway bridge. Large gravel embankments, constructed from debris that has choked the channel, currently direct the active channel straight down the fan to the Makarora River (*GNS Science photo, Jan 2009*)

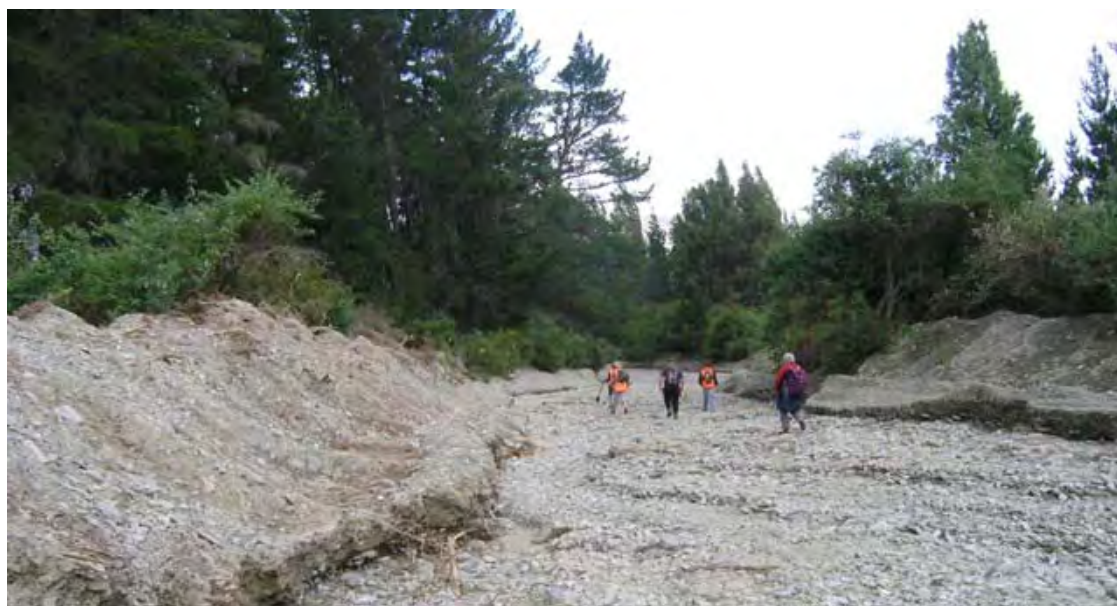
The active channel of Hospital Creek, downstream of Hawea Back Rd, is contained between artificial embankments. The accumulating gravelly sediment is episodically bulldozed to contribute to the embankments; some is stockpiled. This is one of the few sites of active sediment build-up in the assessment area (*Opus photo, Jan 2009*).

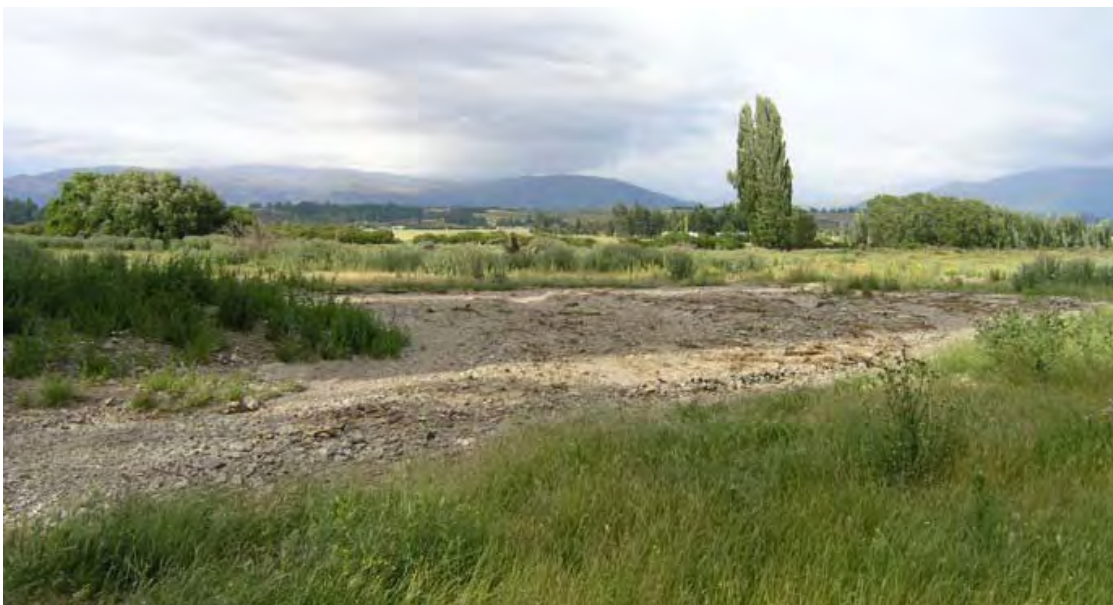
At the downstream end of the constrained active channel of Hospital Creek, floods have deposited gravel on the alluvial fan surface. Upstream, the active gravel bed between the embankments now stands 1 – 2 m above the surrounding farmland. If an embankment were to fail, a gravel flood like this would break out onto presently stable land (*Opus photo, Jan 2009*).

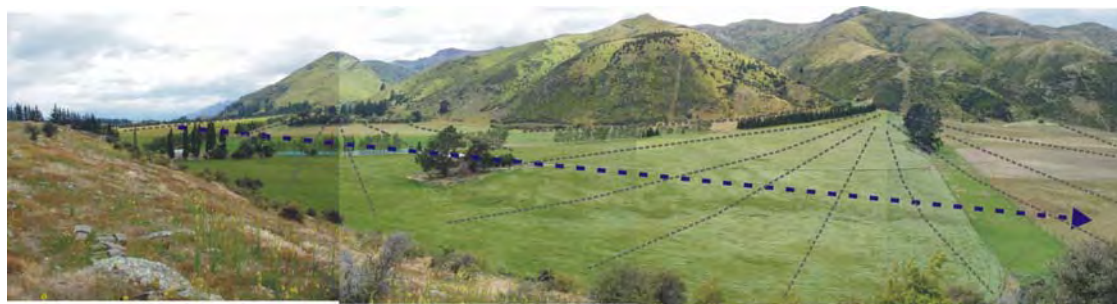
At Lagoon Valley, an abandoned glacial outwash channel (blue line) has been choked by alluvial fans radiating out (grey lines) from the catchments draining the Grandview range (distance). Because there is no longer any through-drainage (from left to right) down the old outwash channel, the sediment that the streams bring down from the catchments is not carried away, and will continue to build up on these fans (GNS Science photo, Jan 2009).

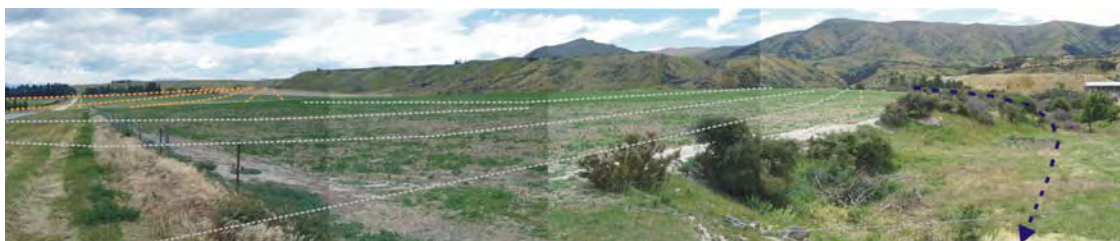
View of the terraced northern margin of the Clutha valley northwest from Sandy Point farm, beside SH 8a (far left). The large alluvial fan of Crook Burn (left distance) radiates out (orange lines) onto a wide abandoned terrace of the Clutha River. This fan is in an aggradational state, with Crook Burn only slightly incised into its fan. In contrast, the fan of Trig Burn (foreground, radiating grey lines) has formed where the Clutha River terrace is narrower, and river-bank erosion of the Clutha has trimmed the toe of the fan. This has caused Trig Burn incise a gully (blue arrow) that gets progressively deeper towards the river (out of sight behind the photographer). Trig Burn fan is currently in an equilibrium to degradational state (*GNS Science photo, Jan 2009*).

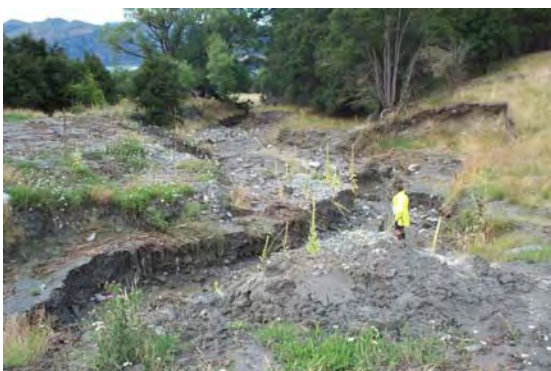
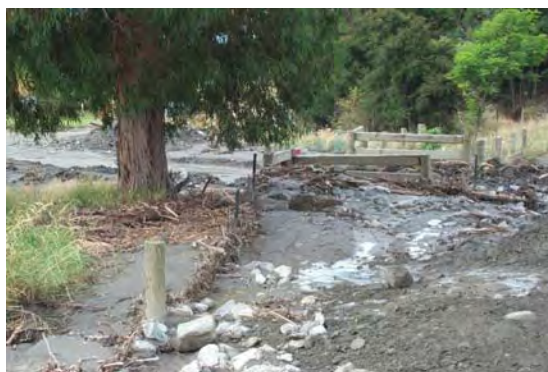
Stoney Creek, downstream of Studholme Rd, following a major rainstorm in 2004. LEFT: Sediment-laden water overflowed the channel, depositing sand and gravel on the surface of the alluvial fan, beyond the confines of the channel. RIGHT: During the flood, sediment-laden water spilled from the channel and built up behind fences, partly burying them (*Otago Regional Council photos*).

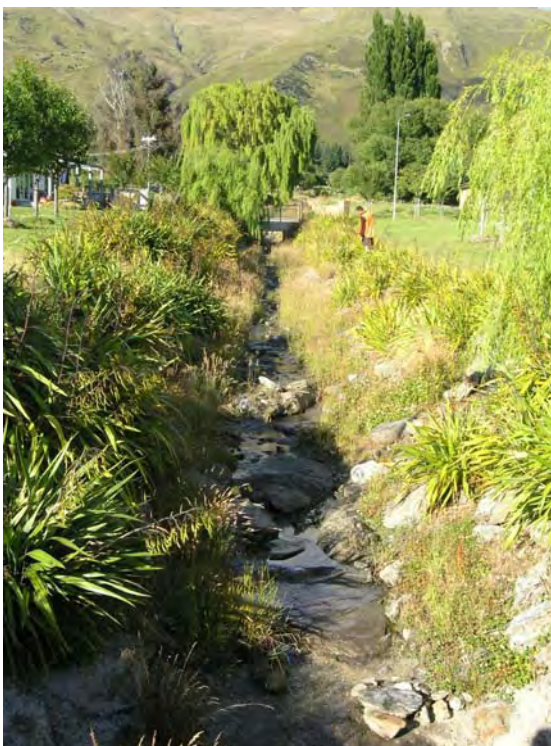
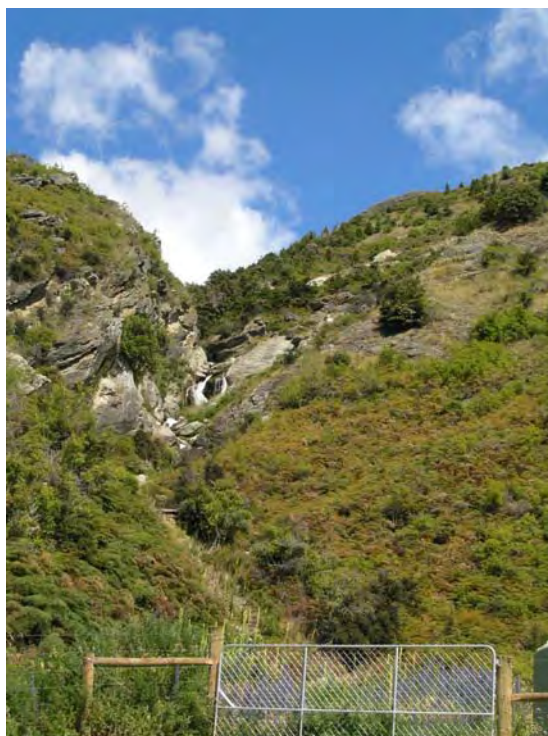
Stoney Creek, looking upstream from Old Station Avenue. Landscaping disguises the engineered nature of the channel. It has been widened, deepened and its floor armoured with large boulders to prevent erosion (*Opus photo, Jan 2009*).

At the head of its fan, Waterfall Creek descends a very narrow and steep channel from its catchment. The Waterfall Creek catchment is several times larger than that of Stoney Creek, so would be expected to produce a flood several times larger than could occur in Stoney Creek. Blockage of the channel by a small landslide movement could generate debris flows (*Opus photo, Jan 2009*).

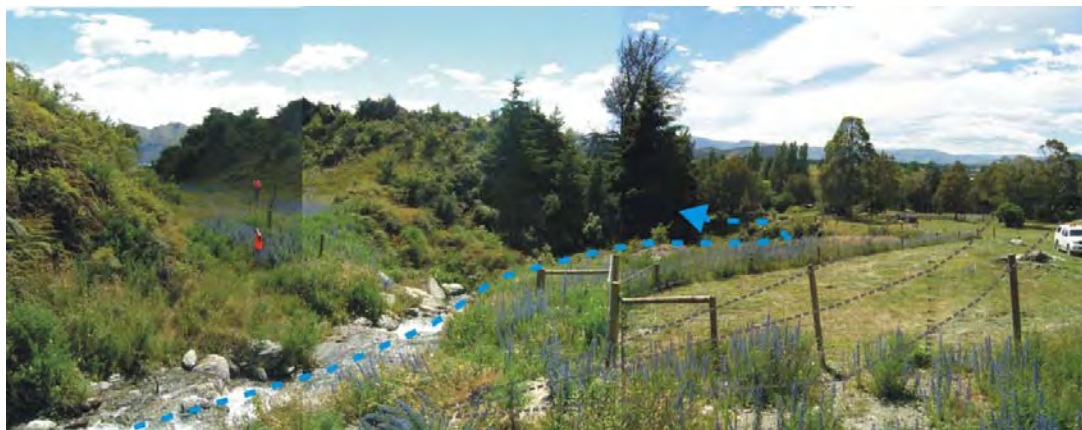
The head of Waterfall Creek fan, looking northeast. The photo above was taken from the paddock (right). The alluvial fan radiates out (grey lines) to the right. At the fan head (foreground), Waterfall Creek (blue arrow) is incised less than 2 m, but the incision increases rapidly downstream; under the two trees (centre), the incision is about 5 m. A small build-up of sediment could be enough to allow Waterfall Creek to break out onto its fan and spread debris sediment out towards the right, in the opposite direction to its present channel (*Opus photo, Jan 2009*).

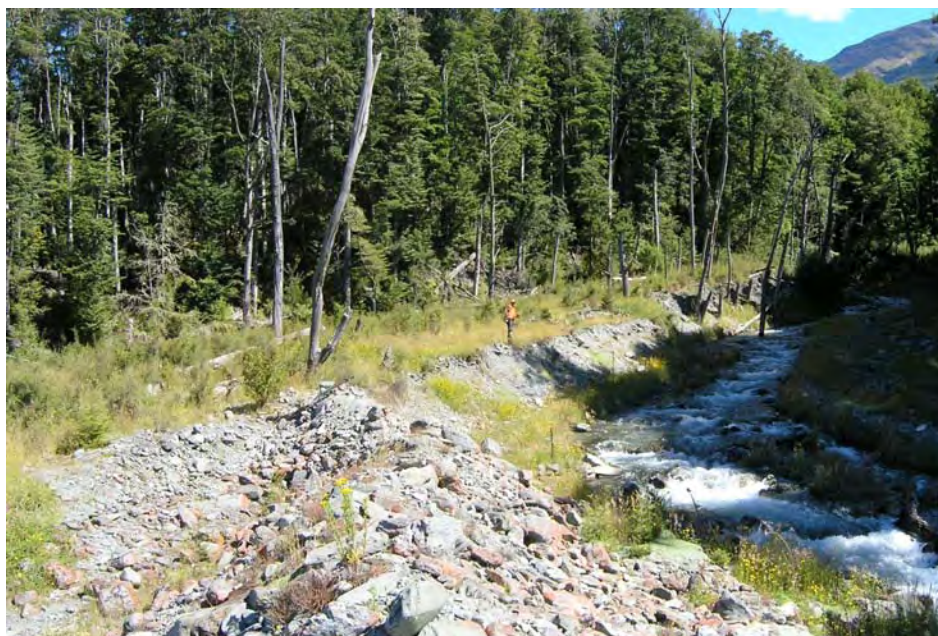
In Glacier Burn, recent sediment aggradation during sediment-laden floods and debris flows has killed trees beside the stream channel. A small artificial embankment of gravel lies in the foreground (*Opus photo*).

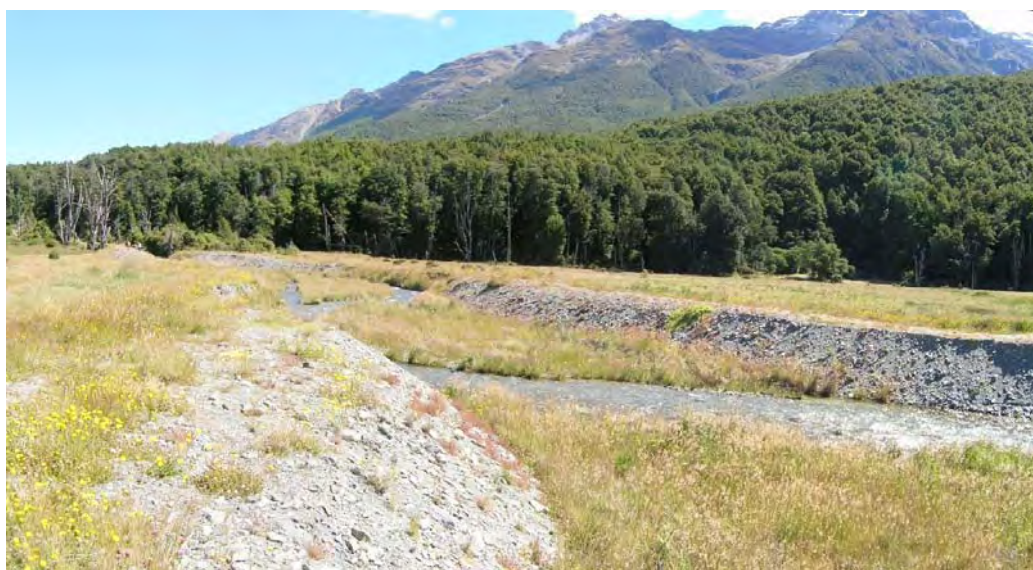
Near the toe of its fan, the active channel of Glacier Burn is trained between gravel embankments (*Opus photo*).

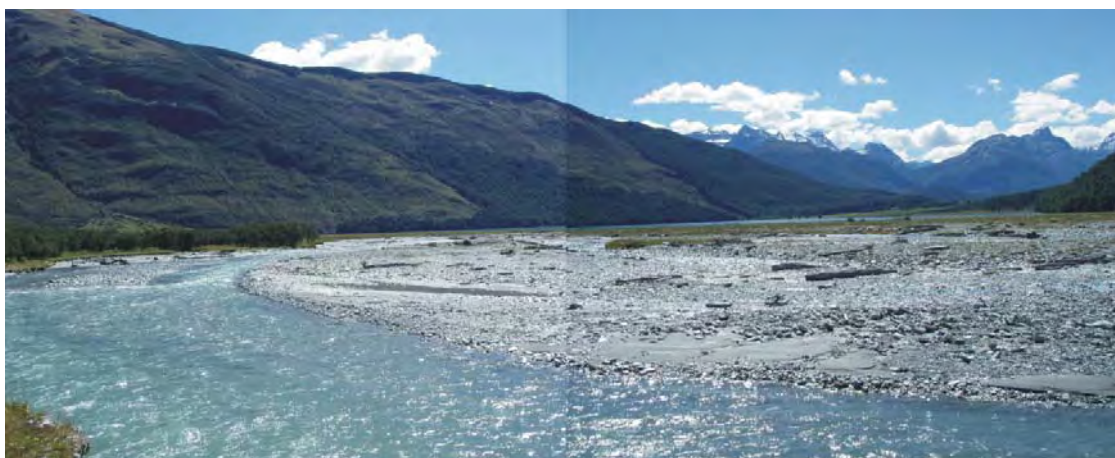
Earnslaw Burn is a sizable river draining into Diamond Lake, visible in mid-centre to the west-northwest. The grassed low-lying parts of its fan away from the present active bed have raw soils, indicating that the river has occupied its fan surface within the past few hundred years (*GNS Science photo*).

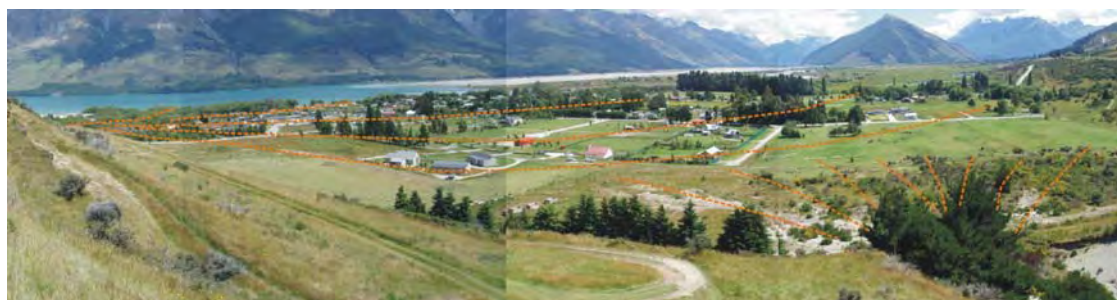
A view northwest across Glenorchy from the Bible Terrace. Buckler Burn (far left) has constructed a broad fan out to the north (orange lines) against part of the delta of the Rees River floodplain (centre middle distance). A small fan radiates out (orange lines, lower right) from a gully draining off the Bible Terrace. This terrace is an abandoned fan-delta of Buckler Burn, constructed at the '50 m lake level' (GNS Science photo).

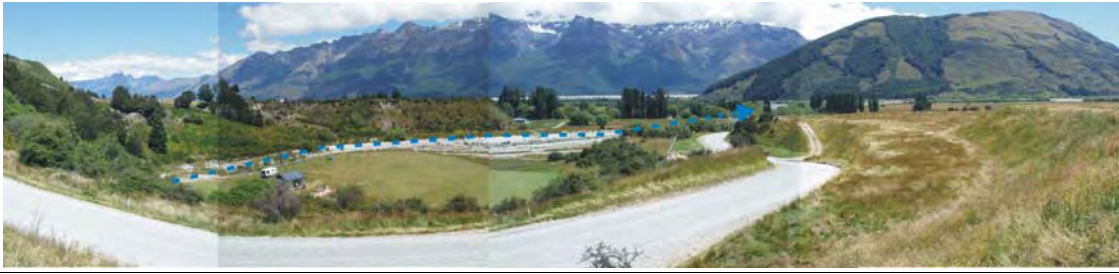
Looking west from on top of the '50 m lake level' fan-delta of Precipice Creek. After the lake level fell, the creek cut a set of terraces into its fan delta. The present creek bed (blue arrow) has built a large aggradational fan (centre middle distance) out into the Rees valley floor. The Rees River runs from right to centre (*GNS Science photo*).

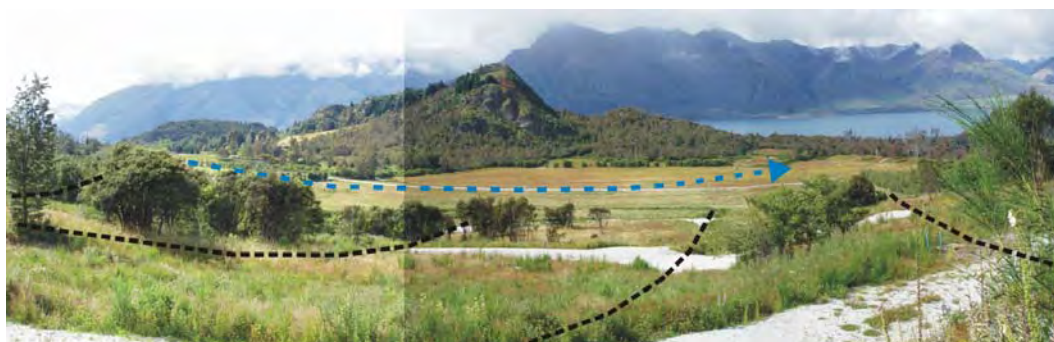
An apron of small, steep, fans (foreground, with black lines illustrating directions of fall) have accumulated at the foot of a ridge facing the Bobs Cove area (centre). The fan sediments have built onto the edge of an abandoned fan-delta. The fan-delta was constructed by an overflow of sediments that had built out (blue line) from the Twelve Mile Stream catchment, when Lake Wakatipu stood at its '50 m level'. View is to the south (GNS Science photo).

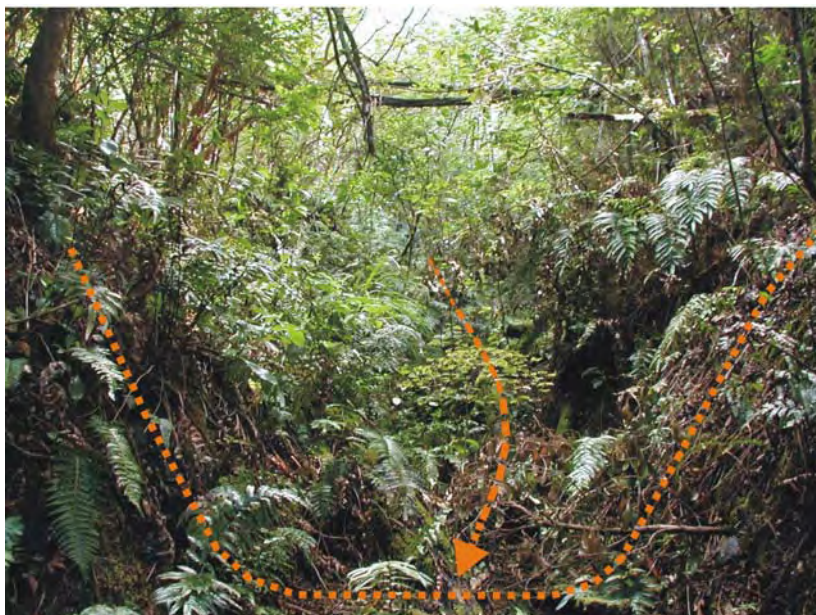
A 2-m deep channel with steep sides (orange dots) on the mid-part of the Bobs Cove fan complex, with the orange arrow indicating the channel axis and flow direction (*GNS Science photo*).

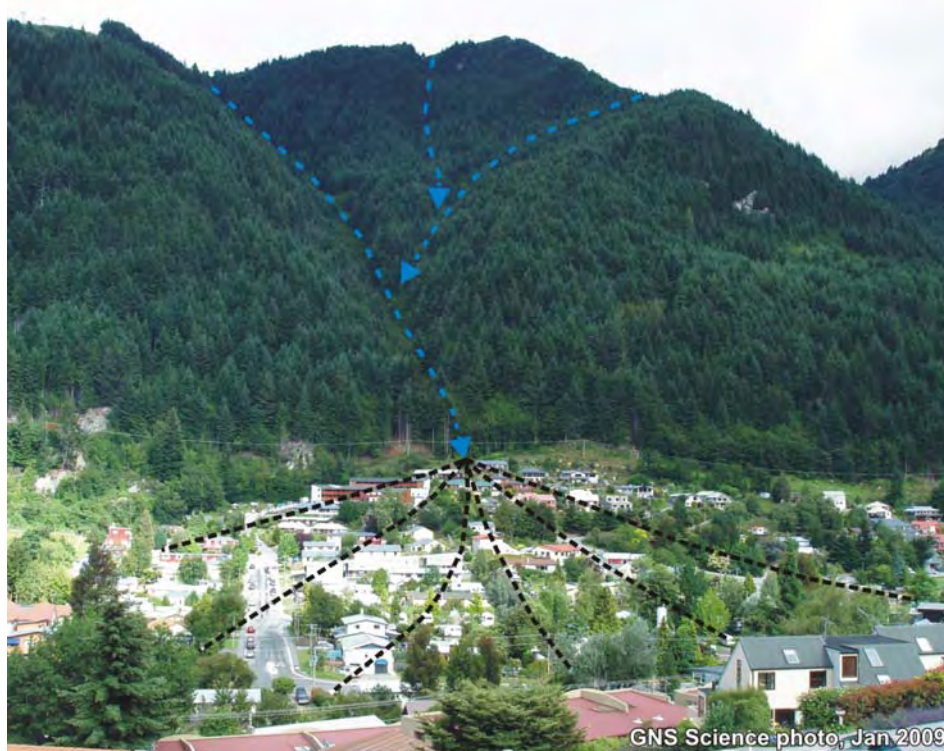
A forested catchment, with an area of about 46 hectares, drains into the Bodytown suburb of Queenstown on the eastern side of the Skyline Gondola (skyline, far left). Sediment brought down by the gully draining this catchment (blue line) has accumulated in a fan that radiates out from the gully mouth (black lines), at Reavers Lane. View is to the west-northwest. (*GNS Science photo*).

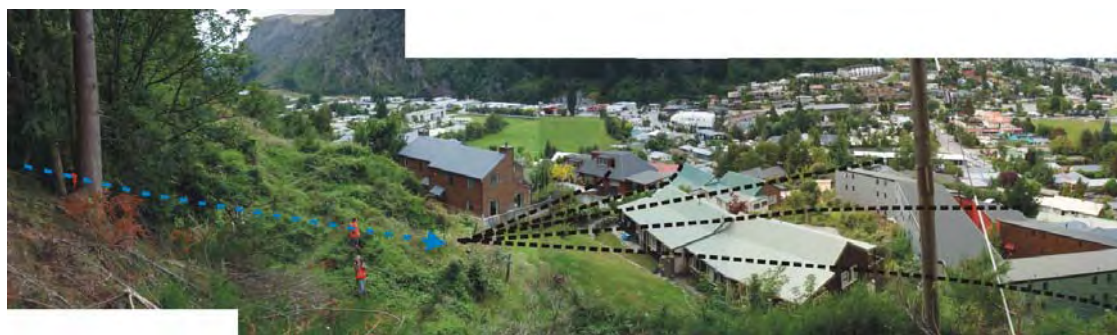
The Reavers Lane fan, looking east-northeast. At the head of the fan, where the blue line marking the gully meets the radiating black lines illustrating the directions of fall on the fan, a culvert transfers the drainage from the gully into the stormwater system (see photos below). (*GNS Science photo*).

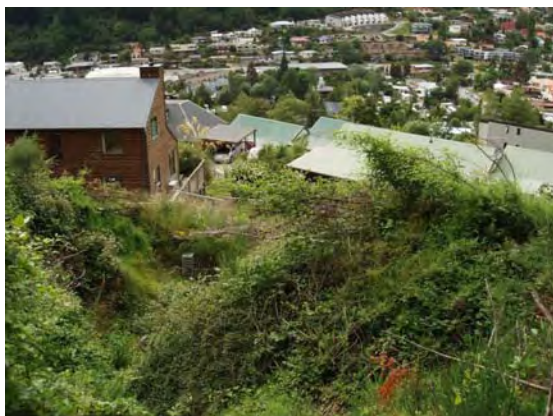
A view down the lowest reach of the gully that has formed the Reavers Lane fan, upon which the buildings are sited. The culvert that collects drainage from the gully is to the left of centre (neighbouring photo) (*GNS Science photo*).

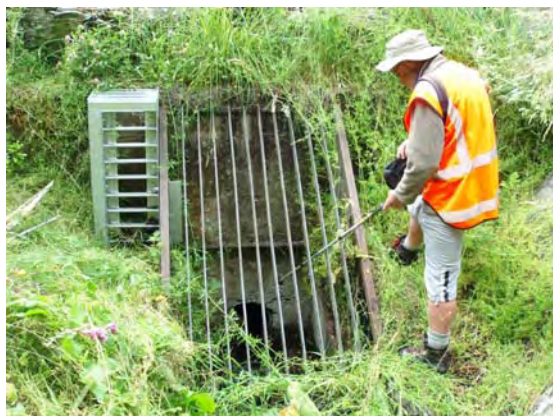
The culvert at the head of the Reavers Lane fan has a grill and narrow-diameter pipe intended for water, but not for coarse sediment (i.e. gravel or boulders) (*GNS Science photo*).

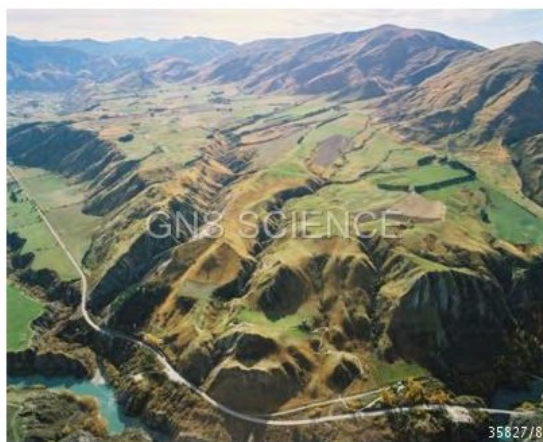
Aerial view looking north across the Crown Terrace. Alluvial fans have built out across the terrace from catchments in the Crown Range (right background). The main streams have cut deep gullies over the western lip of the Crown Terrace (left to right foreground). As a result, some parts of the fans are now isolated above the levels of fan flooding or sedimentation activity, whereas other parts near the heads of the fans (distance) show signs of more recent fan activity. (GNS Science photo; D.L. Homer).

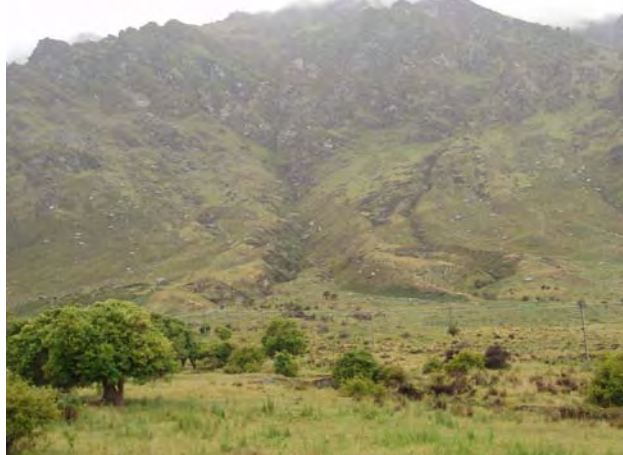
An aggradational fan on the uphill side of State Highway 6. The stream is barely incised into its fan surface and soils are immature, indicating that sedimentation has occurred on the fan surface within the past few hundred years. Behind the photographer, the toe of the aggradational fan passes down-slope into gullies incised into the '50 m lake level' terrace (*GNS Science photo*).

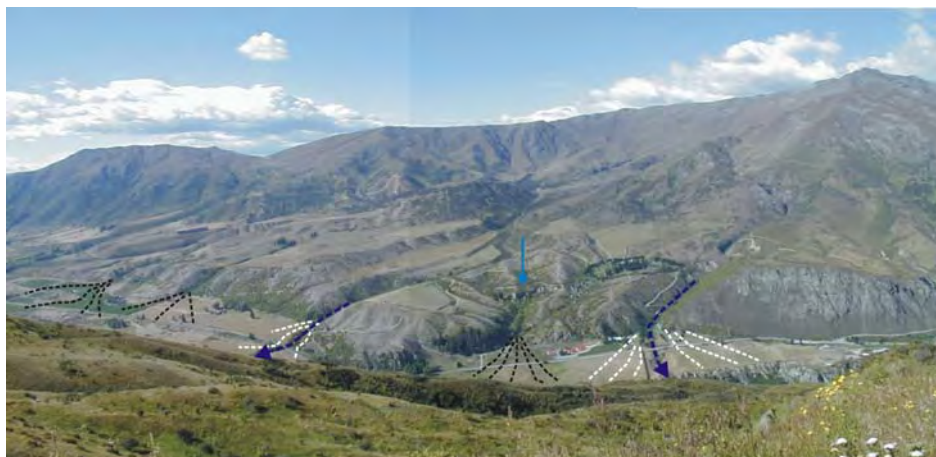
The terraced fan landscape of Gibbston basin, seen from the Crown Range Road. Small fans radiating out (black lines) from the mouths of creeks draining the fan terraces are aggradational, with no well-defined stream channels. Any sediment brought down from their catchments will accumulate on their surfaces, in the absence of human intervention. Gold sluicings (blue arrow) probably contributed to construction of the small fan in the centre. Larger streams (dark blue) draining from the range behind have built fans (white lines) out across the river terrace. The streams then cut gullies over the terrace margin (almost obscured from view, in the foreground), down to the Kawareau River. As a result the streams have cut down into their fan surfaces. Under present conditions, these streams are probably in equilibrium, with channel depths and gradients that are sufficient to transport their sediment to the Kawareau River (*GNS Science photo*).

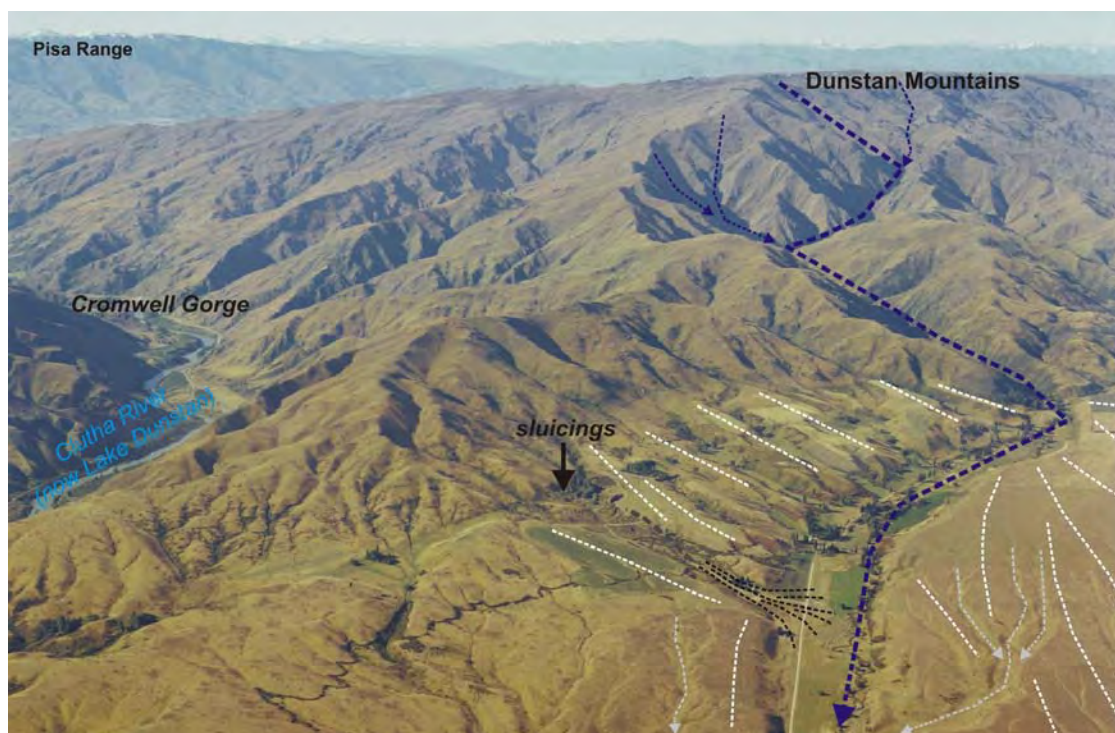
Far back in the past, Waikerikeri Creek and its tributaries built a large alluvial fan (white lines) out into the Manuherikia basin. More recently, the creek has incised a valley (navy blue arrow) into its fan, leaving older parts of the fan isolated far above present stream levels. Rainfall runoff has had sufficient time to incise substantial gullies (grey arrows) on the older fan terraces. A fan (black lines) built into Waikerikeri valley probably formed during the gold rush due to sluicing upstream (*GNS Science photo; D.L. Homer*).

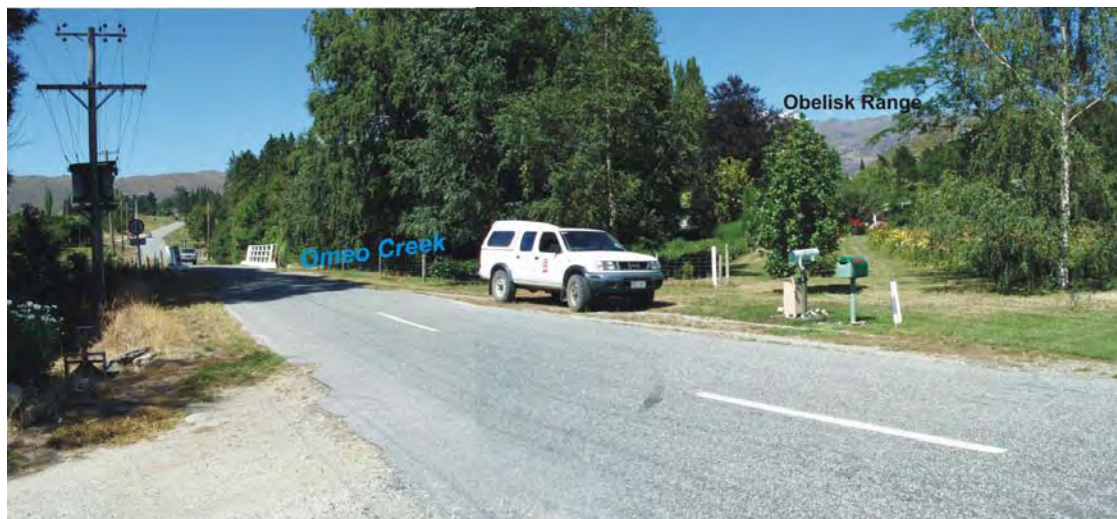
At Hawley Road, Omeo Creek flows (from right to left) in a narrow 2 m deep, tree-lined channel. The straightness of the channel suggests that it is an engineered ditch, formed as part of the early agricultural development of the valley. Immature soils on the valley floor indicate that prior to its channelization, Omeo Creek flowed unconfined on the valley floor. In the left distance is the rise up to an abandoned terrace of the Omeo fan, isolated far above the level of recent fan activity (*GNS Science photo*).

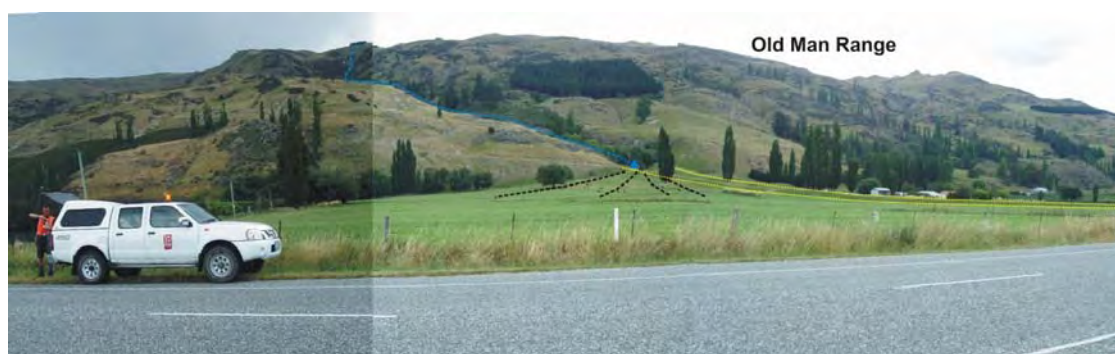
West of State Highway 8, near Coal Creek Flat north of Roxburgh, a classic aggradational fan (black lines) radiates out from the mouth of moderate-sized catchment (blue arrow), onto an abandoned terrace of the Clutha River (fore- and mid-ground). The fan has no well-defined stream channel on it. Ever since the Clutha River abandoned this river terrace, there has been no natural means of removing the sediment brought down from the fan catchment. Large embankments of gravel (yellow) create an artificial channel for the stream, extending from the mouth of the catchment (see below) (*GNS Science photo*).

Looking up the artificial channel seen in the photo above. The fan is very small (6 ha) for the size of its catchment (140 ha). The most likely explanation for this is that there have been few areas of active erosion (i.e. places where sediment is produced) in this catchment since the fan began to form. The construction of this substantial channel was presumably motivated by flooding problems associated with this catchment. This channel is likely to be effective for conveying floodwater, but its gradient is too gentle to allow transport of gravel. Any gravel or sand brought down from the catchment will accumulate in this channel, and would need to be removed mechanically in order to maintain the channel's floodwater-carrying capacity (*GNS Science photo*).

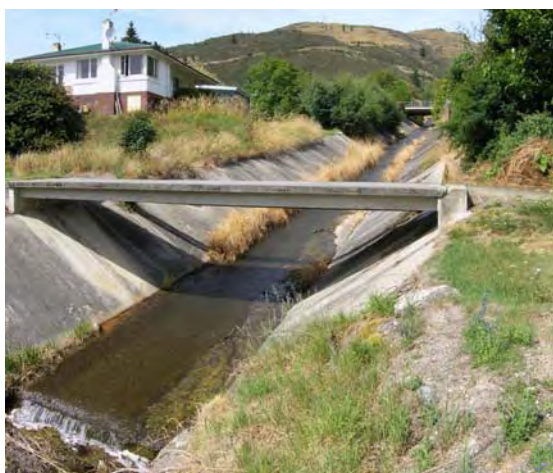
A steep concrete-lined channel conveys Reservoir Creek through the Roxburgh urban area. The Reservoir Creek fan is graded to the Clutha River. It is essentially in equilibrium, though the Clutha River has trimmed the toe of the fan. The house is built on the fan terrace at the top of the river-trimmed terrace riser (*Opus photo*).

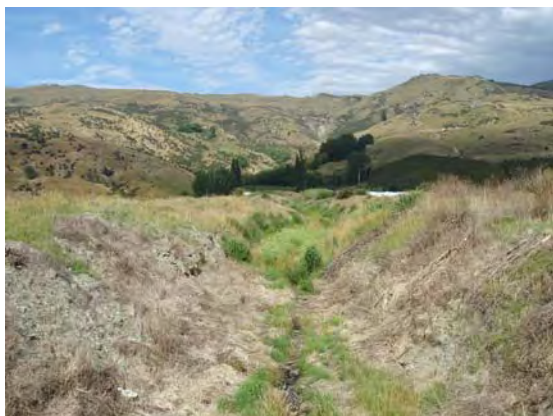
Gravel embankments up to 4 m high constrain the course of Slaughterhouse Creek on the centre of its fan, above State Highway 8. This fan is in an equilibrium to aggradational state. Its channel gradient is far less than that of Reservoir Creek. This reduces its capacity to carry gravelly sediment. Such sediment is likely to build up in this channel, and require manual removal (*GNS Science photo*).
