**Otago Alluvial Fans Project: Supplementary
maps and information on fans in selected
areas of Otago**

**GNS Science Consultancy Report 2009/052
April 2009**

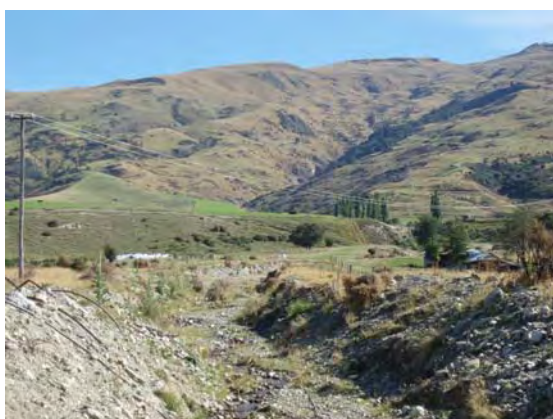
At Stevenson Creek, Dumbarton, sediment has aggraded upstream of the State Highway 8 bridge, and historically has spread across the road during floods. Gravel from the stream channel has been formed into rough bunds either side of the channel. Stevenson Creek is an equilibrium fan graded to the Clutha River. The stream flows in a shallow channel on the surface of its fan, and immature soils occur only close to its present channel. This suggests that the stream channel width and gradient are about right for transporting the sediment carried during floods in this stream, and has been so for the past many hundreds of years. The sediment build-up illustrated here is therefore at odds with the long-term behaviour of this stream, and may possibly be attributable to human activities related to the highway (*GNS Science photo*).

From Slaughterhouse Creek southwards, the Clutha River lies closer to the western side of its valley, and has partly trimmed the toes of the fans, causing the lower reaches of the stream channels to incise slightly into their fans. Under present conditions these streams are in approximate equilibrium, and providing their channels are wide enough and steep enough to transport the sediment delivered from their catchments, the Clutha River will maintain their equilibrium by carrying the sediment away down-valley. Disruption of this equilibrium could occur through an increase in sediment load of a stream or by migration of the active channel of the Clutha River. Either of these scenarios could occur as a result of natural or human activity.
