Otago Regional Council  
**Roxburgh Debris Flow and Debris  
Flood Study**

Hydrogeomorphic Modelling and Quantitative Risk  
Assessment Report

30 January 2026

Otago Regional Council

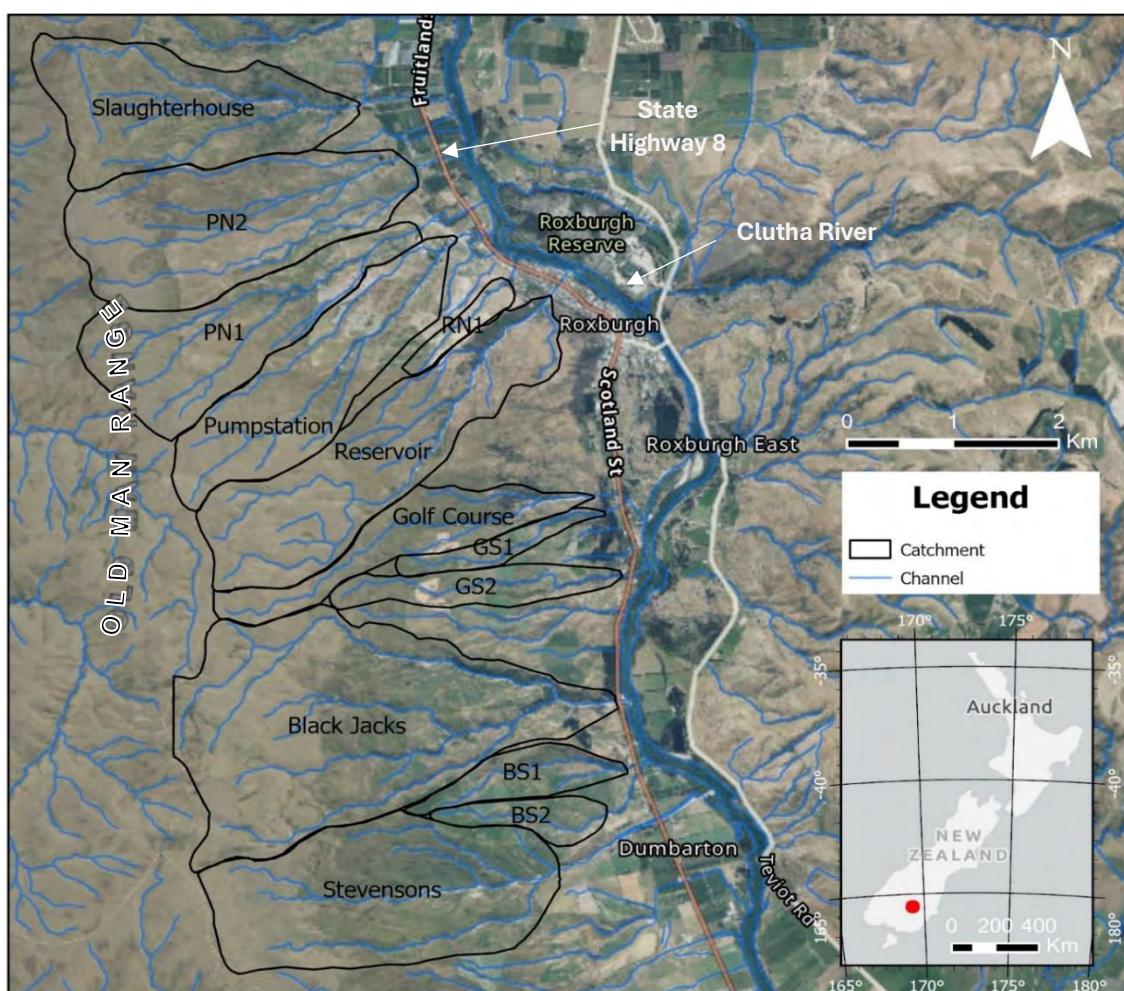
Figure 1: A map of the 13 catchments covered in this study.

The Roxburgh area in Central Otago, New Zealand, is exposed to destructive flows of water and sediment from adjacent hillside catchments. These hydrogeomorphic hazards (also known as debris flows or debris floods) are triggered by high-intensity rainfall events and have a history of causing damage and disruption to the built environment in the town. The Otago Regional Council (ORC) requires detailed hazard and risk assessment of 13 catchments in Roxburgh to inform potential spatial planning, mitigation/adaptation options, and to understand the potential runouts of hydrogeomorphic events (Figure 1).

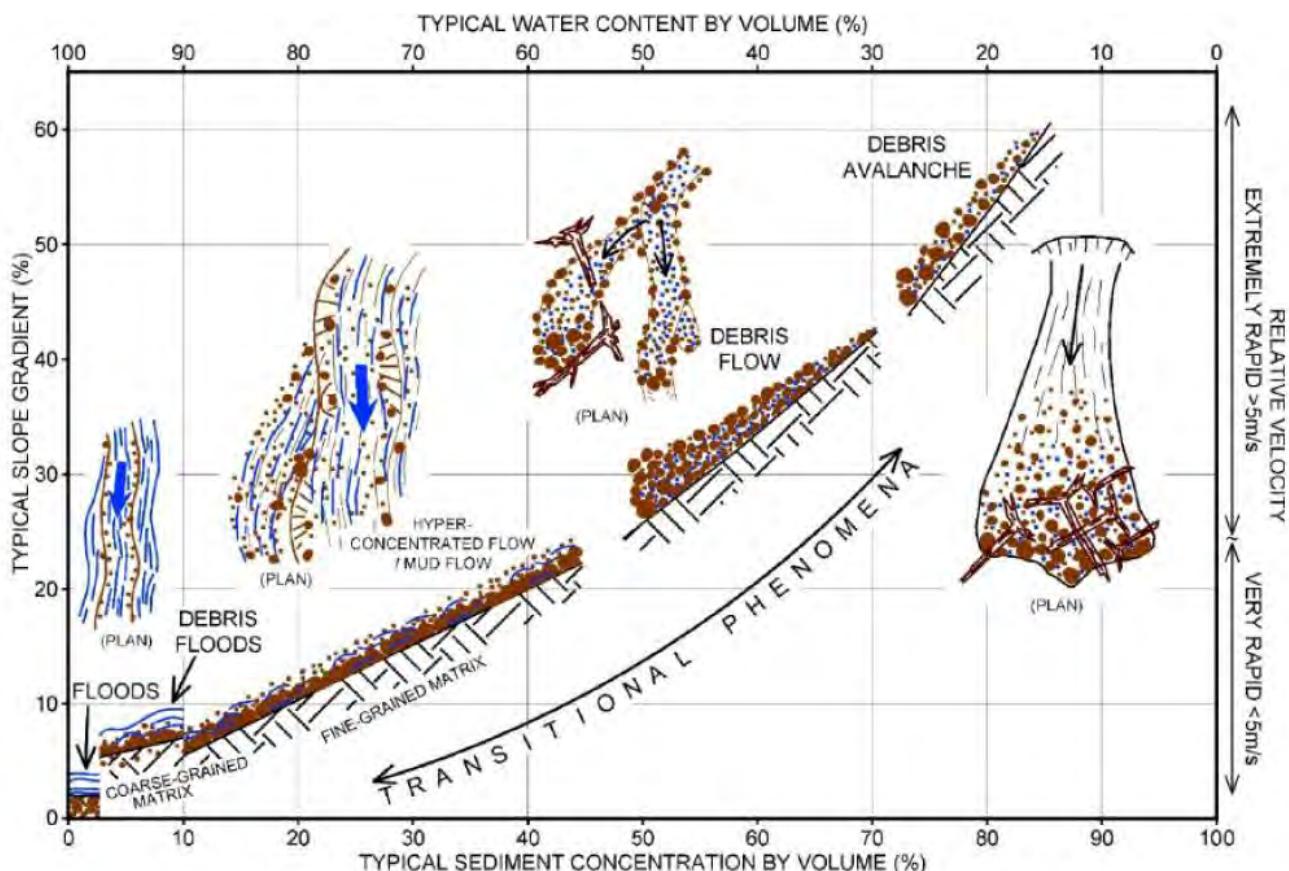
Figure 4: The main types of hydrogeomorphic hazards by typical slope angles and sediment concentration (BGC Engineering Inc, 2020).

Hydrogeomorphic hazards such as debris floods and debris flows are a type of landslide that impact alluvial fans (Figure 4).

Hydrogeomorphic hazards range from fluid-dominated floods which typically occur on gentler slopes to sediment-dominated debris flows and debris avalanches which occur on steeper slopes (Figure 4). Figure 4 was developed to describe the range of hydrogeomorphic processes in Canada; therefore, geomorphic factor ranges (typical sediment concentration, slope gradient, and water content) may not reflect those of hydrogeomorphic hazards in New Zealand.

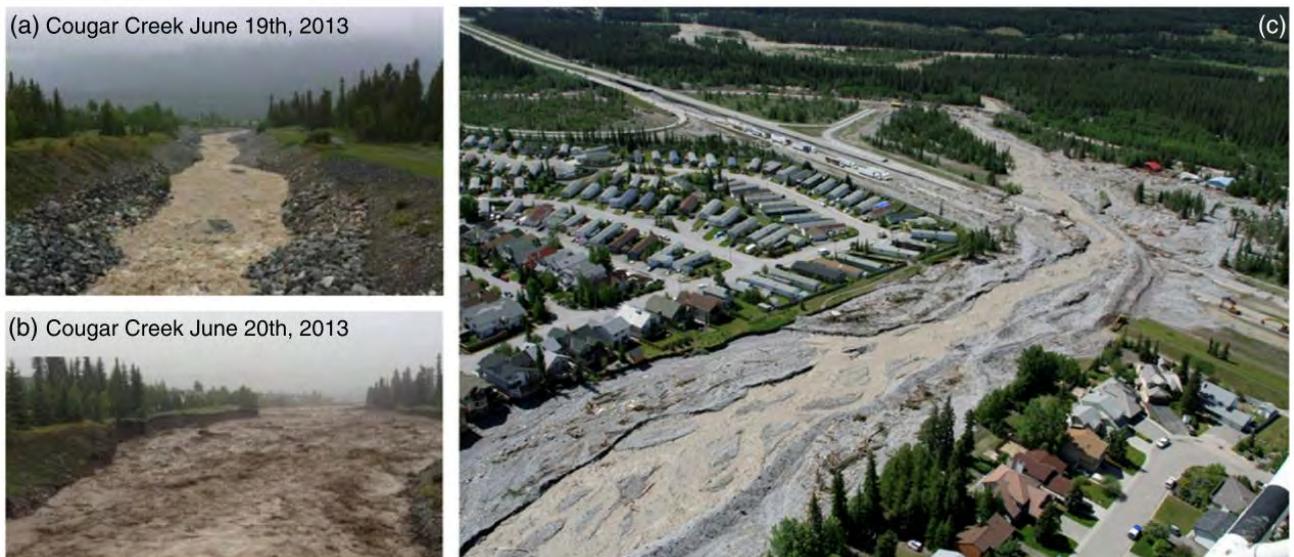
Figure 5: The 2013 Cougar Creek debris flood event in Alberta, Canada on (a) 19 and (b) 20 June 2013. (c) The channel of Cougar Creek after the debris floods downstream of location (a) and (b) (Church & Jakob, 2020).

The Cougar Creek debris flood occurred in a similar geomorphic context to Roxburgh and the Teviot Valley and serves as an example of potential debris flood characteristics. Cougar Creek is situated in the Front Range of the Canadian Rockies, characterised by steep slopes and a complex geological structure. The region has undergone phases of glaciation and de-glaciation, which have shaped the landscape and contributed to the accumulation of loose debris which were mobilised during the 2013 event.

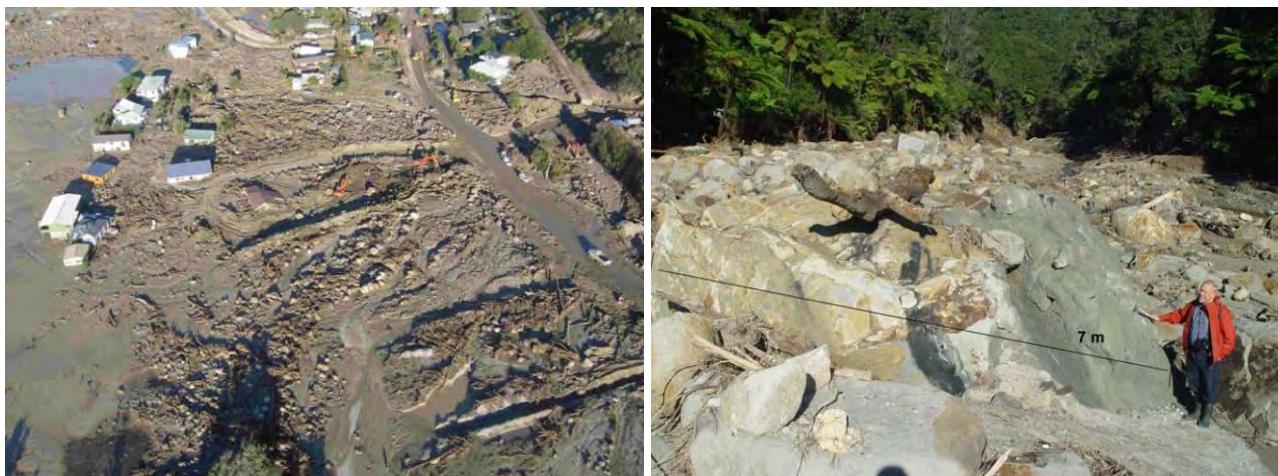
Figure 6: The 2005 debris flow in Matata, New Zealand (McSaveney et al., 2005). Left: The boulder-laden debris flow deposit on the fan at Awatarariki Stream. Right: Debris flows are known for their ability to transport huge boulders as part of their mix of water, sand, gravel, cobbles, and boulders such as this boulder of bedded siltstone in the bed of Awatarariki Stream.

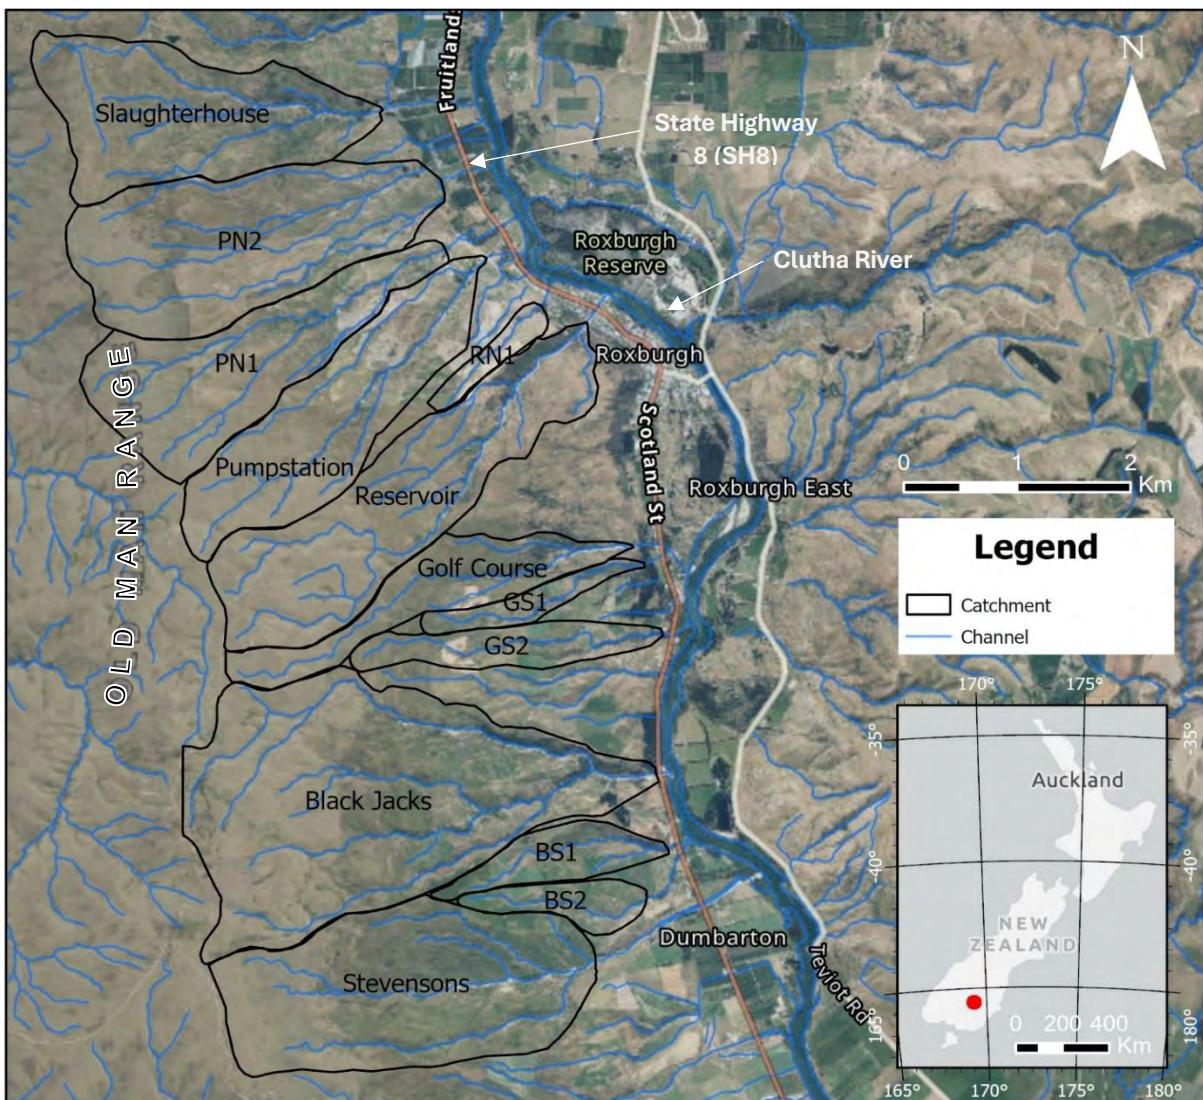
Figure 7: The 13 catchments assessed in this study.

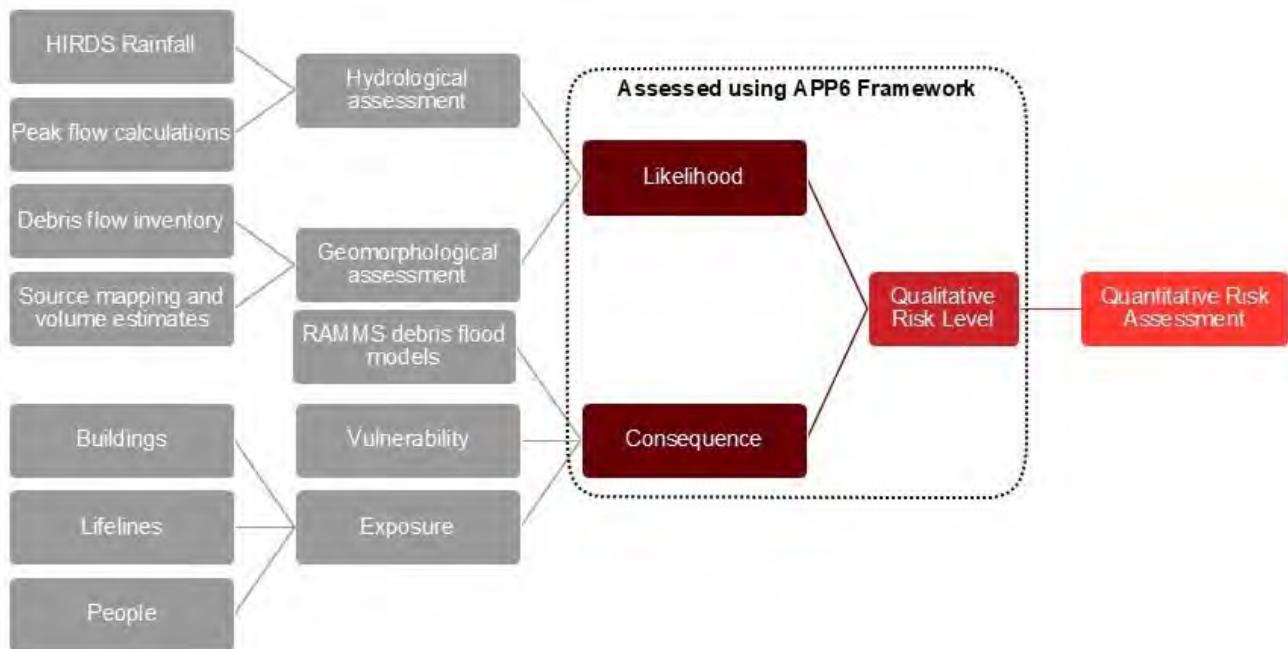
Figure 8: Methodological process for hydrogeomorphic modelling and risk assessment of catchments in Roxburgh.

Previous reporting has established that Roxburgh is prone to frequent and repeated hydrogeomorphic hazards. Further risk assessment is required to quantify risk to people and the built environment, inform planning decisions, and focus risk mitigation efforts. This report presents the methodology and results for the hydrogeomorphic modelling and risk assessment for Roxburgh which includes (Figure 8):

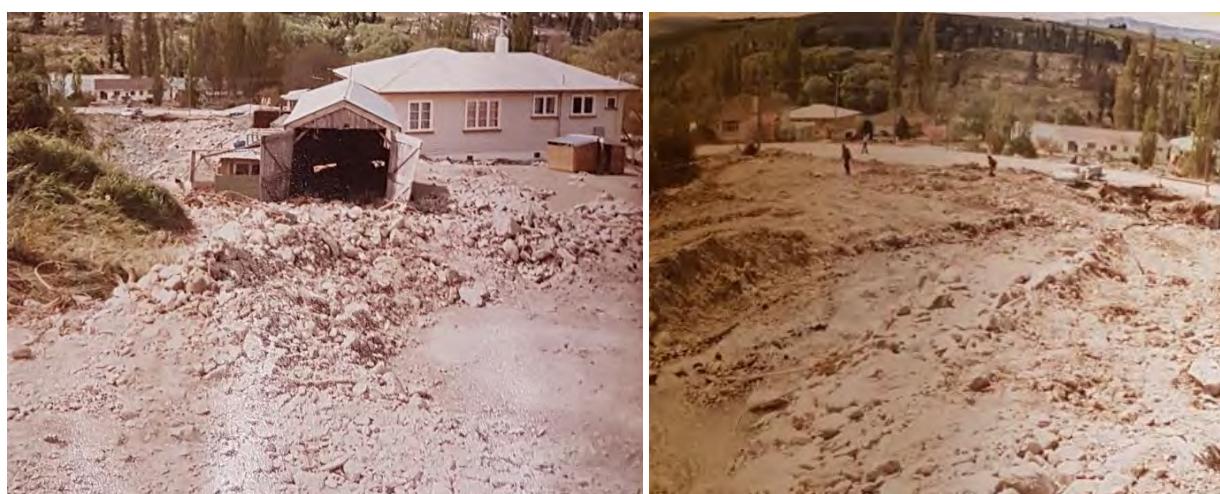
Figure 9: Photographs showing damage to a shed and extent of debris deposits at Reservoir Creek October 1978

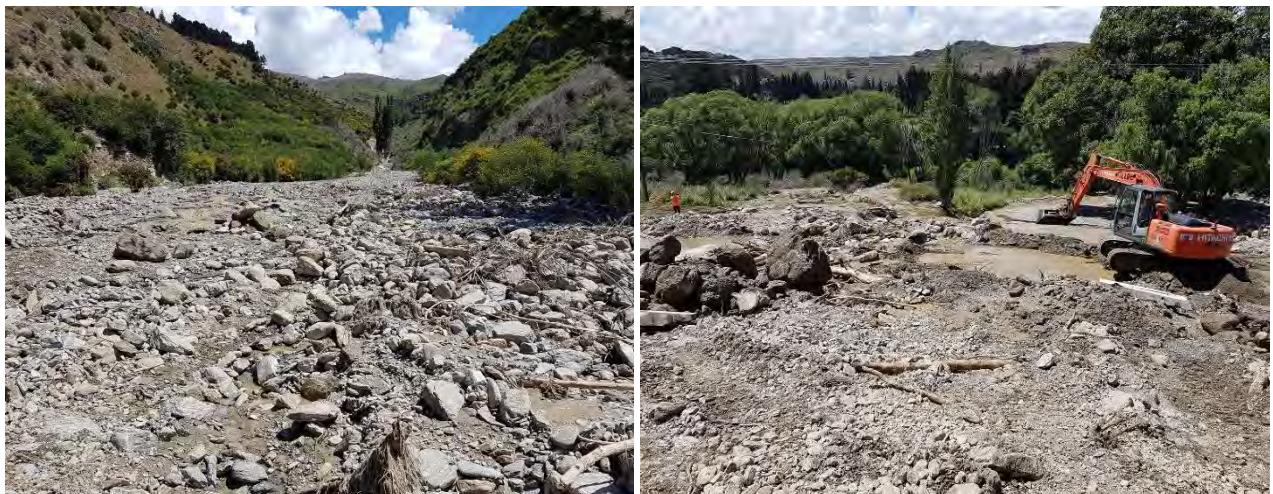
Figure 10: Left: Debris flood deposit in Black Jacks Creek upstream of SH8 November 2017. Right: Debris flood deposit on SH8 from Black Jacks catchment. The surface of the road has been exposed by the excavator.

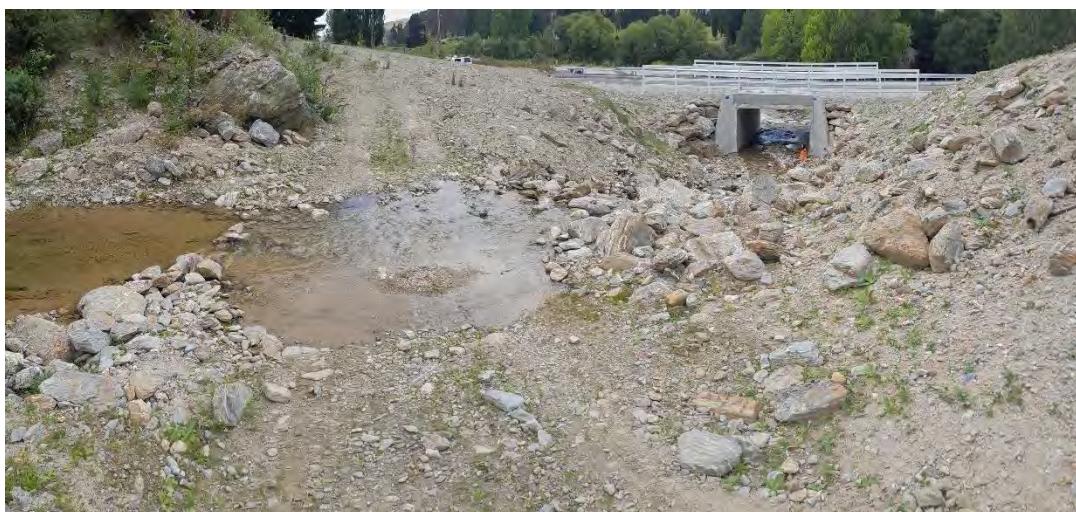
Figure 11: The new culvert at Black Jacks Creek SH8 crossing following the 2017 event.

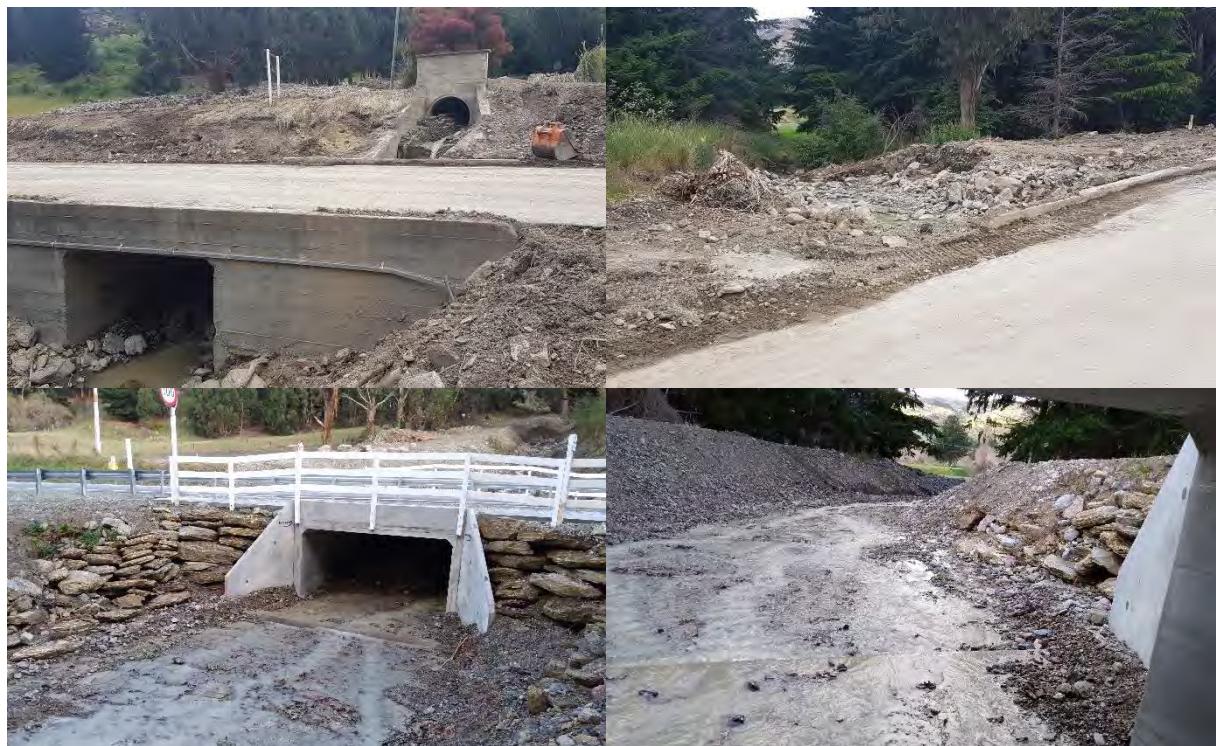
Figure 12: Top left and top right: The 2017 debris flood at SH8 crossing of Golf Course Creek. Bottom left and bottom right: The new culvert at Golf Course Creek pictured in 2023.

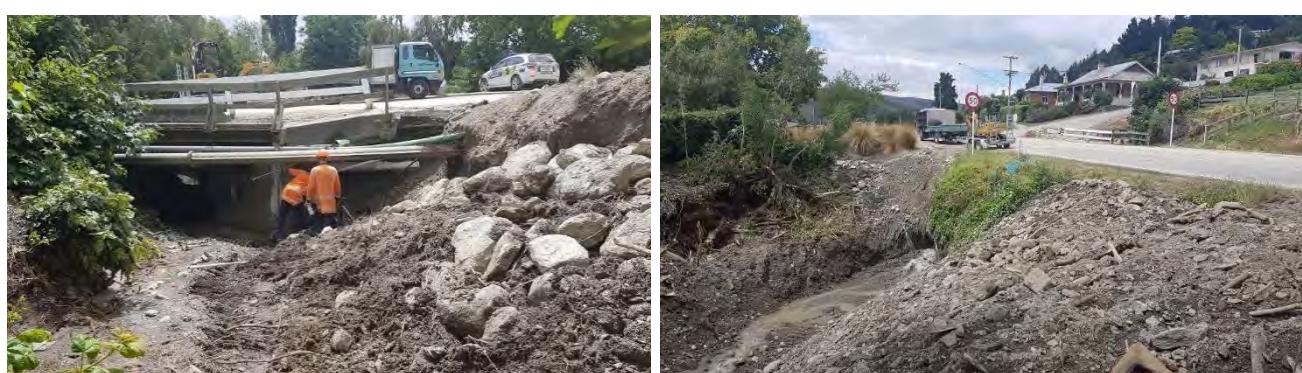
Figure 13: Photos of the Edinburgh Street culvert along SH8 following a debris flood.

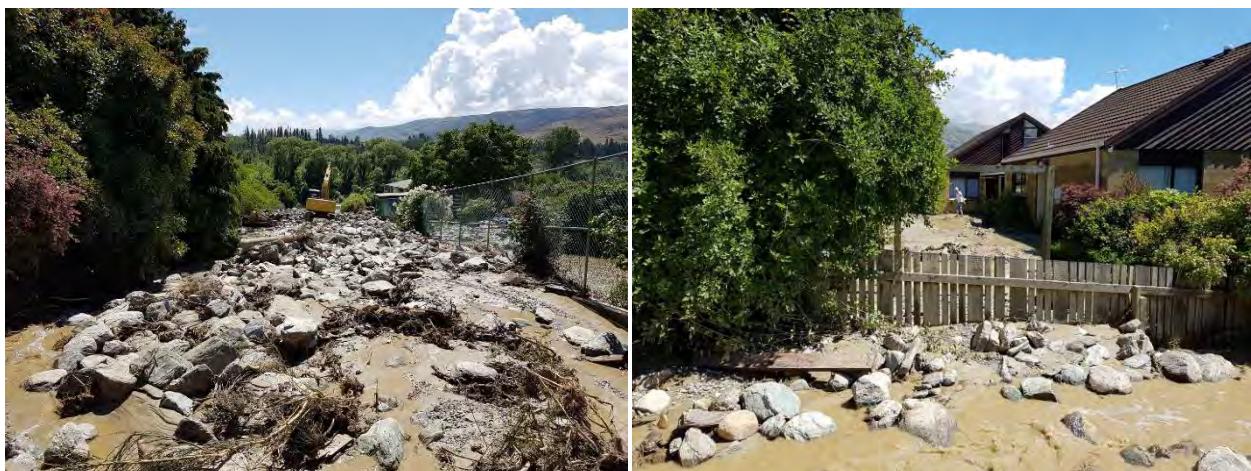
Figure 14: 2017 Reservoir Creek debris flood inundation in Roxburgh.

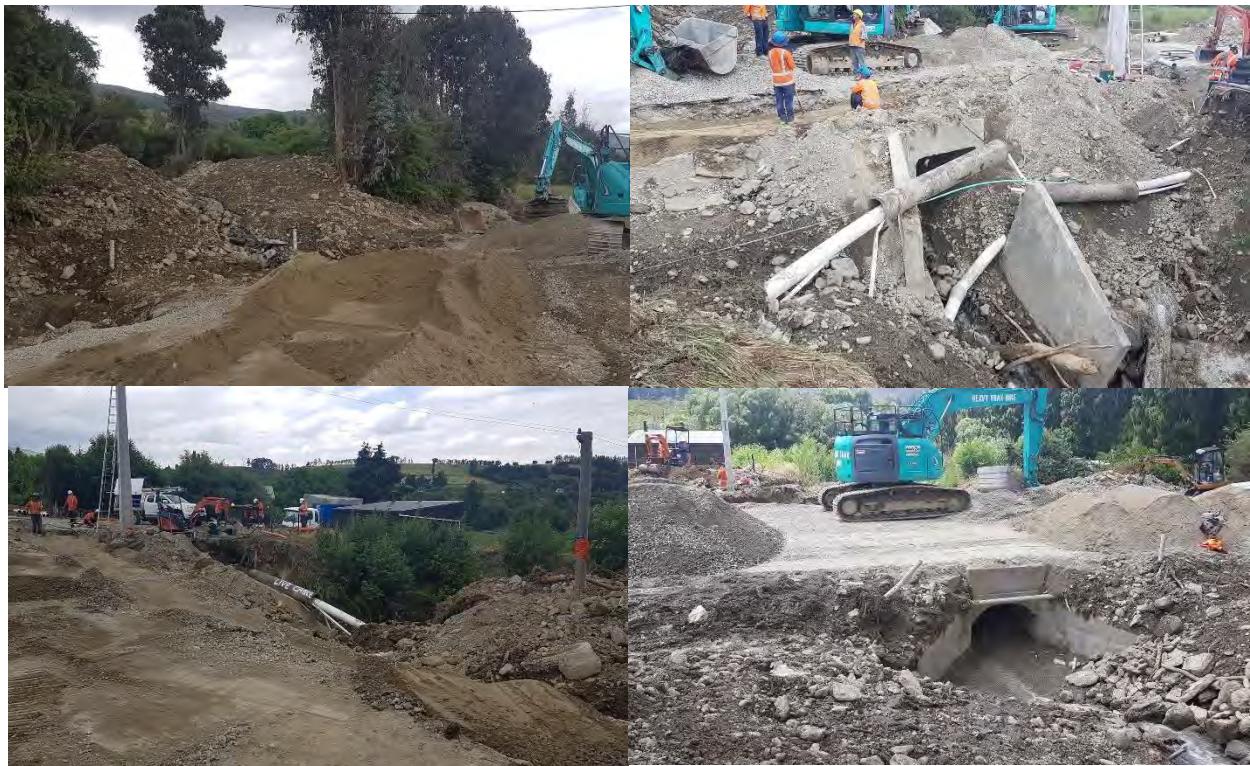
Figure 15: SH8 culvert damage at Pumpstation Creek as a result of the 2017 debris flood.

Pumpstation Creek experienced debris floods with boulders up to 0.5 meters in size, triggered by 40 mm of rainfall in one hour. The debris flood exited the channel at a farm bridge and a culvert under SH8, spreading debris across the fan and around a house. The estimated debris volume was approximately 1,500 m<sup>3</sup> (Dellow et al., 2018); however, based on the extent of debris in this catchment (c. 20,000 m<sup>2</sup>) and assuming an average depth of debris inundation of c. 1 m the true volume of debris inundation is more likely to have been around 20,000 m<sup>3</sup> at this fan. Similarly, estimation of total debris volumes using empirical relationships of peak water discharge to debris discharge also yield larger volumes of debris inundation, albeit with significant variability (Appendix D). A landslide above the fan-head showed movement and was suggested to be monitored at the time (Dellow et al., 2018). The event destroyed a small farm bridge, blocked the culvert beneath SH8, and deposited debris on the road and around at least one house. There was minor damage to the cladding on a farm shed.

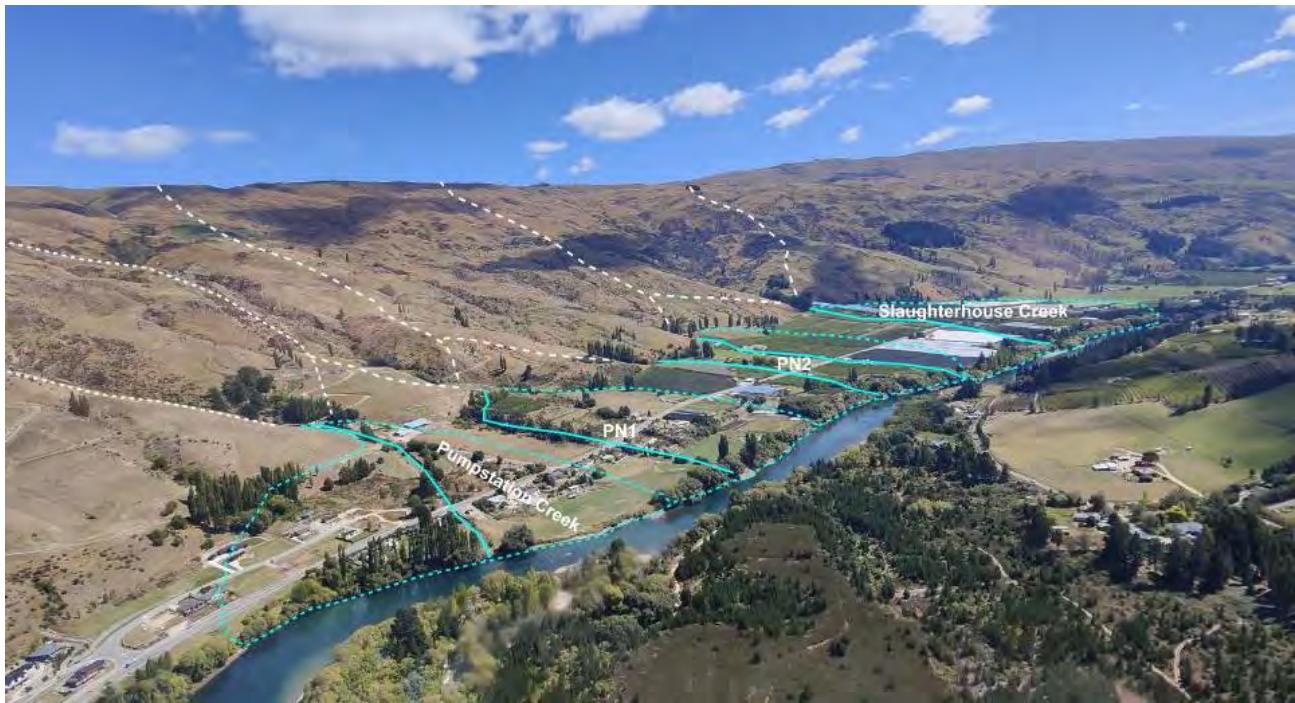
Figure 16: Alluvial fans of the catchments north of Roxburgh township with the Clutha River in the centre of the photo.

To the north of Roxburgh township, Slaughterhouse Creek, PN2, PN1, Pumpstation Creek drain the slopes of the Old Man Range to the northeast (Figure 16). Alluvial fans in this area are extensive and primarily comprise orchards and productive agricultural land. Building and infrastructure development increases towards the Pumpstation Creek alluvial fan which includes the proposed Quail Haven subdivision.

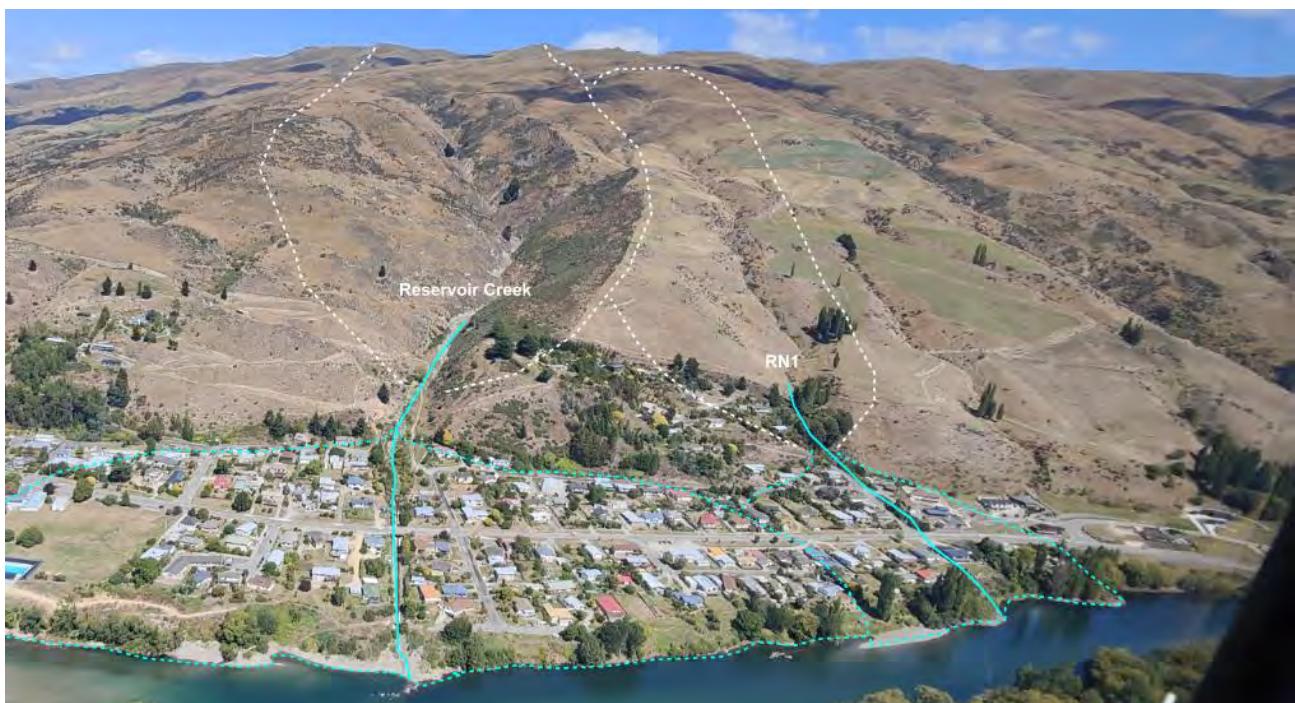
Figure 17: Alluvial fans of the catchments in Roxburgh township with the Clutha River at the bottom of the photo.

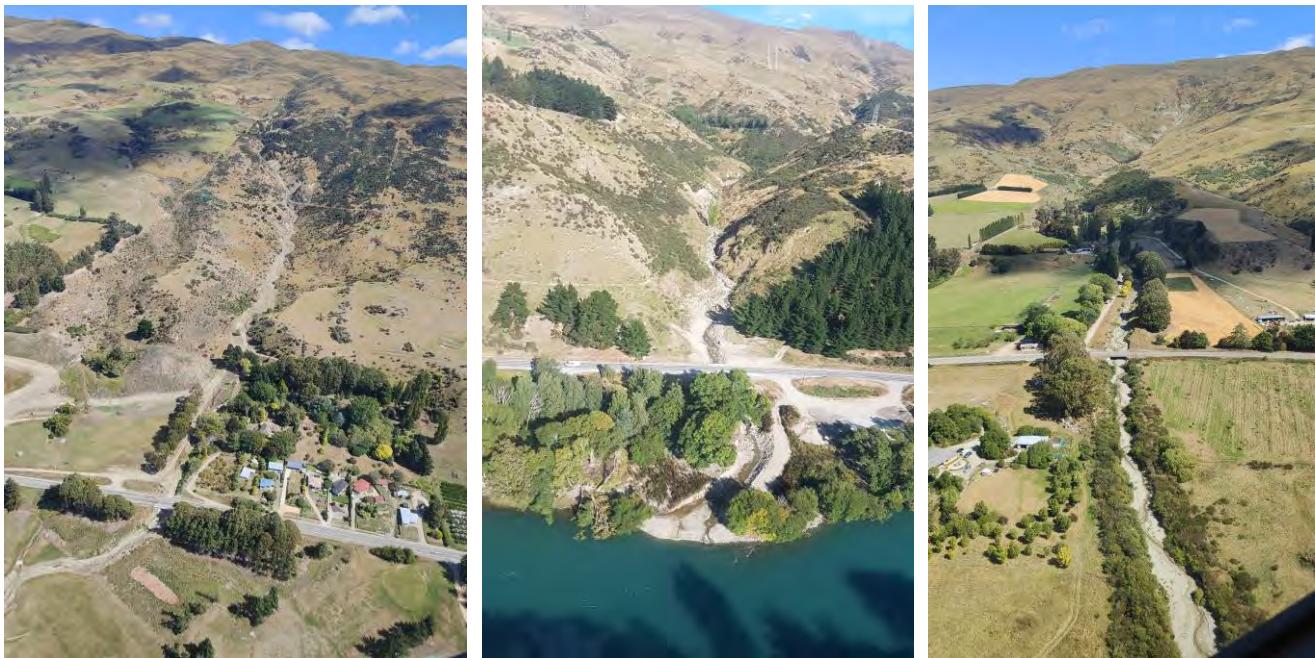
Figure 18: Aerial photographs of three of the catchments to the south of Roxburgh township; Golf Course (left), Black Jacks (middle), and Stevensons (right) catchments.

South of the Roxburgh township, Golf Course Creek, GS1, GS2, Black Jacks Creek, BS1, BS2, and Stevensons Creek drain the slopes of the Old Man Range to the east towards the Clutha River. The alluvial fans of these catchments are largely undeveloped with large areas of orchard and agricultural land with minor developments such as the Roxburgh Golf Course. With the exception of Stevensons Creek, alluvial fans in this area are comparably small and restricted by the Clutha River which runs close to areas of bedrock along the base of the Old Man Range.

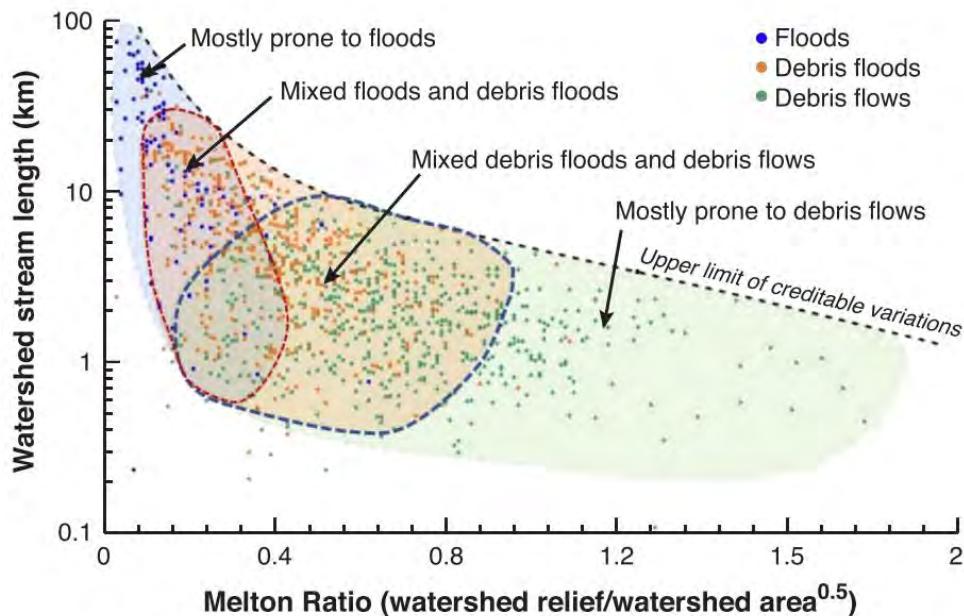
Figure 19: Characterisation of hydrogeomorphic hazards due to Melton Ratio and catchment length using data from fans in Alberta and British Columbia, Canada (Church & Jakob, 2020).

Previous reports have indicated that Melton and Relief Ratios are useful preliminary indicators for characterising which hydrogeomorphic hazard is likely to occur (Wilford et al., 2004; Jakob, et al., 2020; Golder, 2019a). As described in Section 1.3, hydrogeomorphic hazards can be fluid-dominated floods and debris floods to sediment-dominated debris flows and debris avalanches. Typically, a greater melton ratio indicates that debris flows are more likely; however, catchments producing various hydrogeomorphic hazards are not uncommon (Figure 19).

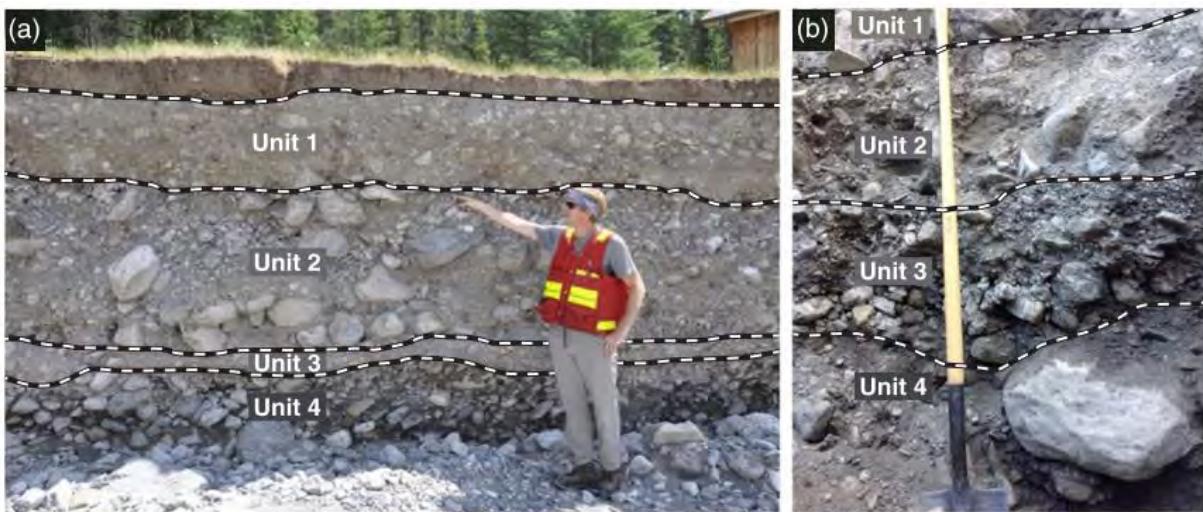
Figure 20: Typical debris flood stratigraphy from Cougar Creek, Alberta, Canada (Church & Jakob, 2020). Unit 1 is described as a matrix-supported outbreak flood deposit with little stone imbrication while Units 2 and 4 are high-energy debris flood deposits. Unit 3 is interpreted as a basal density flow (part of flow in contact with the ground) of Unit 2.

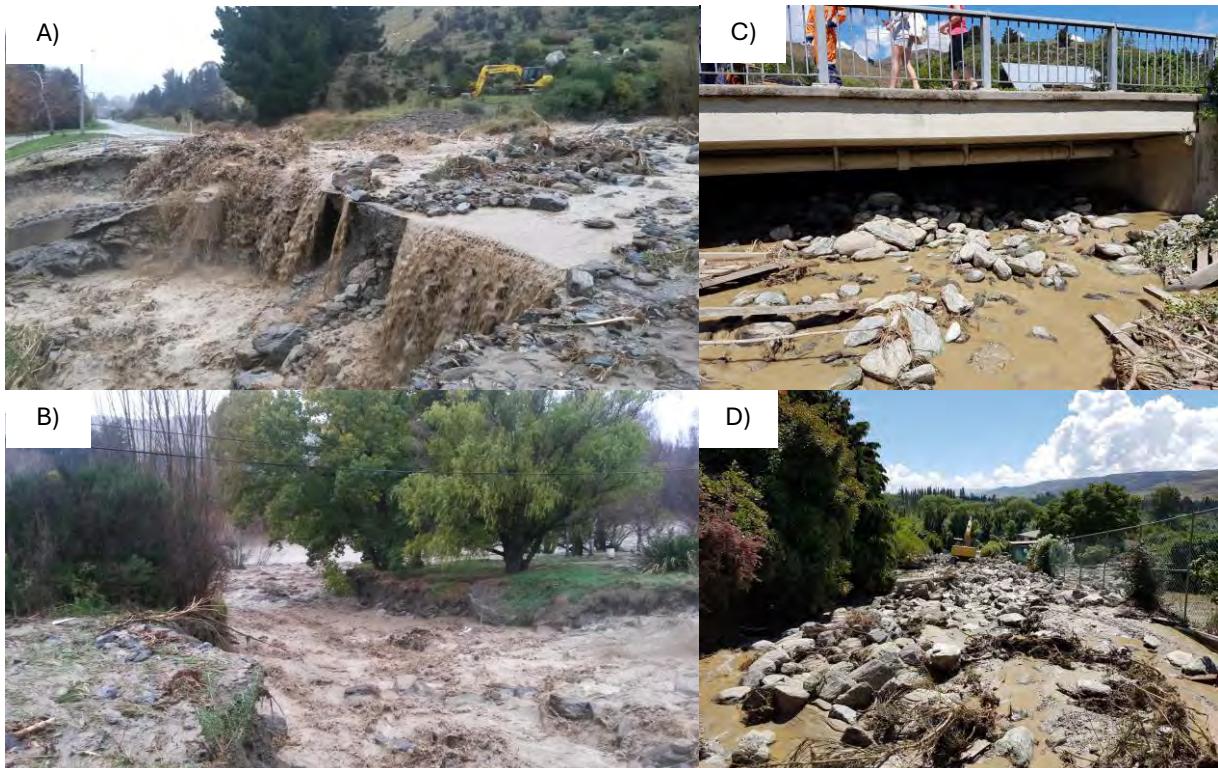
Figure 21: 2017 Debris flood events in Roxburgh. A and B) Black Jacks Creek during active debris flood in 2017. C and D) Debris flood deposits in Reservoir Creek shortly following the 2017 event.

In Roxburgh, photos taken during and immediately following the 2017 events, generally indicate high-energy debris flood characteristics dominated by water transporting large boulders with less than 40% sediment (Figure 21). While deposits suggest a range of hydrogeomorphic hazards have occurred in Roxburgh (Figure 22). Exposed stratigraphy in stream channels indicate alternating events between matrix-dominated debris floods and coarse gained pebble and cobble-dominated deposits suggesting high-energy debris floods or debris flows. Deposits include marginal levees, terminal lobes, fans, and bars which indicate both debris floods and debris flows (Wilford et al., 2004). We infer that hydrogeomorphic events in Roxburgh are dominated by high energy debris floods (as shown in Figure 21) with infrequent debris flows. This is consistent with the Melton ratio calculated for each catchment.

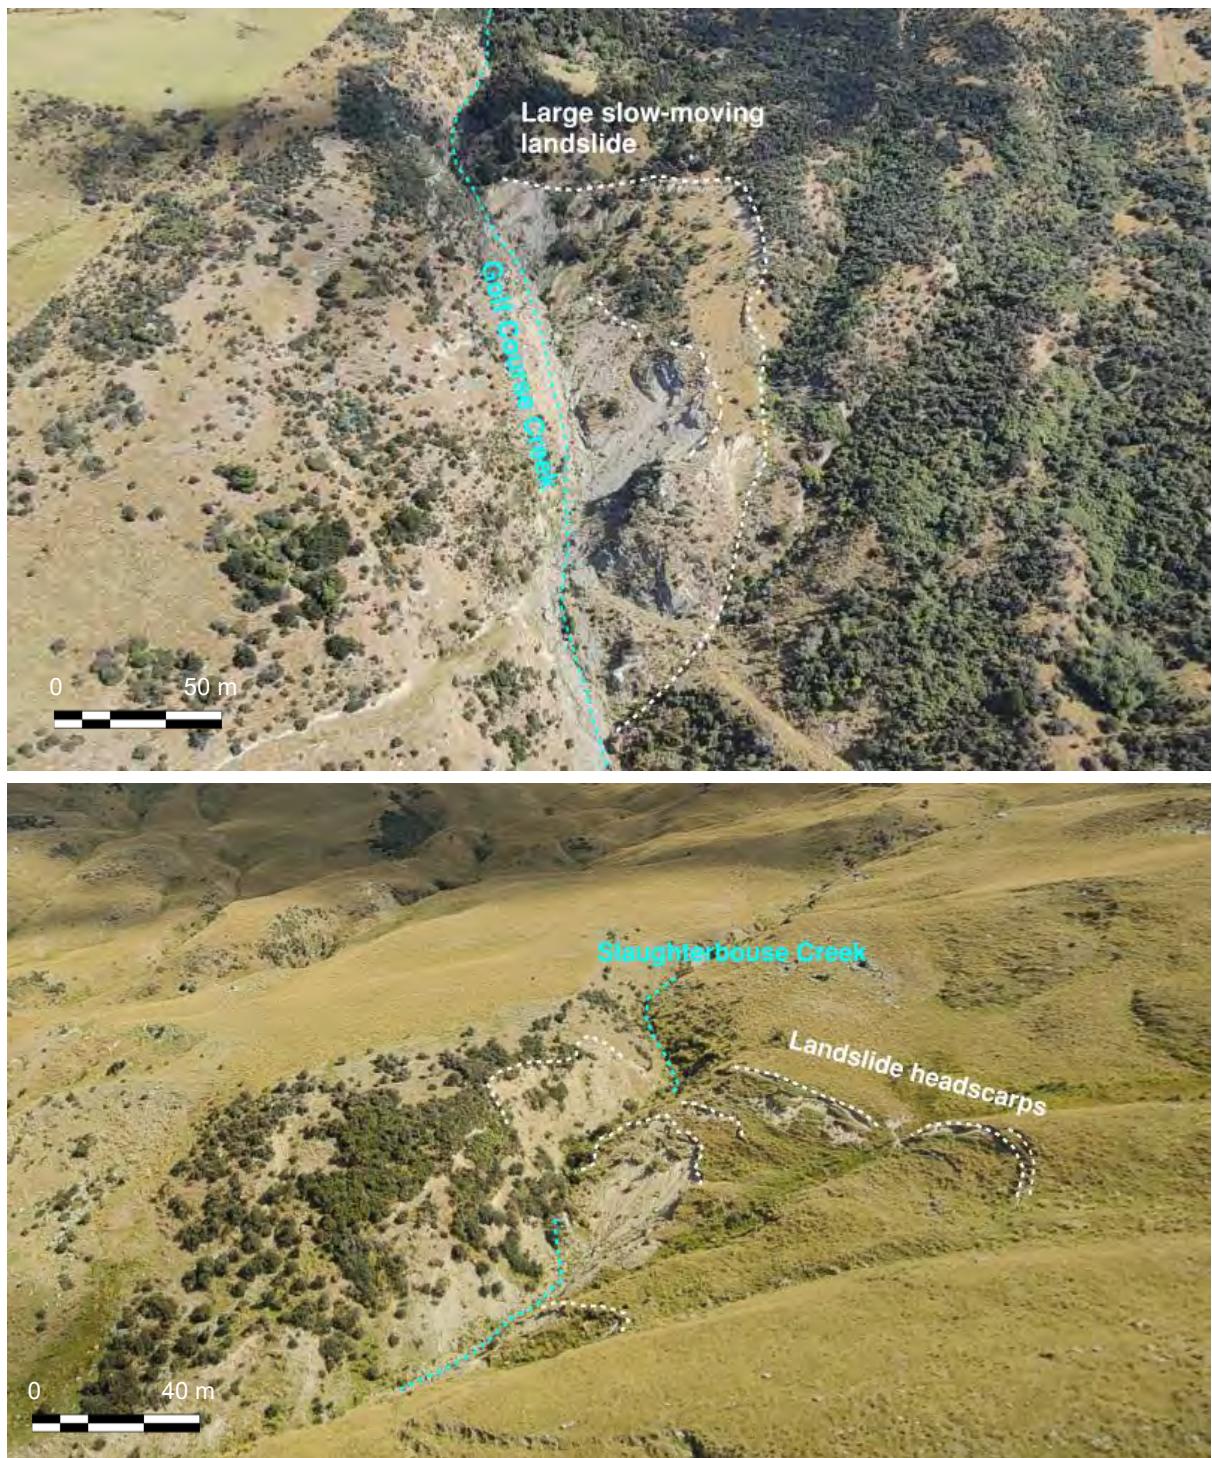
Figure 24: Different landslides identified in the study area acting as potential sources for future debris floods.

There is evidence of recent and frequent landslides in the study area including rotational and translational slides and rockfalls (Figure 24). Additionally, the study area is known to be susceptible to widespread slow creeping landslides which can be observed in the landscape (Figure 25). Slow creeping landslide features are much larger than typically surficial landslides observed in the aerial imagery and photographs. These types of landslides are typical of schist landscapes in Central Otago and are thought to be less likely to contribute to debris floods due to much slower rate of movement and relatively intact rock material. For the purposes of this study, we refer to these features as deformed slopes, and large-scale creeping landslides.

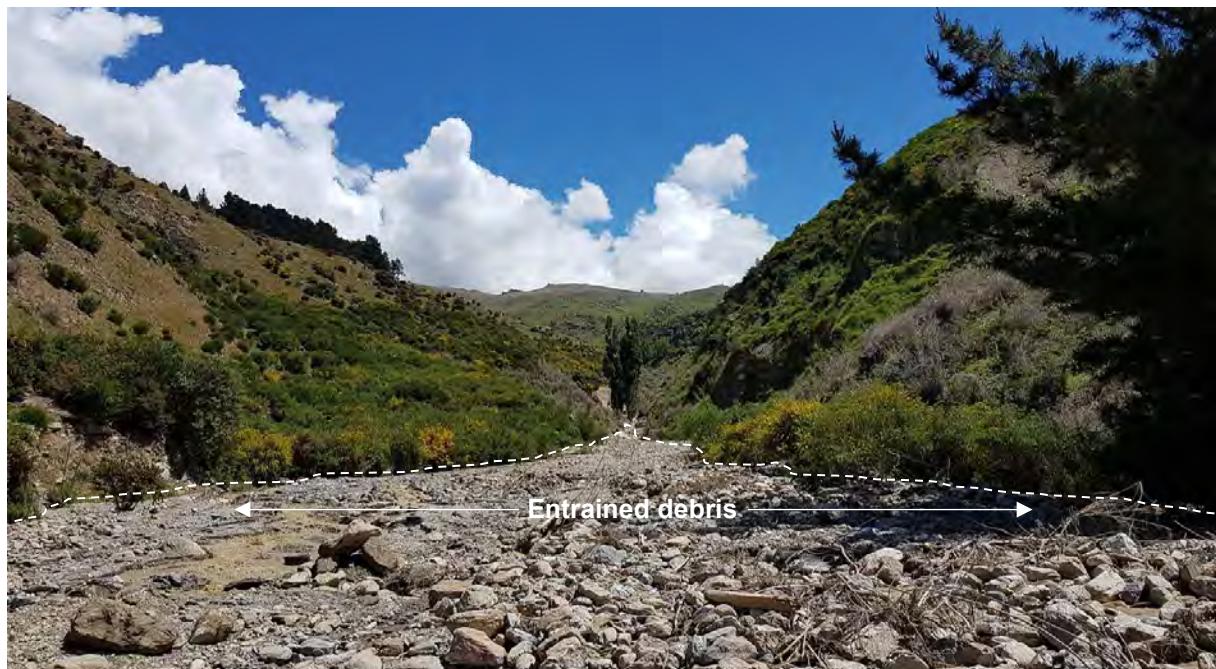
Figure 26: Debris in the Black Jacks Creek channel following the 2017 debris flood event. Deposited material is a key source for future debris flood events.

Entrained debris in the channel refers to channel floor material that can be readily mobilized and incorporated into a debris flood. This process significantly increases the volume and complexity of the debris flood. Previous debris floods and erosion processes have also deposited significant material within the channel margins of catchments in the study area. These deposits are also potential source material for subsequent debris flood events (Figure 26).

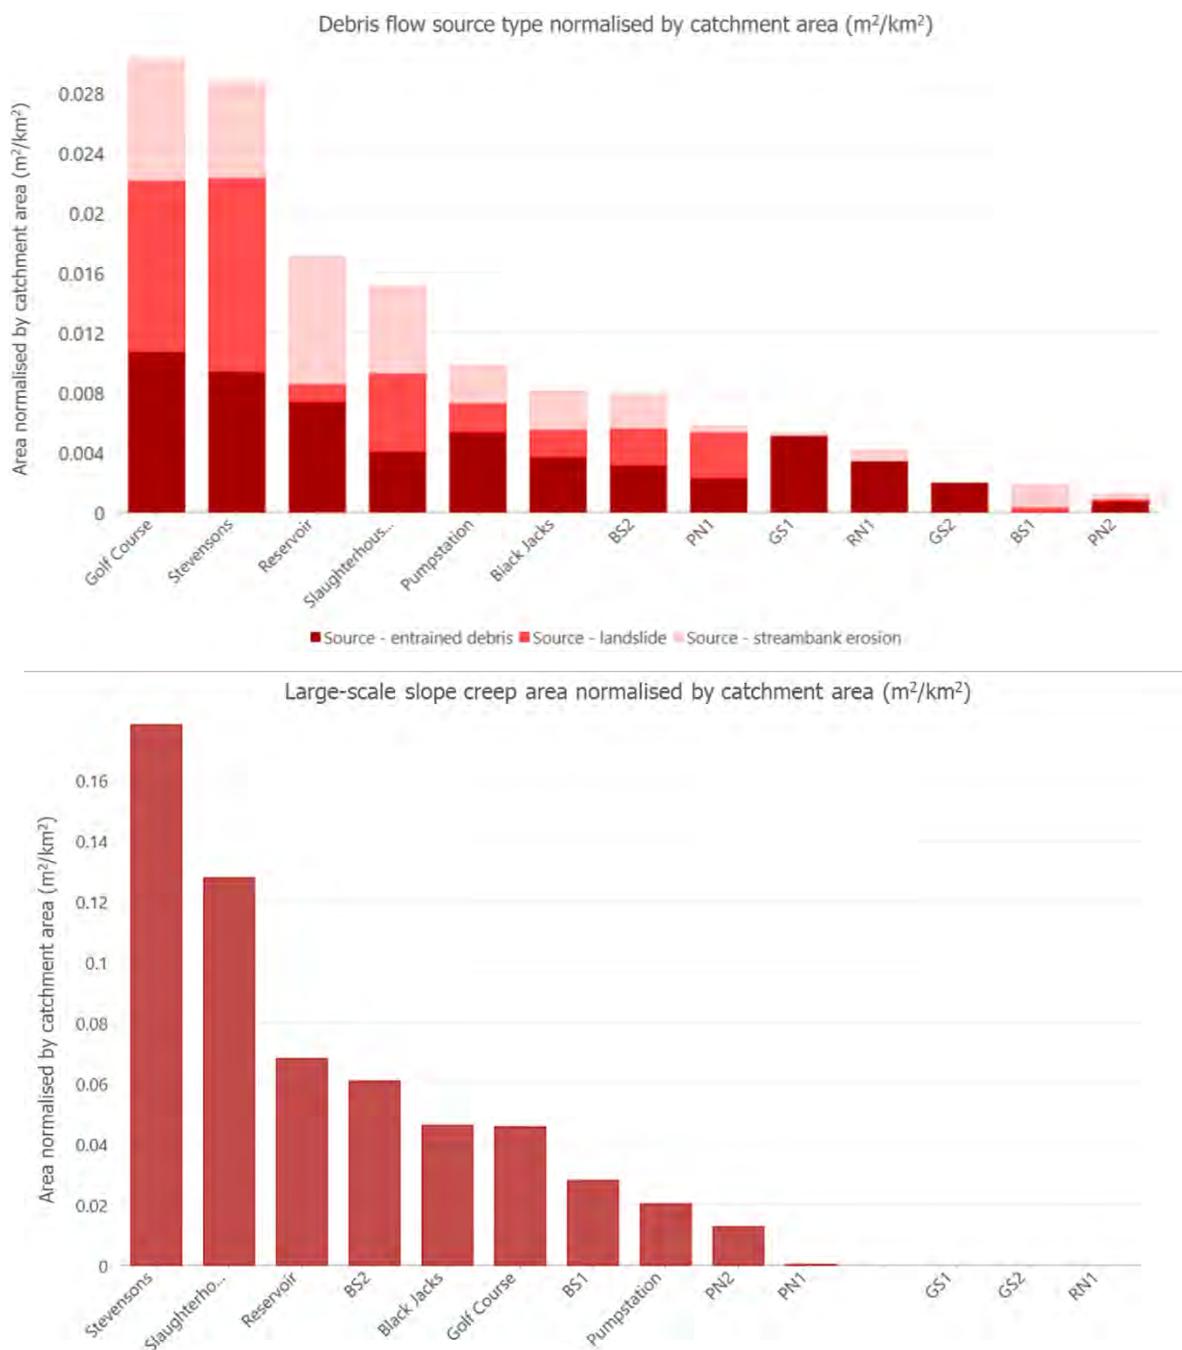
Figure 27: Mapped source area totals in each catchment normalised by catchment area ( $\text{m}^2/\text{km}^2$ ). Top: Recently active and generally smaller scale debris flood source areas in each catchment. Bottom: Larger scale deformed slopes or slope creep in each catchment.

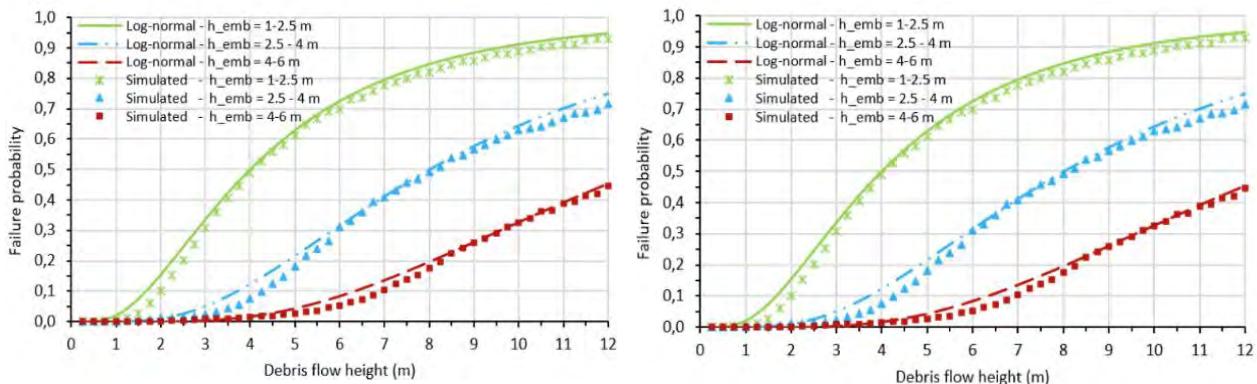
Figure 32: Failure probability of road embankments (left) and probability of headcut erosion (right) with debris flow height.

- Nieto et al (2021) developed fragility curves for road embankments, showing a higher probability of embankment sliding and headcut erosion with increasing inundation debris flow depths (Figure 32).
