Otago Regional Council  
**Roxburgh Debris Flow and Debris  
Flood Study**

Hydrogeomorphic Modelling and Quantitative Risk  
Assessment Report

30 January 2026

Otago Regional Council

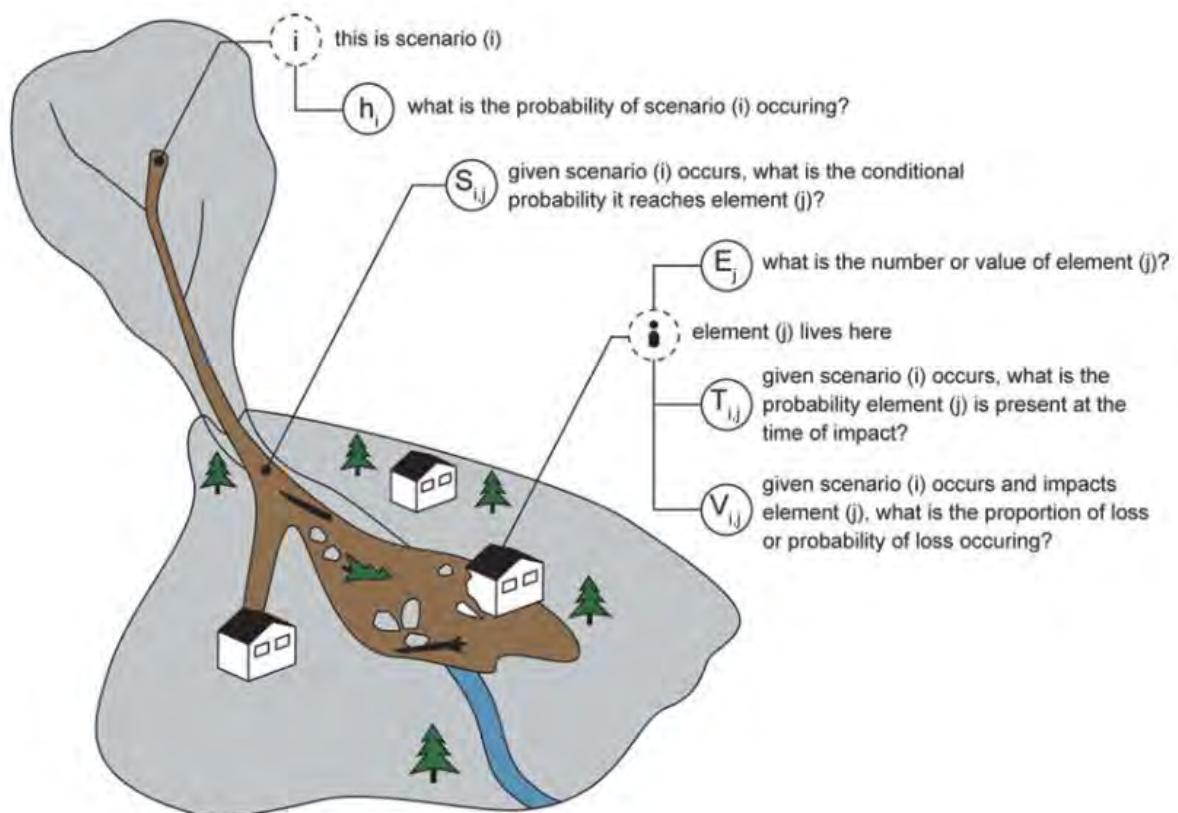
Figure 33: An illustration of quantitative risk inputs for debris floods (from Jakob, et al., 2022).

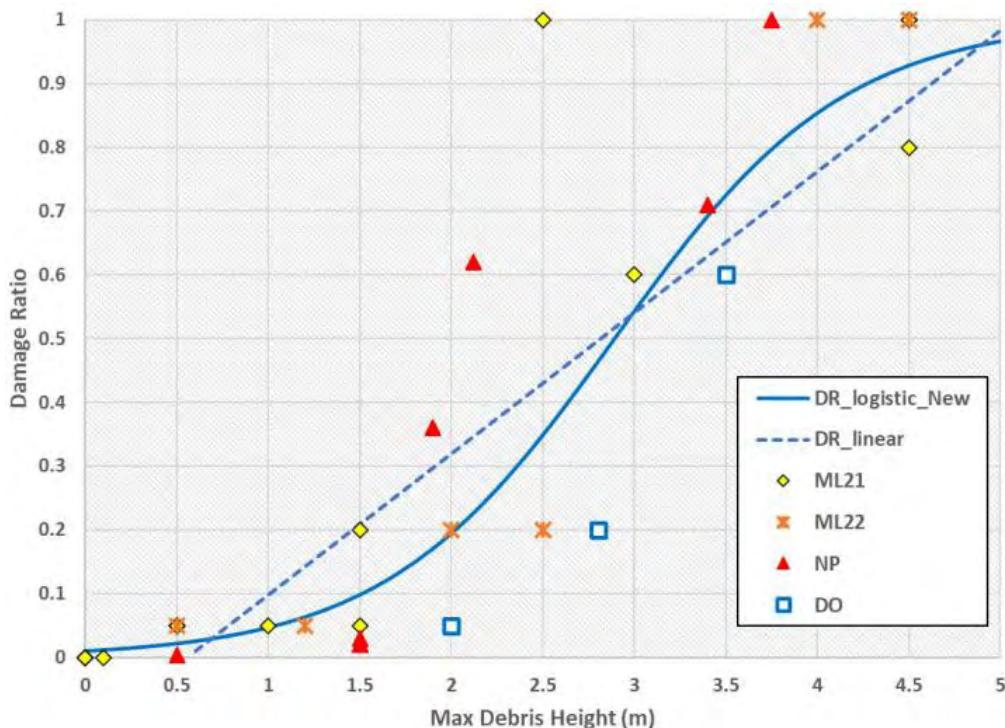
Figure 34: The damage function for buildings used in this assessment (Wolter et al., 2024).

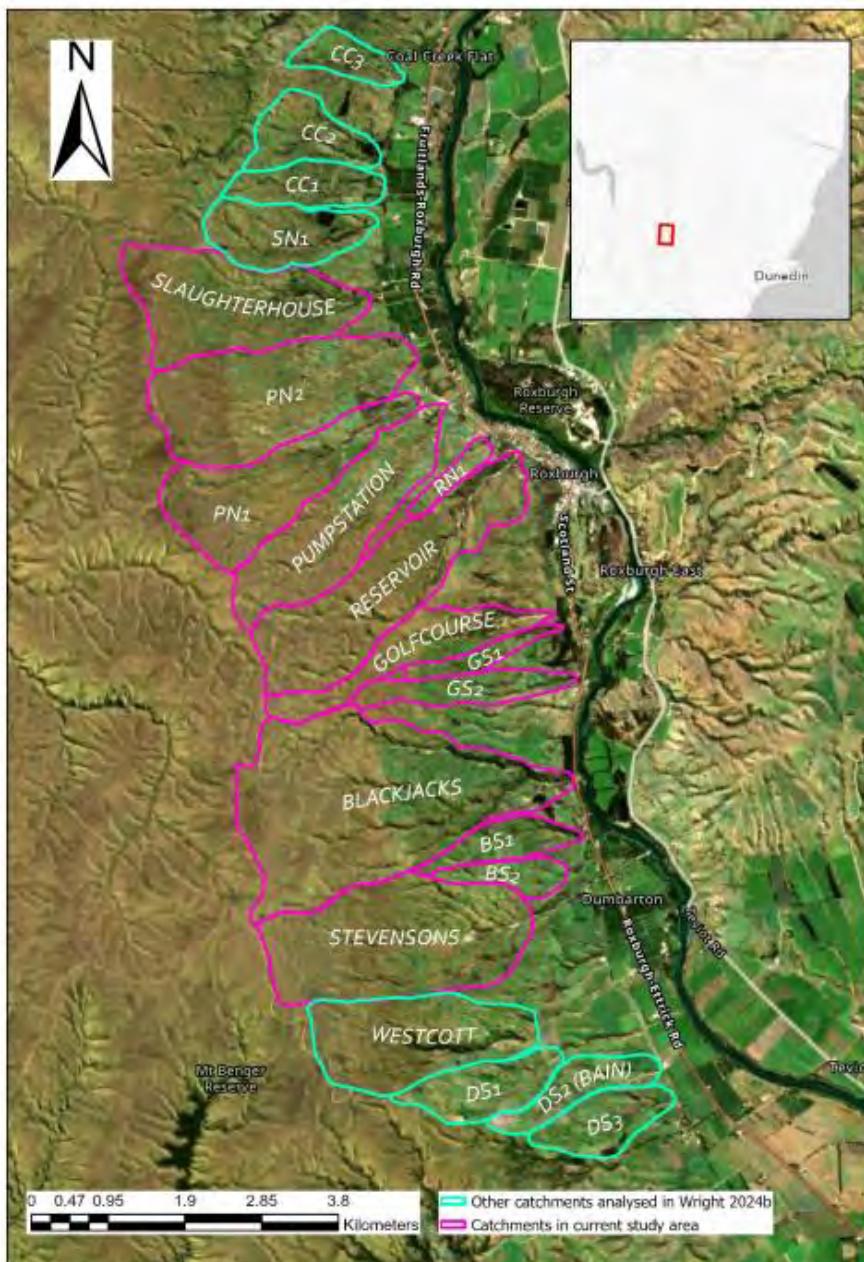
Figure 1: The 13 debris flow catchments to be assessed in this study in Pink. Other catchments analysed in previous studies outlined in green. Figure from ORC Request for Proposal (RFP) dated 05/09/24.

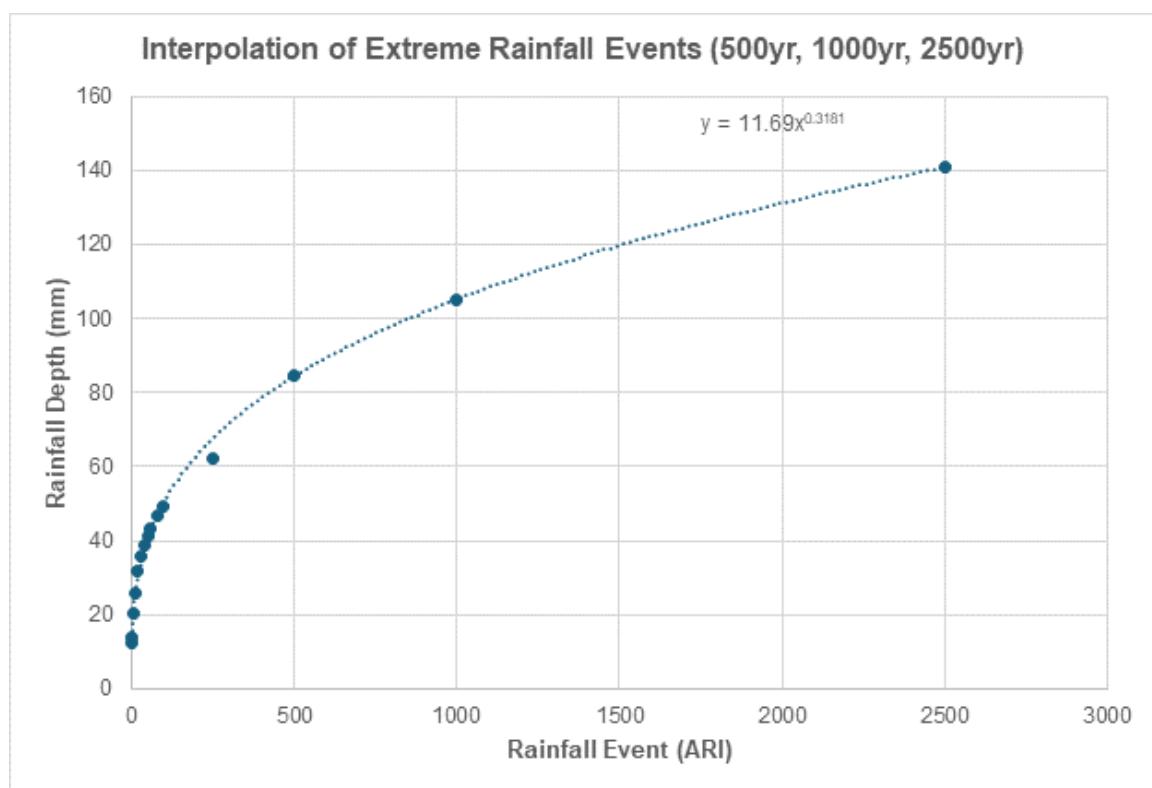
Figure 40: The extrapolation curve used to estimate depth of rainfall events currently not covered by HIRDS.

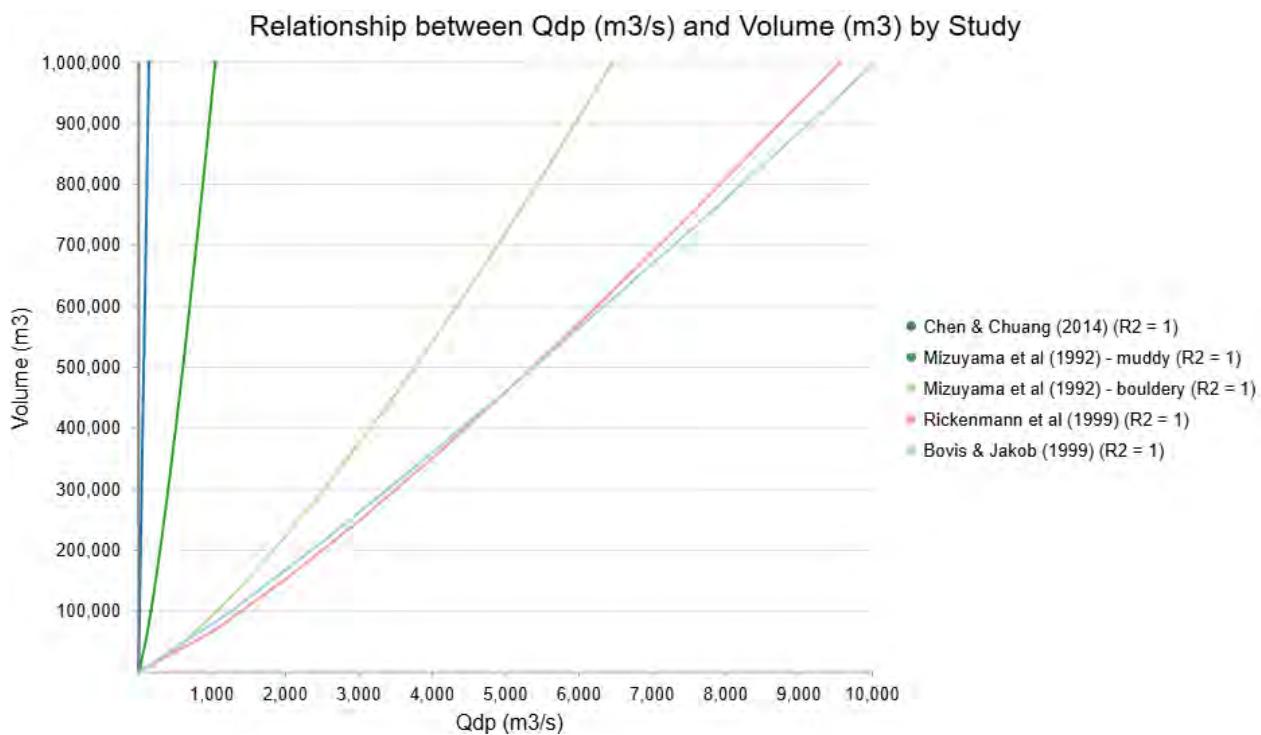
Figure 41: Existing empirical relationships for Peak debris flow discharge (Qdp) and debris flow volume.

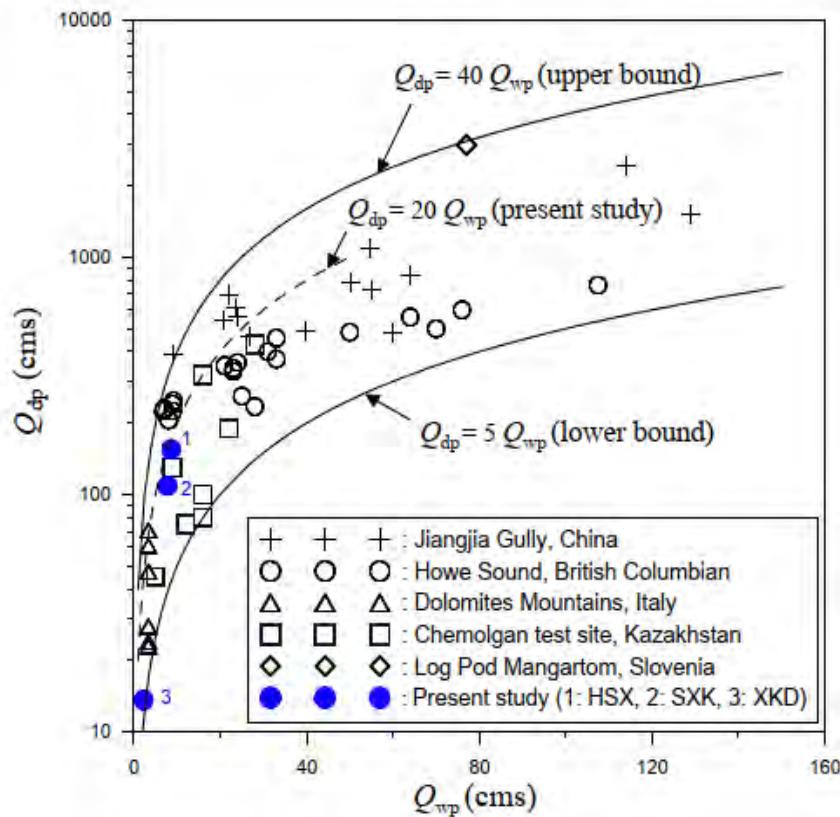
Figure 42: Relationship between debris flow discharge ( $Q_{dp}$ ) and water-flow discharge ( $Q_{wp}$ ). From Chen & Chuang (2014).

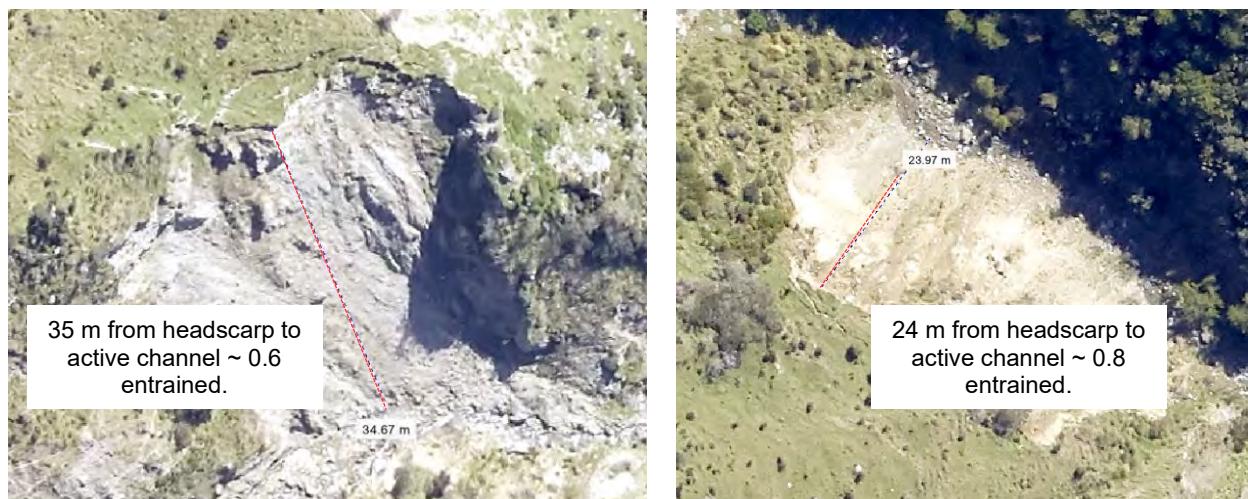
Figure 44: Examples of how data was captured for entrainment factor. Left: Landslide/block slide with headscarp 35 m from stream, 60% (0.6) of material estimated to be entrained in slide or deposited into the channel. Right: Surficial landslide with a headscarp 24 m from stream, a higher proportion estimated to be entrained ~80% (0.8) due to landslide geometry and type (shallow translational landslide).

To evaluate an entrainment factor for each buffer, we estimated the proportion of debris for each mapped source that was entrained into a flow (i.e. material removed from the feature compared to material remaining). This was assessed in ArcGIS Pro using the 2017 and 2024 orthophotography to estimate the amount of material that had been entrained in the flow or deposited in the channel compared to the amount of material that remained on the slope (Figure 44). The distance from the feature headscarp to the active stream was also recorded. This process was undertaken for all catchments and included approximately 400 data points.

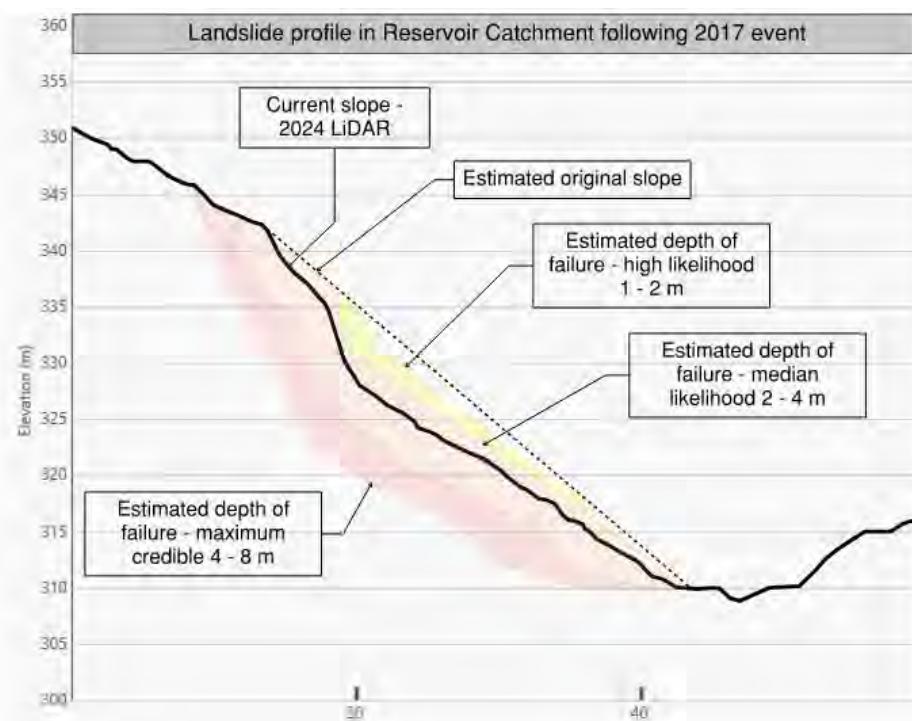
Figure 46: An example of a cross section for a landslide feature in Reservoir Creek with annotations for high likelihood, median, and maximum credible failure depths.

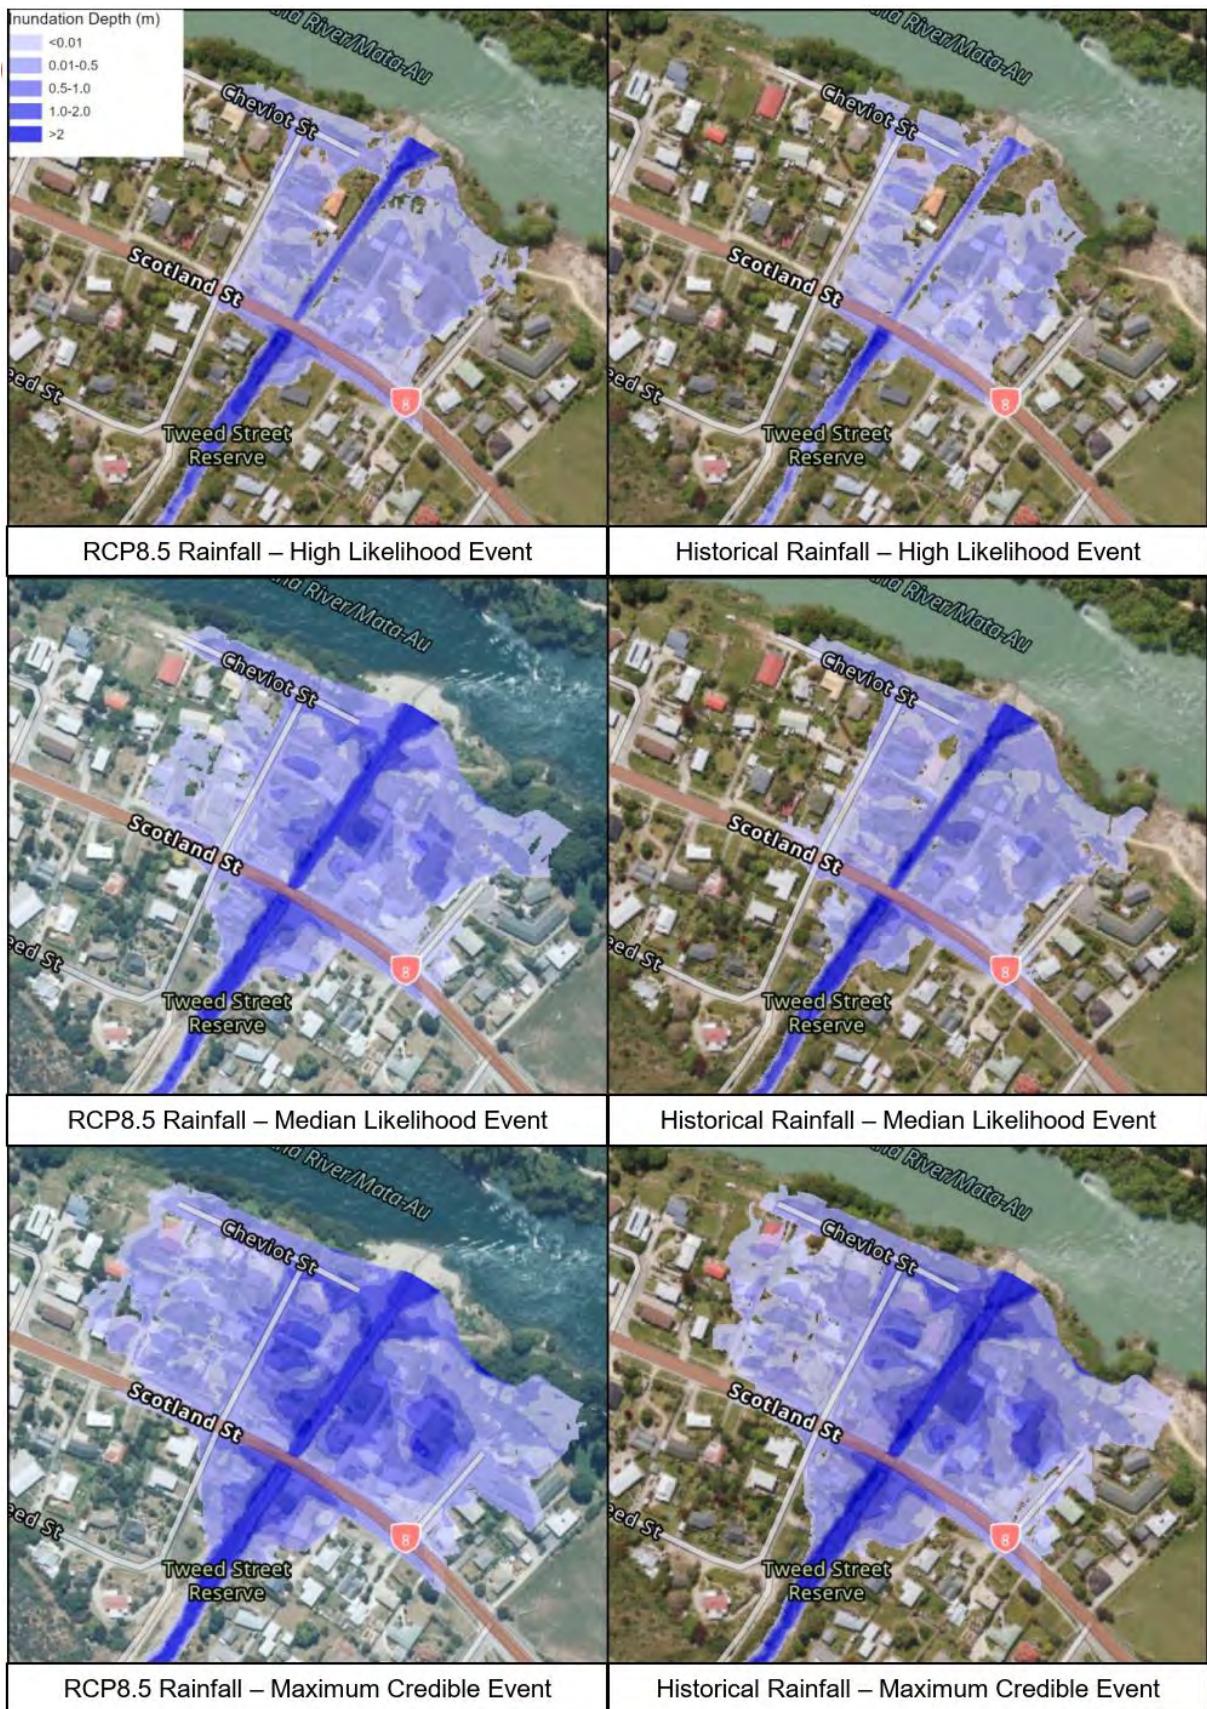
Figure 48: Comparison of debris flood depth using RCP8.5 rainfall and peak flow as inputs (left) and using historical rainfall and peak flow as inputs (right).

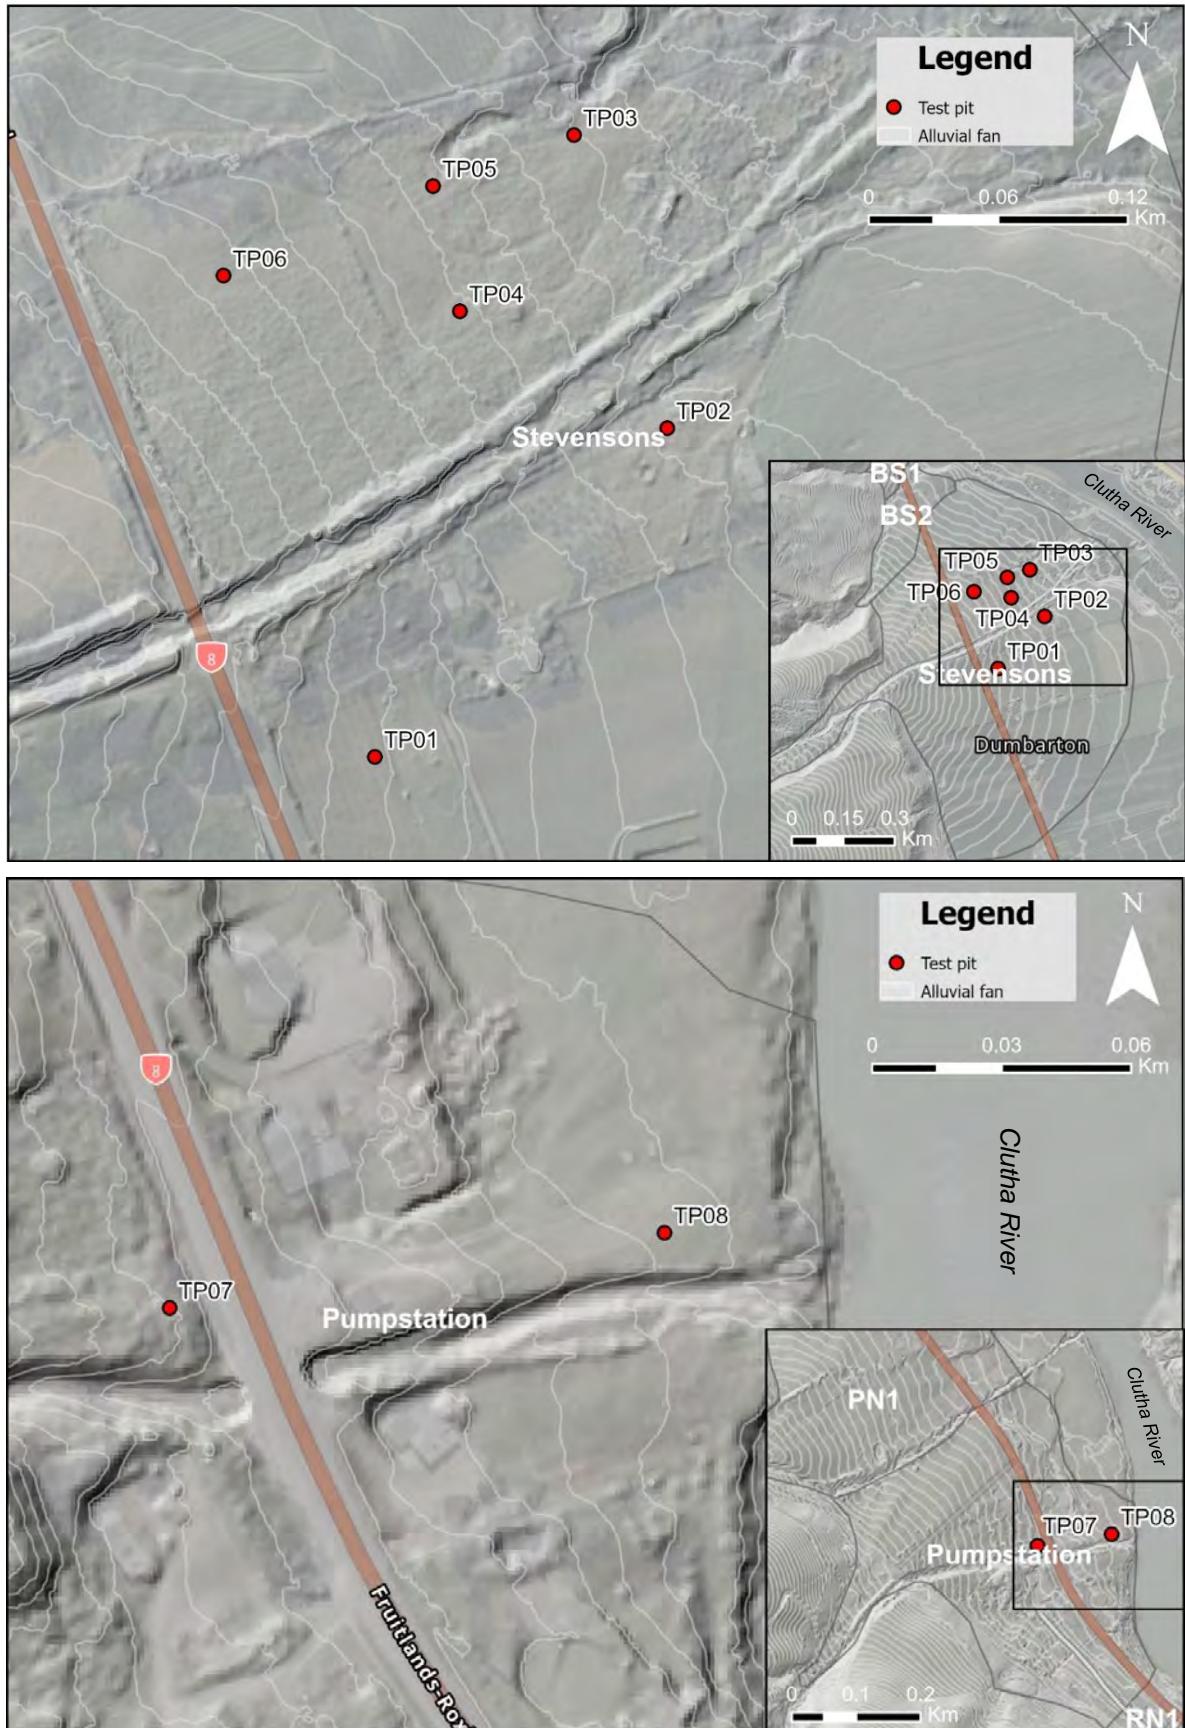
**Figure 2: Test pit locations on Stevensons (top) and Pumpstation (bottom) alluvial fans.**

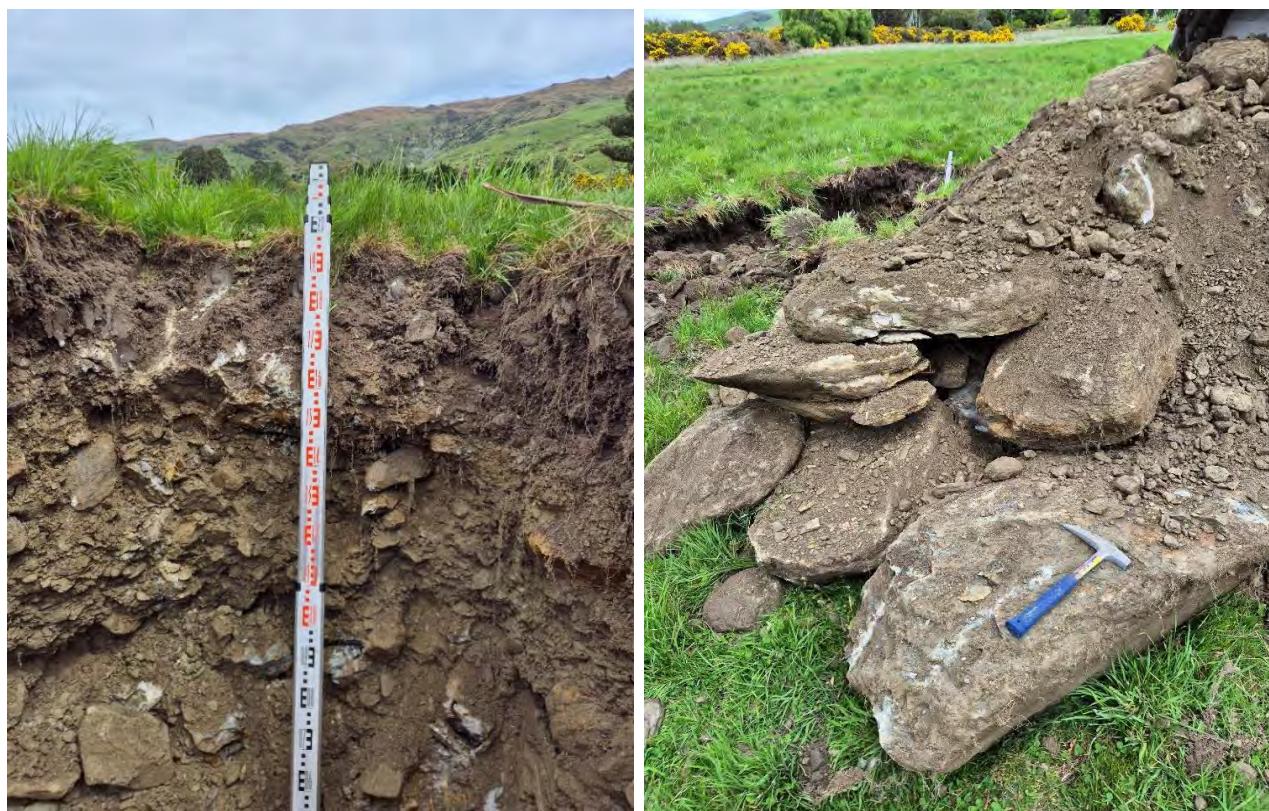
**Figure 3: Typical appearance of silty gravels in a test pit – TP03 (left), and in the spoil (TP04).**

- A. **Silty and sandy gravel with some cobbles and boulders.** These materials dominated the near-surface stratigraphy, and were typically unsorted, loosely packed, and weakly bedded in layers approximately 0.2–4.0 m thick (Figure 3). Significant variability in grainsize, degree of sorting, and bedding was observed in TP01 on the southern side of Stevensons Fan, with some gravel layers that were well sorted and bedded in moderately thin layers. Cobbles and boulders were surrounded schist predominantly 100–200 mm in diameter and up to 1 m diameter. No organic material was observed within these layers.

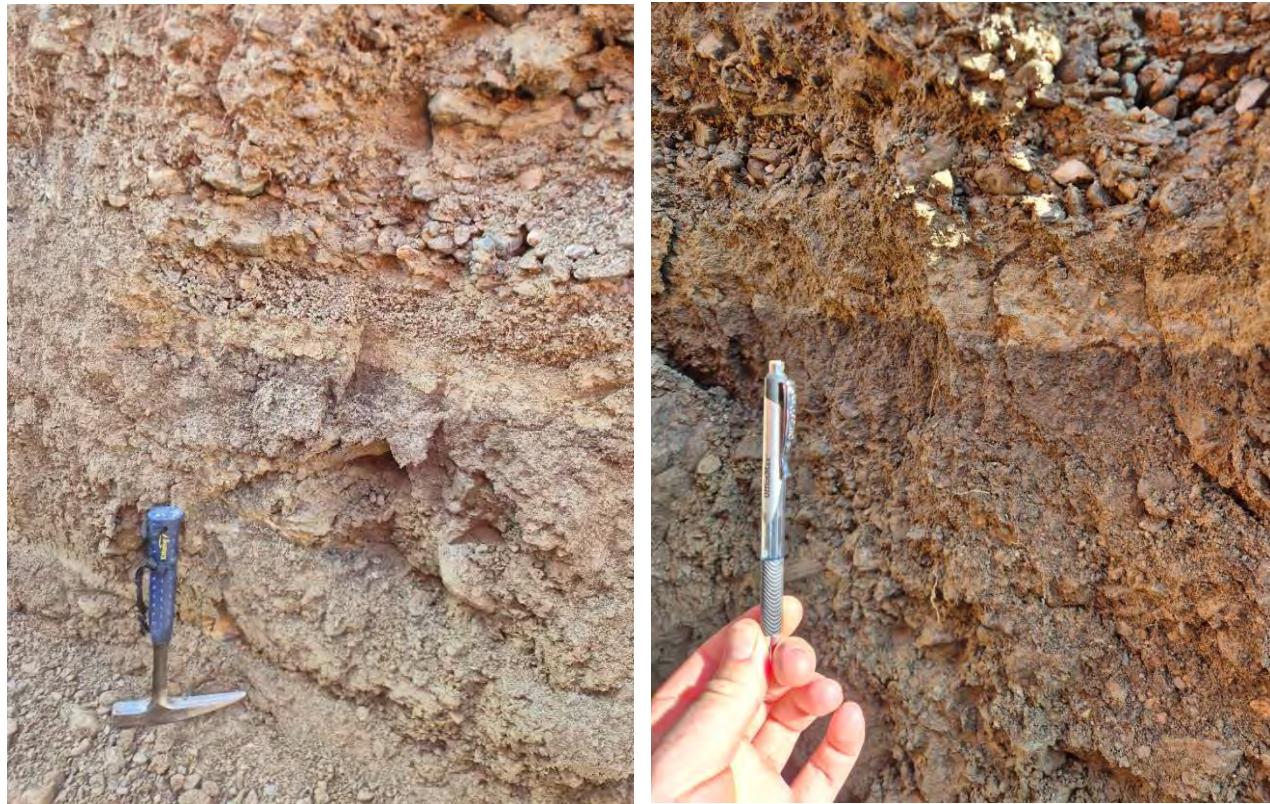
**Figure 4: Possible paleosol layer in TP01 overlain and underlain by silty gravel and cobble layers.**

- B. **Sandy silt** (some silty sand and clayey silt) of brownish grey colour, sometimes with thin layers of imbricated fine gravel (Figure 4). Layers were up to 0.2 m thick. A few zones containing small rootlets (<3 cm long and <0.1 cm diameter) were found in these layers below gravels and cobbles (Figure 5). Some plasticity in clayey silt layers.

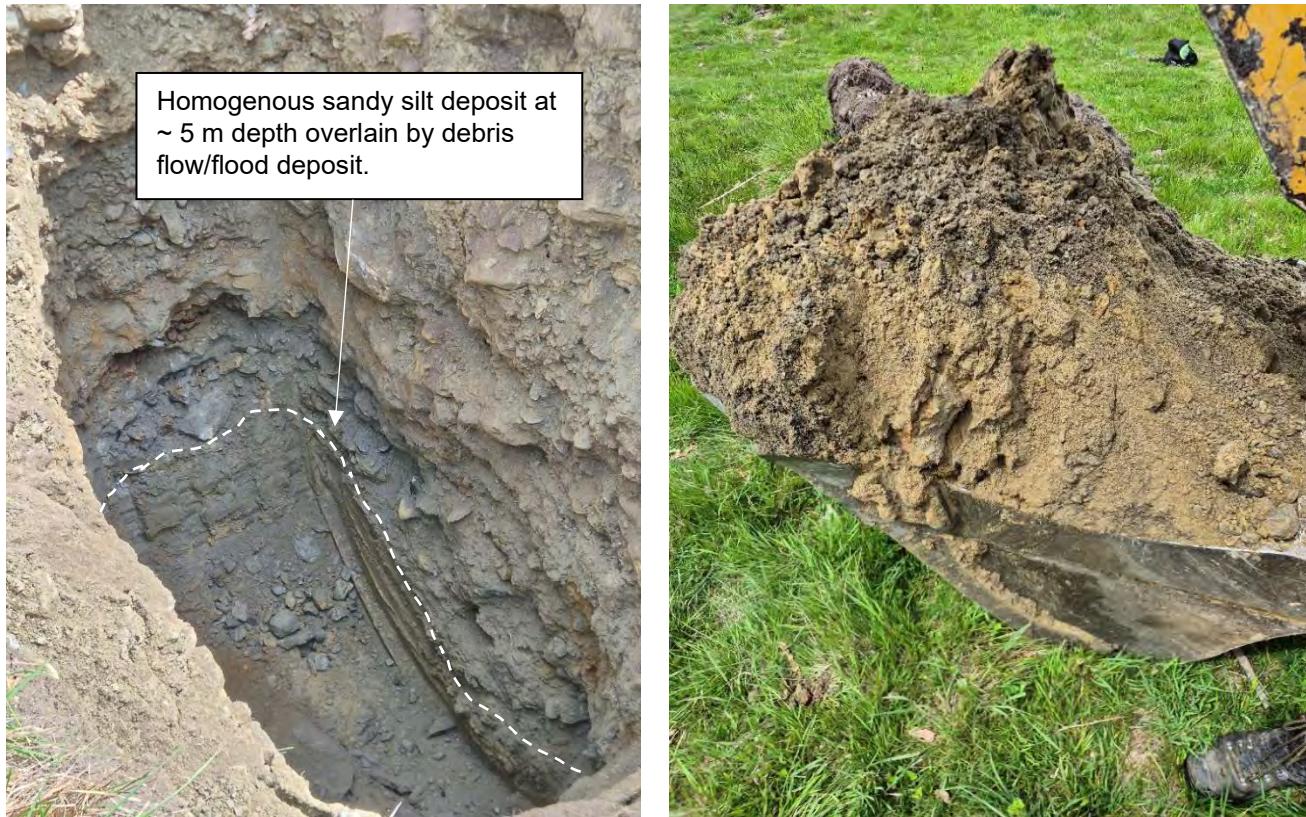
Figure 5: Sandy silt deposit in TP03 (left) and in excavator bucket out of the hole (right).

- C. **Thick homogenous gravelly silt layer** with some clay and sand. This was encountered in TP02 at 1.5 m to EOH at 5.0 m depth, TP03 at 5.0 m depth, and TP08 at 1.8 m depth. Above this layer were gravels, cobbles, and boulders in a matrix of fines (Figure 5).

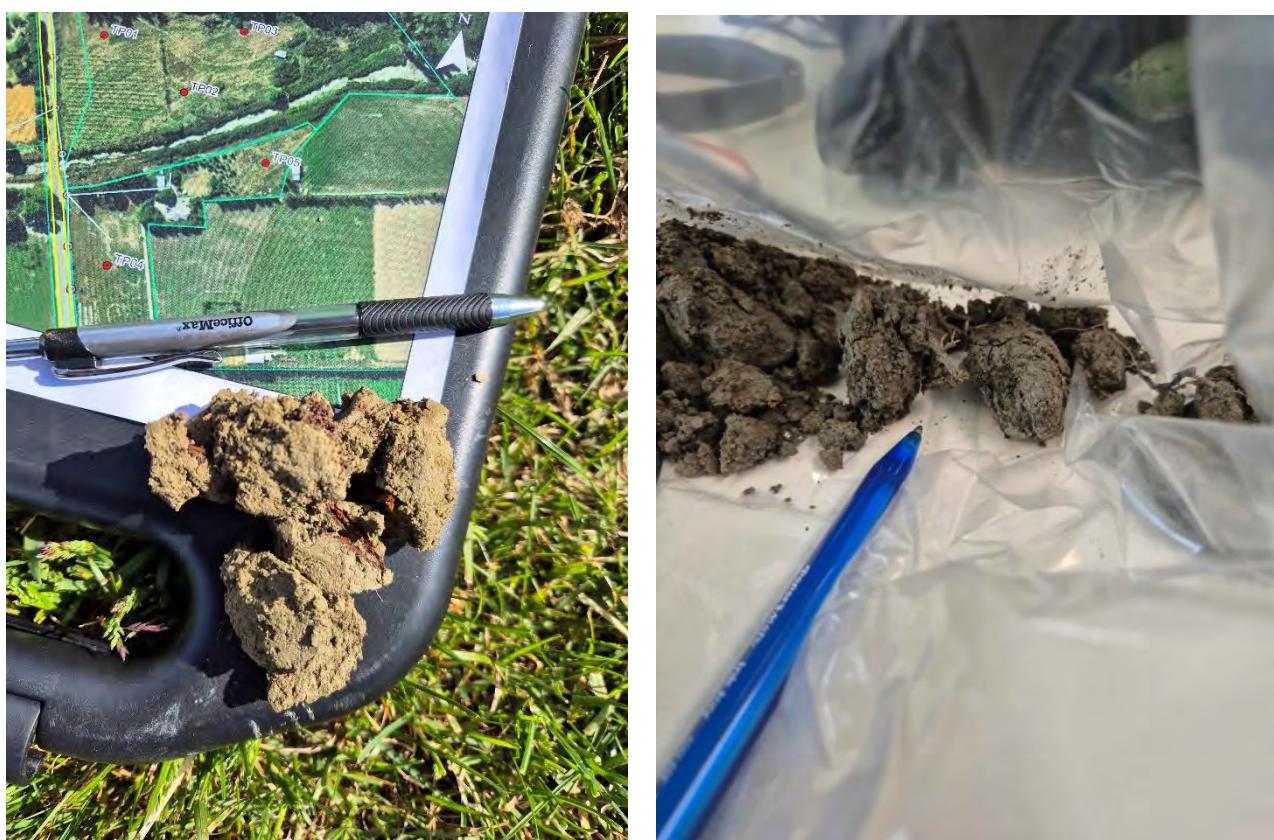
Figure 6: Organics (rootlets) retrieved from some of the silty layers in the test pits.

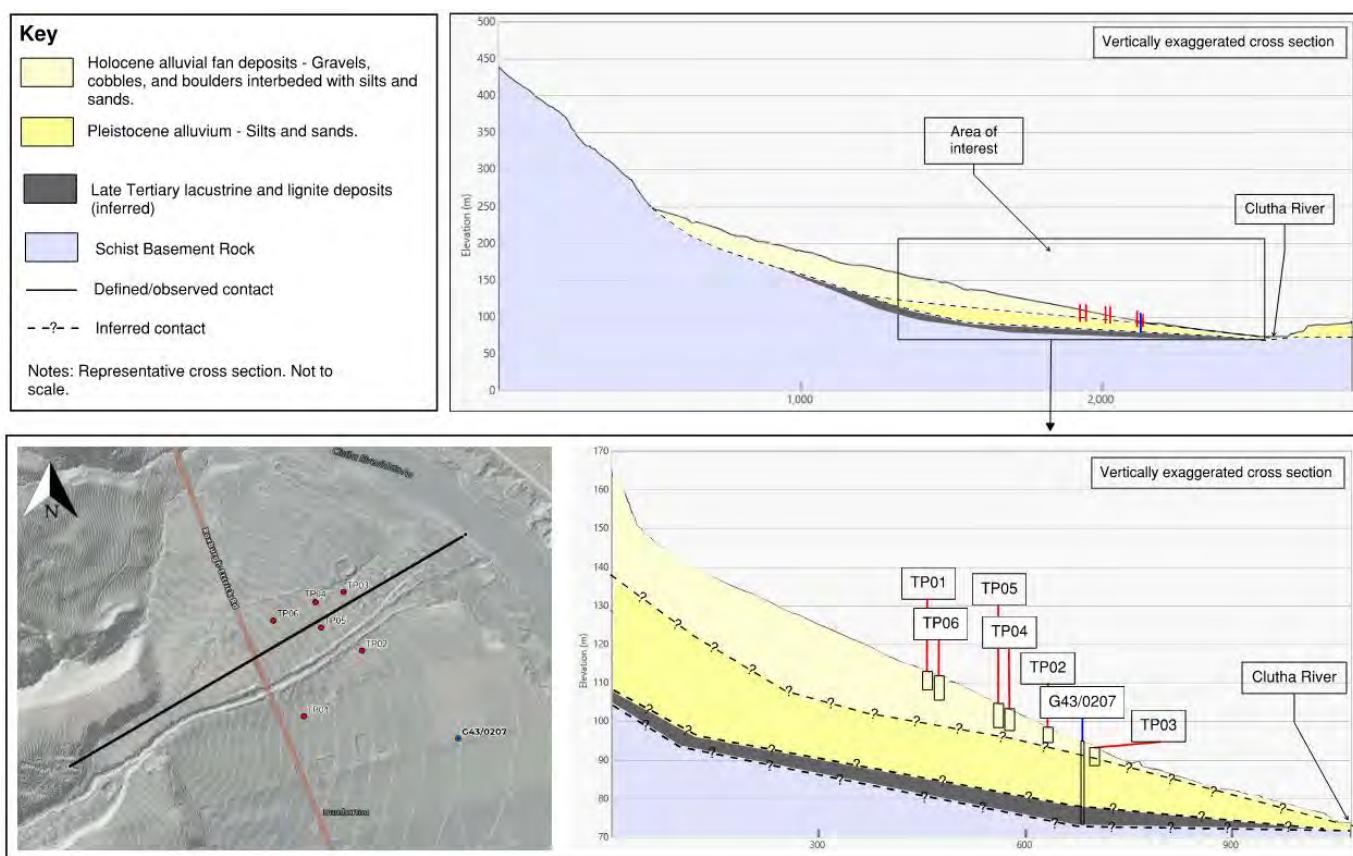
**Figure 7: Schematic cross sections of the Stevensons alluvial fan illustrating inferred thicknesses of soil and rock layers.**
