# **Outram Floodbank Stability Assessment**

Seepage, Slope Stability and Flood Modelling

Prepared for Otago Regional Council Prepared by Beca Limited

**21 November 2024**

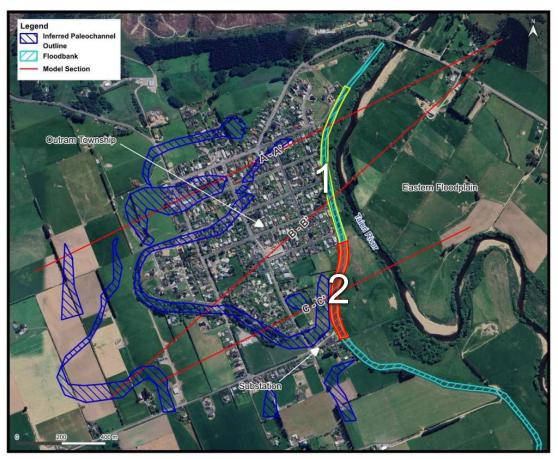
Figure 1-1. Overview Map of Outram Showing the Floodbank, Taieri River, Paleochannels, and 2D model Sections. The floodbank assessed in this report is outlined in yellow (Zone 1) and red (Zone 2). Paleochannels are inferred from Taieri Flood Hazard maps and LiDAR. (Image source: Google Earth)

An assessment of the floodbank was undertaken to determine the level of risk and potential type of floodbank failure, to provide high level remedial options for the floodbank, and to feed into a review of the Outram Flood Response protocols (to be carried out by others). An overview map of the site is shown in Figure 1-1.

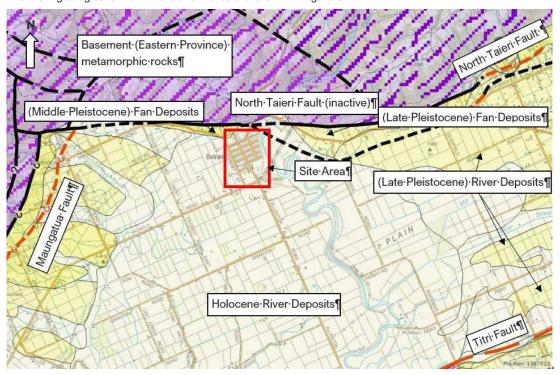
Figure 3-1. Annotated geological map of the area (Image source: GNS Webmap 250,000, not to scale).

The main geological units in the Outram area are shown in Figure 3-1.

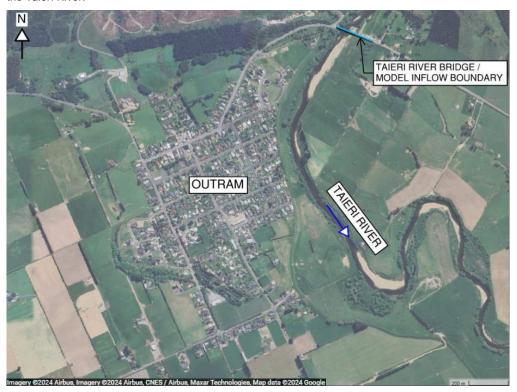
Figure 9-2. Locality plan of area of Outram and Taieri River. Changes to the HEC-RAS model provided by ORC have been limited to this area (Image source: Google Earth).

Outram is located at the northern extent of the model, immediately downstream of the Taieri River inflow boundary. Figure 9-2 shows Outram, the adjacent reach of the Taieri River, and the model inflow location for the Taieri River.

The following sections of this report focus on the details of the HEC-RAS model for the extents shown in Figure 9-2. The details of the model outside of these extents have not been changed as part of this project and can be found in 20210121 Taieri Model Development Report DRAFT.

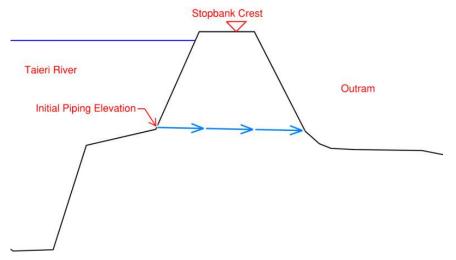
Figure 9-5. Cross section sketch of the Taieri River floodbank showing the initial stage of piping failure.

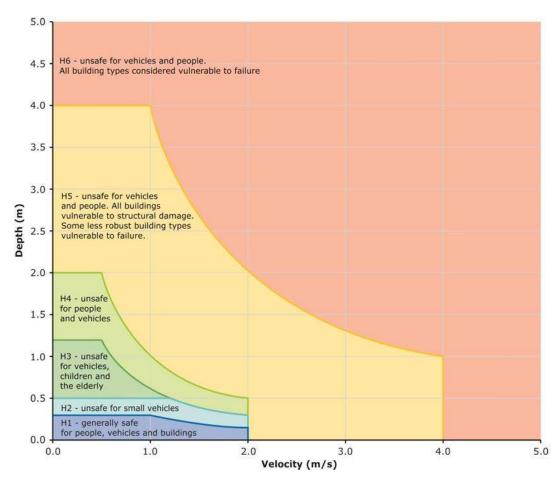
Figure 9-7. General flood hazard vulnerability curve.

For assessing flood hazard as part of this project, we have adopted the combined flood hazard curves produced by Smith et al. (2014) and reported in Australian Rainfall and Runoff (2019). Figure 9-7 presents these flood hazard curves, which reflect the vulnerability of people and assets when interacting with floodwater, as a combined function of water depth and velocity.

We have used this method to define hazard categories in Outram and its immediate surroundings. The hazard maps for each of the breach locations are presented in Section 9.5.

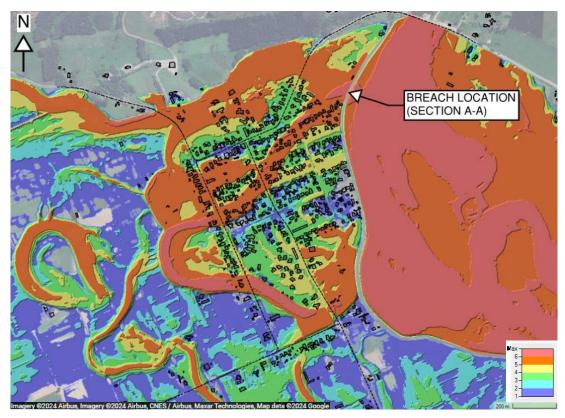
Figure 9-10. Flood hazard map for floodbank breach at Section A-A (Image source: Google Earth).

Figure 9-10 and Figure 9-11 show the flood hazard maps for each of the breach locations. We have included the *NZ Building Outlines* layer from LINZ to show what individual buildings sit within the different hazard categories. We have also included the centrelines of the public roads providing access in and out of Outram to show the viability of residents using these roads to escape flooding.

The flood hazard maps are similar for the two breach locations. In both cases the paleochannels (and areas adjacent to the channels) show a combination of mostly H5 and H6, representing areas of significant flood hazard. The flood hazard in other areas throughout Outram varies between no hazard and H4. The results are discussed in more detail in the following sections.

Figure 9-10 shows that the breach at section A-A causes all access routes to be cut off by areas of H5, meaning that most people located within Outram would have no way of evacuating the town once a breach has developed. Figure 9-11 shows that the breach at section C-C would have similar impacts, except State Highway 87 appears to provide a safe exit route from buildings located in the northern part of the town. It's important to note that the model inflow boundary for the Taieri River is located on the downstream side of the bridge, meaning that the impact of the flood event on the bridge has not been investigated as part of this project. This would need to be done to confirm whether State Highway 87 does in fact provide a safe access route from some of the town in the event of a floodbank breach at section C-C.

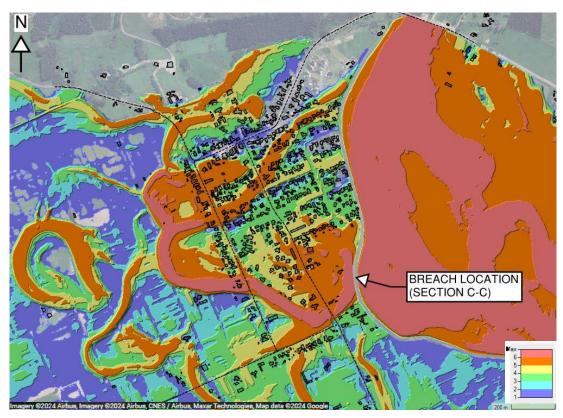
Figure 9-11. Flood hazard map for floodbank breach at Section C-C (Image source: Google Earth).

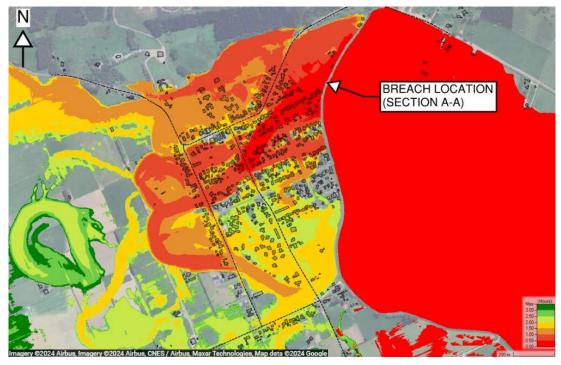
Figure 9-12. Arrival time results map for breach at section A-A. Colours represent time taken since beginning of breach formation for water depth to reach 0.30 m (Image source: Google Earth).

The hazard maps show maximum water depth multiplied by the maximum flow velocity, but do not provide any information on how long these hazard categories take to develop. The best opportunity for people to evacuate the town would be before the flooding reaches its maximum extents. To help understand the feasibility of this, the maps shown in Figure 9-12 and Figure 9-13 have been produced to show how long it takes, from the beginning of the breach formation, for 300 mm water depth to develop. A flow depth of 300 mm has been selected as it represents the upper depth limit of the H1 category, which is considered safe for people and vehicles (refer Figure 9-7), so would allow for people to safely evacuate the township.

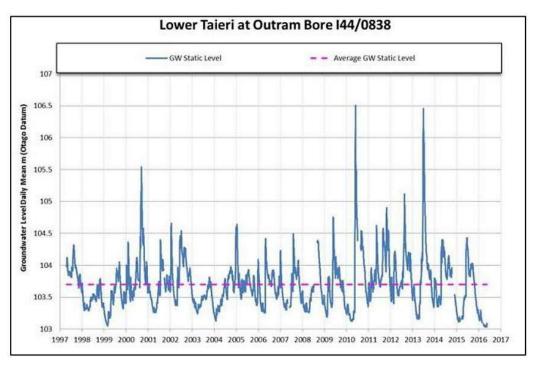
Figure 10-3. Groundwater Levels at Bore I44/0838 on Orme Street in Outram from 1997 to 2016.

To derive an approximate seasonal range in groundwater levels, historic groundwater levels in bore I44/0838 on Orme Street were found, beginning in April 1997, shown in Figure 10-3 (note that the data references the Otago Datum). The important point to take away from this data is the seasonal range, which is about 1.5 m, with some short periods of significantly higher groundwater level in 2000, 2010, and 2013.

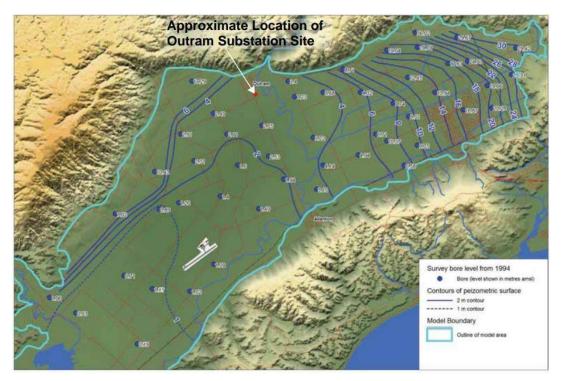
Figure 10-4. Contours / potentiometric surface from the 1994 survey of Groundwater Levels. Source: ORC, 2010. Lower Taieri Groundwater Allocation Study Report.

The direction of regional groundwater flow is broadly from the northeast to the southwest. Regionally, groundwater moves perpendicular to the contour lines as shown in Figure 10-4.

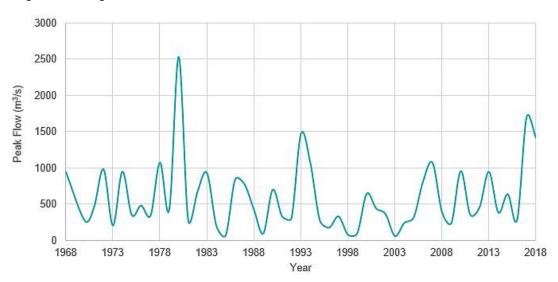
Figure 10-5. Taieri at Outram Annual Maxima Series. (Source: ORC, 2021)

The peak river flows recorded in the Taieri River in Outram each year over 50 years from 1968 to 2018 are shown in Figure 10-5. Note the large spike in 1980 which corresponds with a large flood event which resulted in significant damage in the local area.

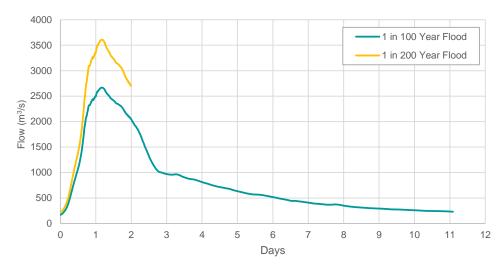
Figure 10-6. Hydraulic Model Flood Flow Outputs for 1 in 1—and 1 in 200-year Flood Events. (Source: ORC Hydraulic Model)

A hydraulic model was provided to Beca from ORC which was used to derive the average or 'starting' river levels and to export both 1 in 100 and 1 in 200-year flood flows as shown in Figure 10-6. The flood responses are typical of most rivers with a sharp rise in river level followed by a gradual decline in flow after the peak. In the 1 in 200-year event, the model fails and crashes after the peak flow. This instability could not be resolved. Hence there is no data for most of the flow recession in the 200-year event. This does not impact our ability to assess the effects of flood flows on the floodbanks.

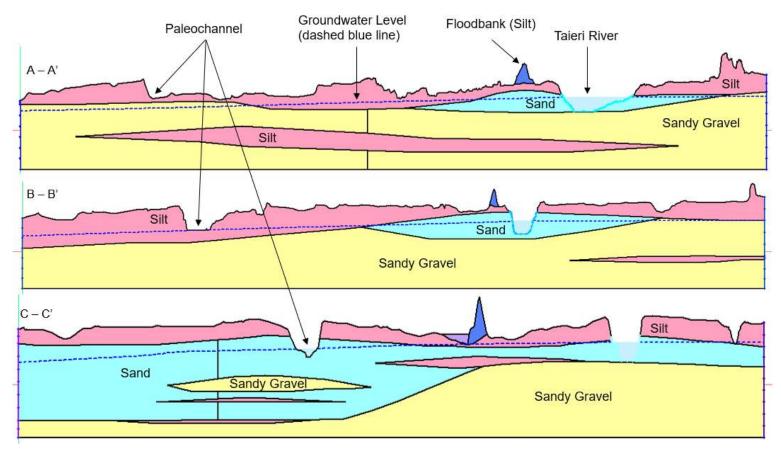
Figure 10-9. Simulated Model Head in Average Water Table Conditions: A – A' at the Top, B – B' in the Centre and C – C' at the Bottom

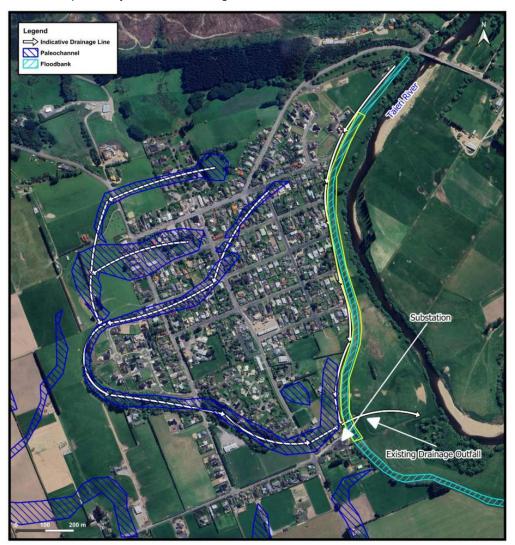
Figure 10-11. Sketch of possible future drainage option connecting the paleochannels and relief drain in the toe area to the existing gravity outlet near the substation. (Image source: Google Earth).

The paleochannels and relief drain in the toe area could be connected to the main river channel via the existing gravity outlet near the substation. A pump station could also be considered for high flow events. An indicative map of this system in shown in Figure 10-11.

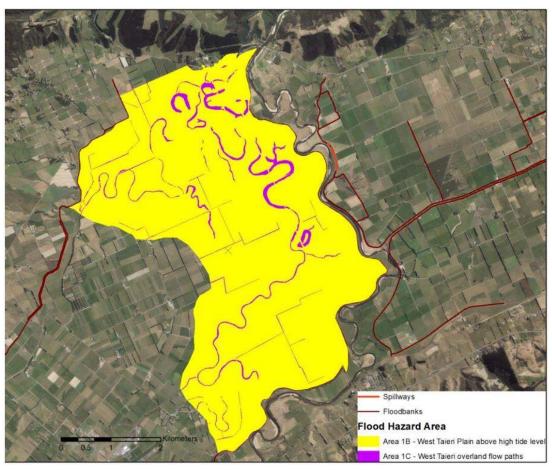
Flood Hazard Map Showing Paleochannels/ Overland Flow Paths in Pink. Source: ORC, 2015.

The Taieri Flood Hazard map on the ORC Natural Hazards Database shows the paleochannels through Outram, which act as seepage pathways beneath the floodbank, and are particularly noticeable near the northern section at Holyhead Street and in the southern section at Bell Street (Figure 1-1). The open paleochannels are predominantly in the western half of the town and are currently utilised as natural storage / soakage areas within the town, with rainwater and manmade culverts diverting surface water into them. There appears to be no remaining surface outlet from the paleochannels.

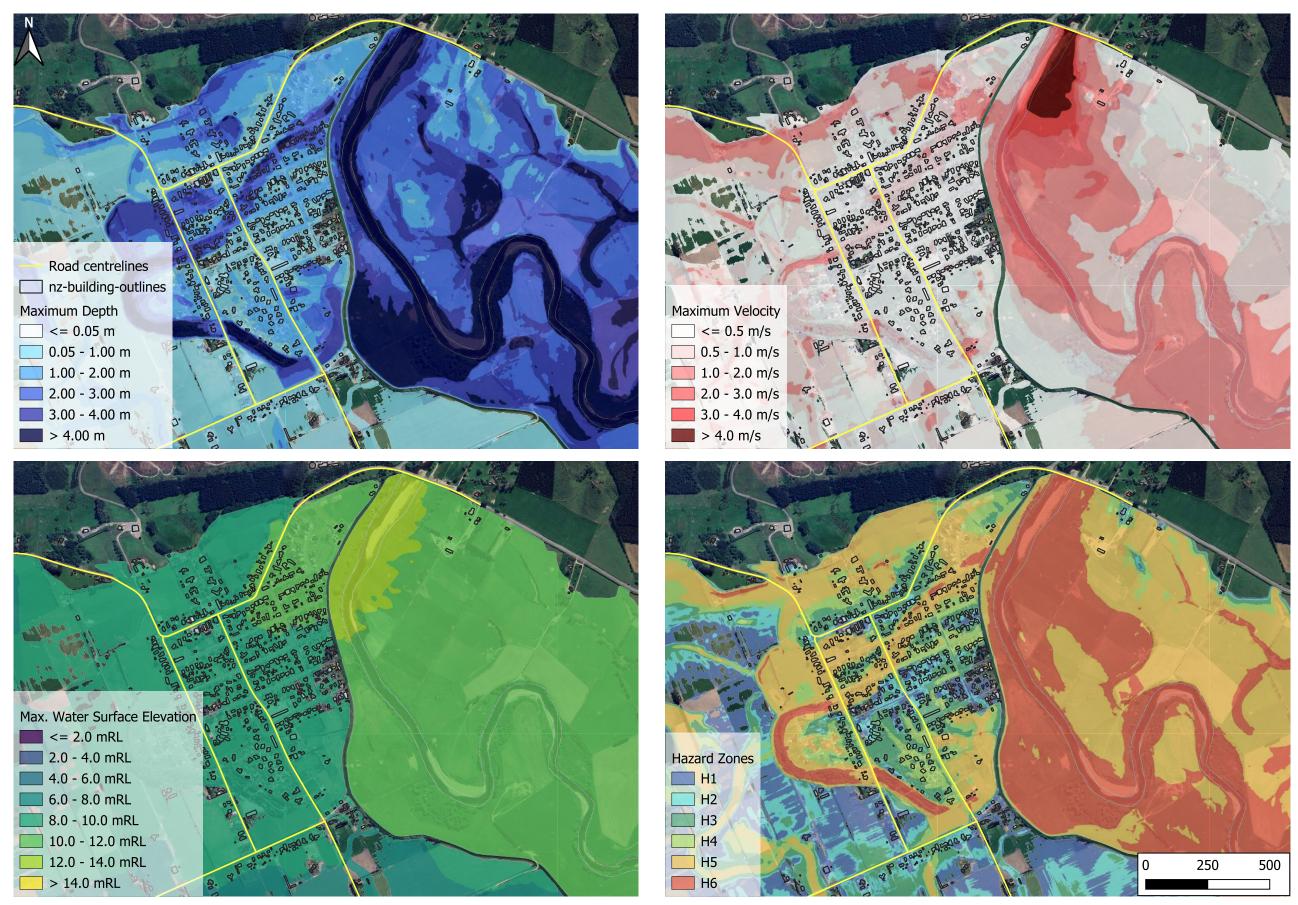
200-year ARI Breach 390CH Scenario

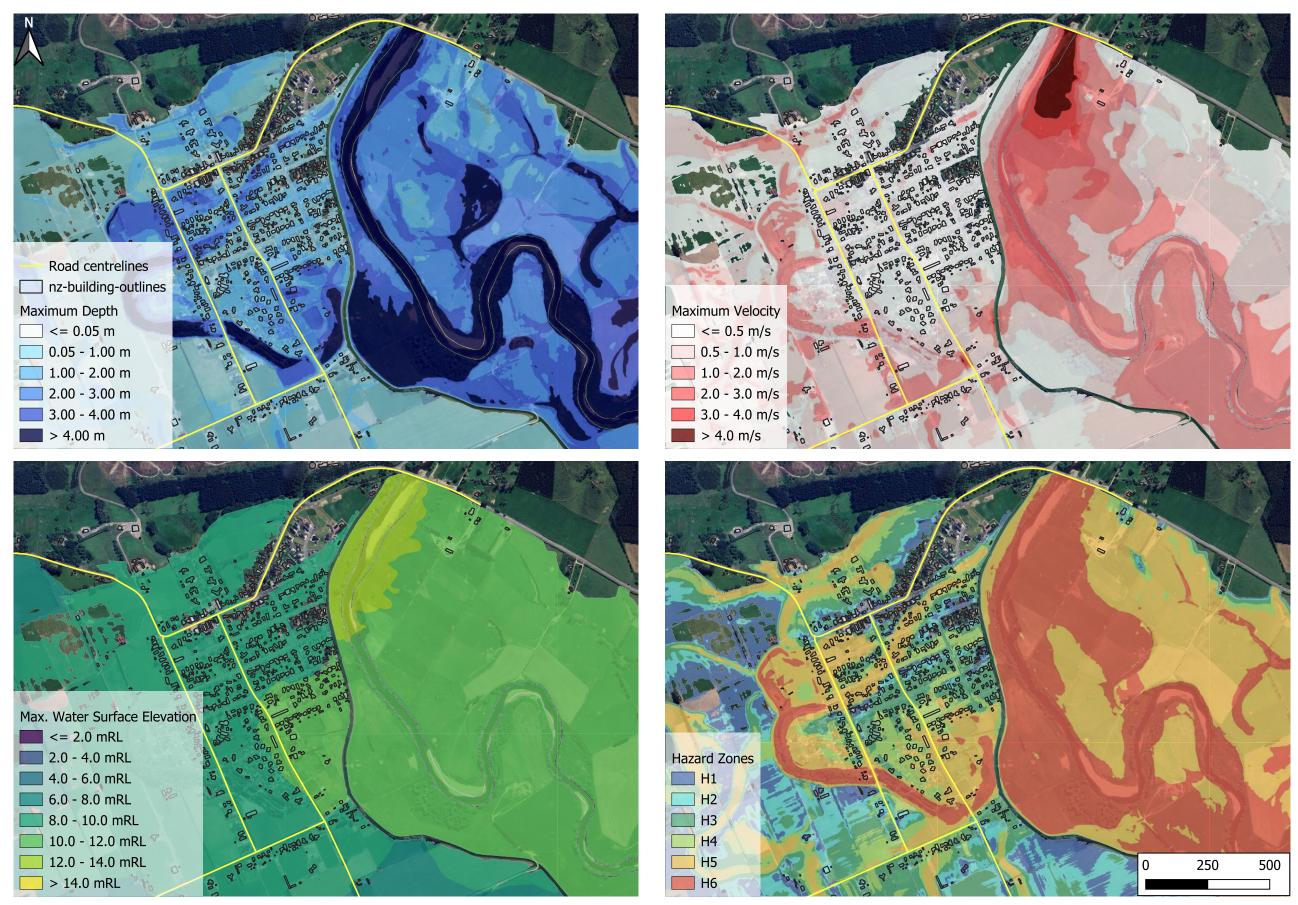
200-year ARI Breach 1250CH Scenario
