Macraes Phase 4 Consenting

Project Element 4.3.2: Open Pit Extensions

PSM71-287R Rev 2

15 August 2024

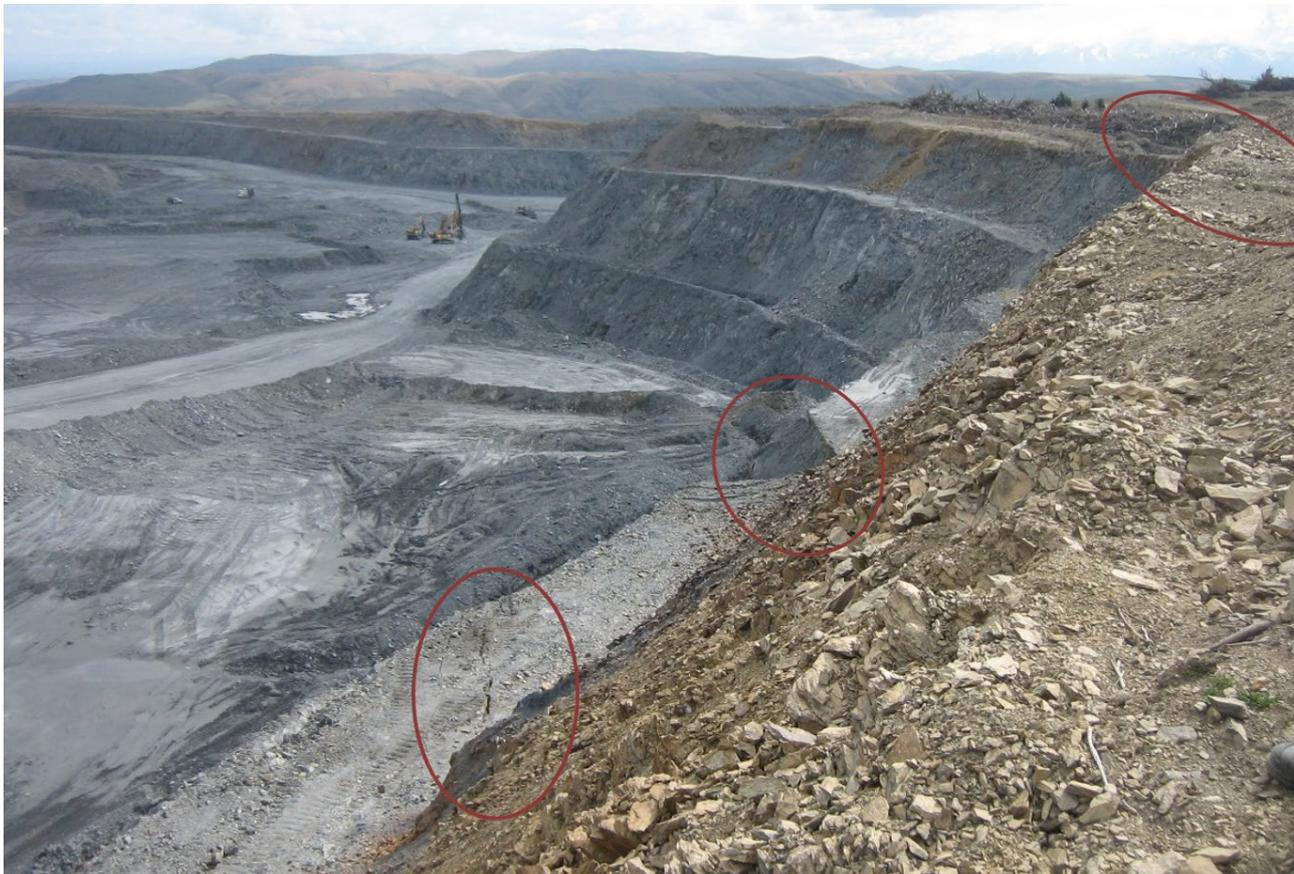
Photo 3: South-eastern wall of Coronation Pit Stage 1. Wedge failures and cracking have formed along north-south trending, westerly dipping faults, 2015.

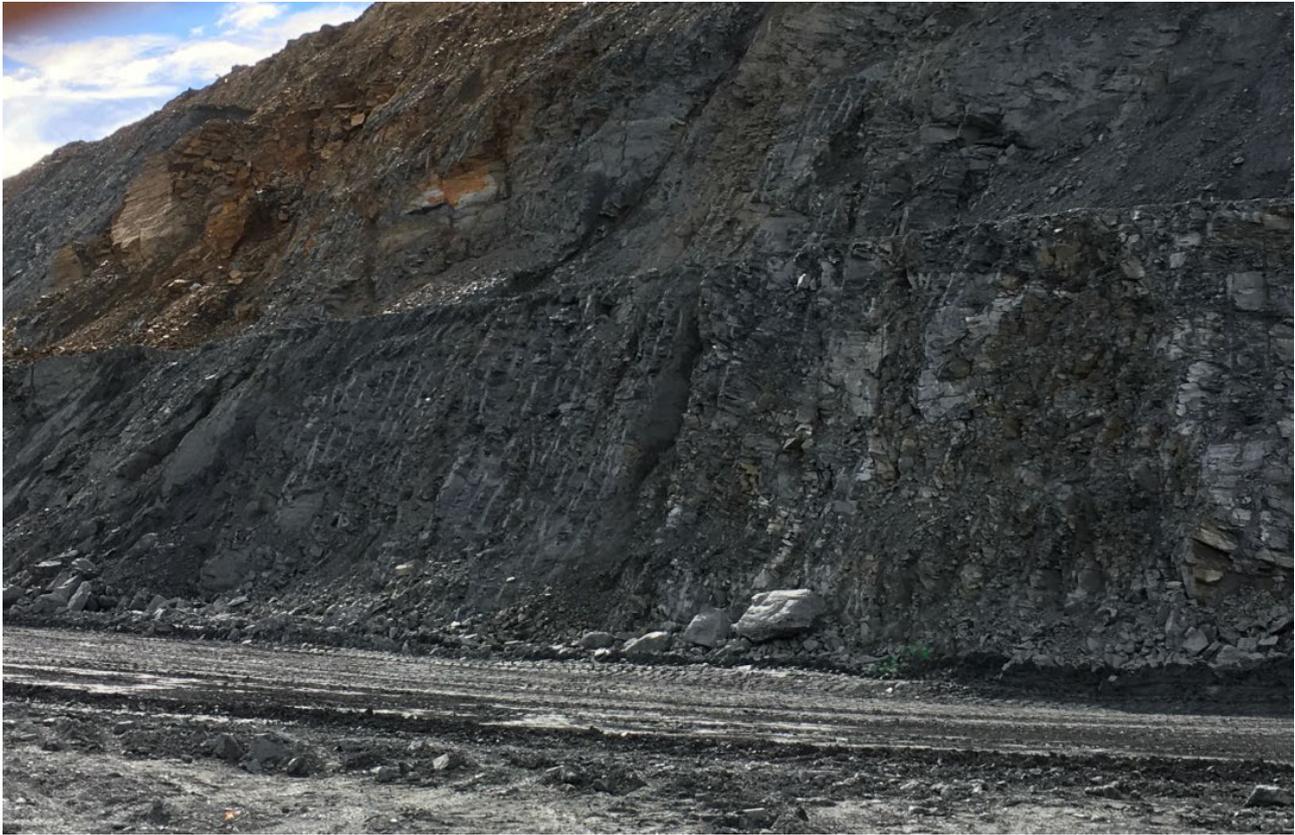
Photo 4: Coronation Pit Stage 2– eastern wall immediately south of the ‘fish bowl’. Westerly dipping faults can be seen outcropping at 270°.

The performance of Stage 2 eastern wall was reviewed in July 2017²⁶. A 'nose' oriented towards 270° at approximately 19700 mN south of the 'fish bowl' performed poorly with 22.5 m batters due to outcropping north-south trending, westerly dipping faults, Photo 4. The southern limb of the slope south of the 'nose' also performed poorly in this rock mass, Photo 5. It was recommended that for future slopes cutback in this area, the batter height should return to 15 m²⁶. This section of wall in relation to CO6 design is presented in Figure 1.

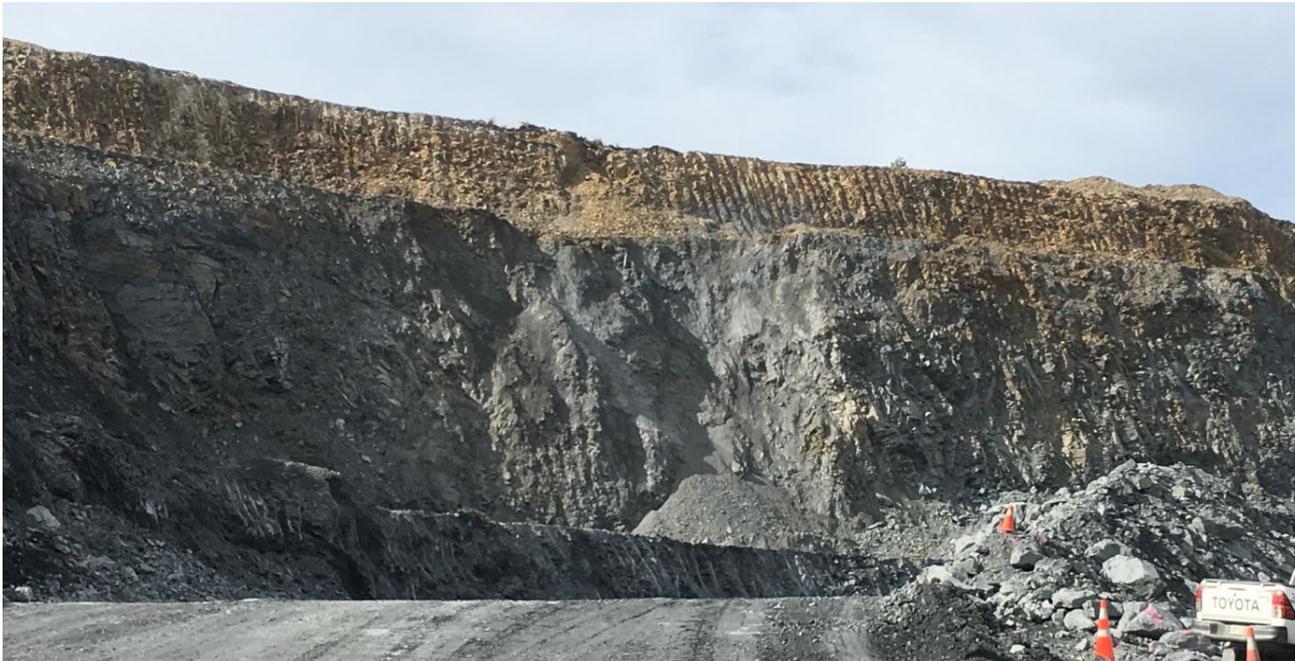
Photo 5: Coronation Pit Stage 2 – eastern wall of the ‘southern limb’. The 22.5 m high batters have not performed well in this rock mass.

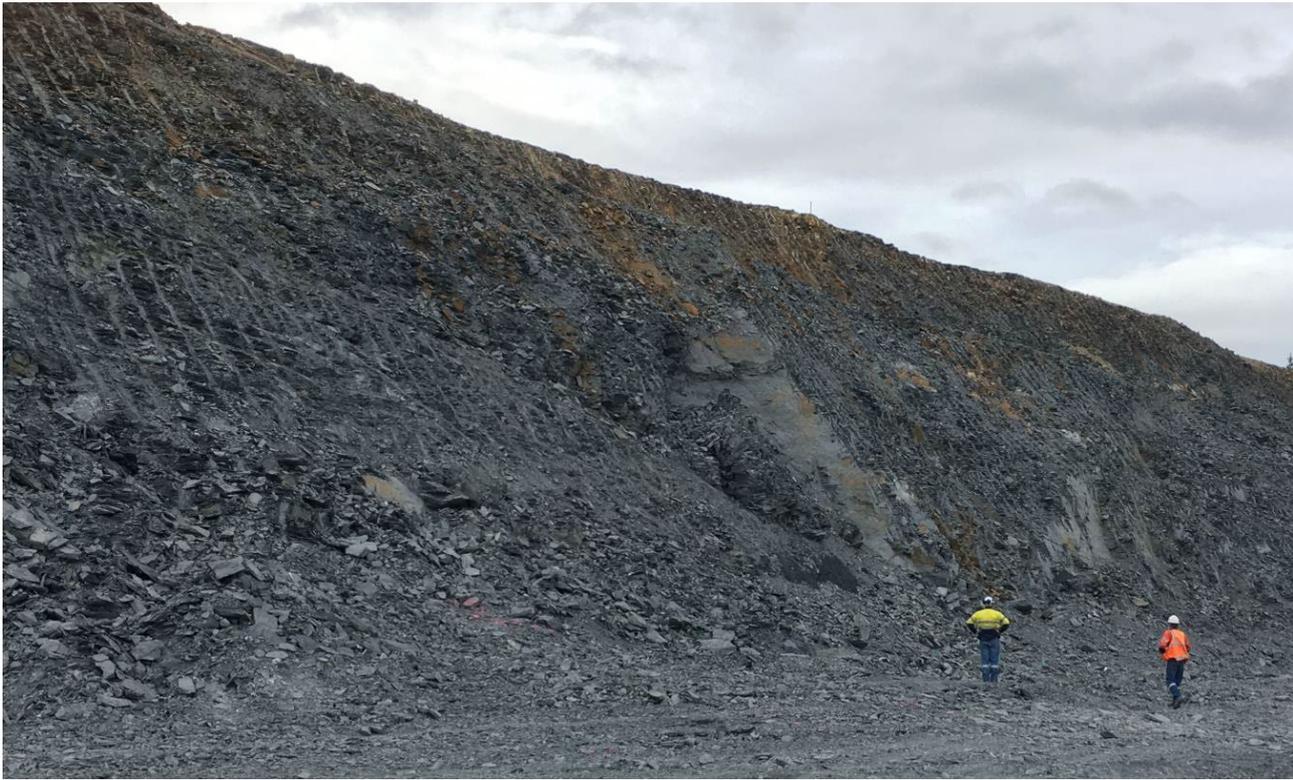
Photo 6: East wall of Coronation Stage 5 pit. The floor is 675 mRL.

In 2019 the first two batters had been mined of Stage 5 and performance was favourable considered to be good²⁷. Several expected large-scale faults and shears were exposed in the batter. No record of slope performance was captured by PSM after the March 2019 site visit.

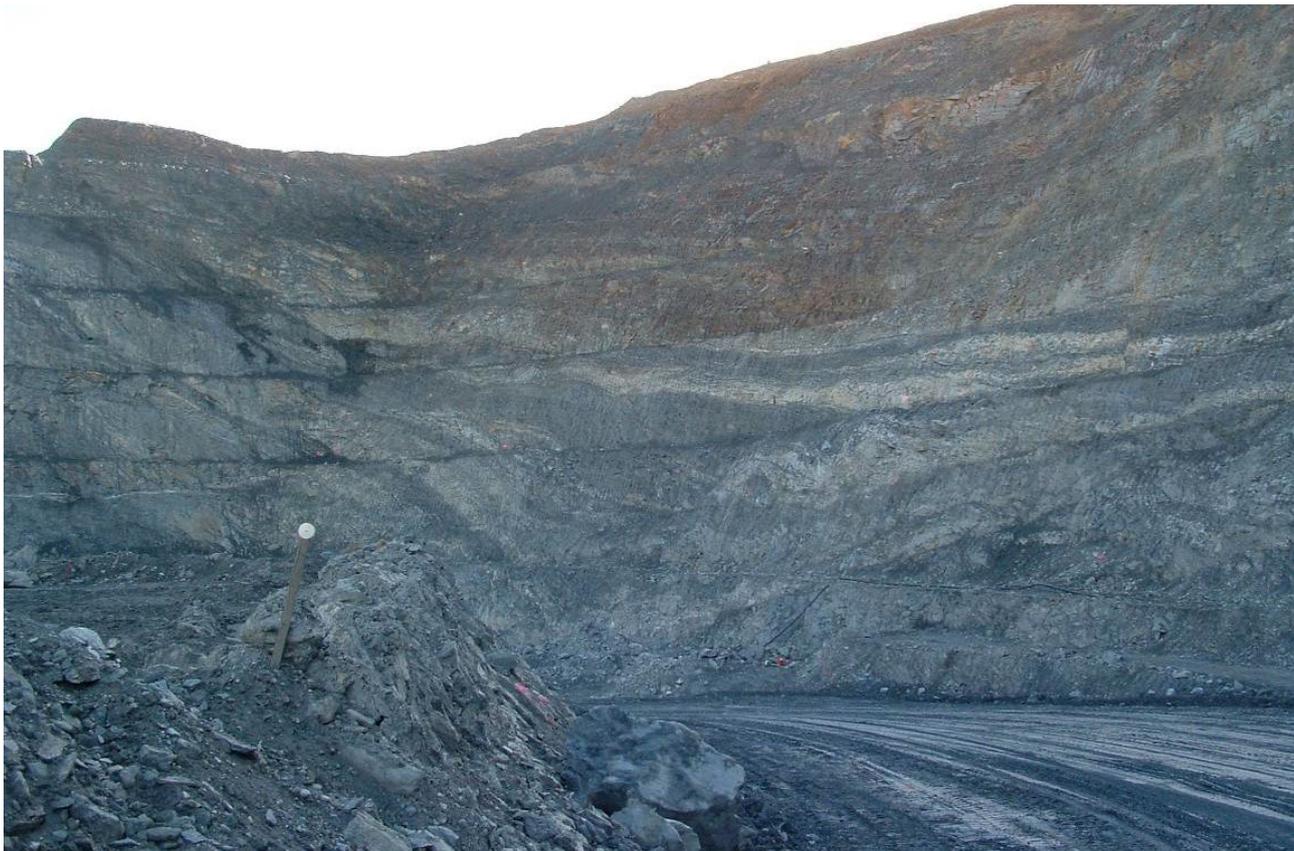
Photo 7: View of north-east wall taken July 2005. Notice the depth of weathering, the prominent quartz veins, and the very good performance of the slopes in fresh rock.

In addition to the results in the site visit report, a visual review of final pit walls was completed using photographs from July 2005³², April 2022 and photogrammetry survey from July 2022 (Photo 7 – Photo 10). This review supports the observations summarised in Table 7 and little has changed with respect to ongoing slope performance since mining ceased in 2005.

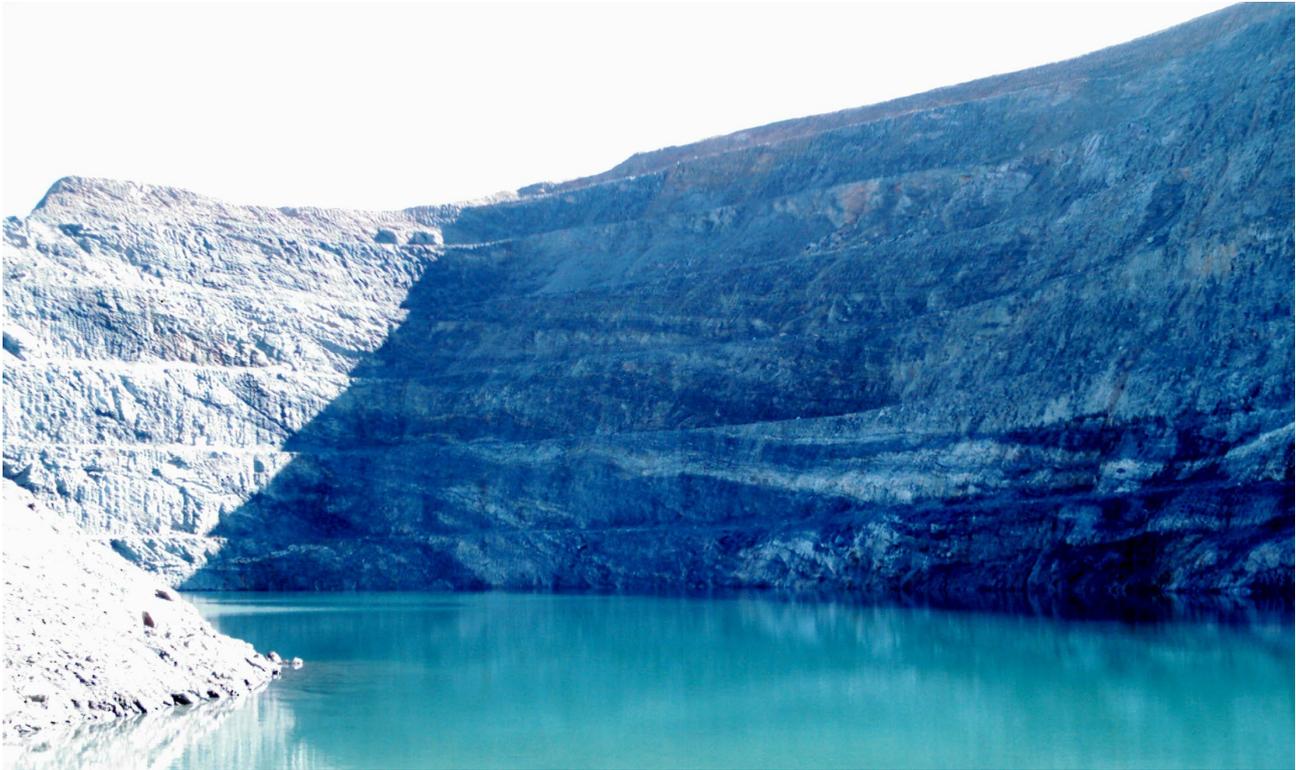
Photo 8: North-east wall of Stage 1 in 2005 taken from base of ramp.

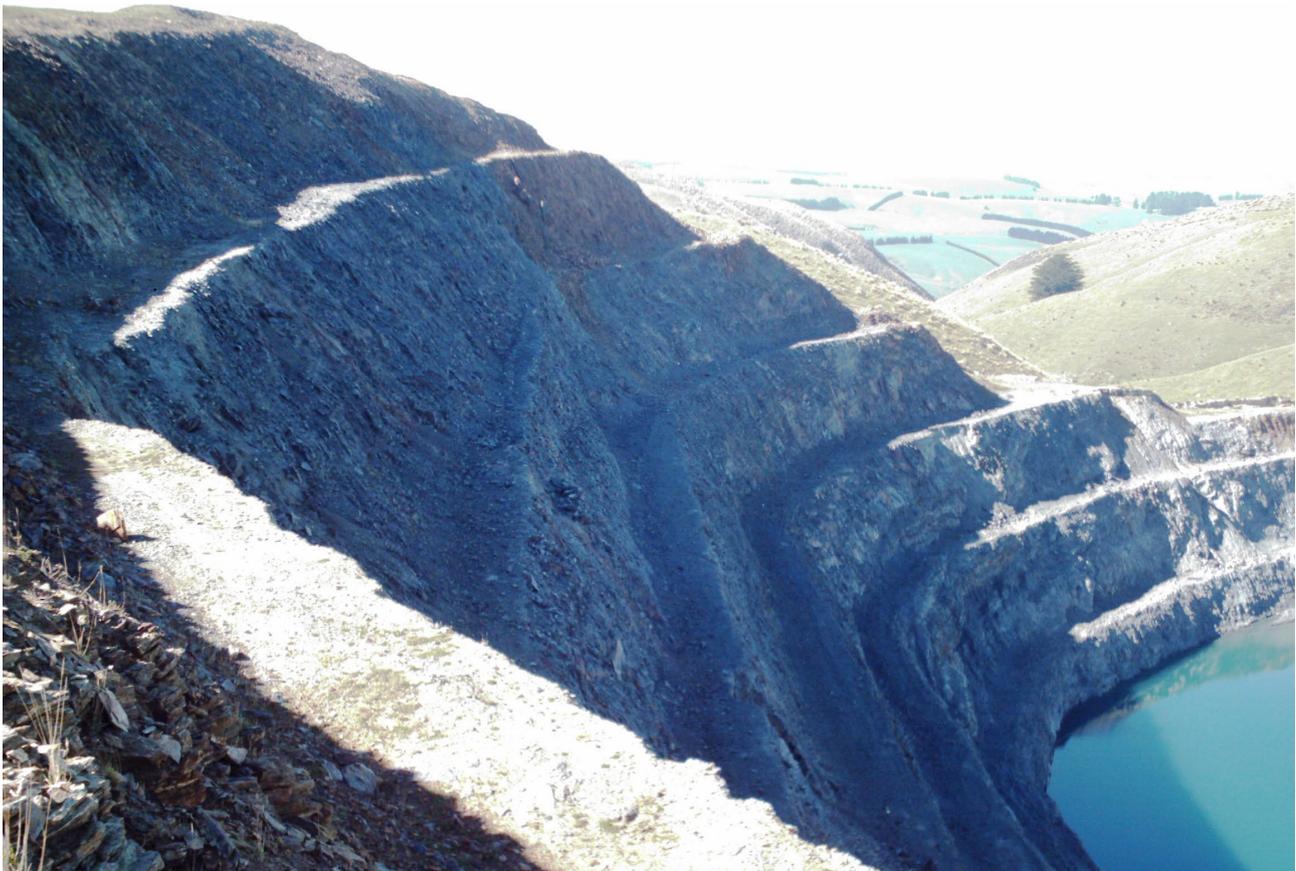
Photo 9: January 2009 - east wall taken from crest facing south. Berms are relatively clean.

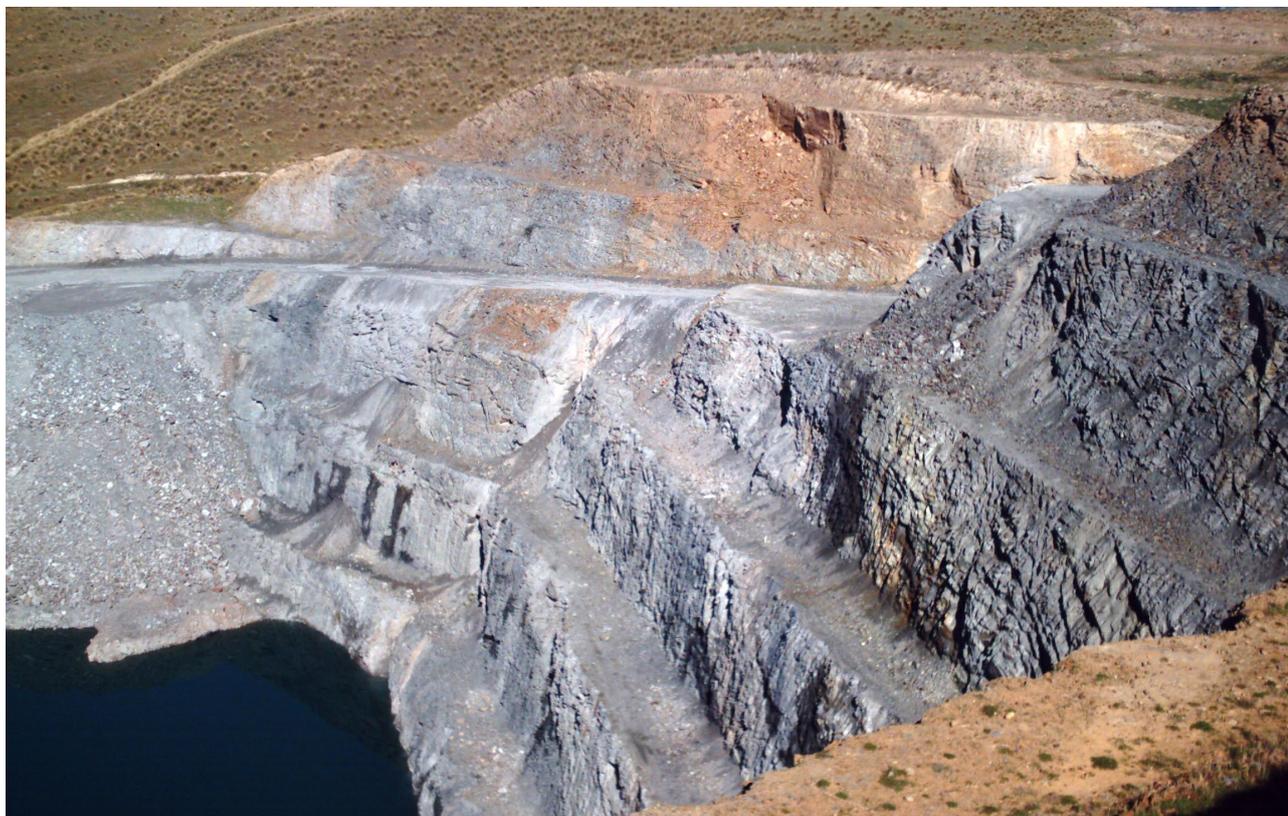
Photo 10: January 2009 – north wall. Photo taken from crest looking west. Pre-split 75° batters. Note joint bound wedges.
