Project Number: 6-XO015.00

# Shepherds Hut Creek Debris Flow Hazard Report

14 September 2022

Date: September 2022 Reference: 6-XO015.00 Status: Issue 2

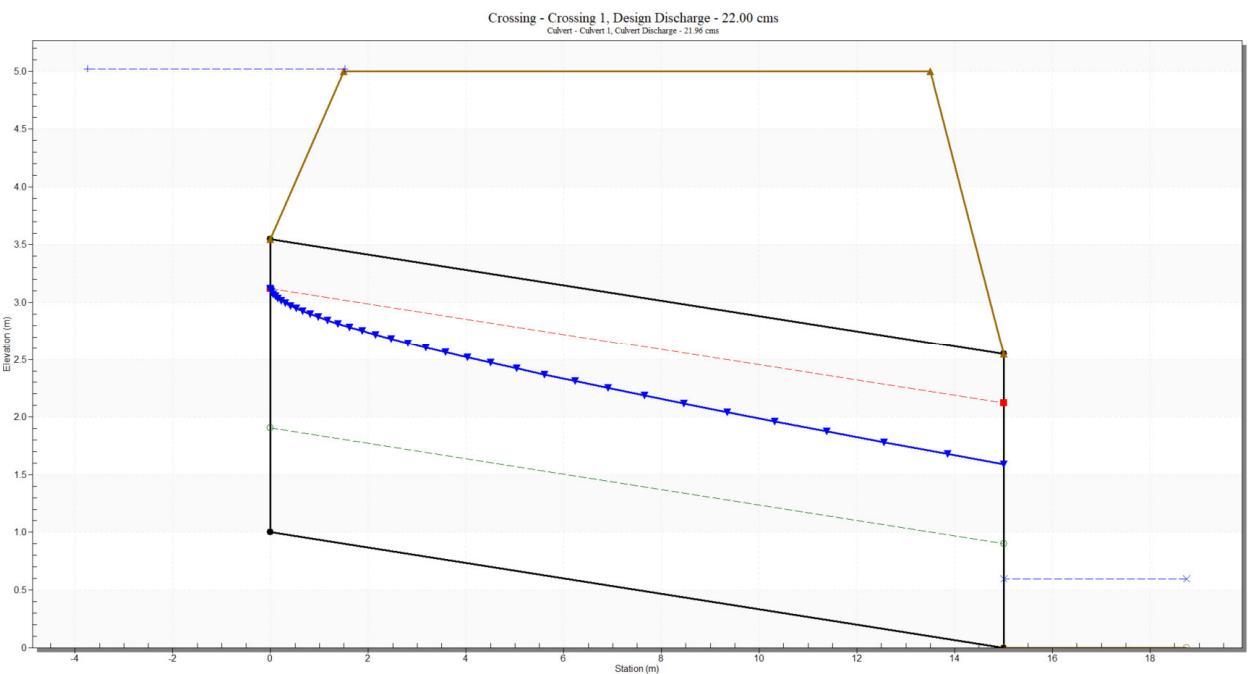
Figure 6. A new precast skid-ring joint concrete 2550% overtopping at  $22 \text{ m}^3$ /s discharge.

To assess options to increase discharge capacity, new culvert options were modelled using HY-8. Figures 6-8 show the results of different culvert replacement options.

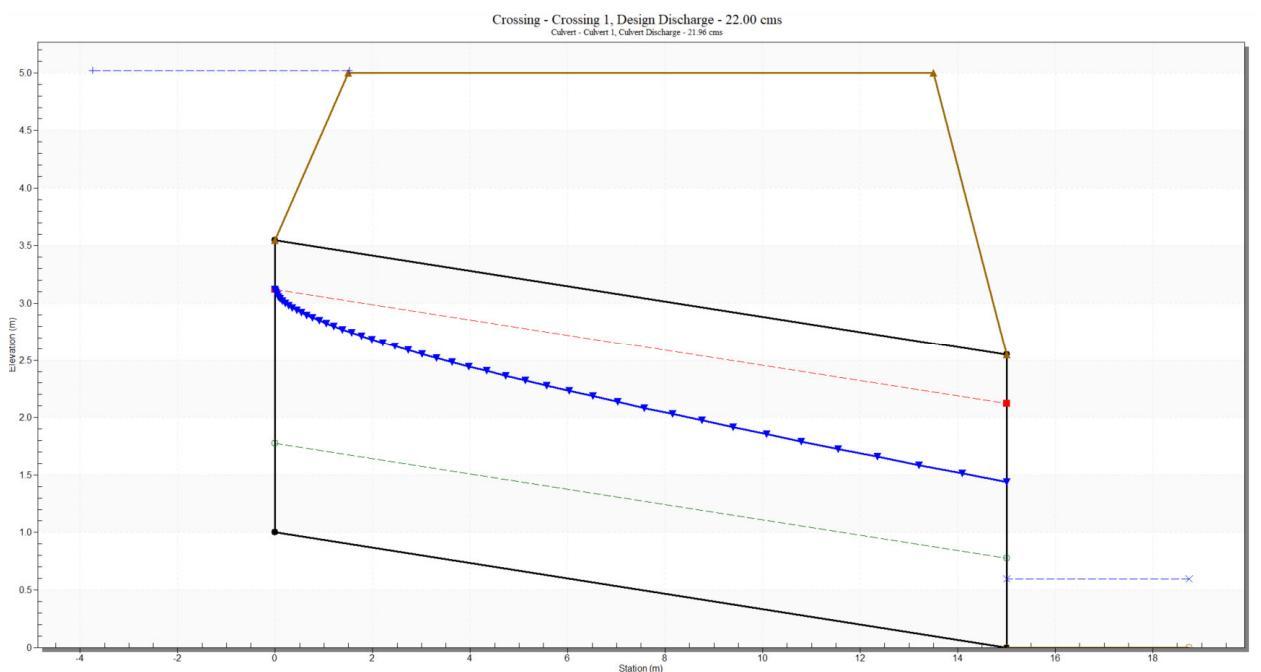
Figure 7. A new smooth GRP (or similar) 2550% overtopping at 22 m<sup>3</sup>/s discharge.

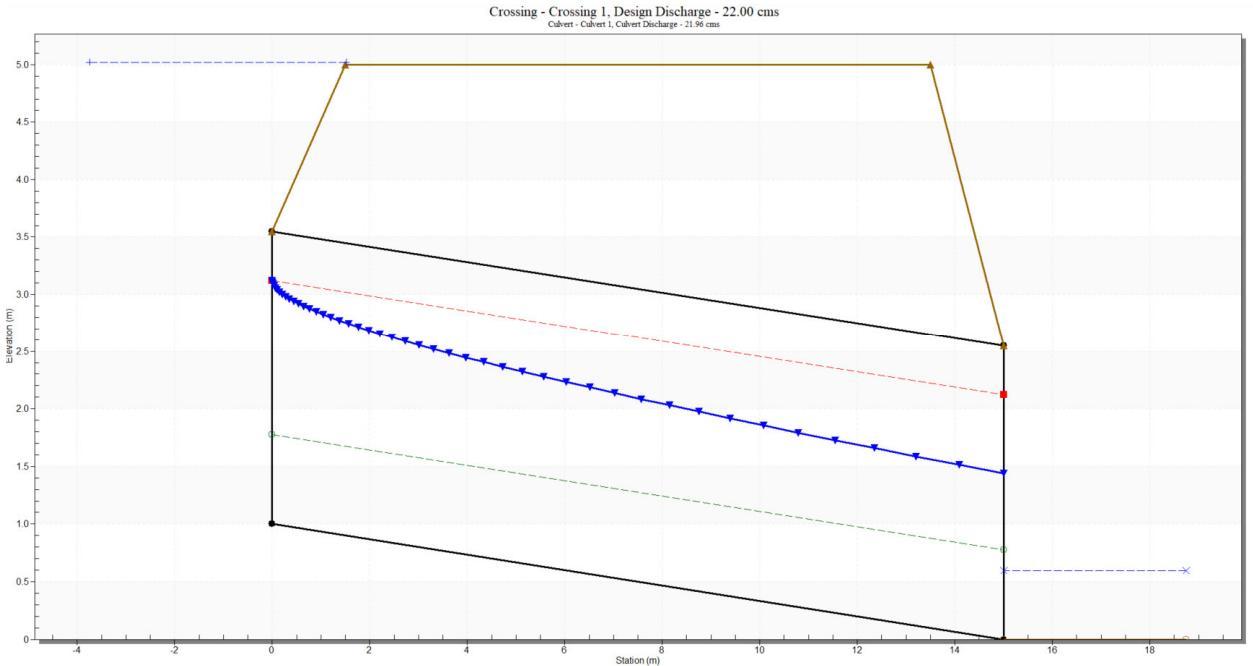
Figure 8. A new 3 m x 2.5 m concrete box culvert overtopping at 27.5 m<sup>3</sup>/s discharge.

Note that as the culvert is inlet controlled during flood events, hence the culvert slope has little effect on the total discharge.
