Morphology of the Clutha River/Mata- Au between Roxburgh Dam and the Pacific Ocean

March 2017

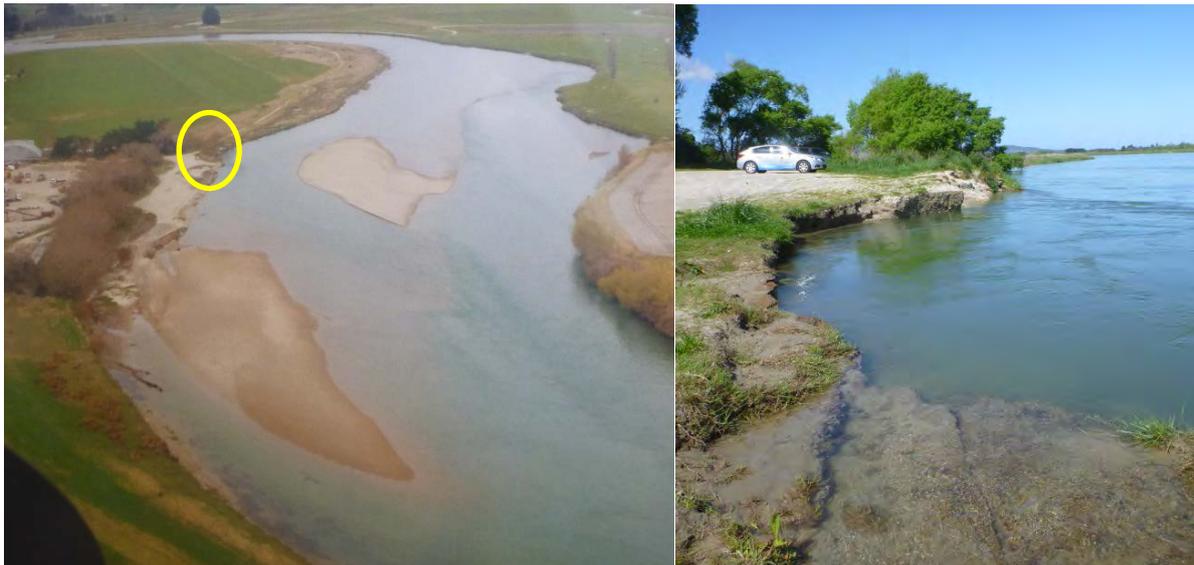
Concerns were also raised about erosion of the true right bank of the Koau branch just south of Balclutha, near the end of Glasgow Street. Understanding was that the island of gravel in the centre of the river had built up in the recent past and was now pushing current hard into the true right bank, causing rapid erosion (Figure 16).

The site was visited on October 21st 2016. Significant erosion has occurred along this bank and at the time of visiting, during spring high flows in the Clutha, the bank had been actively eroding into the river at a rate of ~2 metres over the past few weeks, according to local observers.

Figure 16. Left: Aerial view of Koau branch immediately south of Balclutha, looking upstream. Right: Eroding bank highlighted in left image, 21 October 2016. This is also the approximate location of cross section K12.

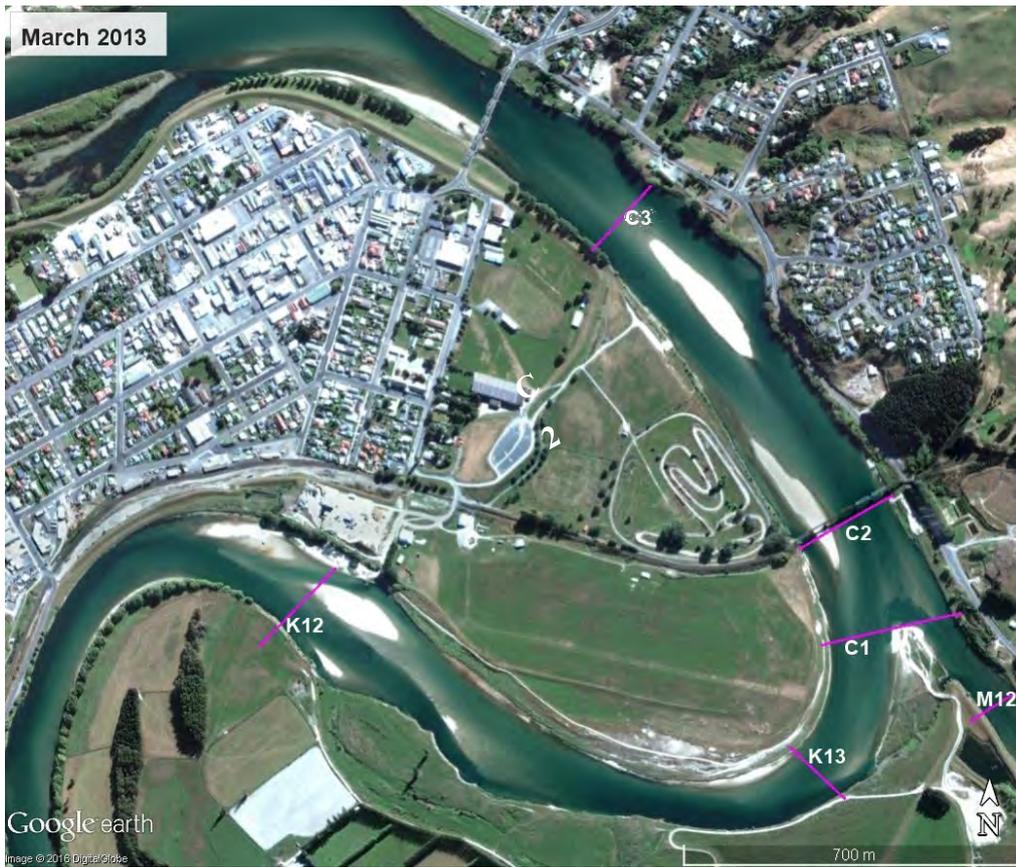
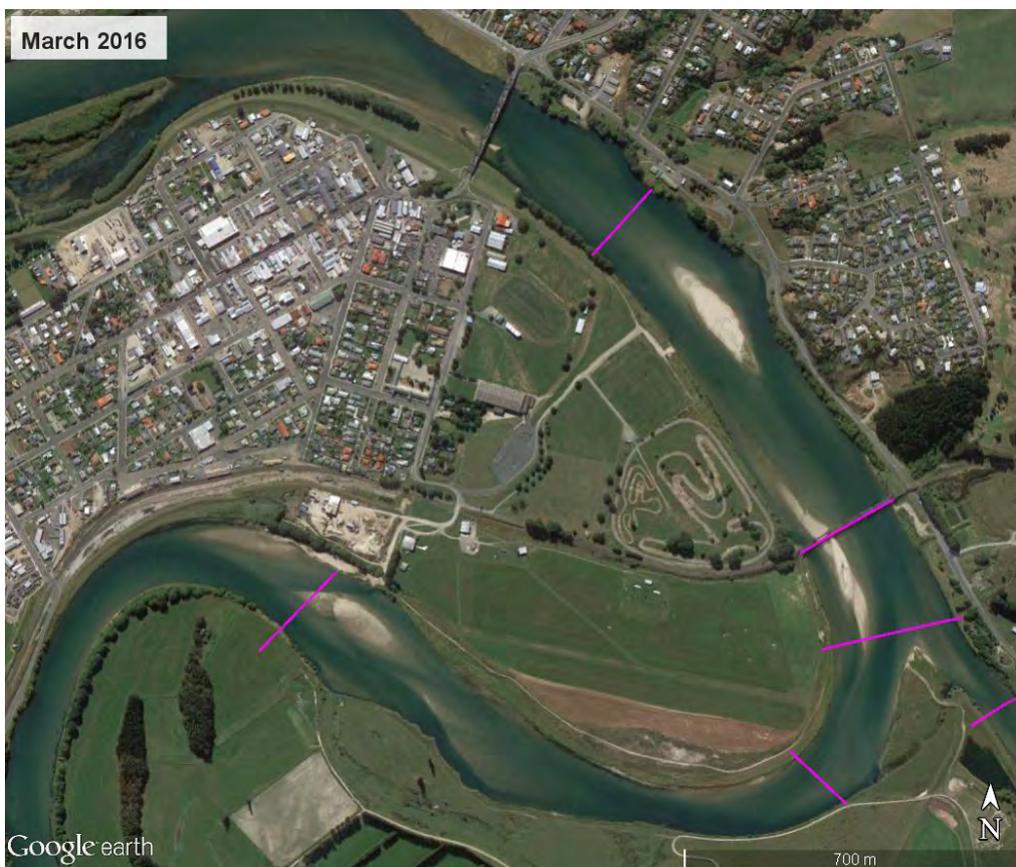
Aerial photos from 1950, 2006, 2013 and 2016 were compared in ArcGIS and Google Earth historic imagery to show movement of the gravel bars (Figure 17). The gravel point in the middle of the bifurcation of the Koau and Matau branches was ~80 m further north in 2006 than in 2016. The mid-channel gravel islands that cross sections C3 and C2 cross have migrated south over this time period. The comparison photos in Figure 17 indicate the highest areas of the islands have moved about 20-40 m downstream over the last 3 years. See Figure 3 for comparison with historic (1950) imagery of the area.

Figure 17. Google Earth images showing changes in gravel bars visible during summer low-flow. Cross section locations shown.

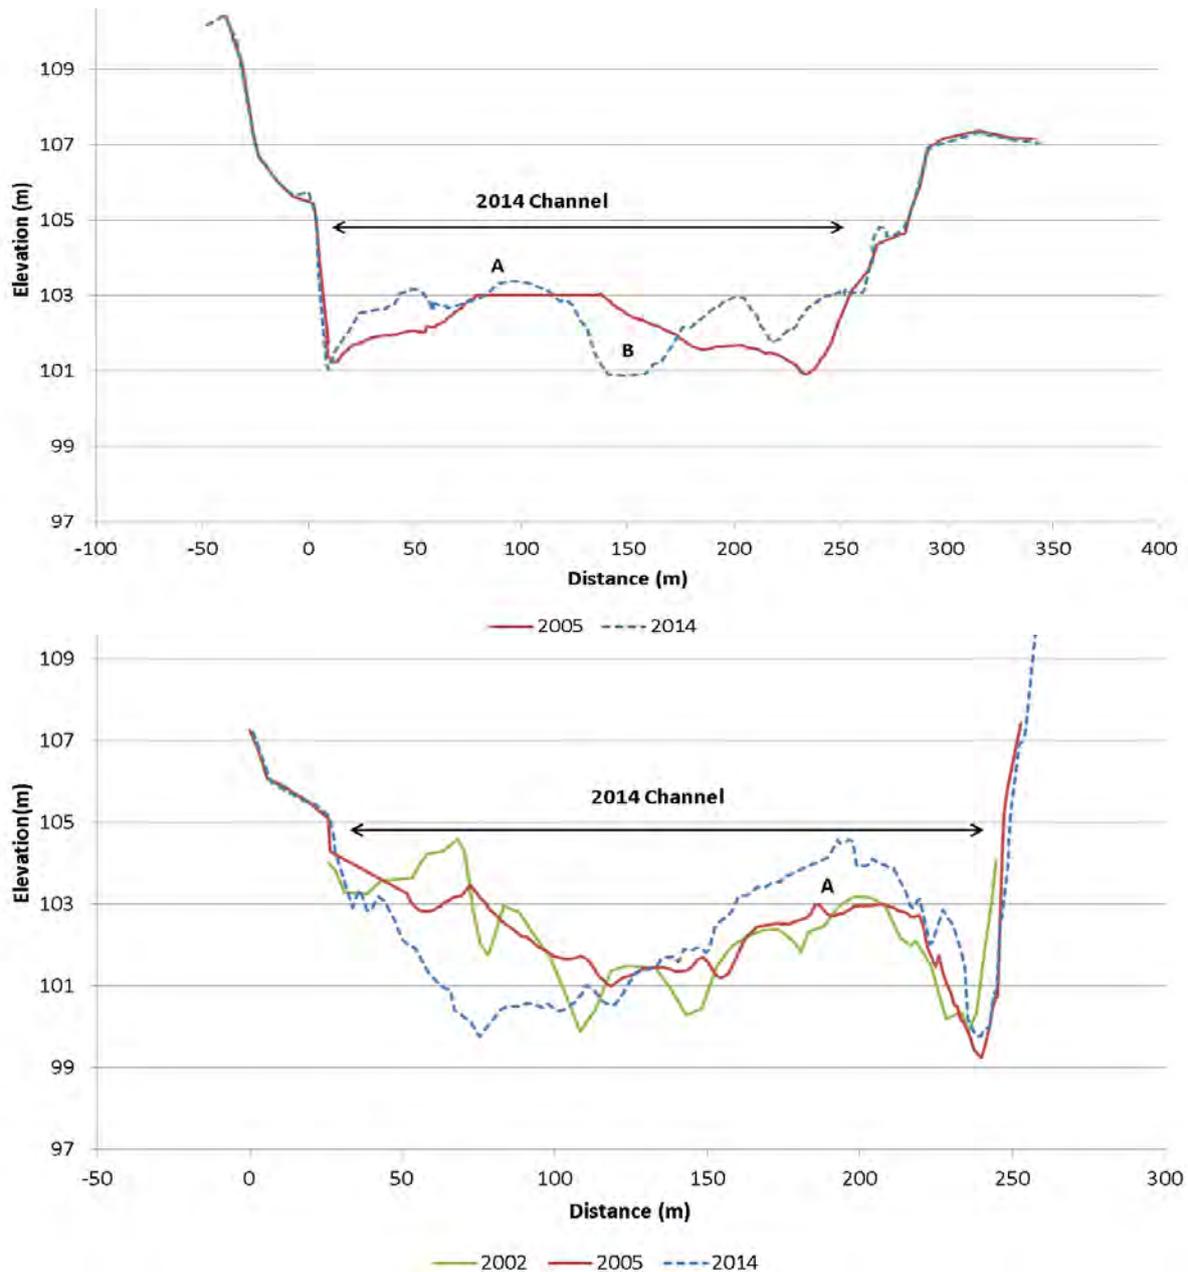
Cross section C1 backs up the aerial imagery by showing major redistribution of gravel in the region of the mid channel/bifurcation point (Figure 18). C2 shows the growth of the gravel bar seen in the aerial photographs, as the high-point at its centre migrates downstream. NB the MBL of this section has remained relatively constant, as the channel to the left of this bar has incised (see Figure 19). Cross section K12 shows erosion of the true right bank by about 30 m between 2002 and 2014 and a further ~10 m by 2016 as shown by a partial cross section collected by a gravel extraction consent holder (Figure 19). The 2005 cross section does not extend far enough up the bank to further constrain timing. Section K13 also shows erosion and steepening of the true right bank.

Figure 18. Changes in channel profile of cross sections C1 and C2.

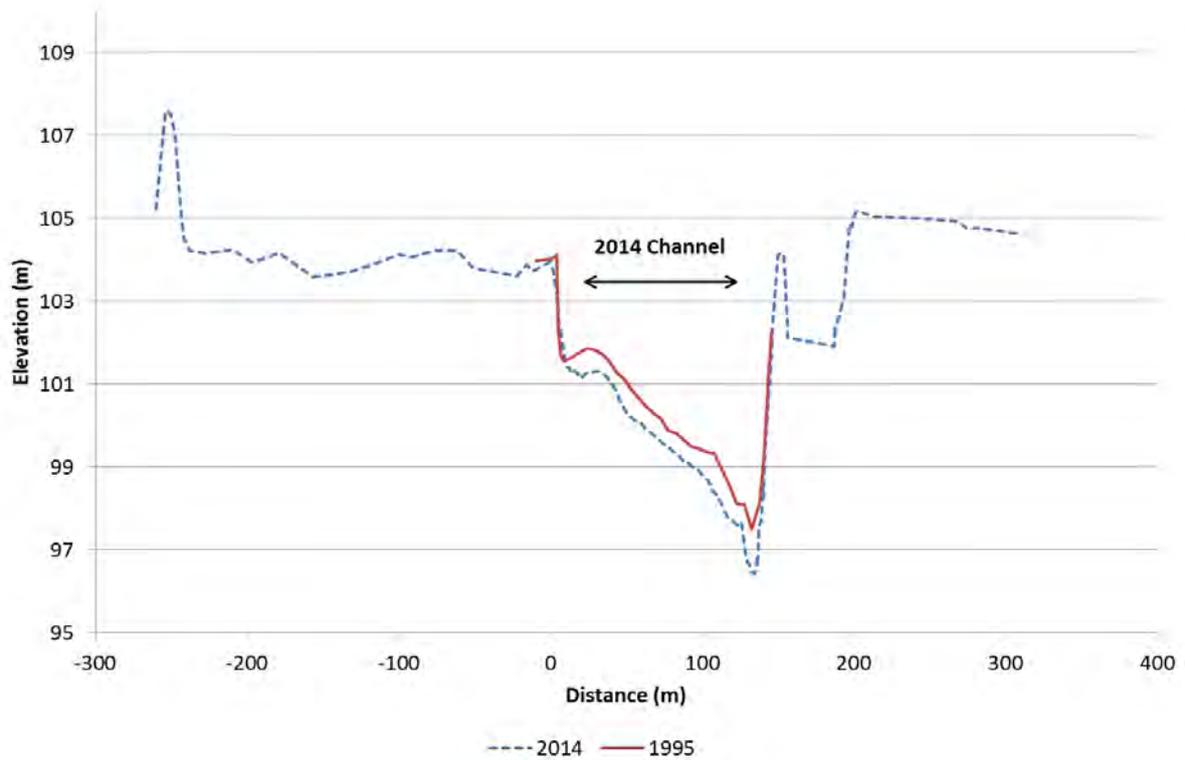
Figure 25. Clutha River/Mata-Au cross-section K9, looking downstream

Cross-section K9 is located 10.5 km upstream of the confluence of the Koau branch of the Clutha River/Mata-Au with the Pacific Ocean. The backwater (point labelled A) aggraded between 2005 and 2014. The main channel remained similar between 2002 and 2005 with some degradation occurring through the main channel.

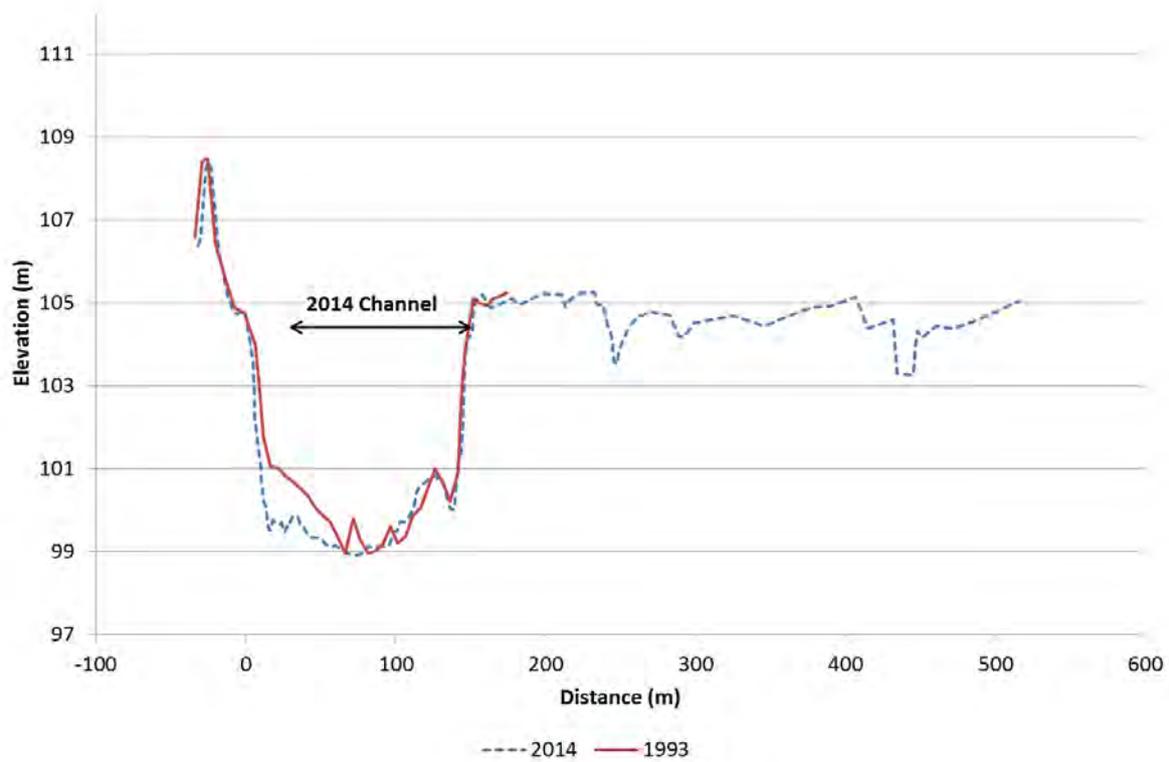
Figure 27. Clutha River/Mata-Au cross-section K10A, looking downstream

Cross-section K10A is located 11.5 km upstream of the confluence of the Koau branch of the Clutha River/Mata-Au with the Pacific Ocean. Between 2005 and 2014 the main channel has both aggraded and degraded with the thalweg staying at a similar position. The true right floodplain has degraded between 2005 and 2014.

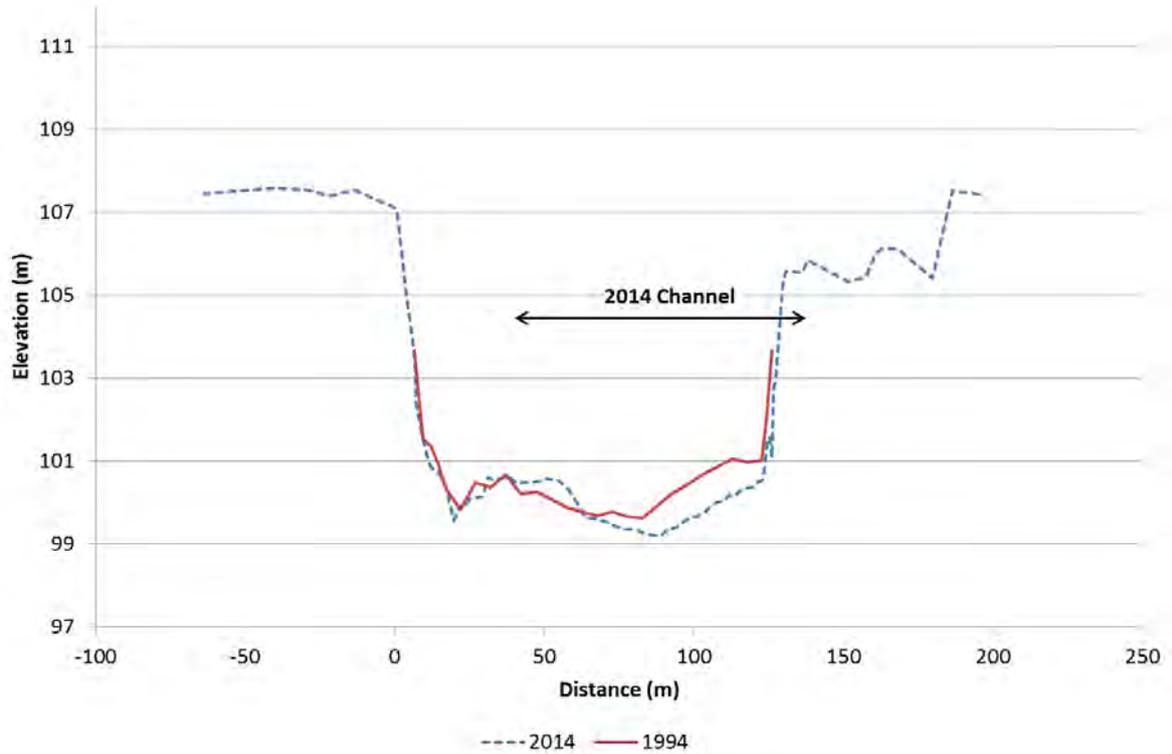
Figure 28. Clutha River/Mata-Au cross-section K11, looking downstream

Cross-section K11 is located 12.9 km upstream of the confluence of the Koau branch of the Clutha River/Mata-Au and the Pacific Ocean. Between 2005 and 2014, the main channel experienced mostly degradation with a small increase in the thalweg level. The true left and right floodplains also degraded between 2005 and 2014.

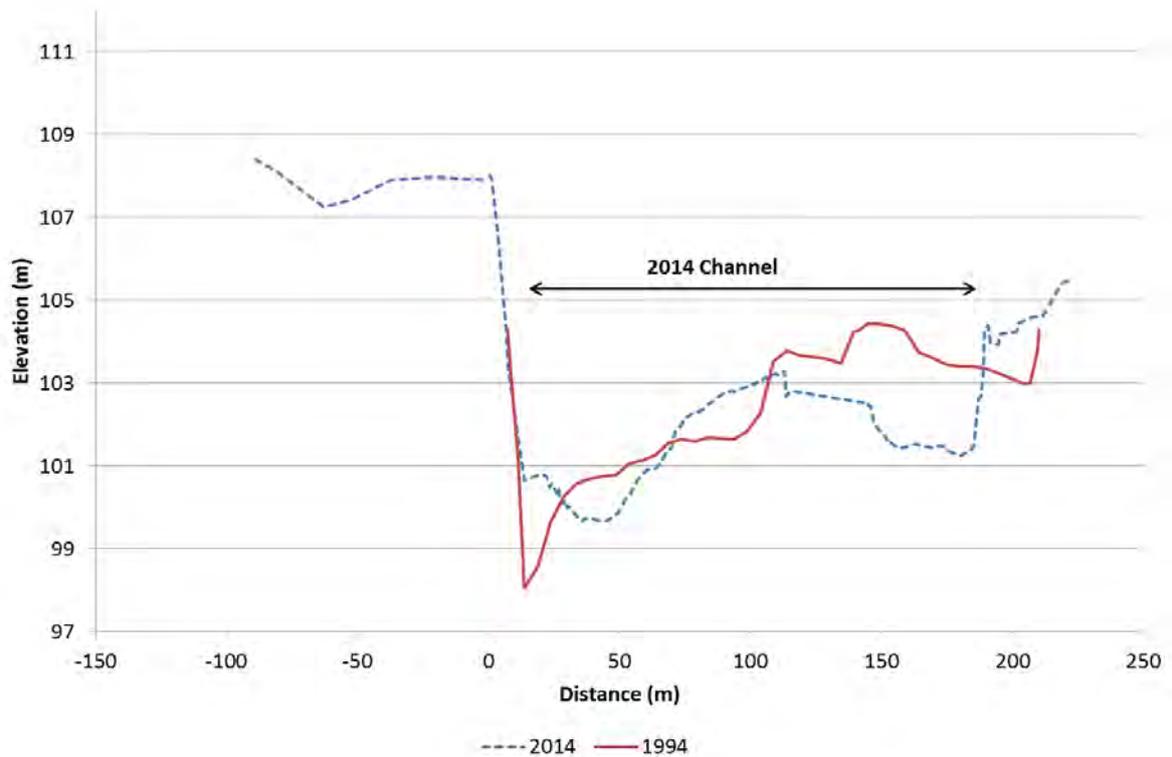
Figure 29. Clutha River/Mata-Au cross-section K12, looking downstream

The partial cross-section K12 (Figure 19) collected in 2016 by the gravel extraction consent holder indicates there has been a build-up of the mid-channel bar and erosion of the bank, but whether the erosion can be attributed more to overall gravel stripping or gravel build-up and displacement of the channel is not clear without a complete cross section and data from up- and down-stream of the site. A full re-survey of this and surrounding cross sections is recommended before any further gravel extraction is consented in the area, given the fact

Cross-section K12 is located 14.9 km upstream of the confluence of the Koau branch of the Clutha River/Mata-Au with the Pacific Ocean. Between 2005 and 2014 the main channel has experienced both aggradation and degradation on the true left bank, the centre of the channel has aggraded. The true right bank of the main channel appears to have eroded, however the 2005 survey did not extend far enough on the right bank to confirm this.

that is still unclear whether extraction has helped stop bank erosion or exacerbated it in recent years, and the overall trend of recent bed degradation in the Koau branch.

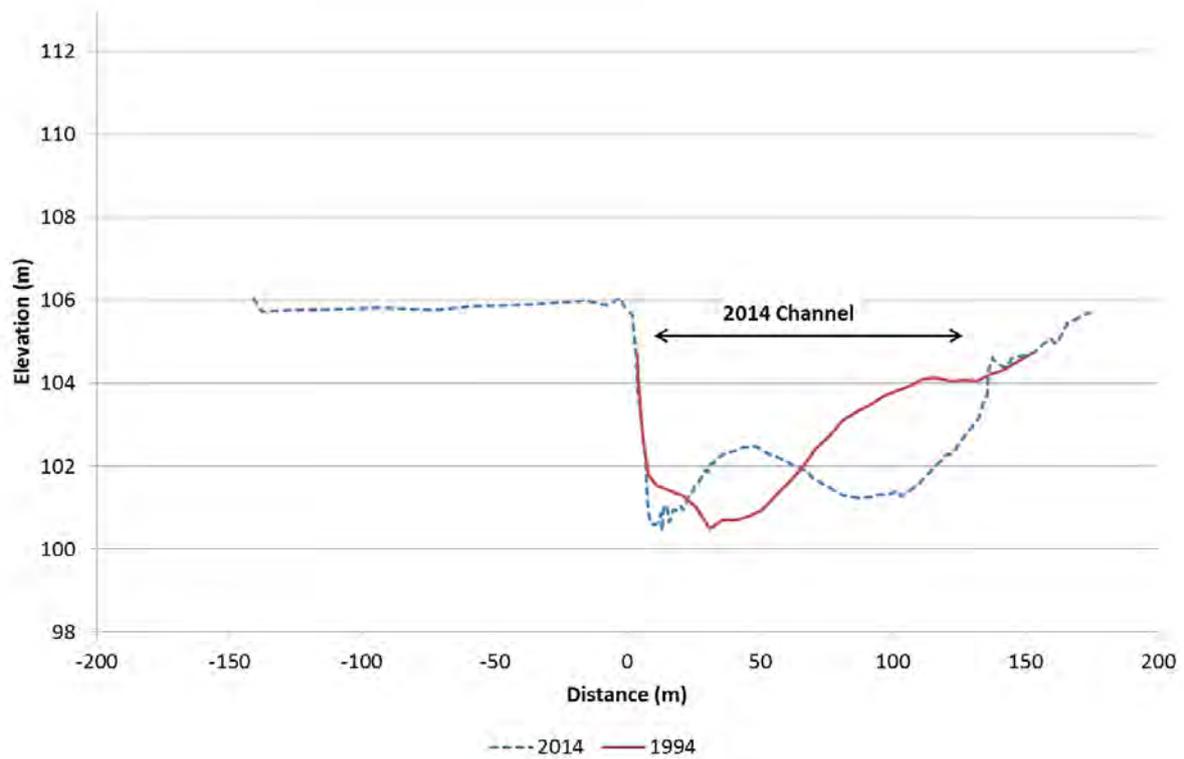
Figure 30. Clutha River/Mata-Au cross-section K13, looking downstream

Cross-section K13 is located 16 km upstream of the confluence of the Koau branch of the Clutha River/Mata-Au with the confluence of the Pacific Ocean. The true left of the main channel has remained similar between 2005 and 2014, the centre of the main channel has aggraded with degradation and bank erosion occurring on the true right of the main channel.

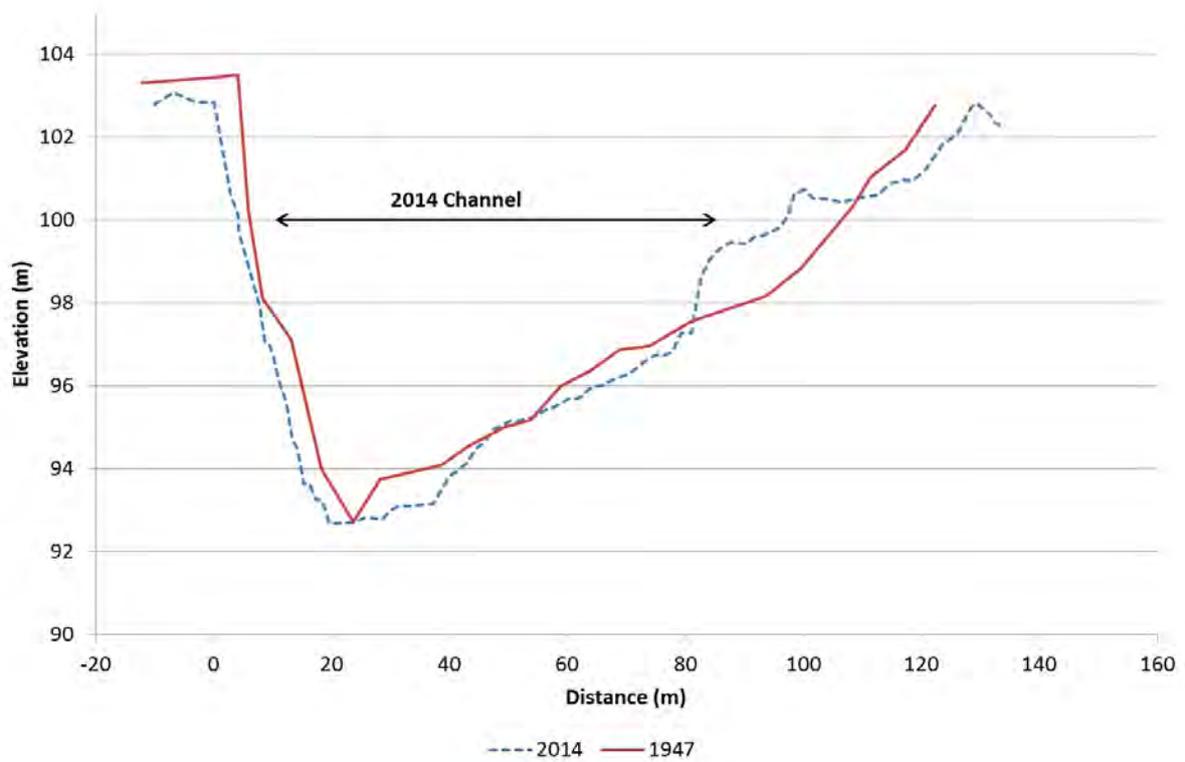
Figure 33. Clutha River/Mata-Au cross-section M195, looking downstream

Cross-section M195 is located 5.3 km upstream of the confluence of the Matau Branch of the Clutha River/Mata-Au with the Pacific Ocean. The channel has degraded between 2005 and 2014 with some aggradation occurring on the true left bank.

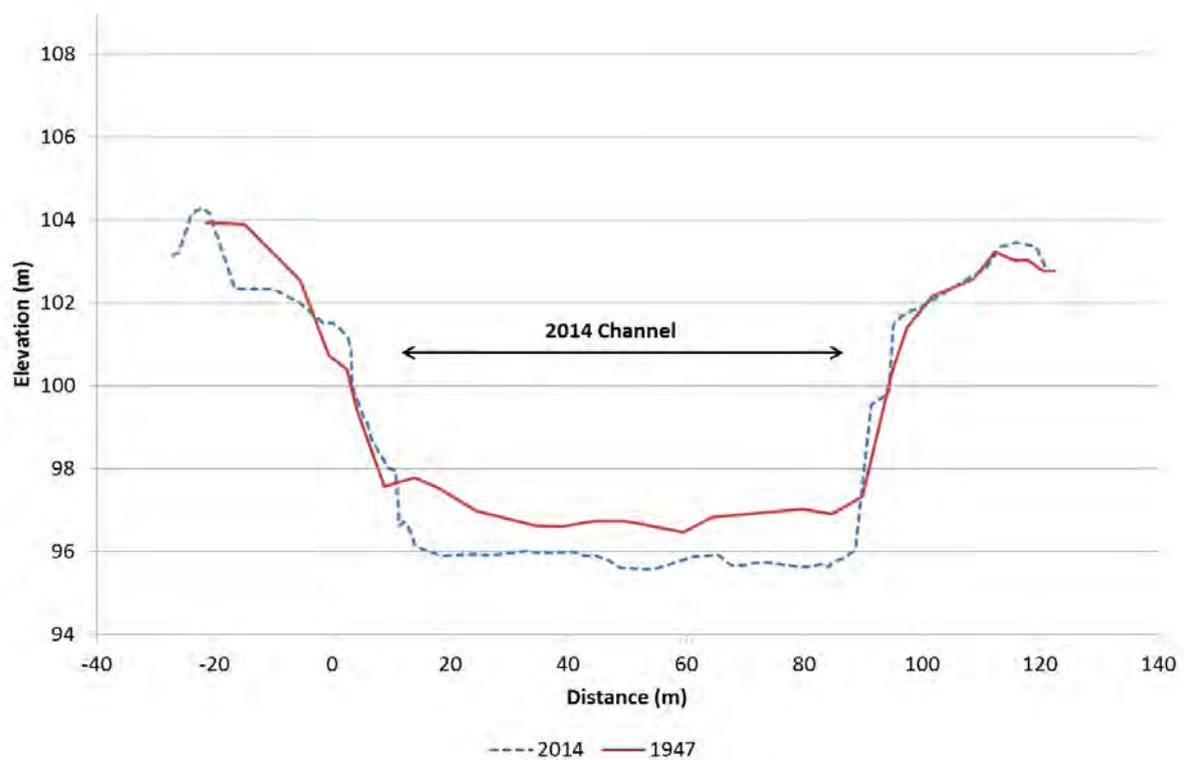
Figure 35. Clutha River/Mata-Au cross-section M147, looking downstream

Cross-section M147 is located 9.8 km upstream of the confluence of the Matau Branch of the Clutha River/Mata-Au and the Pacific Ocean. There has been minimal change in the channel between 2005 and 2014 with both aggradation and degradation occurring. The channel has degraded by about 0.5 m between 2000 and 2014.

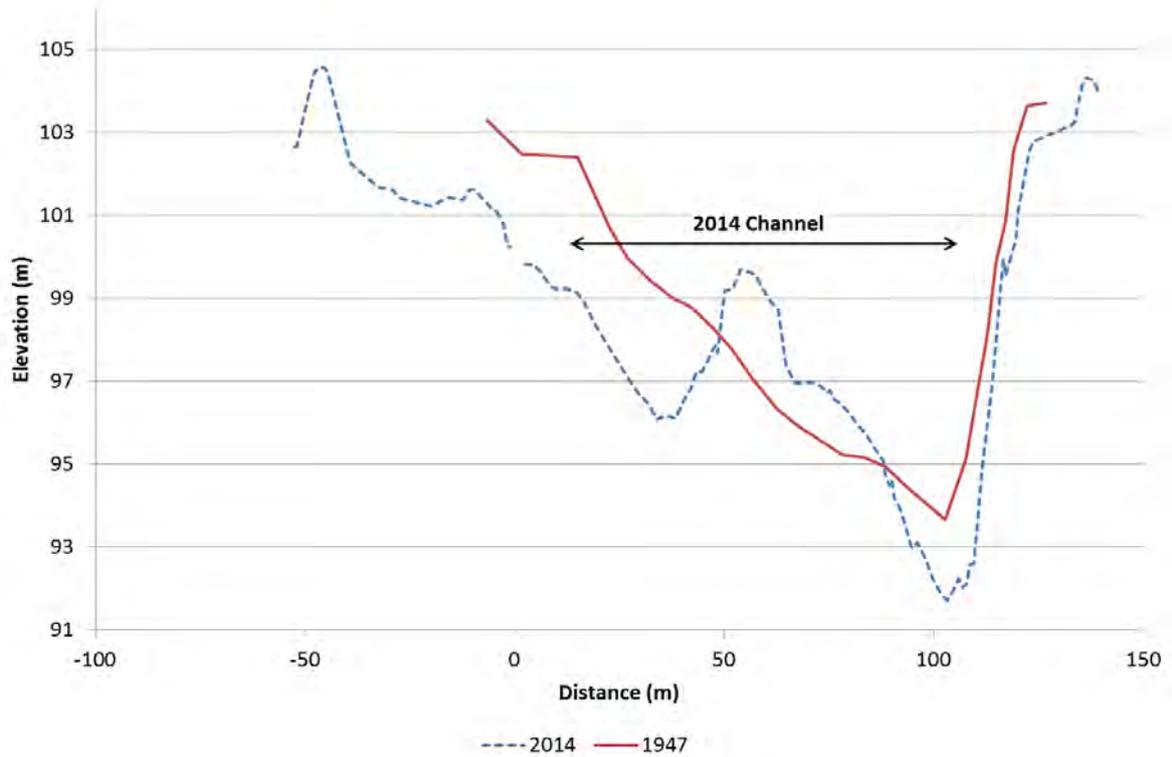
Figure 36. Clutha River/Mata-Au cross-section M140 looking downstream

Cross-section M140 is located 10.7 km upstream of the confluence of the Matau Branch of the Clutha River/Mata-Au and the Pacific Ocean. The true left of the channel (point labelled A) forms part of a backwater channel during low flows and has aggraded between 2005 and 2014, but has degraded significantly since 2000. The true right of the channel has degraded between 2005 and 2014 with degradation occurring on both banks.

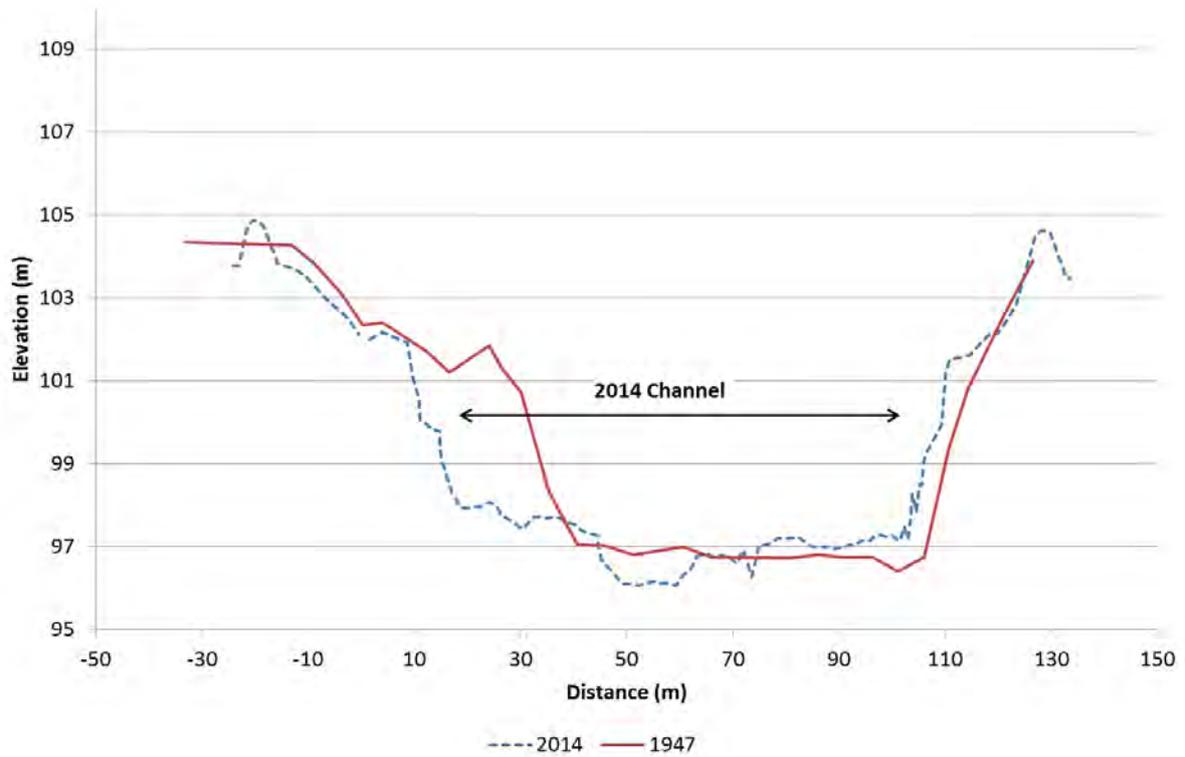
Figure 37. Clutha River/Mata-Au cross-section M128, looking downstream

Cross-section M128 is located 11.7 km upstream of the confluence of the Matau Branch of the Clutha River/Mata-Au and the Pacific Ocean. The main channel has predominately degraded between 2005 and 2014; the 2005 survey did not extend significantly enough on the banks to allow a comparison to be made.

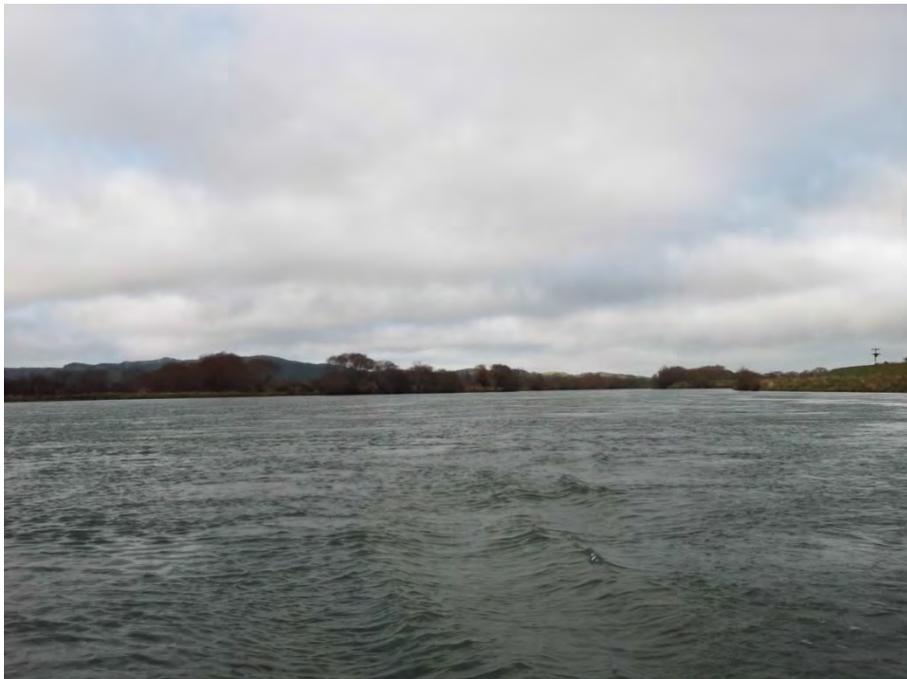
Figure 94. Clutha River/Mata-Au cross-section K67, looking downstream

Cross-section K67 is located 6.8 km upstream of the confluence of the Koau branch of the Clutha River/Mata-Au with the Pacific Ocean. Between 2005 and 2014 the main channel has deepened with some erosion and topography change on the true left floodplain.

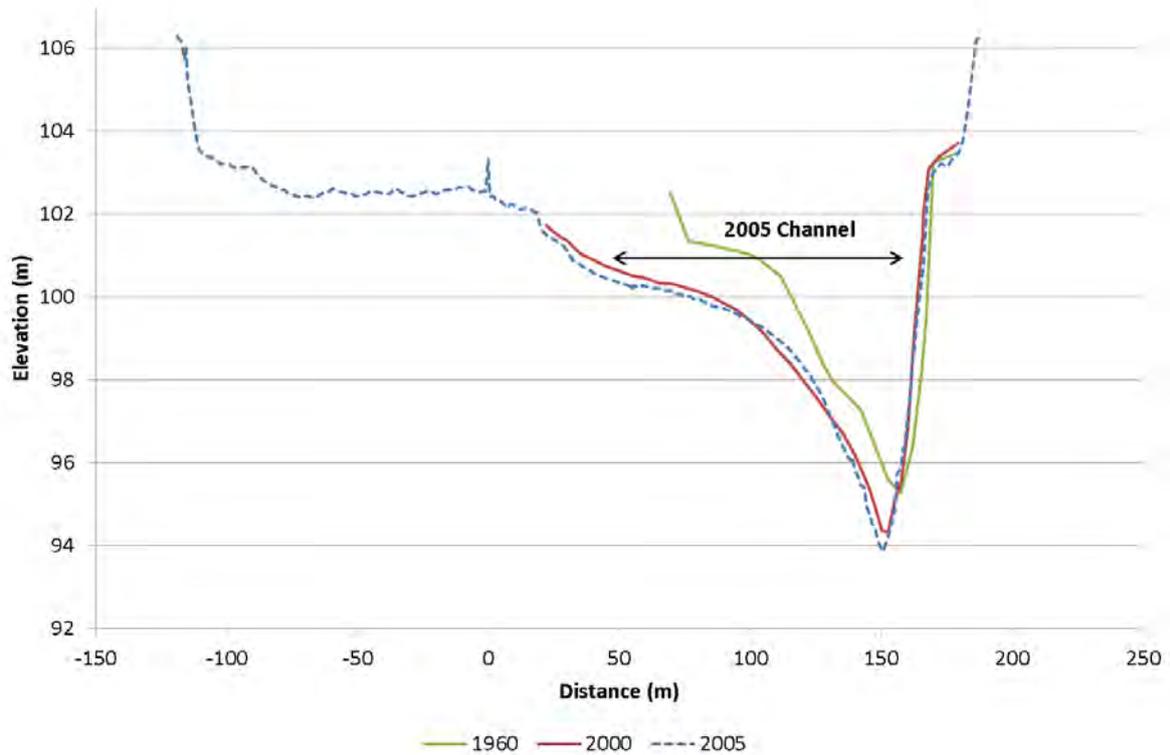
Figure 95. Clutha River/Mata-Au cross-section K64, looking downstream

Cross-section K64 is located 7.1 km upstream of the confluence of the Koau branch of the Clutha River/Mata-Au with the Pacific Ocean. Limited change occurred between the two latest surveys of 2000 and 2005, the thalweg has decreased and there has been aggradation of the true left of the main channel.

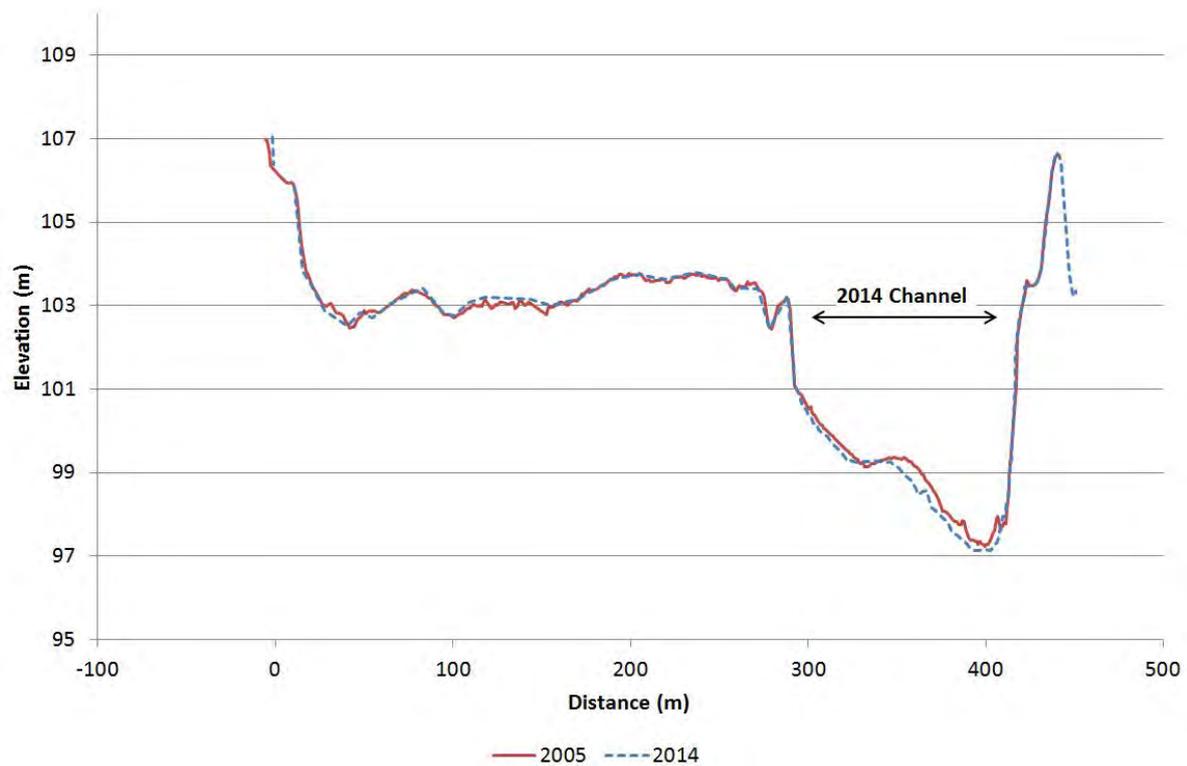
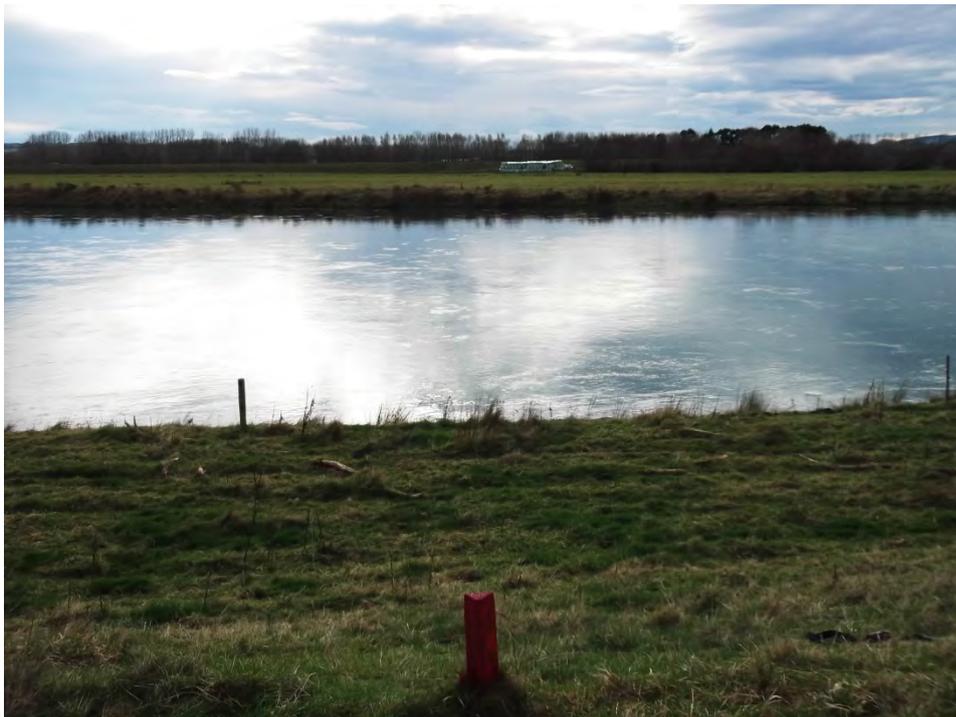
Figure 97. Clutha River/Mata-Au cross-section K54 looking from true right to true left bank

Cross-section K54 is located 9 km upstream of the confluence of the Koau branch of the Clutha River/Mata-Au with the Pacific Ocean. Between 2014 and 2005 the main channel has degraded slightly.

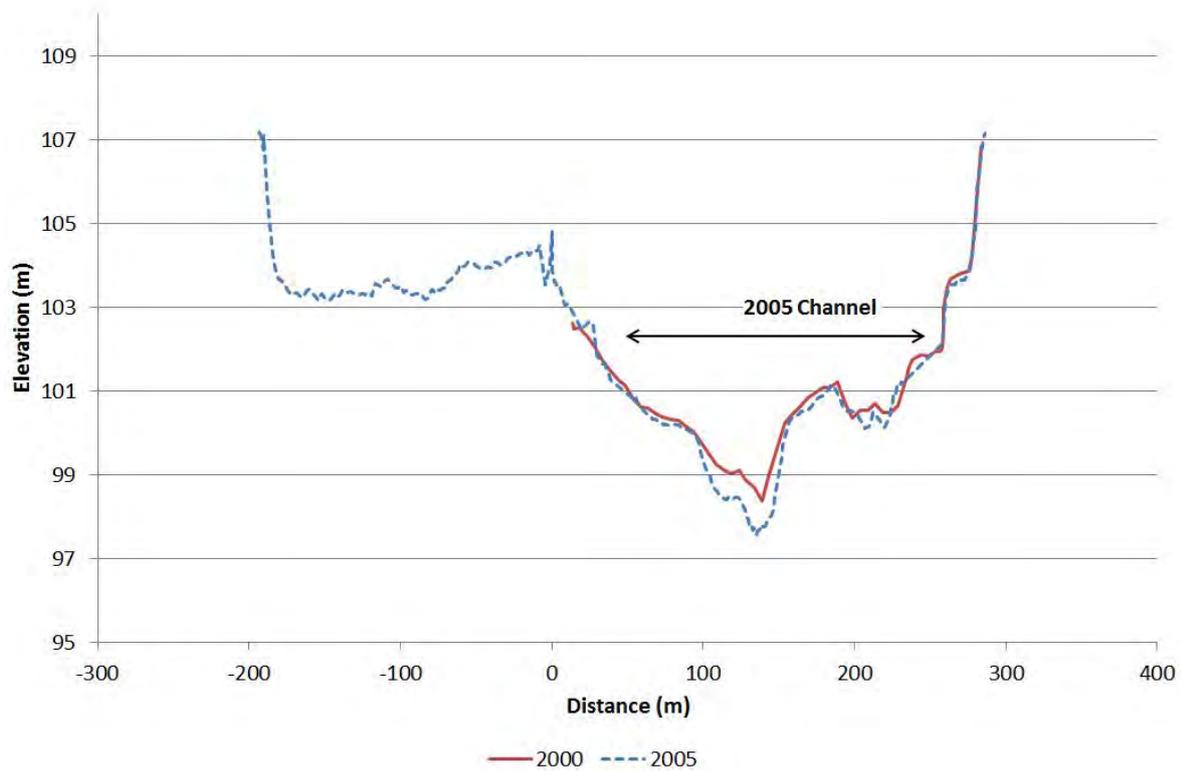
Figure 98. Clutha River/Mata-Au cross-section K48, looking downstream

Cross-section K48 is located 9.3 km upstream of the confluence of the Koau branch of the Clutha River/Mata-Au with the Pacific Ocean. The main channel experienced degradation with the thalweg lowering by about 1 m between 2000 and 2005.

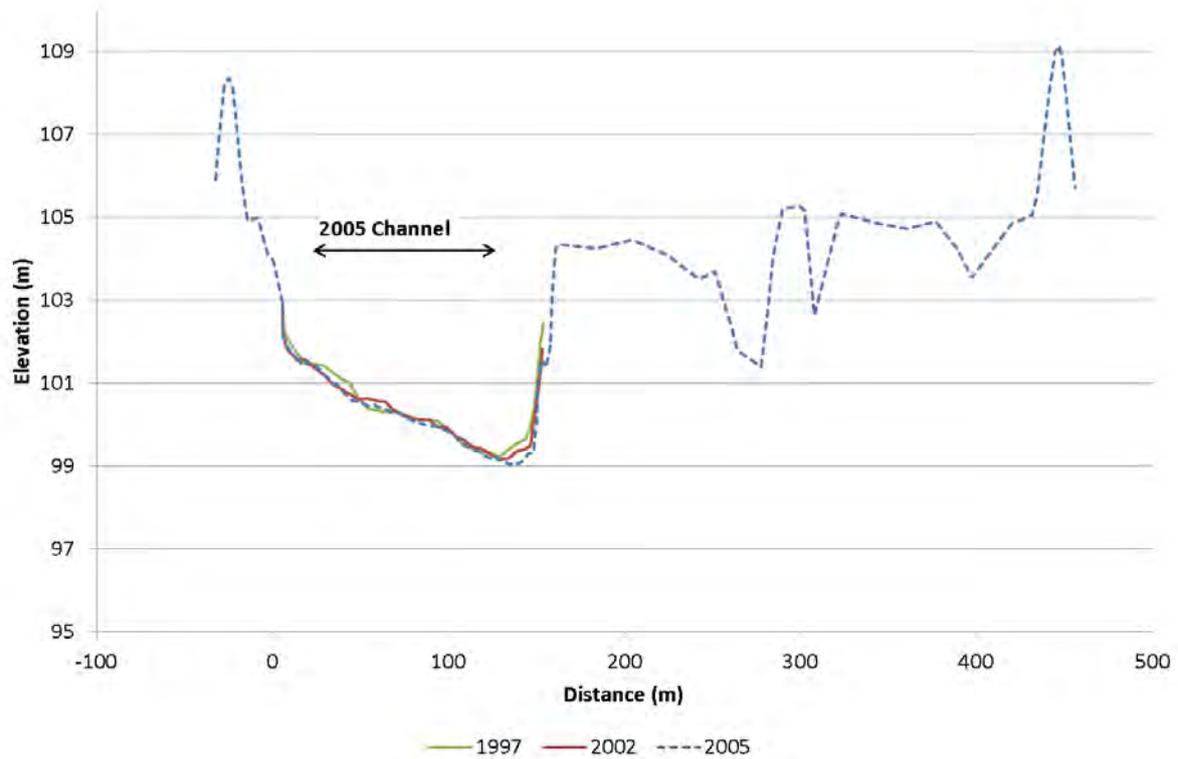
Figure 101. Clutha River/Mata-Au cross-section K10, looking downstream

Cross-section K10 is located 11.2 km upstream of the confluence of the Koau branch of the Clutha River/Mata-Au with the Pacific Ocean. Between 2002 and 2005 the channel bed has remained similar. The 2002 survey did not extend sufficiently up the banks to allow a comparison to be made.

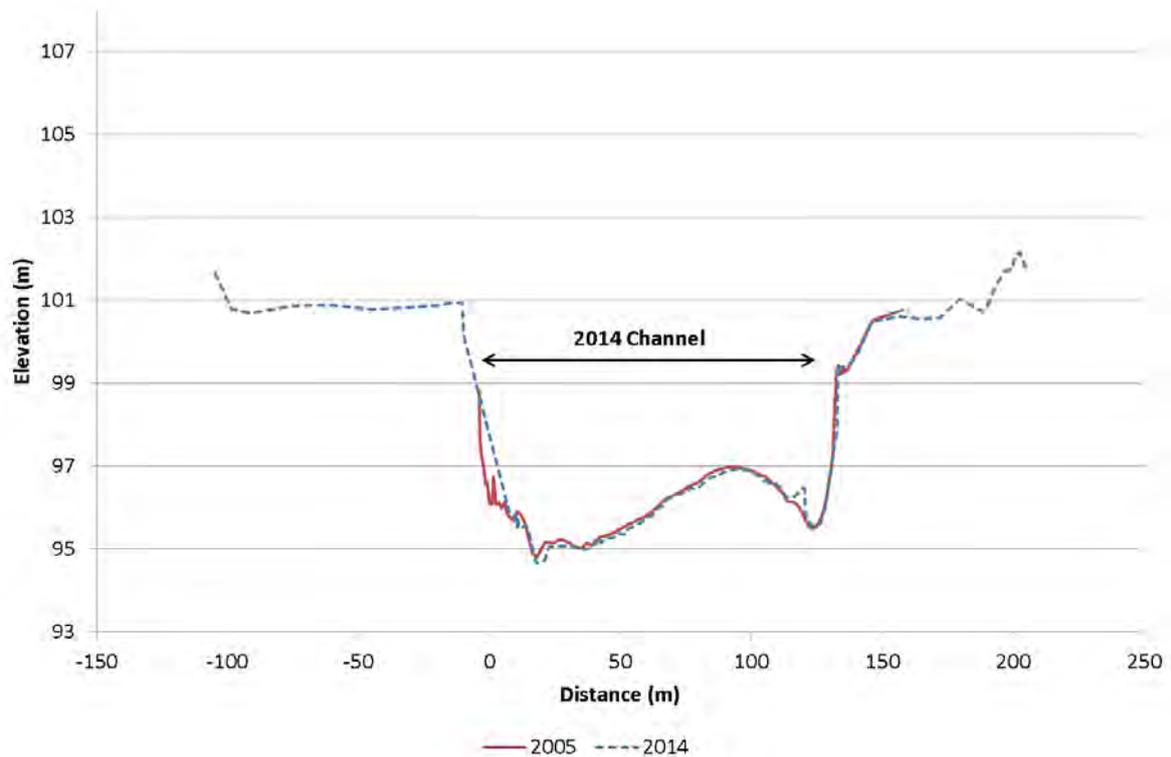
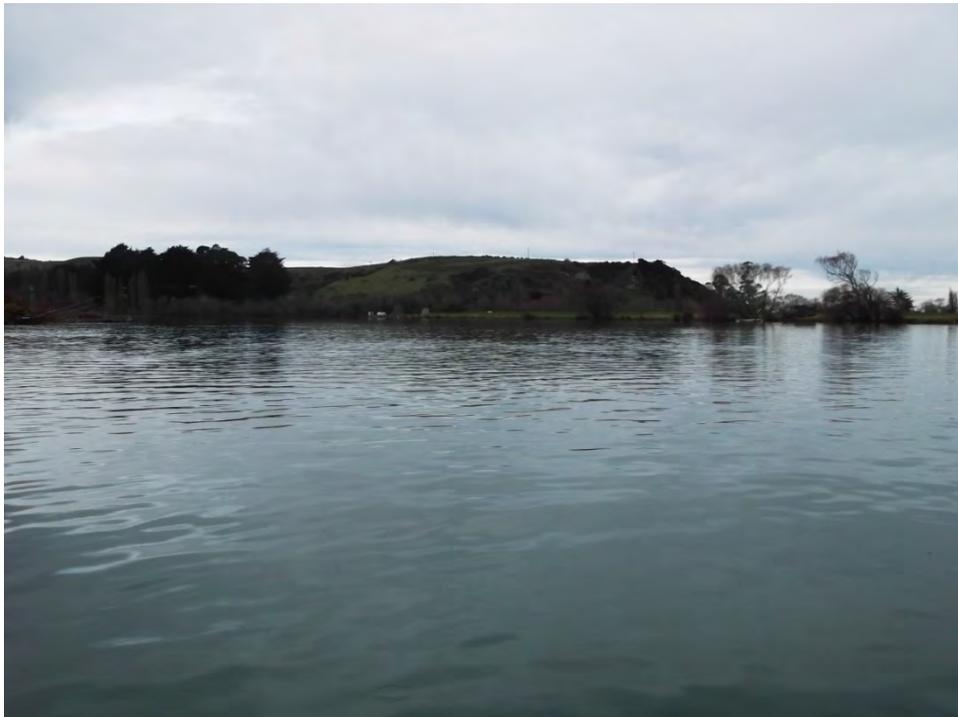
Figure 111. Clutha River/Mata-Au cross-section M223, looking downstream

Cross-section M223 is located 3.3 km upstream of the confluence of the Matau Branch of the Clutha River/Mata-Au with the Pacific Ocean. The main channel has remained in a similar position between 2005 and 2014 with aggradation occurring on the true left bank.

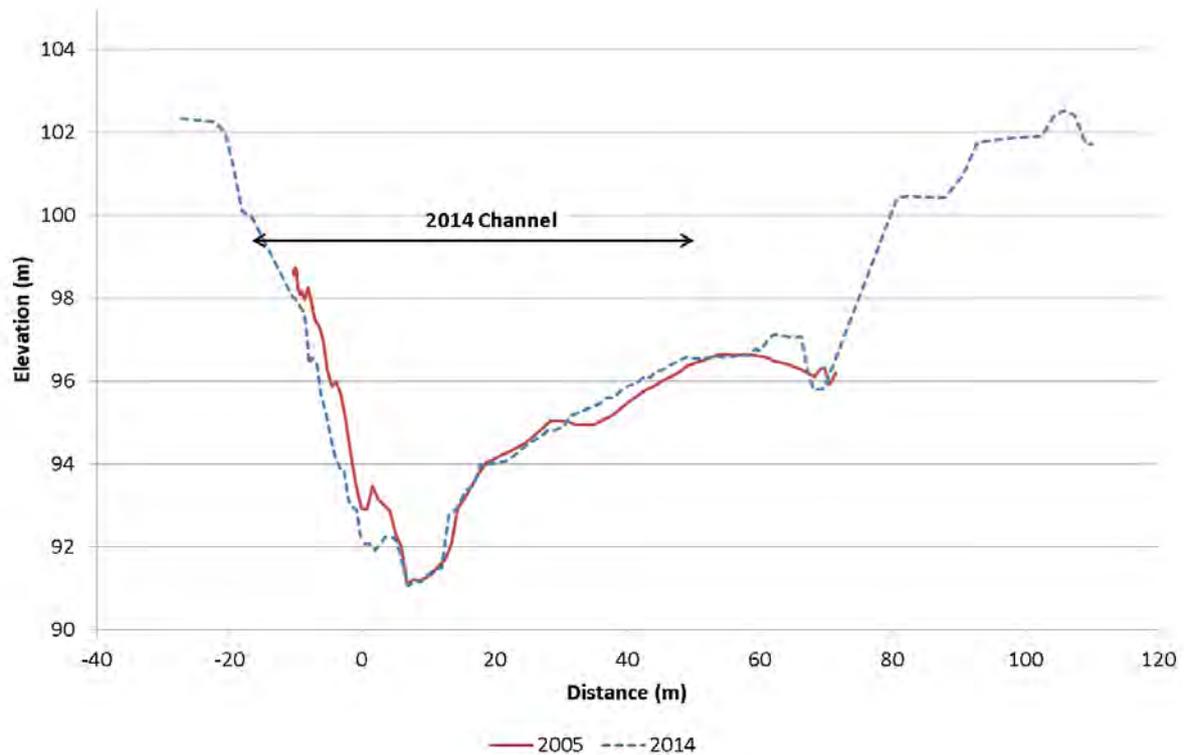
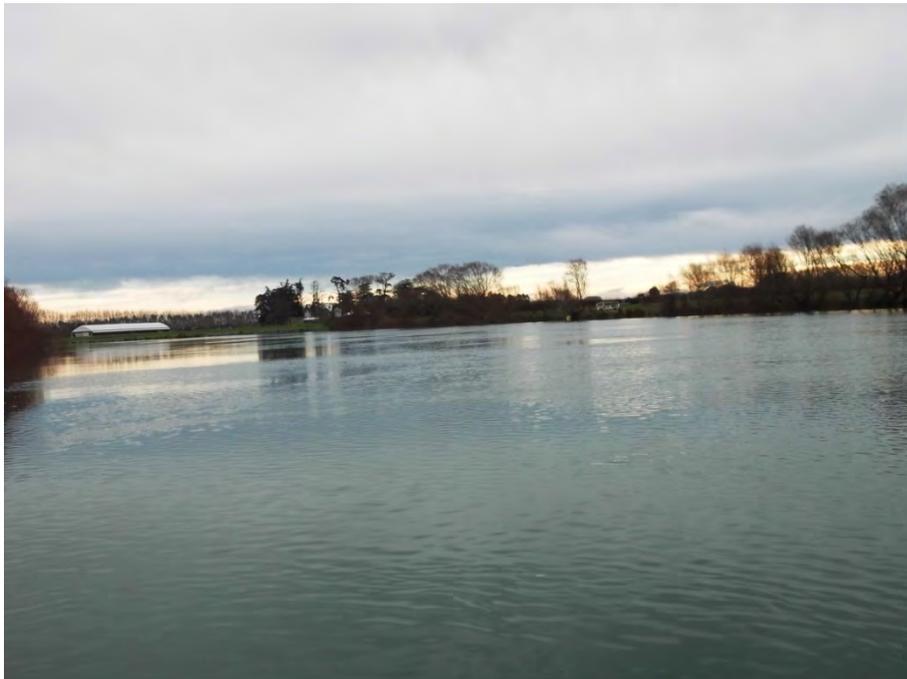
Figure 113. Clutha River/Mata-Au cross-section M202, looking upstream

Cross-section M202 is located 4.9 km upstream of the confluence of the Matau Branch of the Clutha River/Mata-Au with the Pacific Ocean. Between 2005 and 2014 there has been erosion of the true left bank and aggradation of the true right side of the main channel. The 2005 survey did not extend sufficiently far enough on the true right bank to allow a comparisons to be made.
