Morphology of the Clutha River/Mata- Au between Roxburgh Dam and the Pacific Ocean

March 2017

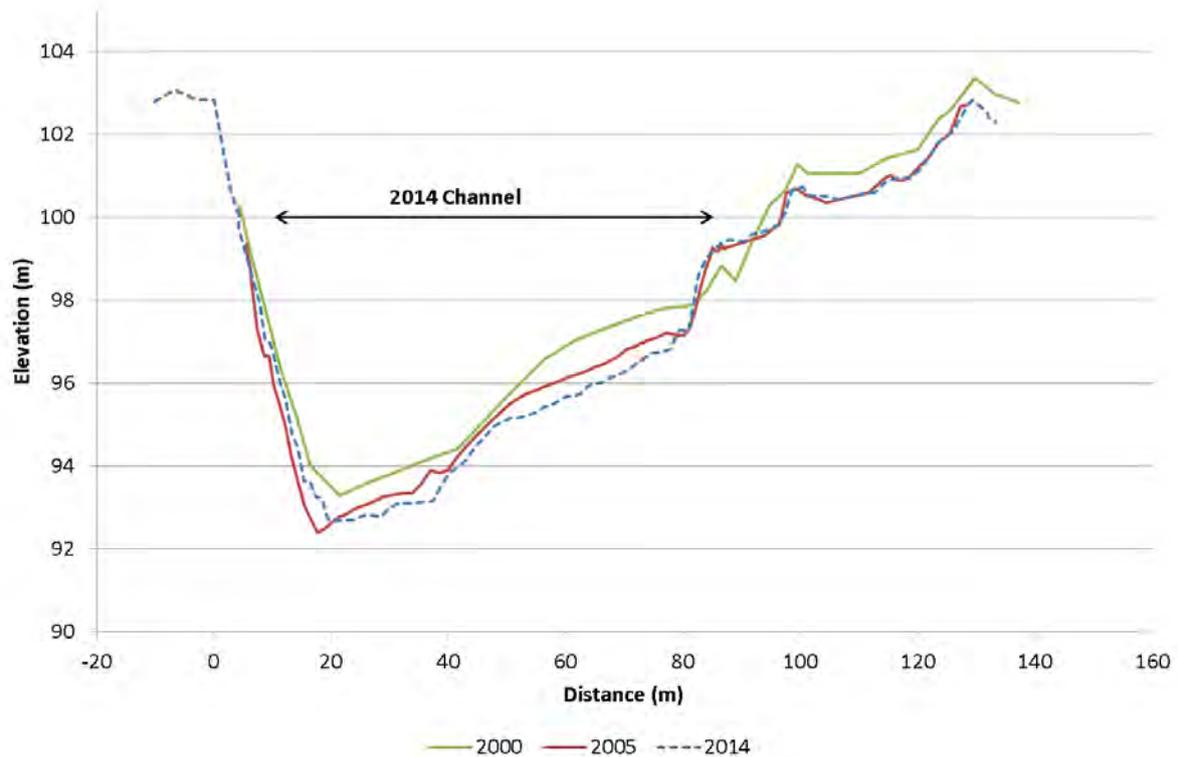
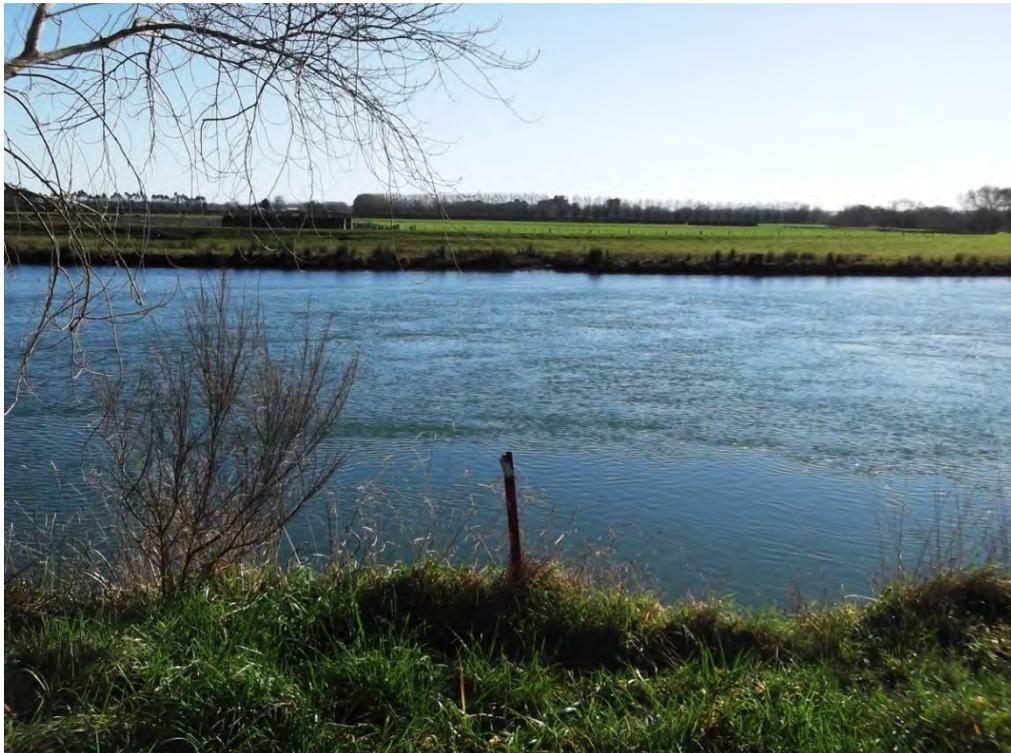
Figure 115. Clutha River/Mata-Au cross-section M195, looking from true left to right bank

Cross-section M195 is located 5.3 km upstream of the confluence of the Matau Branch of the Clutha River/Mata-Au with the Pacific Ocean. The channel has degraded between 2005 and 2014 with some aggradation occurring on the true left bank.

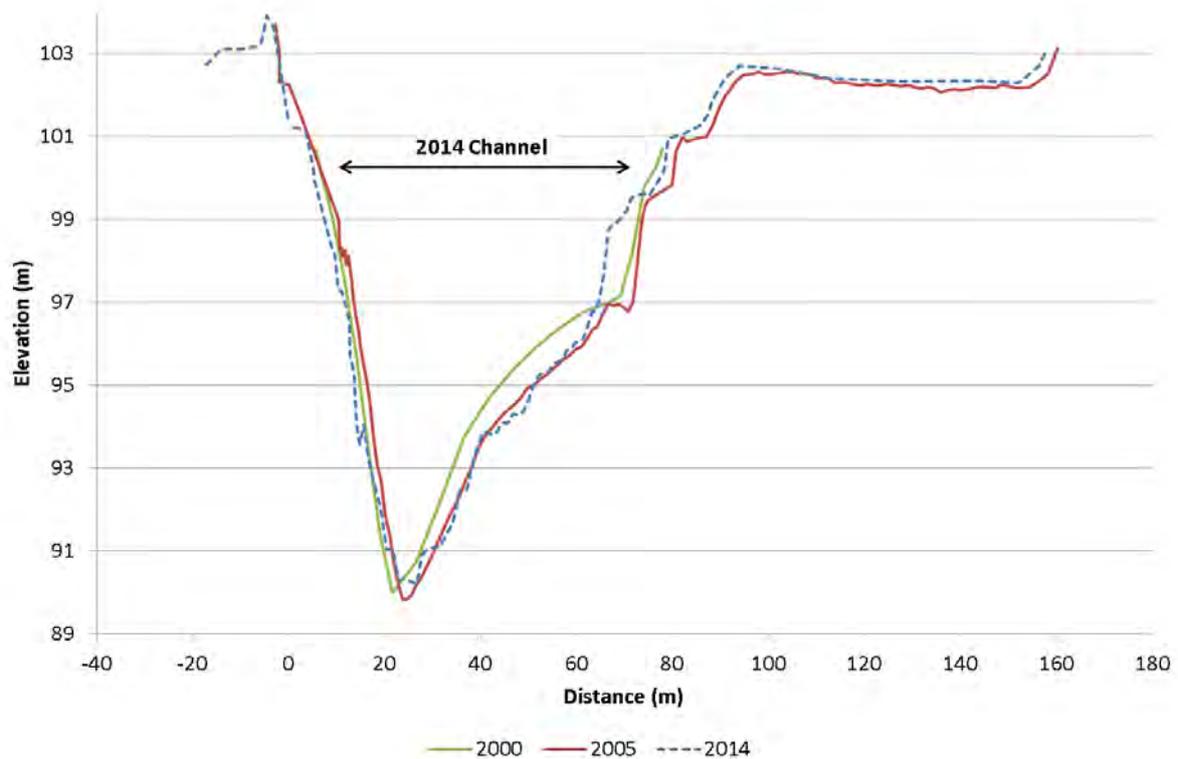
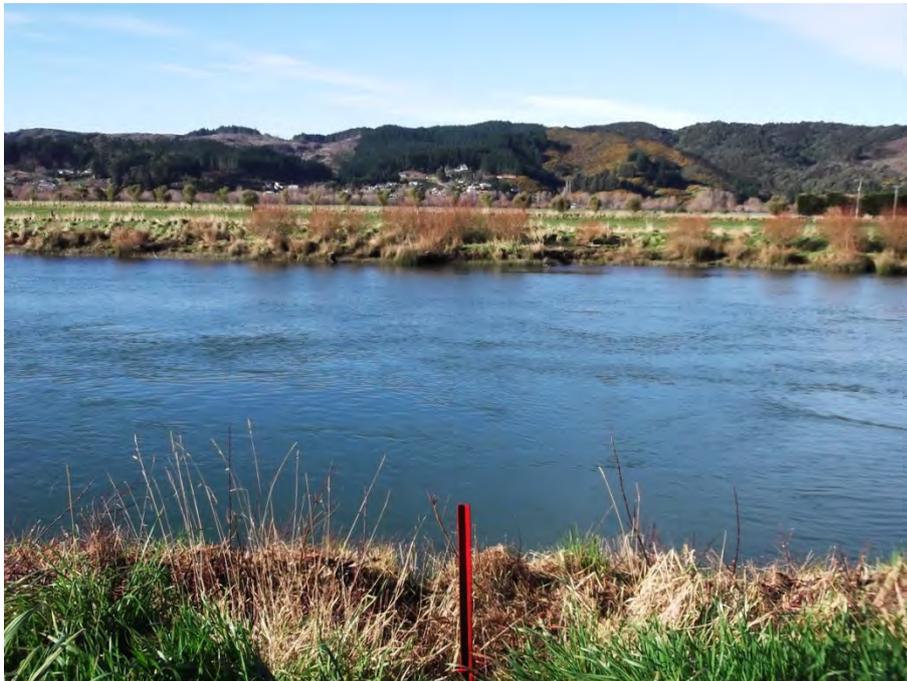
Figure 117. Clutha River/Mata-Au cross-section M154, looking from true left to right bank

Cross-section M154 is located 9 km upstream of the confluence of the Matau Branch of the Clutha River/Mata-Au with the Pacific Ocean and 150 m upstream of the Riverside Road bridge. The true left bank has eroded between 2005 and 2014 with a small increase in the thalweg level. The true right bank has aggraded and there is minor change in the true right floodplain between 2005 and 2014.

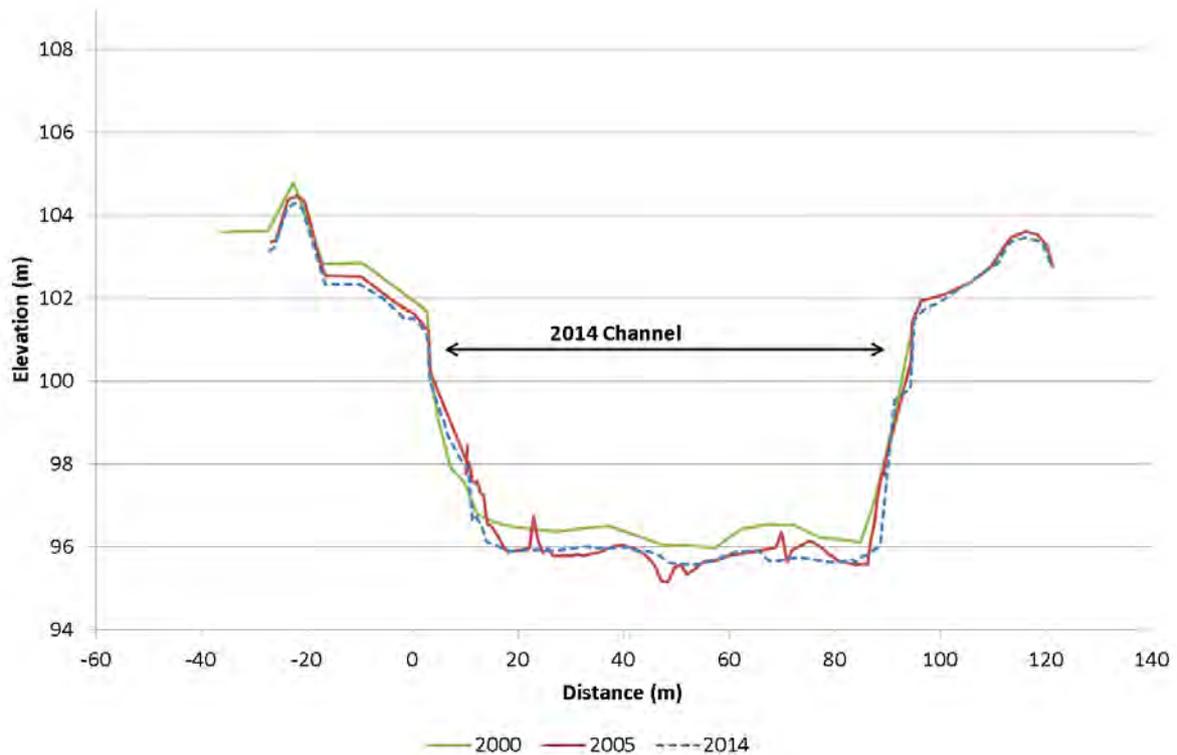
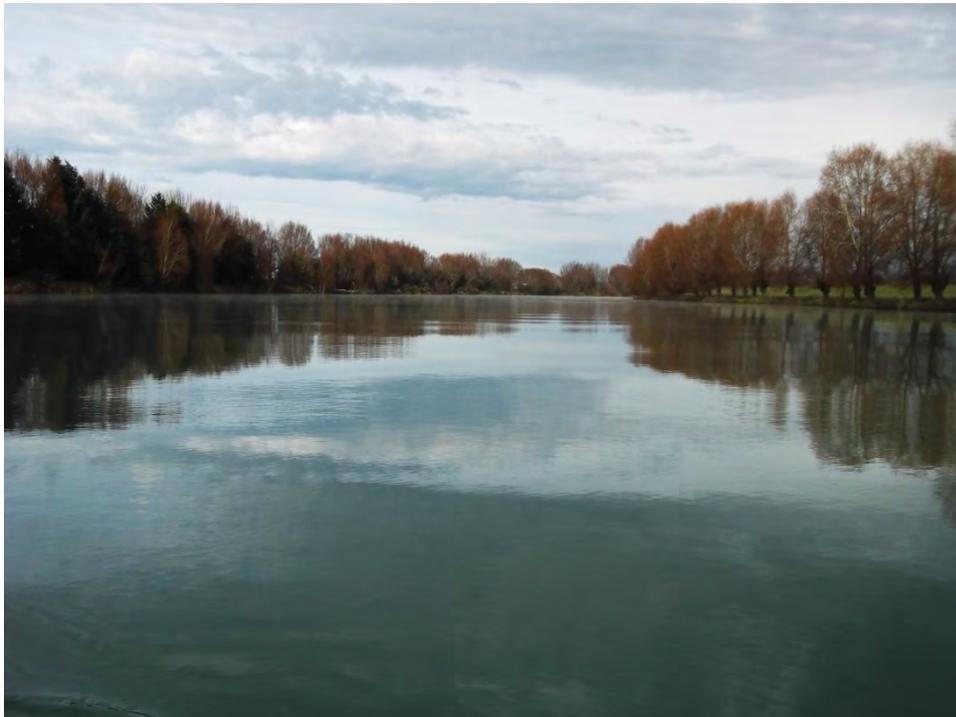
Figure 119. Clutha River/Mata-Au cross-section M147, looking upstream

Cross-section M147 is located 9.8 km upstream of the confluence of the Matau Branch of the Clutha River/Mata-Au and the Pacific Ocean. There has been minimal change in the channel between 2005 and 2014 with both aggradation and degradation occurring. The channel has degraded by about 0.5 m between 2000 and 2014.

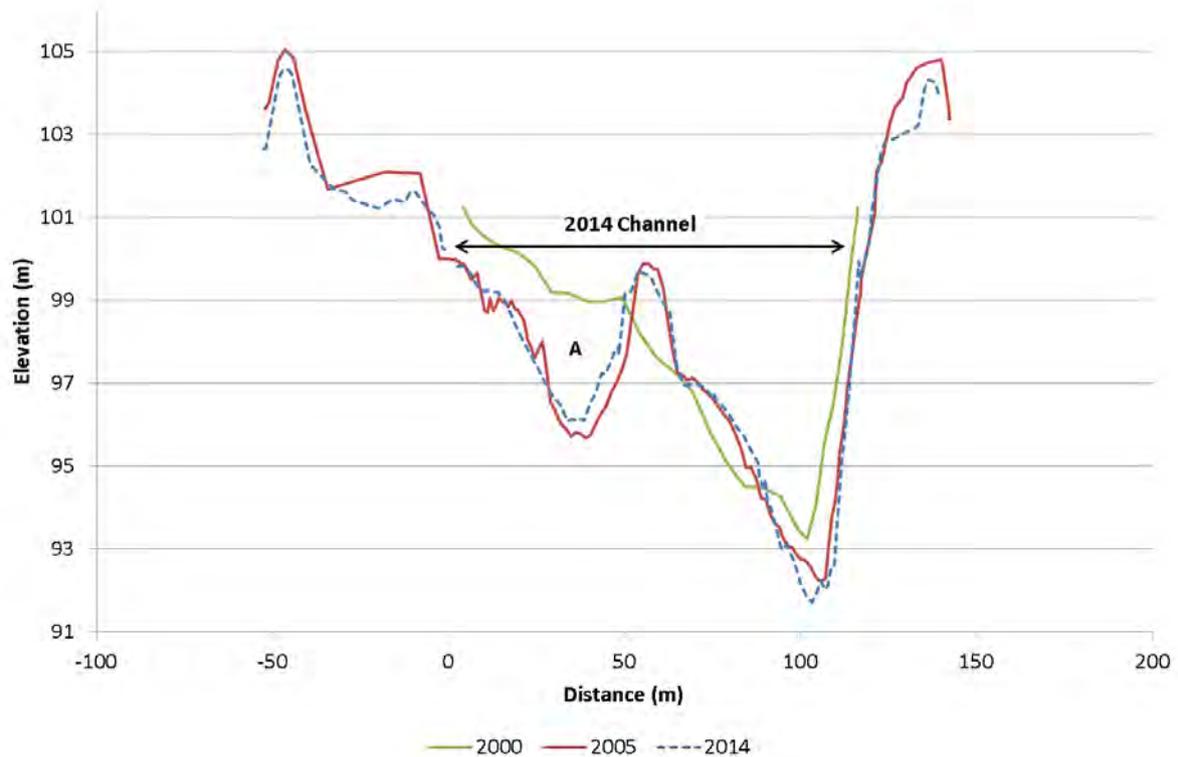
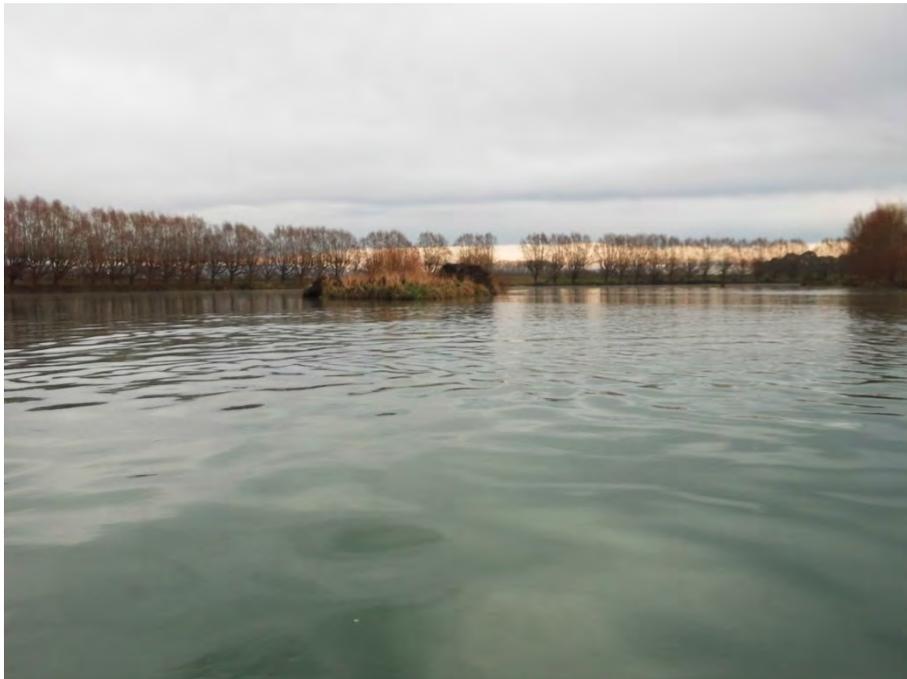
Figure 121. Clutha River/Mata-Au cross-section M140, looking upstream

Cross-section M140 is located 10.7 km upstream of the confluence of the Matau Branch of the Clutha River/Mata-Au and the Pacific Ocean. The true left of the channel (point labelled A) forms part of a backwater channel during low flows and has aggraded between 2005 and 2014, but has degraded significantly since 2000. The true right of the channel has degraded between 2005 and 2014 with degradation occurring on both banks.

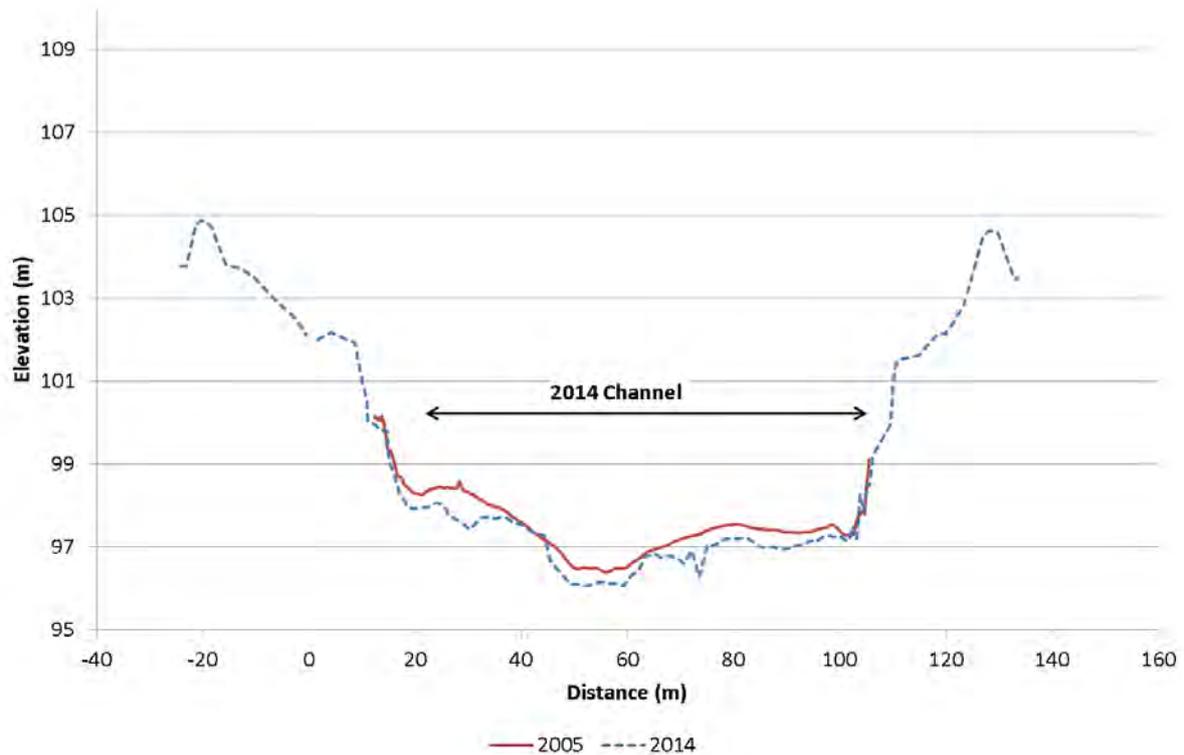
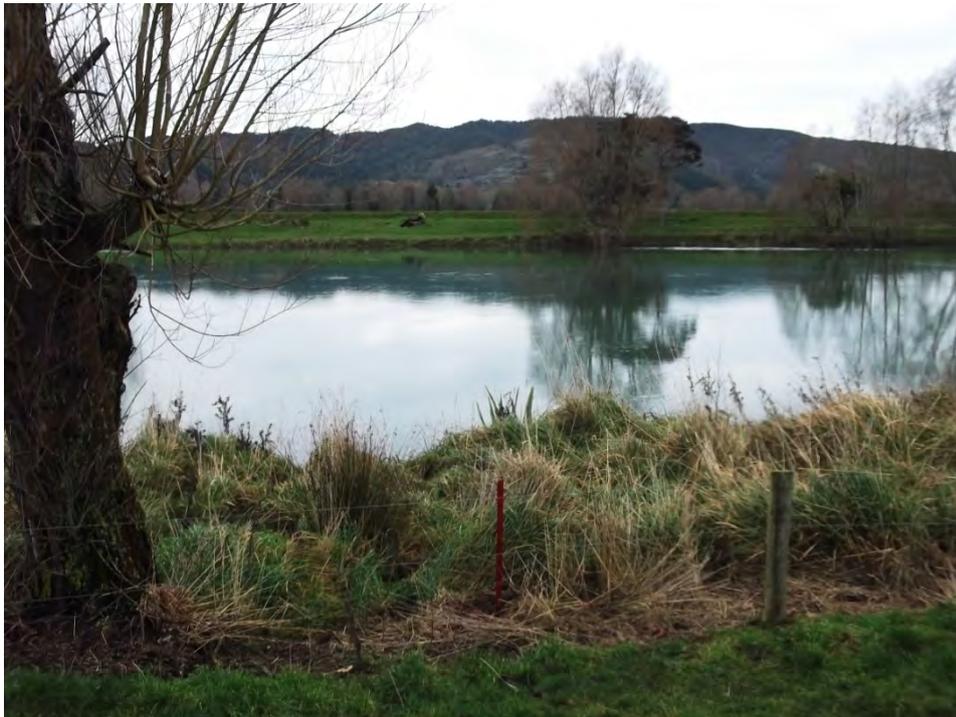
Figure 123. Clutha River/Mata-Au cross-section M128, looking from true right to left bank

Cross-section M128 is located 11.7 km upstream of the confluence of the Matau Branch of the Clutha River/Mata-Au and the Pacific Ocean. The main channel has predominately degraded between 2005 and 2014; the 2005 survey did not extend significantly enough on the banks to allow a comparison to be made.

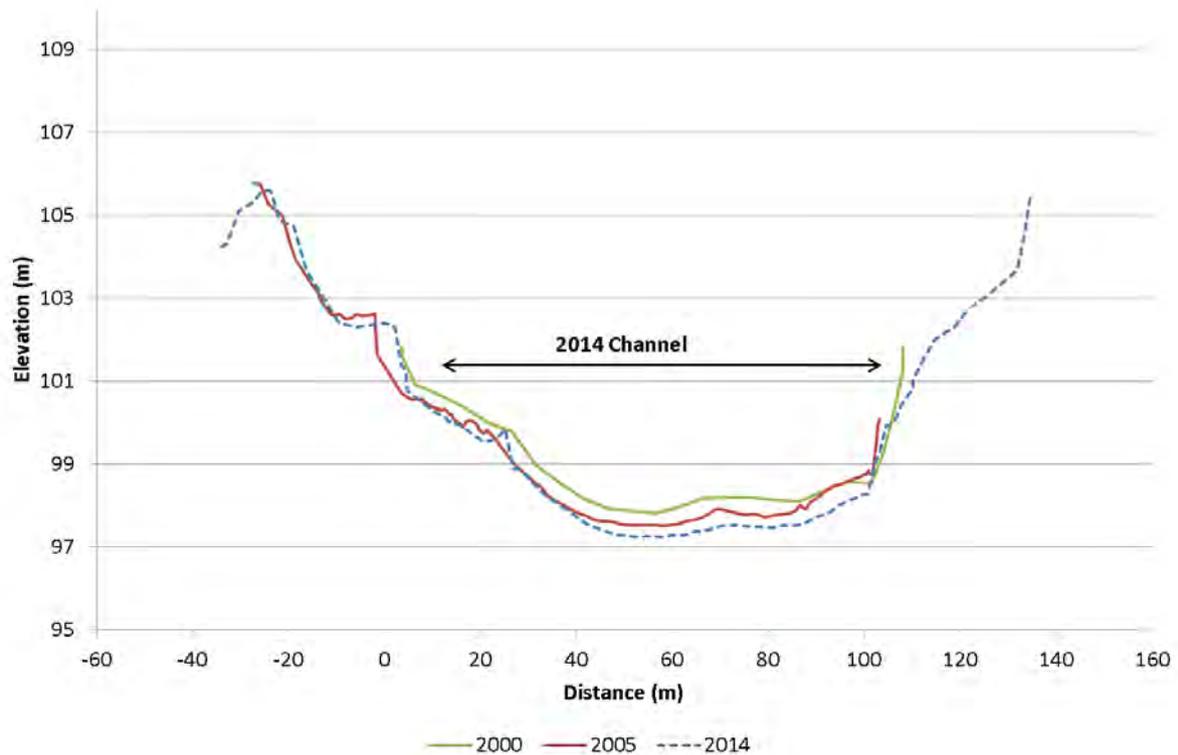
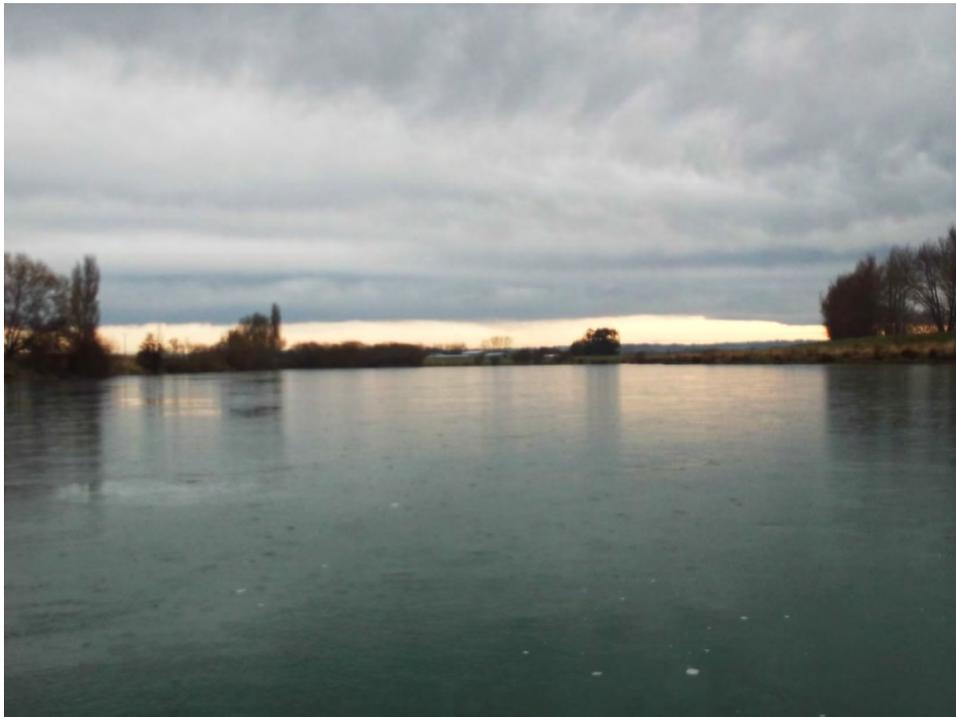
Figure 124. Clutha River/Mata-Au cross-section M99, looking downstream

Figure 125. Clutha River/Mata-Au cross-section M99, looking upstream

Cross-section M99 is located 11.9 km upstream of the confluence of the Matau Branch of the Clutha River/Mata-Au and the Pacific Ocean. The main channel has degraded between 2005 and 2014 with some aggradation occurring on the true left bank. The 2005 survey did not extend sufficiently enough to allow a comparison of the true right bank to be undertaken.

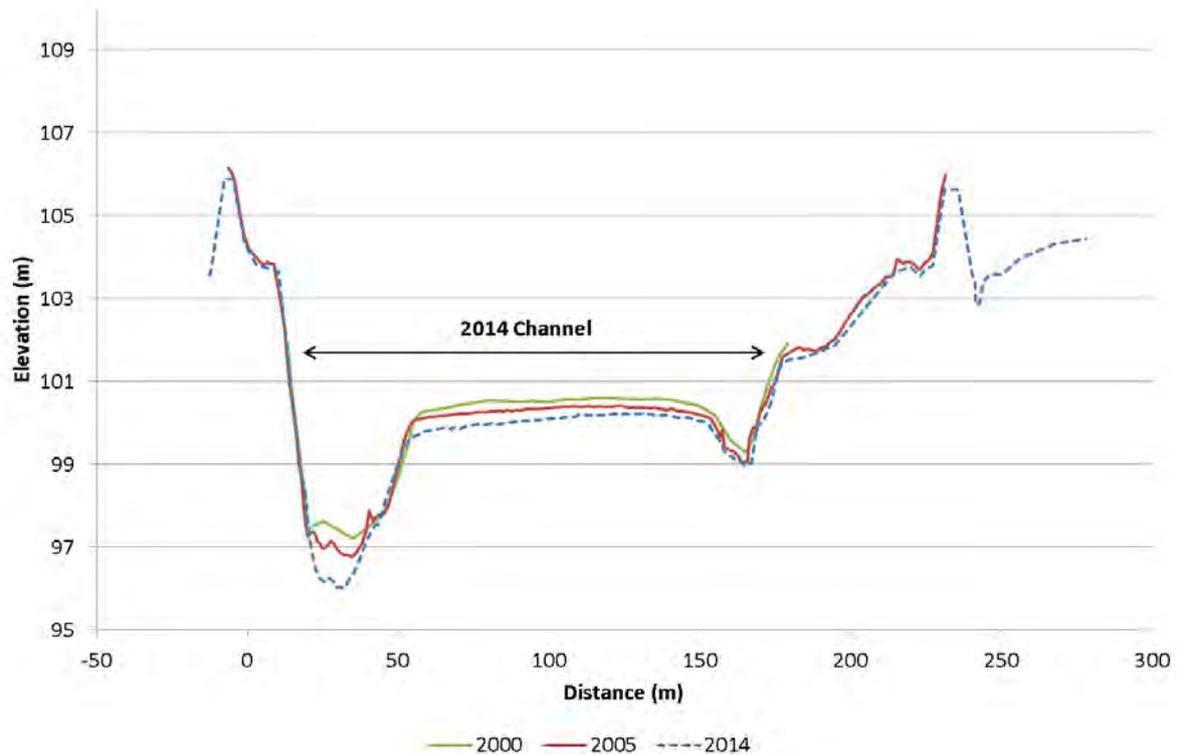
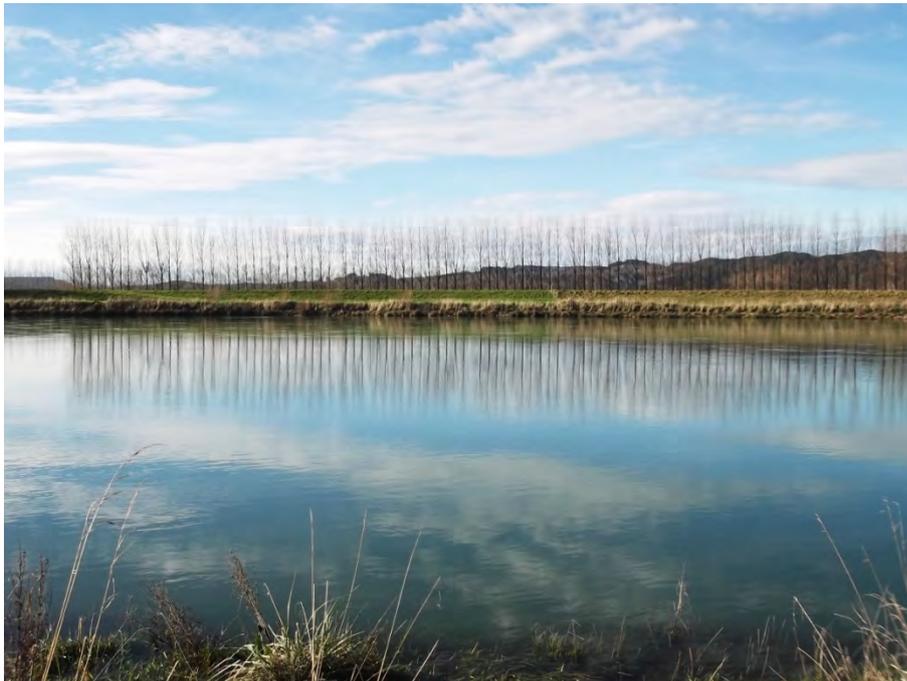
Figure 126. Clutha River/Mata-Au cross-section M94, looking downstream

Figure 127. Clutha River/Mata-Au cross-section M94, looking from true right to left bank

Cross-section M94 is located 15.7 km upstream of the confluence of the Matau Branch of the Clutha River/Mata-Au and the Pacific Ocean. The channel thalweg has lowered between 2005 and 2014 with degradation occurring across the wider channel between 2005 and 2014. The wider left and right bank floodplains have remained similar between 2005 and 2014.

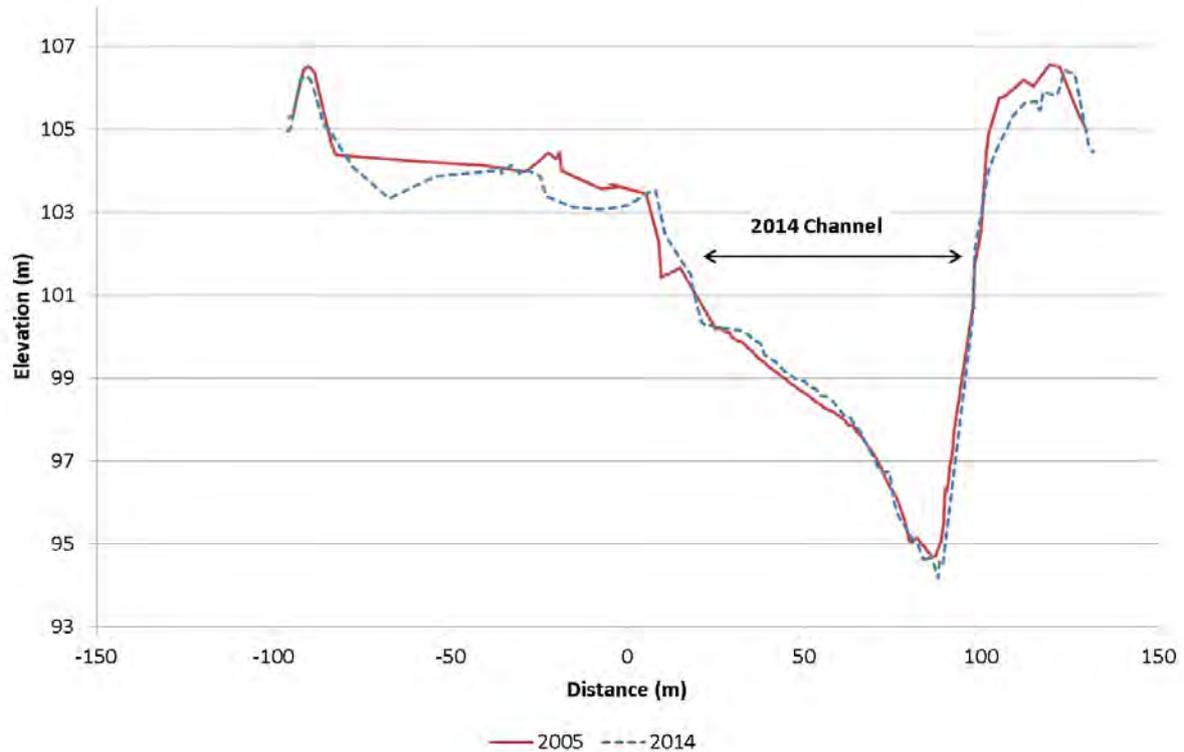
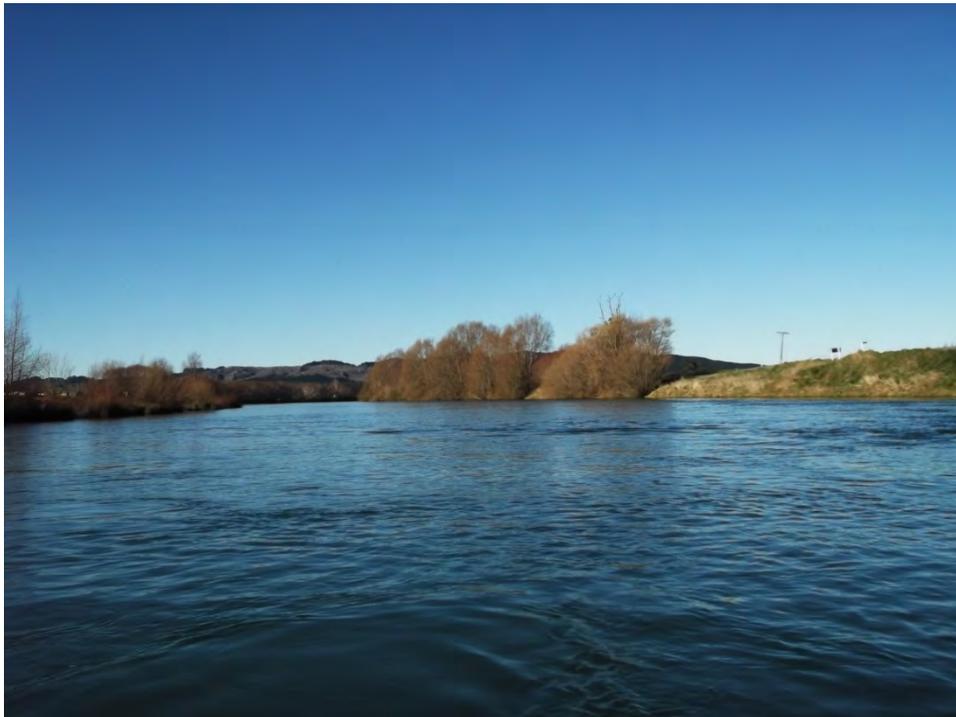
Figure 128. Clutha River/Mata-Au cross-section M5, looking downstream

Figure 129. Clutha River/Mata-Au cross-section M5, looking downstream

Cross-section M5 is located 17.1 km upstream of the confluence of the Matau Branch of the Clutha River/Mata-Au with the Pacific Ocean. Minimal change has occurred in the main channel between 2005 and 2014. Both the left and right banks and the wider floodplain have experienced degradation between 2005 and 2014.

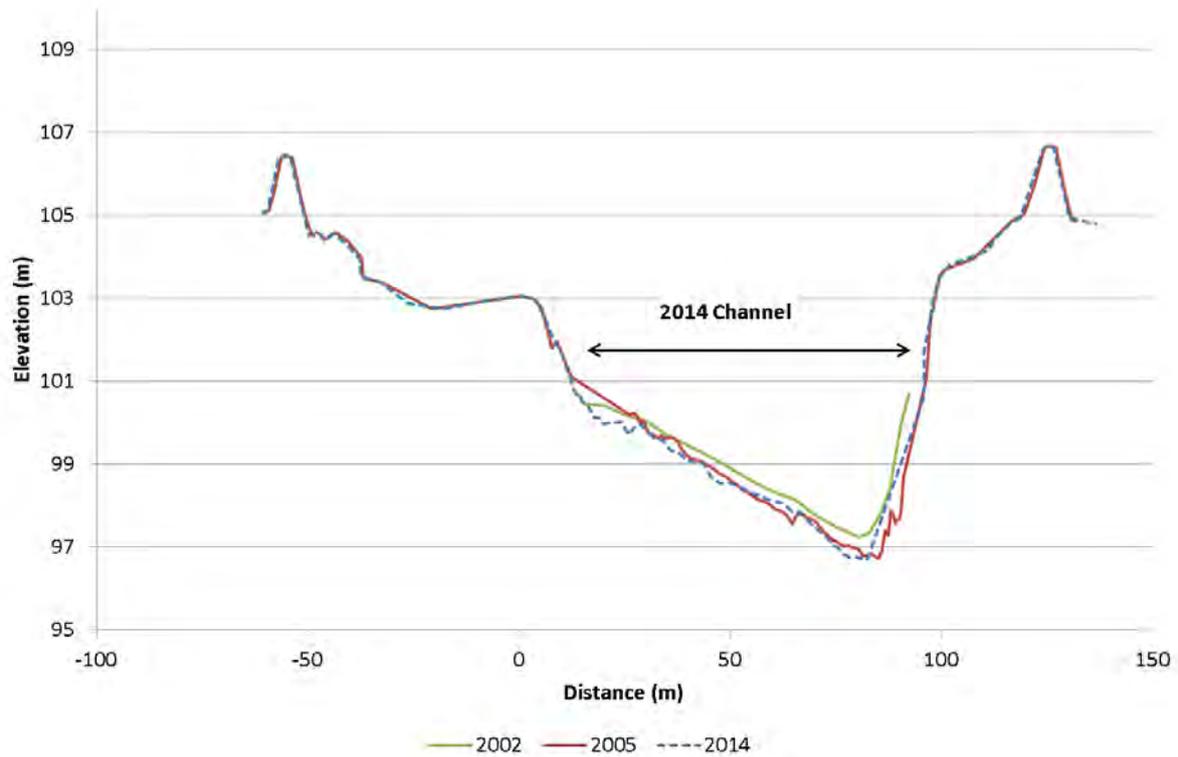
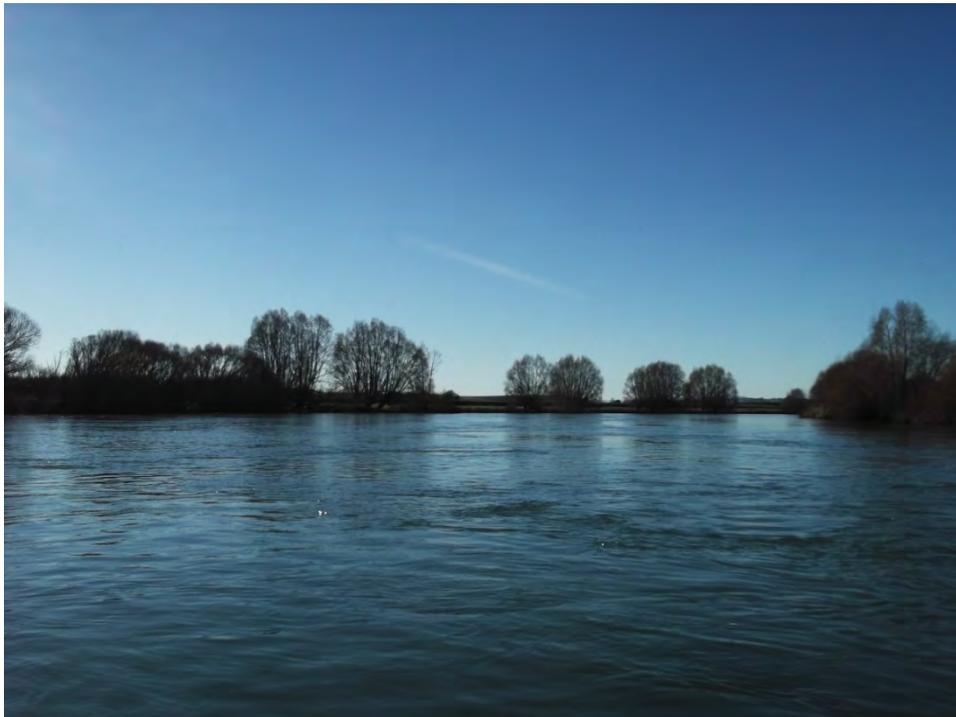
Figure 130. Clutha River/Mata-Au cross-section M6, looking downstream

Figure 131. Clutha River/Mata-Au cross-section M6, looking upstream

Cross-section M6 is located 18.5 km upstream of the confluence of the Matau Branch of the Clutha River/Mata-Au with the Pacific Ocean. The thalweg has shifted towards the true left bank between 2005 and 2014 with both aggradation and degradation occurring across the main channel. The wider floodplain has remained similar between 2005 and 2014.

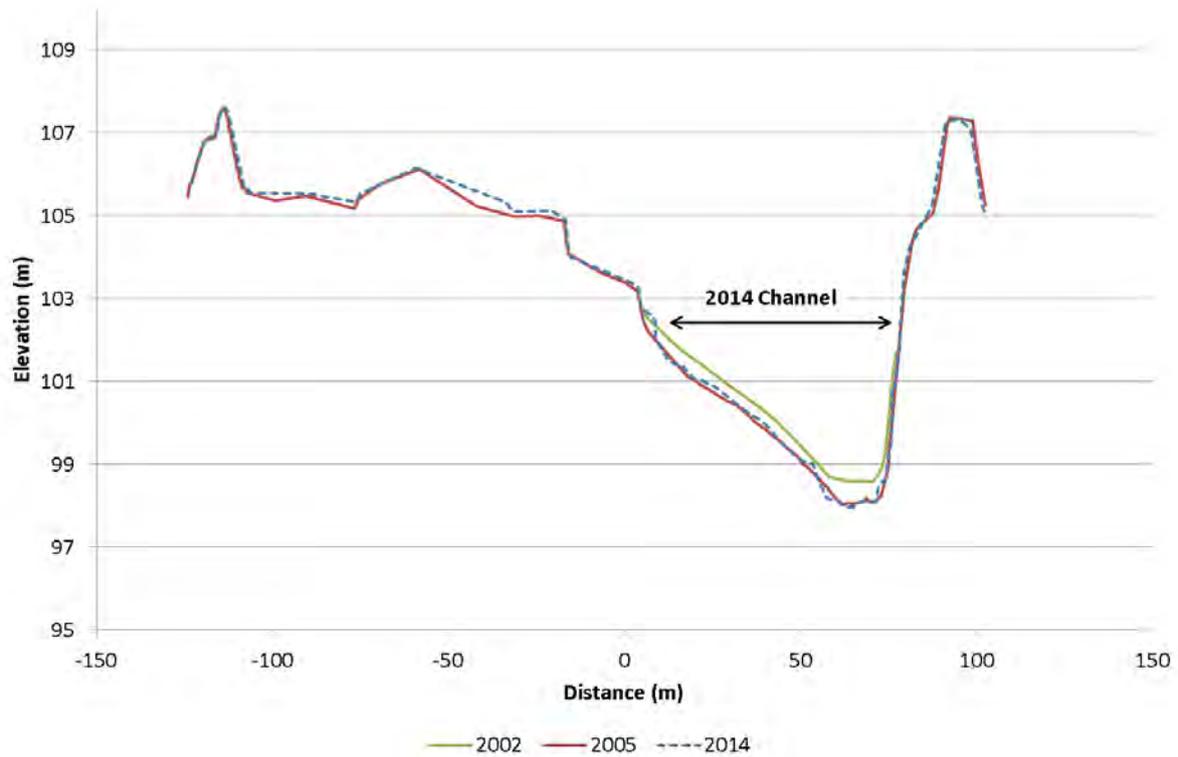
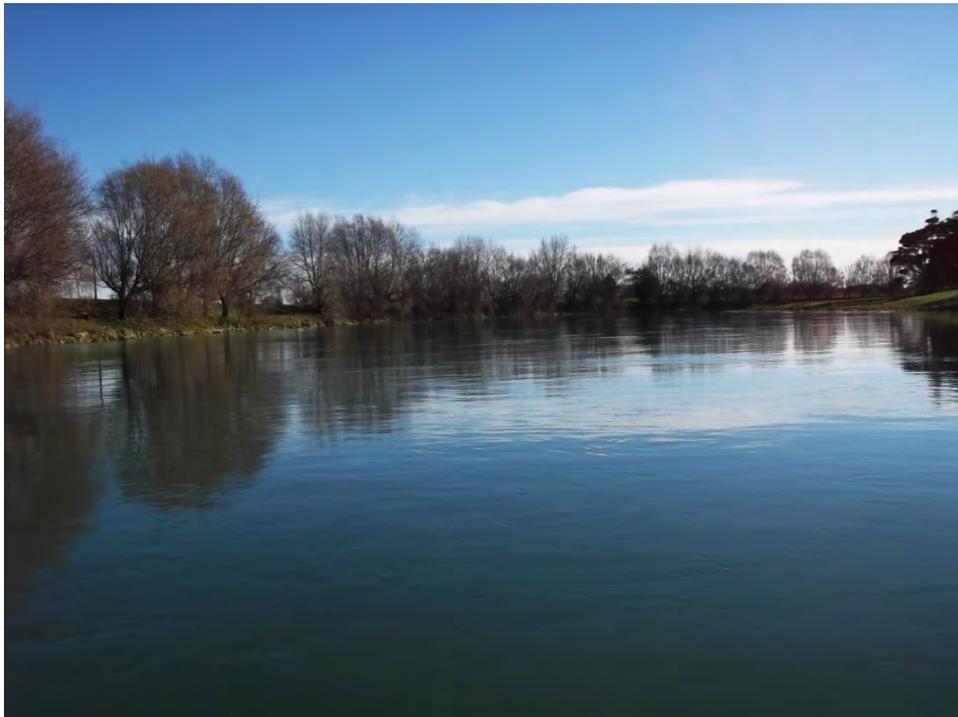
Figure 132. Clutha River/Mata-Au cross-section M7, looking downstream

Figure 133. Clutha River/Mata-Au cross-section M7, looking upstream

Cross-section M7 is located 21.8 km upstream of the confluence of the Matau Branch of the Clutha River/Mata-Au with the Pacific Ocean. The channel and wider floodplain has remained similar between 2005 and 2014, but the main channel has degraded between 2002 and 2014.

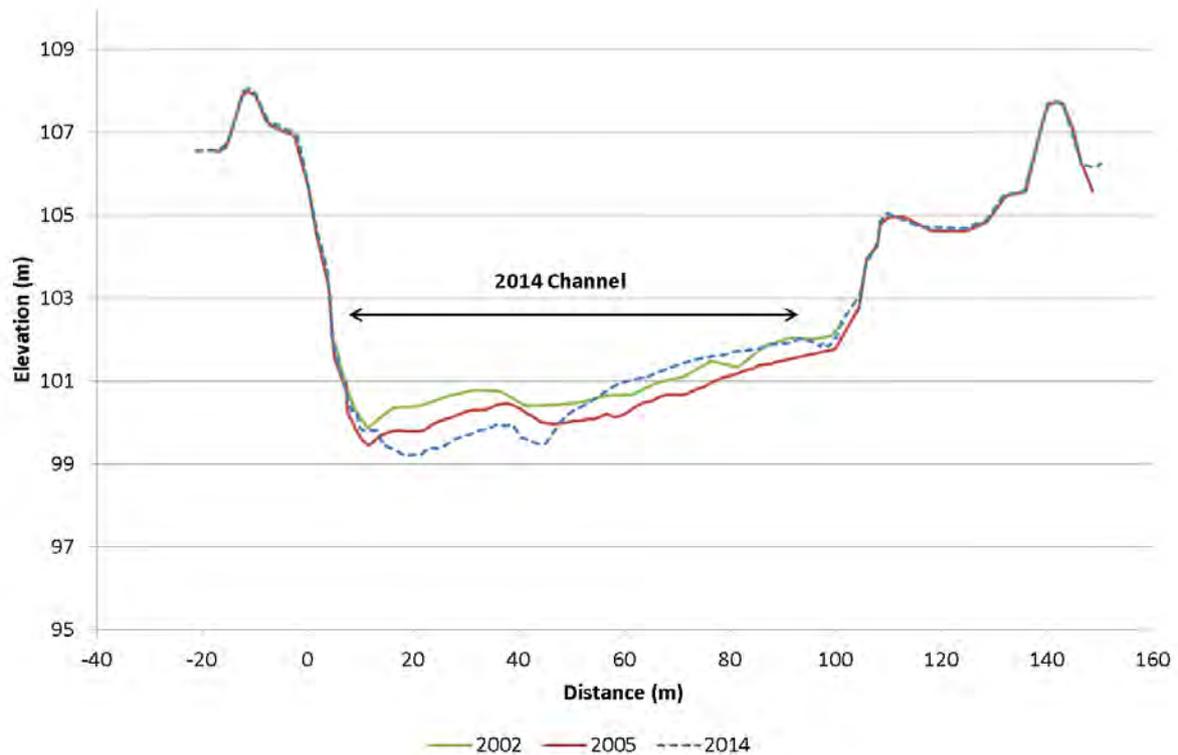
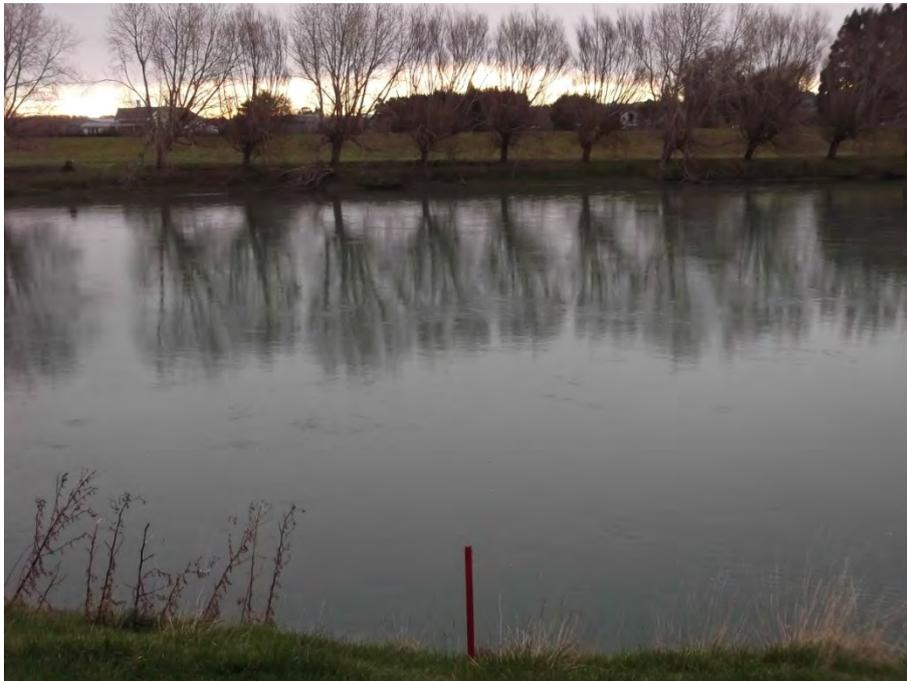
Figure 134. Clutha River/Mata-Au, cross-section M8, looking downstream

Figure 135. Clutha River/Mata-Au cross-section M8, looking from true left to right bank

Cross-section M8 is located 22.6 km upstream of the confluence of the Matau Branch of the Clutha River/Mata-Au with the Pacific Ocean. The true left of the channel has degraded with aggradation occurring on the right side between 2005 and 2014 which has caused the channel to become more restricted. The wider floodplain has remained similar between 2005 and 2014.

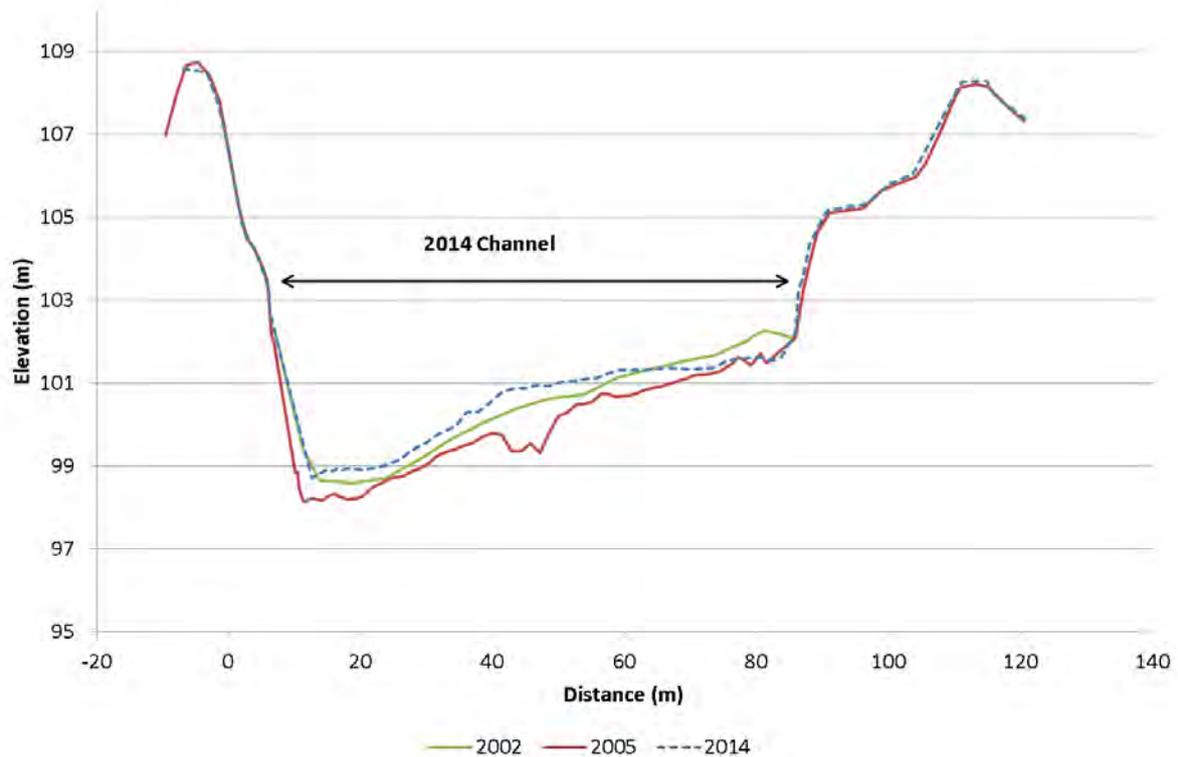
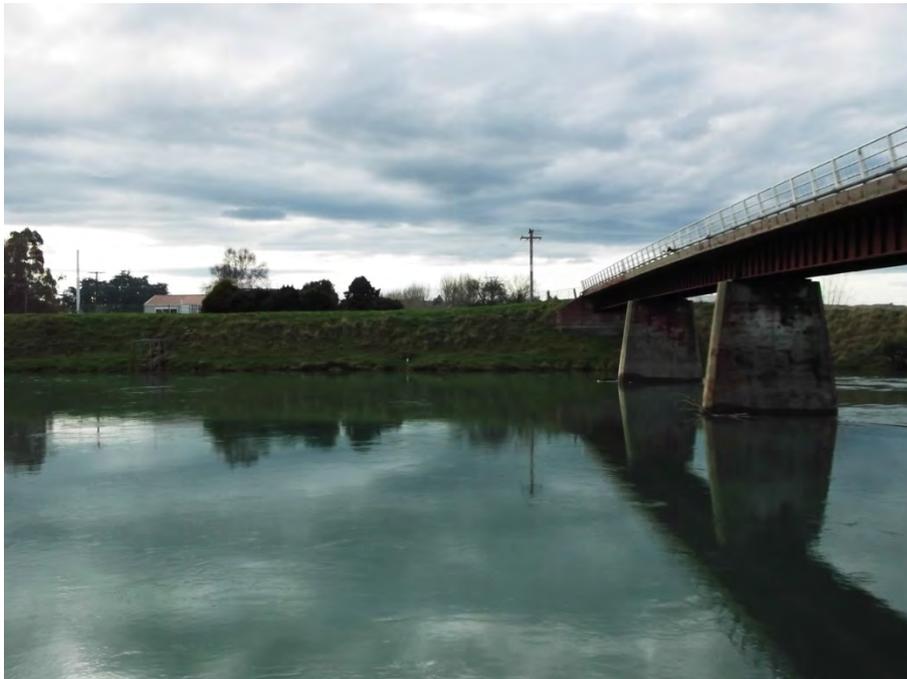
Figure 136. Clutha River/Mata-Au cross-section M9, looking downstream

Figure 137. Clutha River/Mata-Au cross-section M9, looking true right to left bank

Cross-section M9 is located 23.4 km upstream of the confluence of the Matau Branch of the Clutha River/Mata-Au and the Pacific Ocean at the Riverbank Road bridge. The channel has shown aggraded across its length between 2005 and 2014 with the thalweg being located in a similar horizontal position. The wider floodplain has remained similar between 2005 and 2014.

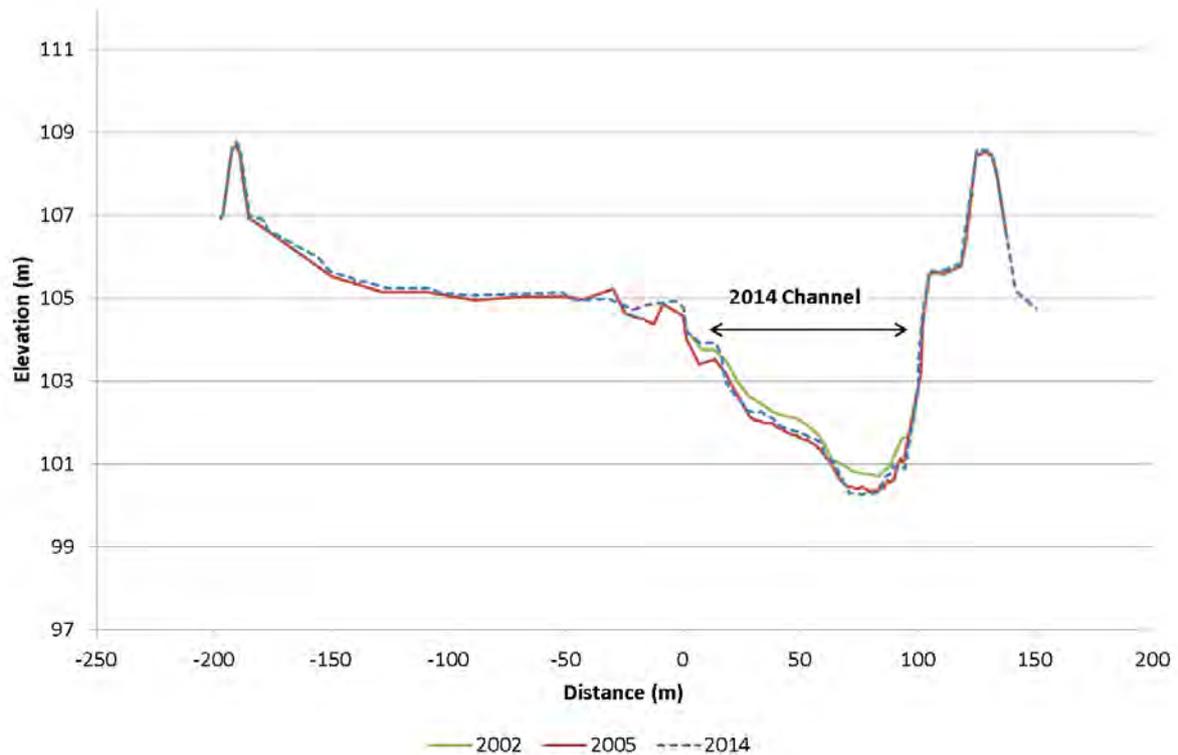
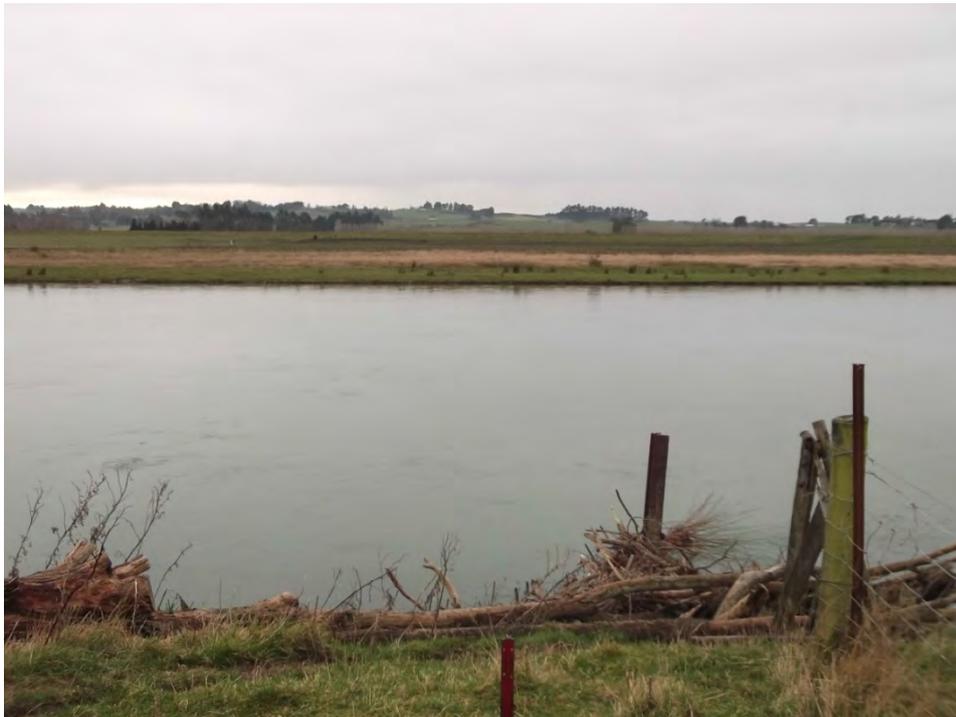
Figure 138. Clutha River/Mata-Au cross-section M10, looking downstream

Figure 139. Clutha River/Mata-Au cross-section M10, looking from true right to left bank

Cross-section M10 is located 25.2 km upstream of the confluence of the Matau Branch of the Clutha River/Mata-Au with the Pacific Ocean. The channel has remained similar between 2005 and 2014 with aggradation occurring on the true left bank and minor degradation of the channel thalweg. The wider floodplain has remained similar between 2005 and 2014.
