Morphology of the Clutha River/Mata- Au between Roxburgh Dam and the Pacific Ocean

March 2017

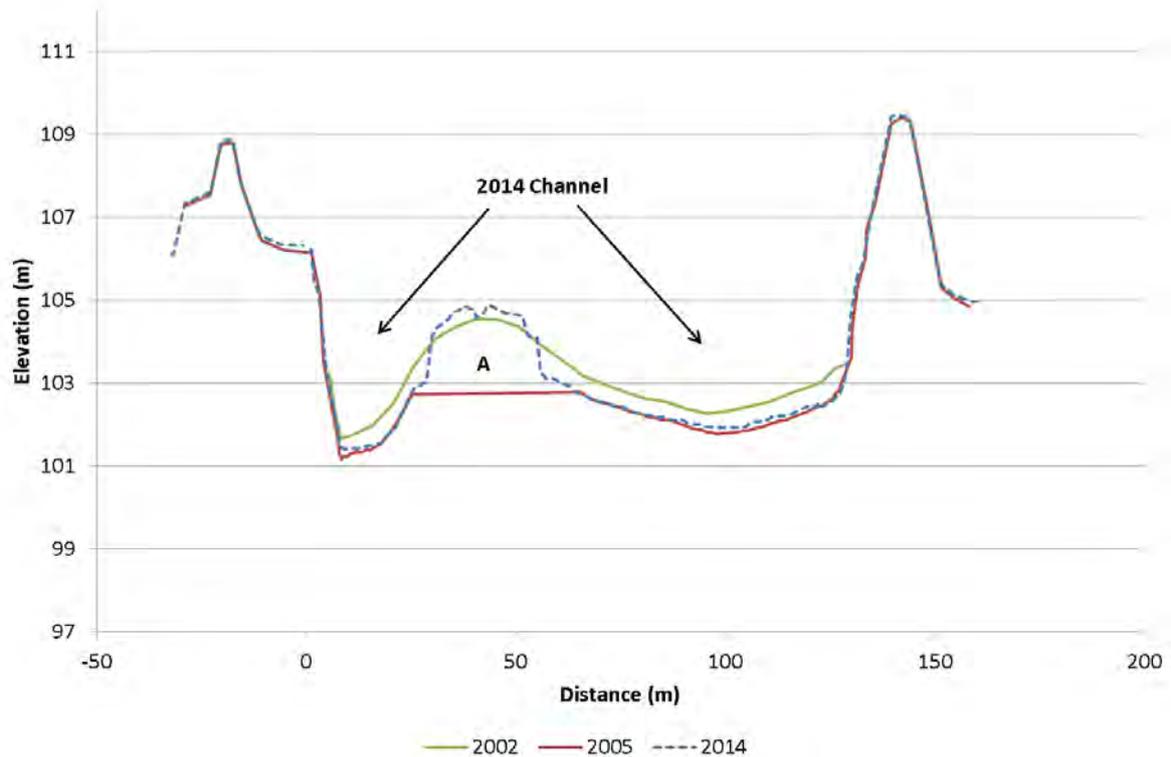
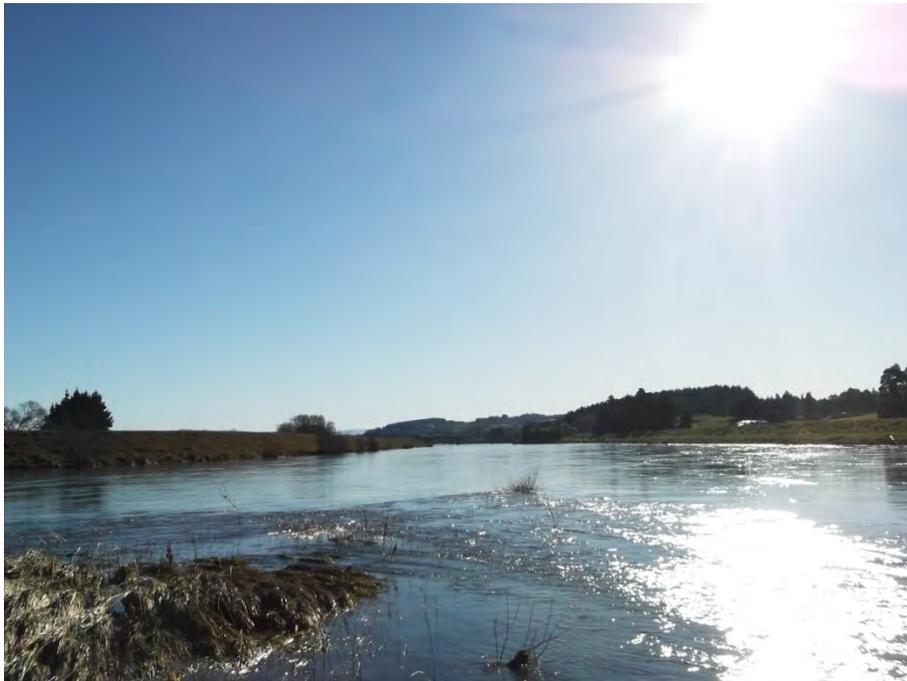
Figure 140. Clutha River/Mata-Au cross-section M11, looking downstream

Figure 141. Clutha River/Mata-Au cross-section M11, looking upstream

Cross-section M11 is located 26.4 km upstream of the confluence of the Matau Branch of the Clutha River/Mata-Au with the Pacific Ocean. A mid channel bar is present at this cross-section (point labelled A), there is missing data for this bar evident in the 2005 survey. The true left and right channels have remained similar between 2005 and 2014 but have degraded since 2002. The wider floodplain has remained similar between 2005 and 2014.

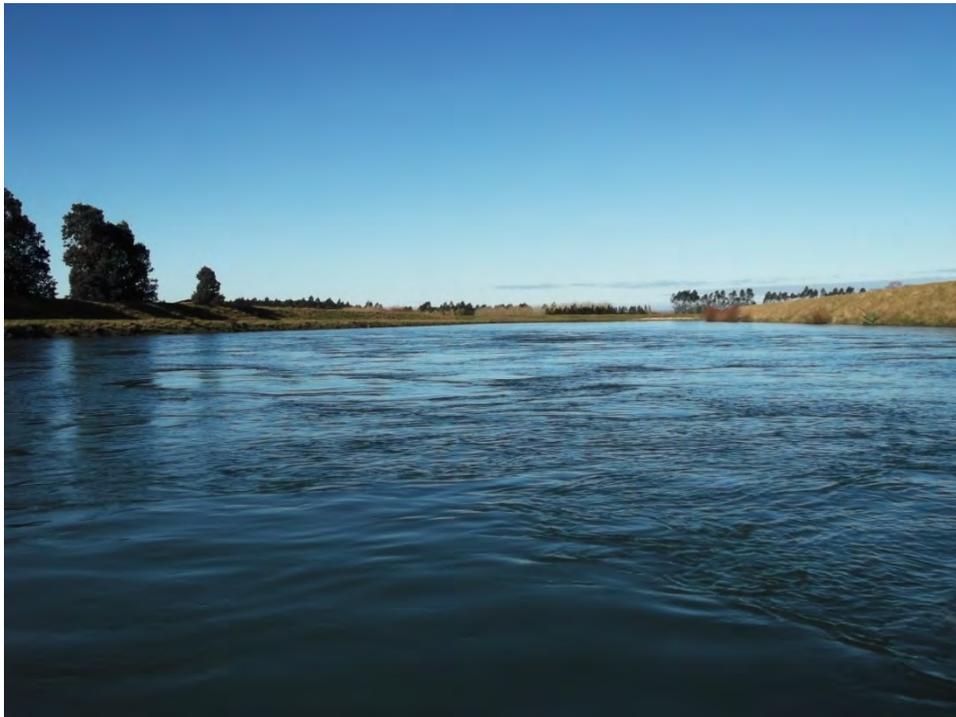
Figure 143. Clutha River/Mata-Au cross-section M12, looking downstream

Cross-section M12 is located 27 km upstream of the confluence of the Matau Branch of the Clutha River/Mata-Au with the Pacific Ocean. The true left of the channel has aggraded and the true right has degraded between 2005 and 2014 with the wider floodplain remaining similar.

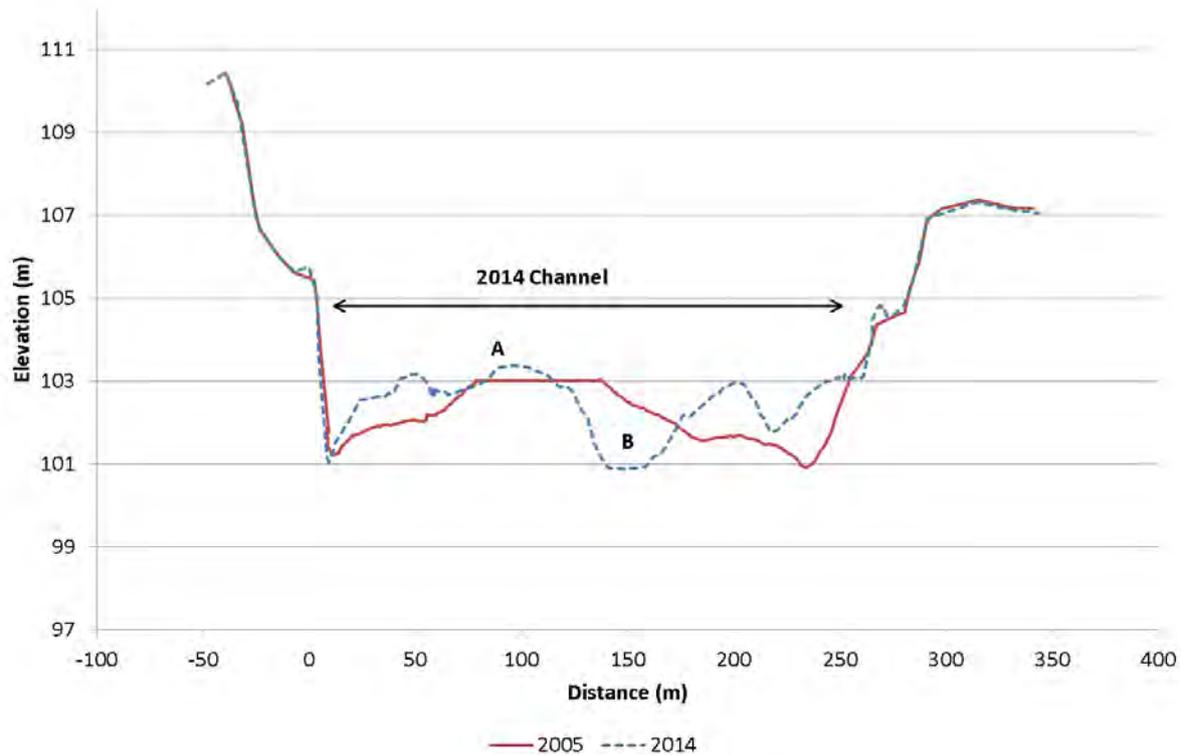
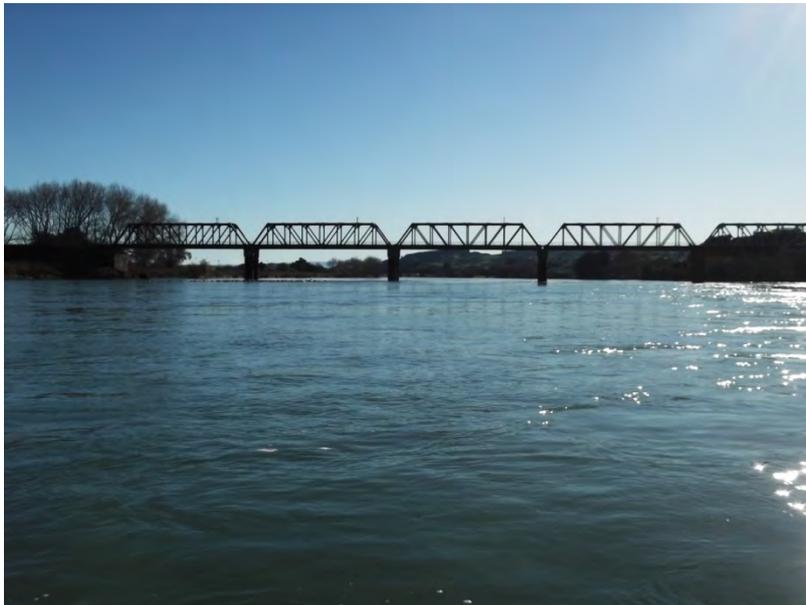
Figure 144. Clutha River/Mata-Au cross-section C1, looking downstream

Figure 145. Clutha River/Mata-Au cross-section C1, looking upstream

Cross-section C1 is located at the bifurcation (channel splitting) of the Clutha River/Mata-Au at Balclutha. The point of the bifurcation can extend into the cross-section C1 at the point labelled A, the 2005 survey did not cover this area of land and therefore can not be compared to previous and subsequent years. Gravel extraction has occurred historically at this location. Between 2005 and 2014 the true left and right channels have aggraded with a new channel forming in the middle (point labelled B) which has eroded into the point of the bifurcation.

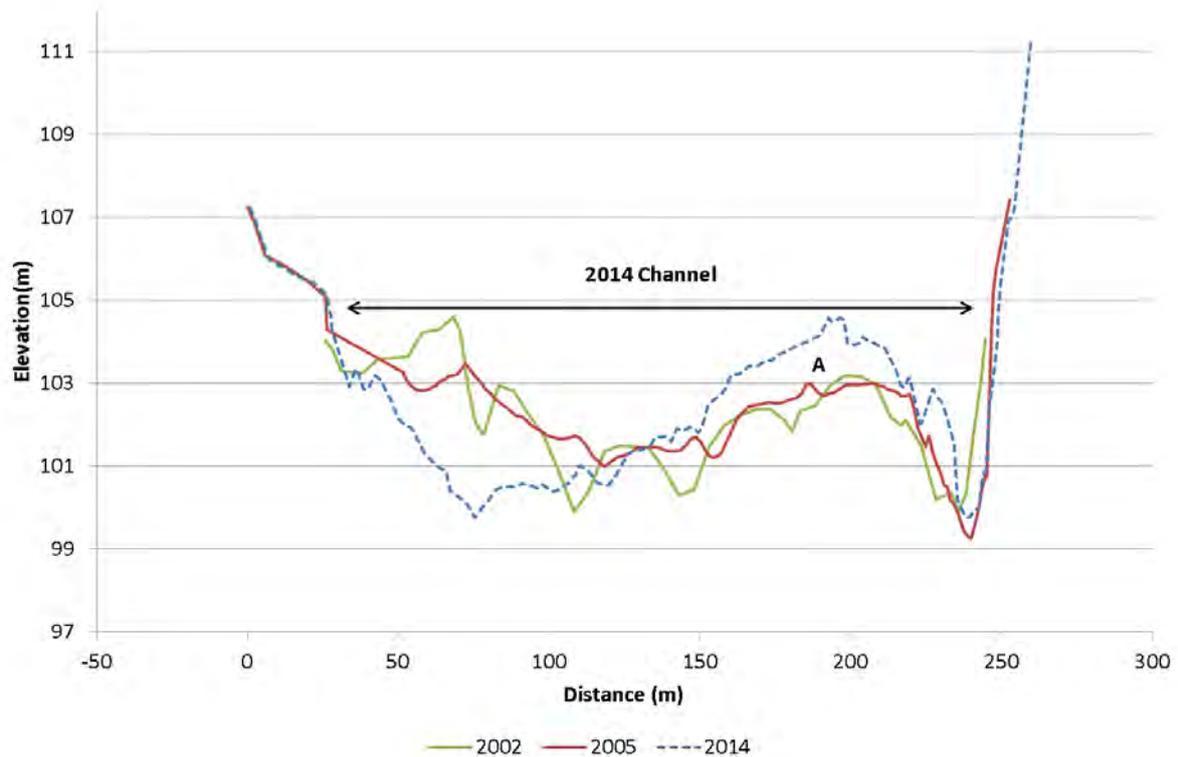
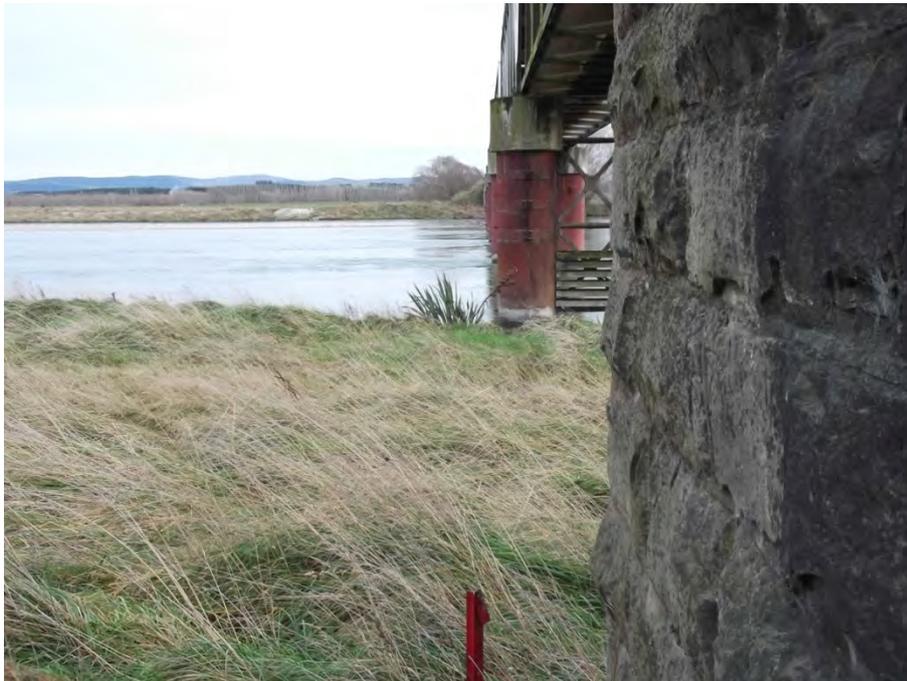
Figure 146. Clutha River/Mata-Au cross-section C2, looking downstream

Figure 147. Clutha River/Mata-Au cross-section C2, looking from true left to right bank

Cross-section C2 is located 0.2 km upstream of the Clutha River/Mata-Au bifurcation at the Balclutha railway bridge. The point labelled A is a mid-channel bar that is often exposed when flows are low enough. The true left of the main channel has degraded by about 4 m at the deepest point between 2005 and 2014, the true right of the channel has subsequently aggraded with a narrowing of the channel creating more distinct channels than in 2005.

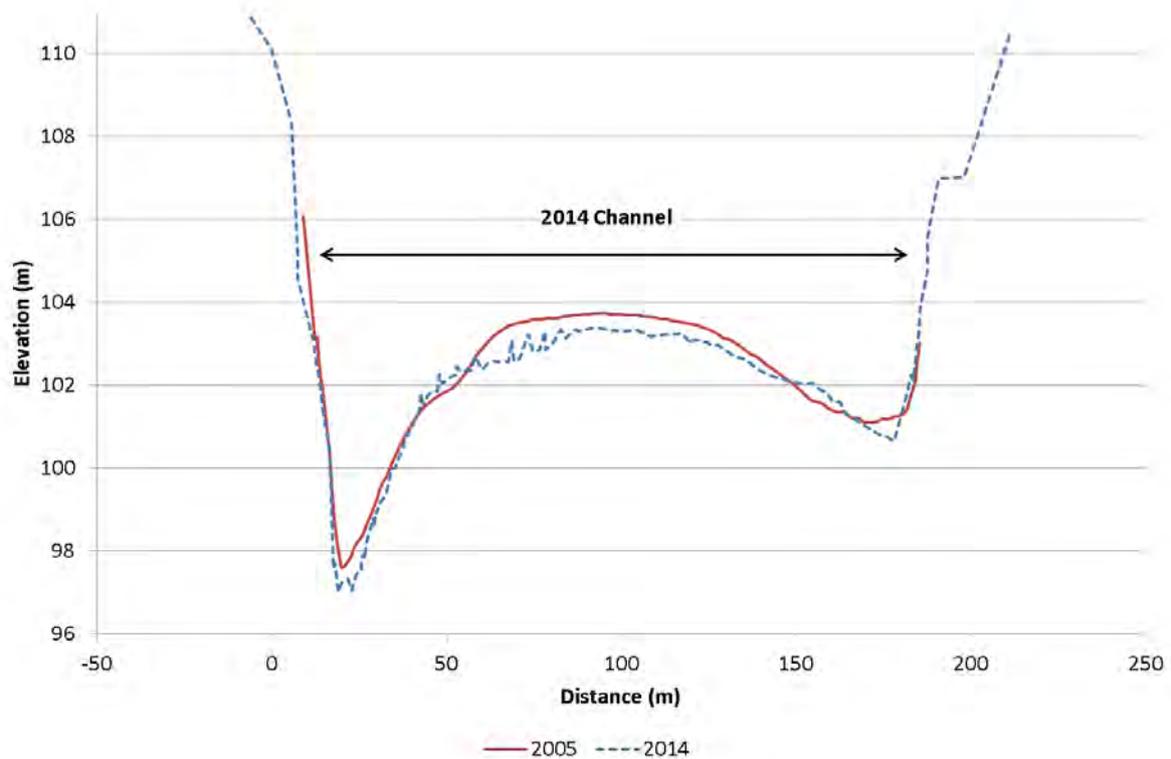
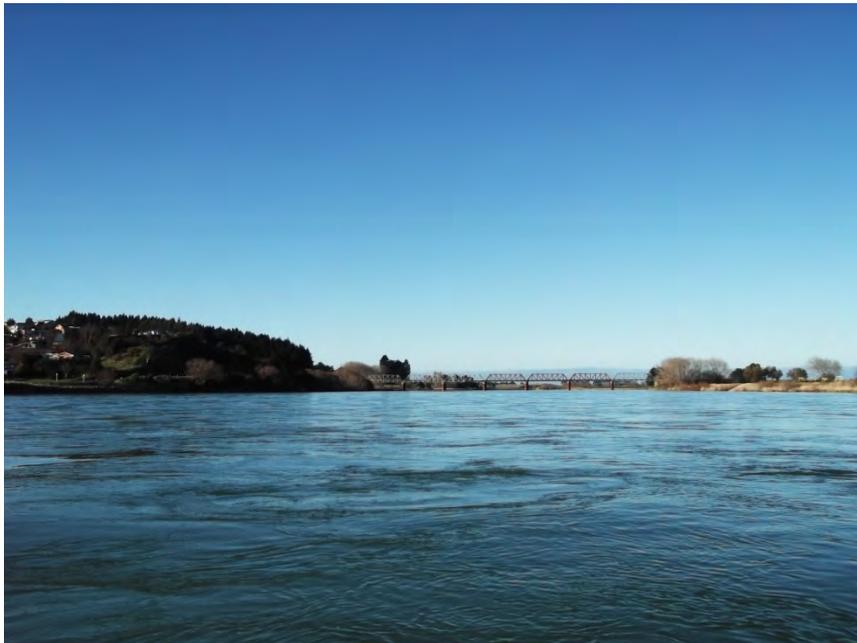
Figure 148. Clutha River/Mata-Au cross-section C3, looking downstream

Figure 149. Clutha River/Mata-Au cross-section C3, looking downstream

Cross-section C3 is located 1 km upstream of the Clutha River/Mata-Au bifurcation at Balclutha and 300 m downstream of the SH1 bridge. Between 2005 and 2014, the true left channel and thalweg have lowered, with a decrease in the mid channel bar (which can be located below water level). The true right of the channel has also degraded between 2005 and 2014. The 2005 survey does not extend sufficiently to allow a comparison of the river banks.

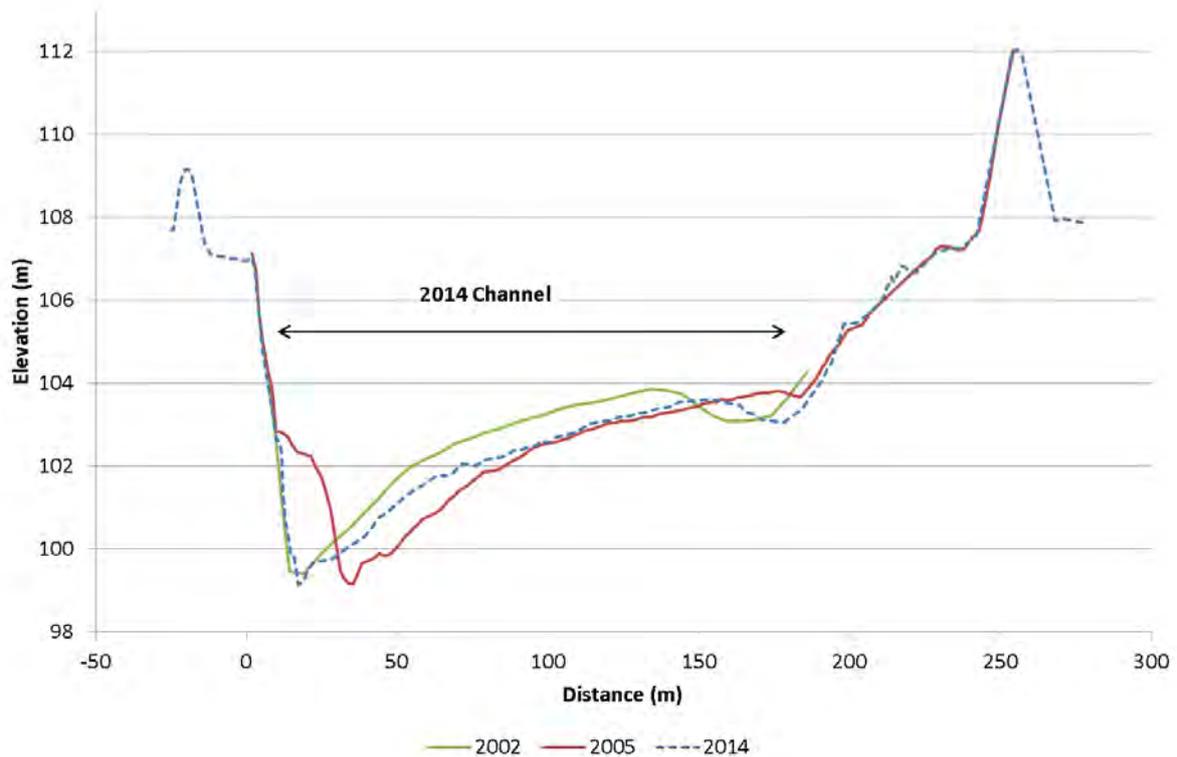
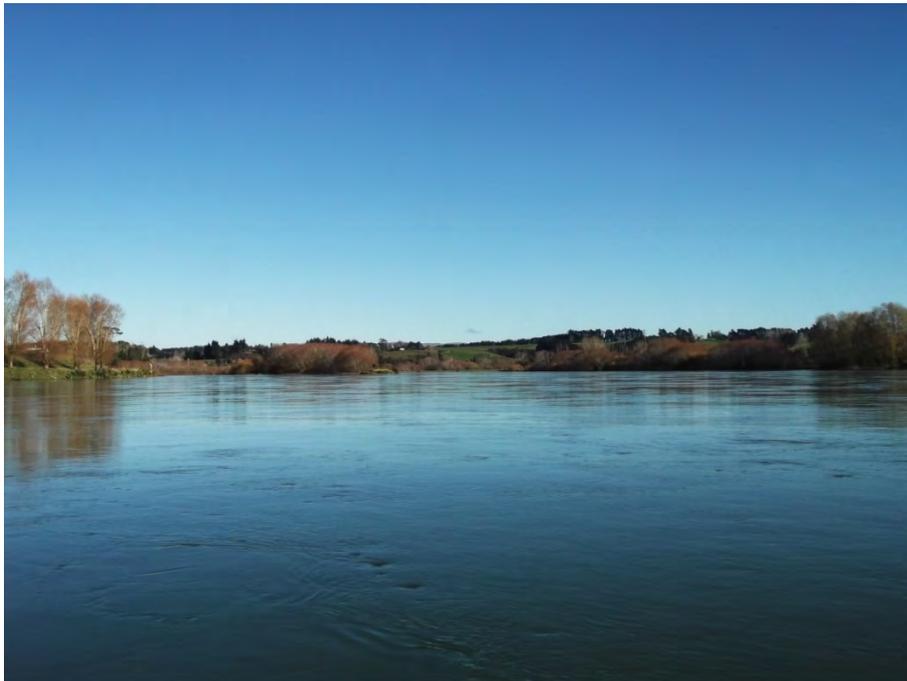
Figure 150. Clutha River/Mata-Au cross-section C5, looking downstream

Figure 151. Clutha River/Mata-Au cross-section C5, looking upstream

Cross-section C5 is located 1.7 km upstream of the Clutha River/Mata-Au bifurcation at Balclutha. The true left of the channel has eroded between 2005 and 2014 with the thalweg currently positioned against the left bank. The right side of the thalweg channel has aggraded between 2005 and 2014 with minimal change occurring across the rest of the channel and the wider floodplain.

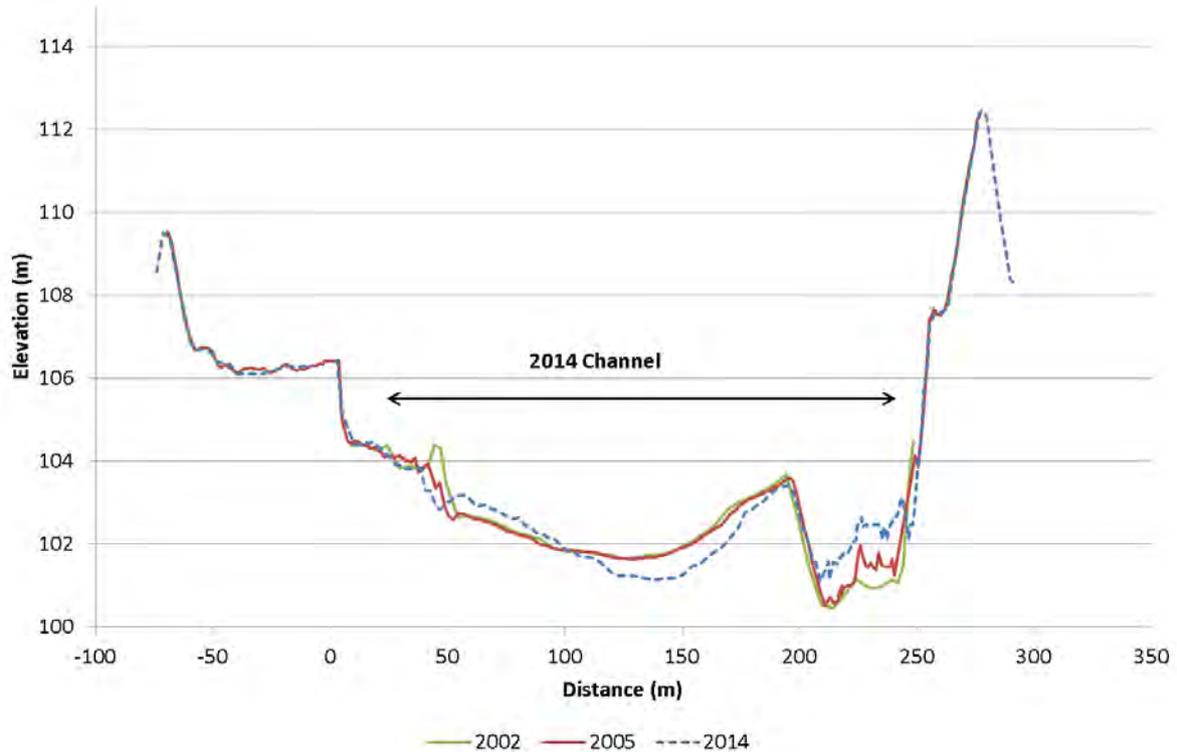
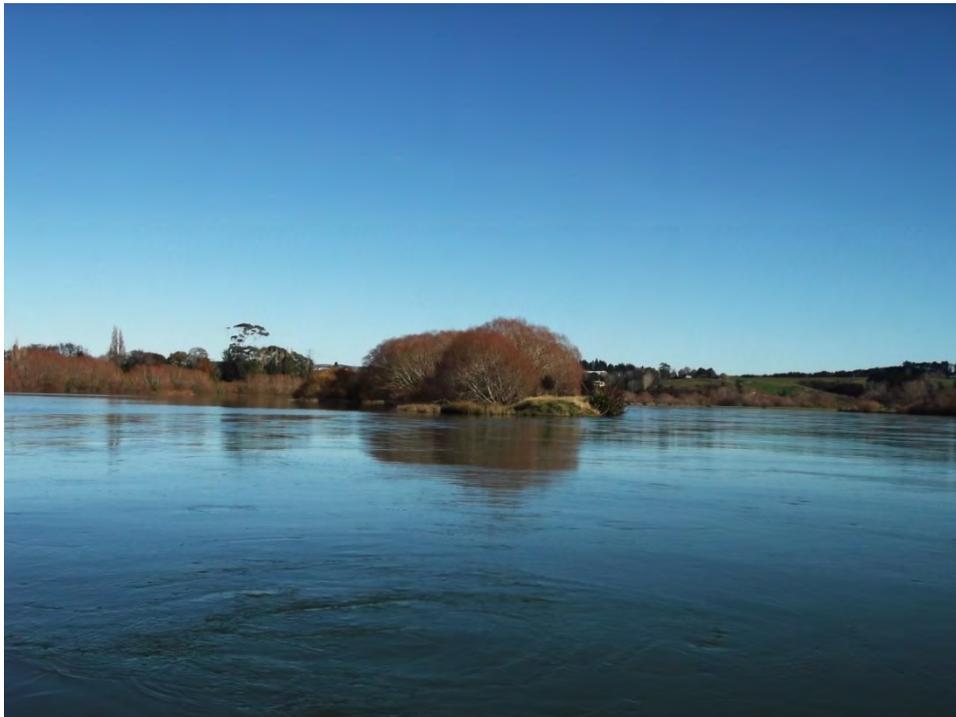
Figure 152. Clutha River/Mata-Au cross-section C6, looking downstream

Figure 153. Clutha River/Mata-Au cross-section C6, looking upstream

Cross-section C6 is located 2 km upstream of the Clutha River/Mata-Au bifurcation at the start of the Balclutha Lagoon. The true left and right of the channel has aggraded with degradation occurring on the true right between 2005 and 2014. The true wider floodplain has remained in a similar position between 2005 and 2014.

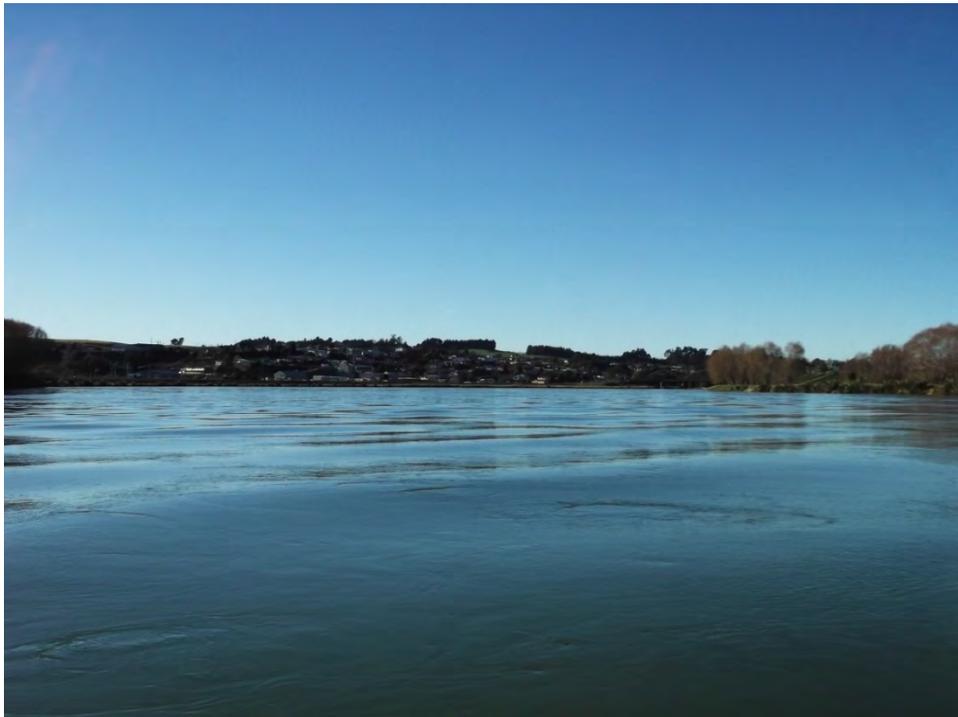
Figure 155. Clutha River/Mata-Au cross-section C7, looking downstream

Cross-section C7 is located 2.3 km upstream of the Clutha River/Mata-Au bifurcation at Balclutha, adjacent to the Balclutha Lagoon. Between 2005 and 2014 the true left of the channel has degraded with the thalweg section of the channel eroding and moving towards the right bank.

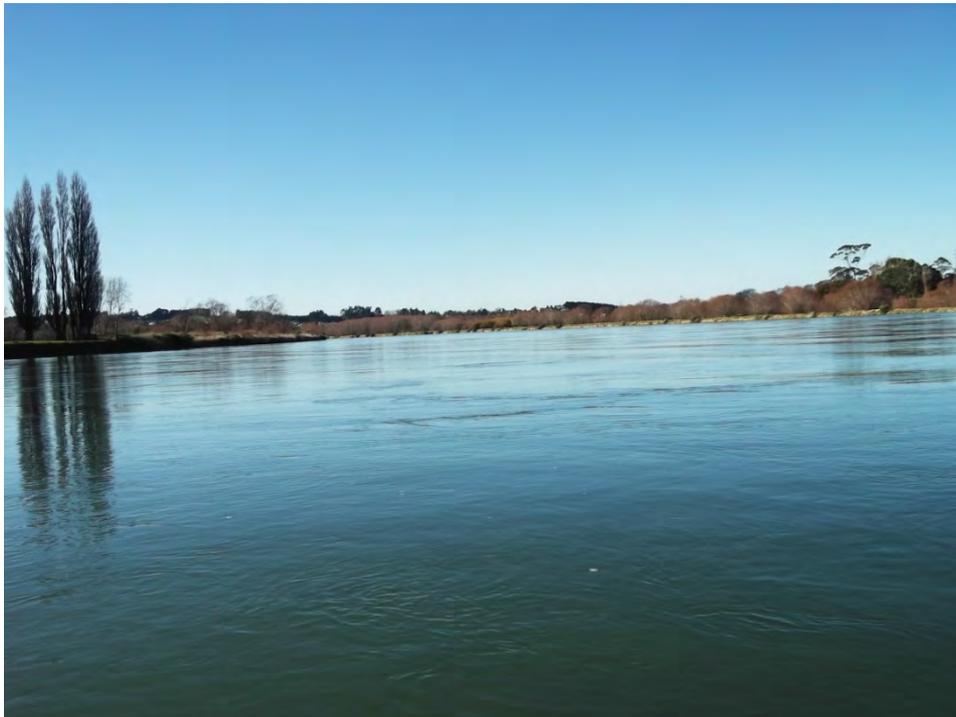
Figure 157. Clutha River/Mata-Au cross-section C8, looking downstream

Cross-section C8 is located 3.2 km upstream of the Clutha River/Mata-Au bifurcation at Balclutha. The true left of the main channel has remained similar between 2005 and 2014 with the right side of the channel degrading by 1 m at the deepest location. The 2005 survey did not extend sufficiently on the true left bank to allow a comparison to be made.

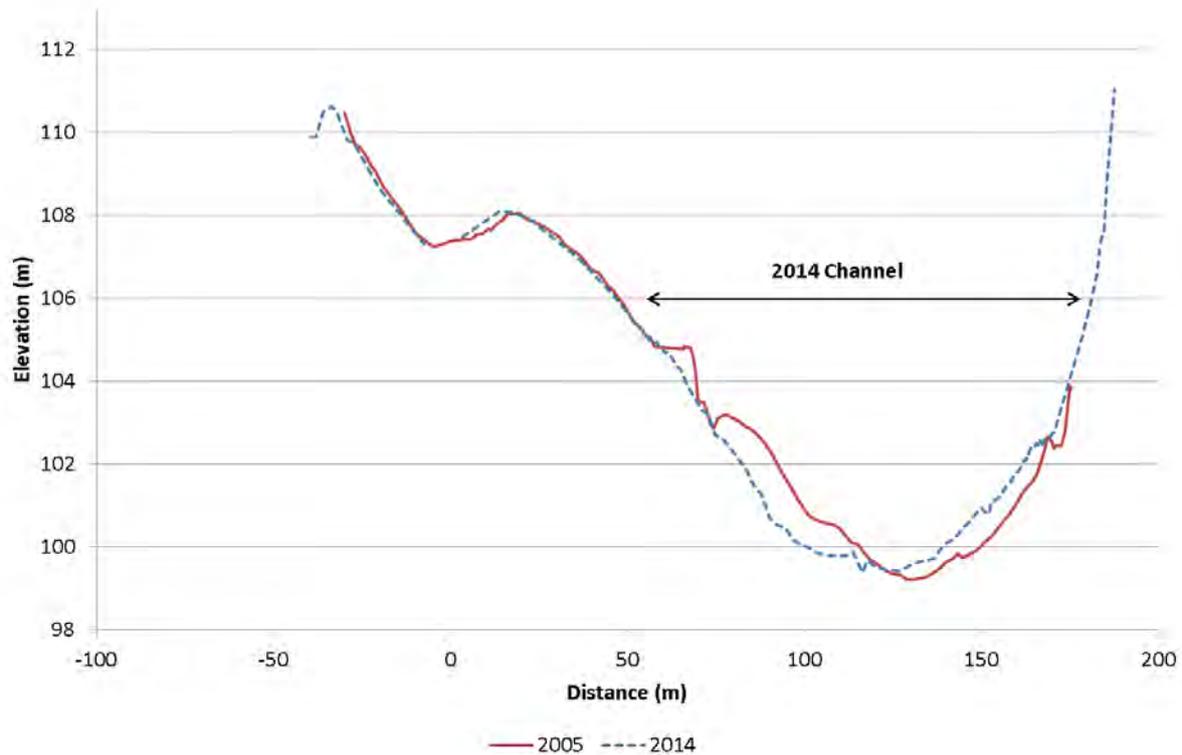
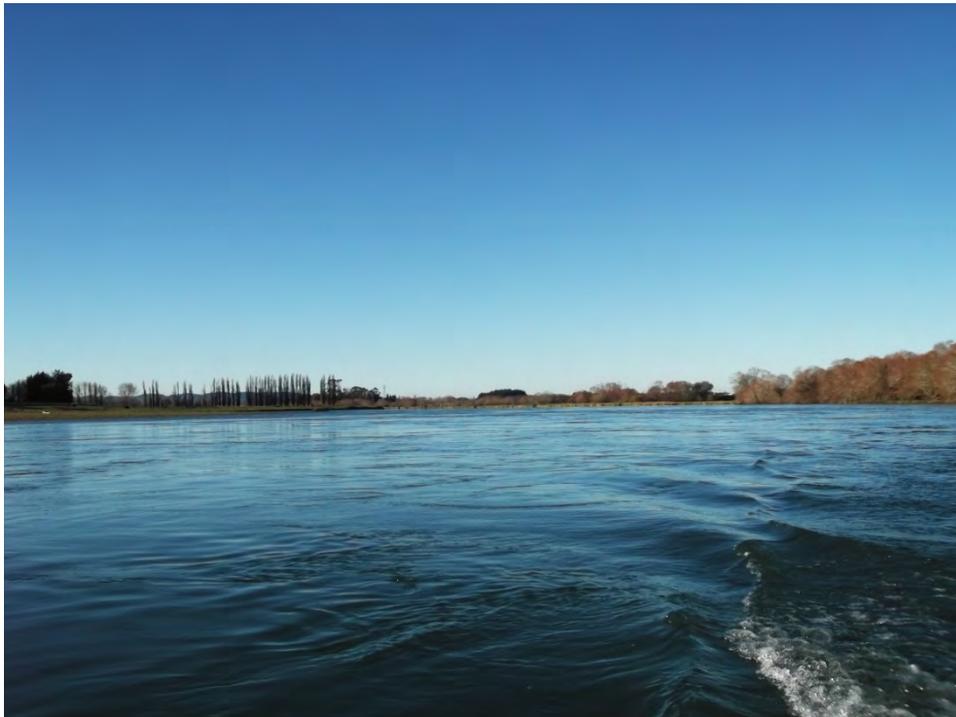
Figure 158. Clutha River/Mata-Au cross-section C9, looking downstream

Figure 159. Clutha River/Mata-Au cross-section C9, looking downstream

Cross-section C9 is located 4 km upstream of the bifurcation of the Clutha River/Mata-Au at Balclutha. Between 2005 and 2014 the channel has shifted towards the true left bank with the thalweg remaining at a similar height. The wider floodplain has remained similar between 2005 and 2014.

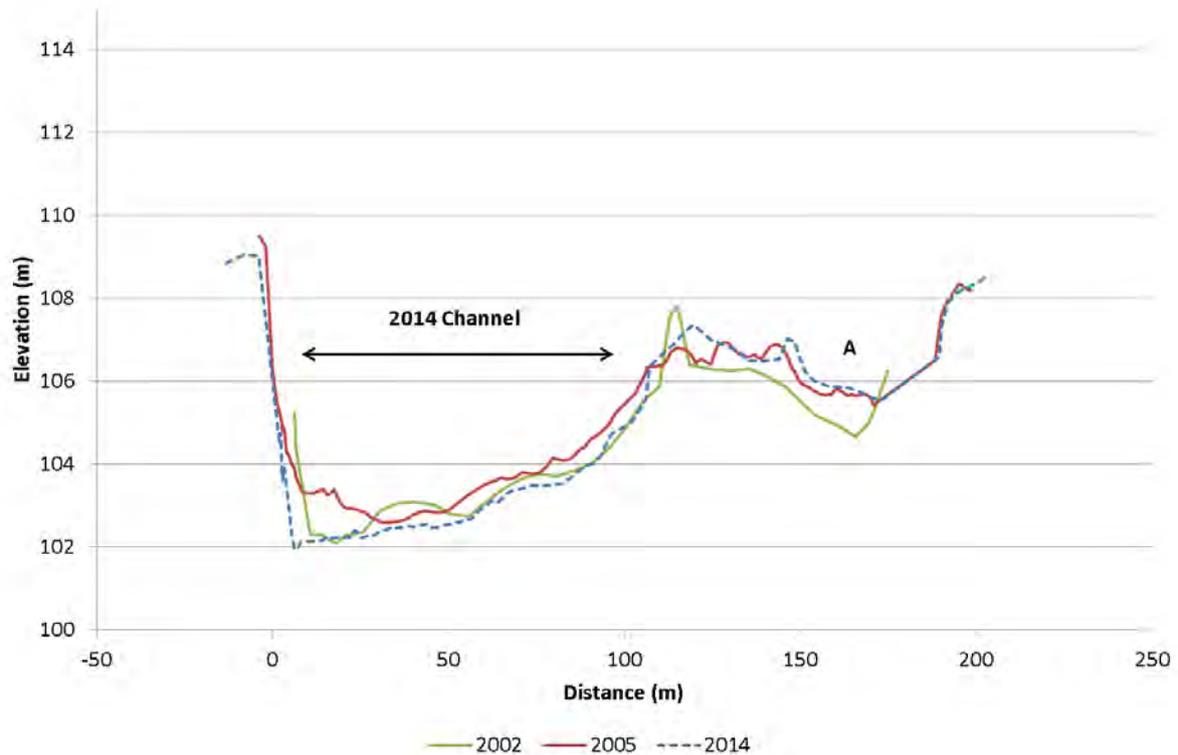
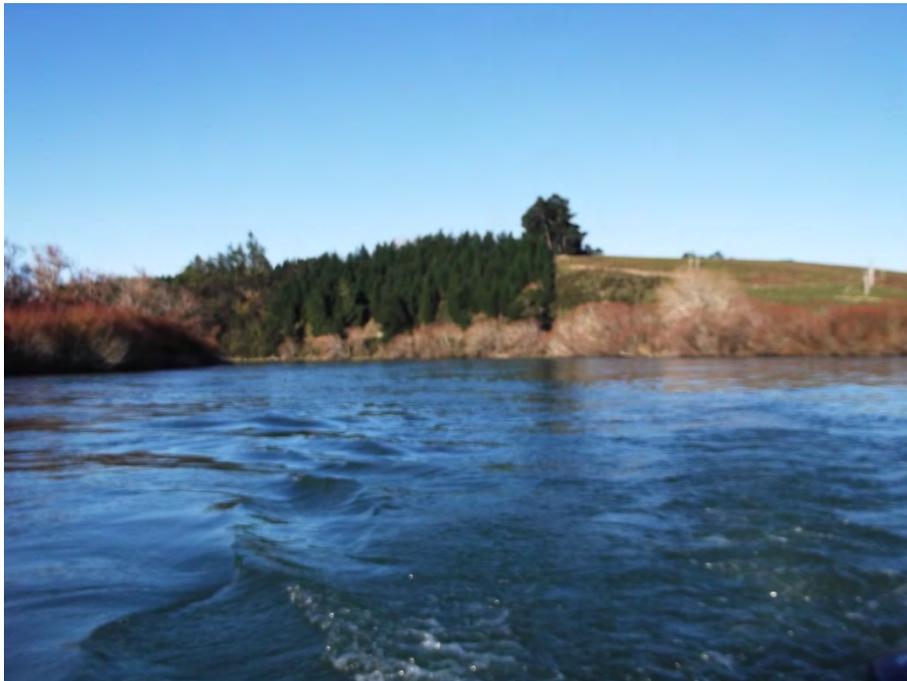
Figure 160. Clutha River/Mata-Au cross-section C10, looking downstream

Figure 161. Clutha River/Mata-Au cross-section C10, looking downstream

Cross-section C10 is located 4.9 km upstream of the Clutha River/Mata-au bifurcation at Balclutha and is on the true right channel that passes an island adjacent to Barnego. The main channel has shown overall degraded between 2005 and 2014 with both aggradation and degradation occurring in the backwater channel (point labelled A).

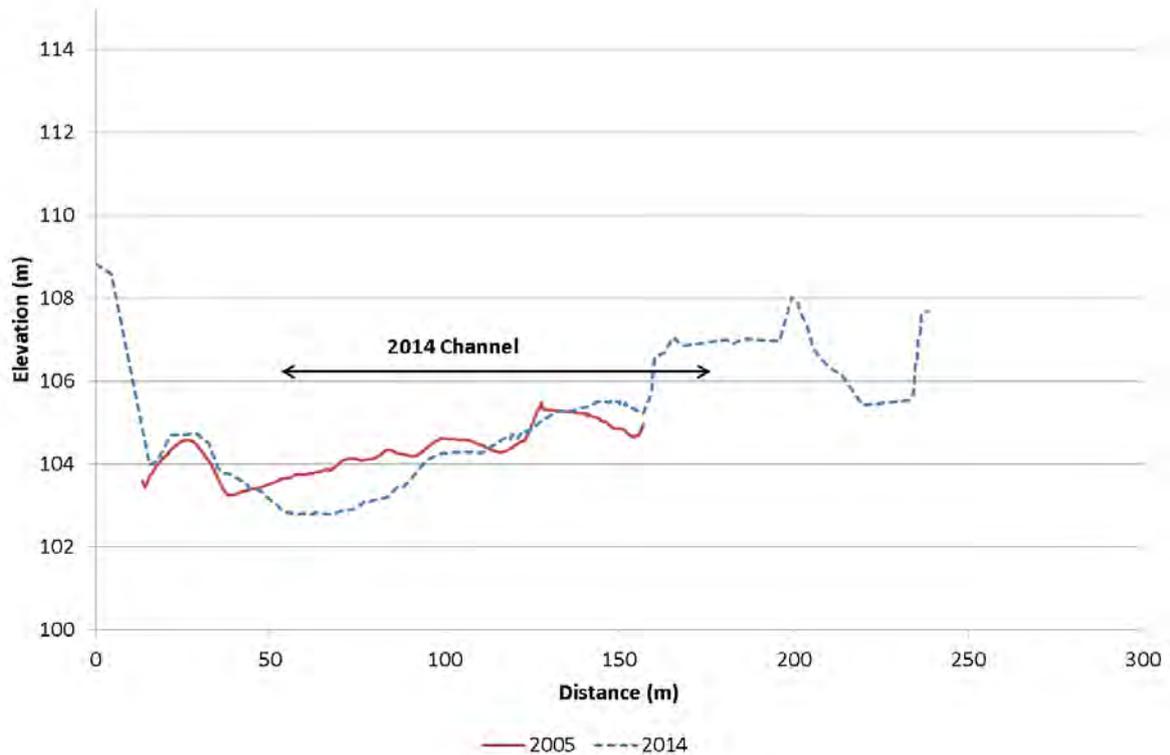
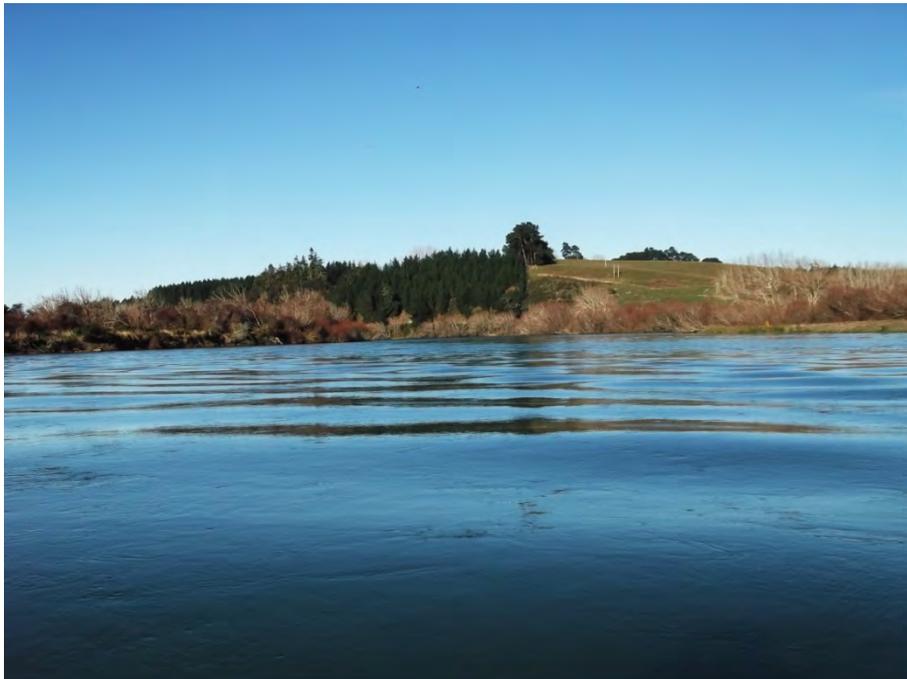
Figure 162. Clutha River/Mata-Au cross-section C11, looking downstream

Figure 163. Clutha River/Mata-Au cross-section C11, looking downstream

Cross-section C11 is located 5.1 km upstream of the Clutha River/Mata-Au bifurcation at Balclutha and is on the true right channel that passes an island adjacent to Barnego. The channel has degraded in the centre between 2005 and 2014 with both aggradation and degradation occurring on the true right. The 2005 survey did not extend sufficiently to allow a comparison of the wider floodplain.

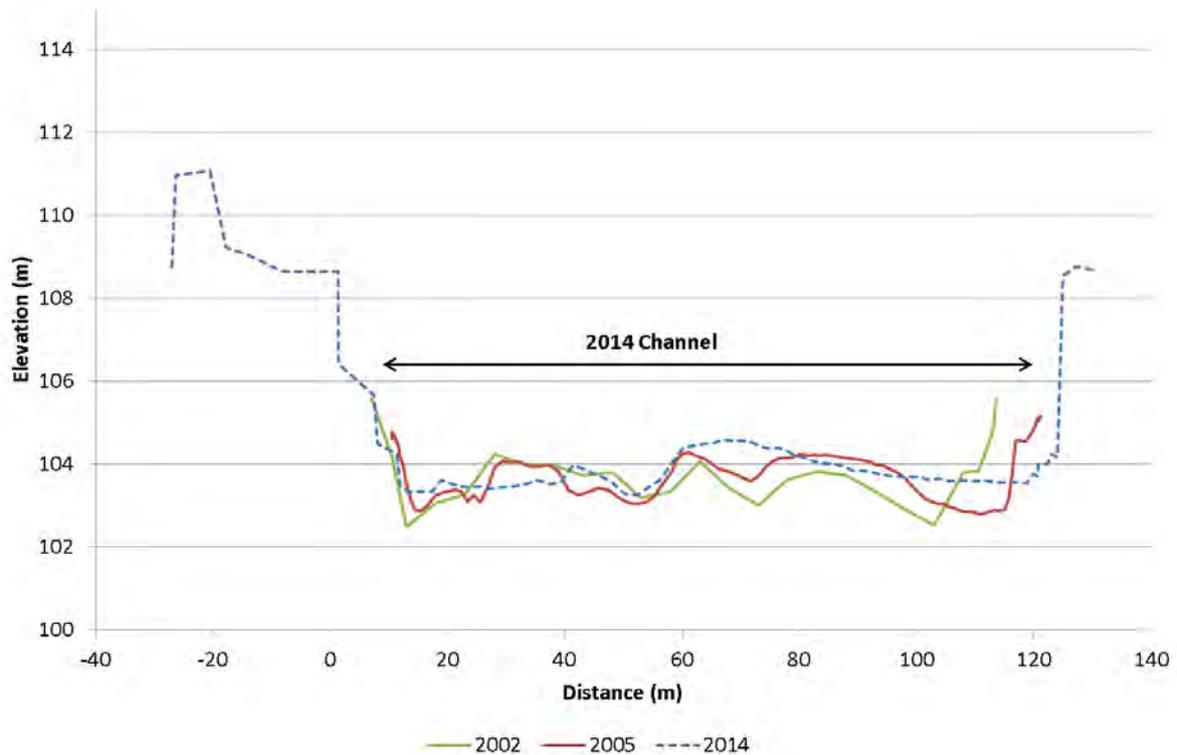
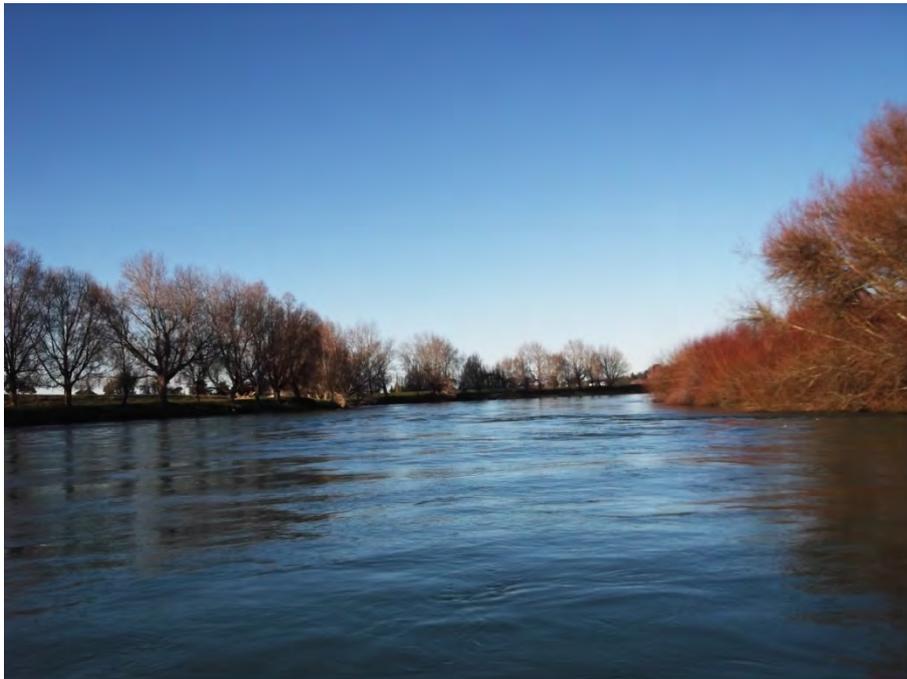
Figure 164. Clutha River/Mata-Au cross-section C12, looking downstream

Figure 165. Clutha River/Mata-Au cross-section C12, looking downstream

Cross-section C12 is located 5 km upstream of the Clutha River/Mata-Au bifurcation at Balclutha and is on the true left channel that passes an island adjacent to Barnego. Between 2005 and 2014 the channel has both aggraded and degraded, the thalweg has moved towards the true left bank. The 2005 survey did not extend sufficiently to allow a comparison of the wider floodplain.

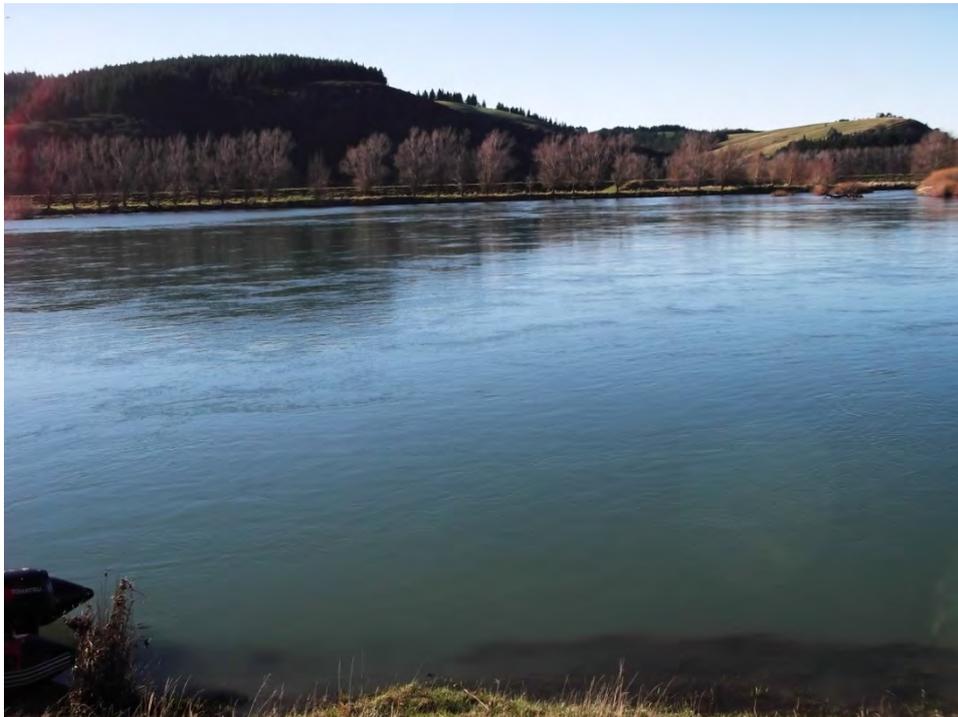
Figure 167. Clutha River/Mata-Au cross-section C13, looking true right to left bank.

Cross-section C13 is located 5.5 km upstream of the Clutha River/Mata-Au bifurcation at Balclutha. The true left of the channel has widened and degraded between 2005 and 2014 with degradation also occurring in the centre of the channel. The true right bank has aggraded between 2005 and 2014.

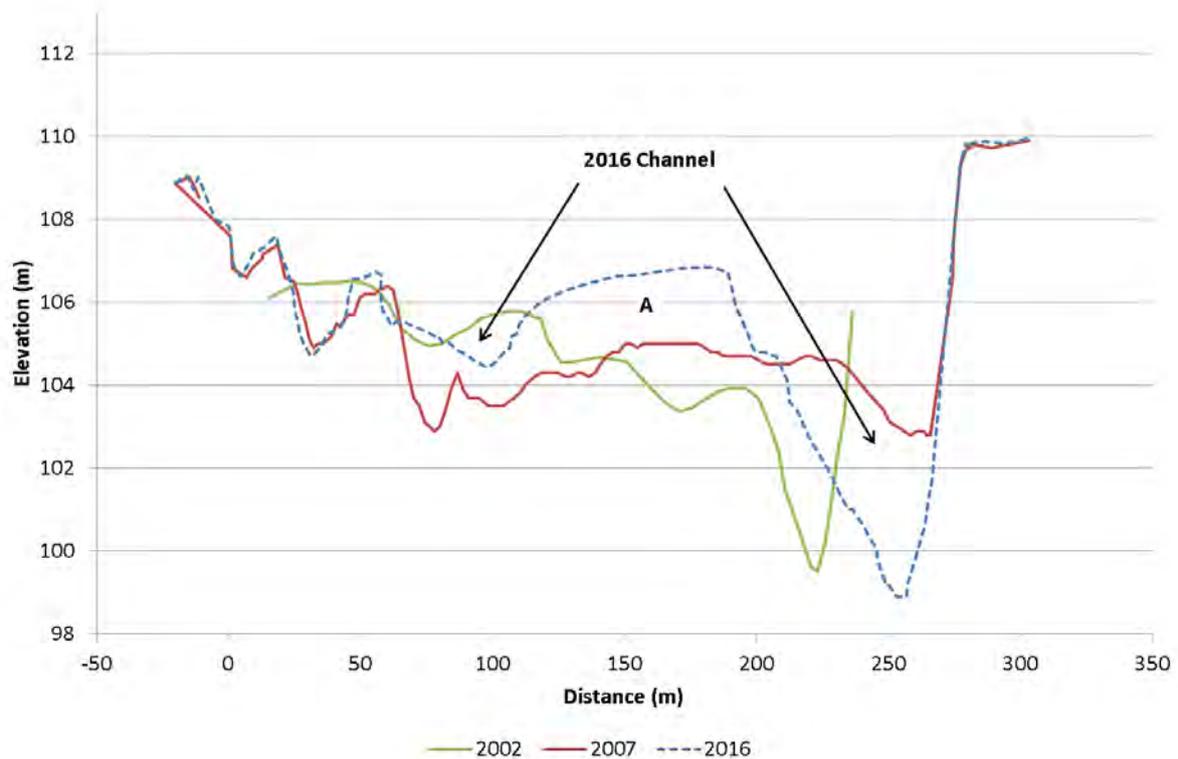
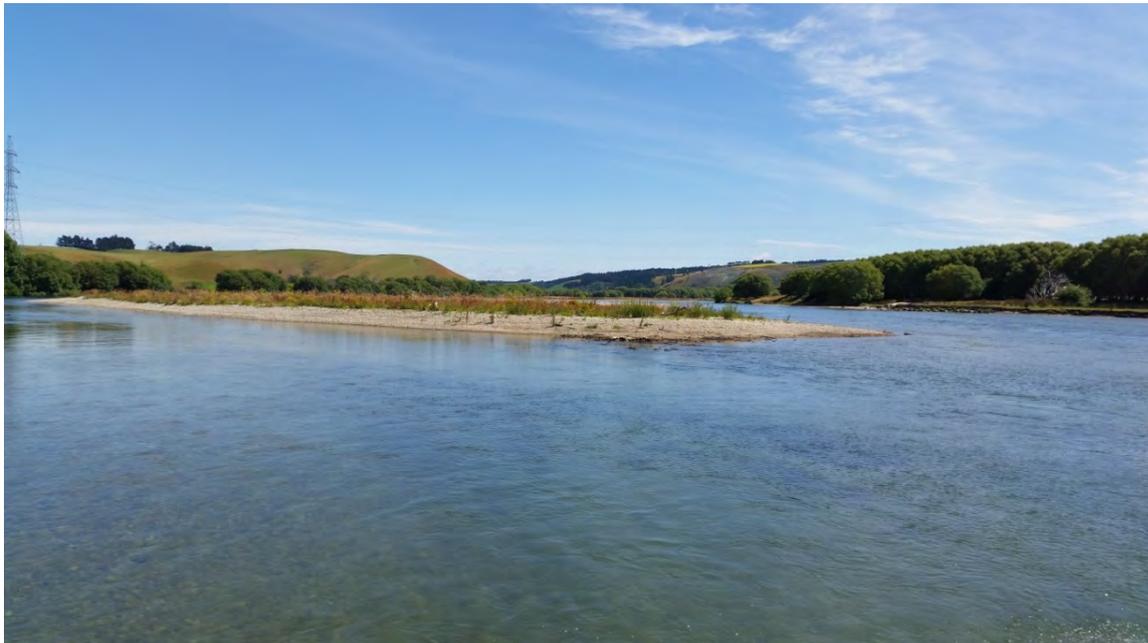
Figure 168. Clutha River/Mata-Au cross-section C14, looking downstream

Figure 169. Clutha River/Mata-Au cross-section C14, looking upstream

Cross-section C14 is located 6.4 km upstream of the Clutha River/Mata-Au bifurcation at Balclutha. The centre of the cross-section (point labelled A) is a mid channel gravel bar which can be seen in Figure 169. The true left channel and mid channel bar have aggraded by up to 1.8 m between 2007 and 2016, the true right channel has degraded significantly during this same timeframe. The wider floodplain has remained similar between 2007 and 2016.
