Morphology of the Clutha River/Mata- Au between Roxburgh Dam and the Pacific Ocean

March 2017

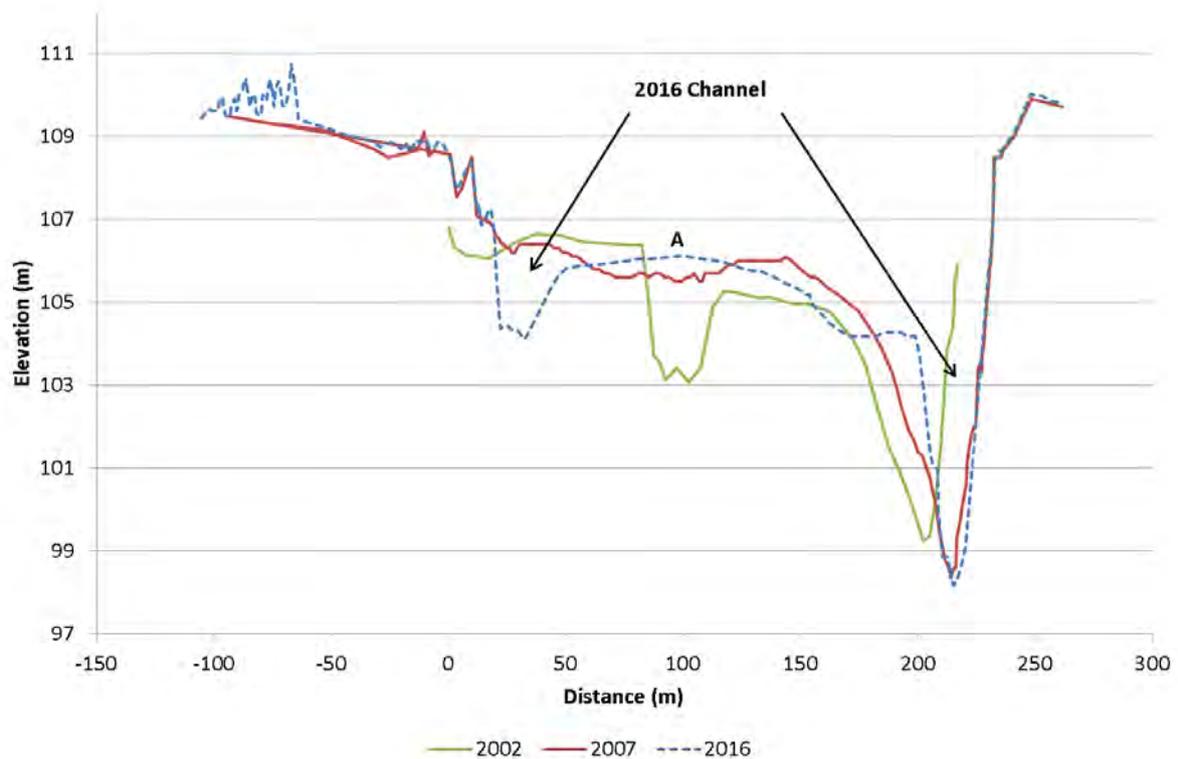
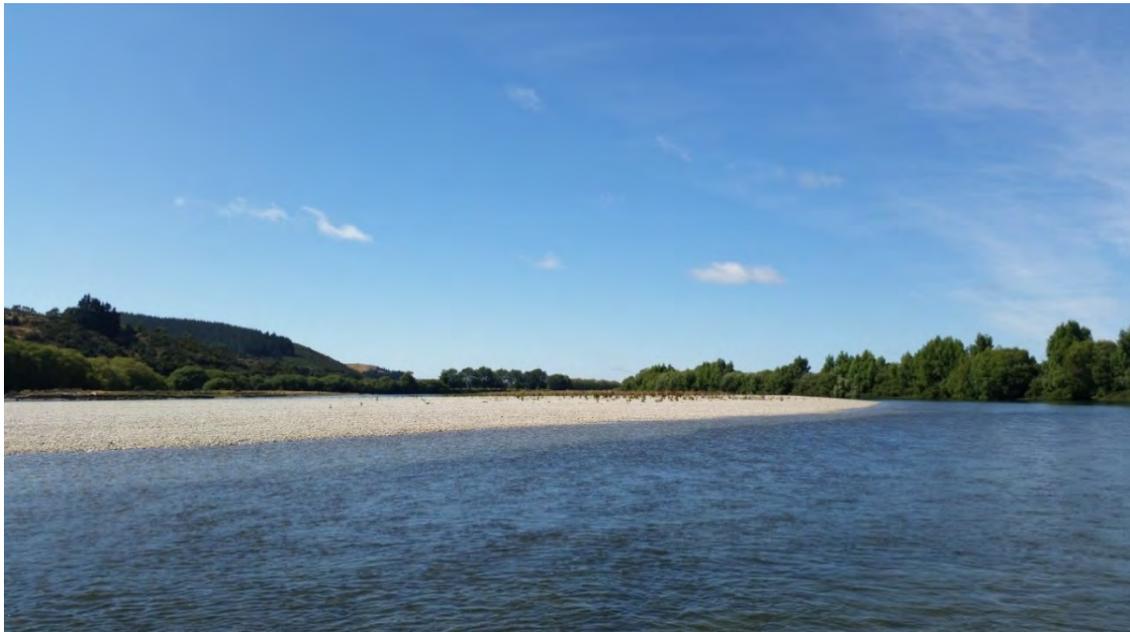
Bank erosion is considered to be the erosion of the margins of the active channel fairway and not the erosion of the low flow channels. Minor bank erosion was observed at several cross-sections between the latest survey periods with larger areas of erosion observed at cross-sections C17 and C20 (Figure 170, Figure 176). As the coverage of survey data across the cross-sections varies a direct comparison of the banks and any erosion cannot be made for every cross-section. Bank erosion also occurs in areas outside of the cross-section coverage and has been observed in previous reports (Figure 12) (ORC, 2008, ORC 2013).

Figure 170. Clutha River/Mata-Au cross-section C15, looking downstream

Figure 171. Clutha River/Mata-Au cross-section C15, looking downstream

Cross-section C15 is located 6.7 km upstream of the Clutha River/Mata-Au bifurcation at Balclutha. The centre of the cross-section (point labelled A) is a mid channel gravel bar which can be seen in Figure 171. The true left channel has eroded and moved towards the true left bank between 2007 and 2016 possibly due to the growth of the mid channel bar. The 2007 true left channel has become infilled and the true right channel has become more confined in 2016.

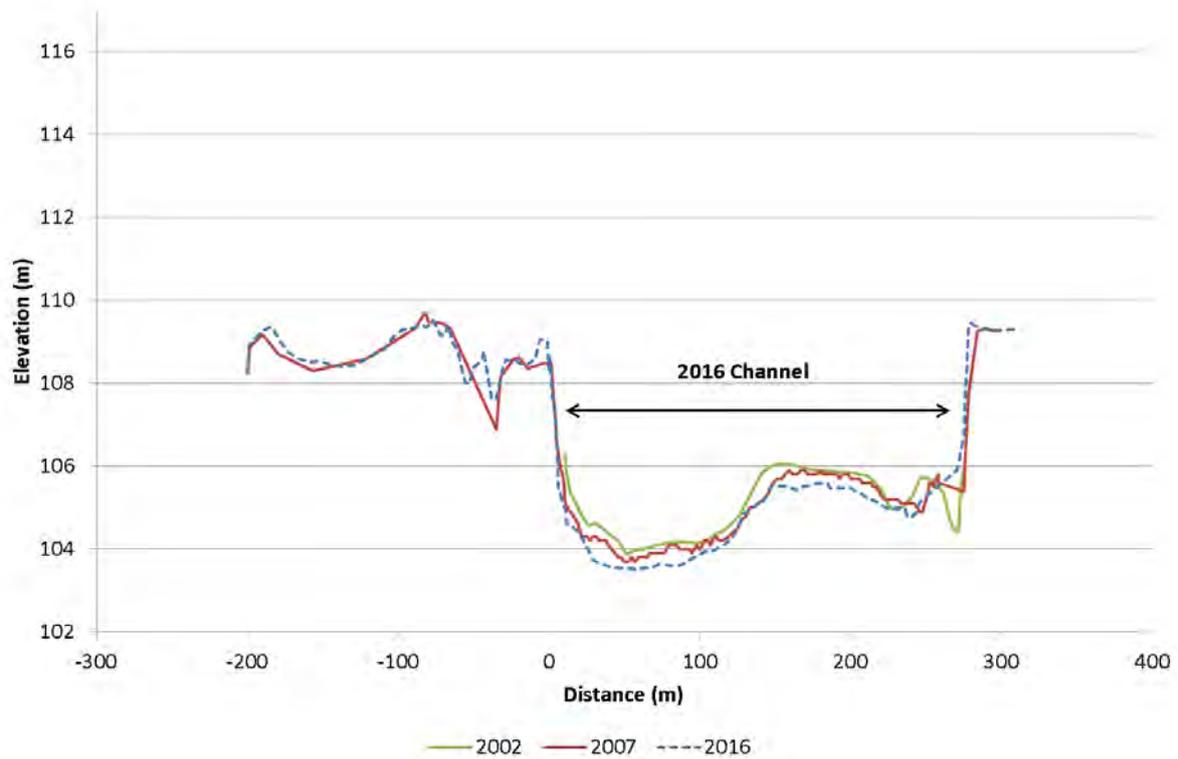
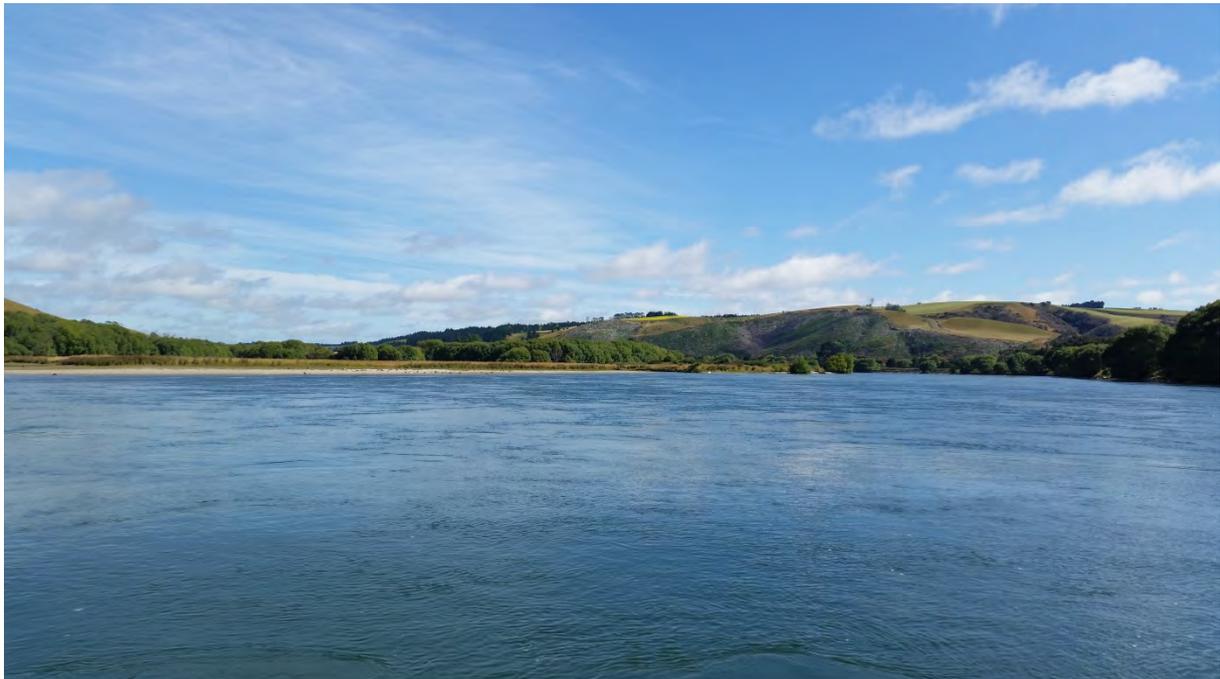
Figure 172. Clutha River/Mata-Au cross-section C16, looking downstream

Figure 173. Clutha River/Mata-Au cross-section C16, looking upstream

Cross-section C16 is located 7.1 km upstream of the Clutha River/Mata-Au bifurcation at Balclutha and is situated at the downstream end of Manuka Island. The channel has predominantly degraded between 2007 and 2016 with minimal change occurring in the wider floodplain.

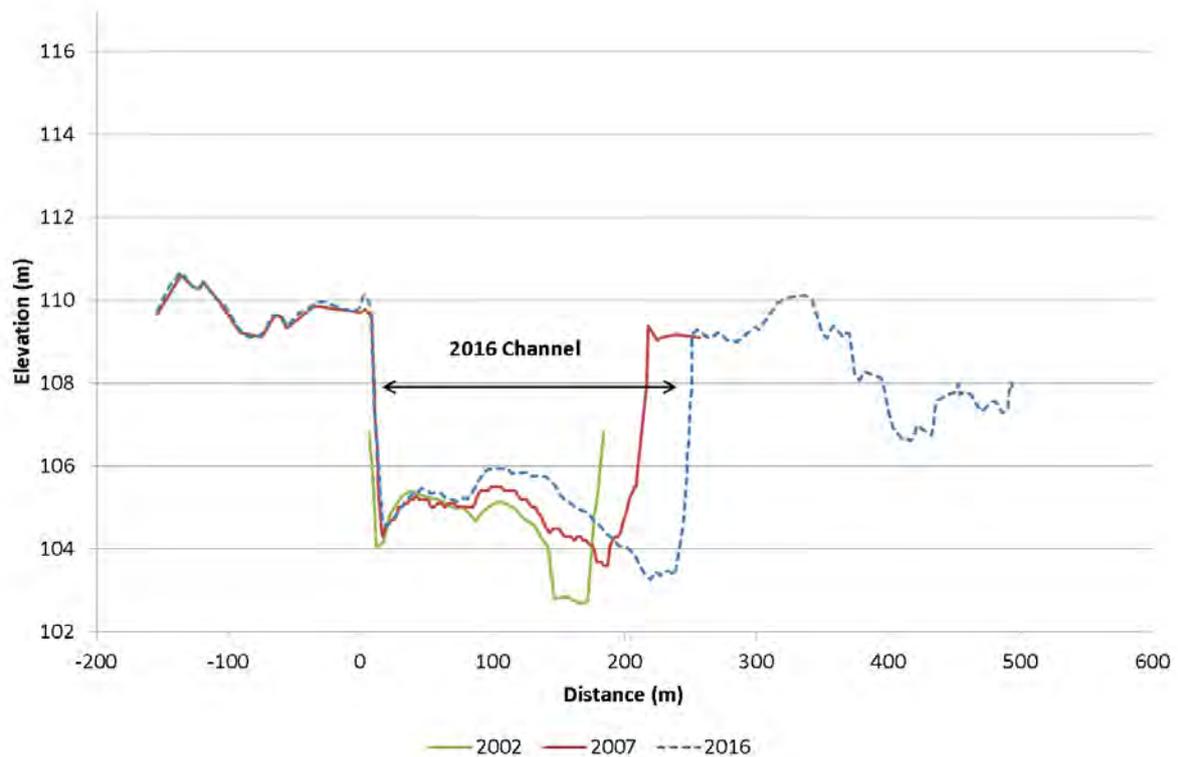
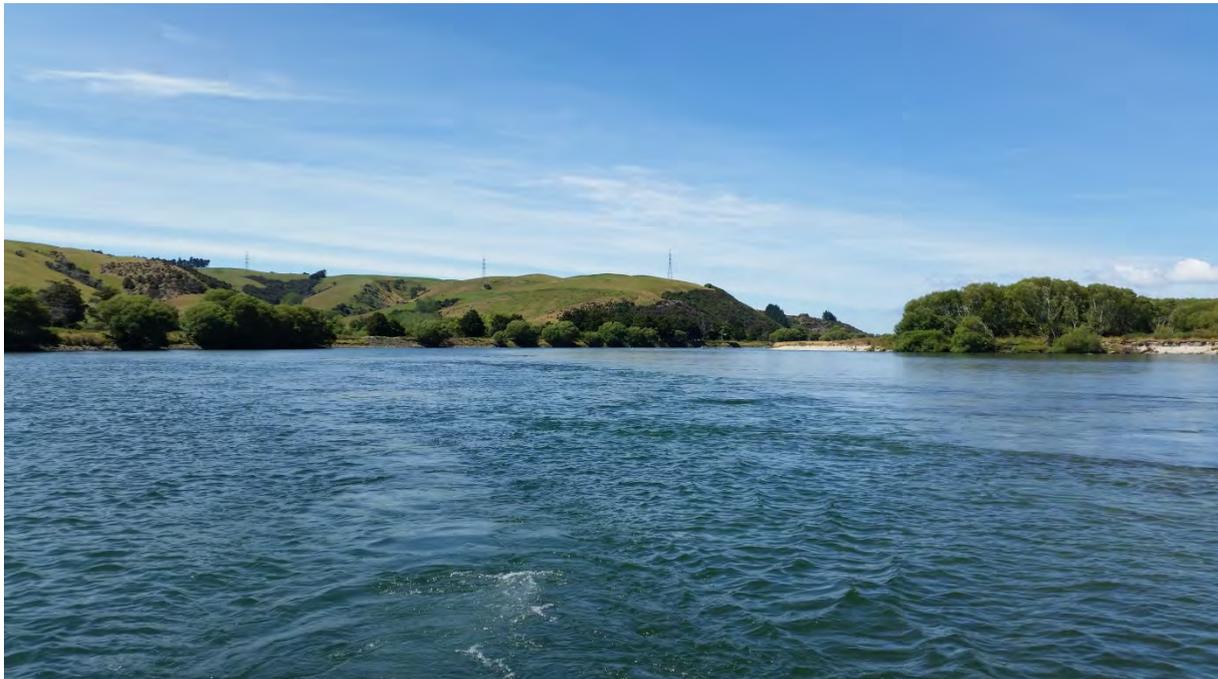
Figure 174. Clutha River/Mata-Au cross-section C17, looking downstream

Figure 175. Clutha River/Mata-Au cross-section C17, looking downstream

Cross-section C17 is located 8.1 km upstream of the Clutha River/Mata-Au bifurcation at Balclutha and is situated adjacent to Manuka Island. The channel has eroded into the true right bank by about 37 m and the thalweg has moved further towards the right bank between 2007 and 2016. The centre of the channel has aggraded with minimal change on the true left floodplain between 2007 and 2016.

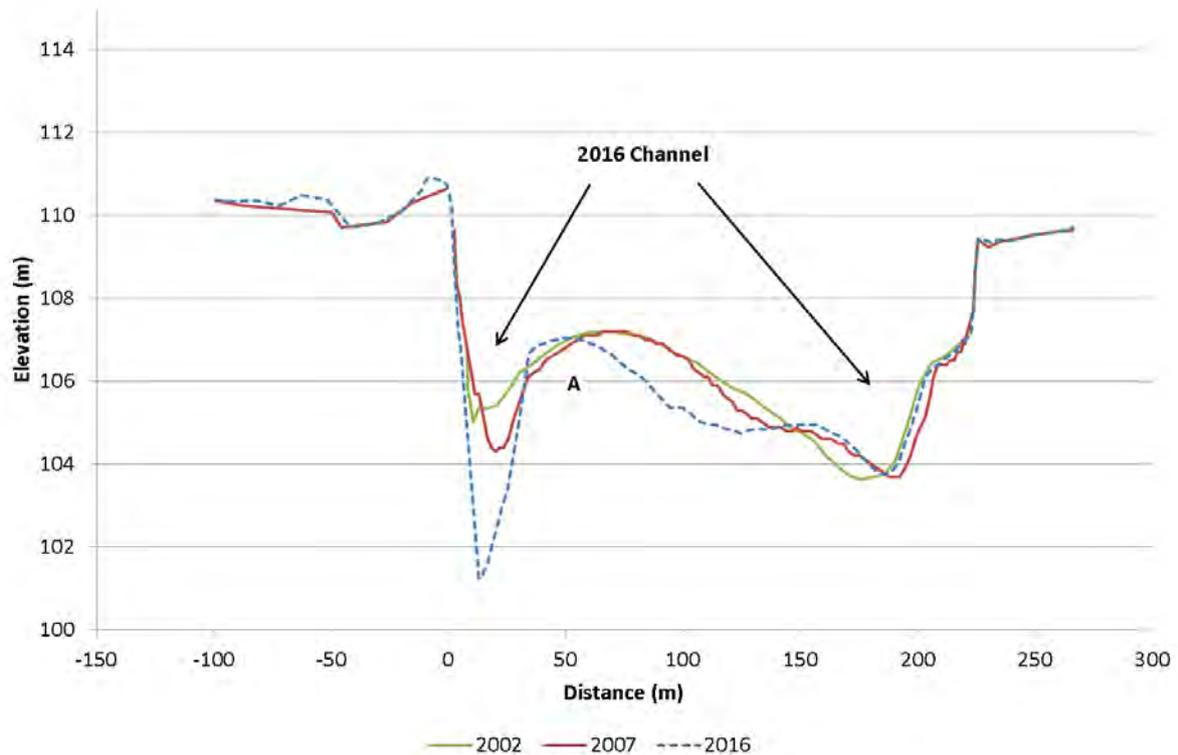
Figure 176. Clutha River/Mata-Au cross-section C18, looking downstream

Cross-section C18 is located 8.6 km upstream of the Clutha River/Mata-Au bifurcation at Balclutha. The point labelled A is a mid channel bar that becomes exposed at low flows. The true left channel has degraded by 3 m and become more confined between 2007 and 2016. The true right side of the gravel has degraded and the true right channel has remained in a similar position between 2007 and 2016.

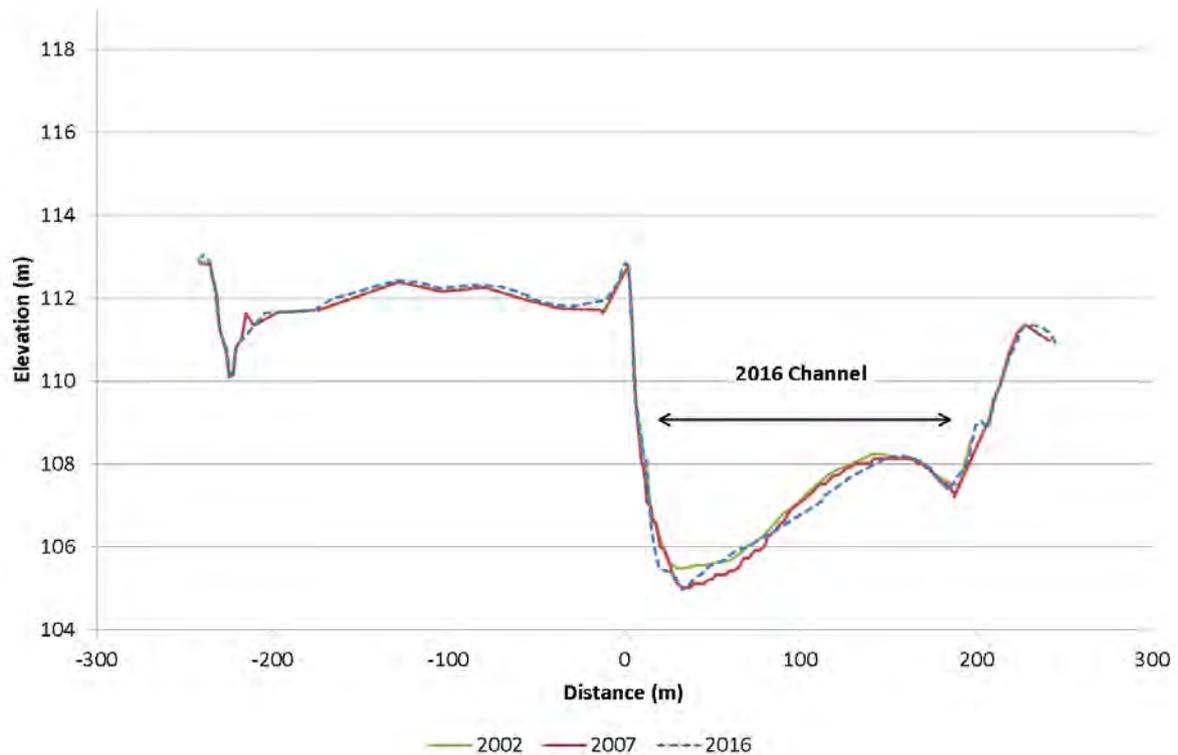
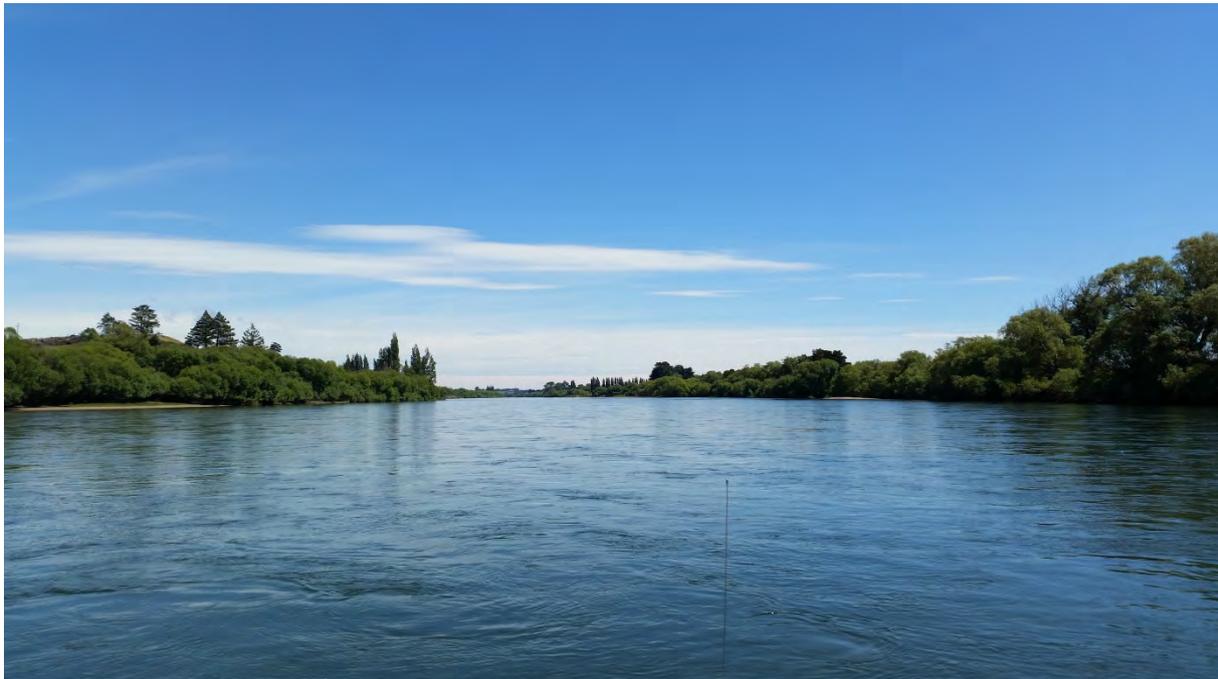
Figure 178. Clutha River/Mata-Au cross-section C19, looking downstream

Figure 179. Clutha River/Mata-Au cross-section C19, looking upstream

Clutha River/Mata-Au cross-section C19 is located 13.3 km upstream of the Clutha River/Mata-Au bifurcation at Balclutha. Between 2007 and 2016 the true left of the channel has aggraded with degradation occurring in the centre of the channel, the true right of the channel has remained in a similar position. The true left floodplain has remained similar between 2007 and 2016.

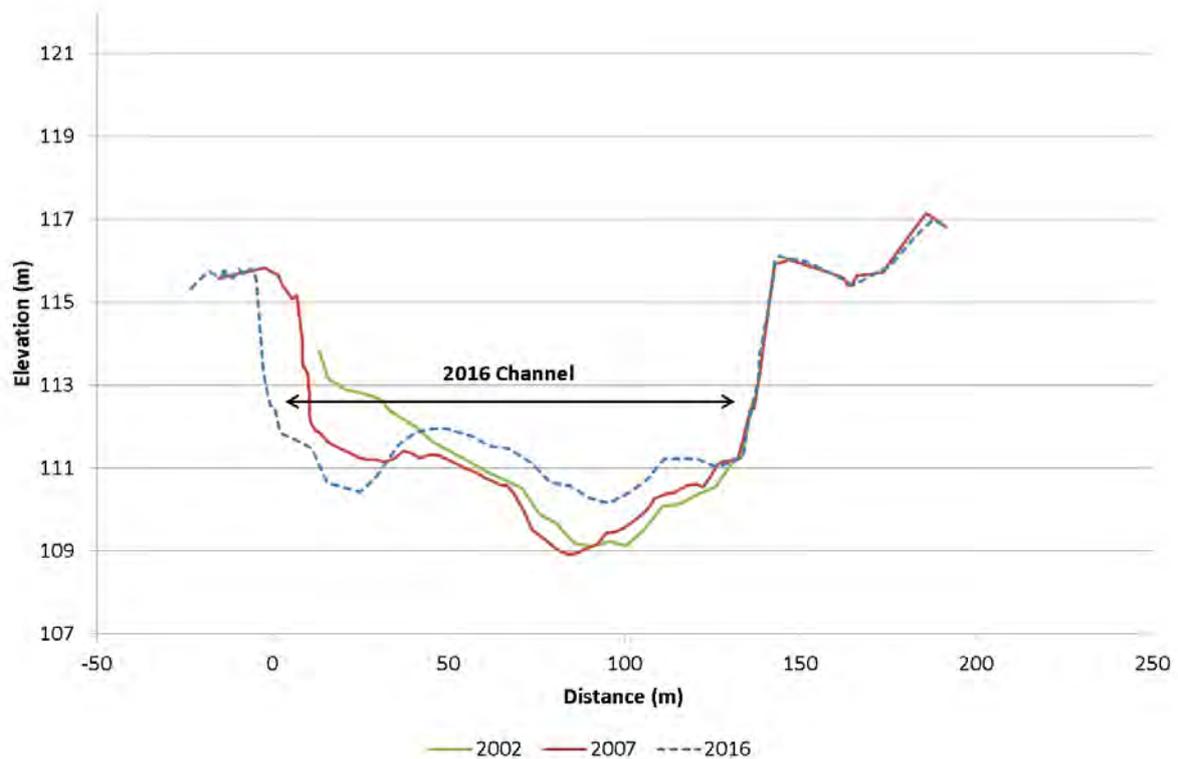
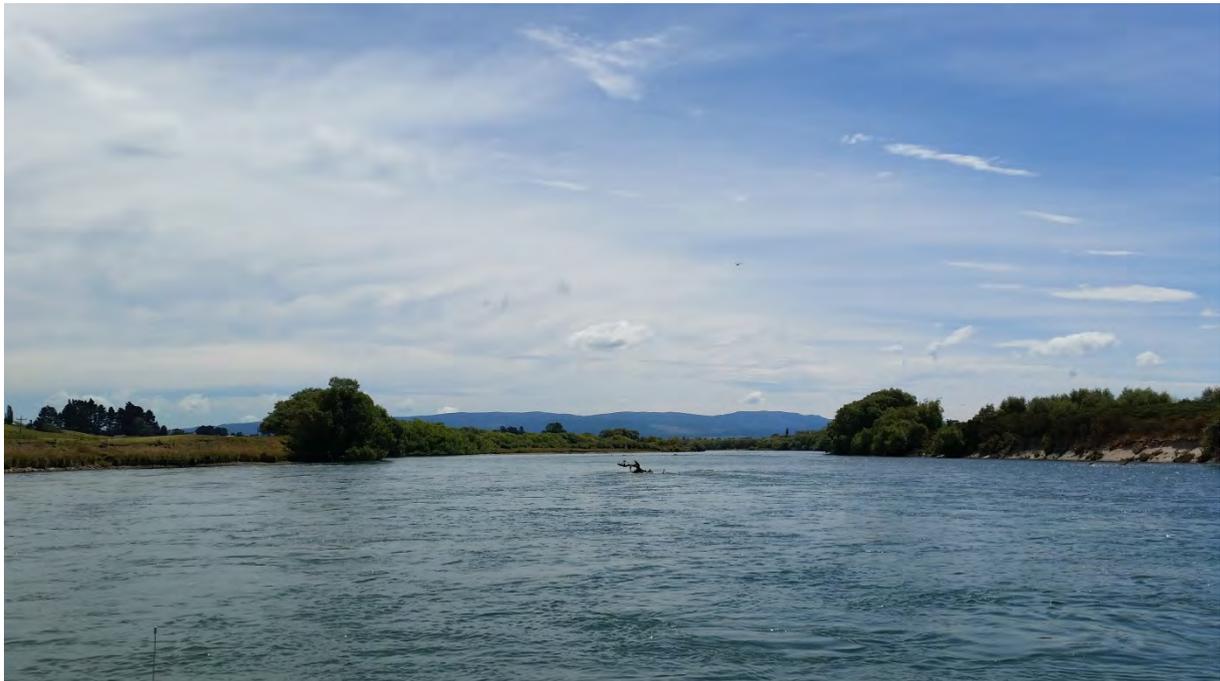
Figure 180. Clutha River/Mata-Au cross-section C20, looking downstream

Figure 181. Clutha River/Mata-Au cross-section C20, looking upstream

Cross-section C20 is located 24.2 km upstream of the Clutha River/Mata-Au bifurcation at Balclutha. The true left bank has eroded by about 12 m and the channel bed has aggraded between 2007 and 2016. The true right floodplain has experienced minimal change between 2007 and 2016.

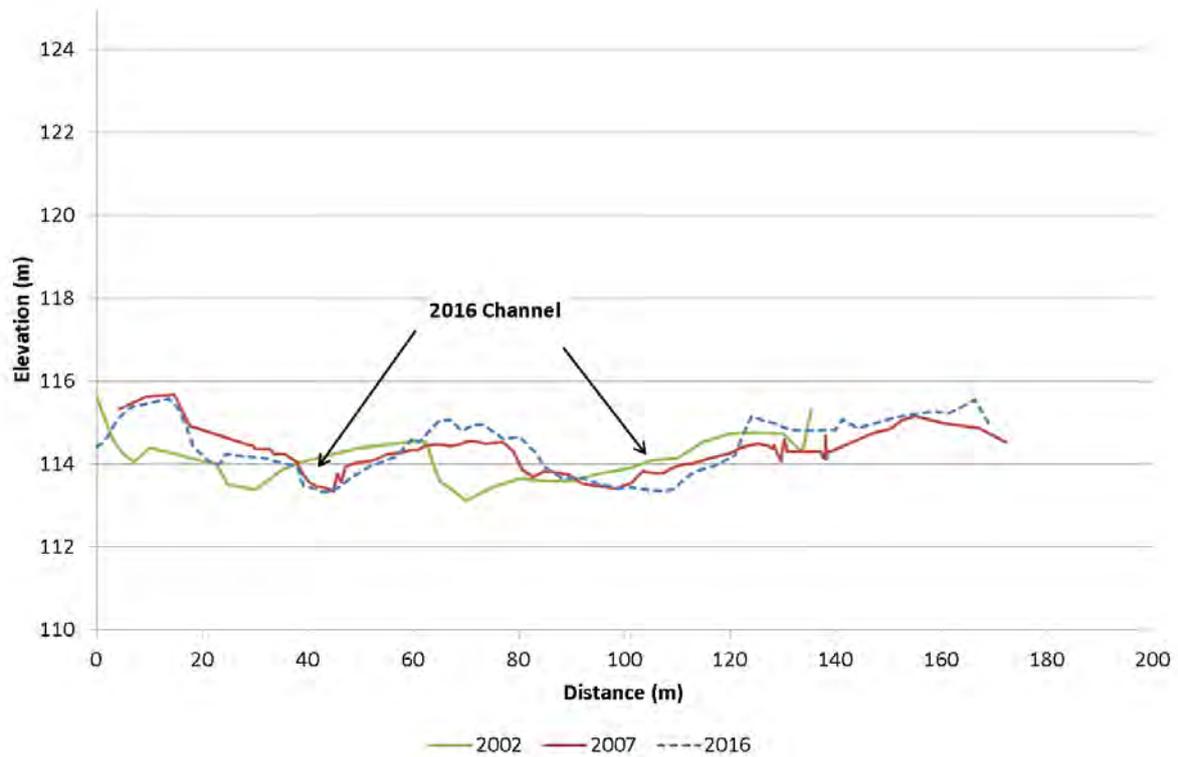
Figure 182. Clutha River/Mata-Au cross-section C21, looking downstream

Cross-section C21 is located 25.6 km upstream of the Clutha River/Mata-Au bifurcation at Balclutha and is situated on a secondary channel that flows around a gravel island just downstream of the Allangrange Road bridge in Clydevale. The channel has both aggraded and degraded with the creation of two, more defined, channels between 2007 and 2016.

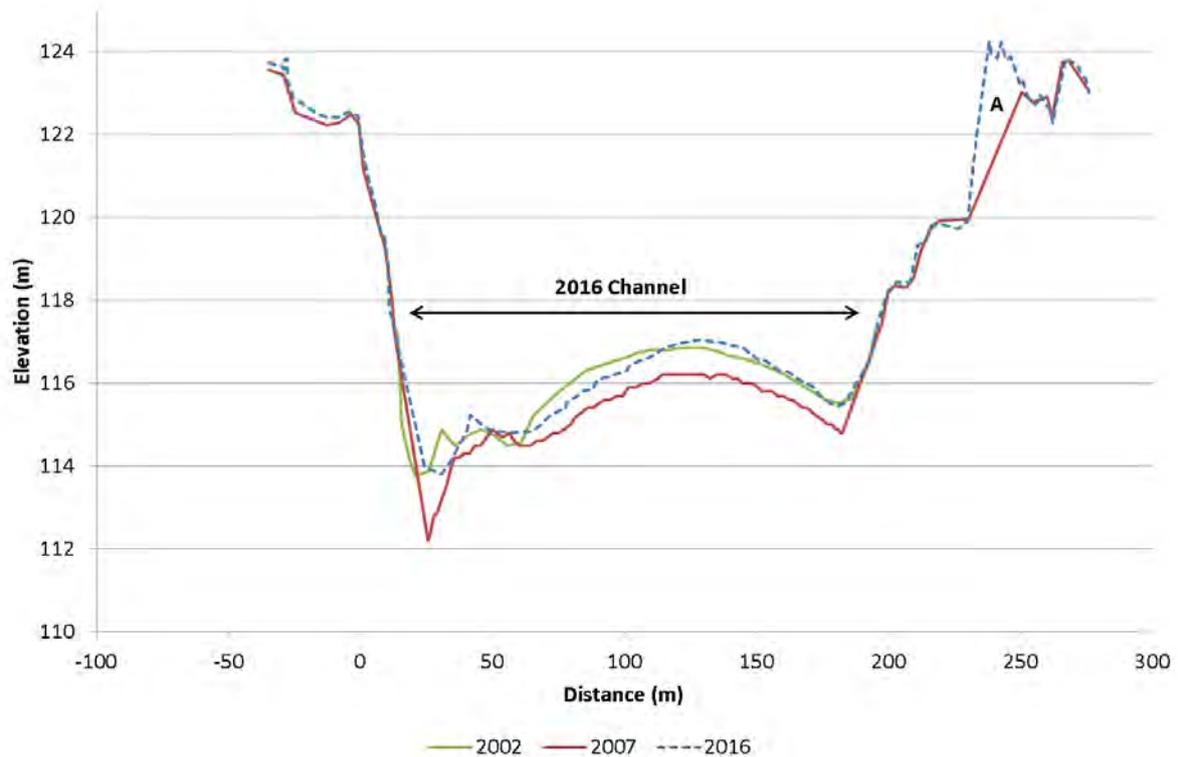
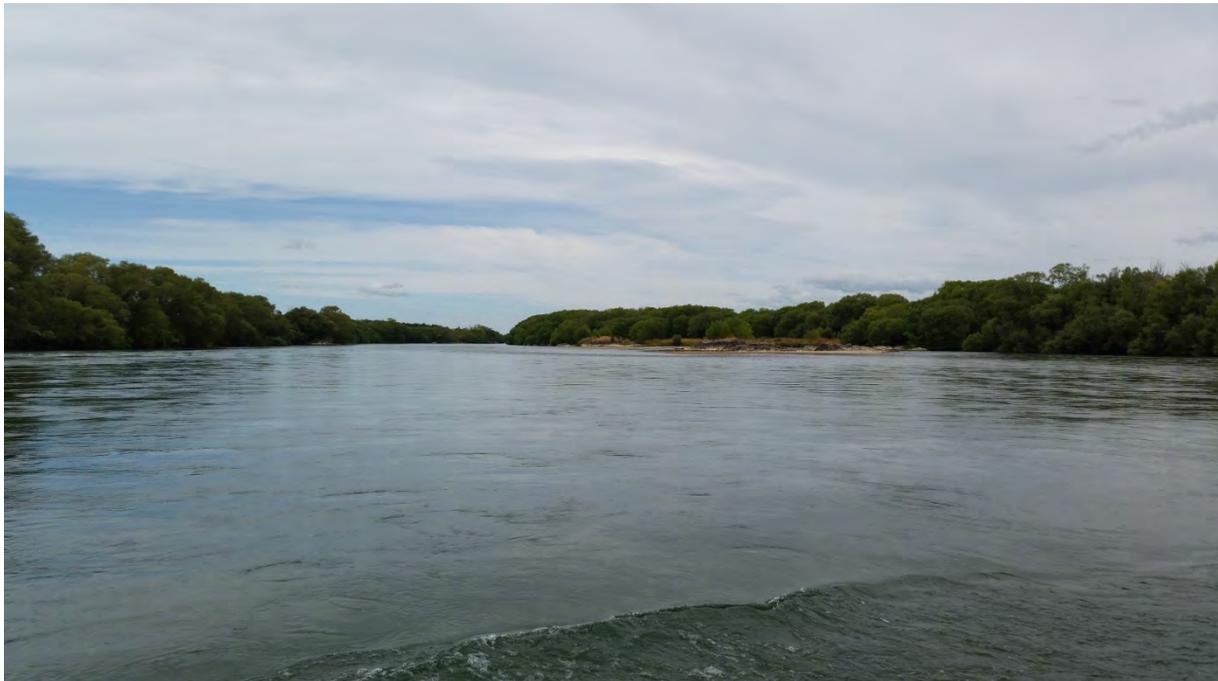
Figure 186. Clutha River/Mata-Au cross-section C23, looking downstream

Figure 187. Clutha River/Mata-Au cross-section C23, looking downstream

Cross-section C23 is located 32.6 km upstream of the Clutha River/Mata-Au bifurcation at Balclutha. Between 2007 and 2016 the channel has experienced mostly aggradation of about 0.8 m; the thalweg has increased in height by about 1.6 m. A bank has formed on the true right bank at the point labelled A between 2007 and 2016 which may be associated with the emplacement of a power pole.

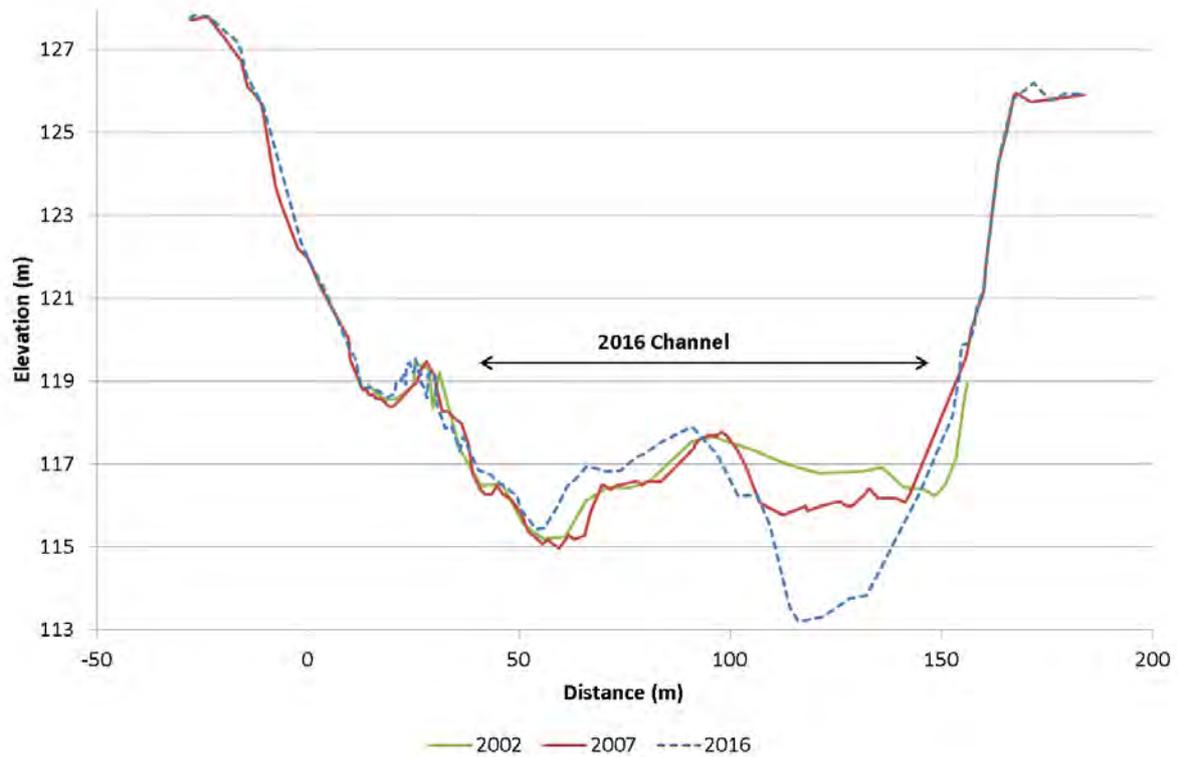
Figure 188. Clutha River/Mata-Au cross-section C24, looking downstream

Cross-section C24 is located 36.9 km upstream of the Clutha River/Mata-Au bifurcation at Balclutha and is situated at the Tuapeka Mouth ferry crossing. The true left of the channel has aggraded between 2007 and 2016 while the true right of the channel has degraded by about 2.8 m. The banks have remained in a similar position between 2007 and 2016.

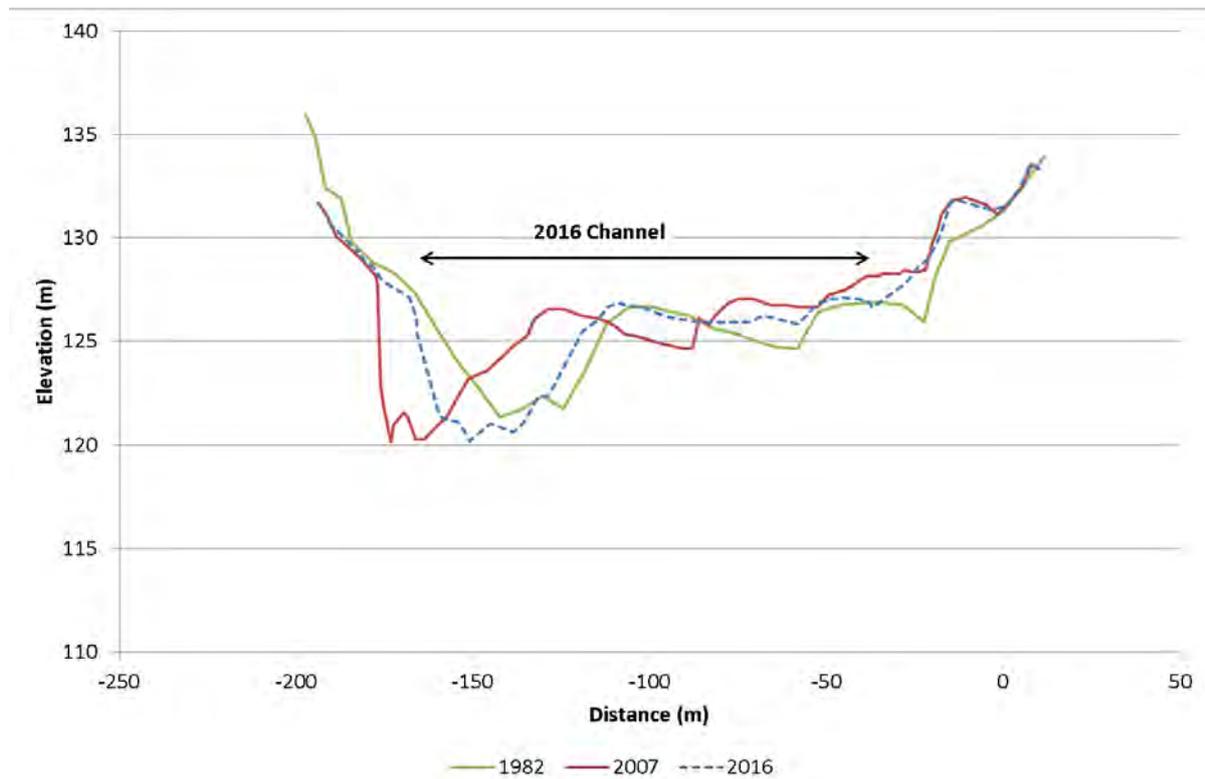
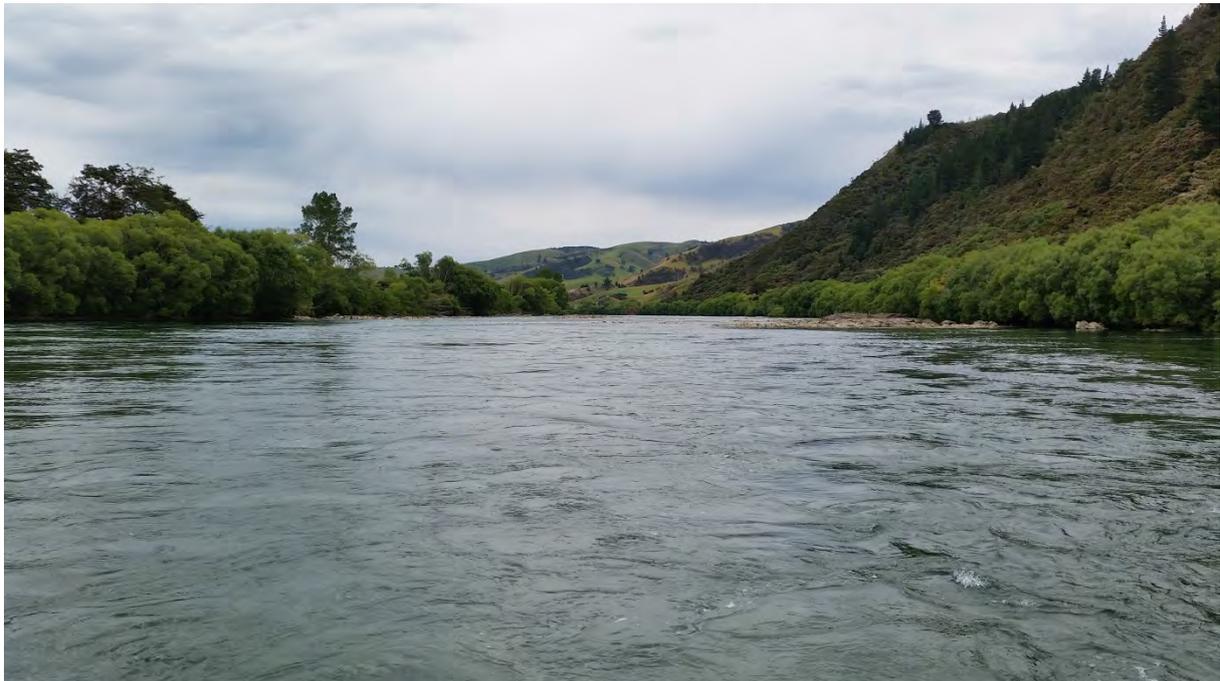
Figure 192. Clutha River/Mata-Au cross-section C26, looking downstream

Figure 193. Clutha River/Mata-Au cross-section C26, looking downstream

Cross-section C26 is located 51.5 km upstream of the Clutha River/Mata-Au bifurcation in Balclutha and is situated in the Rongahere Gorge. The true left (thalweg section) of the channel has moved to the right of the cross-section between 2007 and 2016 with both aggradation and degradation occurring on the right side of the channel.

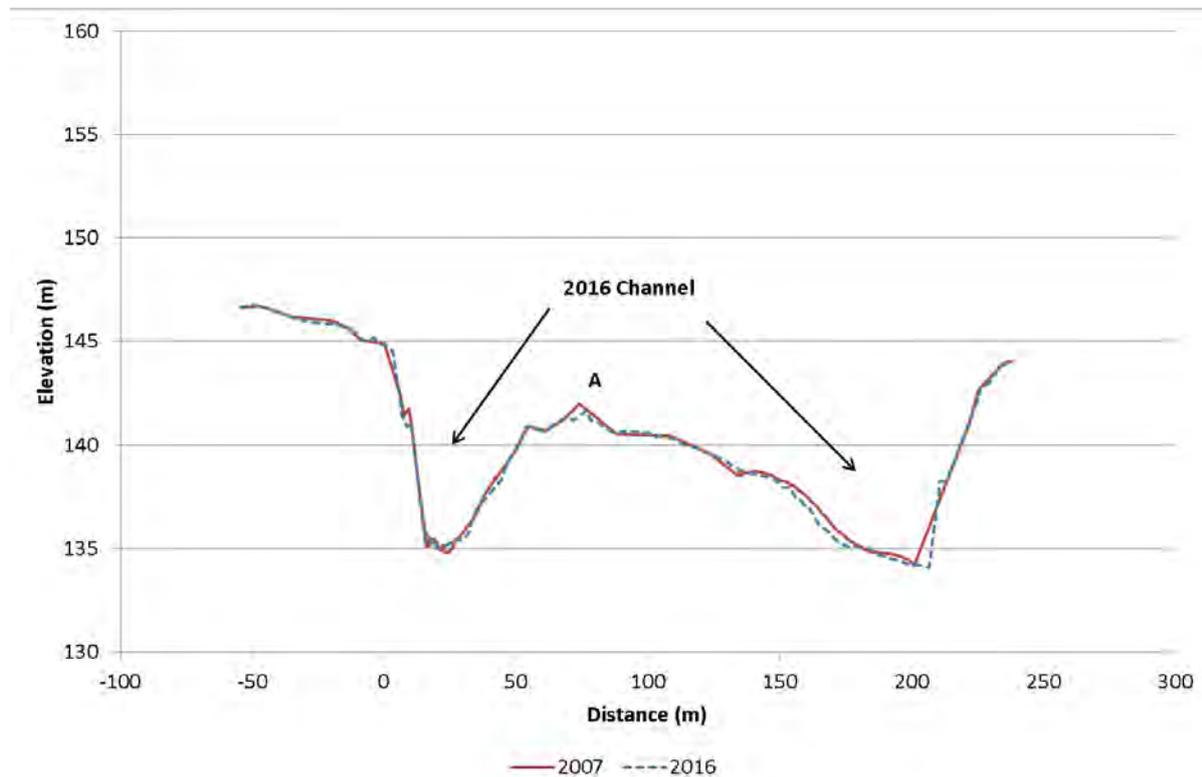
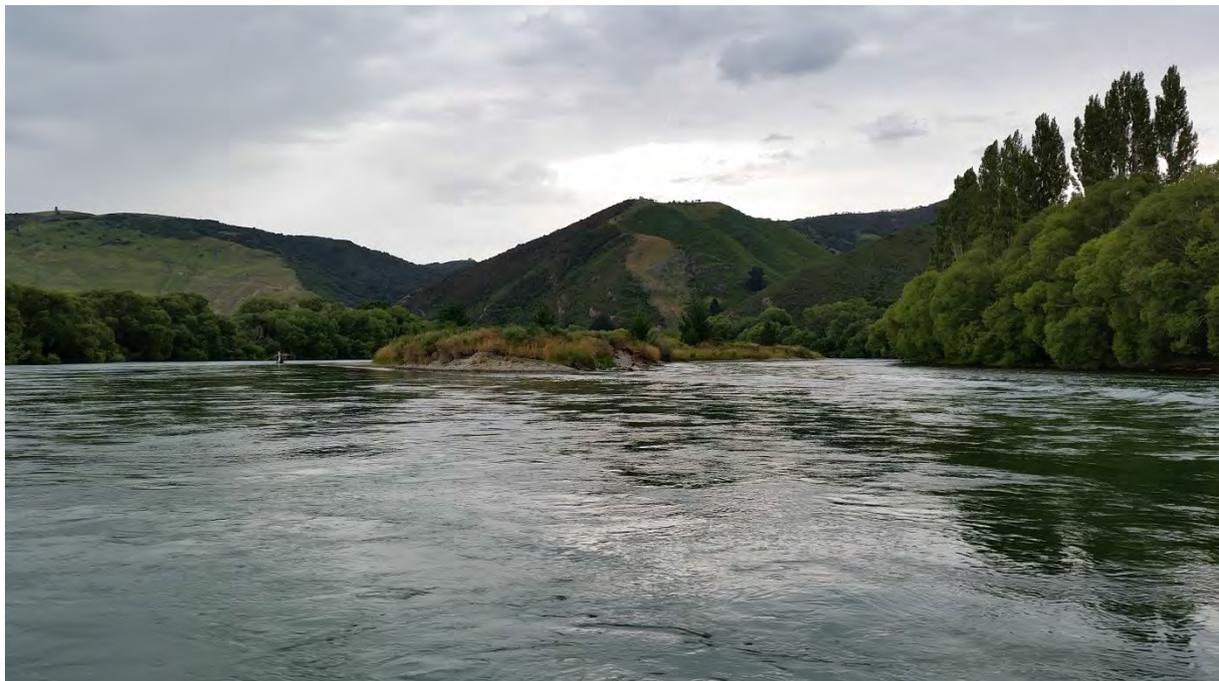
Figure 194. Clutha River/Mata-Au cross-section C27, looking downstream

Figure 195. Clutha River/Mata-Au cross-section C27, looking upstream

Cross-section C27 is located 62.1 km upstream of the Clutha River Mata-Au bifurcation at Blaclutha. A mid channel bar is present at his location and is located at the point labelled A and is visible in Figure 195. There has been minimal change at this cross-section between 2007 and 2016 with small amount of degradation and bank erosion occurring in the true right channel.

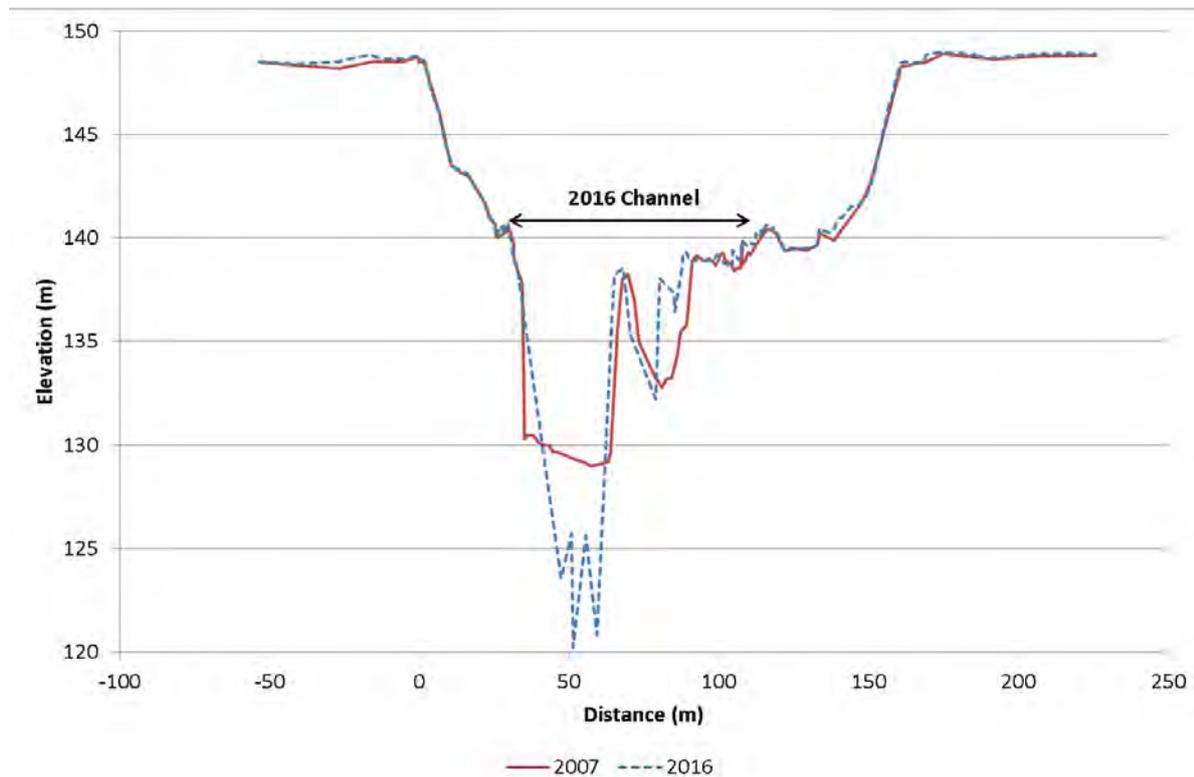
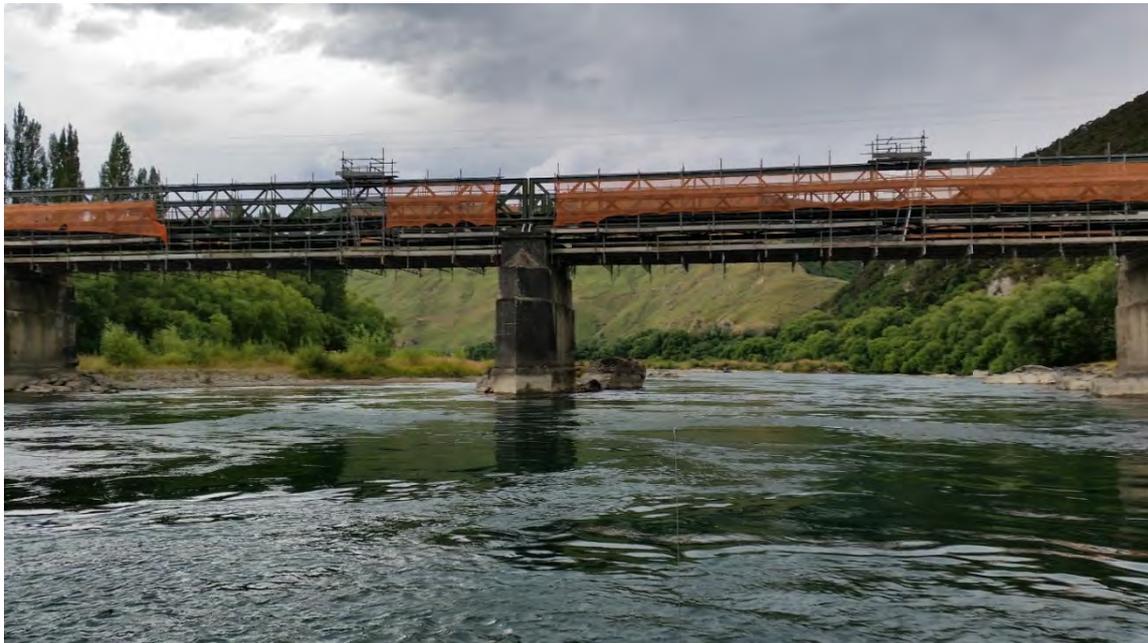
Figure 196. Clutha River/Mata-Au cross-section C28, looking downstream

Figure 197. Clutha River/Mata-Au cross-section C28, looking upstream

Cross-section C28 is located 62.8 km upstream of the Clutha River-Mata-Au bifurcation at Balclutha and is situated at the SH8 bridge in Beaumont. Issues were experienced during the bed survey in 2016; as such the surveyed levels of the main part of the channel are indicative only and at best indicate the uneven channel bottom. The true right of the channel has become more confined between 2007 and 2016 with minimal change occurring across the wider floodplain.

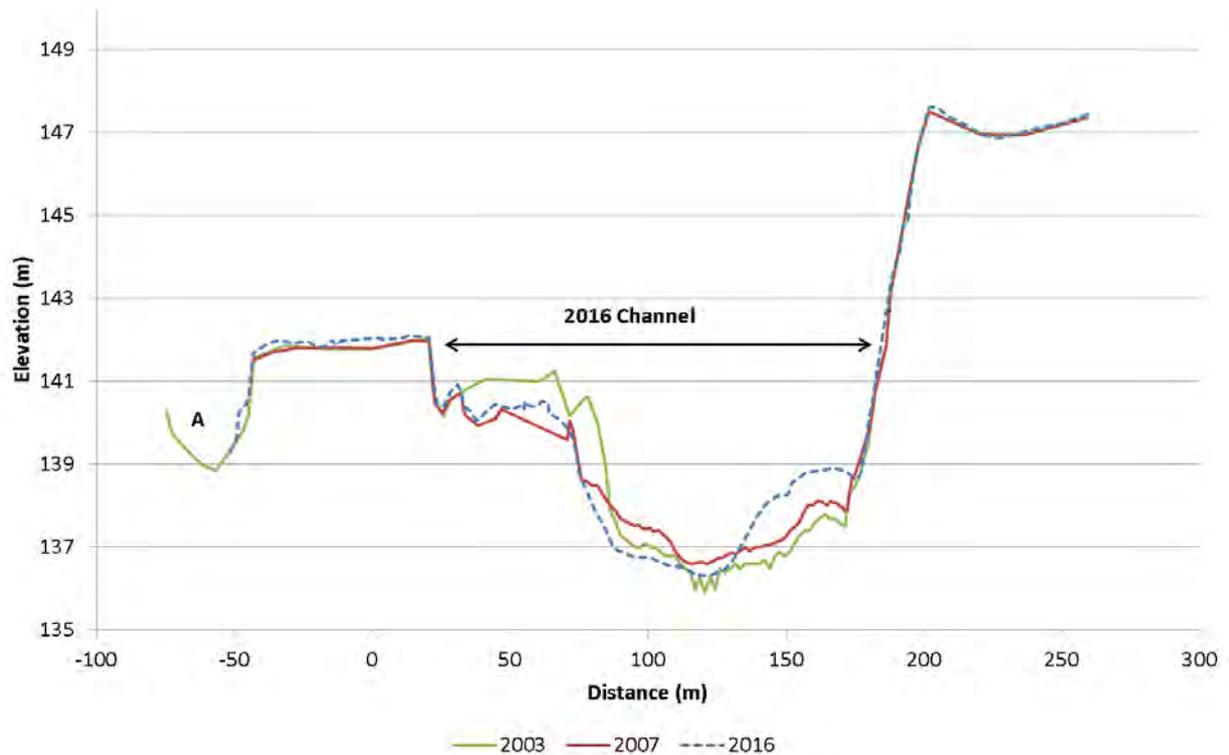
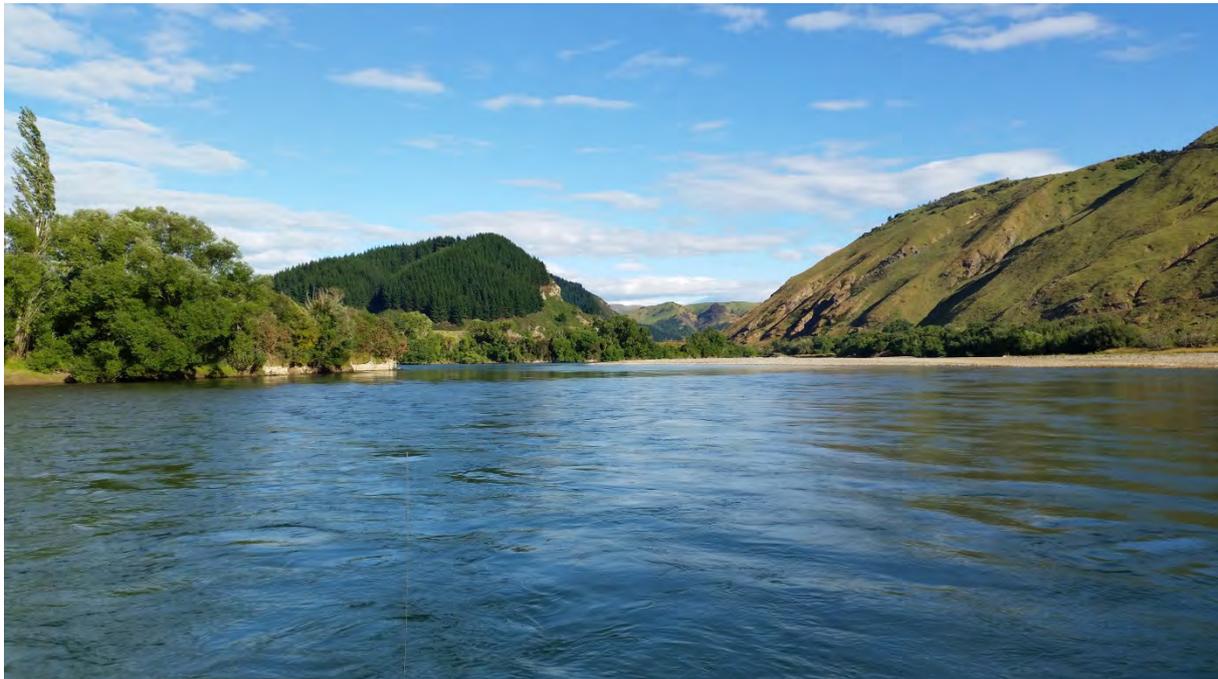
Figure 198. Clutha River/Mata-Au cross-section B10, looking downstream

Figure 199. Clutha River/Mata-Au cross-section B10, looking upstream

Cross-section B10 is located 63.3 km upstream of the Clutha River/Mata-Au Bifurcation at Balclutha. Between 2007 and 2016 the main channel has degraded on the true left and aggraded on the true right with the thalweg staying in the same horizontal position. The point labelled A is a secondary channel that contains water during higher flows.
