Morphology of the Clutha River/Mata- Au between Roxburgh Dam and the Pacific Ocean

March 2017

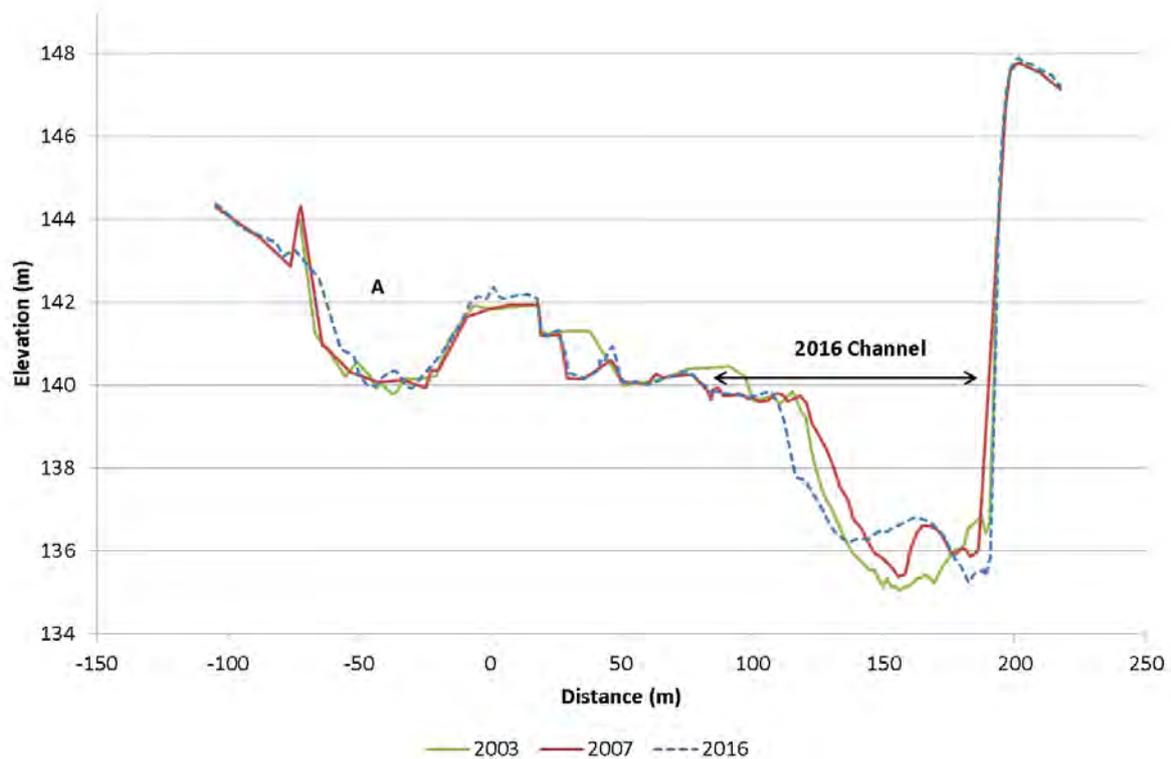
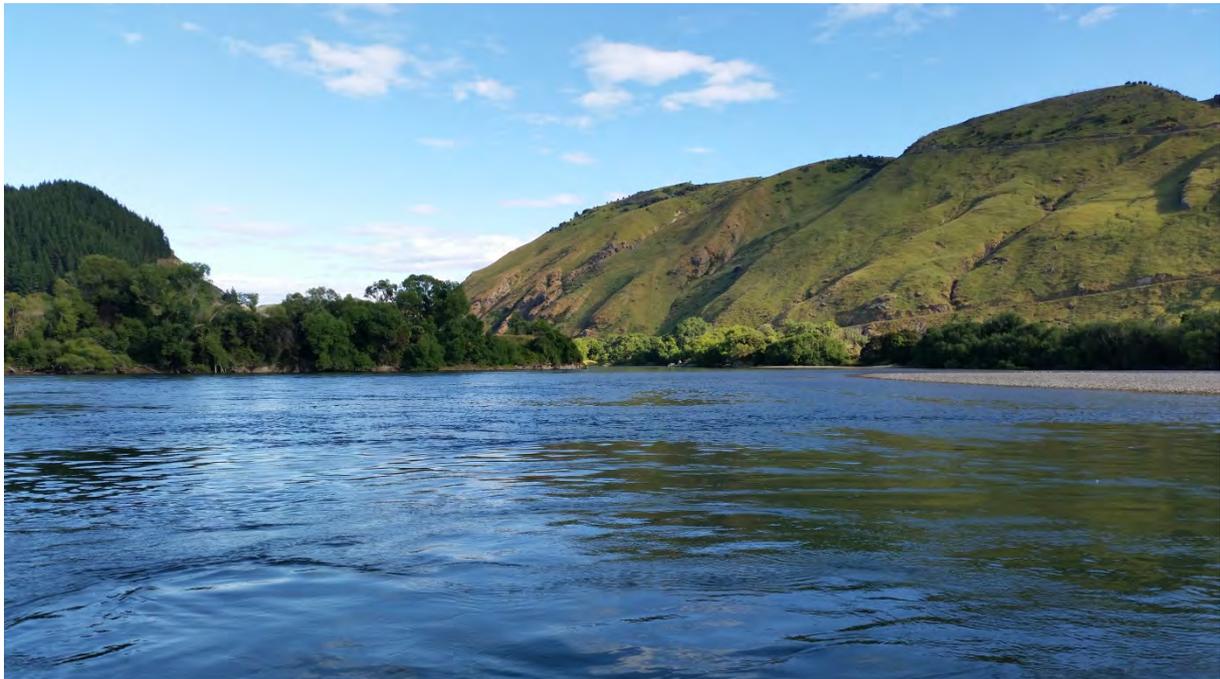
Figure 200. Clutha River/Mata-Au cross-section B11, looking downstream

Figure 201. Clutha River/Mata-Au cross-section B11, looking upstream

Cross-section B11 is located 63.4 km upstream of the Clutha River/Mata-Au bifurcation at Balclutha. Between 2007 and 2016 the main channel has eroded on the true left, aggraded in the centre and degraded on the true right to create a less confined channel. The secondary channel (point labelled A) has aggraded on the true left bank between 2007 and 2016.

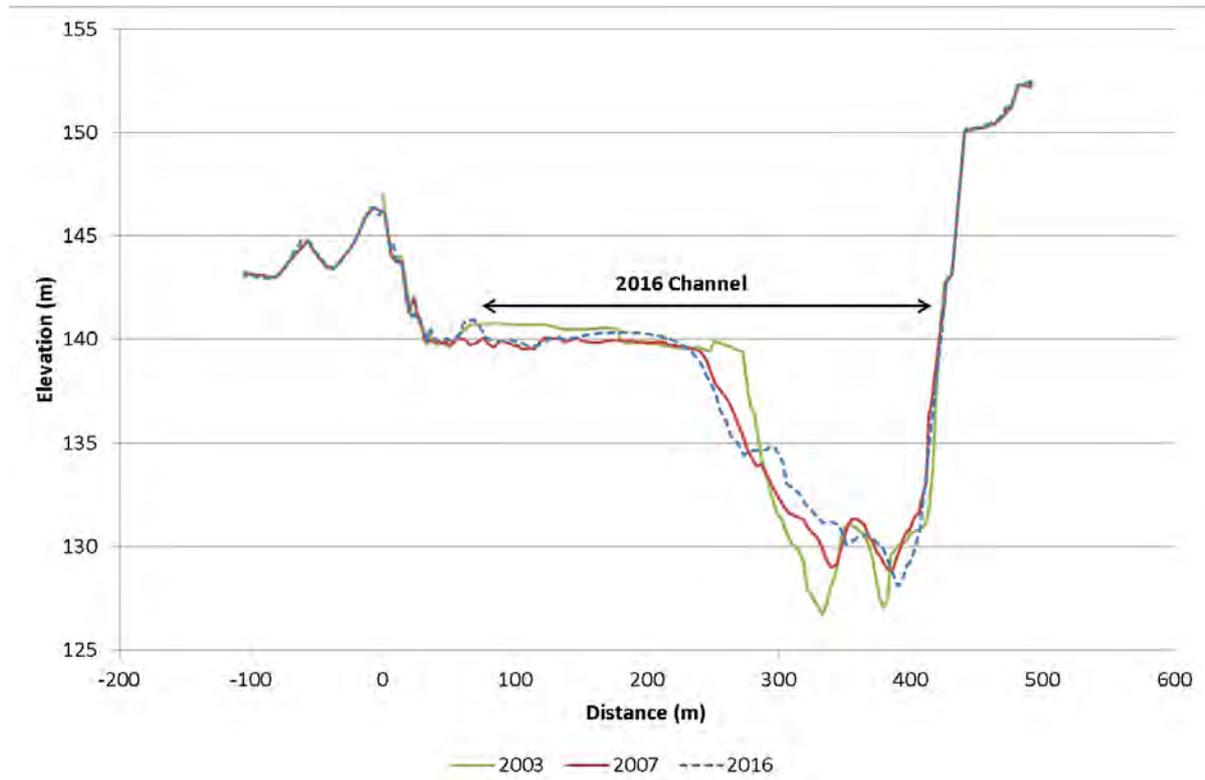
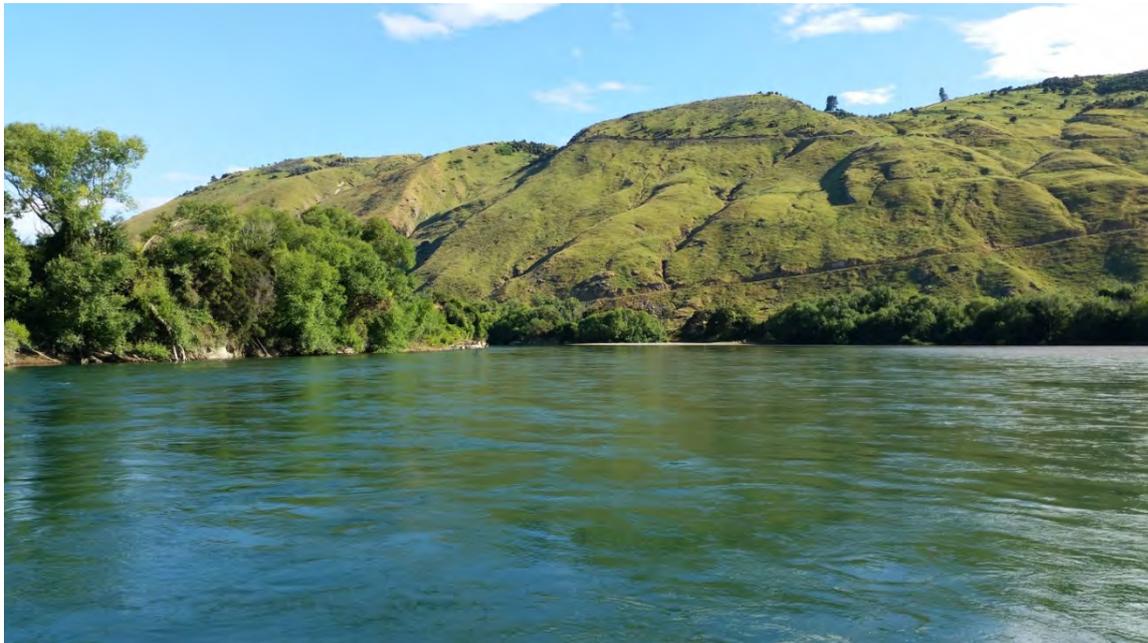
Figure 202. Clutha River/Mata-Au cross-section B12, looking downstream

Figure 203. Clutha River/Mata-Au cross-section B12, looking upstream

Cross-section B12 is located 63.5 km upstream of the Clutha River/Mata-Au bifurcation in Balclutha. The true left of the main channel is a gravel bar that is often exposed when flows are low with majority of the flow being located on the true right of the channel. Between 2007 and 2016 the main section of the channel has become more confined with aggradation on the true left and degradation in the thalweg section. The rest of the channel and wider floodplain has remained similar between 2007 and 2016.

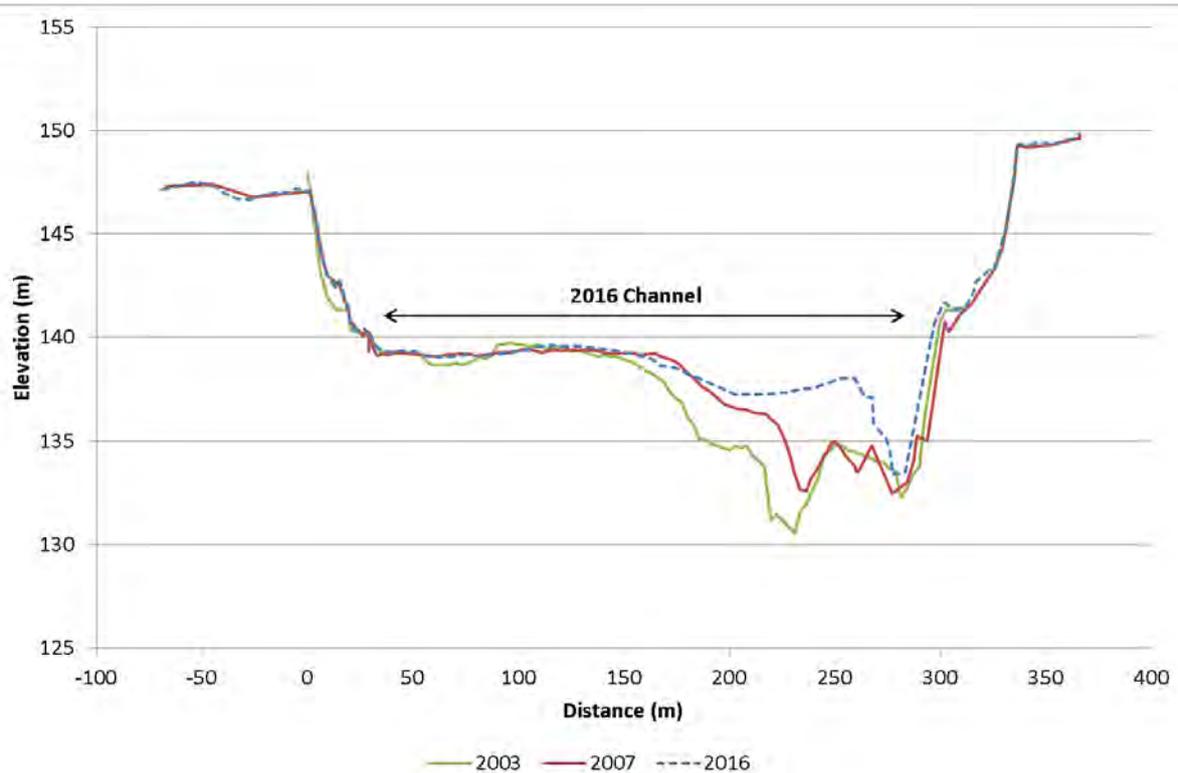
Figure 204. Clutha River/Mata-Au cross-section B13, looking downstream

Cross-section B13 is located 63.6 km upstream of the Clutha River/Mata-Au bifurcation at Balclutha. The channel has experienced maximum aggradation of about 5 m and a confining of the thalweg section of the channel between 2007 and 2016. The wider floodplain and true left of the channel have remained similar between 2007 and 2016.

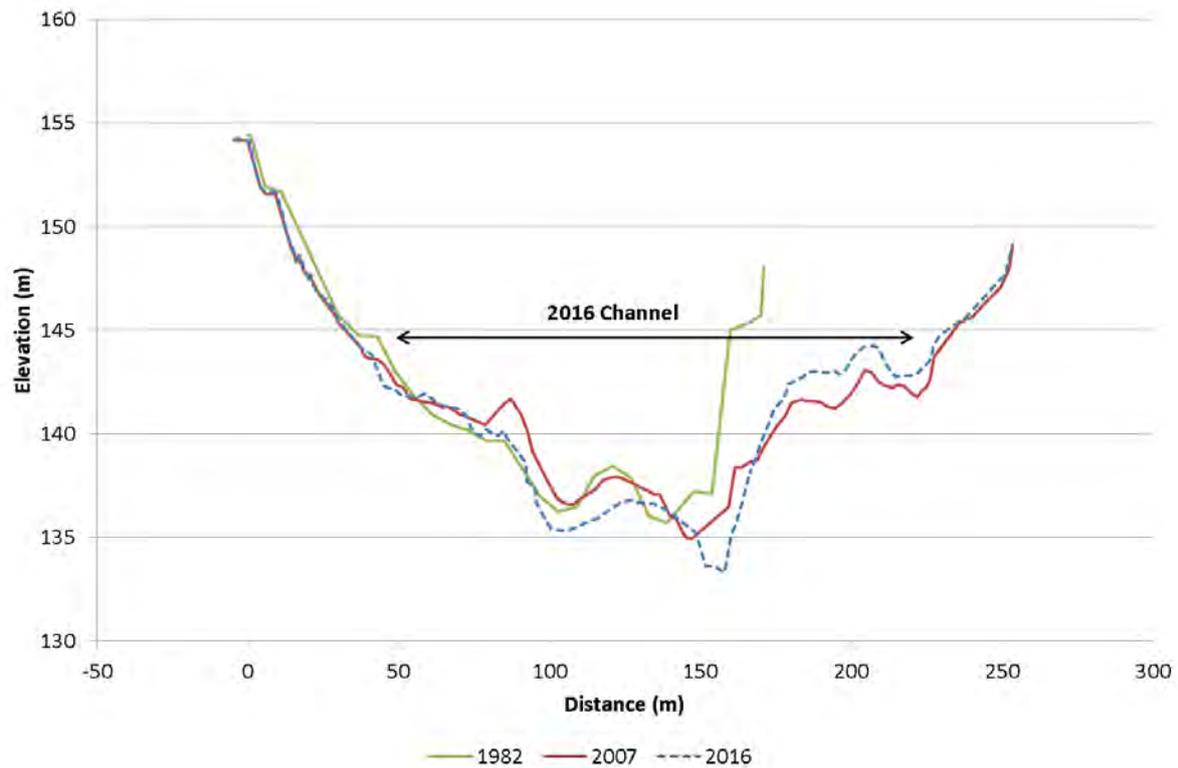
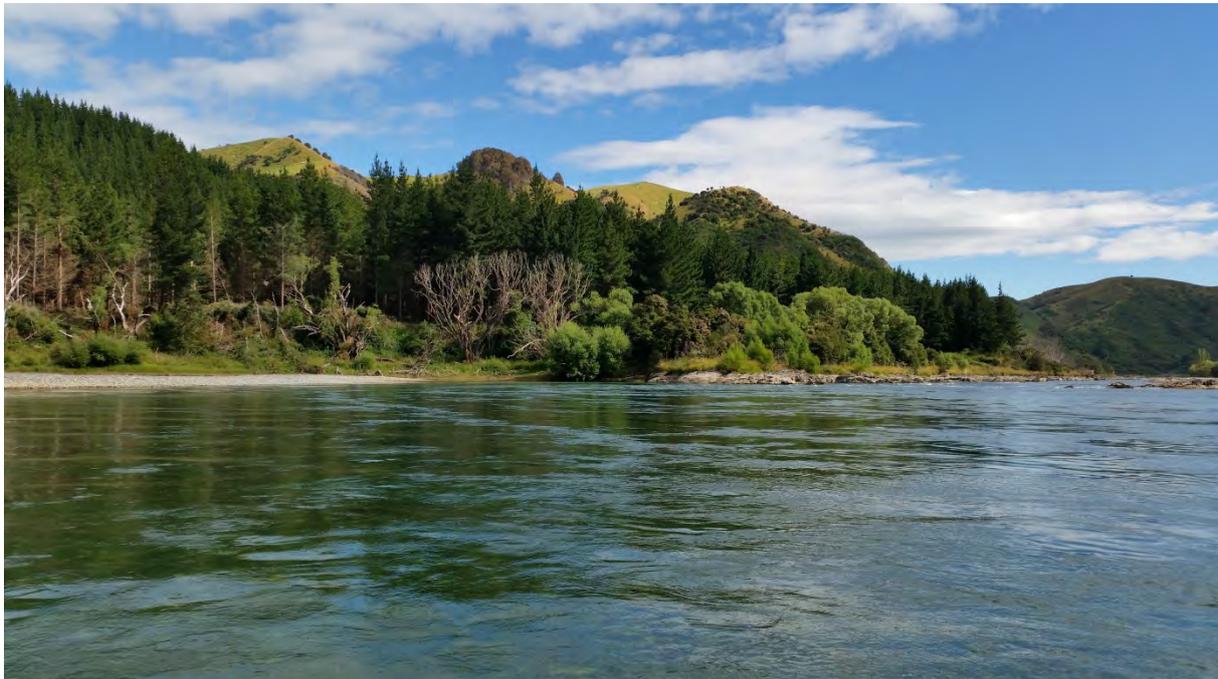
Figure 205. Clutha River/Mata-Au cross-section C29, looking downstream

Figure 206. Clutha River/Mata-Au cross-section C29, looking upstream

Cross-section C29 is located 66.5 km upstream of the Clutha River/Mata-Au bifurcation at Balclutha. The centre of the main channel has experienced degradation with the true right showing aggradation between 2007 and 2016.

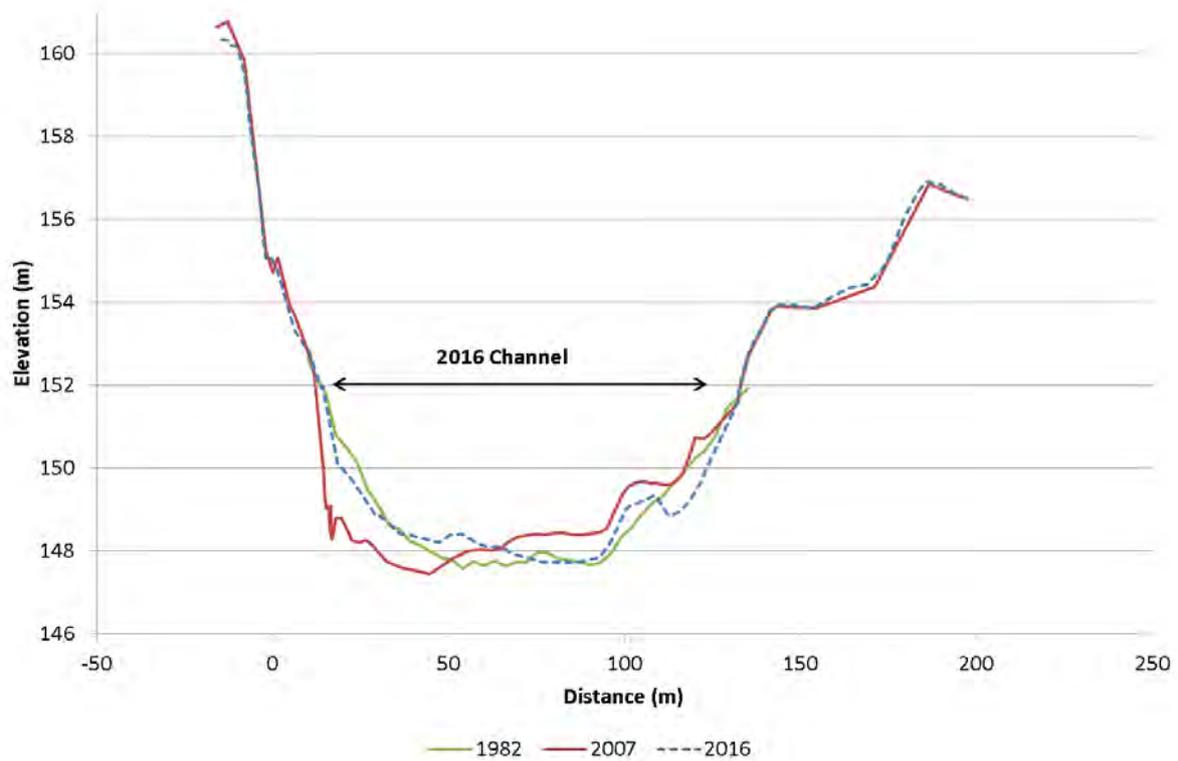
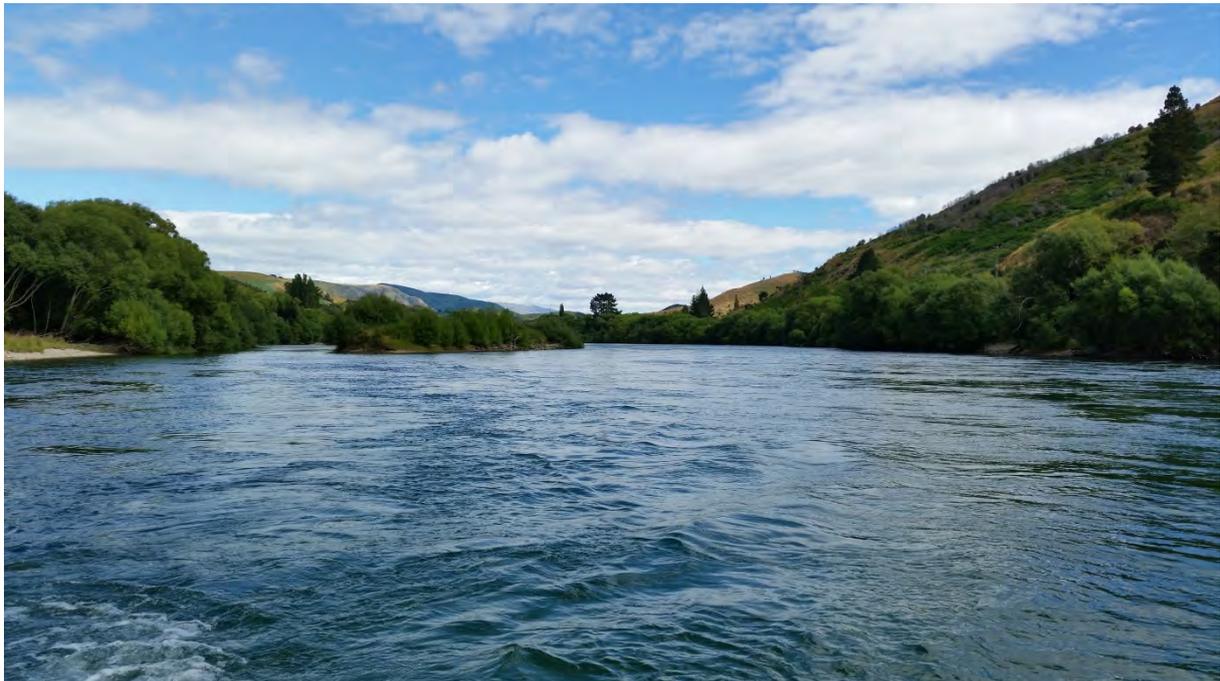
Figure 207. Clutha River/Mata-Au cross-section C30, looking downstream

Figure 208. Clutha River/Mata-Au cross-section C30, looking upstream

Cross-section C30 is located 71.9 km upstream of the Clutha River/Mata-Au bifurcation at Balclutha. Between 2007 and 2016 the true left of the main channel has aggraded by about 0.9 m and the right of the channel has degraded by about 0.6 m with the thalweg shifting towards the right bank.

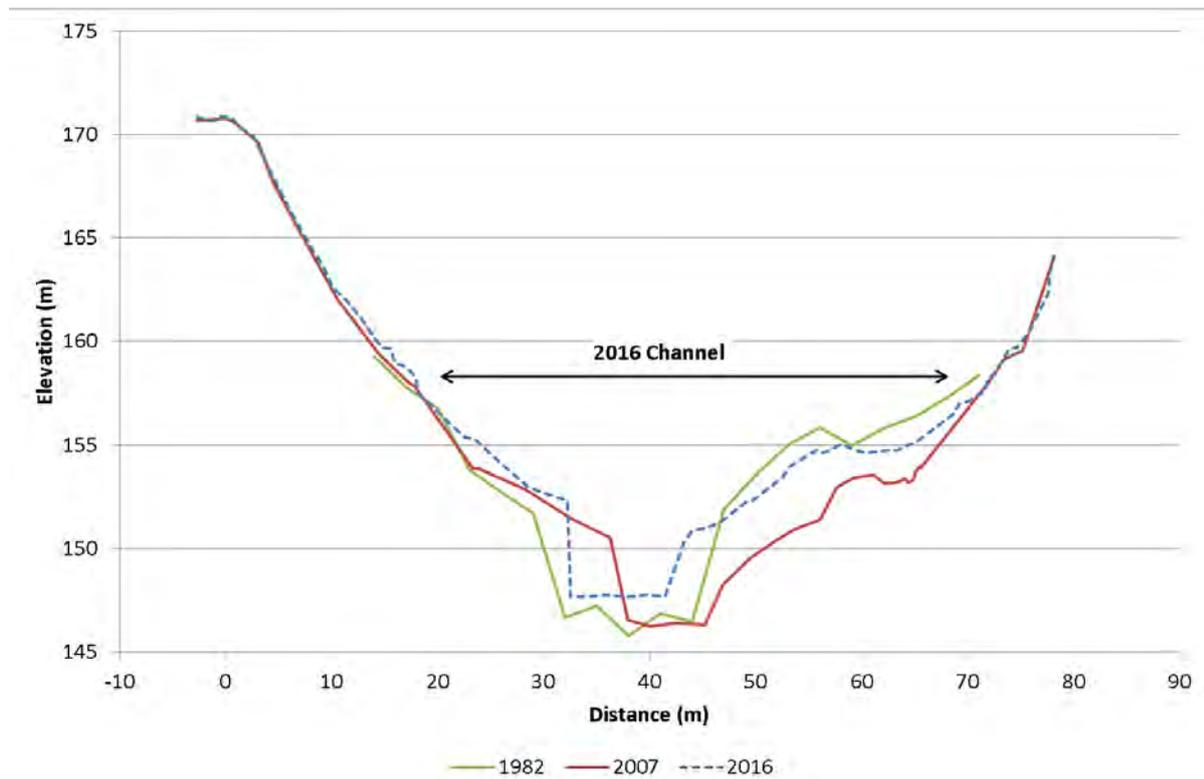
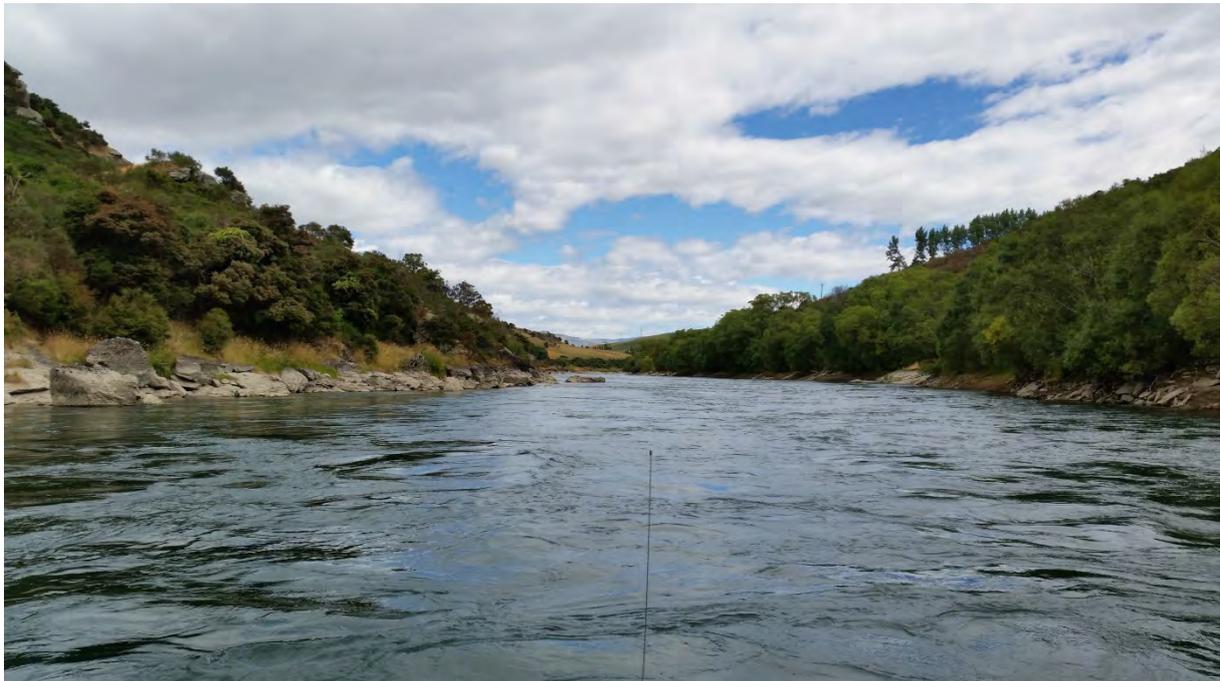
Figure 209. Clutha River/Mata-Au cross-section C31, looking downstream

Figure 210. Clutha River/Mata-Au cross-section C31, looking upstream

Cross-section C31 is located 78.9 km upstream of the Clutha River/Mata-Au bifurcation at Balclutha. Between 2007 and 2016 the channel has eroded the true left bank with the thalweg section increasing in height. The true right of the channel has aggraded by a maximum of about 3 m.

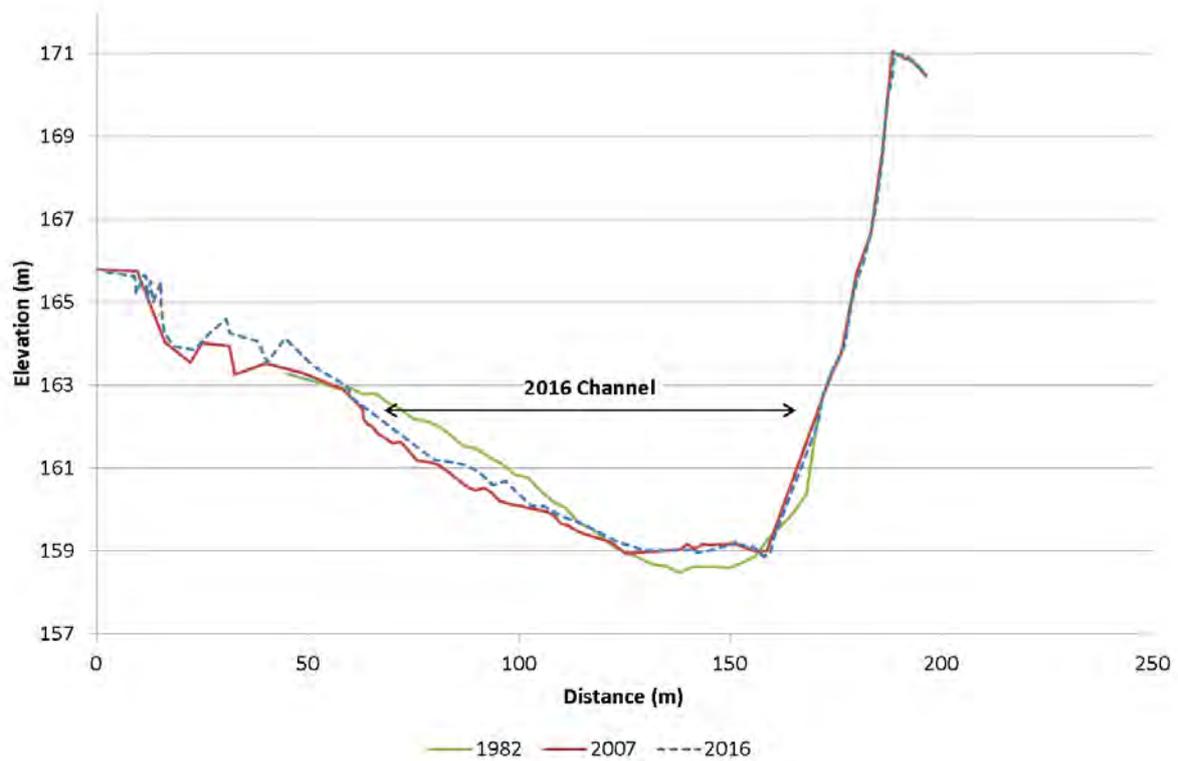
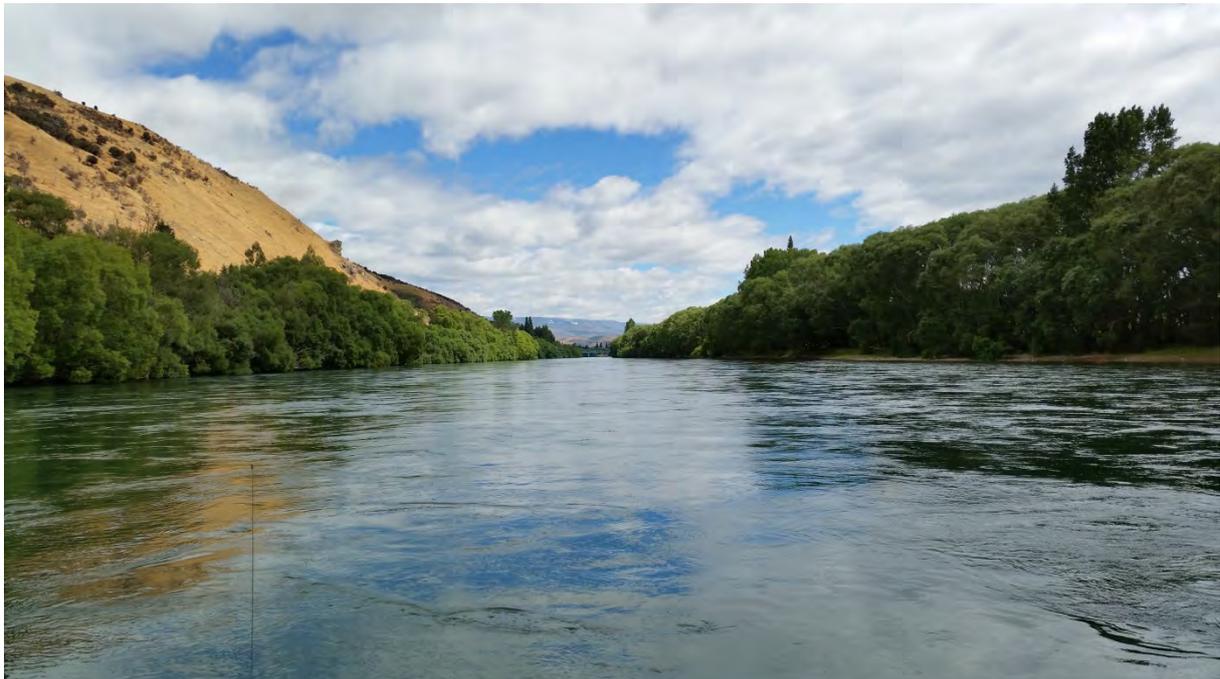
Figure 211. Clutha River/Mata-Au cross-section C32, looking downstream

Figure 212. Clutha River/Mata-Au cross-section C32, looking upstream

Cross-section C32 is located 82.8 km upstream of the Clutha River/Mata-Au Bifurcation at Balclutha. The true left floodplain and berm area has aggraded between 2007 and 2016 with aggradation also occurring on the true left of the channel. The true right of the channel and the right bank have remained similar between 2007 and 2016.

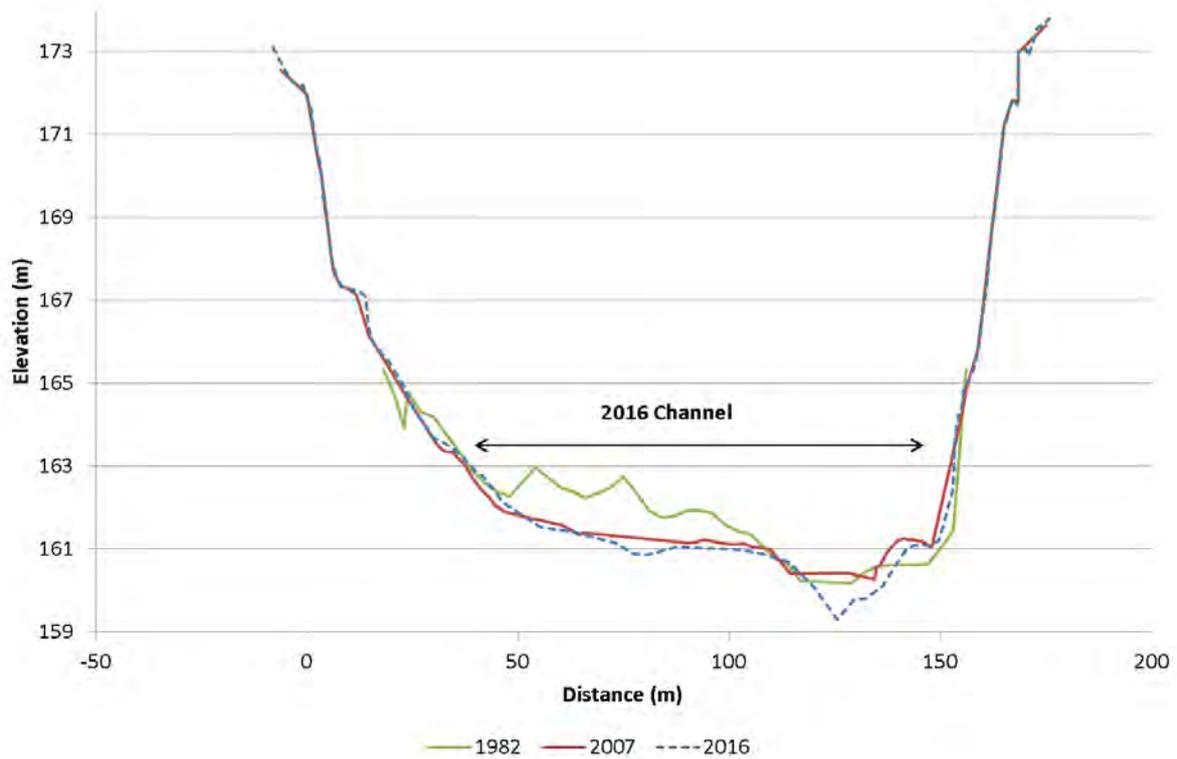
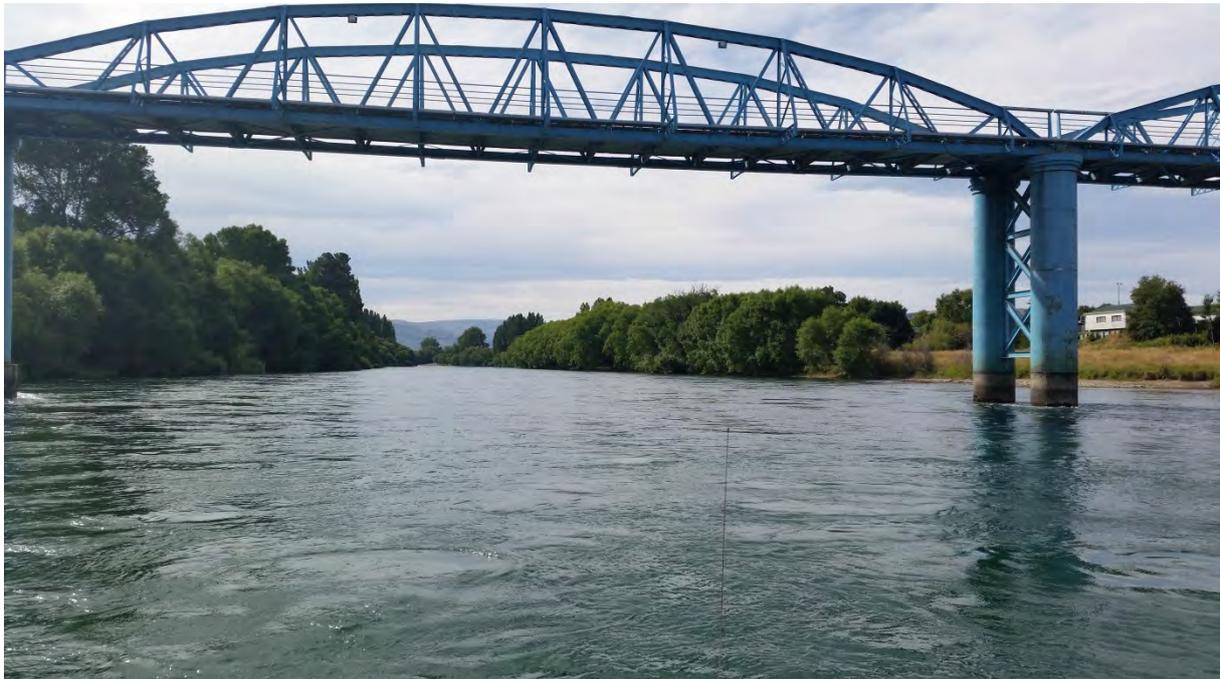
Figure 213. Clutha River/Mata-Au cross-section C33, looking downstream

Figure 214. Clutha River/Mata-Au cross-section C33, looking upstream

Cross-section C33 is located 85 km upstream of the Clutha River/Mata-Au bifurcation at Balclutha and is situated at the Miller Flat bridge. The wider floodplain has remained similar between 2007 and 2016 with mostly degradation occurring in the channel. The thalweg has lowered by about 1 m between 2007 and 2016.

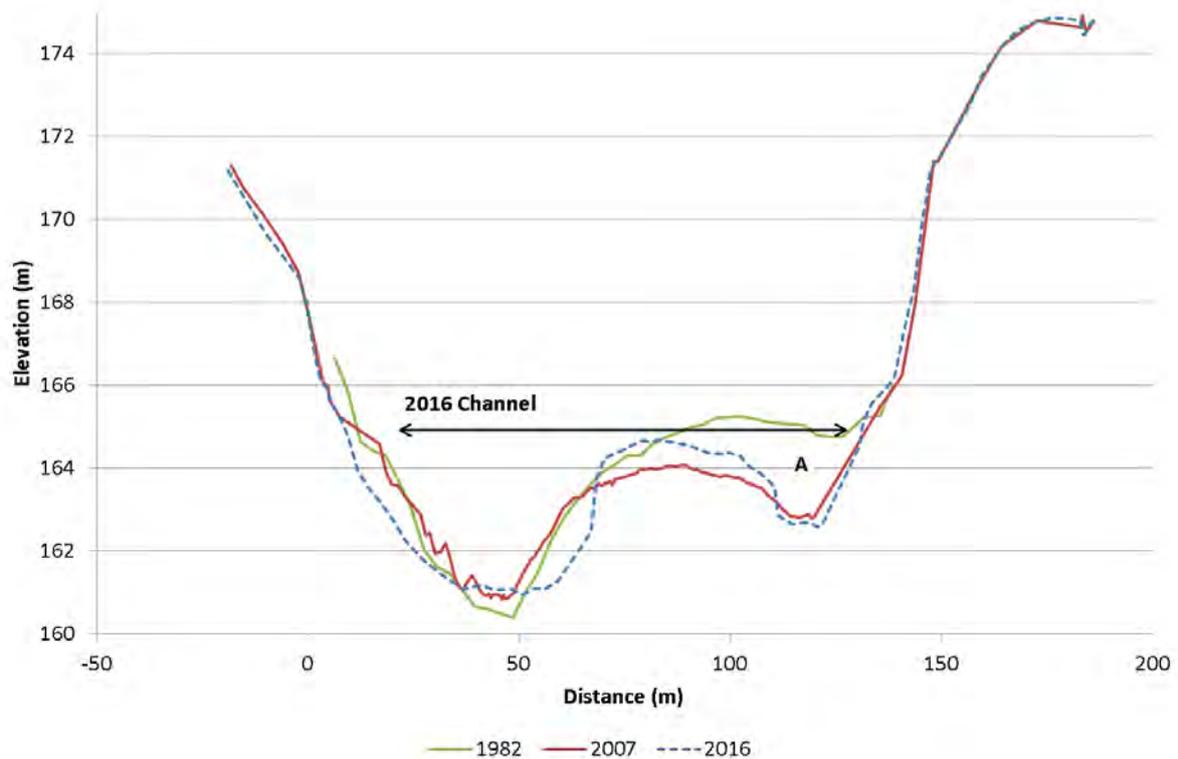
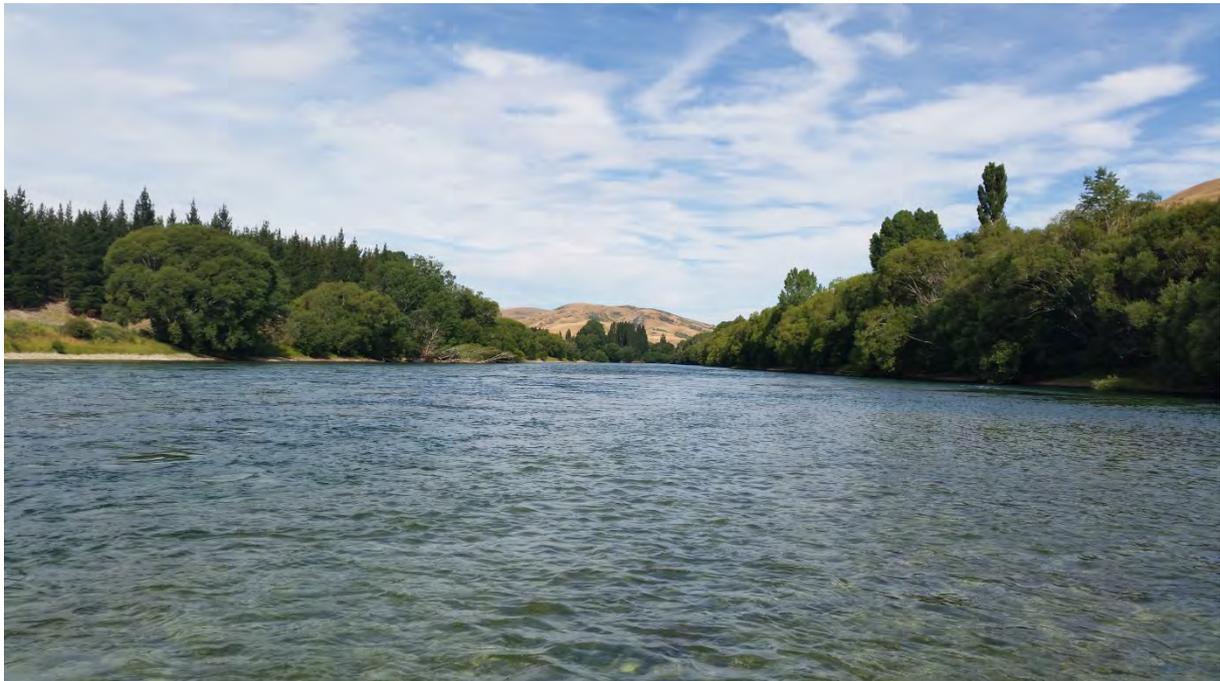
Figure 215. Clutha River/Mata-Au cross-section C34, looking downstream

Figure 216. Clutha River/Mata-Au cross-section C34, looking downstream

Cross-section C34 is located 87 km upstream of the Clutha River/Mata-Au bifurcation at Balclutha. The true left of the channel has eroded its banks with no change in the thalweg section of the channel between 2007 and 2016. The centre of the channel has aggraded with the true right of the channel becoming more confined (point labelled A) between 2007 and 2016.

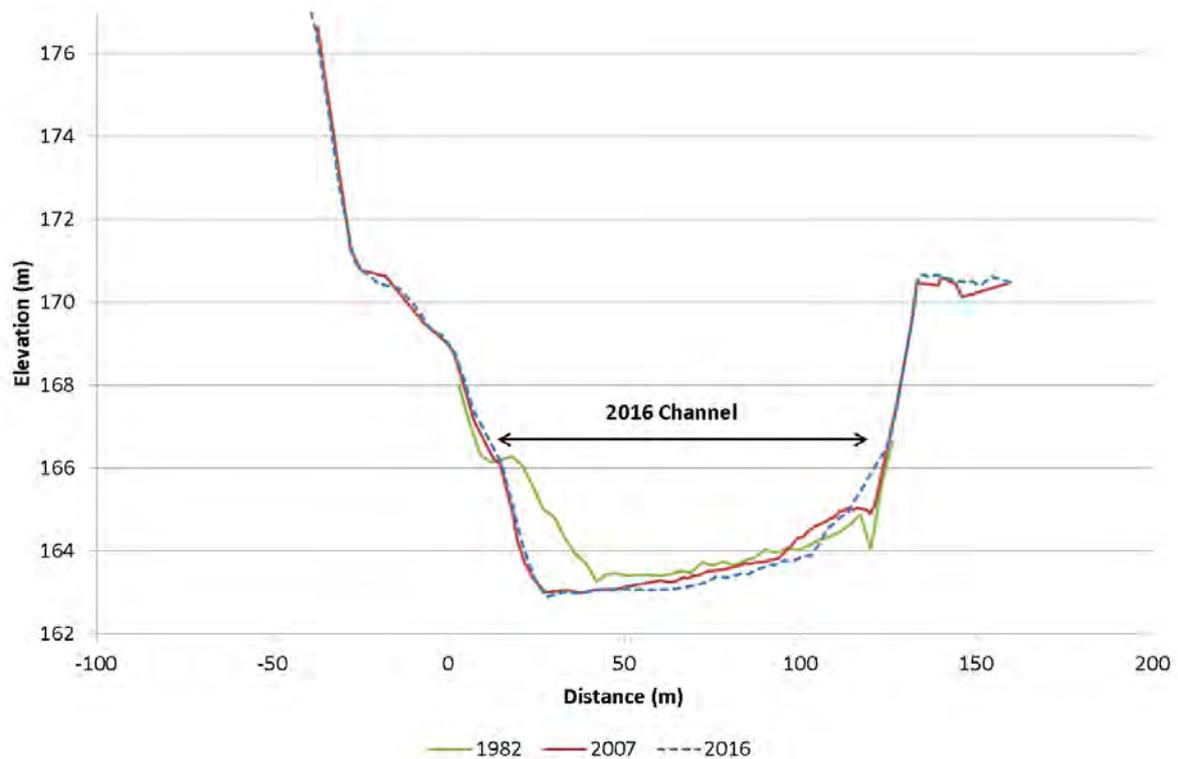
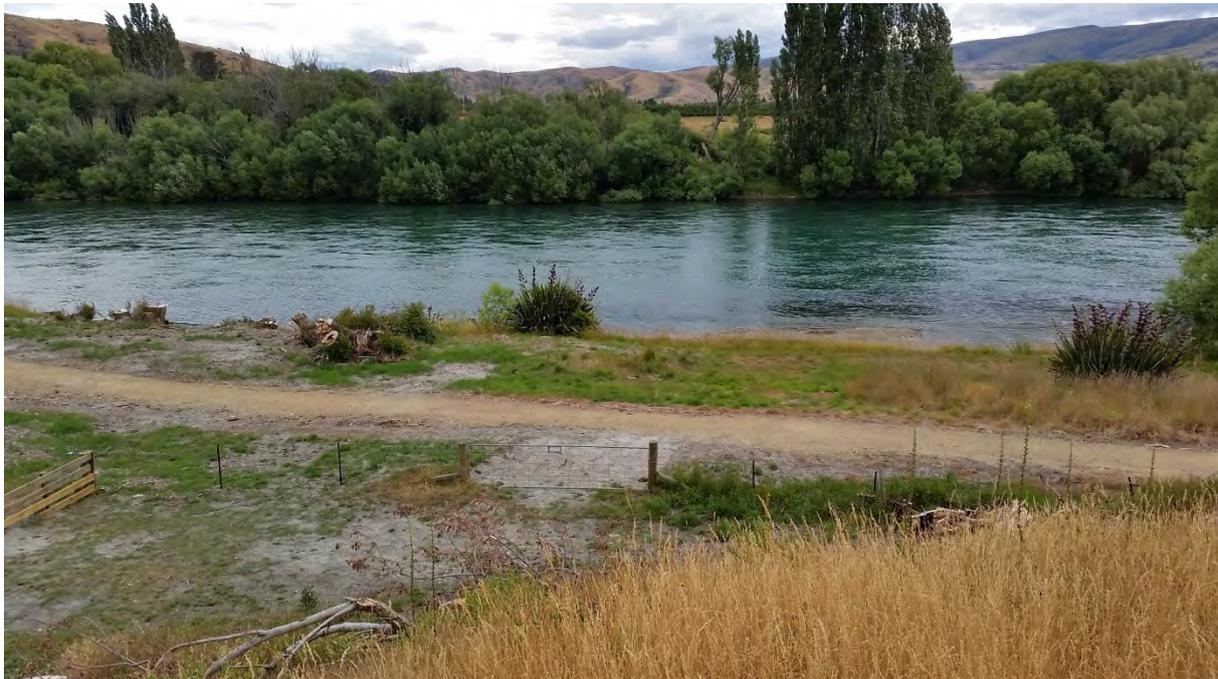
Figure 217. Clutha River/Mata-Au cross-section C35, looking downstream

Figure 218. Clutha River/Mata-Au cross-section C35, looking from true left to right bank

Cross-section C35 is located 88.9 km upstream of the Clutha River/Mata-Au bifurcation in Balclutha. The channel has remained similar between 2007 and 2016 with minor degradation occurring in the centre and aggradation occurring on the true right bank of the channel.

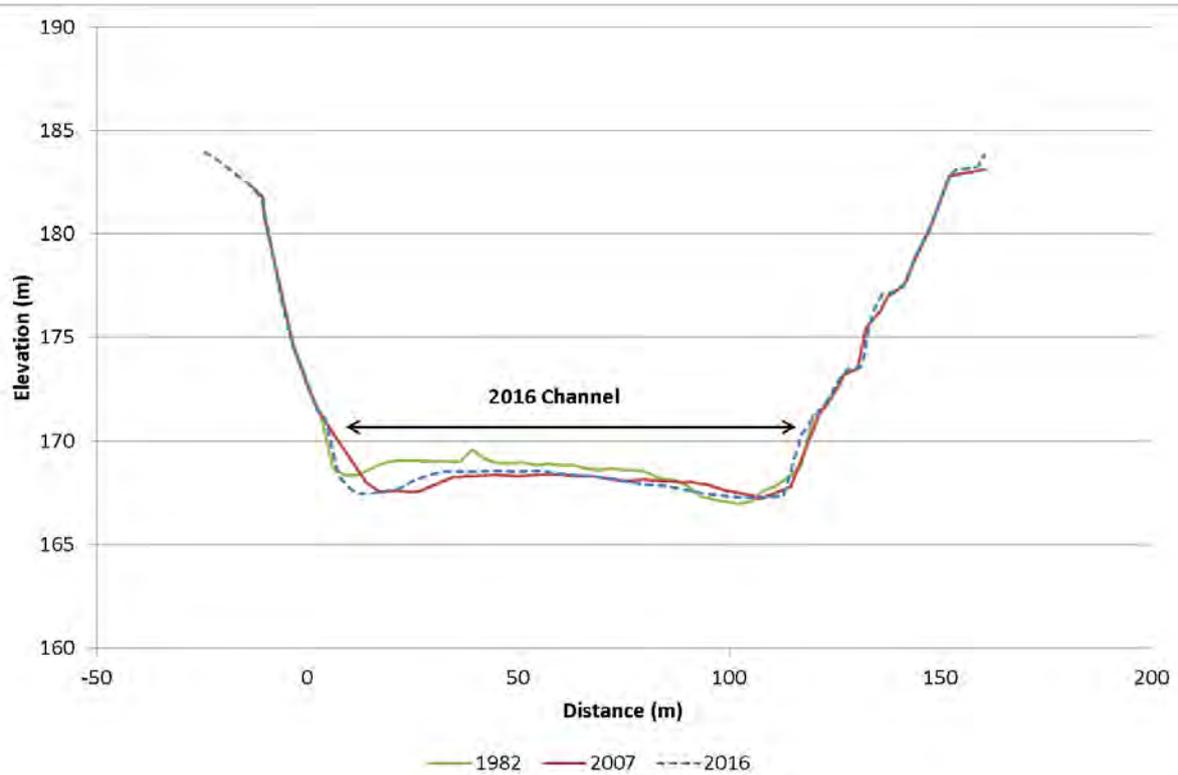
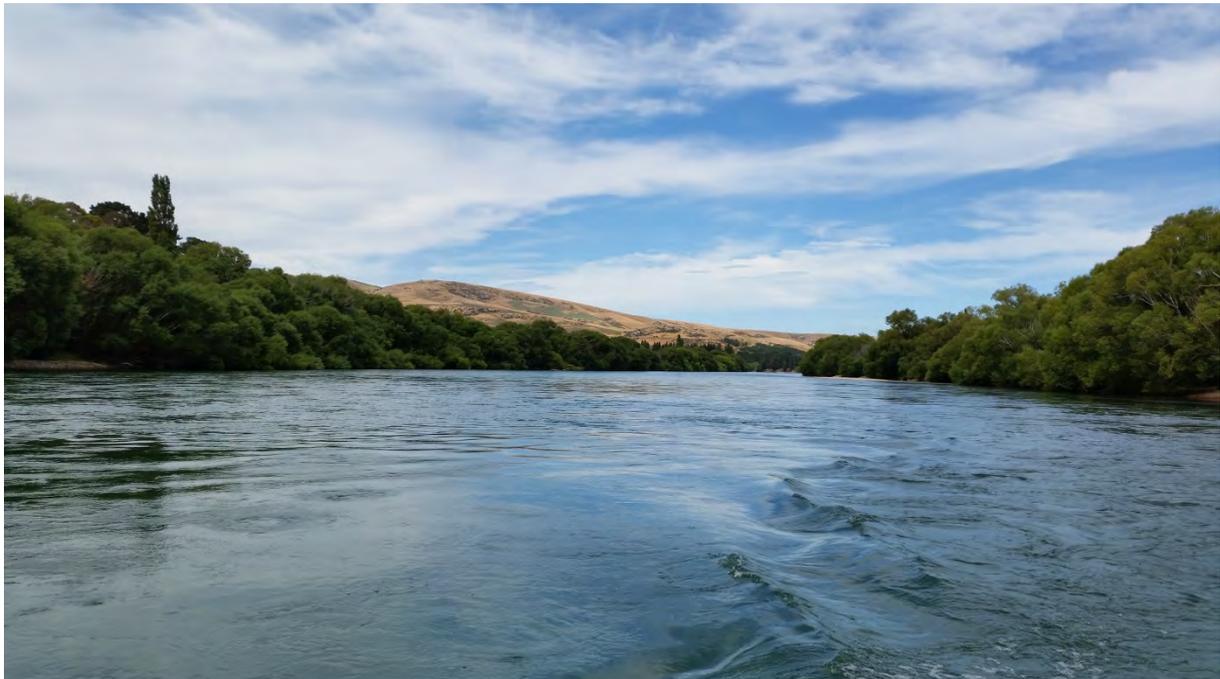
Figure 219. Clutha River/Mata-Au cross-section C36, looking downstream

Figure 220. Clutha River/Mata-Au cross-section C36, looking downstream

Cross-section C36 is located 93.9 km upstream of the Clutha River/Mata-Au bifurcation at Balclutha. The channel has remained similar between 2007 and 2016 with erosion occurring on the true left bank and minor aggradation and degradation occurring across the channel. Both banks have remained similar between 2007 and 2016.

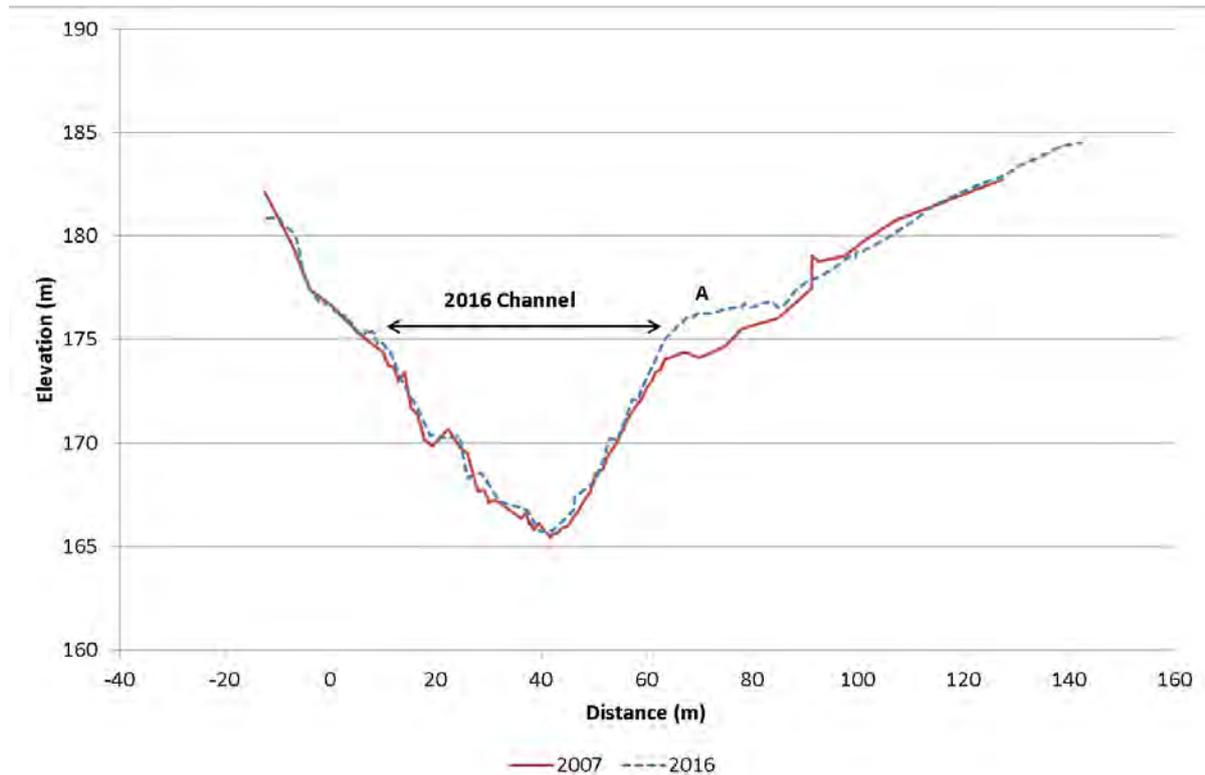
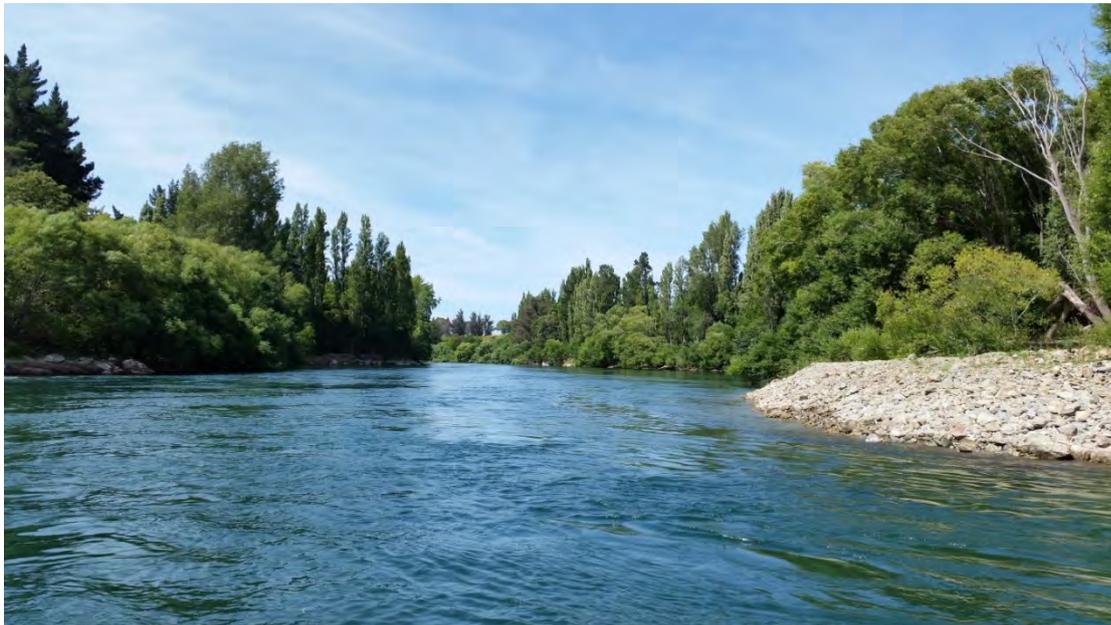
Figure 221. Clutha River/Mata-Au cross-section C37, looking downstream

Figure 222. Clutha River/Mata-Au cross-section C37, looking downstream, Black Jacks Creek meets the Clutha River/Mata-Au on the right of the photograph

Cross-section C37 is located 99 km upstream of the Clutha River/Mata-Au bifurcation at Balclutha and is situated where Black Jacks Creek meets the Clutha River/Mata-Au. The true left bank and the channel have remained similar between 2007 and 2016 with the true right bank showing experiencing aggradation which may be attributed to sediment deposited by Black Jack's Creek (point labelled A).

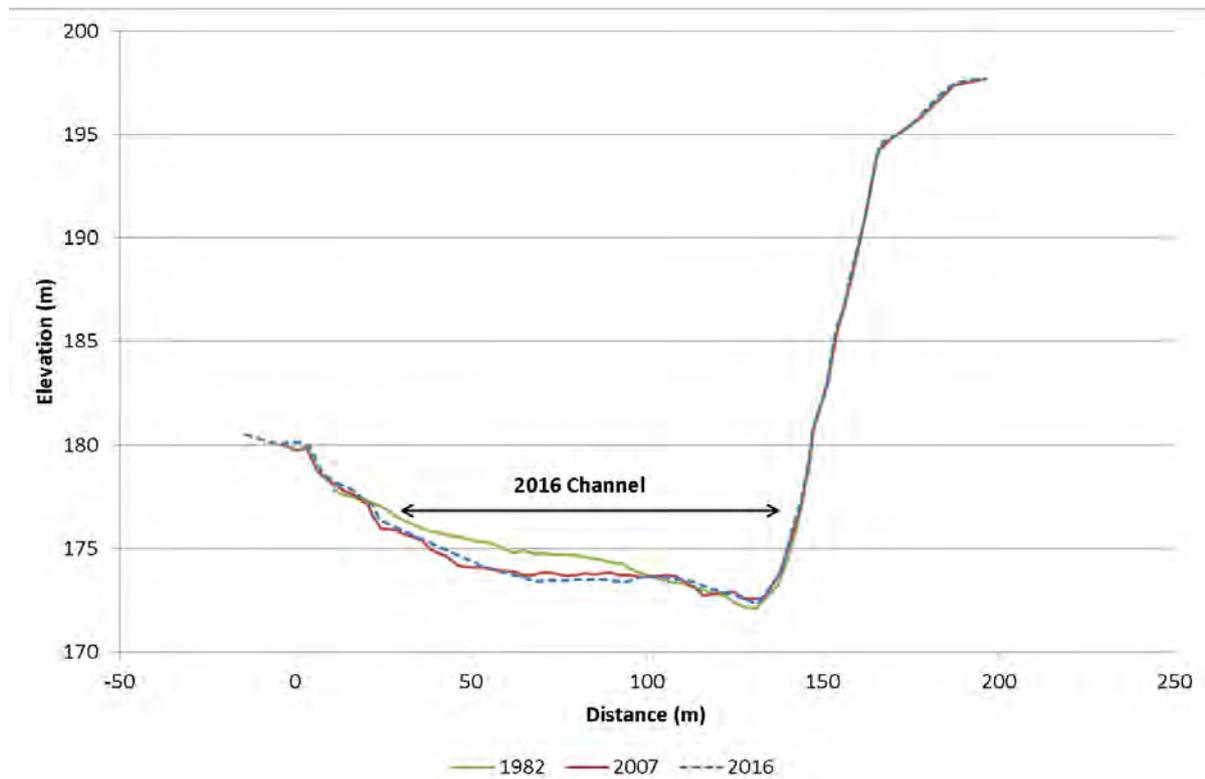
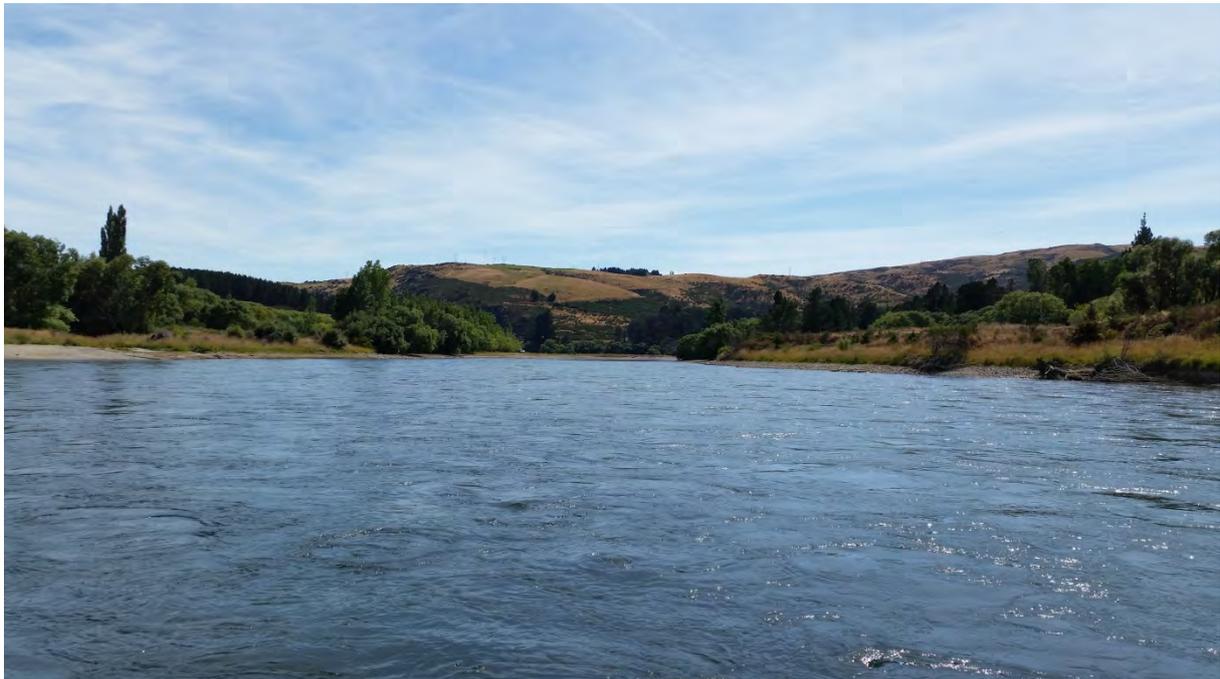
Figure 223. Clutha River/Mata-Au cross-section C38, looking downstream

Figure 224. Clutha River/Mata-Au cross-section C38, looking upstream

Cross-section C38 is located 100.8 km upstream of the Clutha River/Mata-Au bifurcation at Balclutha. The channel has remained similar between 2007 and 2016 with both minor aggradation and degradation occurring.
