Morphology of the Clutha River/Mata- Au between Roxburgh Dam and the Pacific Ocean

March 2017

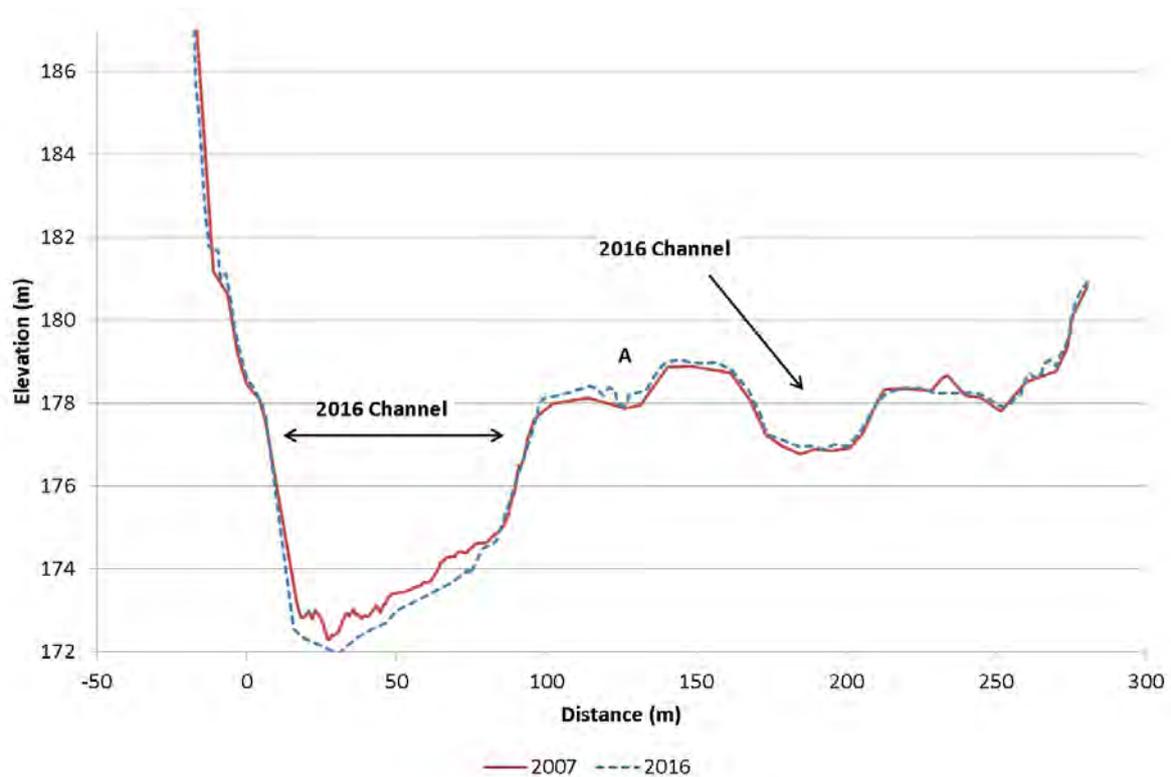
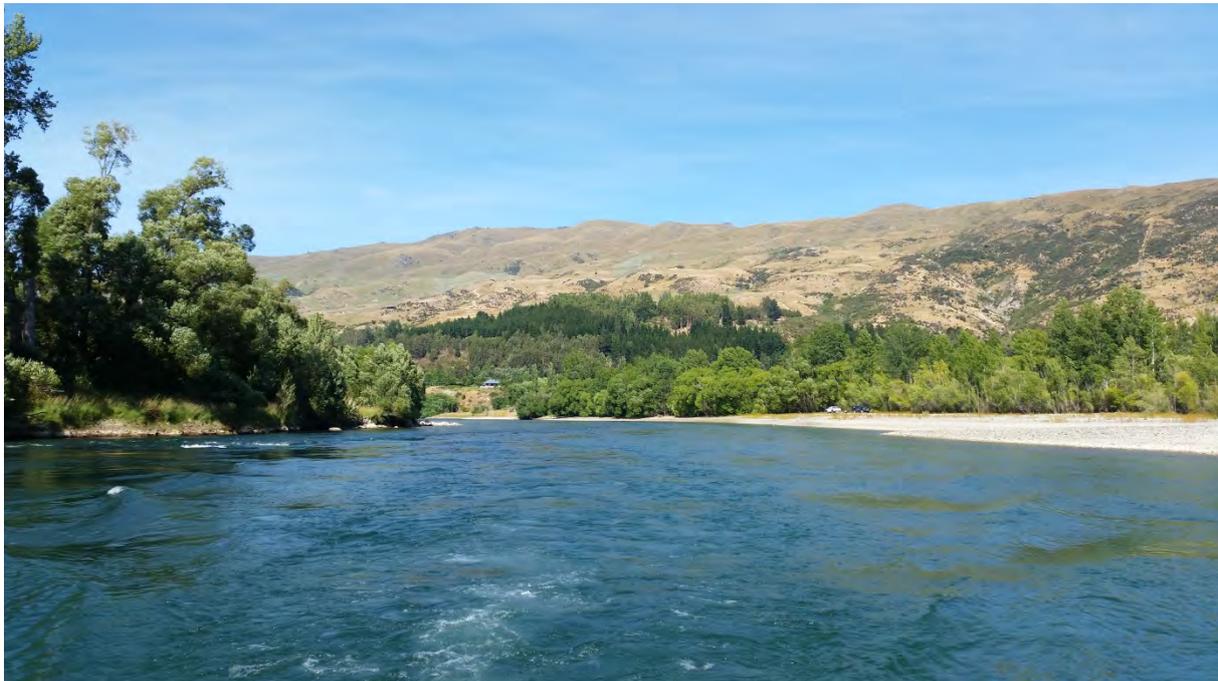
Figure 225. Clutha River/Mata-Au cross-section C39, looking downstream

Figure 226. Clutha River/Mata-Au cross-section C39, looking downstream

Cross-section C39 is located 101.6 km downstream of the Clutha River/Mata-Au bifurcation in Balclutha. At this cross-section a large gravel bar is present (point labelled A) with the channel splitting into two and passing around the bar. Between 2007 and 2016 the true left channel has degraded, and the mid channel bar and true right channel have experienced minor aggradation.

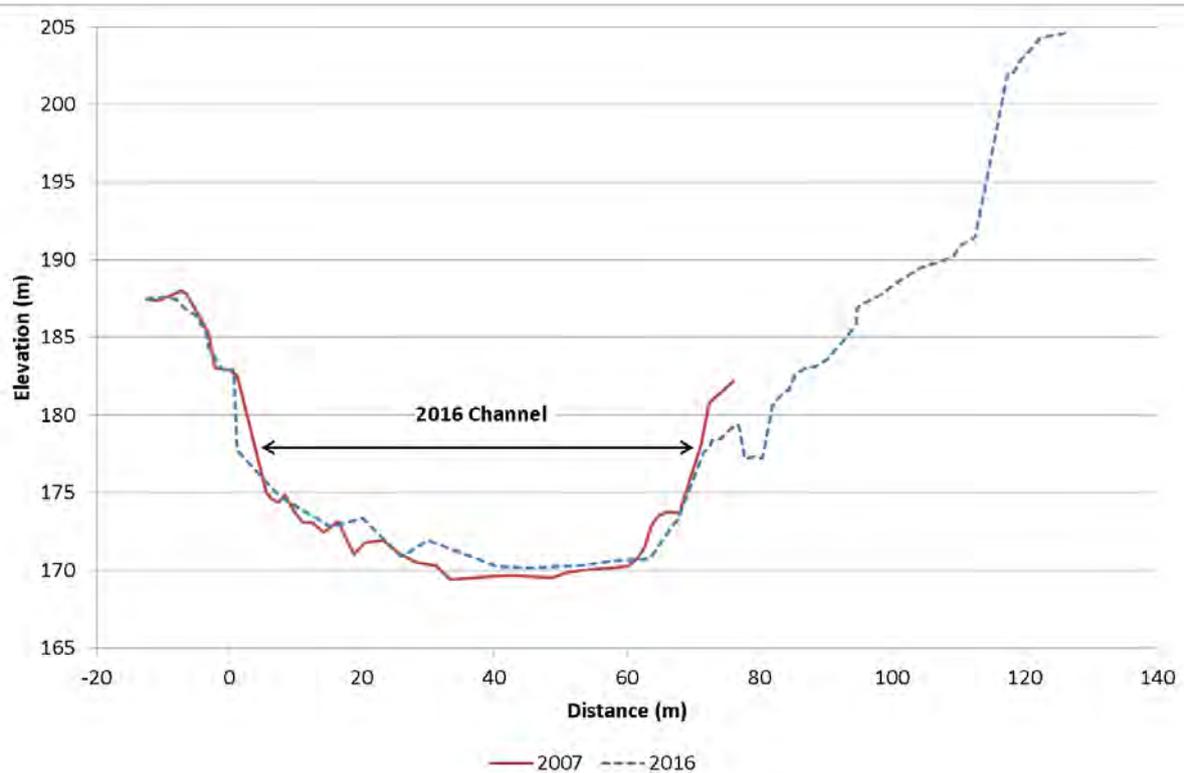
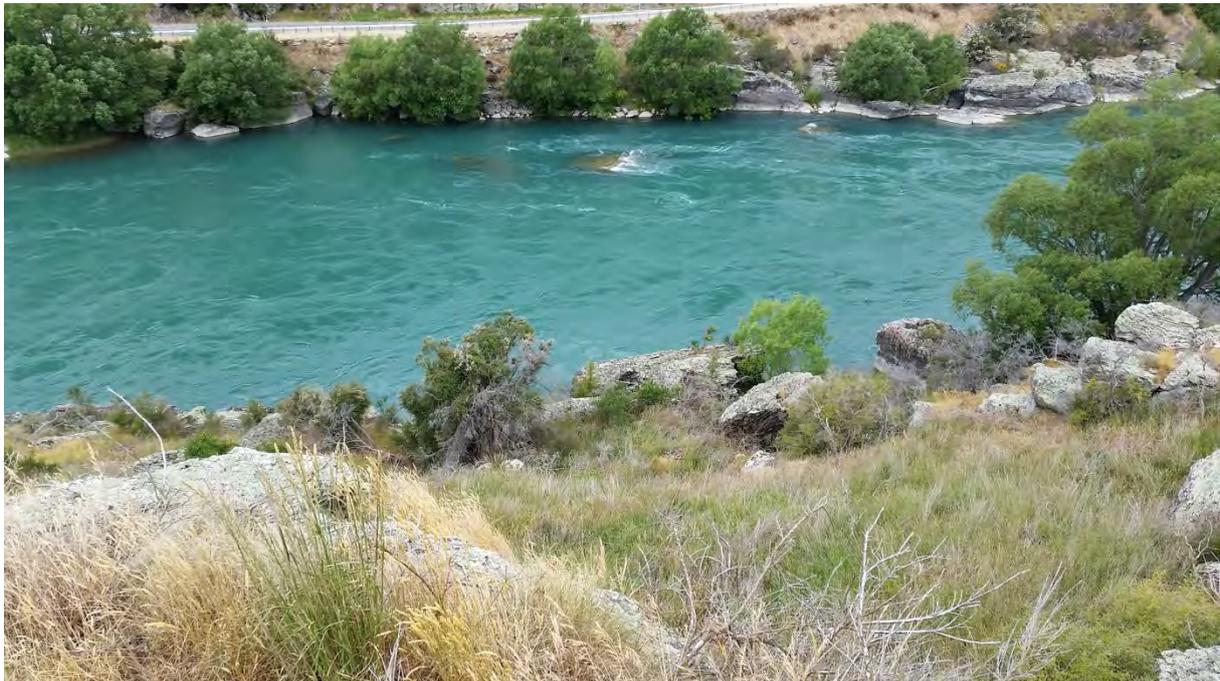
Figure 227. Clutha River/Mata-Au cross-section C40, looking downstream

Figure 228. Clutha River/Mata-Au cross-section C40, looking from true right to left bank

Cross-section C40 is located 102.3 km upstream of the Clutha River/Mata-Au bifurcation at Balclutha. The true left bank has eroded with aggradation occurring across most of the channel bed between 2007 and 2016. The 2007 survey of the true right bank does not contain sufficient survey points to allow a comparison to be made with the 2016 survey.

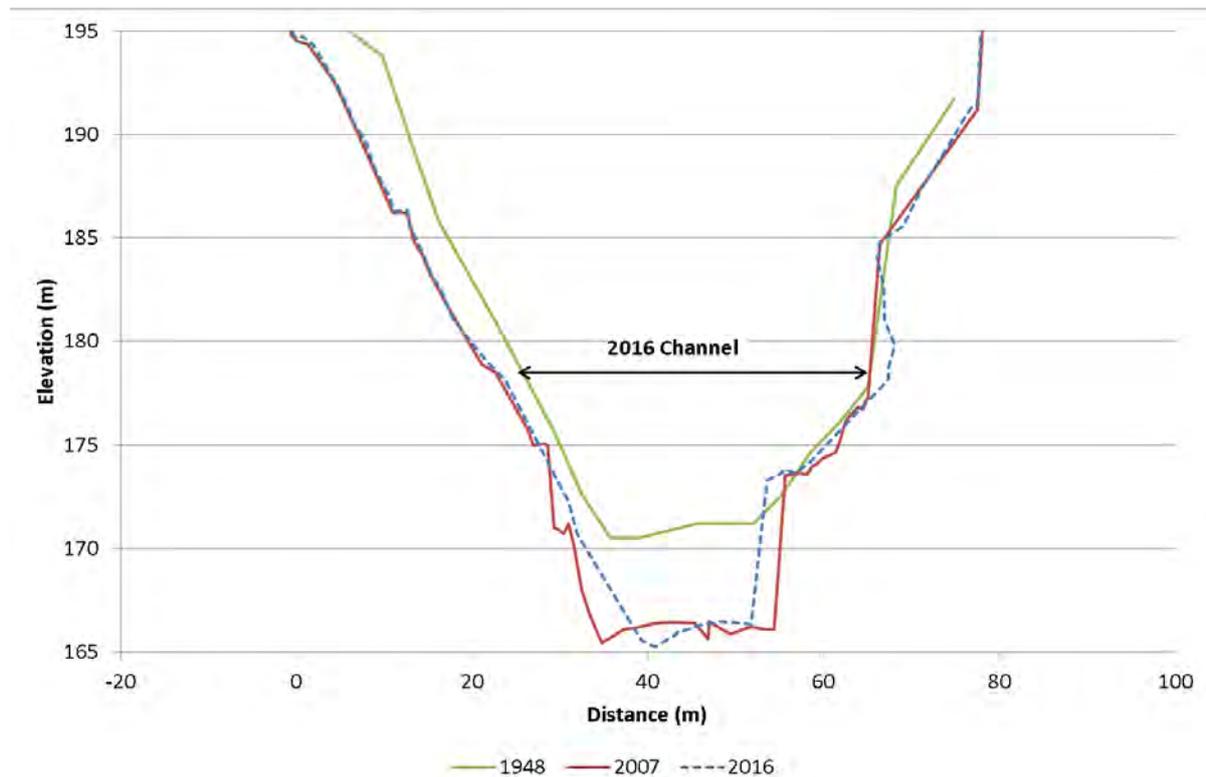
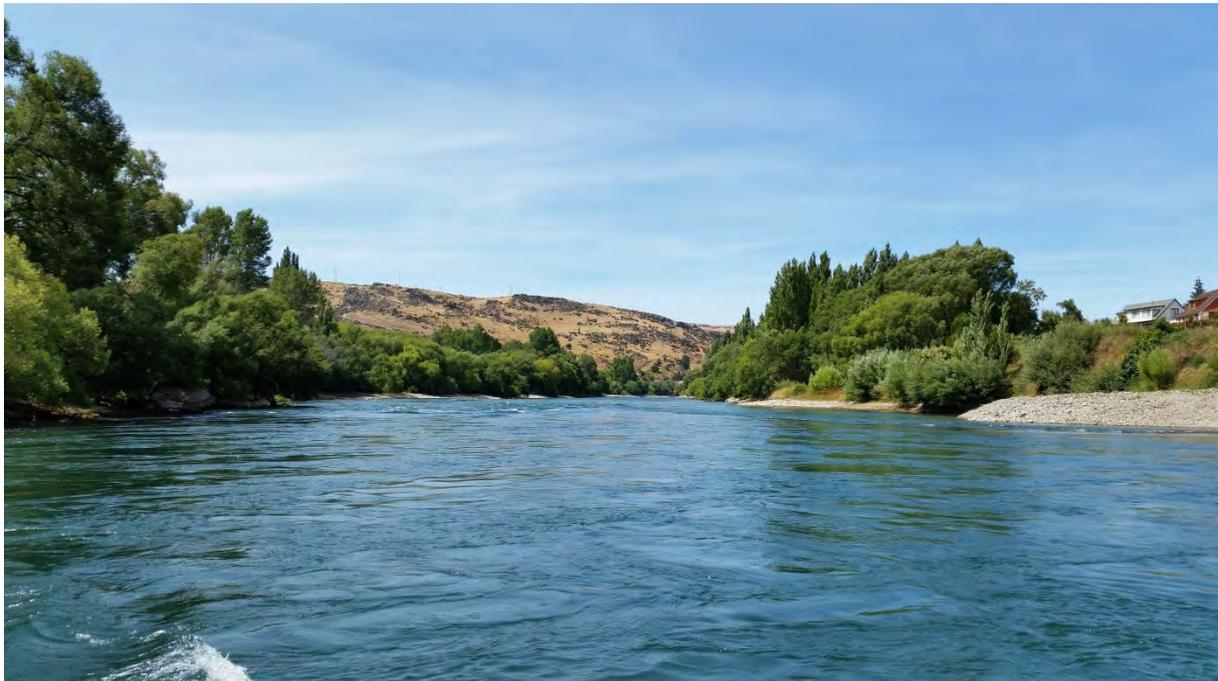
Figure 229. Clutha River/Mata-Au cross-section C41, looking downstream

Figure 230. Clutha River/Mata-Au cross-section C41, looking downstream

Cross-section C41 is located 103 km upstream of the Clutha River/Mata-Au bifurcation at Balclutha and is situated at the Roxburgh township bridge. The channel has become more confined with aggradation occurring on the true left and right banks between 2007 and 2016, the centre of the channel has degraded between this period.

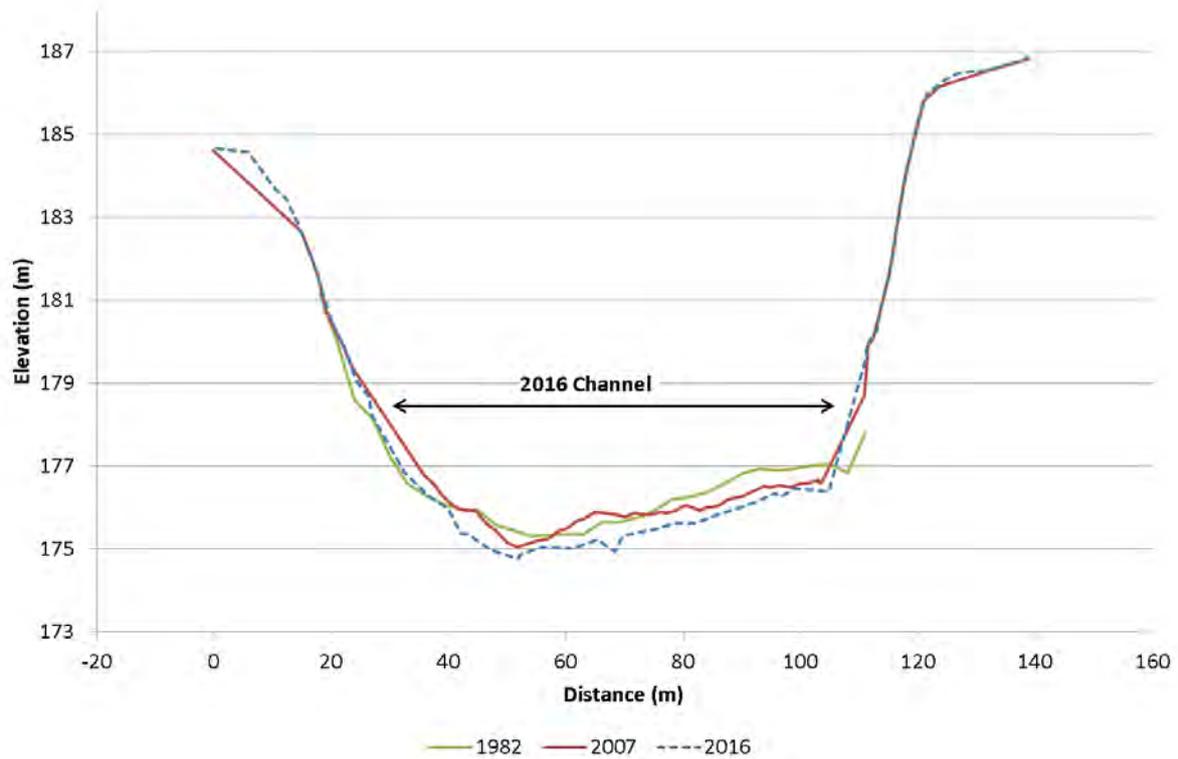
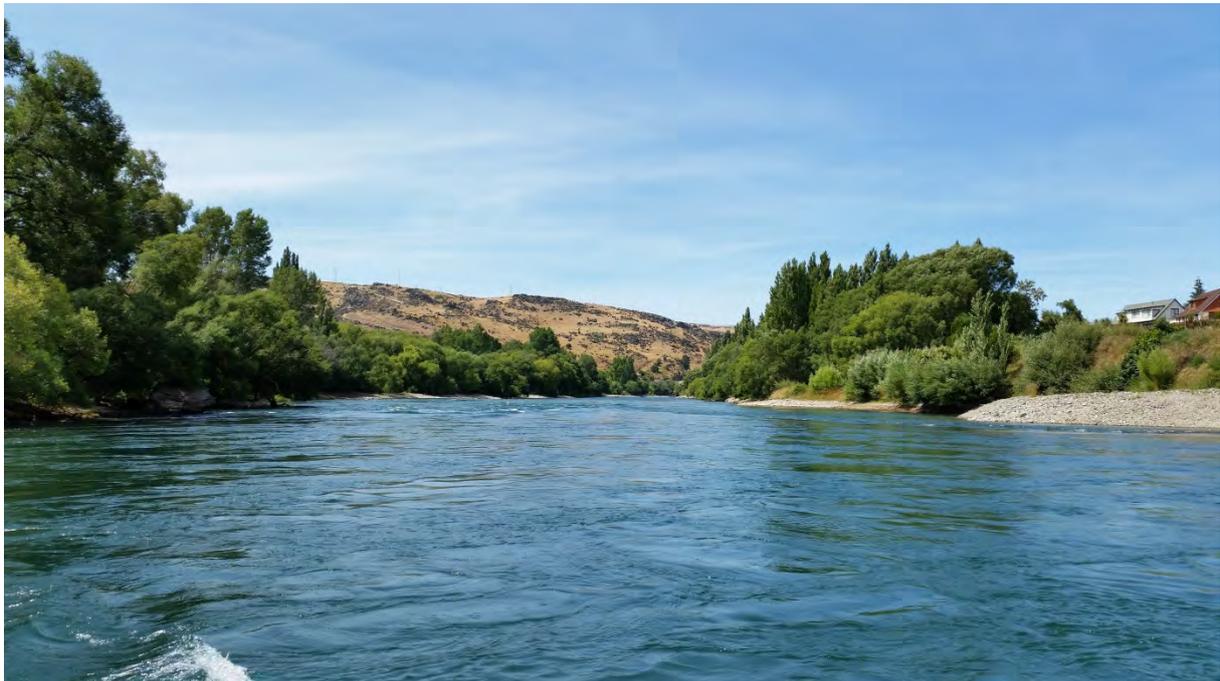
Figure 231. Clutha River/Mata-Au cross-section C42, looking downstream

Figure 232. Clutha River/Mata-Au cross-section C42, looking downstream

Cross-section C42 is located 104.3 km upstream of the Clutha River/Mata-Au bifurcation at Balclutha. Between 2007 and 2016 the channel has degraded with the true left and right banks remaining in a similar position.

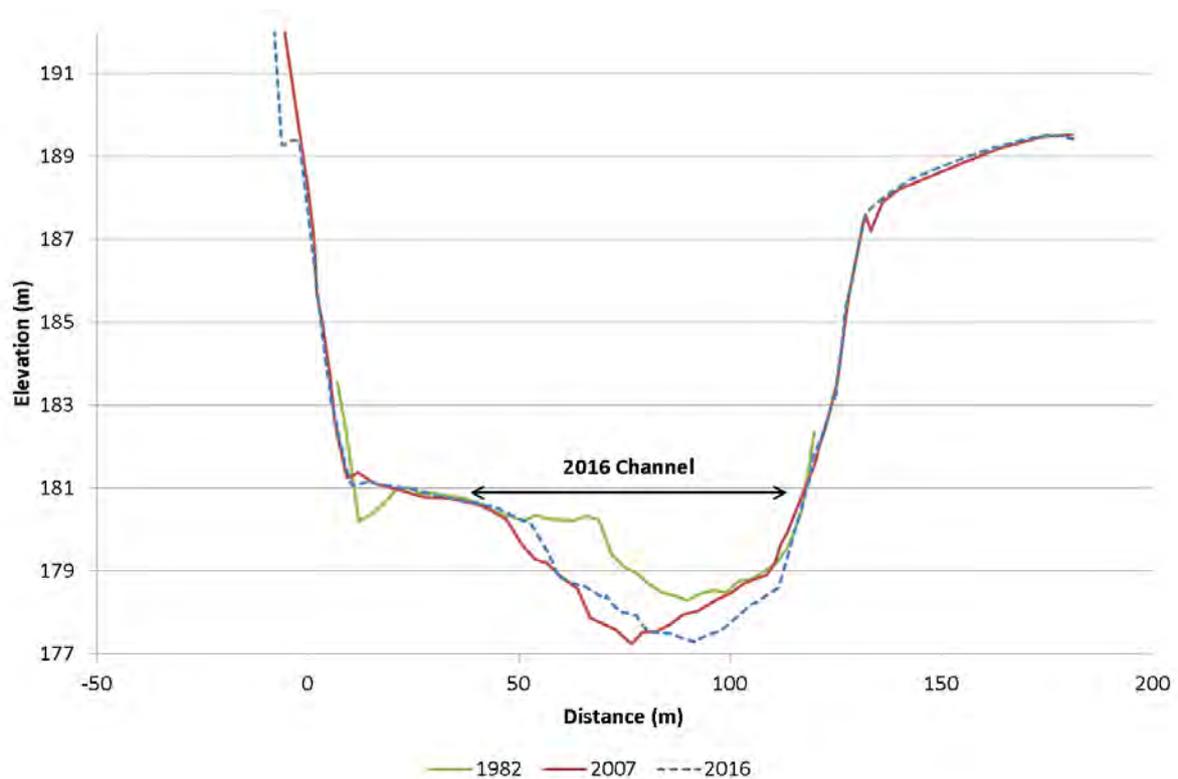
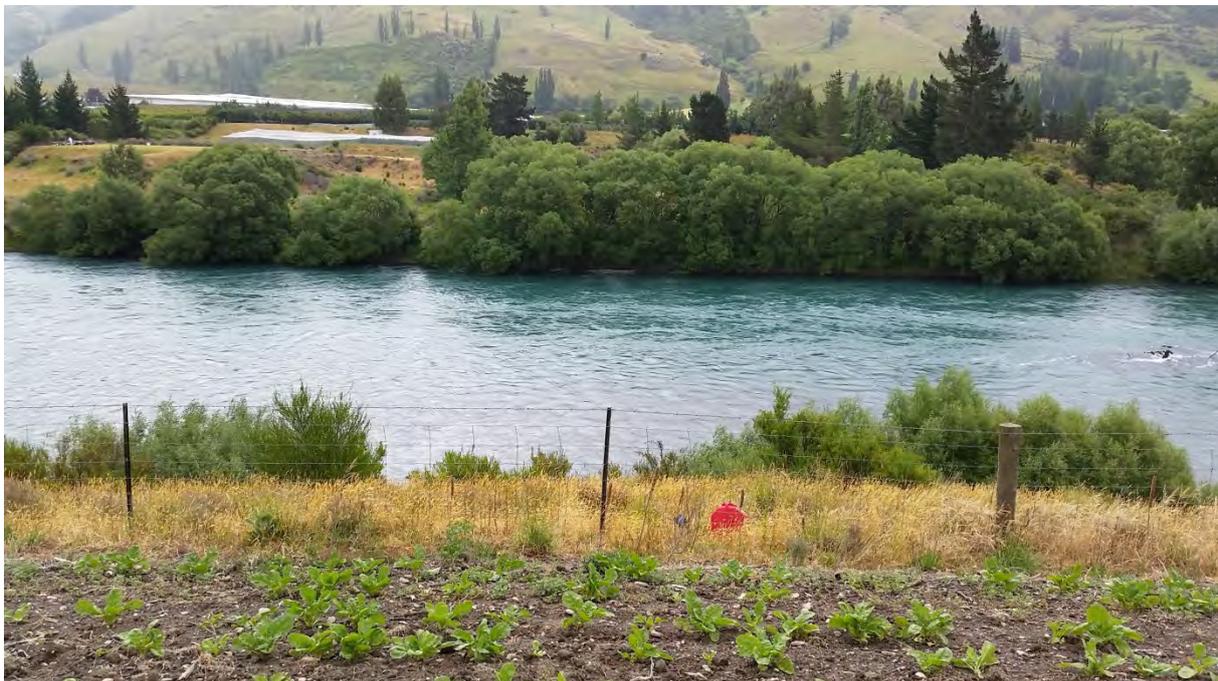
Figure 233. Clutha River/Mata-Au cross-section C43, looking downstream

Figure 234. Clutha River/Mata-Au cross-section C43, looking from true left to right bank

Cross-section C43 is located 107.2 km upstream of the Clutha River/Mata-Au bifurcation at Balclutha. The thalweg section of the channel has moved towards the true right bank between 2007 and 2016 with aggradation occurring on the true left of the channel and degradation on the true right.

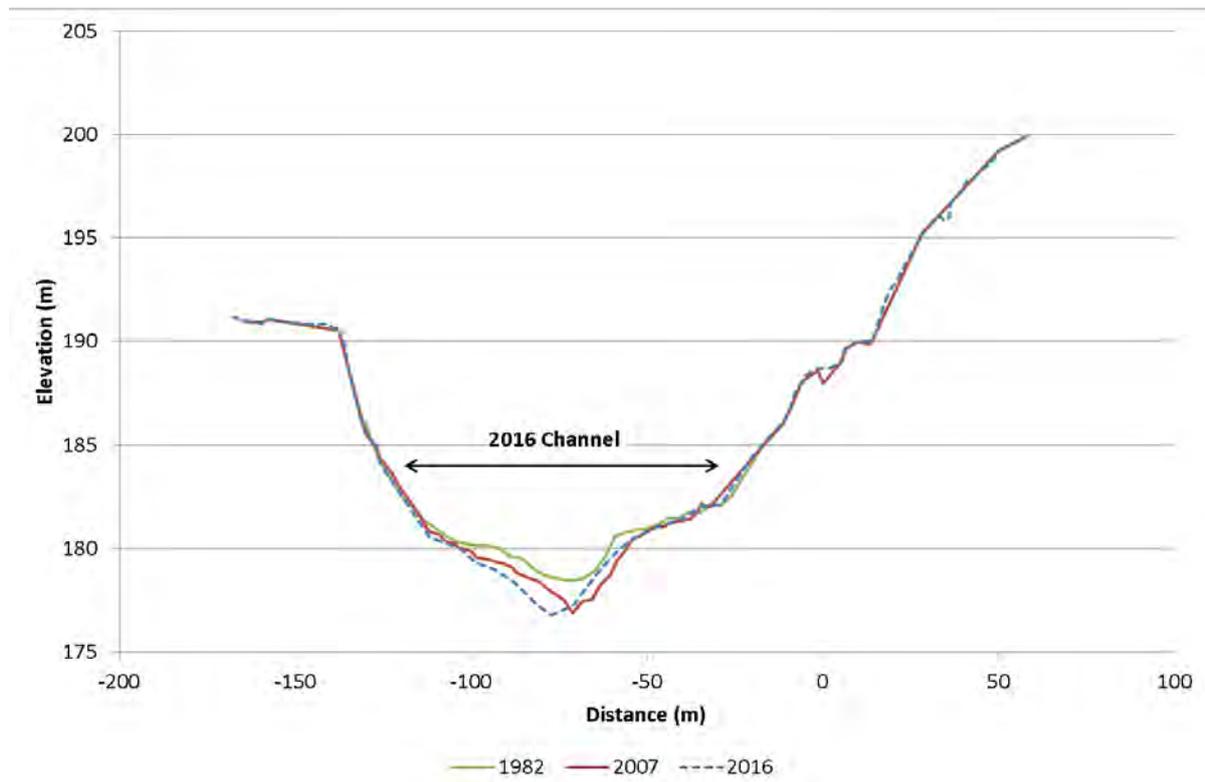
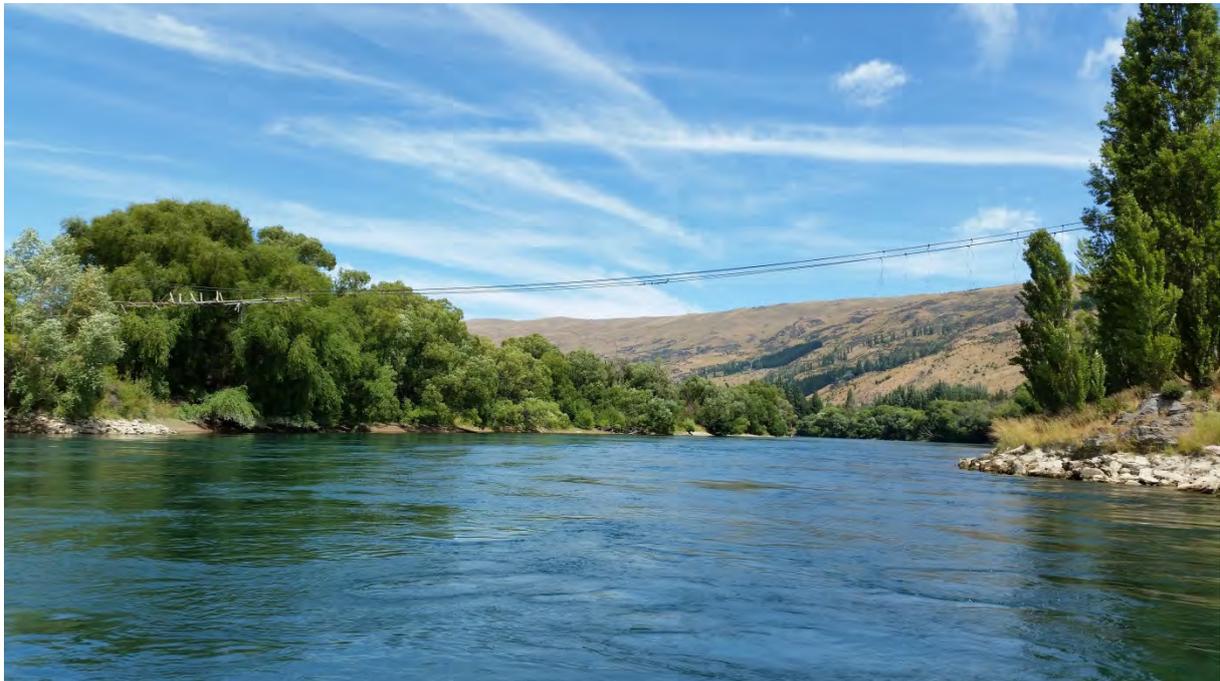
Figure 235. Clutha River/Mata-Au cross-section C44, looking downstream

Figure 236. Clutha River/Mata-Au cross-section C44, looking downstream

Cross-section C44 is located 110.3 km upstream of the Clutha River/Mata-Au bifurcation at Balclutha. Between 2007 and 2016 the thalweg section of the channel has moved towards and eroded the true left channel bank, the thalweg has remained in the same vertical position. The true right of the channel has aggraded with the wider floodplain remaining similar between 2007 and 2016.

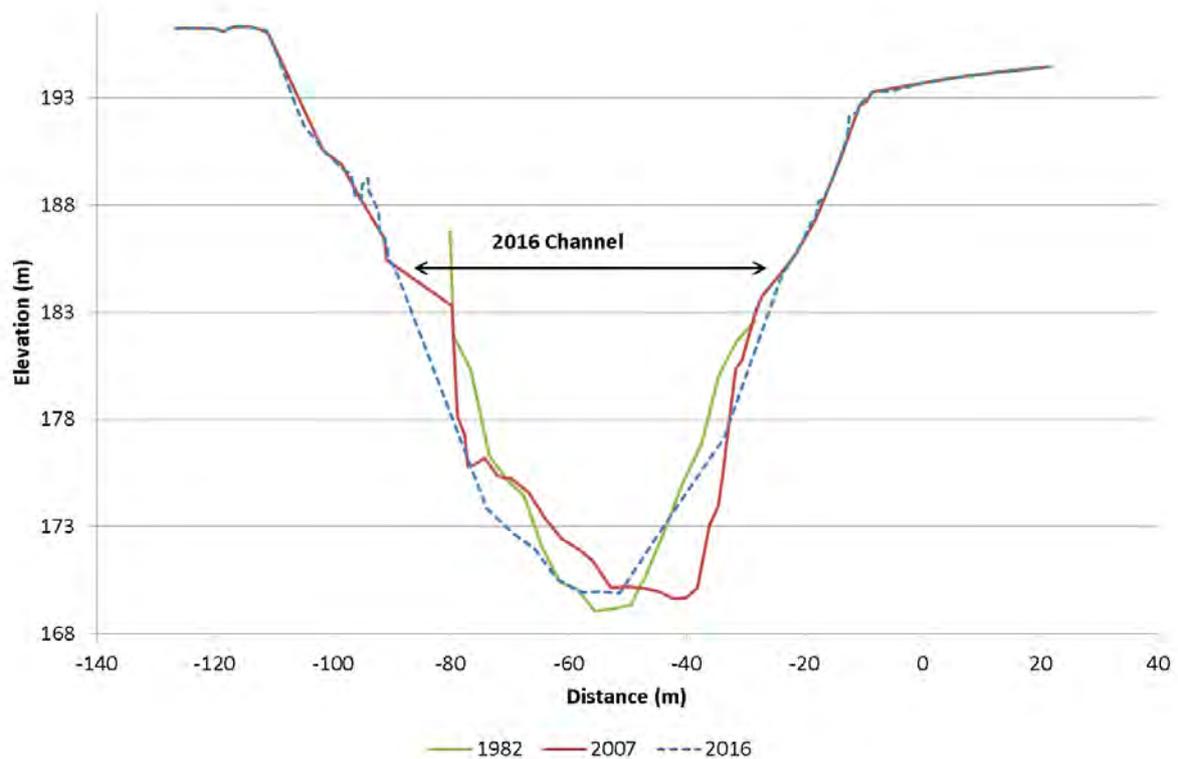
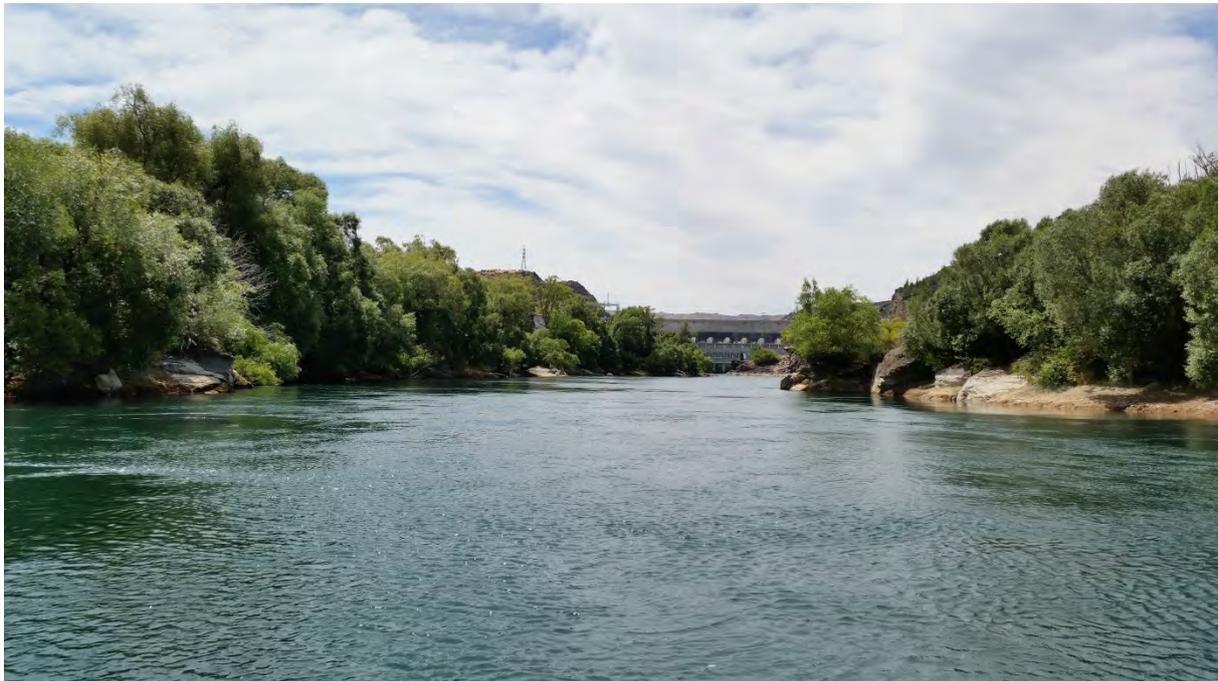
Figure 237. Clutha River/Mata-Au cross-section C45, looking downstream

Figure 238. Clutha River/Mata-Au cross-section C45, looking upstream

Cross-section C45 is located 111.2 km upstream of the Clutha River/Mata-Au bifurcation at Balclutha and is situated 0.8 km downstream of the Roxburgh Dam which can be seen in Figure 238. The channel has moved towards and eroded the true left bank with aggradation occurring on the true right bank between 2007 and 2016. The wider floodplain has remained similar between 2007 and 2016.
