Channel Morphology and Sedimentation in the Shag River, North Otago

Published November 2009

This report explores how the morphology and sedimentation of the Shag River has changed over the surveyed periods, while providing a synthesis of the study's results to guide river management into the future.

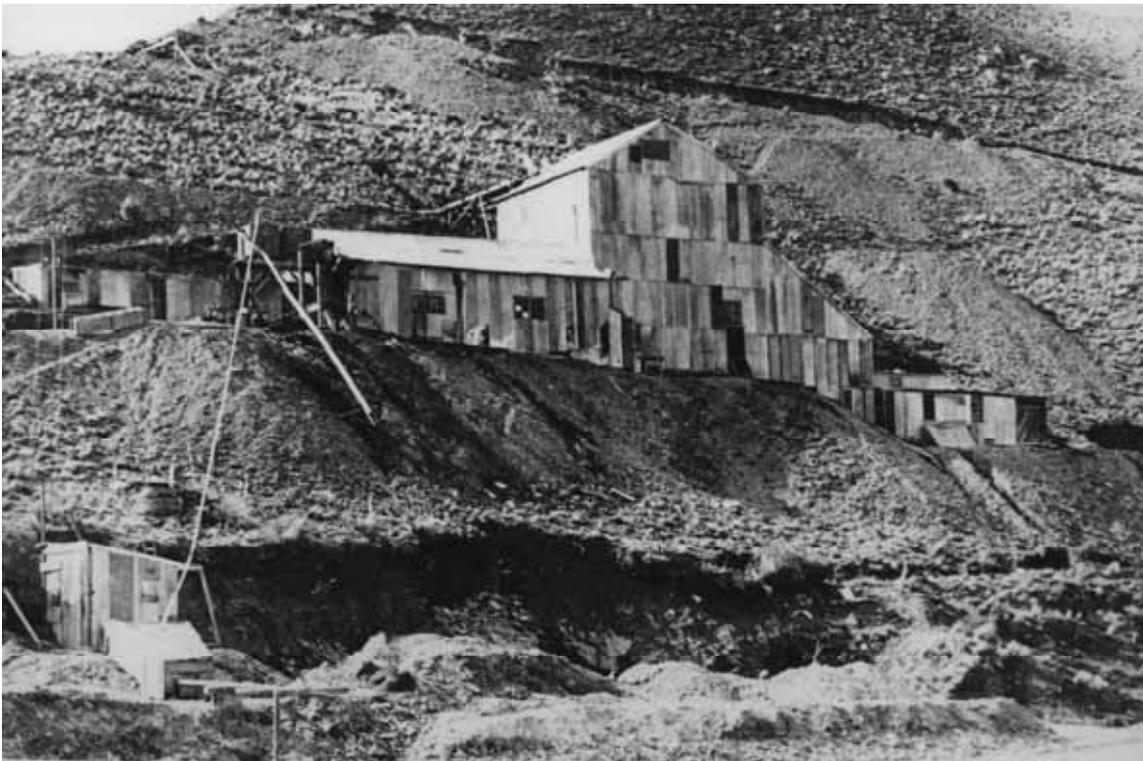
Extensive gold mining operations in the Shag River Catchment mainly occurred in Deepdell Creek, the largest tributary of the Shag River, between 1890 and 1946 (Figure 2.3) (Black et al, 2004). Black et al (2004) estimated that discharged mine tailings contributed one hundred times (at least 85,000 tonnes) more sediment to Deepdell Creek than otherwise would naturally occur over this period.

Figure 2.3 A gold mining battery located in the Deepdell Creek Catchment during the 1890s. Image courtesy of Hocken Library Collections
