Cardrona River Channel Morphology

May 2016

Otago Regional Council

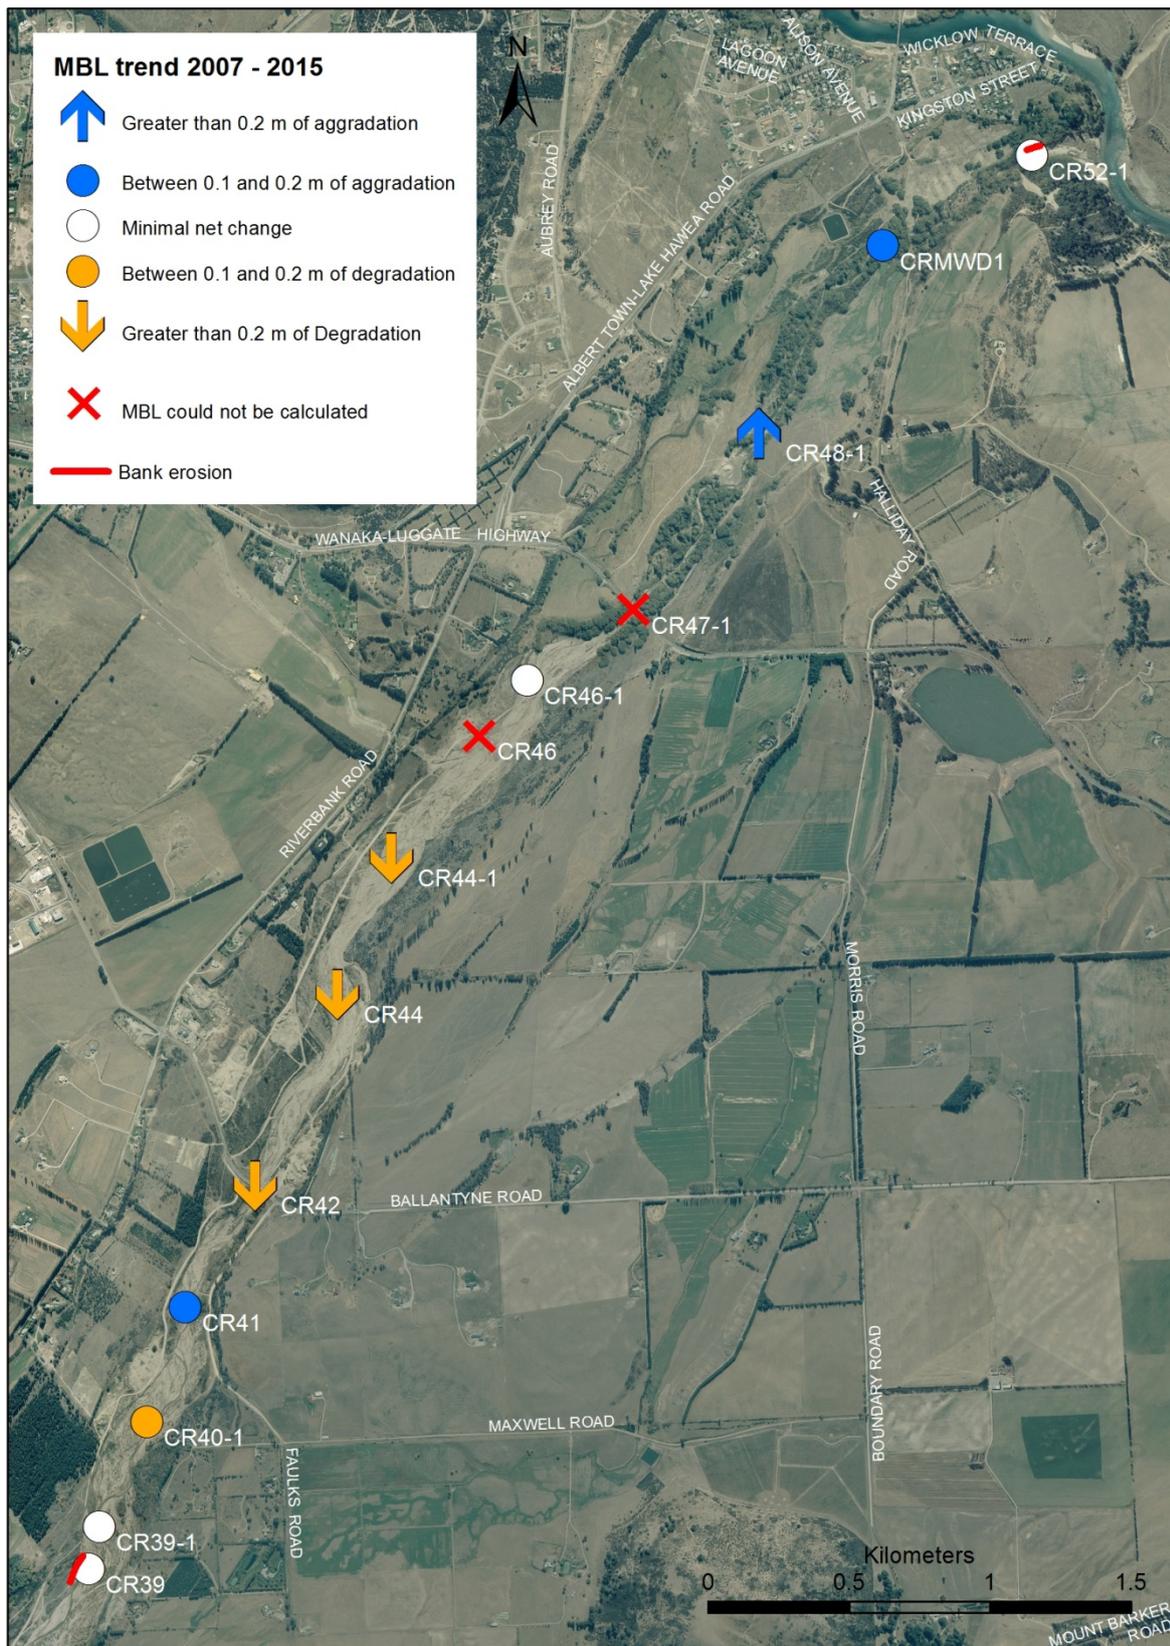
For the most recent survey period (2007 to 2015) the lower reaches of the surveyed reach of the Cardrona River (cross-section CR39 to CR52-1) (Figure 4) experienced areas of aggradation, degradation, and areas of minimal change. MBL changes could not be calculated for two cross-sections in the lowest reach (CR47-1 and CR46).

Figure 4. Location of Cardrona River cross-sections. The white, orange, and blue symbols show the magnitude of MBL change at each cross-section between 2007 and 2015. Locations where significant bank erosion has been observed are shown as red lines, a red cross indicates a cross-section where MBL could not be calculated. Individual cross-sections are shown in Appendix 3.

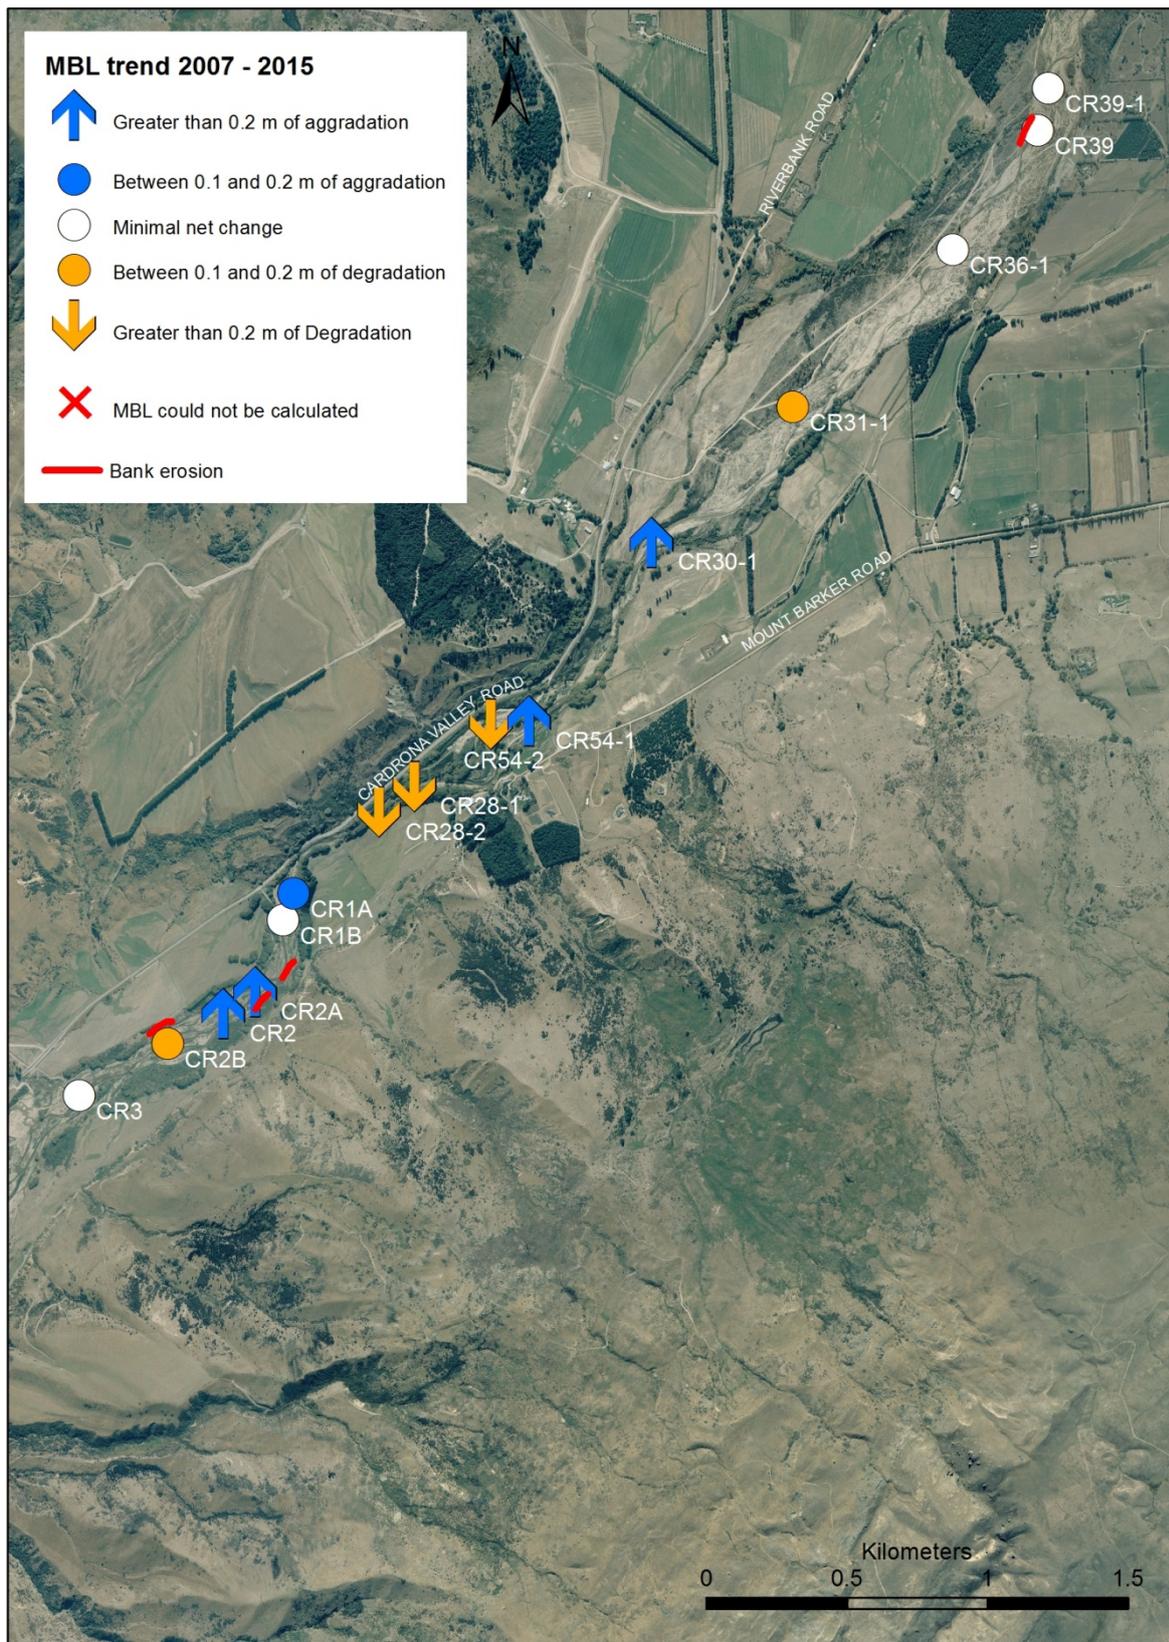
The reach of the Cardrona River between cross-section CR3 and CR39 (Figure 5) experienced areas of aggradation, degradation, and minimal change between 2007 and 2015, areas of degradation were at the downstream end of the reach while areas of aggradation were located at the upstream end (Figure 5).

Figure 5 Location of Cardrona River cross-sections. The white, orange, and blue symbols show the magnitude of MBL change at each cross-section between 2007 and 2015. Locations where significant bank erosion has been observed are shown as red lines, a red cross indicates a cross-section where MBL could not be calculated. Individual cross-sections are shown in Appendix 3.

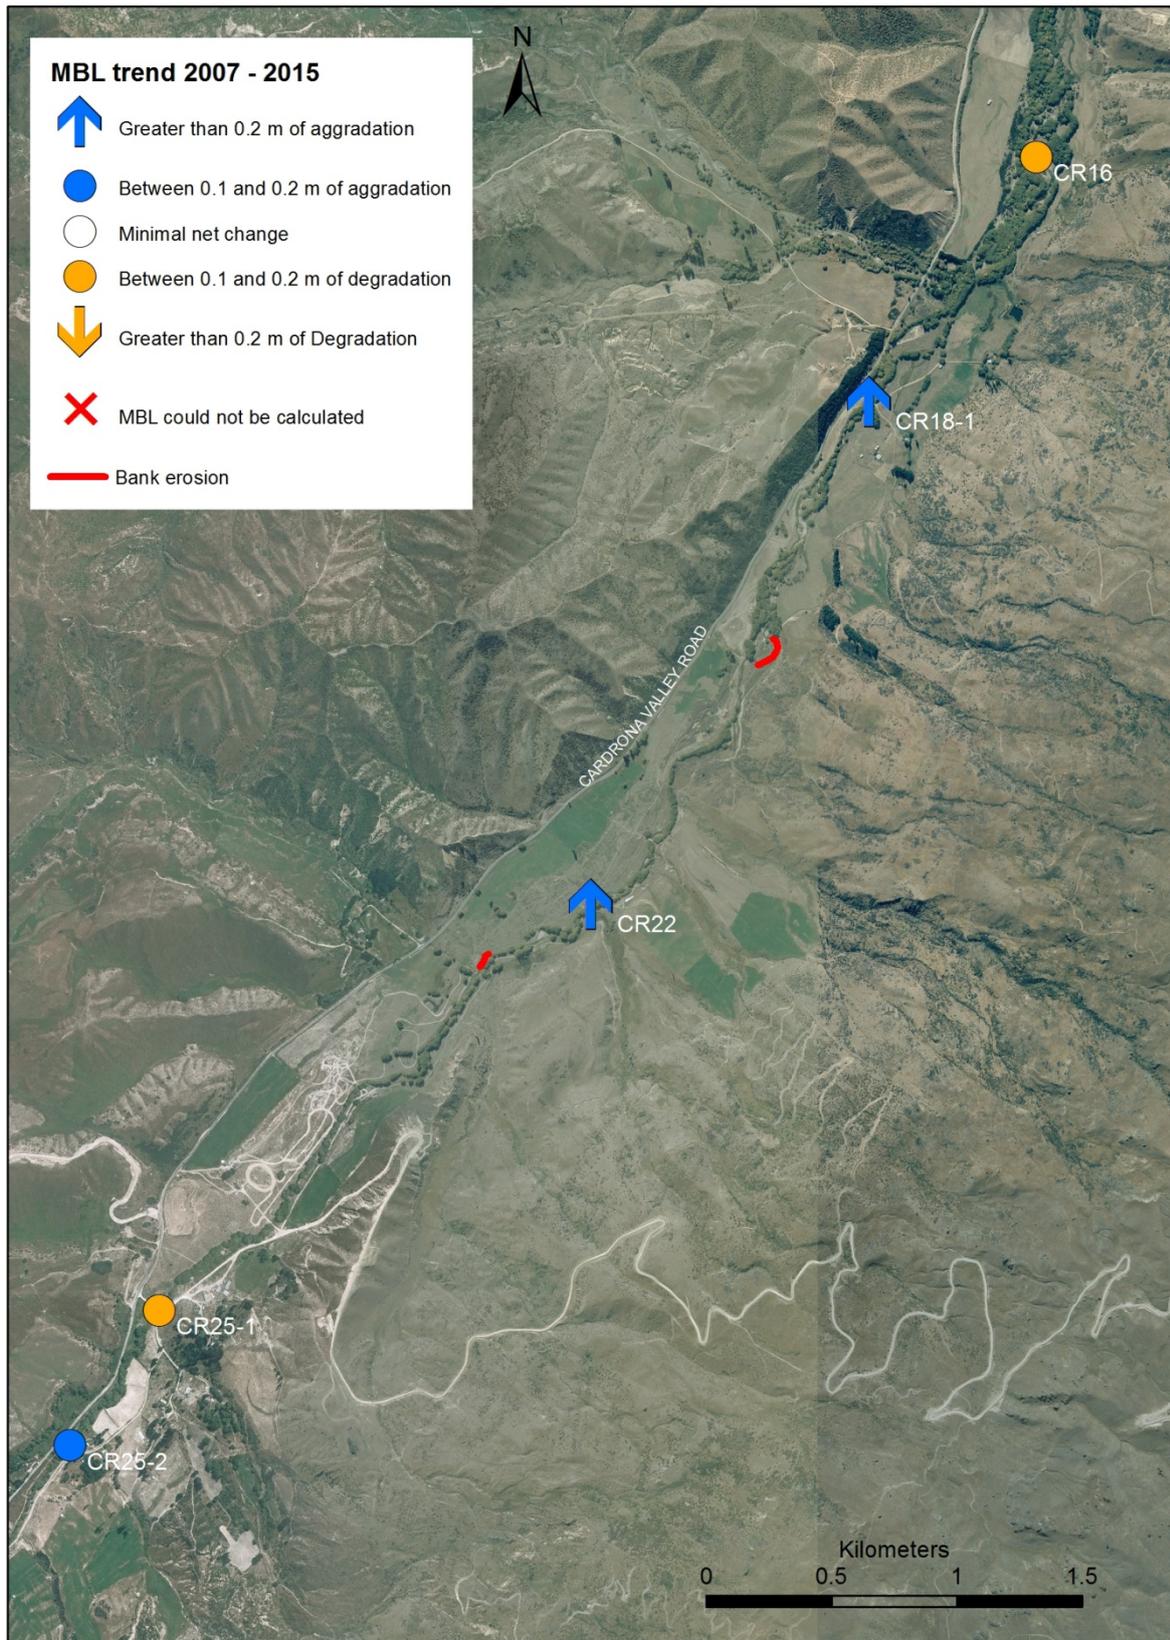
Between 2007 and 2015 the reach of the Cardrona River between cross-section CR25-2 and CR16 (Figure 7) experienced greater than 0.2 m of aggradation at two of the five cross-sections with two sections experiencing degradation (CR25-1, CR16).

Figure 7. Location of Cardrona River cross-sections. The white, orange, and blue symbols show the magnitude of MBL change at each cross-section between 2007 and 2015. Locations where significant bank erosion has been observed are shown as red lines, a red cross indicates a cross-section where MBL could not be calculated. Individual cross-sections are shown in Appendix 3.

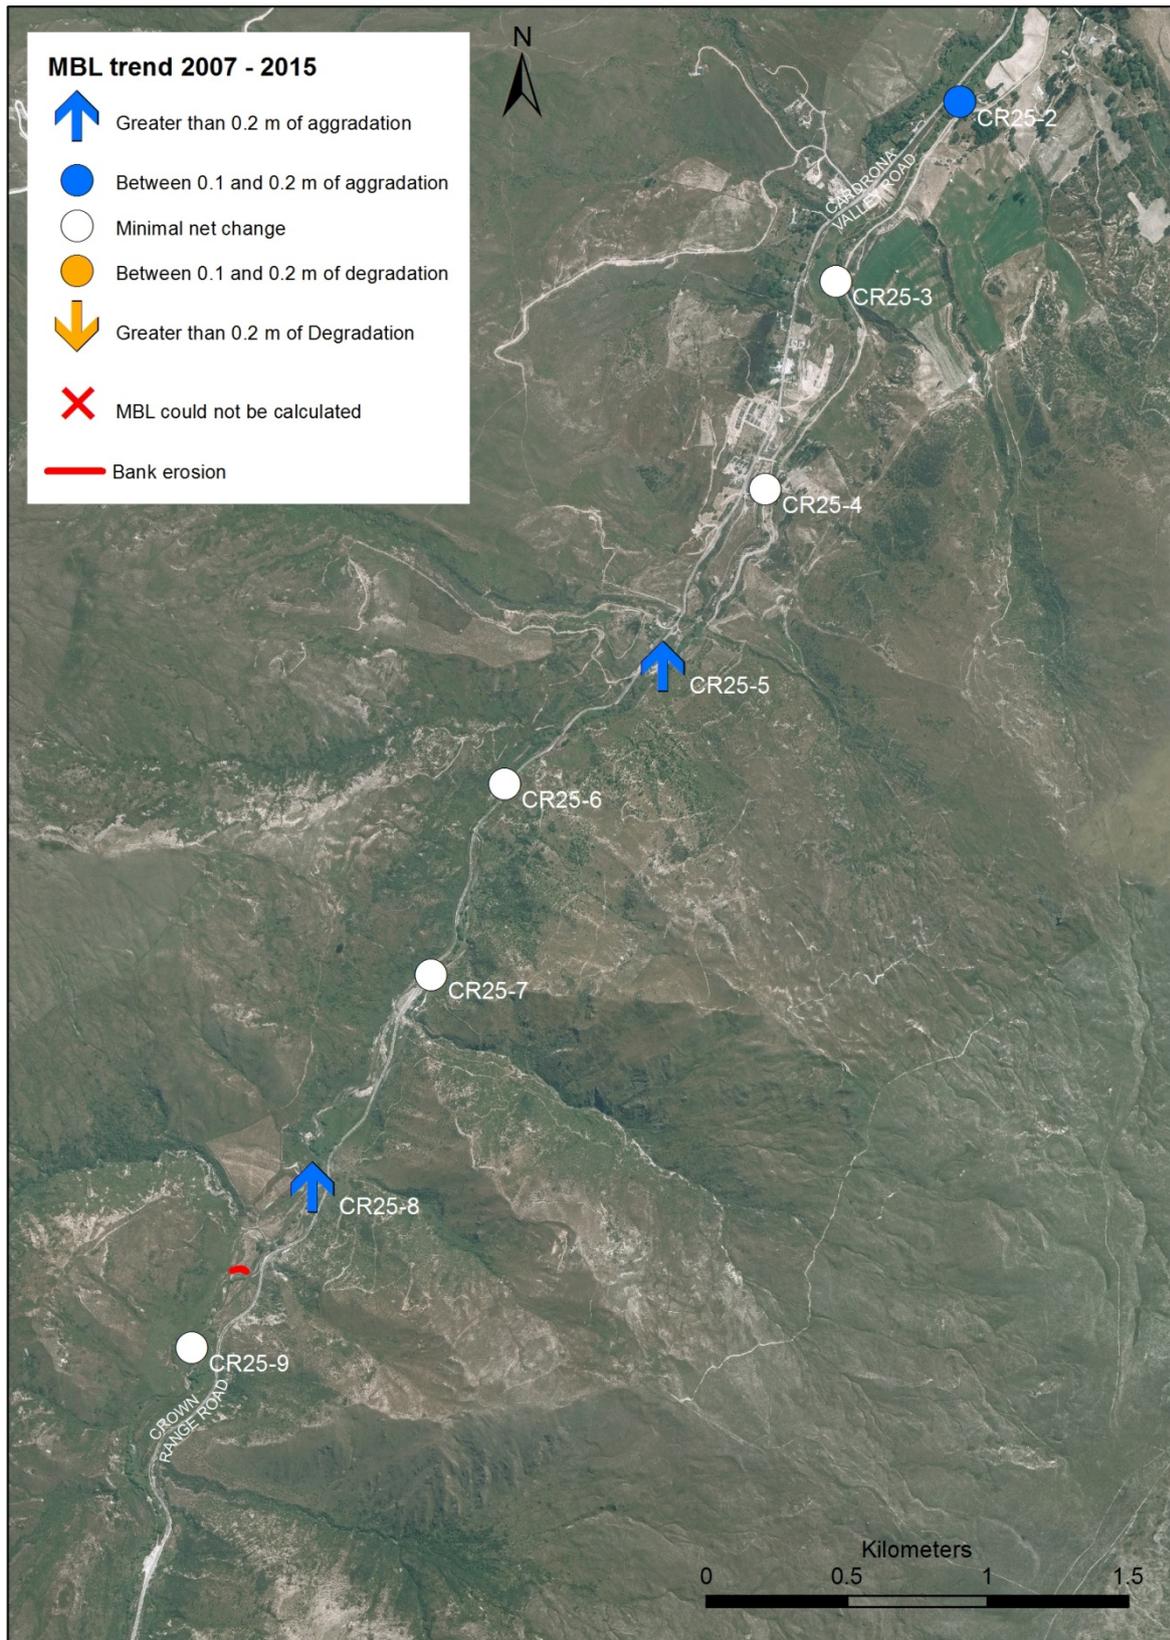
Cross-sections in the upper reaches of the Cardrona River (cross-section CR25-9 to CR25-3) (Figure 8) experienced minimal change in MBL or aggradation at all seven of the surveyed cross-section locations.

Figure 8. Location of Cardrona River cross-sections. The white, orange, and blue symbols show the magnitude of MBL change at each cross-section between 2007 and 2015. Locations where significant bank erosion has been observed are shown as red lines, a red cross indicates a cross-section where MBL could not be calculated. Individual cross-sections are shown in Appendix 3.

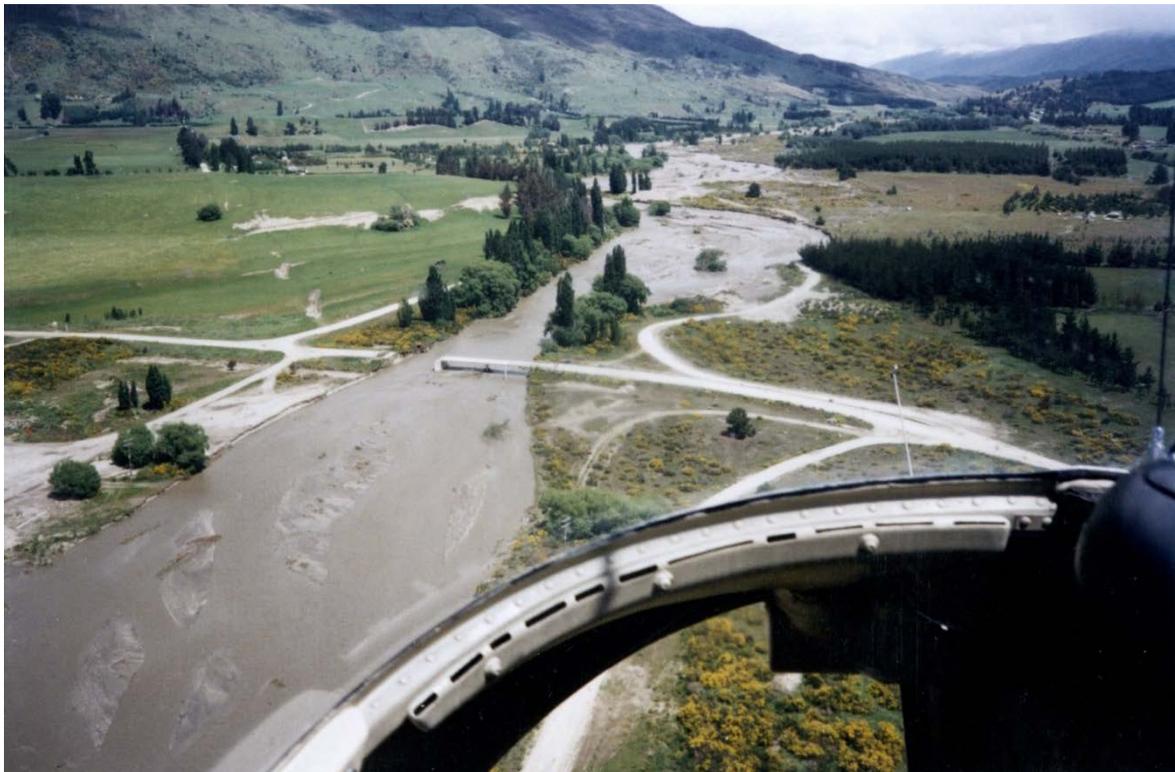
experienced big flood events in the past with the November 1999 event being the largest on record at the Albert Town flow recorder (Figure 11). The November 1999 event caused significant damage to the bed and banks of the Cardrona River as well as destroying the Ballantyne Road bridge (Figure 12). The mapped flood hazard area for the Cardrona River can be seen in the ORC report '*Natural Hazards in the Cardrona Valley*' (2010).

Figure 12. Ballantyne Road bridge (Cardrona River), looking upstream (photography taken after the peak of the flood, November 1999)

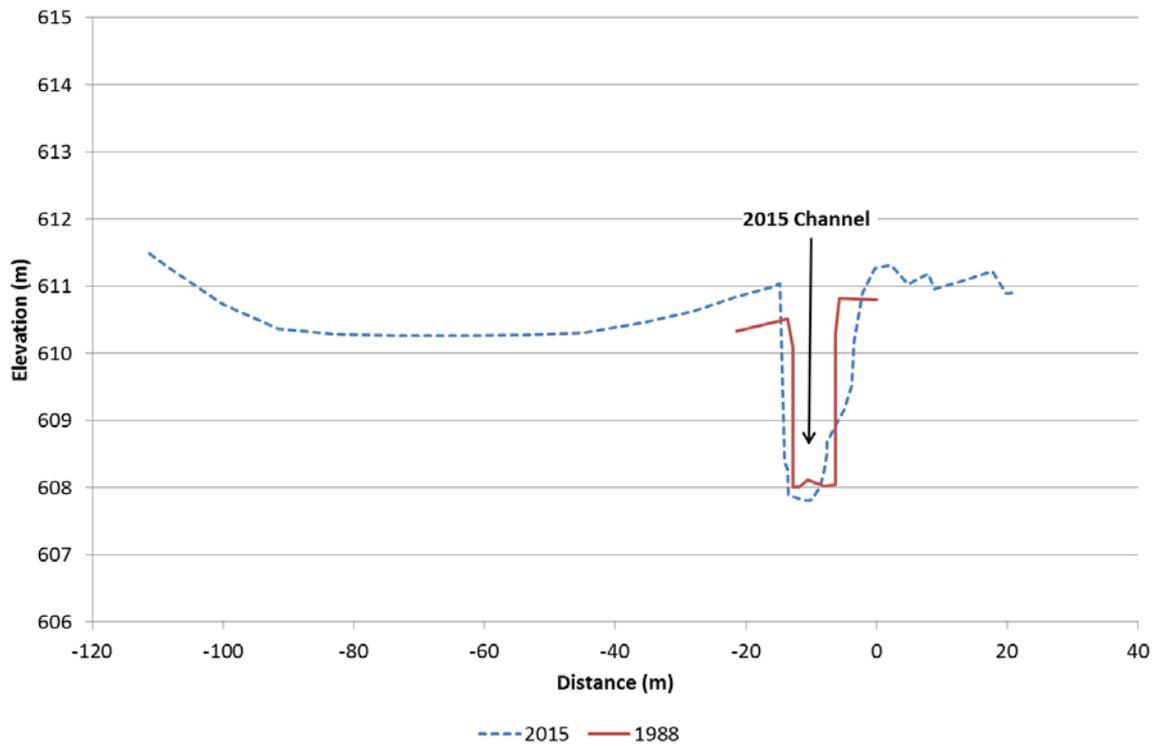
Figure 14. Cardrona River cross-section CR25-1, looking downstream, refer to Figure 7 for location.

Cross-section CR25-1 is located 26.5 km upstream of the confluence with the Clutha River/Mata-Au. Between 2003 and 2015 the main channel has experienced degradation. Aggradation has occurred on the true left channel bank between 2003 and 2015 with degradation occurring on the wider true left and right bank floodplain between 2007 and 2015.

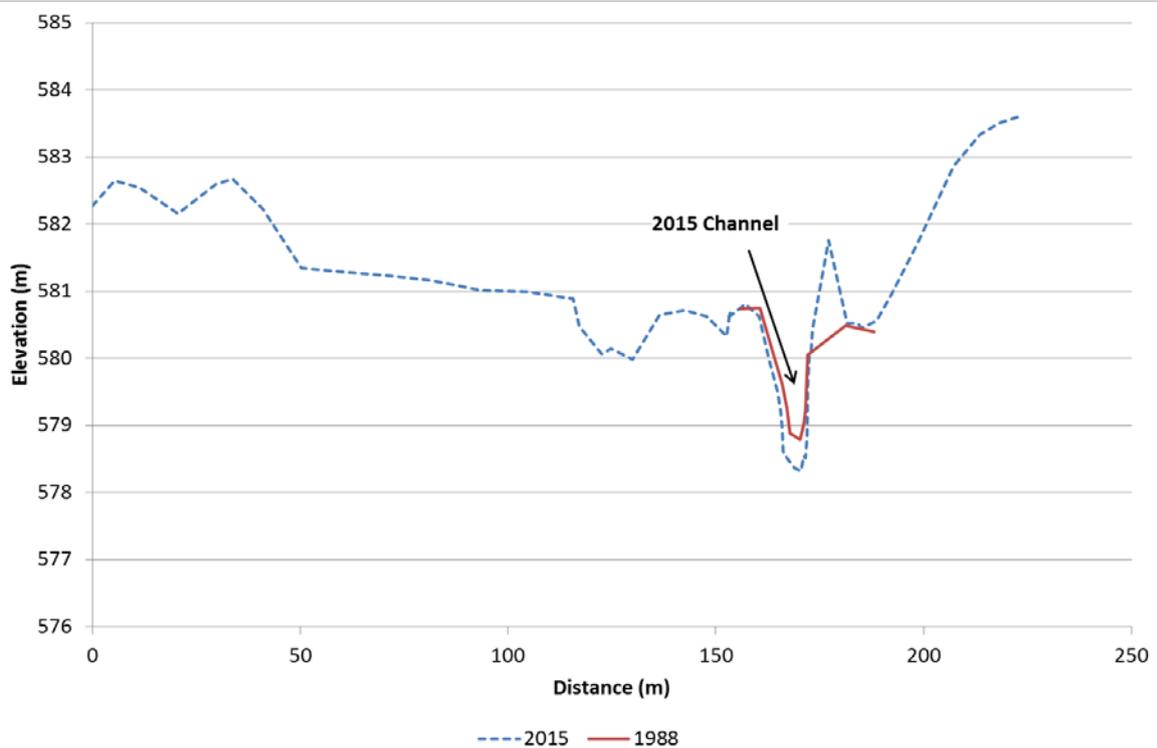
Figure 15. Cardrona River cross-section CR22, looking downstream, refer to Figure 7 for location.

Cross-section CR22 is located 24.1 km upstream of the confluence with the Clutha River/Mata-Au. The main channel has degraded between 2003 and 2015 with the creation of a feature at the point labelled A. Bank erosion occurred on the true right bank between 2003 and 2015.

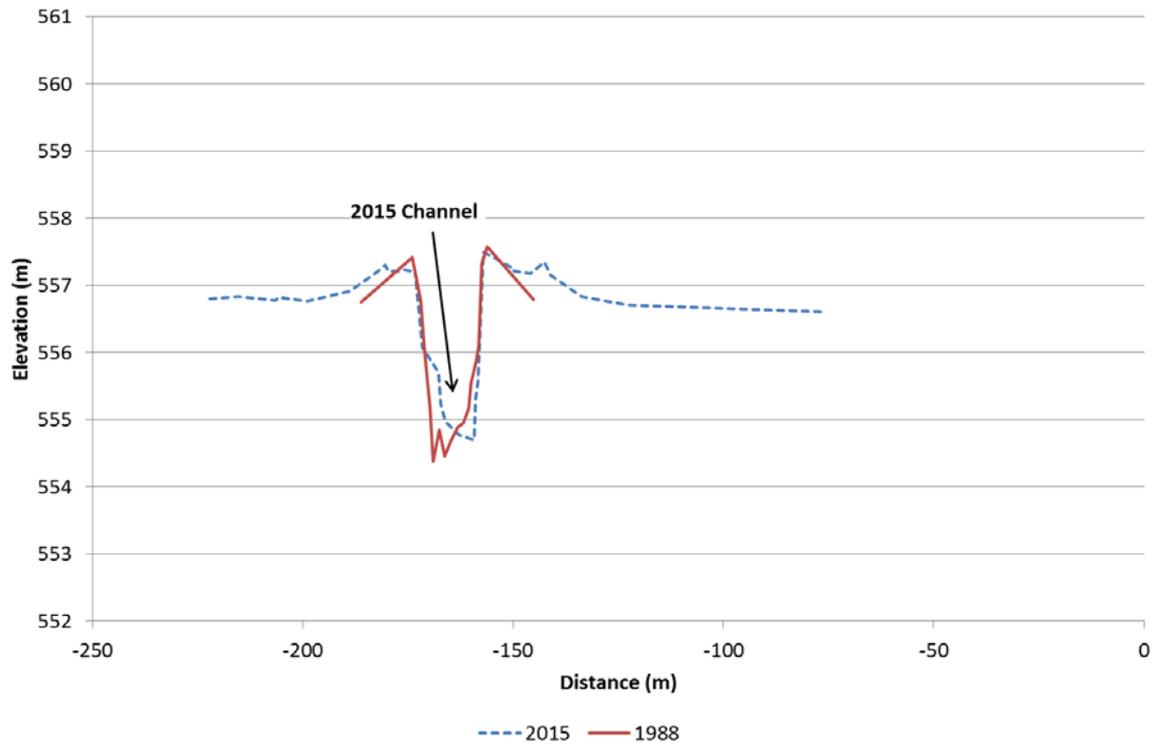
Figure 16. Cardrona River cross-section CR18-1, looking downstream, refer to Figure 7 for location.

Cross-section CR18-1 is located 21.74 km upstream of the confluence with the Clutha River/Mata-Au. The channel has aggraded between 2003 and 2015 but has remained in a similar position between 2007 and 2015. The true right floodplain has aggraded between 2003 and 2015. The true left floodplain has degraded between 2003 and 2015 but has remained in a similar position between 2007 and 2015.

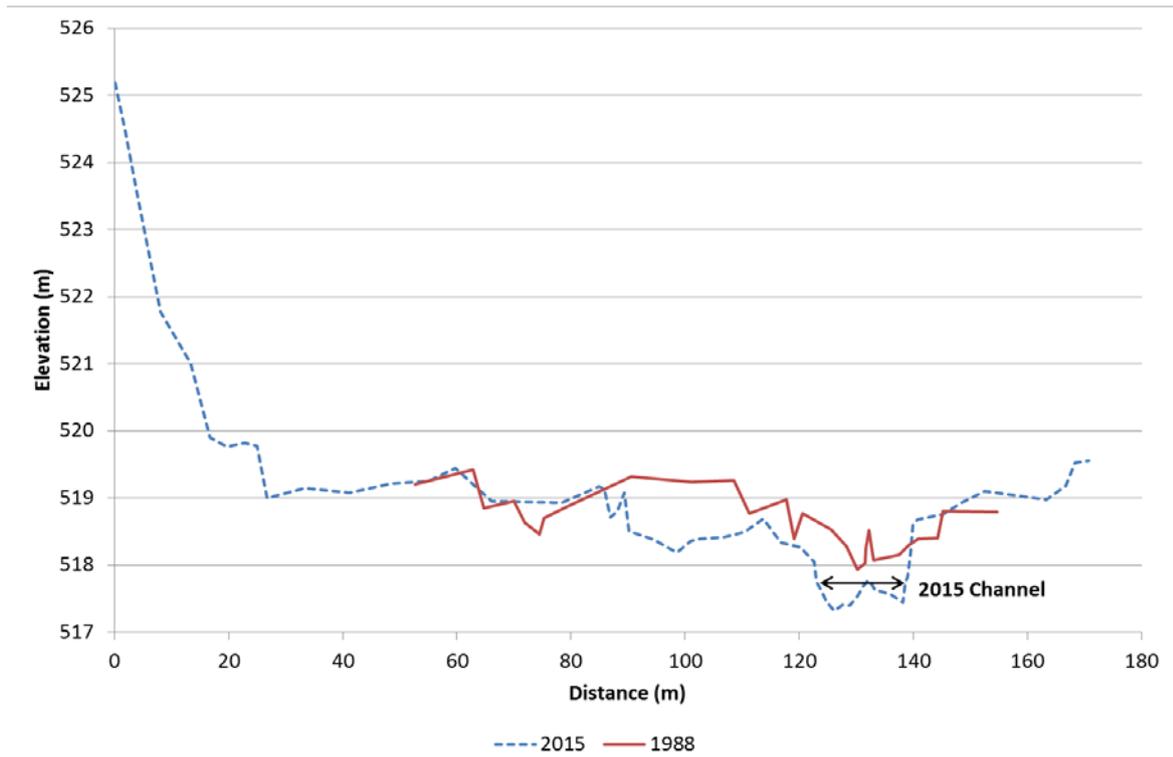
Figure 18. Cardrona River cross-section CR11-1, looking downstream, refer to Figure 6 for location.

Cross-section CR11-1 is located 17.5 km upstream of the confluence with the Clutha River/Mata-Au. Between 2003 and 2015 the main channel has degraded and become more confined. The true left floodplain has aggraded between 2007 and 2015.

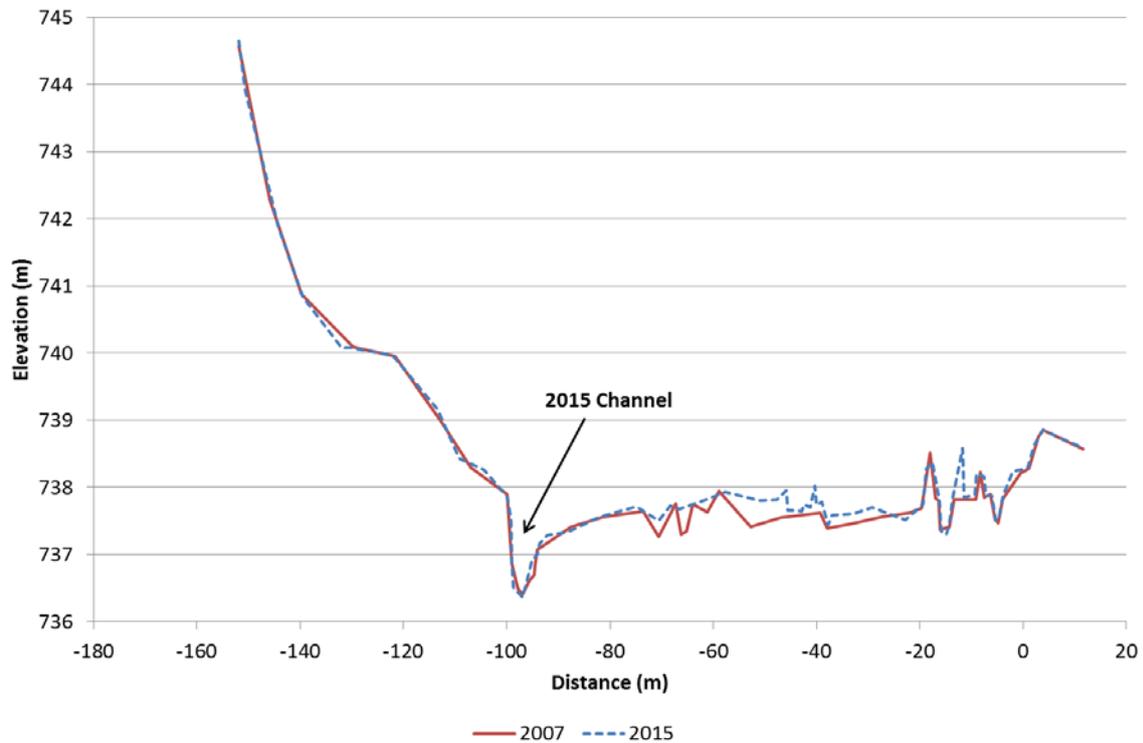
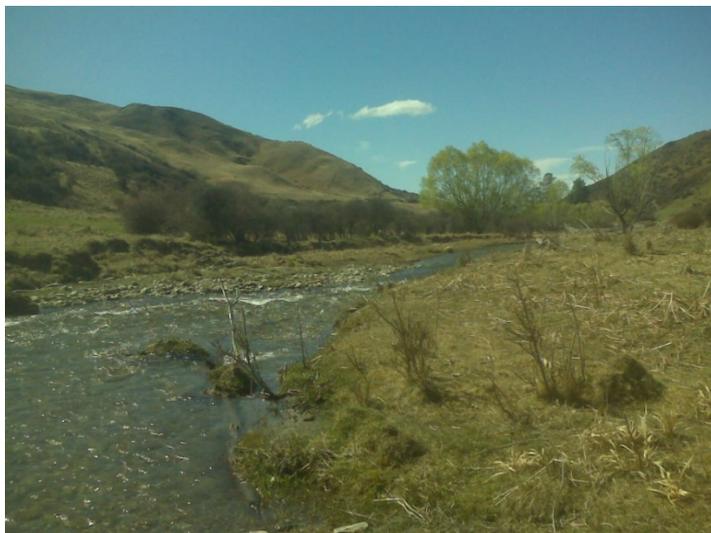
Cardrona River cross-section CR25-9

Figure 42. Cardrona River cross-section CR25-9, looking downstream refer to Figure 8 for location

Figure 43. Cardrona River cross-section CR25-9, looking downstream, November 2015

Cross-section CR25-9 is located 32.8 km upstream of the confluence with the Clutha River/Mata-Au and is the most upstream survey location. The channel has remained in the same position between 2007 and 2015. The true right floodplain has aggraded between 2007 and 2015.

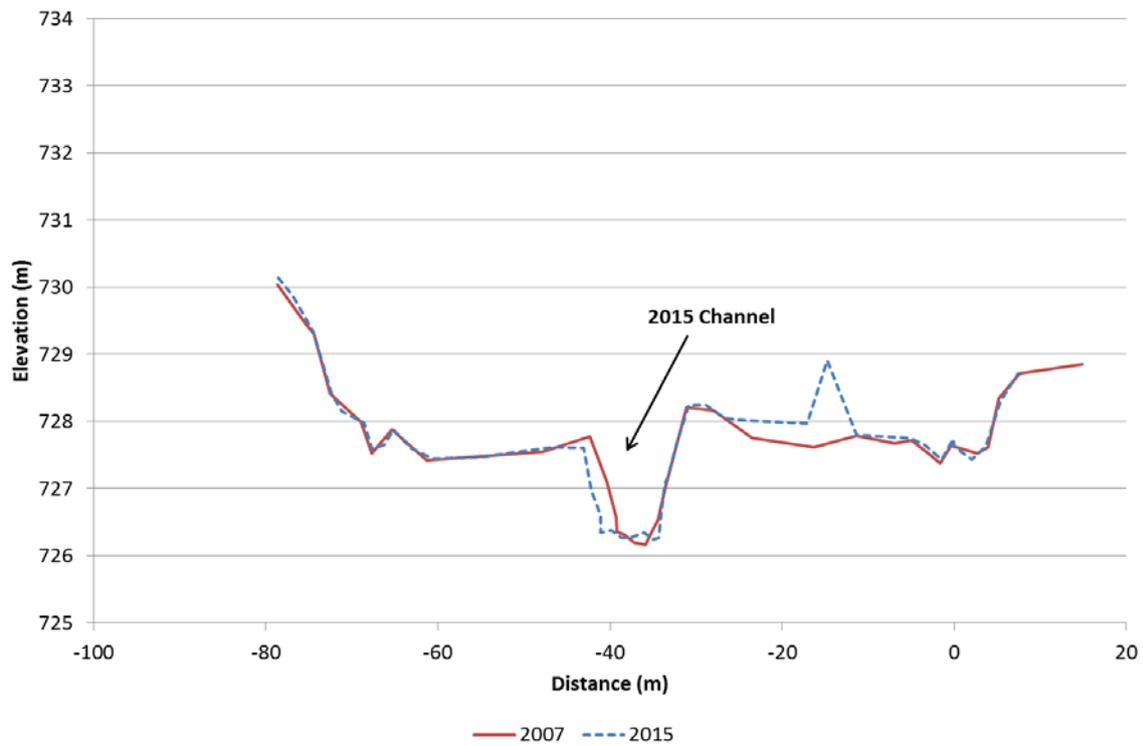
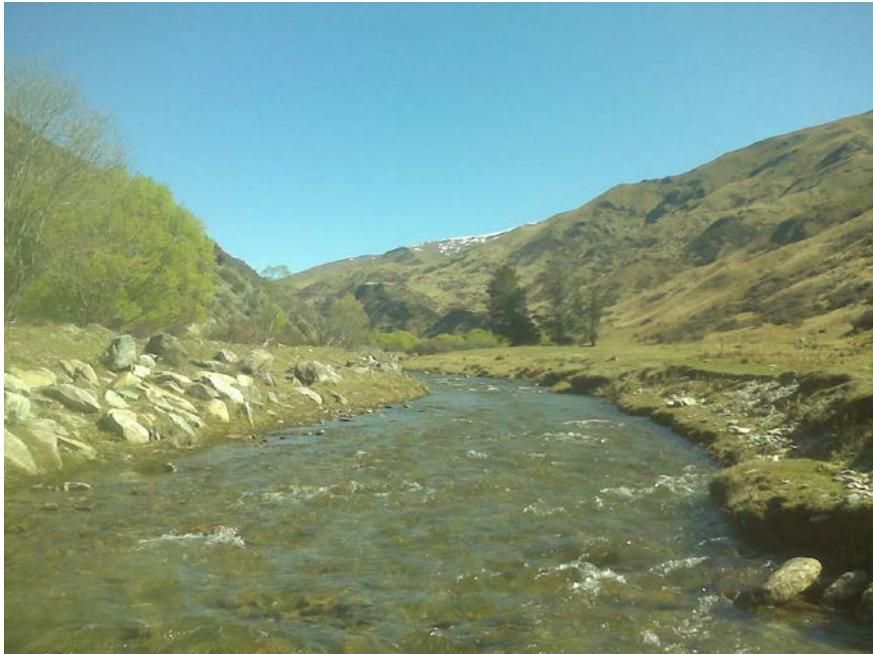
Cardrona River cross-section CR25-8

Figure 44. Cardrona River cross-section CR25-8, looking downstream refer to Figure 8 for location

Figure 45. Cardrona River cross-section CR25-8, looking upstream, November 2015

Cross-section CR25-8 is located 32.1 km upstream of the confluence with the Clutha River/Mata-Au. There has been erosion of the true left bank and some aggradation of the true right floodplain.

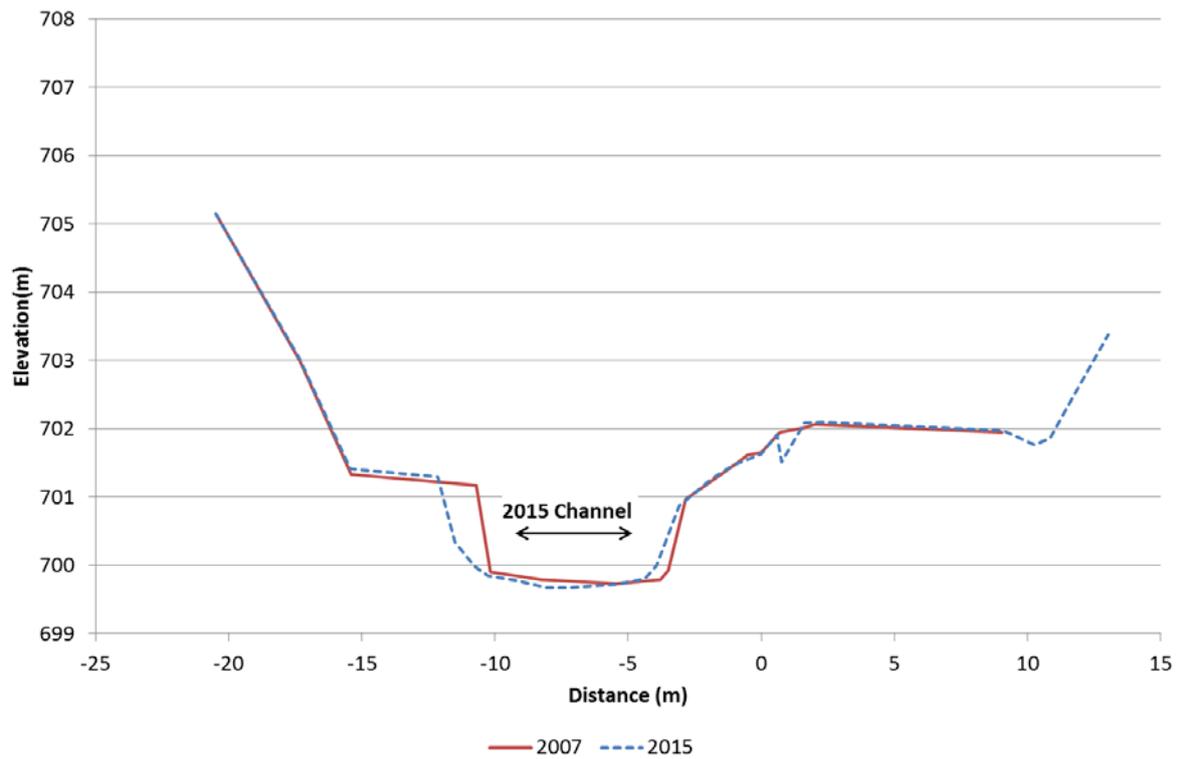
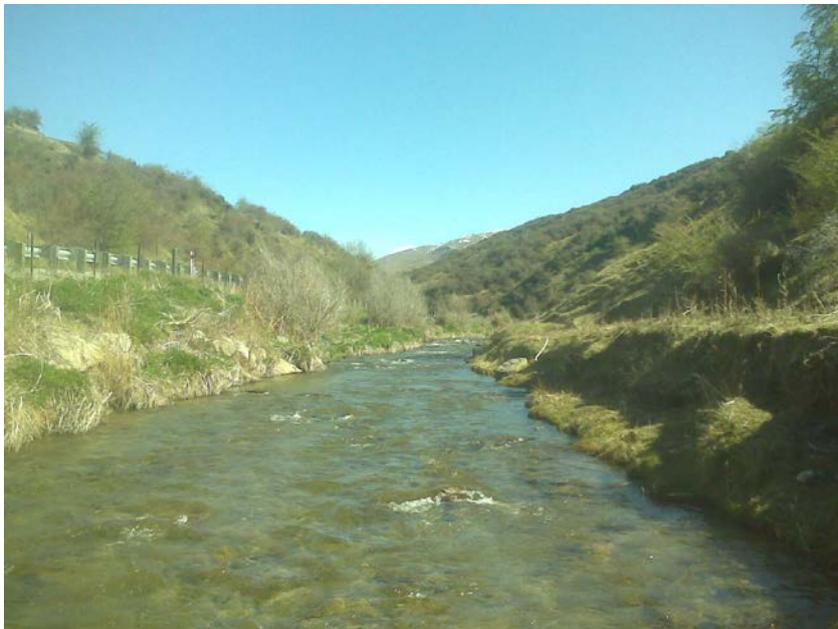
Cardrona River cross-section CR25-6

Figure 47. Cardrona River cross-section CR25-6, looking downstream refer to Figure 8 for location

Figure 48. Cardrona River cross-section CR25-6, looking upstream, November 2015

Cross-section CR25-6 is located 30.2 km upstream of the confluence with the Clutha River/Mata-Au. The true left bank eroded and the true right bank aggraded between 2007 and 2015 with minimal change occurring across the wider floodplain.

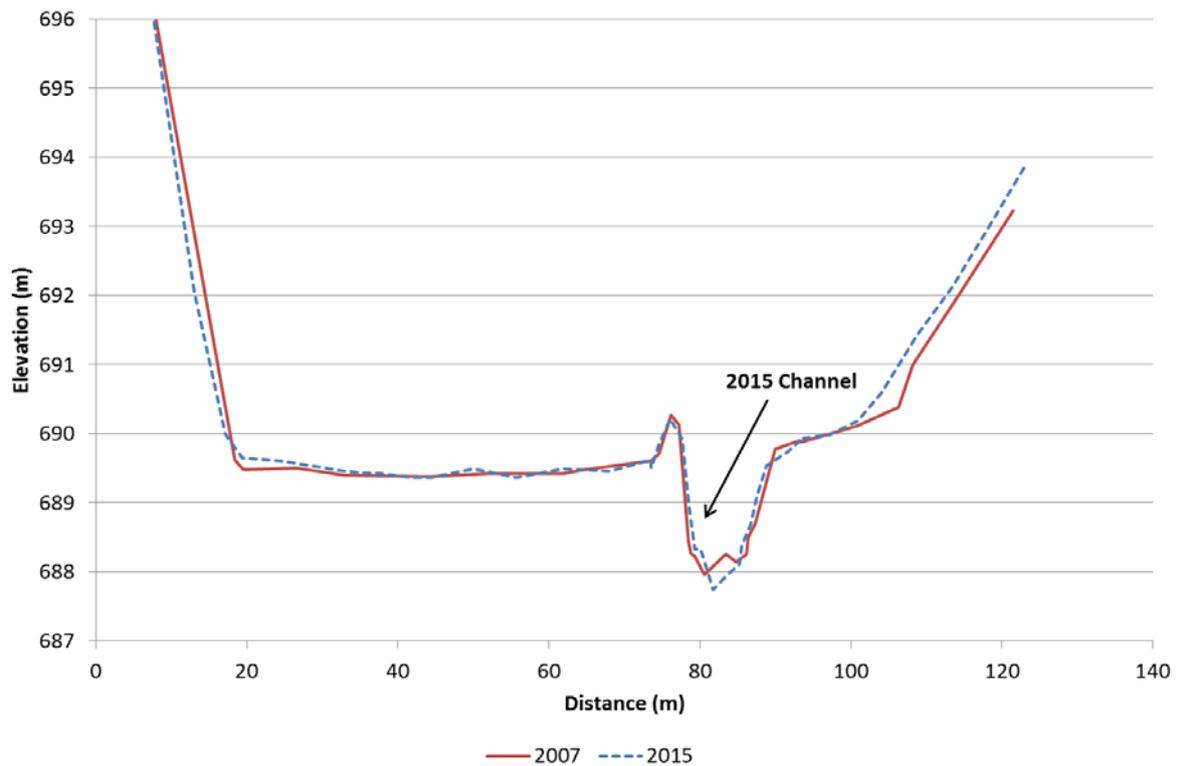
Cardrona River cross-section CR25-5

Figure 49. Cardrona River cross-section CR25-5, looking downstream refer to Figure 8 for location

Cross-section CR25-5 is located 29.5 km upstream of the confluence with the Clutha River/Mata-Au. The channel has degraded between 2007 and 2015 with aggradation occurring on the true right bank.

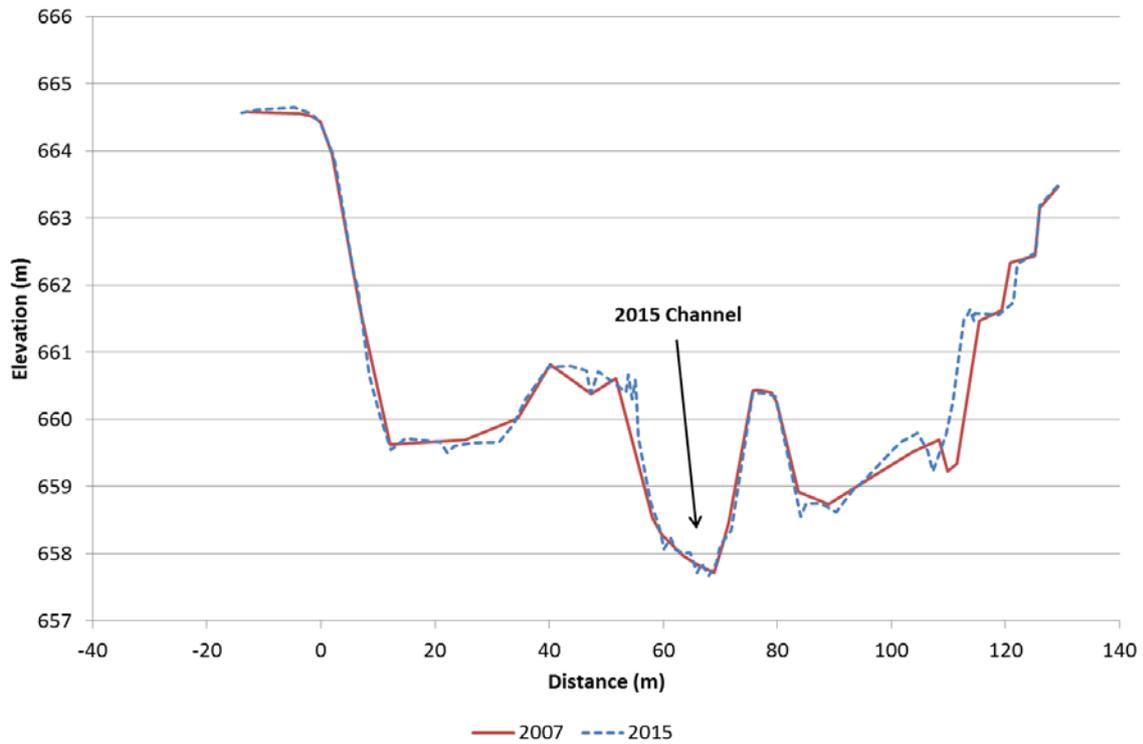
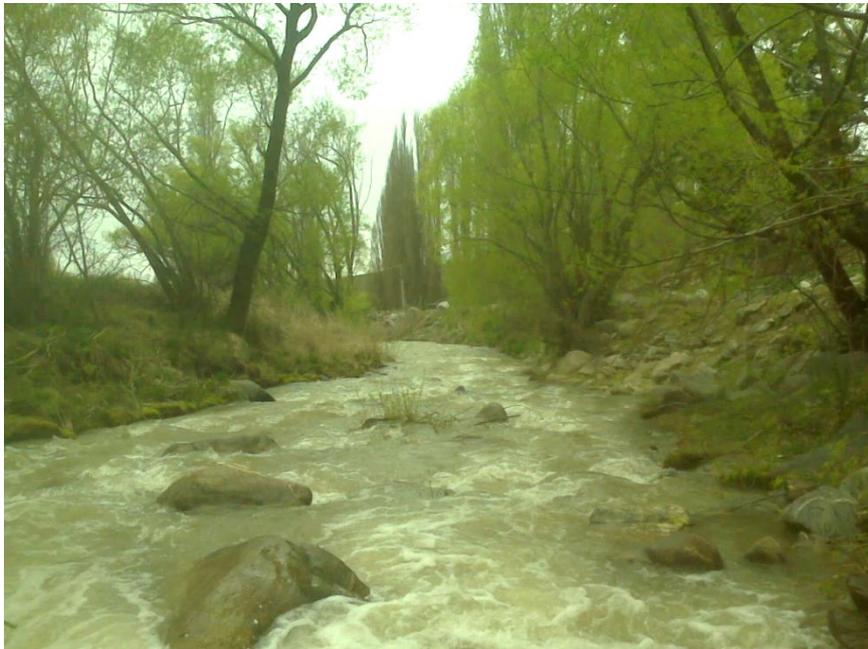
Cardrona River cross-section CR25-4

Figure 51. Cardrona River cross-section CR25-4, looking downstream refer to Figure 8 for location

Figure 52. Cardrona River cross-section CR25-4, looking downstream, November 2015

Cross-section CR25-4 is located 28.8 km upstream of the confluence with the Clutha River/Mata-Au. There has been little change in the main channel between 2007 and 2015, the true right floodplain bank and the true left channel bank aggraded during this period.

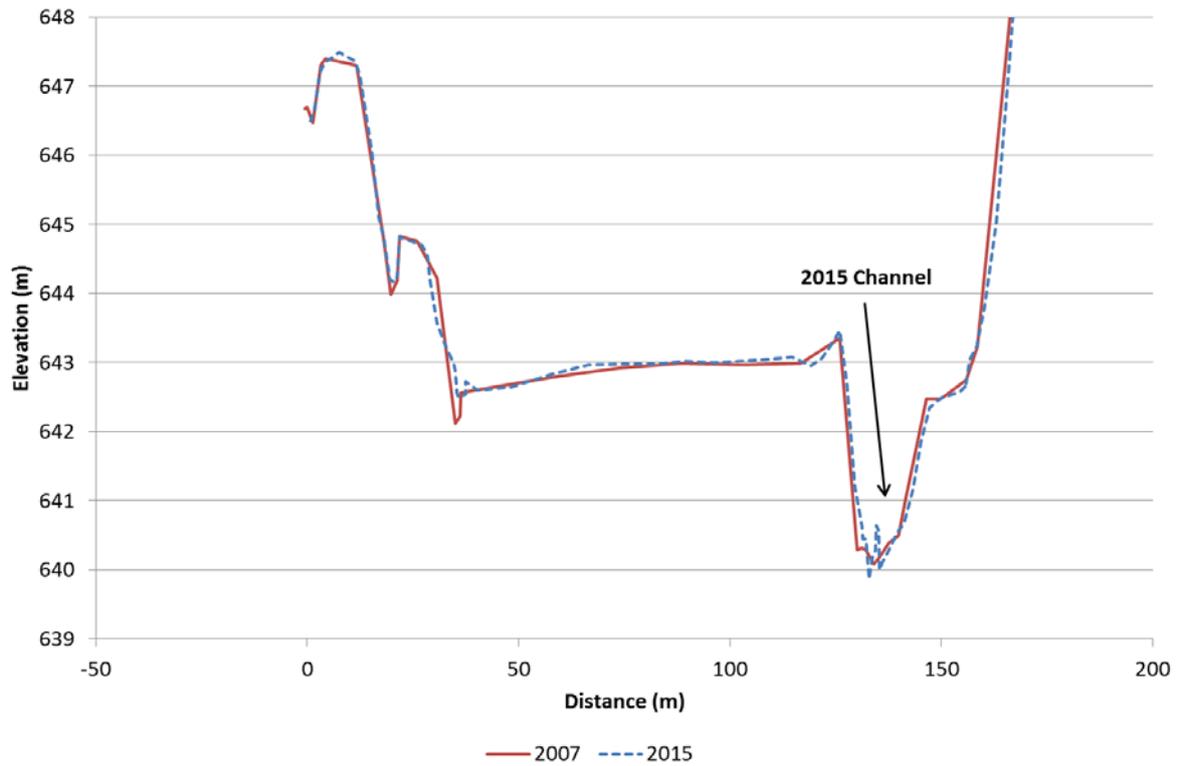
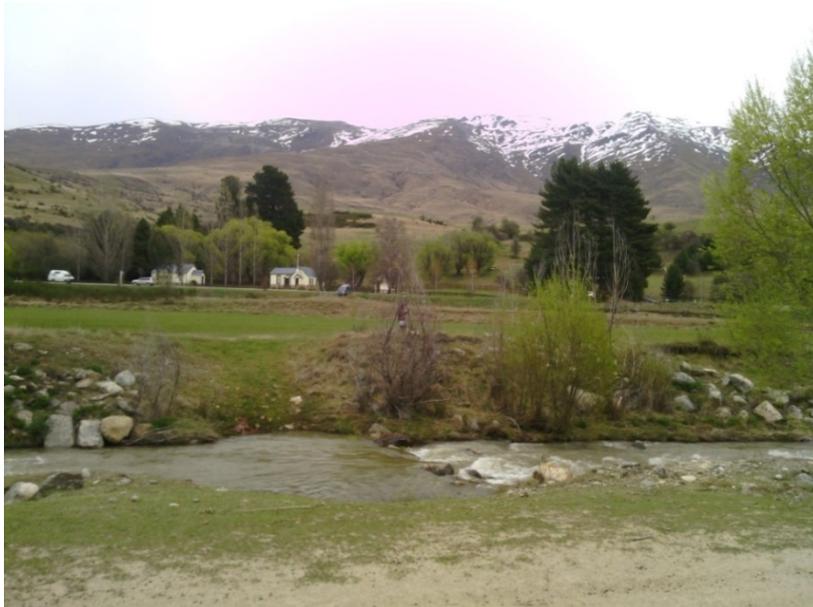
Cardrona River cross-section CR25-3

Figure 53. Cardrona River cross-section CR25-3, looking downstream refer to Figure 8 for location

Figure 54. Cardrona River cross-section CR25-3, looking from true right to true left bank, November 2015

Cross-section CR25-3 is located 27.9 km upstream of the confluence with the Clutha River/Mata-Au. Minimal change in the main channel and wider floodplain occurred between 2007 and 2015.

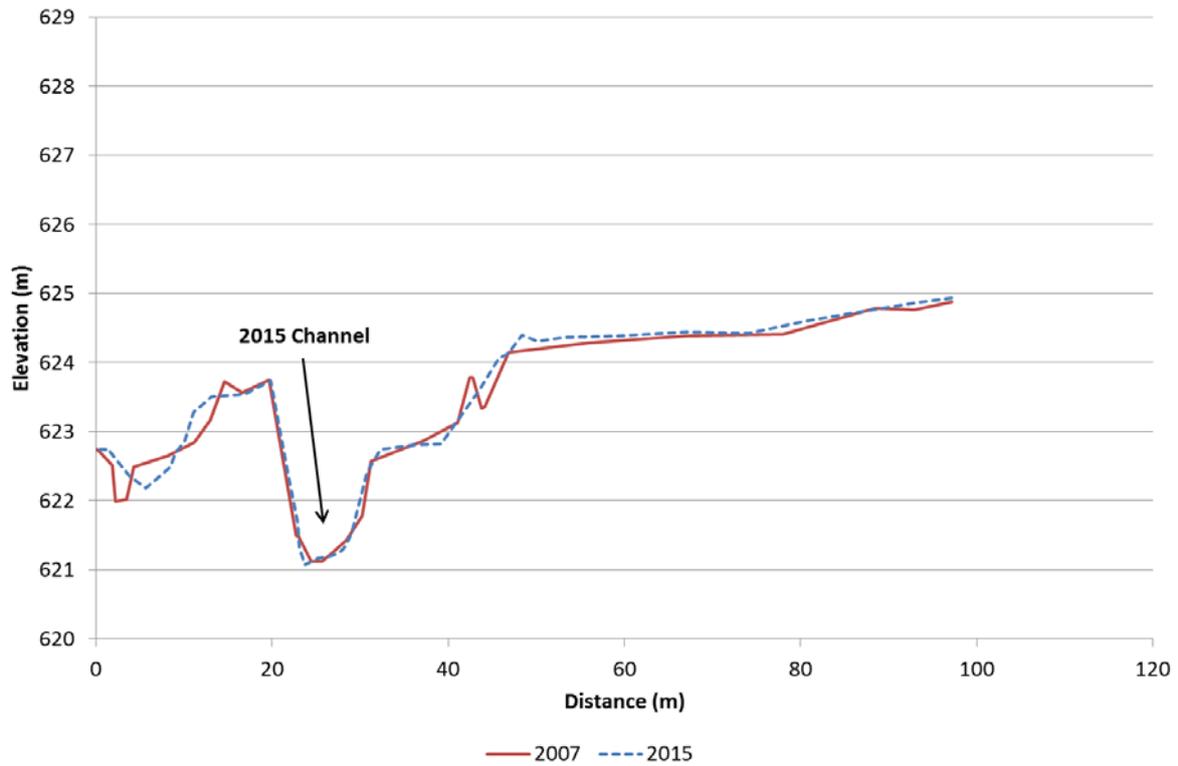
Cardrona River cross-section CR25-2

Figure 55. Cardrona River cross-section CR25-2, looking downstream refer to Figure 7 for location

Cross-section CR25-2 is located 27.1 km upstream of the confluence with the Clutha River/Mata-Au. The main channel has remained in a similar position between 2007 and 2015. The true left floodplain has both aggraded and degraded between 2007 and 2015.
