Cardrona River Channel Morphology

May 2016

Otago Regional Council

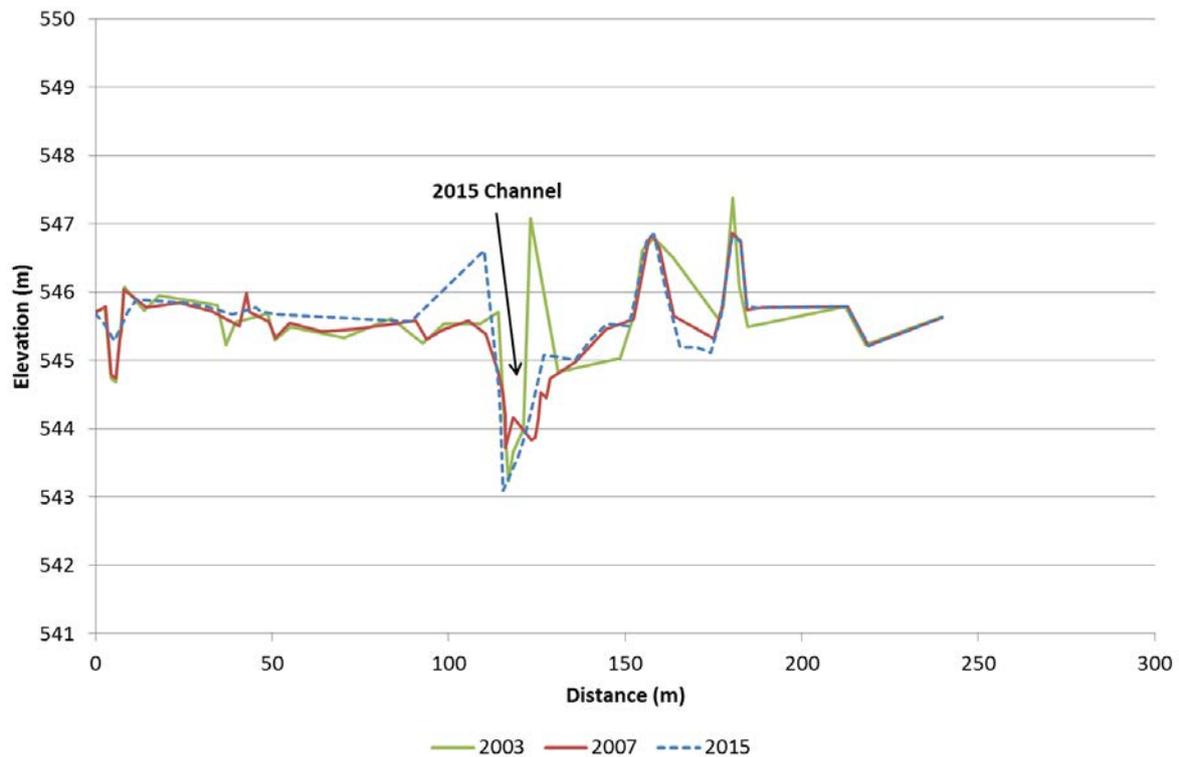
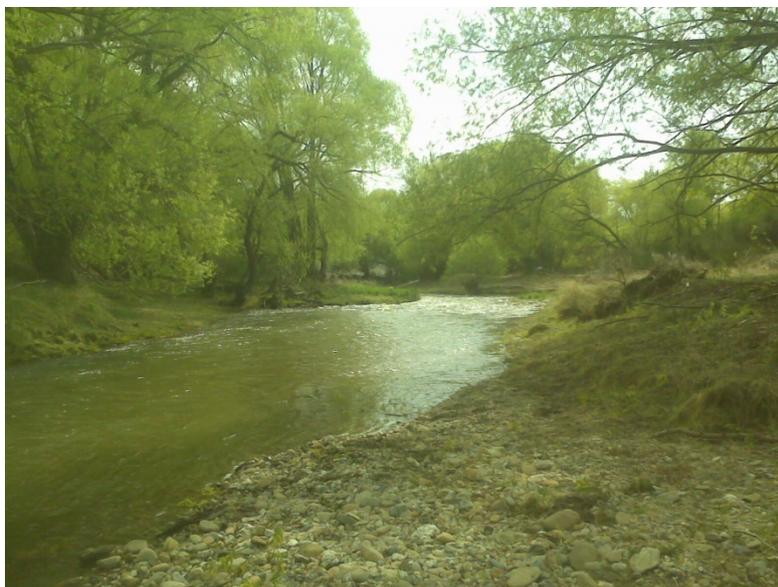
Cardrona River cross-section CR16

Figure 63. Cardrona River cross-section CR16, looking downstream refer to Figure 7 for location

Figure 64. Cardrona River cross-section CR16, looking downstream, November 2015

Cross-section CR16 is located 20.5 km upstream of the confluence with the Clutha River/Mata-Au. The main channel has become more confined between 2007 and 2015 with aggradation occurring on the true right bank. The top of the true left berm has aggraded between 2003 and 2015.

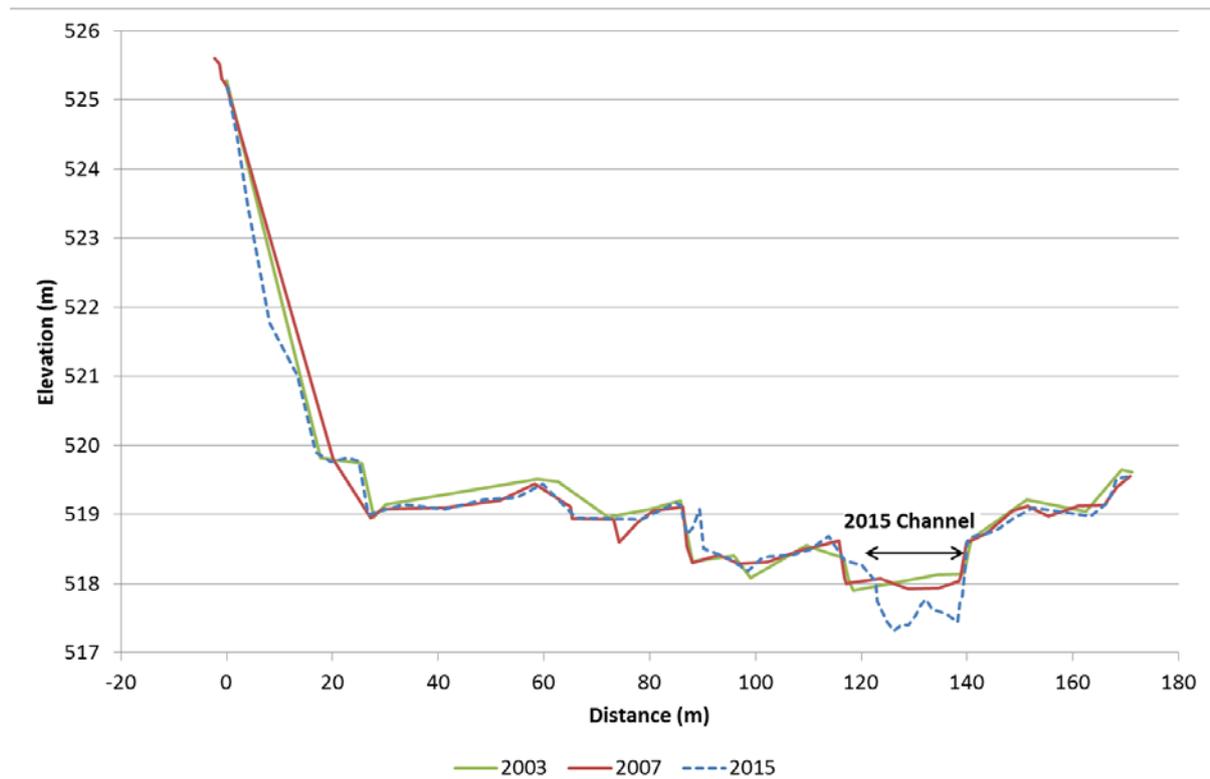
Cardrona River cross-section CR11-1

Figure 65. Cardrona River cross-section CR11-1, looking downstream refer to Figure 6 for location

Cross-section CR11-1 is located 17.5 km upstream of the confluence with the Clutha River/Mata-Au. Between 2003 and 2015 the main channel has degraded and become more confined. The true left floodplain has aggraded between 2007 and 2015.

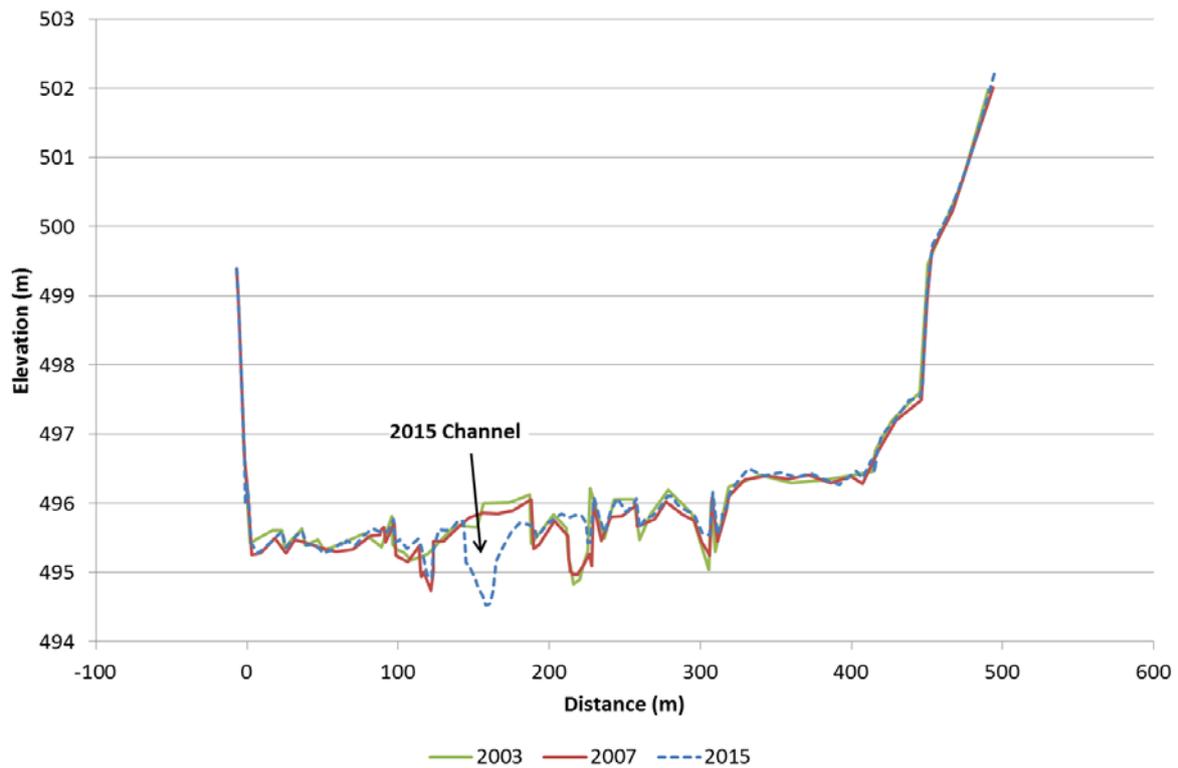
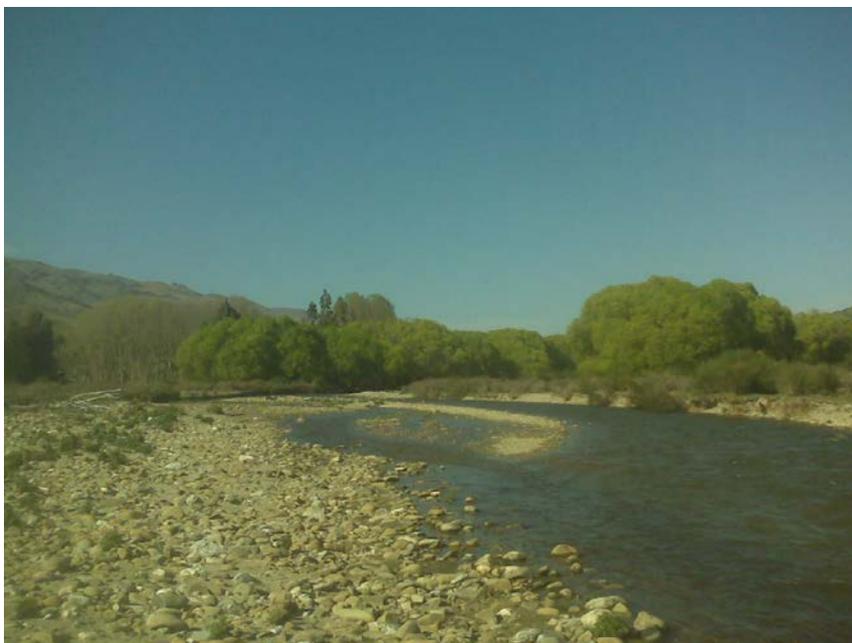
Cardrona River cross-section CR8

Figure 69. Cardrona River cross-section CR8, looking downstream refer to Figure 6 for location

Figure 70. Cardrona River cross-section CR8, looking upstream, November 2015

Cross-section CR8 is located 14.8 km upstream of the confluence with the Clutha River/Mata-Au. Between 2007 and 2015 there has been some infilling of previous channel with the main channel now occupying the centre of the active fairway.

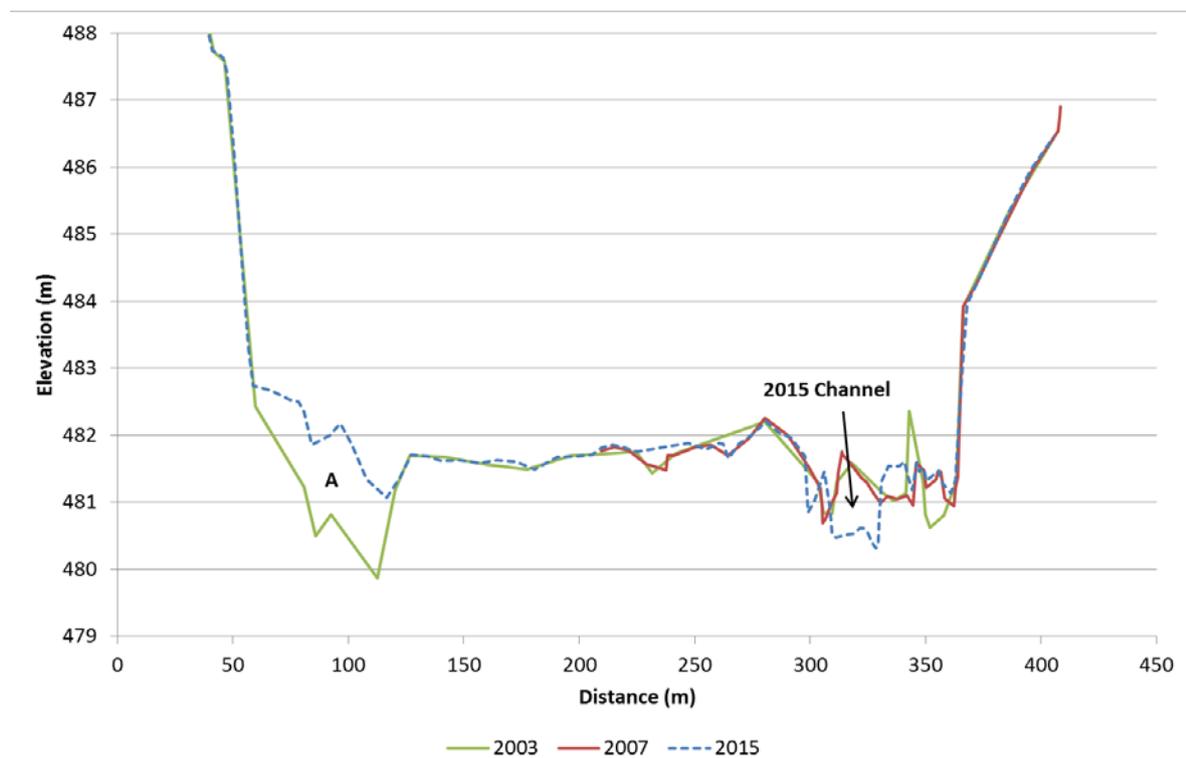
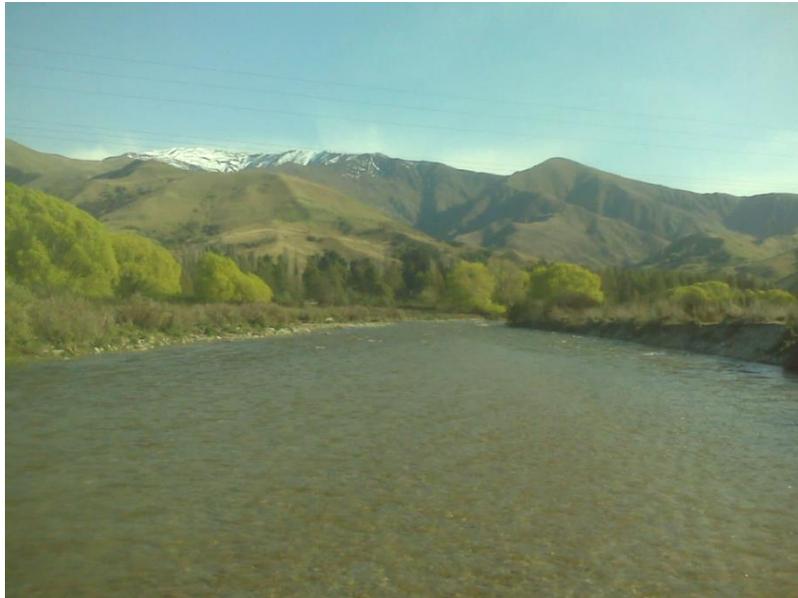
Cardrona River cross-section CR5

Figure 71. Cardrona River cross-section CR5, looking downstream refer to Figure 6 for location

Figure 72. Cardrona River cross-section CR5, looking downstream, November 2015

Cross-section CR5 is located 13 km upstream of the confluence with the Clutha River/Mata-Au. The main channel has become more defined between 2007 and 2015 with aggradation occurring in the 2003 and 2007 secondary channels. Aggradation of the true left bank floodplain at the point labelled A occurred between 2003 and 2015.

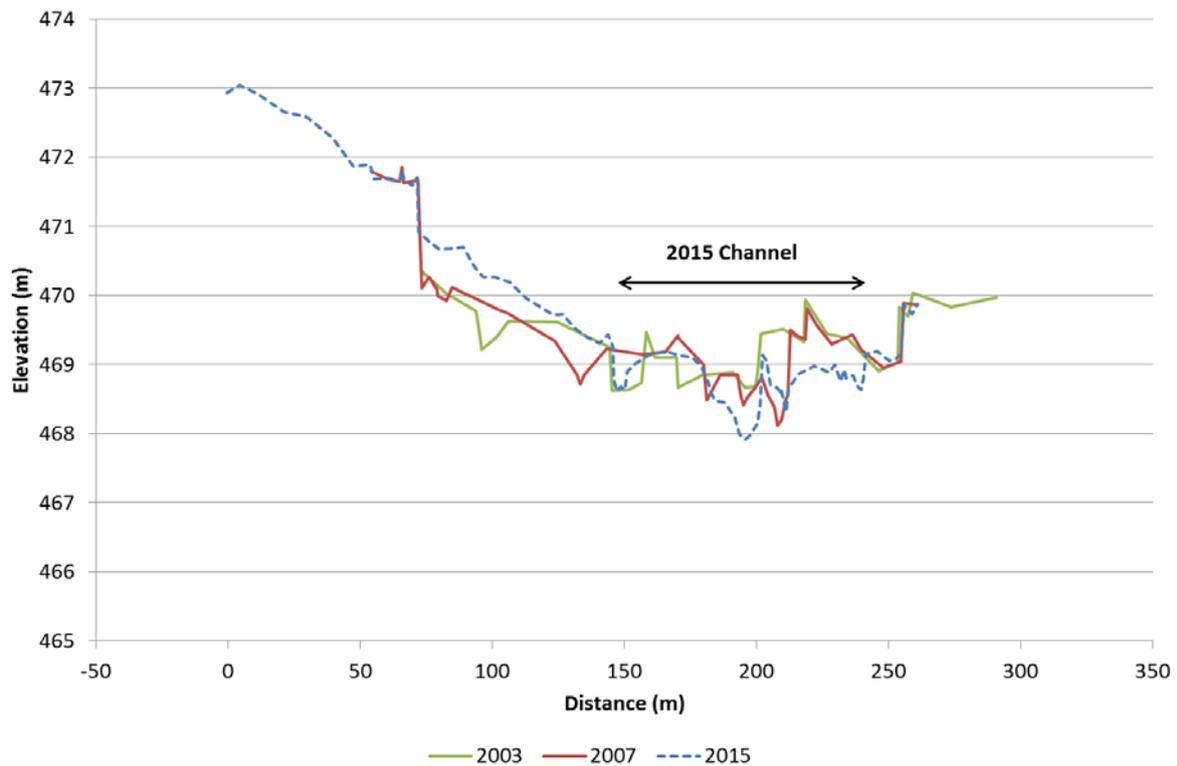
Cardrona River cross-section CR3

Figure 73. Cardrona River cross-section CR3, looking downstream refer to Figure 5 for location

Cross-section CR3 is located 11.7 km upstream of the confluence with the Clutha River/Mata-Au. The channel at this location is braided with one main channel in the centre of the active fairway and several low flow channels. These channels have both aggraded and degraded between 2003 and 2007. Aggradation of the true left bank terrace has occurred between 2007 and 2015.

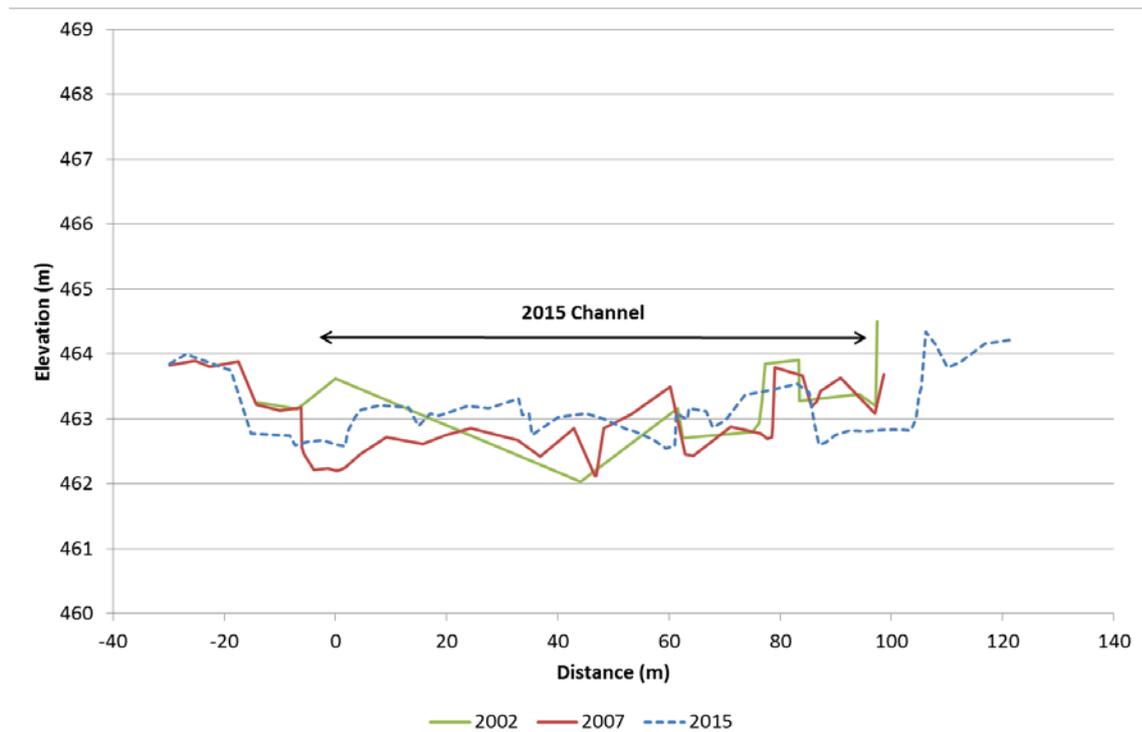
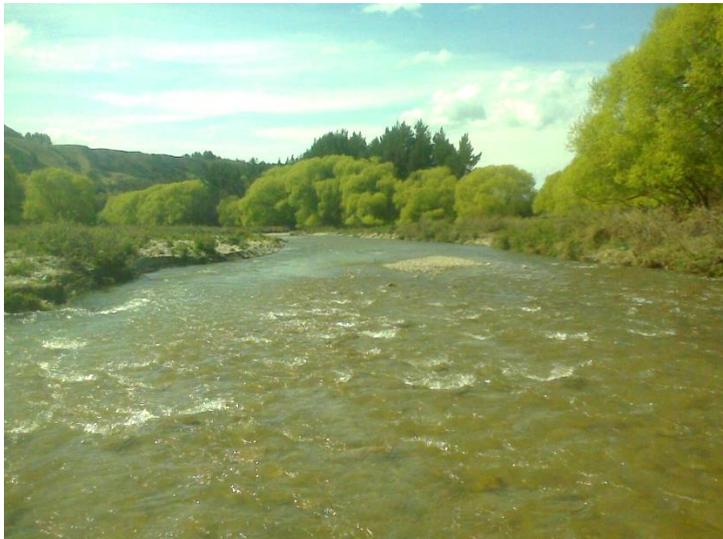
Cardrona River cross-section CR2A

Figure 79. Cardrona River cross-section CR2A, looking downstream refer to Figure 5 for location

Figure 80. Cardrona River cross-section CR2A, looking downstream, November 2015

Cross-section CR2A is located 11 km upstream of the confluence with the Clutha River/Mata-Au. The true left bank has eroded between 2007 and 2015, with aggradation of the true left side of the braid network occurring. Bank erosion occurred on the true right bank (between 2007 and 2015 with the creation of a new secondary channel).⁷

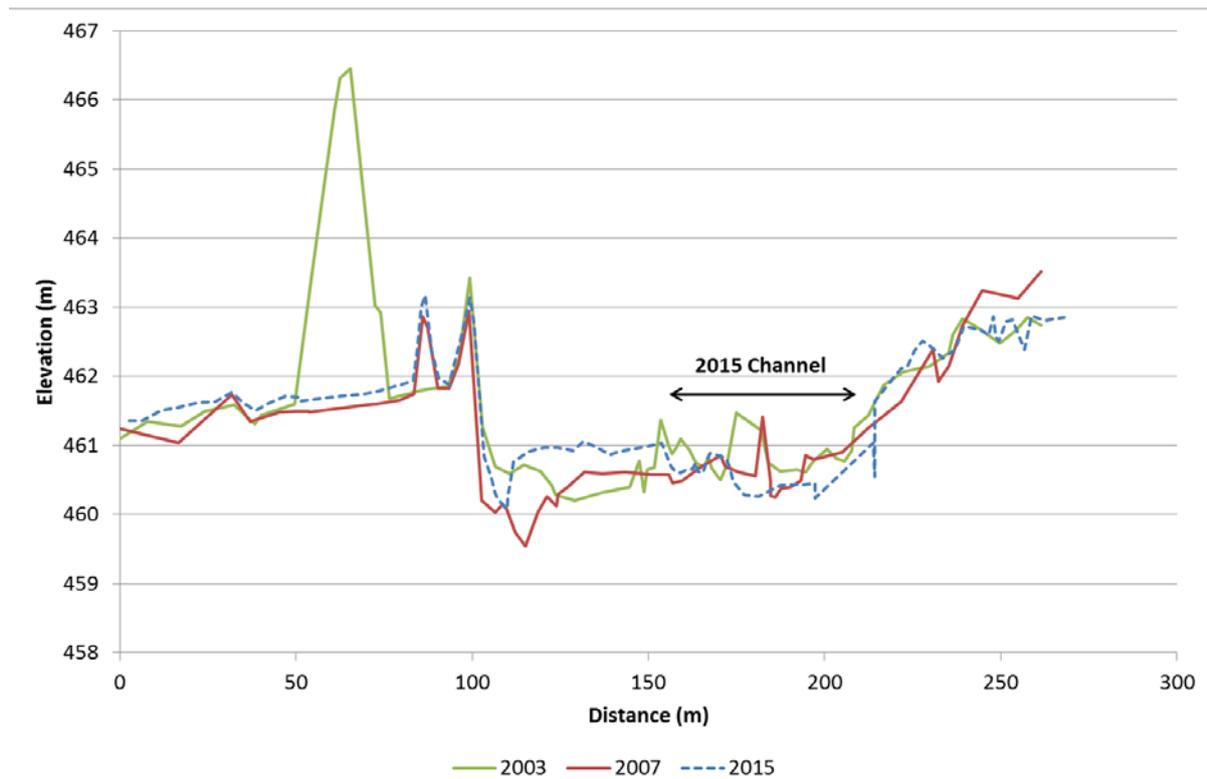
Cardrona River cross-section CR1B

Figure 81. Cardrona River cross-section CR1B, looking downstream refer to refer to Figure 5 for location

Cross-section CR1B is located 10.7 km upstream of the confluence with the Clutha River/Mata-Au. Aggradation has occurred on the true left of the fairway with degradation occurring on the true right between 2007 and 2015. The main channel has switched from the true left of the fairway in 2007 to the true right side of the fairway in 2015. Aggradation has occurred on the true right bank between 2007 and 2015.

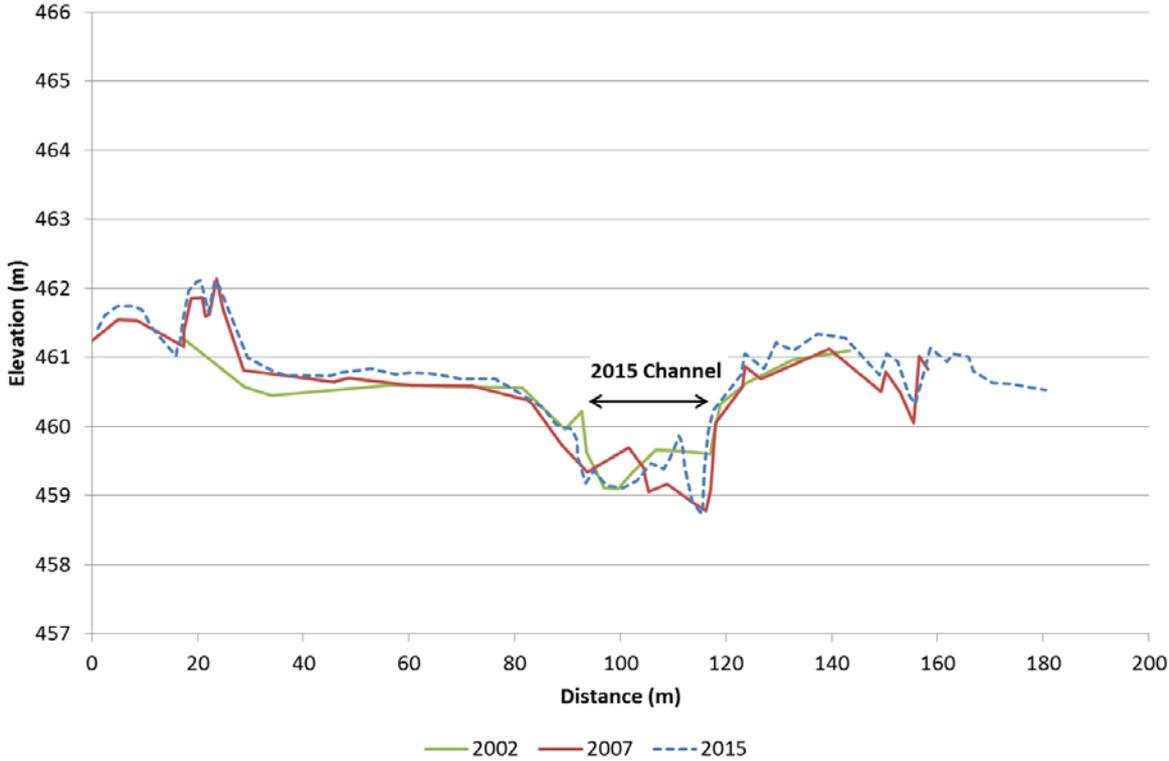
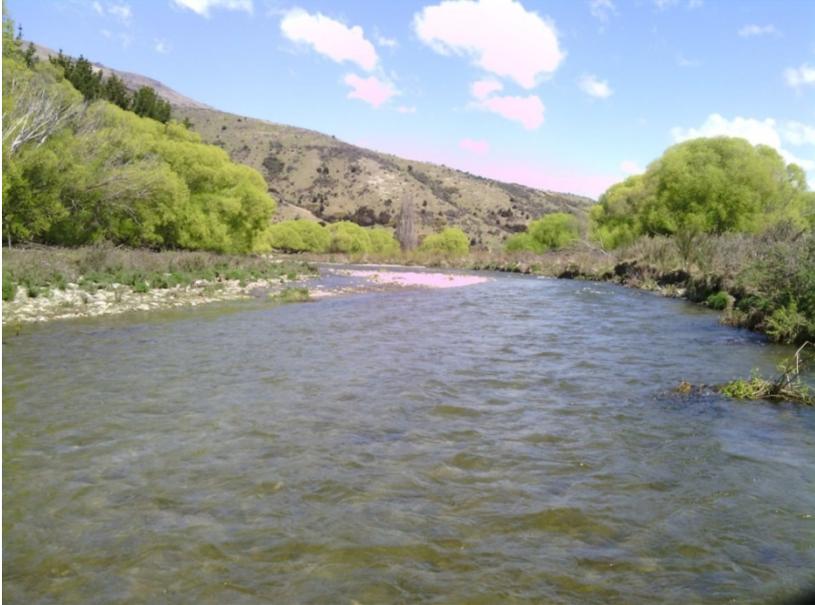
Cardrona River cross-section CR1A

Figure 83. Cardrona River cross-section CR1A, looking downstream refer to Figure 5 for location

Figure 84. Cardrona River cross-section CR1A, looking upstream, November 2015

Cross-section CR1A is located 10.6 km upstream of the confluence with the Clutha River/Mata-Au. Aggradation has occurred across the wider floodplain between 2003 and 2007. A mid channel bar has formed in the main channel between 2007 and 2015.

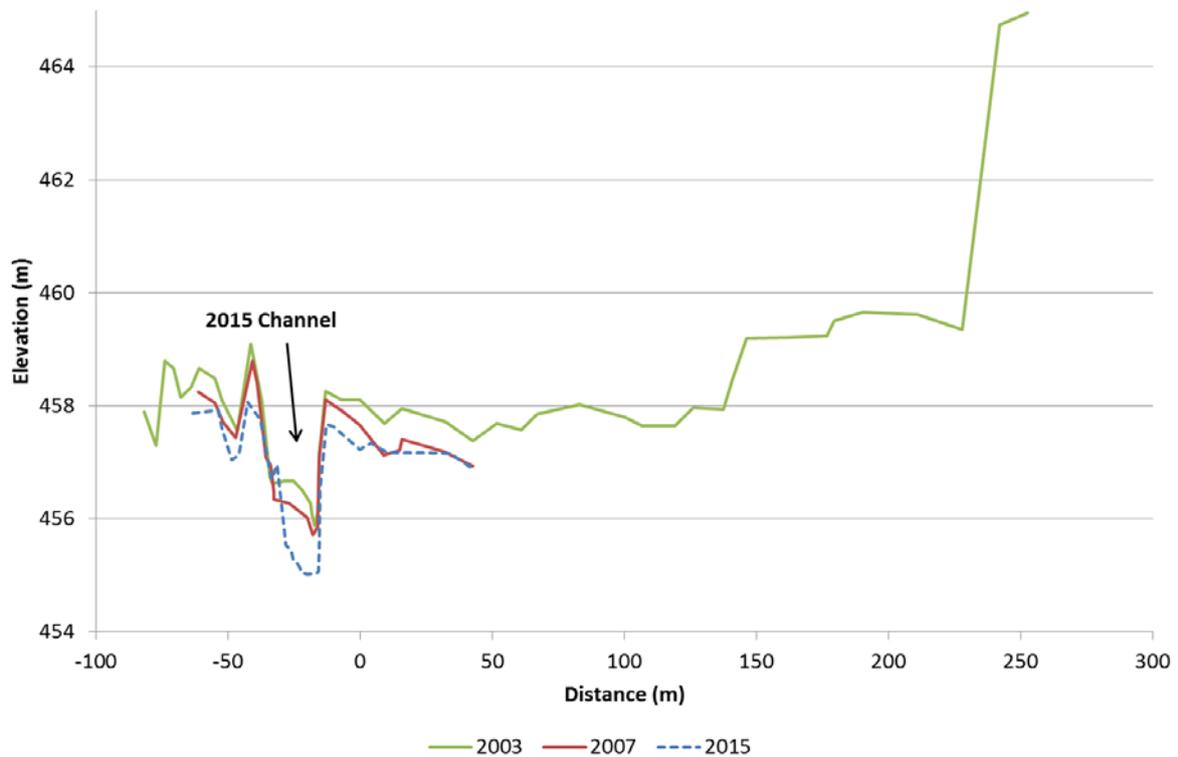
Cardrona River cross-section CR28-2

Figure 85. Cardrona River cross-section CR28-2, looking downstream refer to Figure 5 for location

Cross-section CR28-2 is located 10.18 km upstream of the confluence with the Clutha River/Mata-Au. The main channel has degraded between 2007 and 2015 with degradation occurring on the true left and right bank floodplain.

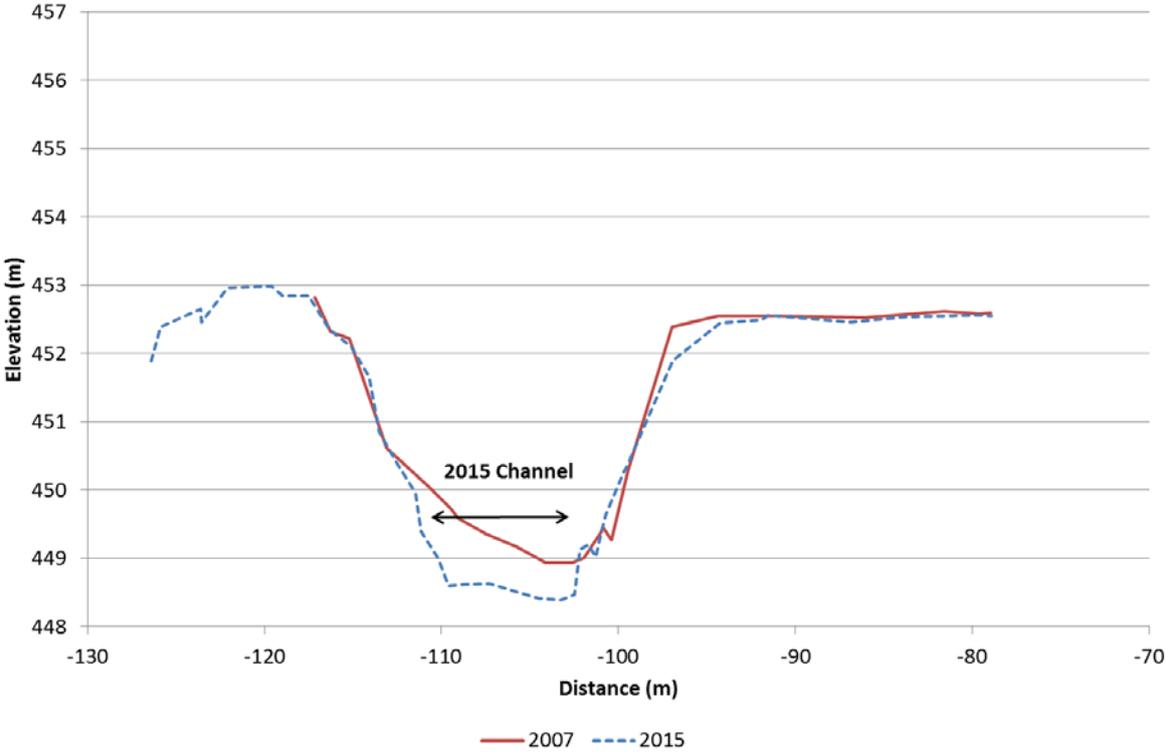
Cardrona River cross-section CR54-1

Figure 91. Cardrona River cross-section CR54-1, looking downstream refer to Figure 5 for location

Cross-section CR54-1 is located 9.4 km upstream of the confluence with the Clutha River/Mata-Au. The main channel has degraded between 2007 and 2015 with some degradation occurring on the true right bank floodplain.

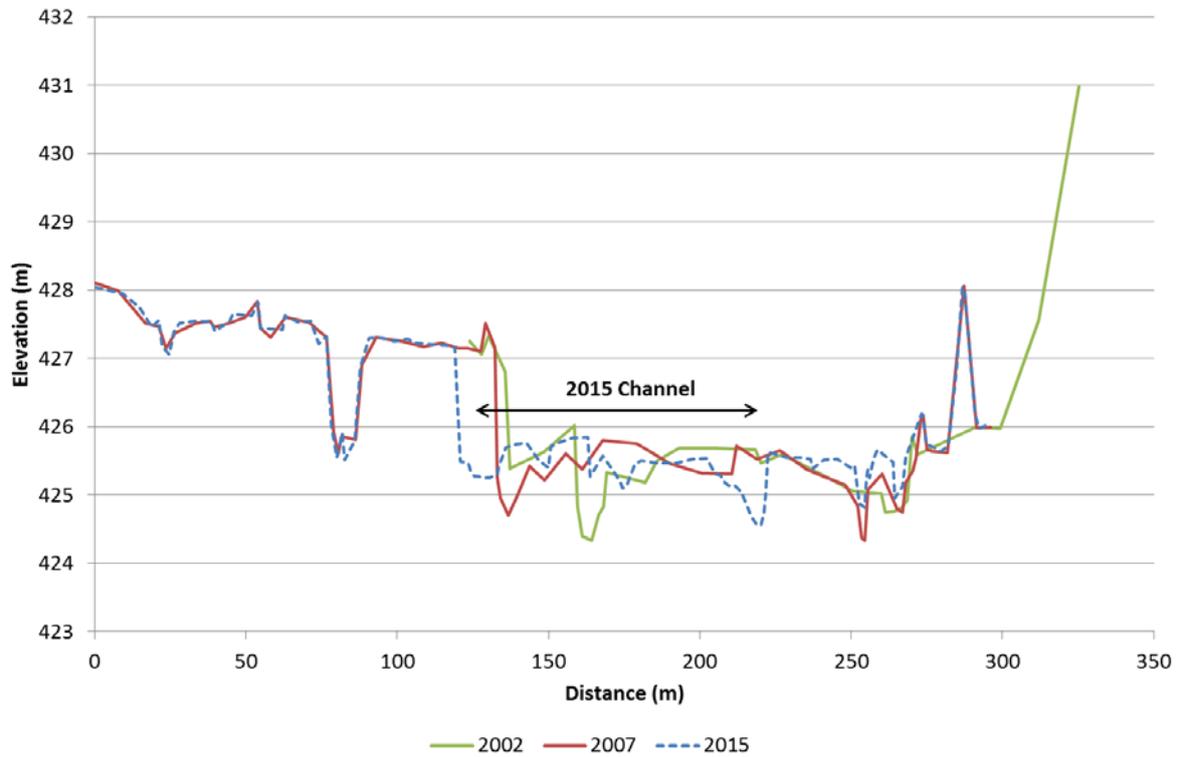
Cardrona River cross-section CR39

Figure 99. Cardrona River cross-section CR39, looking downstream refer to Figure 5 for location

Cross-section CR39 is located 6.6 km upstream of the confluence with the Clutha River/Mata-Au. The true left bank of the active fairway has eroded between 2007 and 2015. The active fairway has both aggraded and degraded between 2007 and 2015 as the river braids migrate across the river fairway.

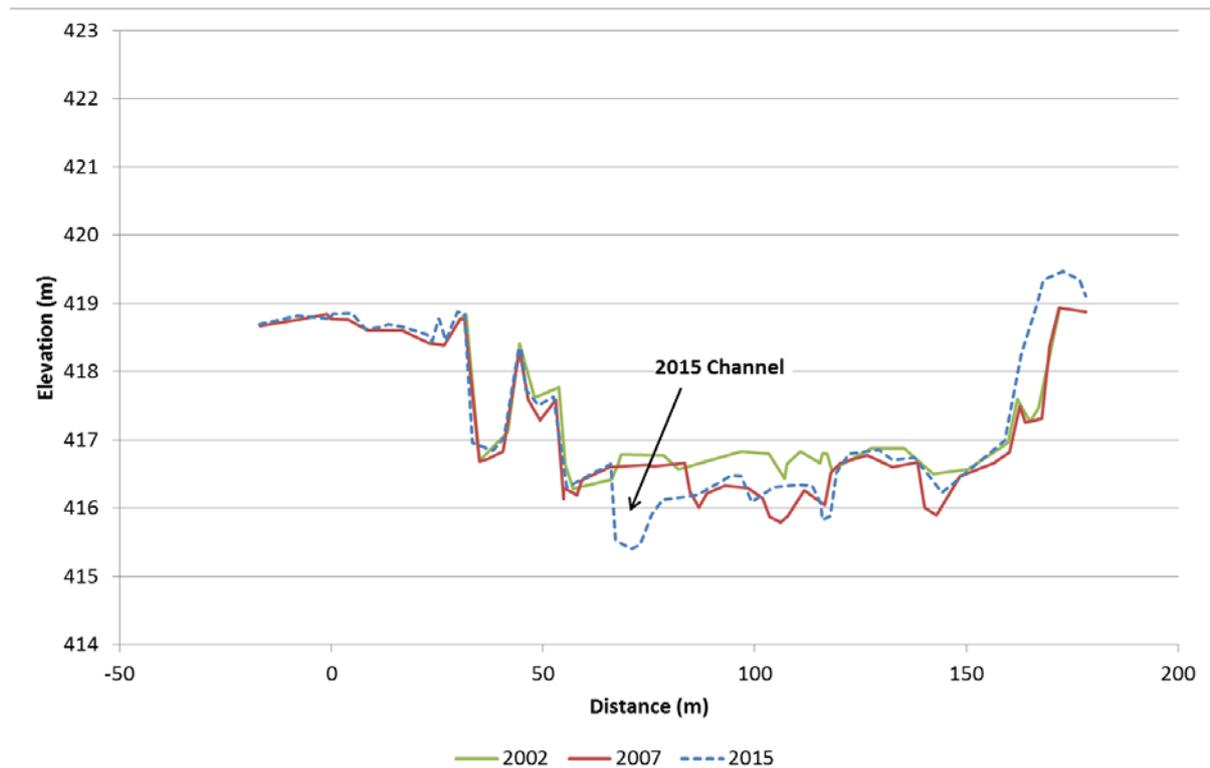
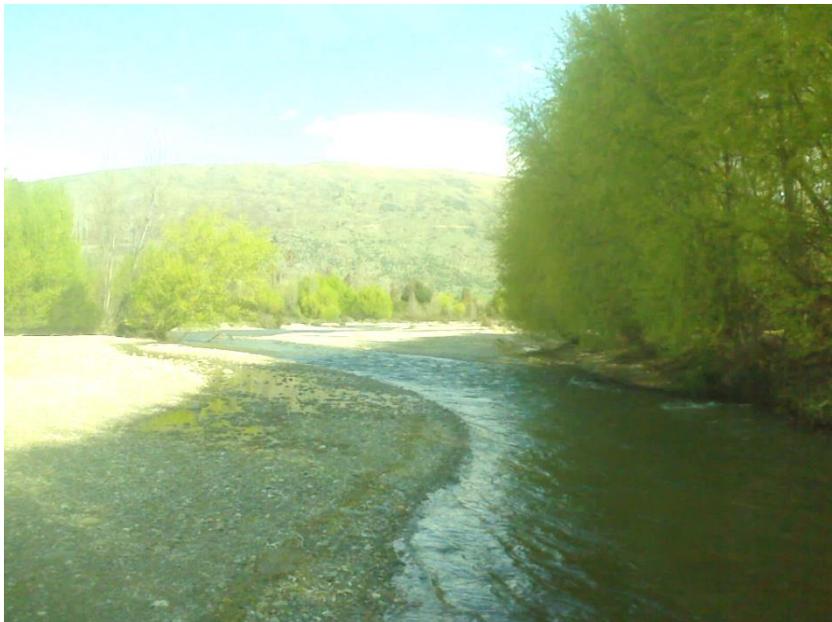
Cardrona River cross-section CR41

Figure 105. Cardrona River cross-section CR41, looking downstream refer to Figure 4 for location

Figure 106. Cardrona River cross-section CR41, looking upstream, November 2015

Cross-section CR41 is located 5.6 km upstream of the confluence with the Clutha River/Mata-Au. The main channel has switched from the centre of the active fairway in 2007 to the true left side in 2015. The true right bank has experienced aggradation between 2007 and 2015.

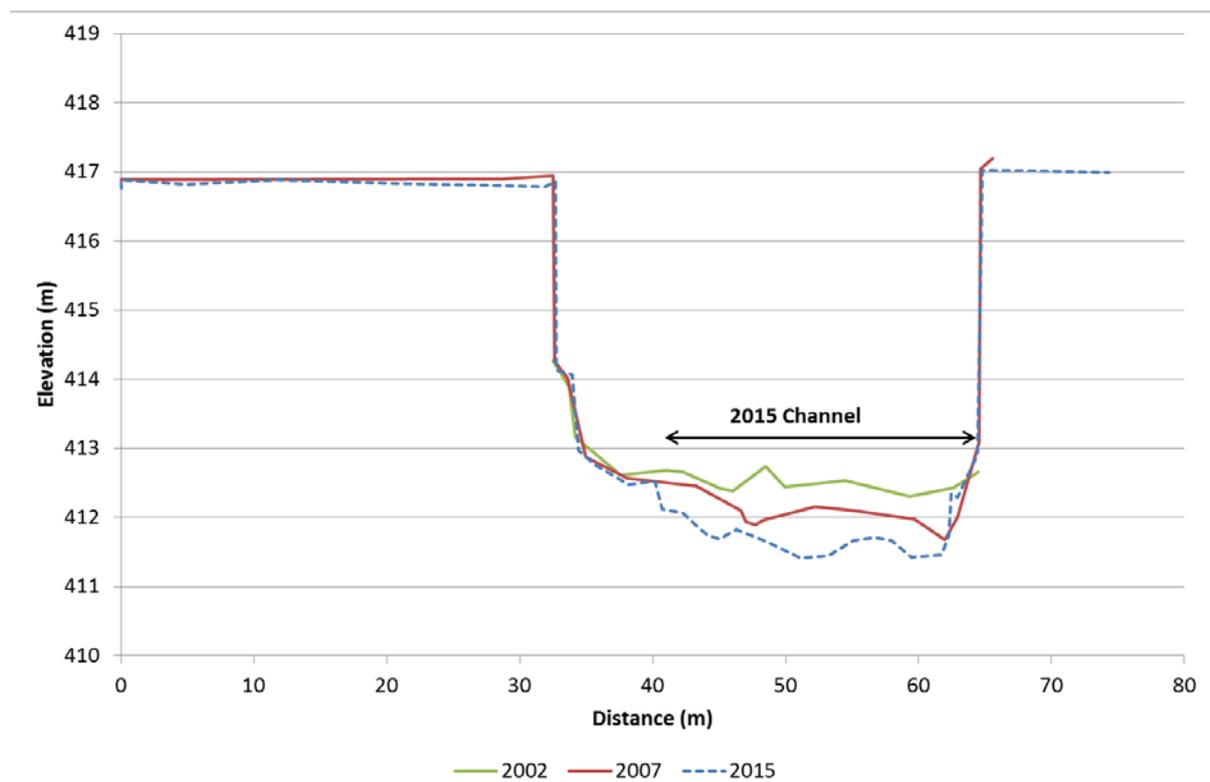
Cardrona River cross-section CR42

Figure 107. Cardrona River cross-section CR42, looking downstream refer to Figure 4 for location

Cross-section CR42 is located 5.1 km upstream of the confluence with the Clutha River/Mata-Au at the Ballantyne Road bridge. The active channel at this location is confined by the presence of the bridge and has continued to degrade between 2002 and 2015.

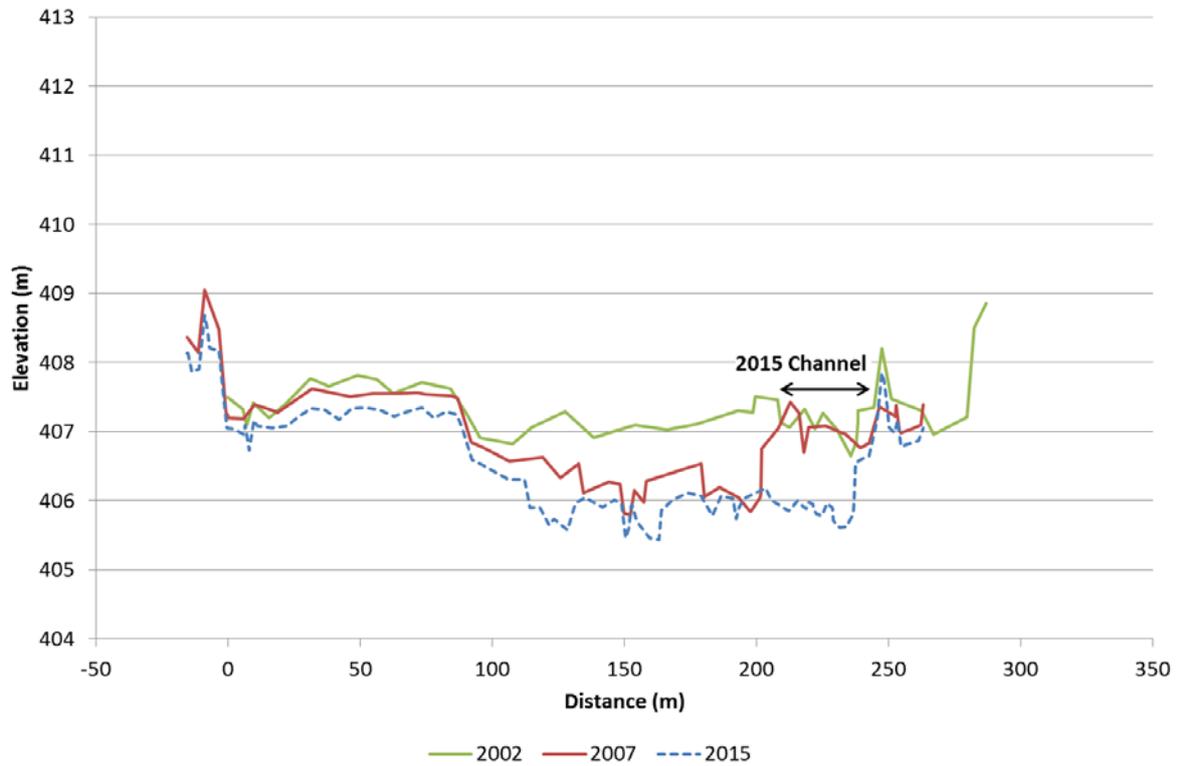
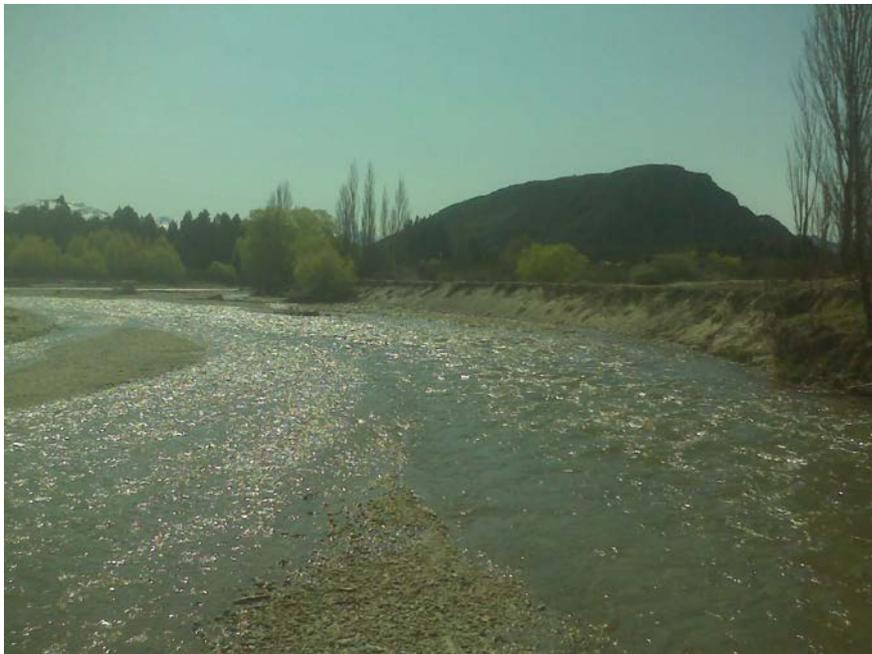
Cardrona River cross-section CR44

Figure 109. Cardrona River cross-section CR44, looking downstream refer to Figure 4 for location

Figure 110. Cardrona River cross-section CR44, looking downstream, November 2015

Cross-section CR44 is located 4.3 km upstream of the confluence with the Clutha River/Mata-Au. The active fairway has degraded between 2002 and 2015. Degradation of the true left bank floodplain has occurred between 2002 and 2015.

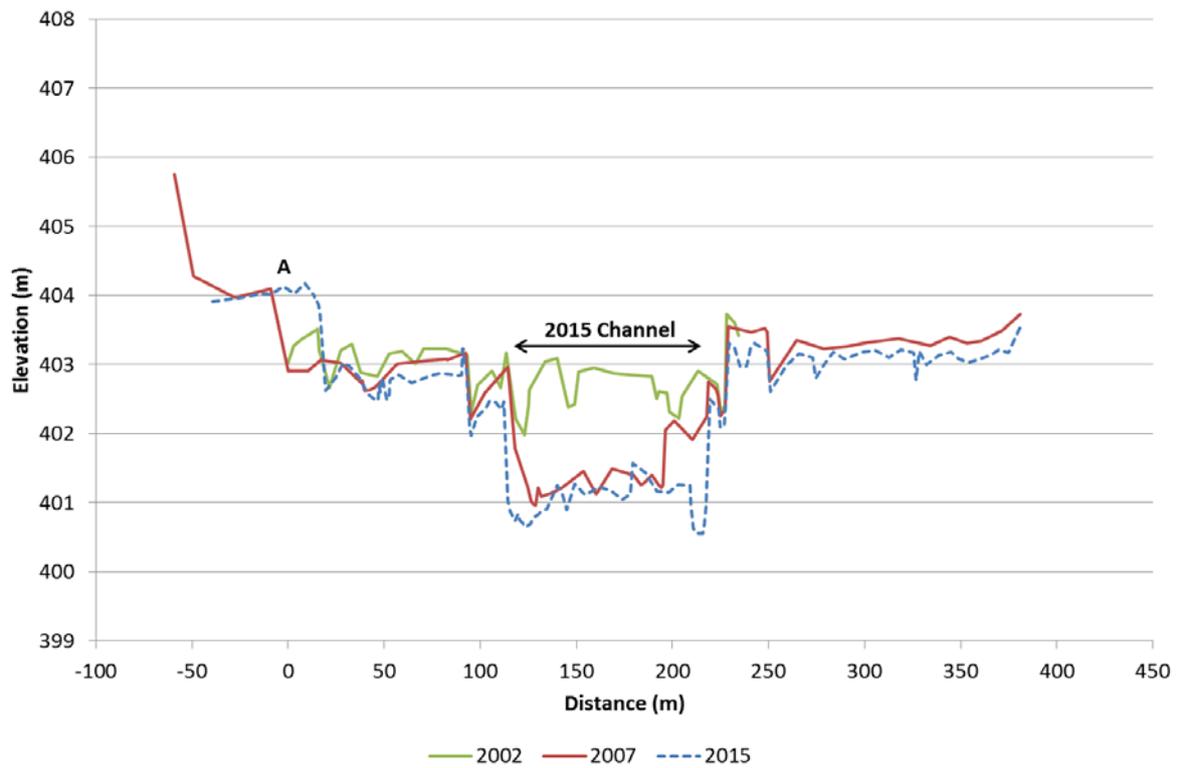
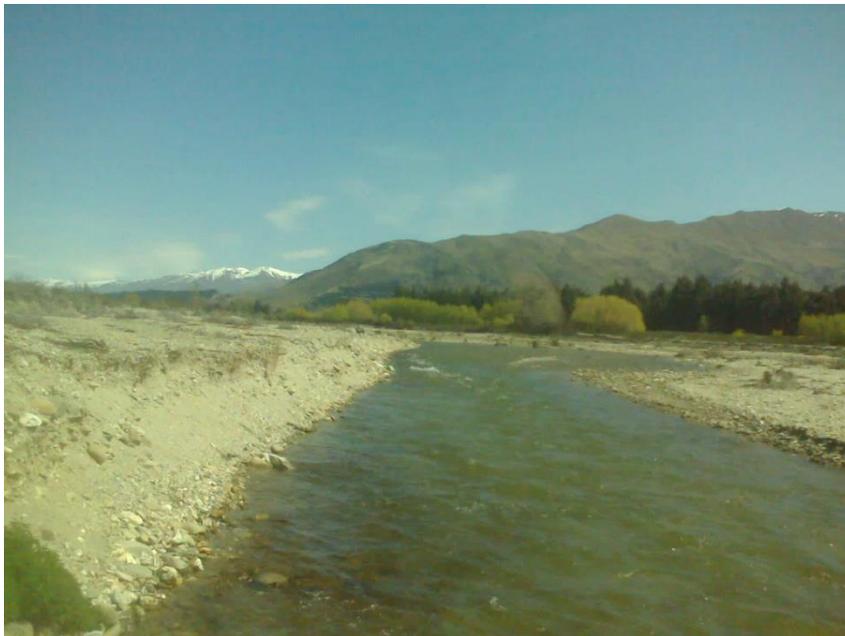
Cardrona River cross-section CR44-1

Figure 111. Cardrona River cross-section CR44-1, looking downstream refer to Figure 4 for location

Figure 112. Cardrona River cross-section CR44-1, looking downstream, November 2015

Cross-section CR44-1 is located 3.8 km upstream of the confluence with the Clutha River/Mata-Au. The active fairway and the true left and right bank floodplain have degraded between 2007 and 2015. The true left bank terrace has aggraded (at the point labelled A).

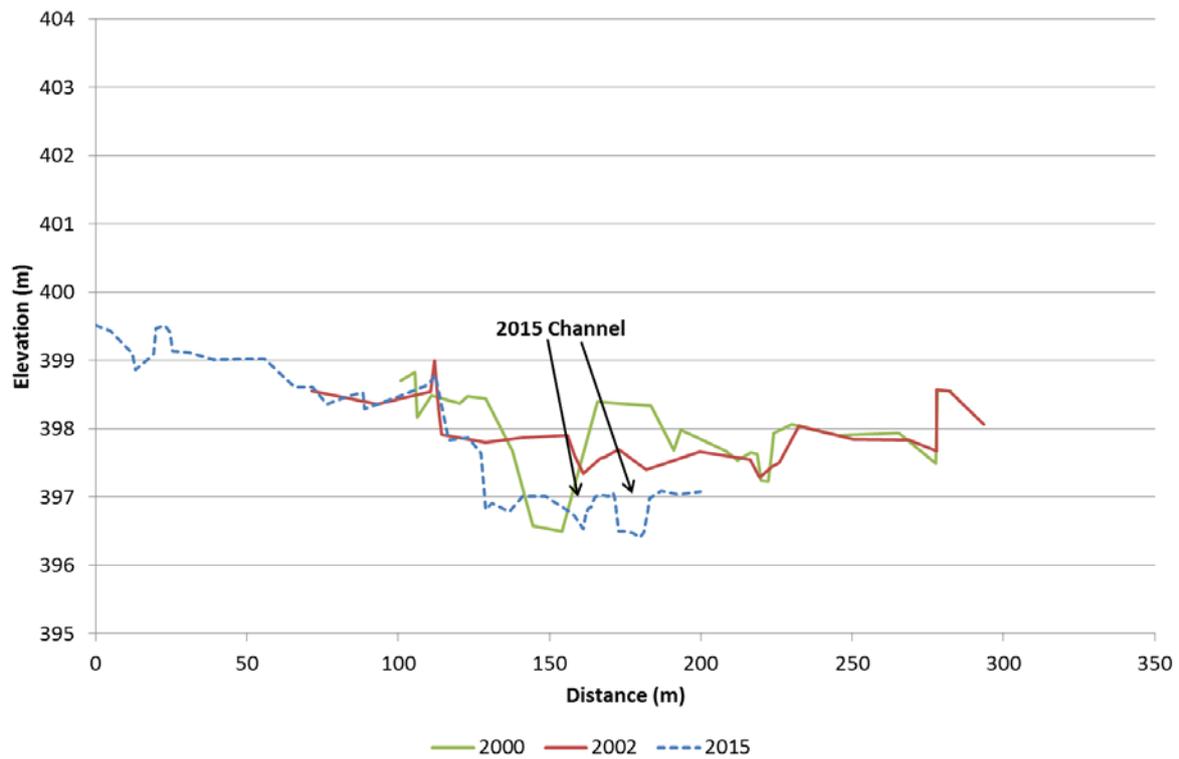
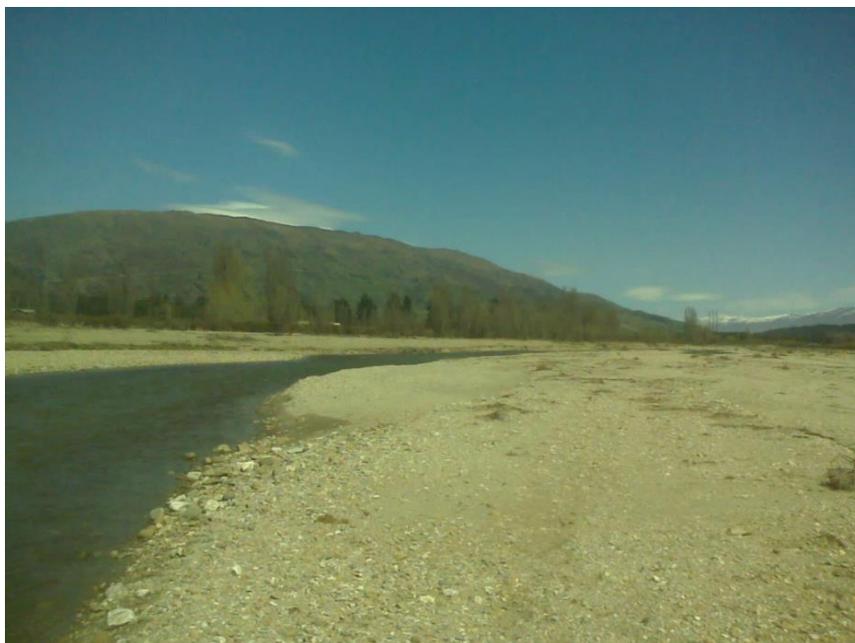
Cardrona River cross-section CR46

Figure 113. Cardrona River cross-section CR46, looking downstream refer to Figure 4 for location

Figure 114. Cardrona River cross-section CR46, looking upstream, November 2015

Cross-section CR46 is located 3.3 km upstream of the confluence with the Clutha River/Mata-Au. The active fairway has degraded between 2002 and 2015. The 2015 survey does not extend sufficiently onto the true right floodplain to allow a comparison to be made.

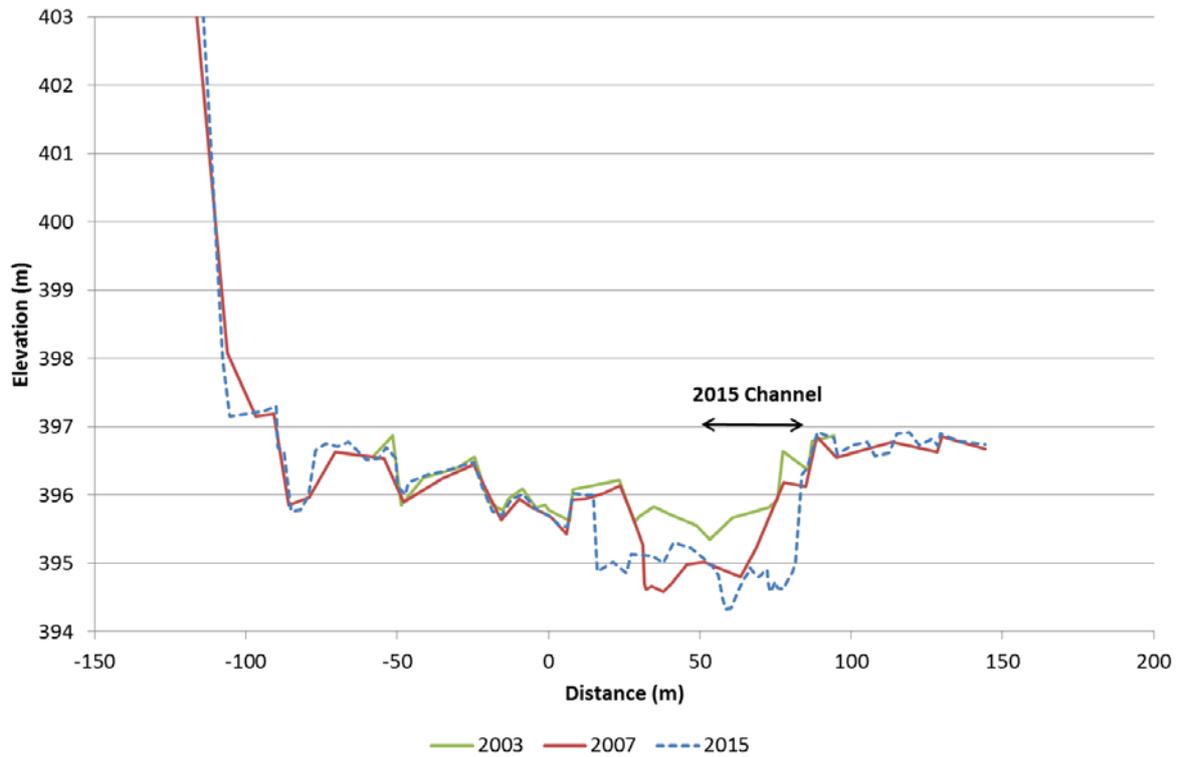
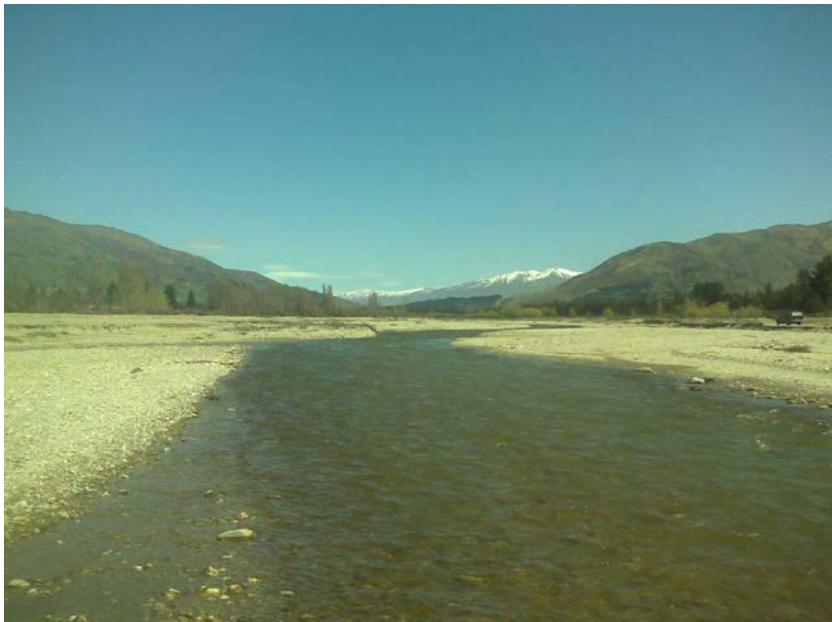
Cardrona River cross-section CR46-1

Figure 115. Cardrona River cross-section CR46-1, looking downstream refer to Figure 4 for location

Figure 116. Cardrona River cross-section CR46-1, looking upstream, November 2015

Cross-section CR46-1 is located 3 km upstream of the confluence with the Clutha River/Mata-Au. Between 2007 and 2015 the active fairway has both aggraded and degraded with erosion occurring on the true left and right banks. The wider floodplain has remained similar between 2007 and 2015.
