Cardrona River Channel Morphology

May 2016

Otago Regional Council

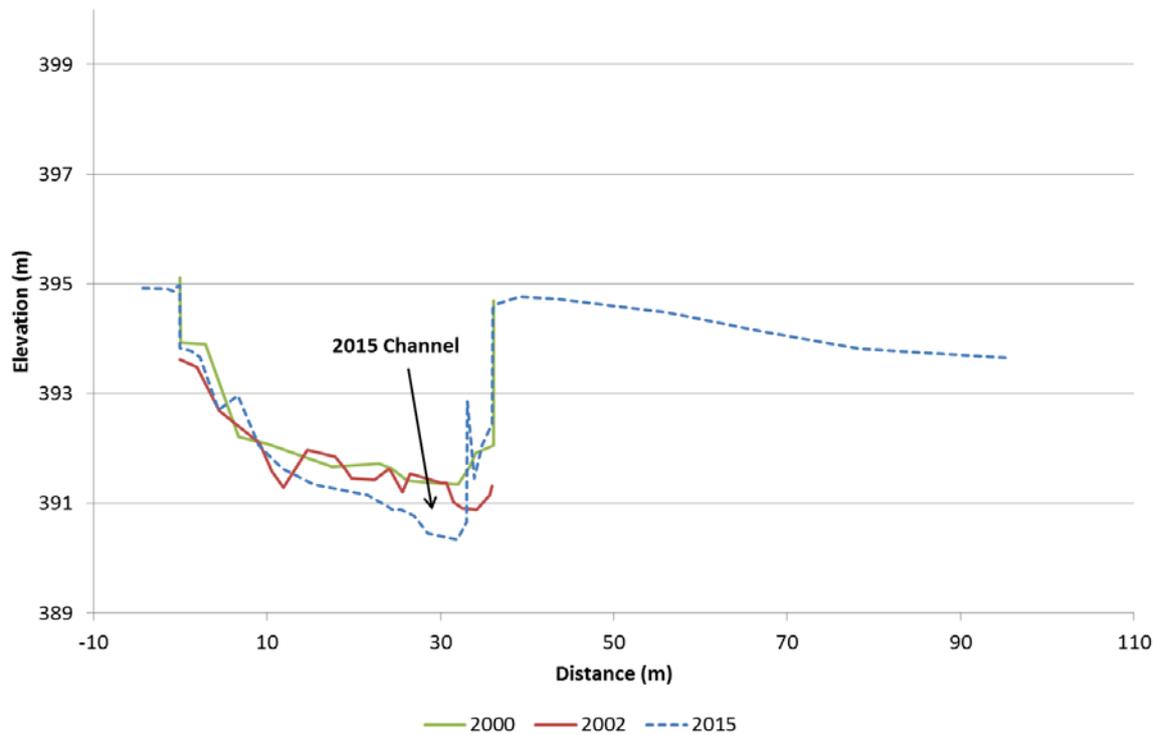
Cardrona River cross-section CR47-1

Figure 117. Cardrona River cross-section CR47-1, looking downstream refer to Figure 4 for location

Cross-section CR47-1 is located 2.5 km upstream of the confluence with the Clutha River/Mata-Au at the SH6 bridge. This cross-section was not surveyed in 2007. Between 2000 and 2015 the main channel has degraded creating a more confined river channel.

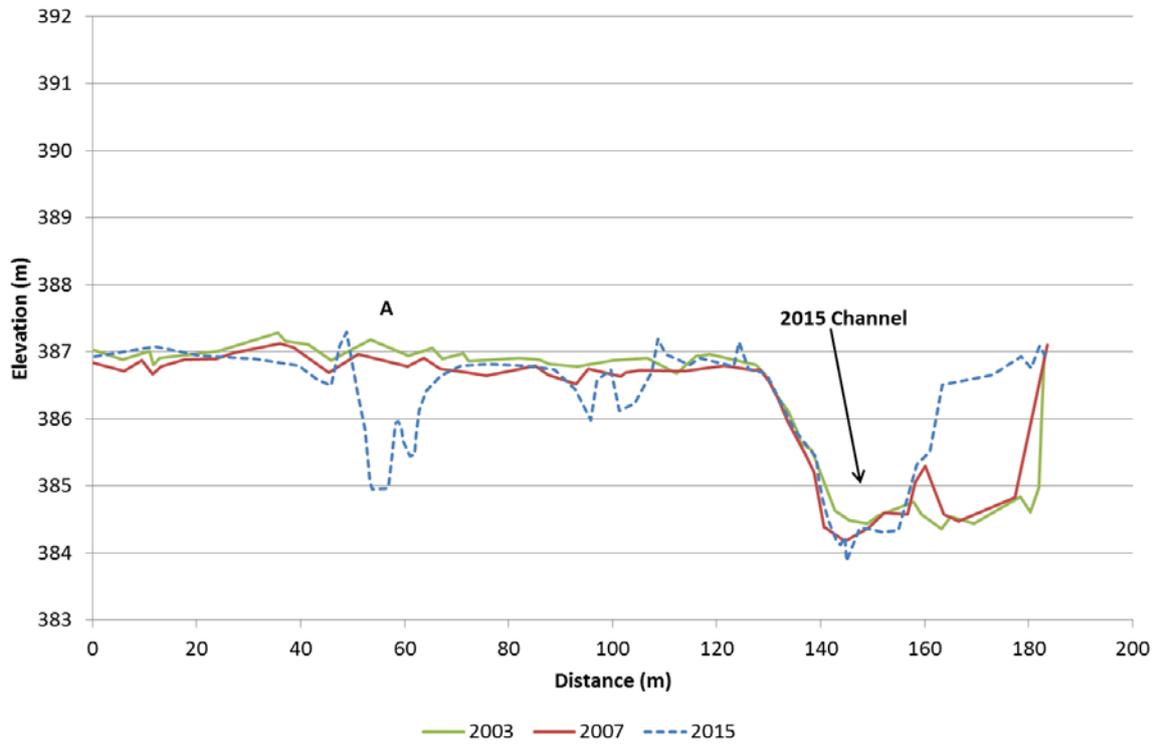
Figure 119. Cardrona River cross-section CR48-1, looking downstream refer to Figure 4 for location

Cross-section CR48-1 is located 1.7 km upstream of the confluence with the Clutha River/Mata-Au. The main channel in 2015 has remained in a similar position to 2007; there has been a large quantity of aggradation of the true right bank between 2007 and 2015. A new channel that has formed on the true left floodplain (at the point labelled A) is associated with a new industrial development.

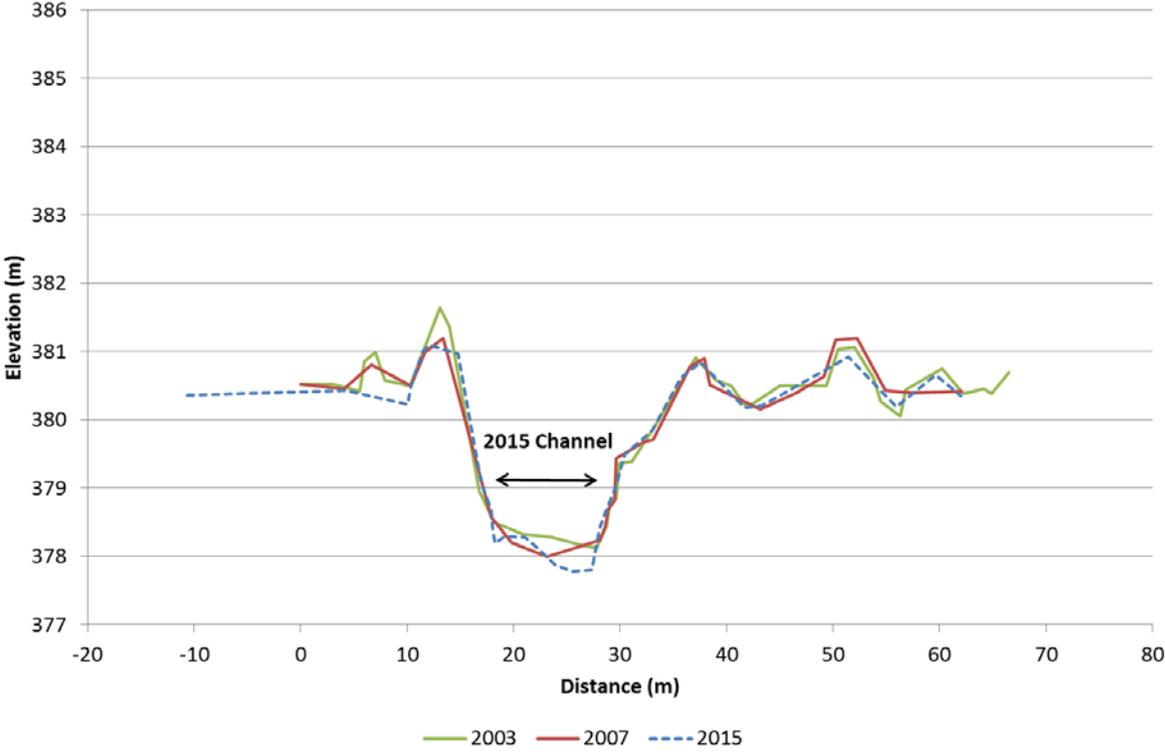
Figure 121. Cardrona River cross-section CRMWD1, looking downstream refer to Figure 4 for location

Cross-section CRMWD1 is located 0.9 km upstream of the confluence with the Clutha River/Mata-Au. Between 2007 and 2015 the main channel has degraded while the wider floodplain has remained similar.

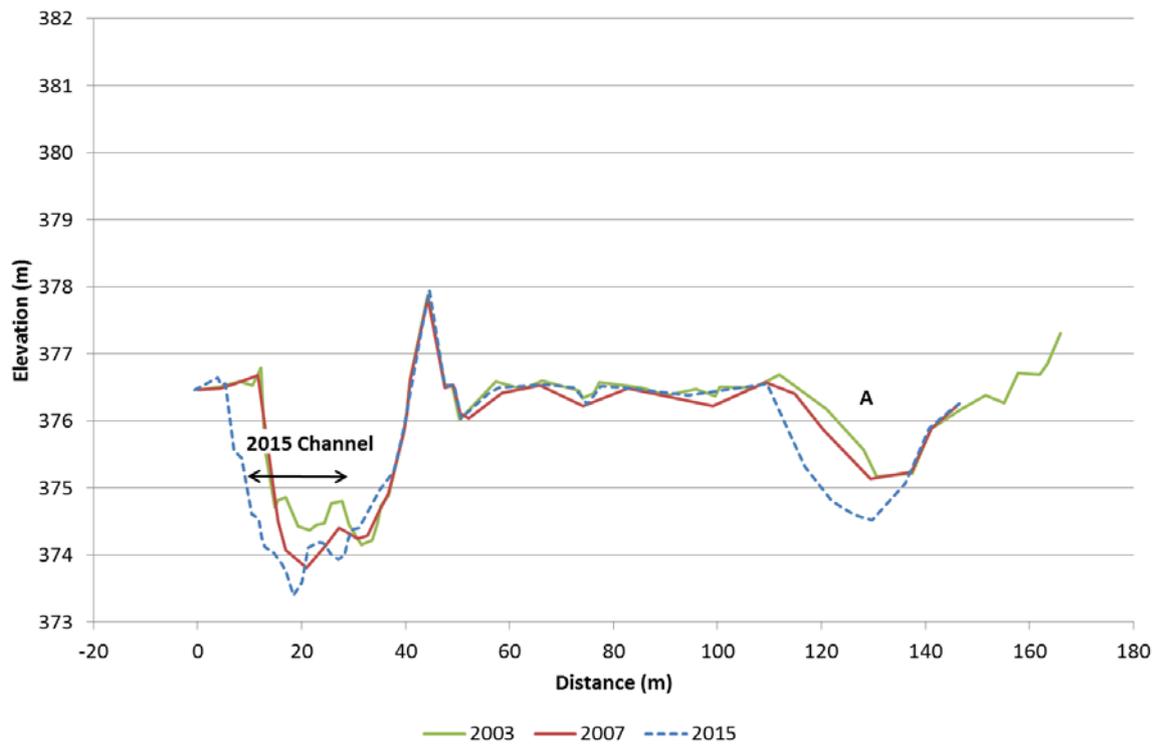
Figure 122. Cardrona River cross-section CR52-1, looking downstream refer to Figure 4 for location

Cross-section CR52-1 is located 0.2 km upstream of the confluence with the Clutha River/Mata-Au. Between 2007 and 2015 the true left bank eroded with degradation occurring in the main channel. A secondary channel (at the point labelled A) degraded between 2007 and 2015.
