# **Channel morphology and sedimentation in the Cardrona River**

**January 2010**

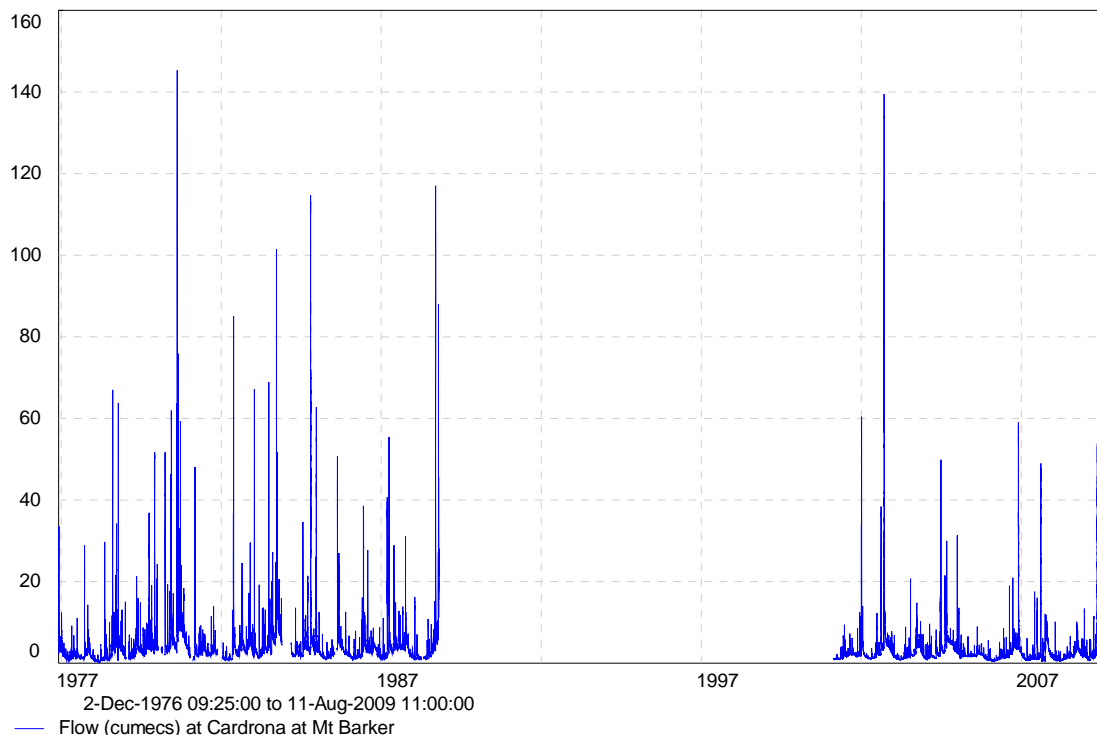
The movement of sediment along the length of the Cardrona River is largely dependent on hydrological flows, which have sufficient energy to erode, transport and deposit this material. Figure 2.3 shows that high flows have become less frequent over the last decade compared to

**Figure 2.3** Flow record in  $\text{m}^3/\text{sec}$  for the Cardrona River at Mt Barker recorder, 2 December 1976 to 11 August 2009

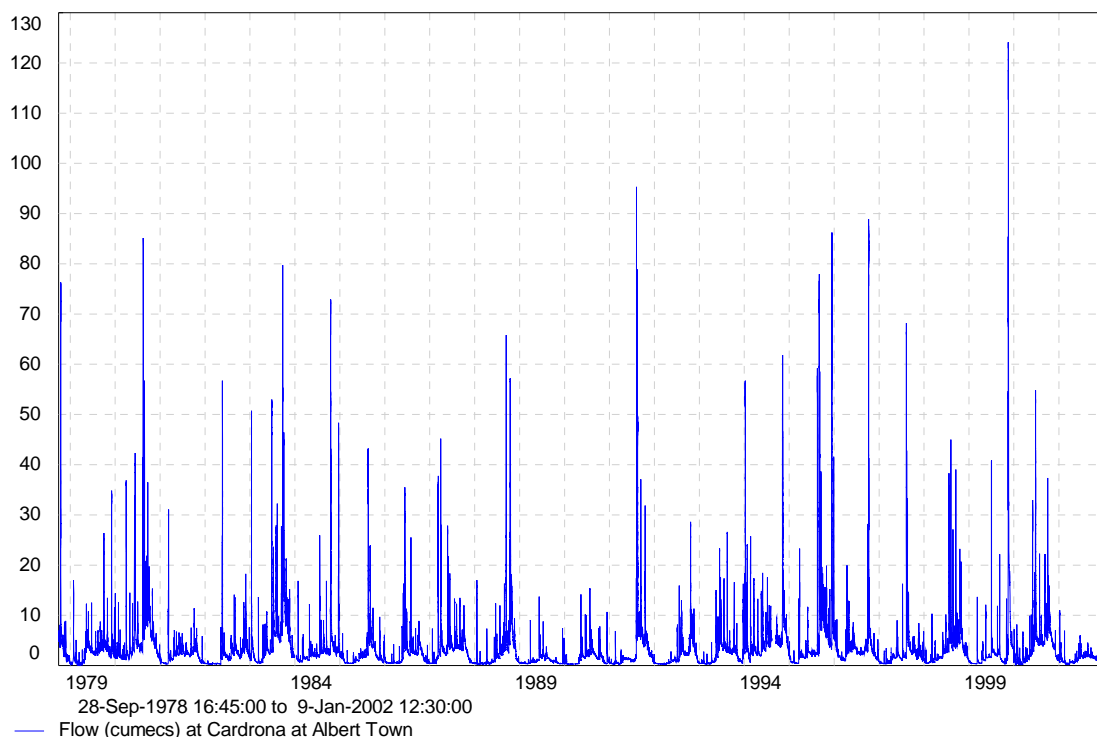
those observed during the late 1970's and 1980's. The highest flow recorded at the Albert Town gauge was  $124.2\text{m}^3/\text{s}$  on 17 November 1999 (Figure 2.4). Having had significant influence on current channel form and morphology this flood was the largest recorded event with no flows of similar or higher magnitude recorded over the last decade.

**Figure 2.4** Flow record in  $\text{m}^3/\text{sec}$  for the Cardrona River at Albert Town recorder, 28 September 1978 to 9 January 2002

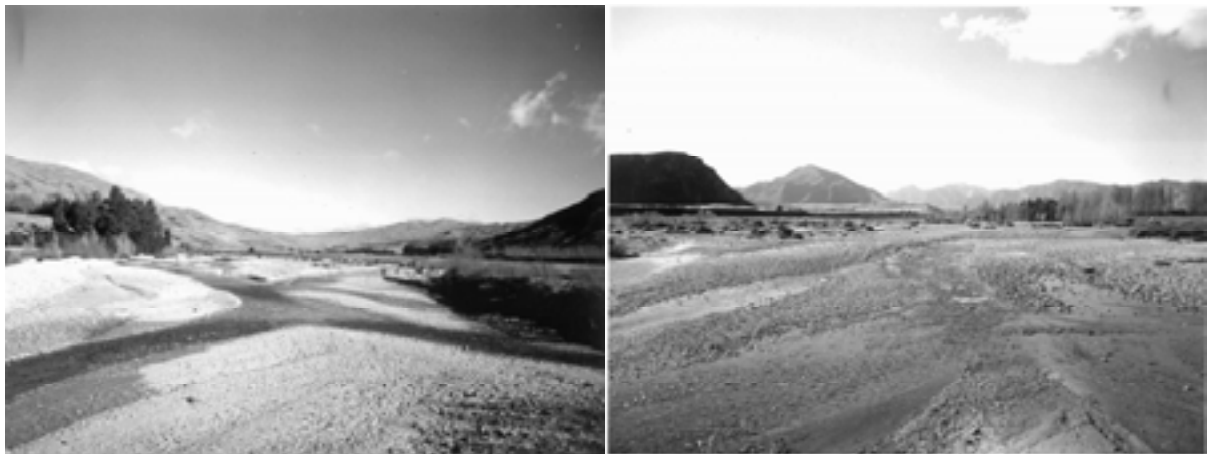
Downstream of The Larches to the State Highway, a prevailing depositional zone in the river form exists, as the river loses transport potential beyond the confines of The Larches. Naturally, these reaches are dominated by a wide, braided channel margin (Figure 5.1), which is subject to lateral migration. However, over recent decades, extensive modification of these areas, including commercial gravel extraction, has removed the braided complexity of the channel's form (Figures 8.2.2 and 8.2.3). Furthermore, this location experienced significant channel migration and aggradation during the November 1999 flood event, necessitating extensive works to re-establish the river's primary flowpath (Figure 5.2).

**Figure 5.1** Braided form of the Cardrona River lower reaches in July 1952. The image was taken looking upstream (left) and downstream (right) in the reach between Ballantyne Road and the State Highway

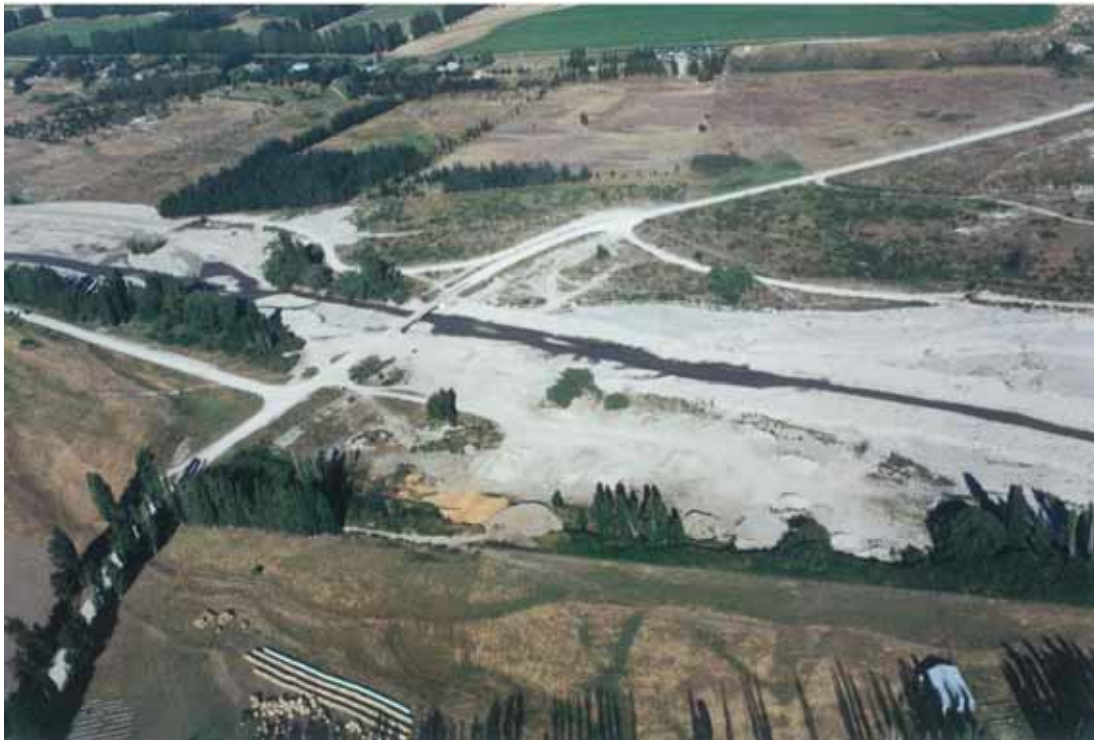
**Figure 5.2** Ballantyne Road Bridge on 14 January 2000. Artificial embankments are evident along each side of the Cardrona River; part of the post-November 1999 remedial works

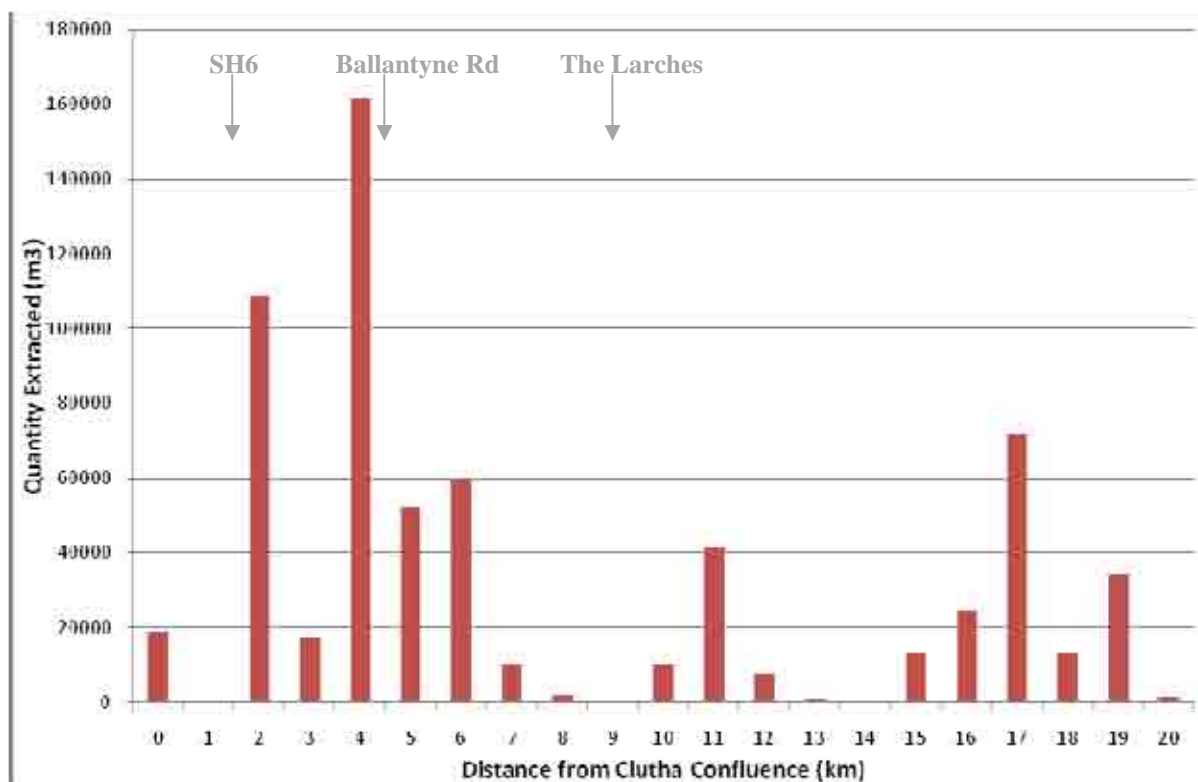
Figure 5.4 shows volumes of gravel extracted from the Cardrona River over the period 1984 to 2009, based on returns provided by gravel extractors. Historically, precise volumes of extracted gravel are not readily available, and therefore, the noted volumes are based on returns received for individual resource consents. Thus, these totals are an approximation, as they assume that returns have been filed diligently, and that they also accurately reflect the quantity extracted. Figure 5.4 represents the spatial extent of gravel extraction activities from the Clutha confluence to some 20km upstream. Over this period, in excess of 650,000m<sup>3</sup> of gravel has been extracted over this reach, with greater than 410,000m<sup>3</sup> extracted between State Highway 6 and The Larches. These equate to average annual volumes of 24,993m<sup>3</sup> and 15,841m<sup>3</sup>, respectively.

Interestingly, it is this reach that has exhibited the greatest morphological change over surveyed periods and comparative aerial photograph flights. Notably, a reduction in the complexity of the braided system along these reaches is apparent and may be attributed in part to modification from gravel extraction and large flood events, such as that which occurred in November 1999.

Figure 5.4 Returned gravel volumes for the period 1984 to 2009, showing indicative totals from the Clutha confluence for 20km upstream

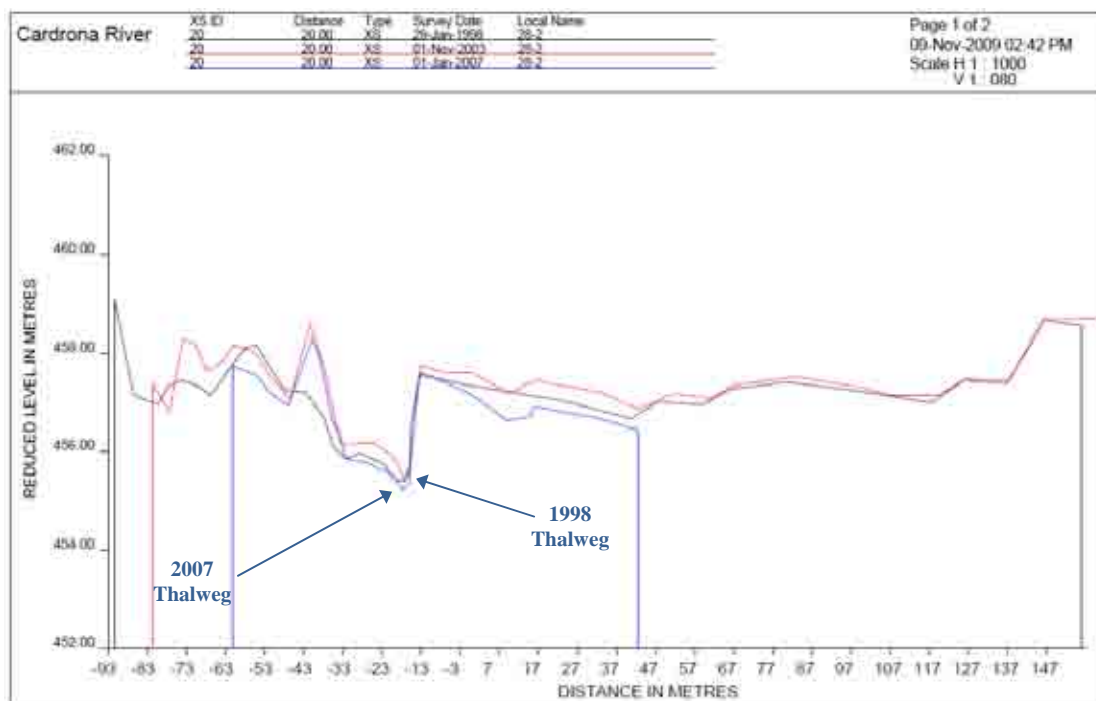
Figure 8.3.20 Cross section 28-2, looking downstream

Mean bed-level analysis shows net aggradation of 0.09m over the active channel margin during the period 1998 to 2007 (Table 8.1.2). Mean bed-levels at this location experienced net aggradation of 0.36m during the period 1998 to 2003; while the most recent survey period, 2003 to 2007, experienced net degradation of 0.27m. The thalweg at this location has experienced lowering of 0.18m over the surveyed periods.

The channel morphology at this location is indicative of this reach and has remained relatively constant over the surveyed periods. This reach is very confined by willow growth, which may be the primary reason for channel confinement and stable nature.

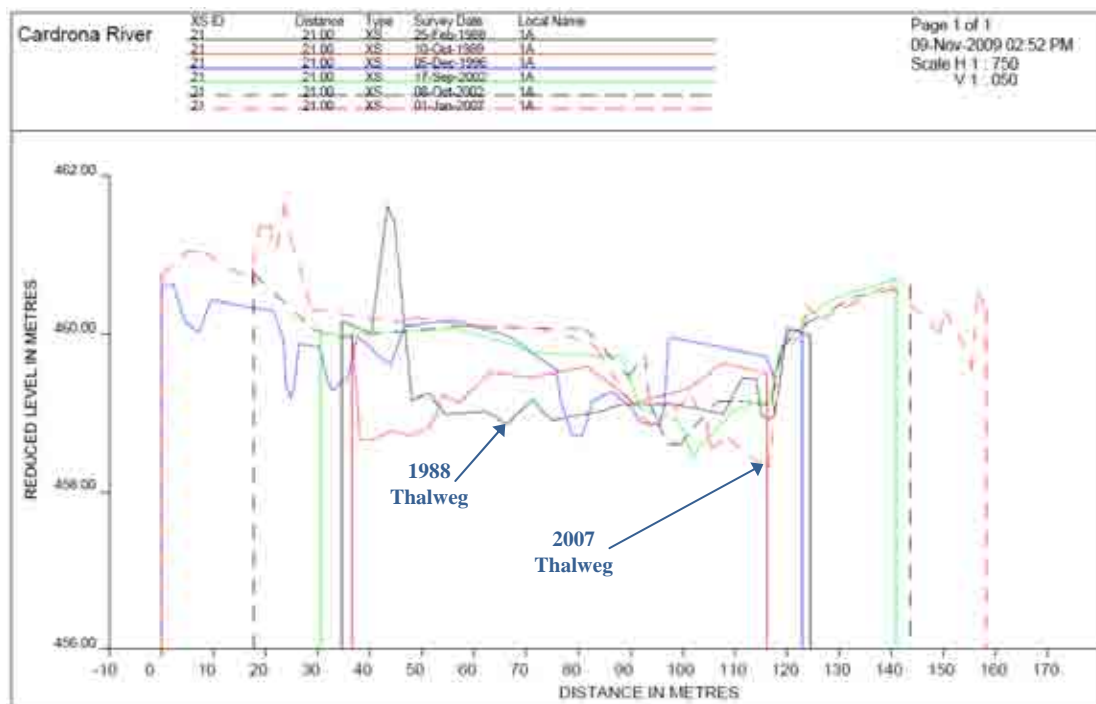
Figure 8.3.21 Cross section 1A, looking downstream

Mean bed-level analysis shows net aggradation of 0.53m over the active channel margin during the period 1988 to 2007 (Table 8.1.2). Mean bed-levels have varied between periods of both aggradation and degradation over the surveyed periods with the greatest proportion of aggradation occurring during the period 1989 to 1996. Comparatively, the thalweg at this location has experienced lowering of 0.58m over the surveyed periods.

The active channel margin widens at this cross section location to exhibit a more braided form than the cross sections immediately downstream. Bed-level variability is more pronounced at this location, which is reflected in the mean bed-level variation over surveyed periods.

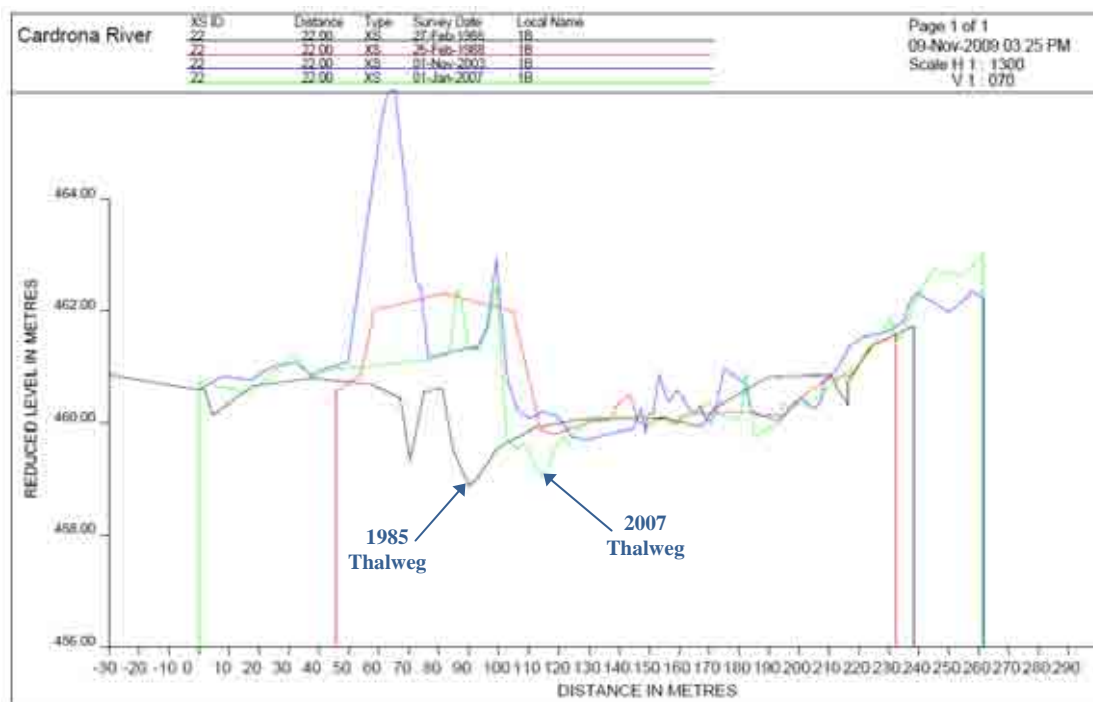
Figure 8.3.22 Cross section 1B, looking downstream

Mean bed-level analysis shows net degradation of 0.10m over the active channel margin during the period 1985 to 2007 (Table 8.1.2). Mean bed-levels have varied between periods of both minor aggradation and degradation over surveyed periods. Comparatively, the thalweg at this location has experienced aggradation of 0.15m over the surveyed period 1985 to 2007.

Similar to cross section 1A, the active channel margin widens at this location to exhibit a more braided form. Channel form within this reach is related to the sediment input from Timber Creek just upstream. Bed-level variability is more pronounced at this location, which is reflected in the mean bed-level variation over surveyed periods.

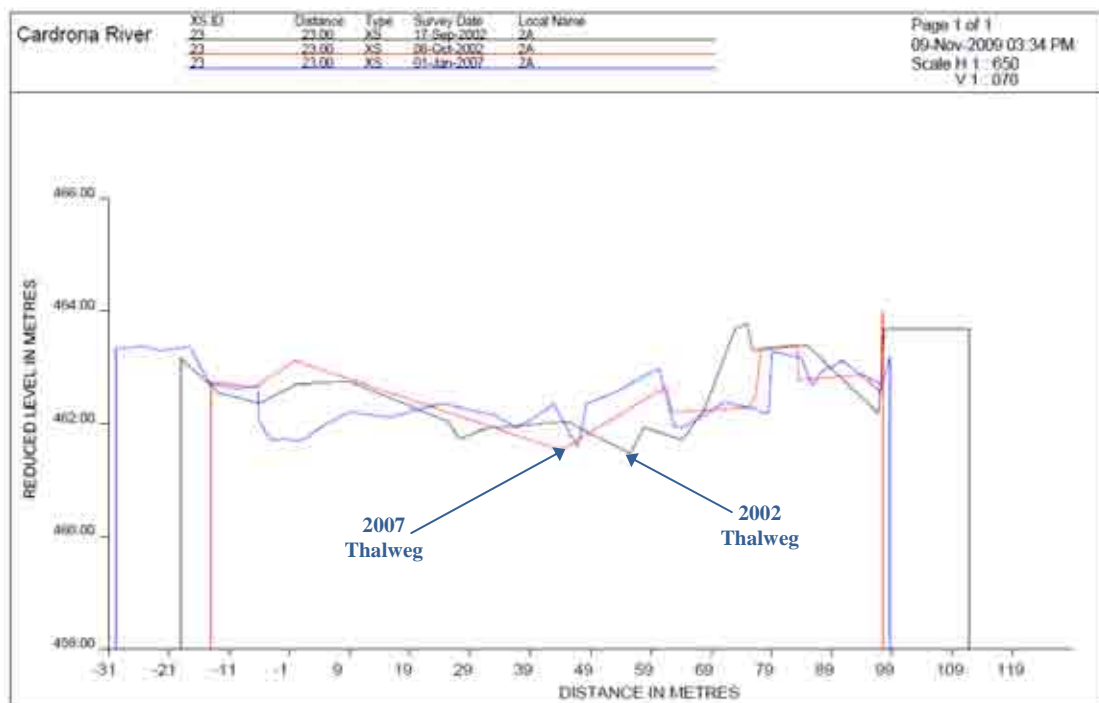
Figure 8.3.23 Cross section 2A, looking downstream

Mean bed-level analysis shows net degradation of 0.17m over the active channel margin during the period 2002 to 2007 (Table 8.1.2). Both surveyed periods exhibited periods of net degradation. Comparatively, the thalweg at this location has experienced aggradation of 0.15m over the surveyed period 2002 to 2007.

Similar to cross section 1B, the active channel margin widens at this location to exhibit a more braided form. Channel form within this reach is related to the sediment input from Timber Creek just upstream. Bed-level variability is more pronounced at this location, which is reflected in the mean bed-level variation over surveyed periods.

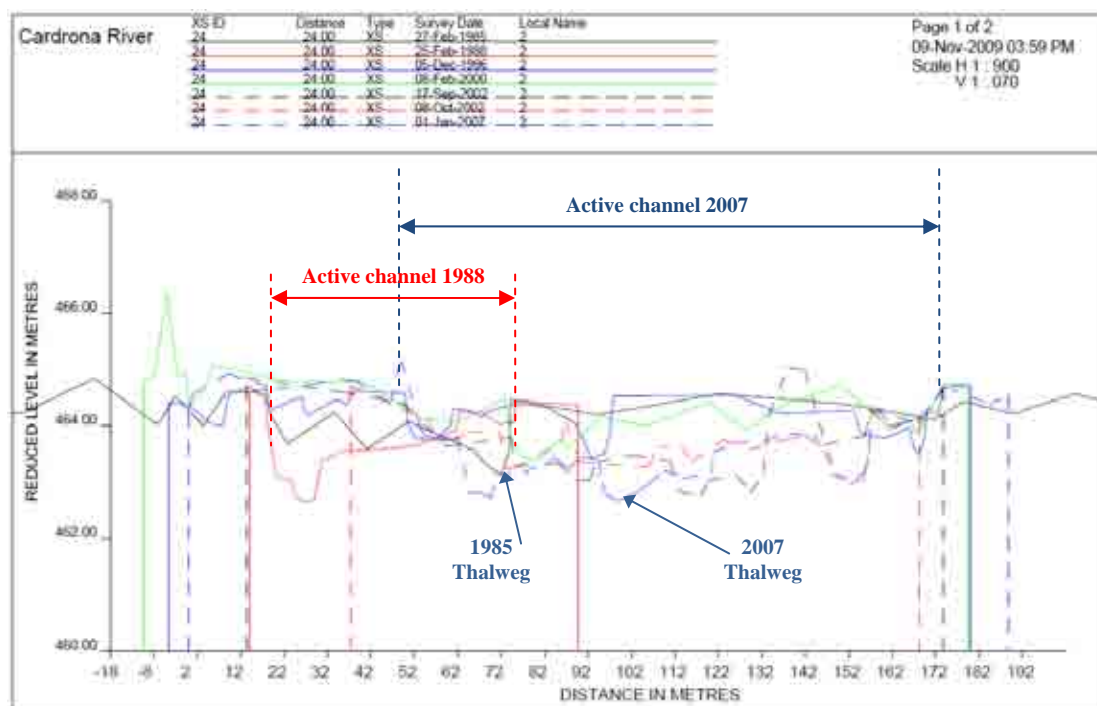
Figure 8.3.24 Cross section 2, looking downstream

Mean bed-level analysis shows net degradation of 0.77m over the active channel margin during the period 1985 to 2007 (Table 8.1.2). Mean bed-levels have varied between phases of both aggradation and degradation over the surveyed periods, with net degradation of 0.82m occurring between 2000 and 2007. This net degradational trend is further reflected in lowering of the channel thalweg by 0.44m over the period 1985 to 2007.

Similar to cross section 2A, the active channel margin widens at this location to exhibit a more braided form. The active channel margin has significantly increased over surveyed periods, where the channel occupied the true left in the 1985 and 1988 surveys, by February 2000 it had widened significantly. Channel form within this reach is related to the sediment input from Timber Creek just upstream. Bed-level variability is more pronounced at this location, which is reflected in the mean bed-level variation over surveyed periods.

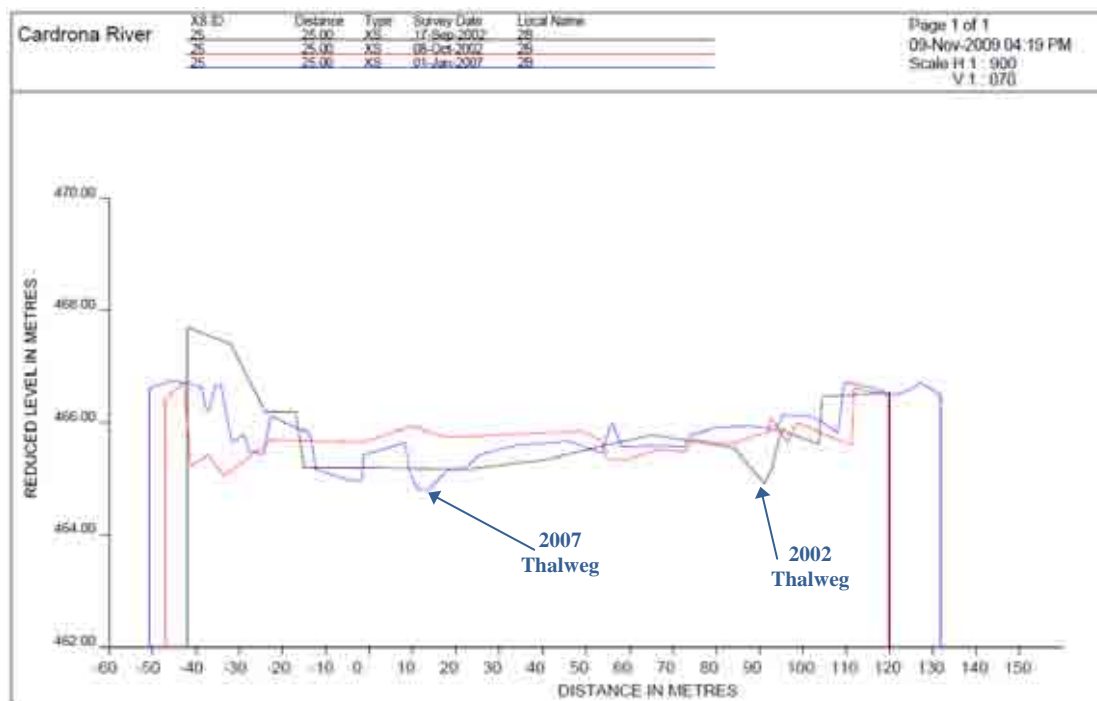
Figure 8.3.25 Cross section 2B, looking downstream

Mean bed-level analysis shows net aggradation of 0.15m over the active channel margin during the period 2002 to 2007 (Table 8.1.2). Both surveyed periods exhibited periods of net aggradation. Comparatively, the thalweg at this location has experienced degradation of 0.11m over the surveyed period, 2002 to 2007.

Similar to cross section 2 located just downstream, the active channel margin widens at this location to exhibit a more braided form. Channel form within this reach is related to the sediment input from Timber Creek just upstream. Bed-level variability is more pronounced at this location, which is reflected in the mean bed-level variation over surveyed periods.

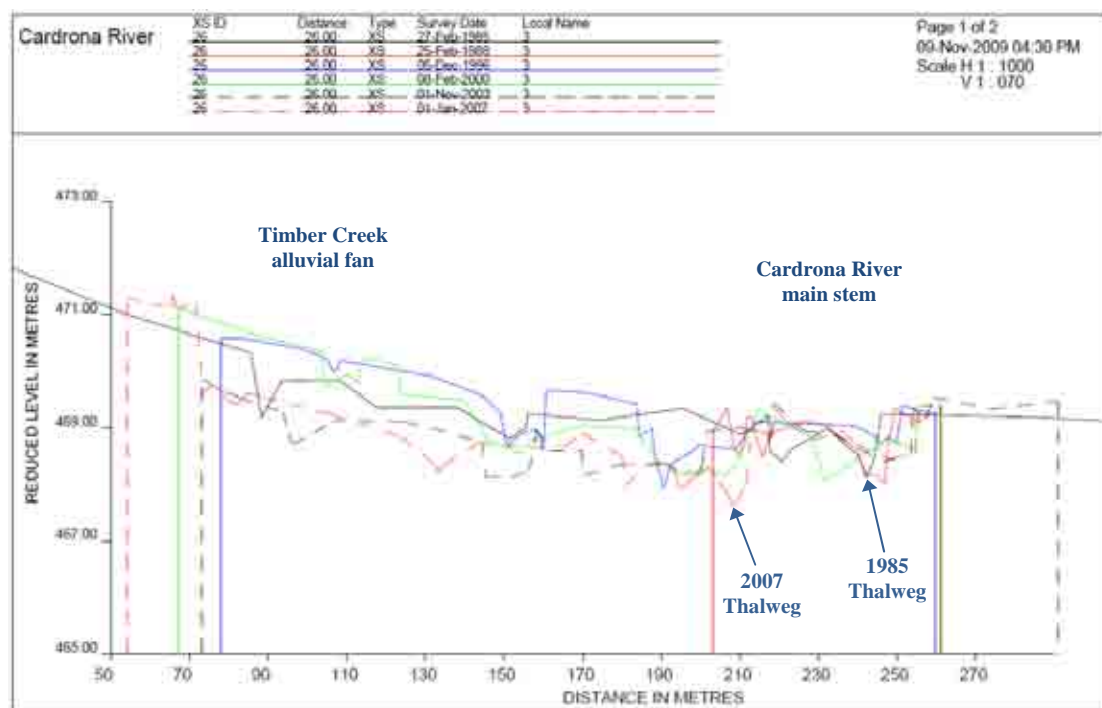
Figure 8.3.26 Cross section 3, looking downstream

Mean bed-level analysis shows net degradation of 0.41m over the active channel margin during the period 1985 to 2007 (Table 8.1.2). Surveyed periods all experienced net degradation, apart from 1988 to 1996, which experienced aggradation of 0.56m. This trend in net degradation is further reflected by lowering of the channel thalweg by 0.5m over the period 1985 to 2007.

Channel morphology and bed levels are highly influenced by sediment fluxes by Timber Creek. During periods of high flow, toe-cutting of the Timber Creek alluvial fan surface, true left of the cross section, by the axial Cardrona River channel may occur. Comparatively, the active channel margins of the Cardrona River main stem may be affected by encroachment of the alluvial fan, with depositional phases of the Timber Creek catchment contributing to intermittent sediment fluxes across the Cardrona River floodplain.

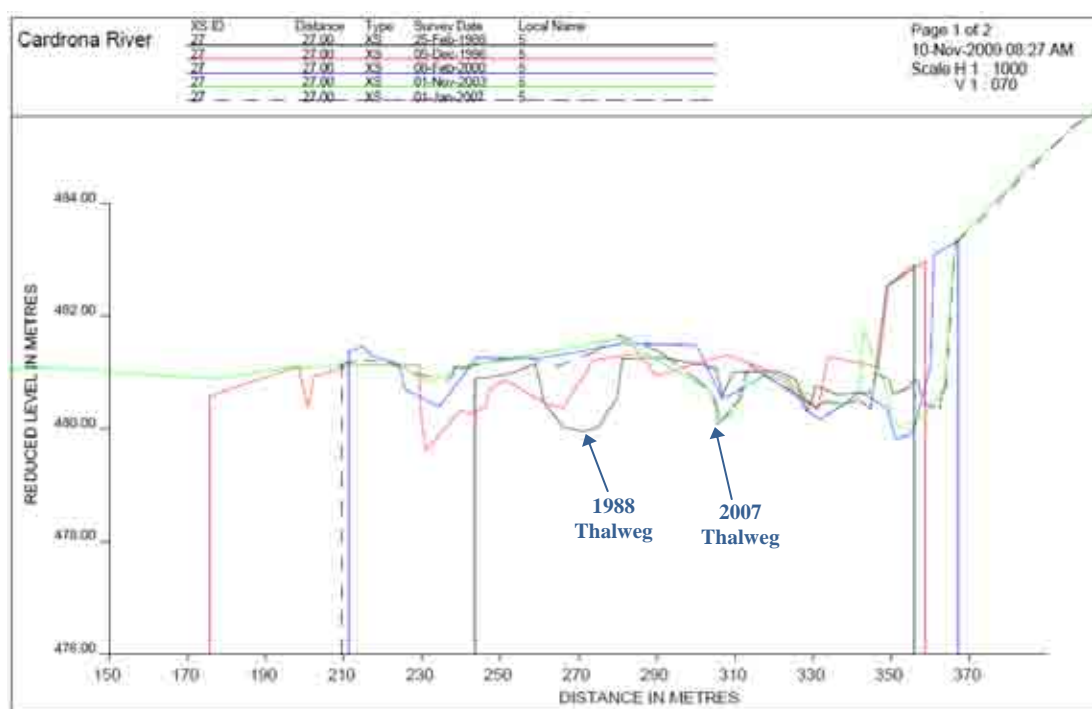
Figure 8.3.27 Cross section 5, looking downstream

Mean bed-level analysis shows net aggradation of 0.15m over the active channel margin during the period 1988 to 2007 (Table 8.1.2). Mean bed-levels have remained relatively consistent at this cross section location over surveyed periods. All periods exhibited net aggradation, apart from the most recent, 2003 to 2007, which exhibited minor degradation. The thalweg reflects the net aggradational trend, by rising 0.13m during the period 1988 to 2007.

The channel morphology and bed level at this cross section location is inferred to be influenced by sedimentation from the adjacent tributaries both up and downstream on the true right of the valley. These tributaries extend to the top of the Criffel Range and pass through ancient, highly erodible terrace deposits, which may contribute to sedimentation at this location. The topography at this cross section is very generic, which means that the river may easily migrate laterally across the wider floodplain during relatively frequent periods of high flow.

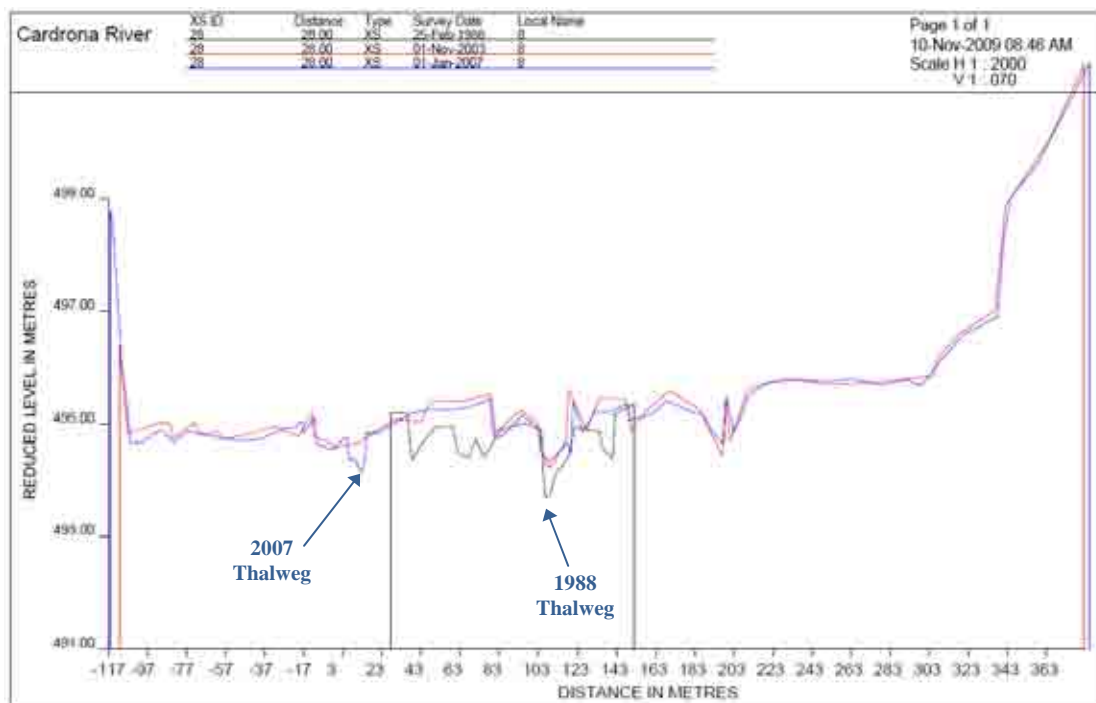
Mean bed-level analysis shows net aggradation of 0.28m over the active channel margin during the period 1988 to 2007 (Table 8.1.2). Mean bed-levels exhibited a period of net aggradation of 0.36m between 1988 and 2003, with the most recent survey period exhibiting net degradation. The net aggradational is also reflected in the thalweg rising by 0.68m at this location.

The active channel margins at this location are primarily within the central part of the wider floodplain. Similar to the cross sections located downstream of this site, the topography is quite generic and relatively frequent flood events may leave the active channel margin.

Figure 8.3.28 Cross section 8, looking downstream

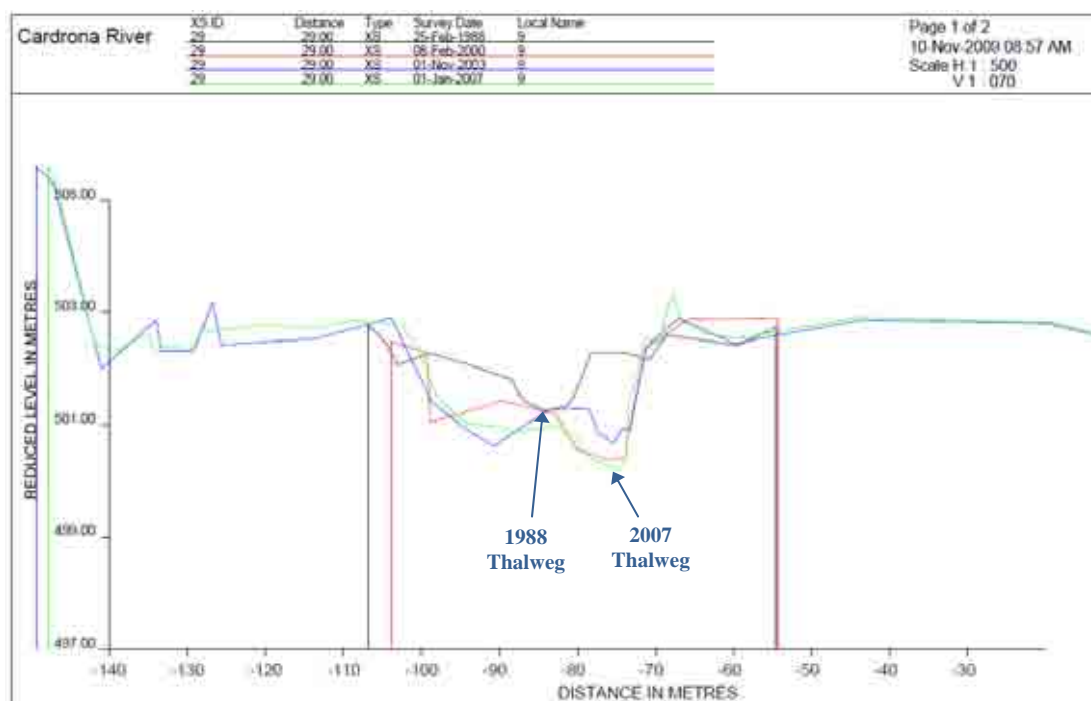
Mean bed-level analysis shows net degradation of 0.27m over the active channel margin during the period 1988 to 2007 (Table 8.1.2). Surveyed periods have generally exhibited net degradation at this location, apart from the period 2000 to 2003, which exhibited minor aggradation. The net degradational trend is further reflected by a lowering of the channel thalweg by 1.1m.

The active channel margins at this location are primarily within the central part of the wider floodplain. Similar to the cross sections located downstream of this site, the topography is quite generic and relatively frequent flood events may leave the active channel margin.

Figure 8.3.29 Cross section 9, looking downstream

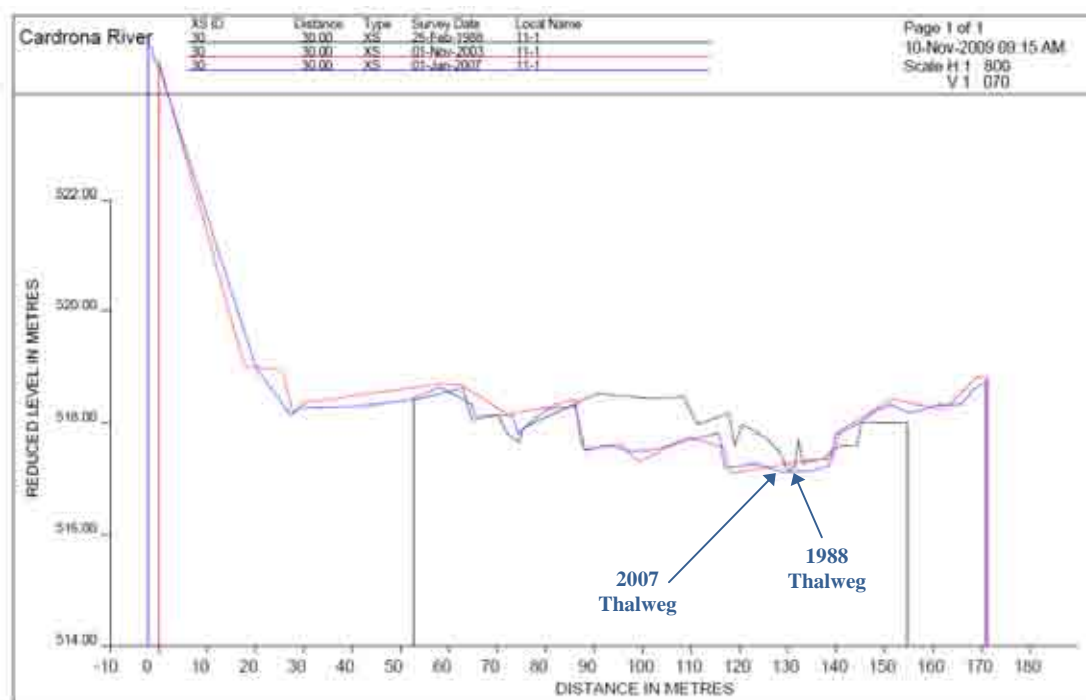
Mean bed-level analysis shows net degradation of 0.46m over the active channel margin during the period 1988 to 2007 (Table 8.1.2). All surveyed periods exhibited net degradation, with the largest proportion, 0.41m, occurring during the period 1988 to 2003. Net degradation at this location has occurred across the extents of the active channel margin, which is reflected by minor movement, 0.01m degradation, of the channel thalweg at this location.

The channel morphology at this location is largely constrained by the slopes on either side of the valley and is subject to intensive willow growth. This differs from the braided form exhibited by cross sections immediately downstream.

Figure 8.3.30 Cross section 11-1, looking downstream

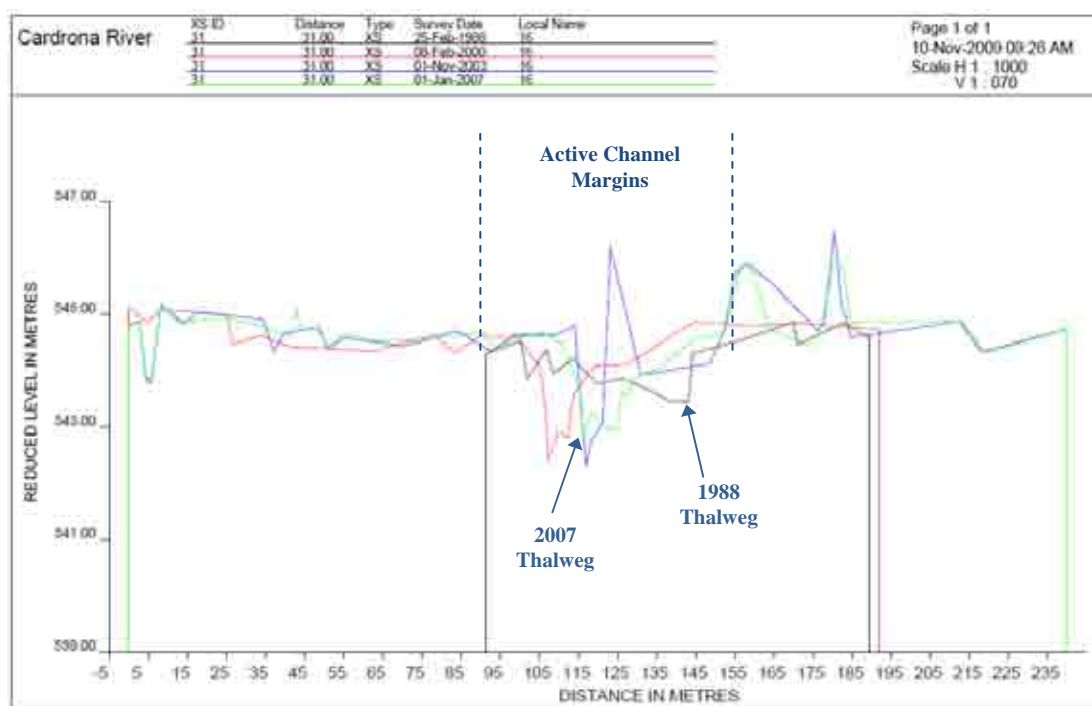
Mean bed-level analysis shows net aggradation of 0.22m over the active channel margin during the period 1988 to 2007 (Table 8.1.2). Both surveyed periods between 1988 and 2003 exhibited net aggradation at this location; while the most recent survey period to 2007 exhibited net degradation of 0.14m. Comparatively, the channel thalweg experienced lowering of 0.63m over all surveyed periods.

The active channel margin is located mid-cross section and appears to have been modified. Peaks towards the true right in both the 2003 and 2007 cross sections are inferred to be embankments or banks created by extensive willow growth. The general topography is very generic at this cross section, with willow growth on either side of the channel, maintaining the confinement of active channel margins.

Figure 8.3.31 Cross section 16, looking downstream

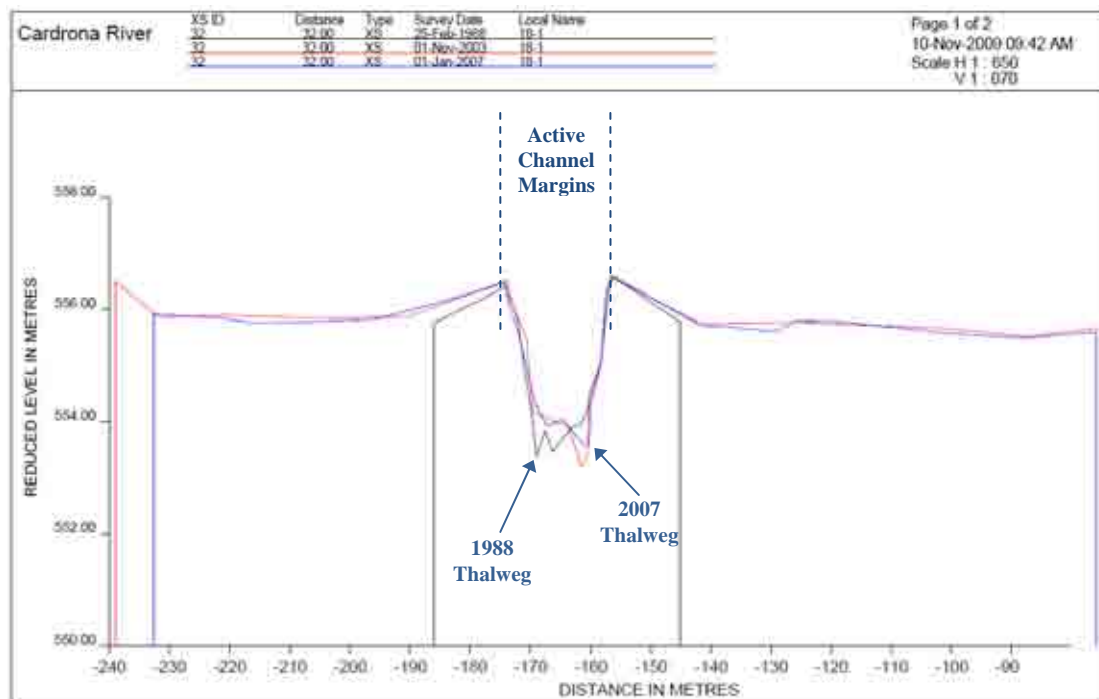
Mean bed-level analysis shows net aggradation of 0.03m over the active channel margin during the period 1988 to 2007 (Table 8.1.2). Both surveyed periods between 1988 and 2007 exhibited minor net aggradation. The channel thalweg also exhibits net aggradation, 0.2m, at this location over the surveyed periods.

The channel morphology at this location is largely dictated by a private bridge located immediately downstream. Both banks are confined by the bridge abutments at this location. The floodplain topography is very generic at this location, and the river will leave its active margins and spread laterally during frequent flood events.

Figure 8.3.32 Cross section 18-1, looking downstream

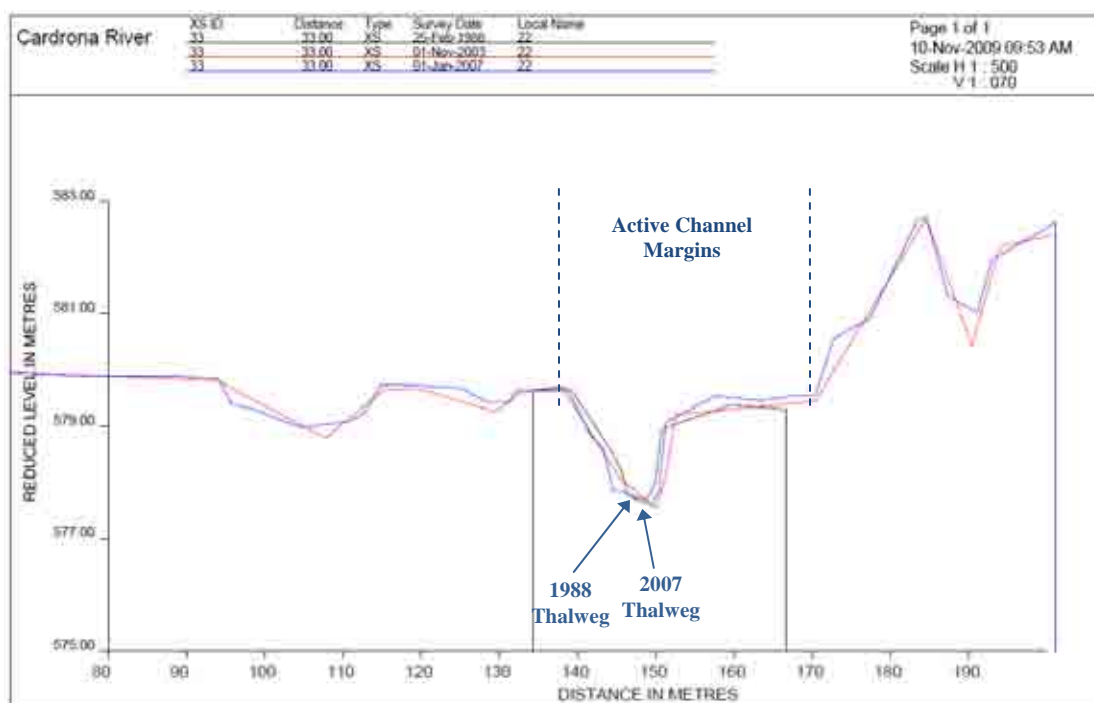
Mean bed-level analysis shows net aggradation of 0.07m over the active channel margin during the period 1988 to 2007 (Table 8.1.2). The minor change in bed levels between survey periods is attributable to this reach primarily being a transport zone of the river, rather than depositional. The channel thalweg experienced 0.08m of degradation at this location over the period 1988 to 2007.

The channel morphology at this location is indicative of this reach of the Cardrona River, where a willow-lined, single-thread channel dominates in generic topography. This area is still within the primary transportation zone of the river.

Figure 8.3.33 Cross section 22, looking downstream

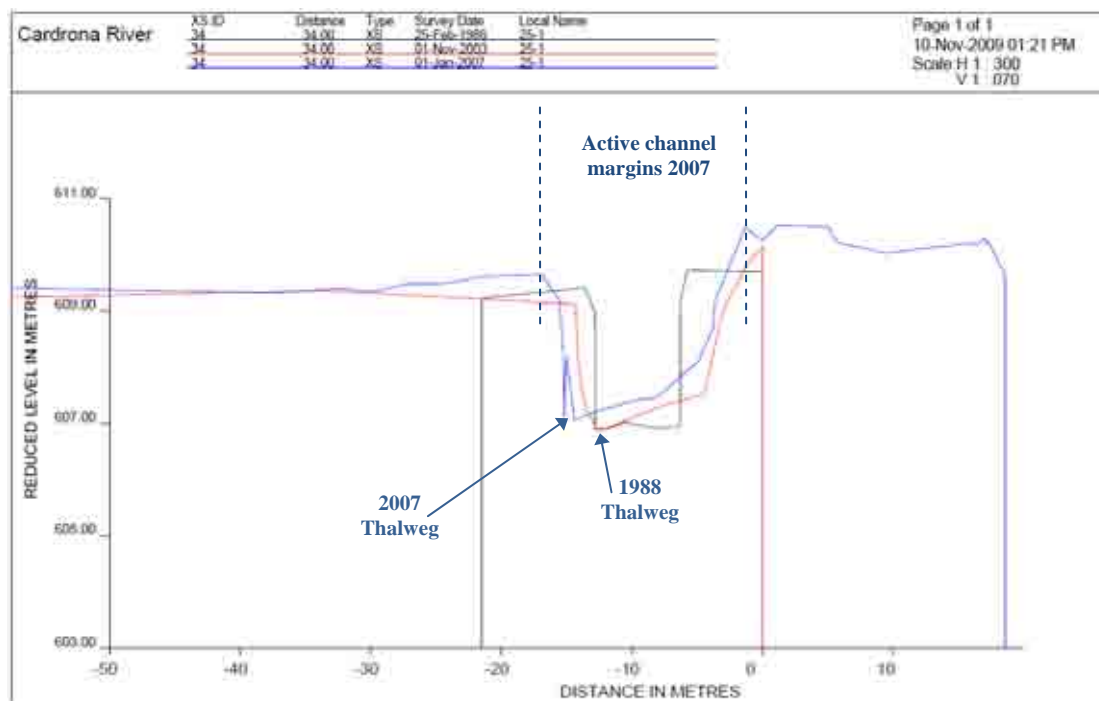
Mean bed-level analysis shows net aggradation of 1.01m over the active channel margin during the period 1988 to 2007 (Table 8.1.2). Both surveyed periods experienced net aggradation, with the most recent survey period, 2003 to 2007, experiencing 0.59m of aggradation. This net aggradational trend is also evident in a 0.21m increase in the channel thalweg level over surveyed periods.

The channel morphology at this location is similar to the cross sections immediately downstream. These areas are within a transportation zone of the Cardrona River and are largely confined within a single-thread, willow-bound channel.

Figure 8.3.34 Cross section 25-1, looking downstream
