# REPORT Management and Reduction of Debris Flow Risk in Roxburgh, Otago

Geomorphological Assessment Report

18113634\_7407-003-R-Rev0

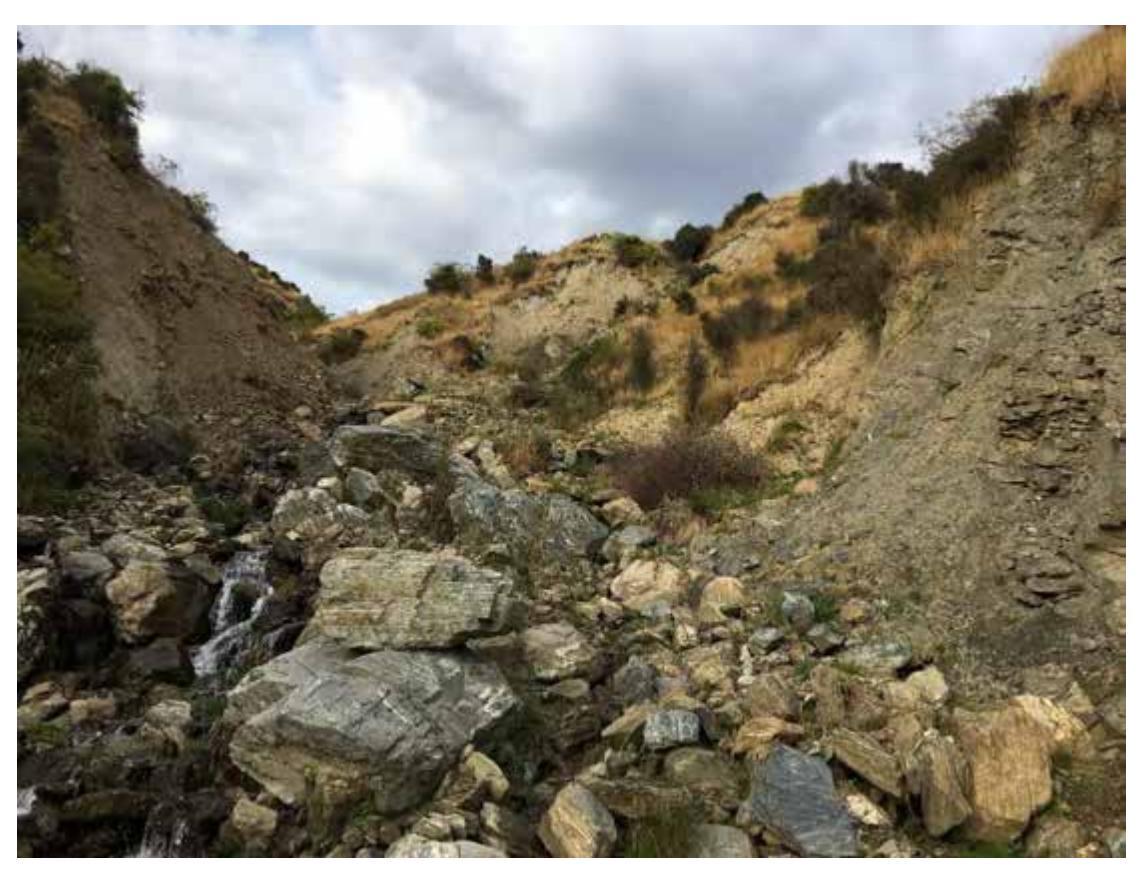
Figure 6: Channel at about 250 m asl looking upstream towards the active landslide area; in-situ rock is exposed along some length of this creek section; the bedload contains boulders of up to 2 m in diameter.

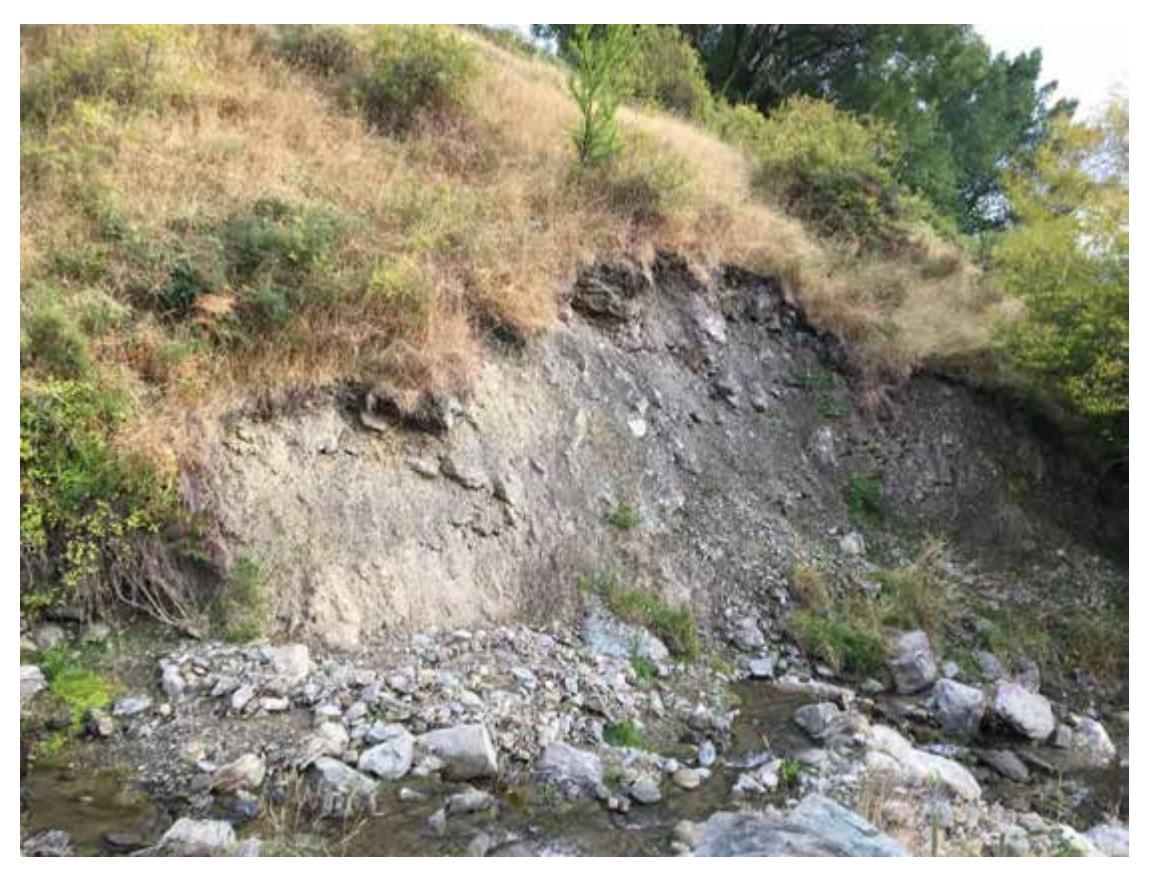
Figure 7: Channel at about 230 m asl looking upstream (left) and downstream (right). Bedload consists of bouldery material with individual boulders reaching diameters of up to 2 m.

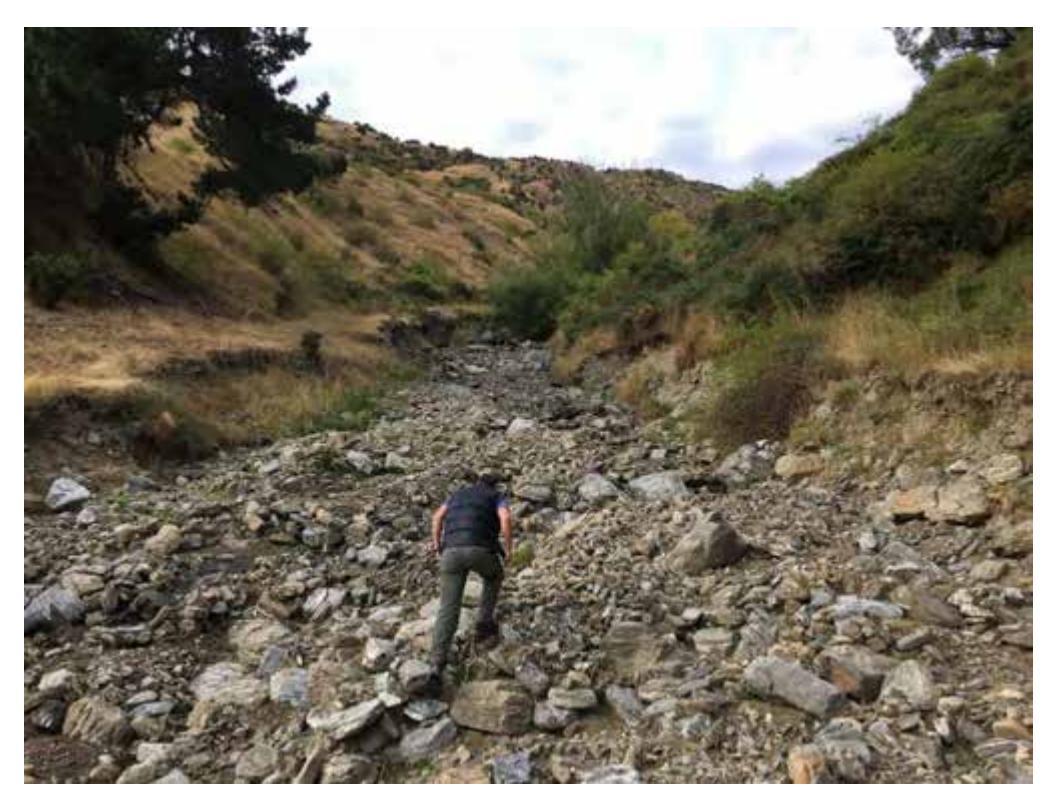
Figure 11: Channel looking upstream from debris fan apex at about 170 m asl; widening of the channel and deposition of debris. Max. diameter of deposited boulders are about 0.5 m in diameter. Erosion along true left bank visible.

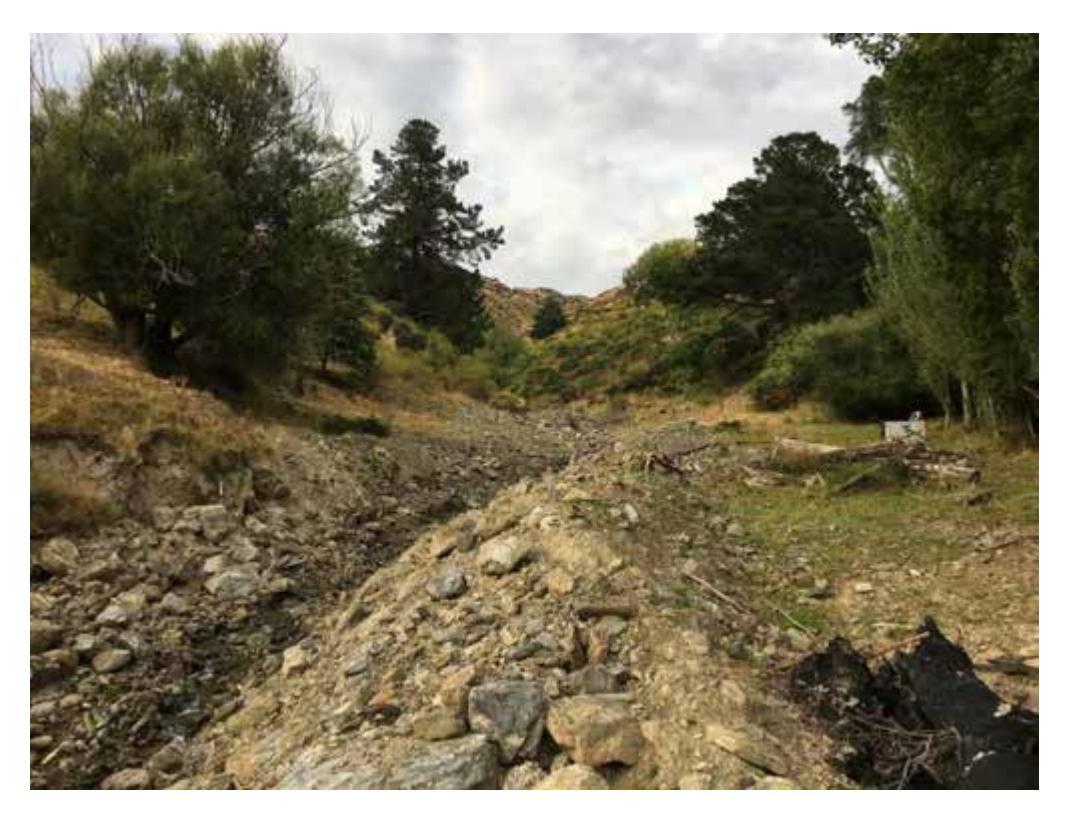
Figure 12: Fan apex area looking upstream at about 150 m asl showing creek bed along true right bank and erosion along this bank. A levee has been built up along the left bank of the creek channel by excavation of creek material.

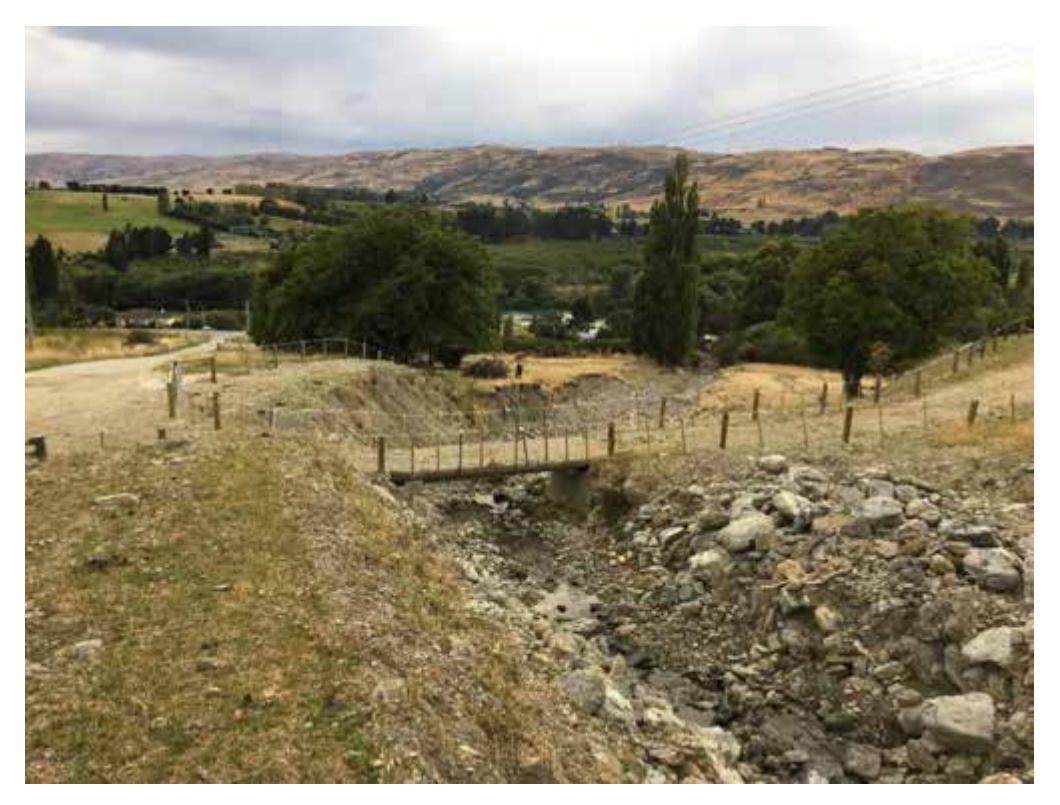
Figure 16: View downslope from about 130 m asl at farm access bridge. Boulders in the channel are up to 1 m in diameter. Erosion along channel banks visible.

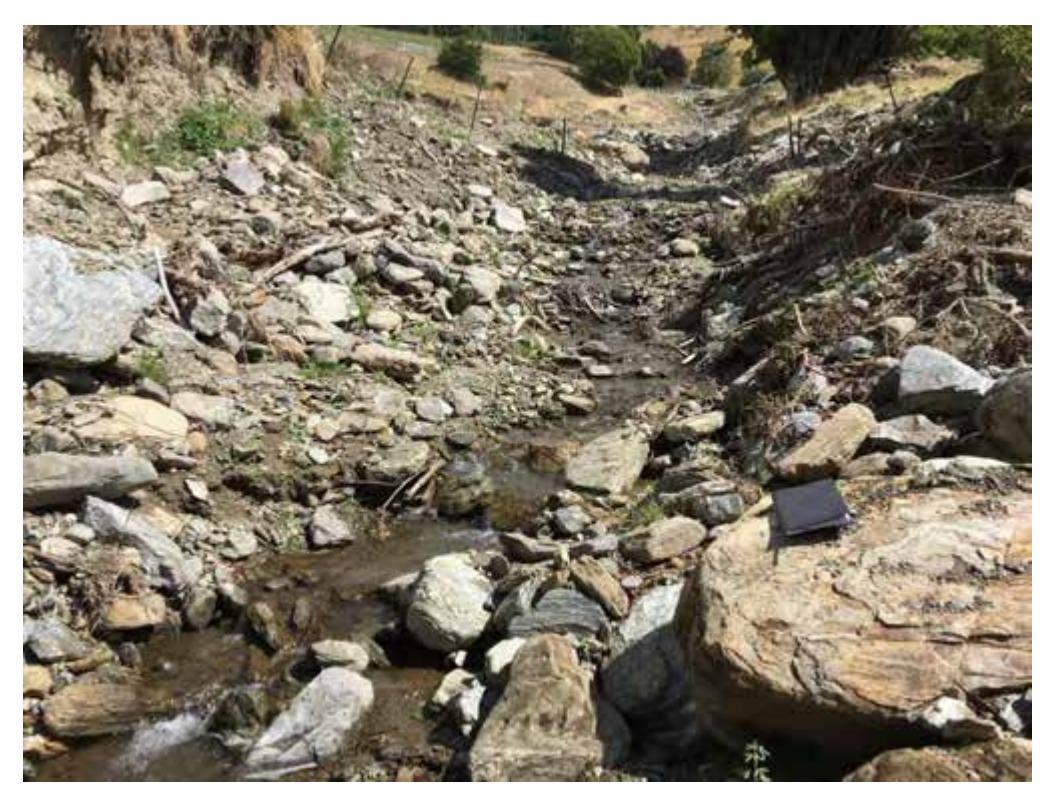
Figure 17: Upstream view at about 100 m asl; boulder max. size about 1.5 m in diameter. Average slope angle of the creek channel here about 5-7°.

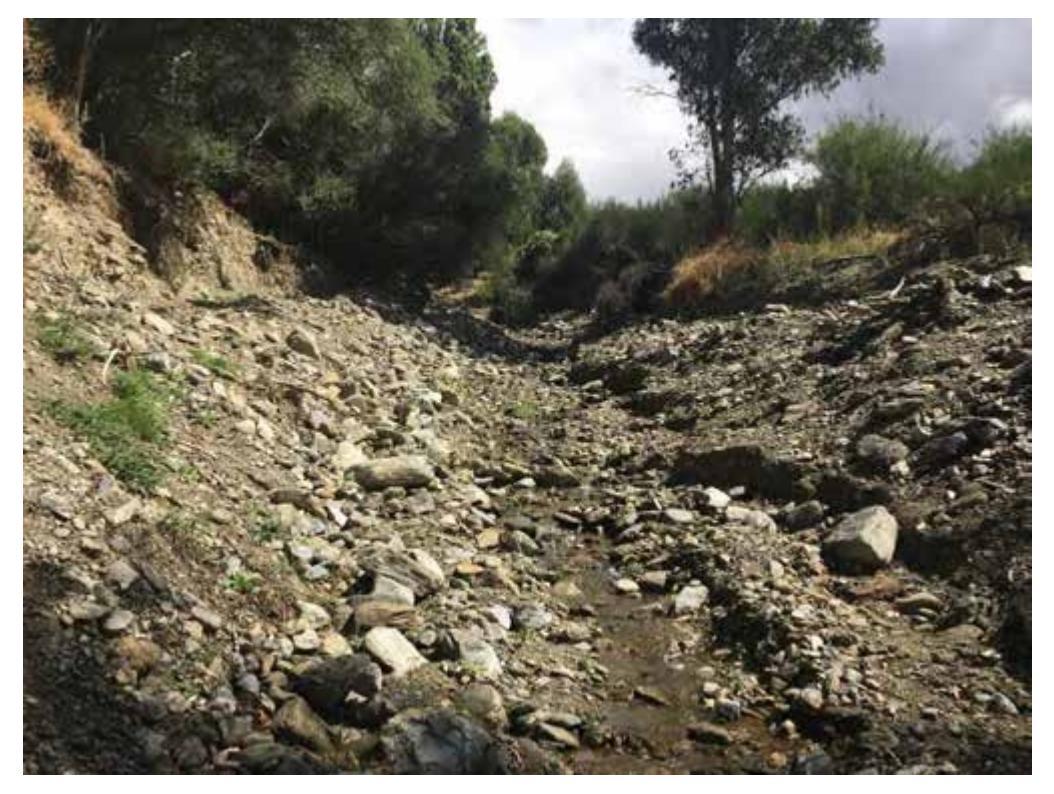
Figure 19: Creek channel bed above SH8 crossing looking upslope. Material deposition at channel slope angle of about 5°. Largest boulders are about 1 m in diameter.

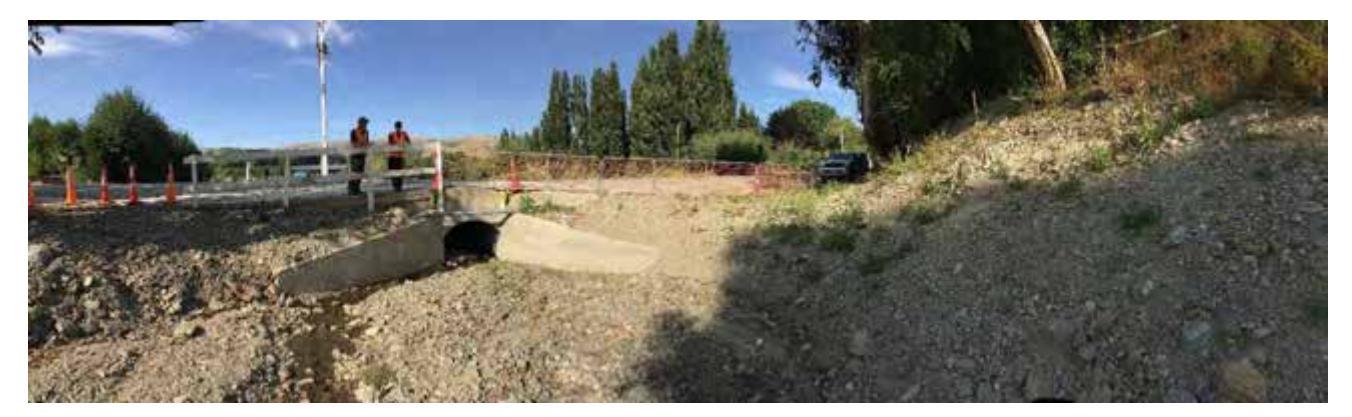
Figure 20: Upslope panoramic view of the current culvert infrastructure at the SH8 crossing. Debris has been excavated after the Nov 2017 event to reinstate channel capacity.

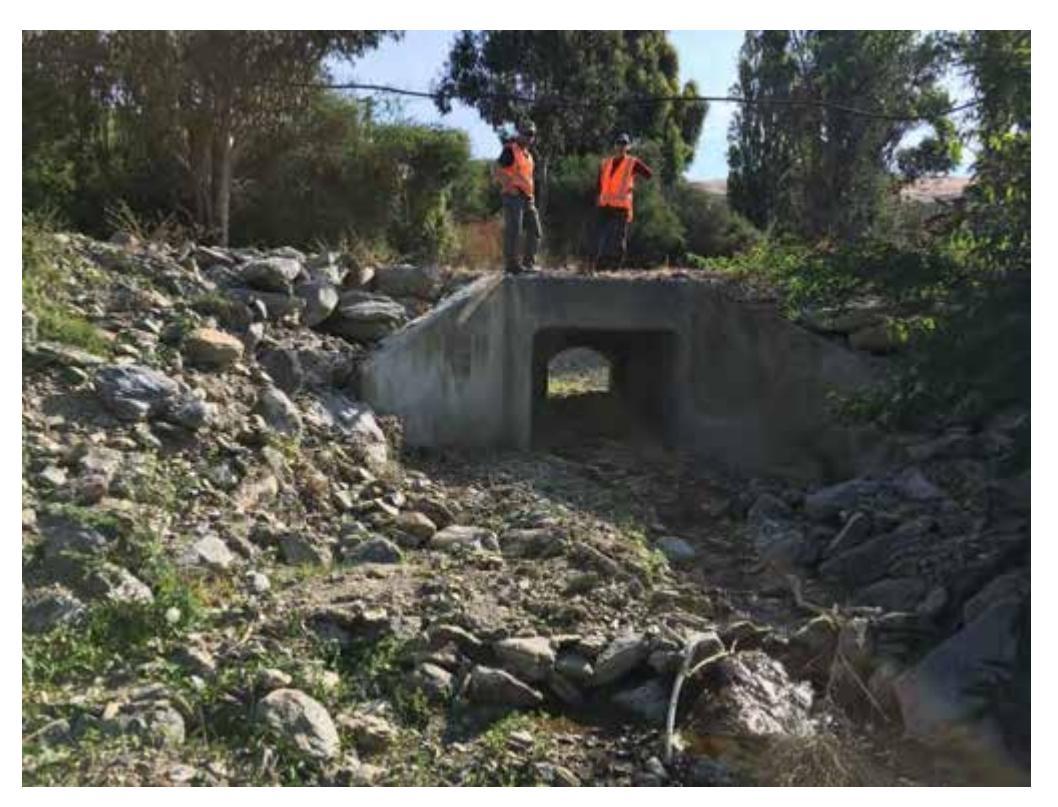
Figure 21: View of existing culvert at SH8 crossing from the downstream side.

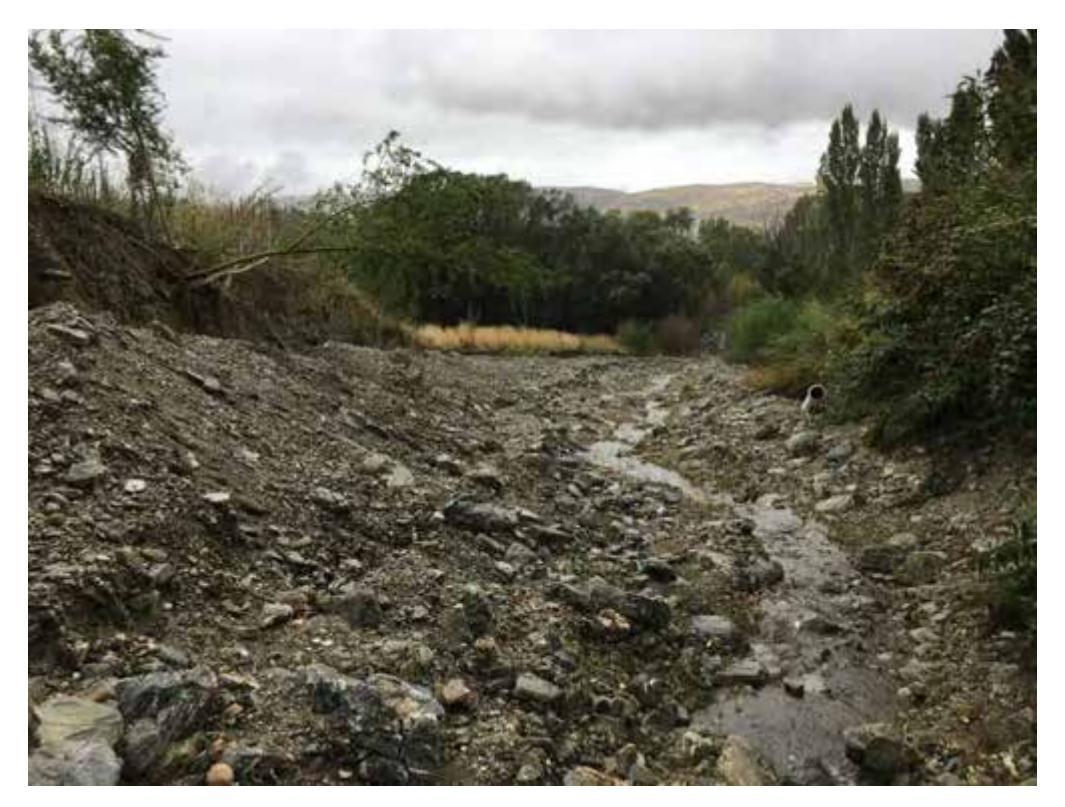
Figure 22: Creek channel below SH8 crossing, view towards Clutha River. The average channel slope is 6° at this section of the channel. Deposition and bank erosion visible along the true left bank.

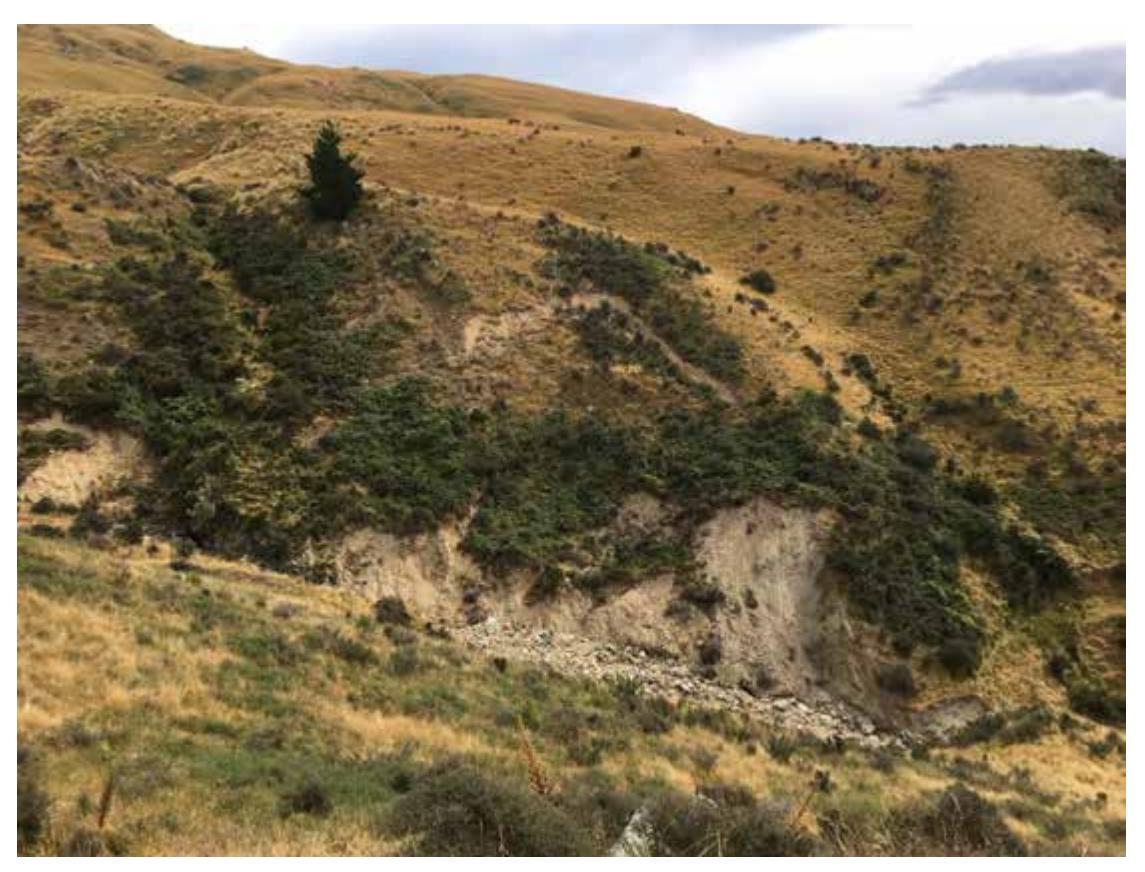
Figure 4: Evidence of a shallow slip in colluvium and undercutting of slope along true left of creek at about 490 m asl. Deposition of bouldery debris visible along the creek bed in this section. Slope are partially occupied by trees and shrubs.

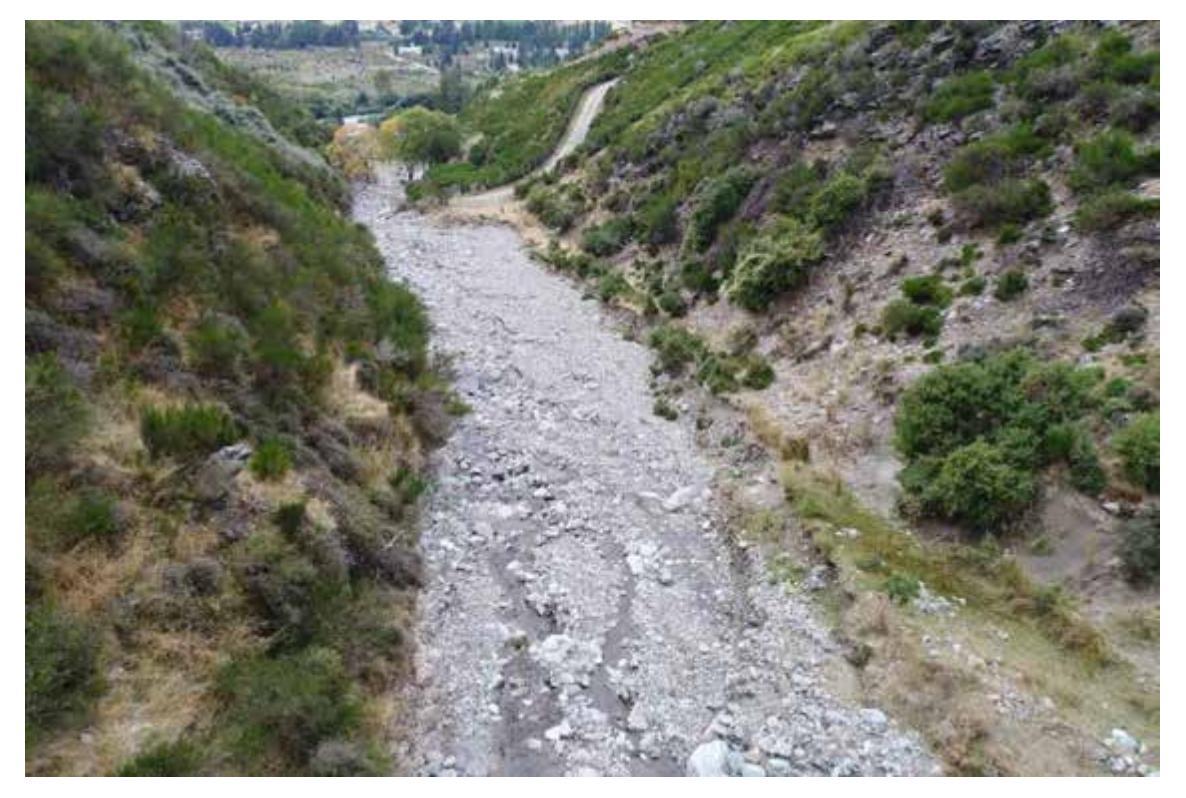
Figure 12: View from about 160 m asl in downslope direction showing depositional section upstream from the start of the debris fan. Left bank dominated by schist bedrock whereas right bank dominated by colluvium.

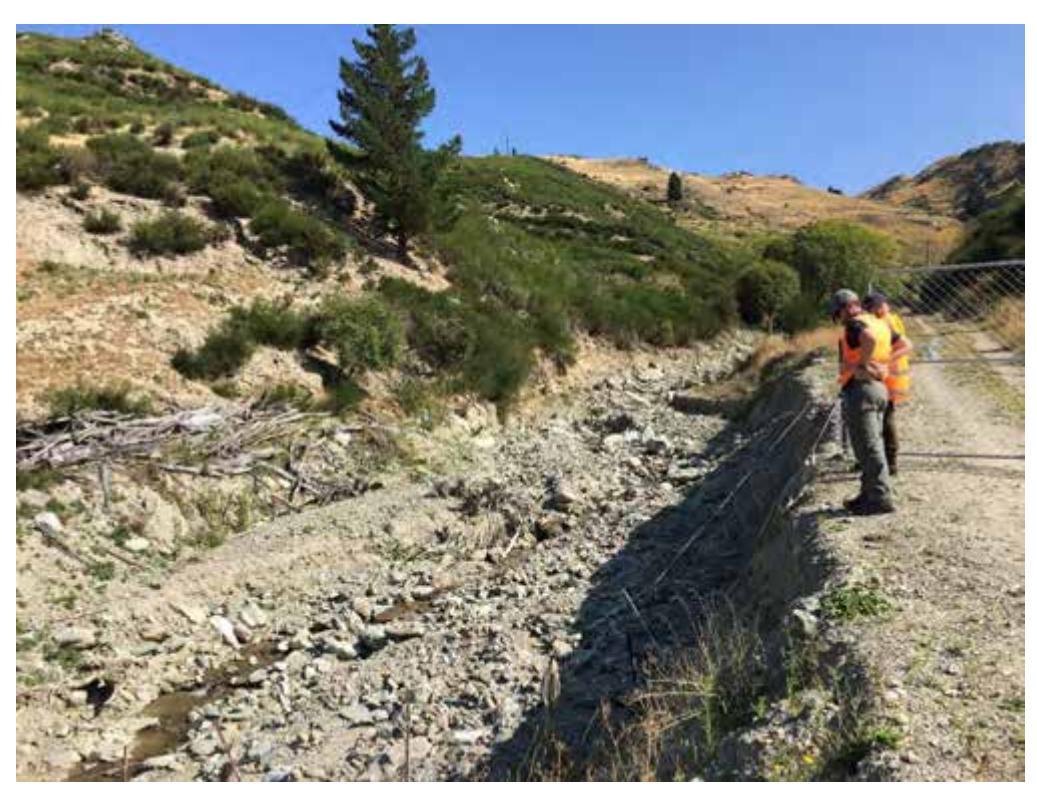
Figure 14: View upstream from fan apex at about 120 m asl. Undercutting and steepening of the access track along the true left bank occurred during the November 2017 event.

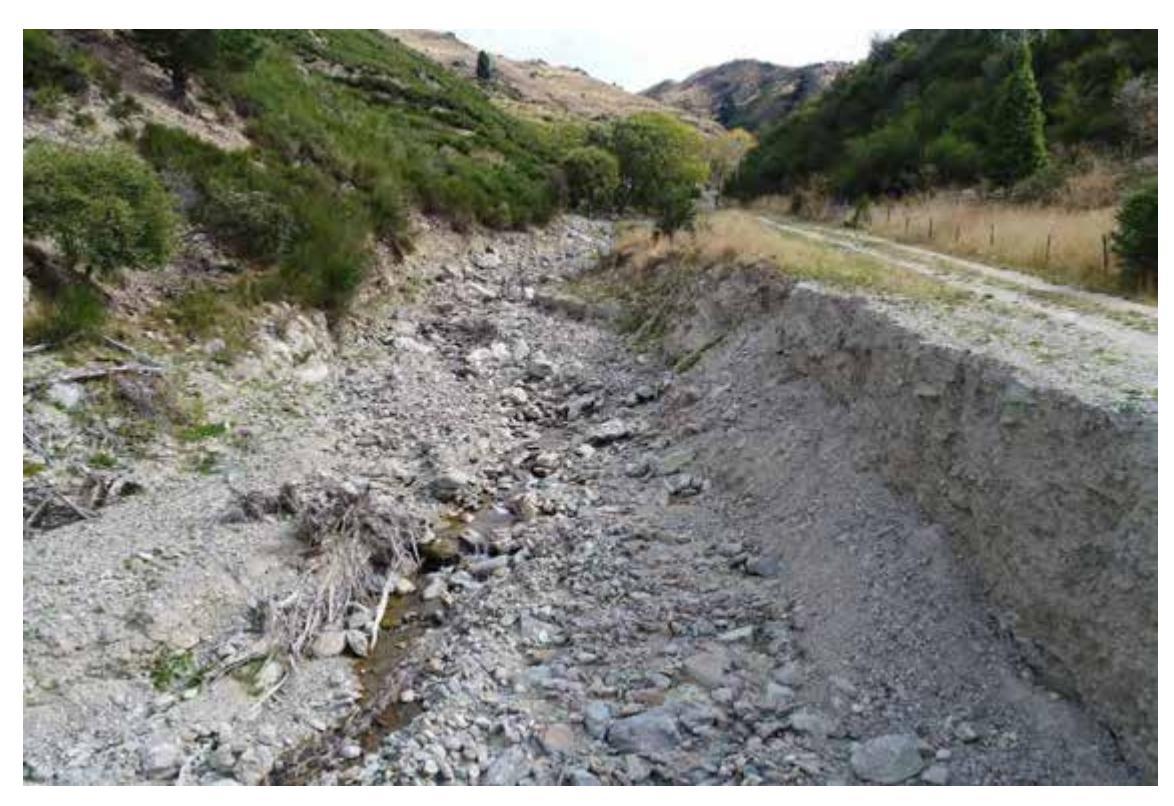
Figure 15: Undercutting and erosion along the access track at the true left of the channel at about 120 m asl.

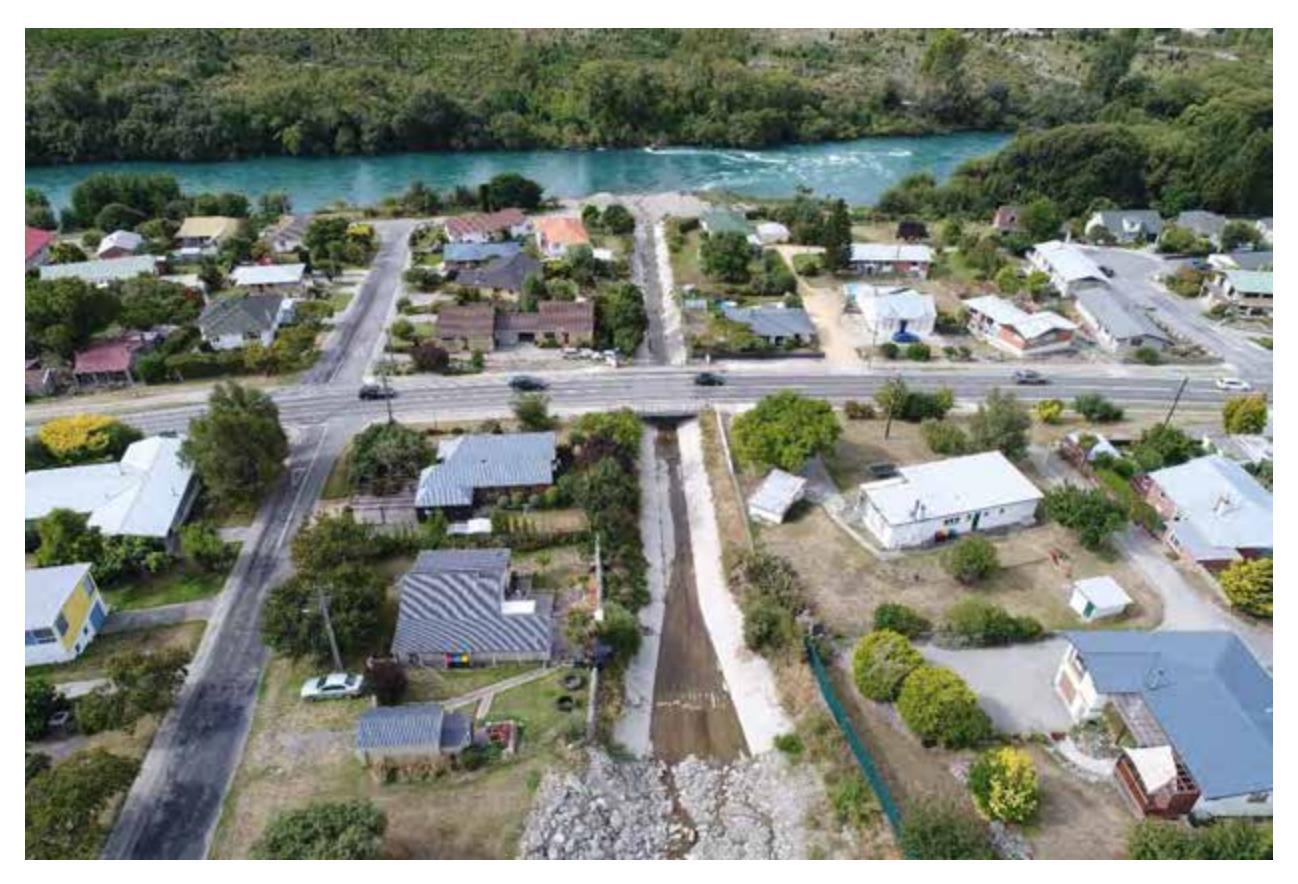
Figure 18: UAV image of the concrete flume with SH8 crossing and the Clutha River in the background.

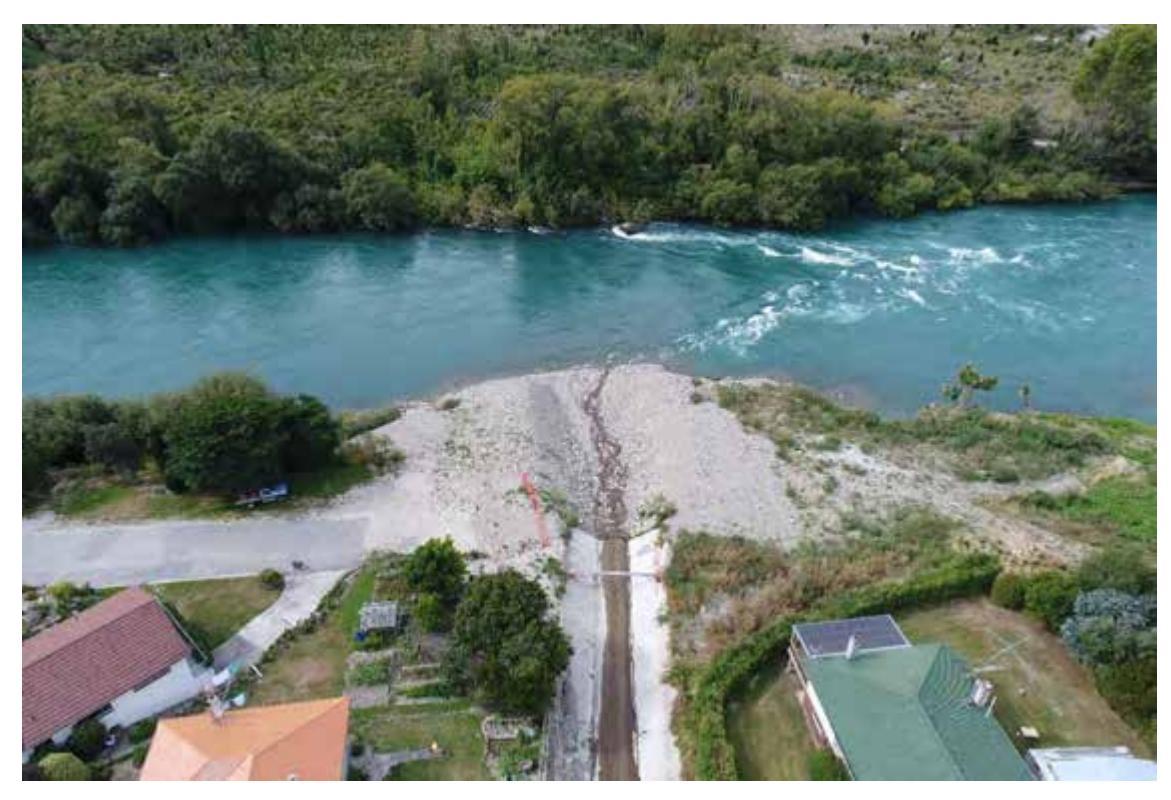
Figure 19: Debris fan downstream of the concrete flume and confluence with the Clutha River at about 80 m asl which built up during the November 2017 event.

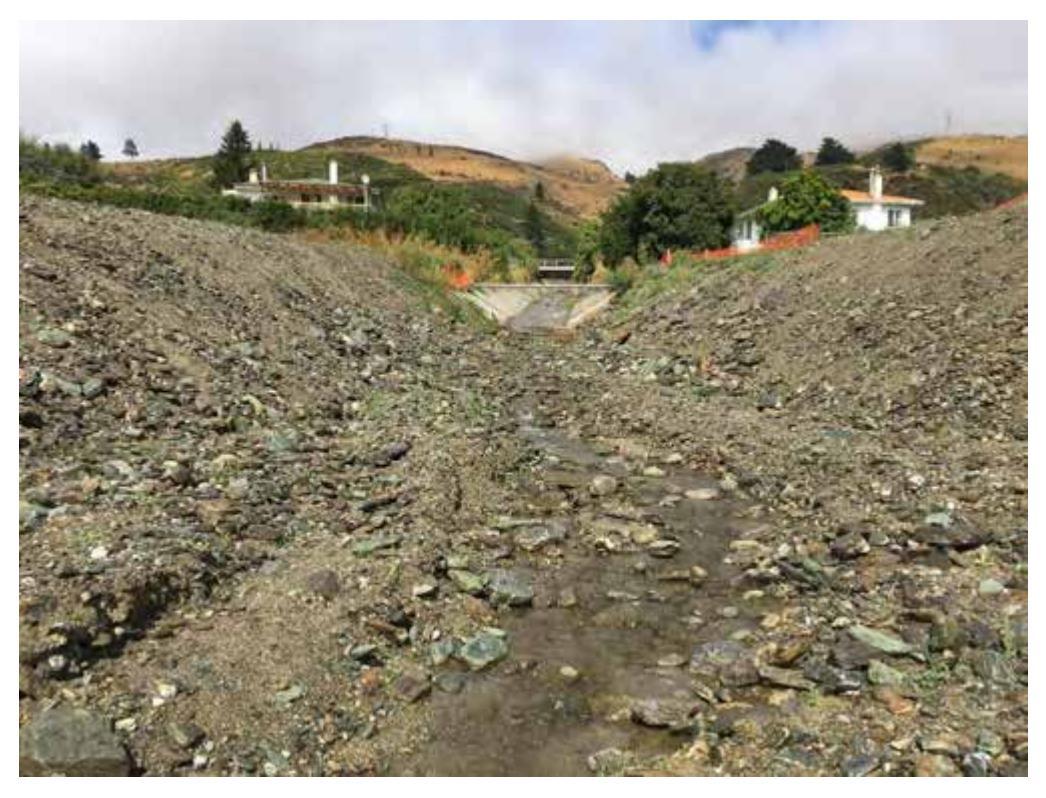
Figure 20: Photo looking up the debris fan and concrete flume at the confluence with Clutha River. Fan material consists mostly of sand, gravel and cobbles.

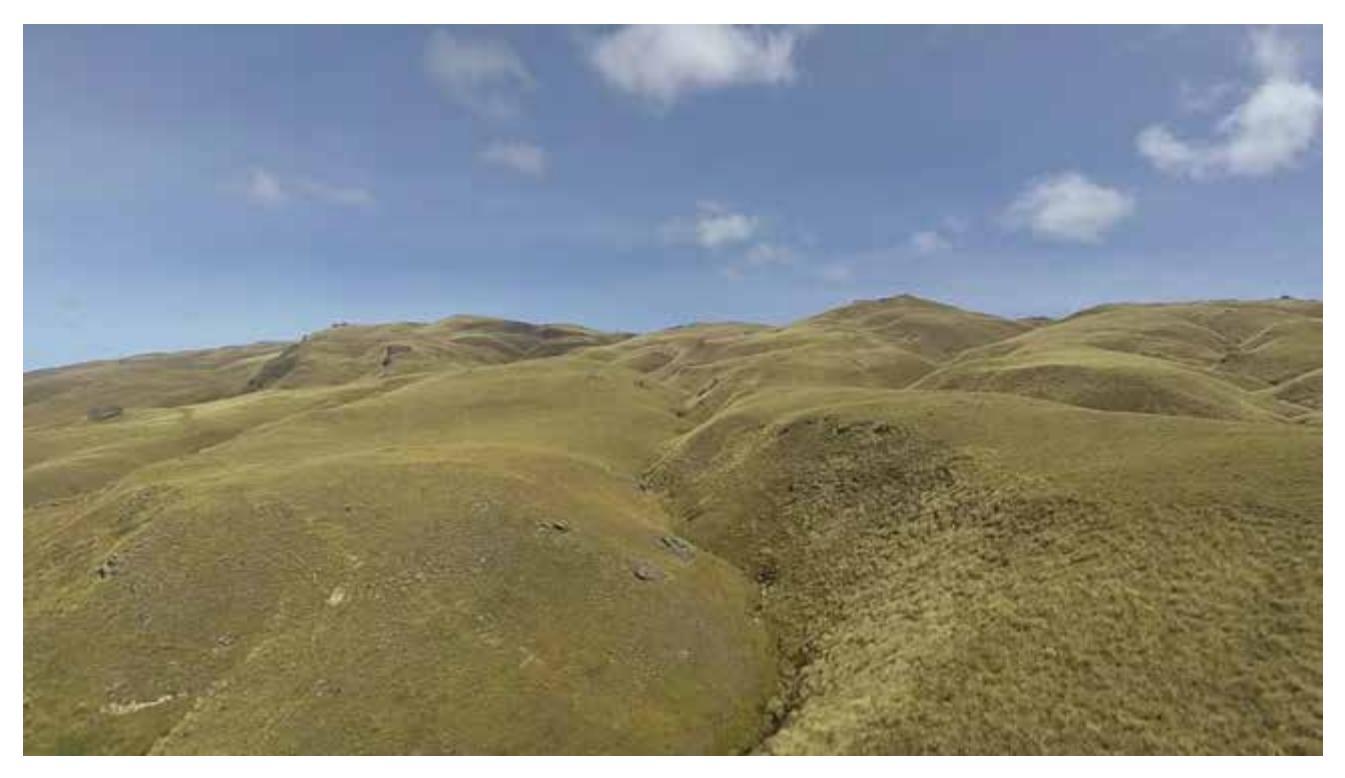
Figure 1: Upper catchment area - Golfcourse Creek – view from about 750 m asl showing typical tussock grass vegetation. No recent erosion is visible along this section of the channel.

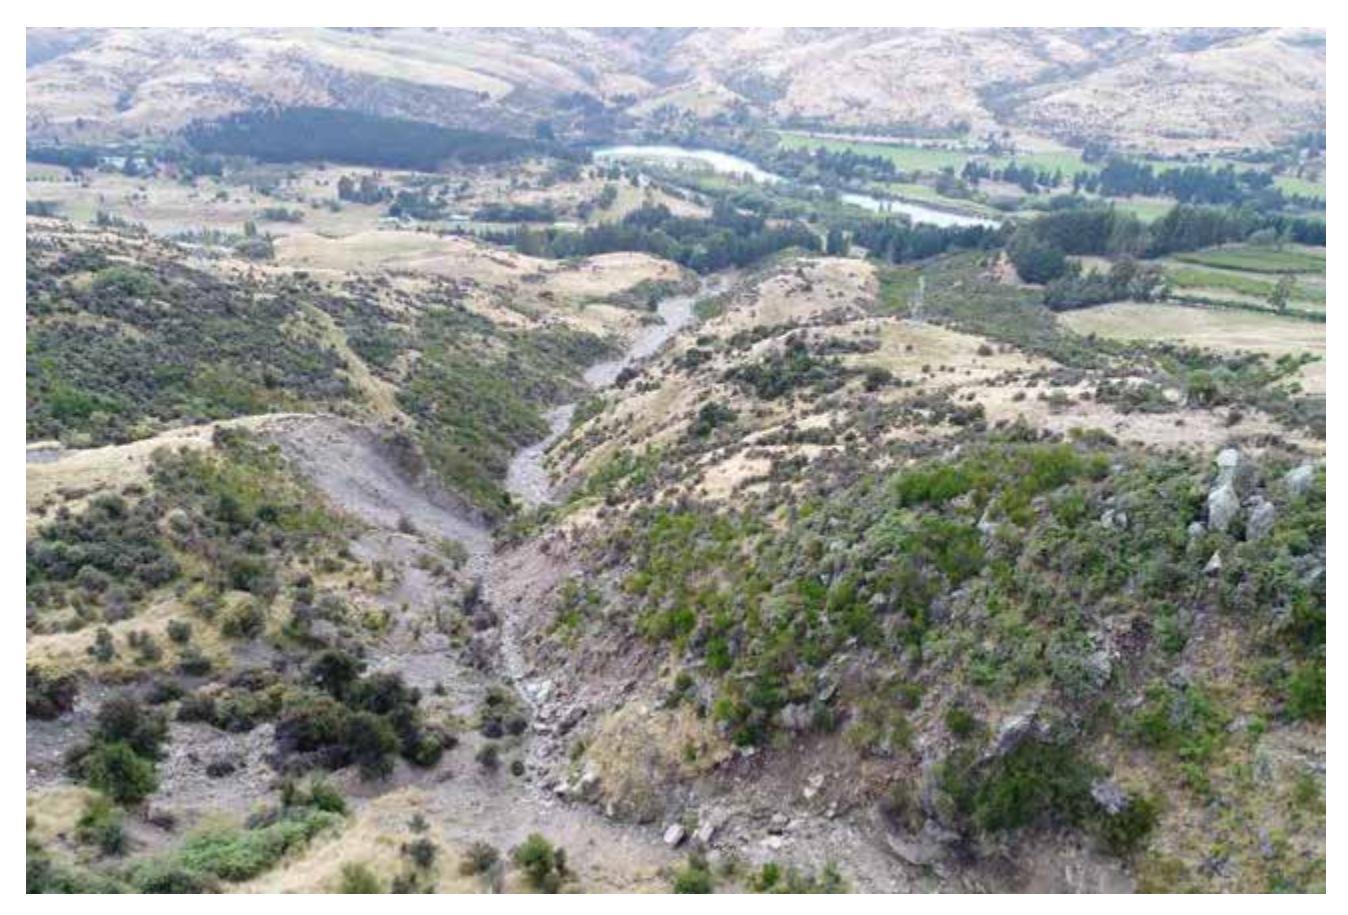
Figure 7: View from the landslide area at about 300 m as I downstream towards the Clutha River. Schist bedrock is present along both sides of the channel in this section but slopes are dominantly consist of colluvium.

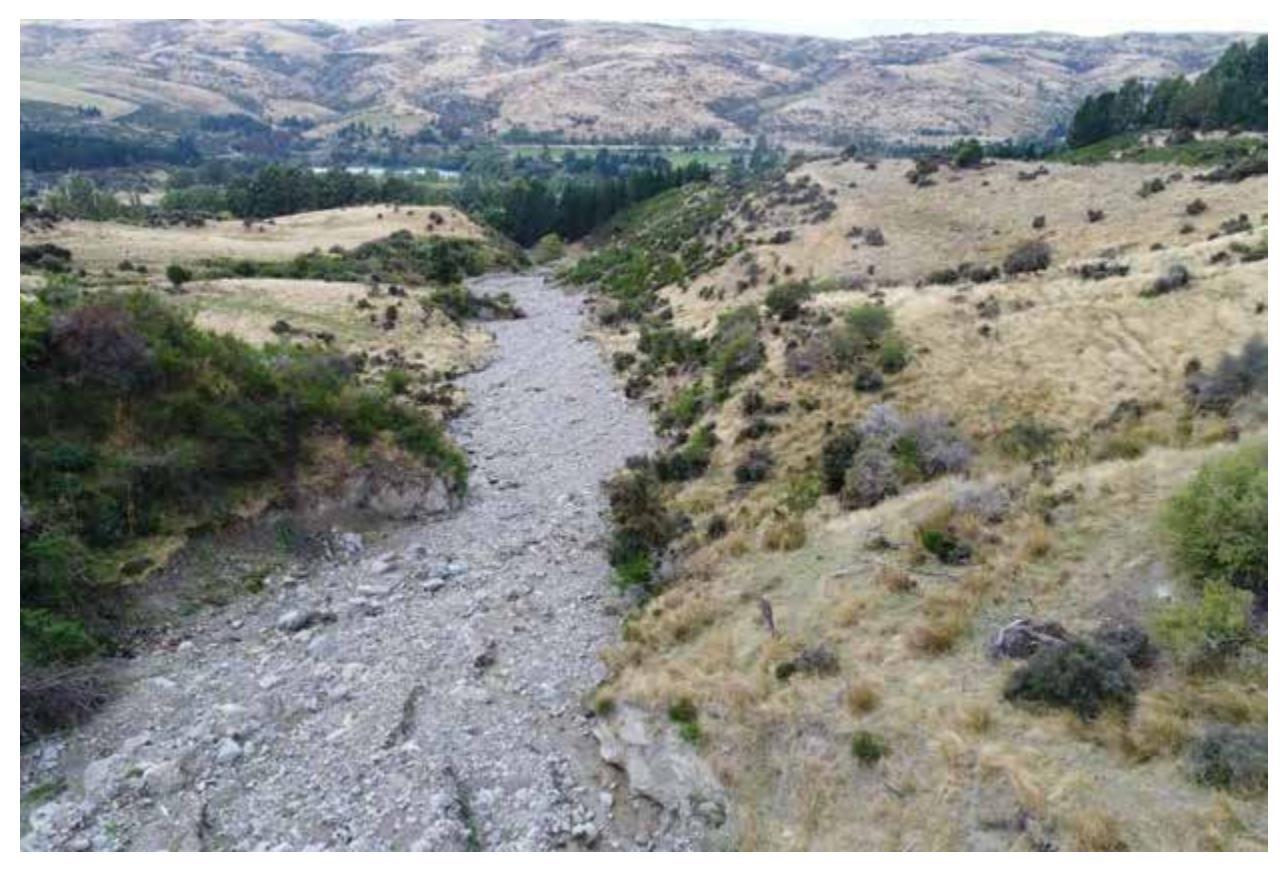
Figure 11: UAV image of channel section between 180 - 140 m asl, looking downstream. Deposition of debris is dominant in this section of the channel.

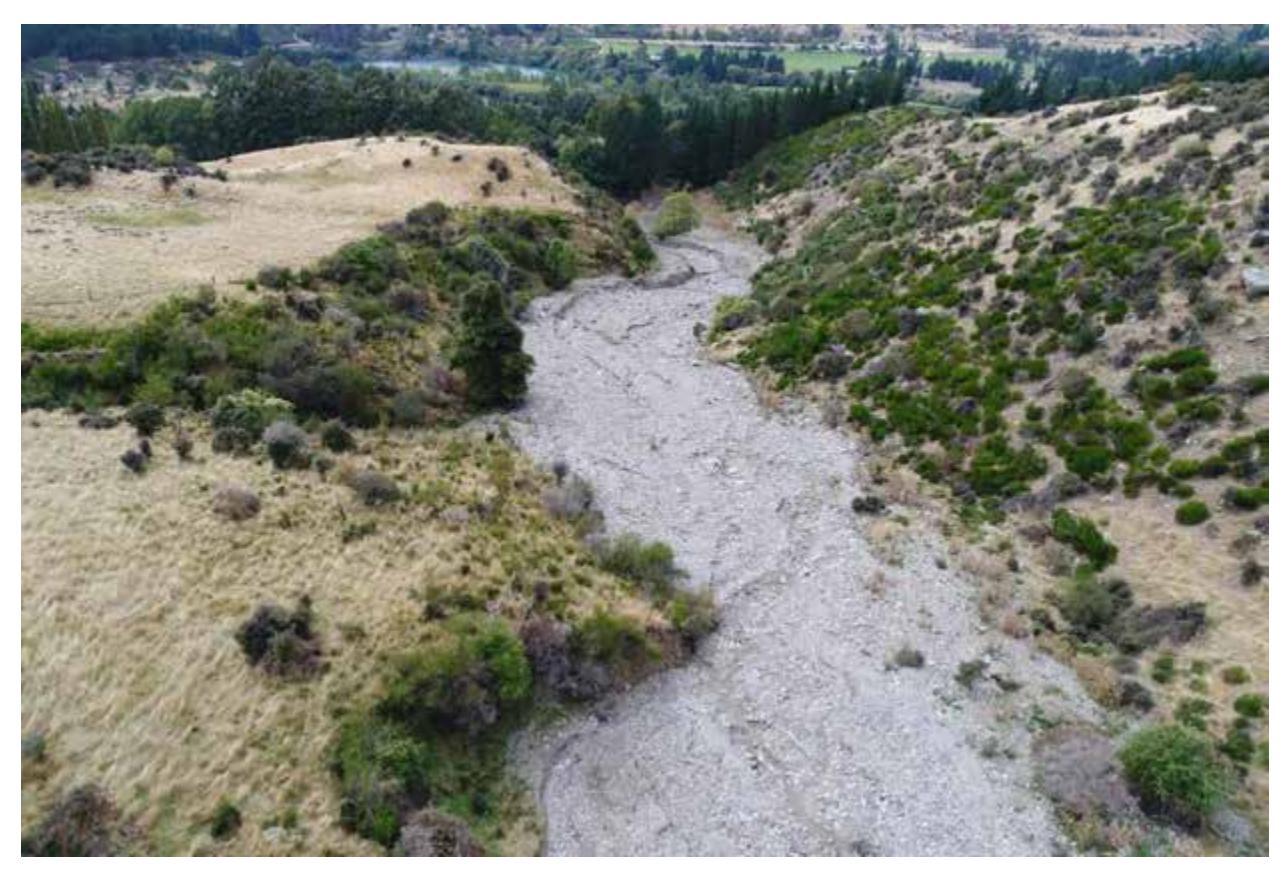
Figure 12: Channel just upstream of the debris fan, looking downslope from about 160 m asl. Depositional environment but also source area for entrainment of debris during lager flood events.

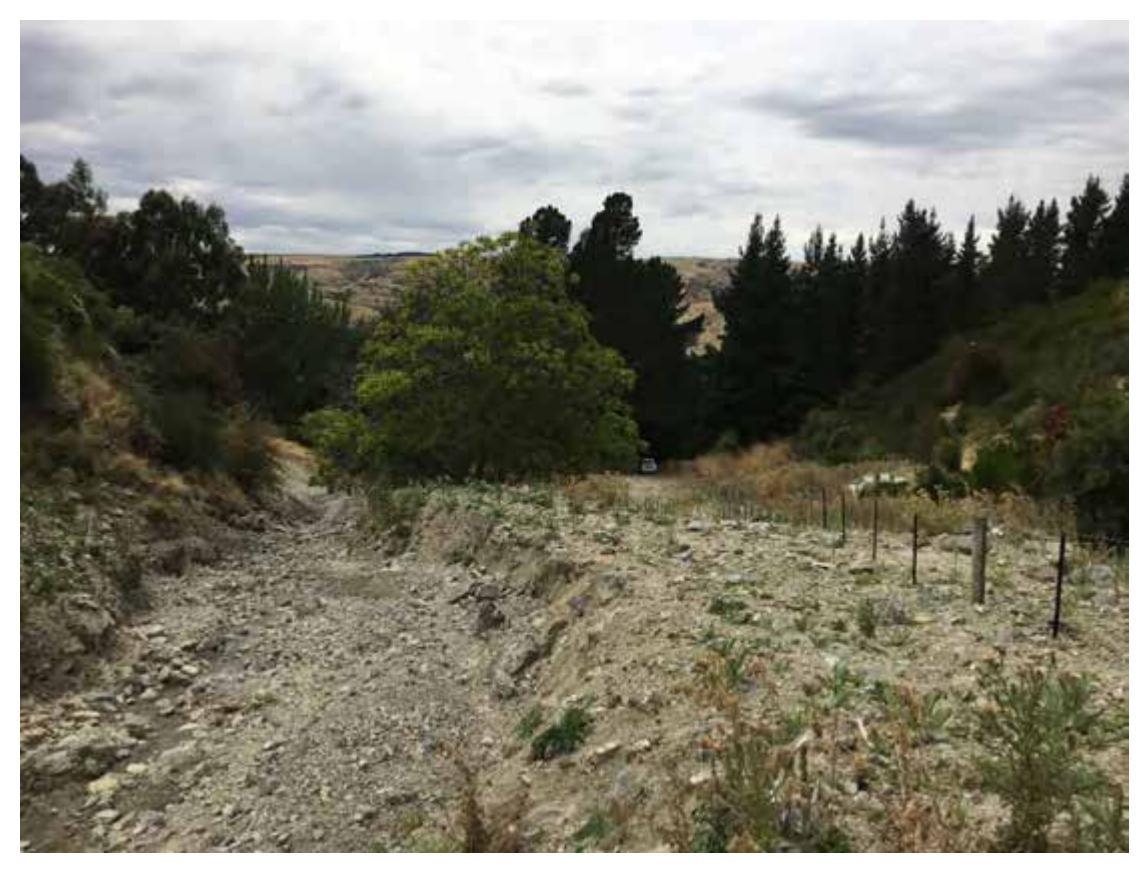
Figure 15: Incision of current stream into existing debris at about 145 m asl, looking downstream. Deposits along the true right of the current channel overtopped during the November 2017 event.

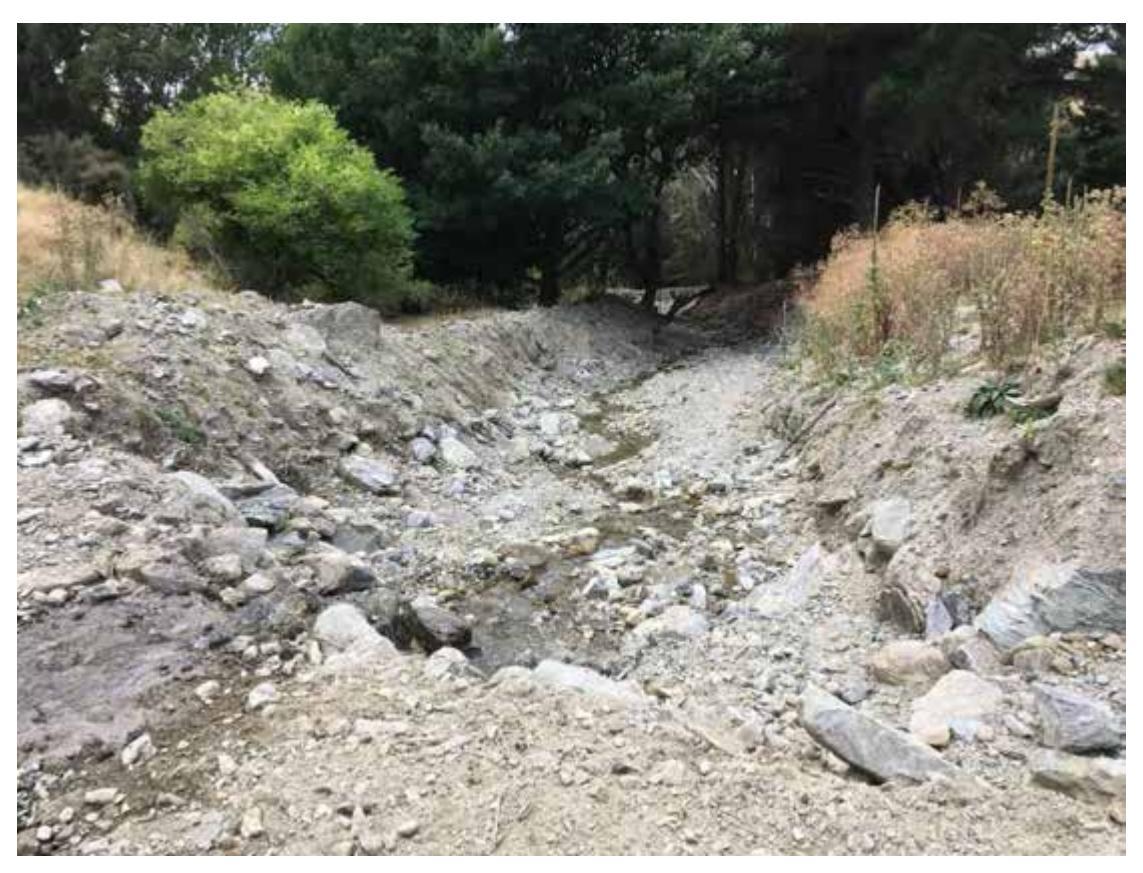
Figure 16: Narrowing of current creek bed at fan apex area (about 140 m asl), looking downstream from farm access track crossing. Residential dwellings are located downstream along the true left of the channel.
