# REPORT Management and Reduction of Debris Flow Risk in Roxburgh, Otago

Geomorphological Assessment Report

18113634\_7407-003-R-Rev0

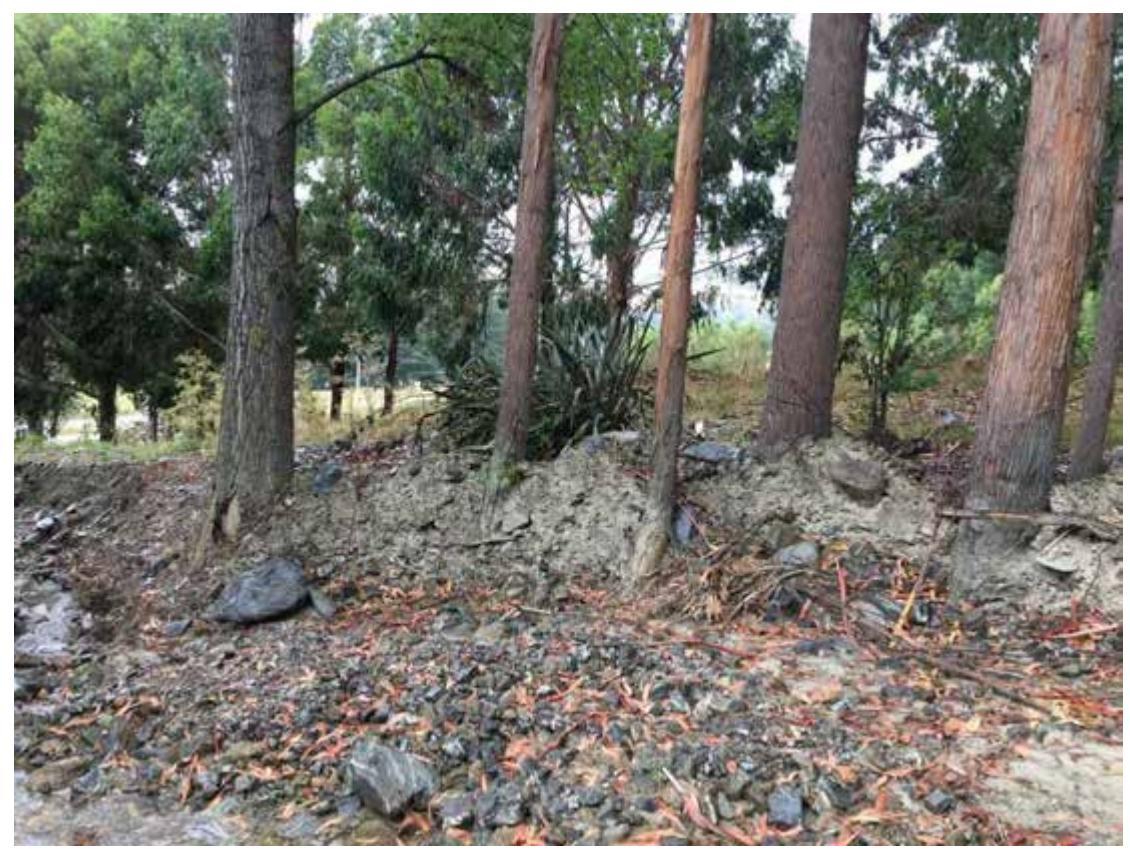
Figure 19: Recent debris deposition and impact marks on trees visible; channel at about 125 m asl.

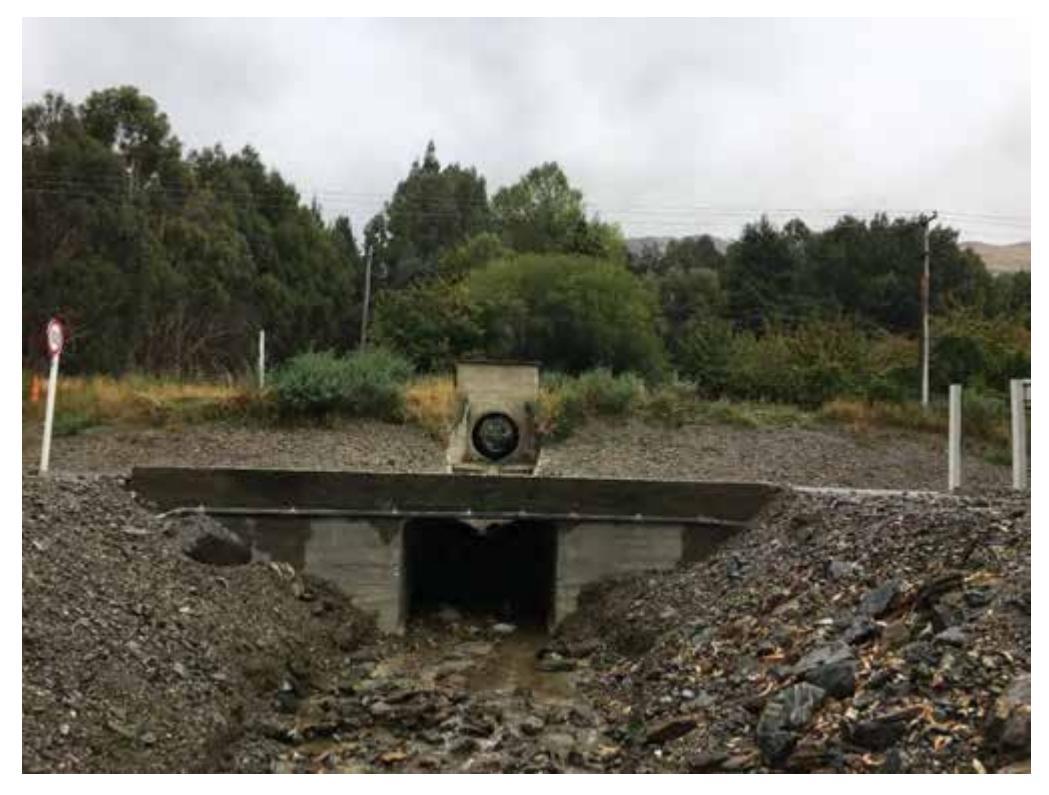
Figure 23: View of SH8 culvert setup and old road crossing with circular culvert, looking upstream.

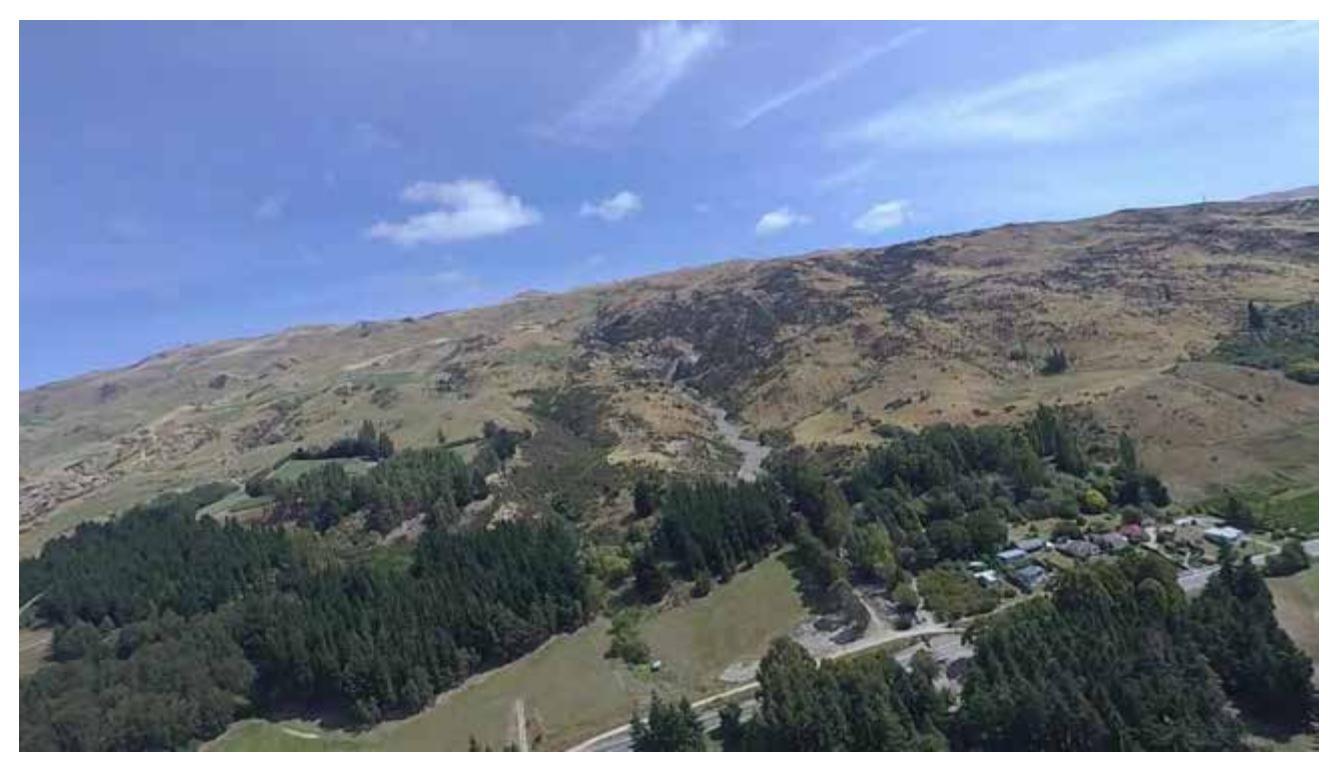
Figure 25: Overview of Golfcourse Creek looking upstream from above SH8 with the debris fan and the current path of the creek through the center.

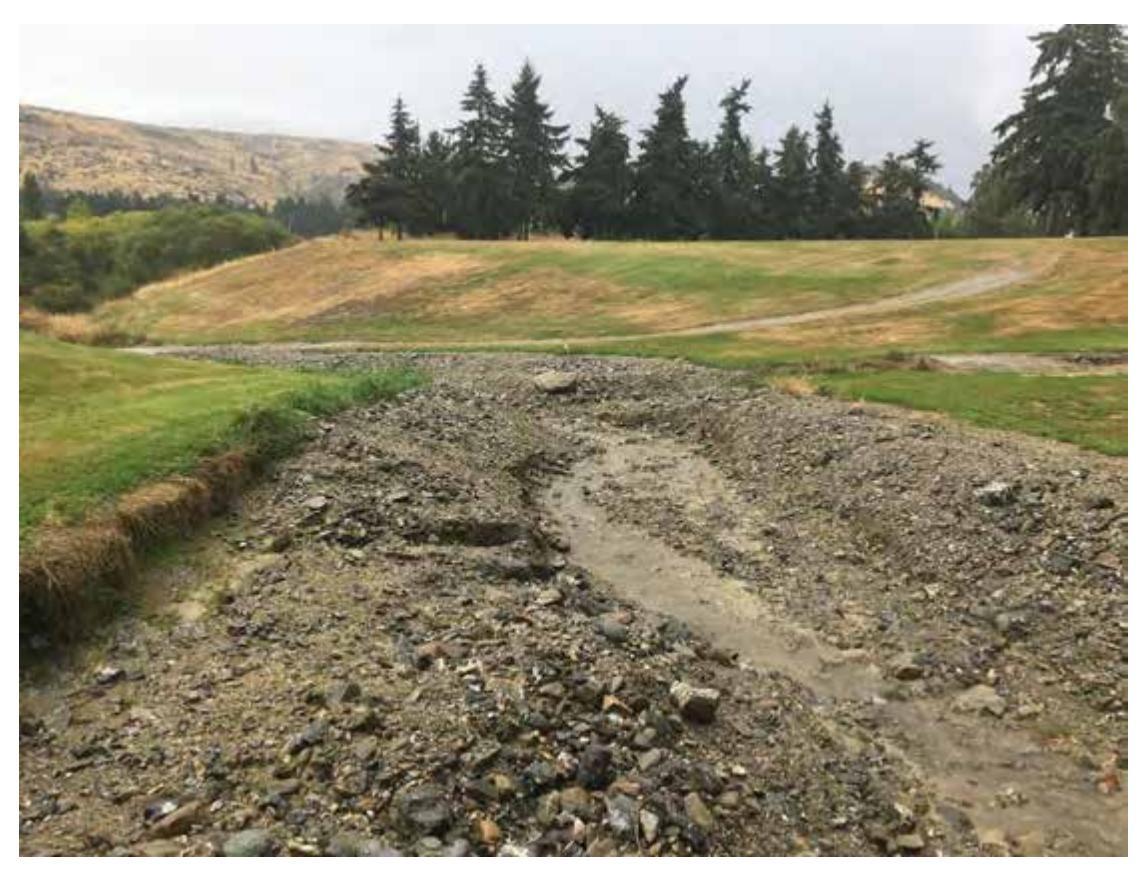
Figure 27: Creek crossing the local golf course above the confluence with Clutha River downstream of the SH8 crossing; view downstream at about 95 m asl.

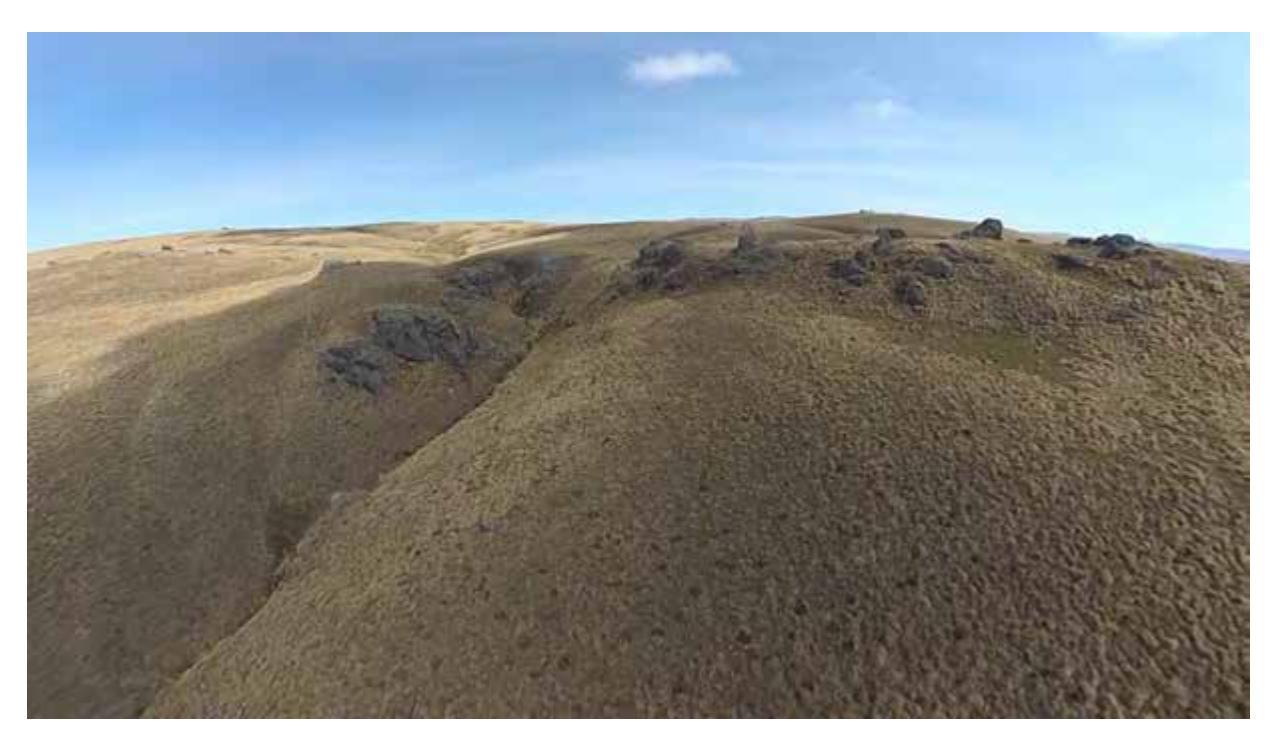
Figure 1: Top of the catchment at about 1100 m asl. Insitu schist bedrock visible. No recent erosion is present in this section of the catchment.

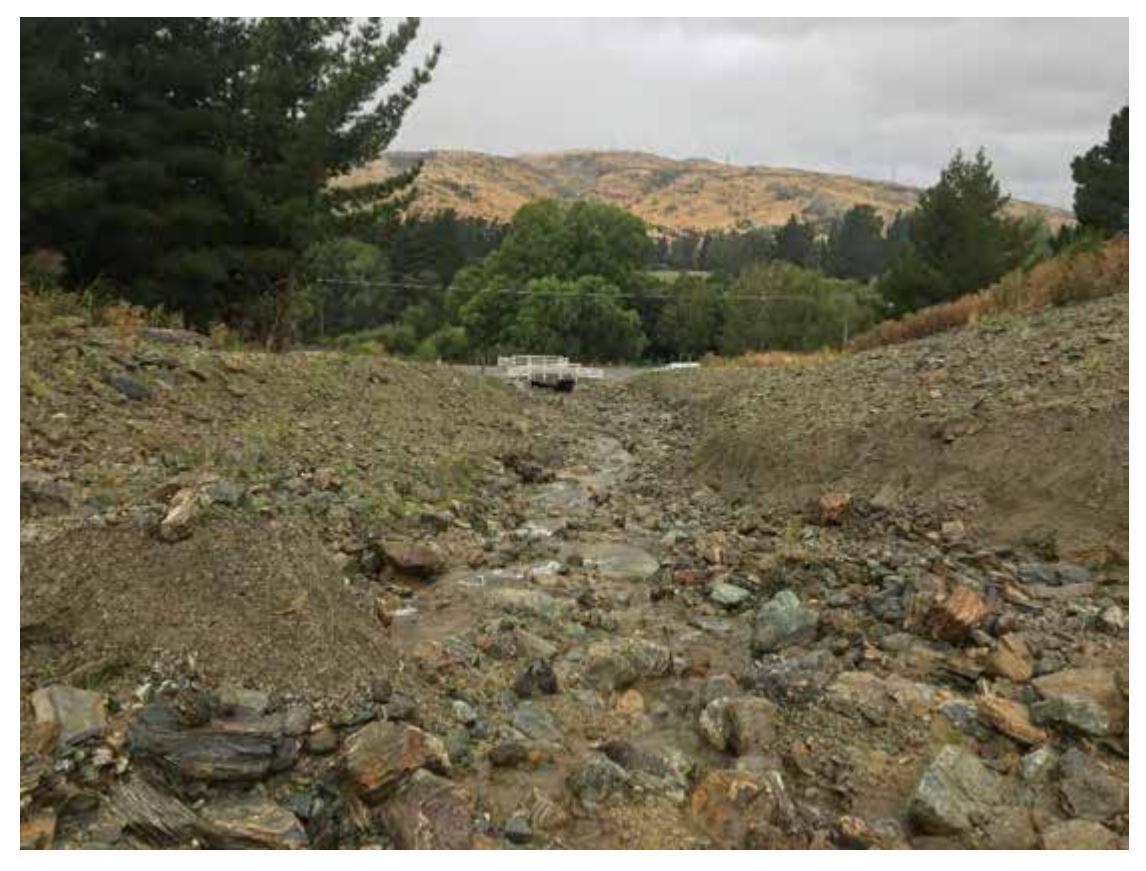
Figure 11: Upstream view from debris fan (average slope angle of 8 °) towards the crossing at SH8.

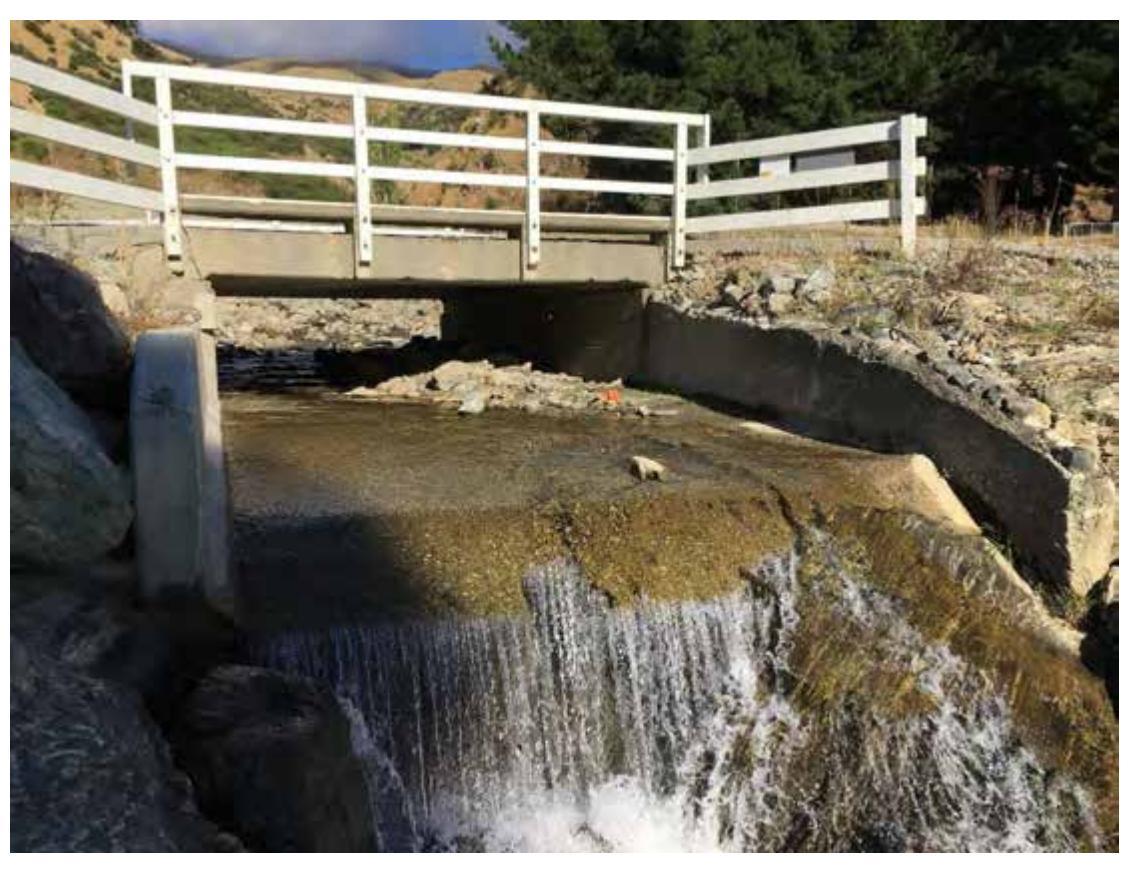
Figure 13: Downstream view of SH8 crossing and current culvert setup at Black Jacks Creek.

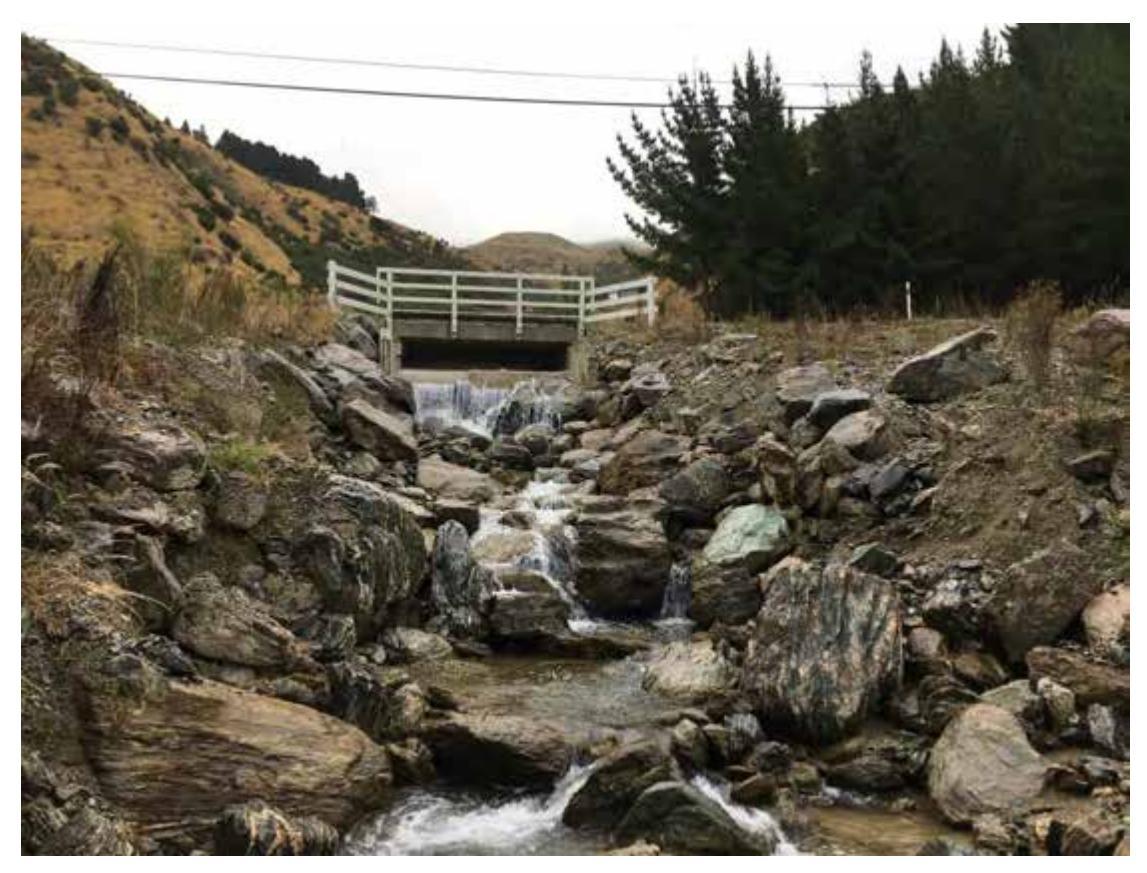
Figure 14: View of SH8 crossing from downstream at about 90 m asl. Boulders are present with diameters of up to about 1.5 m.

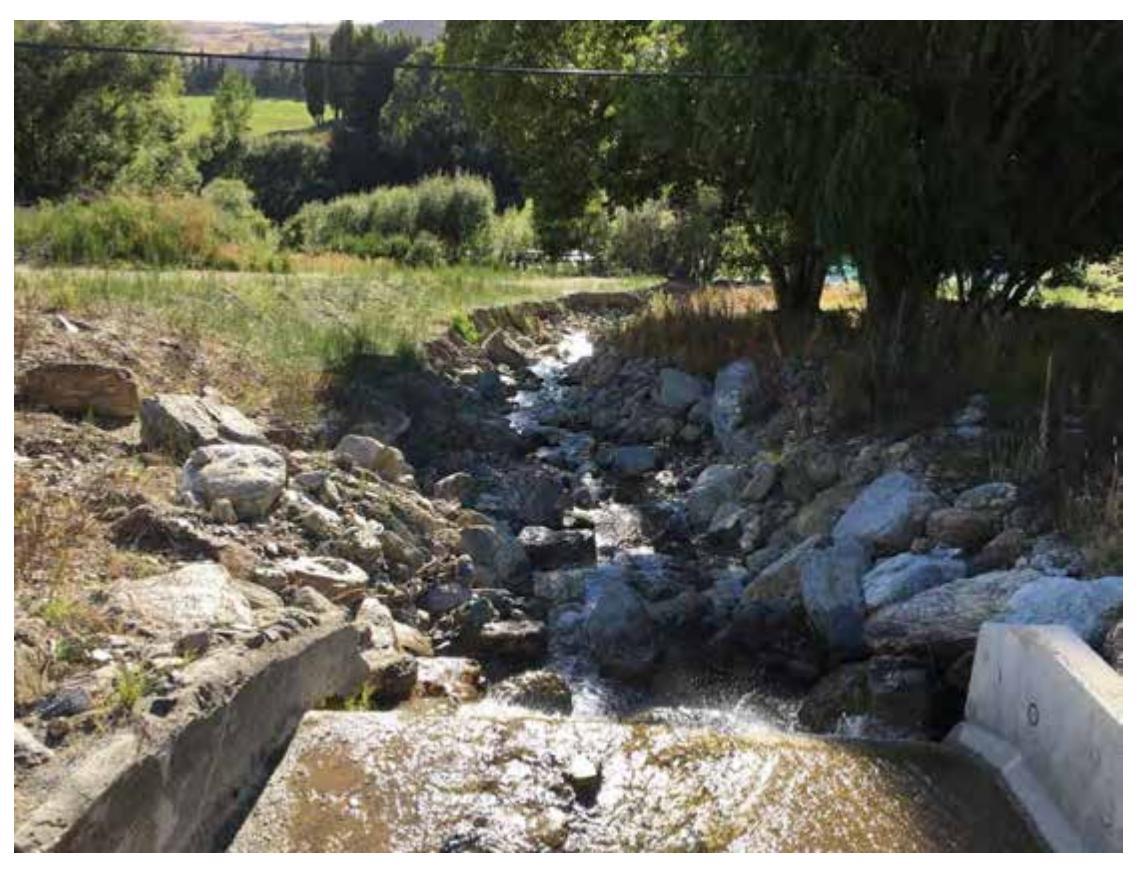
Figure 15: View from SH8 crossing downstream towards the Clutha River. Recent bank erosion is visible along the creek channel.

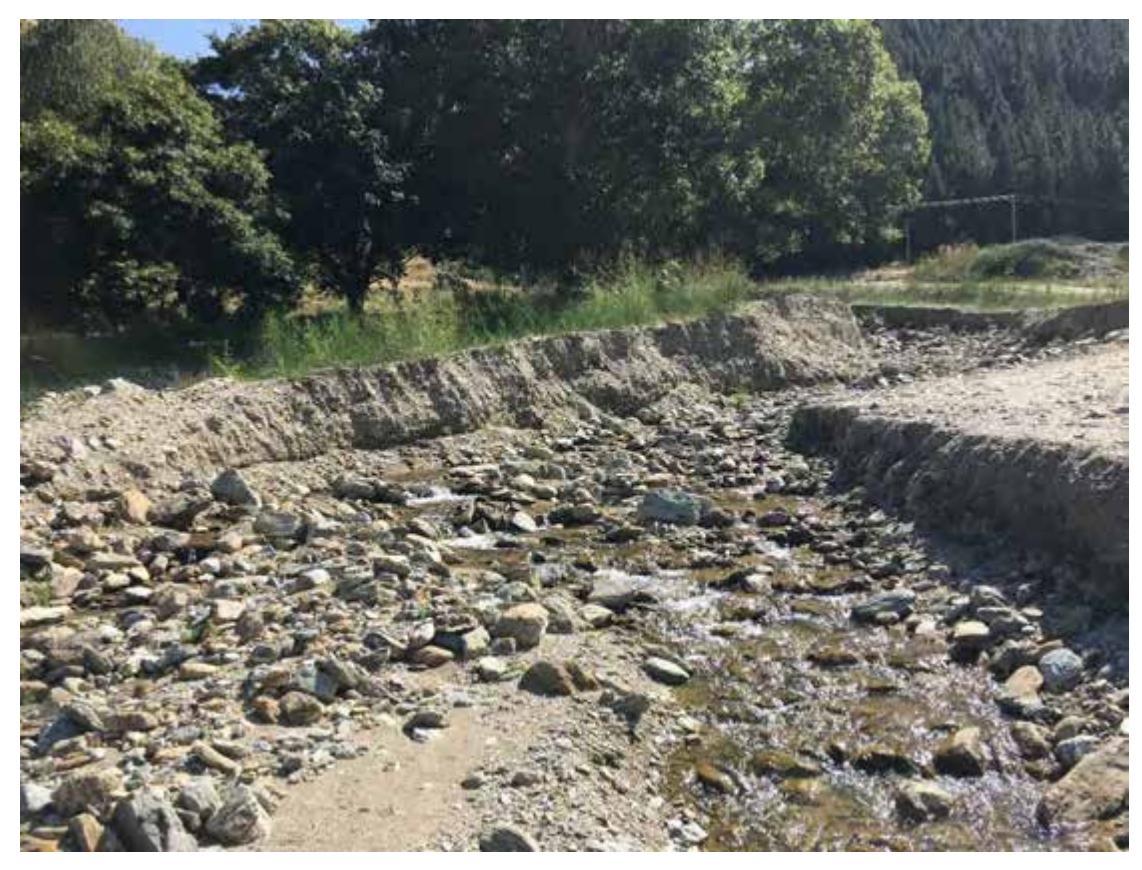
Figure 17: View of channel, looking upstream from confluence at Clutha River. Incision of the current creek bed into debris deposits on the fan below SH8.

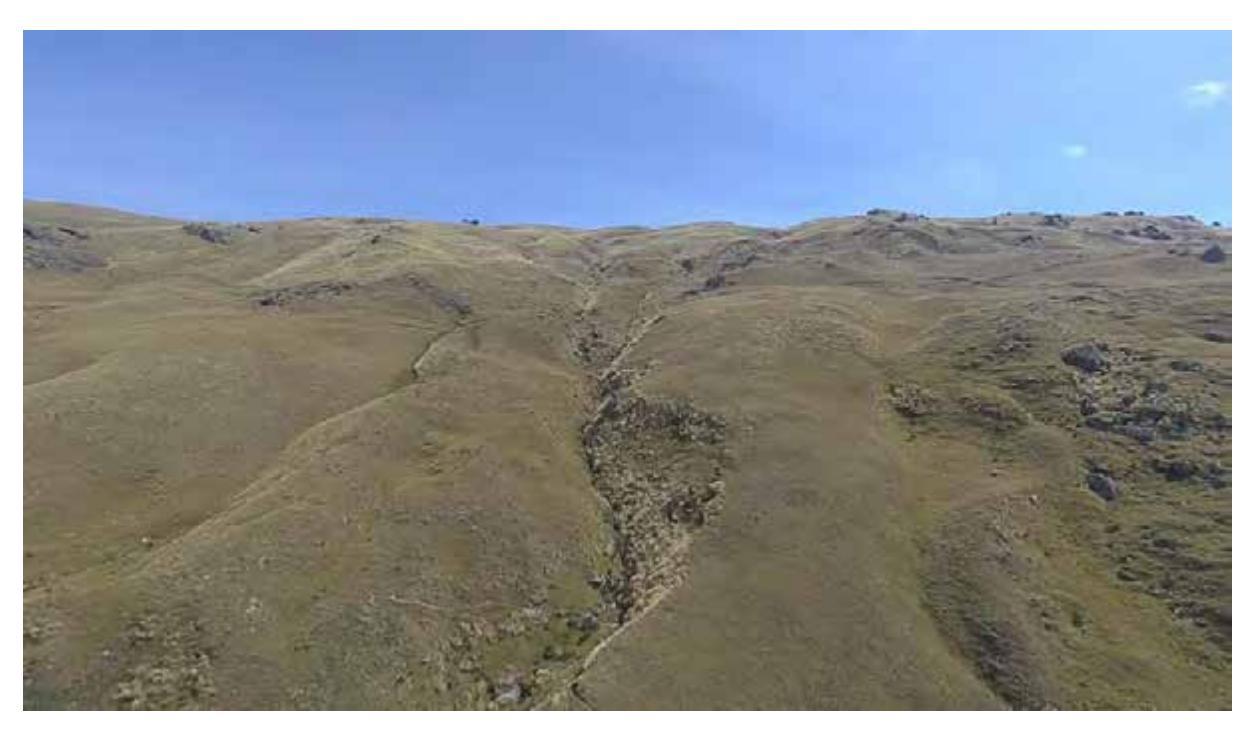
Figure 1: Upper catchment area, looking towards the top of Old Man Range from about 850 m asl. No recent erosion is visible in this area of the catchment.

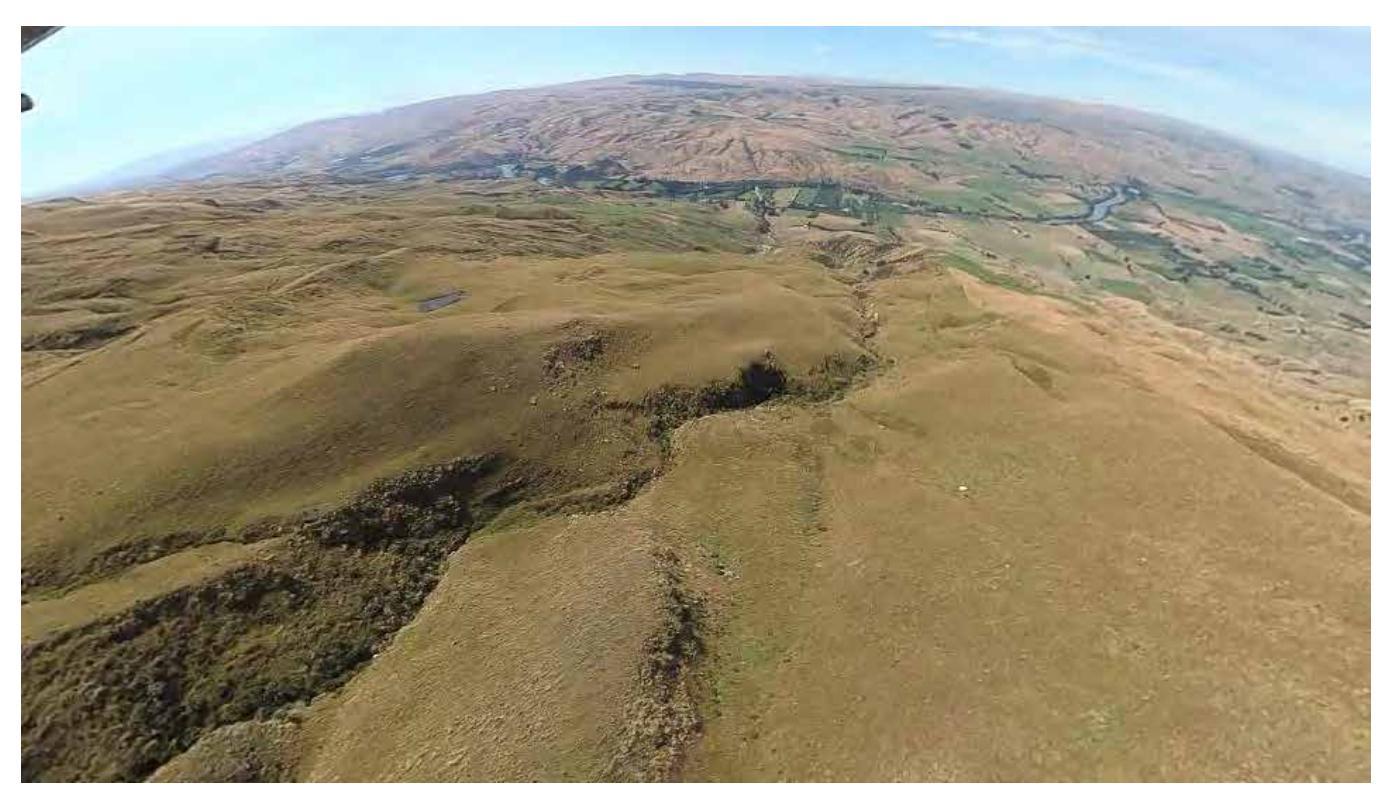
Figure 2: View from Old Man Range downslope into upper reaches of the south branch of Stevensons Creek from about 950 m asl. This area is still dominated by tussock grass vegetation. No recent erosion is visible.

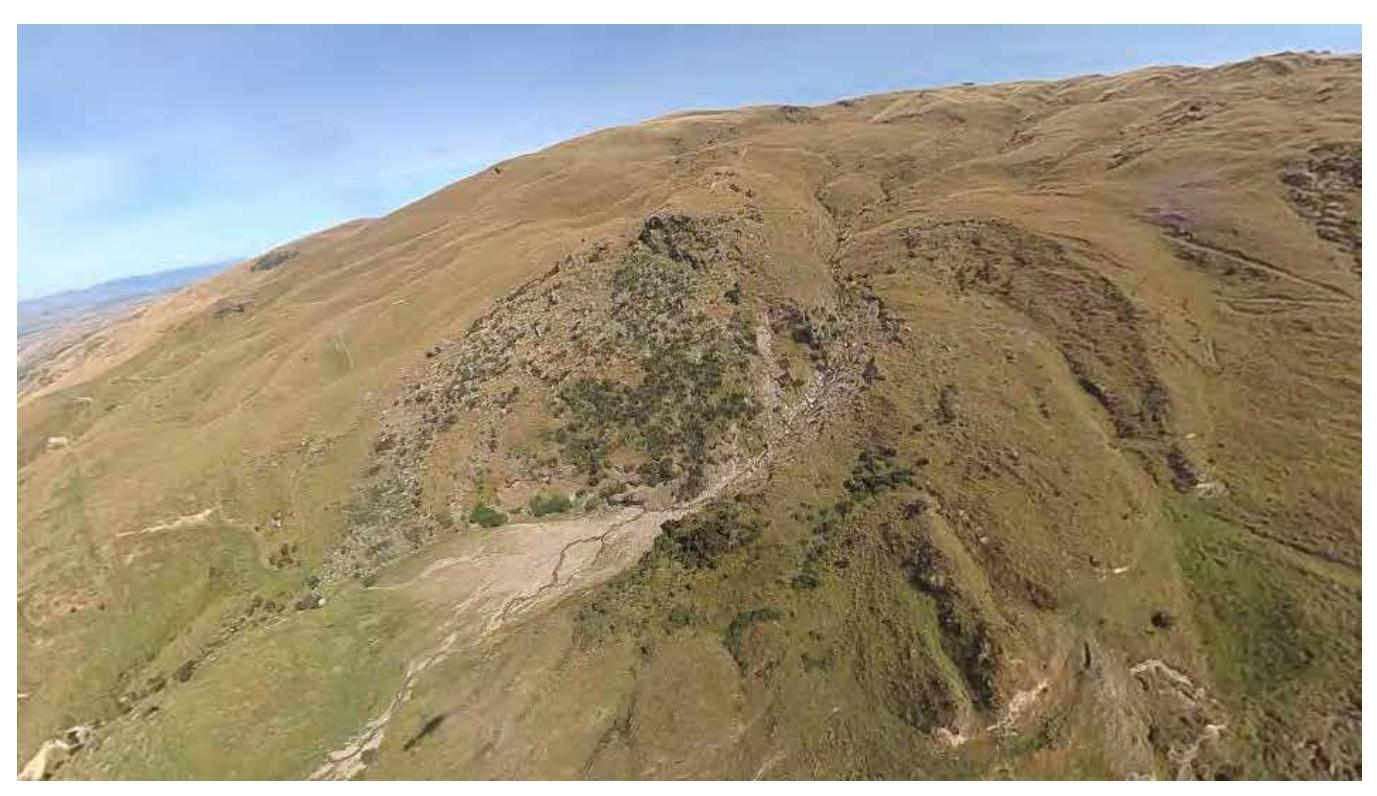
Figure 4: Debris fan in the upper catchment at about 690 m asl below a knickpoint of the channel. The debris fan shows evidence of recent debris deposition.

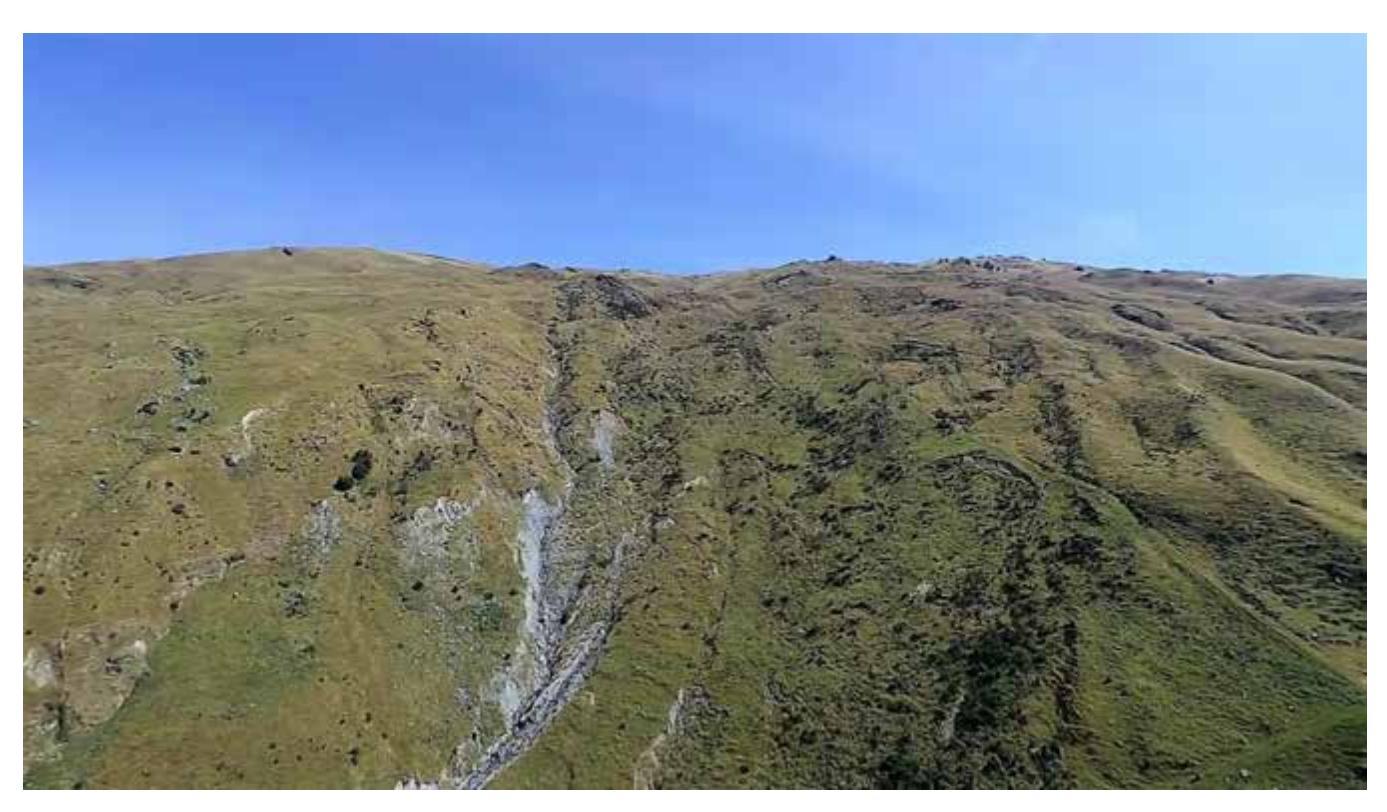
Figure 5: Overview of the catchment from about 500 m asl looking into the upper reaches of the Blue Slip area. Visible evidence of recent erosion along the channel banks as well as slope instabilities on both sides of the main channel.

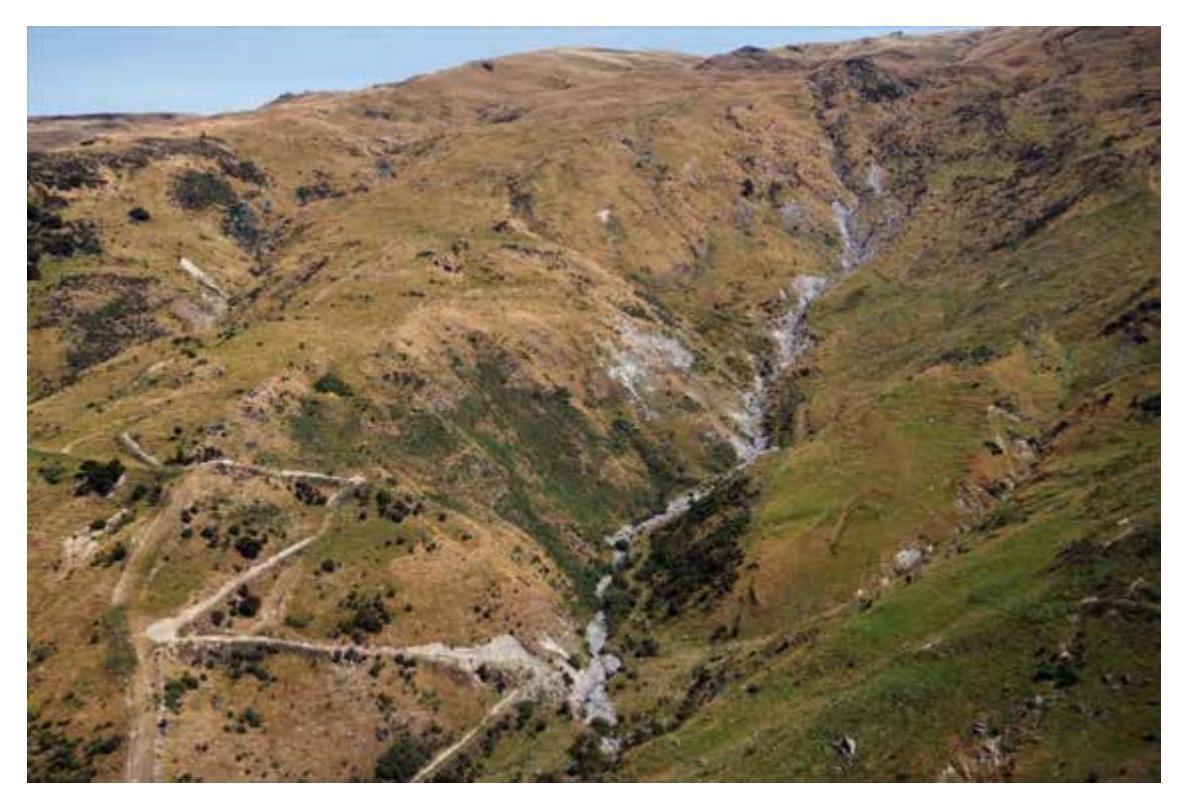
Figure 6: View of catchment from about 250 m asl upslope. The channel banks show evidence of recent bank erosion.

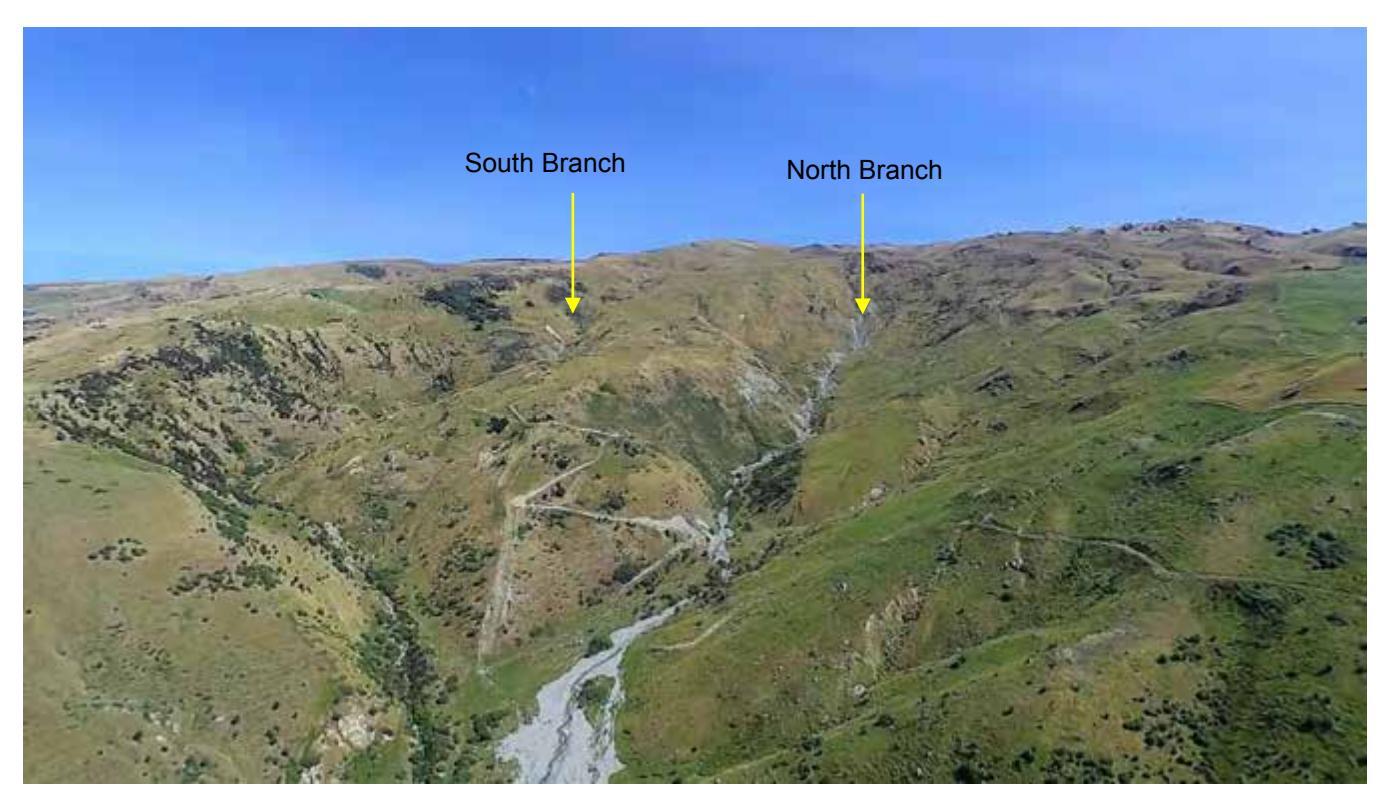
Figure 7: Aerial view of the of the main catchment below Blue Slip and the confluence of the south branch at about 230 m asl. The channel witdh of the North Branch increases below the are of the "Blue Slip" and deposition of debris is present.

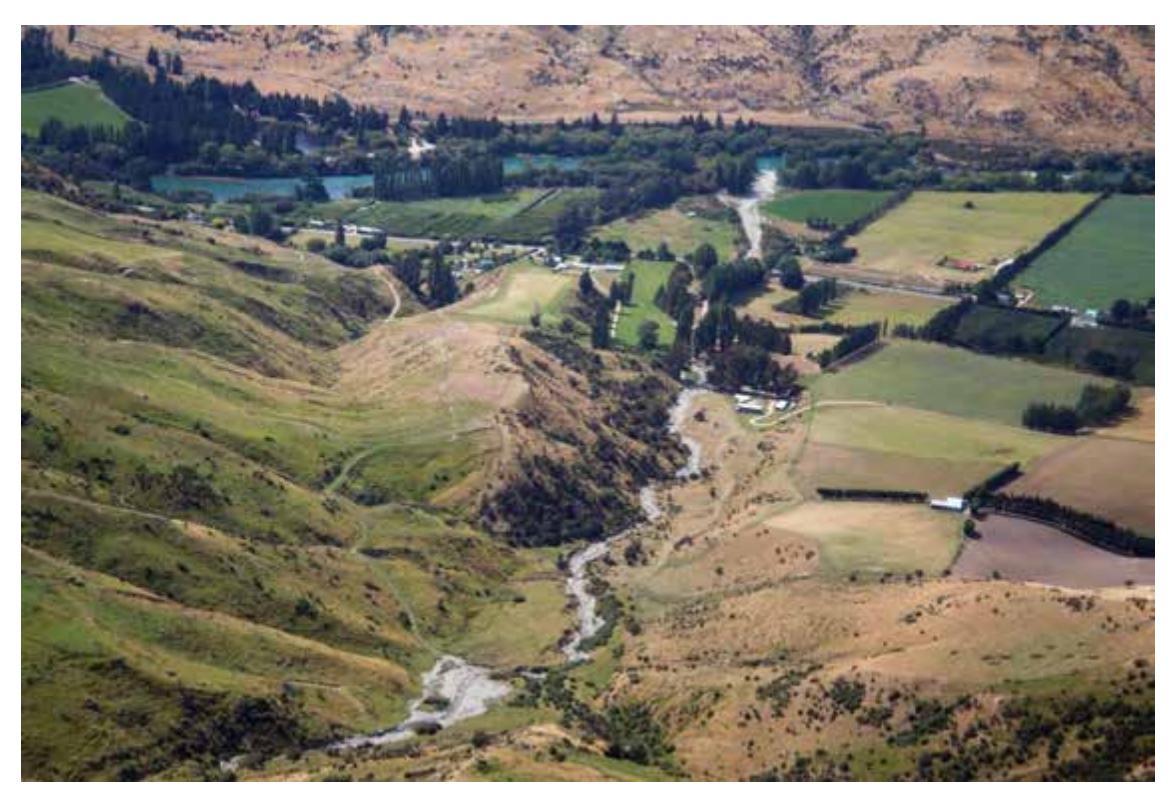
Figure 8: Aerial view downstream from the confluence with the south branch at about 230 m as showing areas of deposition and recent erosion along the channel bed until the creek reaches the Clutha River.

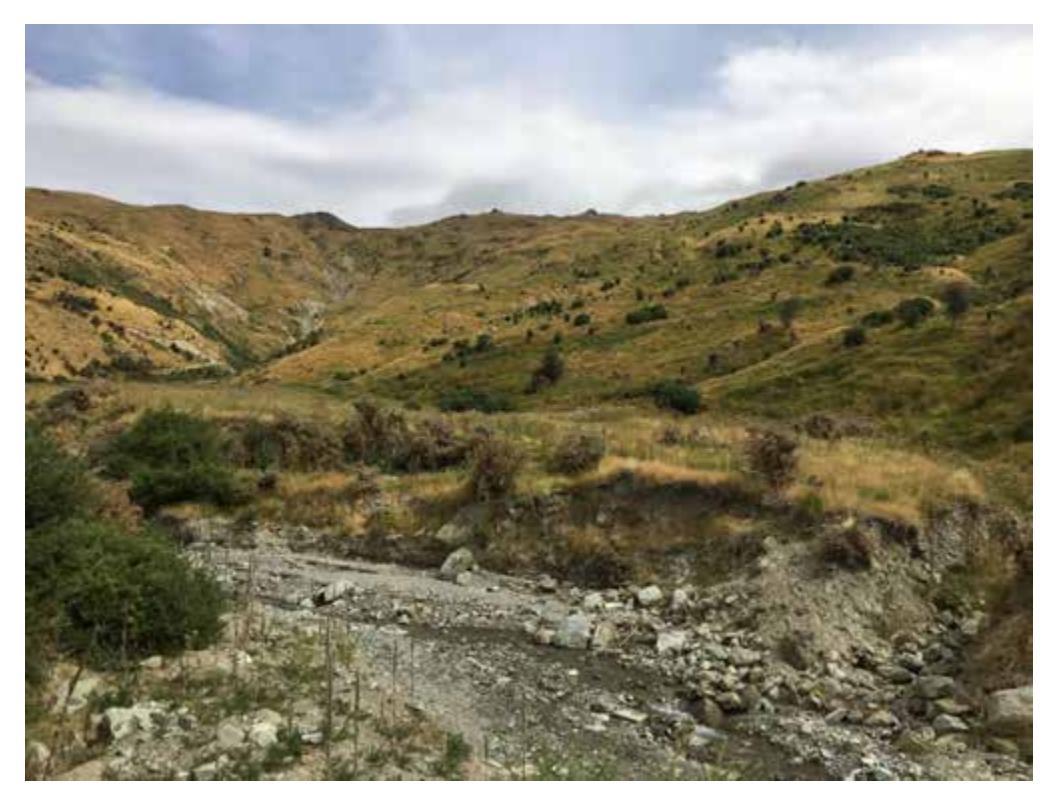
Figure 9: View looking upstream from about 210 m asl where the current creek has incised into older debris deposits. Boulder sizes are up to 1.5 m in diameter along this reach.

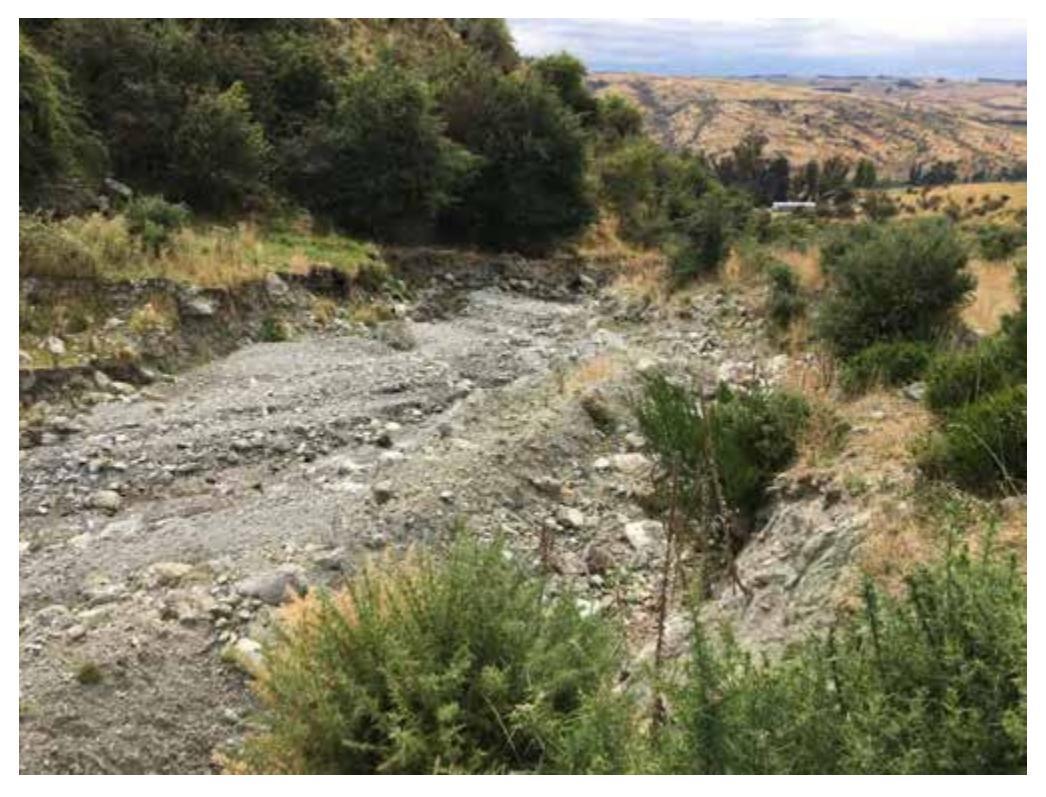
Figure 10: Channel at about 200 m asl, looking downstream, showing recent erosion along the channel banks.

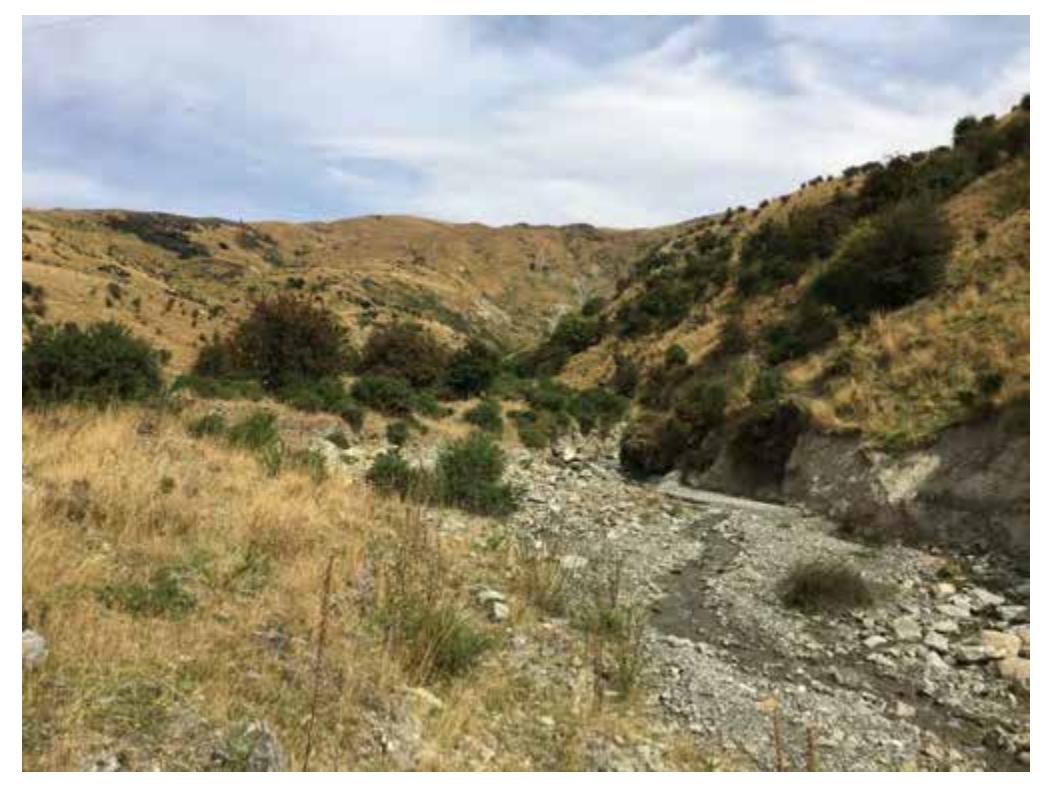
Figure 11: View of channel at about 175 m asl looking upstream. Undercutting and erosion of the true left bank into colluvium is visible.

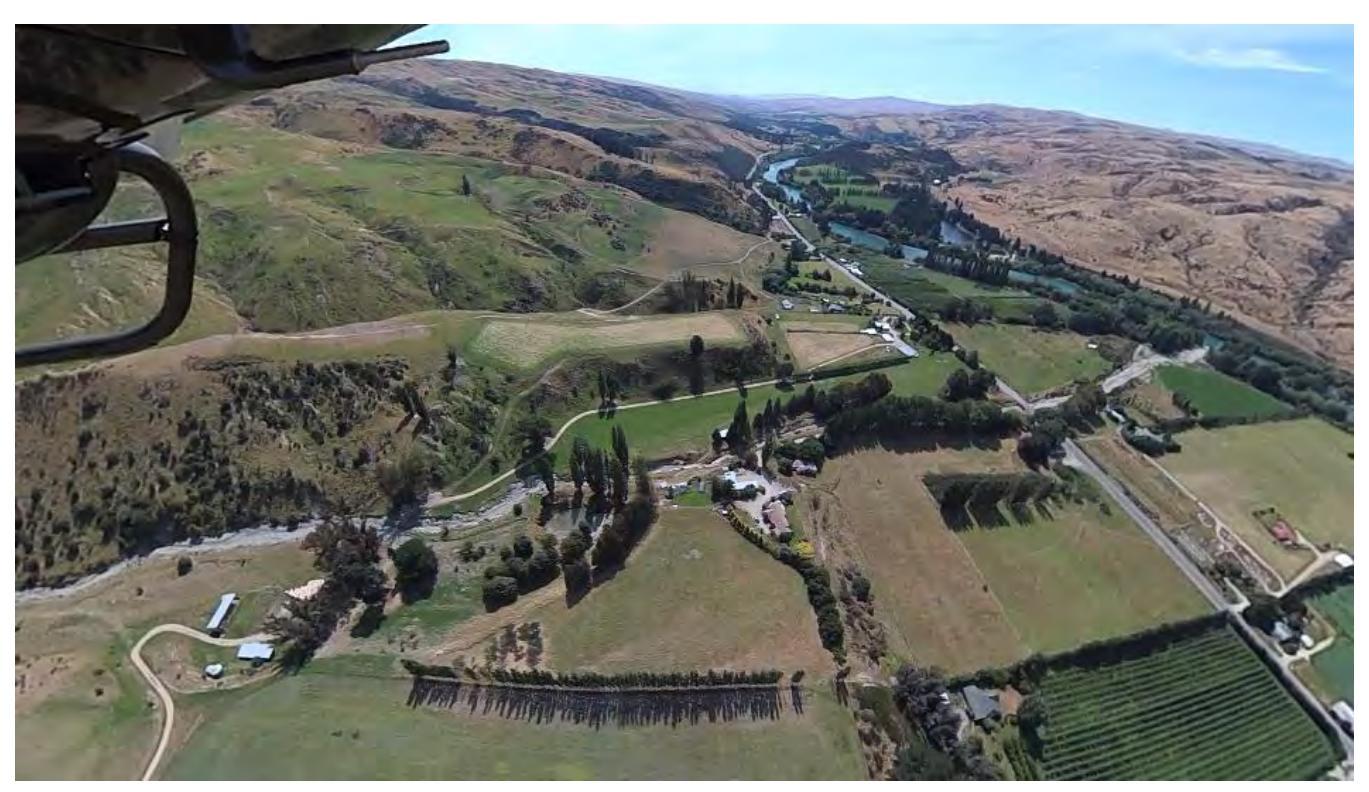
Figure 13: Aerial overview of the channel and the debris fan area from 145 m asl towards the confluence with the Clutha River. Recent erosion along the channel is visible along the creek's length to the Clutha River.

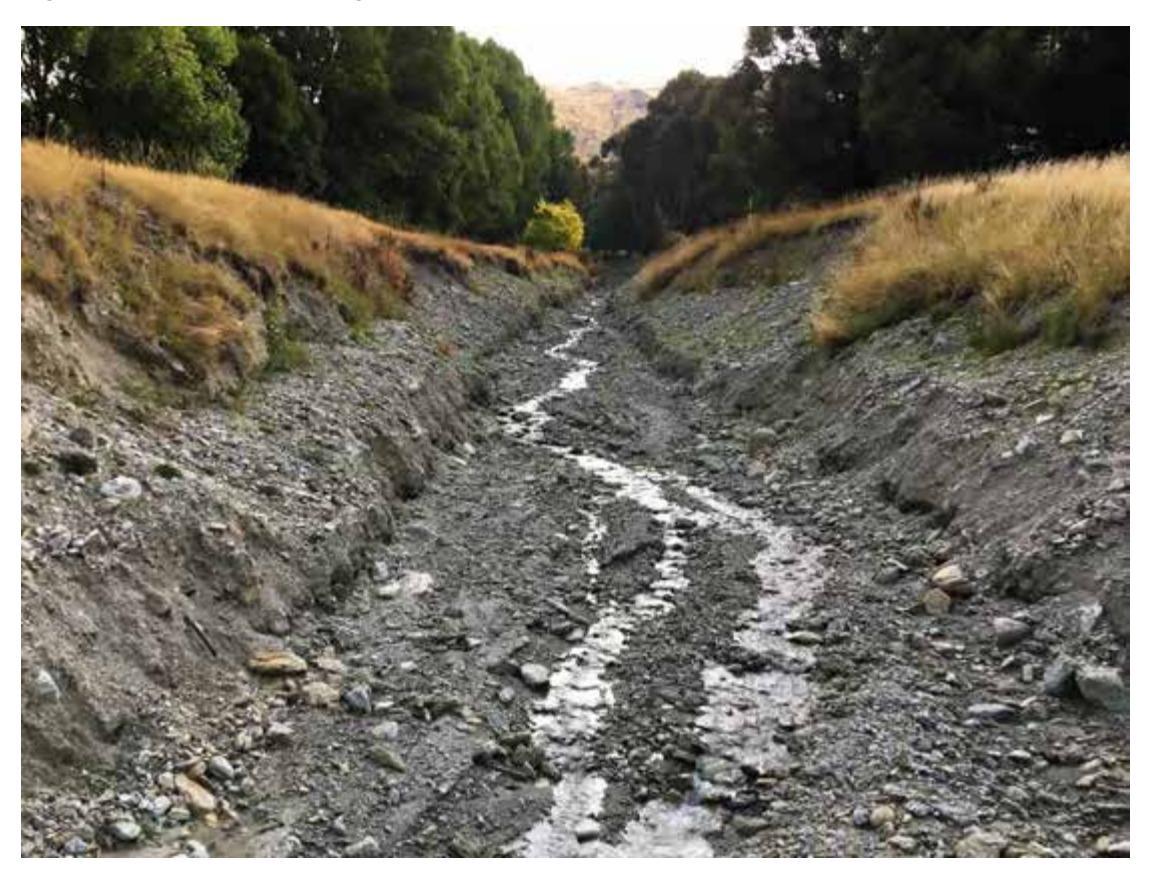
Figure 15: View of channel looking upstream from SH8 at about 115 m asl. The channel bed has been recently reworked and cleaned out by heavy machinery. The lateral levees have been implemented after the October 1978 event that caused widespread erosion and channel incision along this section.
