# REPORT Management and Reduction of Debris Flow Risk in Roxburgh, Otago

Geomorphological Assessment Report

18113634\_7407-003-R-Rev0

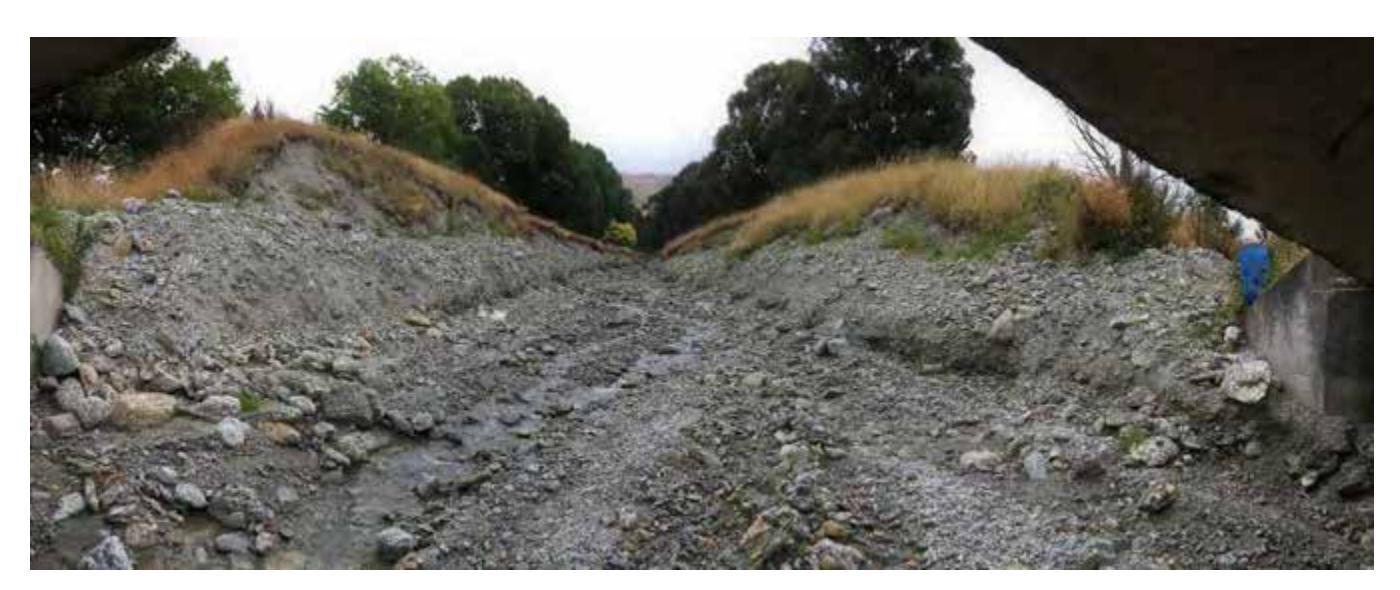
Figure 16: View of channel from SH8 crossing at 110 m asl looking upstream. Recent work within the channel has reinstated capacity after the November 2017 event.

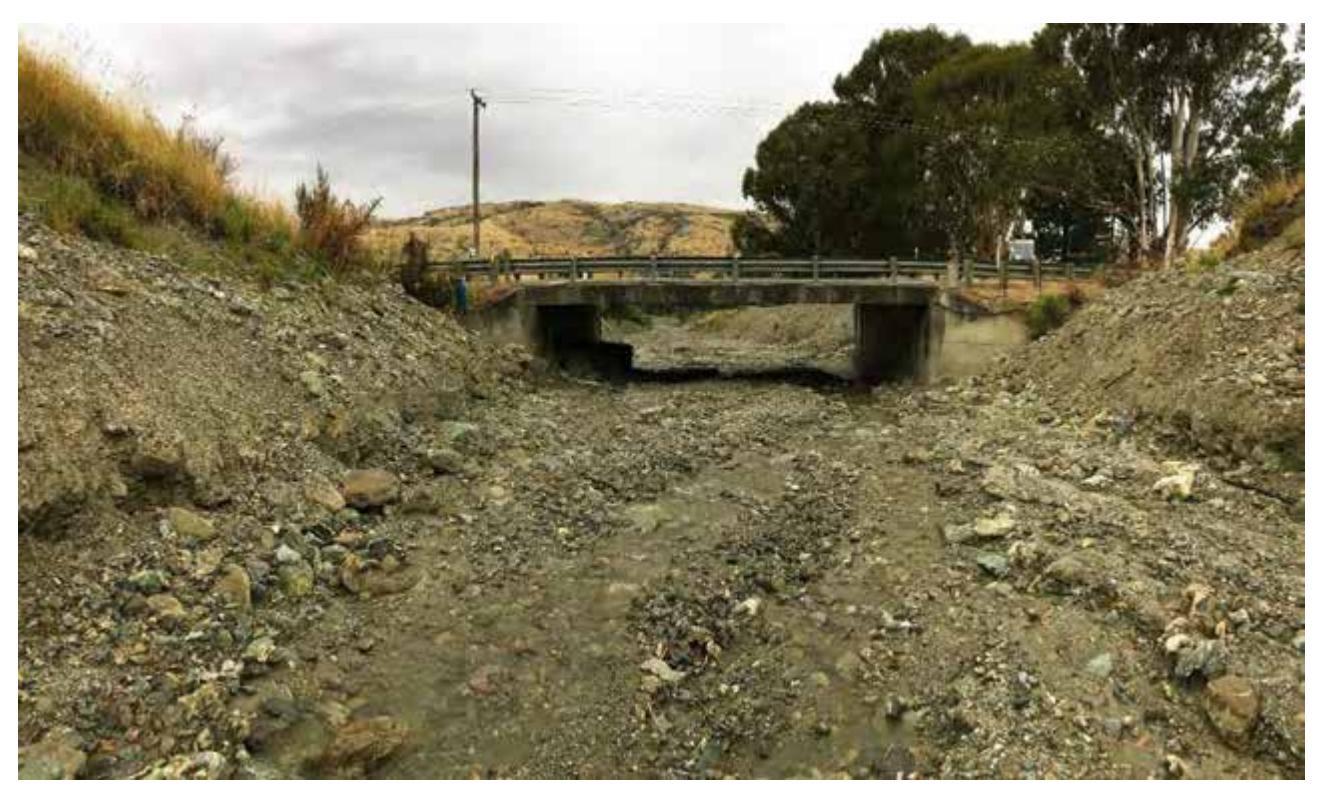
Figure 18: View of the channel looking downstream towards the SH8 crossing. The channel has been recently cleared to reinstate capacity at the culvert.

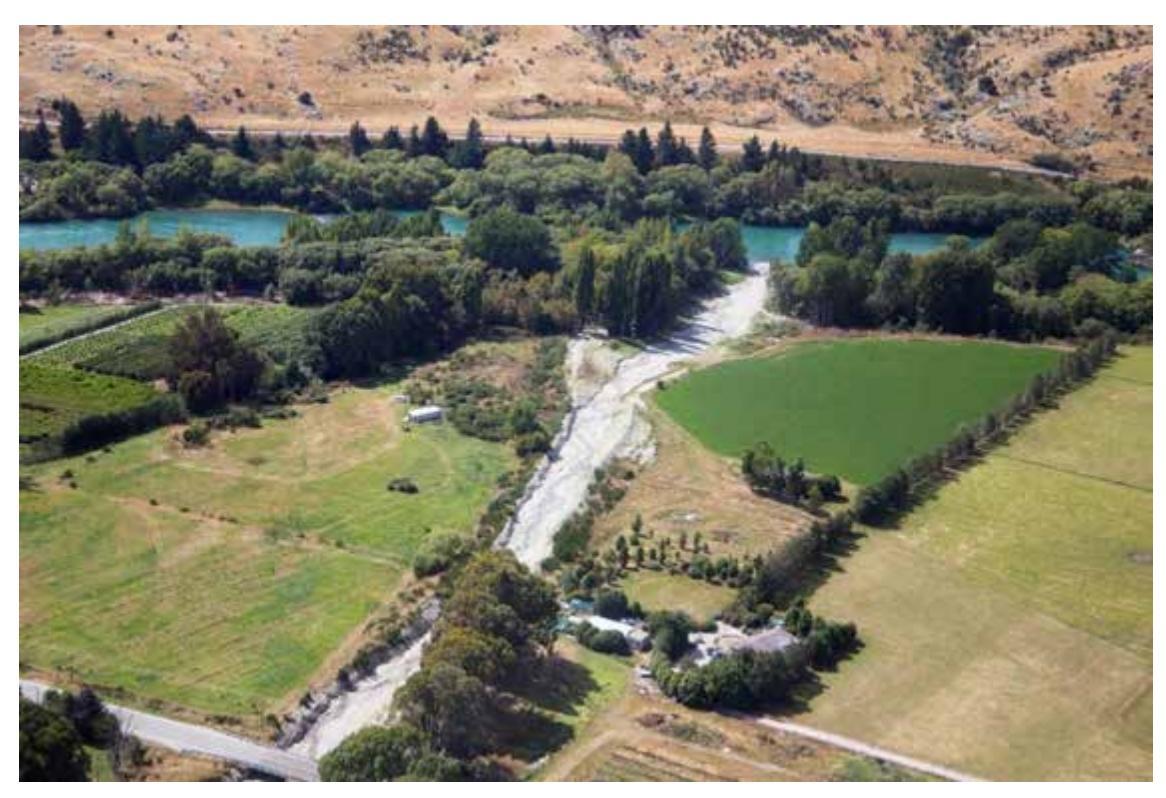
Figure 19: Aerial overview of Stevensons Creek below SH8 towards confluence with Clutha River; deposition of debris is prominent along this section of the channel as the channel slope decreases and the channel width increases.

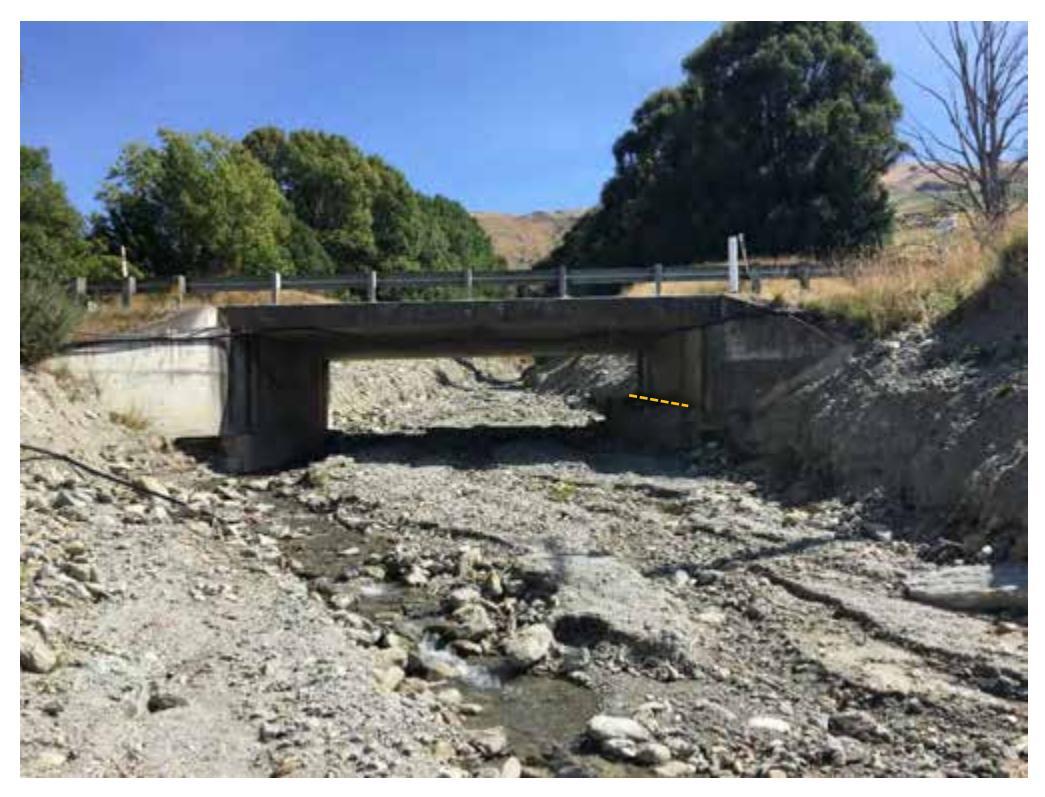
Figure 20: SH8 crossing, looking upstream from about 105 m asl; yellow marker indicates the channel bed level after the November 2017 event.

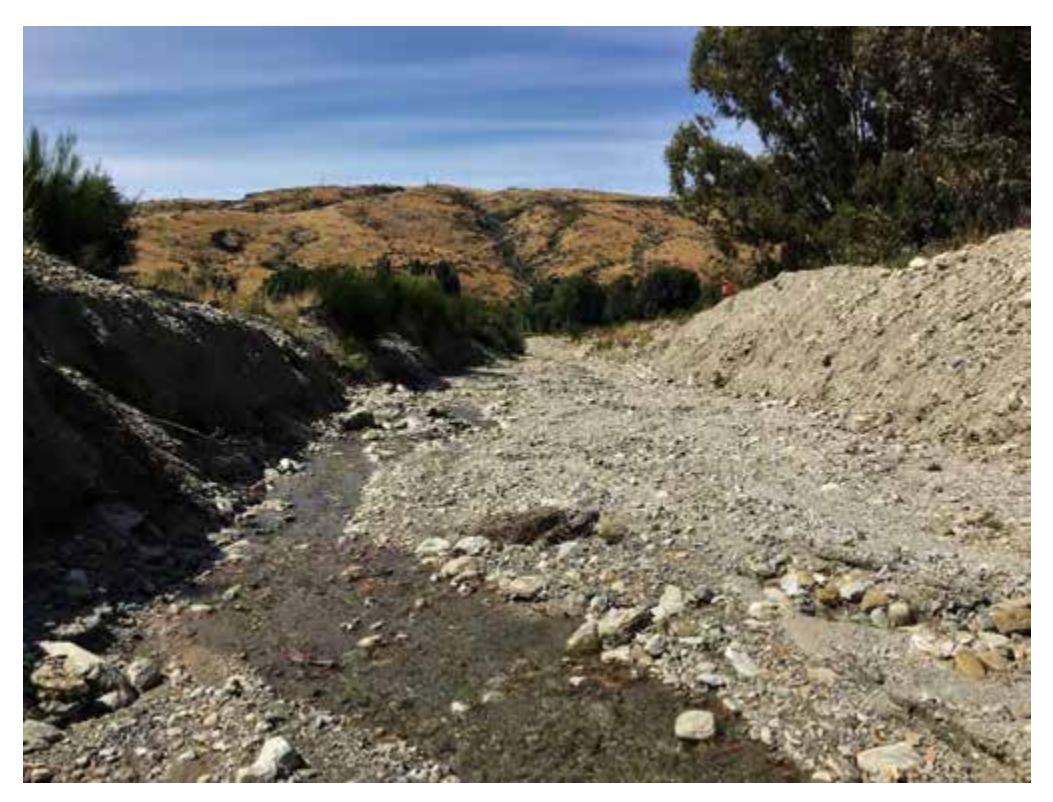
Figure 21: Channel looking downstream from about 105 m asl. Levees are located along both banks of the creek. Creek level is about 2,5 m below the current banks in sections.

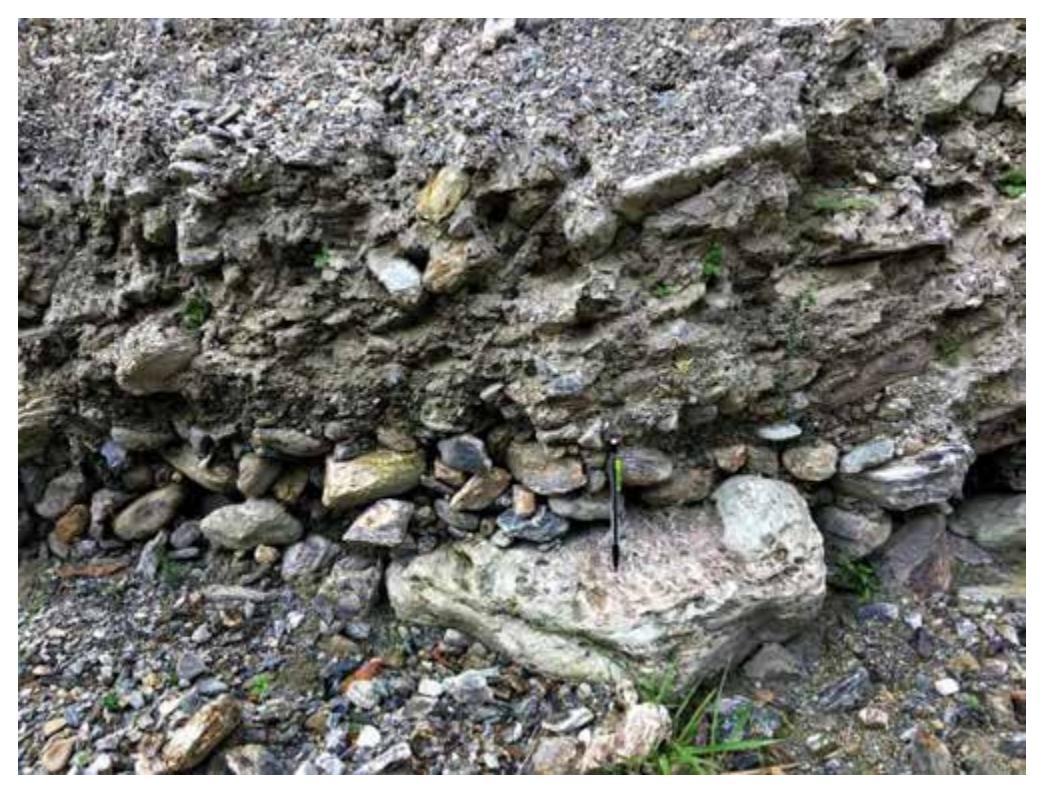
Figure 22: Older debris deposits along the bank below SH8 crossing at about 105 m asl.

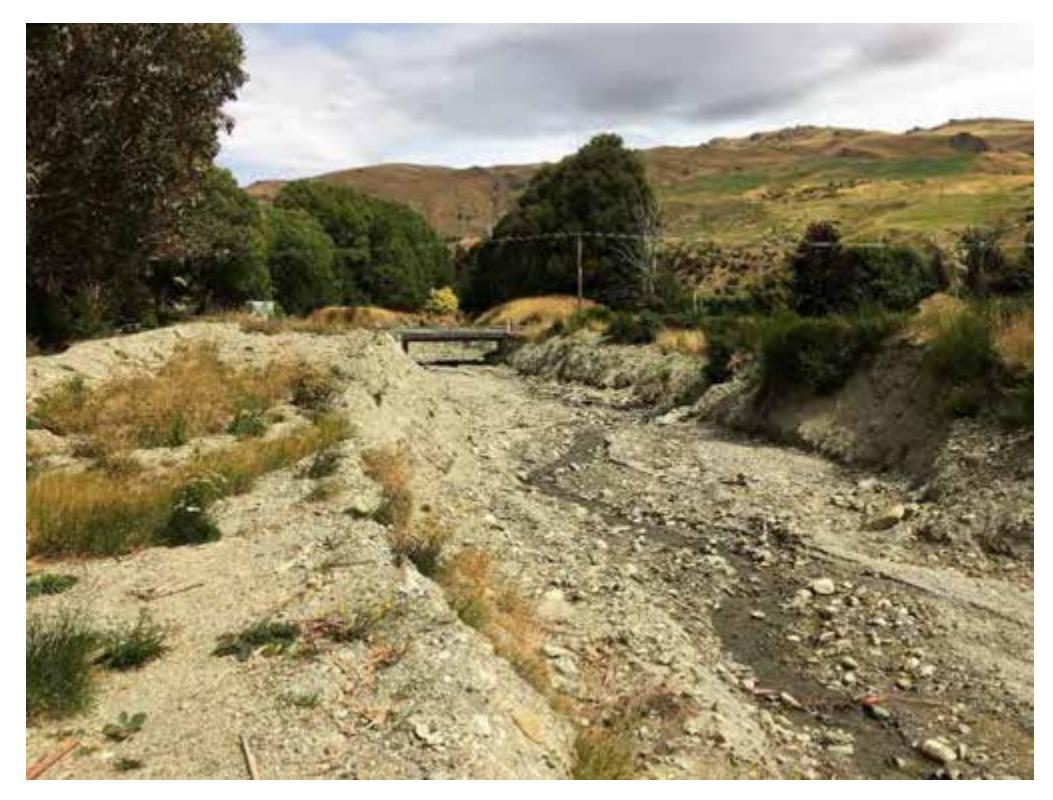
Figure 23: View of channel and SH8 crossing, looking upstream from about 95 m asl. Current channel level is about 2-3 m below the banks along this section.

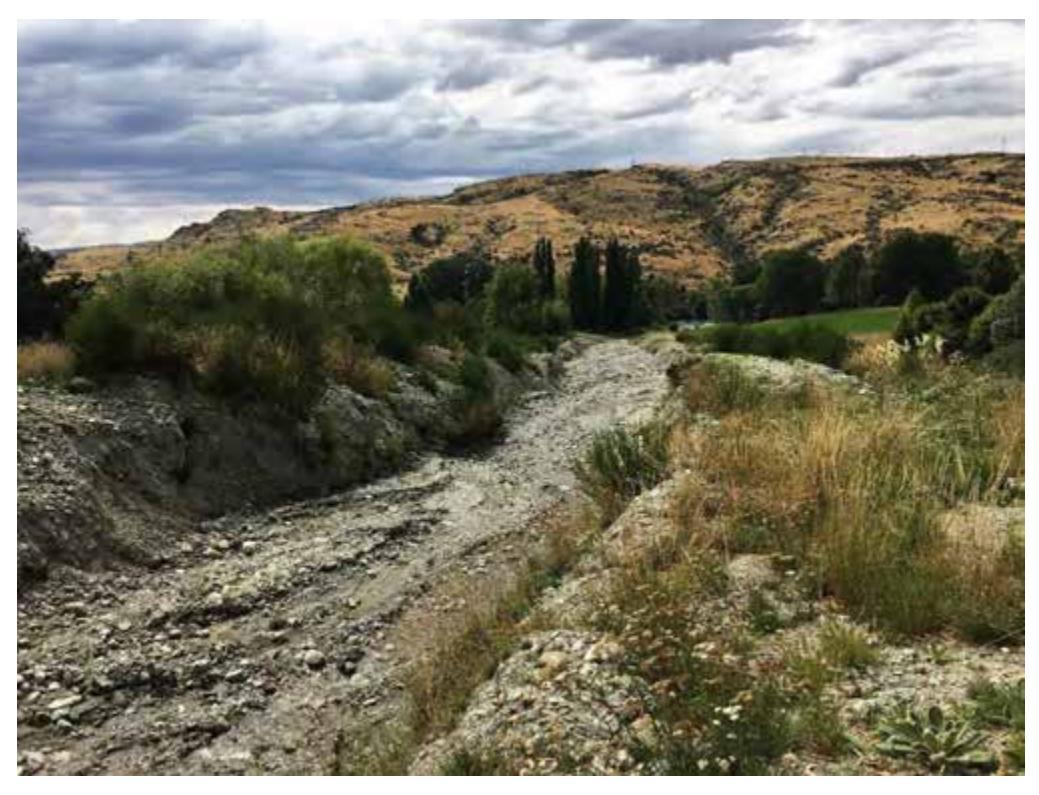
Figure 24: View of Stevensons Creek looking towards the Clutha River from about 95 m asl. The height of the banks decreases towards the confluence of the Clutha River.

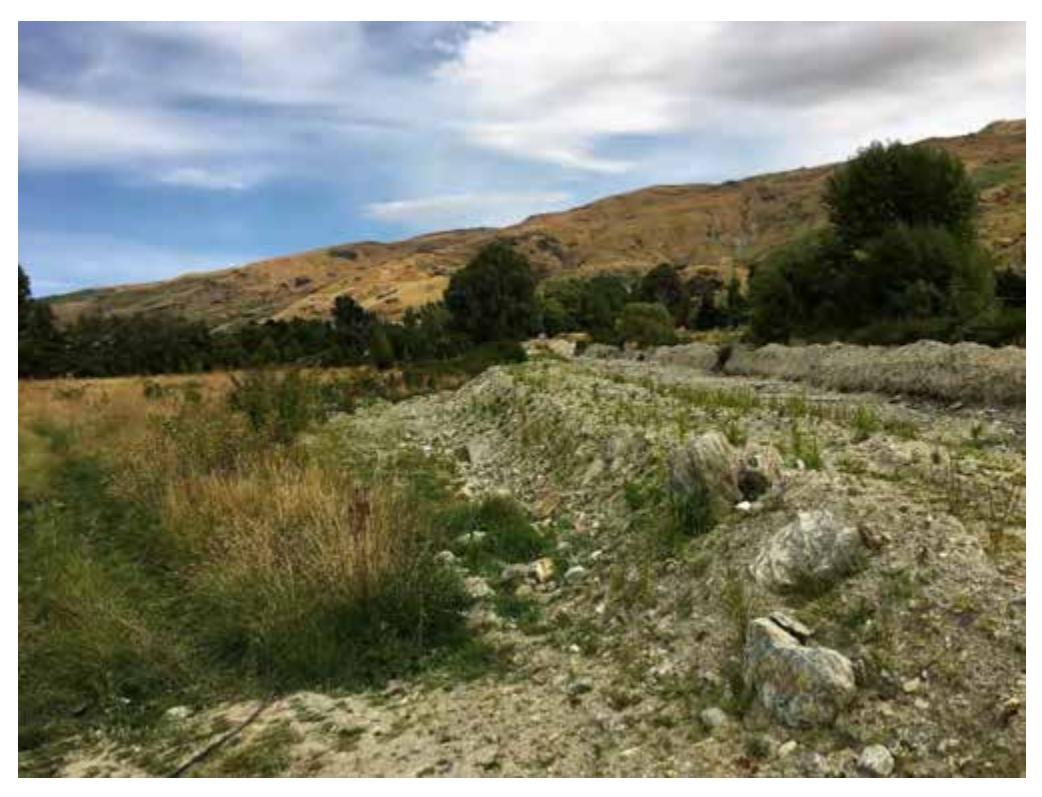
Figure 26: Built up levees along the bank of the channel at about 90 m aslo, looking upstream. Approximate height of up to 1 m along this section.

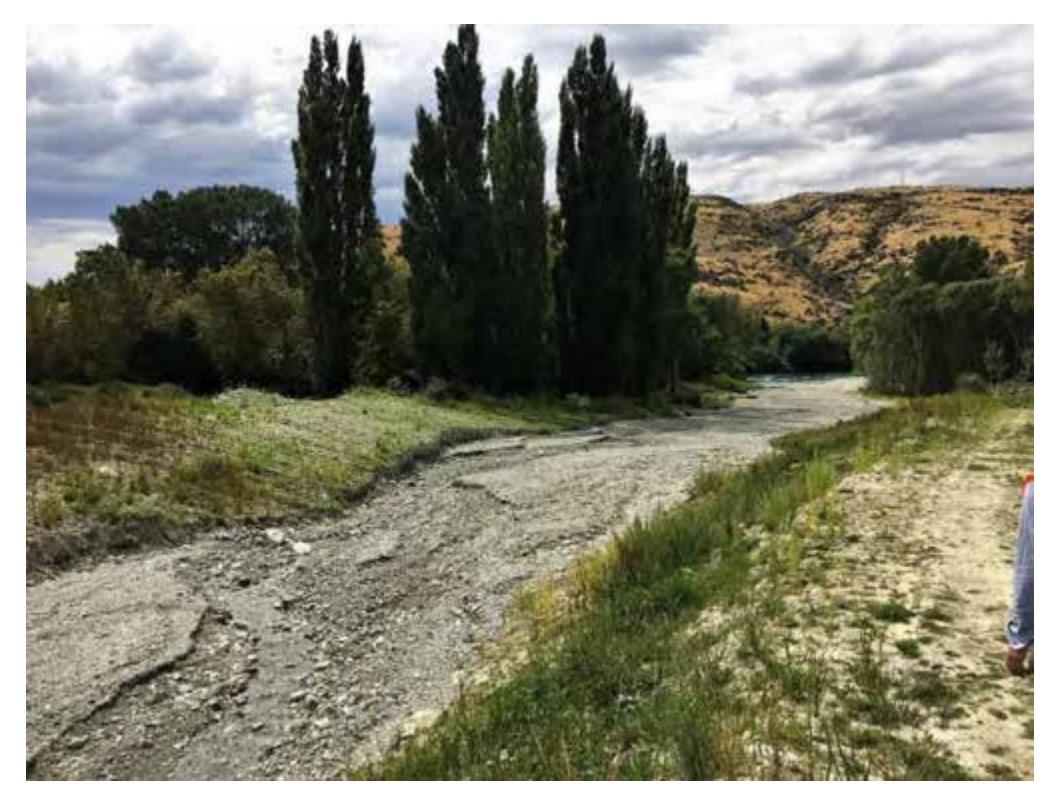
Figure 27: View of the channel towards the Clutha River. The channel bed and banks have been recently reshaped by heavy machinery.

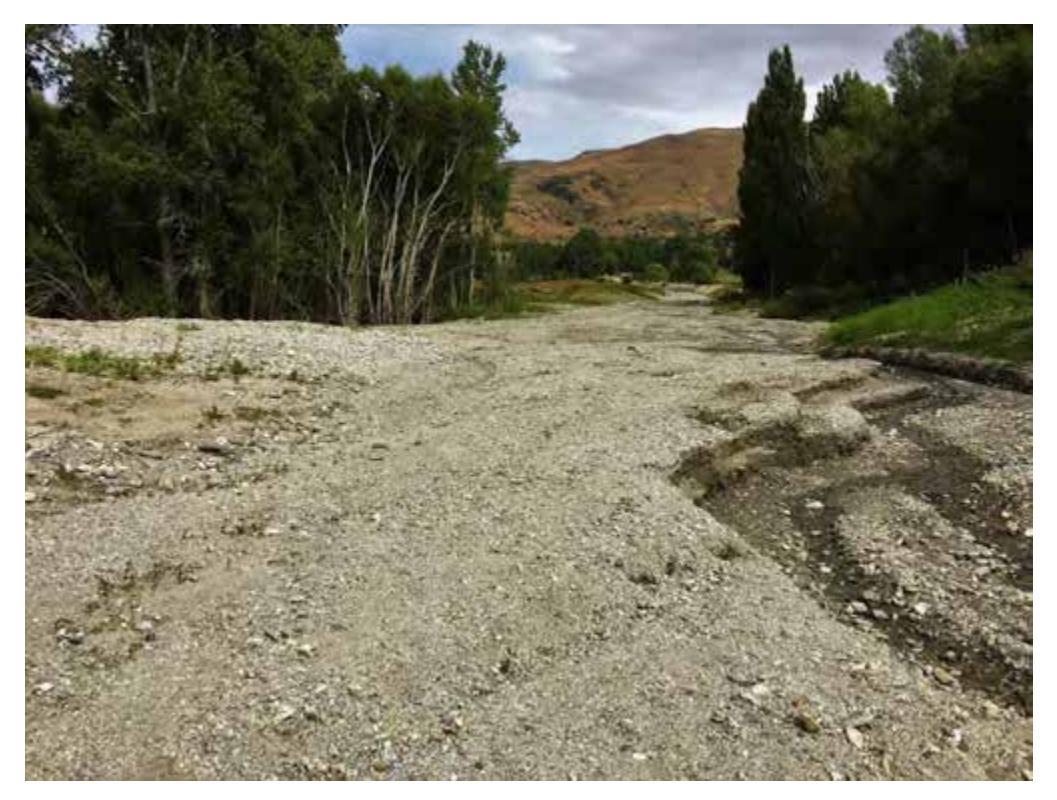
Figure 28: View of the channel near the confluence with the Clutha River looking upstream. The bedload is dominated by gravel and sand at this section of the channel.
