## Glenorchy Area Geomorphology and Geo-hazard Assessment

**Otago Regional Council**

5 September 2007

.....  
Dr Mark Mabin  
Senior Environmental  
Scientist

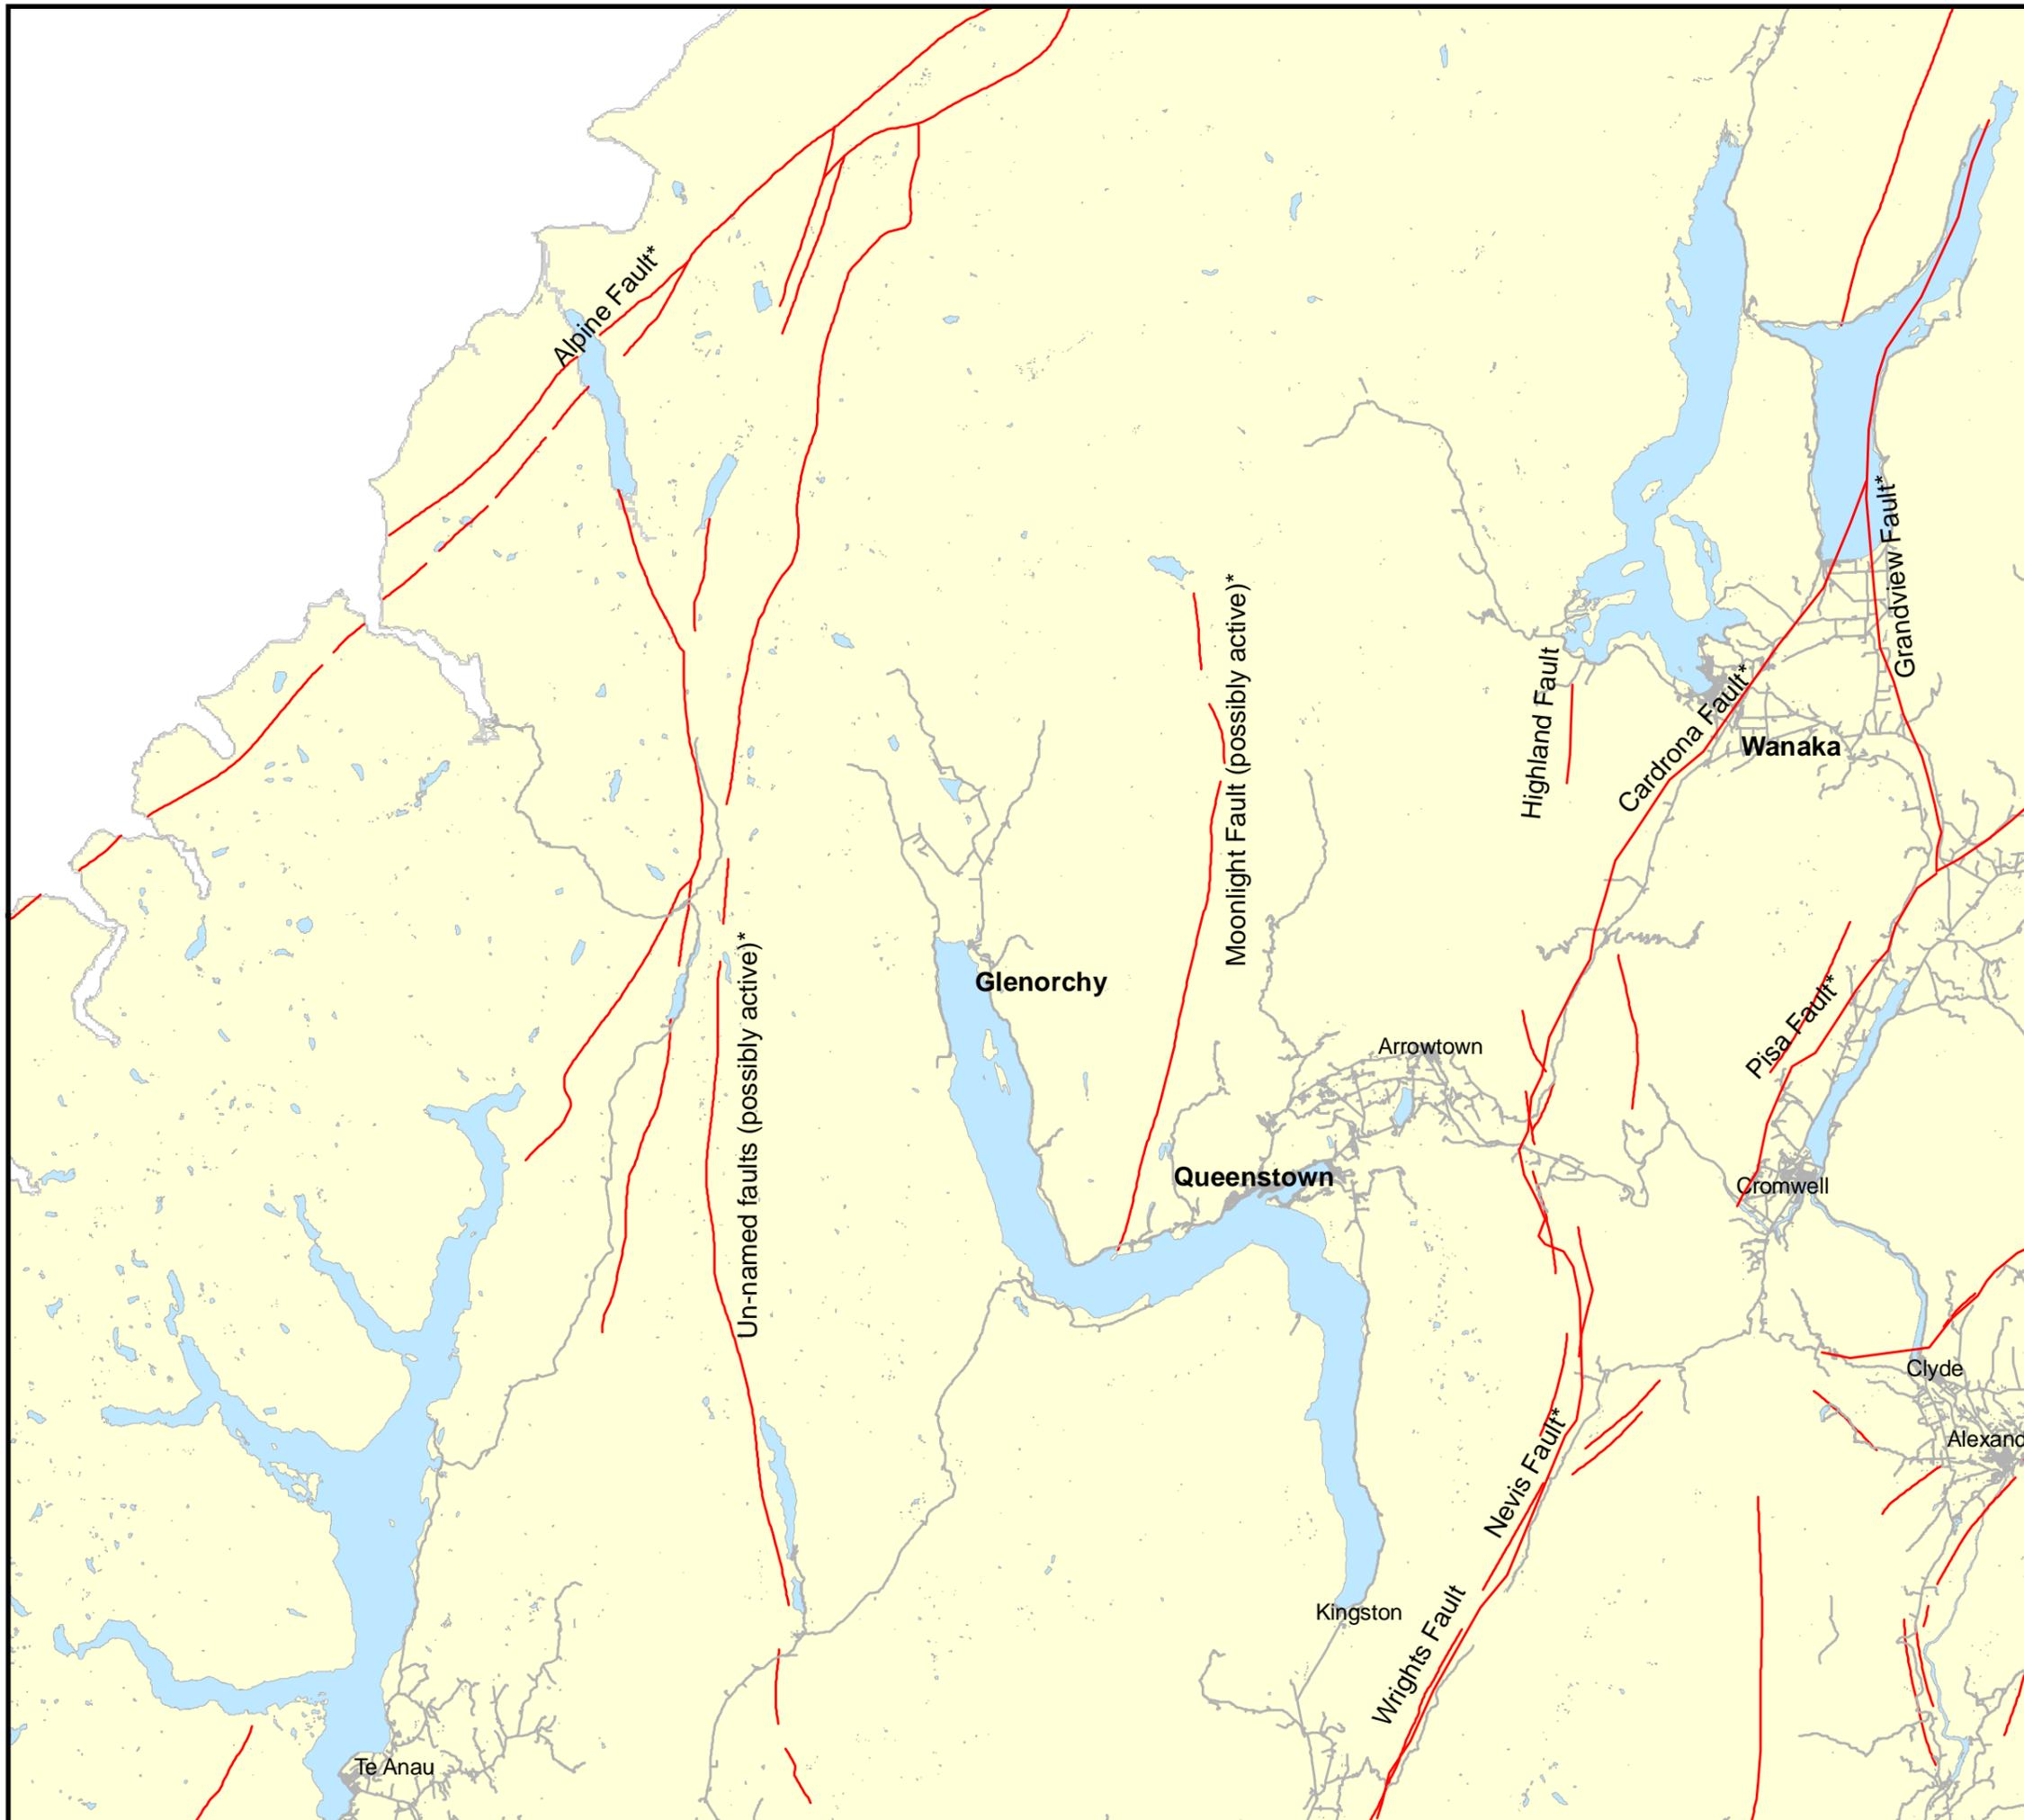
Drawing Number **Figure 9-2** Rev **Draft**

The Alpine Fault is located along the western edge of the Southern Alps (Figure 9-2) and it contributes significantly to seismic hazard because it is thought to generate very large earthquakes (~ $M_w$  8.0) relatively frequently (estimated return period of 200 to 300 years), and currently has a high probability of occurrence (85% in the next 100 years) (Yetton *et al* 1998<sup>2</sup>). The Alpine Fault passes within about 55 km of Glenorchy and an  $M_8$  earthquake is expected to generate peak ground accelerations of about 0.25 g in Glenorchy (using the attenuation relation of McVerry *et al* 2006<sup>3</sup>). The duration of shaking is expected to be up to about 2 minutes for an earthquake of  $M_w$  8.0 (Yetton *et al* 1998).

The nearest significant active fault to Glenorchy shown on the current regional geology map (Turnbull 2000) is the Nevis - Cardrona Fault system, which reaches to within about 45 km east of Glenorchy (Figure 9-2). The Cardrona Fault has a return period for  $M_w$  7.1 of between 5000 and 10 000 years (Stirling *et al* 2002<sup>4</sup>).

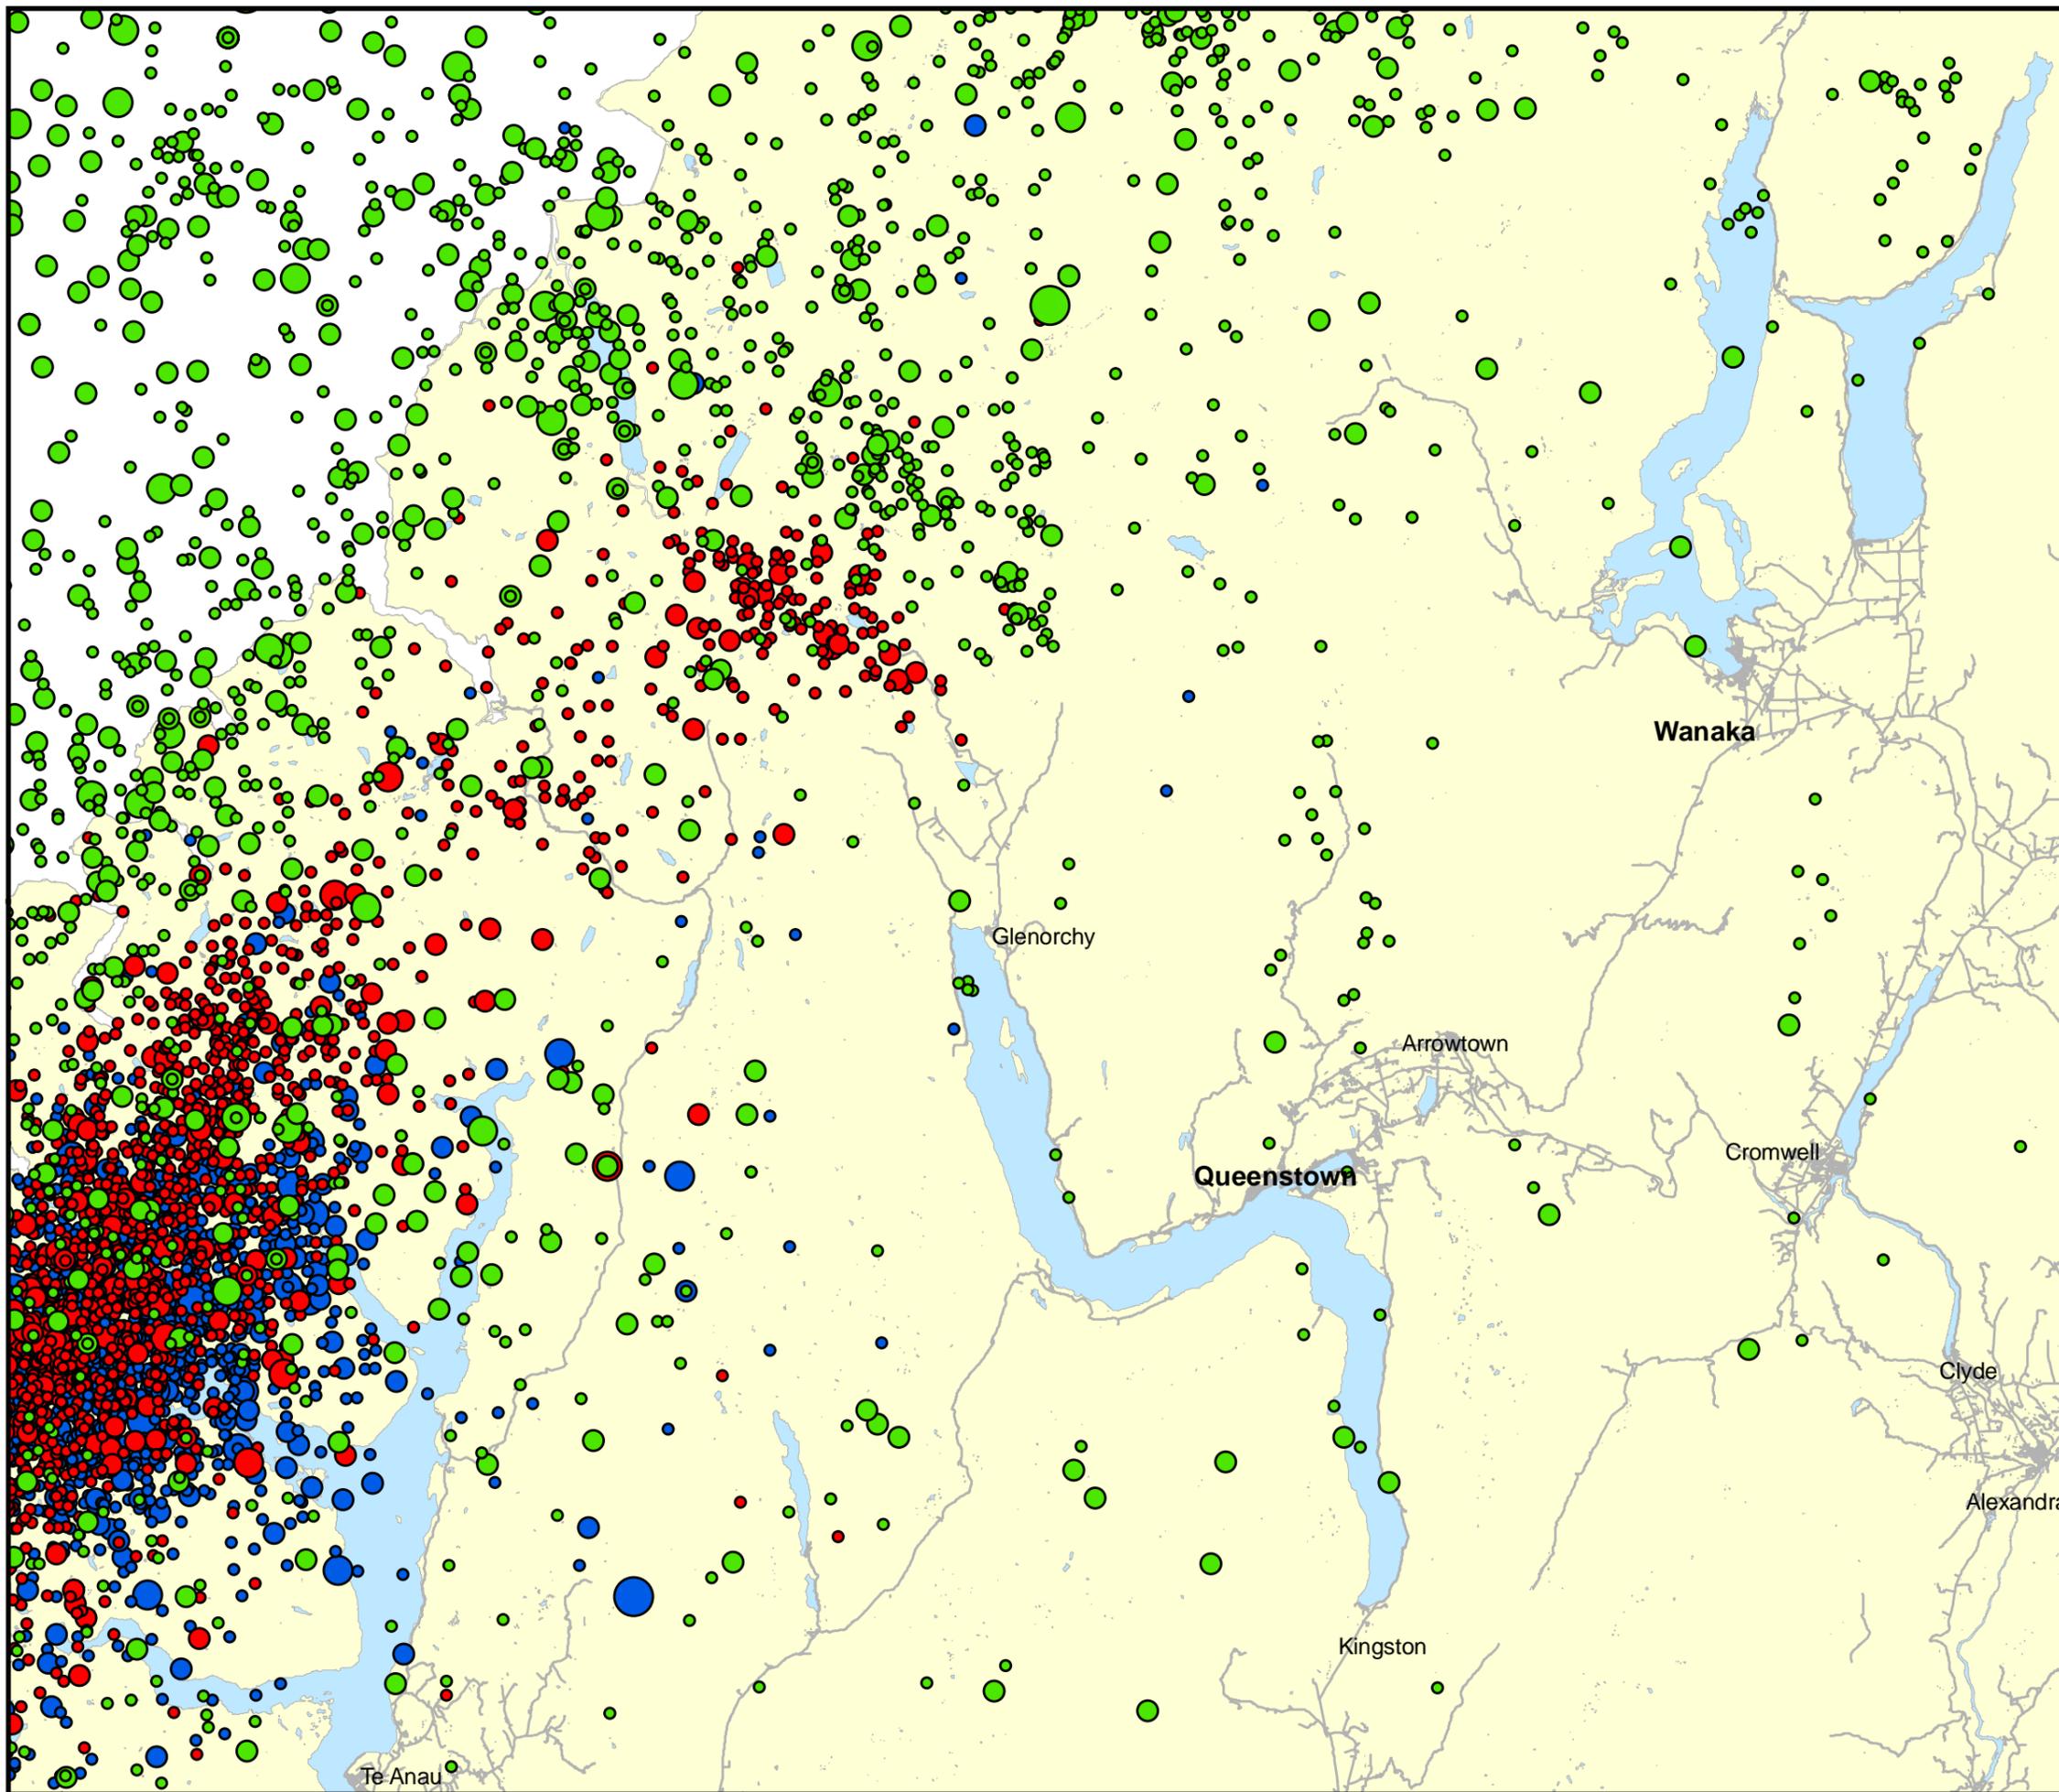
Drawing Number  
**Figure 9-3**

Historical seismicity is summarised in Figure 9-3. This shows earthquakes of magnitude three and greater.  $M_{3.0}$  is usually the minimum magnitude that can be felt, and then only if the observer is very close to the earthquake epicentre. Typically engineering studies ignore anything smaller than  $M_{5.0}$  to  $M_{5.5}$  because smaller earthquakes are not recognised to be capable of damaging engineered structures. For example the NZ National Seismic Hazard Model (Stirling *et al* 2002) has a minimum magnitude of  $M_5$ . Including earthquakes between  $M_{3.0}$  and  $M_{5.0}$  in Fig 9-3 helps to illustrate that the whole region is tectonically deforming and that random larger earthquakes could occur anywhere.

Figure 9-3 shows that most of the relatively few earthquakes that have occurred in the vicinity of Glenorchy are shallow (<40 km depth) and of less than  $M_{5.0}$ . The large number of earthquake epicentres to the southwest of Glenorchy relate to the location of the northern limit of the Australian Plate subducting beneath the South Island.
