Project Number: 6-XO011.00

Glenorchy Rees Floodbank

Floodbank Assessment

3 September 2020

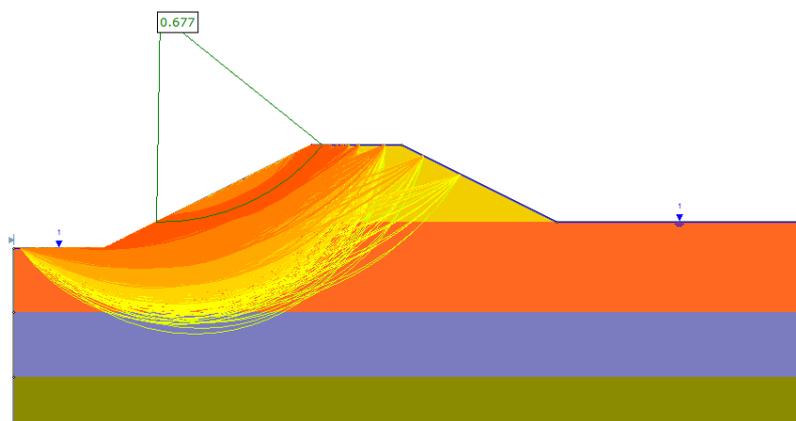
Figure 3 - Example slope stability assessment output

An example input to the modelling is provided below, and an example output, showing a factor of safety of FOS 0.6, is presented in Figure 3. A diagrammatic representation of slope failure is shown in Figure 4.

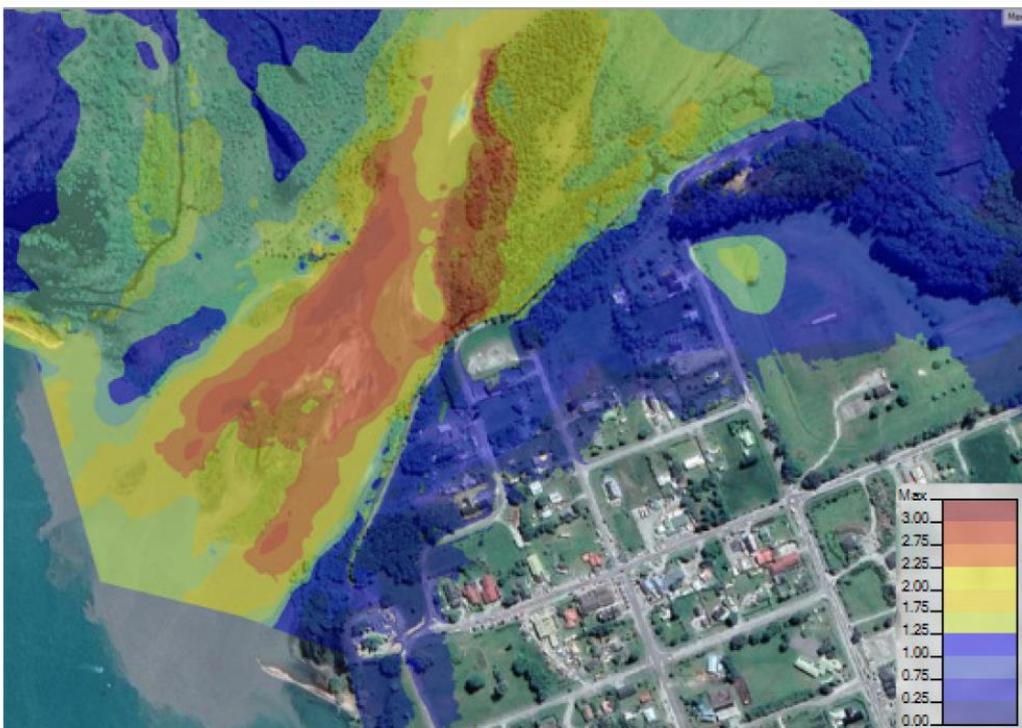
Figure 5 - Extract from ORC memo showing velocity distribution expected.

The water levels in the river have not been assessed as part of this assessment, but it can be seen from the modelling undertaken by ORC (Figure 5) that the extent of the flood bank should be reviewed to ensure that the floodbank is not 'outflanked' by the overflow from the Lagoons. In the scenario shown in Figure 5, the flood bank is shown to have water on each side and is therefore performing as intended.

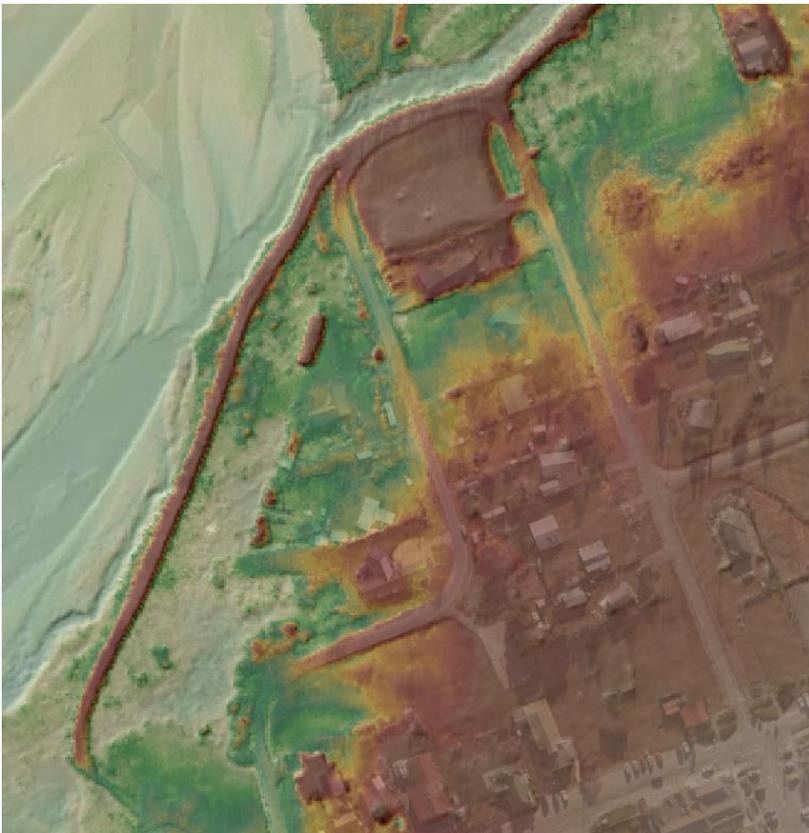
Figure 6 – Extract from Lidar, showing low lying properties

If any part of the stopbank is breached or outflanked then it is expected that the lower lying properties would be affected. Based on the Lidar information, the buildings at 14 and 18 Butement Street and 53 Argle Street would appear to be affected in such a scenario.
