## 11.6. November 2017 Roxburgh Debris flow

**Prepared for:** Technical Committee  
**Activity:** Safety & Hazards - Natural Hazards  
**Prepared by:** Dr Jean-Luc Payan, Manager Natural Hazards  
Dr Ben Mackey, Natural Hazards Analyst  
**Date:** 25 January 2018

Flooding caused by the 26 November 2017 intense thunderstorm in the Roxburgh Township area resulted in extensive sedimentation in the Township. The purpose of this report is to present the observations and preliminary assessments made after the event and associated flooding. The report also describes the alluvial fan hazards for this area.

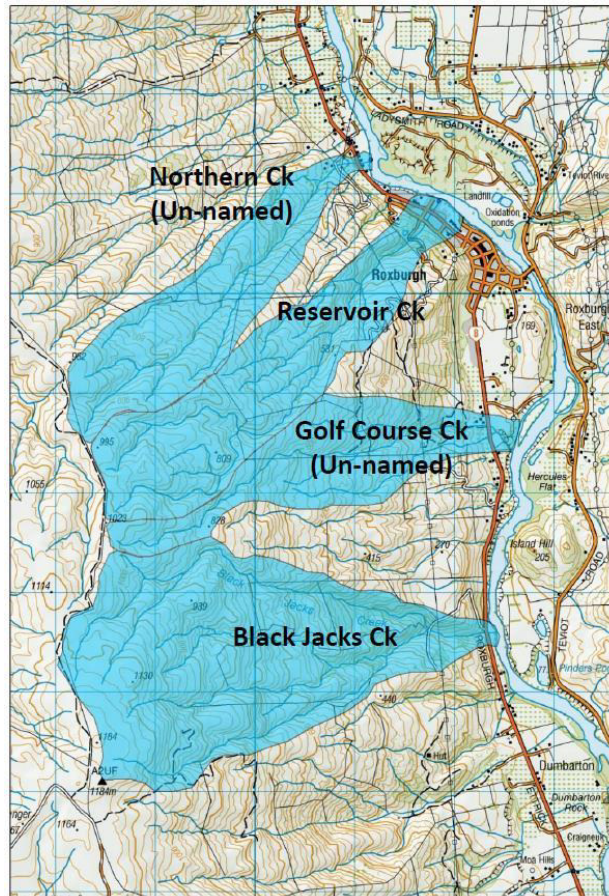
The most severe out of channel sedimentation occurred on the alluvial fans of Reservoir Creek, which flows through northern Roxburgh and of Black Jacks Creek 3km south of the township. Un-named creeks near the golf course in southern Roxburgh, and just north of Roxburgh Township were also impacted (Figure 2).

**Figure 2.** Location of catchments where substantial alluvial fan sedimentation occurred on 26 November 2017.

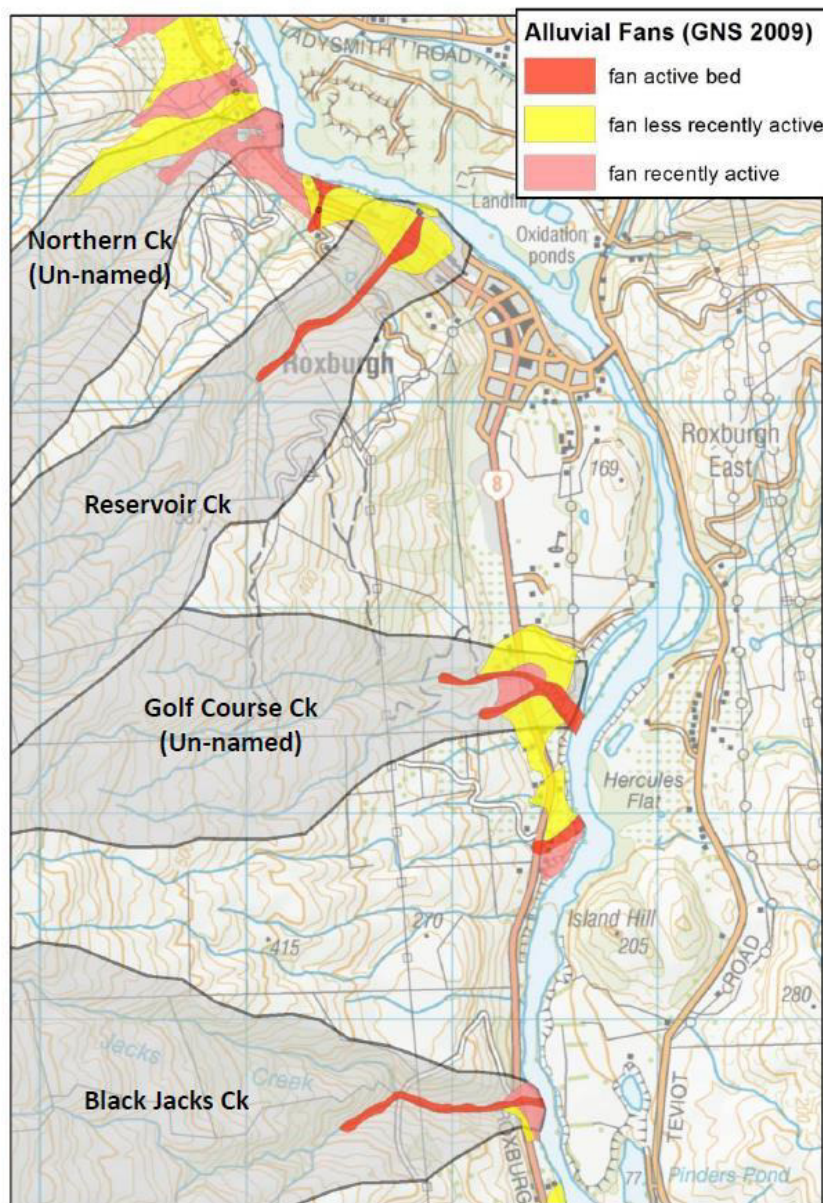
All catchments in the Roxburgh area with alluvial fan activity on 26 November 2017 were previously identified as having active and recently active alluvial fans (e.g., Figure 6).

Figure 6. Mapped alluvial fan landforms near Roxburgh Township (GNS 2009).

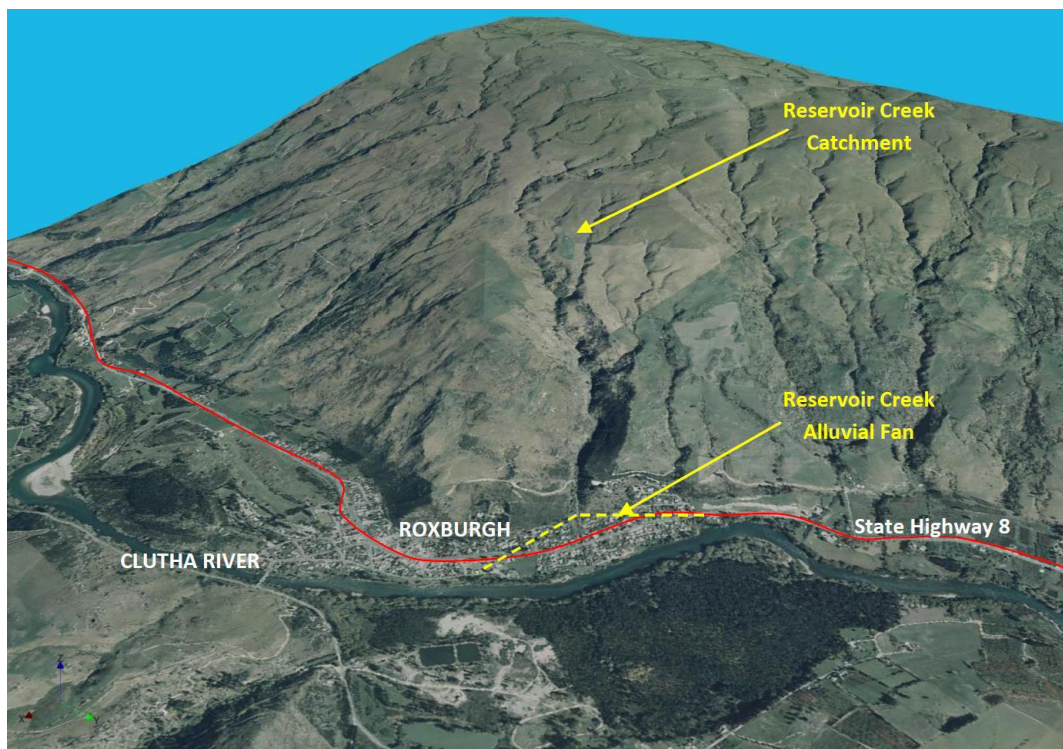
Reservoir Creek is a 3.5 km<sup>2</sup> catchment which runs through northern Roxburgh. Reservoir Creek alluvial fan was specifically described in the 2011 ORC report (ORC, 2011, Appendix A). This fan has been modified extensively by urban development and is bisected by State Highway 8 (SH8) (Figure 7).

Figure 7. Image showing the Reservoir Creek alluvial fan with respect to the surrounding environment (from ORC, 2011).
