# Shotover WWTP Enforcement

Technical Assessment - Shotover WWTP  
Compliance

December 2024

Otago Regional Council  
70 Stafford St  
Dunedin 9054

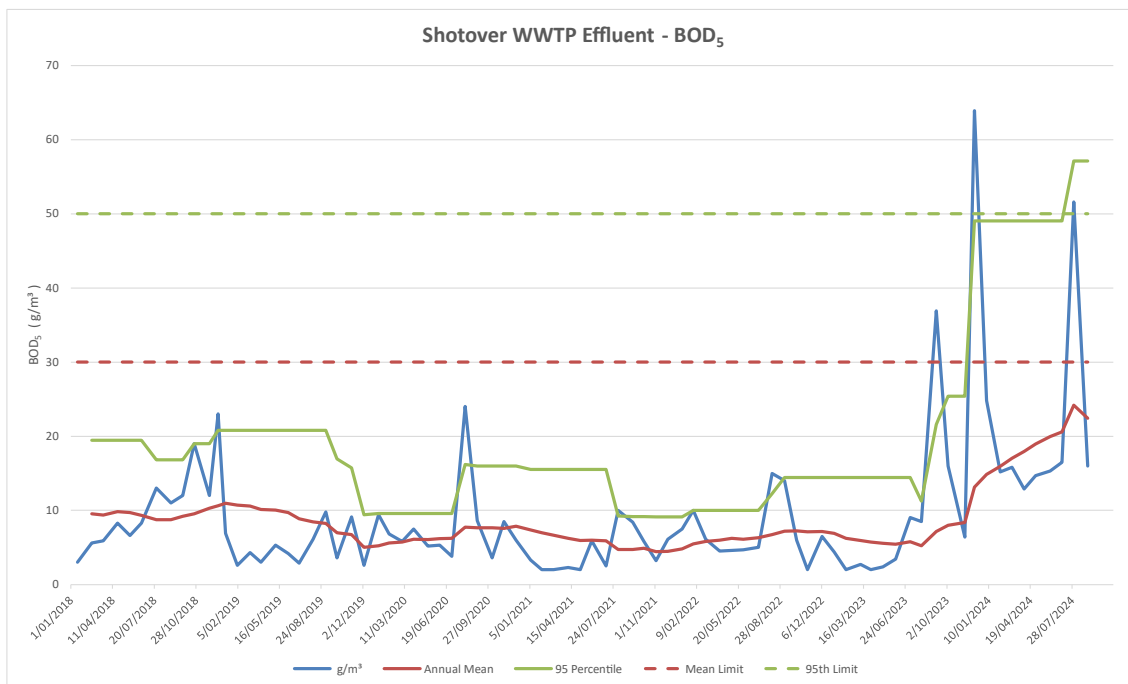
**Figure 2.2: BOD<sub>5</sub> in Shotover WWTP Effluent**

The results show that there was a high TSS in the effluent from the plant on the 7 December 2023 and 1 August 2024, and that this correlates with the elevated cBOD<sub>5</sub>, Total Nitrogen, Total Ammoniacal-Nitrogen, and E. coli results. It seems likely that the low DO and the loss of solids from the MLE process contributed to the loss of nitrification and elevated ammonia levels seen in the December 2023 sample.

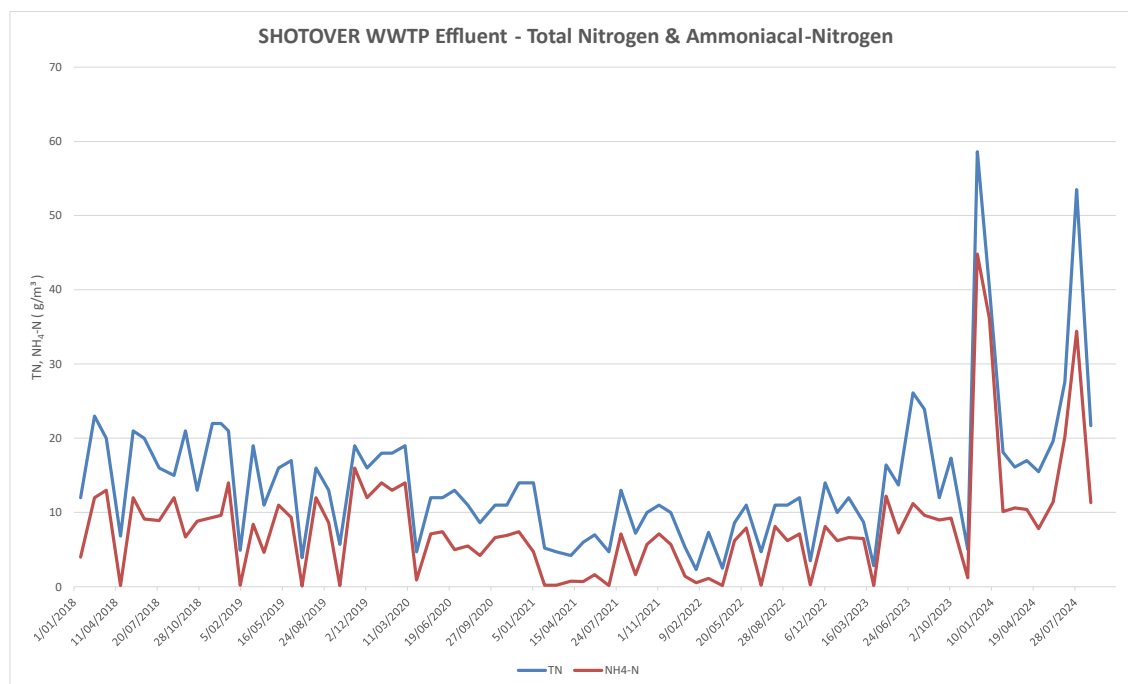
**Figure 2.5: Total Nitrogen and Ammonical-Nitrogen in Shotover WWTP Effluent**

By the 4 April 2024 the results appeared to be trending downwards towards normal levels again, suggesting the issues had been resolved and the plant was approaching a more stable performance. However, the results from July and August 2024 suggested that this was not the case, as discussed in Section 2.4.6.

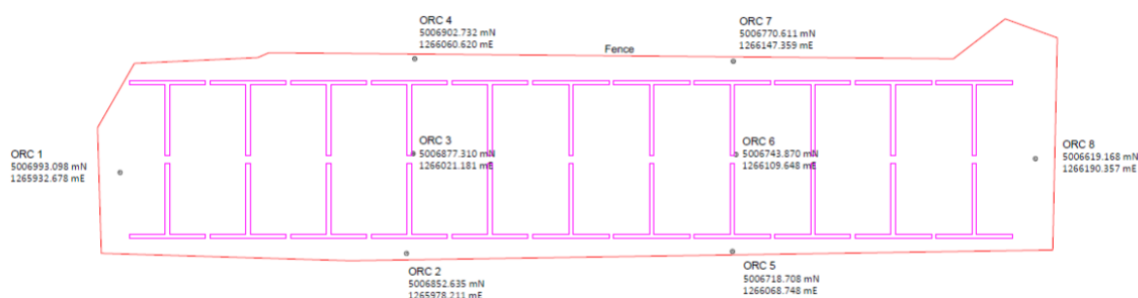
**Figure 2.6: Location of the 8 monitoring bores within the disposal field**

The effects of discharge are monitored through monthly quality sampling of the 8 groundwater bores located at the disposal field. The up gradient (bore 1) and down gradient (bore 8) are required to be sampled monthly to meet consent compliance; the other bores are sampled monthly for monitoring purposes.

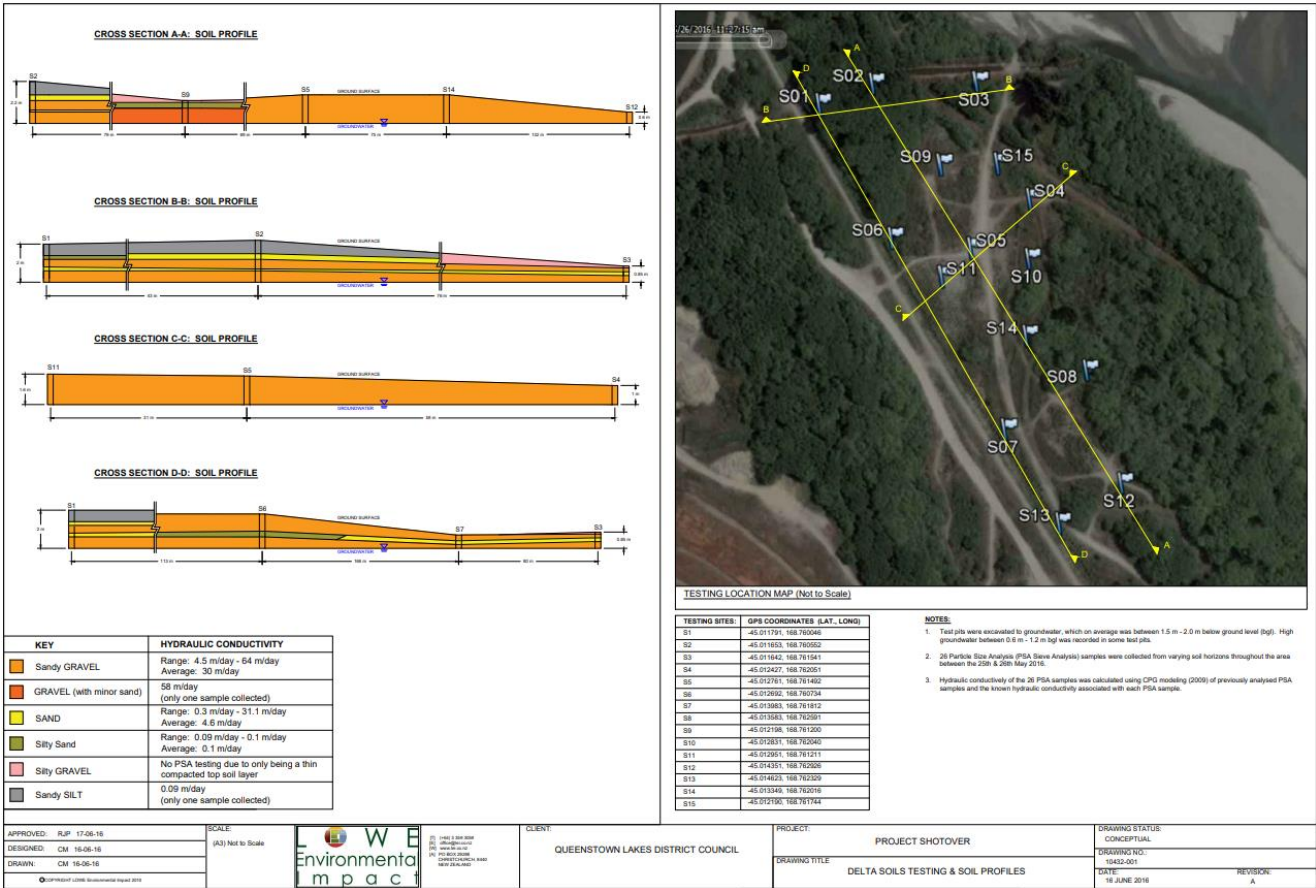
Figure 3-1: Conceptual ground models at the DAD (Lowe Environmental Impact, 2016).

As part of the DAD design report (Lowe Environmental Impact, 2016) a total of fifteen test pits have been dug to groundwater level, ranging between 0.5m and 2.2m below ground level (mbgl). The encountered ground generally comprised gravel to sandy gravel with thin layers of sand and silty sand interbedded. At higher elevations in the north, a maximum 0.6m thick capping layer comprising sandy silt (silty gravel in the northeast) was encountered. Conceptual ground models (Lowe Environmental Impact, 2016) are presented in Figure 3-1. The deltaic sediments extend to roughly 15mbgl (Lowe Environmental Impact, 2016).

The PSA assessment results for each encountered layer are given in Figure 3-1, they range between 4.5m/d and 64m/d for the sandy gravels. Encountered sand and silty sand layers show average hydraulic conductivities of 4.6m/d and 0.1m/d respectively. It must be noted that no infiltration testing was undertaken as part of the DAD design. The PSA results were used to predict infiltration (Lowe Environmental Impact, 2020 - 2023).
